Building and Timber Pest Inspection Report

Inspection Date: Fri, 20 Mar 2026

Property Address: 91 Fairway Dr, Sanctuary Point NSW 2540, Australia

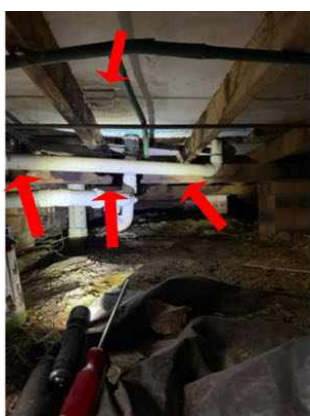
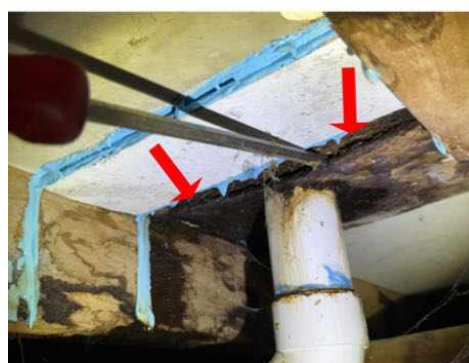
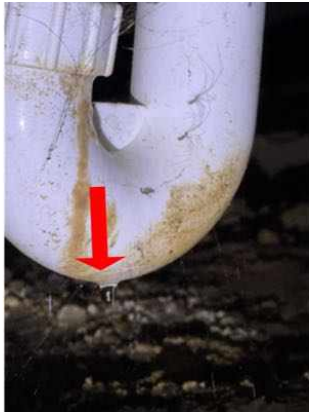
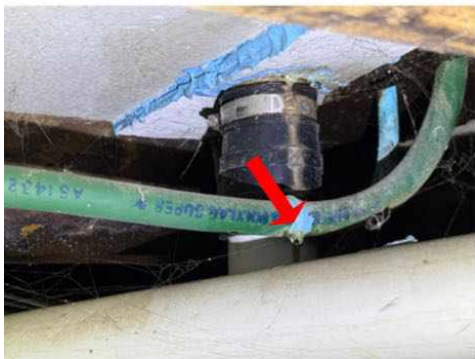
Building: Building 1
Location: Bathroom
Finding: Bathroom areas Leaking
Information: Leaking was evident to at least 3 bathroom subfloor areas/ pipes at the time of inspection. It is suspected that the leaking has occurred as a result of a failed waterproofing membrane and substandard plumbing as the bathroom does not appear very old.

Leaking from the bathroom and shower base has lead to water damage to adjoining flooring. Such damage can necessitate extensive remedial works being required.

An invasive inspection may also find wood rotted wall frames in the bathroom perimeter walls. These active water leaks are also resulting in mould growth.

Appointment of a bathroom contractor and plumber is required to repair or replace these damaged areas. Such works should be performed as soon as possible to ensure that no further damage occurs. Quotes should be obtained before purchase as they will be substantial.

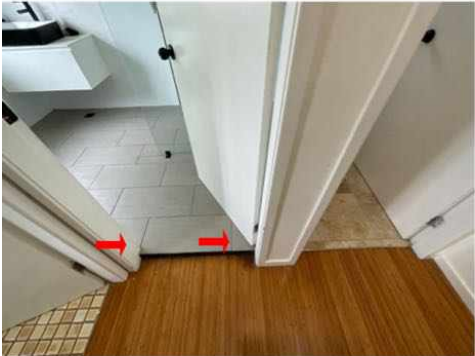
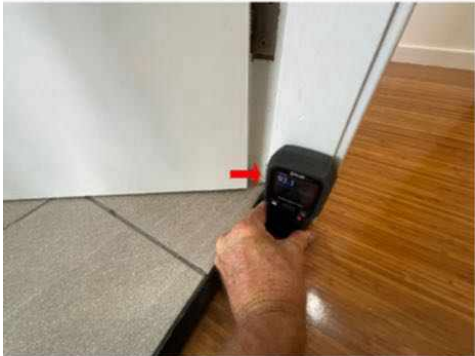
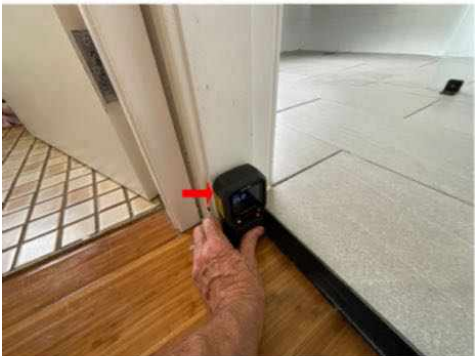
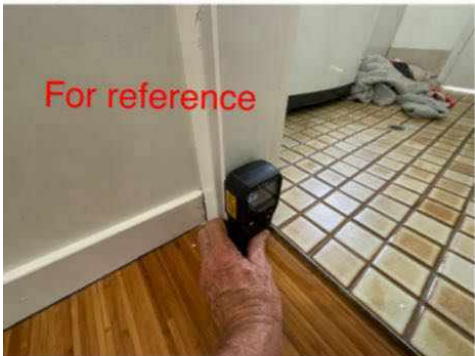
Finding 3.01

Building:	Building 1
Location:	Bathroom/ toilet wall
Finding:	Evidence of excessive moisture was present at the time of inspection
Information:	Excessive moisture was found in the bathroom door frame and toilet wall at the time of the inspection. A high reading of 93.1 was recorded in the right side bathroom door and 25 on the left side. The toilet rear left wall showed a maximum reading of 100. The adjacent laundry frame showed a zero reading for reference.

Excessive moisture can attract termites and produce conditions that promote termite attack, fungal growth and wood decay. Excessive moisture is generally caused by deteriorated, inadequate or missing, leaking plumbing pipes or fixtures, poorly plumbed HWS overflows or condenser units and poor site drainage. Damaged paint and minor mould is also evident in the door frame. A sealant specialist or licensed plumber can be consulted for advice.

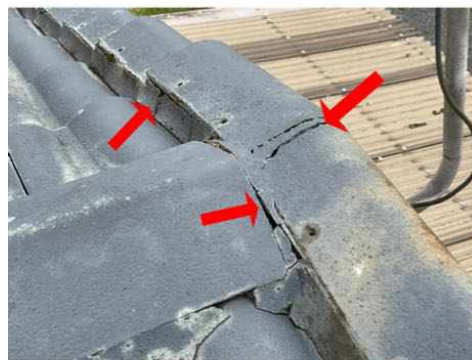
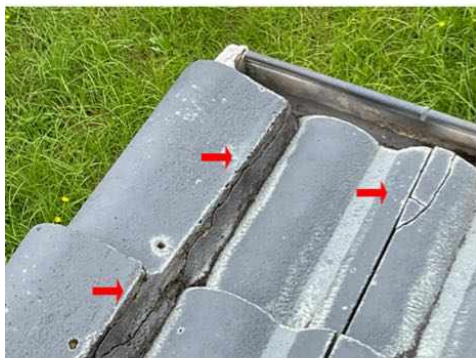
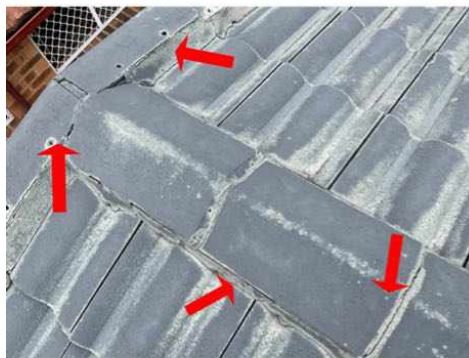
Finding 3.02

Building:	Building 1
Location:	Roof Exterior
Finding:	Roofing areas - Weathered
Information:	Upon inspection of the exterior roofing, the majority of the roof areas were considered to be in a fair condition. While weathering of these pictured areas is consistent with the age of the property, maintenance works are required.

Re-sealing and replacing gaps and damage must be undertaken immediately to help preserve and extend the life span of these roofing areas and protect the internal building. Where left unmanaged, deteriorating roofing materials are likely to lead to a number of secondary defects, including minor water leaks and weather exposure to internal roofing structures.

Consultation with a roofing contractor is highly advised to repair these areas immediately. Remedial works are likely to increase the longevity of the exterior roofing structure.

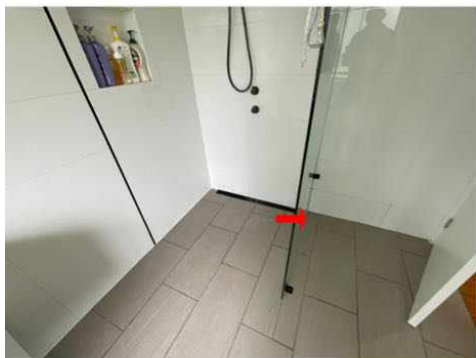
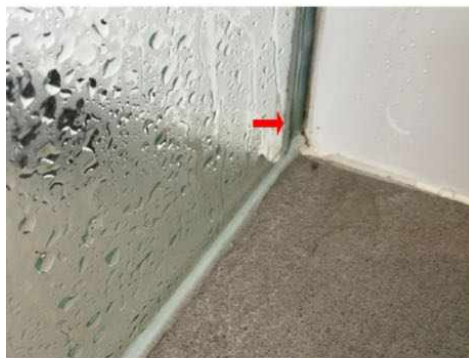
Finding 3.03

Building:	Building 1
Location:	Bathroom
Finding:	Shower screen - Leaking
Information:	Leaking was evident to the shower screening at the time of inspection. It is suspected that the leaking has occurred as a result missing sealant. Leaking from the shower , where left unattended, is likely to lead to water damage to adjoining flooring and walls. Such damage can lead to water damage and necessitate extensive remedial works being required. Active water leaks may also create an environment that is susceptible to the formation and development of mould.

Appointment of a sealant expert is required to repair or replace this missing sealant. Such works should be performed as soon as possible to ensure that no further damage occurs.

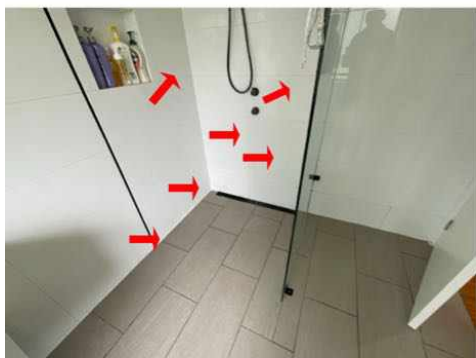
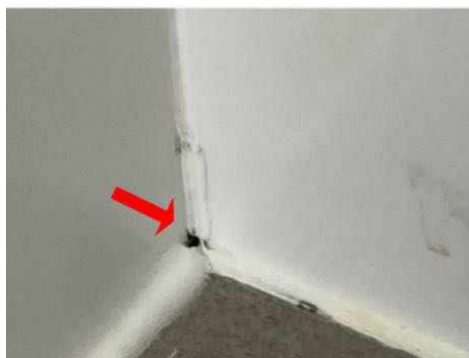
Finding: Sealant and grouting - Missing or damaged
Information: It was noted on inspection that sealant or grout is degraded to these pictured wet areas.

Different materials and floor areas move at different rates, generally causing cracking to grout or sealant at this point. A flexible sealant is required to allow for expected expansion and contraction, while keeping the joint water tight and protective of all associated building materials.

Flexible and mould resistant materials should be applied to affected areas to prevent any subsequent water damage that is likely to occur. Regular maintenance and replacement of damage or missing or damaged sealant and grout is highly recommended to the wet areas, as this is a regular wear and tear defect. Sealant and grouting in areas that come into regular contact with water should be maintained for the long term care of your property.

A sealant specialist or tiling contractor should be appointed to complete these works as soon as possible

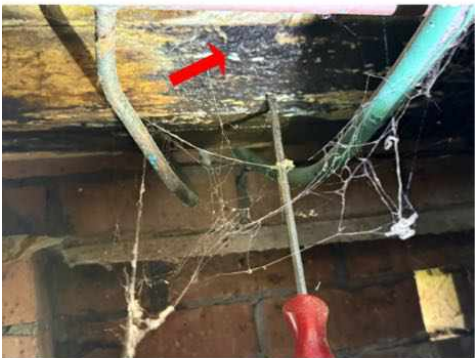
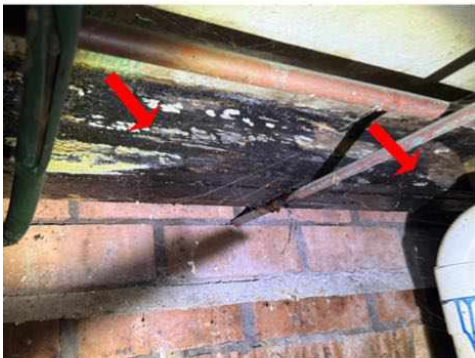
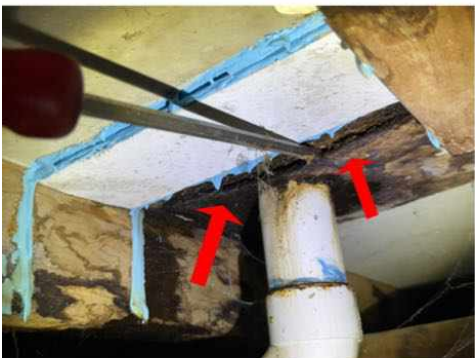
Finding 3.06

Building: Building 1
Location: Subfloor and carport areas

Finding: Wood rot

Information: The subfloor and carport shows evidence of wood rot. Wood rot, also known as Fungal Decay, occurs when timbers and other cellulose building materials are exposed to damp conditions on an ongoing basis. This could be the result of exposure to weathering over a prolonged period of time, or the attraction of excessive moisture from other abutting building materials.

Early intervention and regular maintenance, particularly of exterior timbers, will prolong the useful life of these building elements. Prior to any works being performed, the cause of the moisture that has created the visible wood rot should be identified and addressed in a suitable manner. Replacement of affected timbers may then be a necessary step in protecting surrounding building elements from such deterioration. Some carport posts need urgent paint protection or will need replacement in the near future.

A qualified carpenter or registered builder may also be required to replace affected building materials.

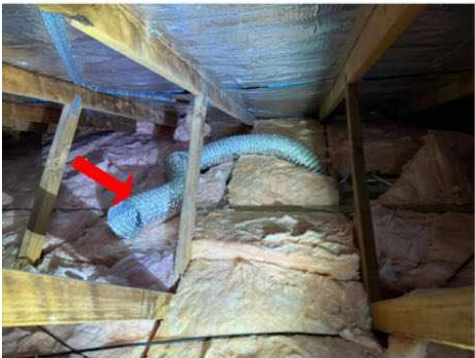
Finding 3.07

Building: Building 1
Location: Kitchen Roof cavity
Finding: Rangehood - Flue disconnected
Information: The range hood flue has not been disconnected and is allowing the emission of steam into the roof void. This create high potential for secondary defects including the development of grease in the surrounding roof void.

Consultation with a licensed electrician may be required to reconnect the flue outside the house walls and thus allow the emission of gases into the external environment.

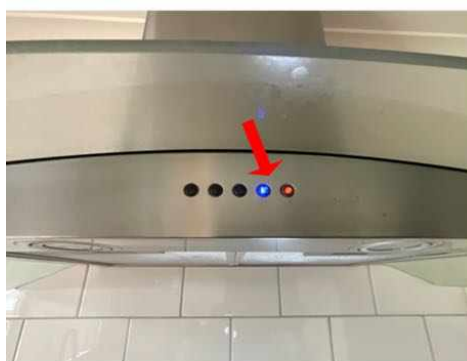
Finding 3.08

Building:	Building 1
Location:	Kitchen
Finding:	Rangehood not working
Information:	The rangehood fan and light were not working despite the buttons lighting up at the time of inspection.

Without a functional fan, a build-up of grease and evaporative moisture is likely to accelerate deterioration of the range hood and associated flue. This potential build up may also create a minor fire hazard, particularly if left uncleaned.

A licensed electrician should be appointed to replace the fan on the range hood to restore it to a fully operational state.

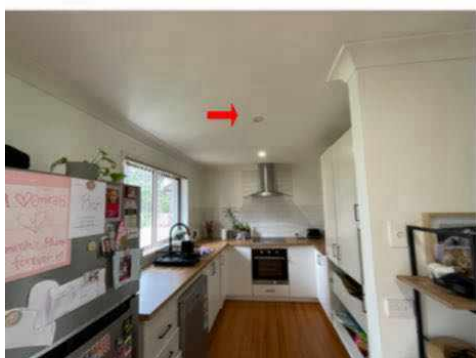
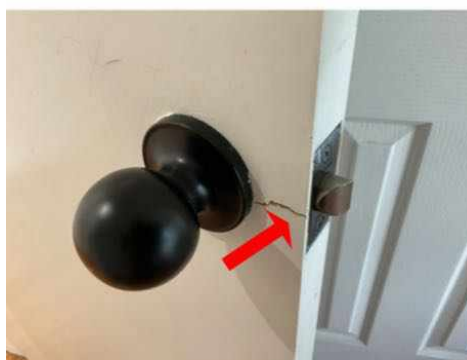
Finding 3.09

Building:	Building 1
Location:	Pictured external areas
Finding:	Building elements - Damaged
Information:	Evidence of minor missing or damaged areas was identified at the time of the inspection. These include -

1. The front door is starting to delaminate and may need replacement in the next few years.
2. One kitchen and one bathroom downlight do not work.
3. Some kitchen cupboard doors were missing.
4. The laundry door is binding on the frame and requires sanding. Two other door shows minor splitting.

A carpenter and electrician would be the trades responsible for rectification of these areas when convenient.

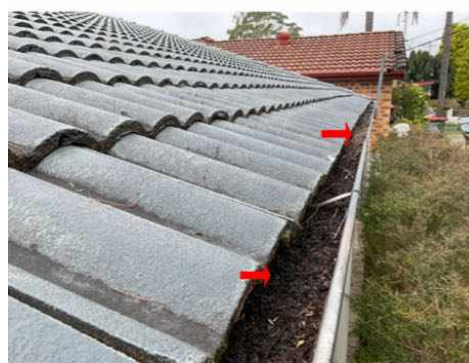
Building:	Building 1
Location:	Roof exterior
Finding:	Gutters - Full and blocked
Information:	The guttering on around the roof was found to be blocked at the time of the

Blocked gutters are likely to lead to high levels of moisture in the affected areas which can cause rust and decay of the gutters and downpipes and wood rot to adjoining timber areas. Blockages in gutters should therefore be removed immediately to ensure dry conditions are maintained.

It is highly advised that gutters be cleaned by the homeowner or a general handy person as a matter of urgency.

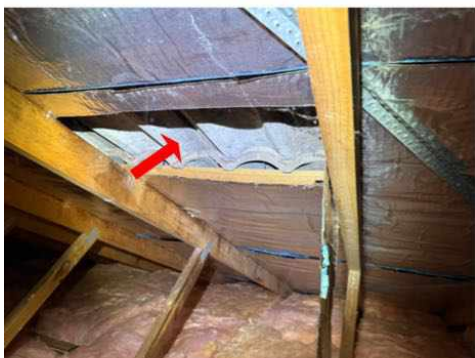
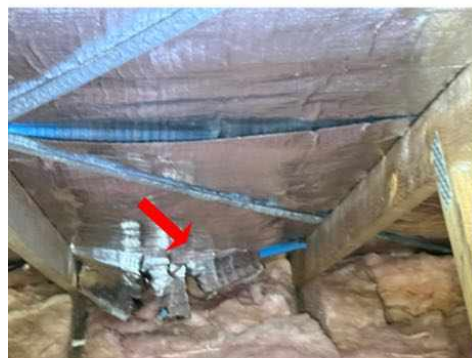
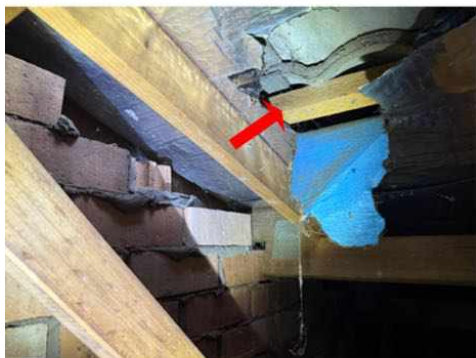
Building:	Building 1
Location:	Some Roof cavity areas
Finding:	Sarking - Damaged
Information:	Sarking, a laminated aluminium foil applied to the interior of the roof covering, assists in insulating the property and acting as a vapour-barrier to the roof void and, subsequently, to the household.

Where sarking is damaged, both insulation and moisture protection of the property are inhibited. This creates a loss of energy and thus negatively impacts the energy efficiency of the property, allowing potential for moisture ingress from condensation or leaking roof tiles.

It is important to repair any holes or damaged sections of sarking to ensure that the building material is fully functional. A registered builder or qualified carpenter should be consulted to provide further advice on this defect and to perform rectification works at client discretion.

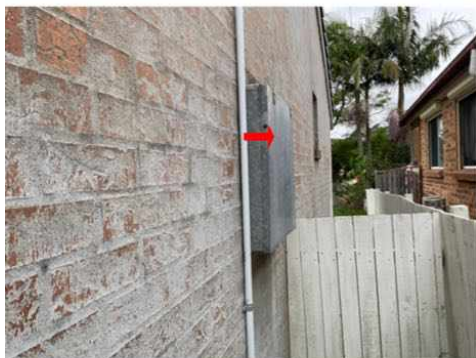
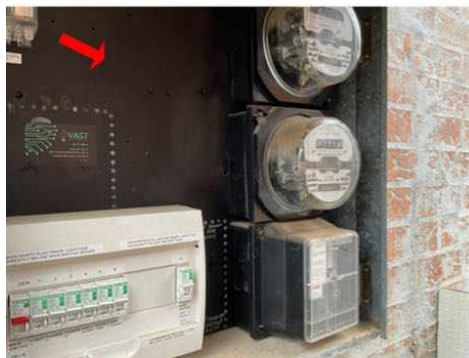
Building:	Building 1
Location:	Meter Box
Finding:	Termite Management System - no evidence of a chemical installation
Information:	The application of a post-construction chemical termite barrier is highly recommended for all properties. Such barriers are highly effective in preventing termite attack on any timber building elements throughout the property.

A durable notice should be placed in the switchboard unit to indicate current termite barriers. At the time of inspection, no durable notice was evident and it appeared as though no chemical termite management system has been installed, with no evidence to suggest preventative works taking place since the property was built.

The client may consider gaining further advice from a pest controller as to the costs and procedures involved with a 'chemical' application. It is recommended that obtaining such advice be a short-term priority.

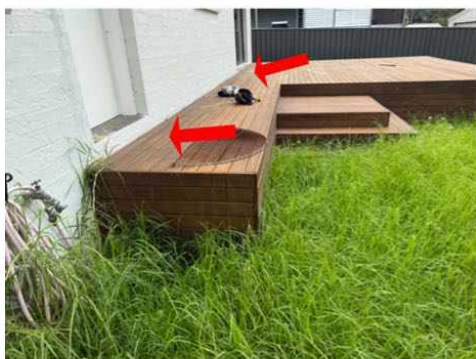
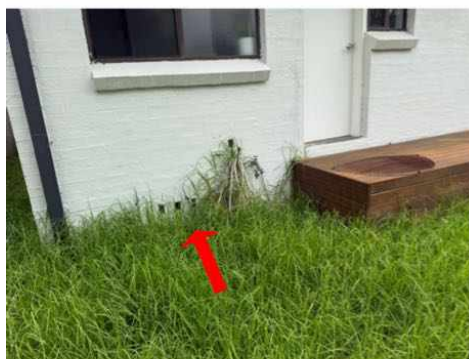
Finding 6.02

Building: Building 1
 Location: Rear wall
 Finding: Bridging - Vegetation and decking
 Information: Where vegetation and decking obstructs inspection of building elements, also known as bridging as it provides a bridging point for the access of termites, full inspection can not be achieved. Consequently moisture or dampness may be present and the areas becomes conducive to termite activity. Plants and decks against or very close to buildings provide cover, shade and can provide an environment that is attractive to termite infestation.

The removal and replanting of plant species that do not provide "cover" or cutting back of existing vegetation and leaving a small gap between decking and the building walls will assist greatly in preventing Bridging from occurring.

The removal of any such stored building or plant materials that may be conducive to termite activity should be carried out as soon as possible and arrange re inspection to minimize the risk of termite attack.

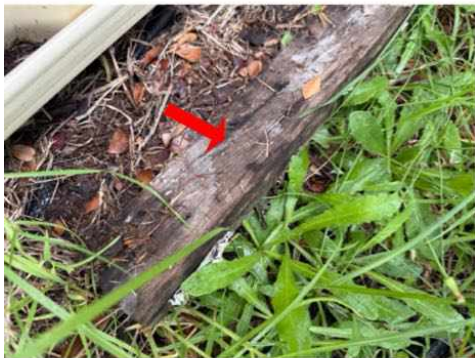
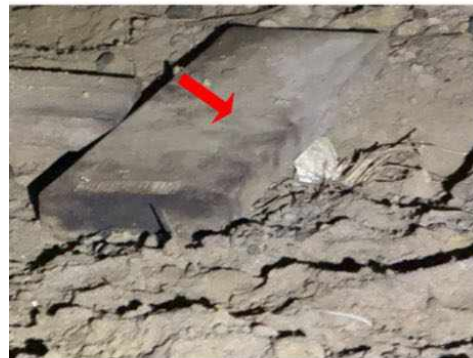
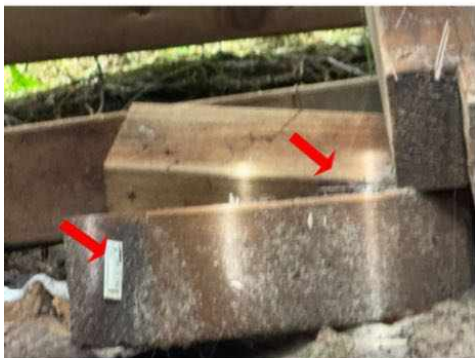
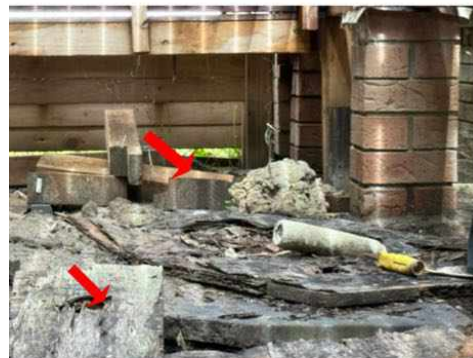
Finding 6.03

Building: Building 1
 Location: Yard & subfloor areas

Finding: Timber in contact with the ground
 Information: Any timbers in direct ground contact provide opportunity for concealed termite entry and are likely to be subject to premature rot and decay as the soil retains moisture or damp conditions against the timbers.

Removal of all waste timber that is in direct contact with ground is highly advised. This timber is promoting mould and wood rot and is very attractive to termites.

Frequent pest inspections are advised to readily identify any termite activity in these areas.

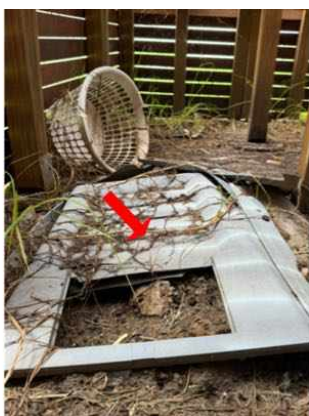
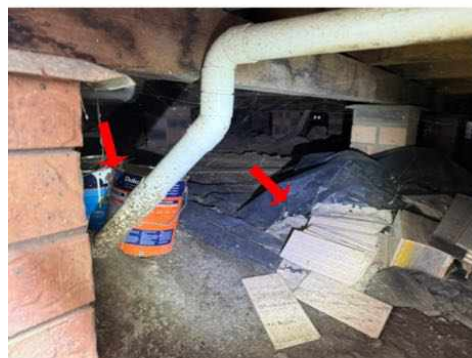
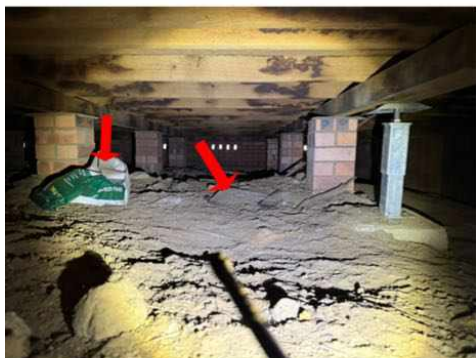
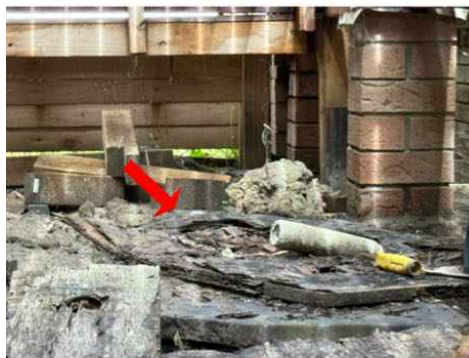
Information: An array of debris was found in the subfloor area at the time of inspection. Debris in this area restricts subfloor ventilation and creates potential for concealed pest entry. Stored timbers and other materials may also make the area susceptible to termite activity and wood rot.

A clear and empty subfloor will be better ventilated and easier to maintain in a dry condition. The removal of any timber debris is vital in minimising the risk of termite or wood borer activity.

Debris in the subfloor should be removed as soon as possible. Depending on the location and amount of debris and stored items, the homeowner may elect to undertake this task. Alternatively there are a large number of rubbish removal subcontractors that could undertake these works.

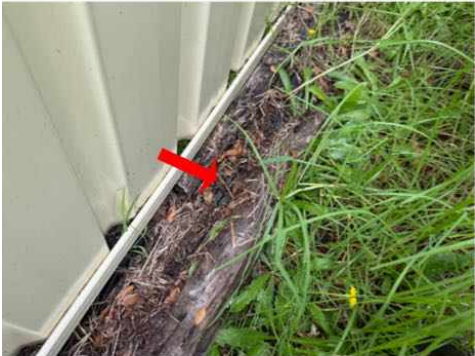
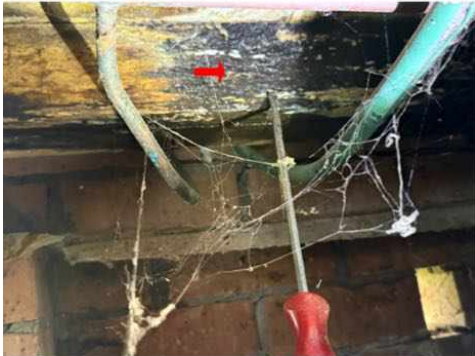
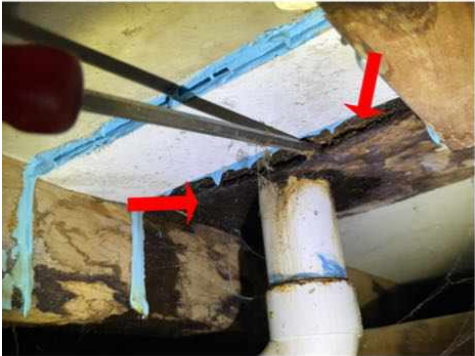
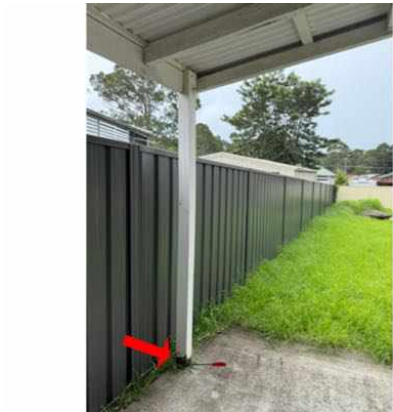
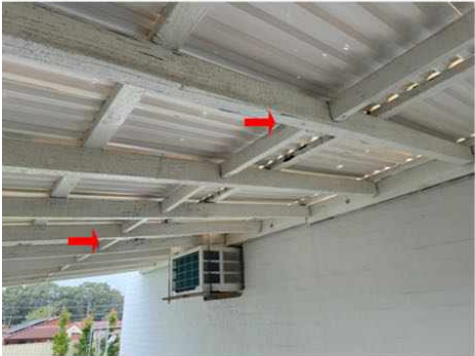
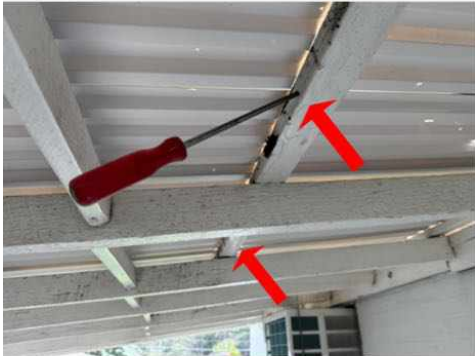
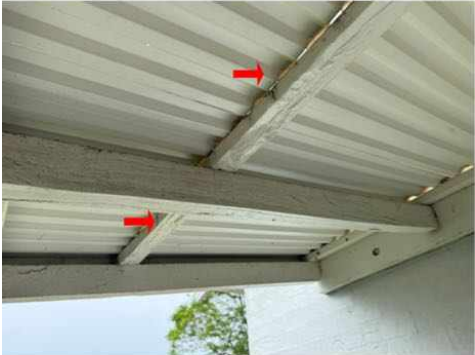
Building: Building 1
Location: Pictured areas
Finding: Fungal decay - present (localised)
Information: Fungal decay also known as wood decay or wood rot generally refers to the deterioration of timber elements when in contact with excessive levels of moisture for a prolonged period of time.

The development of fungal decay is accelerated by temperatures from 5degreeC to 40degreeC as well as the presence of oxygen. Generally fungal decay develops on timber elements that are in use in an external environment which are exposed to rain penetration.

In this case, the affected timber element is in a decaying state and will need replacement by a carpenter or licensed builder.

Note - See ALL wood rot photos, all these show fungal decay.

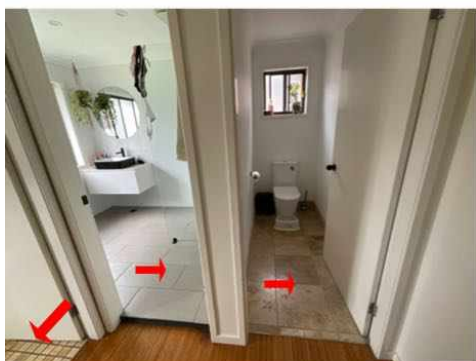
Noted Item

Building: Building 1
 Location: Pictured Areas
 Finding: Repairs evident
 Information:

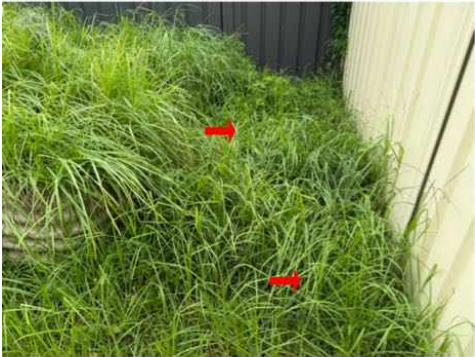
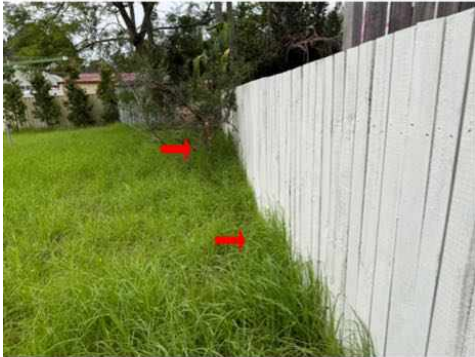
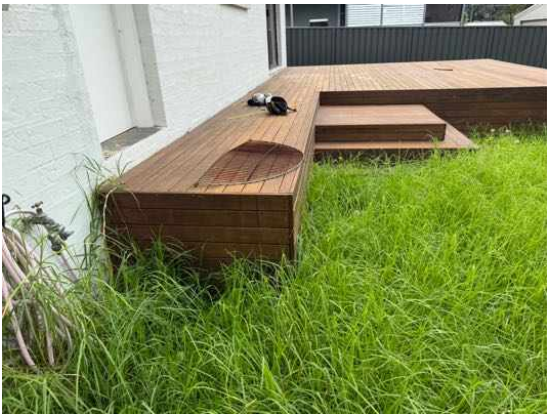
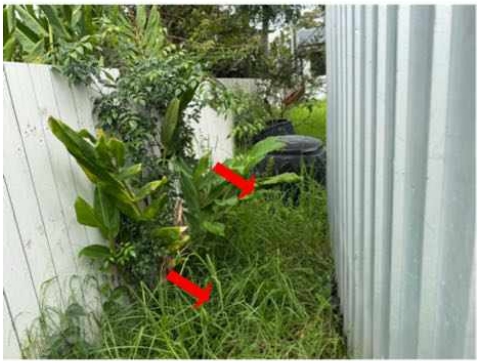
Noted Item

Building: Building 1
Location: All External Areas
Finding: Additional Photos - Obstructions and Limitations of EXTERNAL AREAS
Information: These photographs are an indication of the obstructions and limitations which impeded full inspection of external areas at the time of inspection. These obstructions can hide an array of defects and should be removed to allow full inspection to be carried out. A re-inspection is recommended once the areas are made accessible.

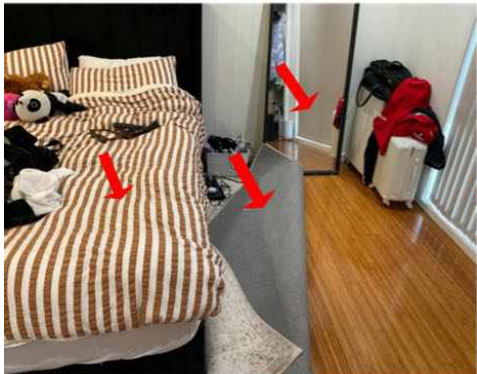
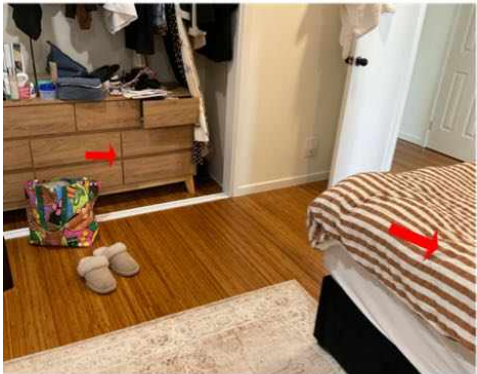
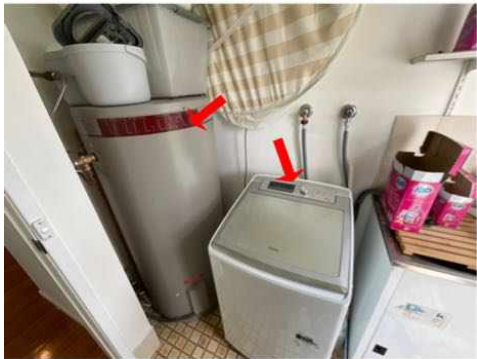
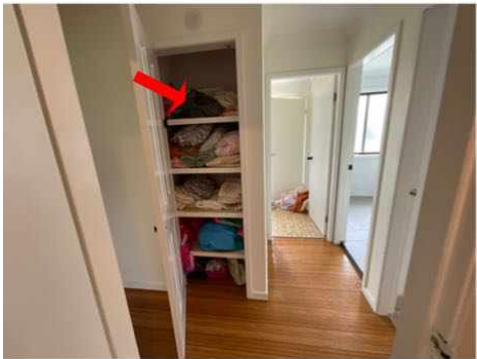
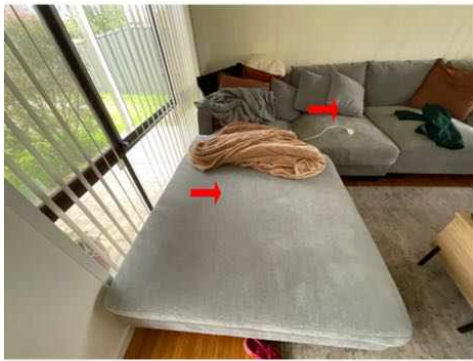
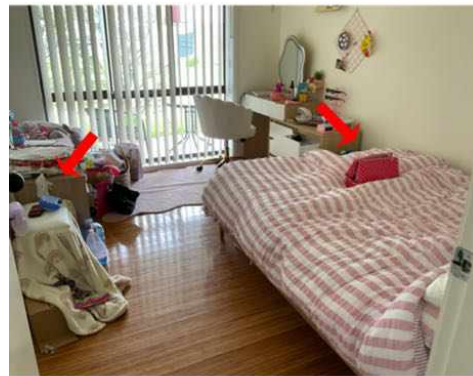
Noted Item

Building: Building 1
 Location: All Internal Areas
 Finding: Additional Photos - Obstructions and Limitations of INTERNAL AREAS
 Information: These photographs are an indication of the obstructions and limitations which impeded full inspection of Internal areas at the time of inspection. These obstructions can hide an array of defects and should be removed to allow full inspection to be carried out. A re-inspection is recommended once the areas are made accessible.

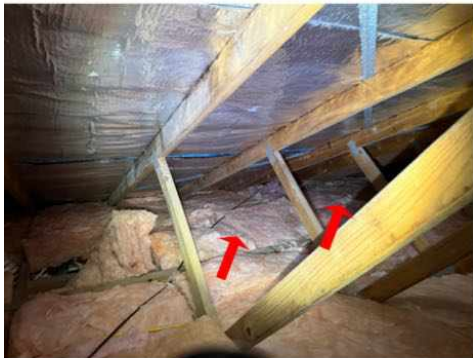
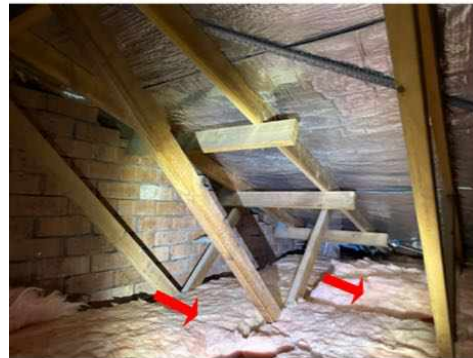
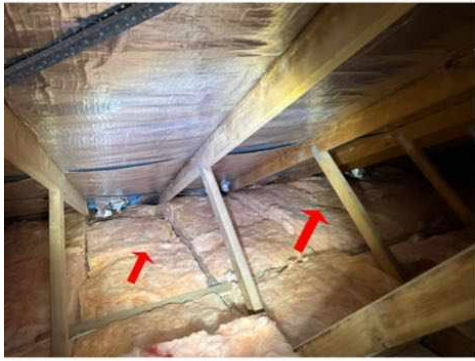
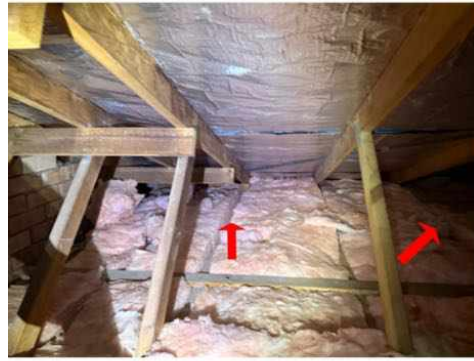
Noted Item

Building: Building 1
 Location: All Roof cavity areas
 Finding: Additional Photos - Obstructions and Limitations of the ROOF CAVITY
 Information: These photographs are an indication of the obstructions and limitations which impeded full inspection of roof cavity areas at the time of inspection. These obstructions can hide an array of defects and should be removed to allow full inspection to be carried out if applicable. A re-inspection is recommended once the areas are made accessible.

The inspection was also limited to areas with an allowable crawl space of 600mm x 600mm, in particular towards the external walls where the roof line diminishes, these areas were not accessible.

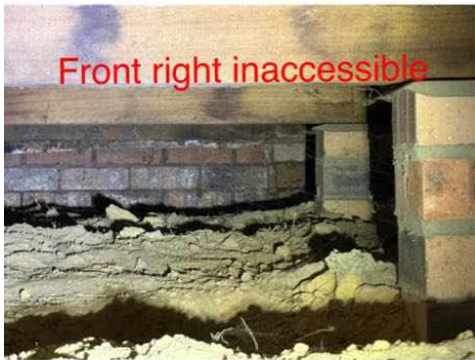
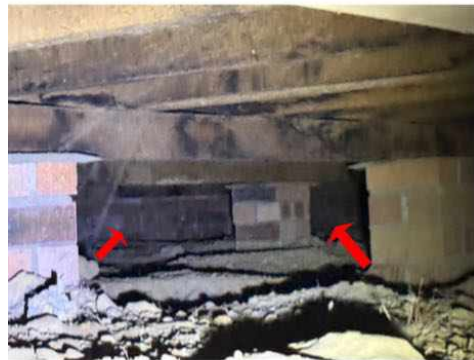
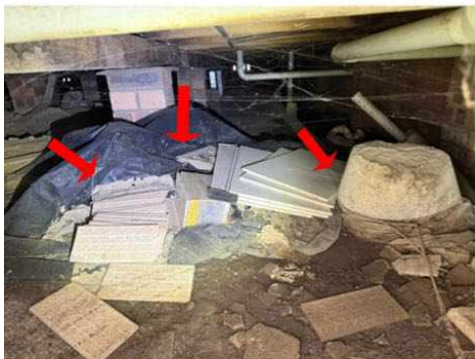
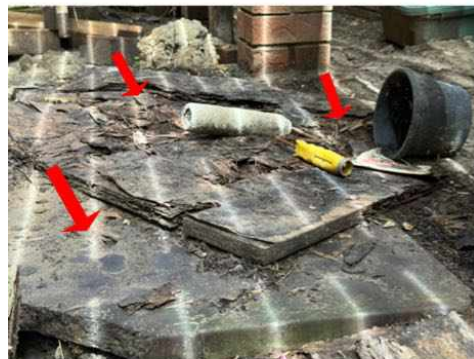
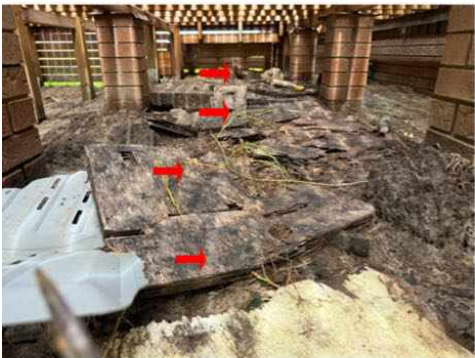
Noted Item

Building: Building 1
Location: All Subfloor & Under Deck Areas
Finding: Additional Photos - Obstructions and Limitations of SUBFLOOR & DECK AREAS
Information: These photographs are an indication of the obstructions and limitations which impeded full inspection of subfloor areas at the time of inspection. These obstructions can hide an array of defects and should be removed to allow full inspection to be carried out. A re-inspection is recommended once the areas are made accessible.

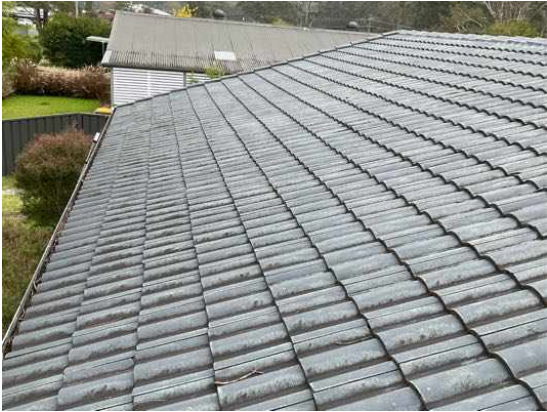
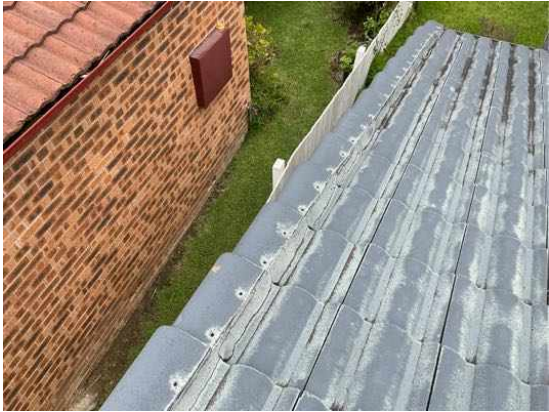
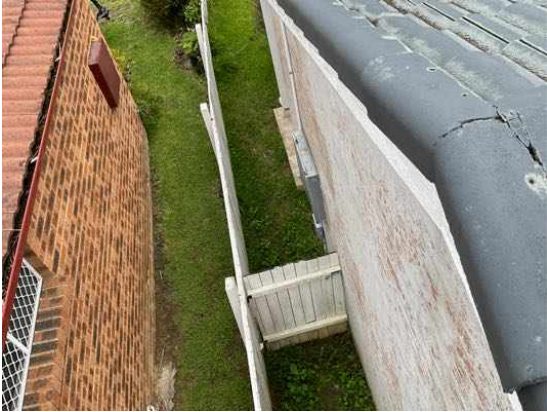
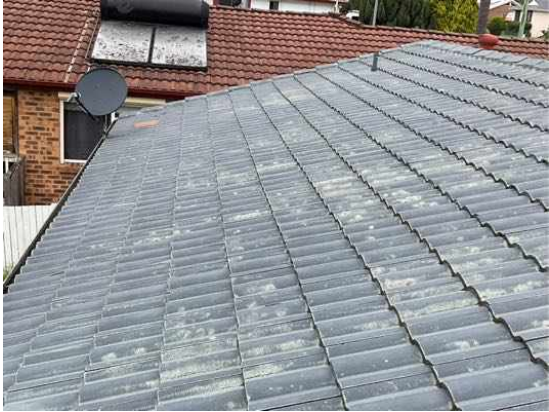
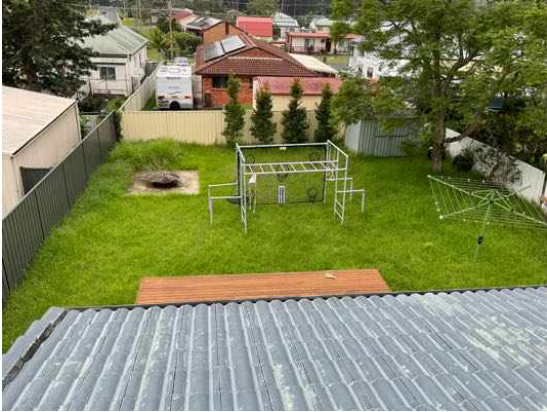
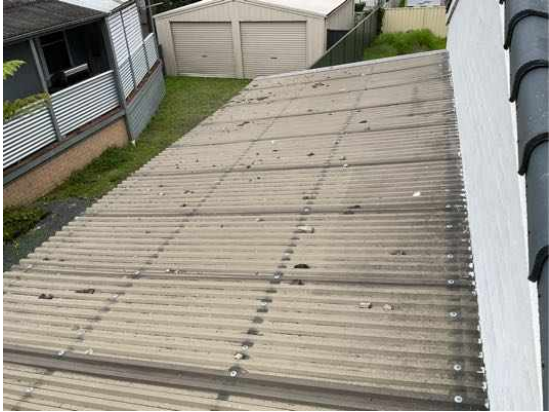
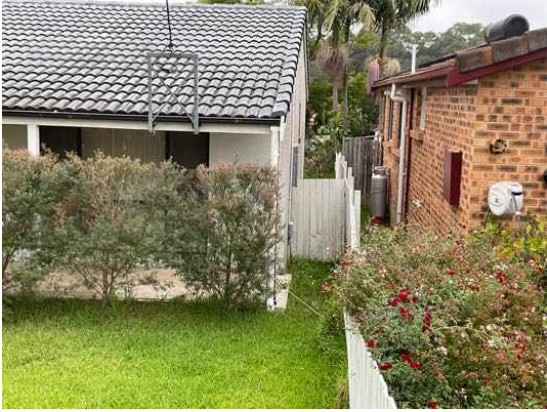
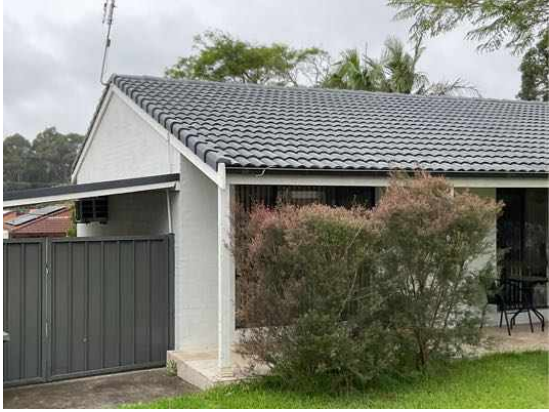
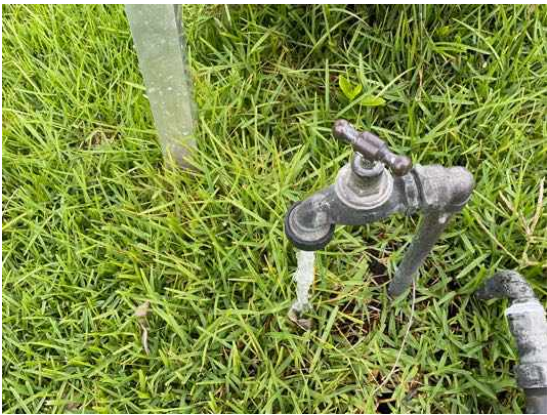
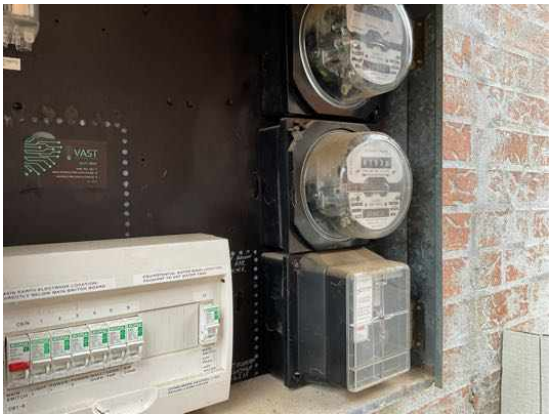
Building: Building 1
Location: All External Areas
Finding: Additional Photos
Information: Additional photos are provided for your general reference

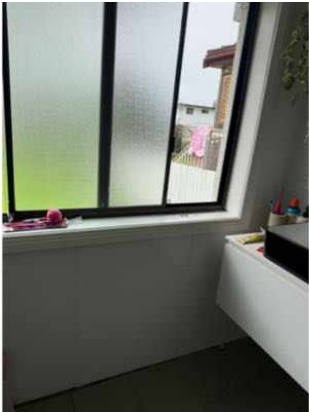
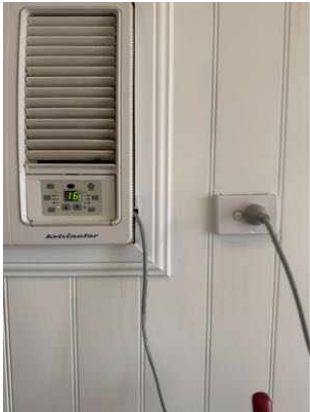
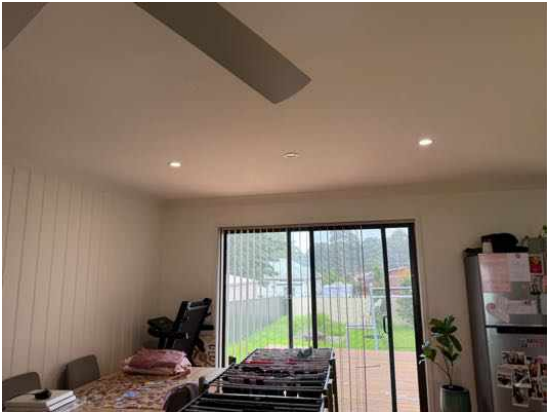
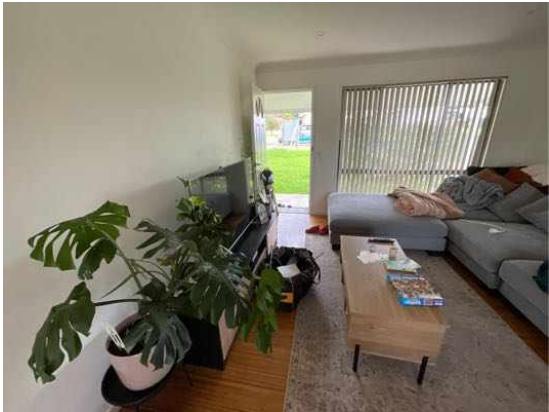
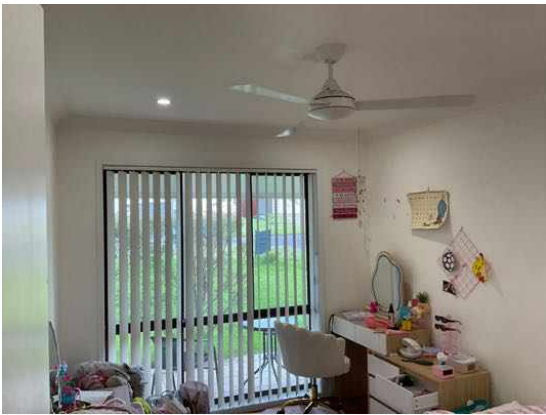
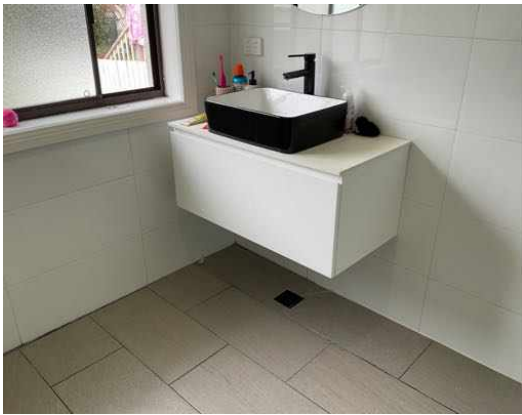
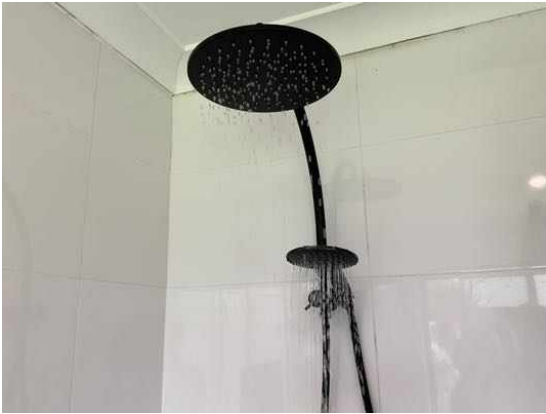
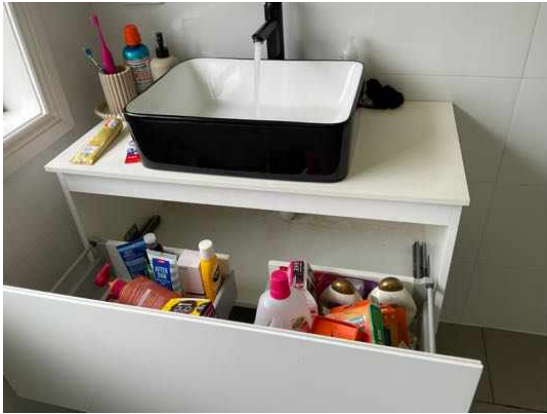
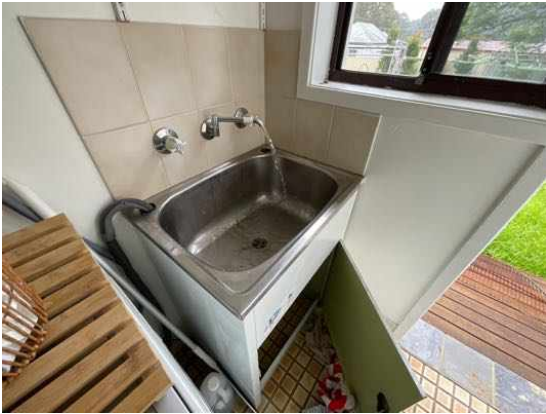
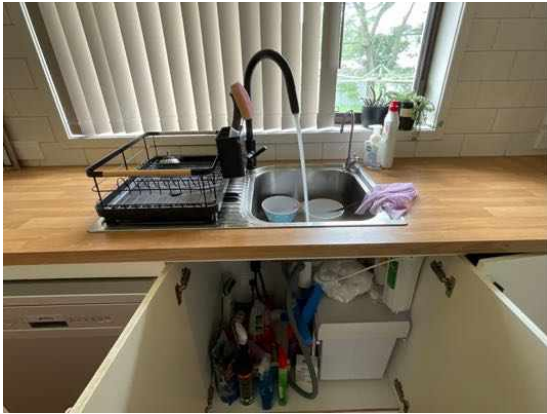
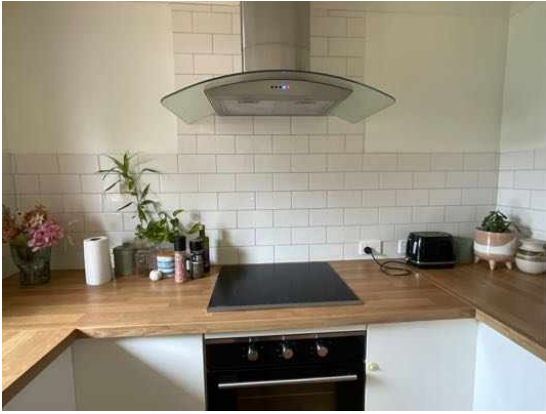
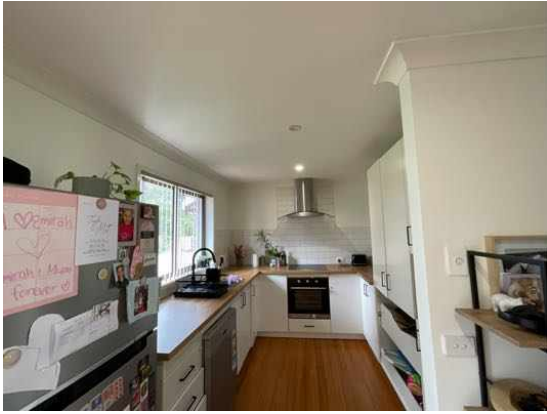
Building: Building 1
 Location: All Internal Areas
 Finding: Additional Photos
 Information: Additional photos are provided for your general reference
