Building and Timber Pest Inspection Report

Inspection Date: Wed, 21 Jan 2026

Property Address: 14 Frances St, LIDCOMBE, NSW, 2141,
Australia

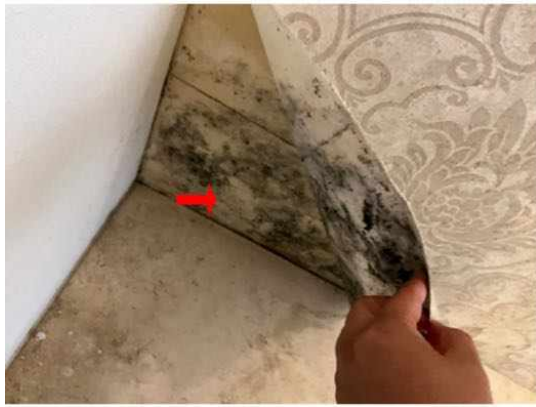
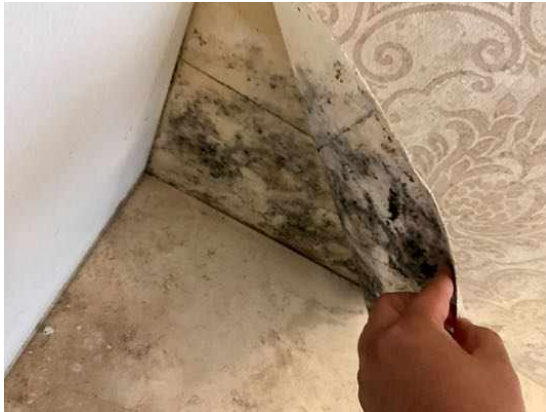
Building:	Main Building
Location:	Basement
Finding:	Mould - Present
Information:	Mold growth is present throughout the property, primarily due to inadequate ventilation. Poor airflow and moisture accumulation within the house have created ideal conditions for mold to thrive.

- **Health Hazards**: Mold growth can pose serious health risks to occupants, particularly those with allergies, asthma, or other respiratory conditions. Prolonged exposure to mold spores can cause respiratory issues, skin irritation, and other allergic reactions.
- **Structural Damage**: Mold can degrade building materials over time, leading to rot and weakening of the structural components such as timber, drywall, and insulation, which can result in costly repairs.
- **Decreased Property Value**: The presence of mold can significantly reduce the value of the property, as it indicates underlying moisture and ventilation issues that need addressing.

A licensed mold remediation specialist should be engaged to remove the mold and treat affected areas. In addition, a ventilation expert or builder should assess and improve the house's ventilation system, possibly installing exhaust fans, vents, or mechanical ventilation systems to ensure adequate airflow and prevent future mold growth.

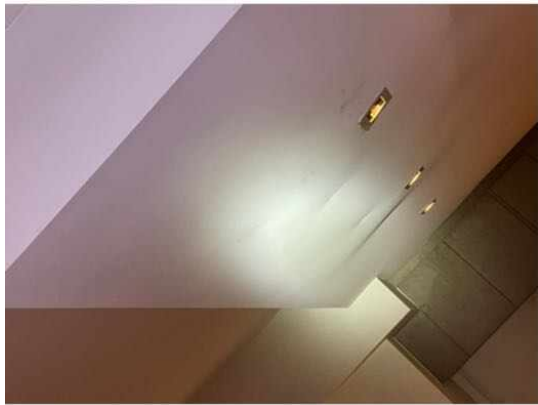
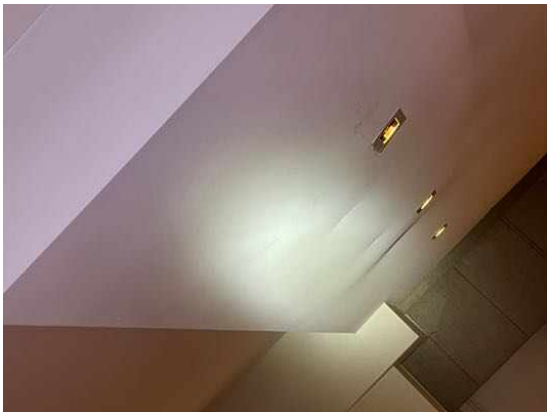
Finding 2.01

Risk: Sagging ceilings pose several risks, including potential collapse or detachment of ceiling materials, which can lead to property damage and serious injuries to occupants. Additionally, sagging ceilings may indicate underlying structural issues, such as water damage or compromised support beams, which could worsen over time if left unaddressed.

A qualified and licensed Builder or structural engineer should be consulted to assess the extent of the sagging and identify the underlying cause. Depending on the severity and cause, repairs may involve reinforcing support structures, addressing water damage, or replacing damaged ceiling materials to ensure safety and structural integrity.

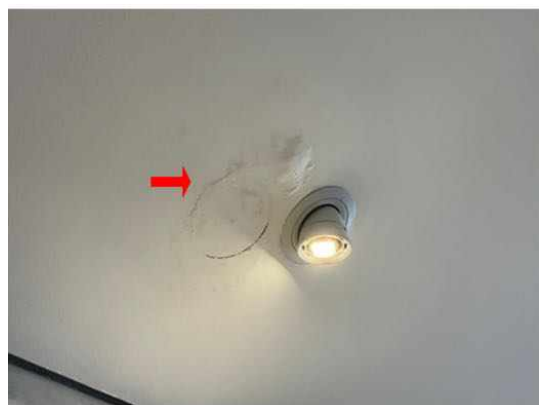
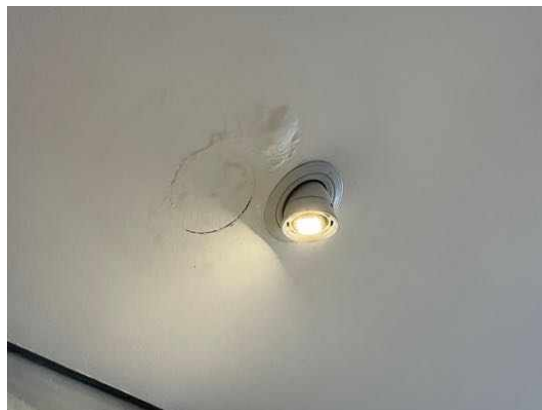
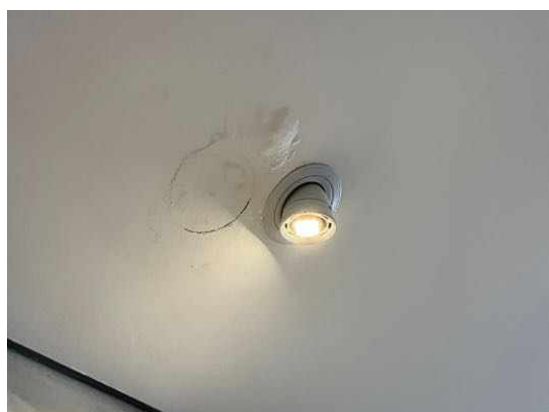
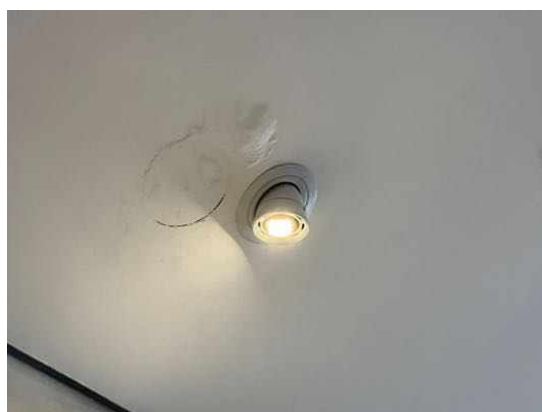
Finding 2.02

Building: Main Building
Location: Basement
Finding: Water damage
Information: The area has sustained water damage resulting in potential structural issues. This damage compromises both the aesthetic and functional aspects.

1 **Plumber:** If the water damage is due to plumbing issues, a plumber can fix leaks and ensure there are no further water-related problems.

2 **General Contractor:** If the damage is extensive and affects the surrounding area, a general contractor can coordinate the repair work, including any related structural or cosmetic repairs.

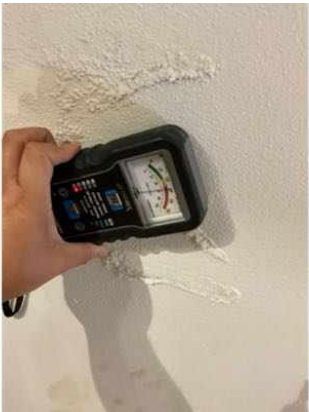
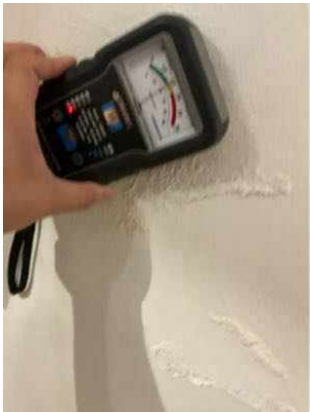
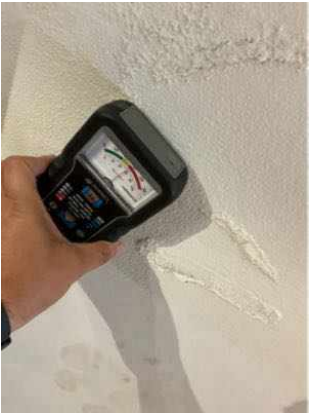
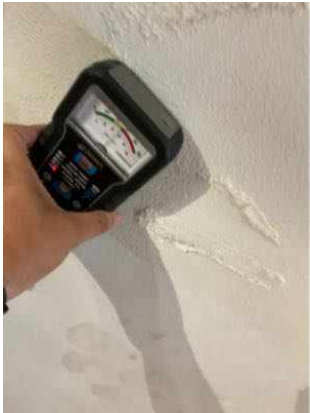
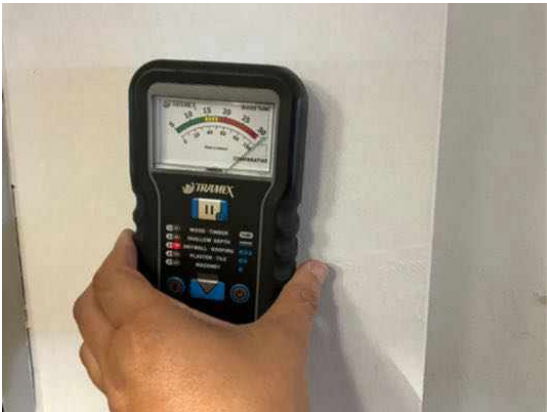
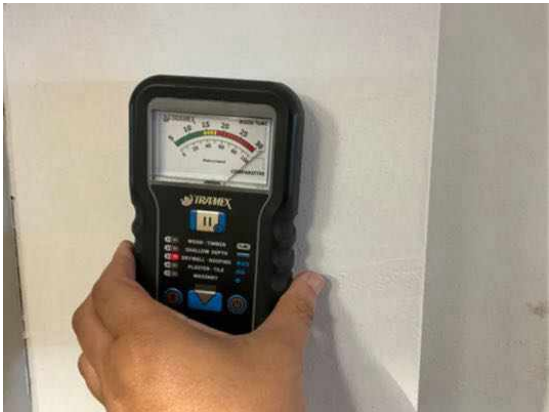
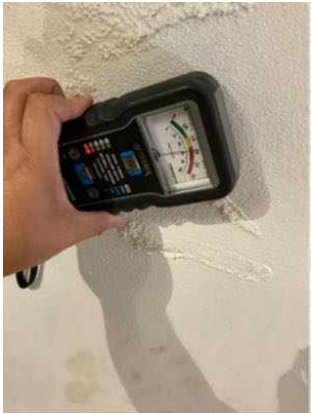
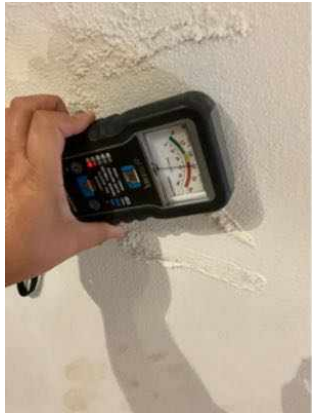
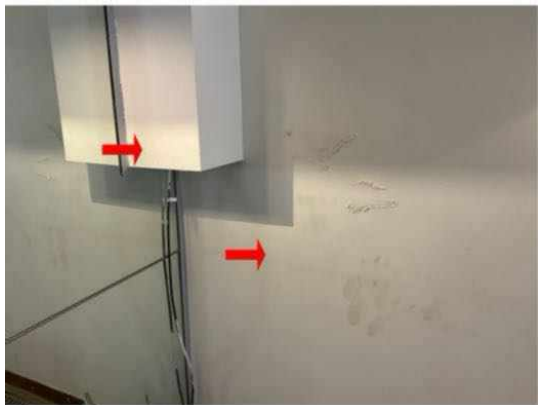
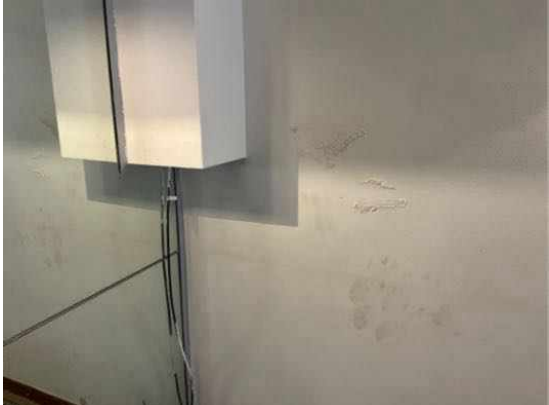
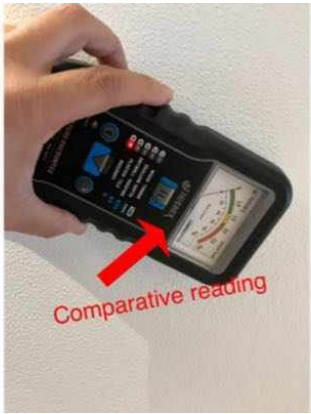
Finding 2.03

Building: Main Building
Location: Basement
Finding: Evidence of excessive moisture - Drywall

Information: Excessive moisture is present at the time of , indicating a potential water leakage issue within the wall.

The prolonged presence of moisture can lead to mold growth, deteriorate the structure, and create an environment conducive to health hazards. Additionally, it may compromise the adhesive holding the tiles, leading to their detachment.

A licensed plumber or a qualified contractor specializing in water damage remediation should investigate the source of the moisture, fix any leaks, and address the damage. Additionally, replacing affected tiles and ensuring proper waterproofing are crucial to preventing future issues.

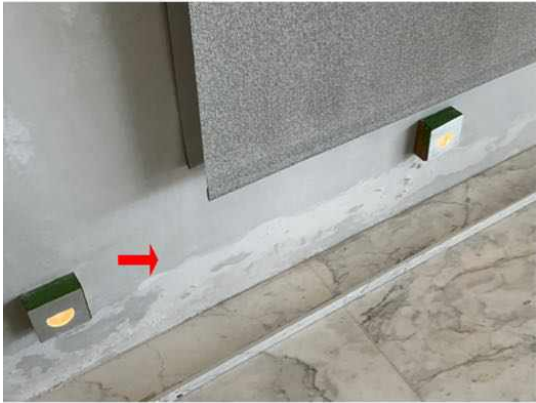
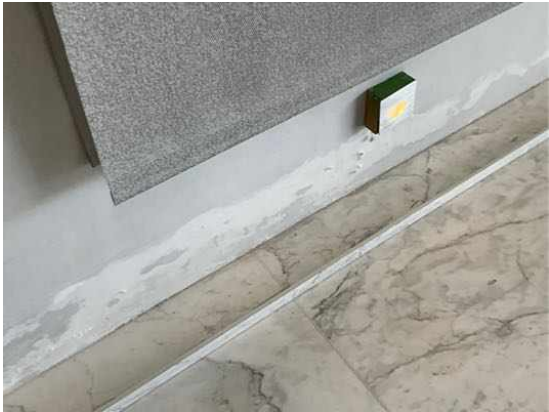
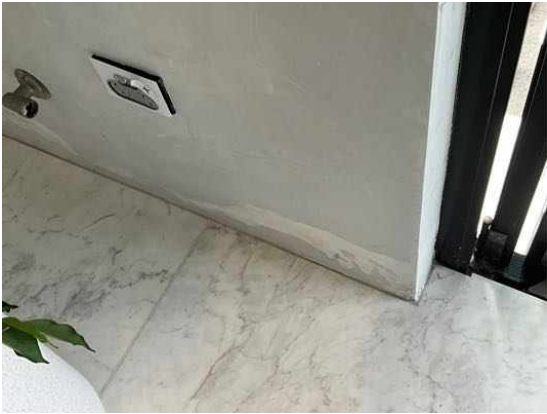
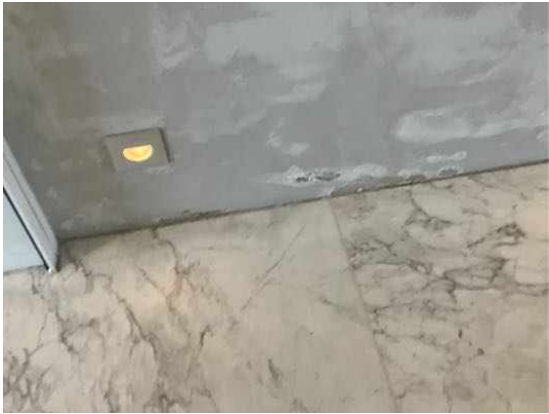
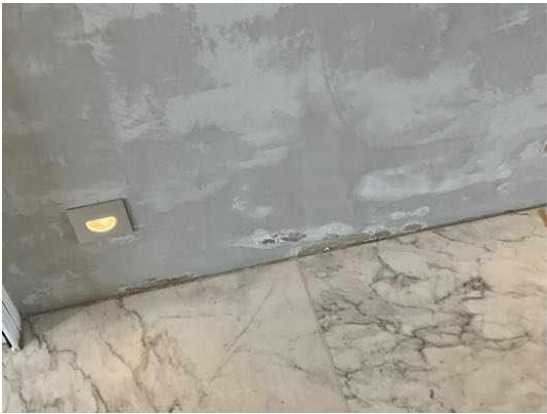
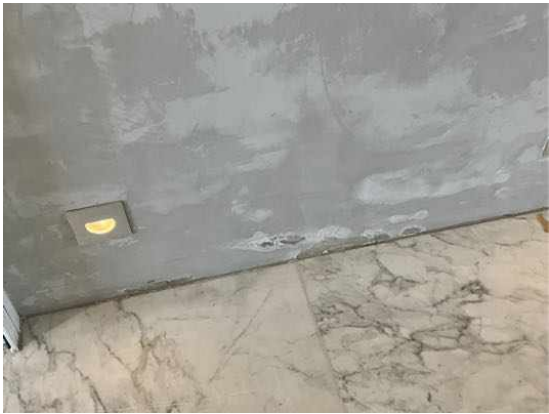
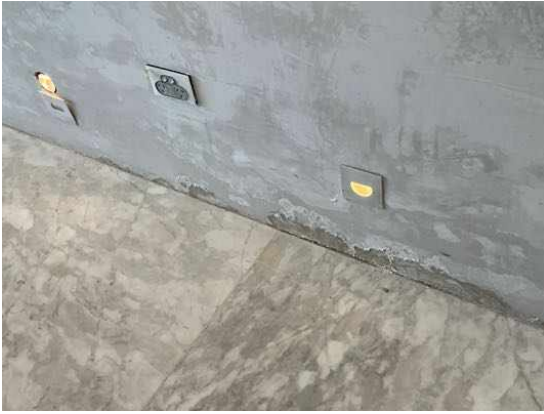
Finding 2.04

Building: Main Building
Location: All Areas
Finding: Flaky Paint
Information: Sections of the paint in this area was found to have deteriorated. Paint deteriorating is generally an indication of excessive moisture in the area that is currently hidden by the painted surface.

The presence of excessive moisture can have major implications on associated building elements if left unattended. While only seemingly minor at this stage, the damage cannot be determined due to the paint, obstructing any further inspection of the damage.

It is highly advised that the affected paint to be cleaned to allow a further, more invasive inspection by a licensed builder/painter. Failure to act on this defect may necessitate major works in the future.

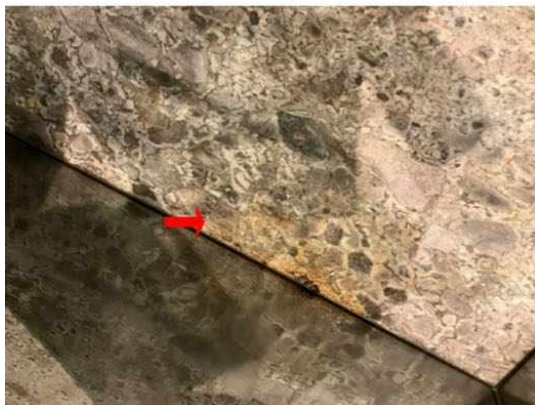
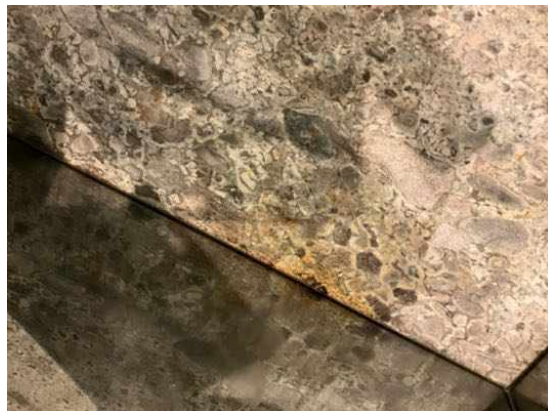
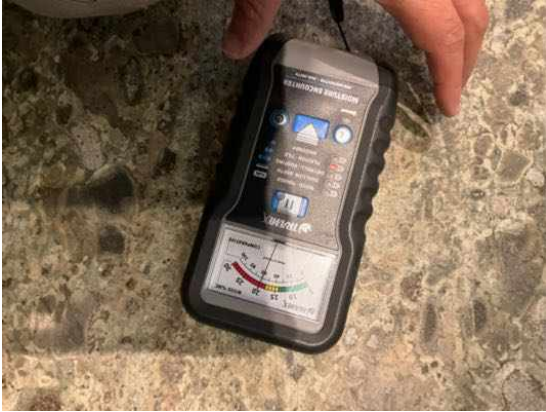
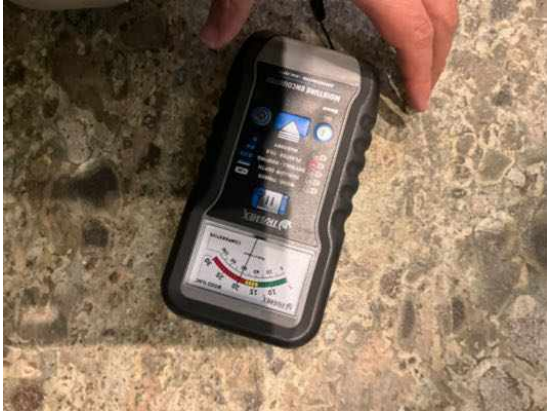
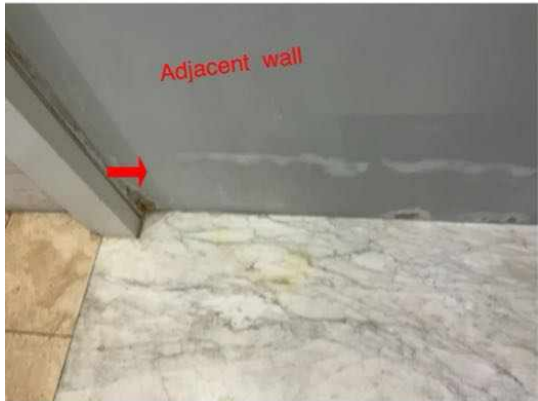
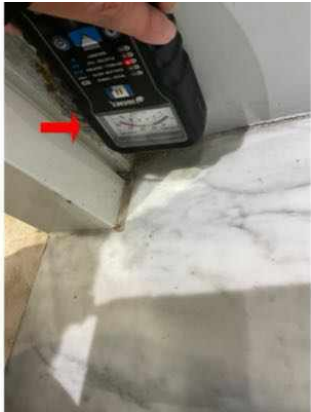
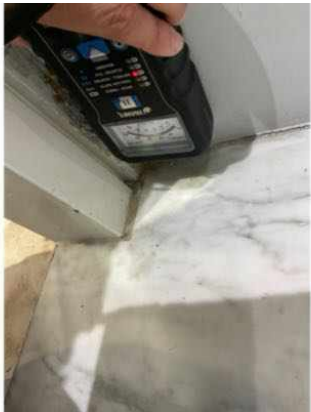
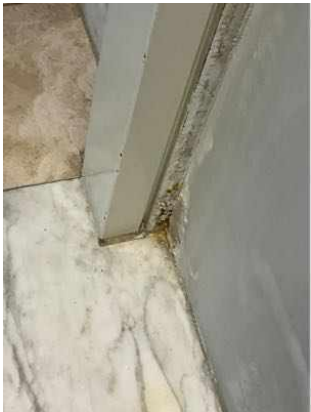
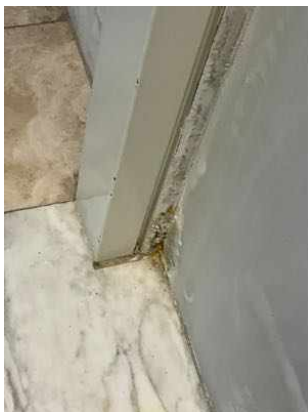
Finding 2.05

Building:	Main Building
Location:	Bathroom downstairs
Finding:	Evidence of excessive moisture was present at the time of inspection
Information:	Excessive moisture is present behind the bathroom tiles, indicating a potential water leakage issue within the wall.

The prolonged presence of moisture can lead to mold growth, deteriorate the structure, and create an environment conducive to health hazards. Additionally, it may compromise the adhesive holding the tiles, leading to their detachment.

A licensed plumber or a qualified contractor specializing in water damage remediation should investigate the source of the moisture, fix any leaks, and address the damage. Additionally, replacing affected tiles and ensuring proper waterproofing are crucial to preventing future issues.

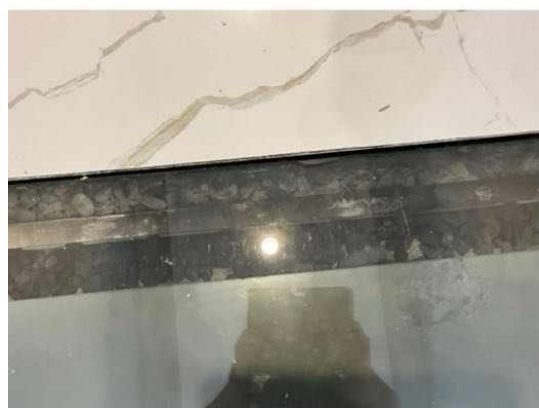
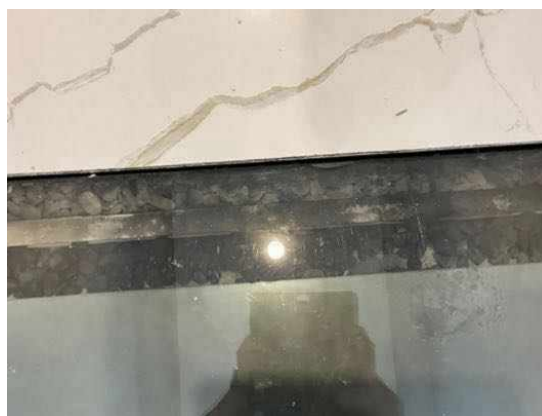
Finding 2.06

Building: Main Building
Location: Foyer upstairs
Finding: Fire Damage
Information: Evidence of fire-related damage, including heat staining and surface deterioration, was observed to finishes. The full extent of damage, including any impact to concealed elements or structural components, could not be determined within the scope of a visual, non-invasive inspection.

Recommendation: A detailed structural inspection by a suitably qualified structural engineer is recommended, along with further assessment and rectification by an appropriately qualified fire restoration or building contractor.

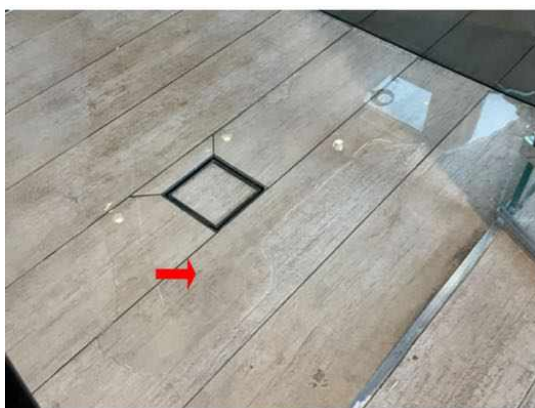
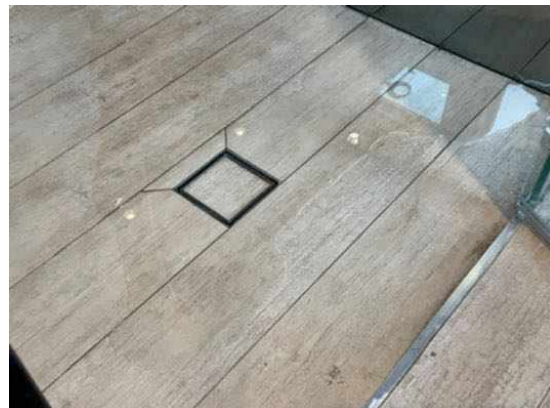
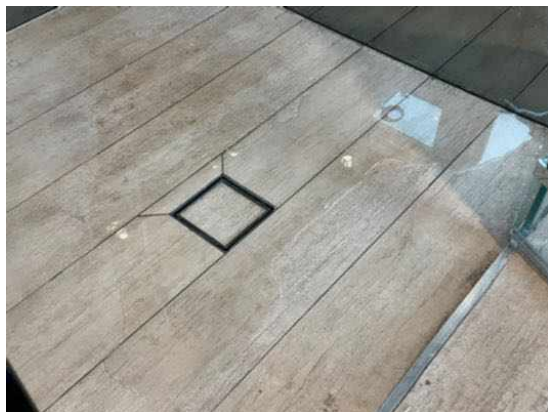
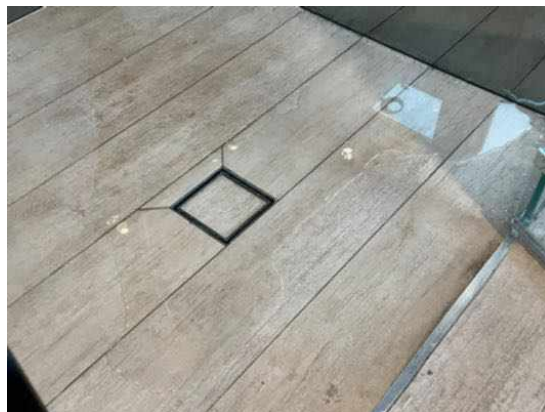
Finding 2.08

Building:	Main Building
Location:	Ensuite - Master
Finding:	Shower base - Water pooling
Information:	Evidence of water pooling around the floor waste in the shower recess was noticed at the time of inspection. It is suspected that this excessive moisture is attributed to insufficient fall in the shower floor tiles.

This pooling is major and considered unsatisfactory, as standard tiling practices would not permit this situation to occur. Pooling water around floor wastes can create a slip hazard in extreme cases and create conditions that are conducive to mould growth over time. Where left unmanaged, the degradation of sealant and grouting is also likely to occur, possibly necessitating further repair works.

Remedial works may involve some sections of tiling and flooring repair and replacement. A tiling contractor or bathroom specialist should be appointed to provide further advice on reparation options and to perform works as necessary.

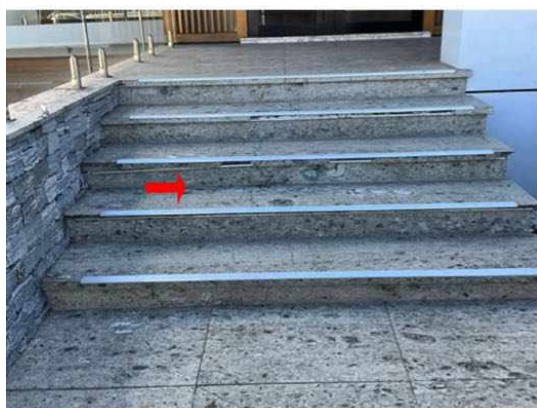
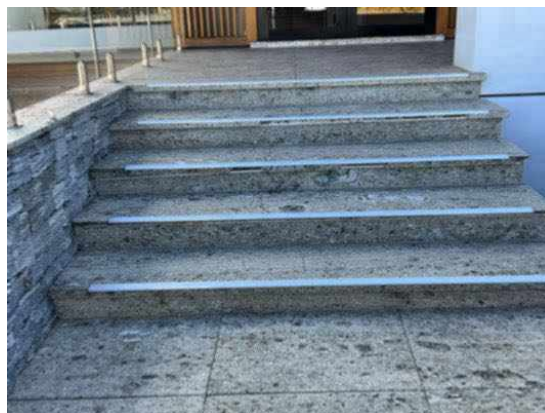
Finding 3.01

Building: Main Building
 Location: All Areas
 Finding: Tile Damaged
 Information: Tiles are visibly damaged, showing a chipped/broken section on the surface.

The damaged tile presents a trip hazard, may lead to cuts if stepped on barefoot, and can allow moisture ingress into the substrate, which may cause further deterioration or loosening of adjacent tiles. It also affects the overall appearance of the floor.

A licensed tiler should be engaged to remove the damaged tile and install a matching replacement. If spare tiles are unavailable, additional remedial work may be required to blend the repair with surrounding finishes.

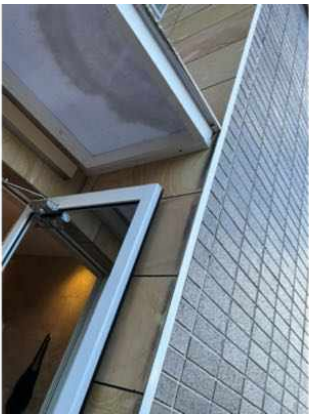
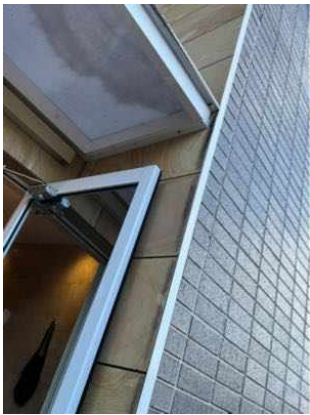
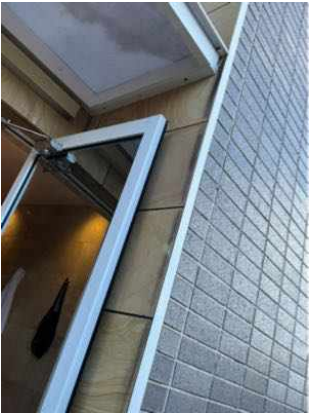
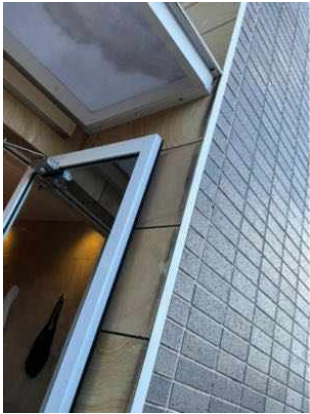
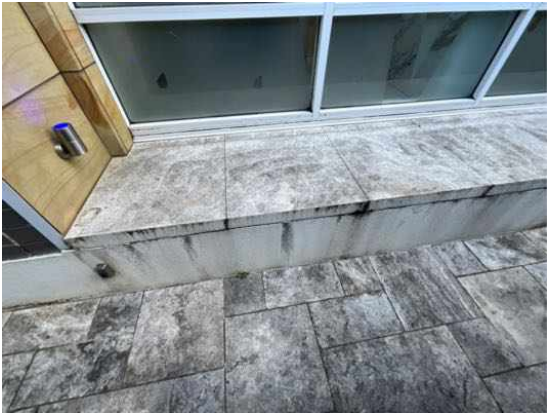
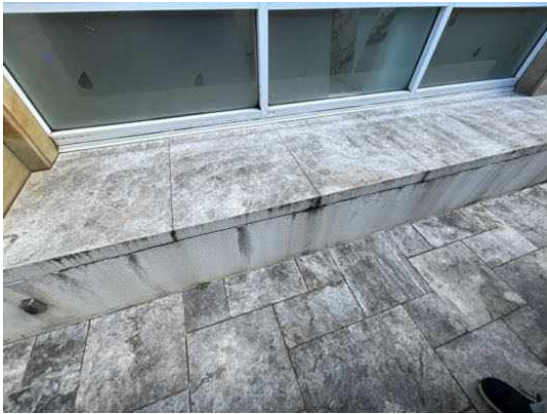
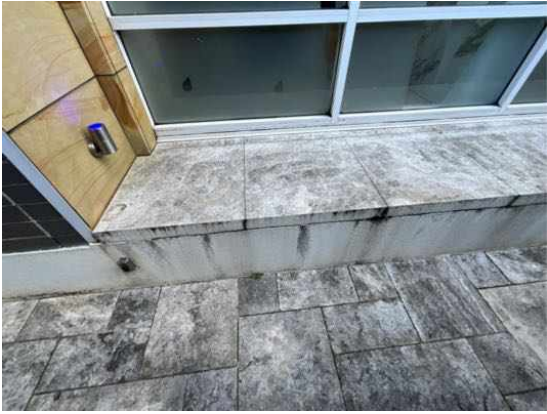
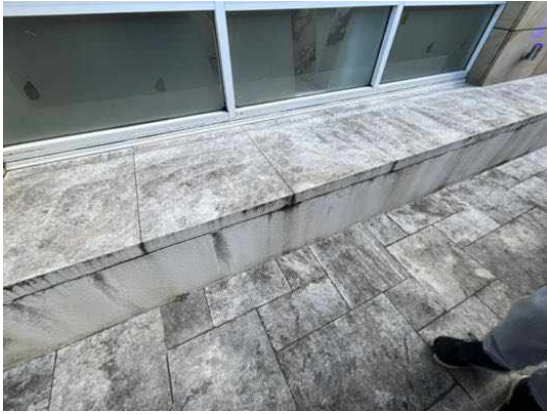
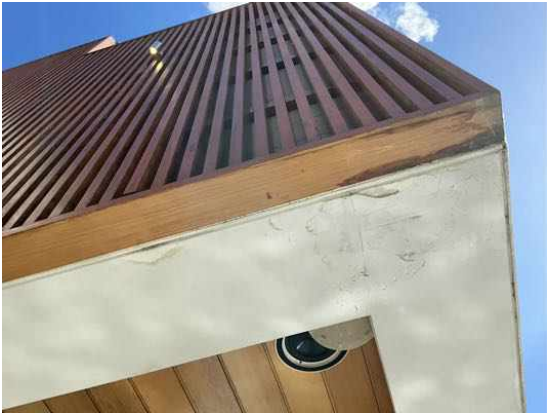
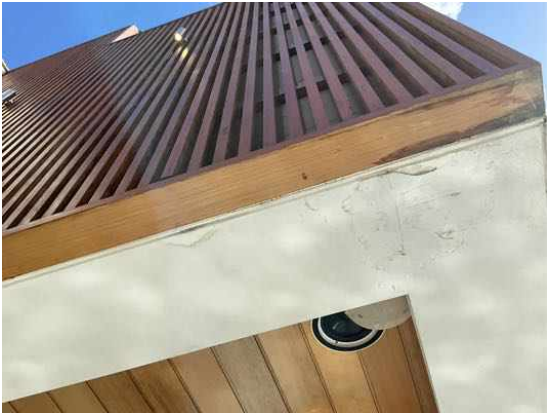
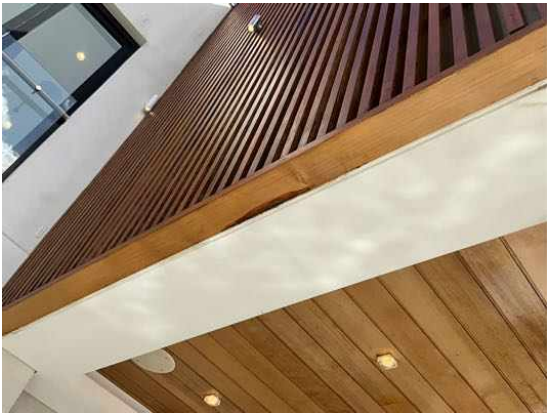
Finding 3.03

Building:	Main Building
Location:	All Areas
Finding:	Water staining
Information:	Water staining was evident in this area at the time of inspection. Water staining indicates that surfaces have been exposed to excessive moisture over time. The minerals and other elements in the water lead to staining, which may graduate to corrosion and deterioration if left unmanaged.

While mostly an appearance defect, water staining can be indicative of more serious defects, which may be currently concealed by other building elements.

Where water staining is active, a licensed plumber must be consulted to identify the cause of the staining and to provide advice on any reparation works that may be required. Replacement of any broken or damaged structures is advised.

Conversely, where water staining is old and inactive, affected building materials may be repaired or replaced at client discretion. A qualified carpenter or registered builder may be appointed to perform these works.

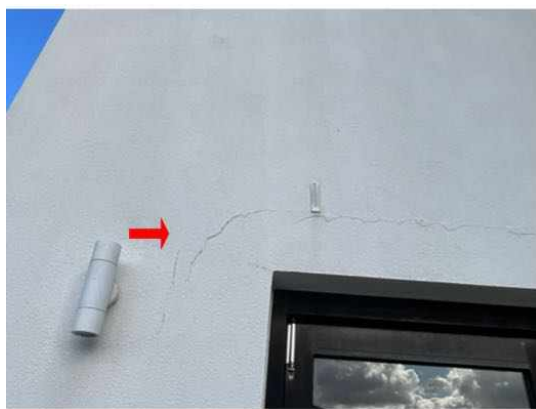
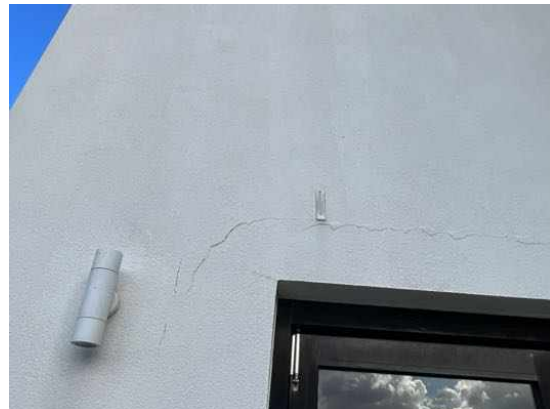
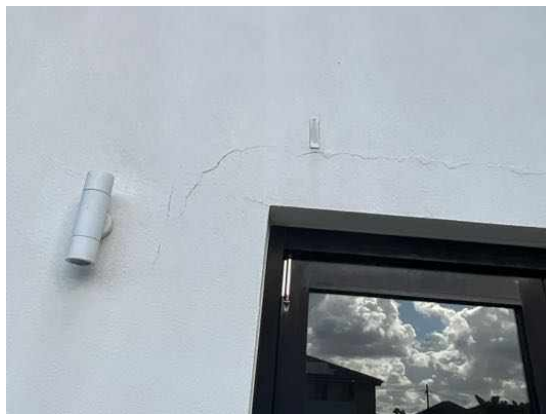
Finding 3.04

Building: Main Building
 Location: Rear Elevation
 Finding: Cracking - Damage Category 0 - Hairline (less than 1mm)
 Information: Hairline cracks are very minor in nature and generally are only ever an appearance defect. While such cracking may be noticeable in some cases, it is quite common and does not indicate any structural damage.

Cracking of this nature can generally be repaired with minor sanding, filling and/or repainting. Such works should be performed by a qualified painter or a general handyman.

Monitoring of all cracking should be conducted frequently. Always contact a building inspector should cracks widen, lengthen, or become more numerous.

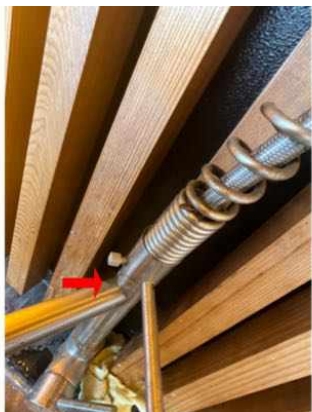
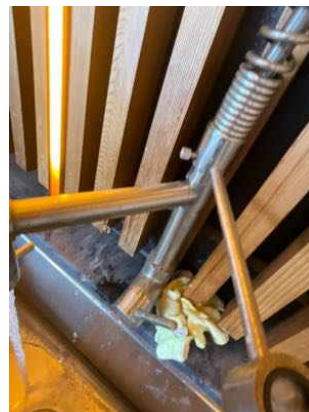
Finding 3.05

Building: Main Building
 Location: Entertainment area
 Finding: Leaking plumbing fitting
 Information: Leaking plumbing fitting identified, posing the risk of water damage and increased water bills.

Potential structural damage, mold growth, and wastage of water resources.

Engage a licensed plumber to inspect and repair the leaking plumbing fitting, ensuring a proper seal and preventing any further water-related issues.

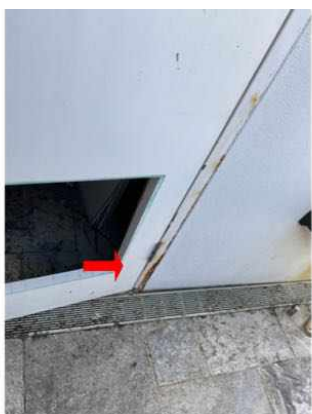
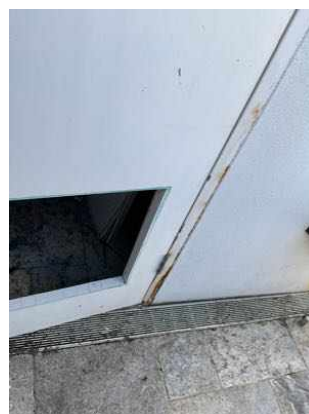
Finding 3.06

Building:	Main Building
Location:	All Areas
Finding:	Building element - Rusted or corroded
Information:	This building element shows evidence of rusting and corrosion, which is likely to have developed as a result of excessive exposure to moisture and or inadequate coatings.

As surface rust provides no protection to the underlying iron, the deteriorating condition is likely to worsen if not addressed in the short-term future.

Where possible, the use of galvanized (treated) metals or aluminium coated metals aid in rust prevention, as does regular general maintenance. Rust formation can be controlled with coatings, such as paint, that isolate the iron from the environment.

Rusting and corrosion should be managed by ideally removing or limiting the affected surface from exposure to moisture. A registered builder may be appointed to replace any building elements that have been severely affected by rust or water damage.

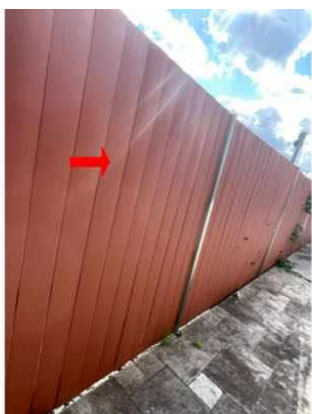
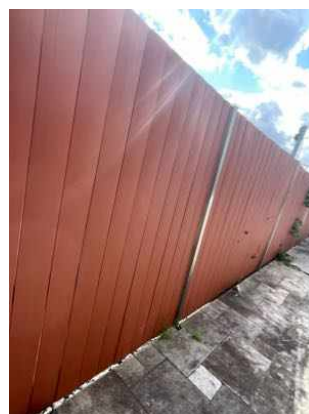
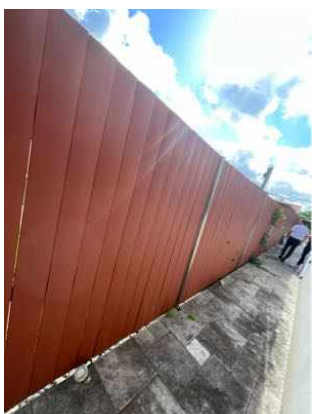
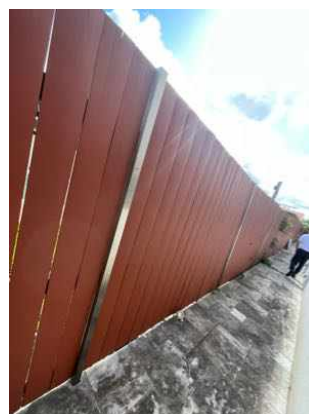
Finding 3.07

Building: Main Building
 Location: Yard - Side
 Finding: Leaning timber fence
 Information: The fence is leaning, deviating from its vertical position, compromising its stability and aesthetic appeal.

The leaning fence poses a risk of collapse, potential property damage, and a security breach, diminishing its effectiveness as a barrier.

A skilled fencing contractor or handyman is needed to assess and rectify the leaning fence. Timely repair is crucial to restore the fence's stability and prevent further damage or safety hazards.

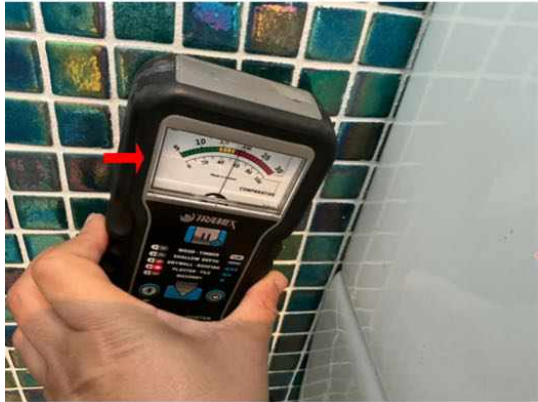
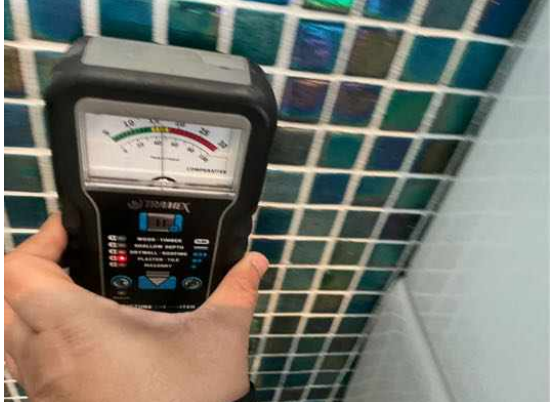
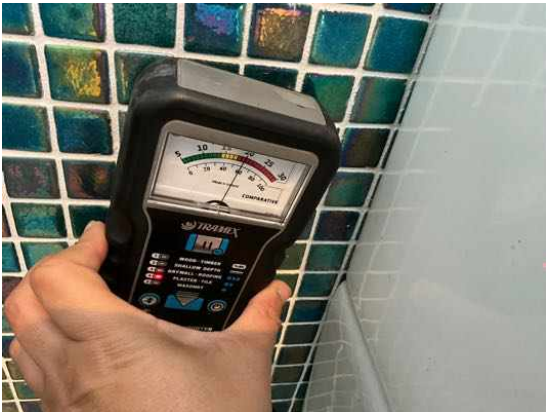
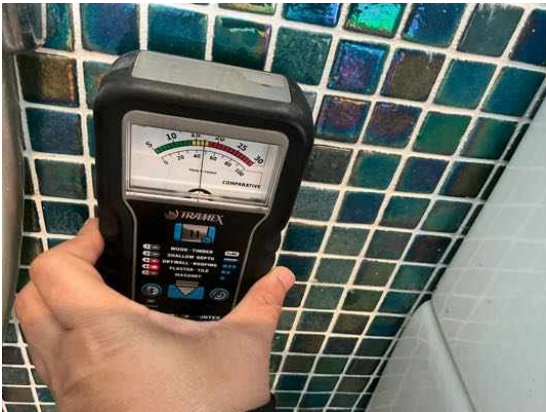
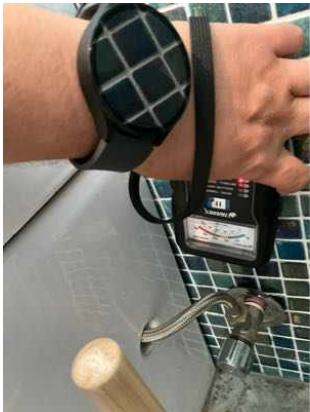
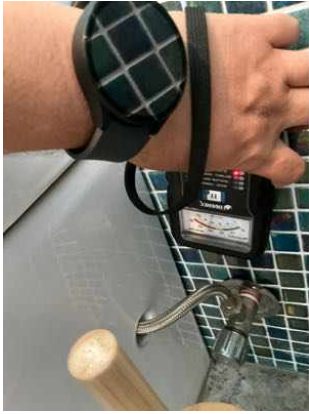
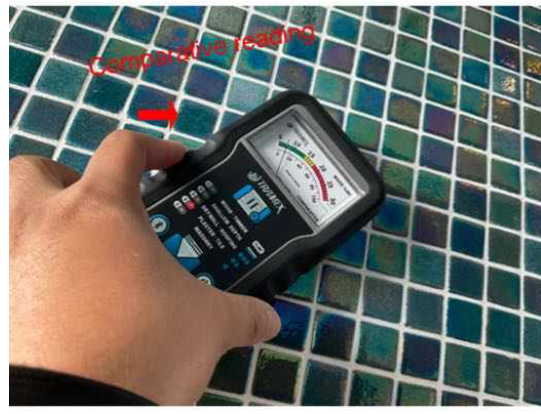
Finding 3.08

Building: Main Building
 Location: Entertainment area / Toilet
 Finding: Evidence of excessive moisture was present at the time of inspection
 Information: Excessive moisture is present behind the bathroom tiles, indicating a potential water leakage issue within the wall.

The prolonged presence of moisture can lead to mold growth, deteriorate the structure, and create an environment conducive to health hazards. Additionally, it may

compromise the adhesive holding the tiles, leading to their detachment.

A licensed plumber or a qualified contractor specializing in water damage remediation should investigate the source of the moisture, fix any leaks, and address the damage. Additionally, replacing affected tiles and ensuring proper waterproofing are crucial to preventing future issues.

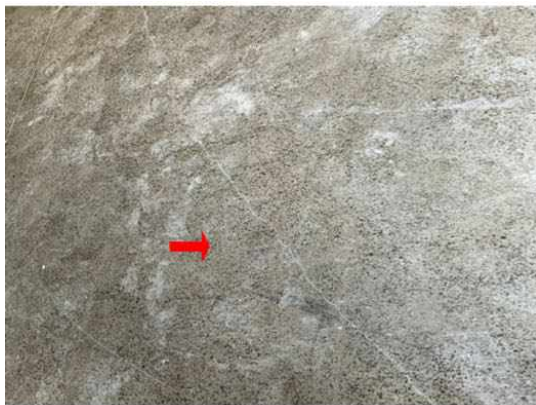
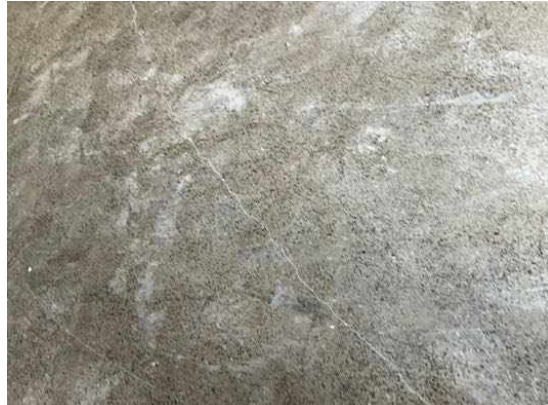
Finding 3.09

Finding: Crack in concrete slab - Category 0

Information: A crack coded as Category 0 was identified in the slab. A Category 0 crack is described as a hairline crack, representing insignificant movement of slab from level.

The approximate width of the crack to be considered Category 0 is 0.3mm, or change in offset of less than 8mm when a 3m straight edge is placed over the defect.

No rectification is required at this time. However, all cracking should be monitored over a 12 month period to identify any further damage in the area.

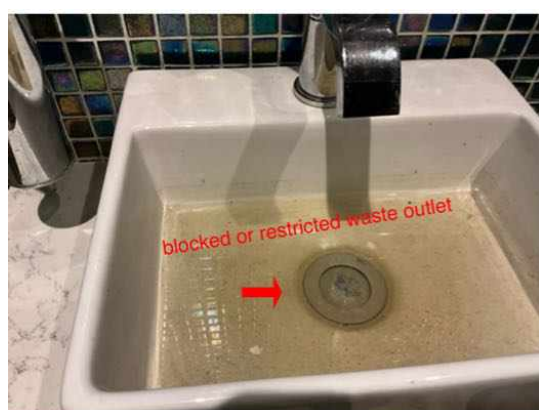
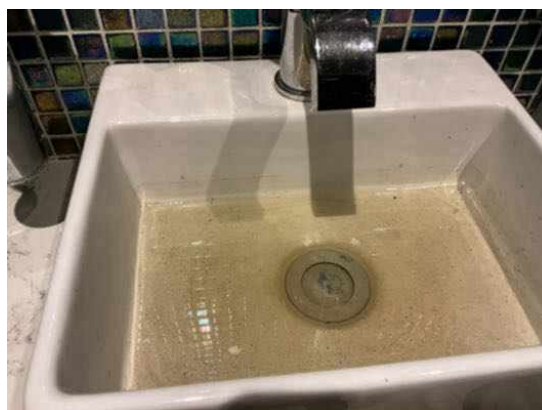
Finding 3.10

Information: The basin drain appeared to be blocked at the time of inspection. Blockages prevent building elements from operating as intended. If left unmanaged, a lack of general maintenance may lead to the development of more significant defects, such as water damage to surrounding building materials.

It is advised that the blockage be removed prior to any further inspection or remedial works. Additionally, check for any secondary or concealed damage and then attempt to address the cause of the blockage to prevent any water damage to associated structures.

A licensed plumber should be appointed as soon as possible to perform any remedial works where required. Please be advised that a cabinet maker or qualified carpenter may be required if water damage is evident.

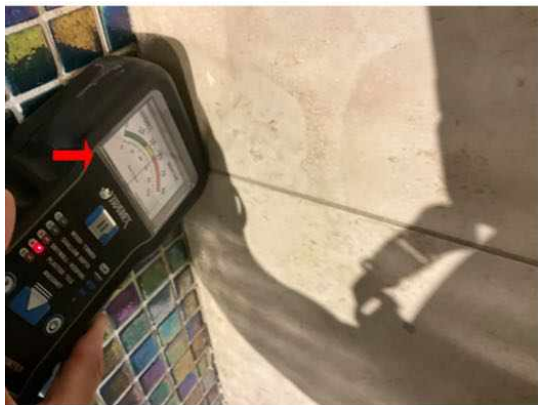
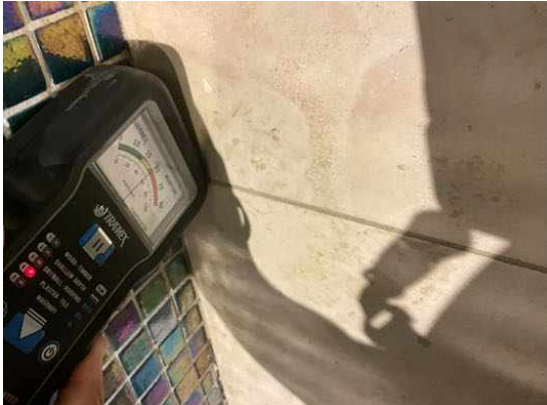
Finding 3.11

Building: Main Building
Location: Basement - Toilet
Finding: Evidence of excessive moisture was present at the time of inspection
Information: Excessive moisture is present behind the bathroom tiles, indicating a potential water leakage issue within the wall.

The prolonged presence of moisture can lead to mold growth, deteriorate the structure, and create an environment conducive to health hazards. Additionally, it may compromise the adhesive holding the tiles, leading to their detachment.

A licensed plumber or a qualified contractor specializing in water damage remediation should investigate the source of the moisture, fix any leaks, and address the damage. Additionally, replacing affected tiles and ensuring proper waterproofing are crucial to preventing future issues.

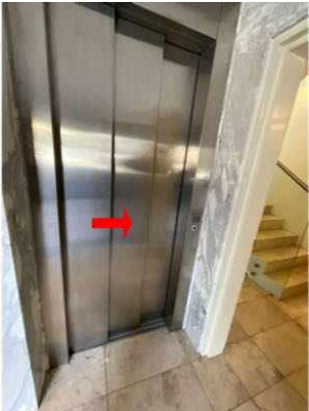
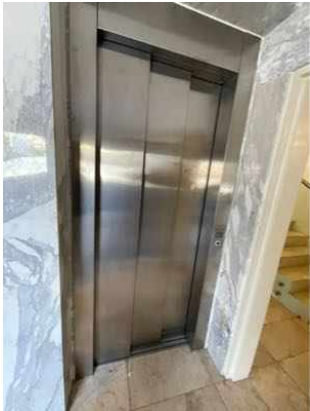
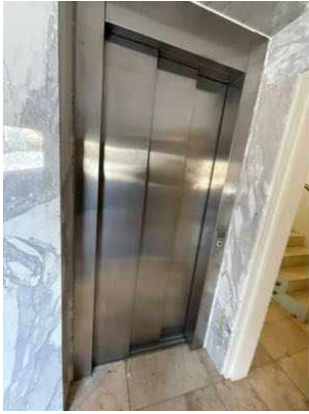
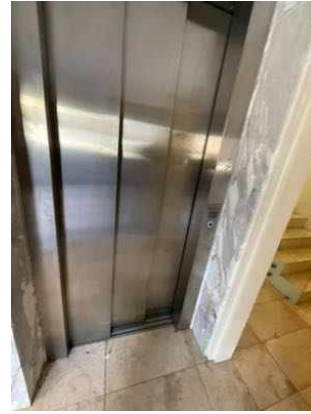
Finding 3.13

Building: Main Building
Location: Basement - Kitchen
Finding: Lift – Not Operating
Information: At the time of inspection, the lift was not operational. The cause could not be determined within the scope of inspection. This presents accessibility and safety concerns.

Recommendation: Arrange inspection and rectification by a licensed lift contractor.

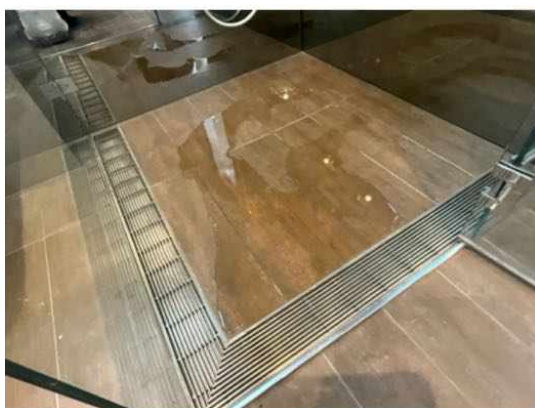
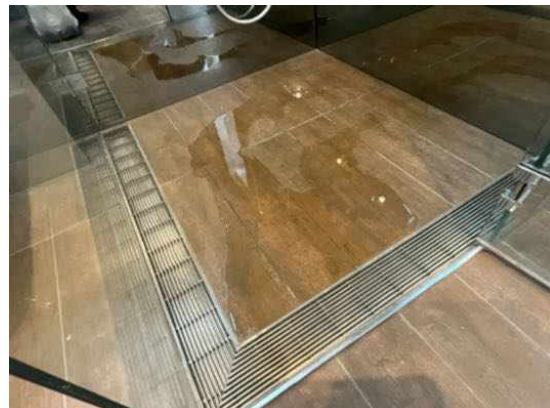
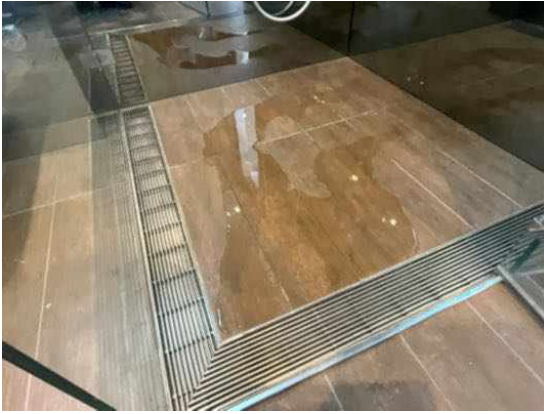
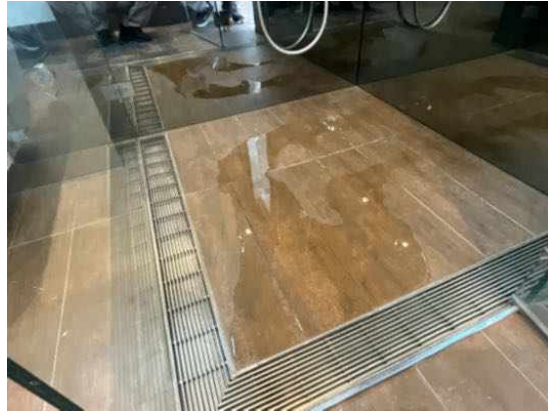
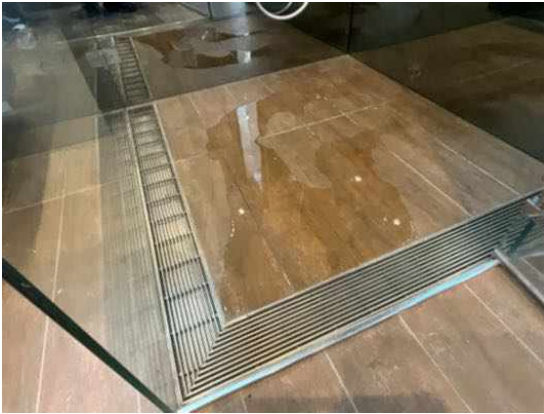
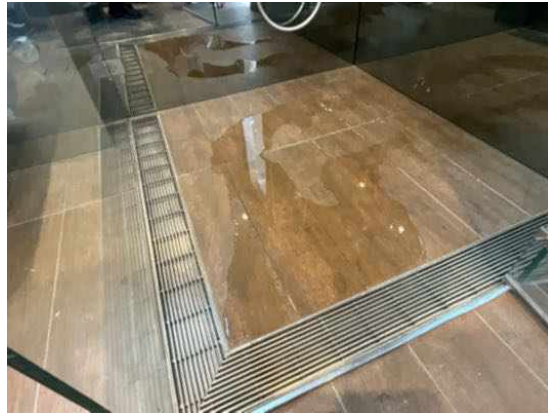
Finding 3.14

Building:	Main Building
Location:	Ensuite 1
Finding:	Shower base - Water pooling
Information:	Evidence of water pooling around the floor waste in the shower recess was noticed at the time of inspection. It is suspected that this excessive moisture is attributed to insufficient fall in the shower floor tiles.

This pooling is minor overall but is still considered unsatisfactory, as standard tiling practices would not permit this situation to occur. Pooling water around floor wastes can create a slip hazard in extreme cases and create conditions that are conducive to mould growth over time. Where left unmanaged, the degradation of sealant and grouting is also likely to occur, possibly necessitating further repair works.

Remedial works may involve some sections of tiling and flooring repair and replacement. A tiling contractor or bathroom specialist should be appointed to provide further advice on reparation options and to perform works as necessary.

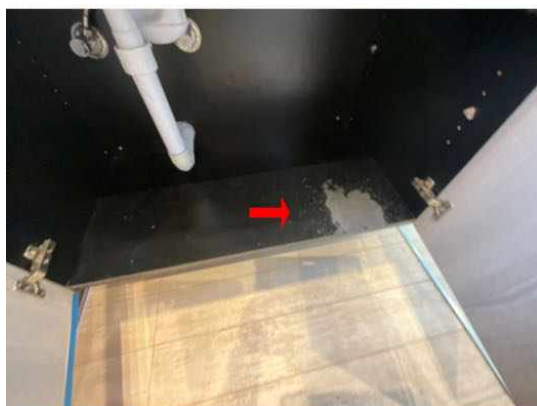
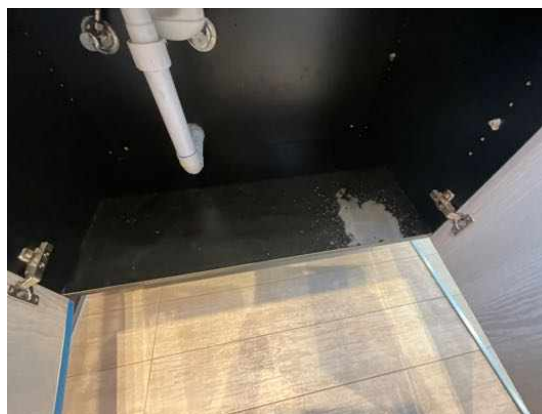
Finding 3.15

Building:	Main Building
Location:	Ensuite - Master
Finding:	Water Stains in Vanity
Information:	"Water stains observed in the vanity area, compromising its appearance and potentially causing damage."

Continued water exposure may lead to material damage, mold growth, and diminished aesthetic appeal.

A licensed plumber or maintenance professional should assess and fix any leaks contributing to the water stains, while a cleaning or restoration service may be needed to address the visible stains and prevent further damage.

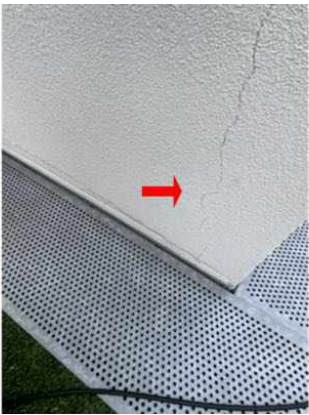
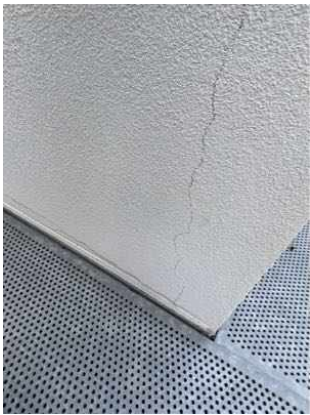
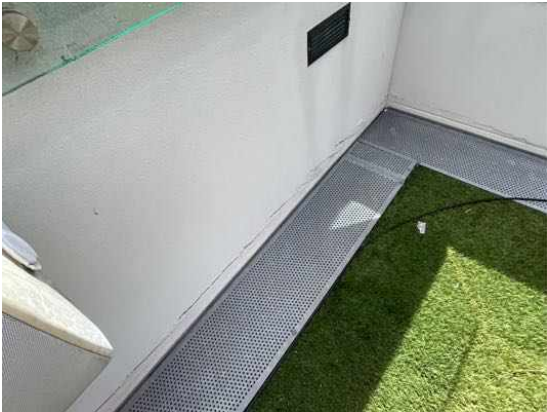
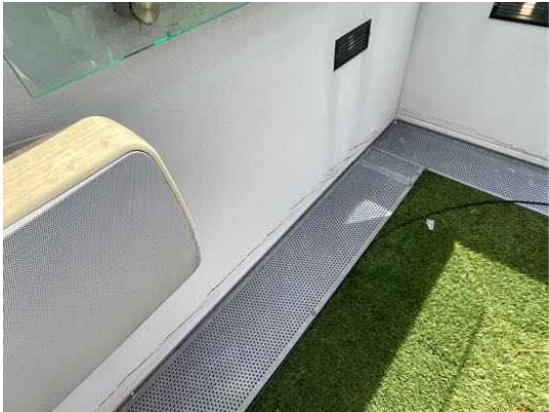
Finding 3.16

Building:	Main Building
Location:	Roof top
Finding:	Deteriorated Rendering
Information:	The rendering on the exterior walls of the building is deteriorating, showing signs of cracking, peeling, and flaking. This can be attributed to weathering, moisture ingress, or poor initial application.

- ****Structural Damage:**** Deteriorated rendering can allow moisture to penetrate the underlying structure, leading to further damage, weakening the integrity of the building, and potentially causing structural issues over time.
- ****Aesthetic Impact:**** The appearance of the building is adversely affected, which can reduce the property's curb appeal and value.
- ****Insulation Problems:**** Poor rendering can affect the thermal insulation properties of the walls, leading to increased energy costs for heating and cooling.
- ****Safety Concerns:**** Loose or falling render poses a safety hazard to occupants and passersby.

- ****Professional Plasterer or Renderer:**** A skilled plasterer or renderer should be engaged to assess the extent of the damage, remove the deteriorated rendering, and apply a new, high-quality render to the affected areas.
- ****General Contractor:**** For extensive damage, a general contractor may be necessary to coordinate the repair work, ensuring that any underlying structural issues are also addressed.
