Building and Timber Pest Inspection Report

Inspection Date: Wed, 21 Jan 2026

Property Address: 14 Frances St, LIDCOMBE, NSW, 2141,
Australia

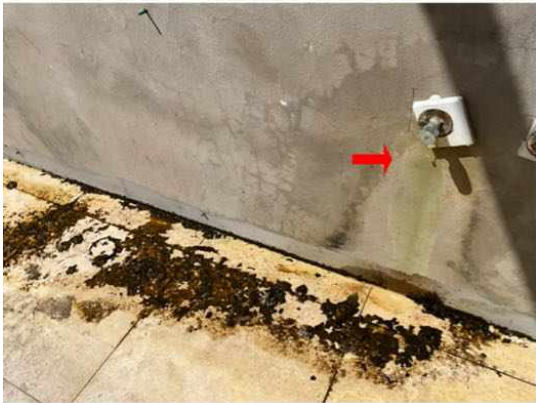
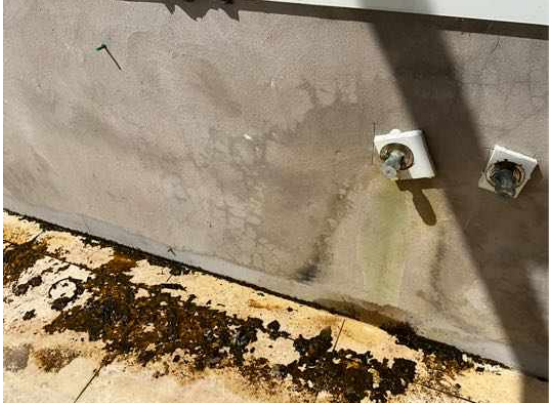
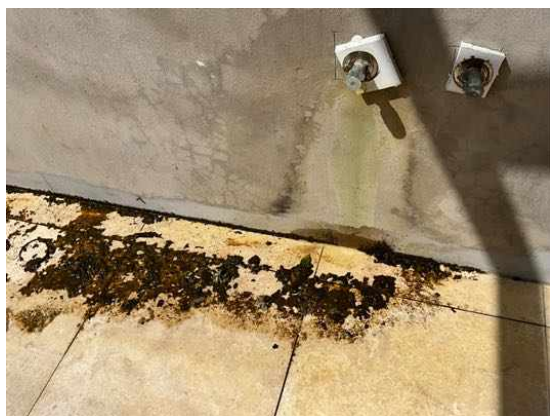
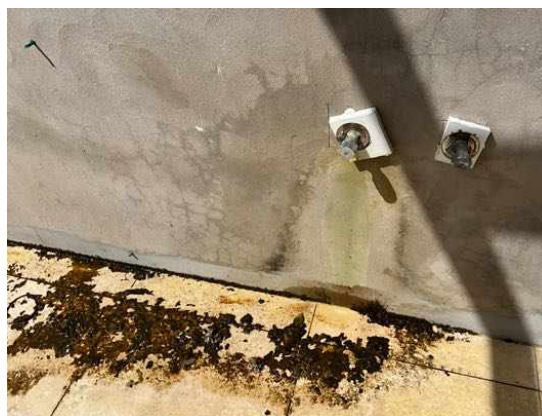
Finding 3.17

Building: Main Building
 Location: Roof top
 Finding: Leaking plumbing fitting
 Information: Leaking plumbing fitting identified, posing the risk of water damage and increased water bills.

Potential structural damage, mold growth, and wastage of water resources.

Engage a licensed plumber to inspect and repair the leaking plumbing fitting, ensuring a proper seal and preventing any further water-related issues.

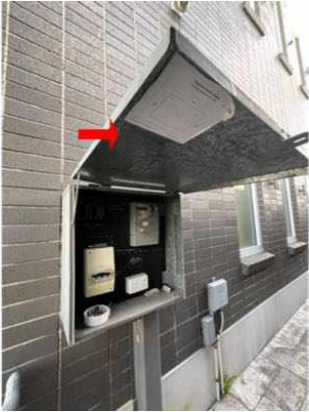
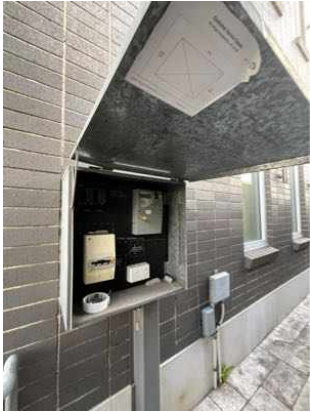
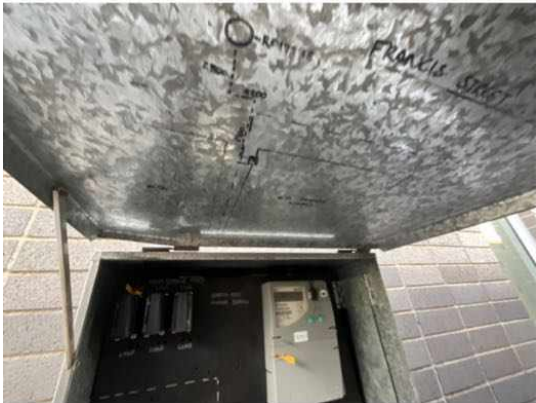
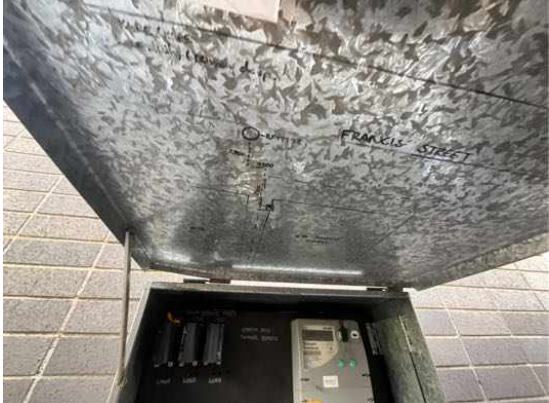
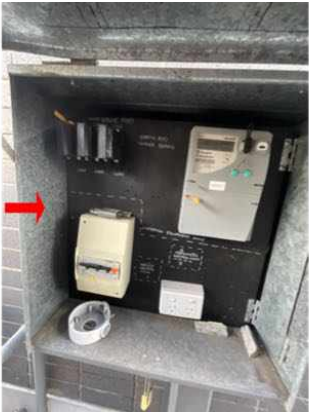
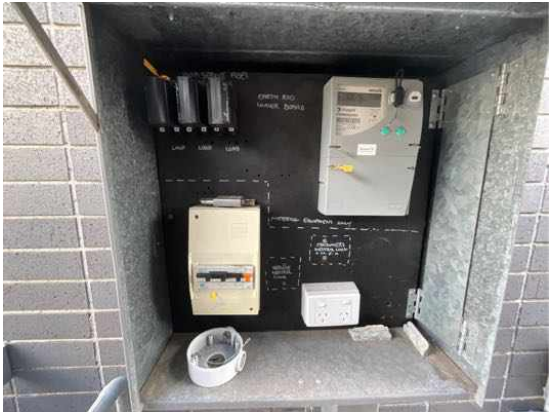
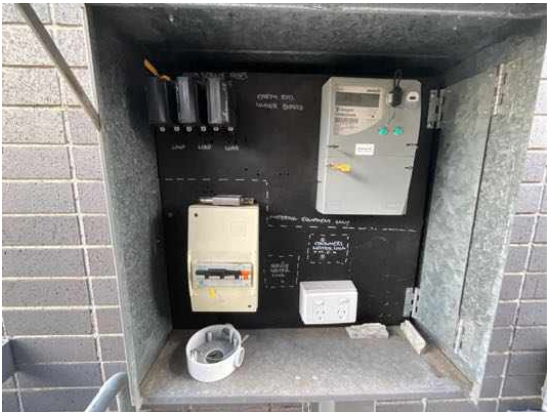
Building: Main Building
 Location: Exterior walls - right side
 Finding: No Evidence of Termite Management System - Durable notice / Legible Sticker
 Information: The application of a pre & post-construction chemical termite barrier is highly recommended for all properties. Such barriers are highly effective in preventing termite attack on any timber building elements throughout the property.

A durable notice was not placed in the switchboard unit to indicate current termite barriers is legible at the time of inspection.

Client must seek further information from the vendor or real estate agent if the conditions of termite management systems were maintained.

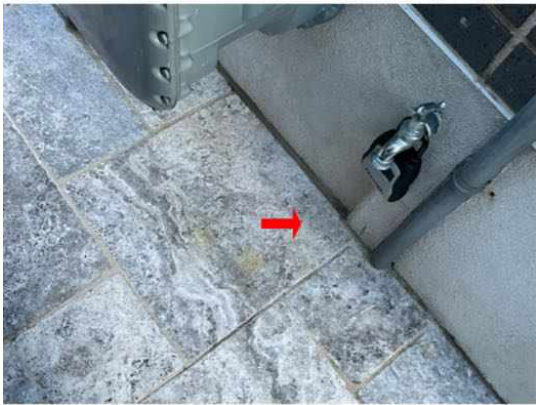
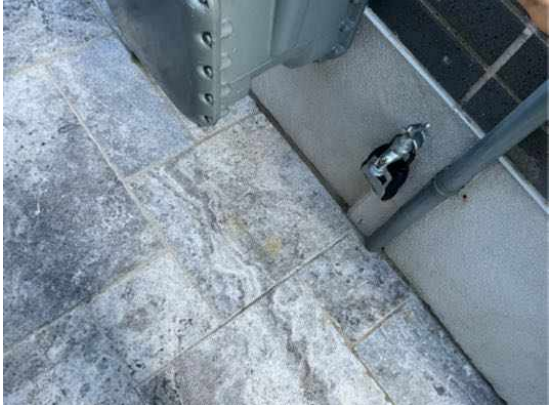
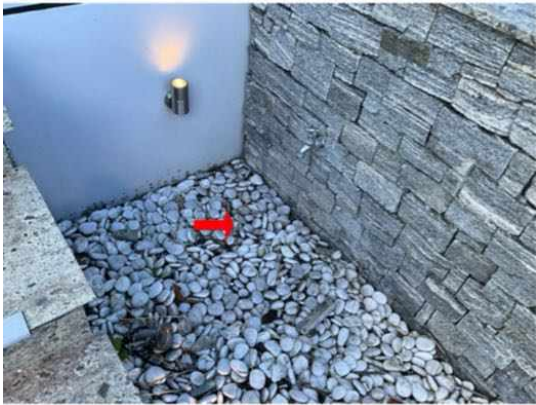
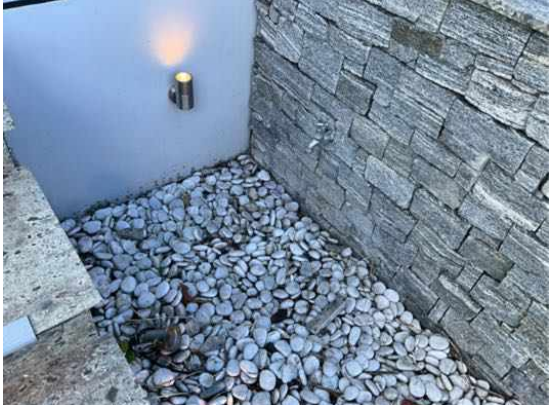
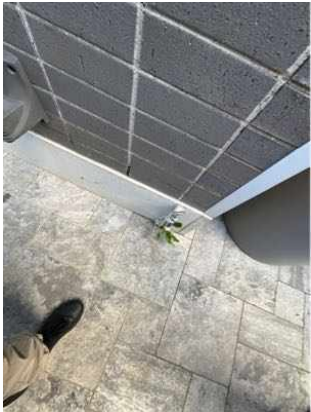
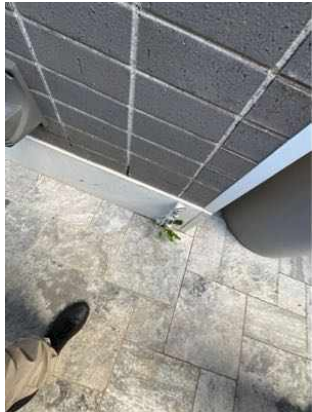
Building: Main Building
Location: All Areas
Finding: No Drain under tap
Information: There is no drain installed under the tap, leading to water accumulation and creating conducive conditions for timber pests. This defect needs immediate attention to prevent potential damage and pest infestation.

1. Water Accumulation: Without proper drainage, water can accumulate around the base of the tap, leading to persistent dampness in the surrounding area.
2. Timber Pest Infestation: The damp environment created by standing water is highly conducive to timber pests, such as termites and wood borers, which thrive in moist conditions and can cause significant damage to wooden structures.
3. Structural Damage: Prolonged exposure to moisture can lead to wood rot and deterioration of structural timber, compromising the integrity of the building.
4. Health Hazards: Persistent dampness can also promote mold and mildew growth, posing health risks to occupants.
5. Aesthetic Damage: Water stains and damage to finishes and materials around the tap area can detract from the appearance of the building and lead to costly repairs.

A licensed plumber or a qualified building contractor can address this defect by:

1. Assessment: Evaluating the area to determine the best approach for installing a proper drainage system under the tap.
2. Installation: Installing a drain that effectively channels water away from the base of the tap, preventing water accumulation and dampness.
3. Repair and Prevention: Inspecting and repairing any existing water damage and implementing measures to prevent future water accumulation and pest infestations.

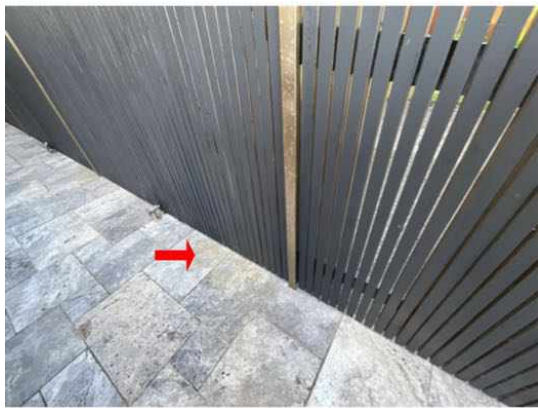
Finding 6.03

Building: Main Building
Location: All Areas
Finding: Timber on ground / conducive conditions to termite damage
Information: Timber on the ground is indeed conducive to termite damage. Termites are known to thrive in moist environments, and wood in contact with soil or moisture is more susceptible to infestation.

To prevent this, it's important to keep timber elevated and away from direct ground contact. Regular inspections and proper termite control measures are also essential to protect your wooden structures from termite damage.

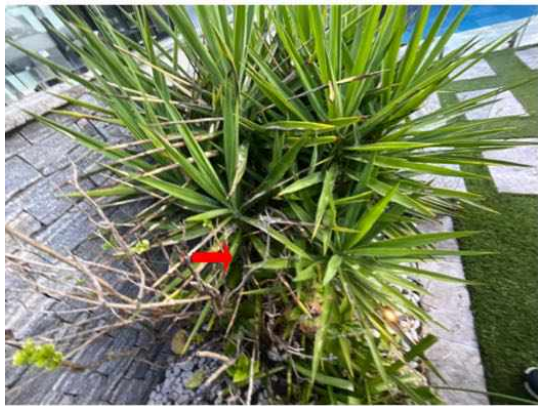
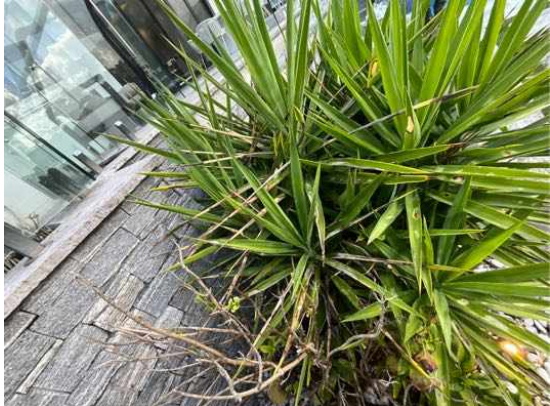
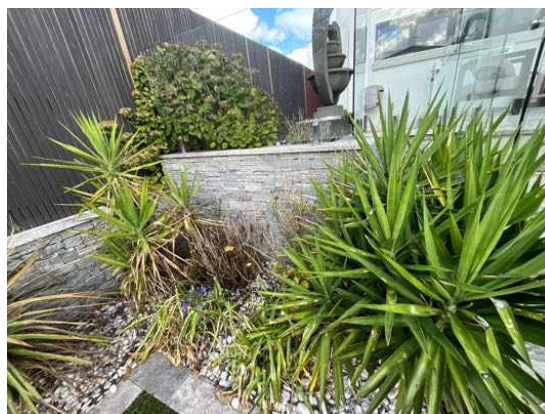
Finding 6.04

Building: Main Building
Location: All Areas
Finding: Dense vegetation around a property can increase the risk of termite infestation
Information: The presence of dense vegetation around a property can increase the risk of termite infestation, as it provides a conducive environment for them. To address this, consider maintaining a clear space between the vegetation and your home. If you suspect a termite issue, it's advisable to consult with a licensed pest control professional for inspection and treatment.

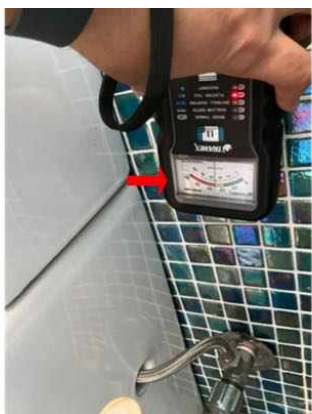
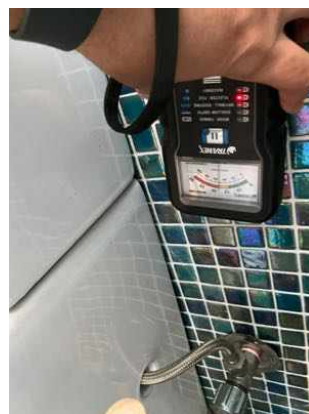
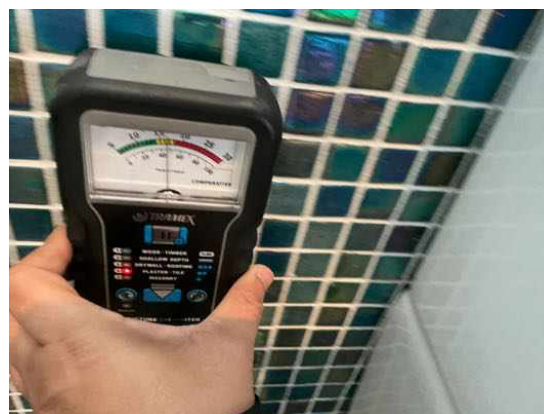
Finding 6.05

Building:	Main Building
Location:	Entertainment area / Toilet
Finding:	Excessive moisture - Conducive to Timber pest
Information:	Excessive moisture can attract termites and produce conditions that promote fungal growth and wood decay.

Excessive moisture is generally caused by deteriorated inadequate or missing roof drainage leaking plumbing pipes or fixtures poorly plumbed HWS overflows or condenser units and poor site drainage.

Prior to any remedial works being performed a qualified plumber should be appointed to further inspect the property and to identify the cause of the excessive moisture. Works to remove affected building elements may then be necessary and should be performed by an appropriate tradesperson.

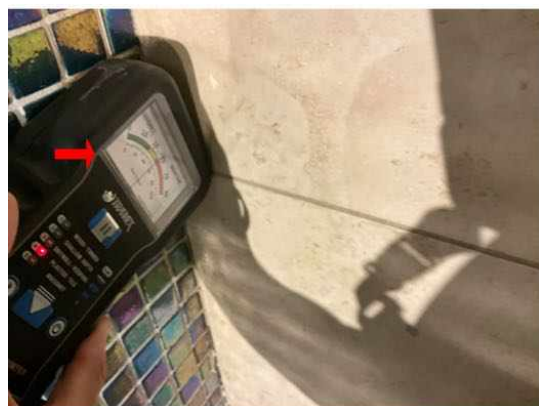
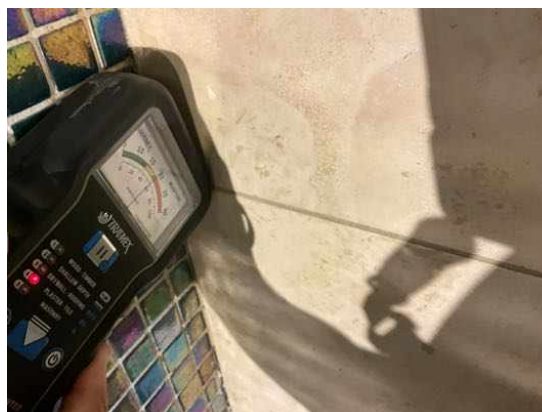
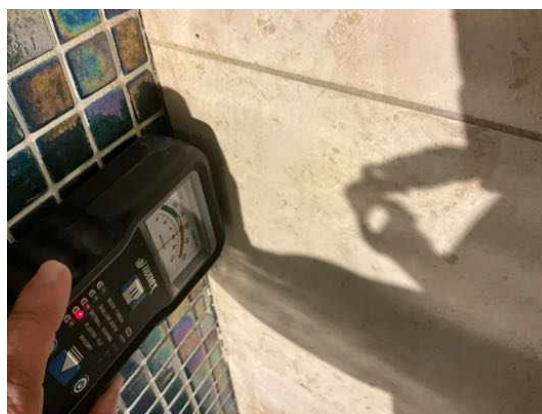
Finding 6.06

Building:	Main Building
Location:	Basement - Toilet
Finding:	Excessive moisture - Conducive to Timber pest
Information:	Excessive moisture can attract termites and produce conditions that promote fungal growth and wood decay.

Excessive moisture is generally caused by deteriorated inadequate or missing roof drainage leaking plumbing pipes or fixtures poorly plumbed HWS overflows or condenser units and poor site drainage.

Prior to any remedial works being performed a qualified plumber should be appointed to further inspect the property and to identify the cause of the excessive moisture. Works to remove affected building elements may then be necessary and should be performed by an appropriate tradesperson.

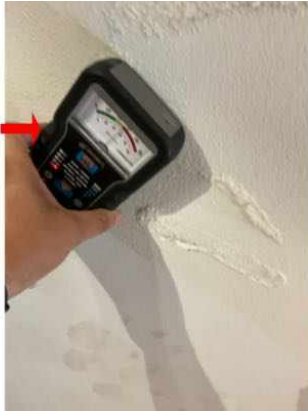
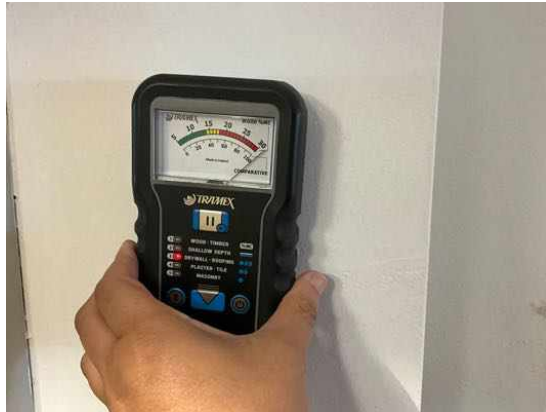
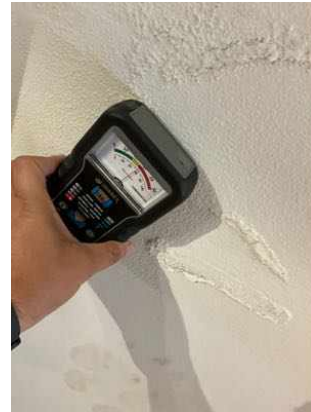
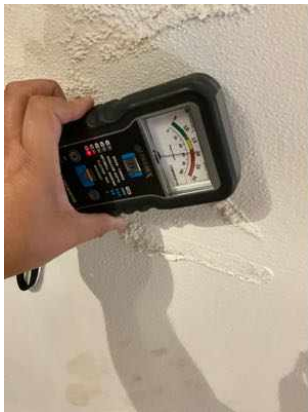
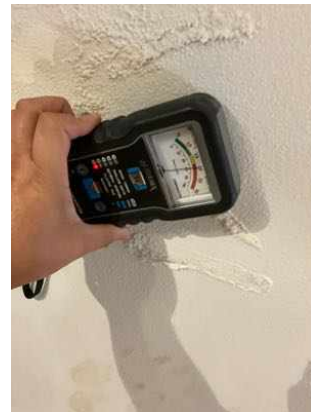
Finding 6.07

Building:	Main Building
Location:	Basement
Finding:	Excessive moisture - Conducive to Timber pest
Information:	Excessive moisture can attract termites and produce conditions that promote fungal growth and wood decay.

Excessive moisture is generally caused by deteriorated inadequate or missing roof drainage leaking plumbing pipes or fixtures poorly plumbed HWS overflows or condenser units and poor site drainage.

Prior to any remedial works being performed a qualified plumber should be appointed to further inspect the property and to identify the cause of the excessive moisture. Works to remove affected building elements may then be necessary and should be performed by an appropriate tradesperson.

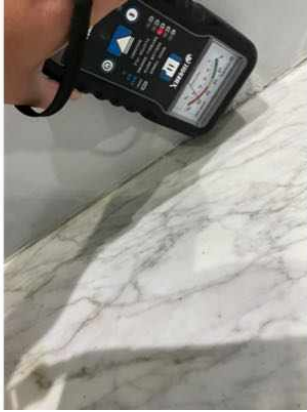
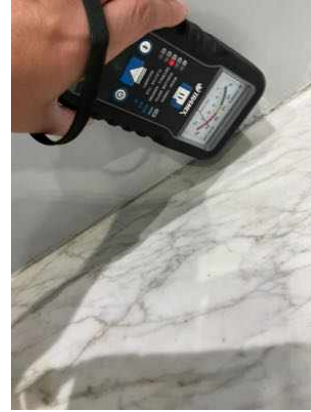
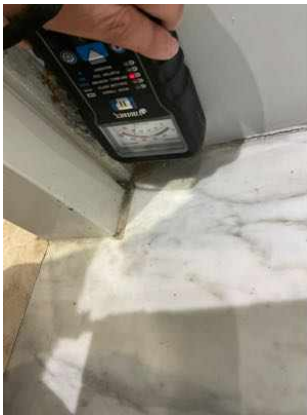
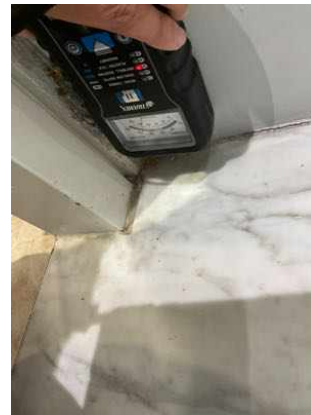
Finding 6.08

Building:	Main Building
Location:	Bathroom downstairs
Finding:	Excessive moisture - Conducive to Timber pest
Information:	Excessive moisture can attract termites and produce conditions that promote fungal growth and wood decay.

Excessive moisture is generally caused by deteriorated inadequate or missing roof drainage leaking plumbing pipes or fixtures poorly plumbed HWS overflows or condenser units and poor site drainage.

Prior to any remedial works being performed a qualified plumber should be appointed to further inspect the property and to identify the cause of the excessive moisture. Works to remove affected building elements may then be necessary and should be performed by an appropriate tradesperson.

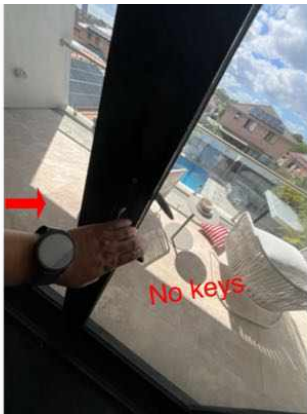
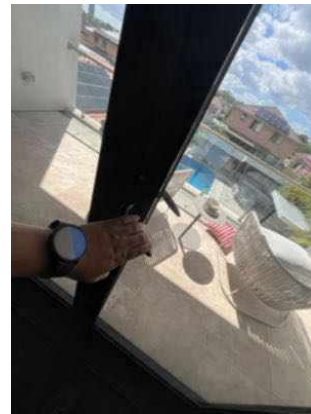
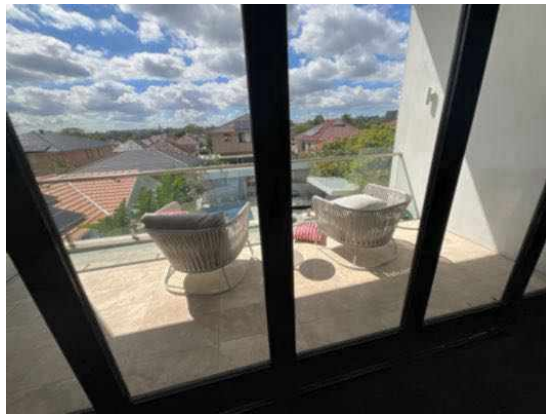
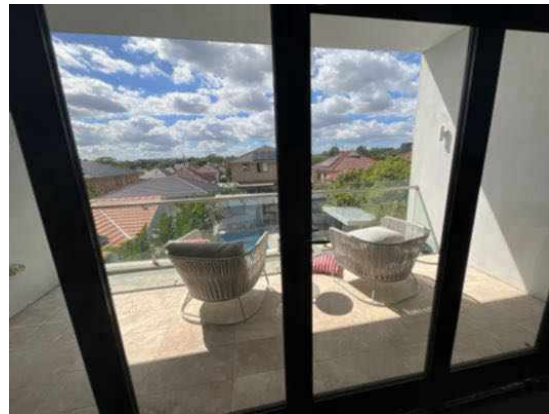
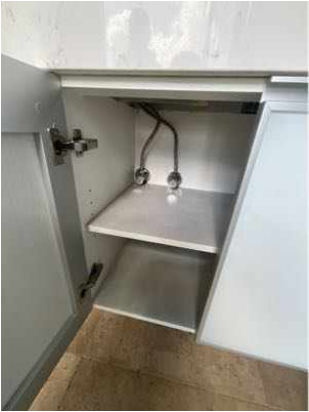
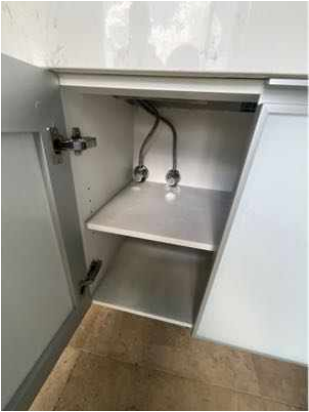
Finding: Additional Photos - Obstructions and Limitations

Information: These photographs are an indication of the obstructions and limitations which impeded full inspection of the property at the time of inspection. These obstructions can hide an array of defects and should be removed to allow full inspection to be carried out. A re-inspection is recommended once the areas are made accessible.
