Building and Timber Pest Inspection Report

Inspection Date: Tue, 24 Mar 2026

Property Address: 213 Somerville Rd, Yarraville VIC 3013,
Australia

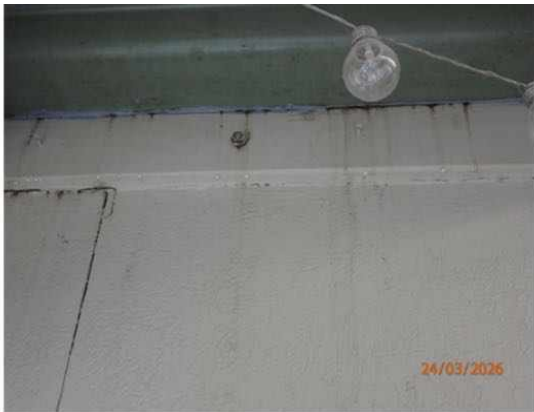
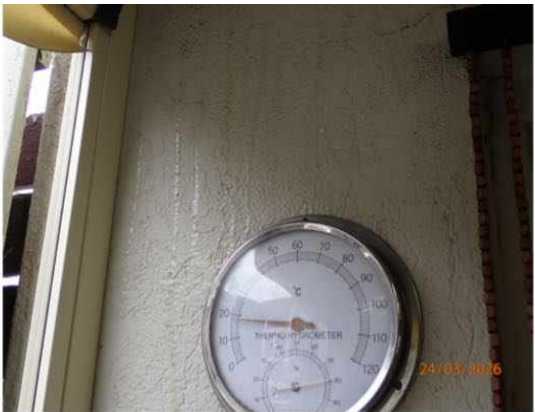
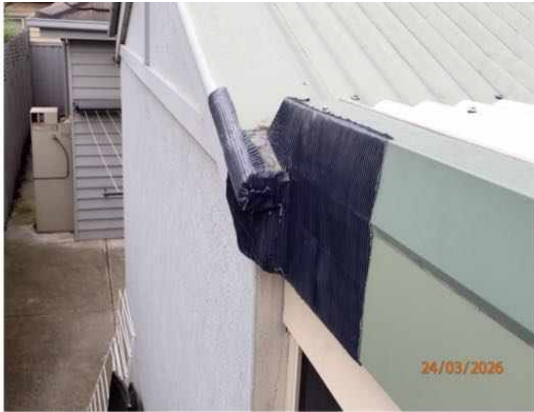
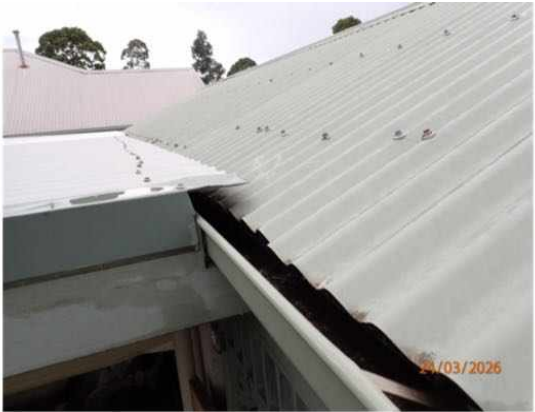
Finding 3.02

Building:	Main Building
Location:	Garage
Finding:	Rear pergola stormwater drainage
Information:	The rear pergola roof was noted discharging toward the garage roof area, with no box gutter installed and evidence suggesting the gutters may overflow during rainfall. This may be due to inadequate stormwater design, insufficient gutter capacity and/or poor drainage arrangement. This should be checked and rectified promptly to reduce the risk of moisture entry and ongoing water damage. A licensed plumber should be engaged promptly.

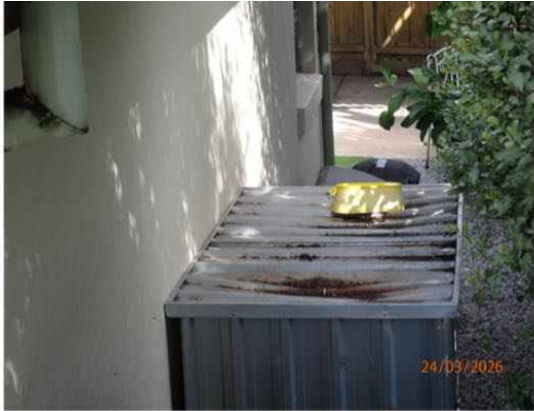
Finding 3.03

Building: Main Building
Location: Exterior walls - rear
Finding: Rear shed:
Information: The rear shed was noted deteriorated, rusted and damaged during inspection. This is consistent with age-related deterioration and prolonged weather exposure. Repairs or replacement should be carried out to prevent further decline and potential safety concerns. A suitable handy person or shed contractor should be engaged in the near term.

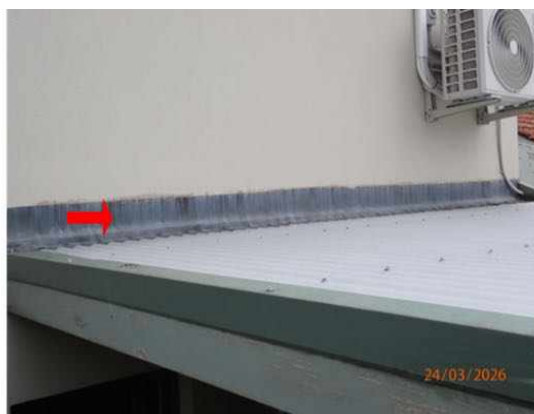
Finding 3.04

Building:	Main Building
Location:	Exterior walls - rear
Finding:	Pergola roof flashing: inadequate
Information:	The flashing to the rear pergola roof was noted inadequate, with a temporary self-adhesive flashing material applied. No active leakage was noted at the time of inspection; however, the current repair appears temporary only and may not provide long-term weatherproofing. A proper flashing repair is recommended. A licensed plumber should be engaged in the near term.

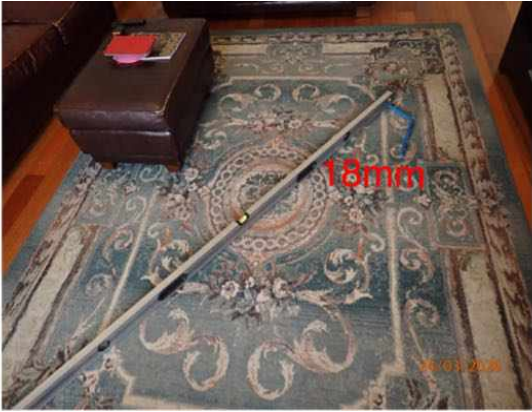
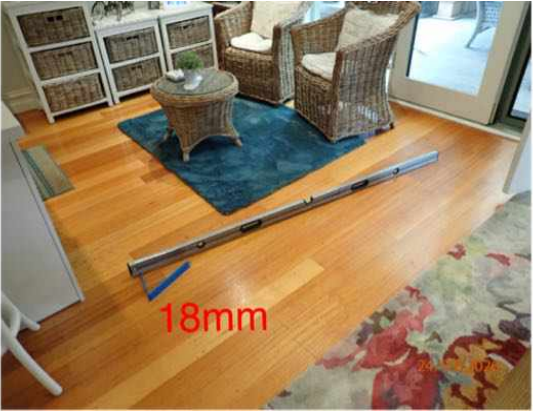
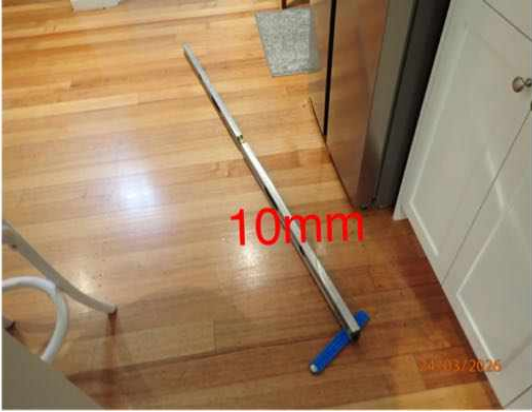
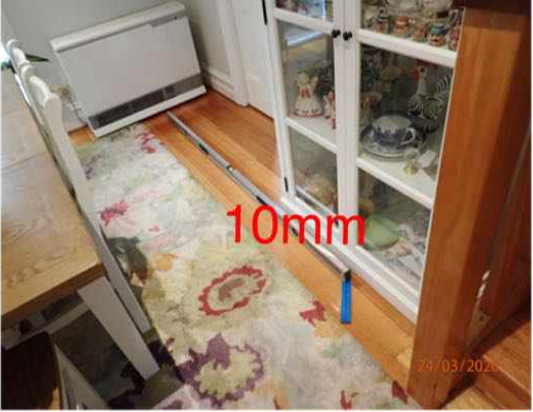
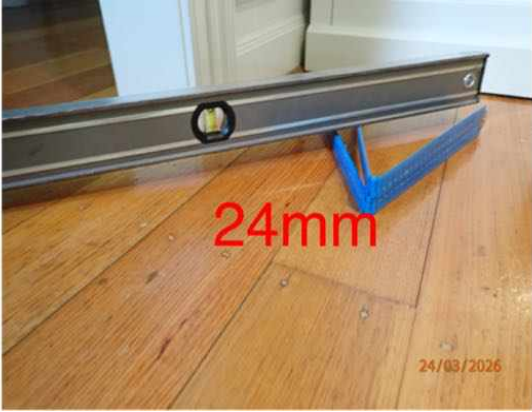
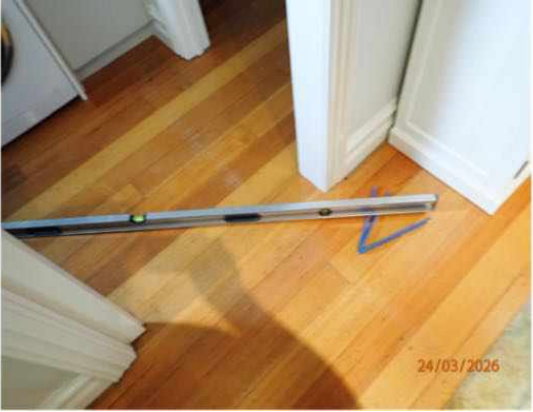
Finding 3.05

Building:	Main Building
Location:	All Internal Areas
Finding:	Flooring - Uneven
Information:	The internal flooring in this area is out of level and uneven, more than what is typically expected. Uneven flooring can indicate minor defects such as movement of the foundations, but in this case, the extent of unevenness suggests potential subsidence of the associated subfloor stumps.

Of greater concern are the the significantly out-of-level flooring to the living room, kitchen, dining and laundry areas, and the wall around the cavity sliding door between the living room and laundry, which appeared out of level and may be inadequately supported. These defects may be associated with substandard building practices and/or movement to the supporting structure over time. A registered builder should be engaged promptly to further assess these areas, and a structural engineer should be consulted if required to determine the extent of movement and any rectification works needed.

It is advised that further inspection of the subfloor structures and stumps be conducted to determine the cause of the excessive unevenness. This may involve a potentially invasive inspection to accurately assess the condition and stability of the subfloor components.

Based on the findings, works to repair the flooring may be required. It is recommended that a registered builder specializing in re-stumping be engaged to carry out these necessary repairs to ensure the structural integrity and levelness of the flooring.

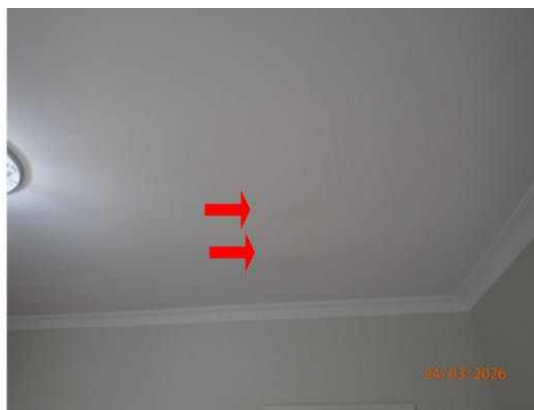
Finding 3.06

Building: Main Building
 Location: Bedroom - Master
 Finding: Master bedroom ceiling moisture staining:
 Information: Water staining and high moisture readings were noted to the ceiling of the master bedroom during inspection. The staining pattern did not appear consistent with a typical roof leak, and a concealed plumbing leak or other moisture source cannot be ruled out. This should be investigated promptly to prevent hidden damage and further deterioration. A licensed plumber should be engaged promptly, with a registered builder to repair any damaged finishes once the source is rectified.

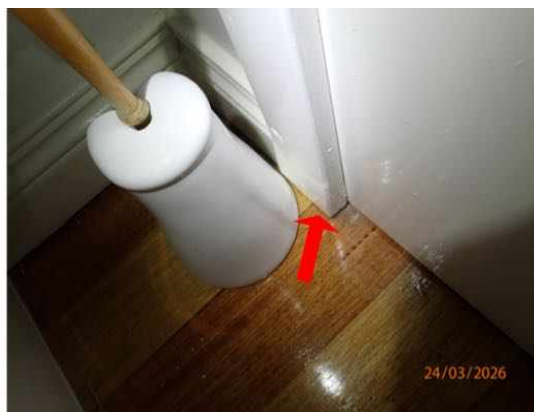
Finding 3.07

Building: Main Building
 Location: Toilet (WC)
 Finding: Swollen architrave:
 Information: The architrave to the storage room next to the toilet was noted swollen during inspection. No elevated moisture was detected at the time of inspection; however, the damage is likely due to past moisture exposure and/or wear over time. Repair or replacement is recommended to prevent further deterioration. A qualified carpenter should be engaged in the near term.

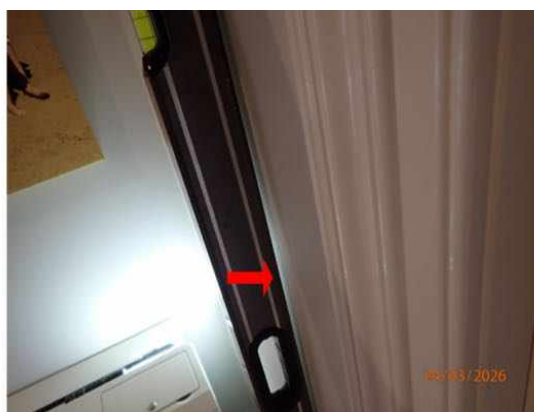
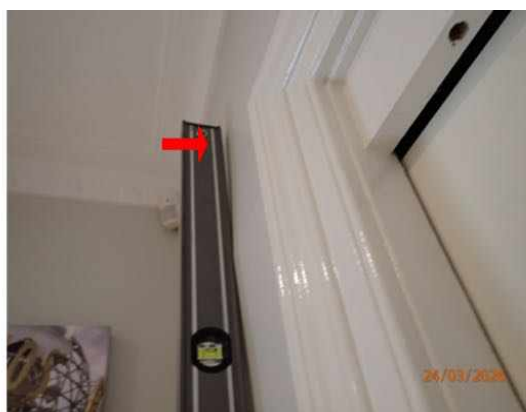
Finding 3.08

Building:	Main Building
Location:	Laundry
Finding:	Cavity sliding door wall alignment/support:
Information:	The wall between the living room and laundry at the cavity sliding door was noted out of level and appeared inadequately supported on one side during inspection. As this may indicate an issue with the framing or support within the cavity wall, further investigation is recommended. This should be checked promptly to determine whether concealed structural defects are present. A registered builder should be engaged promptly to remove the door lining and inspect the cavity, and a structural engineer should be consulted if structural inadequacy is confirmed.

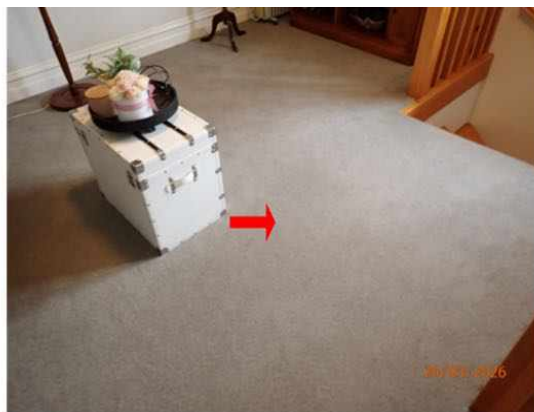
Finding 3.09

Building:	Main Building
Location:	Rumpus Room
Finding:	Squeaky upper floor:
Information:	The retreat floor on the upper level was noted squeaky during inspection. This is likely due to loosened fixings and/or movement between the flooring and supporting joists over time. Repair is recommended to improve performance and prevent further wear. A qualified carpenter should be engaged in the near term.

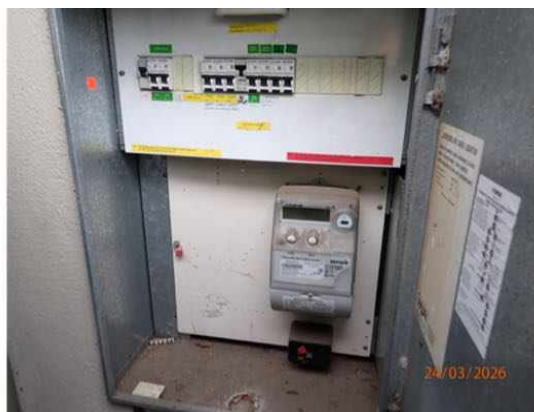
Building:	Main Building
Location:	Meter Box
Finding:	Termite Management System - no evidence of a chemical installation
Information:	The application of a post-construction chemical termite barrier is highly recommended for all properties, particularly if live termite activity has been found on the site previously. Such barriers are highly effective in preventing termite attack on any timber building elements throughout the property.

A durable notice should be placed in the switchboard unit to indicate current termite barriers. At the time of inspection, it appeared as though no termite management system has been installed, with no evidence to suggest preventative works taking place.

The client may consider gaining further advice from a pest controller as to the costs and procedures involved with this application. It is recommended that obtaining such advice be a short-term priority.

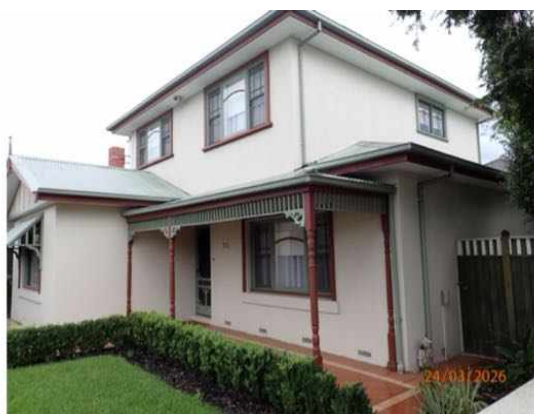
Finding 6.02

Building:	Main Building
Location:	All External Areas
Finding:	Garden Beds - Conditions Conducive to Termites
Information:	Garden beds were found to be evident abutting the external walls of the property. These garden beds can include untreated timber, and with a combination of moisture from watering hosing can make conditions conducive to termite activity and termite ingress.

It is recommended that the property owner be vigilant in reducing conducive conditions around the property where possible. If conducive conditions are present and not removable periodically inspections should be conducted by a licensed pest controller.

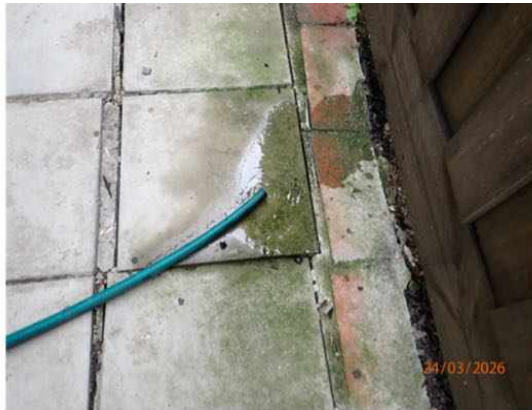
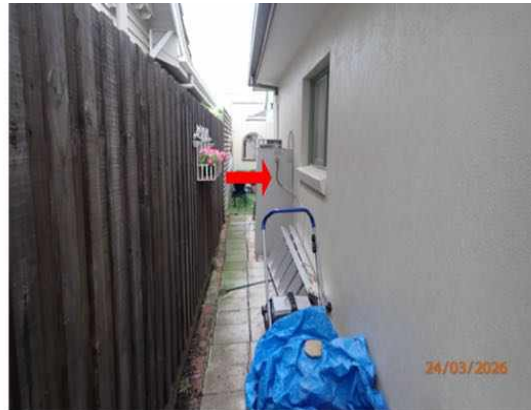
Finding 6.03

Building:	Main Building
Location:	All External Areas
Finding:	HWS Overflow - Not Connected
Information:	The Hot Water System (HWS) overflow was found to be disconnected from storm water drainage and is creating excessive moisture in the surrounding area.

These damp conditions can lead to secondary defects such as rot, rust or corrosion of associated building elements, the formation of fungal decay, or even the creation of potential slip hazards. When coupled with poor site drainage, pooling of water may also attract termite activity to this area.

It is highly recommended that a licensed plumber be appointed to connect the HWS overflow in order to prevent such an environment from being created. These minor works should be carried out as soon as possible.

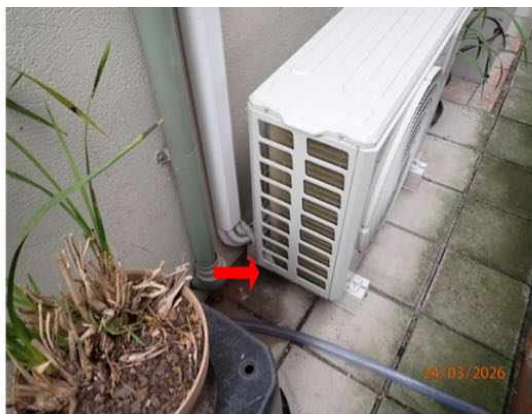
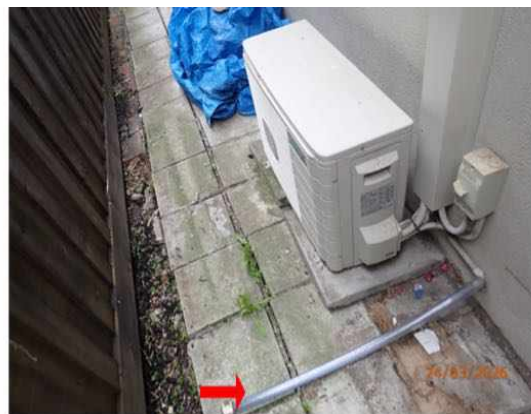
Finding 6.04

Building:	Main Building
Location:	All External Areas
Finding:	Air condition discharge - Not plumbed for drainage
Information:	The Air condition discharge is not plumbed or connected to suitable drainage, which has resulted in the surrounding area becoming excessively damp. These damp conditions can lead to secondary defects such as rot, rust or corrosion of associated building elements, the formation of fungal decay, or even the creation of potential slip hazards. When coupled with poor site drainage, pooling of water may also attract termite activity to this area. It is highly recommended that a qualified plumber be appointed to install adequate drainage to the overflow. These works will ensure that the area remains dry and free of any secondary defects.

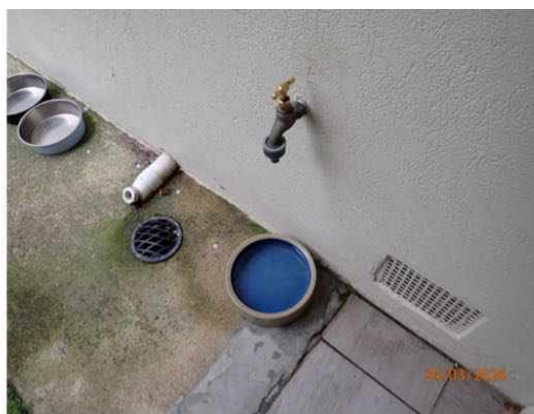
Finding 6.05

Building:	Main Building
Location:	All External Areas
Finding:	Tap - No Drain
Information:	It was found at the time of inspection the tap at this section of the property have no drain or basin below them. This can cause excess water next to the foundation of the property and can also attract termites.

A licensed plumber should be engaged for rectification as soon as possible.

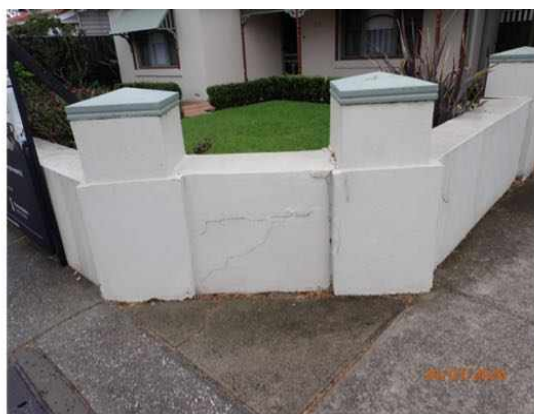
Building:	Main Building
Location:	Exterior walls - front
Finding:	Front fence:
Information:	Cracking and slight lean were noted to the front brick fence during inspection. This is likely due to age, weathering and/or minor movement over time. The fence should be monitored and repaired as required to prevent further deterioration. A registered builder or suitable handy person should be engaged in the near term.

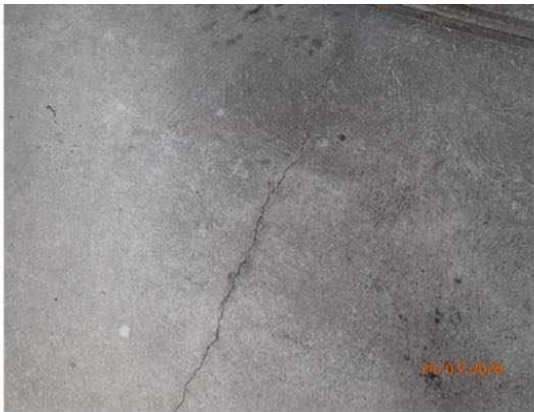
Building:	Main Building
Location:	Exterior walls - rear
Finding:	Driveway slab: Minor crack/s
Information:	Minor crack/s were noted to the concrete driveway slab during inspection. These are minor in nature and are commonly associated with age, shrinkage and/or minor ground movement. The affected areas should be monitored and repaired if cracking worsens. A registered builder or suitable concrete repair contractor should be engaged as required.

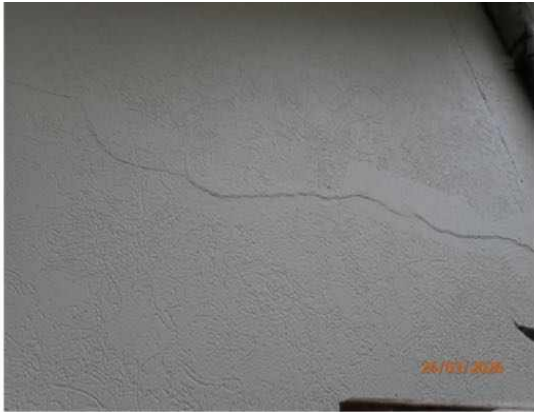
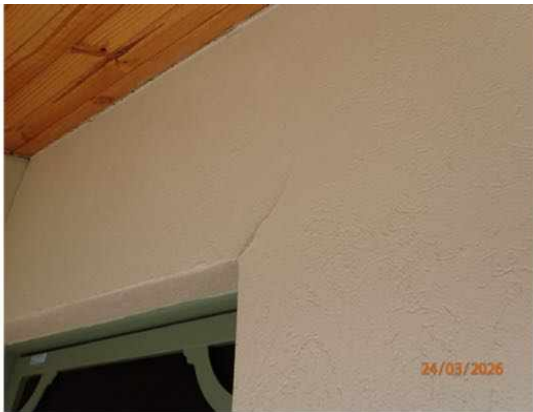
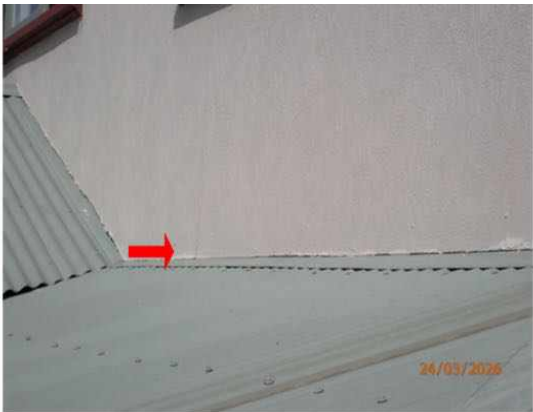
Building: Main Building
Location: All External Areas
Finding: External rendered wall cracking:
Information: Minor cracking was noted to the external rendered walls during inspection. Although some cracks were diagonal, they appear minor in nature at the time of inspection and may be associated with minor movement and/or render shrinkage. These areas should be monitored for any increase in width or further movement. A registered builder should be engaged for repairs, and a structural engineer should be consulted if cracking worsens.

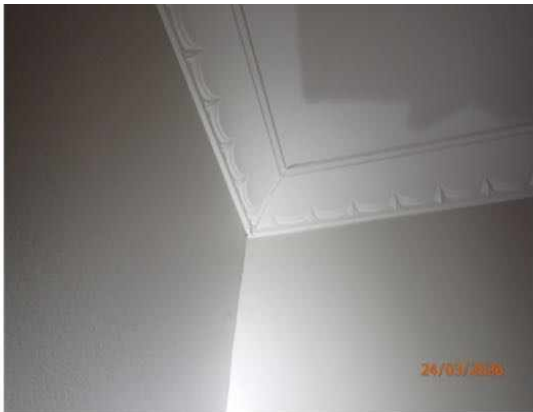
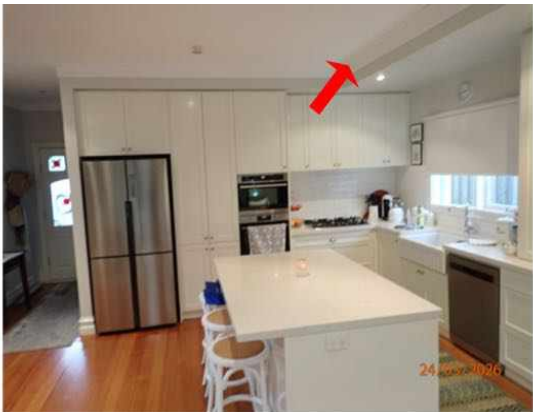
Building: Main Building
Location: All Internal Areas
Finding: Internal plaster cracking:
Information: Minor plaster cracking was noted to internal wall surfaces throughout the house during inspection. This is commonly associated with minor settlement, movement and/or normal age-related building movement. These areas should be monitored and repaired as required. A handy person or registered builder should be engaged if repairs are desired, and a structural engineer should be consulted if cracking worsens.

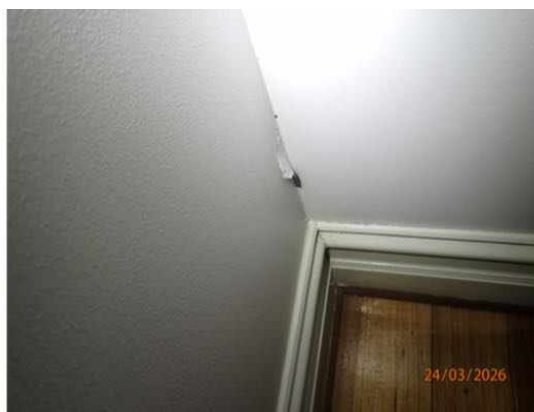
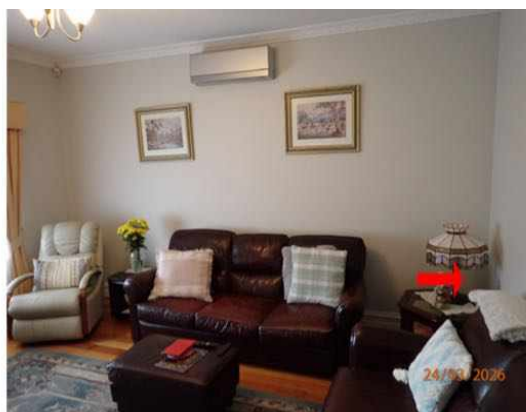
Building: Main Building
 Location: Living Room
 Finding: Living room plasterboard damage:
 Information: Damaged plasterboard was noted in the living room during inspection, likely due to impact damage and general wear and tear. Repair is recommended to maintain the finish and prevent further deterioration. A handy person or qualified carpenter should be engaged in the near term.

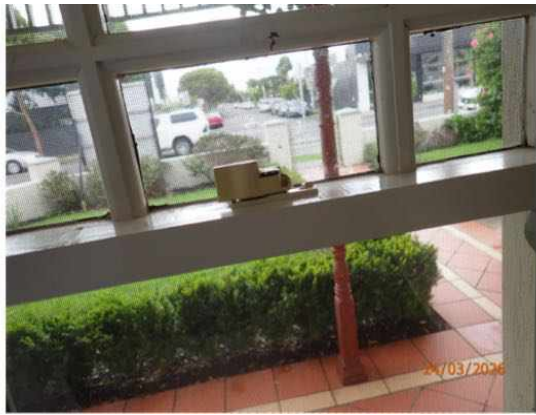
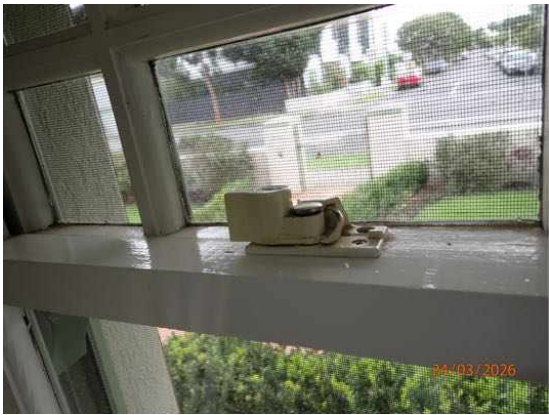
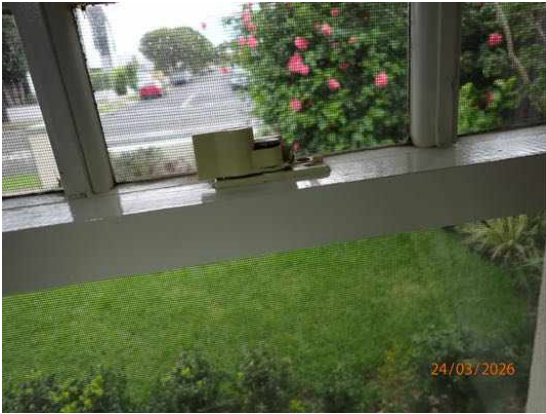
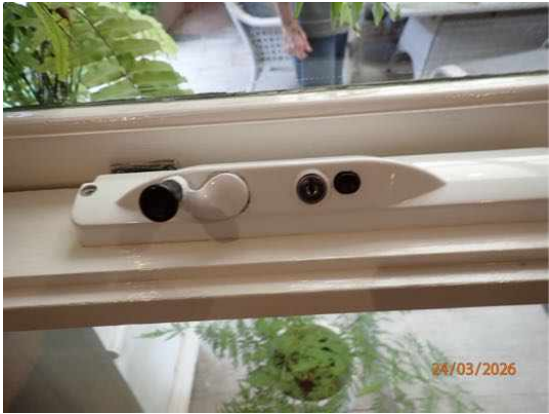
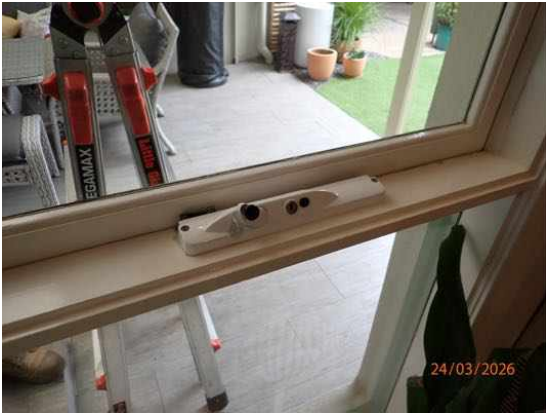
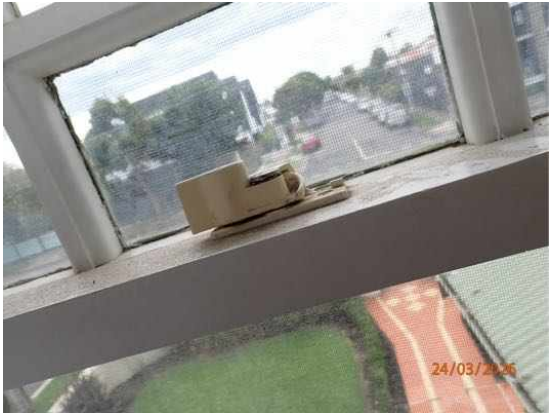
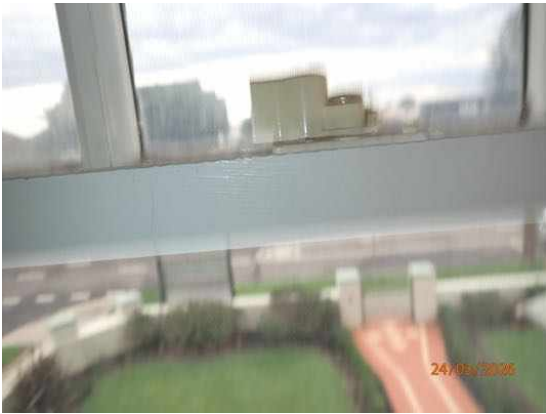
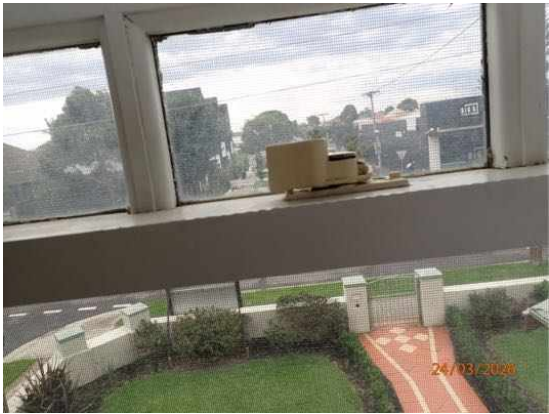
Building: Main Building
 Location: All Internal Areas
 Finding: Window operation not checked:
 Information: Most windows throughout the house were noted locked during inspection, and their operation could not be checked. As a result, defects may exist that were not visible at the time of inspection. The owner should unlock these windows and have them checked. A handy person or qualified carpenter should be engaged if operation issues are later identified.

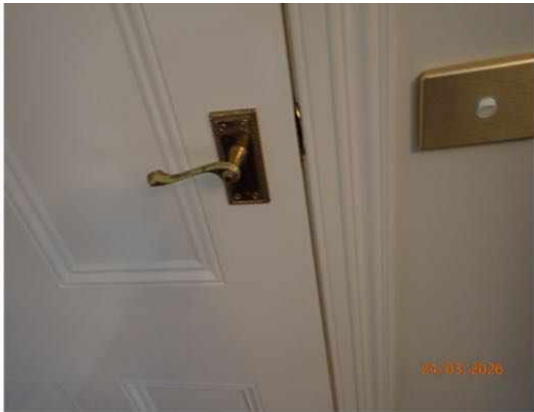
Building: Main Building
Location: All Internal Areas
Finding: Misaligned doors:
Information: Misalignment was noted to the striker plates/door latching to the master bedroom, bathroom, master wardrobe and living room doors during inspection. This is likely due to minor movement, wear and tear and/or poor adjustment of the door hardware. Adjustment and repair are recommended to ensure proper door operation. A qualified carpenter or suitable handy person should be engaged in the near term.

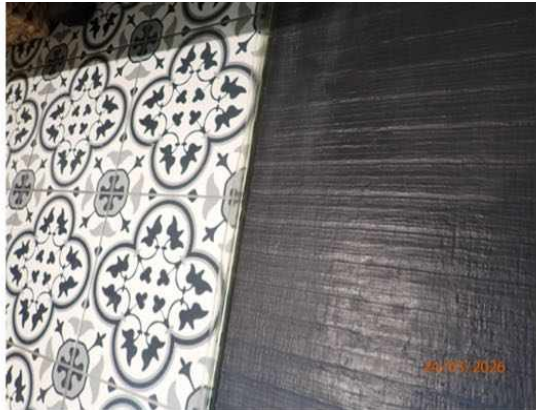
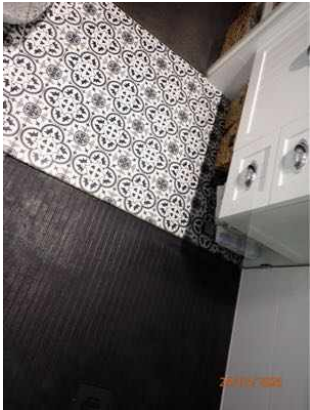
Building: Main Building
Location: Ensuite - Master
Finding: Water stop not visible in shower
Information: During the inspection in the bathrooms, the water stop to the shower area was not visible. Water stops are essential components of waterproofing systems designed to prevent water or moisture from escaping the wet area and causing damage to other materials and structural building elements.

The absence of visible water stops suggests potential issues with the waterproofing of the shower areas. Without proper waterproofing, water leakage can occur, leading to damage to surrounding materials and compromising the structural integrity of the building.

This observation is noted for your reference. Depending on the time the house was built, current regulations may not have been applicable. However, it is recommended to further investigate the waterproofing system of the shower areas to ensure they meet appropriate standards and to address any deficiencies promptly to prevent water damage issues in the future. If necessary, consulting a qualified building inspector or waterproofing specialist for an assessment and potential remediation is advised.

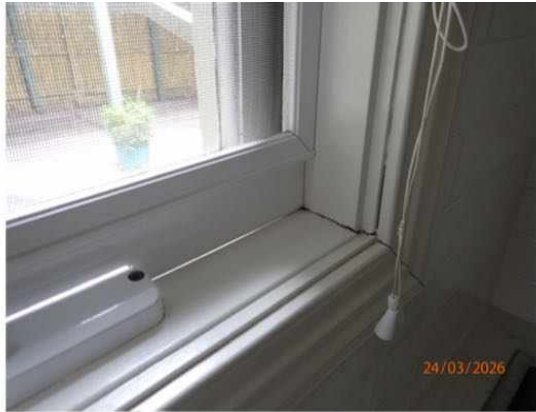
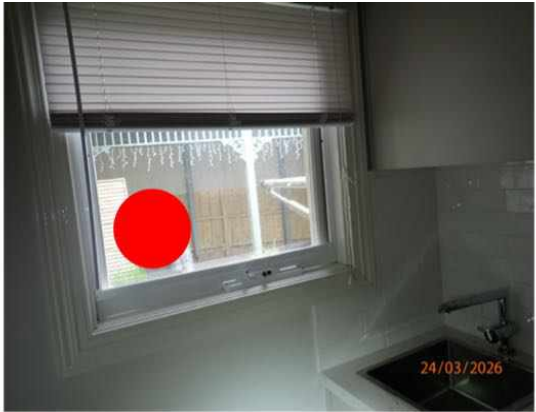
Building: Main Building
 Location: All areas
 Finding: Binding windows:
 Information: Windows in the laundry, rumpus and bathroom were noted binding during inspection. This may be due to minor movement, swelling of timber components, hardware wear and/or poor adjustment. Repair or adjustment is recommended to restore proper operation. A qualified carpenter should be engaged in the near term.

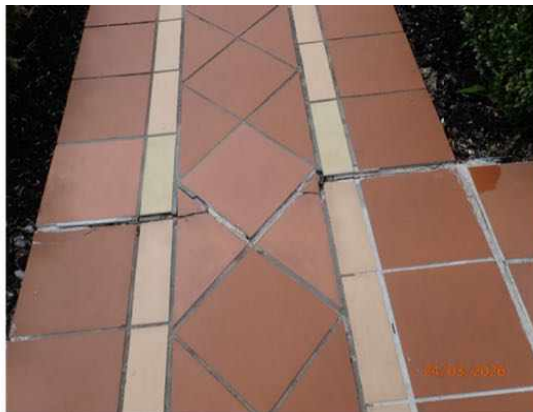
Building: Main Building
Location: Exterior walls - front
Finding: Front paving cracks:
Information: Minor cracking was noted to the front paving/paved tiles during inspection. This is likely due to minor movement of the base, age and/or substandard installation. The affected areas should be monitored and repaired as required to prevent further deterioration and trip hazards. A suitable paving contractor, registered builder or handy person should be engaged in the near term.

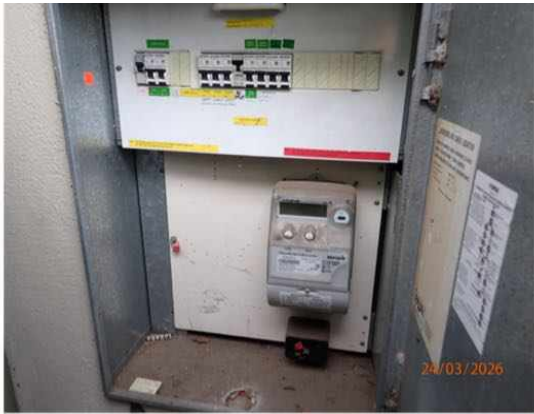
Building: Main Building
 Location: Meter Box
 Finding: Electrical Switch Box
 Information: All electric wiring, meter boxes and appliances need to be checked by a licensed Electrician ensuring any work completed as part of a renovation or extension has been issued with a Certificate of electrical Safety (CES). The checking of any electrical items is out side the scope of this inspection.

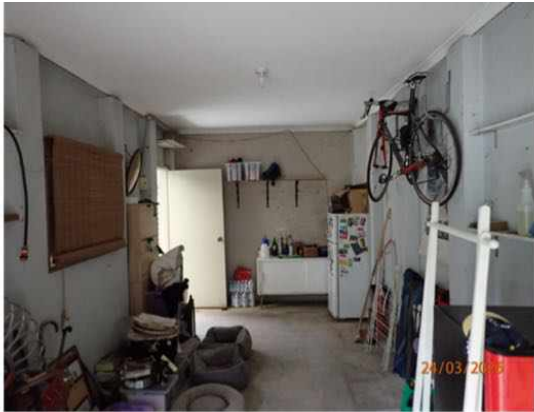
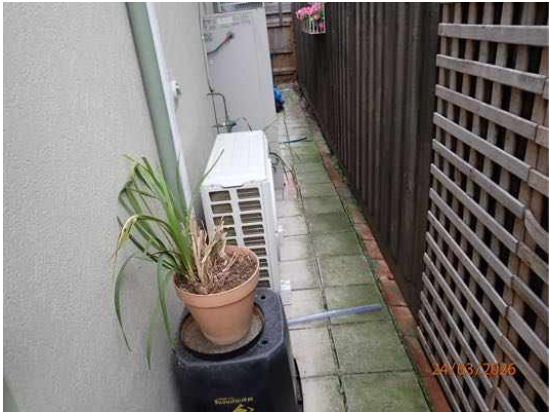
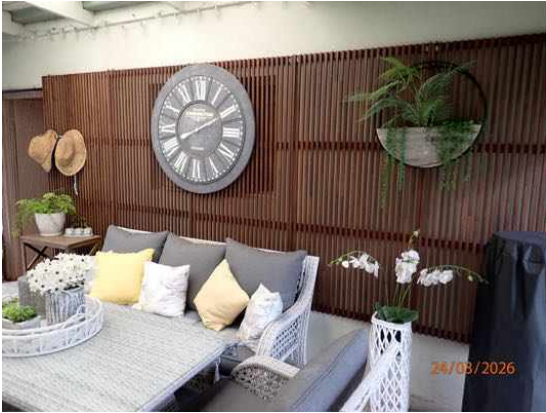
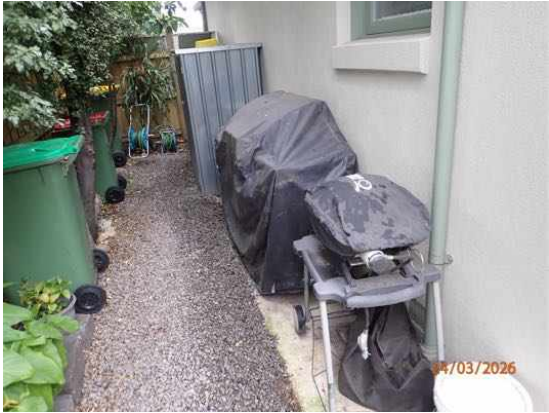
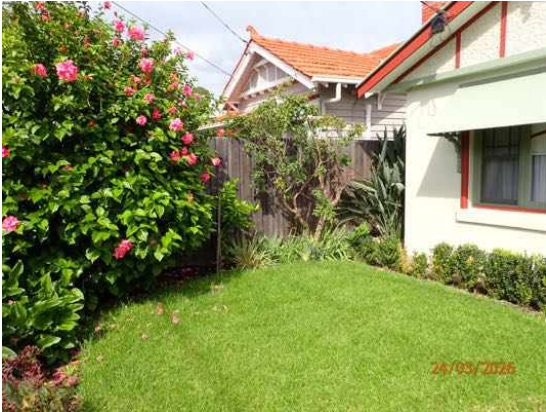
Building: Main Building
Location: All External Areas
Finding: Additional Photos - Obstructions and Limitations External Areas
Information: These photographs are an indication of the obstructions and limitations which impeded full inspection of the External areas of the property at the time of inspection. These obstructions can hide an array of defects and should be removed to allow full inspection to be carried out. A re-inspection is recommended once the areas are made accessible.

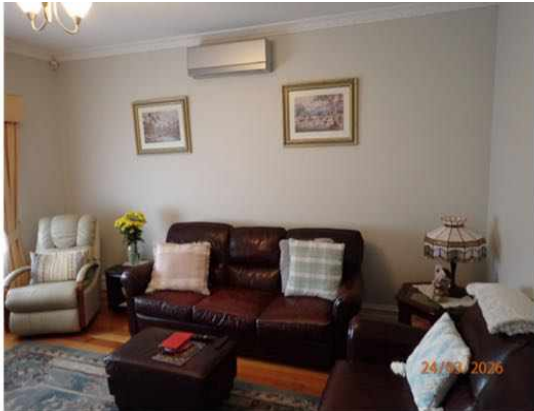
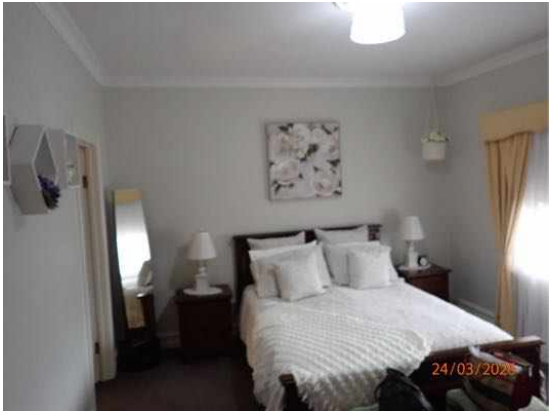
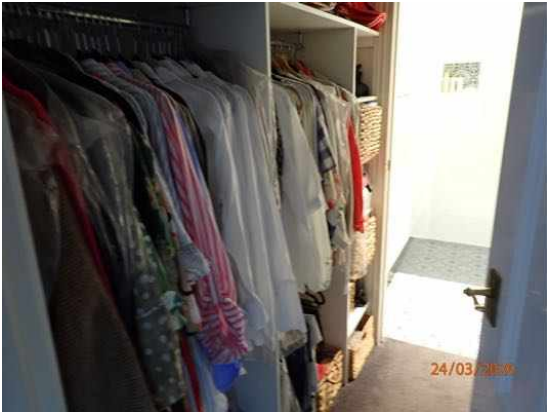
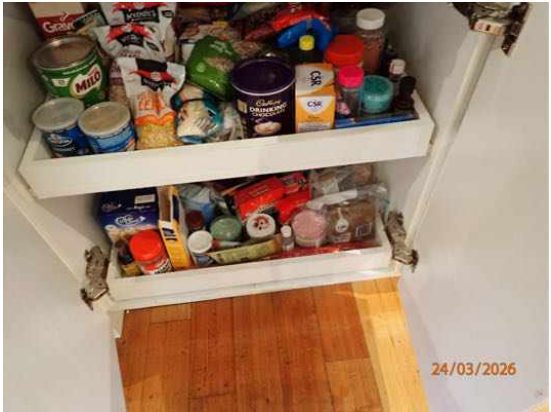
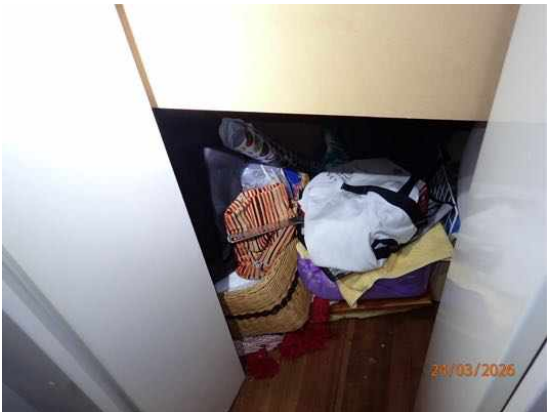
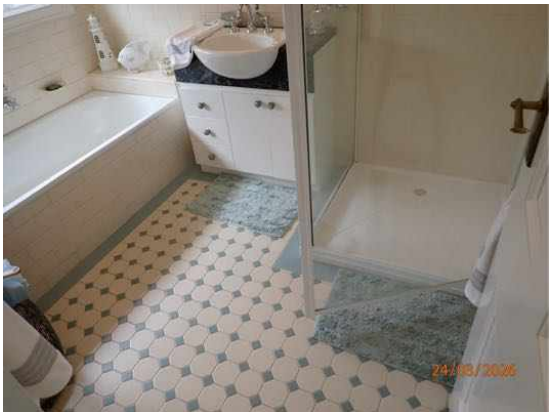
Building: Main Building
Location: All Internal Areas
Finding: Additional Photos - Obstructions and Limitations internal Areas
Information: These photographs are an indication of the obstructions and limitations which impeded full inspection of the internal areas of the property at the time of inspection. These obstructions can hide an array of defects and should be removed to allow full inspection to be carried out. A re-inspection is recommended once the areas are made accessible.

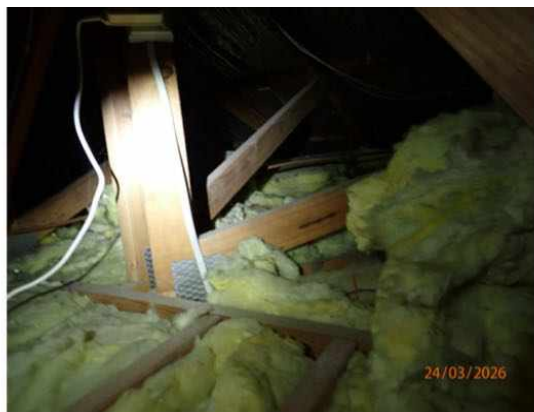
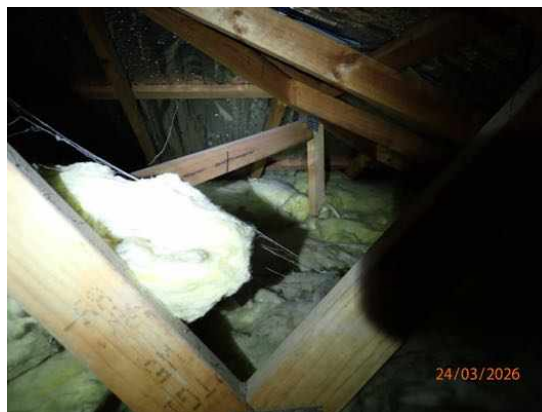
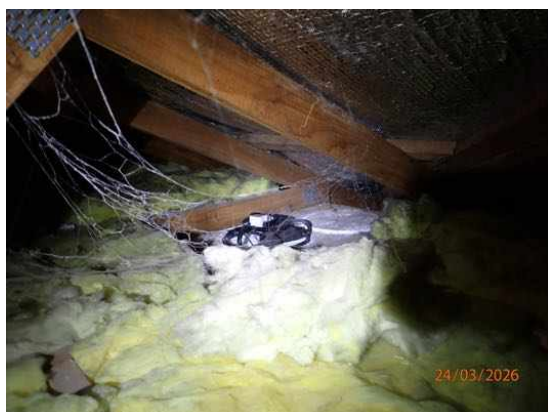
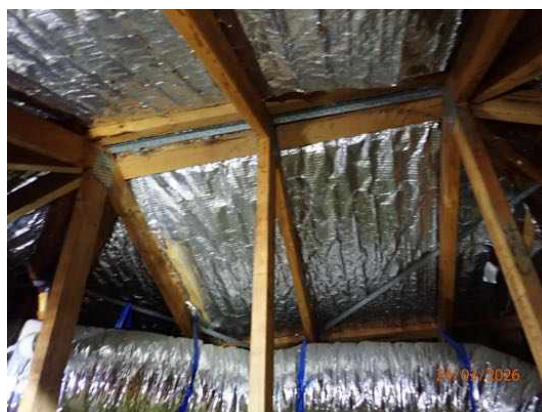
Finding: Additional Photos - Obstructions and Limitations Roof Void

Information: These photographs are an indication of the obstructions and limitations which impeded full inspection of the Roof Void of the property at the time of inspection. These obstructions can hide an array of defects and should be removed to allow full inspection to be carried out. A re-inspection is recommended once the areas are made accessible.

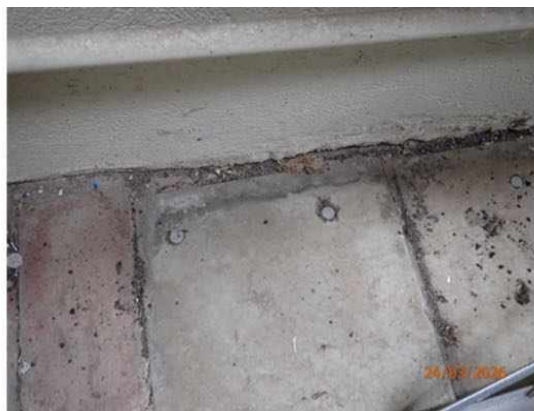
Building:	Main Building
Location:	All External Areas
Finding:	Evidence of a previous termite management system was identified
Information:	Drill marks with plastic plugs were noted in the external concrete at the front and left-hand side of the house, which may indicate a previous termite management treatment. No durable notice was observed during the inspection.

Where a termite management system is present, it is important to confirm the type of barrier installed, the date of installation, warranty conditions, and any supporting documentation from the builder or previous owner. The company that carried out the treatment should be contacted to confirm whether the system remains current or under warranty.
