# Building and Timber Pest Inspection Report

Inspection Date: Wed, 14 Jan 2026

Property Address: 22/6 Jacquinet Pl, Glenfield NSW 2167,  
Australia

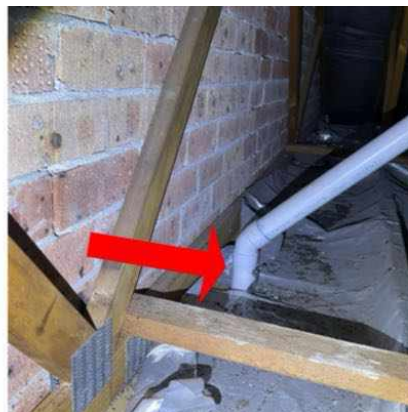
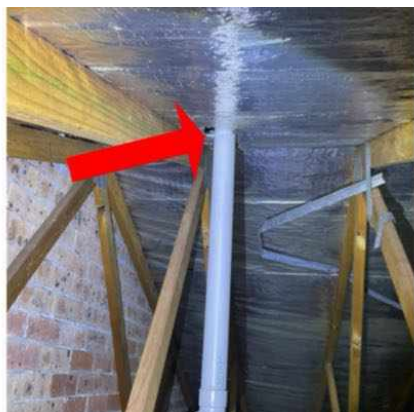
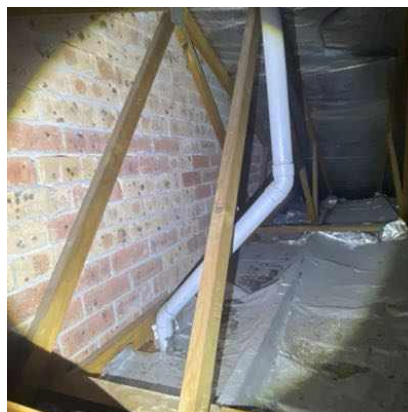
Building: Main Building  
Location: Bathroom  
Finding: Exterior roof - Leaking  
Information: Active roof leaks were evident at the time of inspection. Roof leaks can have a number of causes, including damage to roof coverings, deterioration of roof fixtures and fittings, or loosely associated materials (fascias etc.).

Where water leaks are active, rain penetration is likely to cause water damage to associated structures and building elements in this area, which can have a range of implications. If left unmanaged, the development of major structural damage to the roofing and associated structures may occur.

A roof plumber should be appointed as soon as possible to primarily identify the cause of the leak, and to provide subsequent repair works as necessary. Depending on the extent of the damage, replacement of sections of the roof covering and/or roofing structures may be required, and may be performed by a registered builder or qualified carpenter.

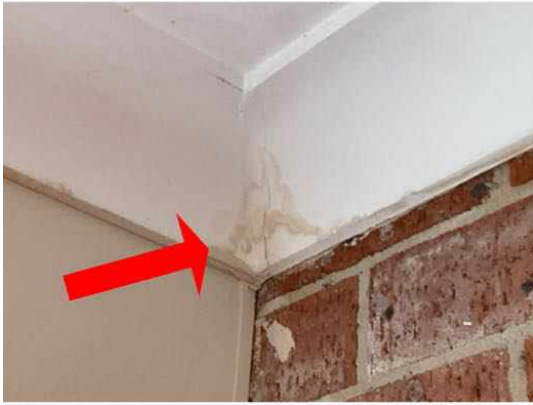
### Finding 2.02

Building:	Main Building
Location:	Living Room
Finding:	Ceiling - Water damaged
Information:	Water damage to the ceiling lining is generally an indication of excessive moisture being present in the roof void, usually via a leak to the roof covering.

Where water damage is evident to the ceiling, the primary requirement is to identify and rectify the source of the leak. A roofing plumber should be appointed as soon as possible to identify the leak and perform rectification works as necessary, ensuring the water damage is restricted.

Once the leak is repaired, consultation with relevant tradespeople, including plasterers and painters, is advised. Rectification works may include replacement of ceiling lining or minor repainting, depending on the extent of the damage.

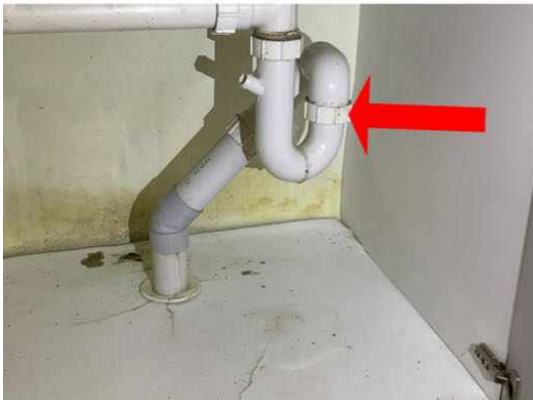
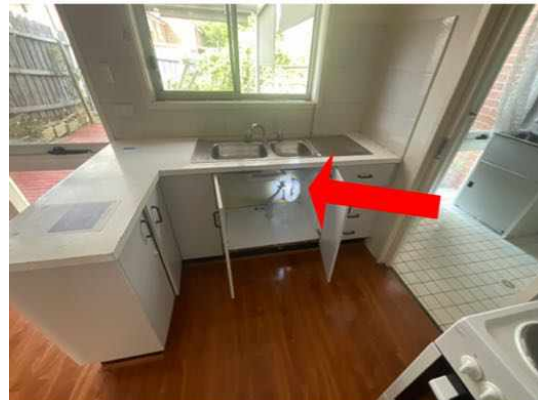
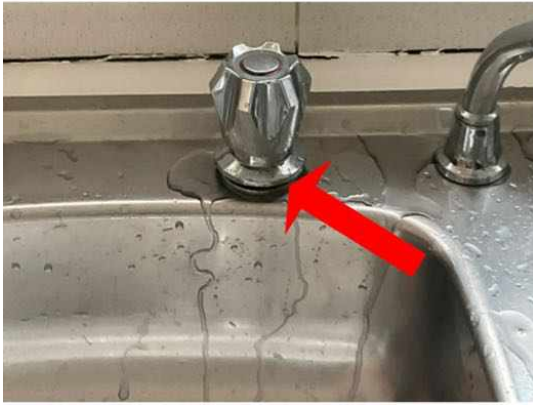
### Finding 2.03

Finding: Water leak - Internal

Information: A water leak was found in this area at the time of inspection. Internal water leaks can be detrimental to surrounding building elements; their potential causes include damage to plumbing fittings and fixtures, through to water damage and deterioration of associated building elements.

Rust, corrosion, decay and water damage are potential outcomes where a minor water leak is left unattended. More serious defects may also result, such as electrical hazards, or water damage to structural building elements.

In extreme cases, structural damage may develop due to a prolonged water leak. It is highly advised that internal water leaks be addressed by a licensed plumber as a matter of relative urgency.

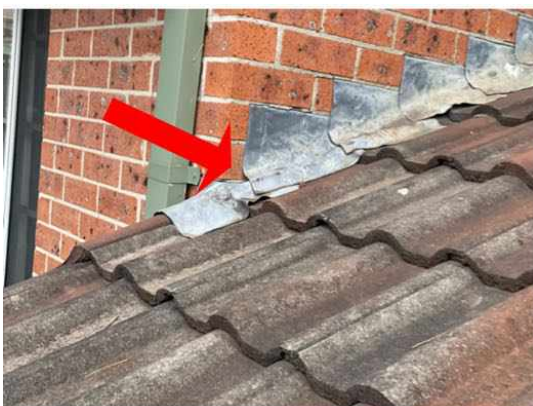
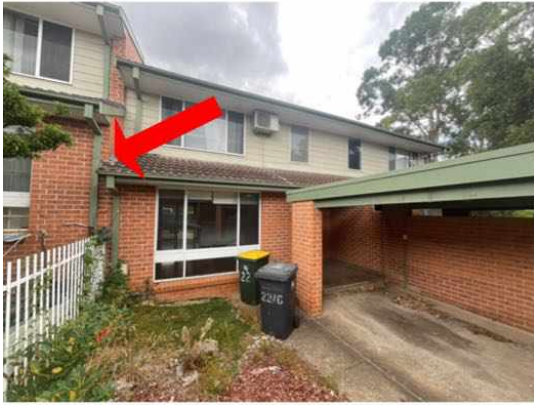
### Finding 2.04

Building:	Main Building
Location:	Roof Exterior
Finding:	Roof plumbing - Flashing inadequate
Information:	Some sections of the roof are missing or have inadequate roof flashings. Flashings are metal and other materials which are applied to seals and intersections between roof coverings and building elements. They are designed to aid in weatherproofing of roof joins.

Flashings that are not installed adequately or are missing are likely to result in water penetration to the interior of the property, as well as creating excessively damp conditions against the exterior surfaces and around the base perimeter of the building.

Premature ageing and secondary building defects are imminent where roof plumbing is missing or inadequately installed. Additionally, water pooling also creates an environment that is susceptible to termite and pest infestation.

A roofing plumber should be appointed as soon as possible to install relevant roof plumbing materials, ensuring that no further damage is sustained.

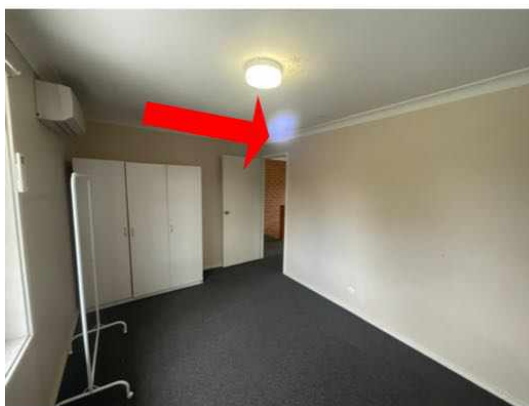
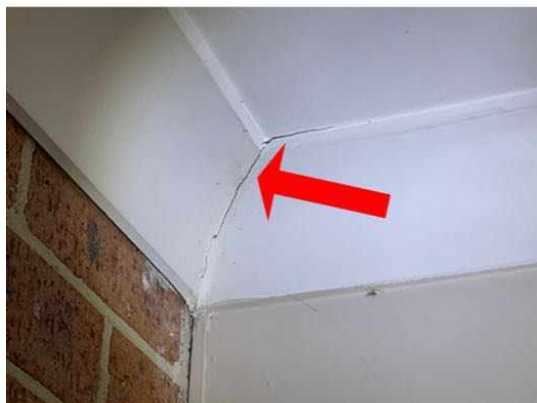
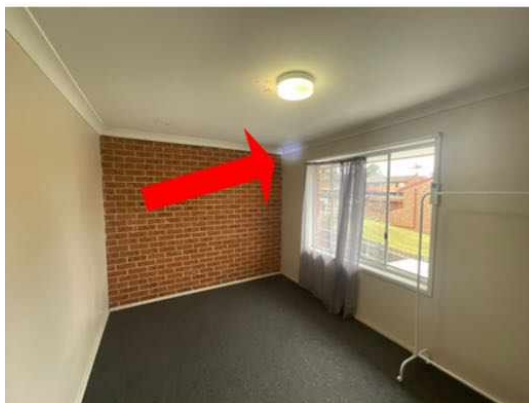
### Finding 3.01

Building:	Main Building
Location:	All Internal Areas
Finding:	Cornices - Sagging
Information:	Sagging and uneven cornices generally indicate that the building materials have swollen, due to contact with water, or the movement of the ceiling joints or that fixings (e.g. nails or glue) have become loose and require reattachment. In some cases, sagging and uneven surfaces may also indicate that there are structural issues causing surfaces to warp, twist, or sag.

Where sagging appears to be major, appointment of a structural engineer is advised to further inspect the property. Otherwise, minor works such as re-gluing of wall/ceiling sheets may be required and should be performed by an aptly qualified plasterer or carpenter.

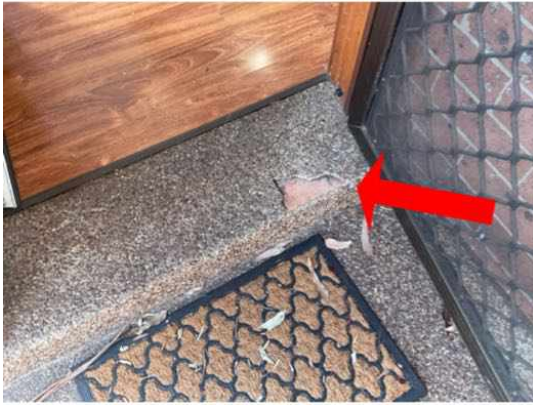
### Finding 3.02

Building:	Main Building
Location:	Entry
Finding:	Entry step - Cracked or damaged
Information:	Cracking was evident to the step in this area at the time of inspection. While the cracking appears to be minor, this area is frequently exposed to water, allowing potential for water penetration into adjoining sections of walls or flooring.

If left unmanaged, water penetration to these areas may lead to subsequent water damage, which is likely necessitate repair work to affected building elements.

A tiling contractor should be appointed to ensure that no further water damage occurs. The re-application of silicone and grouting throughout remaining tile work is also advised, to further protect the area against water penetration.

Where water penetration has led to water damage, appointment of a relevant tradesperson may be required to repair damaged building elements.

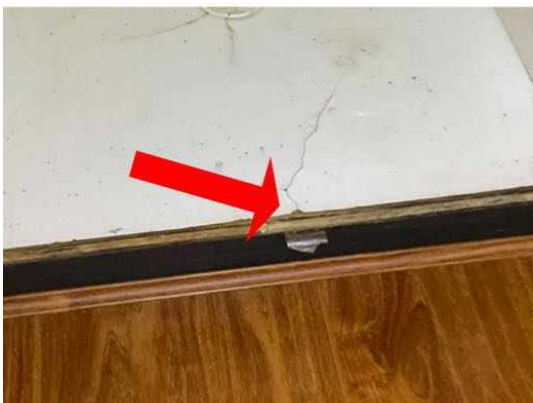
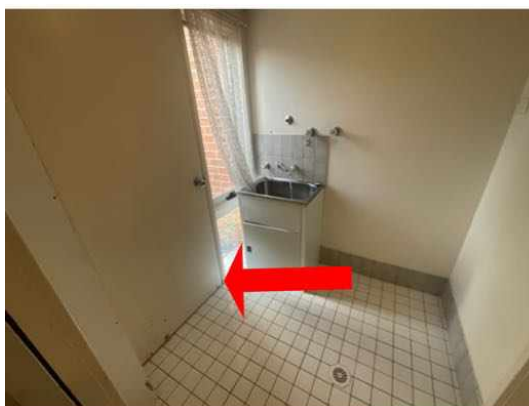
### Finding 3.03

Building:	Main Building
Location:	Kitchen / Laundry
Finding:	Delamination of timbers
Information:	Delamination is one means by which composite materials (e.g. layered timber composites) may fail over time. In laminated materials, repeated cyclic stresses may lead to the formation of mini-structures of separate layers, with significant loss of mechanical toughness. Water penetration or the presence of excessive moisture also generally contributes to delamination.

Where building materials have become delaminated, they lose their structural strength, and are likely to have a variety of appearance and serviceability defects as a result.

Delamination of timbers may be repaired where the area affected is minor and/or easily accessible, by gluing and screwing layers back together. However, this is an interim repair, and where delamination has occurred, the client should plan for the replacement of affected timbers sooner than would otherwise be expected.

All timber structures affected by delamination should be replaced as soon as possible to avoid any further damage. Repair and replacement estimates should be sought from a registered builder or qualified carpenter.

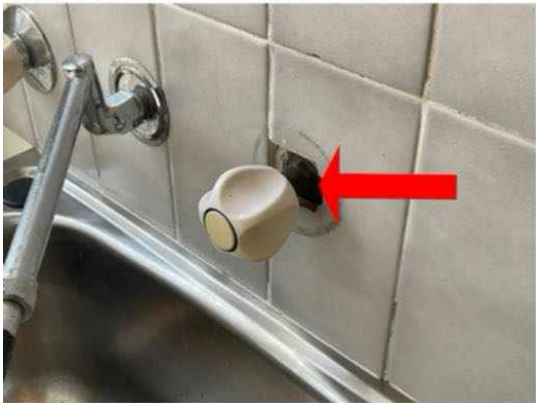
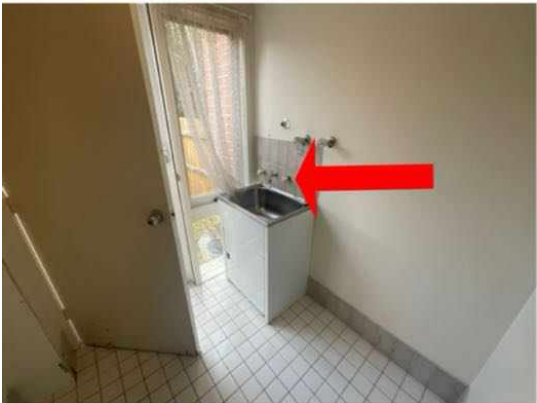
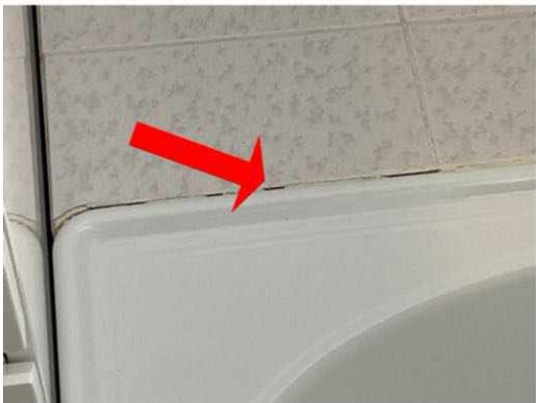
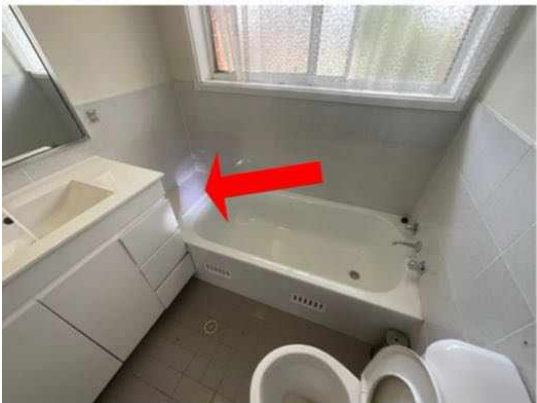
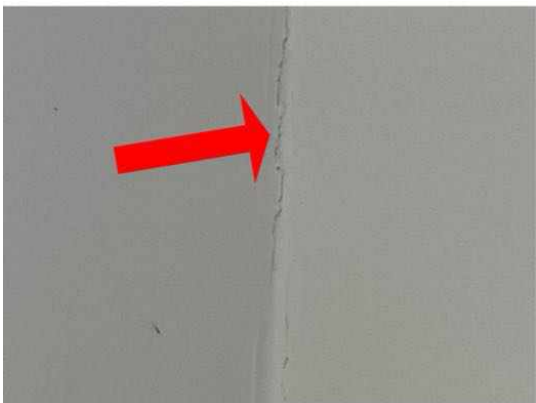
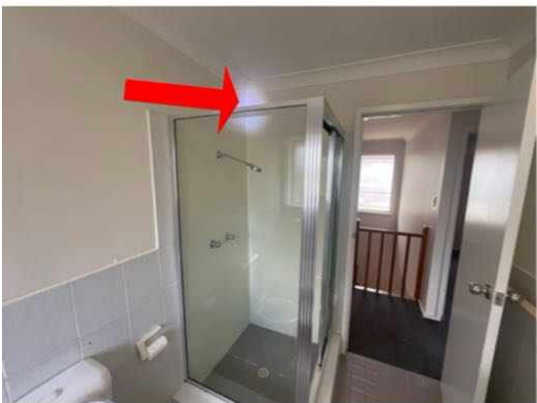
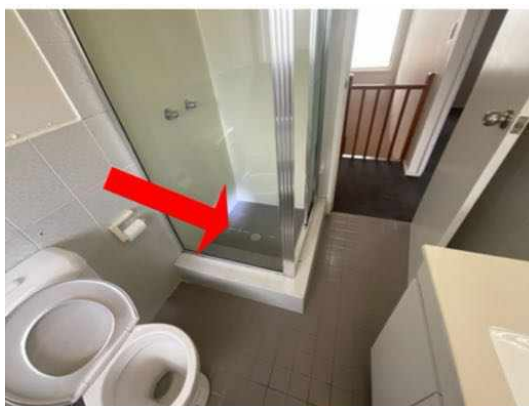
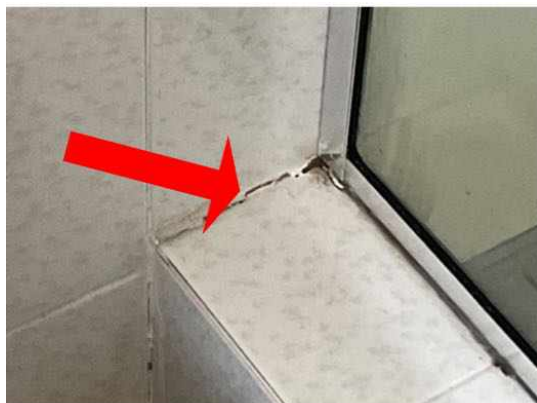
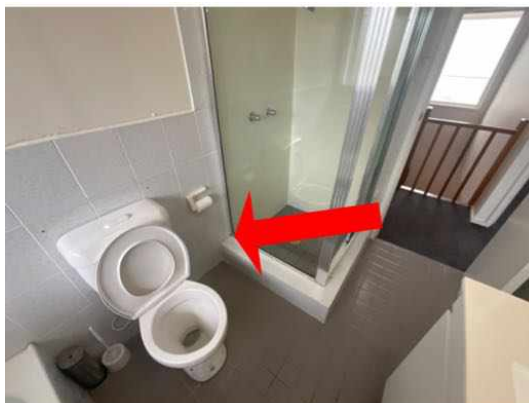
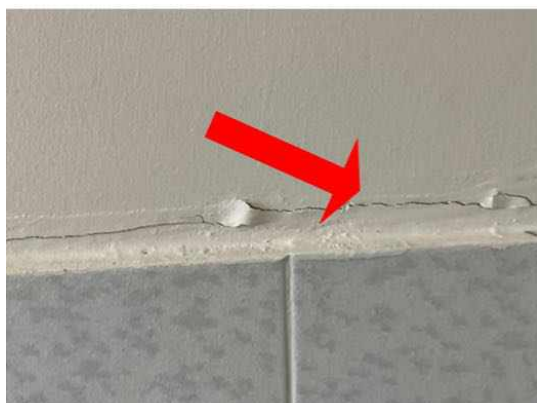
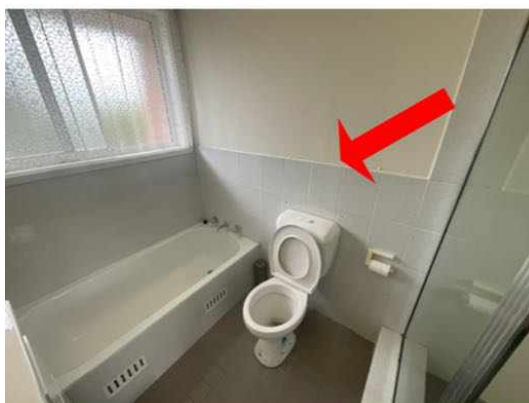
### Finding 3.04

Building:	Main Building
Location:	Kitchen / Laundry / Bathroom
Finding:	Sealant and grouting - Missing or damaged
Information:	It was noted on inspection that sealant or grout is degraded to the tiled shower alcove and or other areas of the bathroom.

Different materials and floor areas move at different rates, generally causing cracking to grout or sealant at this point. A flexible sealant is required to allow for expected expansion and contraction, while keeping the joint water tight and protective of all associated building materials.

There appears to be excessive mould to the sealant and grout which will likely require scraping out and replacement.

Flexible and mould resistant materials should be applied to affected areas to prevent any subsequent water damage that is likely to occur. Regular maintenance and replacement of damage or missing or damaged sealant and grout is highly recommended to the wet areas, as this is a regular wear and tear defect. Sealant and grouting in areas that come into regular contact with water should be maintained for the long term care of your property.

A sealant specialist or tiling contractor should be appointed to complete these works as soon as possible

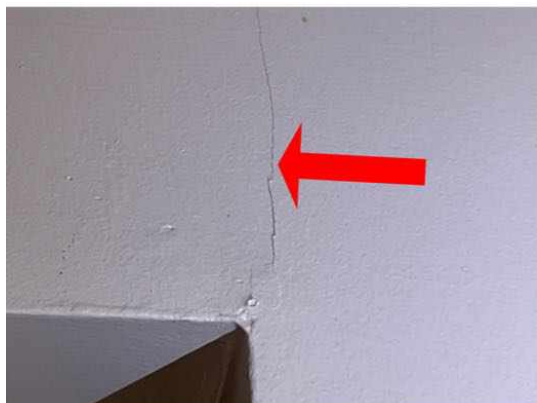
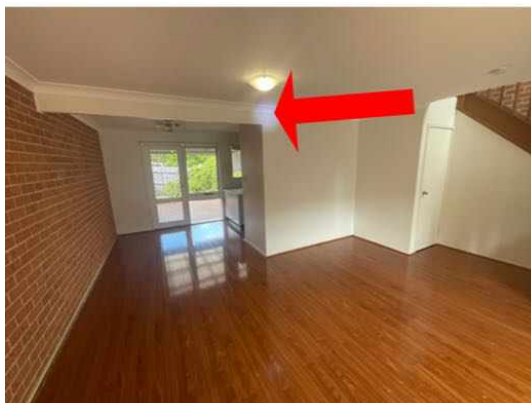
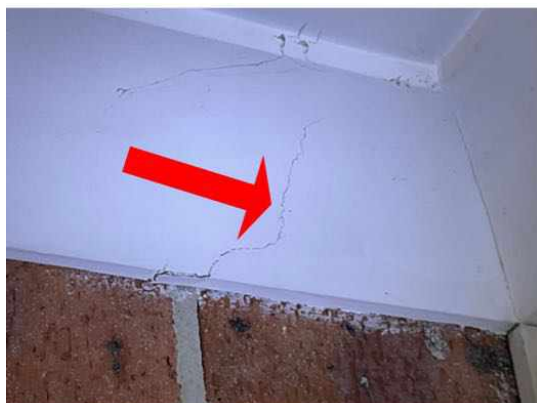
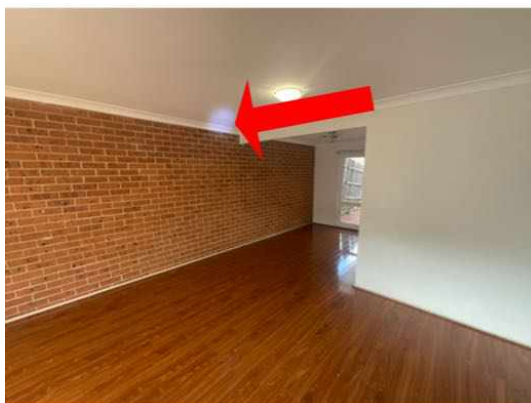
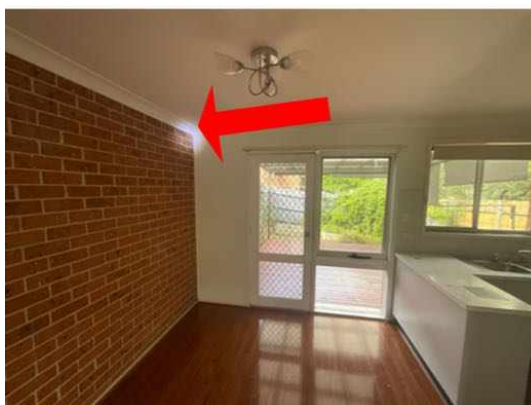
### Finding 3.05

Building:	Main Building
Location:	All Internal Areas
Finding:	Cracking - Damage Category 1 - Fine (up to 1mm)
Information:	Although fine cracks are quite noticeable, they are often only considered to be an appearance defect, and usually do not indicate any structural damage. Generally, the cause of a fine crack is indicative of a separation between building materials and finishes (e.g. paint, plaster, etc.) along joins.

Cracking of this nature can generally be repaired with minor sanding, filling and/or repainting. Such works should be performed by a qualified painter or a general handyman.

Monitoring of all cracking should be conducted frequently. Always contact a building inspector should cracks widen, lengthen, or become more numerous.

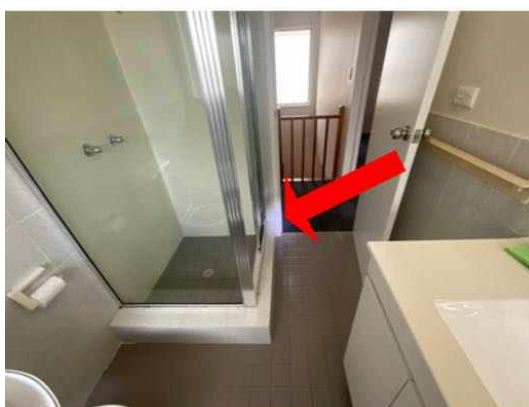
**Finding 3.06**

Building: Main Building  
 Location: Bathroom  
 Finding: Bathroom - Damp  
 Information: Damp is evident to the lower 300mm of wall to the bathroom alcove. This defect is quite common, and is suspected to have been caused by moisture permeating through the grouting in this area, which shows evidence of deterioration. Leaking

pipes within the adjoining wall is also a possible cause. Damp (or structural damp) refers to the presence of unwanted moisture in the structure of a building, either as the result of intrusion from outside, or condensation from within the structure. In the bathroom area, internal water leaks or other sources of excessive moisture are generally the cause of damp. Unmanaged damp in the bathroom recess is likely to facilitate the formation and development of mould and fungi growth, decaying associated building materials and compromising their structural integrity. It is important to address damp conditions, as the World Health Organisation notes that excess moisture leads - on almost all indoor materials - to growth of microbes such as moulds, fungi and bacteria, which subsequently emit spores and other matter into the indoor air. Exposure to these contaminants is associated with a wide range of respiratory and other health-related problems. Consultation with a qualified plumber or bathroom specialist is advised immediately to identify the cause of damp and to perform remedial works as required. Where excessive mould growth is present, further inspection by a specialist environmental health inspector should also be considered. Always ensure that sealant and grout is in good condition to prevent any moisture issues occurring in the future.

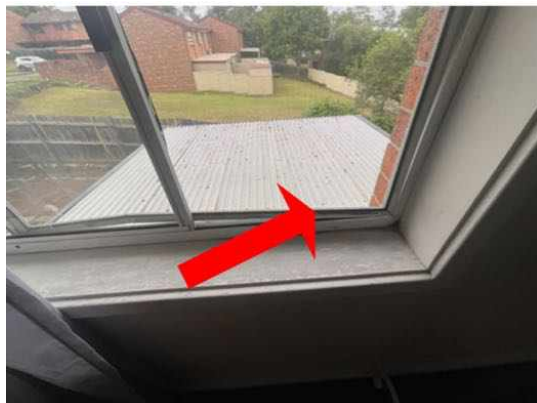
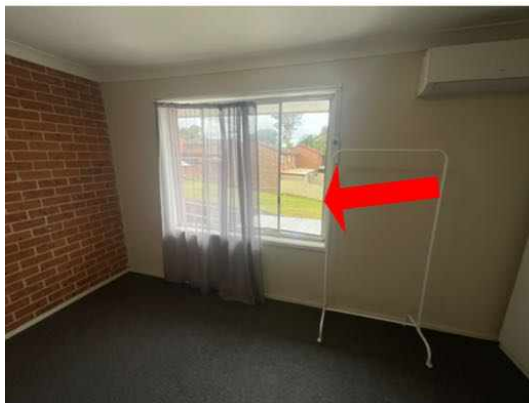
### Finding 3.07

Building:	Main Building
Location:	All Internal Areas
Finding:	Flyscreens - Damaged
Information:	Flyscreens were found to be damaged to the windows in this area at the time of inspection. This damaged building element detracts from the operational state of the window. Where not replaced, damaged flyscreens allow pest and insect ingress into the adjoining room/s. It is advised that all damaged building elements be replaced in order to ensure the full function of all building structures. A general handyperson may be appointed to replace flyscreens at the discretion of the client.

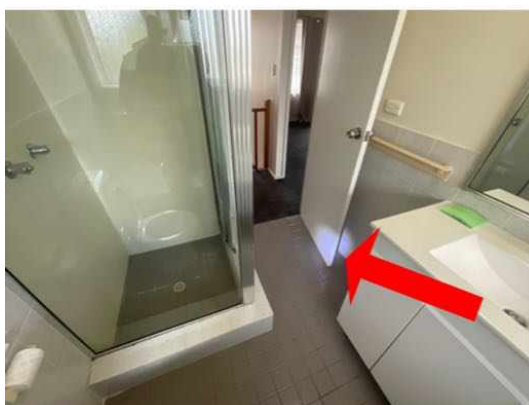
### Finding 3.08

Building:	Main Building
Location:	Bathroom
Finding:	Door stop - Missing
Information:	The door stop is missing or is inadequate to stop the door handle from damaging the wall. Although some building elements may seem irrelevant or unnecessary, all building elements play a key role in the operation and function of the overall structure and its performance.

Re-installation or replacement of the door stop is advised as soon as possible to prevent any subsequent damage to the door or associated structures. A general handyman may be appointed to perform these works at client discretion.

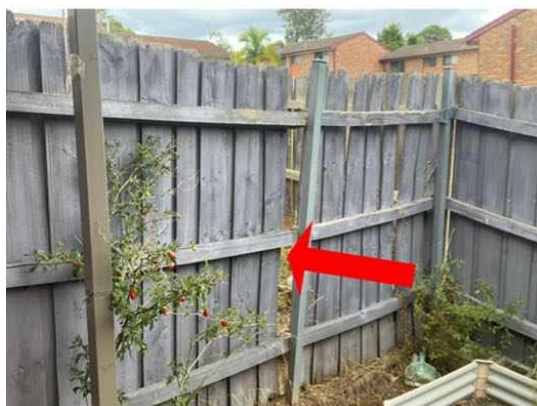
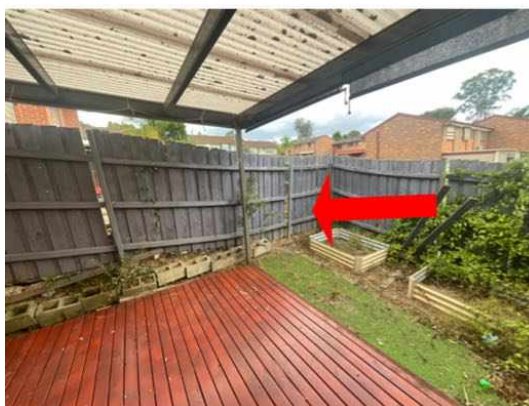
Building:	Main Building
Location:	All Internal Areas
Finding:	Fencing - Deteriorated
Information:	It was noted at the time of inspection that sections of the fencing throughout the property have deteriorated. Typically fencing deteriorates due to age and or wear and or rust which is generally expected for a structure of this age, due to prolonged exposure to weather conditions. Sometimes inadequate installation or maintenance can be to blame.

If left unattended, it is likely that further damage will occur. It is suspected that repair of several elements of the fencing may be required however replacement may be a

consideration of the client also.

A licensed fencing contractor should be appointed to provide further advice and perform rectification works as necessary.

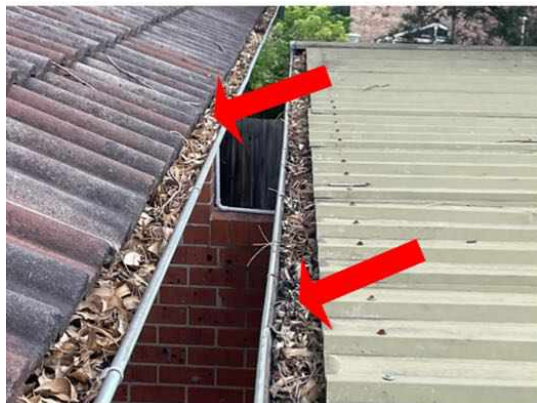
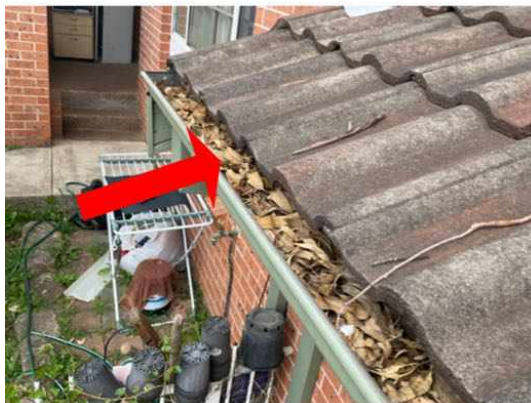
Blocked gutters are likely to lead to high levels of moisture in the affected areas. Such moisture will not only cause rust and decay of the associated building materials, but can also provide conditions that are conducive to termite and timber pest activity. Blockages in gutters should therefore be removed immediately to ensure dry conditions are maintained.

Consult a Licensed Plumber for further specific advice on remedial works that may be required. In the interim, it is highly advised that blocked gutters be removed by the homeowner or a general handyperson as a matter of urgency.

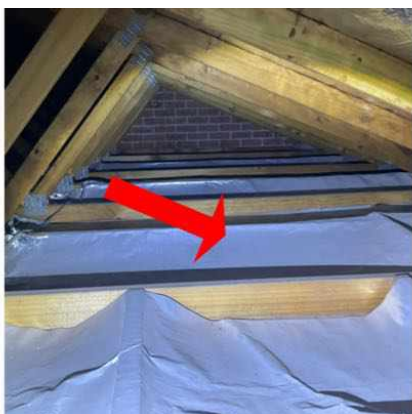
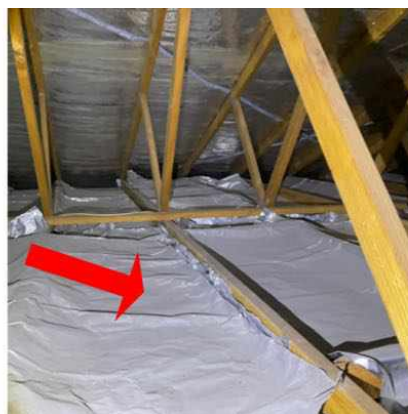
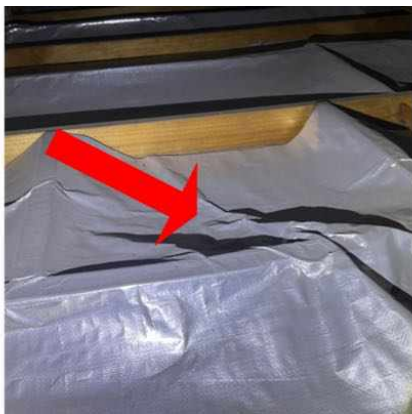
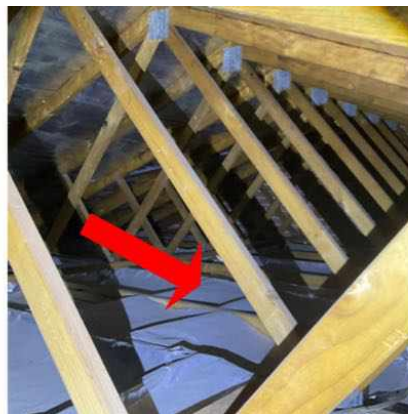
### Finding 3.12

Building: Main Building  
 Location: Roof Void  
 Finding: Insulation - Missing  
 Information: Upon inspection of the roof void it was noted that insulation is not present.

Insufficient insulation will result in a comparatively higher cost to heat and cool a property as there is a lack of Insulation (or uneven coverage of insulation) which works as a barrier to heat transfer. This helps to keep out unwanted heat in summer and preserves warmth inside your home in winter. It can also help soundproof your home from unwanted airborne noise transfer.

Where insulation is absent, the area does not meet current Australian Standards. Installation of adequate insulation is required and should be conducted as soon as possible.

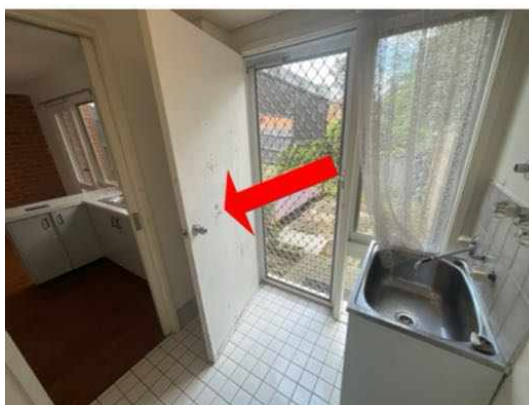
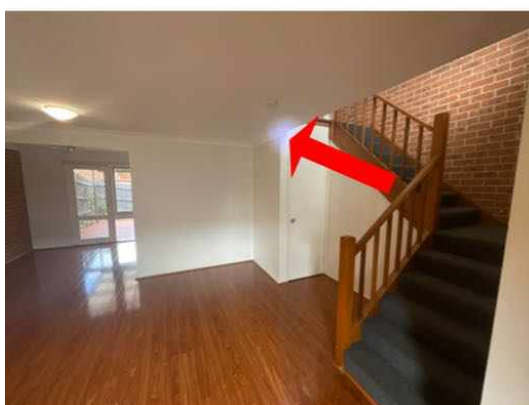
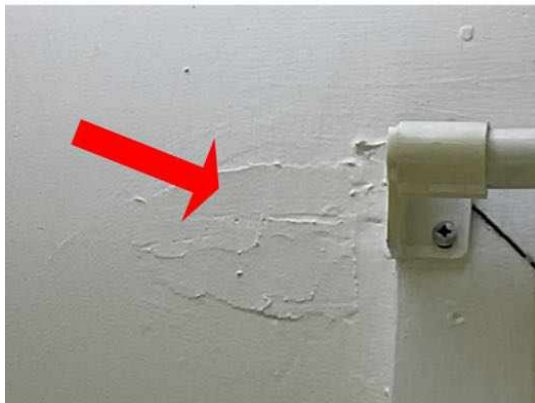
### Finding 3.14

Finding: Paint finish - Substandard, Wear and Tear  
Information: The paint finish in this area was found to have been completed to a substandard level or wear and tear as the normal deterioration of a property from ordinary, everyday use. Exposure to the elements, time, as well as day to day living can cause fair wear and tear.

If this applies, further areas of poor and incomplete finishes could develop over time. Furthermore, substandard, wear and tear paint finishes in areas exposed to moisture, e.g. external areas or wet areas, could lead to deterioration of underlying building materials.

Substandard, wear and tear paint finishes should be sanded back, filled, leveled and repainted, as applicable. Where inadequate paint protection has led to the deterioration of the associated building element, repair and/or replacement of this building element may be required.

A painting contractor should be appointed as soon as possible to perform necessary works to aid the appearance of the affected area and to ensure that the area is protected against further deterioration. Alternatively, the homeowner following manufacturer instructions may be able to provide this service.

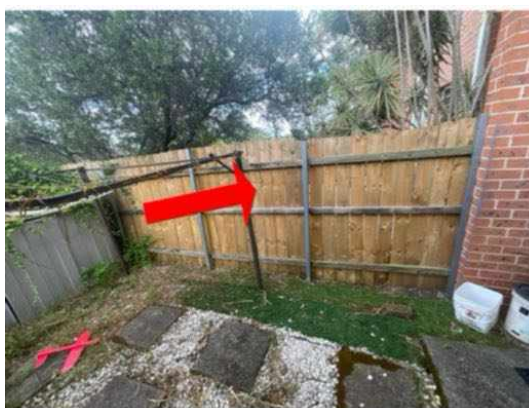
Building:	Main Building
Location:	All Areas
Finding:	Timber - exposed to weather
Information:	External timbers that are frequently exposed to harsh weather conditions require adequate protection in order to maintain their condition. Where timbers have not been painted or treated adequately, general deterioration is likely to occur at an accelerated rate.

If left unattended, replacement of these timbers is likely to be necessary in the short-term future. Adequate treatment of these timbers is required as soon as possible by a painting contractor or general handyman.

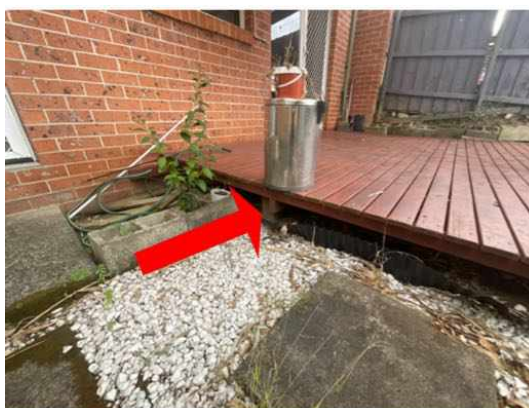
### Finding 6.05

Information: Any timbers in direct ground contact provide opportunity for concealed termite entry and are likely to be subject to premature rot and decay as the soil retains moisture or damp conditions against the timbers.

Remove untreated timber that is in direct contact with external grounds. Consider replacement with more durable materials i.e. treated timber or non timber elements. Frequent pest inspections are advised to readily identify any termite activity in these areas.

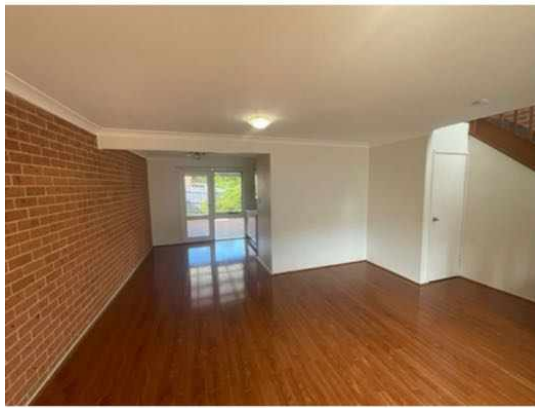
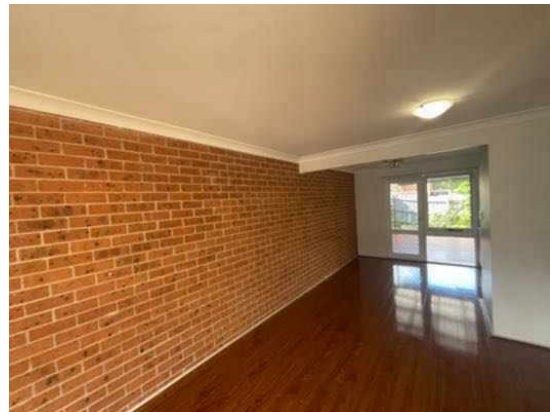
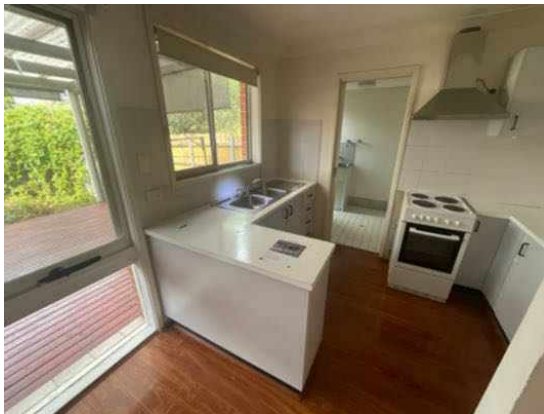
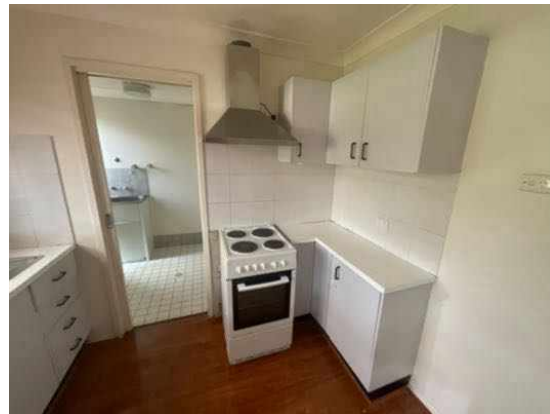
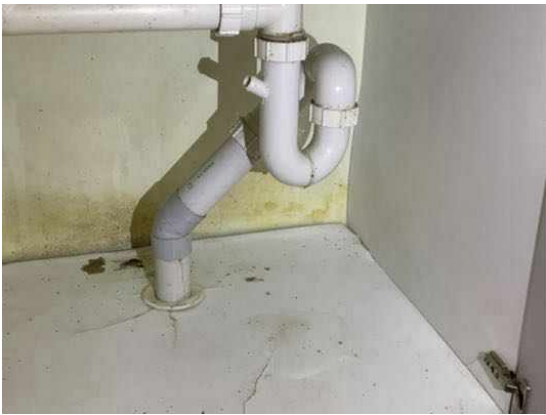
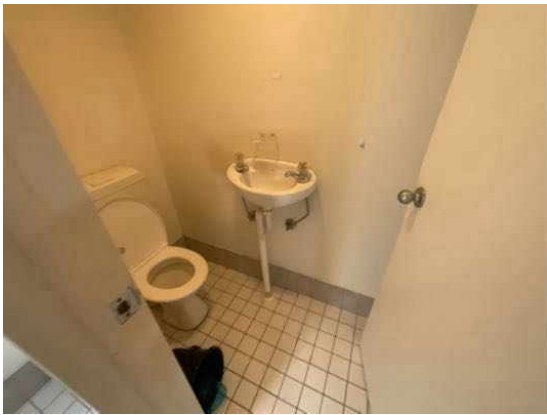
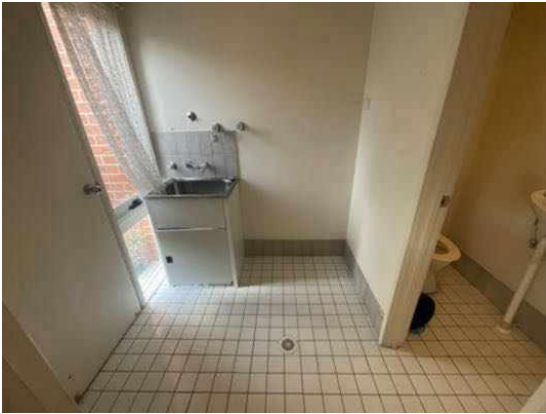
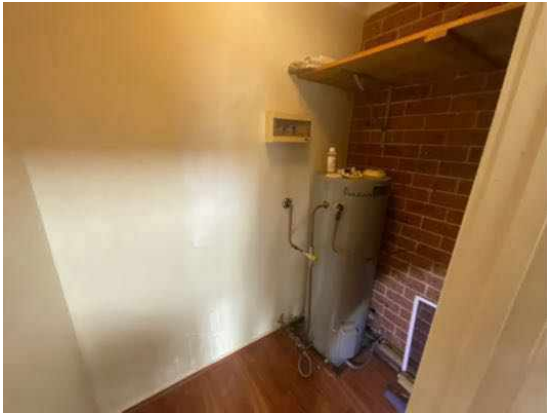
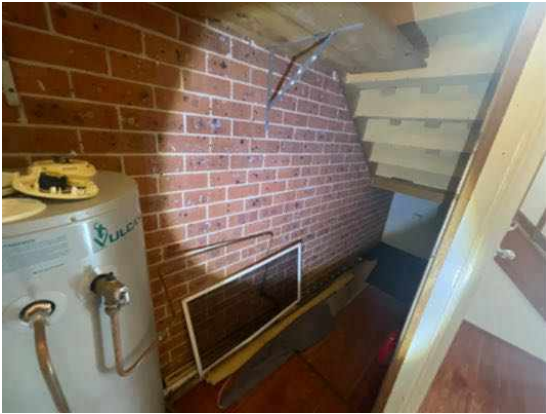
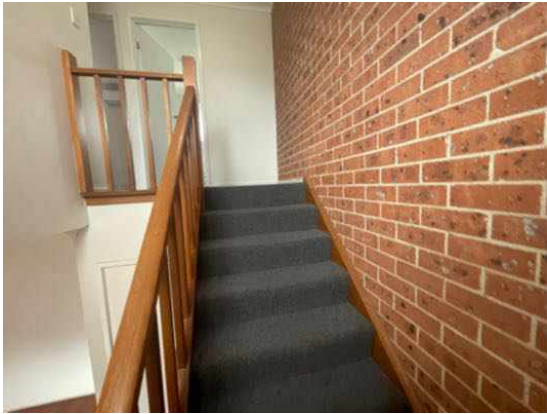
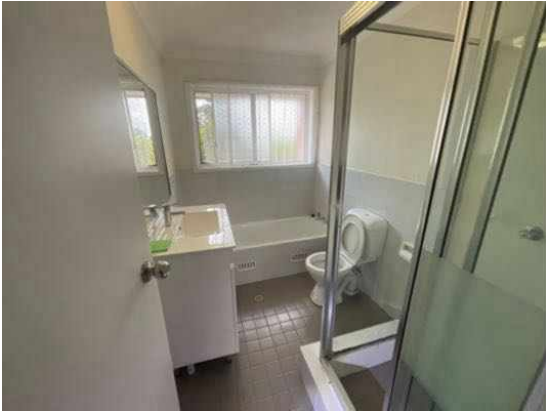
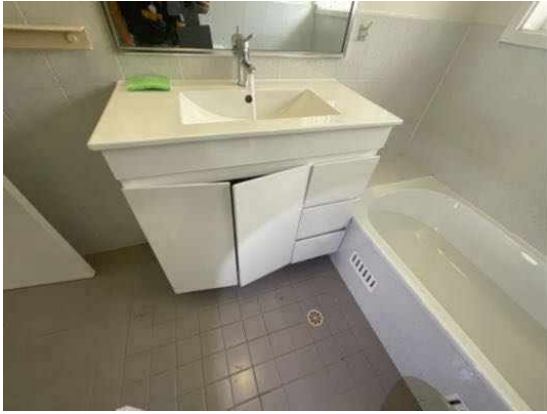
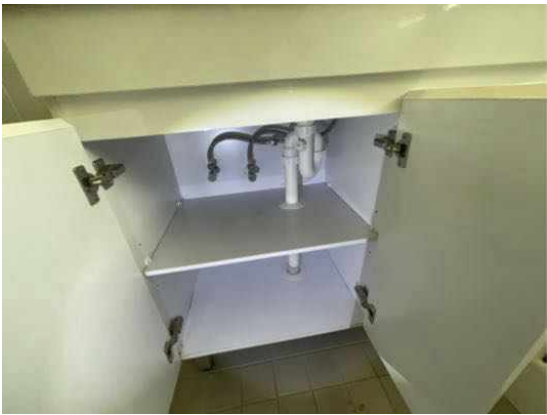
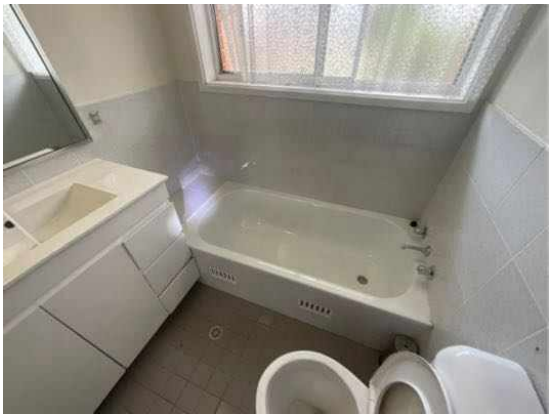
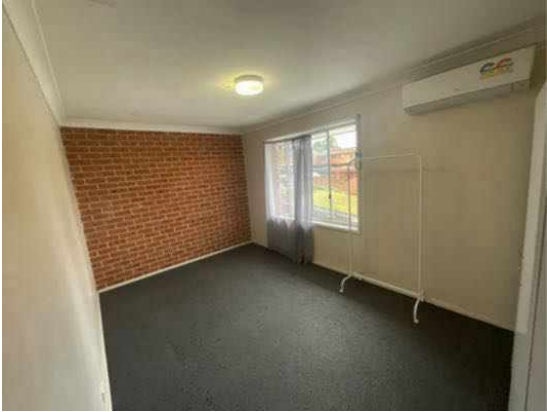
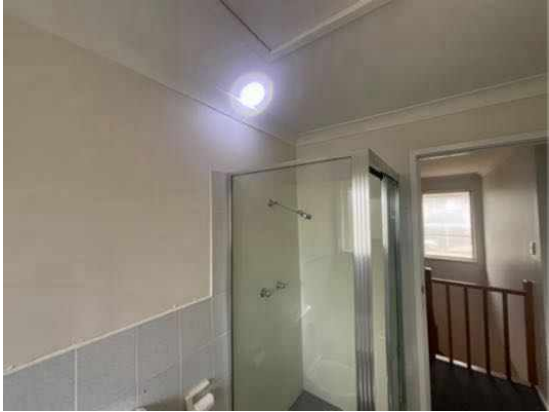
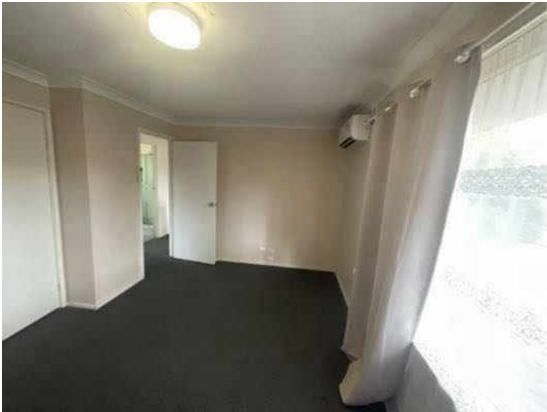
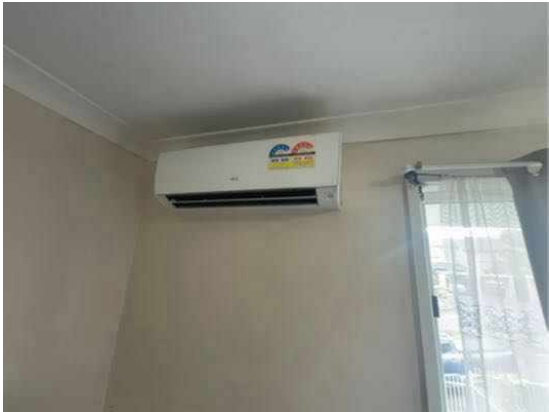
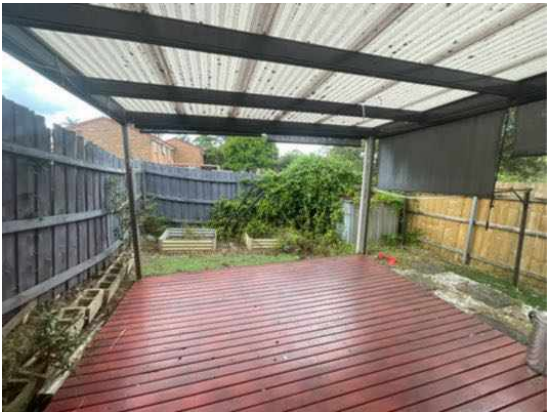
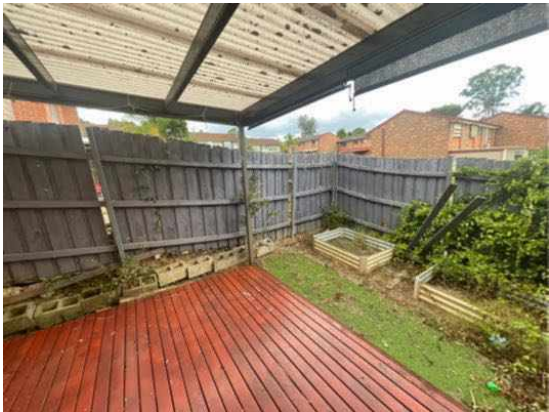
#### Noted Item

Building: Main Building  
Location: All Areas  
Finding: Additional Photos - Obstructions and Limitations  
Information: These photographs are an indication of the obstructions and limitations which impeded full inspection of the property at the time of inspection. These obstructions can hide an array of defects and should be removed to allow full inspection to be carried out. A re-inspection is recommended once the areas are made accessible.
