# Building and Timber Pest Inspection Report

Inspection Date: Wed, 14 Jan 2026

Property Address: 22/6 Jacquinet Pl, Glenfield NSW 2167,  
Australia

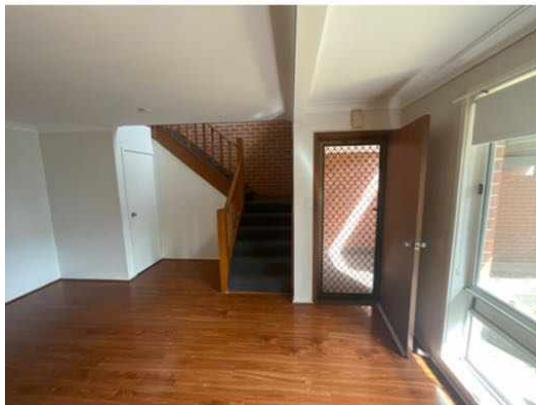
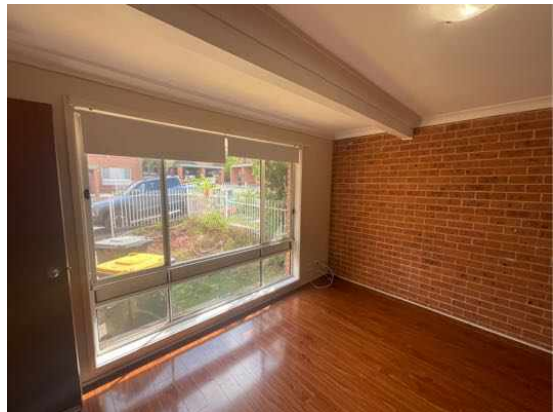
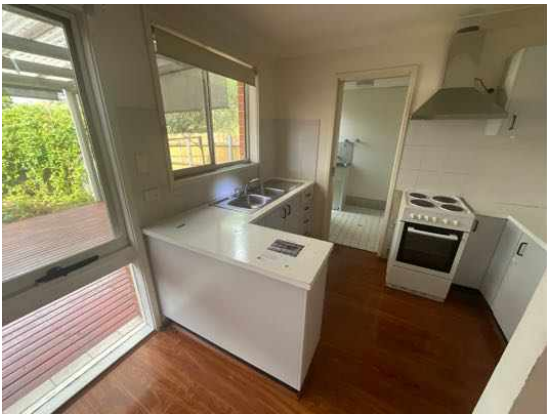
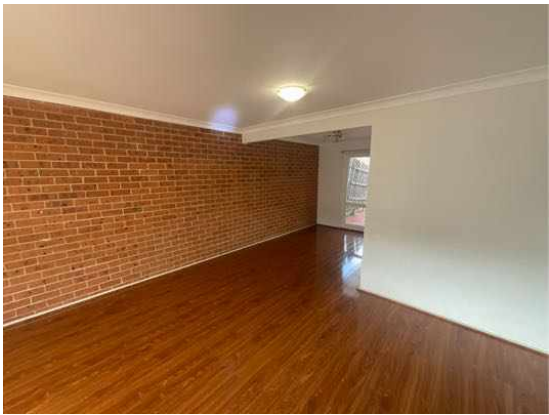
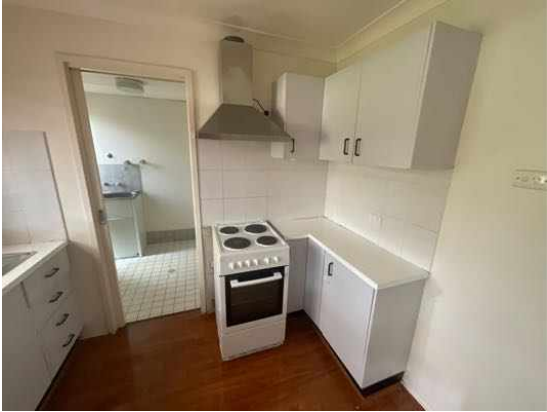
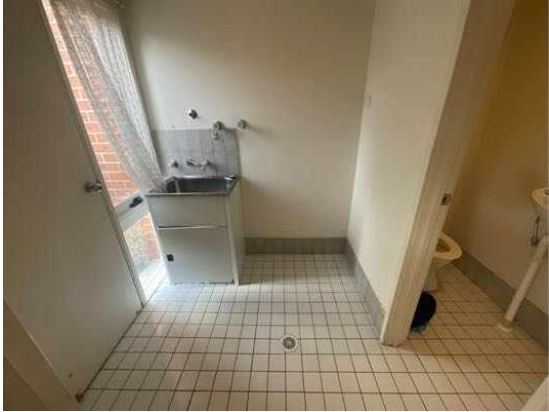
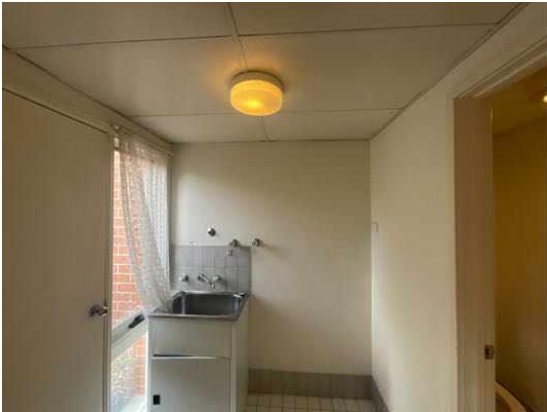
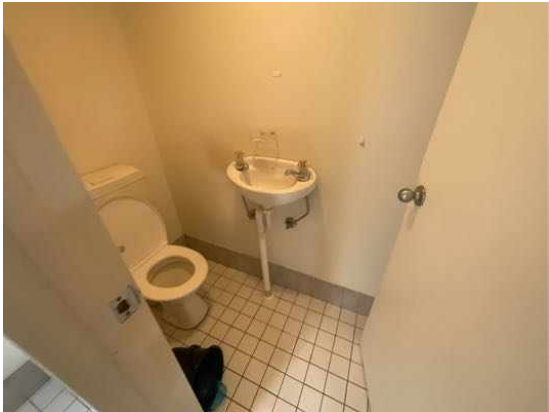
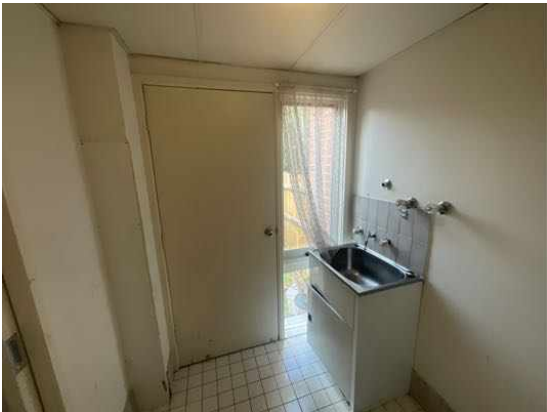
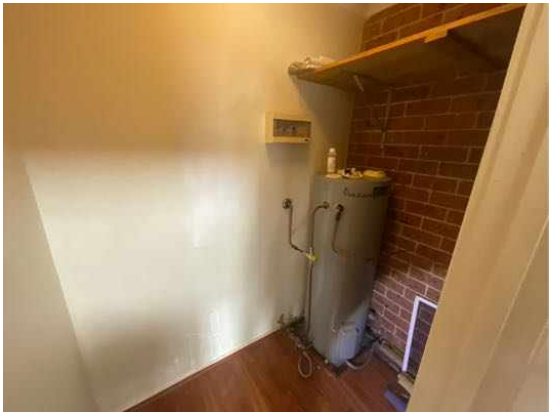
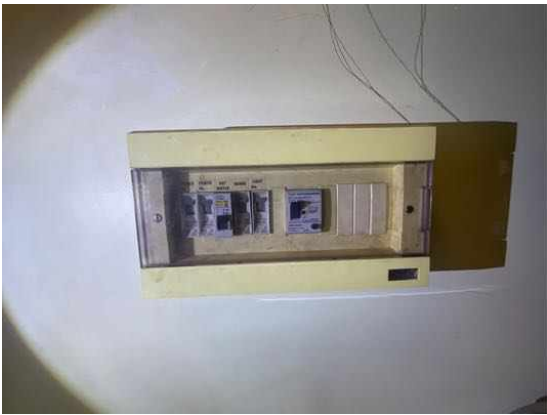
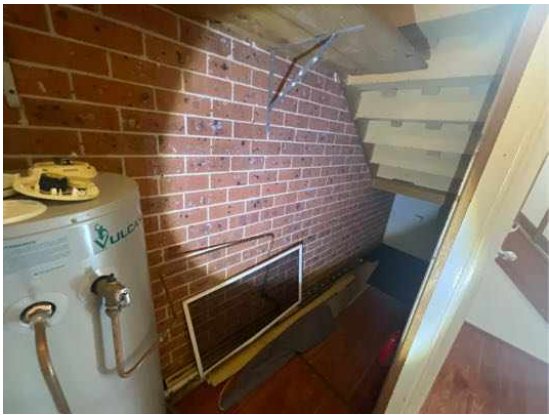
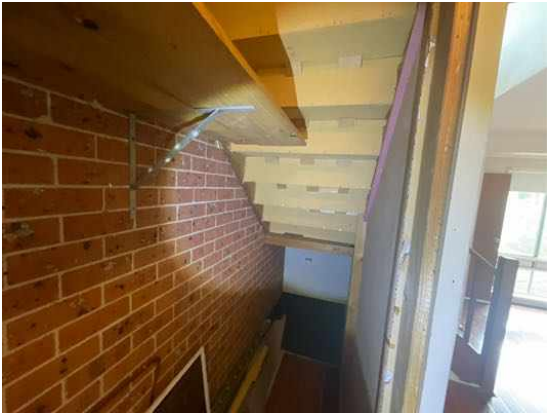
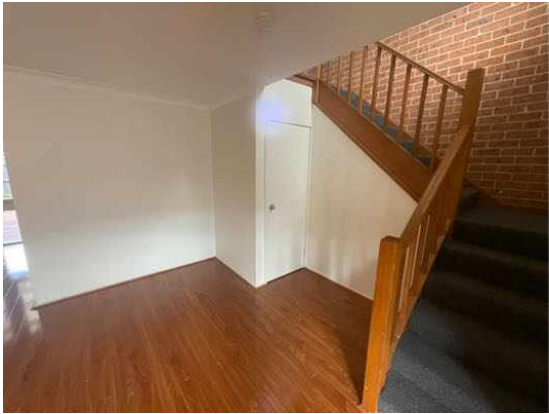
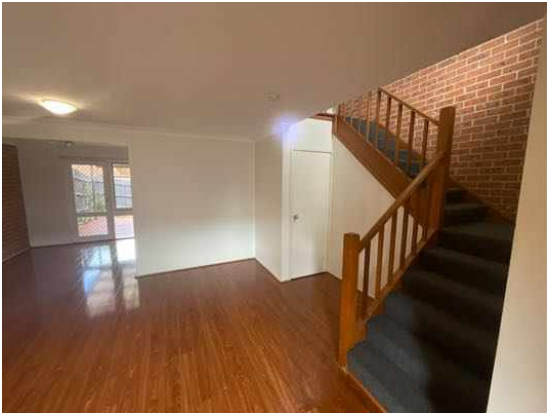
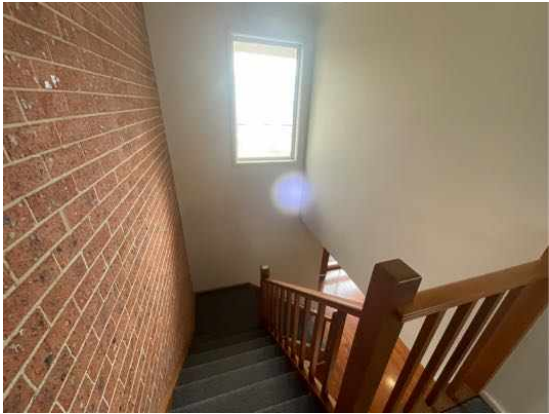
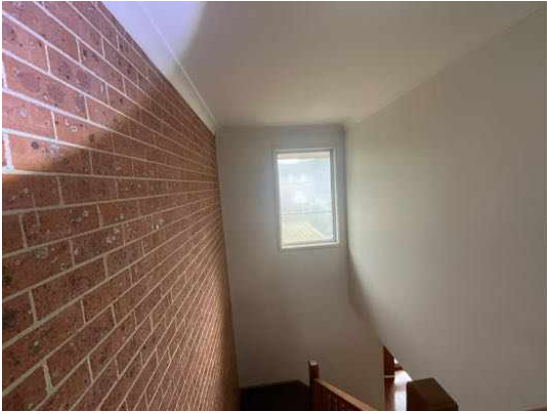
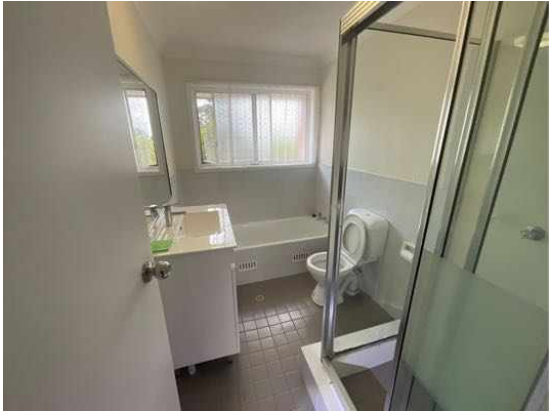
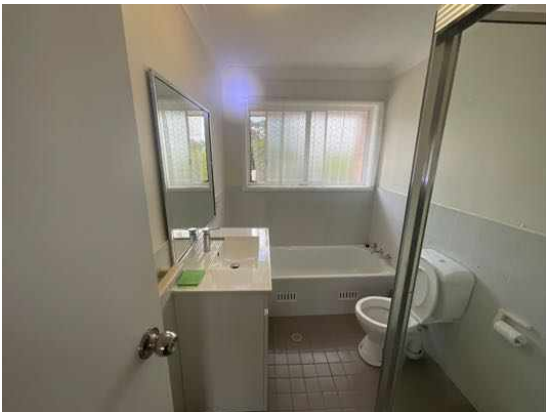
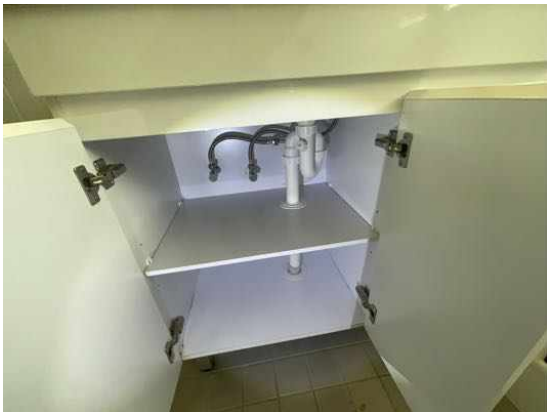
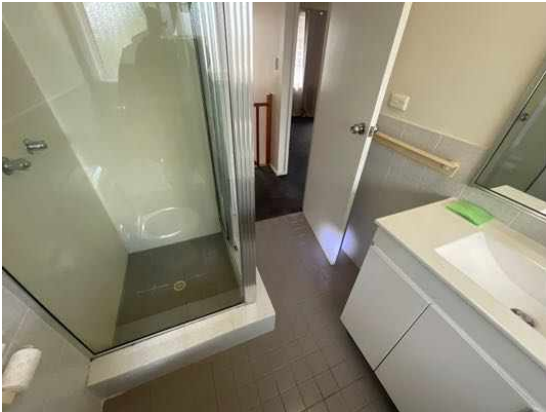
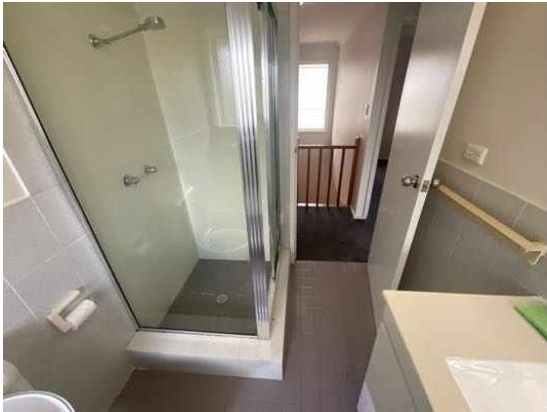
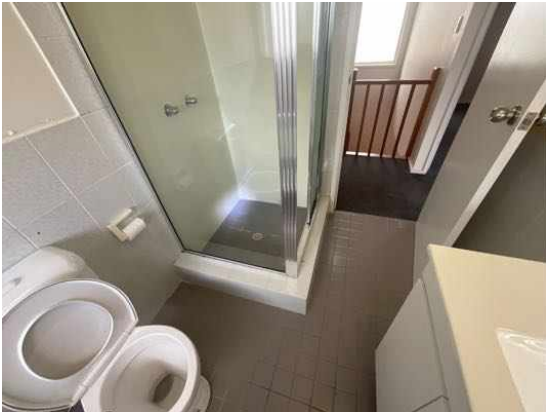
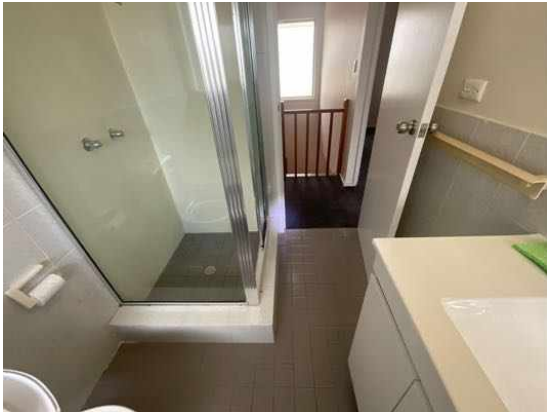
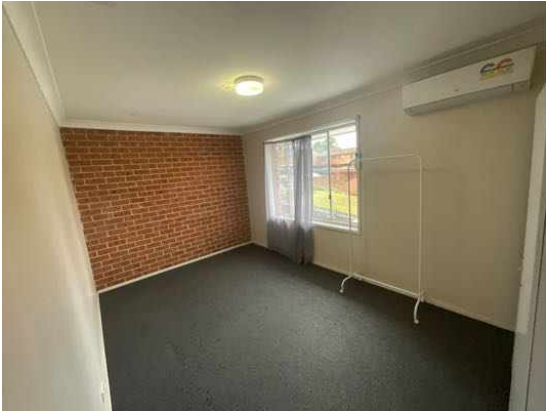
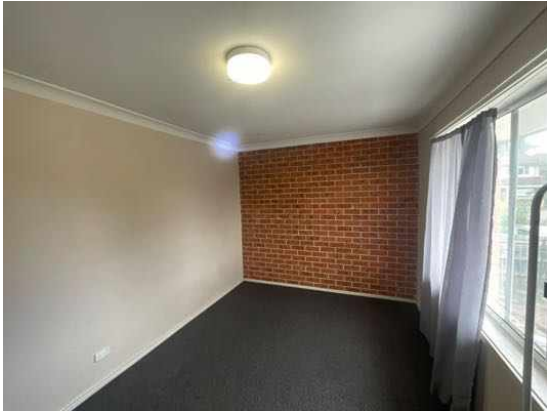
Building: Main Building  
Location: All Areas  
Finding: Additional Photos  
Information: Additional photos are provided for your general reference

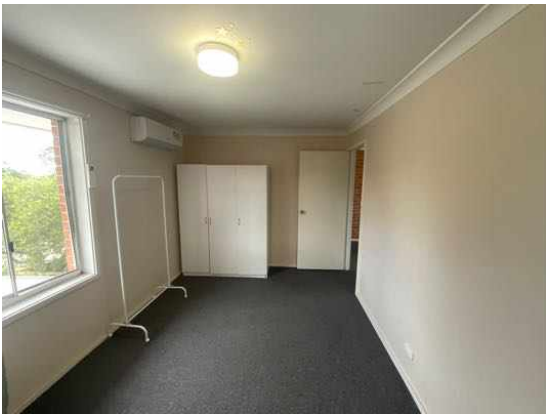
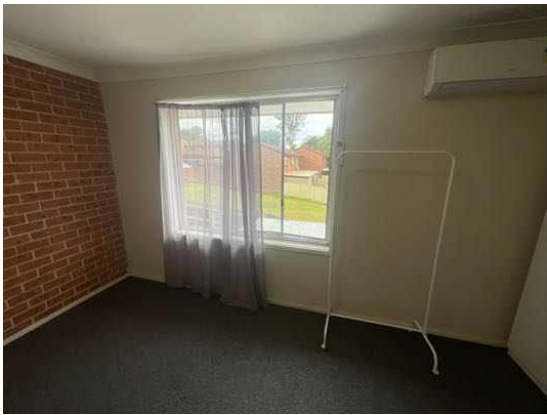
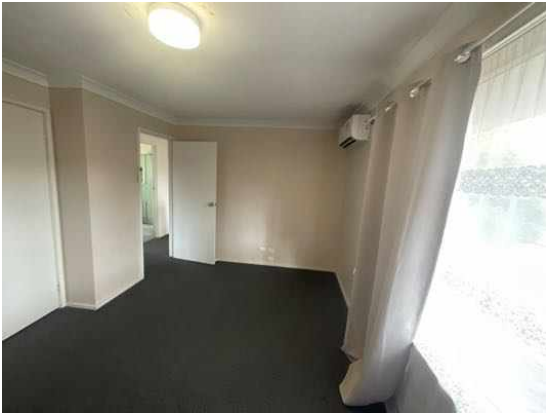
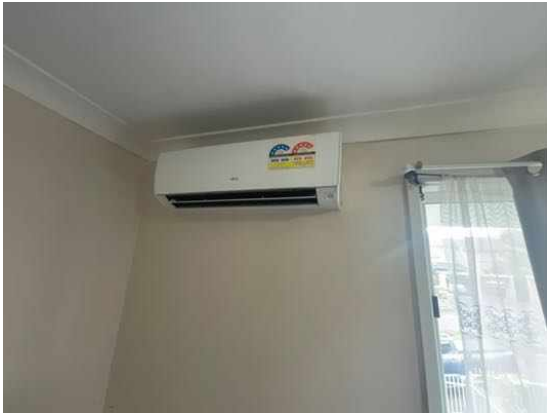
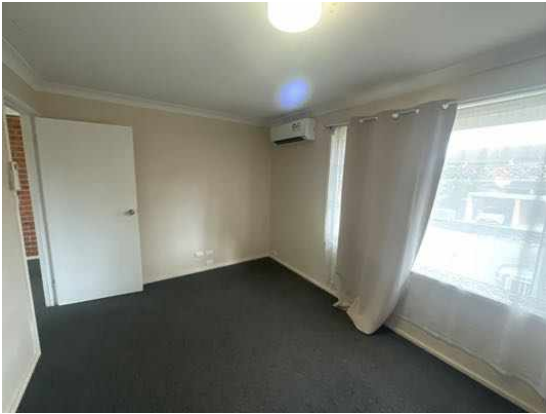
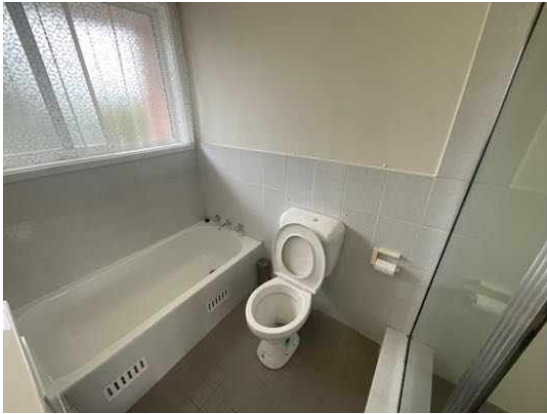
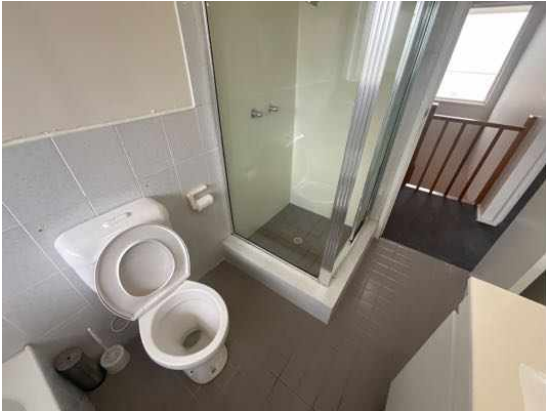
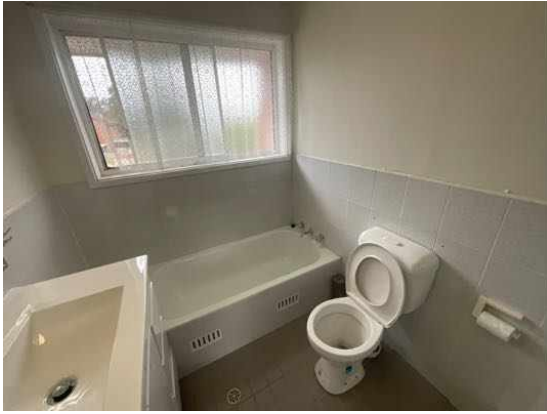
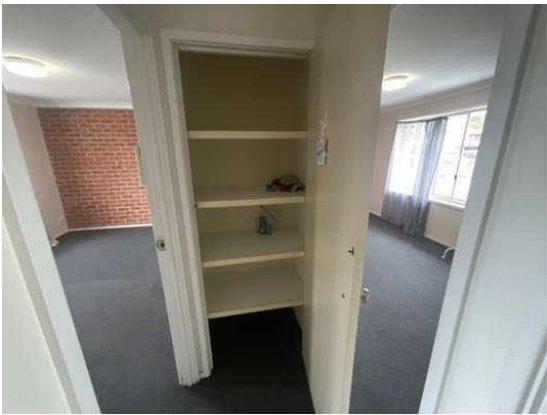
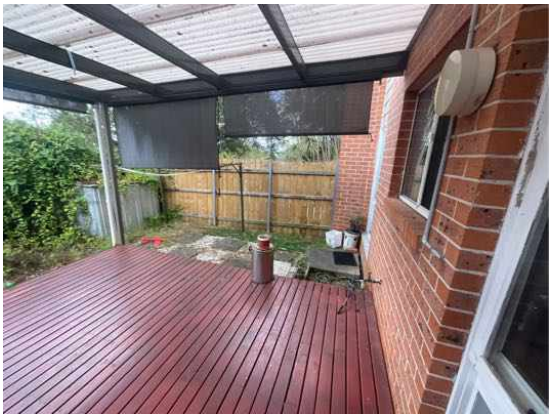
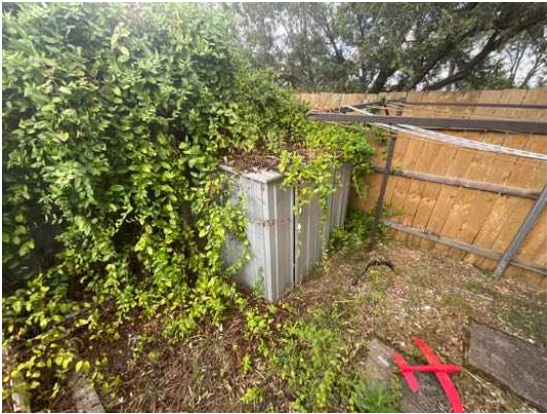
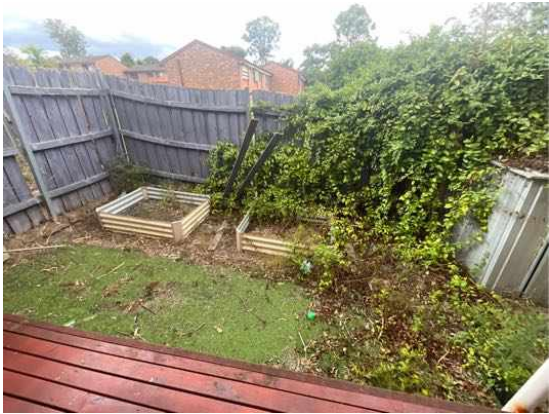
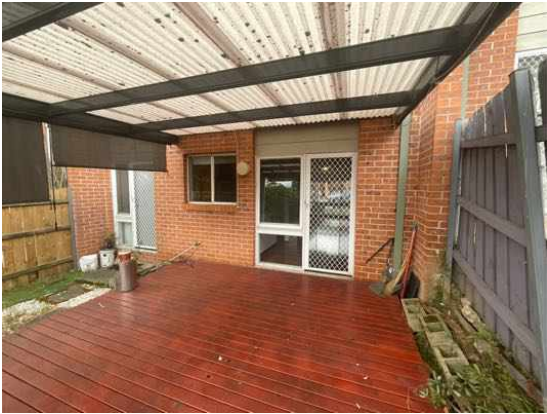
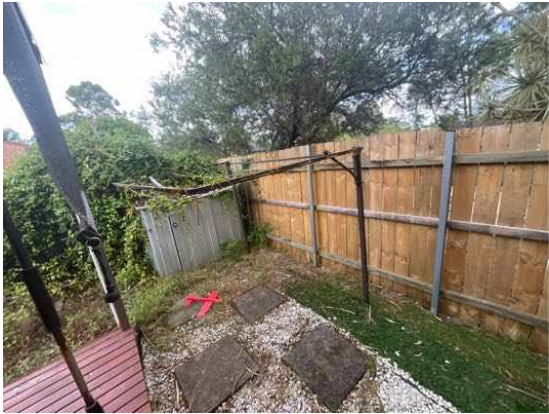
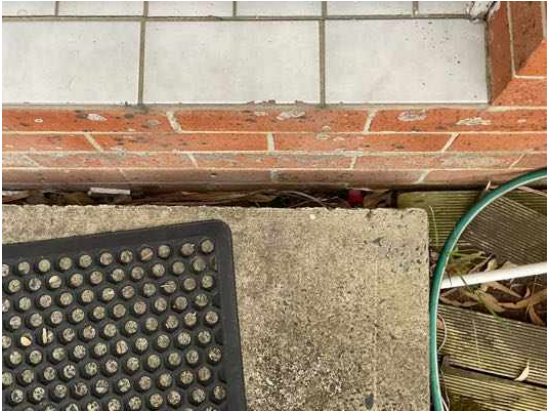
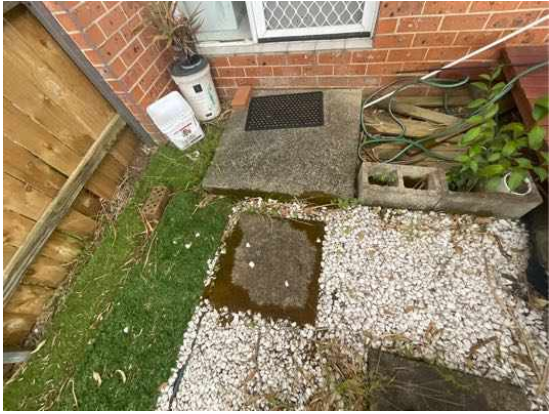
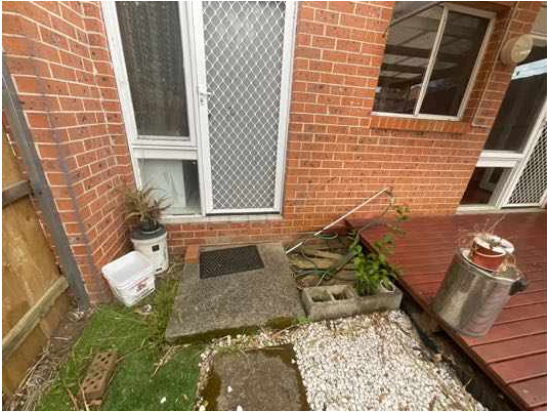
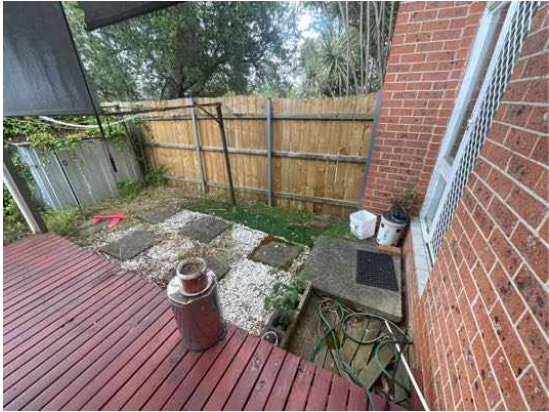
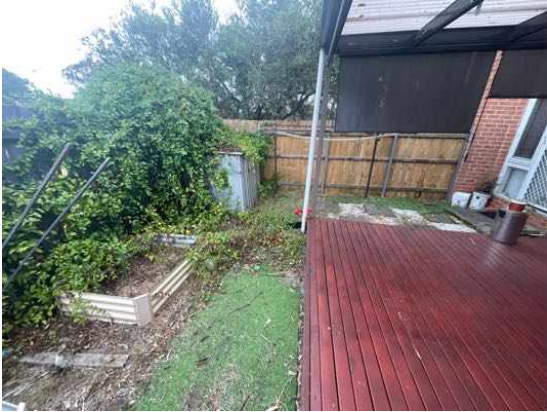
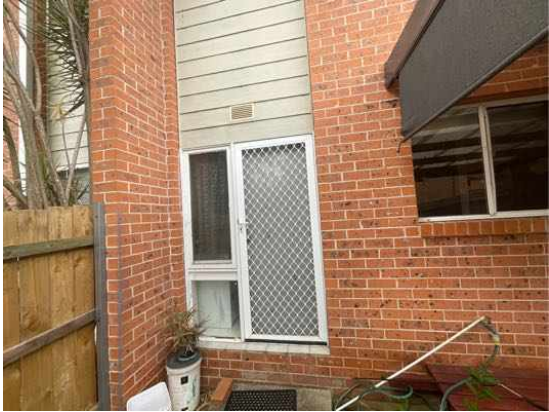
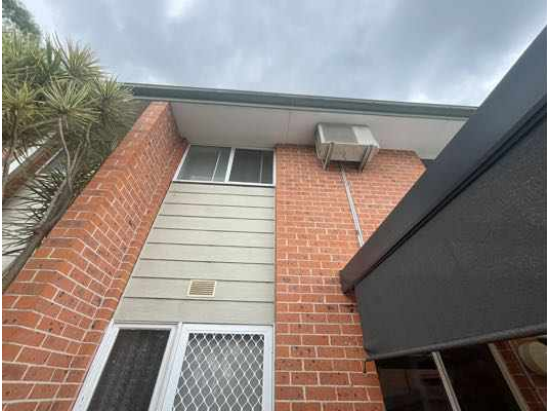
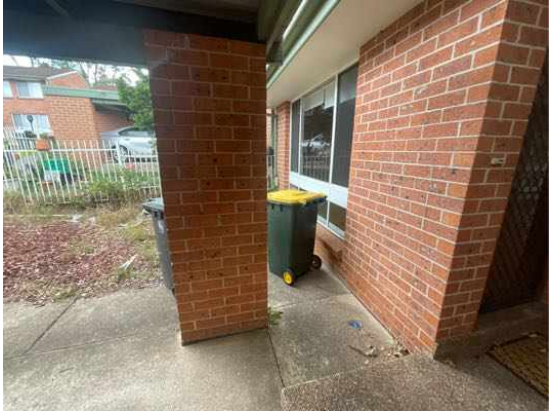
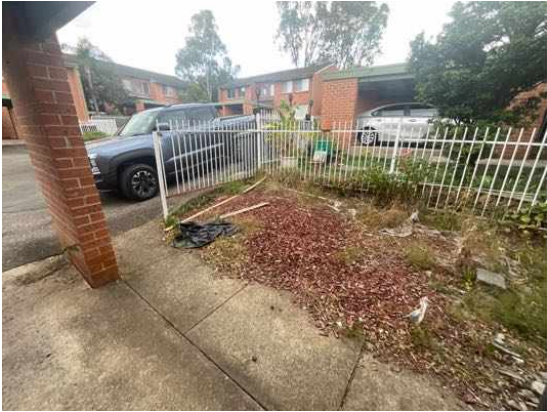
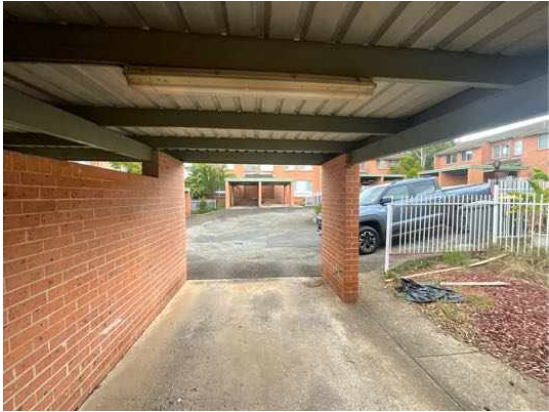
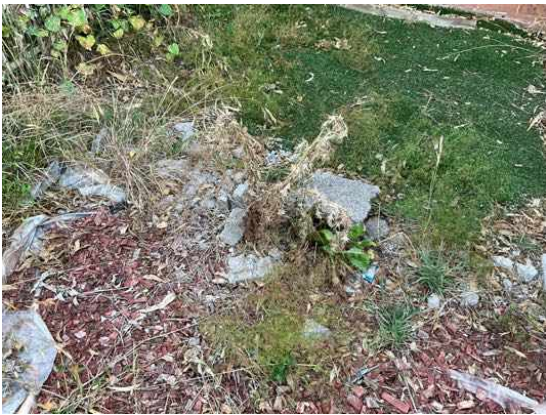
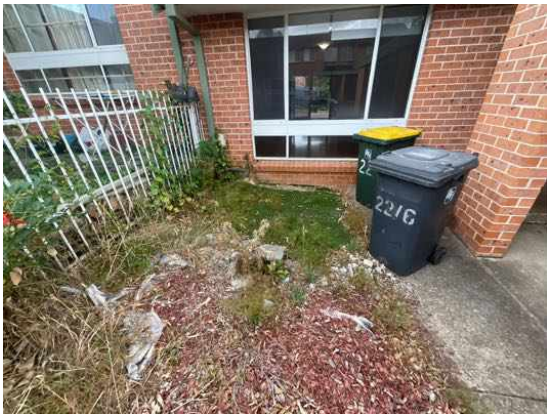
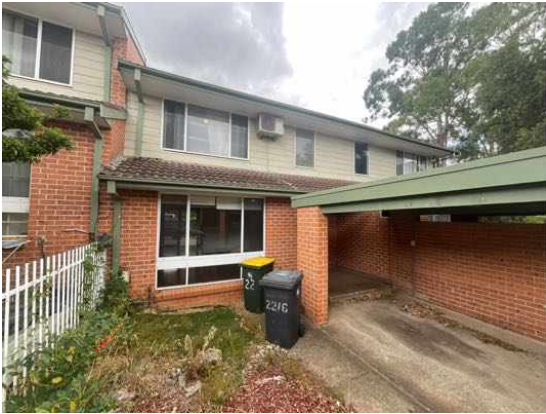
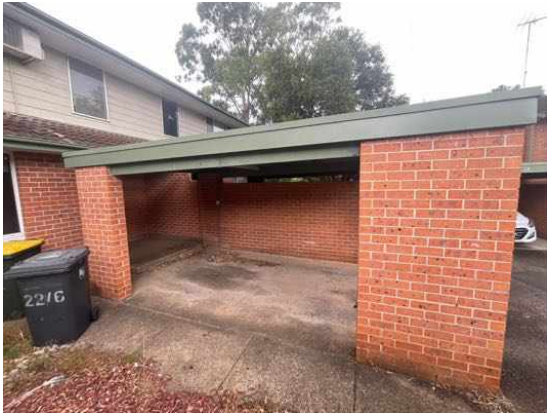
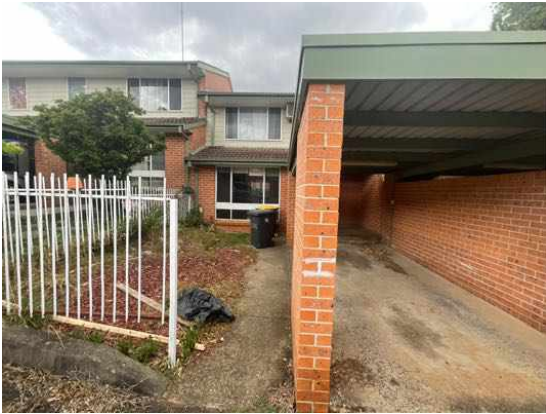
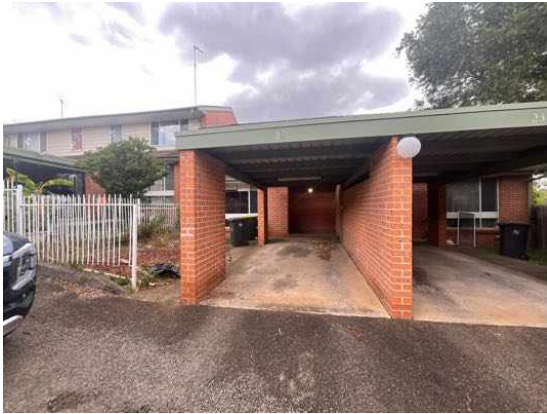
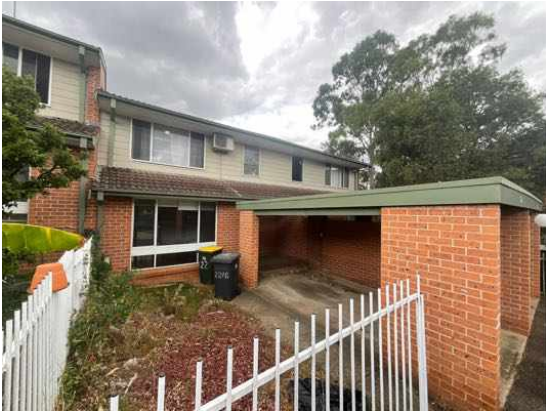
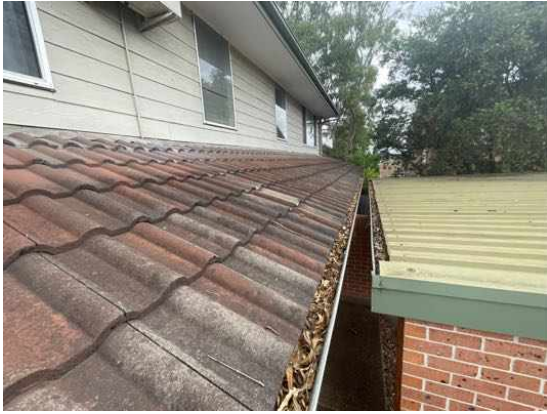
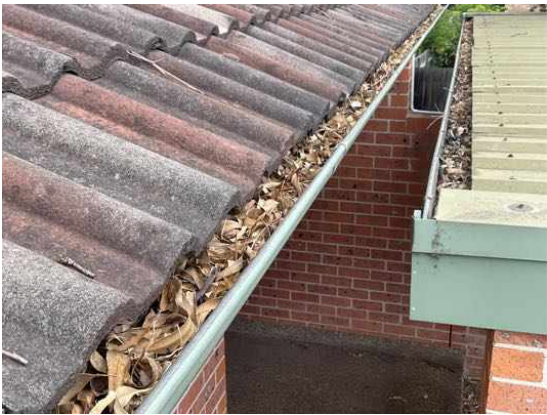
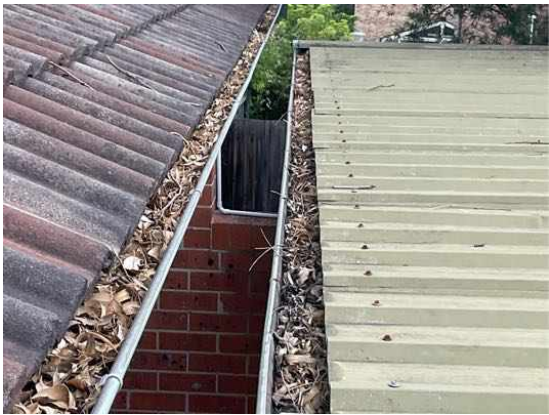
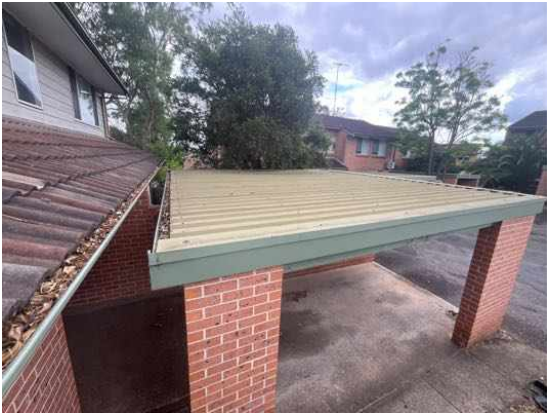
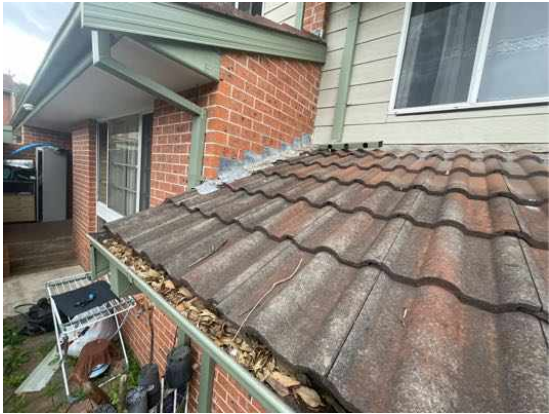
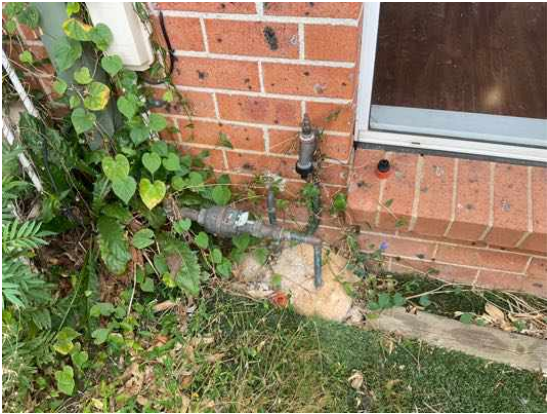
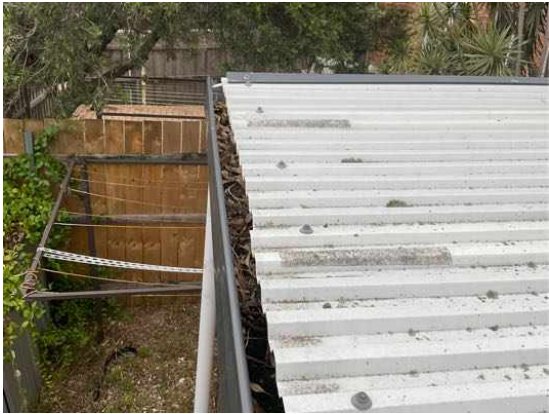
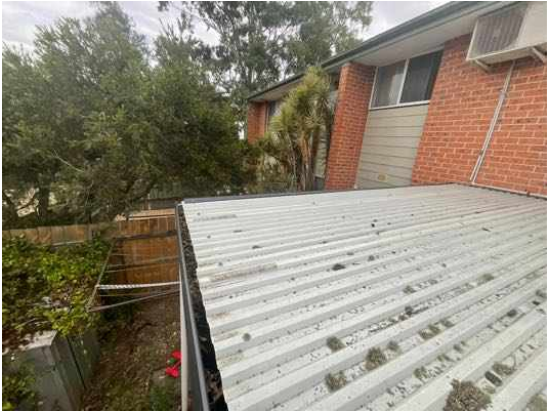
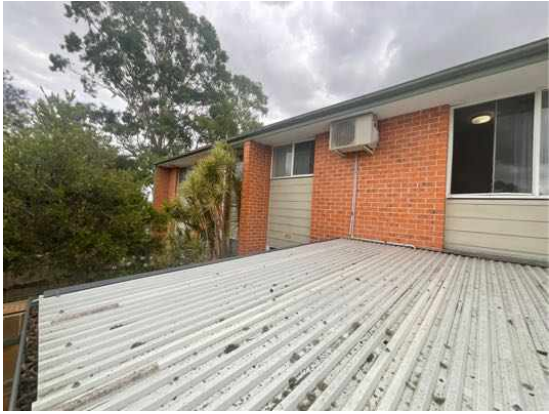
Building: Main Building  
Location: All Areas  
Finding: Additional Photos - Obstructions and Limitations  
Information: These photographs are an indication of the obstructions and limitations which impeded full inspection of the property at the time of inspection. These obstructions can hide an array of defects and should be removed to allow full inspection to be carried out. A re-inspection is recommended once the areas are made accessible.

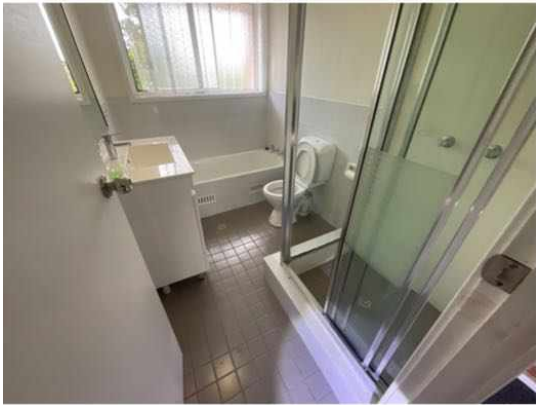
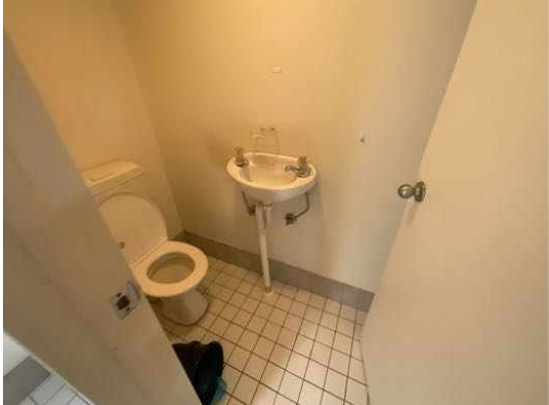
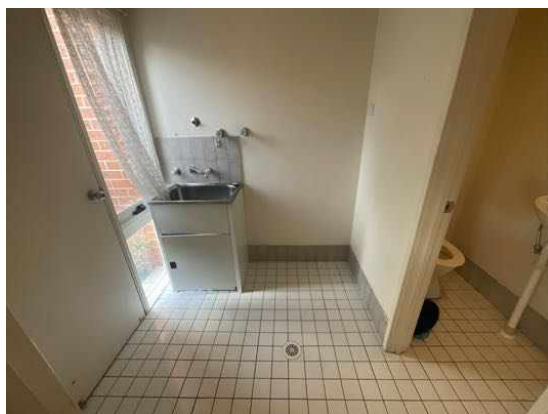
Building: Main Building  
Location: All Areas  
Finding: Water Proofing Membranes - Information Only  
Information: Internal Water Proofing Membranes, are crucial in preventing water ingress into the property is important to know that the Membrane System used is to Australian Standards and has been installed correctly. Please refer to the original Building Documents or Maintenance Schedule for the relevant information including; - Membrane used and Manufacturers Specifications. - The Installer and Installation Certification. Especially with older property's where this information is unavailable, all wet areas should be monitored. Generally new waterproofing with a certificate may only have a guarantee of 8yrs. If any leaks, water staining, peeling or bubbling of the paint become evident to any adjacent walls or ceilings below a licensed builder or waterproofing specialist is recommended to investigate further.
