Building Inspection Report

Inspection Date: Thu, 15 Jan 2026

Property Address: 49 S Station Rd, Booval QLD 4304, Australia

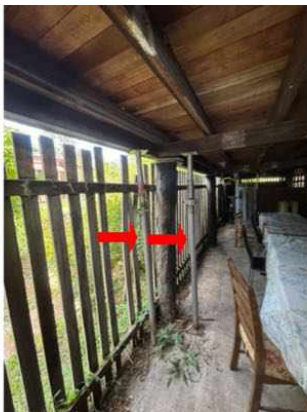
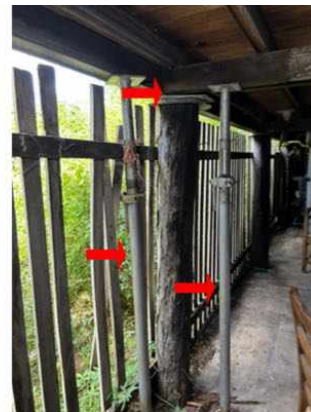
Defects 2.02

Building:	Main Building
Location:	Subfloor
Finding:	Subfloor - timber stump requires replacement
Information:	At the time of the inspection, it was noted that a timber stump on the left hand side of the subfloor area has dropped and is not supporting the timber floor structure.

Two temporary metal props are being used to support the timber floor structure in this area. These temporary props need to be securely attached to the timber floor structure to avoid them being accidentally dislodged. If dislodged, the timber floor structure will sag and could cause major damage to the associated building materials.

A licensed builder or house re-stumping specialist must be engaged to replace this timber stump. This should be done as a matter of urgency.

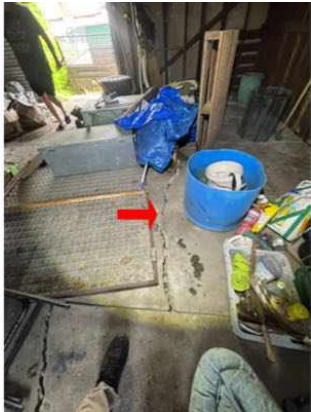
Defects 2.04

Building:	Out Building
Location:	Shed
Finding:	Shed - general deterioration
Information:	At the time of the inspection, it was noted that the shed in the backyard was deteriorating. Timber roof framing has been affected by wood rot. There are cracks in the concrete floor. The timber floor at the front of the shed is not safe to walk on. A section of timber fascia board is broken and sections of the external cladding is cracked. This external cladding may be an Asbestos Containing Material and should be treated as a such until it has been tested for Asbestos.

A licensed builder should be engaged to provide a solution for the above mentioned issues. This should be done as a short term priority.

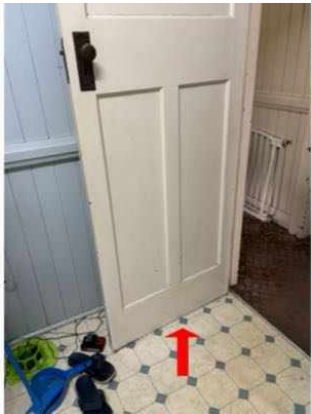
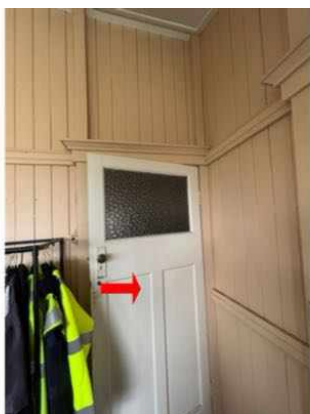
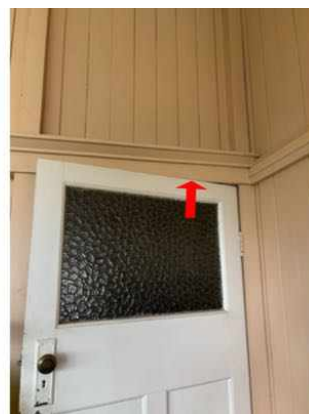
Defects 3.07

The door to the kitchen is binding on the floor and a door to the sunroom is binding on the top of the door frame.

For minor causes, a qualified carpenter or building maintenance professional should be appointed to perform minor rectification works at client discretion.

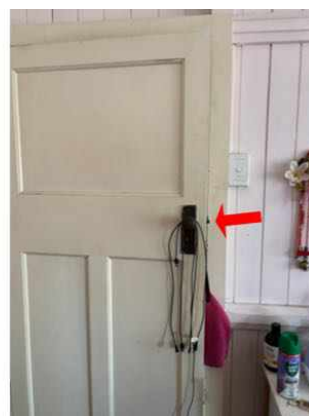
Defects 3.08

Building:	Main Building
Location:	Front bedroom
Finding:	Front bedroom - door handle not latching
Information:	At the time of the inspection, it was noted that the door to the front bedroom was not latching during normal operation. Whilst detracting from the functionality of this building element, this minor defect may also be a privacy issue. This appears to be from general wear and tear.

A qualified carpenter or building maintenance professional may be appointed to perform rectification works as necessary, at client discretion. If left unattended, further functional impairment is likely to occur.

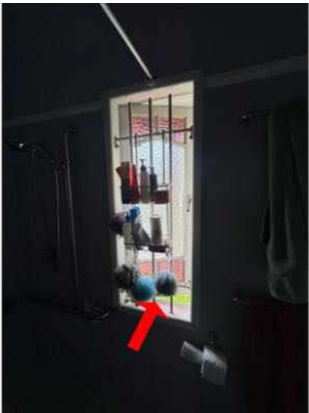
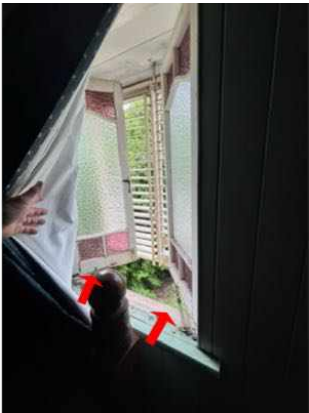
Defects 3.09

Building:	Main Building
Location:	All Internal Areas
Finding:	Windows binding
Information:	At the time of the inspection, it was noted that several windows throughout the dwelling were binding on the window frames during normal operation. This affects the functionality of the affected windows. This is a typical fault found in this style and age of building.

A building maintenance professional or licensed carpenter could be engaged to carry out the necessary repairs to restore full functionality to the affected windows.

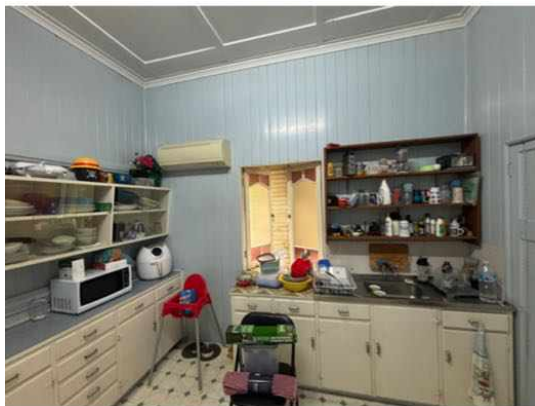
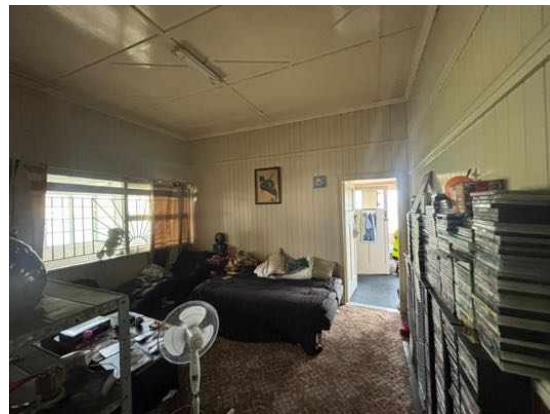
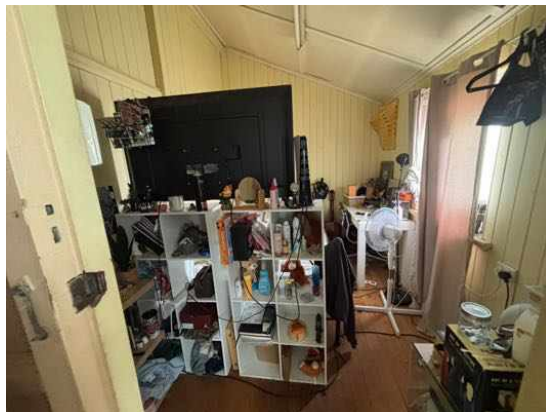
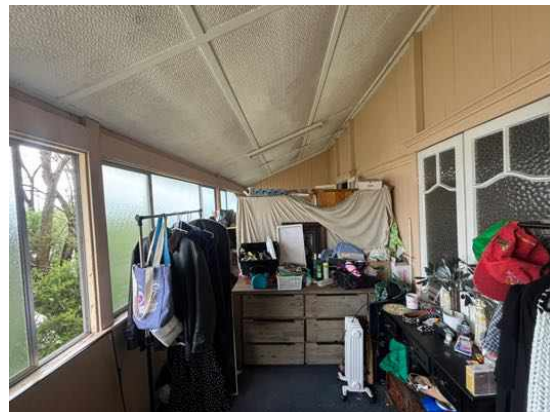
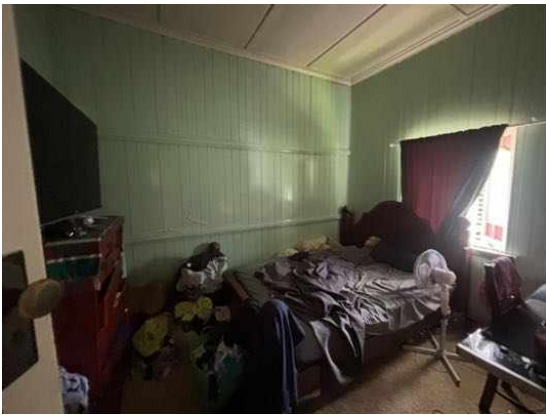
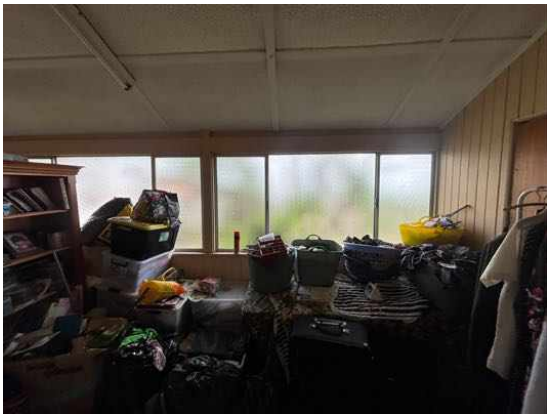
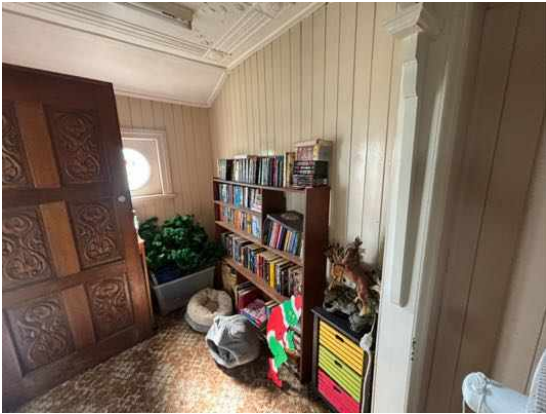
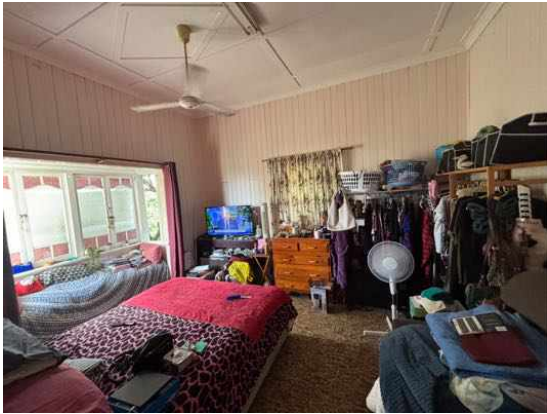
Building: Main Building
Location: All Internal Areas
Finding: Obstructions and Limitations - Internal areas
Information: These photographs are an indication of the obstructions and limitations which impeded full inspection of the property of the internal areas at the time of inspection. These obstructions can hide an array of defects and should be removed to allow full inspection to be carried out. A re-inspection is recommended once the areas are made accessible.

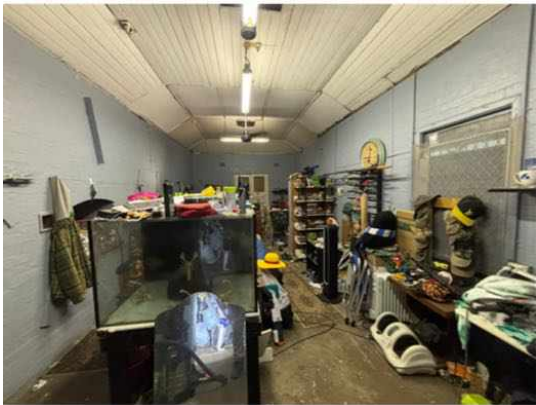
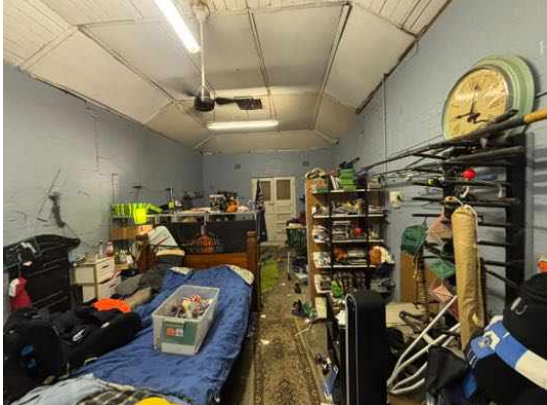
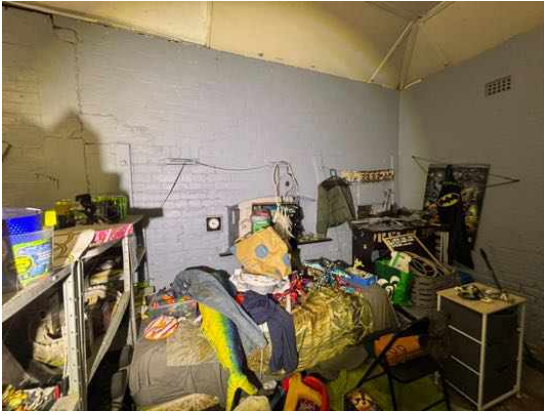
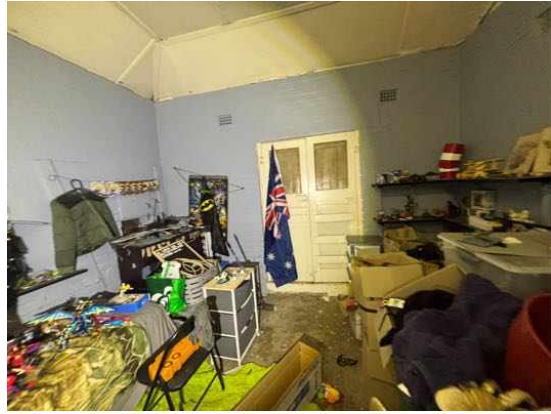
Building: Out Building
Location: All Internal Areas
Finding: Obstructions and Limitations - Internal areas
Information: These photographs are an indication of the obstructions and limitations which impeded full inspection of the property of the internal areas at the time of inspection. These obstructions can hide an array of defects and should be removed to allow full inspection to be carried out. A re-inspection is recommended once the areas are made accessible.

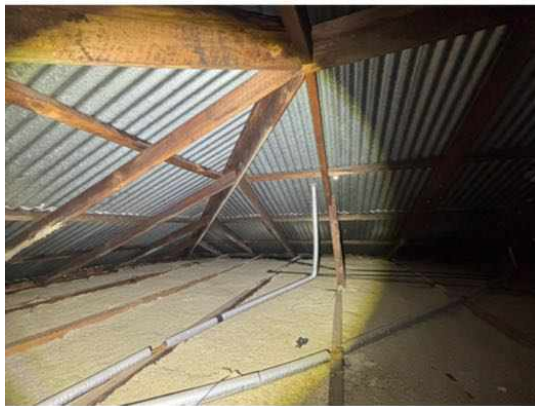
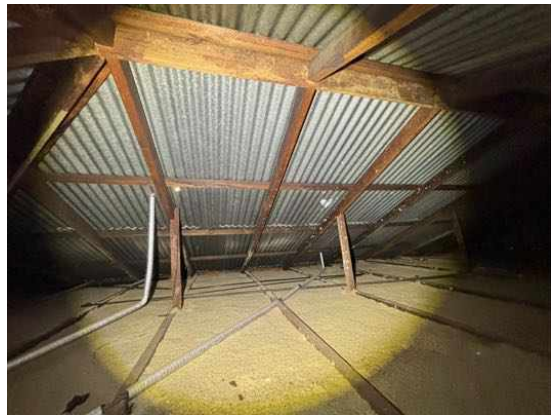
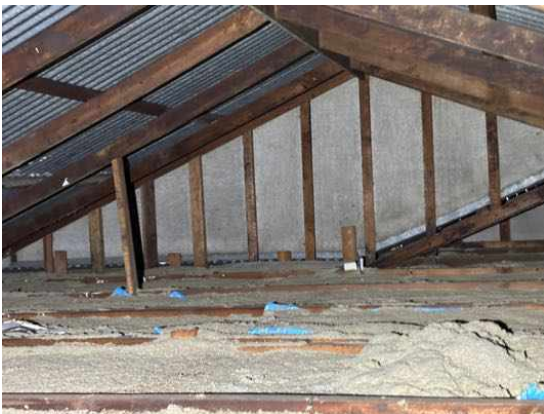
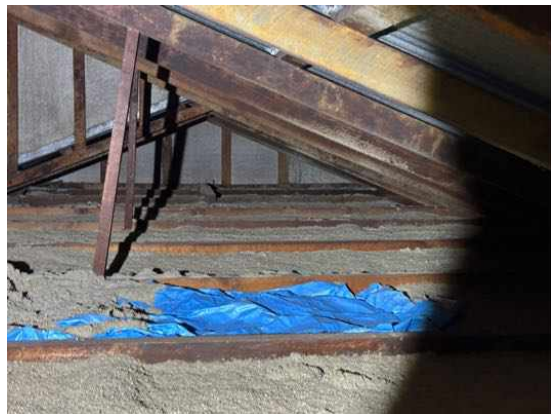
Information: These photographs are an indication of the obstructions and limitations which impeded full inspection of the property of the roof cavity

at the time of inspection. These obstructions can hide an array of defects and should be removed to allow full inspection to be carried out. A re-inspection is recommended once the areas are made accessible.

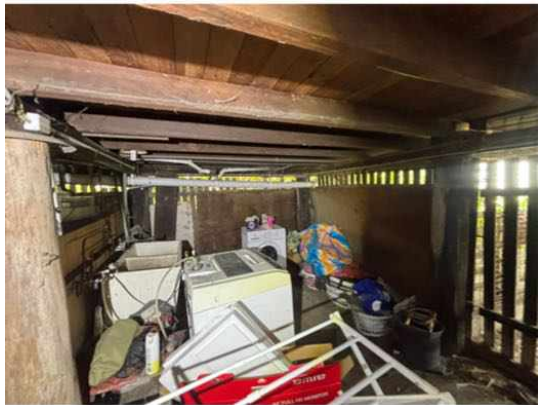
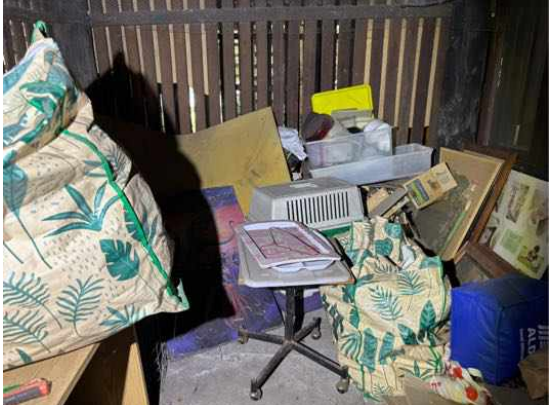
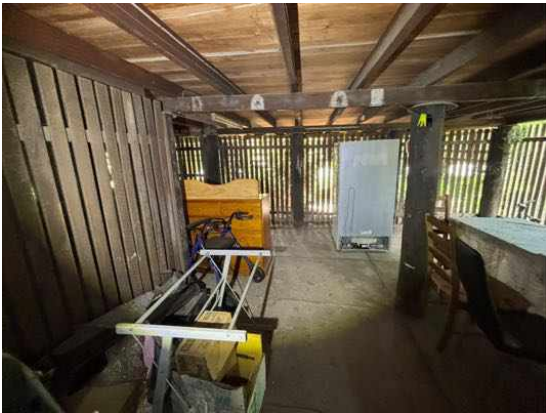
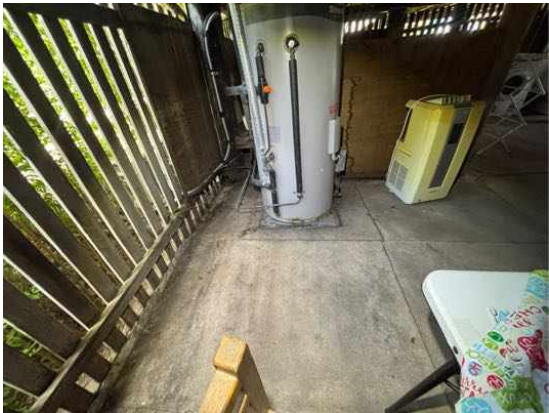
Building: Main Building
Location: Subfloor
Finding: Obstructions and Limitations - Sub floor cavity
Information: These photographs are an indication of the obstructions and limitations which impeded full inspection of the property of the sub floor cavity

at the time of inspection. These obstructions can hide an array of defects and should be removed to allow full inspection to be carried out. A re-inspection is recommended once the areas are made accessible.
