Building Inspection Report

Inspection Date: Fri, 20 Mar 2026

Property Address: Unit 505, 4 Broughton Street, Canterbury
NSW 2193

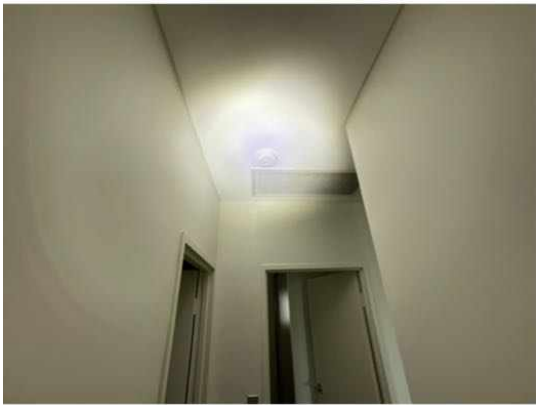
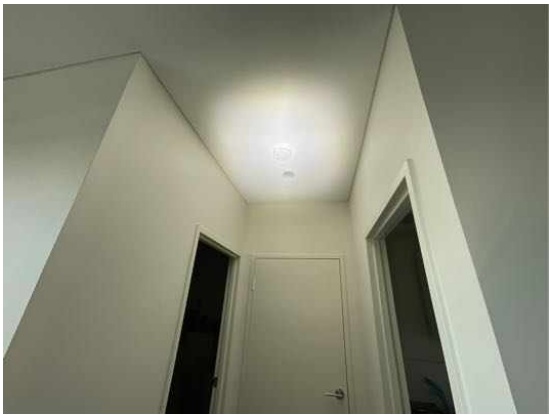
Noted Item

Building:	Main Building
Location:	All Areas
Finding:	Smoke Detectors / Alarms.
Information:	Reporting on the presence, type, location, or compliance of smoke detectors or alarms, including hard-wired smoke detection systems and their legislative requirements, is outside the scope of this inspection report.

- All smoke detectors be tested monthly by the homeowner.
- All systems comply with the requirements of AS 3786 and any applicable state-based legislation.

Failure to comply with these requirements may pose a serious risk to occupant safety.
