Building and Timber Pest Inspection Report VR

Inspection Date: Thu, 26 Feb 2026

Property Address: 34 Allen St, Leichhardt NSW 2040, Australia

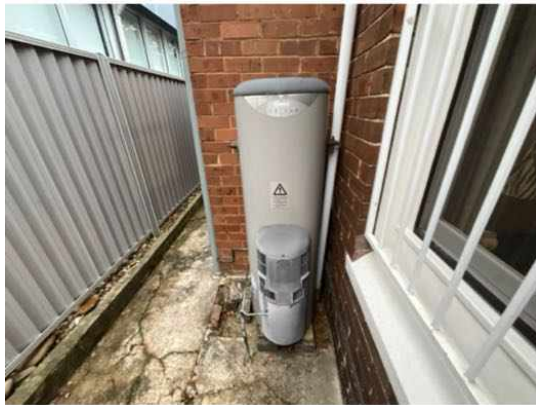
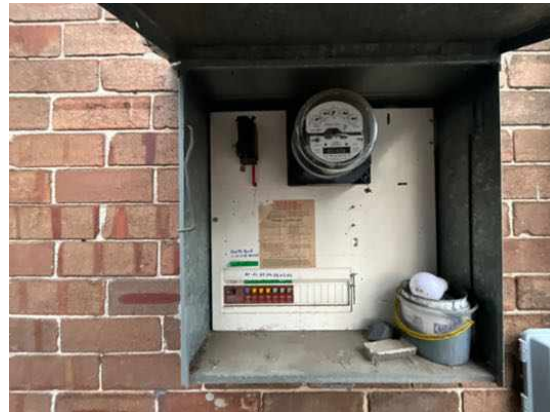
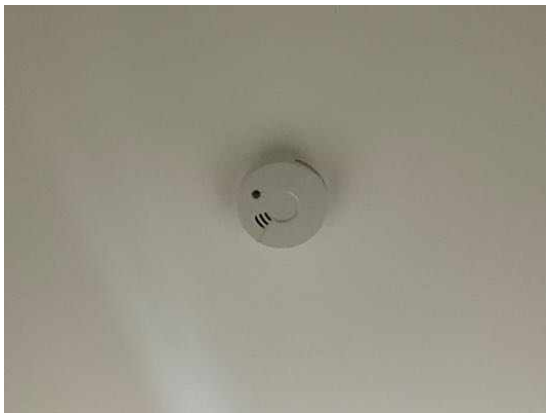
Building: Main Building
Location: All Areas
Finding: Photos Added
Information: Additional photos are provided for your general reference.

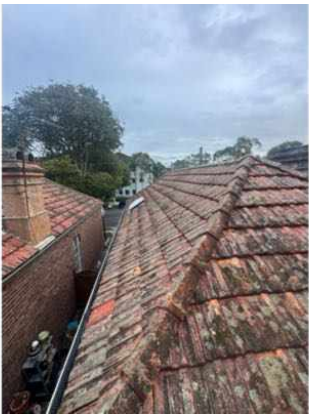
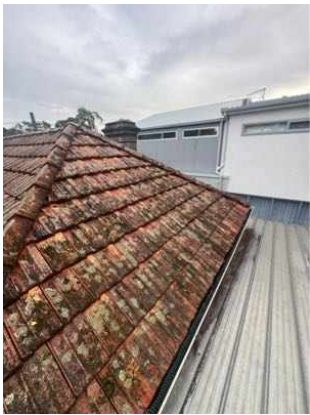
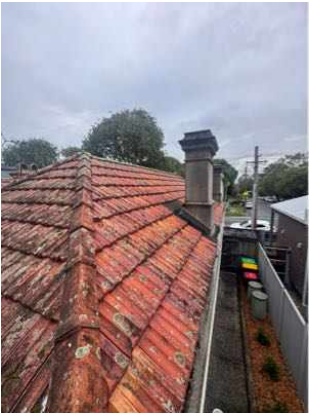
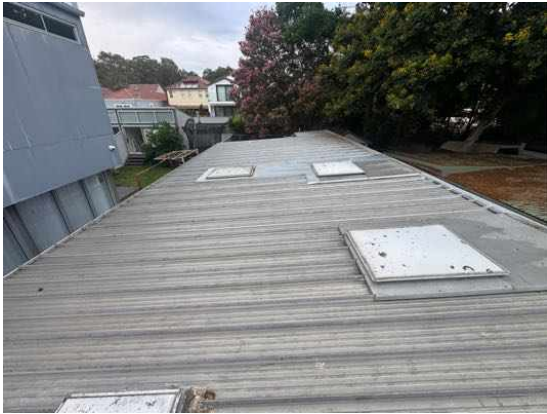
Building: Main Building
Location: Roof Exterior
Finding: Photos Added
Information: Additional photos are provided for your general reference.

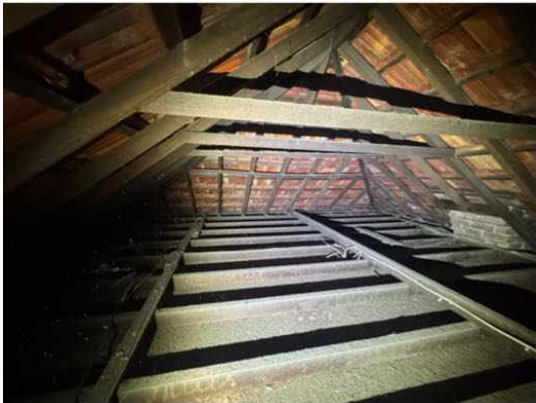
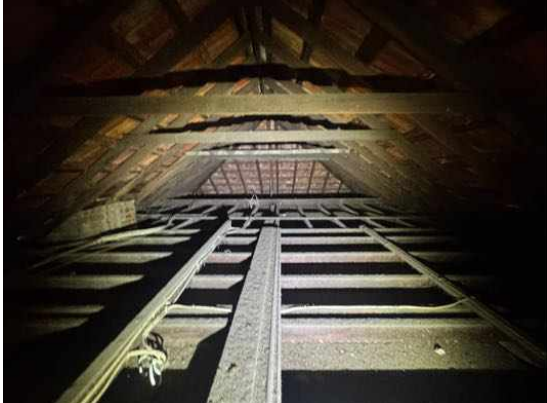
Building: Main Building
 Location: Roof Void
 Finding: Photos Added
 Information: Additional photos are provided for your general reference.
