# Building and Timber Pest Inspection Report

Inspection Date: Tue, 27 Jan 2026

Property Address: 6 Flame Tree Ct, Palmwoods QLD 4555,  
Australia

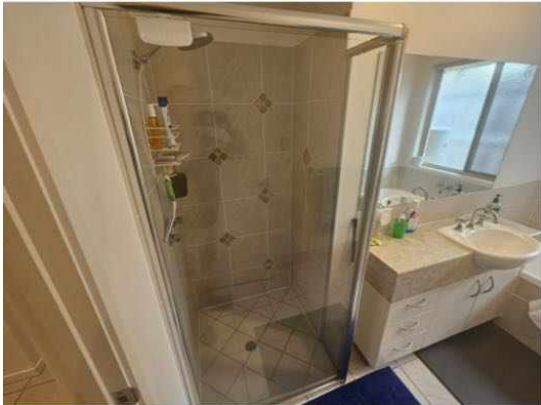
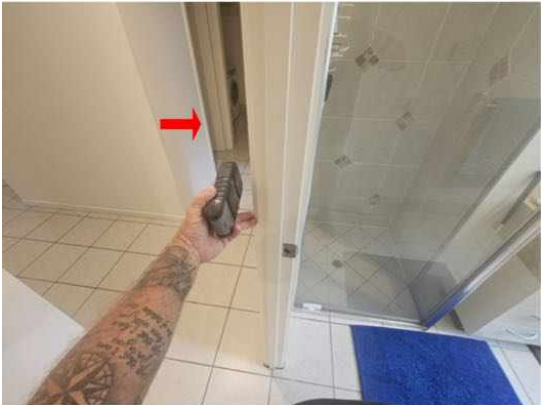
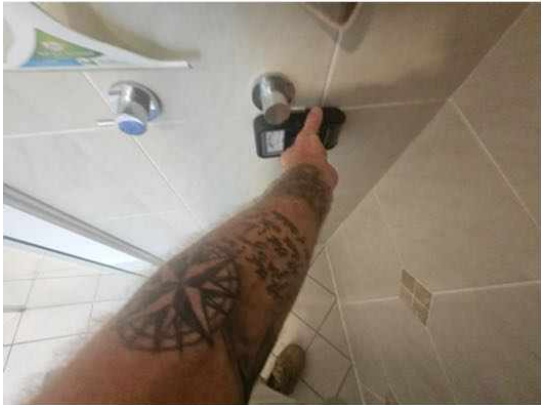
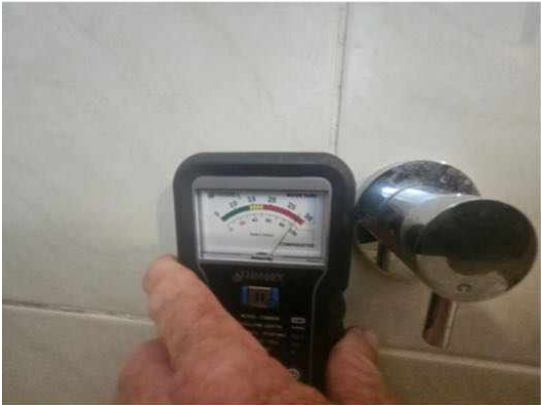
Building: Main Building  
 Location: Bathroom  
 Finding: Elevated moisture present at the time of inspection - bathroom  
 Information: Elevated moisture was noted in the lower tiled wall surfaces of the bathroom shower. The moisture readings were mostly contained in the wall housing the tapware. Moisture readings were recorded on the opposing side of the wall in the hallway.

The levels varied at differing points throughout the recess. This could possibly be due to deteriorated grout and silicone sealants and / or plumbing fittings and fixtures. The grouts and sealants can break down over time and become porous, allowing moisture to enter the wall sheet surface behind the tiles. It is believed that, given the pattern and location of the readings, the moisture ingress is related to the tapware, plumbing service or the wall penetrations.

Elevated moisture can attract timber pests and vermin, and produce conditions that promote timber pest attack, fungal growth and wood decay.

Due to the unknown nature of the moisture in the wall cavity and any possible damage, this has been given a the rating of major defect.

It is recommended that the moisture levels in these areas be investigated further by a licensed plumber.

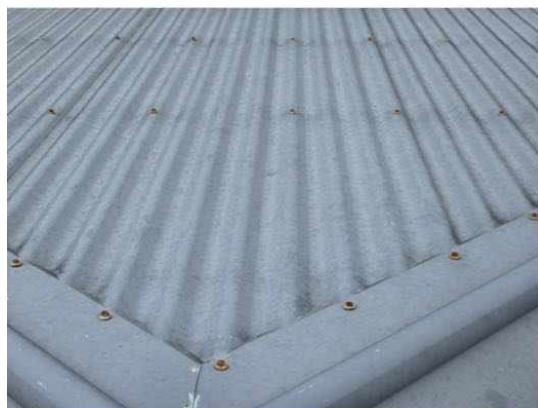
Building:	Main Building
Location:	All External Areas
Finding:	Roof screws - rusting
Information:	It was noted during inspection, that throughout the roof surface the majority of roof screws are showing signs of rust at varying degrees ranging from minor to moderate.

This should be monitored over time, and should the condition worsen, consider replacement of the screws. As roof screws deteriorate they can have an effect on the adjoining roof materials.

A roofing plumber could be appointed at the clients discretion to replace the screws in question.

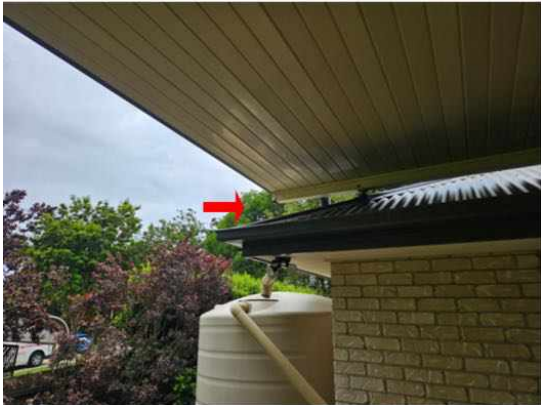
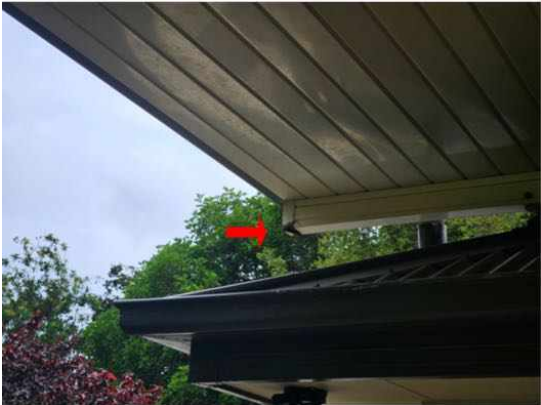
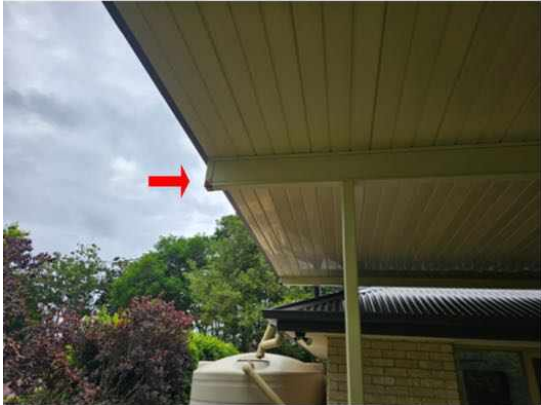
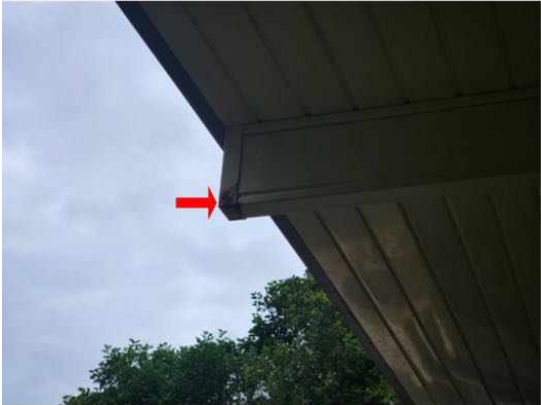
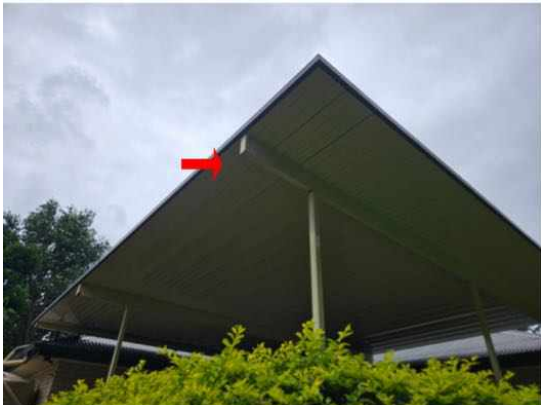
### Finding 3.02

Building:	Main Building
Location:	Rear patio
Finding:	Pergola steel frame - surface rust present.
Information:	<p>On the day of inspection it was noted that the steel framing members of the rear pergola at the right side of the house had surface rust developing. The surface coating / paint has deteriorated and the base metal could be exposed if not re-coated.</p> <p>It is advised that an application of a suitable moisture resistant protective coating and a rust treatment method be implemented.</p> <p>Engaging the services of a licensed painter or suitably qualified handy person could assist with providing a solution.</p>

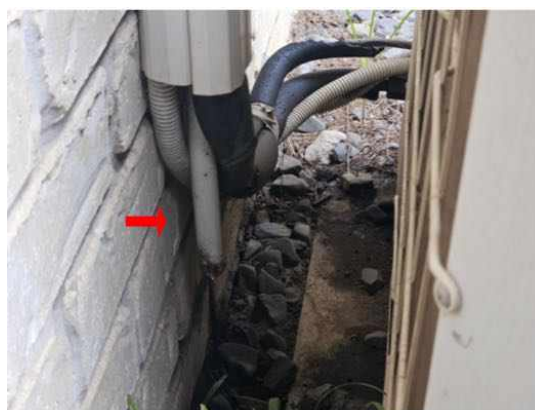
Building:	Main Building
Location:	As shown
Finding:	Air conditioner - Disconnected drain
Information:	The Air Conditioner (A/C) overflow was found to be disconnected from storm water drainage and could create excessive moisture in the surrounding area.

It is recommended that a licensed plumber be appointed to connect the A/C overflow to a drainage source in order to prevent such an environment from being created. An alternative is to extend the overflow further into the garden away from the building perimeter.

These minor works should be carried out in the short term.

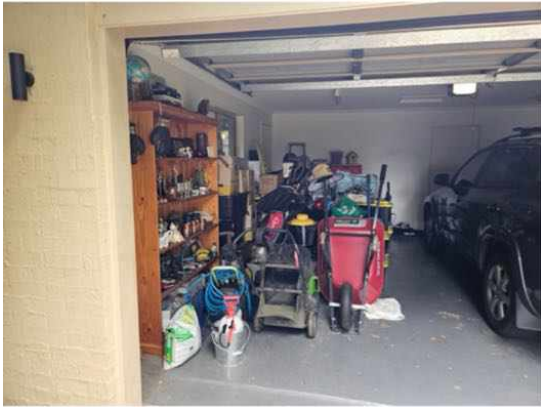
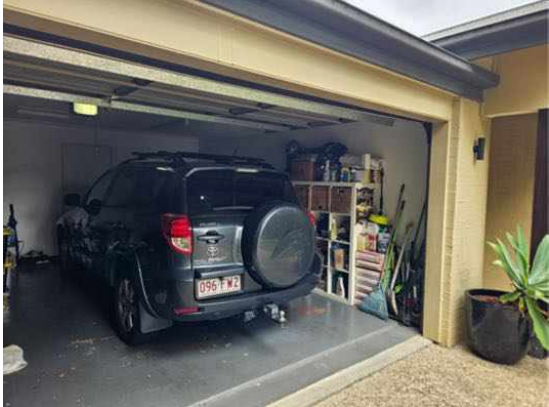
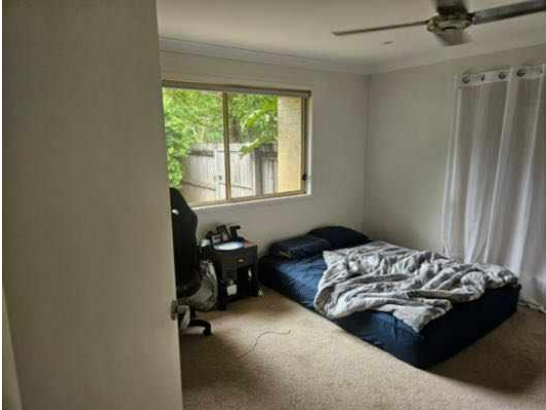
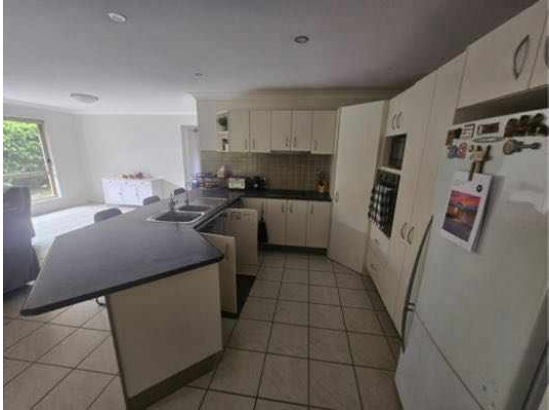
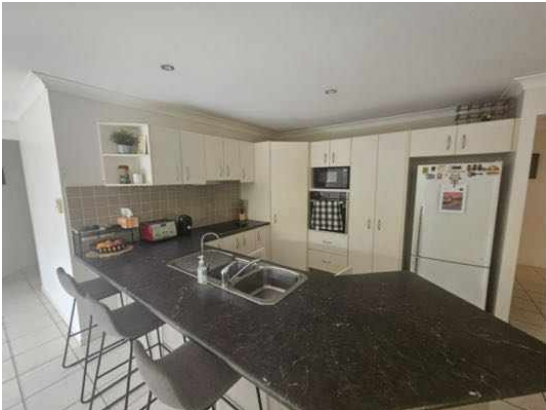
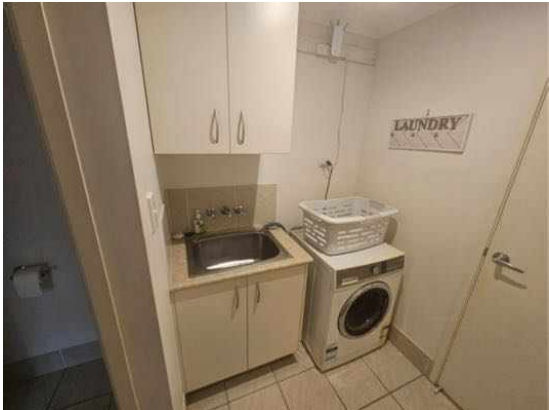
Finding: Additional Photos - Obstructions and Limitations

Information: These photographs are an indication of the obstructions and limitations which impeded full inspection of the property at the time of inspection. These obstructions can prevent full inspections of the areas shown.

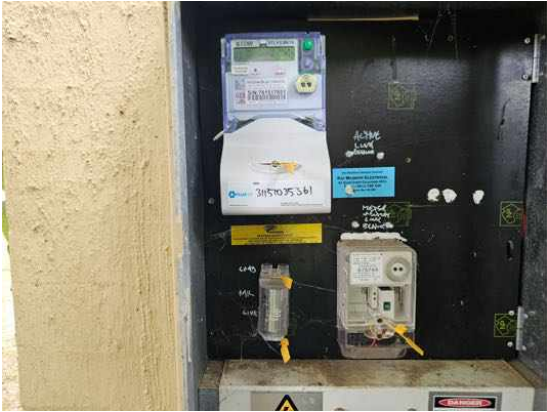
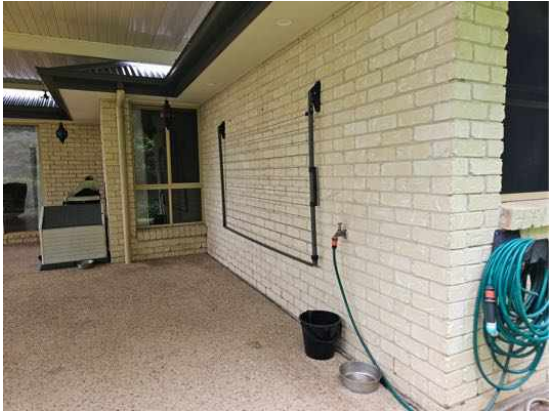
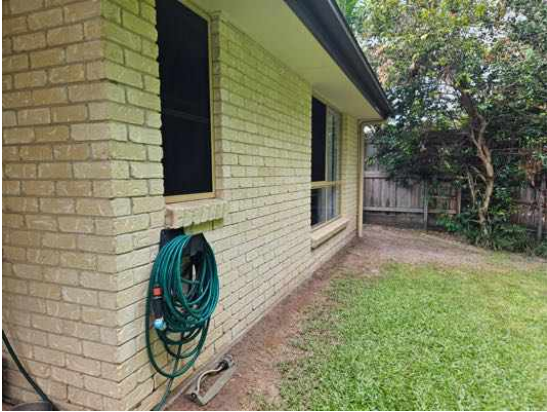
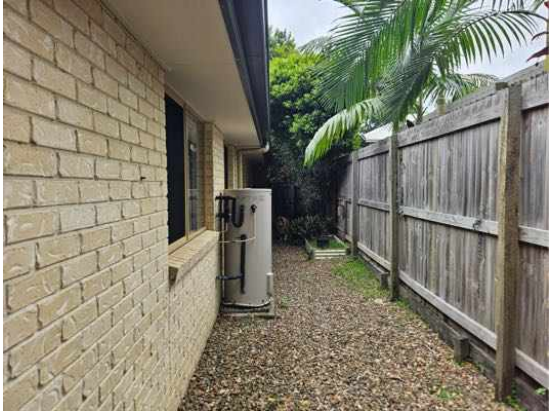
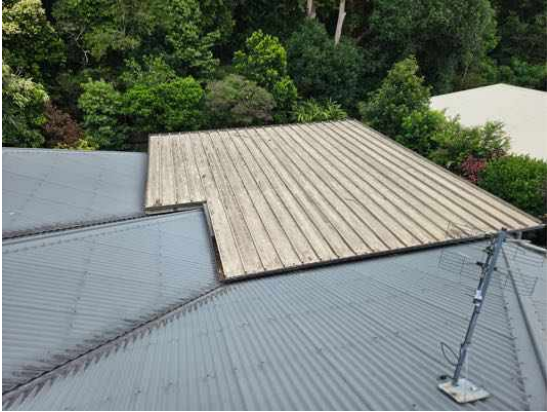
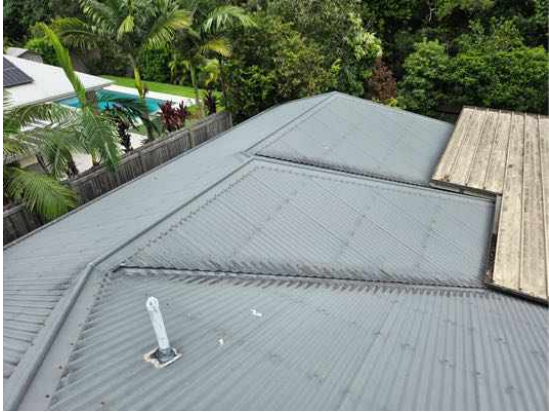
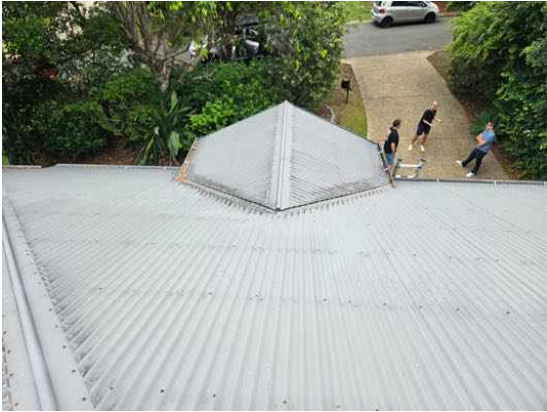
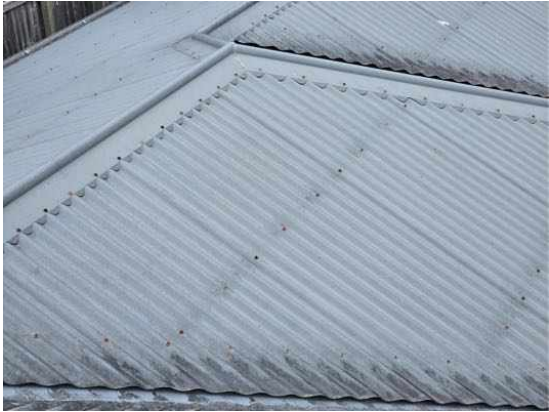
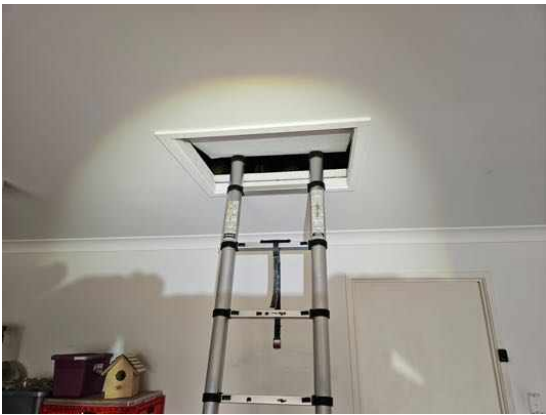
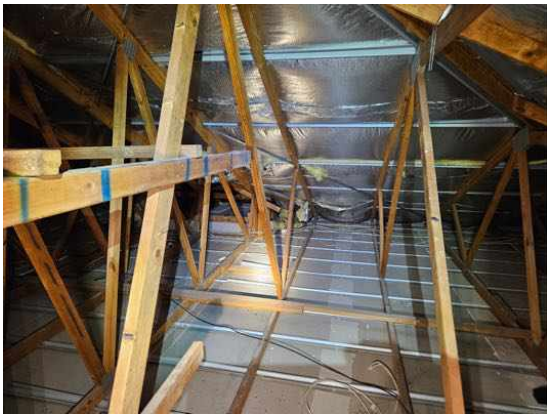
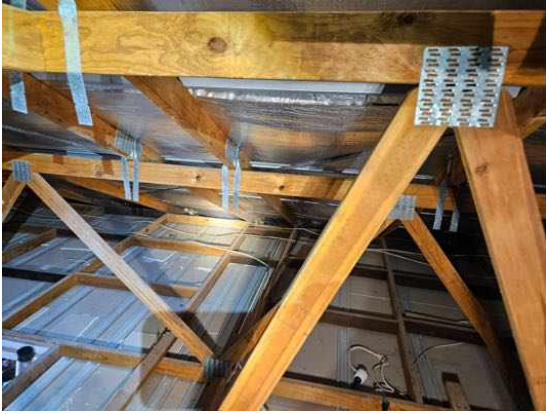
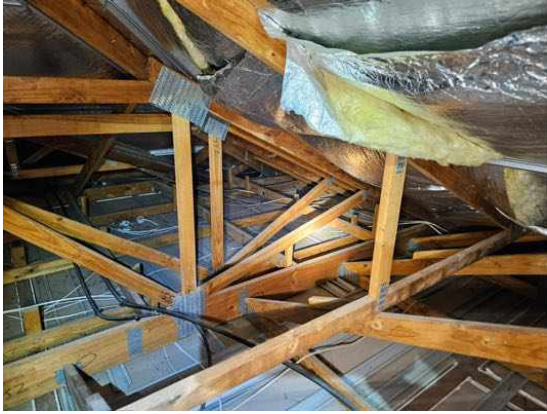
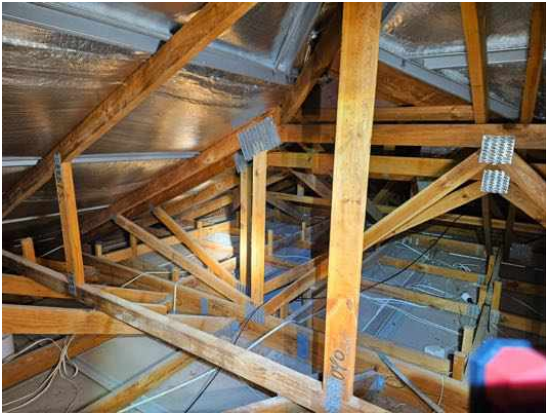
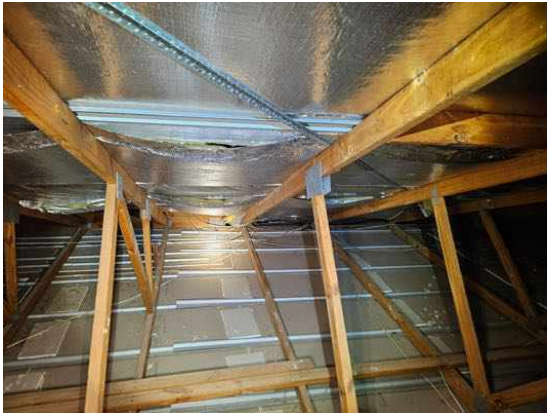
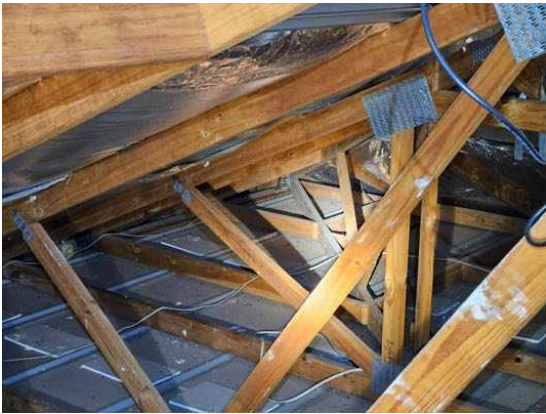
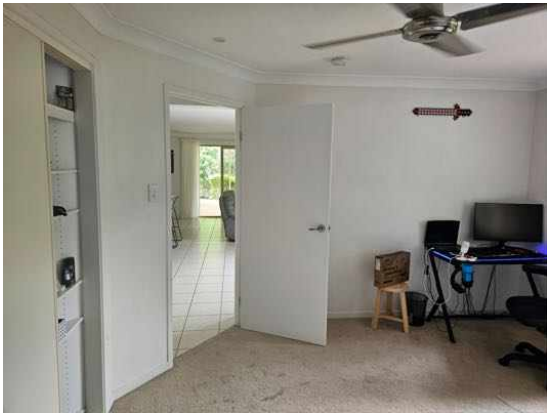
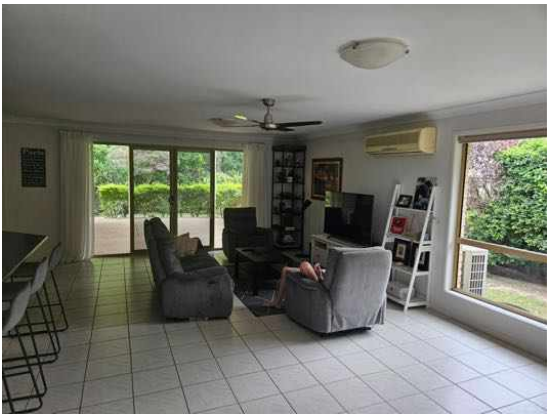
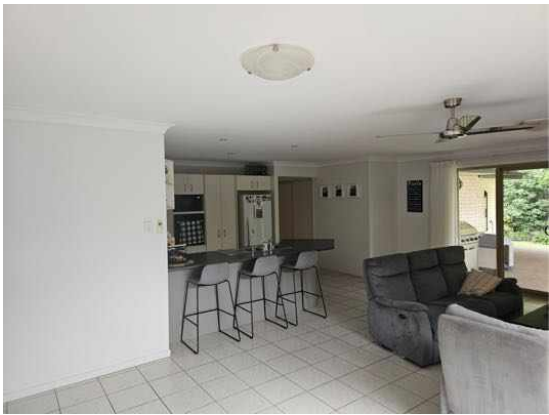
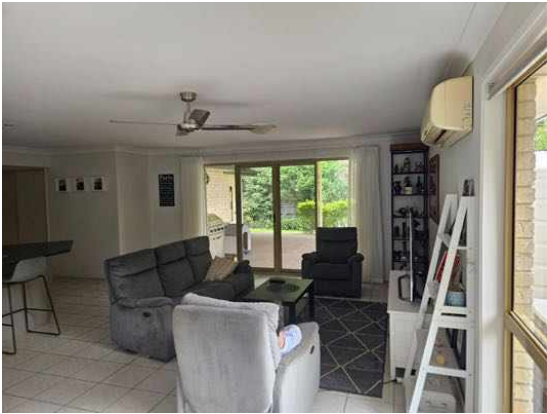
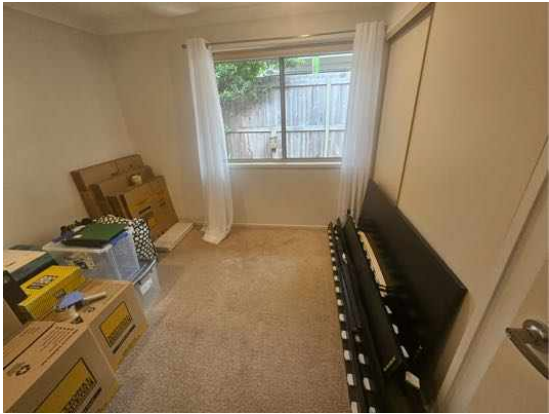
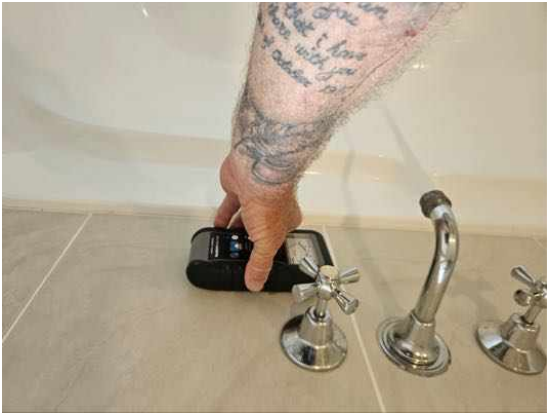
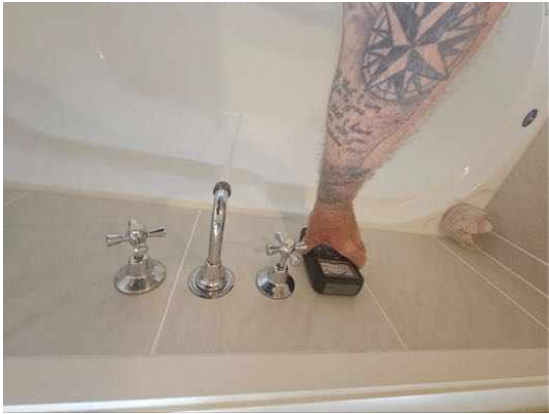
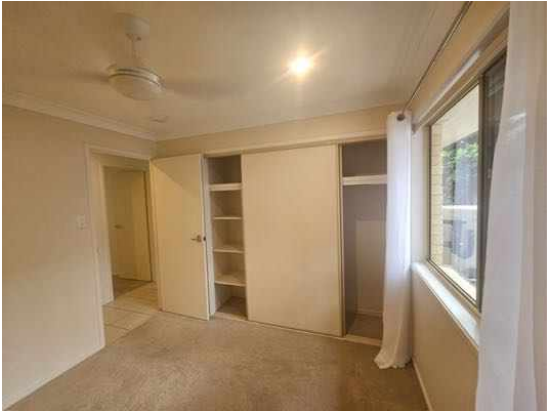
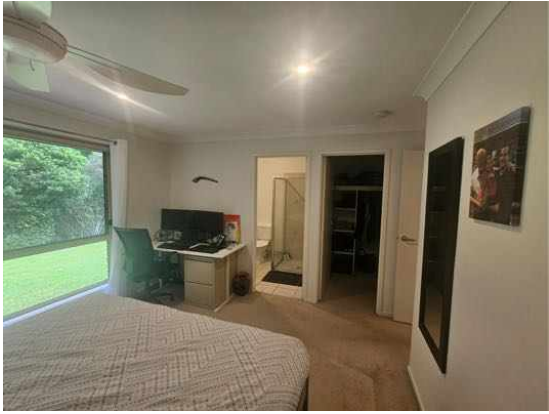
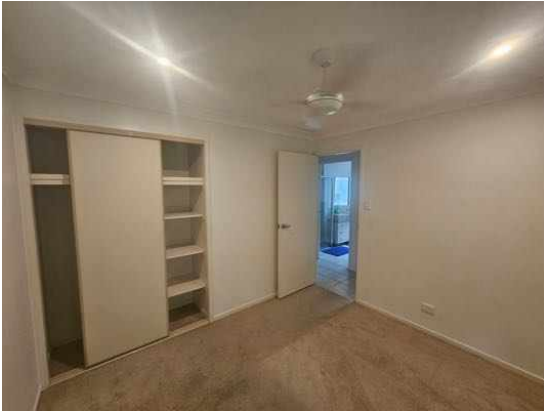
Building: Main Building  
Location: All Areas  
Finding: Additional Photos for client reference  
Information: Additional photos are provided for your general reference.

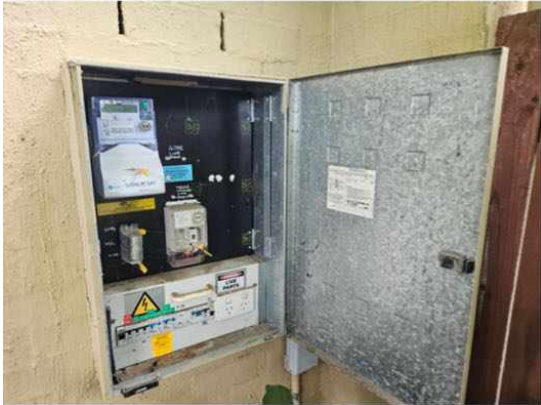
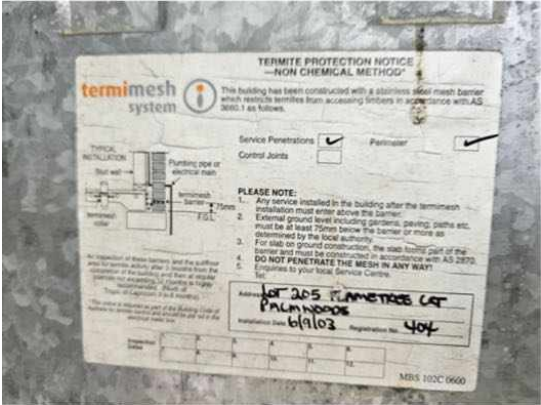
The building employs a "Termimesh" physical barrier system to the perimeter and slab penetrations. In order for a barrier system to be effective, the property must have regular inspections at intervals of not greater than 12 months. Depending on the risk profile attributed to the property, these inspections may be recommended at lesser time periods.

Where a Termite Management System has been identified you should refer to the type of barrier, date of installation, warranty conditions and any documentation provided by a builder or past owner. Consult the company who installed the barrier to confirm whether the system is still under warranty.
