Building and Timber Pest Inspection Report

Inspection Date: Mon, 23 Mar 2026

Property Address: 3 Lawson St, Woodridge QLD 4114,
Australia

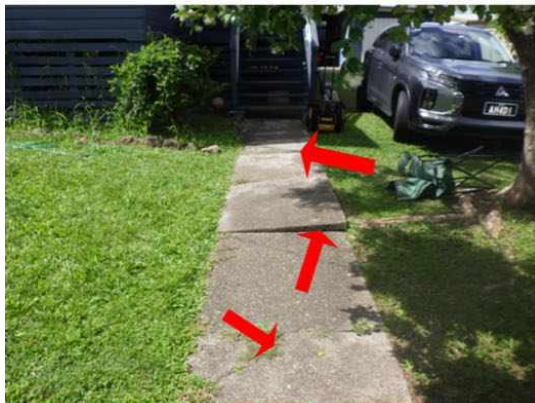
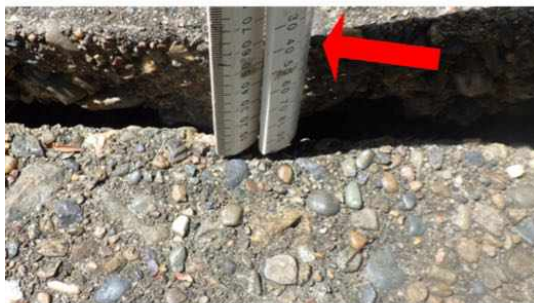
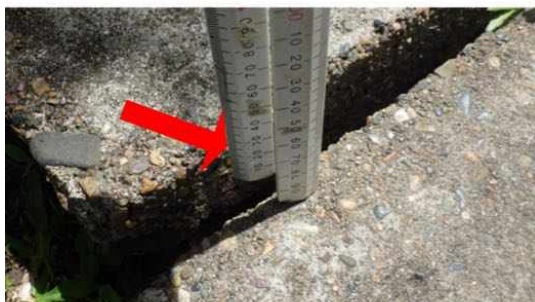
Building: Main Building
 Location: Yard - Front > Ground Level
 Finding: Paving - Uneven
 Information: Sections of the external paved footpath area at the front of the property are uneven, creating a potential trip hazard. It appears as though the area has been subject to rough installation, or that paving sections have lifted due to nearby vegetation growth.

Where paving creates a trip hazard, personal injury may ensue if due caution is not taken by all persons within this area.

Re-paving of the area is required as soon as possible to remedy this situation.

A licensed concreter or landscaper should be engaged to undertake rectification work.

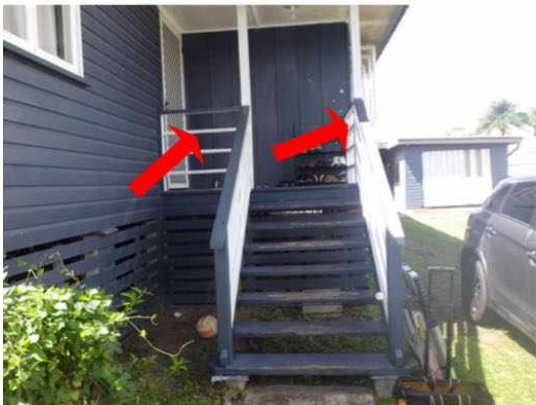
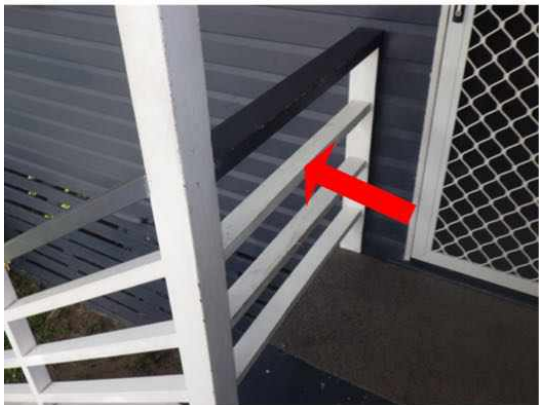
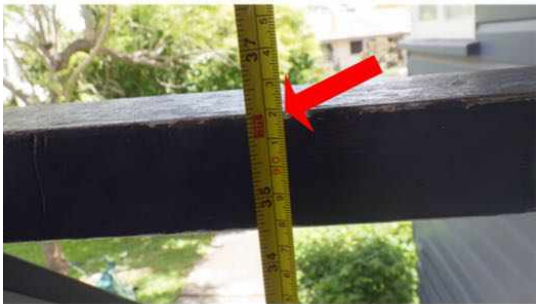
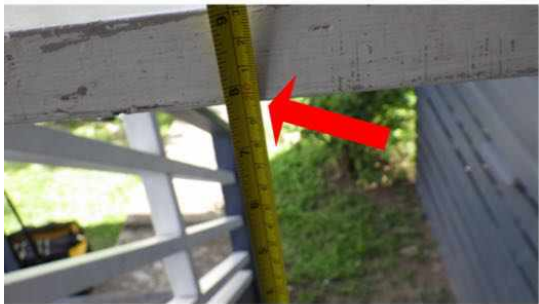
Finding 1.02

Building: Main Building
Location: Stair Landing > Existing
Finding: Balustrade - Suspected Non-Compliance
Information: The balustrade to the front balcony area was measured and found to be (.920mm high) less than the present building regulation requirement of 1000mm high.

Additionally the spacings between the balustrade railings were measured and found to be (.195mm wide) greater than the present building regulation requirement of 125mm.

A registered builder could be contacted to discuss possible rectification solutions.

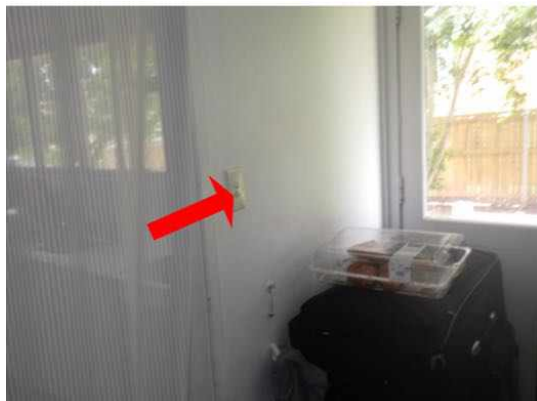
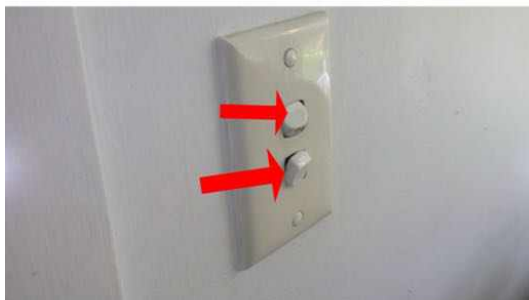
Finding 1.03

Building: Main Building
Location: Laundry > Front Left

Finding: Light Switch
Information: At the time of inspection the light switch activator in the laundry area was loose in the cover panel.

A licensed electrician should be engaged to repair or replace the light switch fitting.

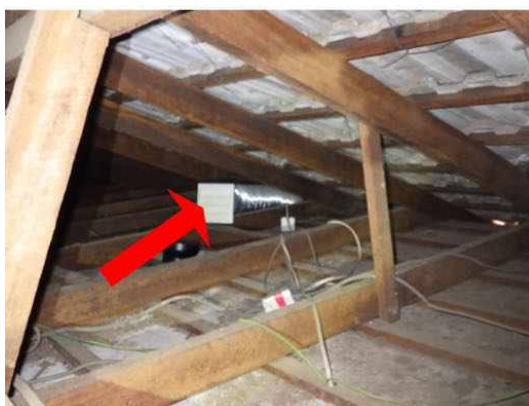
Finding 1.04

Building: Main Building
Location: Attic > Centre Right
Finding: Rangehood - Vented into roof space
Information: The kitchen range hood flue was found to lead directly into the roof space, rather than venting to the exterior of the building.

The positioning of this flue is likely to lead to a build-up of grease and grime in the surrounding area within the ceiling void, which can pose as a fire hazard in the roof void. The presence of insulation surrounding the flue adds to this fire safety risk.

Without re-direction to the exterior of the building, the Rangehood is not considered fully operational and is deemed a minor safety hazard. It is therefore preferable that the flue be re-directed to vent into the external environment. A licensed carpenter or plumber should be appointed as soon as possible to undertake any necessary works.

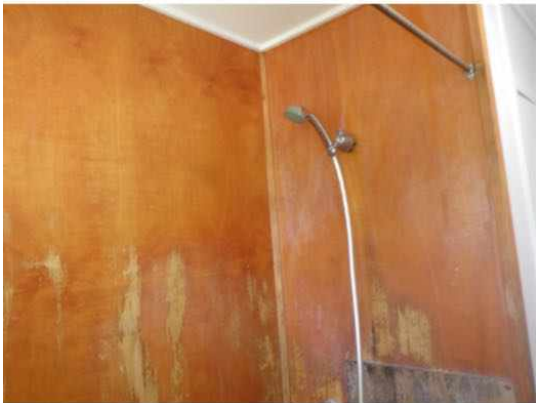
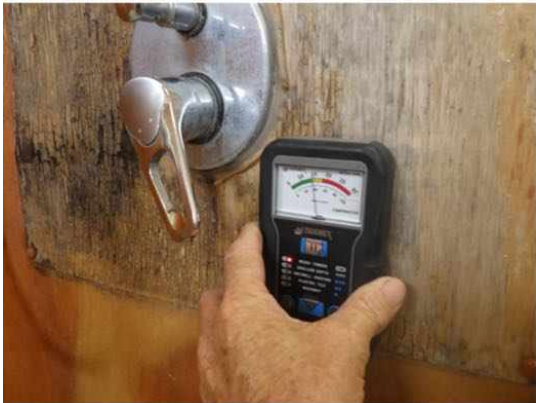
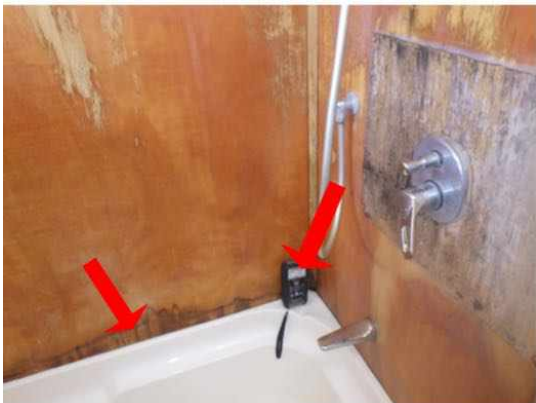
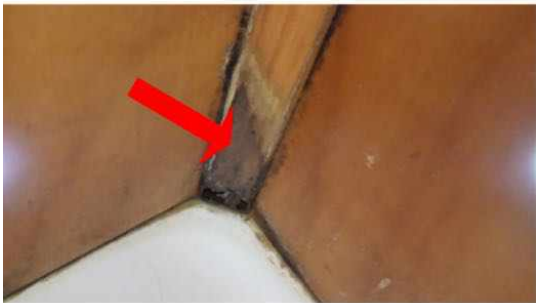
| Finding: | Shower - Leaking |
| Information: | The bathroom shower area registered elevated moisture level readings to wall areas of the shower cubicle at the time of inspection. |

It is suspected that the leaking has occurred as a result of general ageing and deterioration of wall linings. Additionally evidence of mould growth and previous repair work was noted.

Leaking from the shower area, where left unattended, is likely to lead to water damage to adjoining flooring and walls. Such damage can lead to water damage and necessitate extensive remedial works being required. Active water leaks may also create an environment that is susceptible to the formation and development of mould and /or timber termite activity.

Appointment of a licensed builder or shower area specialist will be required to repair or replace the shower area. Such works should be performed as soon as possible to ensure that no further damage occurs.

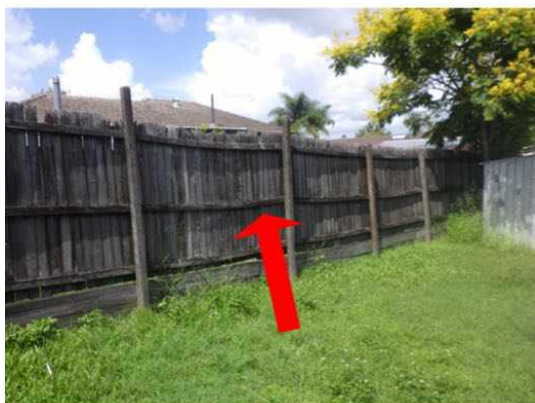
Finding 3.01

Building: Main Building
Location: Yard - Front & Back > Existing
Finding: Fencing - Deteriorated
Information: It was noted at the time of inspection that sections of the fencing to the front and rear of the property have deteriorated (as per example photos). Typically fencing deteriorates due to age and or wear, rot and or rust which is generally expected for a structure of this age, due to prolonged exposure to weather conditions. Sometimes inadequate installation or maintenance can be to blame.

If left unattended, it is likely that further damage will occur. It is suspected that repair of several elements of the fencing may be required however replacement may be a consideration of the client also.

A licensed fencing contractor should be appointed to provide further advice and perform rectification works as necessary.

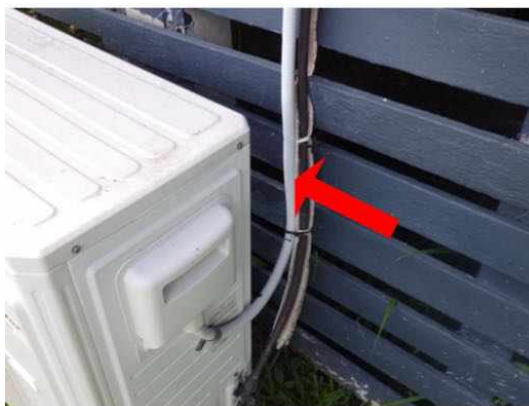
Finding 3.02

| Finding: | Pipework - Insulation deteriorated |
| Information: | <p>At the time of inspection sections of the air conditioning unit pipe work insulation showed evidence of damage and deterioration. It is suspected that this deterioration has developed as a result of excessive exposure to weather, including UV exposure in daylight. Deteriorated insulation reduces the effectiveness of the material in helping to maintain the desired temperature and work most efficiently.</p> <p>If left in an exposed position, it is likely that the deterioration will continue and worsen over time, potentially resulting in secondary building defects as well as a further loss in insulating properties.</p> <p>Some areas of replacement of pipe insulation is likely to be required. Further preventative measures to remove or protect the material from future exposure are also advisable. Consultation with a licensed air conditioning installer is advised to gain quotes for the repair and/or replacement of deteriorated insulation.</p> |

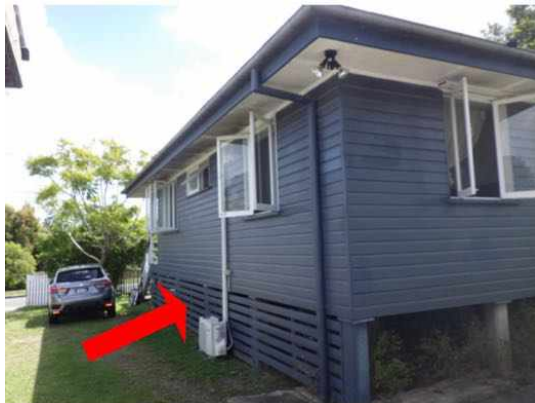
Finding 3.03

| Finding: | Wall Cladding /Screening |
| Information: | <p>It was noted at the time of inspection that sections of the exterior timber screening to the sub floor area of the property have deteriorated. Typically wall cladding and /or timber screening deteriorate due to prolonged exposure to weather conditions. Sometimes inadequate installation or maintenance can be to blame.</p> <p>If left unattended, it is likely that further damage will occur. It is suspected that repair of several elements of the timber screening may be required.</p> <p>A qualified carpenter should be engaged to undertake repair work as required.</p> |

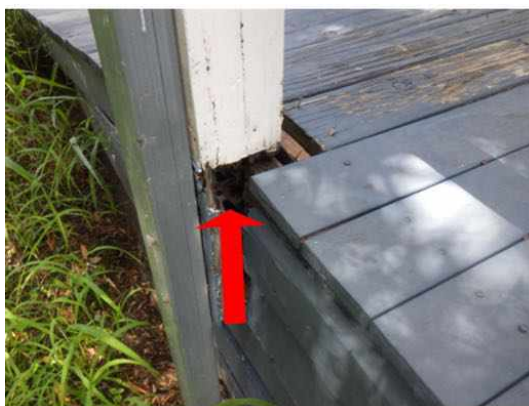
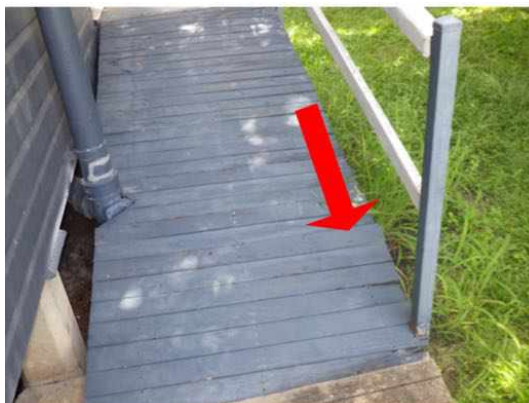
Finding 3.04

| Finding: | Decking - Deteriorated |
| Information: | It was noted at the time of inspection that sections of the timber balustrade, ramp and decking on the left side of the property have deteriorated. Typically timber decking deteriorates due to age and or wear, rot and or rust which is generally expected for a structure of this age, due to prolonged exposure to weather conditions. Sometimes inadequate installation or maintenance can be to blame. |

If left unattended, it is likely that further damage will occur. It is suspected that repair of several elements of the timber balustrade and decking may be required however replacement may be a consideration of the client also.

A licensed builder should be appointed to provide further advice and perform rectification works as necessary.

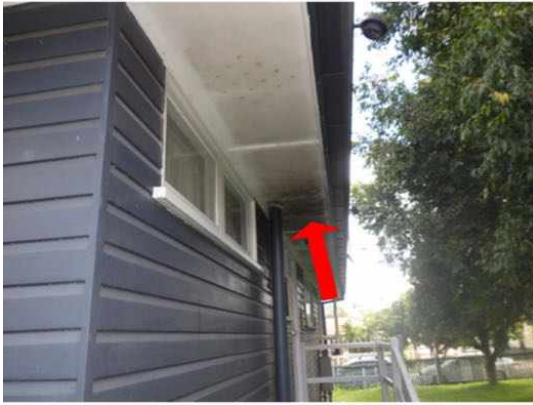
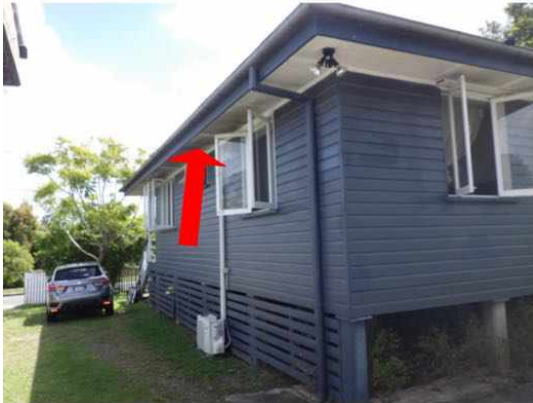
Finding 3.05

| Information: | The eaves linings to the exterior of the property show signs of excessive mould and mildew at the time of inspection (as per example photos). This defect can at times be caused by blocked or overflowing gutters in the areas associated. |

Where evidence of mould growth was noted, there may be environmental, biological or health issues associated with the report. A specialist inspection by a suitably qualified environmental health inspector may be warranted, where mould is extensive or where any queries regarding air quality spores or other related issues apply.

Generally, the client is advised to ensure that the general environment is free of moisture and humidity to aid in the prevention of mould formation and development. Any mould found during the inspection should be cleaned immediately by a cleaning contractor or the homeowner as applicable.

Please note that severely affected building elements may require replacement by a registered builder or qualified carpenter.

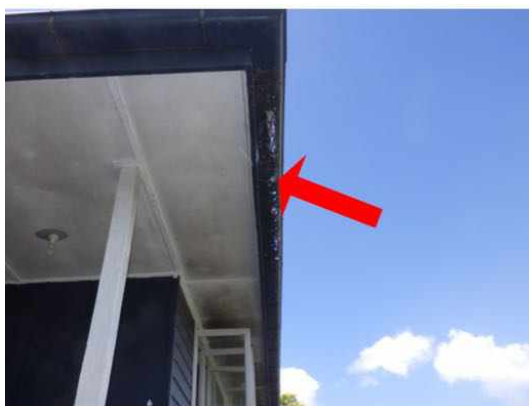
Finding 3.06

| Finding: | Gutter - Rusted |
| Information: | Upon inspection of the exterior guttering, evidence of significant rust to the right side section was identified. |

Metal gutters generally comprise of sections of guttering, which join and overlap. These intersections are particularly prone to lift at the edge and consequently rust at these points.

A roofing contractor could be appointed to assess the damage to the roof guttering in all areas and to perform remedial works as necessary.

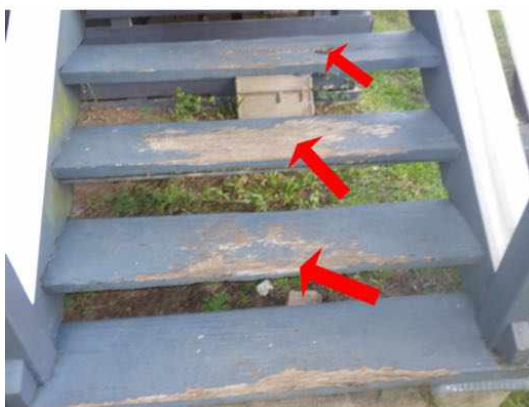
Finding 3.07

| Finding: | Decking - Deteriorated |
| Information: | It was noted at the time of inspection that sections of the timber stair treads at the front of the property have deteriorated. Typically timber treads deteriorate due to age and or wear, rot and or rust which is generally expected for a structure of this age, due to prolonged exposure to weather conditions. |

If left unattended, it is likely that further damage will occur. It is suspected that repair of several stair treads may be required however replacement may be a consideration of the client also.

A licensed carpenter or general handyman could be appointed to perform rectification works as necessary.

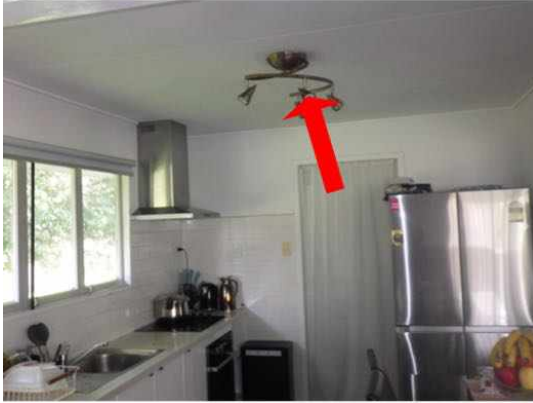
Finding 3.08

| Finding: | Light Fitting Rusty |

surface rust.

Excessive surface rust or corrosion of electrical fittings may compromise the operation and safety of the fitting.

A licensed electrician should be engaged to repair or replace the light fitting.

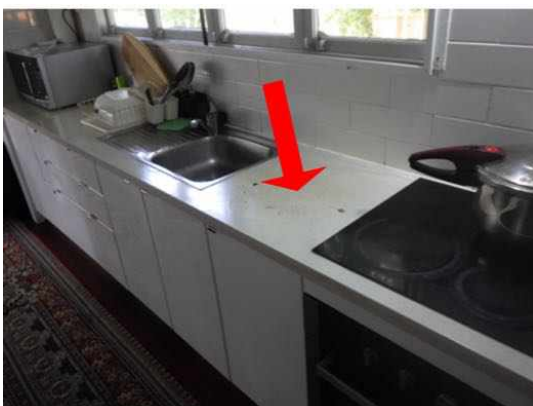
Finding 3.09

Building: Main Building
 Location: Kitchen > Centre Left
 Finding: Cabinetry - Deterioration
 Information: At the time of inspection the kitchen bench top showed signs of deterioration. The level of damage appears consistent with exposure to moisture or general wear and tear.

A qualified cabinet maker or general handyman could be engaged to undertake repair works at the clients discretion.

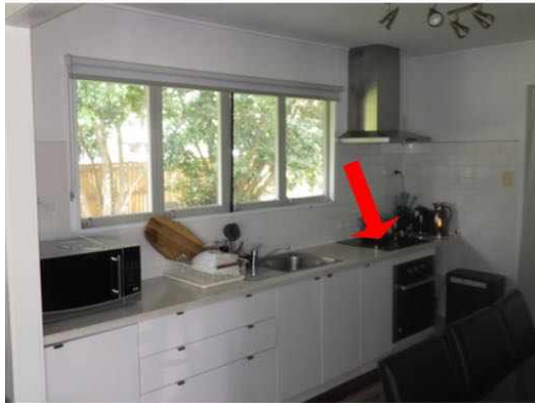
Finding 3.10

Building: Main Building
 Location: Kitchen > Rear Left

Finding: Cooktop
 Information: The cooktop in the kitchen area was found to be damaged or not fully operational at the time of inspection. Damage occurs generally when appliances have aged and decayed.

Repair and/or replacement of the damaged cooktop is advised. A Licensed electrician should be appointed to repair/replace the cooktop at the client's discretion.

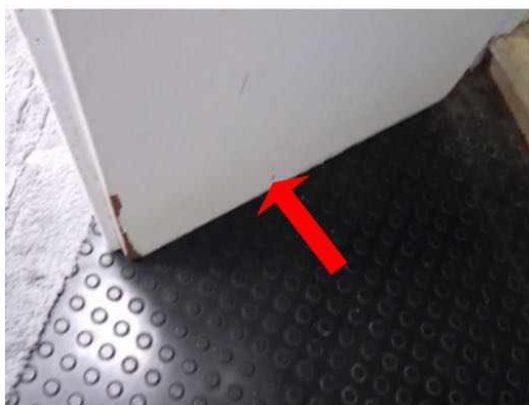
Building: Main Building
 Location: Bathroom > Centre Right
 Finding: Door Rubbing
 Information: It was noted that the bottom edge of the bathroom cupboard door is rubbing on the floor, making the door stiff to open and close at the time of inspection.

This is noted as a minor defect that you need to be aware of.

A licensed carpenter or general handyman could be engaged to ease the door at the clients discretion.

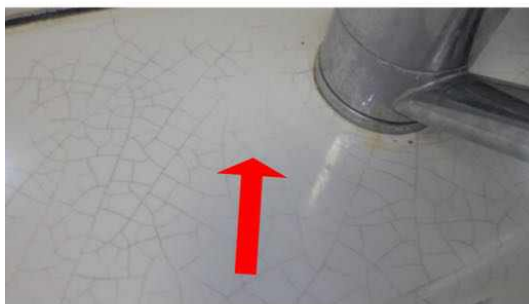
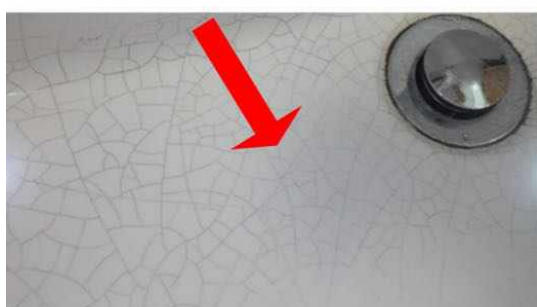
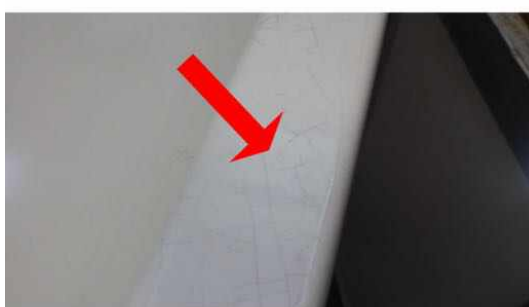
Building: Main Building
 Location: Bathroom > Rear Left
 Finding: Basin - spider web type cracking
 Information: Significant spider web type cracking was evident to the bathroom basin at the time of inspection. Any future impact sustained by the basin may lead to additional cracking.

The cracking may provide potential ingress for water and/or secondary water damage may occur to associated cabinetry if left unmanaged.

Consultation with a plumber regarding basin replacement will be required.

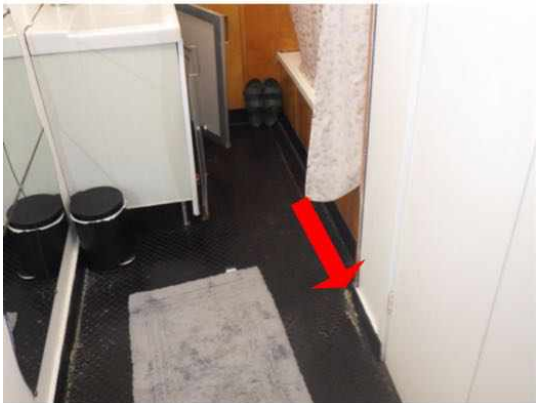
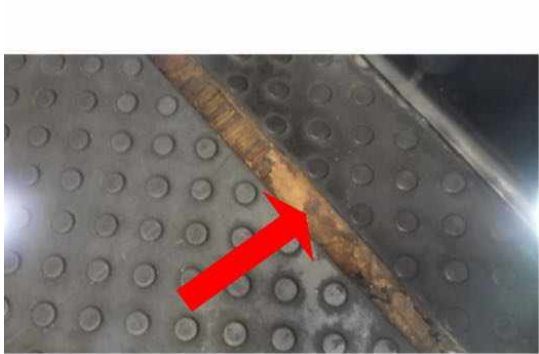
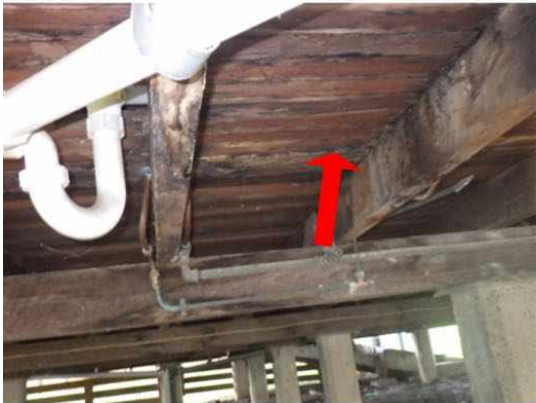
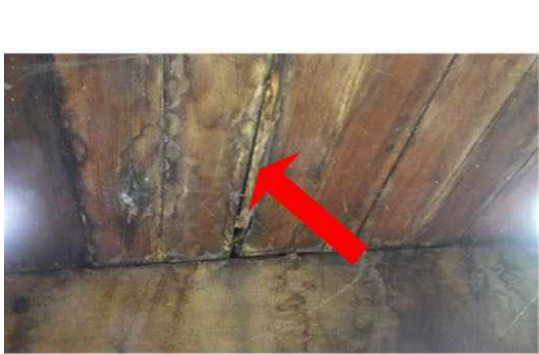
Finding 3.16

Finding: Wood Rot

Information: At the time of inspection an area of the timber floor boards in the bathroom showed signs of wood rot. The wood rot damage appears to be caused from excessive moisture in the area, possibly from a leaking shower.

The client could engage a licensed builder or qualified carpenter to further investigate and/or undertake repair work as required.

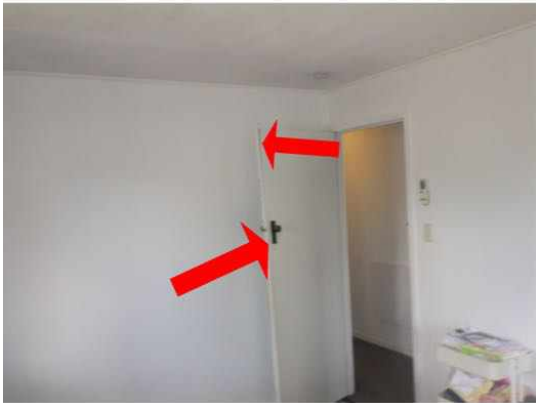
Finding 3.17

Building: Main Building
Location: Bedroom 1 > Front
Finding: Damaged Door
Information: The door leading into bedroom 1 has suffered damage to the front and back panels.

Damage occurs generally when the building materials have aged and decayed, but may be indicative of impact damage.

A qualified carpenter or general handyman could be appointed to replace the door at the clients discretion.

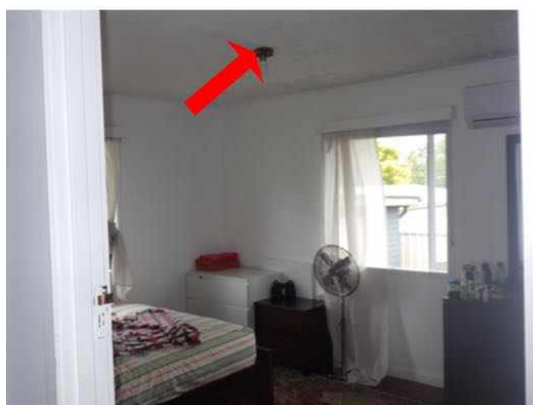
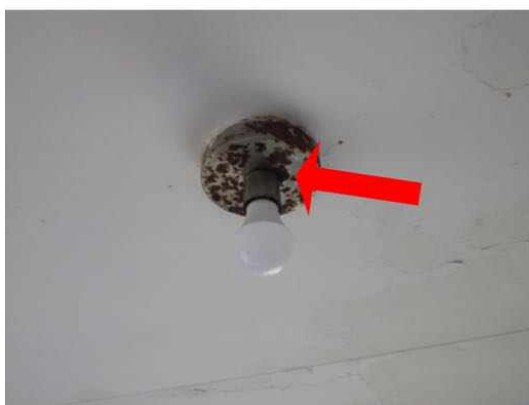
Finding 3.18

| Finding: | Light Fitting Rusty |
| Information: | At the time of inspection the light fitting in bedroom 1 showed signs of significant surface rust. |

Excessive surface rust or corrosion of electrical fittings may compromise the operation and safety of the fitting.

A licensed electrician should be engaged to repair or replace the light fitting.

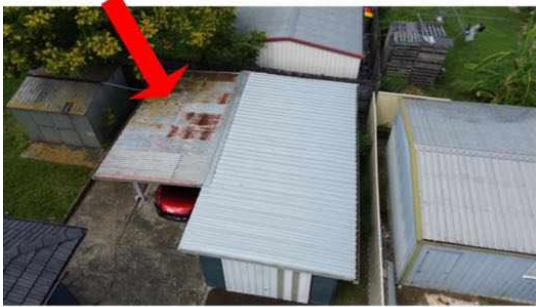
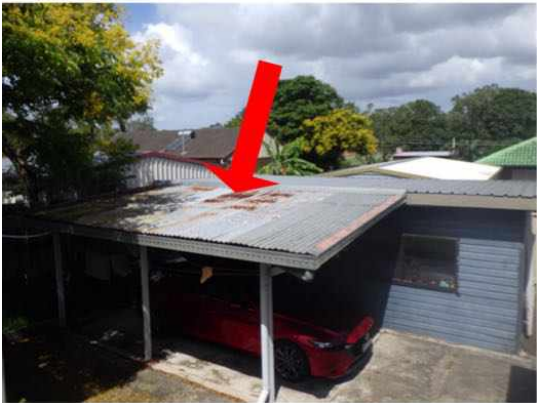
Building: Shed
Location: Roof Exterior > Rear Left
Finding: Roof sheets - Rusted
Information:

Upon inspection of the shed exterior roofing structure, evidence of rust to the carport area metal roof sheeting was identified. If left unmanaged, these degrading roof sheets can allow water ingress to the internal roofing structures, potentially leading to secondary damage of building elements. Accelerated deterioration of the roofing sheets and any associated building elements is also likely to occur.

A roofing contractor should be appointed immediately to assess the damage to the roofing sheets and to perform remedial works as necessary. Works may include replacement of severely affected roofing sheets or minor works such as the application of rust-retardant surface protectors.

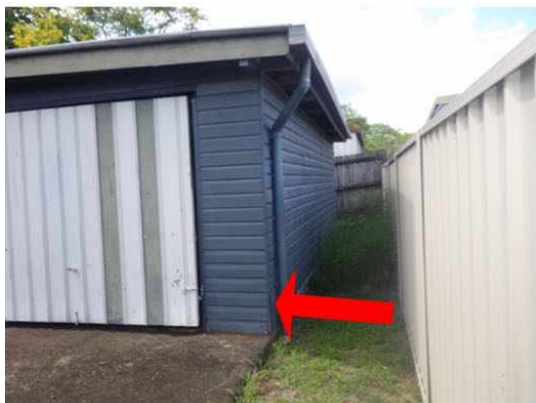
| Finding: | Evidence of termite damage |
| Information: | Despite no live termite or timber pest activity being observed, previous termite damage was found to have affected the exterior wall timber cladding on the front right side of the shed. This damage appears to be inactive in nature. |

It is advised that the area be visually inspected frequently to ensure that the condition of affected building materials does not worsen. At the time of inspection, damage did not appear to be structural and was considered to be superficial.

A building contractor may be appointed to repair the timber wall cladding and provide a further invasive inspection if further damage is evident.

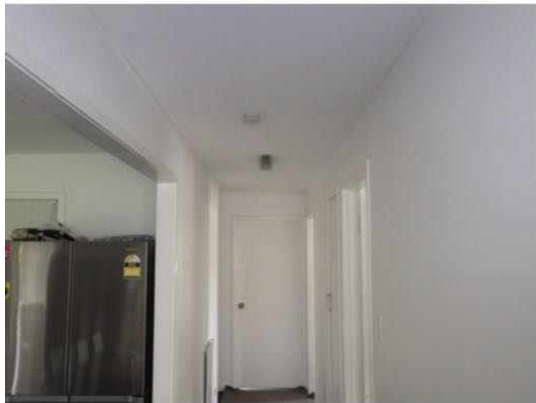
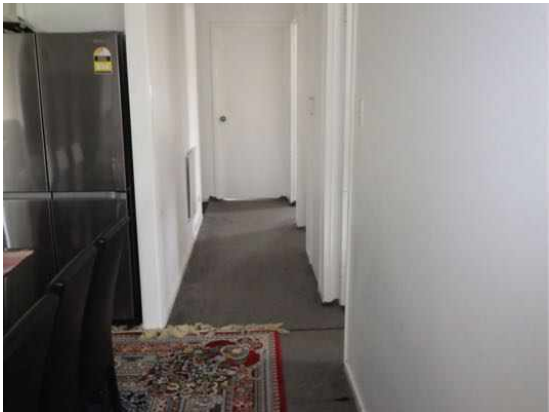
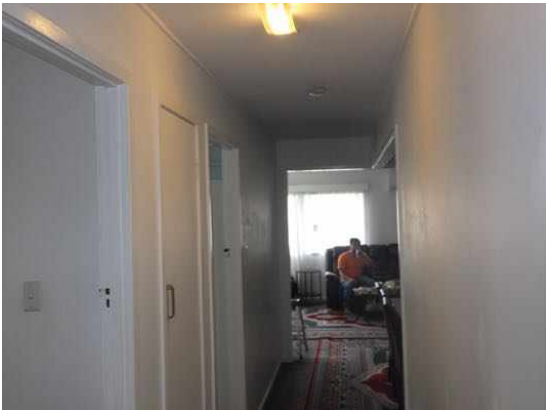
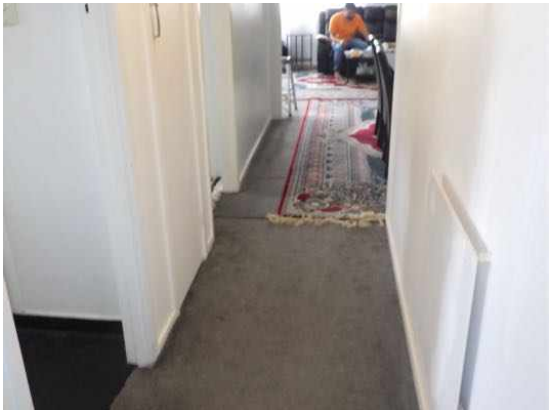
Building: Main Building
 Location: Hallway > Existing
 Finding: No obvious defect

Information: No obvious defects found at the time of inspection.

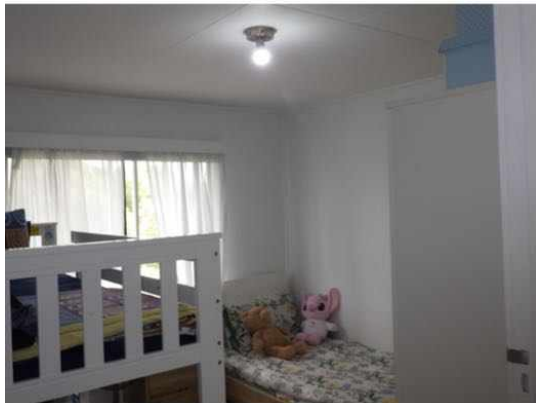
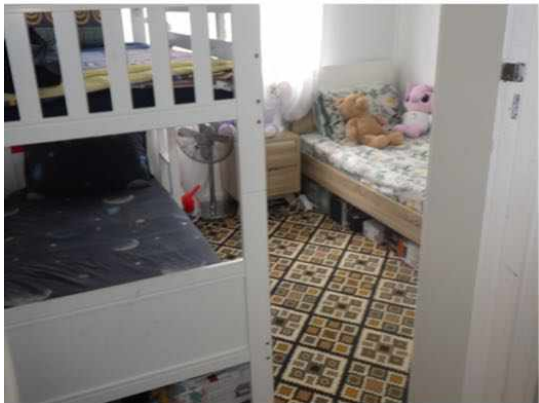
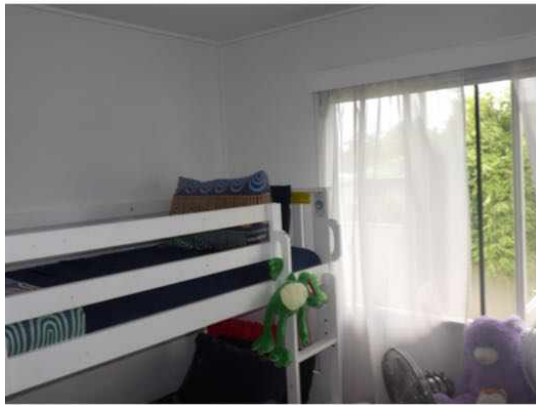
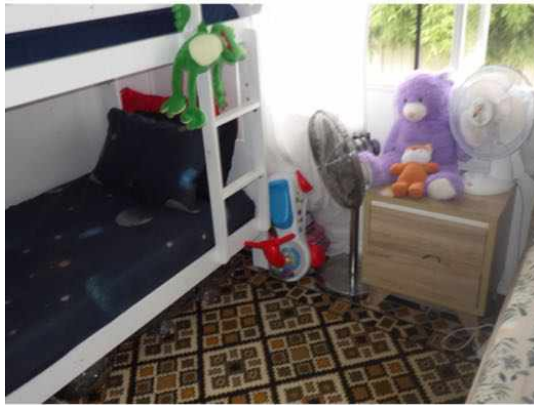
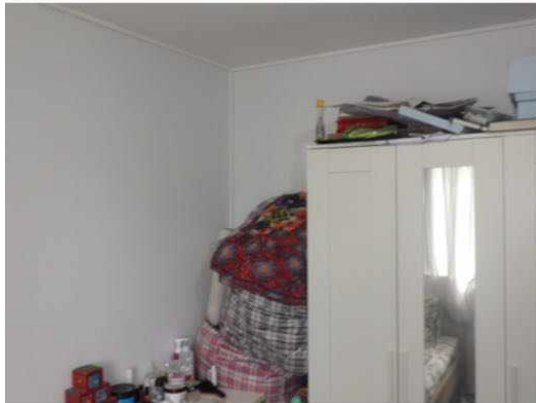
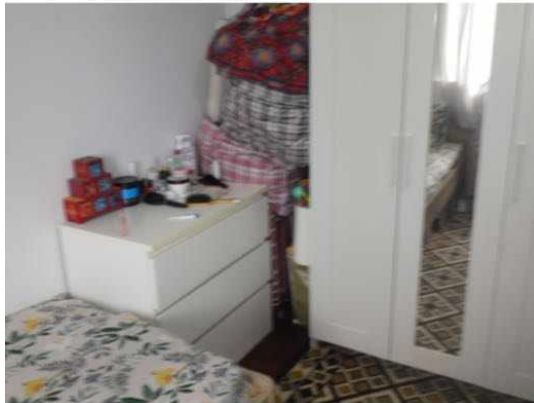
Building: Main Building
Location: Bedroom 2 > Existing
Finding: Additional Photos
Information: Additional photos are provided for your general reference

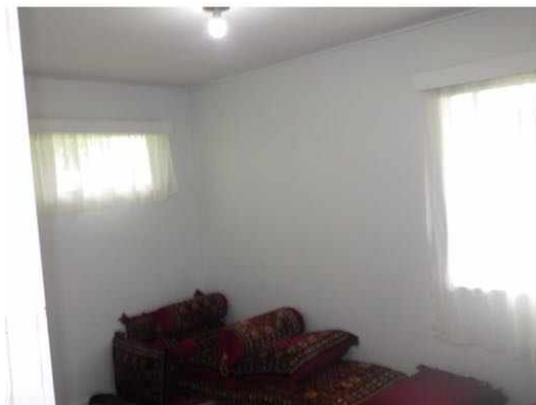
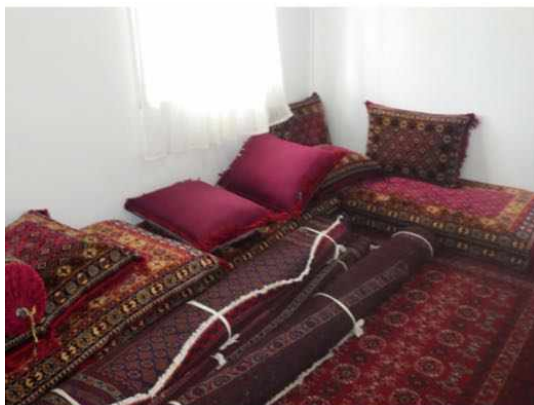
Building: Main Building
Location: Bedroom 3 > Existing
Finding: Additional Photos
Information: Additional photos are provided for your general reference

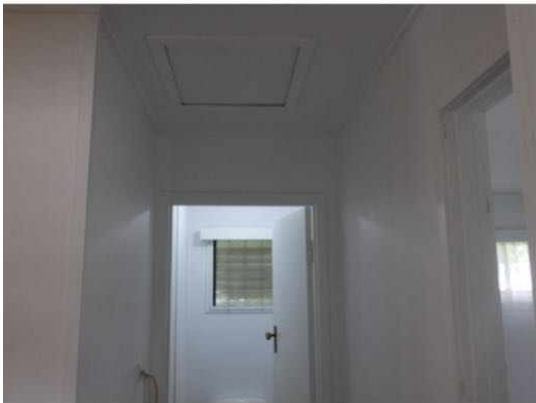
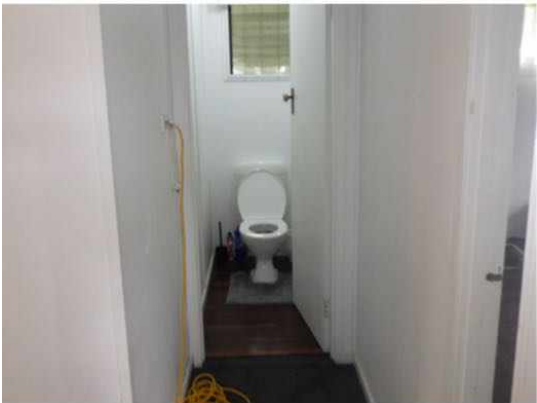
Building: Main Building
Location: Toilet (WC) > Existing
Finding: No obvious defect

Information: No obvious defects found at the time of inspection.

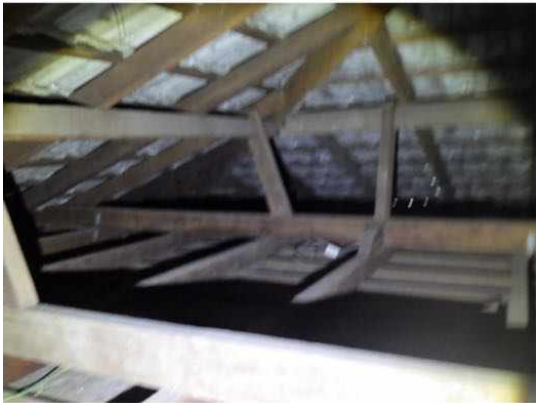
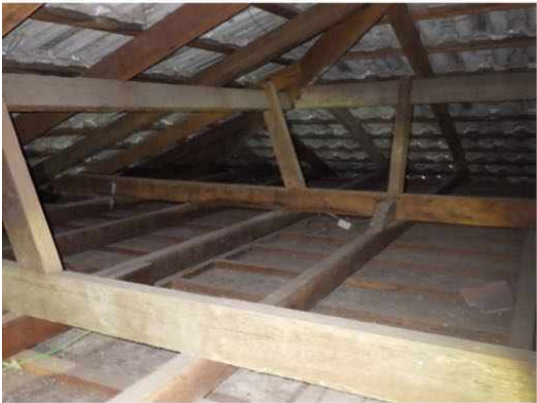
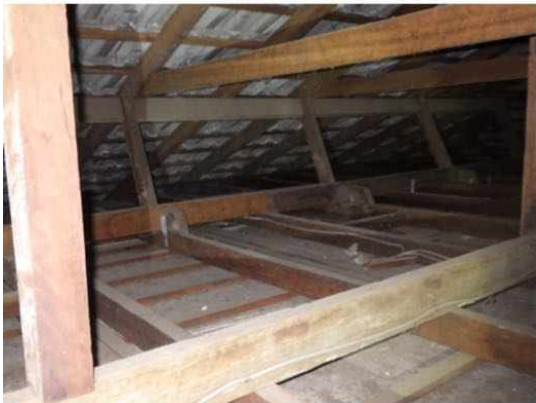
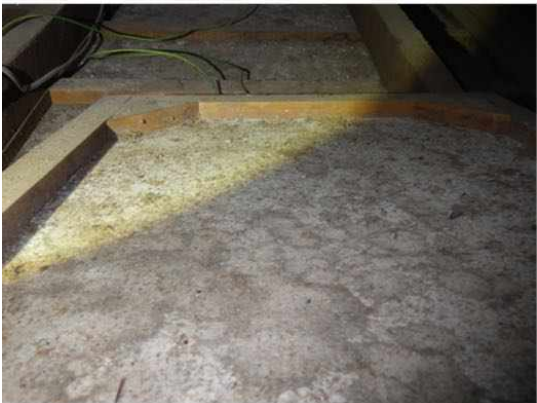
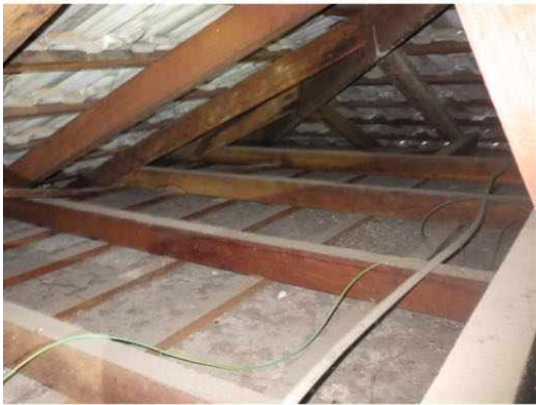
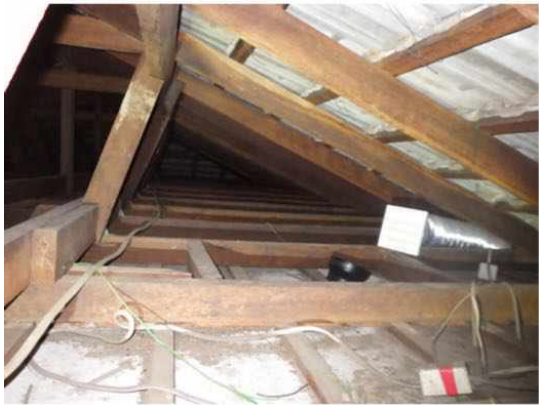
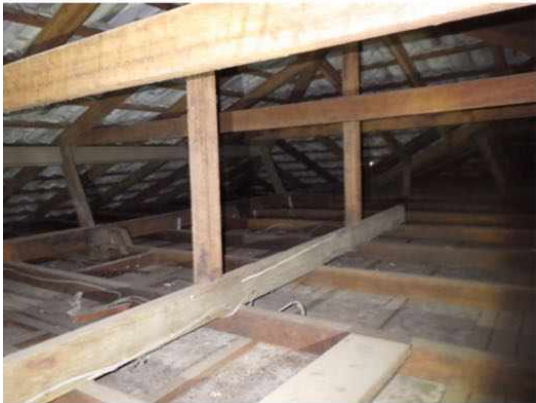
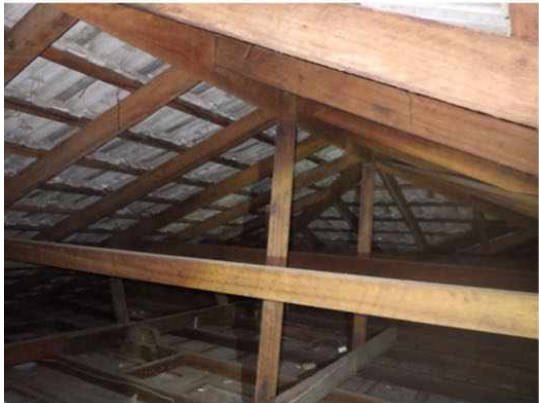
Building: Main Building
Location: Attic > Existing
Finding: Additional Photos
Information: Additional photos are provided for your general reference

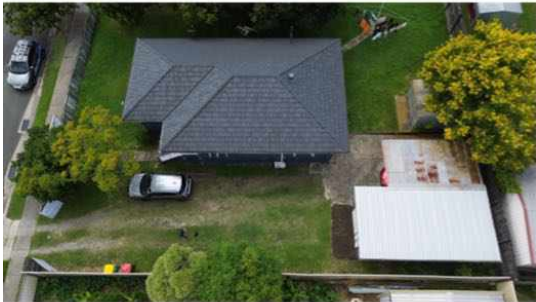
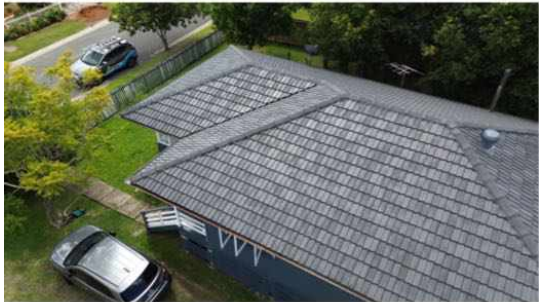
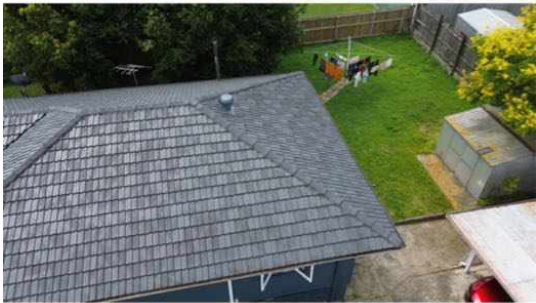
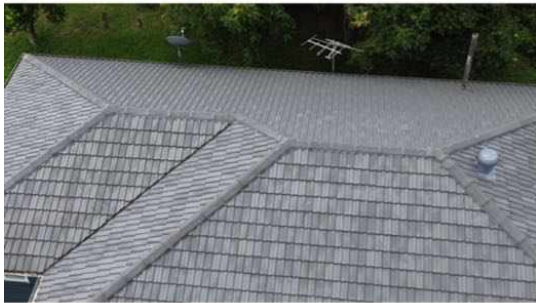
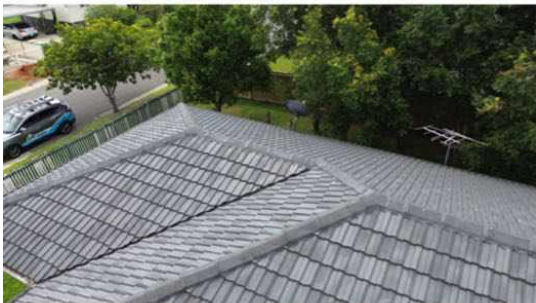
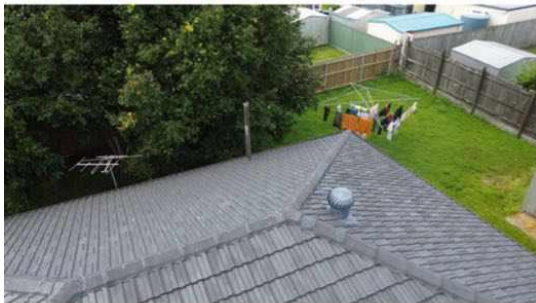
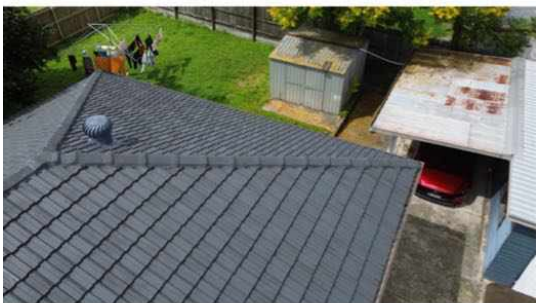
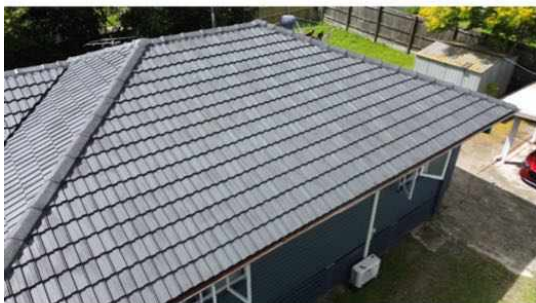
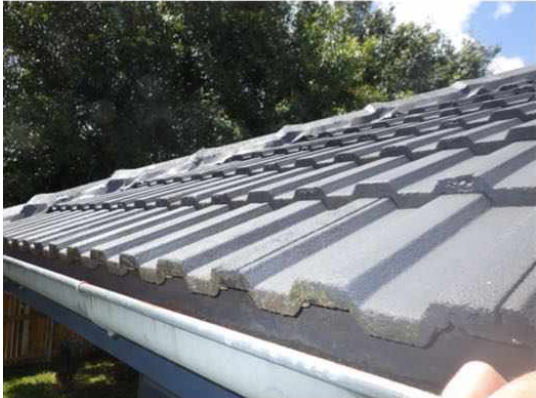
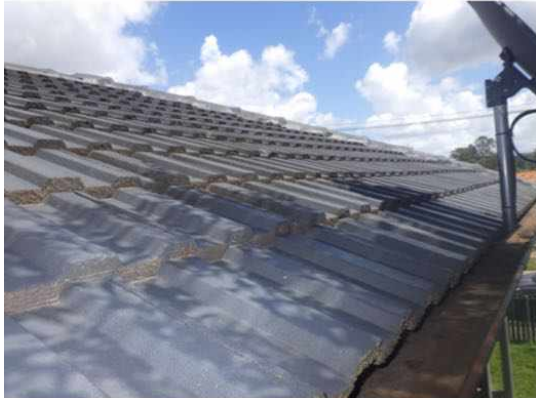
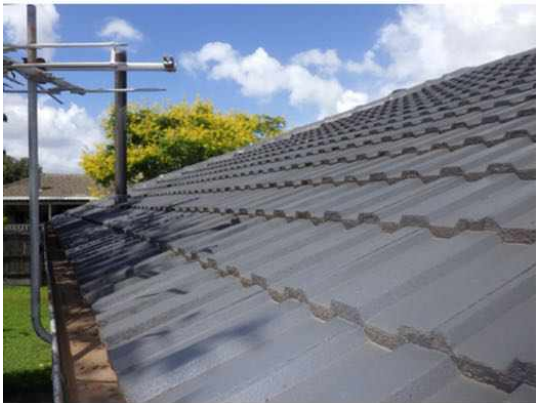
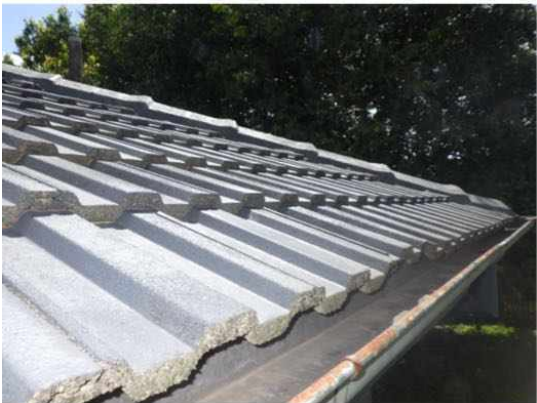
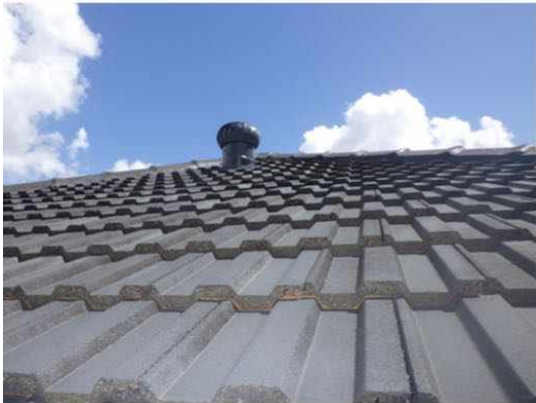
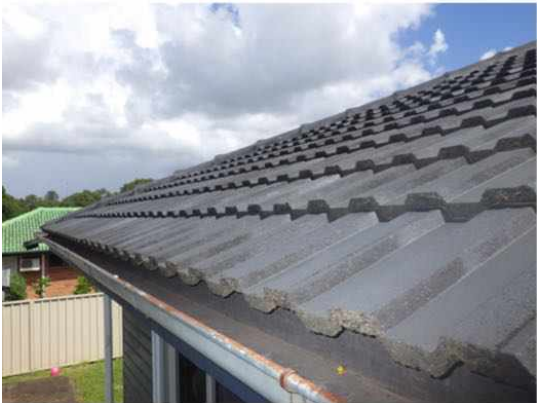
Building: Main Building
Location: Roof Exterior > Existing
Finding: Roof Photos
Information: Roof area photos were taken manually and with the DJI Mini 3 Drone flown over the roof at the time of inspection.

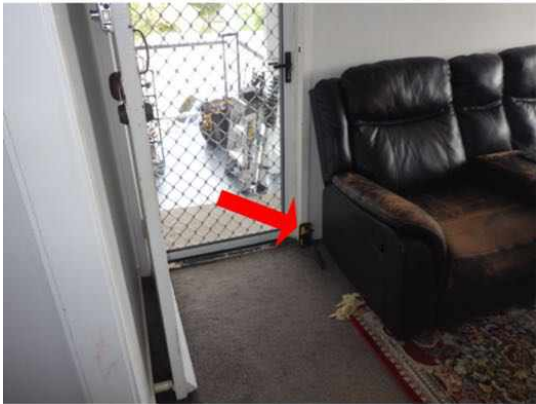
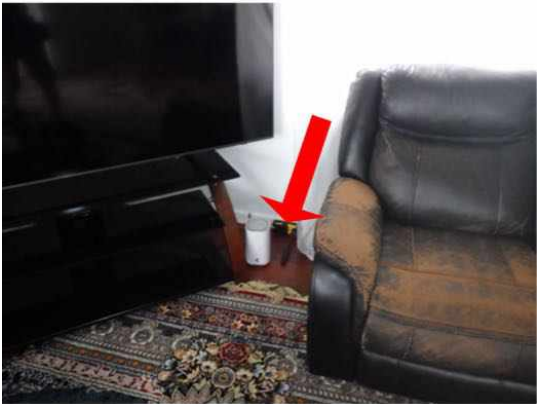
Building: Main Building
Location: Internal Areas > Existing
Finding: Termitracker
Information: The termitracker itracker was positioned randomly to internal wall, timber skirting and window frame areas checking for signs of termite activity.

No activity was recorded at the time of inspection.

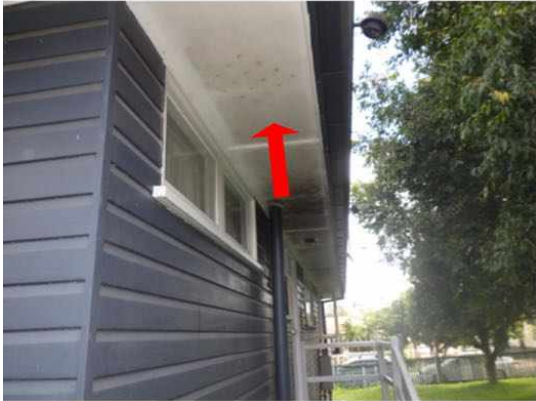
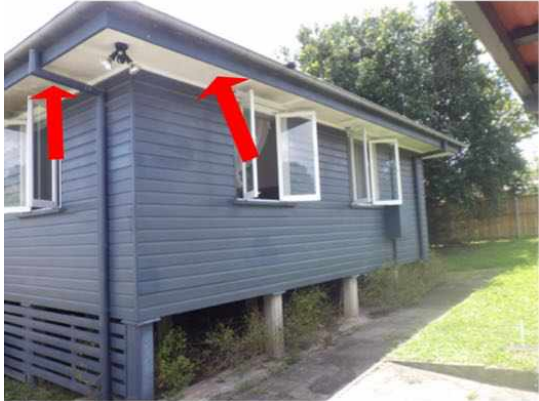
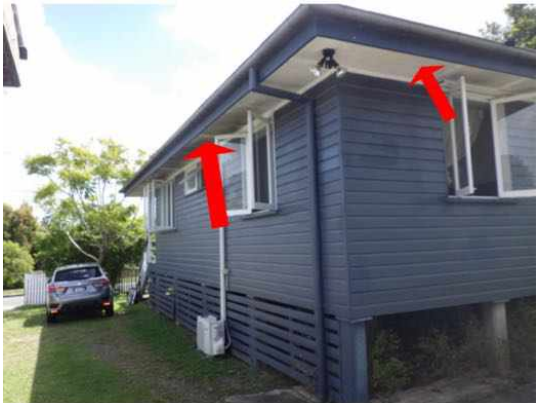
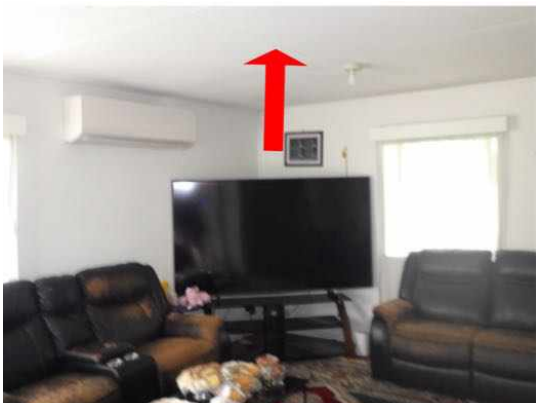
Building: Main Building
 Location: Internal Areas > Existing
 Finding: Asbestos - Suspected ACM Identified on Site
 Information: At the time of inspection it was suspected exterior eaves linings, internal ceiling linings and wet areas wall linings may be of asbestos containing materials.

Reporting on Asbestos is outside the Scope of this Report. This suspected defect is highlighted as a caution only. We suspect, based on our experience in the building industry, that there is a higher risk of the identified building materials containing asbestos.

As Asbestos Reporting is outside the scope of this report, we advise that you consider a separate Asbestos Inspection and Condition Audit, which can include the taking of samples for definitive confirmation of the presence of Asbestos.

In the interim, the client is advised to act with caution, especially when considering any damage to building materials general wear and tear renovations extensions demolition and general maintenance activities due to the suspected presence of Asbestos.

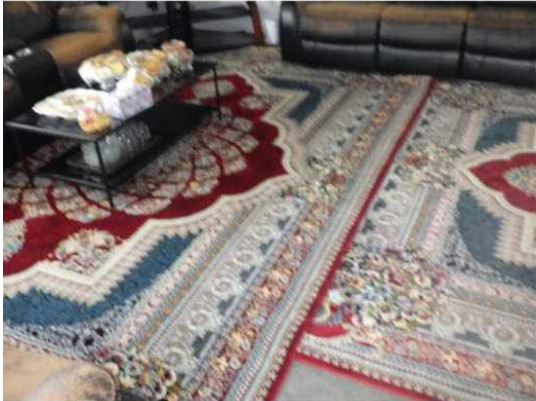
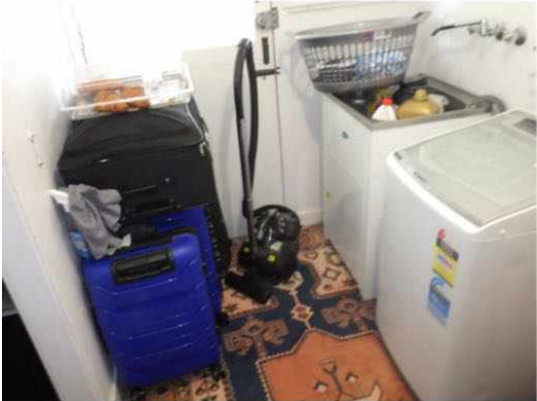
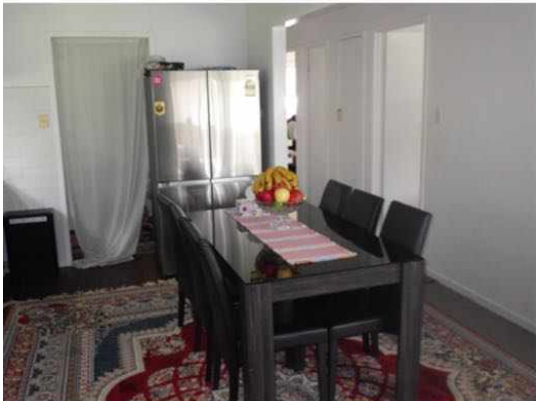
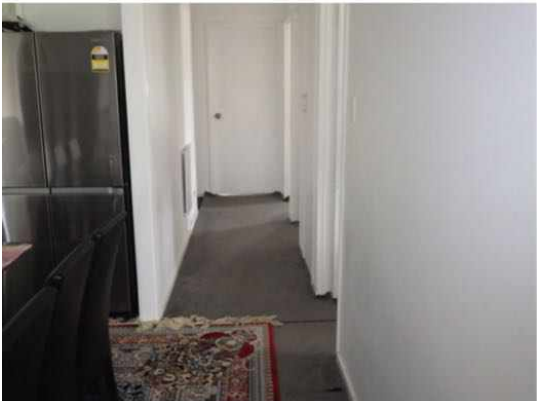
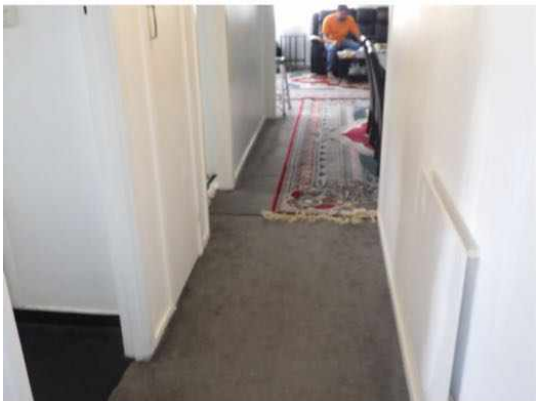
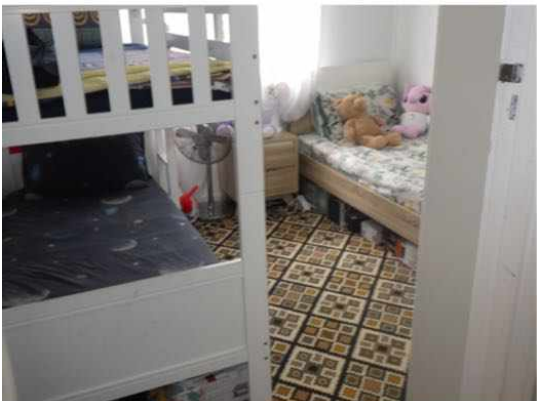
Building: Main Building
Location: Internal Areas > Existing
Finding: Obstructions and Limitations Internal Areas
Information: These photographs are an indication of the obstructions and limitations which impeded full inspection of the internal areas at the time of inspection. These obstructions can hide an array of defects and should be removed to allow full inspection to be carried out. A re-inspection is recommended once the areas are made accessible.
