Building and Timber Pest Inspection Report

Inspection Date: Mon, 23 Mar 2026

Property Address: 3 Lawson St, Woodridge QLD 4114,
Australia

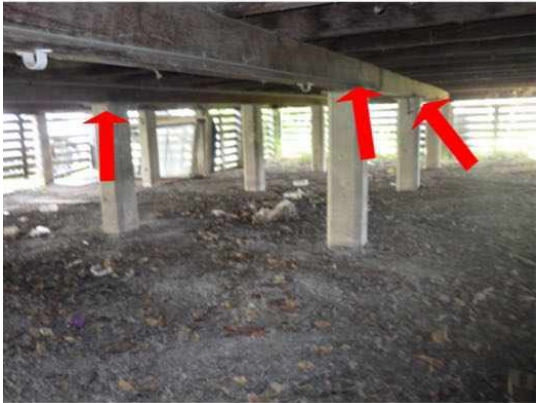
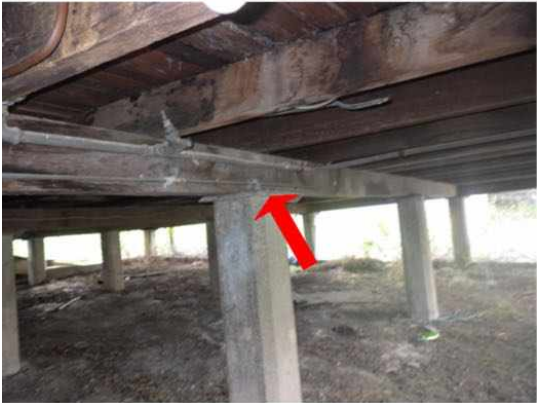
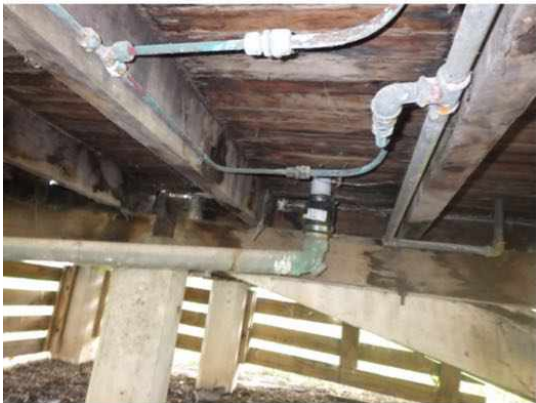
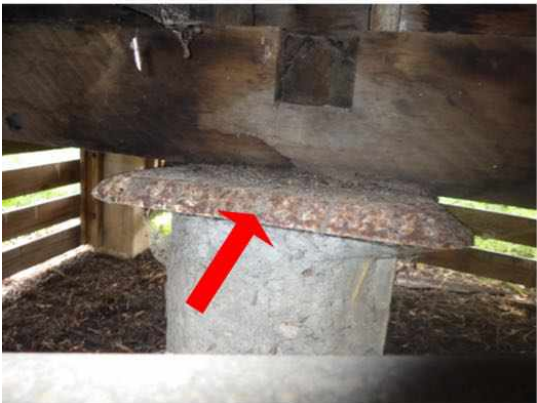
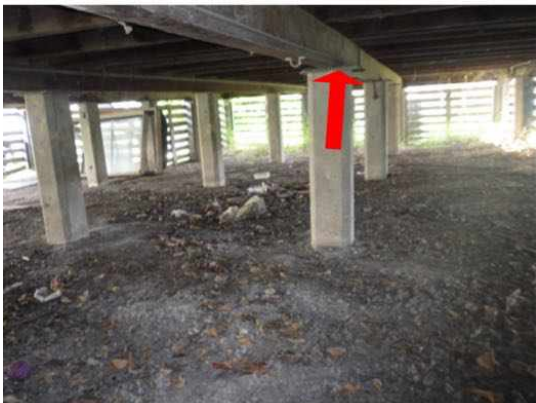
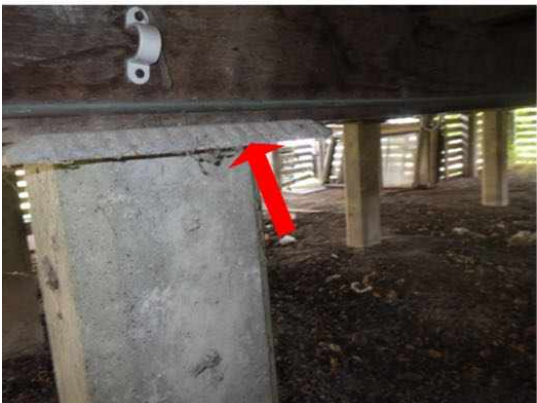
In this instance evidence of a previously installed physical barrier was observed, in the form of metal ant caps to the subfloor concrete piers. This system requires regular annual inspections.

No evidence of regular or annual inspections was found.

Where a Termite Management System has been identified you should refer to the type of barrier date of installation warranty conditions and any documentation provided by a builder or past owner.
