Building Inspection Report

Inspection Date: Fri, 20 Mar 2026

Property Address: 32 Purnana Ave, St Georges SA 5064,
Australia

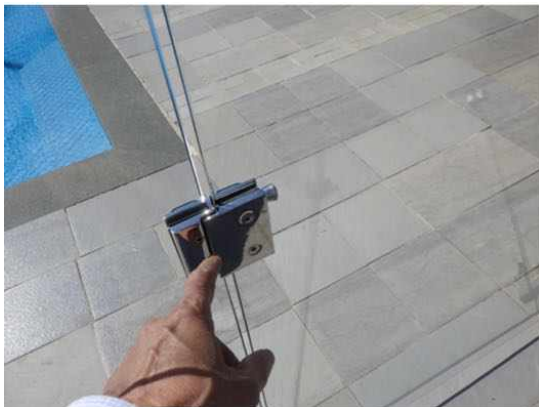
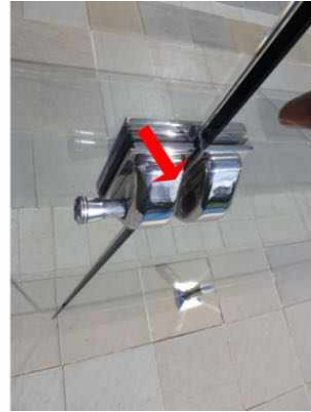
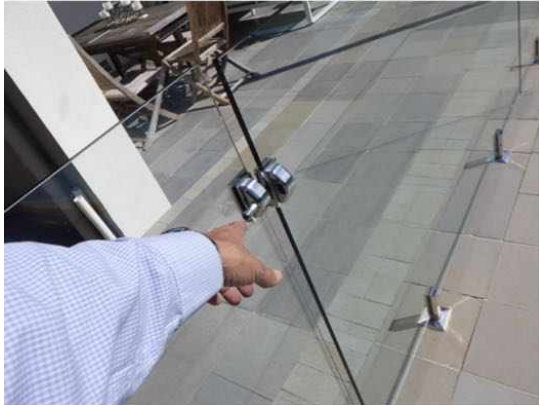
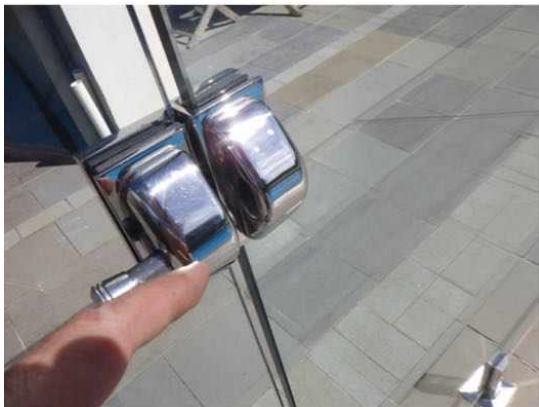
Defects 1.01

Building: Building 1
Location: All External Areas
Finding: Pool fencing - Do not to comply with Australian Standards- Inspection required
Information: It is suspected that areas of the pool fencing do not to comply with Australian Standards and do not appear to be safe. Assessment of the pool area is required.

Please note that this inspection does not cover pool fencing and other pool fittings and fixtures. It is highly advised that a specialist be appointed to inspect the pool and surrounding area and provide advice on rectification works that may be required.

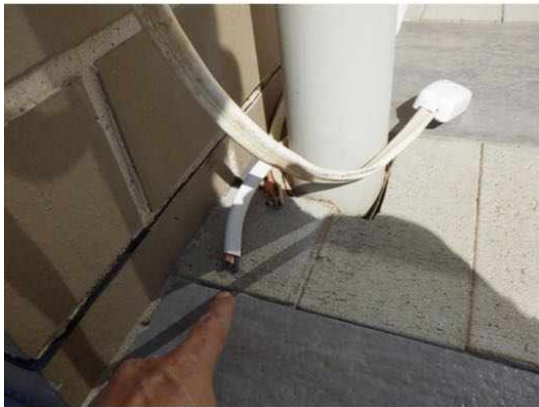
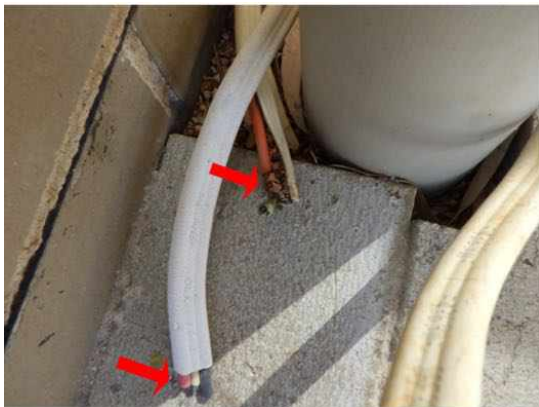
Defects 1.02

Building: Building 1
Location: All External Areas
Finding: External Area - Electrical wires exposed
Information: At the time of inspection it was noticed exposed electrical wiring was identified.

Exposed electrical wiring represents a potential safety hazard including for fire and personal contact.

Contact a licensed electrician urgently for further inspection investigation and rectification.

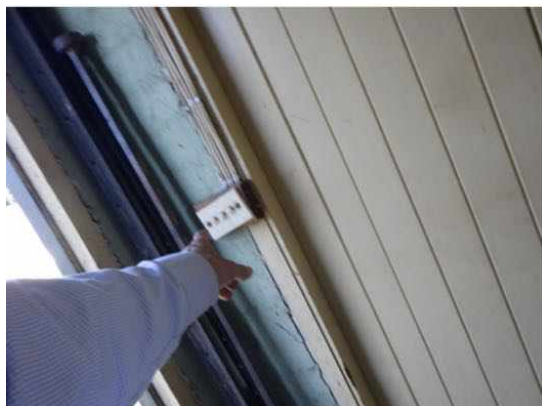
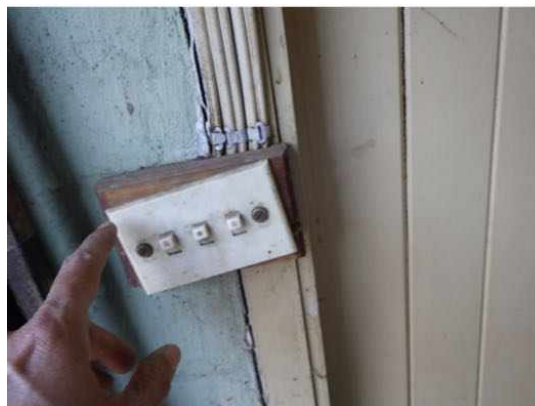
Defects 1.03

Building:	Building 1
Location:	Store Room
Finding:	Electrical fitting - Broken/ Loose from its original fixing
Information:	The electrical fitting in this store room area was found to be broken / loose from its original fixing at the time of inspection. Breakage occurs generally when the building materials have aged and decayed, but may also be indicative of impact damage to the building element (accidental or deliberate).

Left unmanaged, the fitting is unlikely to cause further damage to surrounding building elements. However, the broken fitting does expose electrical works, and may create a

safety hazard if there is potential contact with persons in the area.

Repair and/or replacement of the broken fitting is advised. A Licensed electrician should be appointed to repair/replace the fitting immediately.

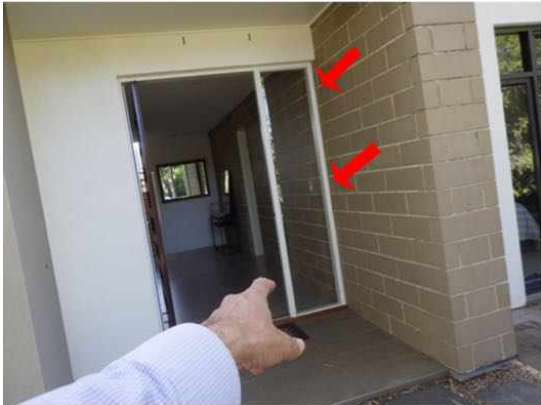
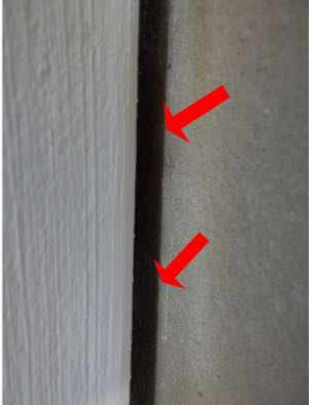
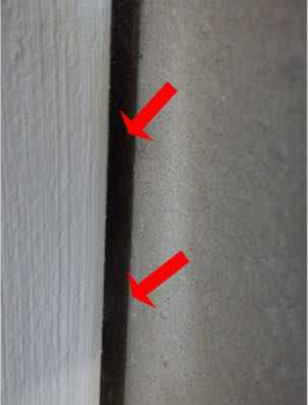
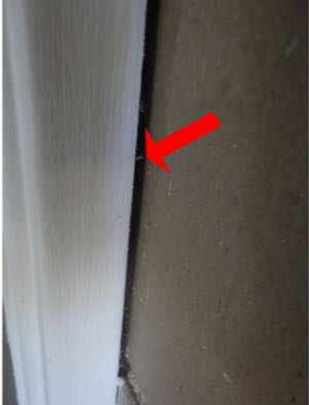
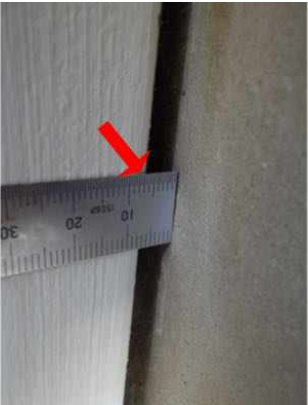
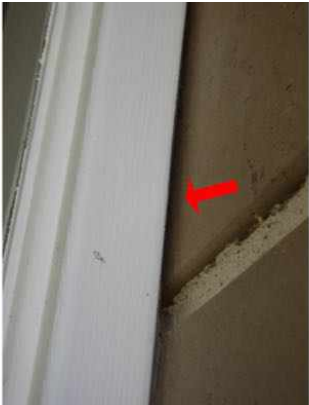
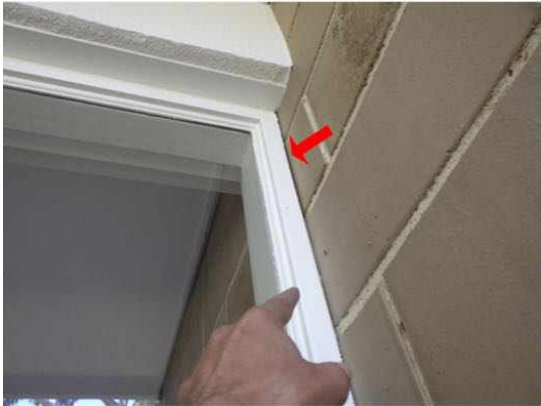
Defects 3.01

Breakage occurs generally when the building materials have either aged and decayed, or as a result of damage (accidental or deliberate).

Repair and/or replacement of broken elements is advised to ensure that additional secondary defects do not arise as a consequence. Such works are necessary, as all building elements play a key role in the operation and function of the overall structure and its performance.

A relevant tradesperson should be appointed to repair or replace the affected building element prior to any subsequent damage being caused.

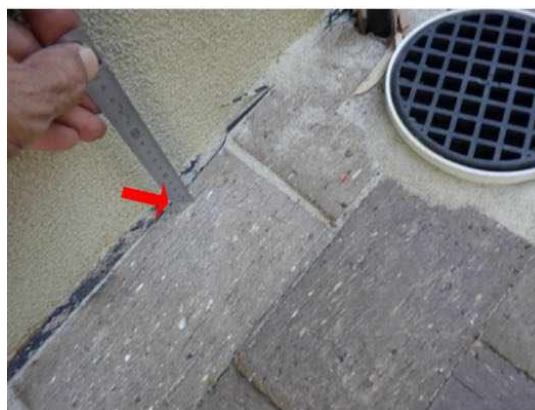
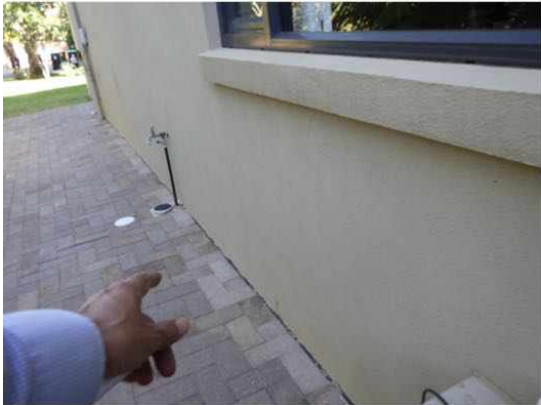
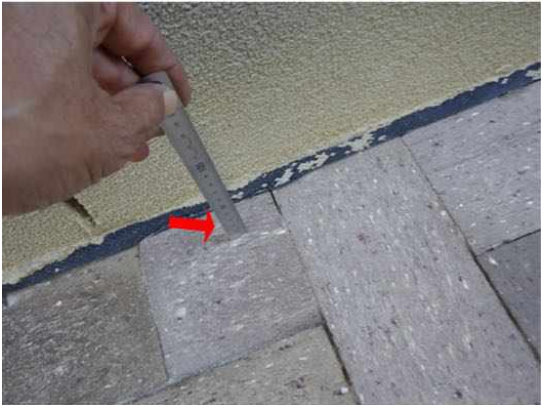
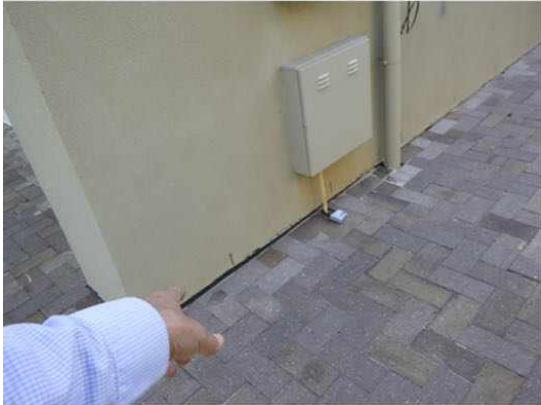
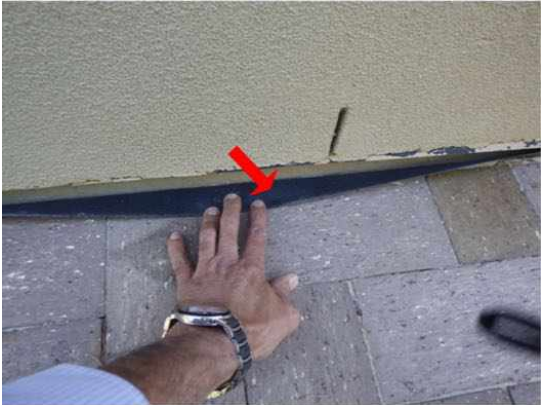
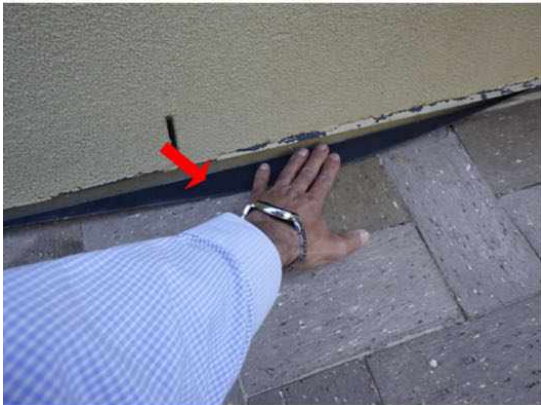
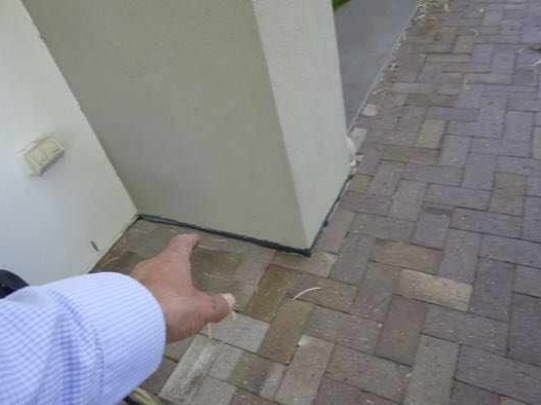
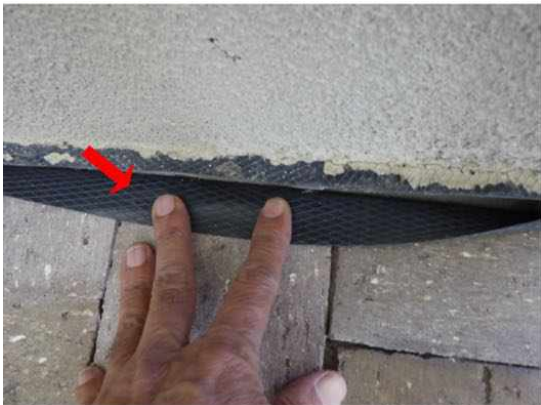
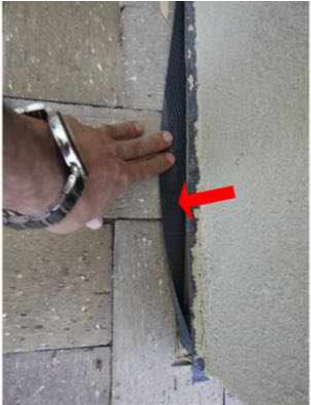
Defects 3.02

Building: Building 1
Location: All External Areas
Finding: Slab Edge - Exposure compromised
Information: At the time of inspection it was noticed that slab edge exposure has been compromised in few sections around the property.

If the slab edge is not properly exposed there is a high risk of termite attack. Sometimes, in order to determine the type of slab, a suitably qualified person such as an architect or builder may be required to consult the construction plans.

Where the slab edge cannot be properly inspected, it is highly recommended that termite or timber pest inspections be carried out every 6-12 months to aid protection of the property against infestation.

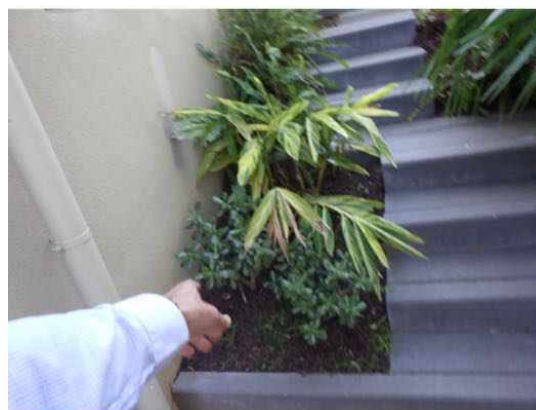
Defects 3.03

Building: Building 1
 Location: All External Areas
 Finding: Bridging - Vegetation
 Information: Where vegetation obstructs inspection of building elements, also known as bridging as it provides a bridging point for the access of termites, full inspection can not be achieved. Consequently moisture or dampness may be present and the areas becomes conducive to termite activity. Plants against or very close to buildings provide cover, shade and can provide an environment that is attractive to termite infestation.

The removal and replanting of species that do not provide "cover" or cutting back of existing vegetation will assist greatly in preventing Bridging from occurring.

The removal of any such materials that may be conducive to termite activity should be carried out as soon as possible and arrange re inspection to minimize the risk of termite attack.

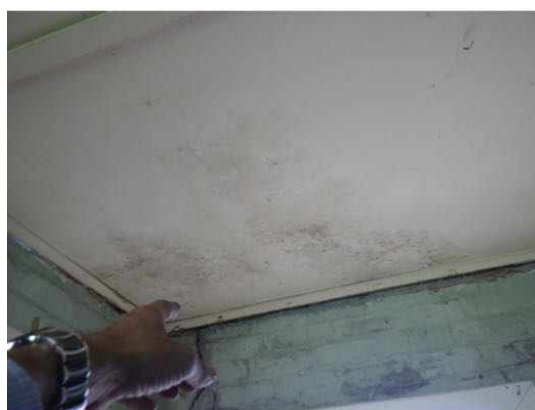
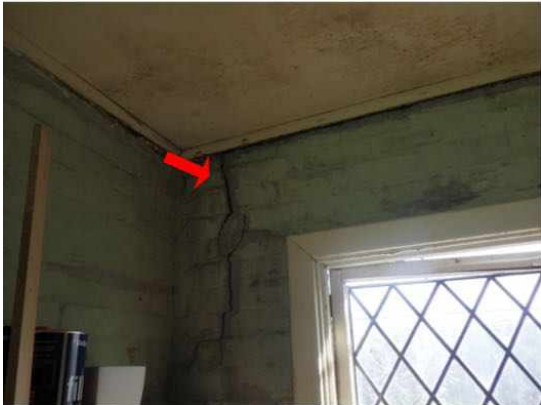
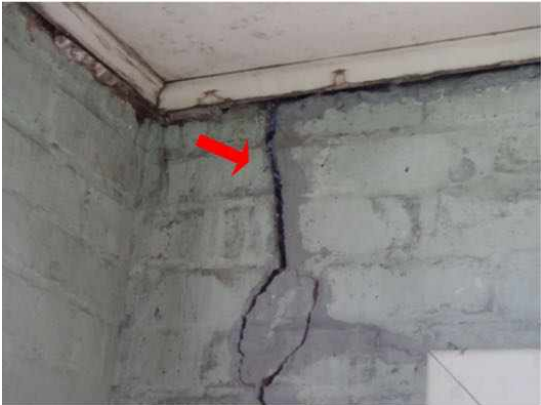
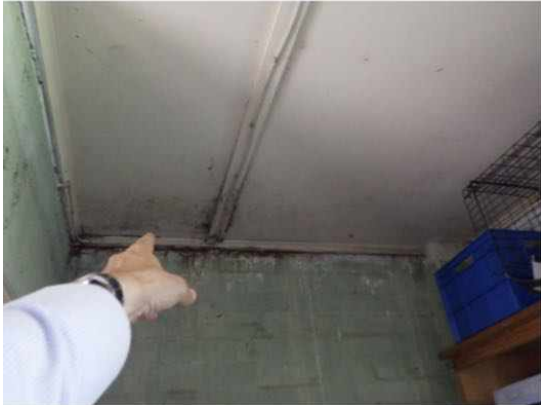
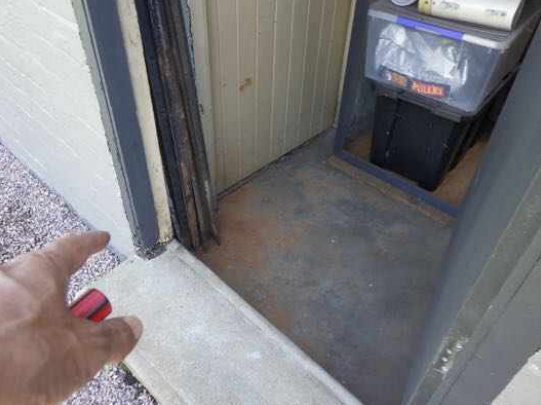
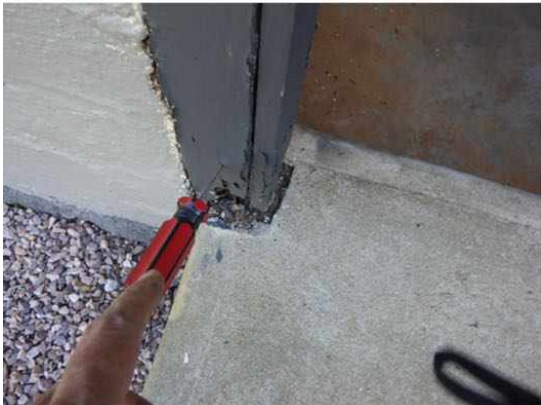
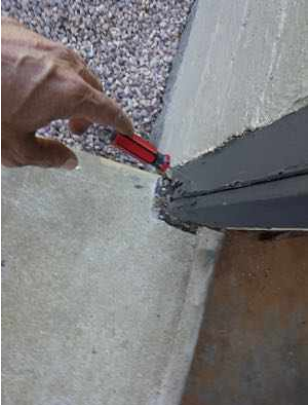
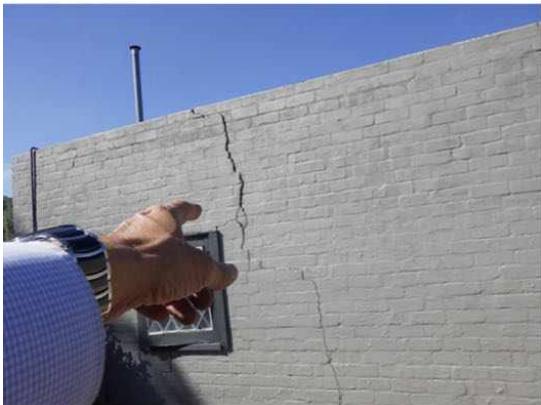
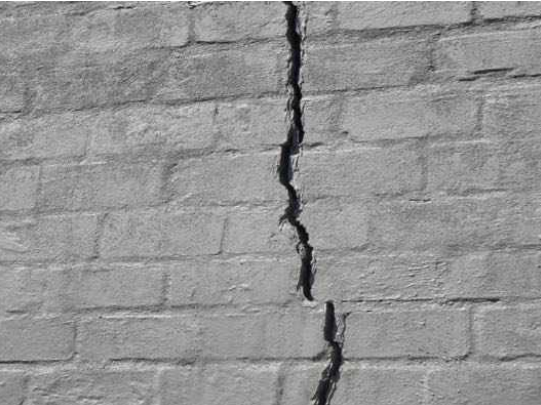
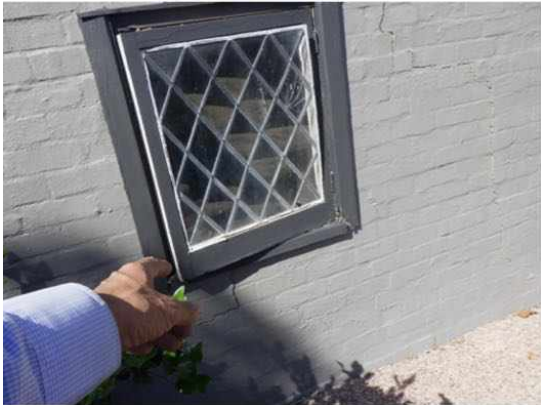
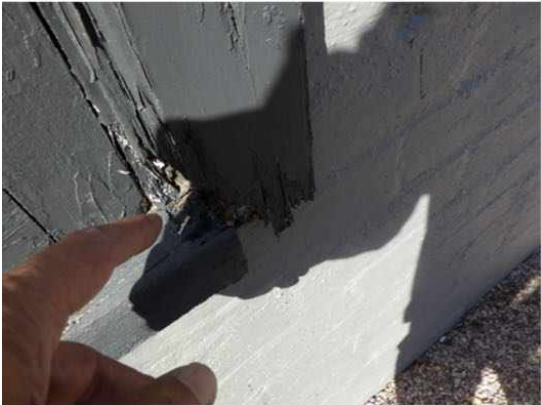
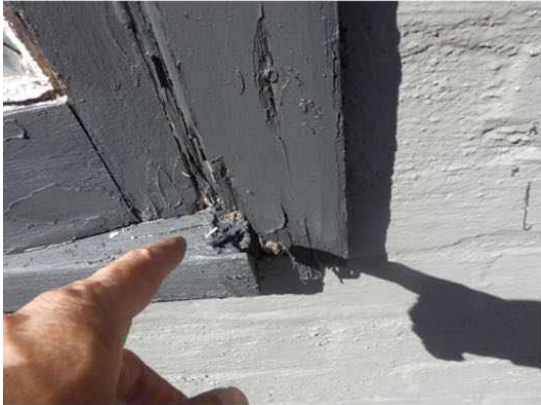
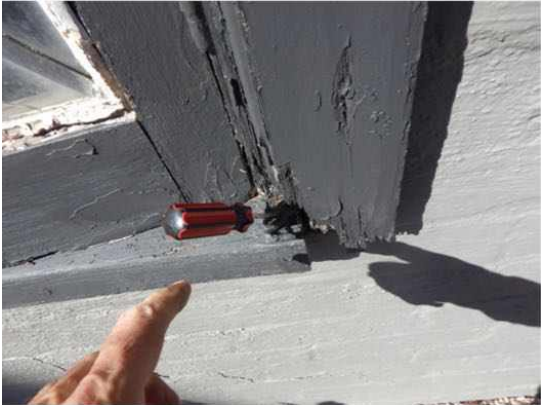
Defects 3.05

Building:	Building 1
Location:	All External Areas
Finding:	Building element - Damaged / Deteriorated
Information:	At the time of inspection it was noticed building elements were damaged / deteriorated in this external store room area.

Breakage occurs generally when the building materials have either aged and decayed, or as a result of damage (accidental or deliberate).

Repair and/or replacement of broken elements is advised to ensure that additional secondary defects do not arise as a consequence. Such works are necessary, as all building elements play a key role in the operation and function of the overall structure and its performance.

A relevant tradesperson should be appointed to repair or replace the affected building element prior to any subsequent damage being caused.

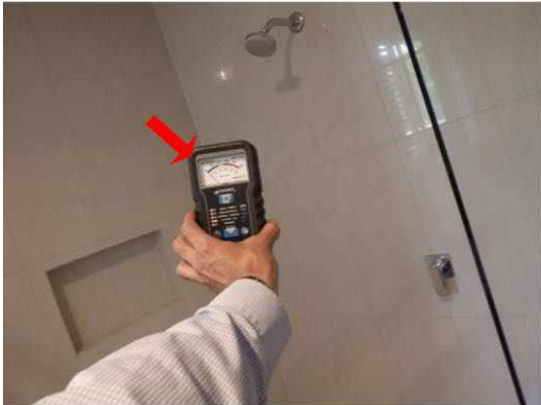
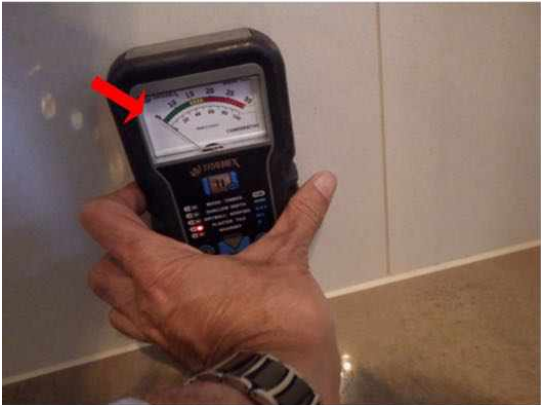
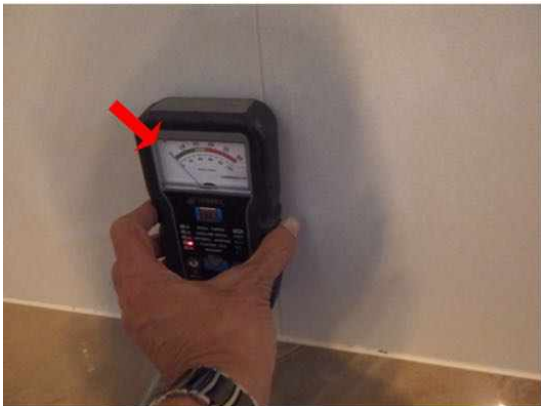
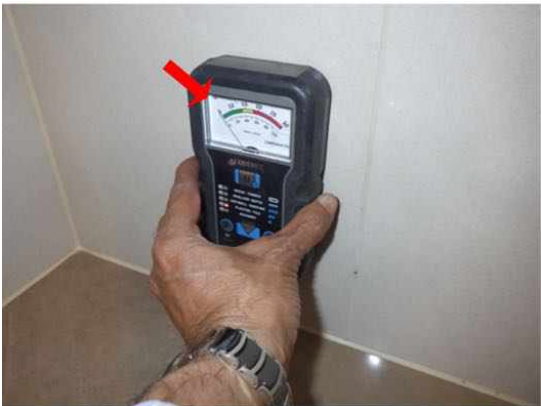
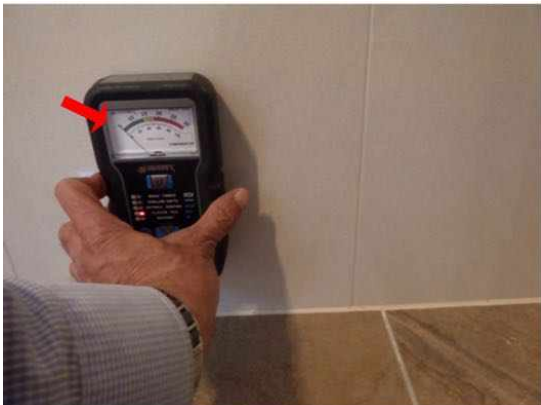
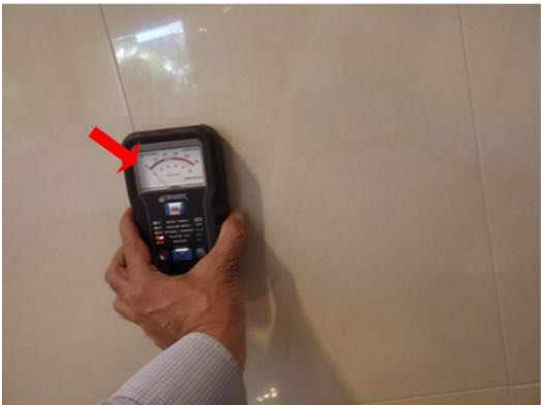
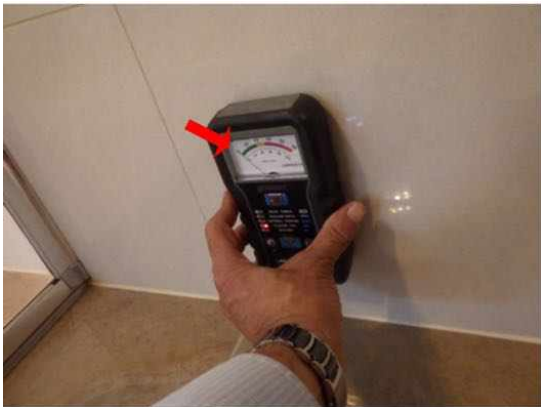
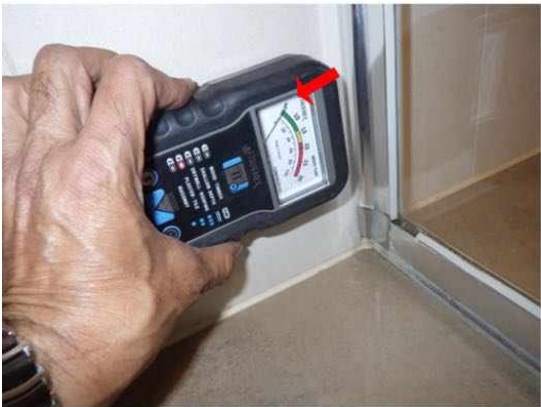
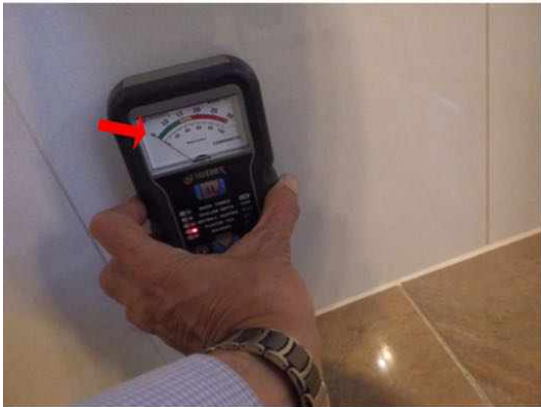
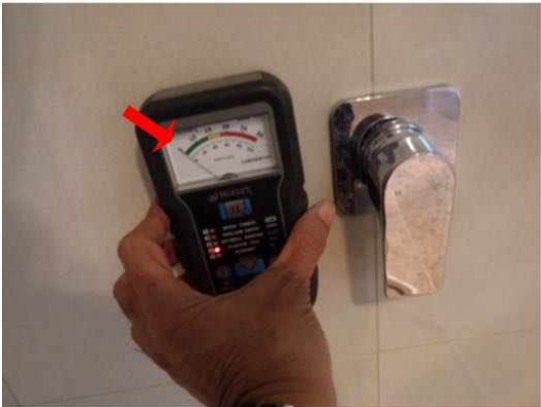
Damp (or structural damp) refers to the presence of unwanted moisture in the structure of a building, either as the result of intrusion from outside, or condensation

from within the structure. In the shower area, internal water leaks or other sources of excessive moisture are generally the cause of damp.

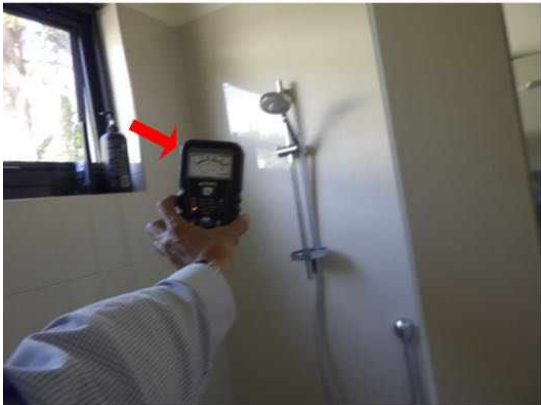
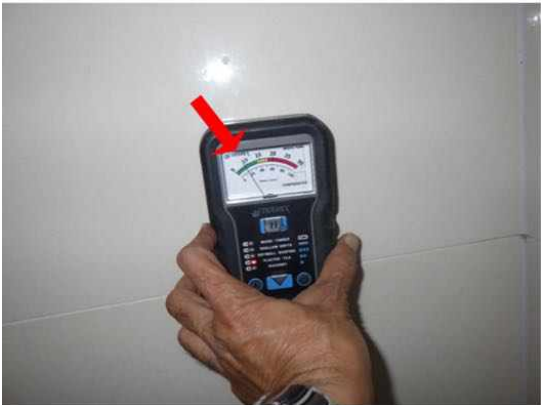
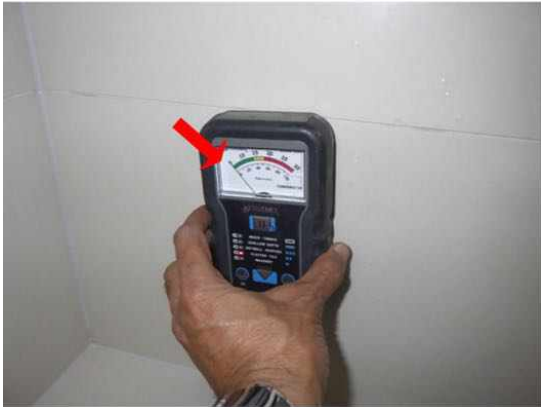
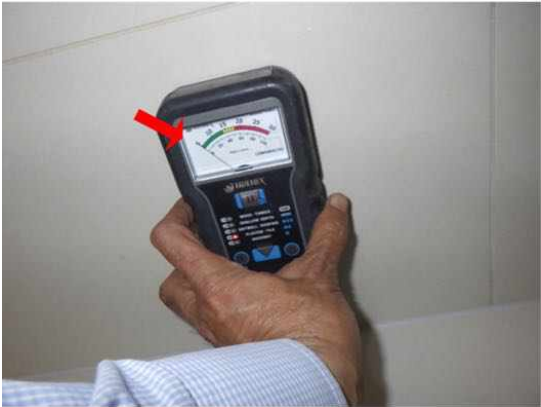
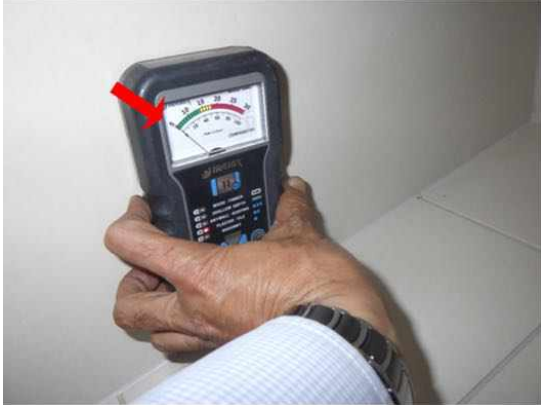
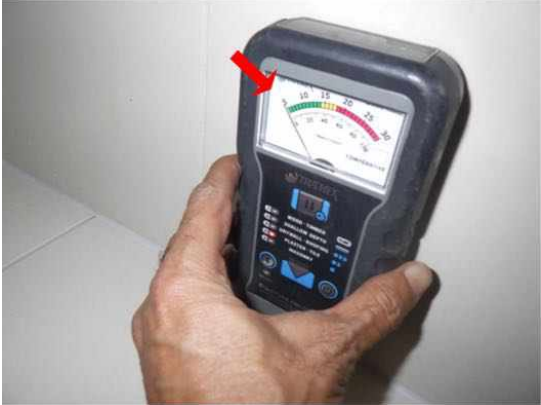
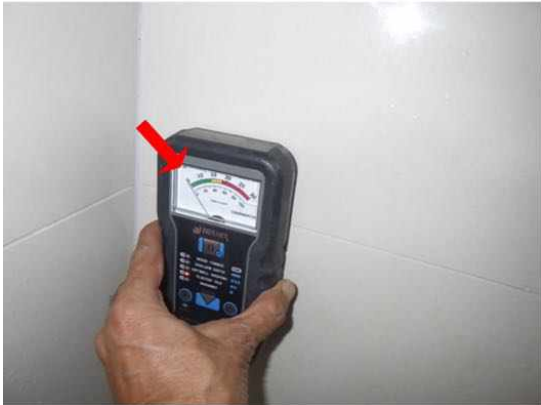
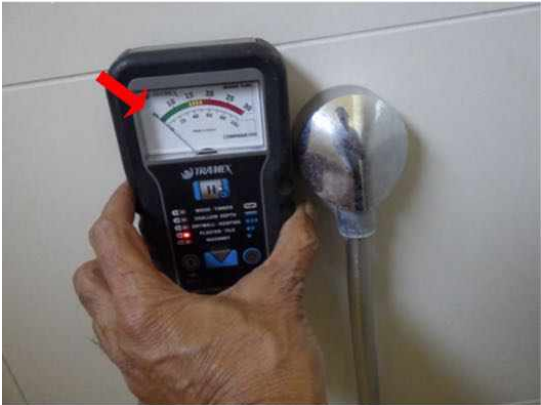
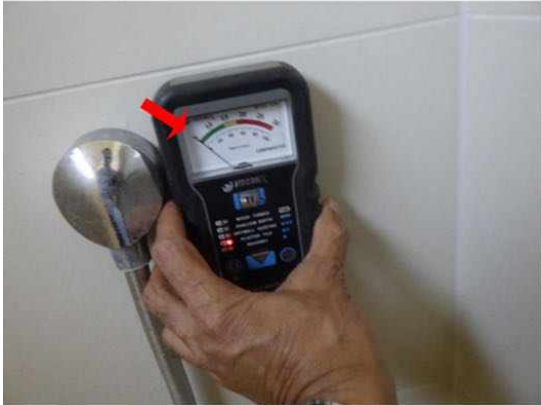
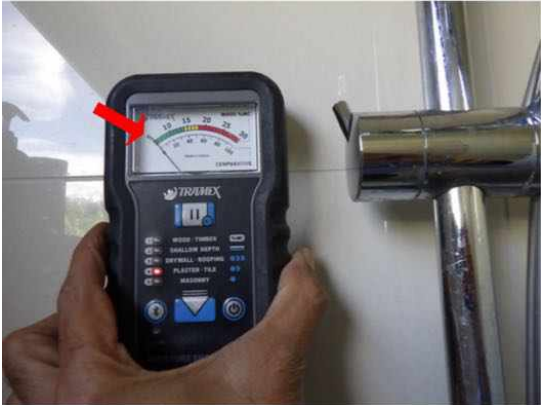
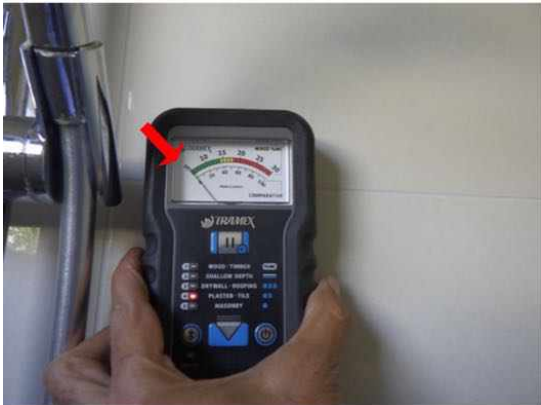
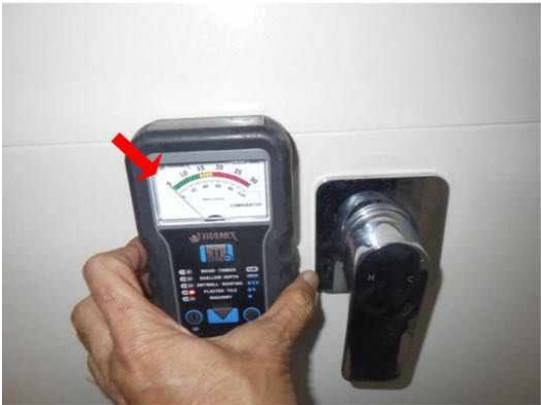
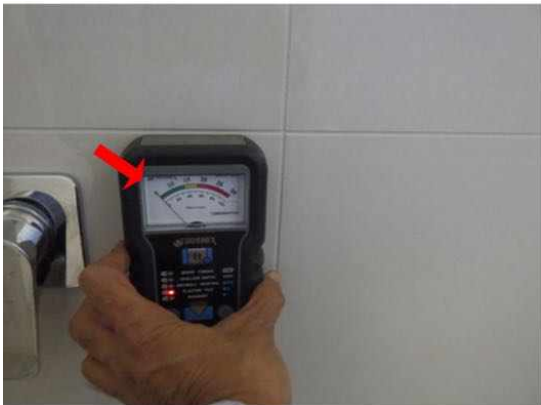
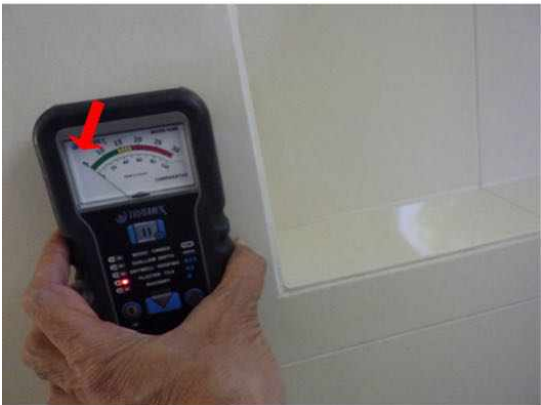
Building: Building 1
Location: Bathroom 2
Finding: Shower Alcove - No Damp
Information: At the time of inspection it was noticed that damp is not evident to the shower alcove.

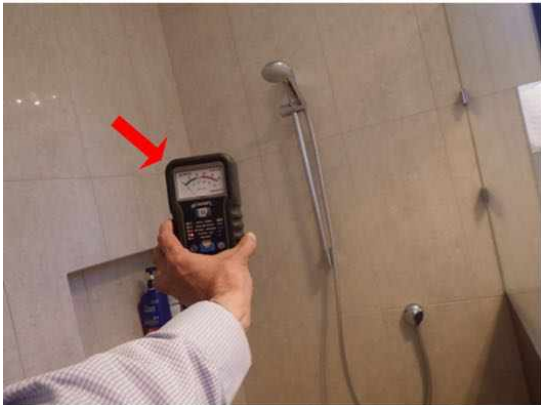
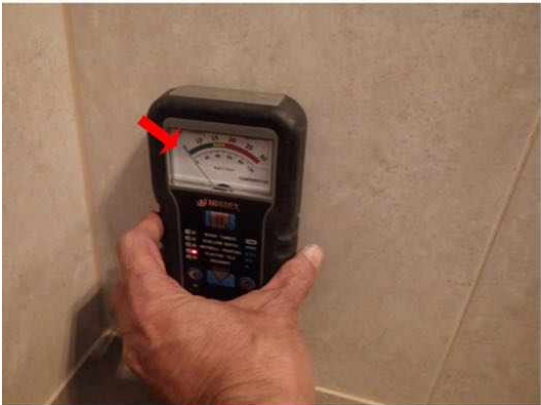
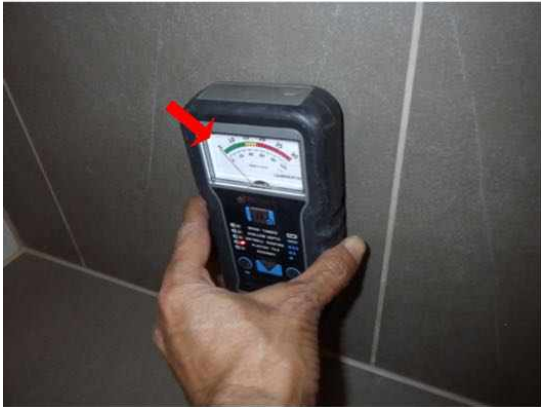
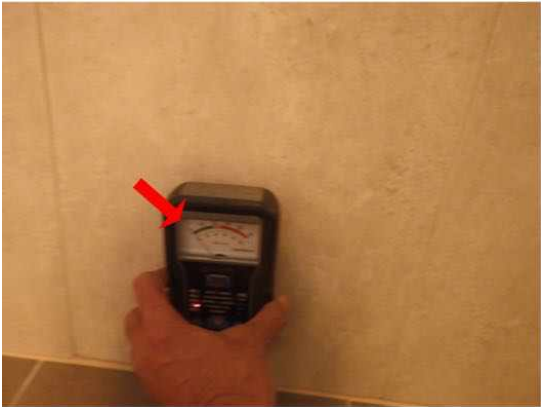
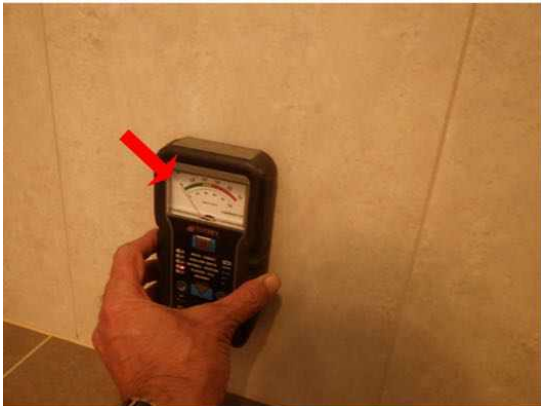
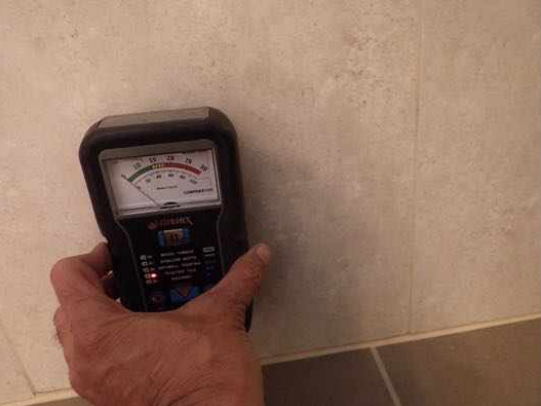
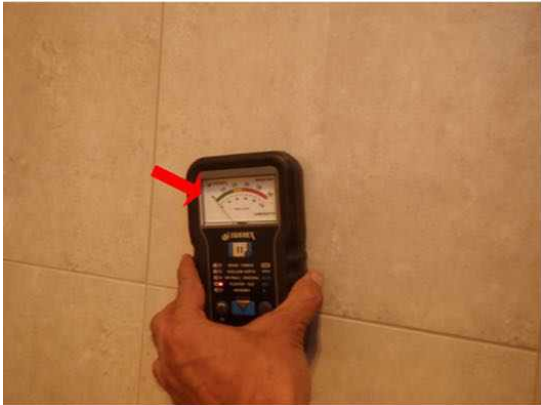
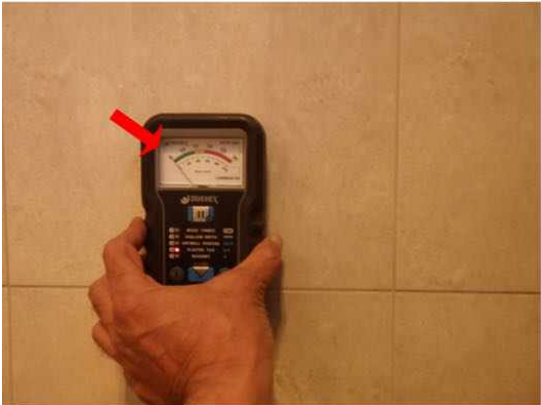
Building: Building 1
Location: Bathroom 3
Finding: Shower Alcove - No Damp
Information: At the time of inspection it was noticed that damp is not evident to the shower alcove.

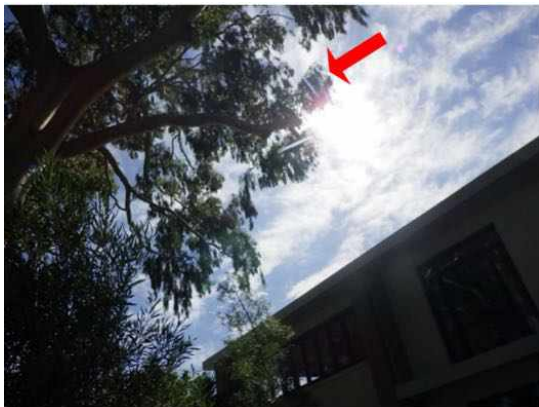
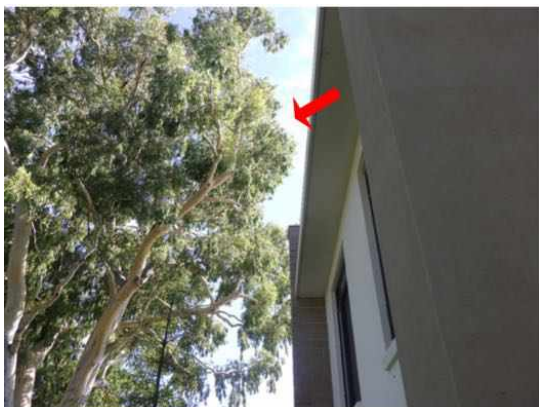
Building:	Building 1
Location:	All External Areas
Finding:	Trees - Overhanging and filling gutters
Information:	Overhanging trees often result in excessive amounts of leaf debris accumulating in gutters.

Gutters are a critical part of the building's management of storm water and rain. It is therefore important that they be kept clear to prevent secondary damage to associated building elements, including exterior and interior walls, ceiling linings and any adjoining building elements. Where gutters are blocked, pooling of rainwater is likely to occur, fast-tracking rust and corrosion of the roof plumbing elements.

It is highly advised that all overhanging tree branches be removed as soon as possible to prevent any further damage. Repair and/or replacement of sections of damaged guttering may also be required where the extent of the damage necessitates.

Such works should be performed by the homeowner; however, appointment of a landscape contractor or an arborist may be required. Consultation with a licensed roof plumber is required where guttering has been damaged.
