Building Inspection Report

Inspection Date: Fri, 20 Mar 2026

Property Address: 32 Purnana Ave, St Georges SA 5064,
Australia

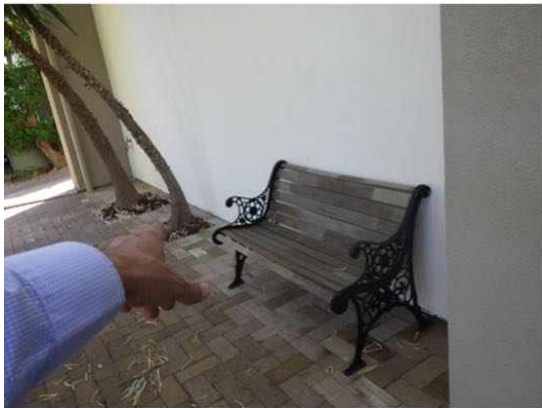
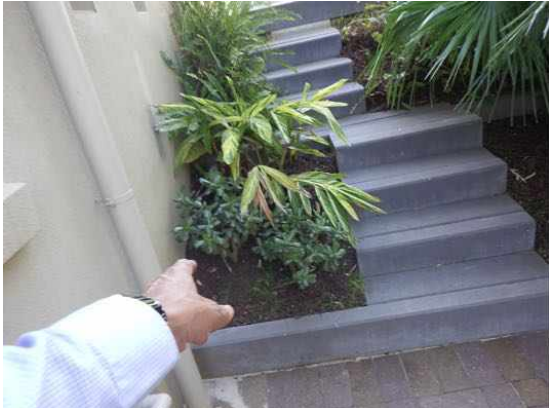
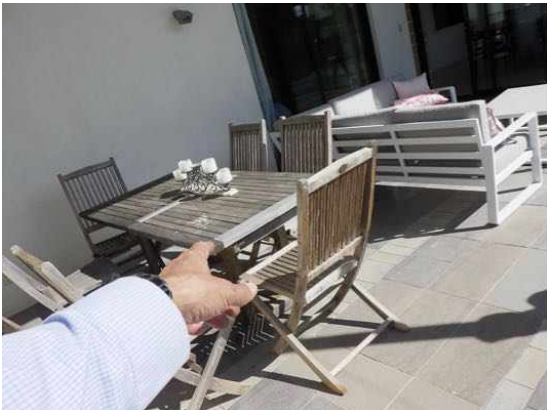
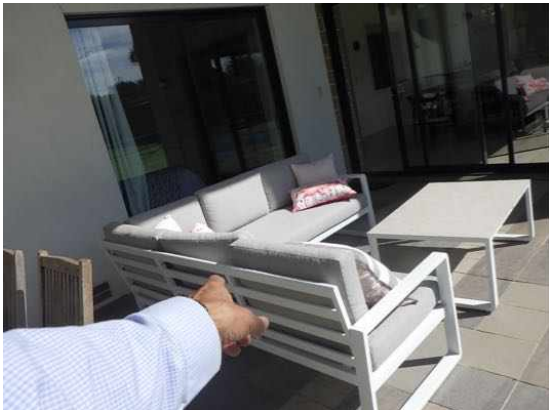
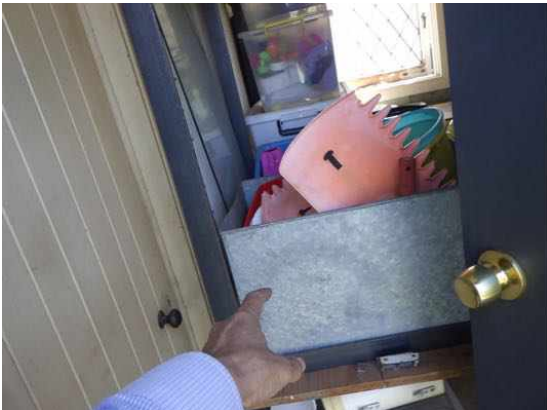
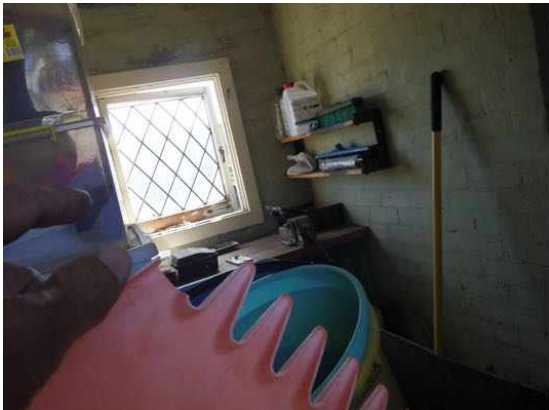
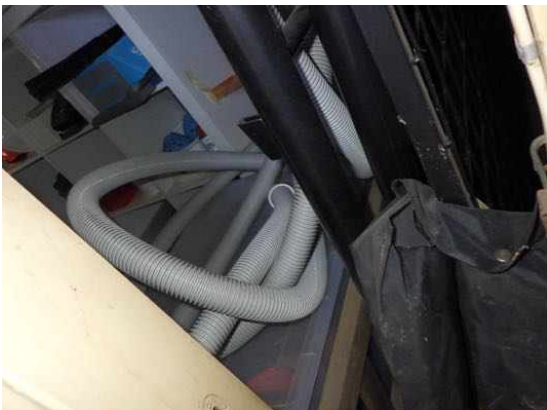
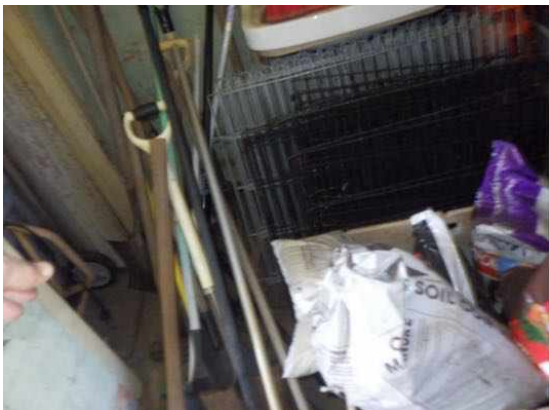
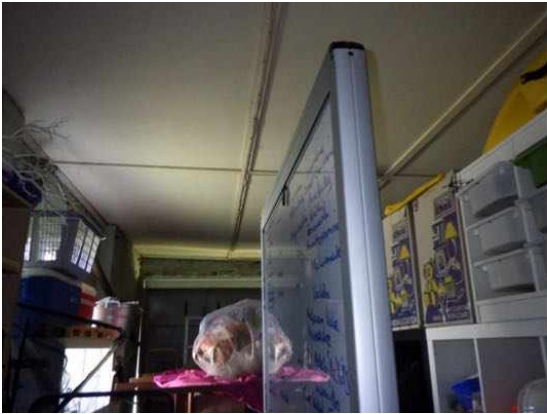
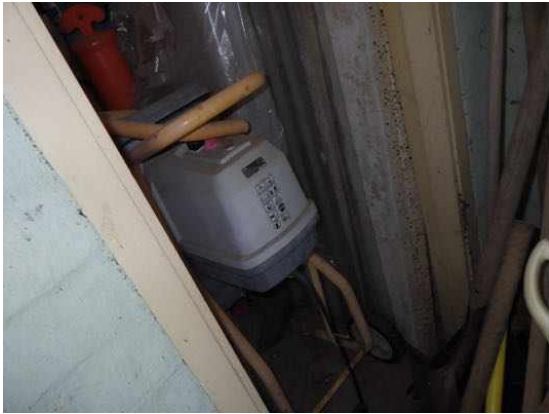
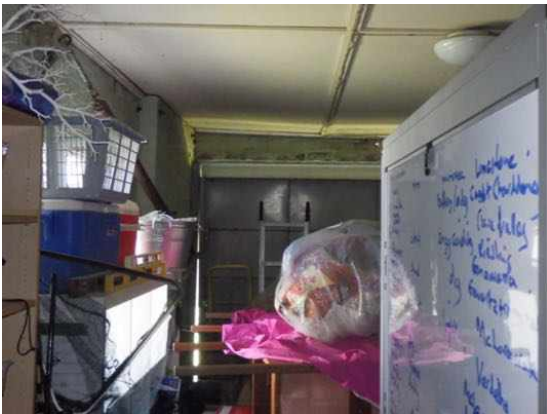
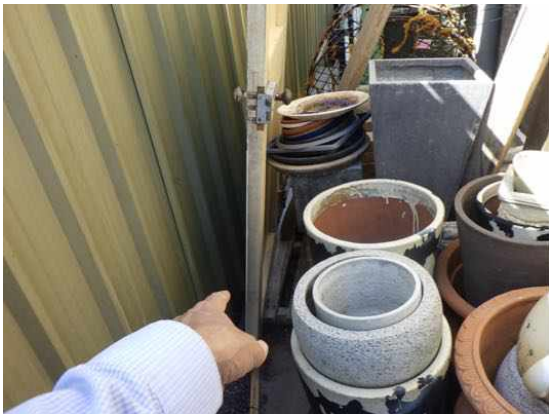
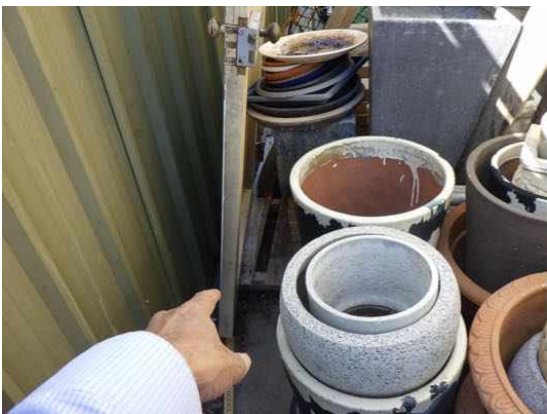
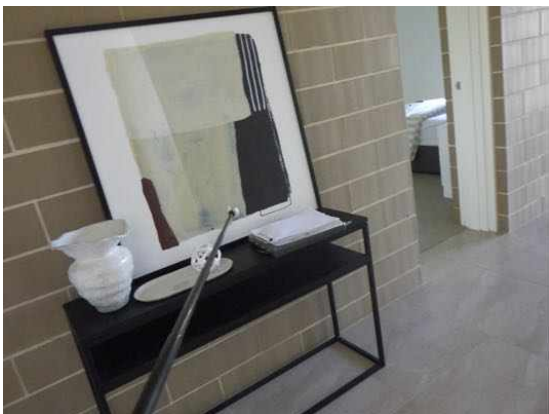
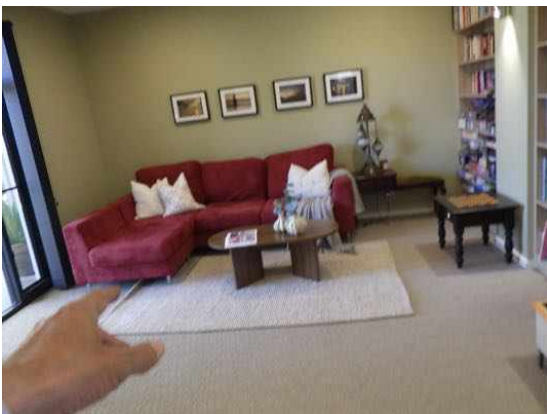
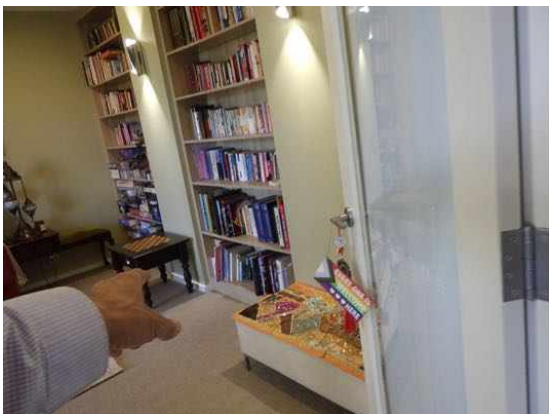
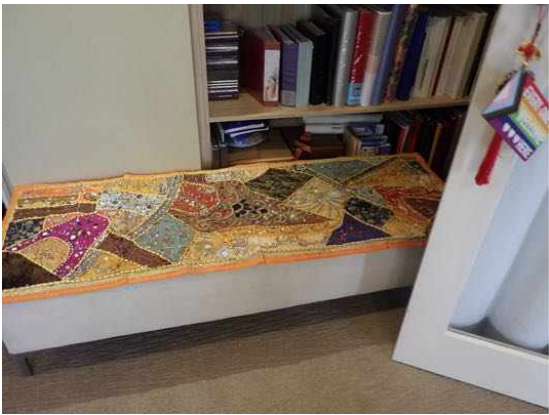
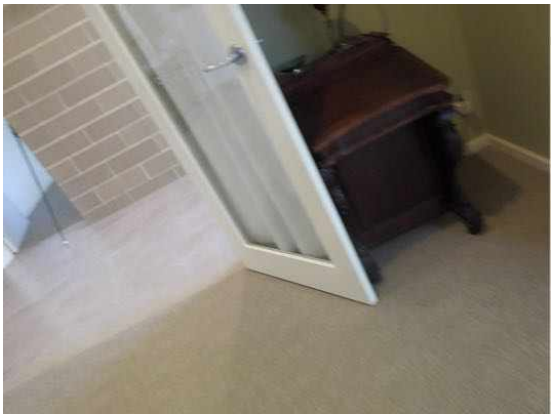
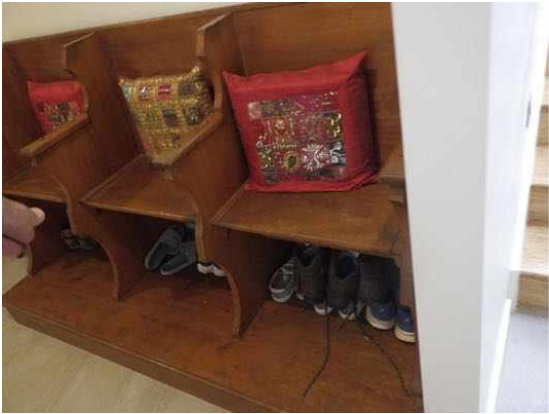
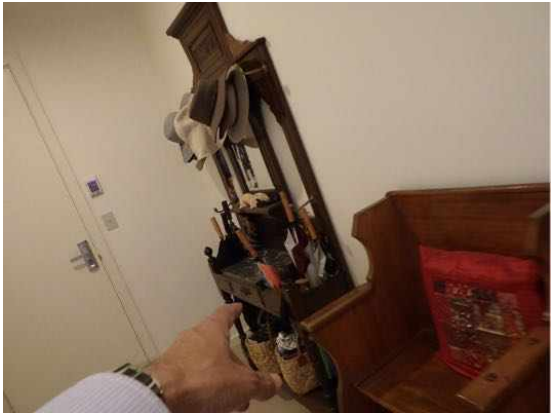
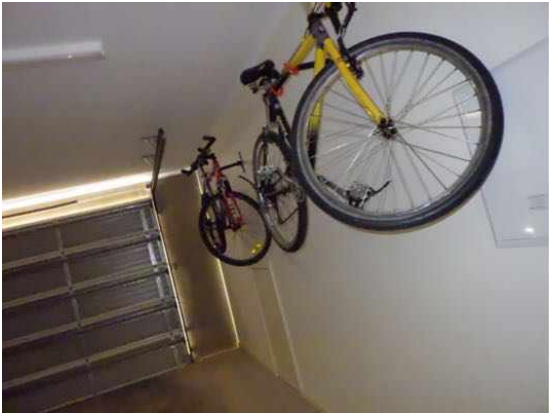
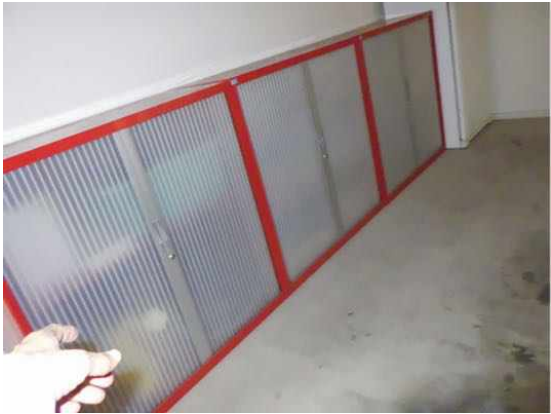
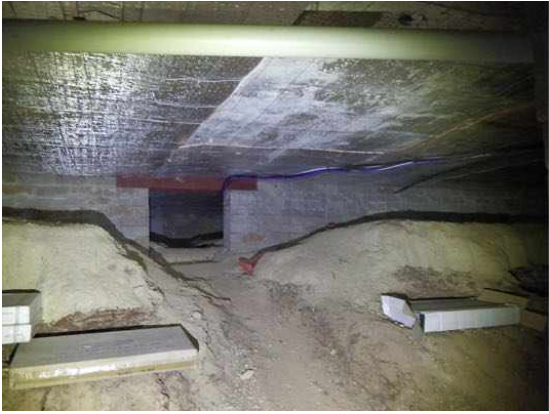
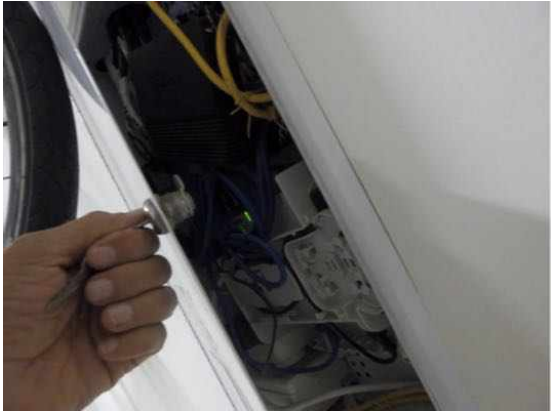
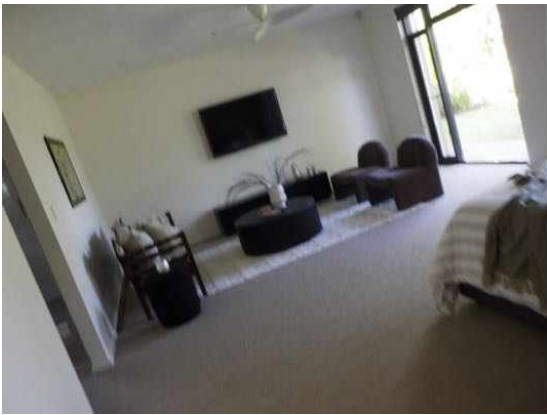
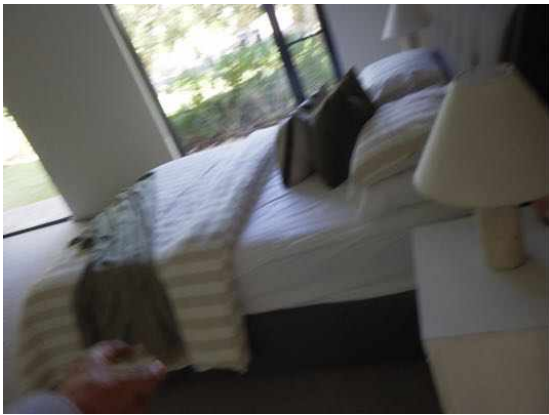
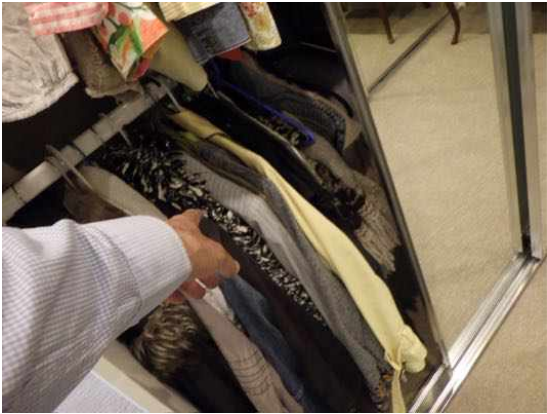
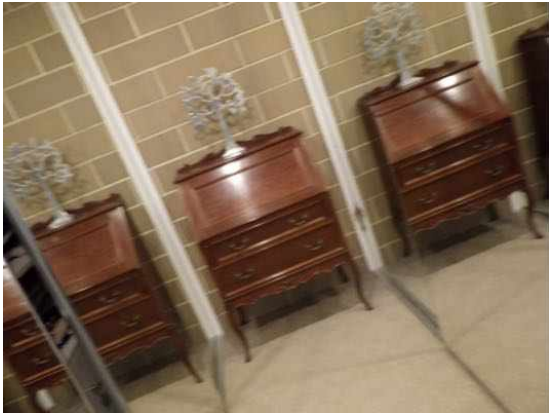
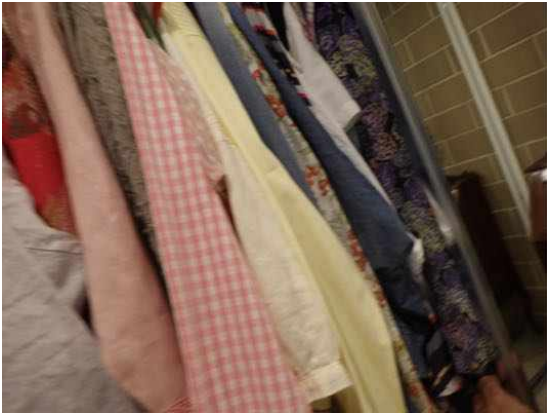
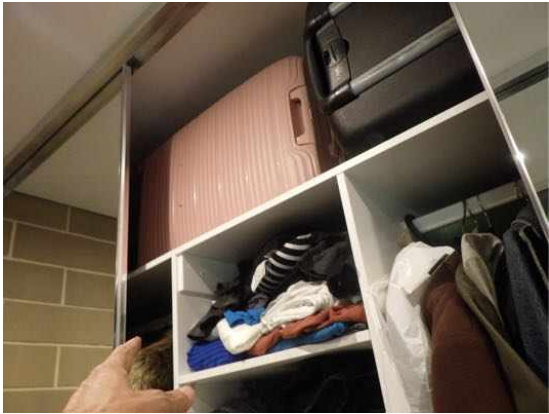
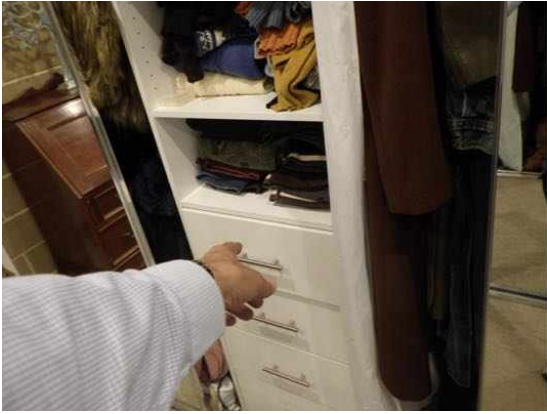
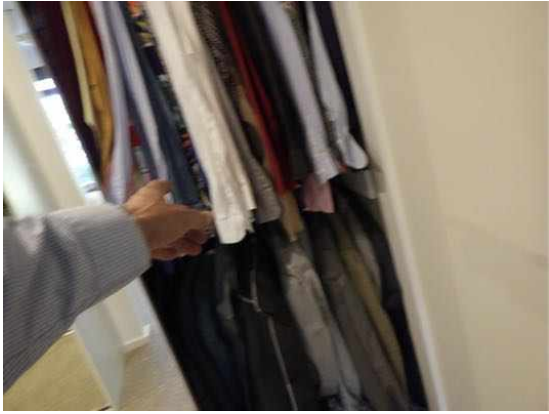
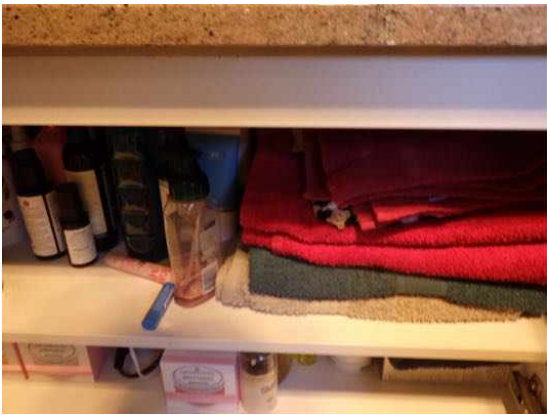
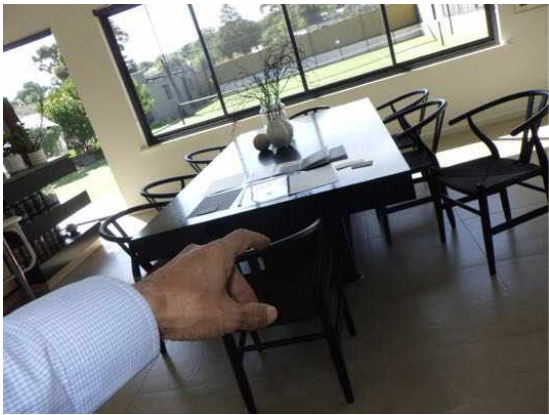
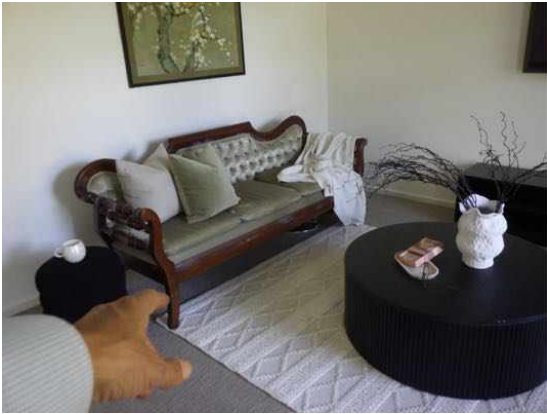
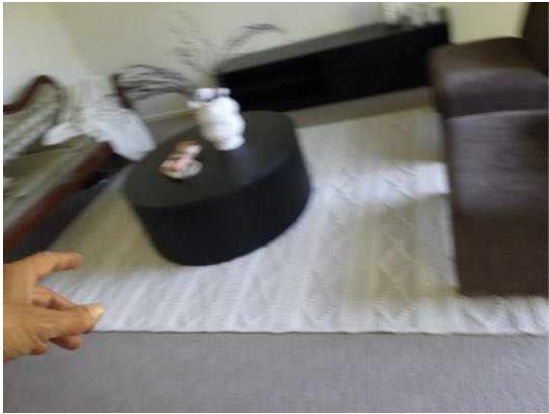
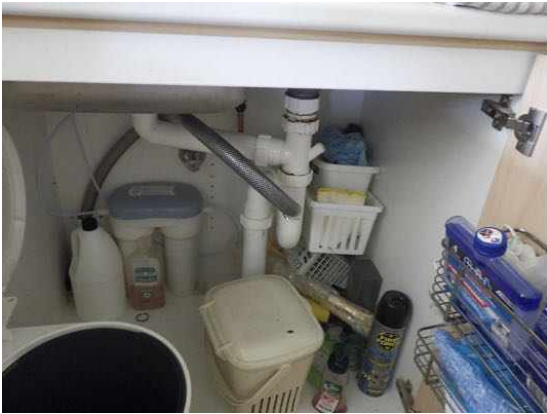
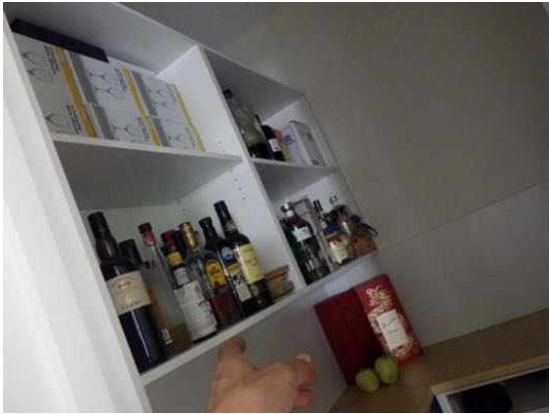
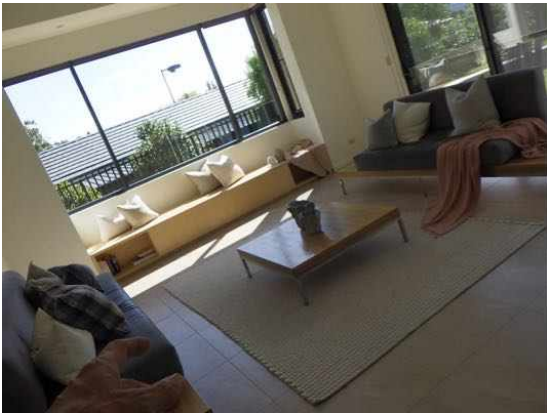
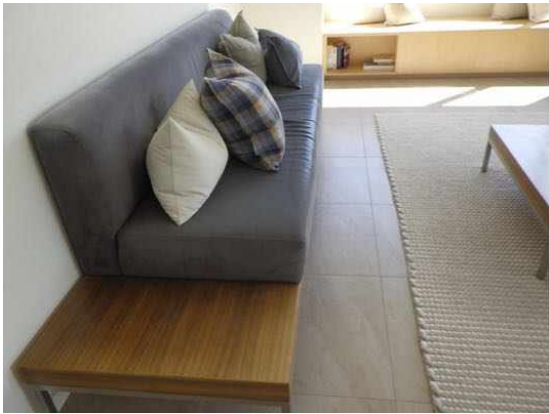
Noted Item

Building: Building 1
 Location: All Areas
 Finding: Additional Photos - Obstructions and Limitations
 Information: These photographs are an indication of the obstructions and limitations which impeded full inspection of the property at the time of inspection. These obstructions can hide an array of defects and should be removed to allow full inspection to be

carried out. A re-inspection is recommended once the areas are made accessible.

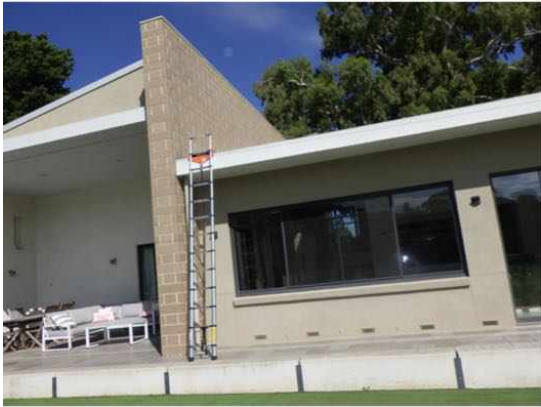
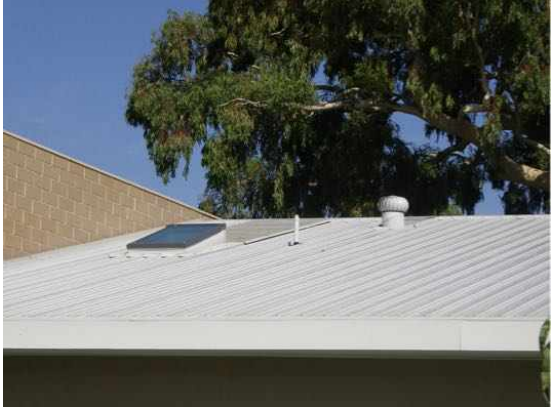
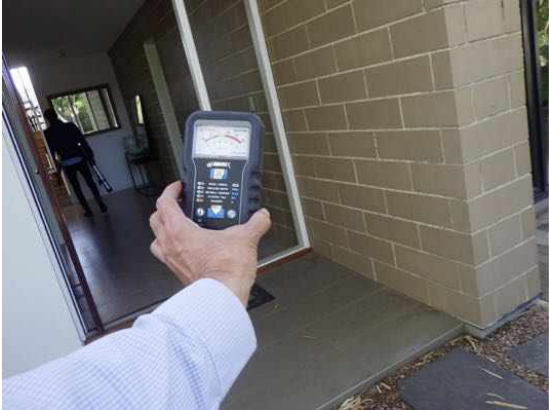
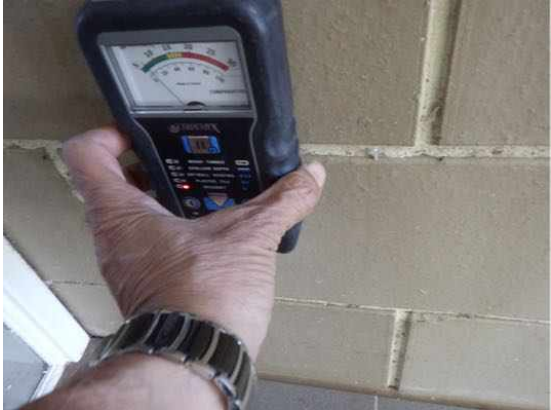
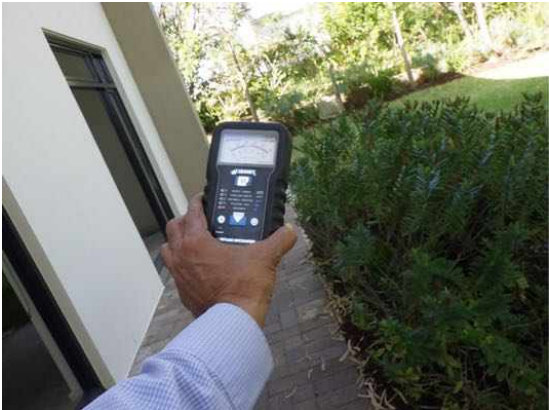
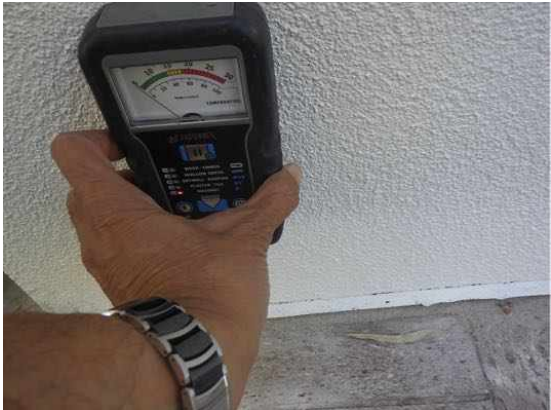
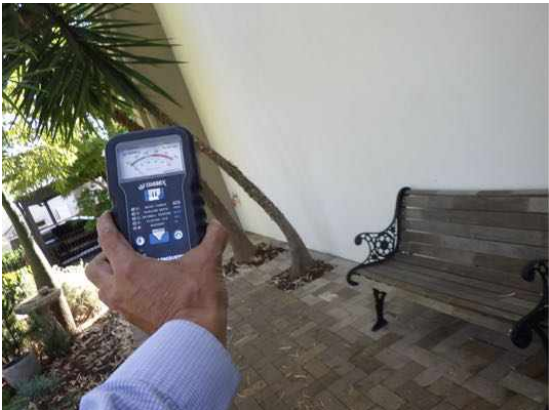
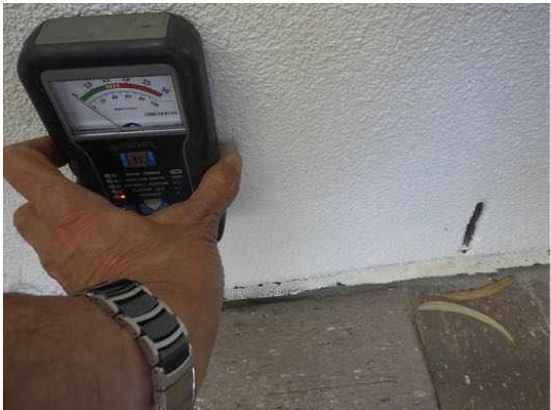
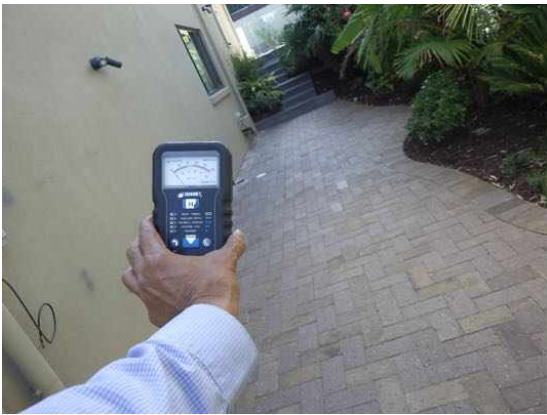
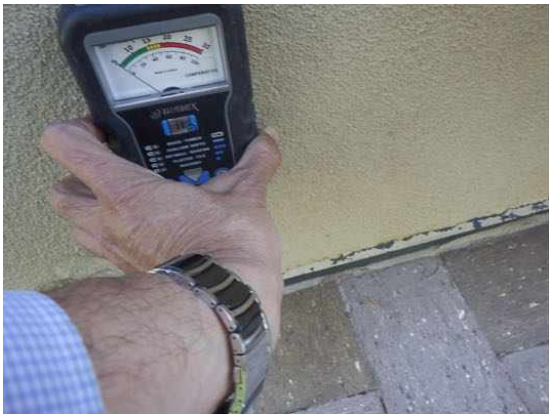
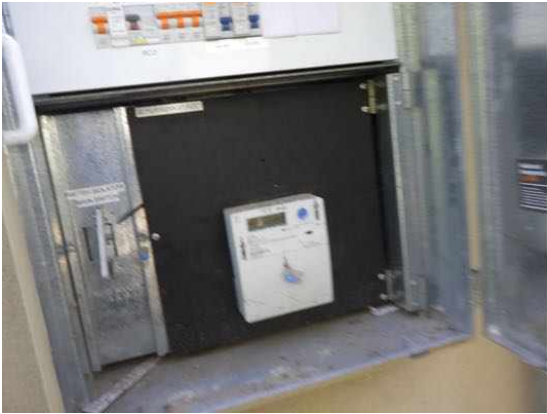
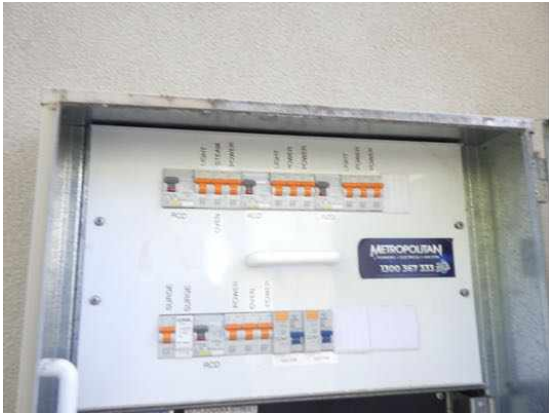
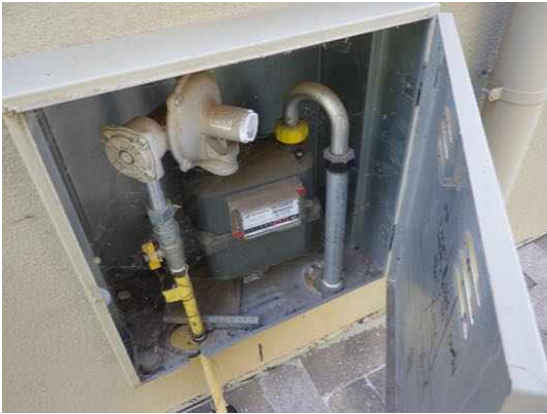
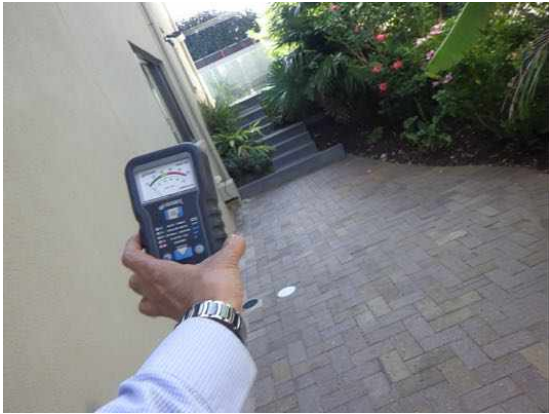
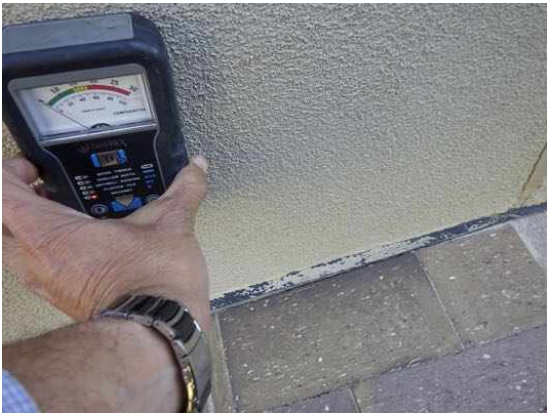
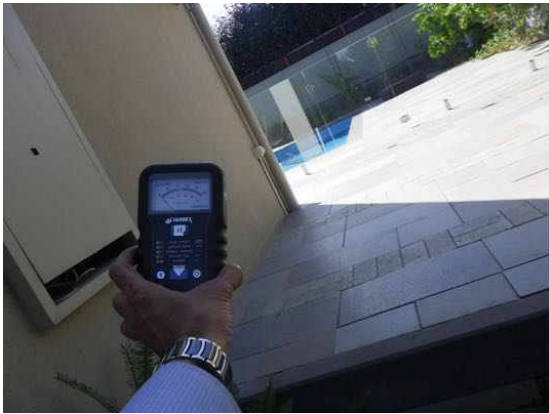
Building: Building 1
Location: All Areas
Finding: Additional Photos
Information: Additional photos are provided for your general reference
