# Building and Timber Pest Inspection Report

Inspection Date: Tue, 24 Mar 2026

Property Address: 1/125 Appin St, Wangaratta VIC 3677,  
Australia

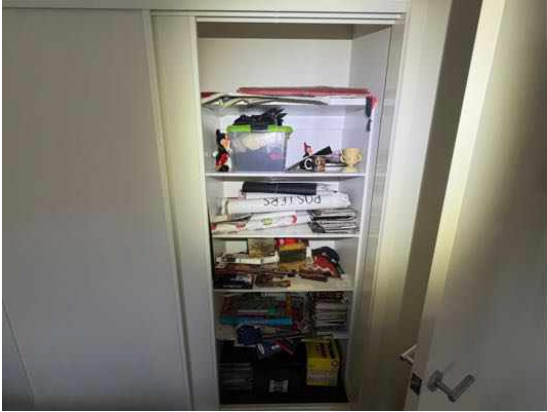
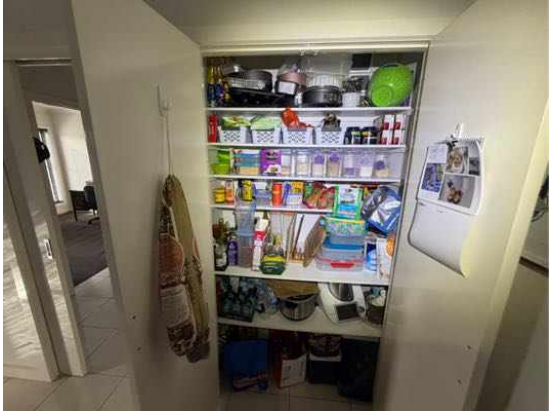
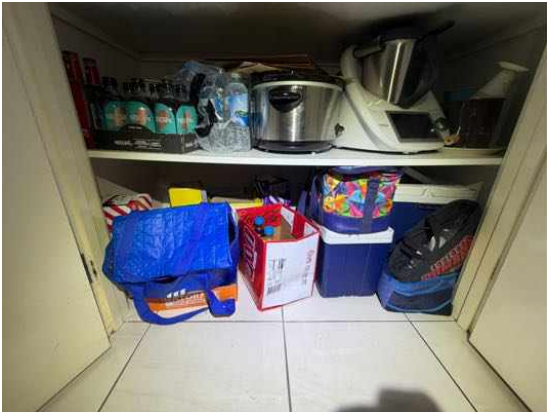
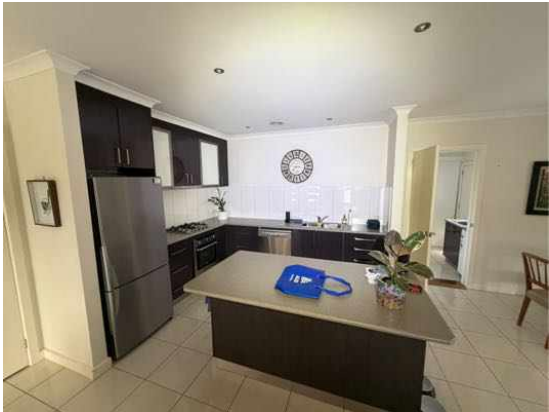
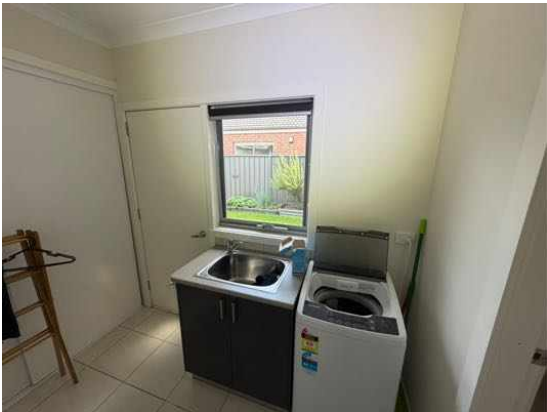
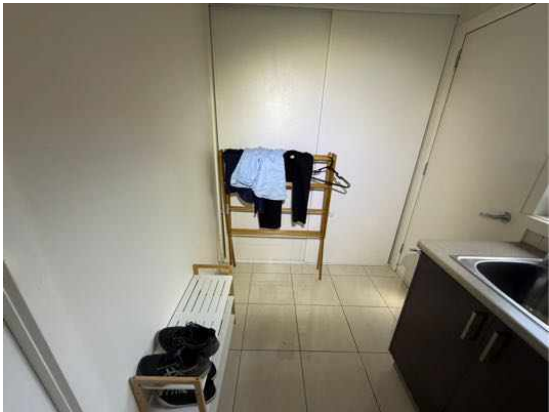
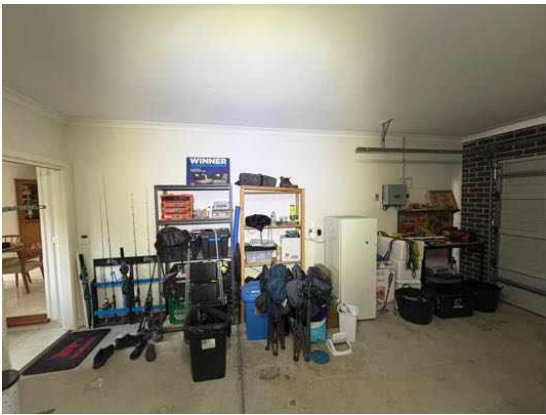
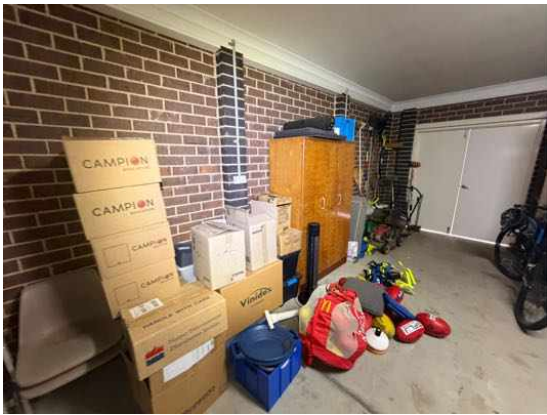
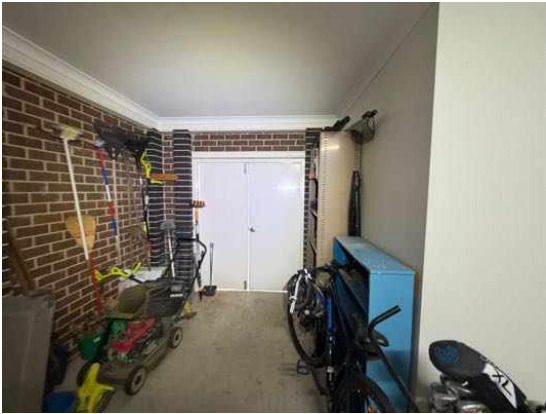
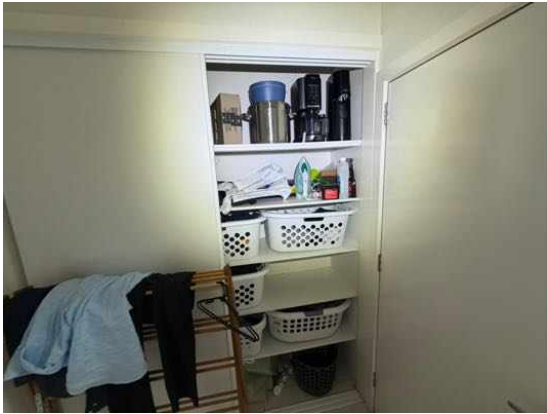
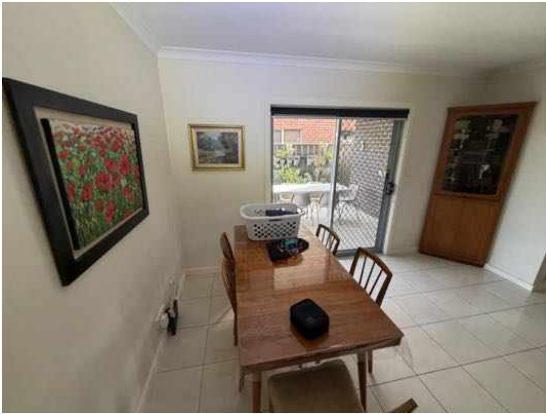
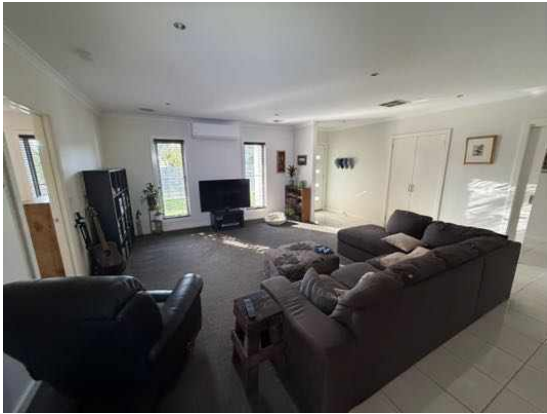
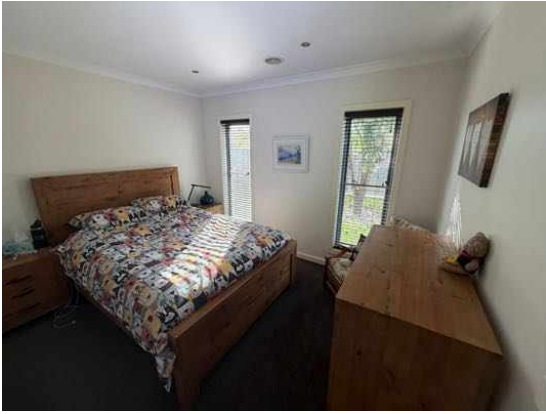
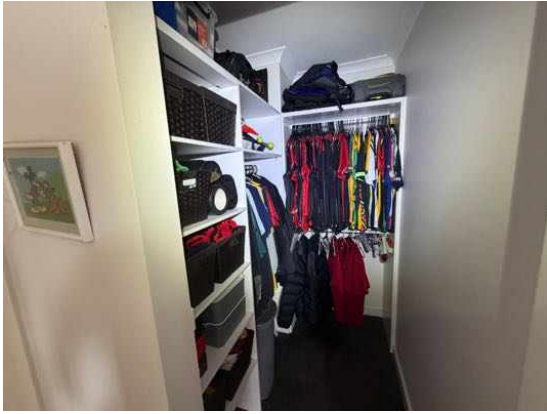
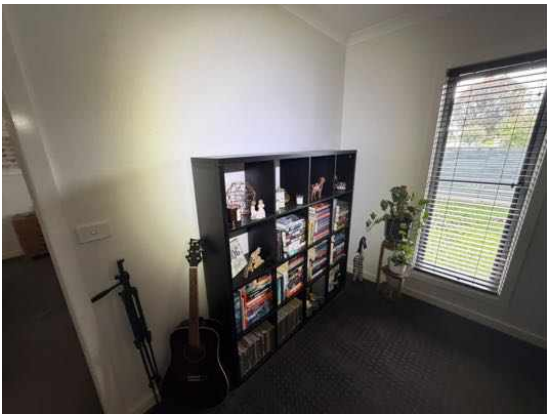
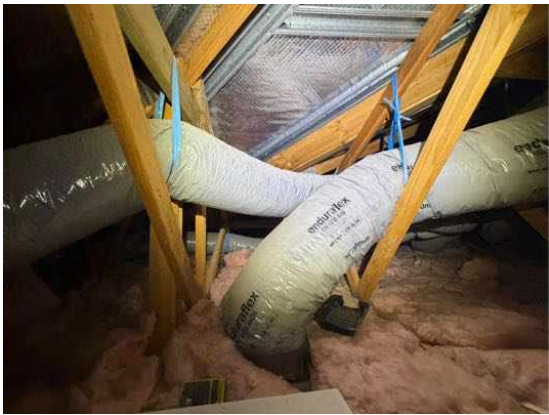
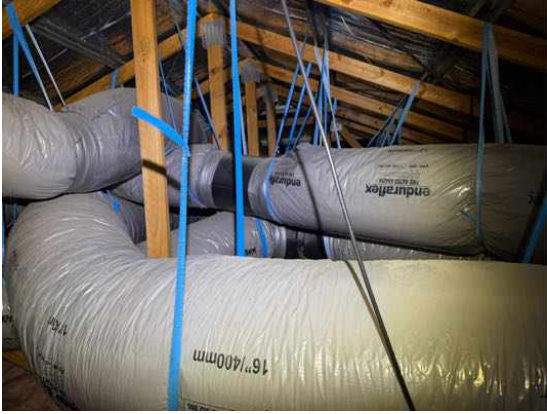
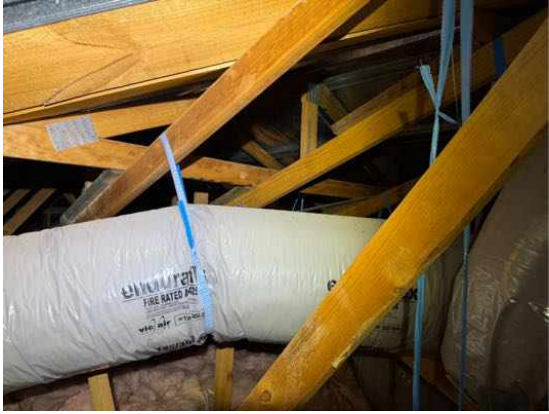
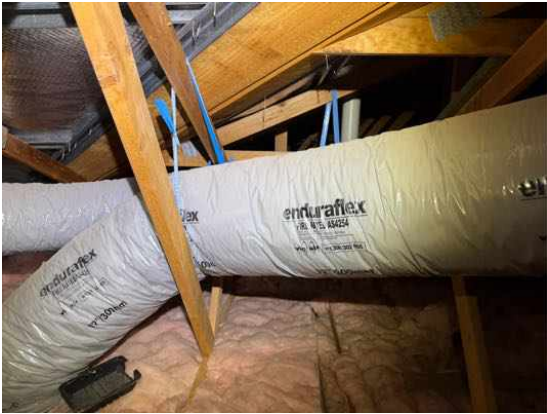
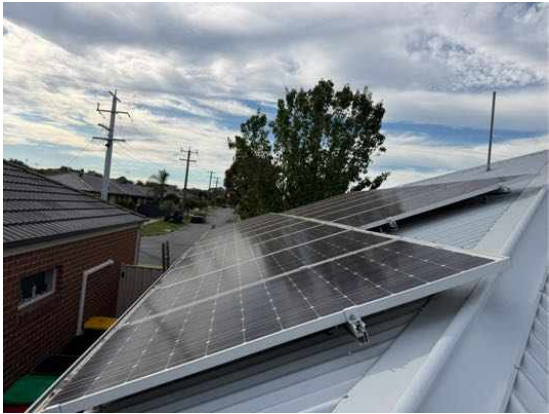
Information: These photographs are an indication of the obstructions and limitations which impeded full inspection of the property at the time of inspection. These obstructions can hide an array of defects and should be removed to allow full inspection to be carried out. A re-inspection is recommended once the areas are made accessible.
