# Building and Timber Pest Inspection Report

Inspection Date: Thu, 29 Jan 2026

Property Address: 63 Tanbark Cct, Werrington Downs NSW  
2747

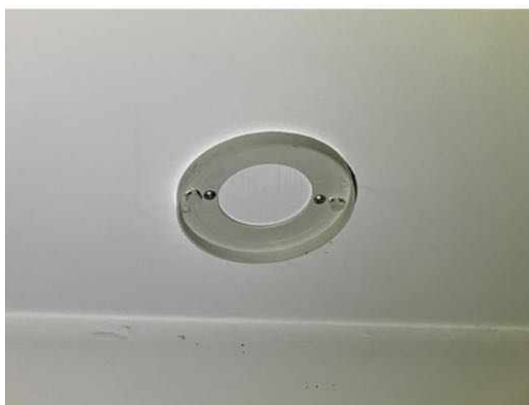
No smoke protectors were found in the house.

To ensure compliance and safety, further inspection and/or advisory services from a qualified specialist are recommended. These services can confirm the sufficiency, type, location, and functionality of all smoke detection devices within the property.

- All smoke detectors be tested monthly by the homeowner.
- All systems comply with the requirements of AS 3786 and any applicable state-based legislation.

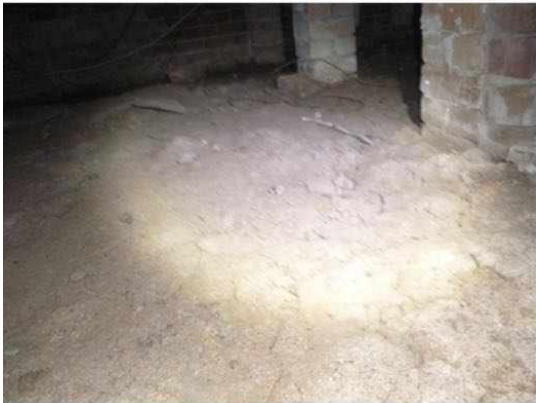
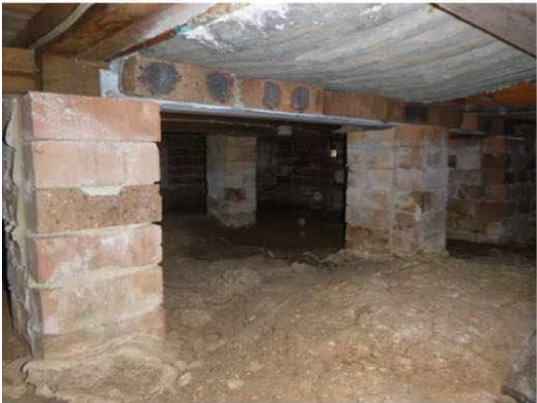
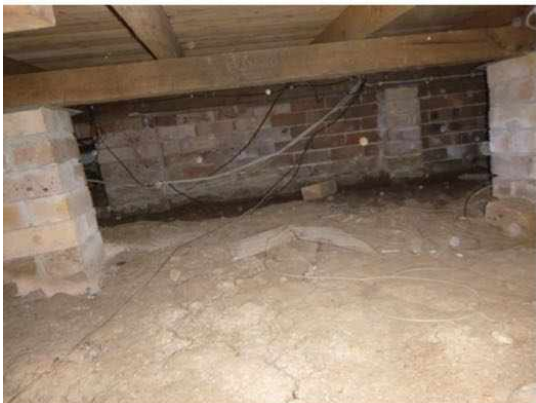
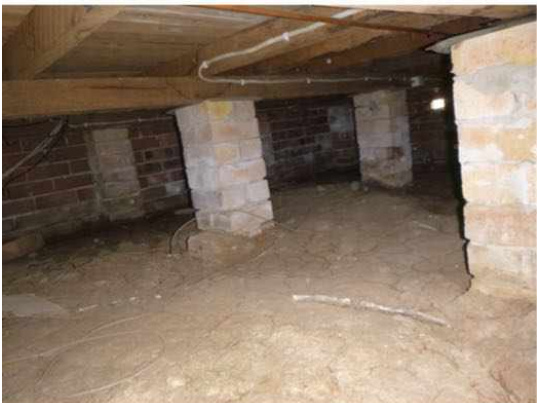
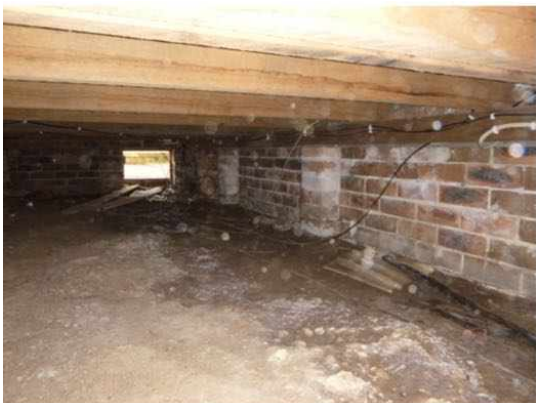
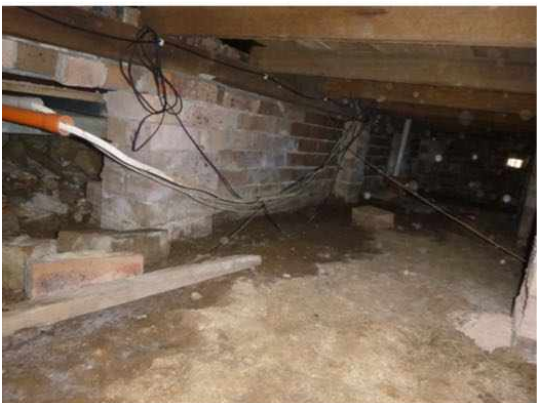
### Finding 2.01

| Finding: | Subfloor - Excessive Moisture identified. |

Evidence of excessive moisture was noted in isolated areas of the subfloor area. These findings indicate that moisture problems are ongoing and likely associated with substandard yard/subfloor drainage and ventilation.

Although the subfloor was mostly dry at the time of inspection, there was evidence of previous dampness and indicators of ongoing moisture-related issues.

- Compacted or cracked soil and minor fretting of some piers was noted, which typically suggests the area has been exposed to excessive moisture that has since dried.
- Such conditions are common in properties with sloping land, where poor site drainage leads to water entering and pooling in the subfloor.

- Inadequate yard or surface drainage, particularly on sloping sites where external ground levels are higher than the subfloor.
- Roof or surface water not effectively directed into the stormwater system, allowing runoff to enter beneath the dwelling.
- Poor natural airflow and ventilation within the subfloor area.

- Redirect all surface water runoff away from the building to prevent further moisture ingress.
- Where subfloor drainage is inadequate, install an agricultural (Aggie) drain or equivalent drainage system.
- Consider the installation of fan-forced subfloor ventilation to improve airflow and assist in drying out excess moisture.
- Engage a qualified roof and drainage plumber experienced in site drainage to assess and rectify contributing issues.
- Consult a subfloor ventilation specialist to design and install an effective ventilation system suited to site conditions.

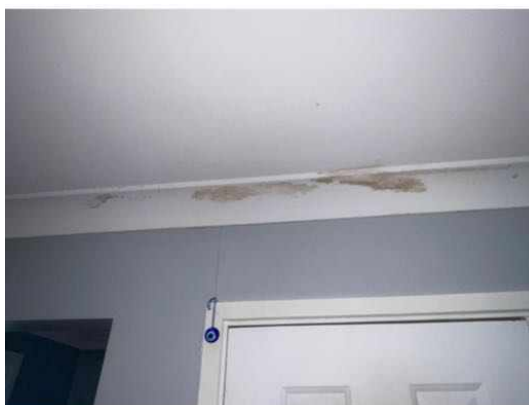
### Finding 3.05

Building: Main Building  
 Location: Dining Room  
 Finding: Ceiling - Water stained.  
 Information: Observation:

Due to the visual-only nature of this pre-purchase inspection, it is not possible to conclusively determine whether water staining is active or inactive at the time of inspection. Further assessment under a special-purpose inspection is recommended if a more detailed diagnosis is required.

Additionally, it is important to note that even minor damage to roofing materials—such as lifted flashings, cracked tiles, or poorly sealed penetrations—can allow water ingress that may lead to costly internal damage. Close-up inspection by a roofing contractor is advised to assess the condition of the roof coverings and associated fixtures more accurately.

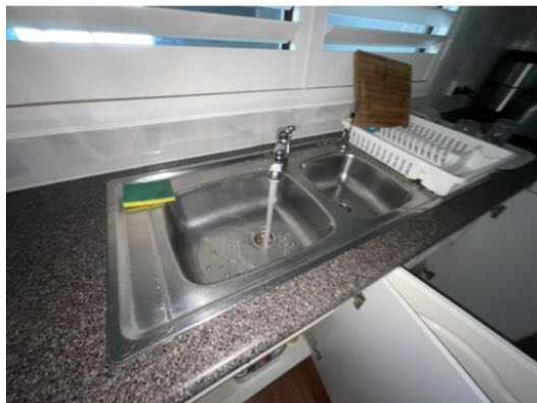
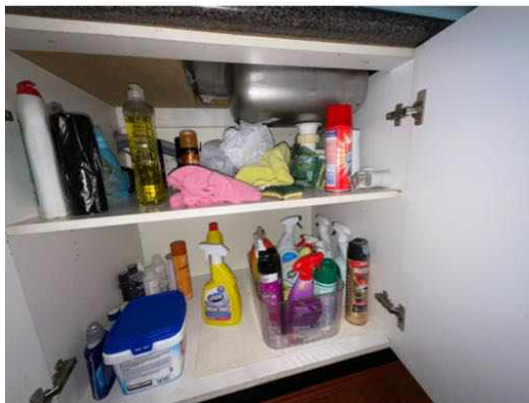
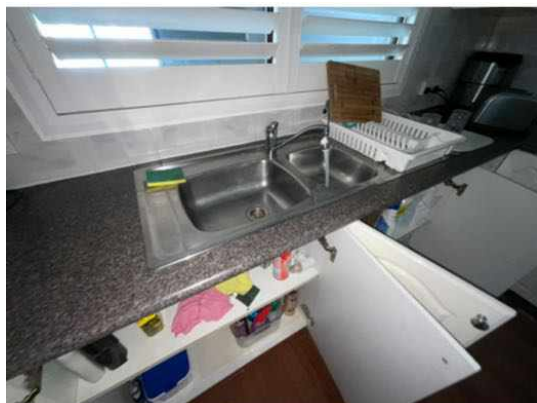
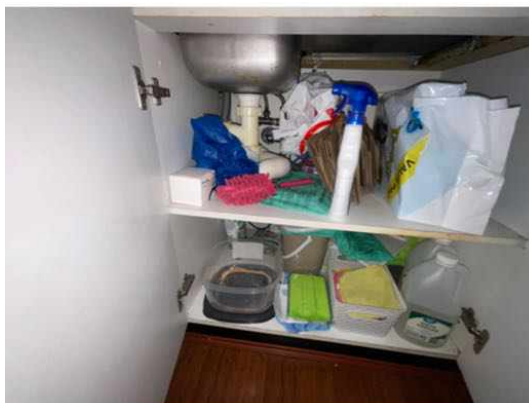
Building: Main Building  
 Location: Laundry  
 Finding: Laundry - Taps/Plumbing/Drainage.  
 Information: Observation: Laundry Tub – Taps, Plumbing, and Cabinetry

- Further monitoring or testing is recommended once the taps are placed into regular use, to ensure no leaks develop over time and that the drainage system continues to perform adequately.
- Sealant and grouting in wet areas should be maintained as part of the long-term care and upkeep of the property.

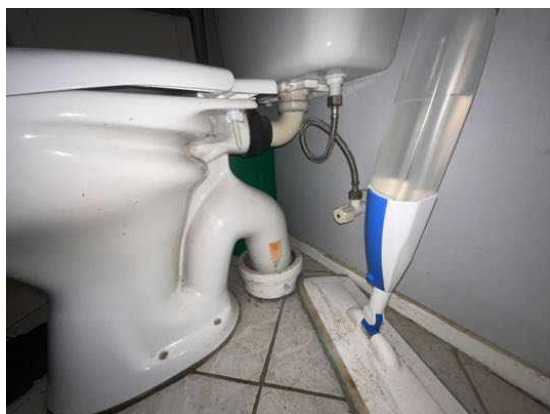
Building: Main Building  
 Location: Bathroom  
 Finding: Wet Areas - Bathroom(s) - Overall Condition & Recommendations.  
 Information: Overall Condition & Recommendations

- Flood testing of the shower recess is recommended. This may reveal inadequacies in the waterproofing or shower screens, which could lead to water damage in surrounding areas.

- Floor waste was found to be clear and free of blockages at the time of inspection. Further monitoring is advised after consistent use to identify any drainage issues or buildup requiring cleaning.

- No elevated moisture readings were detected around the tap fittings or behind the shower walls (as viewed from adjacent rooms), suggesting no active plumbing leaks at the time of inspection.

- Sealing of grout and tiles is recommended to prevent moisture buildup and mould growth in damp areas such as showers.
- The condition of grout and sealant appeared to be Good , with some areas potentially requiring maintenance or replacement.

- The exhaust fan appeared to be damaged and noisy, recommend repairing or replacing.

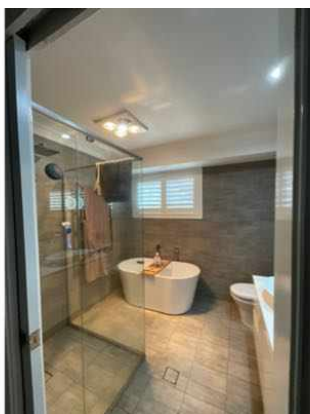
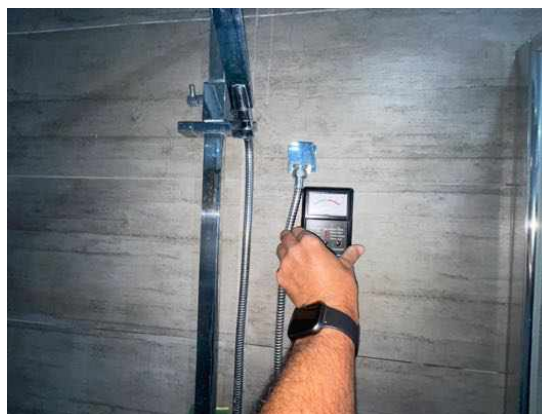
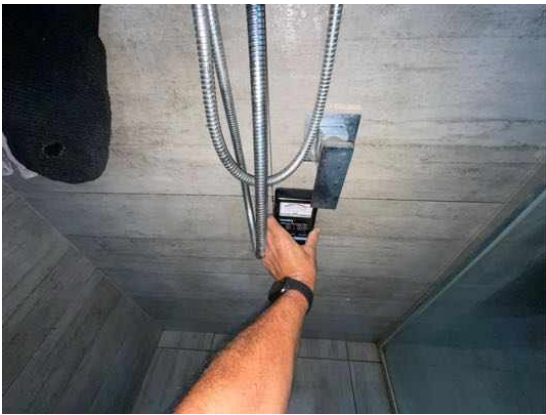
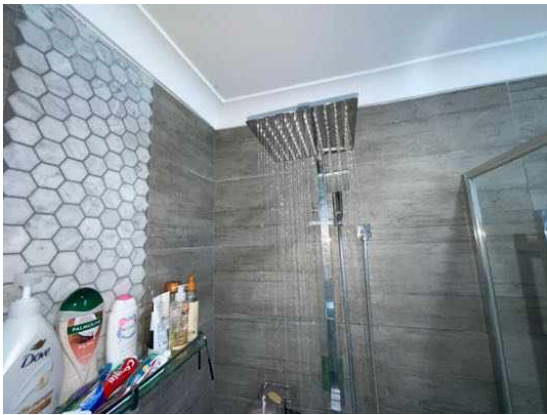
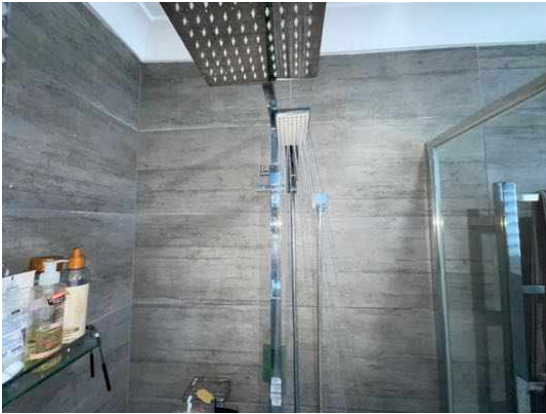
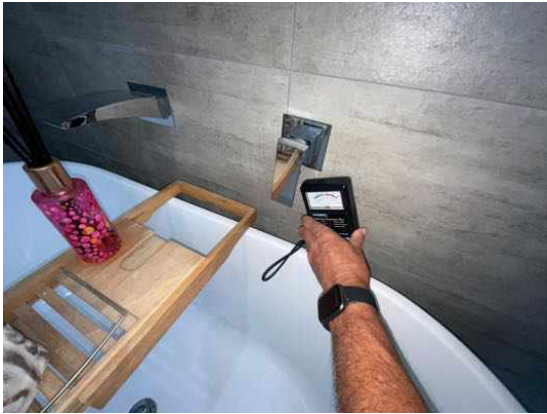
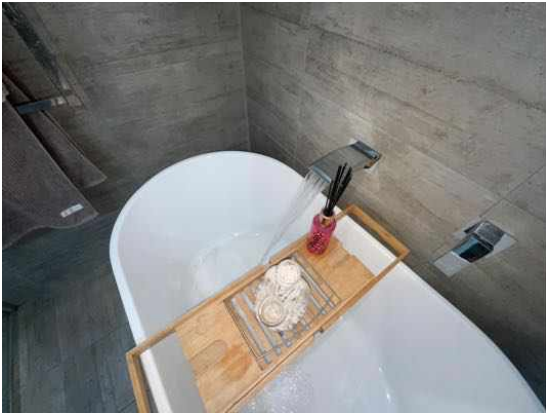
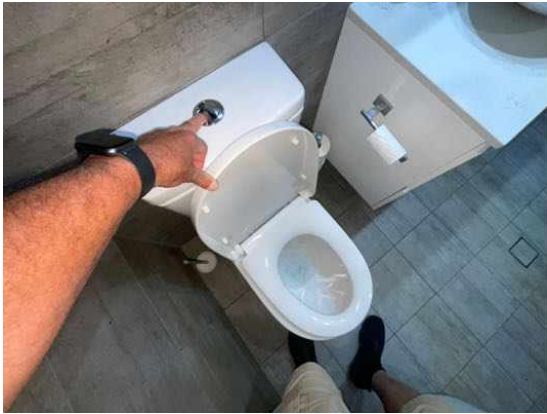
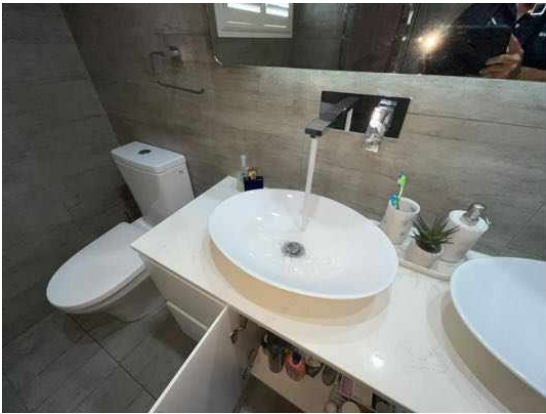
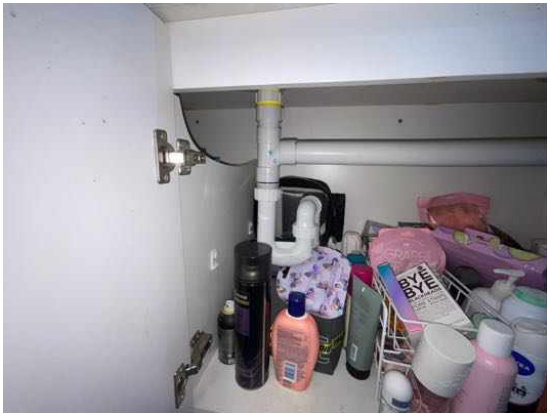
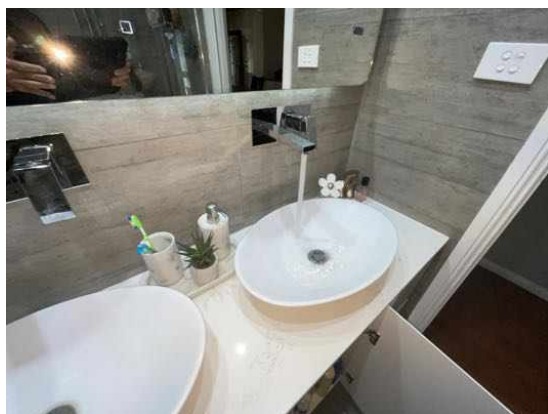
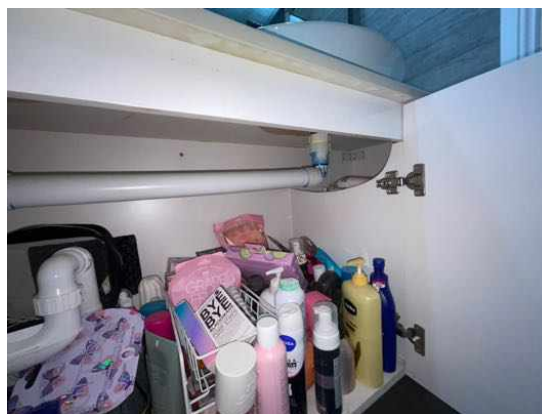
Building: Main Building  
 Location: All Areas  
 Finding: Water Pressure – Observation Only.  
 Information: During the inspection, water pressure appeared to be within a normal operating range based on a basic functional check. However, this observation was made without the use of pressure testing equipment and does not constitute an assessment by a licensed plumber.

It is strongly recommended that a Licensed Plumber be engaged to conduct a comprehensive assessment of the plumbing system to verify its functionality, check for any underlying issues, and confirm compliance with current regulations and standards.

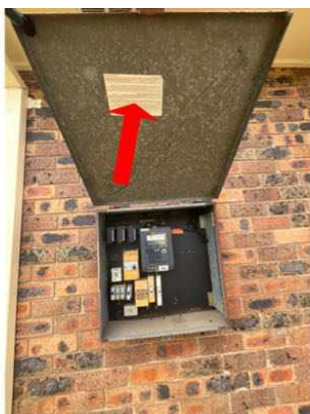
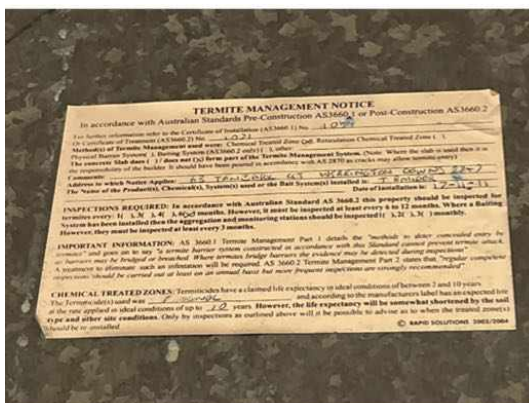
Building: Main Building  
 Location: All Areas  
 Finding: Termite Management System – Previous Barrier Noted..  
 Information: Observation:

At the time of inspection, evidence of a previous termite management system was noted, indicated by the presence of a durable notice affixed to the electrical switchboard.

- The installation of a termite management system is strongly recommended for all
