# Building and Timber Pest Inspection Report

Inspection Date: Wed, 18 Feb 2026

Property Address: 2 McKinnon Dr, Burnside QLD 4560,  
Australia

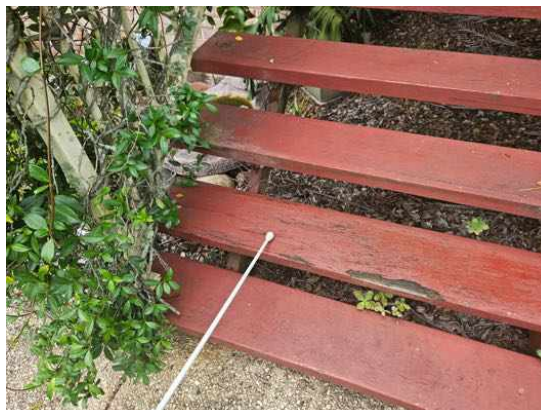
Finding: Wood rot - steps  
 Information: The step tread on the steps to the front entry deck shown have evidence of developing wood rot in the tread shown.

Wood rot, also known as Fungal Decay, occurs when timbers and other cellulose building materials are exposed to damp conditions on an ongoing basis. This could be the result of exposure to weathering over a prolonged period of time, or the attraction of excessive moisture from other abutting building materials. Contributing factors also include poor air ventilation in the area.

Early intervention and regular maintenance, particularly of exterior timbers, will prolong the useful life of these building elements. Prior to any works being performed, the cause of the moisture that has created the visible wood rot should be identified and addressed in a suitable manner. Replacement of affected timbers may then be a necessary step in protecting surrounding building elements from such deterioration.

A licensed carpenter or handy person may be appointed to assess the cause of excessive moisture and to provide advice on any remedial works as required and replace any affected building materials.

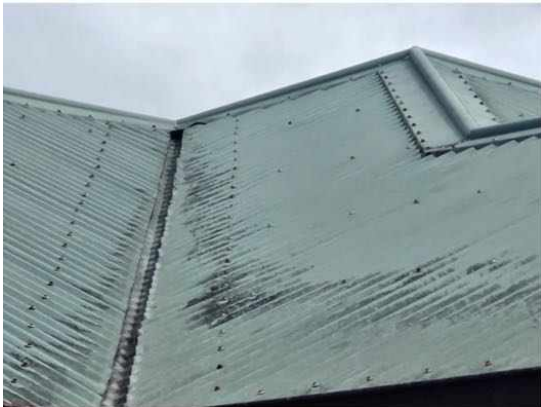
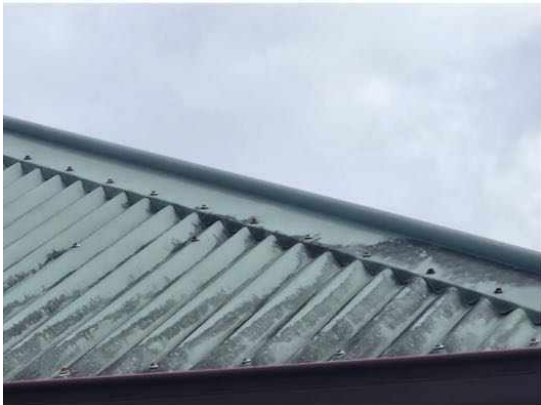
### Finding 3.03

Building: Main Building  
 Location: All External Areas  
 Finding: Roof screws - rusting  
 Information: It was noted during inspection, that throughout the roof surface the majority of roof screws are showing signs of rust to a minor degree.

This should be monitored over time, and should the condition worsen, consider replacement of the screws. As roof screws deteriorate they can have an effect on the adjoining roof materials.

A roofing plumber could be appointed at the clients discretion to replace the screws in question.

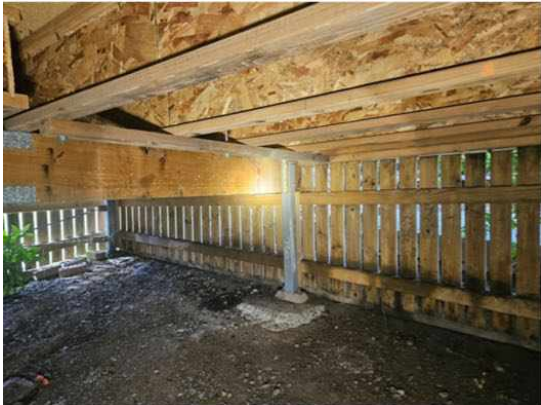
**Finding 3.04**

Building: Main Building  
Location: As shown  
Finding: Post base - rusting.  
Information: It was noted at the time of inspection that surface rust is developing at the base of the house subfloor posts. This should be treated and coated to prevent possible further deterioration.

A licensed painter or suitably qualified handy person could be engaged to carry out the required task.

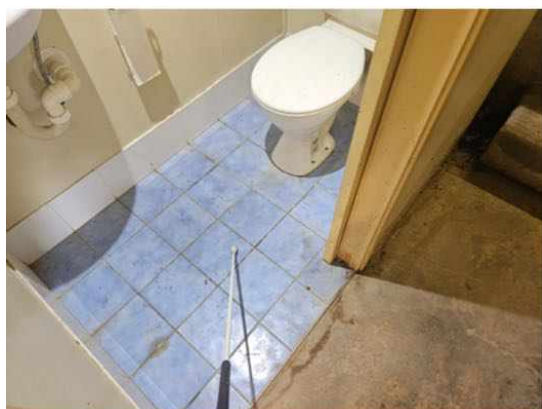
### Finding 3.05

Building:	Main Building
Location:	Ground floor toilet
Finding:	Tiles - Drummy
Information:	Drummy tiled areas were identified at the time of inspection. Please see the attached photos for locations.

The term 'drummy' refers to tiles that have become detached from their fixing, despite otherwise being in relatively good condition. Such defects are generally caused by physical or moisture damage to the area. Drummy tiled areas may also be a direct result of poor workmanship during the construction process.

Tiled areas may swell and shrink with changes in air humidity if the area has sustained moisture damage. Any exposure to moisture is capable of causing tiled areas to become drummy and/or cracked over a prolonged period of time. Drummy tiled areas generally require removal and replacement of affected tiles.

Specialist trades are available for these types of services. A licensed builder may be required to undertake works if damage is extensive or if secondary building defects have resulted. Otherwise, it is advised that a tiling contractor or a tile adhesive injection service may be appointed to perform works as necessary.

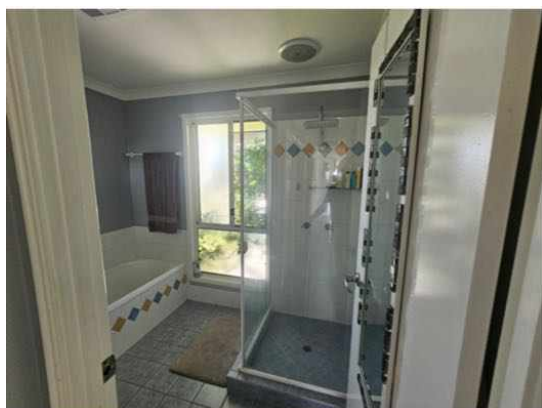
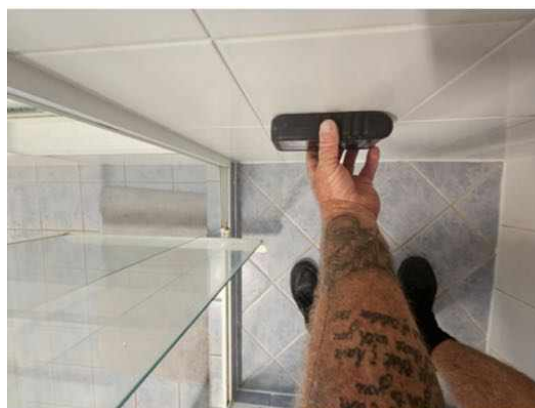
### Finding 3.06

Building: Main Building  
Location: Bathroom  
Finding: Elevated moisture present at the time of inspection - bathroom  
Information: Elevated moisture was noted in the lower tiled wall surfaces of the bathroom shower.

The levels varied at differing points throughout the recess. This could possibly be due to deteriorated grout and silicone sealants and / or plumbing fittings and fixtures. The grouts and sealants can break down over time and become porous, allowing moisture to enter the wall sheet surface behind the tiles.

Elevated moisture can attract timber pests and vermin, and produce conditions that promote timber pest attack, fungal growth and wood decay.

Due to obstructions, the reverse side of the wall could not be measured.

A licensed tiler and / or sealant specialist could be engaged to renew these elements.

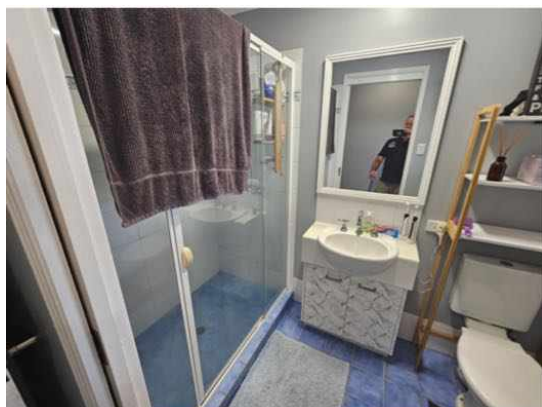
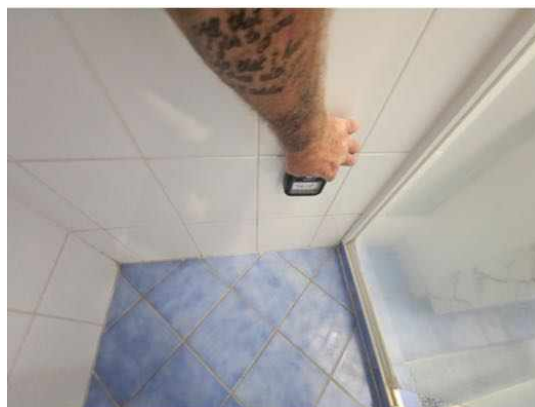
Finding 3.07

Building: Main Building  
Location: Ensuite - Master  
Finding: Elevated moisture present - ensuite shower  
Information: Elevated moisture was noted in the lower tiled wall surfaces of the ensuite shower.

It is recommended that the moisture levels in these areas be monitored over time and the grout and silicone be renewed to possibly eliminate any further moisture penetration.

A licensed tiler and / or sealant specialist could be engaged to renew these elements.

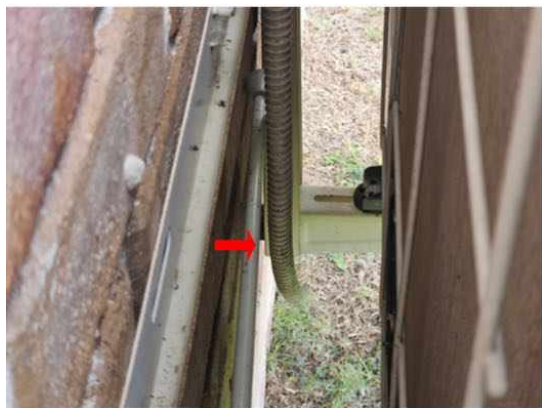
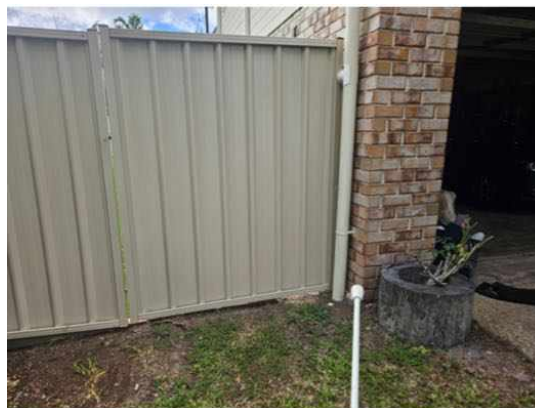
### Finding 6.02

Building:	Main Building
Location:	Rear elevation
Finding:	Downpipe - Connection broken
Information:	The downpipe at the corner of the house shows evidence of breakage and are not connected to the stormwater system adequately.

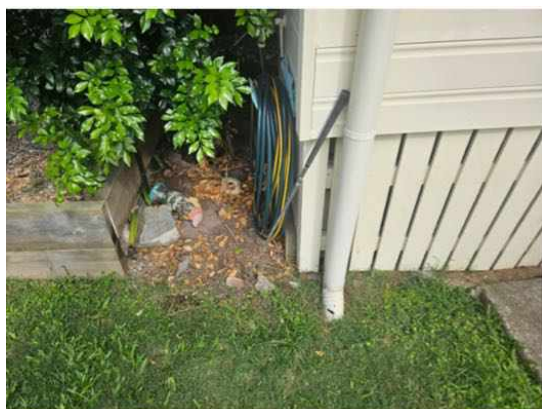
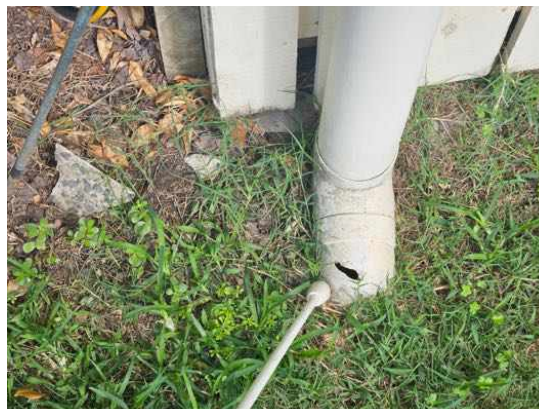
This leads to excessive moisture in the areas around the pipes and against the foundations of the house. This can lead to conducive conditions for timber pests and vermin infestation and have adverse effects on the foundations and external brickwork.

A licensed plumber may be appointed to repair the downpipe connections.

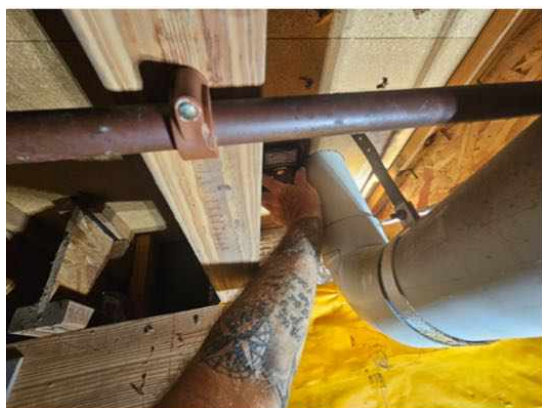
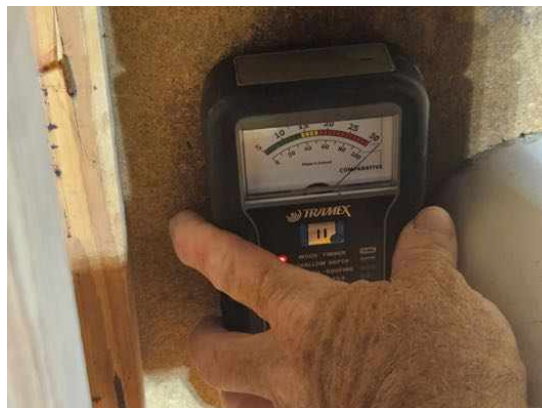
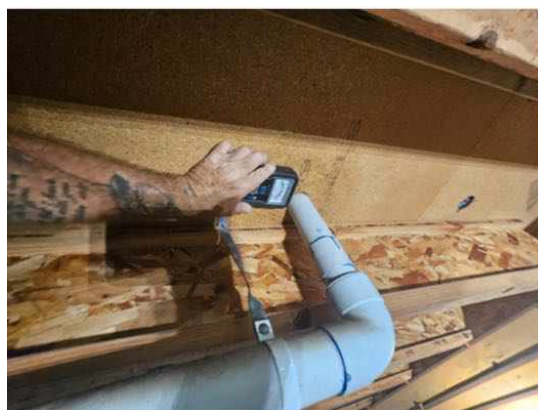
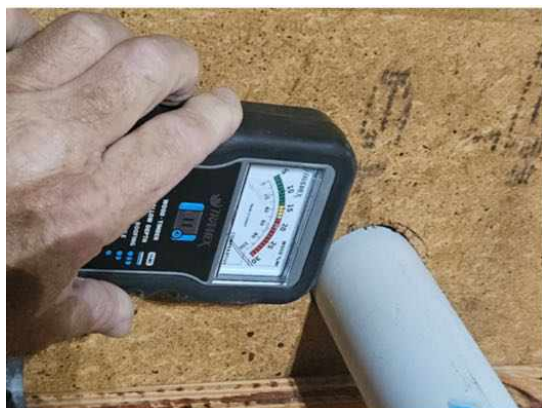
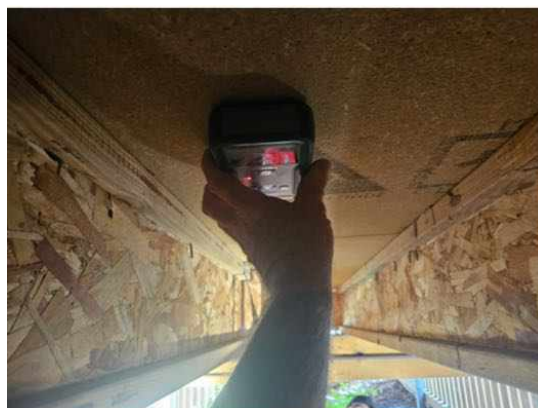
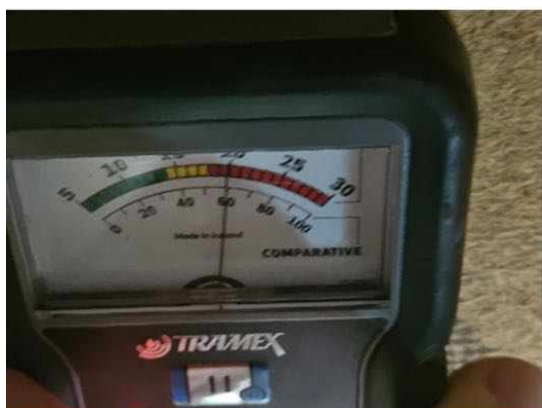
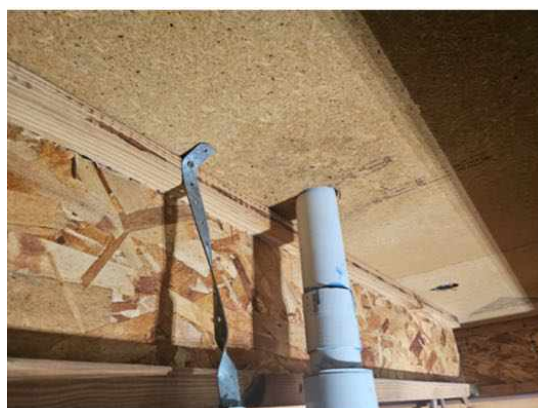
### Finding 6.03

Building:	Main Building
Location:	Toilet, laundry
Finding:	Floor sheets - Water stained, moisture present
Information:	Water staining and elevated moisture levels to underside of the floor sheets of the toilet, and to a lesser degree beneath the laundry, was evident at the time of inspection. Water staining indicates that surfaces have been exposed to moisture over

time, possibly from a leak in the toilet waste pipe. The stains did read as high in moisture on the day of inspection, and when compared to other areas of the floor, the relative difference is high. The plumbing service / fixtures in this area should be assessed.

Minor staining and elevated readings were noted beneath the laundry also and will require assessment of the drains.

While mostly an appearance defect at this time, if left unattended, the water staining / damage can become a more serious defect, which may lead to the breakdown of the flooring substrate.

Where water staining is active, a licensed plumber must be consulted to identify the cause of the staining and to provide advice on any reparation works that may be required. Replacement of any damaged structures is advised.

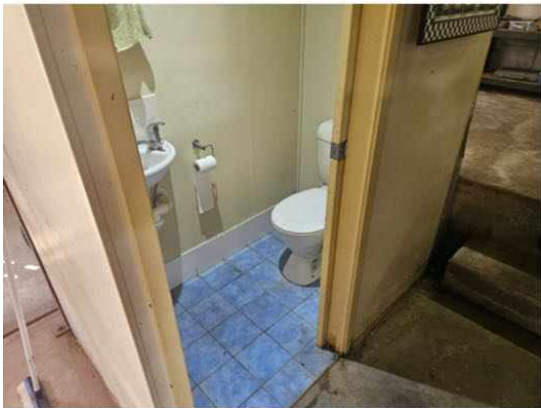
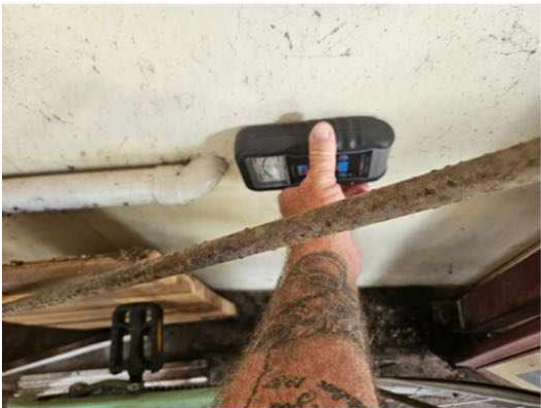
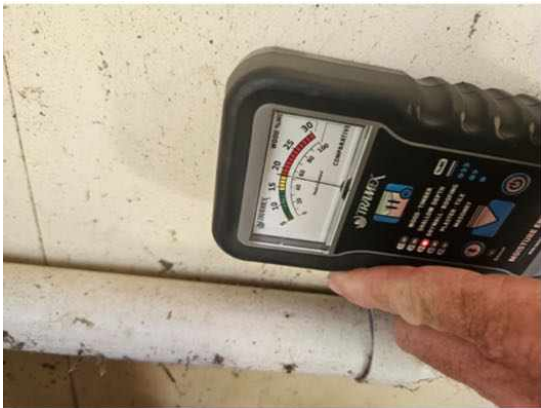
### Finding 6.04

Building: Main Building  
 Location: Ground floor toilet  
 Finding: Elevated moisture noted - toilet  
 Information: During the inspection it was noted that the rear walls of the toilet suite in the garage space under the house had higher than normal moisture readings throughout the walls. It appears that there is weather exposure in this position and with the visible water marks on the floor, has constant exposure to standing water.

Noting the wood rot in the joinery at ground level, it would be prudent to investigate the condition of the wall frames for water affected damage. It has an elevated timber pest risk profile.

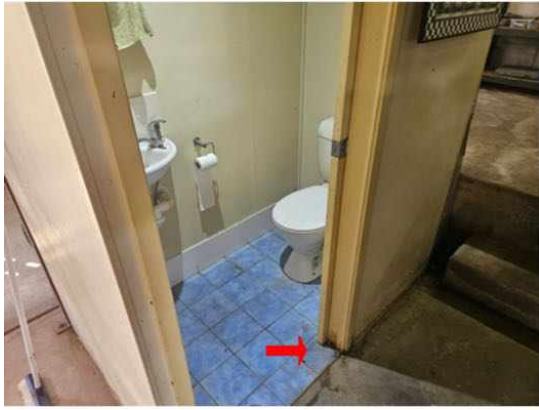
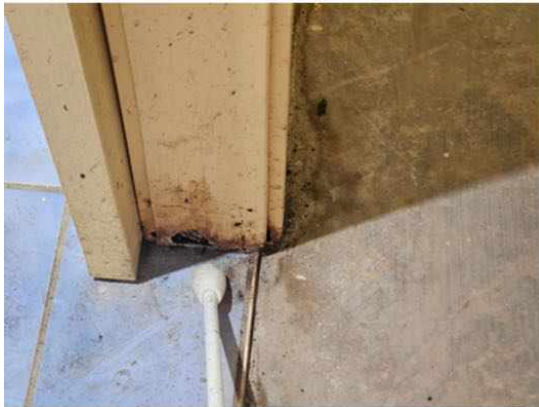
### Finding 6.05

Building: Main Building  
 Location: Ground floor toilet  
 Finding: Wood rot / fungal decay

Information: The timber joinery of the ground floor toilet shows evidence of wood rot in the end sections of the timber. This is most probably due to continued exposure to water in the underside area of the house. Due to the elevated moisture levels in the walls of the toilet, it is most likely that this moisture effect on the timbers is affecting the framing and this should be checked.

Wood rot, also known as Fungal Decay, occurs when timbers and other cellulose building materials are exposed to damp conditions on an ongoing basis. This could be the result of exposure to weathering over a prolonged period of time, or the attraction of excessive moisture from other abutting building materials.

Early intervention and regular maintenance, particularly of exterior timbers, will prolong the useful life of these building elements. Prior to any works being performed, the cause of the moisture that has created the visible wood rot should be identified and addressed in a suitable manner. Replacement of affected timbers may then be a necessary step in protecting surrounding building elements from such deterioration.

A licensed carpenter or licensed builder should be consulted to advise on a solution for the affected building materials.

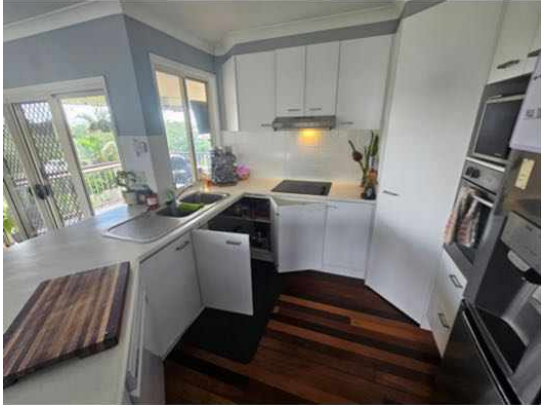
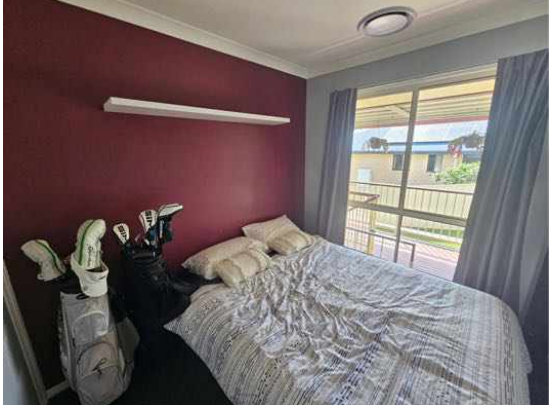
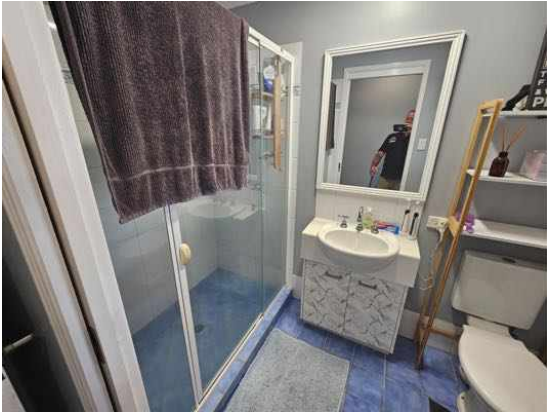
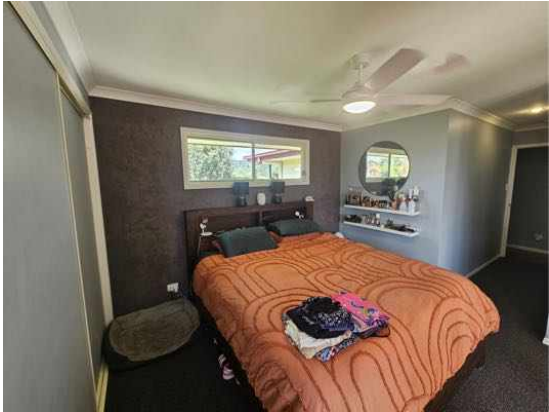
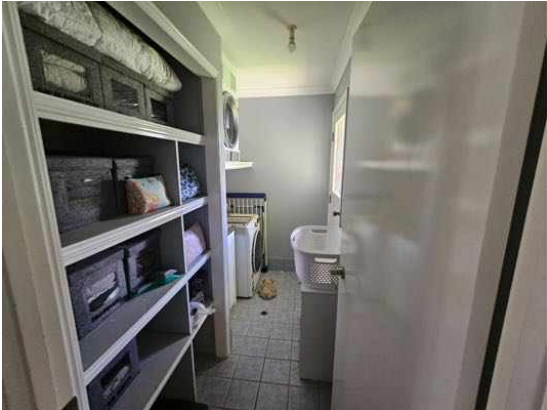
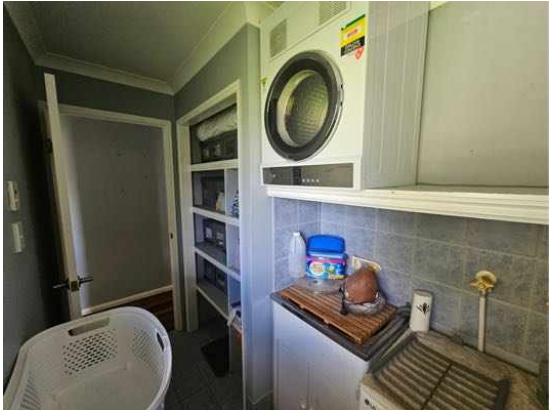
Noted Item

Building: Main Building  
Location: All Areas  
Finding: Additional Photos - Obstructions and Limitations  
Information: These photographs are an indication of the obstructions and limitations which impeded full inspection of the property at the time of inspection. These obstructions can prevent full inspections of the areas shown.

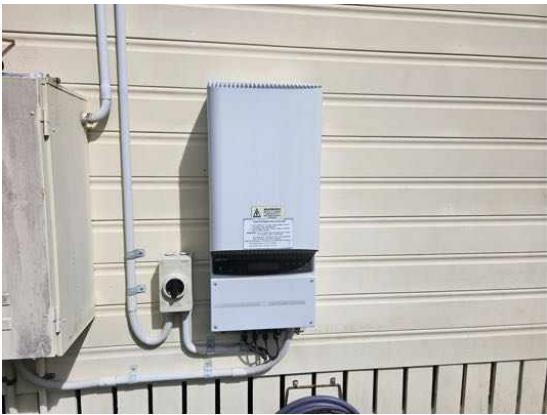
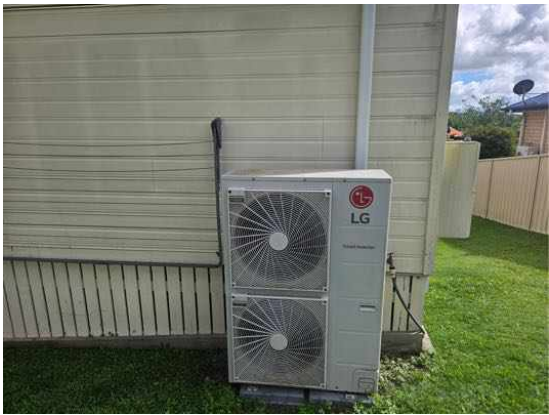
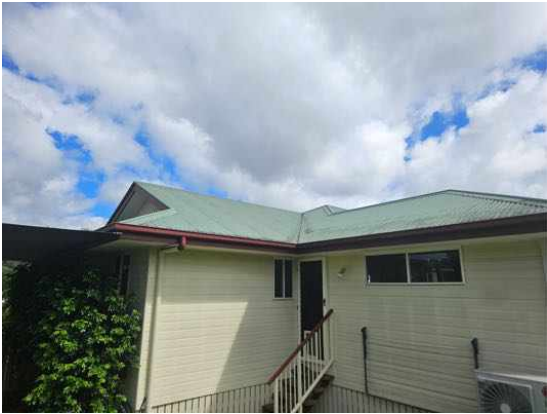
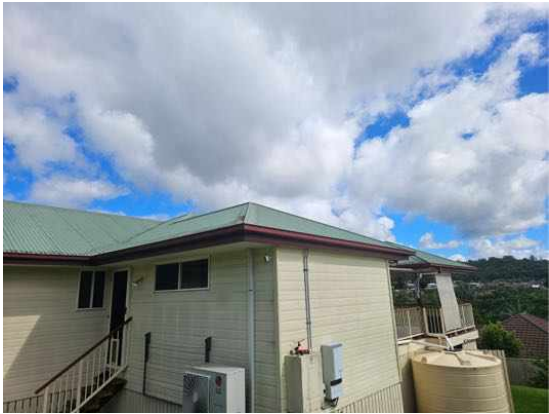
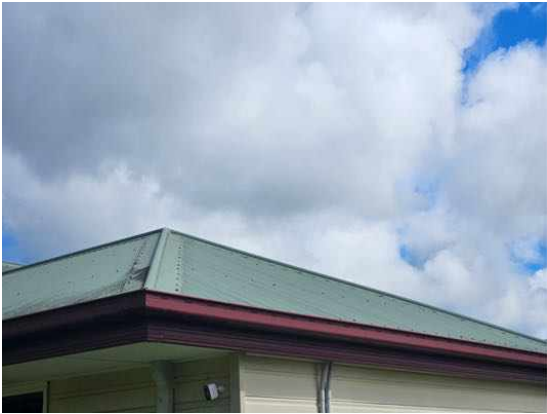
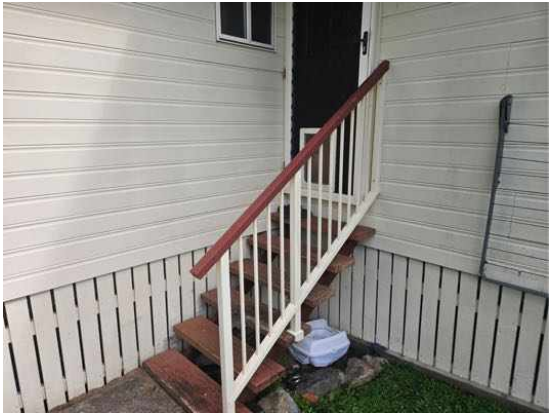
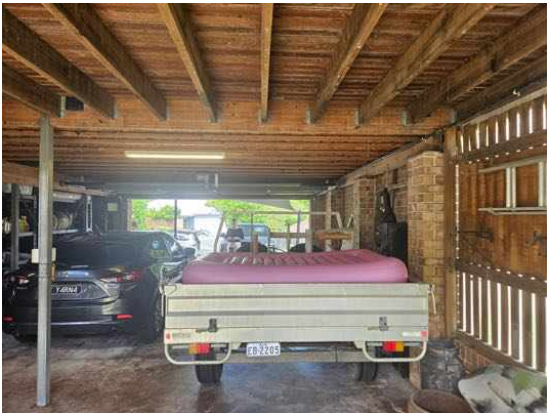
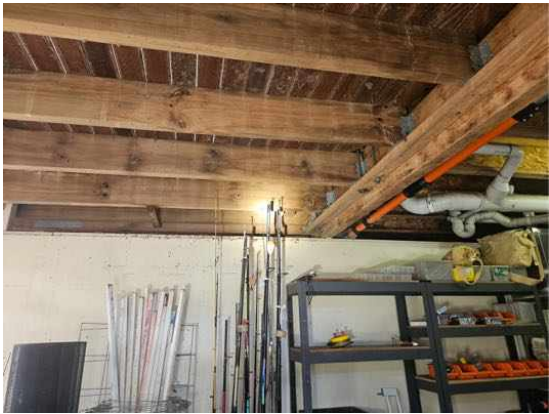
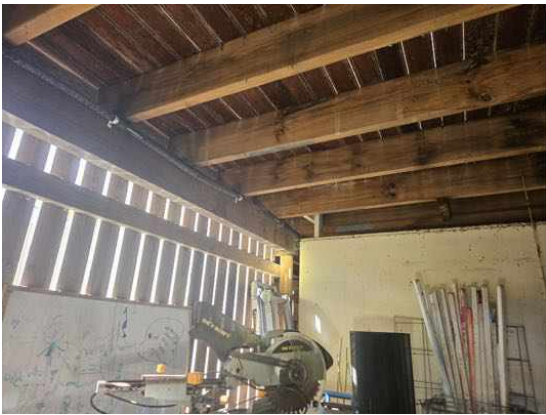
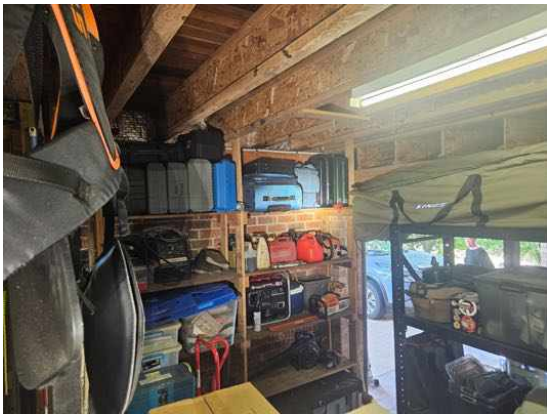
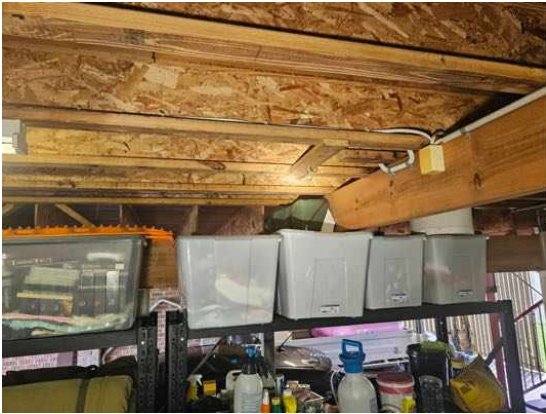
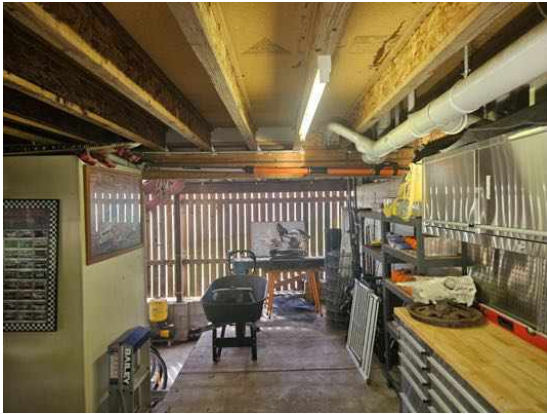
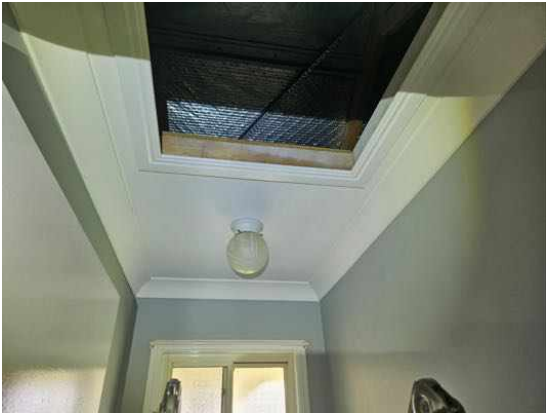
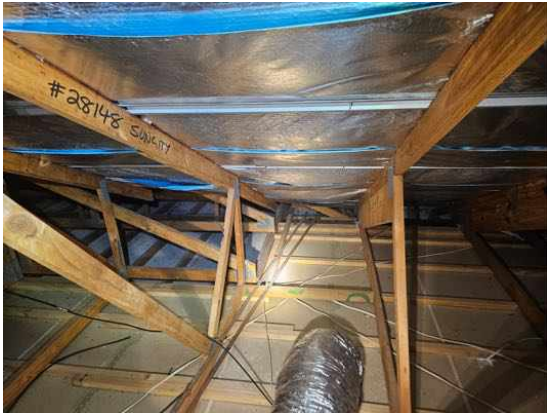
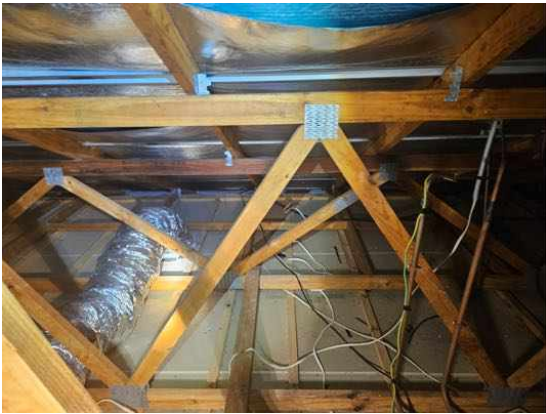
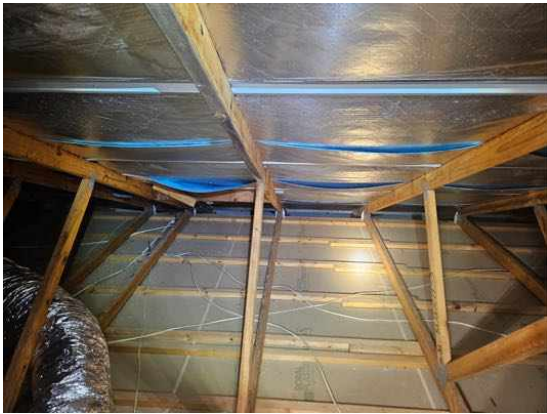
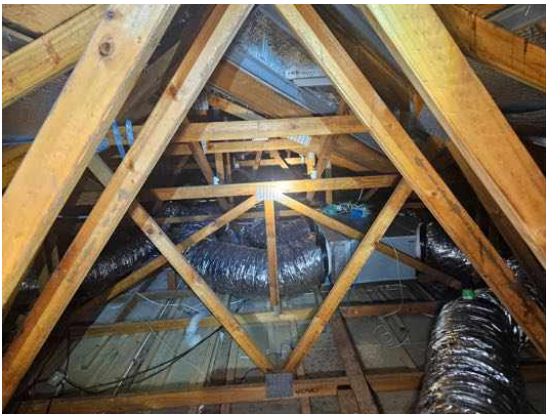
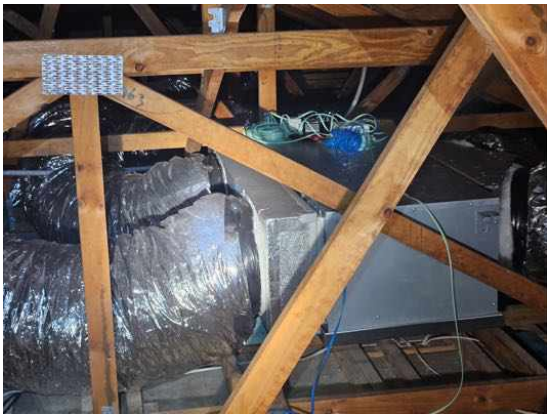
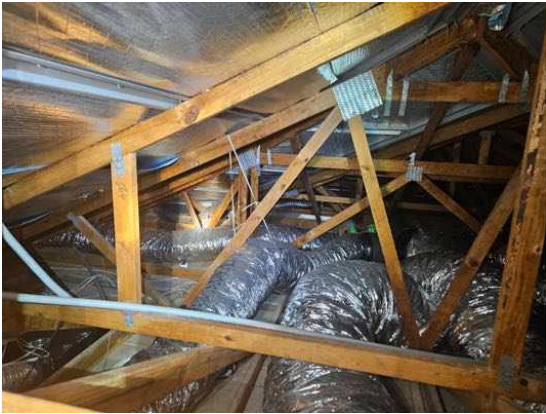
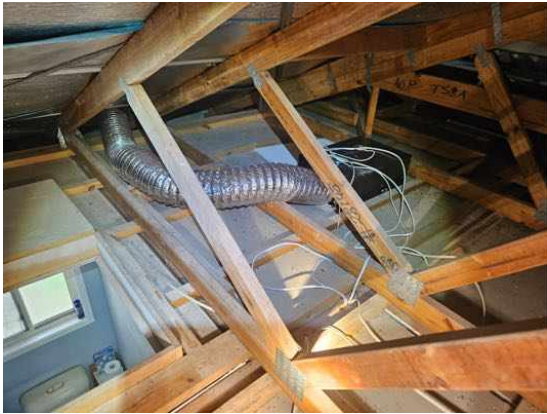
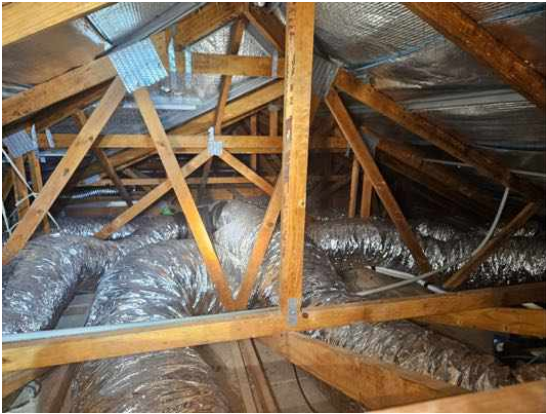
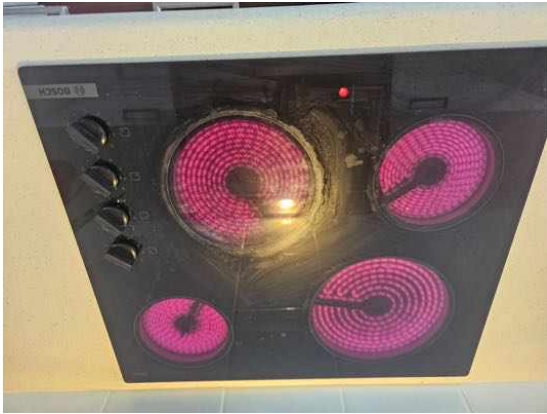
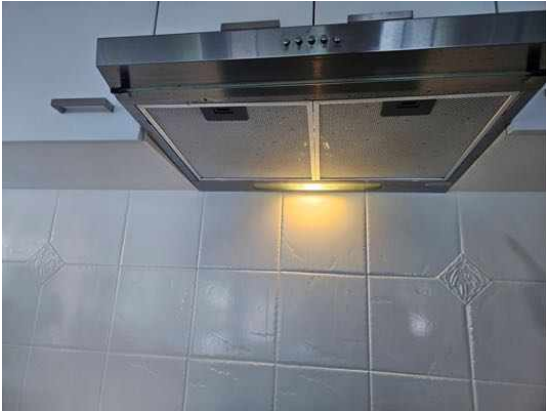
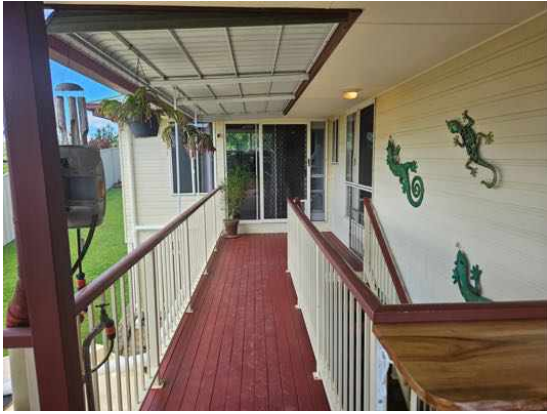
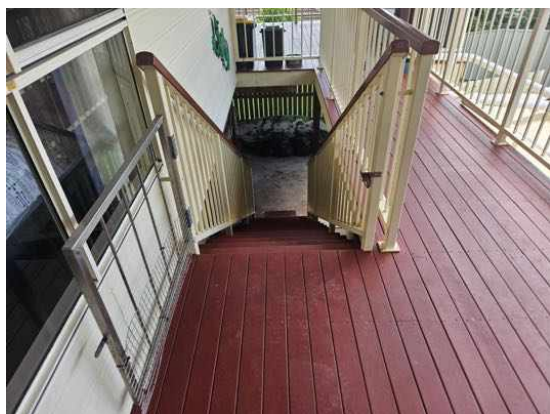
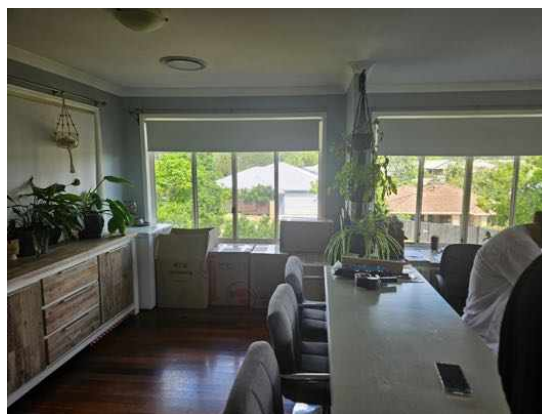
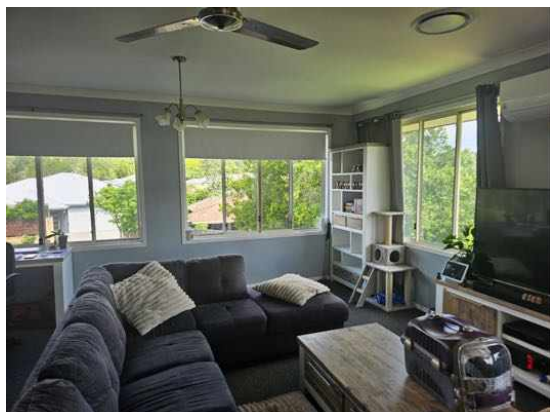
Building: Main Building  
 Location: All Areas  
 Finding: Additional Photos for client reference  
 Information: Additional photos are provided for your general reference.

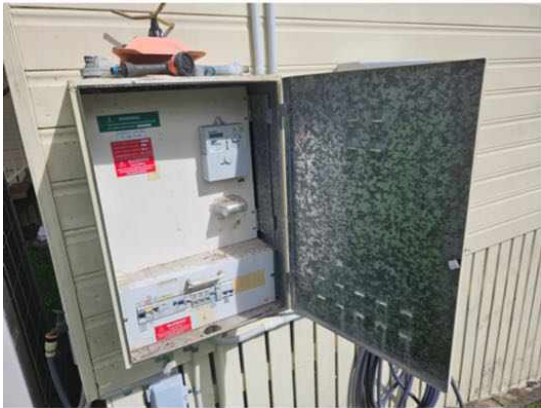
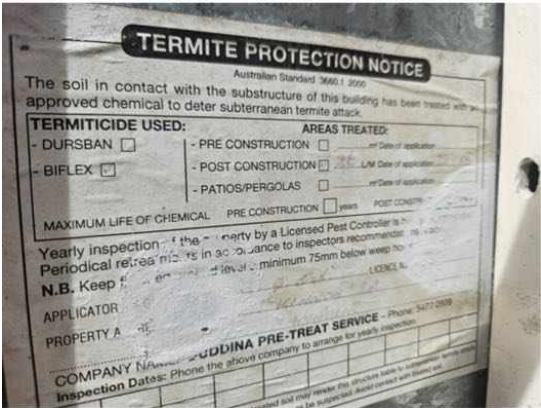
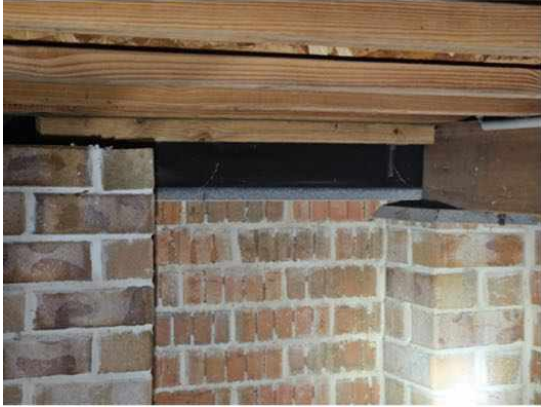
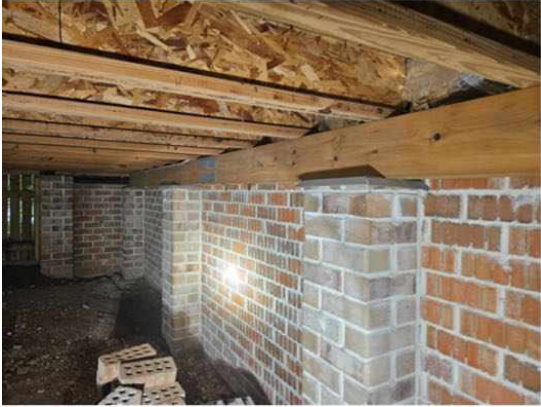
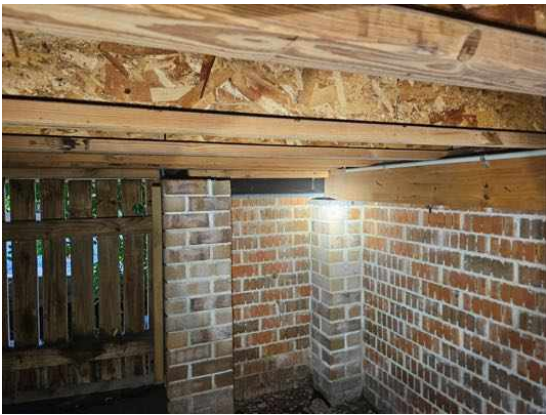
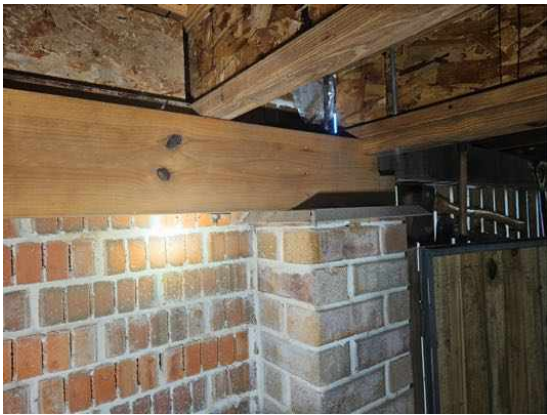
The building employs a physical barrier system to the subfloor in the form of ant caps. There has been a chemical barrier applied at some time in the past; however the durable notice is faded and it cannot be determined what chemical and where it was applied. The client is encouraged to contact the agent or vendor for details. If no information is available, engaging a licensed timber pest controller is advised.

In order for a barrier system to be effective, the property must have regular inspections at intervals of not greater than 12 months. Depending on the risk profile attributed to the property, these inspections may be recommended at lesser time periods.
