Building and Timber Pest Inspection Report

Inspection Date: Fri, 20 Feb 2026

Property Address: 47A Goldmark Cres, Cranebrook NSW 2749,
Australia

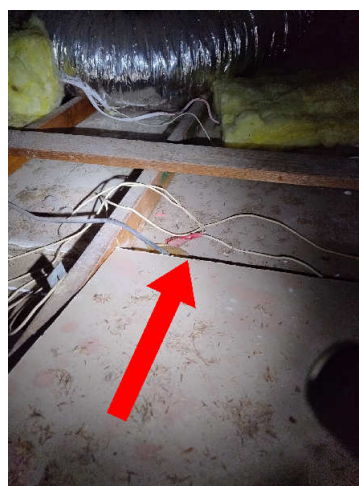
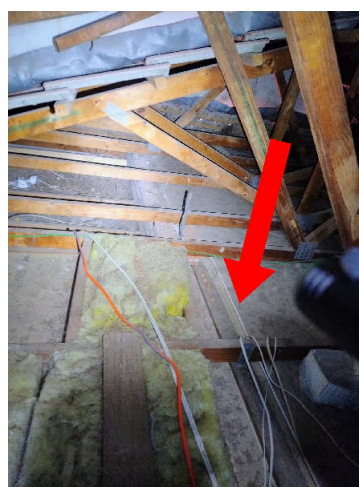
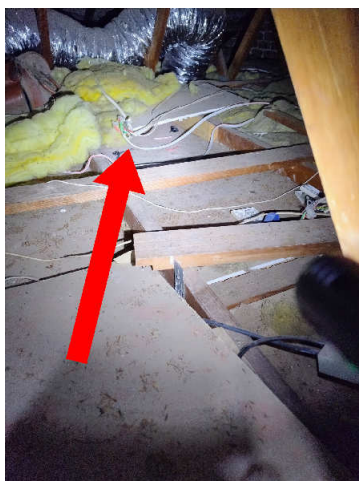
Not fixed electrical wiring at the entrance of this roof space represents a potential safety hazard to personal contact.

Contact a licensed electrician urgently for further inspection investigation and rectification.

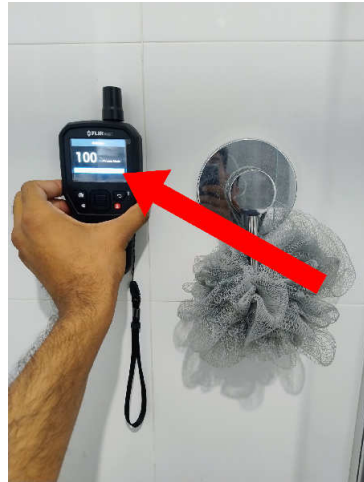
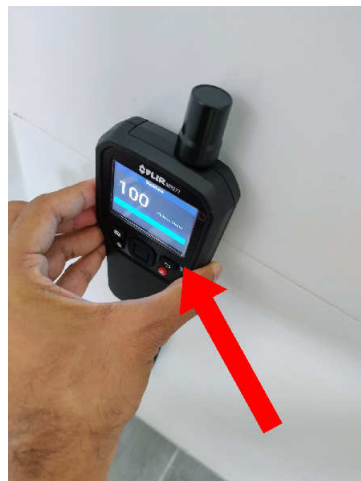
Finding: Evidence of Excessive moisture - identified in both bathroom

Information: Evidence of excessive moisture recorded by moisture meter in both Bathroom and shower area walls at the time of inspection. Excessive moisture can attract termites and produce conditions that promote fungal growth and wood decay.

Excessive moisture is generally caused by deteriorated, inadequate or missing roof drainage, leaking plumbing pipes or fixtures, poorly plumbed HWS overflows or condenser units and poor site drainage.

Prior to any remedial works being performed a qualified plumber should be appointed to further inspect the property and to identify the cause of the excessive moisture. Works to remove affected building elements may then be necessary and should be performed by an appropriate tradesperson as soon as possible.

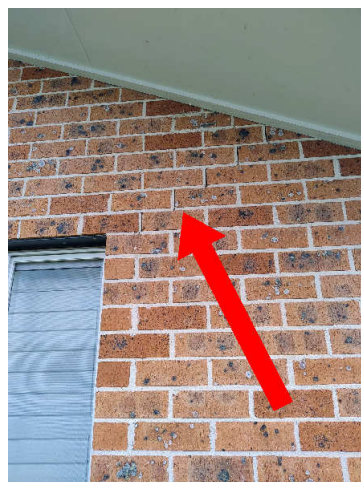
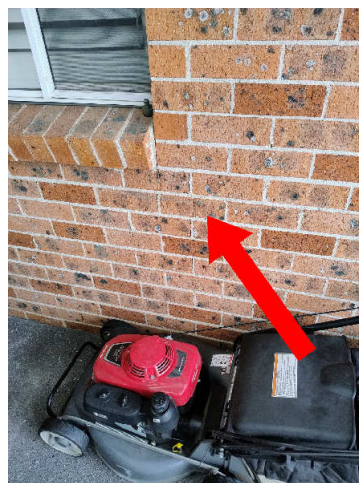
Finding 3.02

Finding: Brickwork - Cracking [Fine] - external wall

Information: Several cracks were observed in the side wall under patio and the exterior rear walls rear elevation.

Generally, the cause of a fine crack is indicative of a separation between brickwork and mortar throughout the structure, but single bricks may also show cracks of this nature.

Cracking of this nature can generally be repaired with minor filling and should be conducted by a qualified bricklayer.

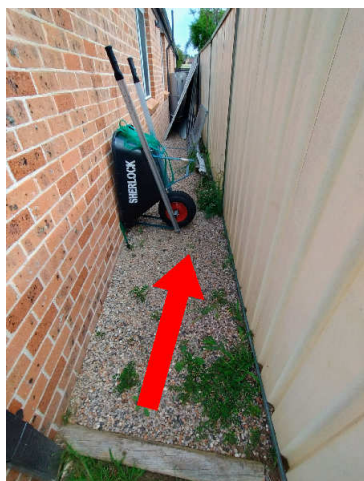
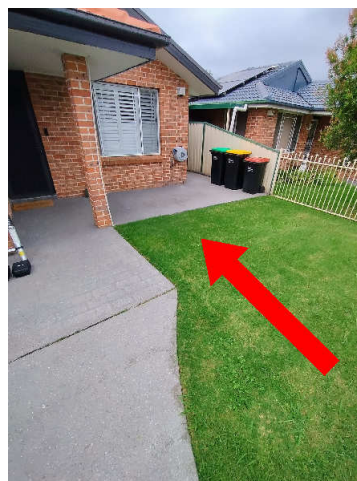
Finding 3.03

Finding: Site drainage - Inadequate

Information: The site drainage in front area was found to be inadequate at the time of inspection, creating potential for subsequent water damage to associated building elements.

Where site drainage is inadequate, installation of an Agricultural (Aggie) Drain may be required. A qualified plumber should be appointed to further inspect the property and perform any remedial works as necessary. Water damage and secondary defects are likely to occur if left unmanaged.

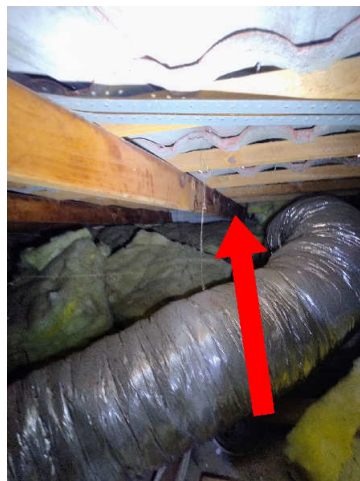
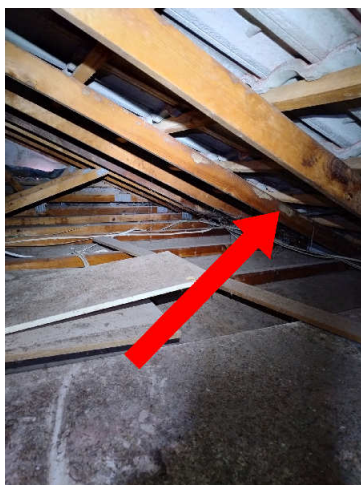
Finding 3.04

Finding: Stained timber

Information: At the time of the inspection, water staining was observed in Roof void areas. The staining was visually evident, with discoloration and marks present on the surface.

This suggests that the staining is likely a result of a previous water intrusion event that has since dried. It is recommended that the cause of the water staining be further investigated by means of an invasive inspection, to ensure that there are no underlying issues that could lead to a MAJOR defect and future moisture problems.

The vendor or the real estate agent might be able to provide further information on the cause of the staining and potential rectification at the time. Otherwise, a roofing contractor is recommended to investigate the roof flashings for any areas of water ingress as soon as possible.

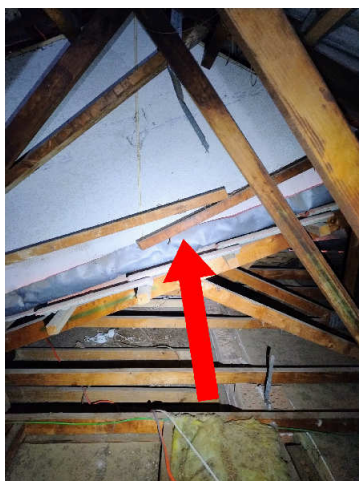
Finding 3.05

Finding: Structural Timber framing connection loose

Information: At the time of the inspection timber member connection was found loose between garage and kitchen roof void area.

Roof timber connection plays an important role in the structural integrity of roof. If not attended can lead to major defect or safety issue.

Experienced and licensed builder or structural engineer should be hired to find fix the issue on priority basis.

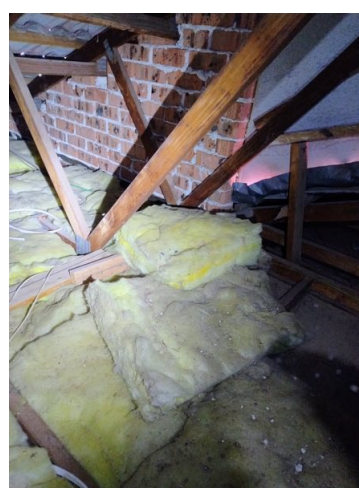
Finding 3.06

Information: Sections of insulation in the roof void have been poorly installed or moved from their original position and are covering down light fittings at the time of inspection. While the down lights have been fitted with appropriate protective covers, the presence of this insulation creates a potential fire hazard.

Any insulation within the vicinity of down light fixtures should be moved and re-applied to more appropriate sections of the roof void, thus ensuring the area is fire-safe. An insulation contractor should be appointed as soon as possible to perform any necessary works as required.

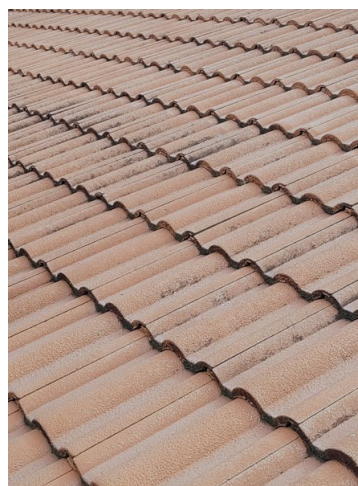
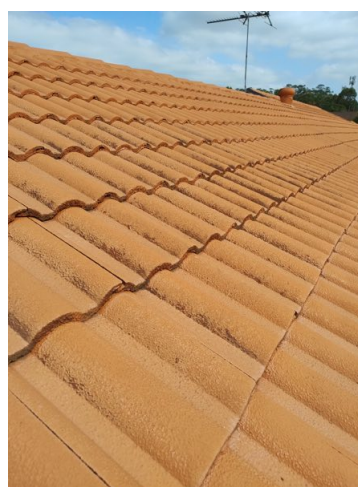
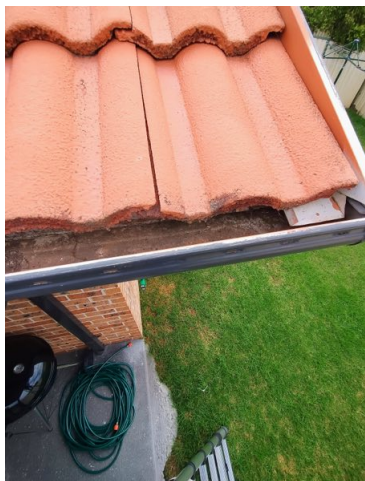
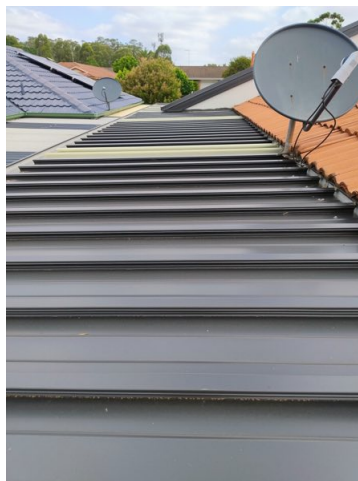
Finding 3.07

Information: Upon inspection of the exterior roofing, the majority of roof tiles were considered to be in a fair condition. While weathering of the tiles is consistent with the age of the property, maintenance works are required.

Isolated areas of mortar have come loose in the valleys and minor cracking is also present. Re-pointing and re-sealing the may be considered as an interim solution by the client to help preserve and extend the life span of the tiles.

Consultation with a roofing contractor is highly advised to gain advice on cost of remedial works that may be required in the short to medium term. Remedial works are likely to increase the longevity of the exterior roofing structure.

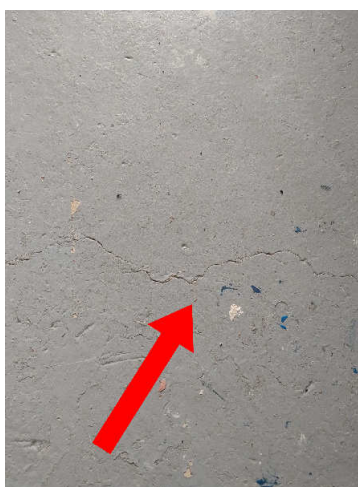
Finding 3.08

Finding: Crack in concrete slab - Category 1

Information: Cracks was observed in the garage slab at the time of inspection. A crack coded as Category 1 was identified in the slab. A Category 1 crack is described as a fine but noticeable crack, with the slab at an otherwise reasonable level.

To be considered Category 1, the approximate width of the crack is less than 1.0mm, or a less than 10mm change in offset when a 3m straight edge is placed over the defect.

Category 1 cracks should be monitored for a period of 12 months. At the end of the monitoring period, identified cracks that are rated greater than Category 2 are considered defects, and require rectification.

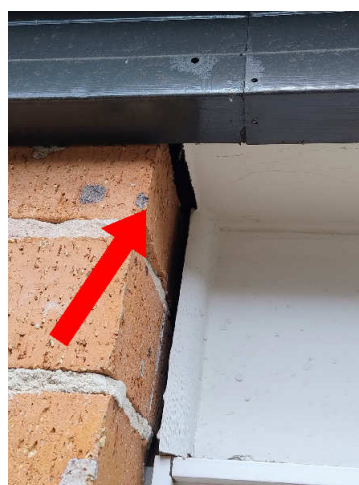
Finding 3.09

Any gaps to the exterior walls of the building that are larger than 3mm are deemed a defect and require filling, beading or replacement of brickwork to close or cover the gaps. Such gaps create potential for pest ingress, excessive moisture and structural issues, and should therefore be minimised prior to the development of secondary defects.

Such works should be carried out by the builder on site to prevent secondary defects and to comply with Australian Standards.

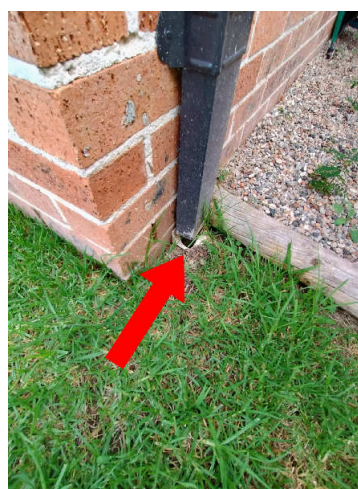
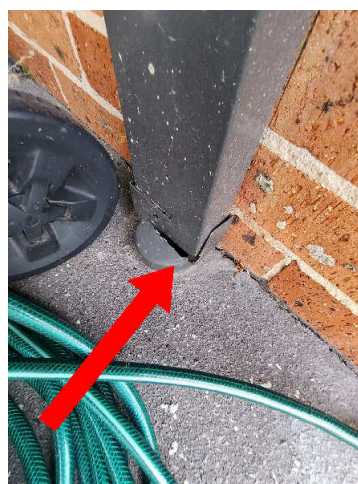
Finding 3.10

Stormwater drain was observed to be not connected to the drain at the time of inspection.

Where roof plumbing doesn't drain adequately, the area at the base perimeter can become excessively damp, potentially creating an environment that is susceptible to rust and corrosion of surrounding building elements, as well as attracting termites and other pests.

It is highly recommended that a plumber be appointed to further inspect the area and to install adequate drainage equipment where necessary.

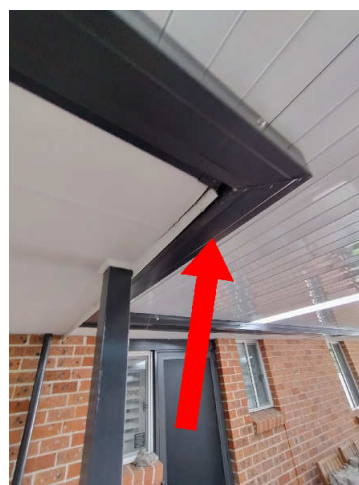
Finding 3.11

Finding: Cracking - Damage Category 2 - Noticeable (up to 5mm)

Information: Cracks were observed in the ceiling of exterior roof at the time of inspection. Noticeable cracks are a common occurrence as a result of many primary defects. Such causes may include age, general wear and tear, expected building movement, general expansion/contraction of building materials in different weather conditions, and/or minor failings in the installation or application of building materials.

Noticeable cracks may result in minor sticking or jamming of associated doors and windows, which require easement. However, noticeable cracks are easily filled and repaired. A plasterer can be consulted to install an expansion joint at this point to allow for this movement during different weather conditions.

Relevant tradespeople, such as carpenters, painters and plasterers, should be appointed to perform remedial works, as deemed necessary.

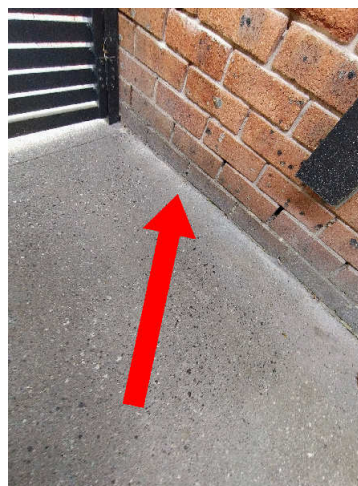
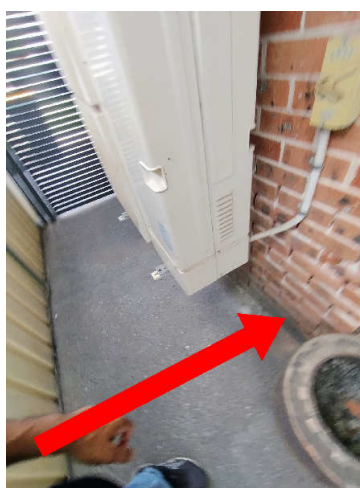
Finding 3.12

Efflorescence appears to be affecting the brickwork, in right side wall area. Below air condition unit at the time of inspection.

It is typically seen as white salt deposits on the surfaces of concrete pavement or mortar between bricks or tiles. While detracting from the overall appearance of the affected area, efflorescence is not likely to develop into secondary damage if left unmanaged.

Generally, soluble salt deposits can be removed by dry brushing with a stiff-bristled brush. Repeated dry brushing is an ideal treatment for eliminating this forming of efflorescence. A cleaning contractor or general handyperson may be appointed to perform these works at the discretion of the client.

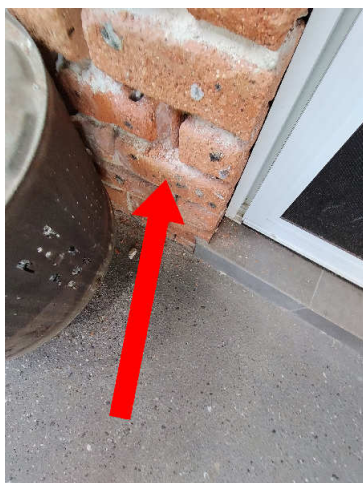
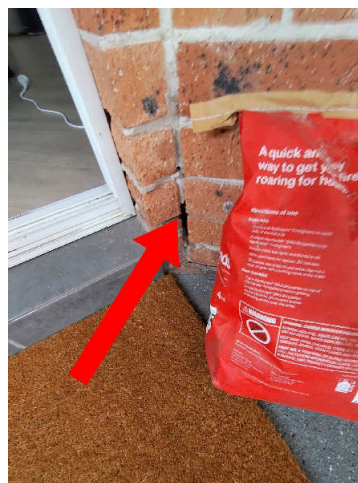
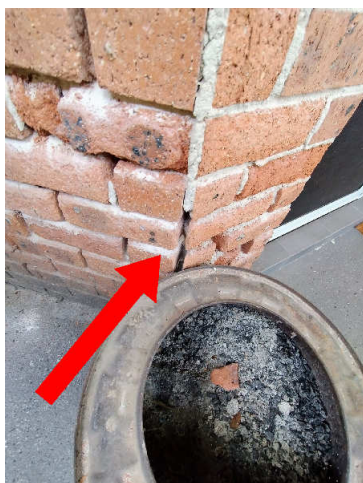
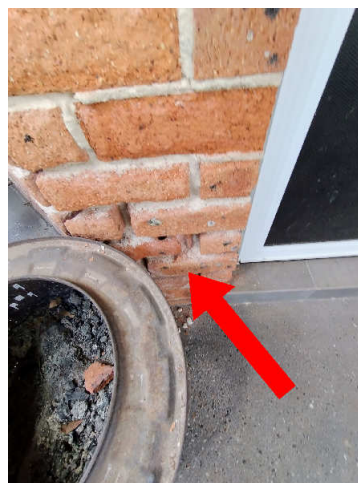
**Finding 3.13**

Finding: Brickwork - Deteriorated mortar

Information: Mortar deterioration was observed in right side exterior wall below patio at the time of inspection.

Mortar may deteriorate as a result of age of building materials, minor movement of bricks, or frequent exposure to weathering. Mortar should be replaced to ensure that bricks remain in their intended location and to prevent gaps, which would allow water or moisture ingress and secondary damage as a result.

Mortar deterioration can be addressed by a bricklayer where areas of deterioration are localised and easily accessible. Alternatively, appointment of a registered builder is advised, to repoint large areas of decaying mortar. Where secondary structural defects have become evident, consultation with a structural engineer may be required.

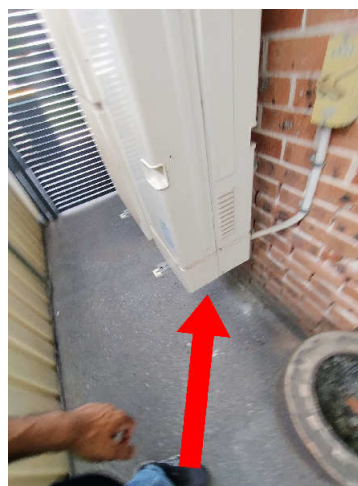
Finding 3.14

Finding: Air conditioner unit - Not connected overflow

Information: The Air Conditioner (A/C) overflow was found to be not connected to storm water drainage and is creating excessive moisture in the surrounding area.

Such leaking creates an environment which is conducive to an array of defects, including water damage to associated building elements and the attraction of termite or timber pest infestation.

It is highly recommended that a licensed plumber be appointed to connect the A/C overflow in order to prevent such an environment from being created. These minor works should be carried out as soon as possible.

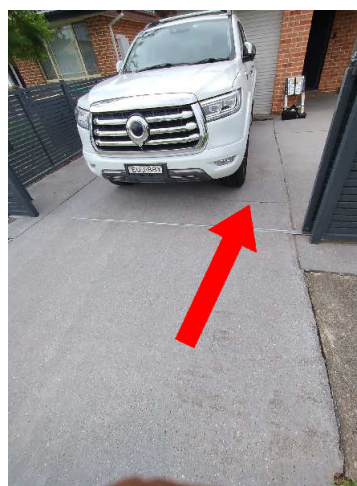
Finding 3.15

Finding: Crack in concrete slab - Category 2

A crack coded as Category 2 was identified in the driveway slab at the time of inspection. A Category 2 crack is described as a distinct crack, with the slab being noticeably curved or changed in level.

To be considered Category 2, the approximate width of the crack is less than 2.0mm, or a change in offset of less than 15mm when a 3m straight edge is placed over the defect.

Category 2 cracks to slabs should be monitored for a period of 12 months. At the end of the monitoring period, cracks rated greater than Category 2 are considered defects that require rectification.

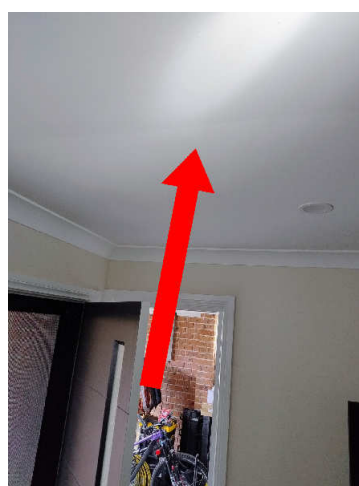
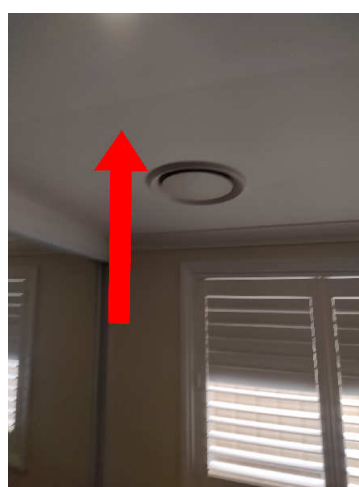
Finding 3.16

Building:	Main Building
Location:	Lounge Room + Bedroom
Finding:	Ceiling - Sagging

Sections of the ceiling were found to be sagging at the time of inspection. Sagging to the fixed ceiling structure generally indicates that the building materials have swollen, due to contact with water, or that fixings (e.g. nails or glue) have become loose and require reattachment.

Where minor sagging is evident, comparatively minor works, such as re-gluing of ceiling sheets, may be required. Such works may be performed by relevant tradespeople, such as plasterers and painters. Where excessive moisture has caused the roofing structure to swell and sag, the source of the water leak should primarily be identified prior to any remedial works being performed.

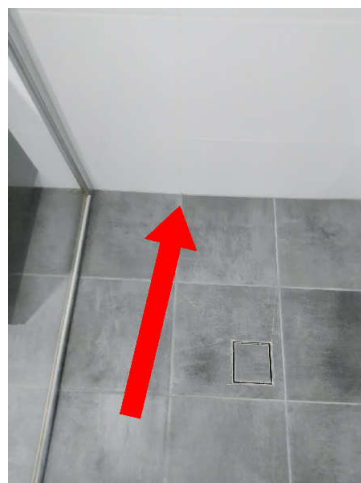
Finding 3.18

Information: It was noted on inspection that sealant or grout is degraded to the tiled shower alcove and or other areas of the bathroom in bathroom.

There mould to the sealant and grout which will likely require scraping out and replacement.

This can lead to water ingress into the shower base and creates conducive condition to termite activity. If left unmanaged can cause further deterioration to building elements.

Qualified trade person or plumber must be appointed for rectification on priority.

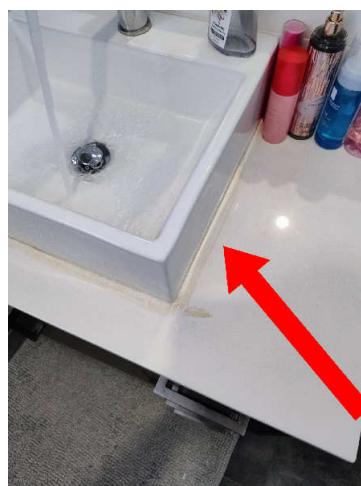
Finding 3.19

Finding: Bench top joint sealant - defective or unprofessional workmanship

Information: It is observed that the joint sealant material of the bench top is defective because it is not sealed and or not flush filled with a suitable flexible sealant of matching colour.

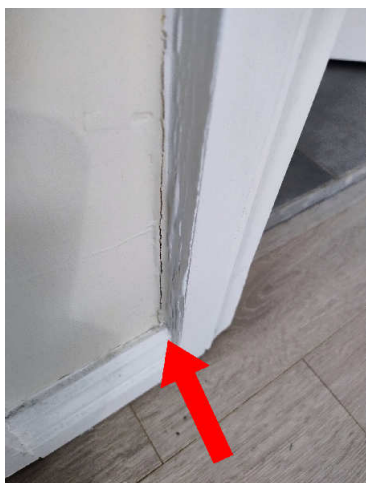
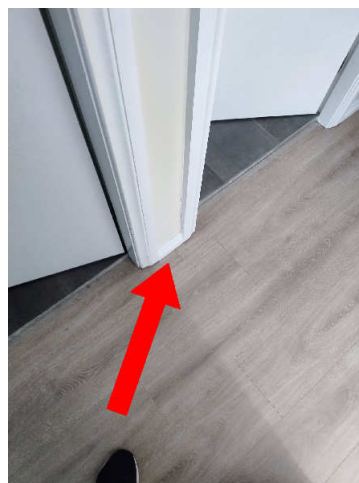
Finding 3.20

Finding: Moisture Damage to Door Jamb and or Architrave

Information: At the time of inspection, it was noted that the lower section of the door jamb and or adjoining architrave near laundry area exhibited signs of moisture damage. This was evidenced by visible staining, discolouration, and possible swelling and deterioration of the timber components near the tiled floor junction. No High moisture readings were also recorded to the area.

A likely contributing factor to this condition is moisture movement beneath the tiled floor surface, migrating toward the adjacent door frame area. This may result from inadequate waterproofing, substandard or poor workmanship when tiling, or installing the door jamb.

Prolonged exposure to moisture may lead to timber decay, mould growth, or further structural deterioration if not addressed.

Monitoring of this area is advised. If the condition worsens, it is recommended that a more invasive inspection be undertaken by a licensed builder, waterproofer, or bathroom specialist to determine the source of moisture, and carry out rectification works as necessary.

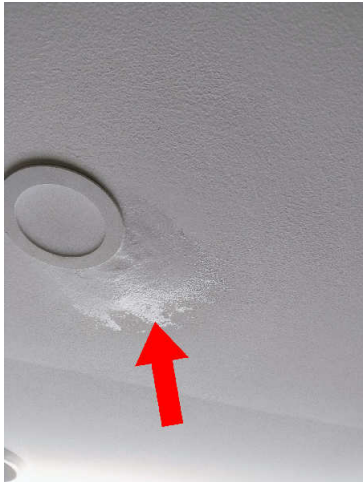
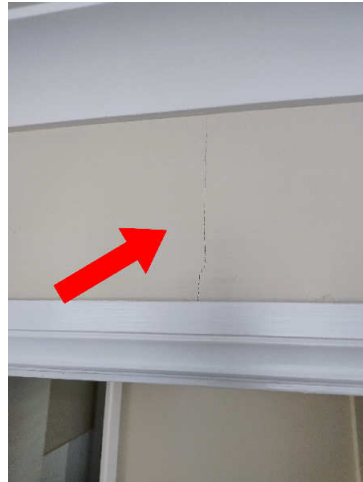
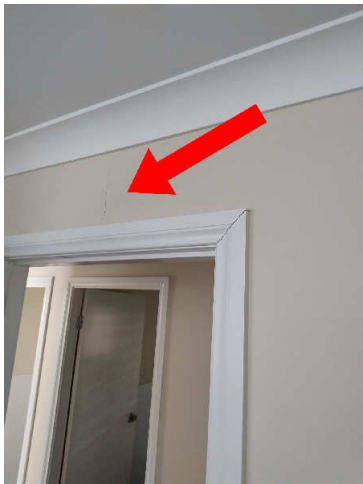
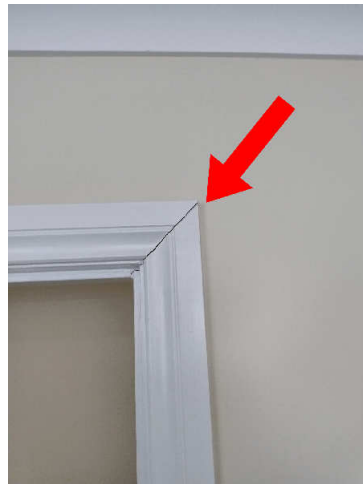
Finding 3.21

Finding: Cracking - Damage Category 2 - Noticeable (up to 5mm) and patches

Information: Crack in wall door frame was observed with some patches near the down light in ceiling of bedroom 1 next to kitchen area at the time of inspection. Noticeable cracks are a common occurrence as a result of many primary defects. Such causes may include age, general wear and tear, expected building movement, general expansion/contraction of building materials in different weather conditions, and/or minor failings in the installation or application of building materials.

Noticeable cracks may result in minor sticking or jamming of associated doors and windows, which require easement. However, noticeable cracks are easily filled and repaired. A plasterer can be consulted to install an expansion joint at this point to allow for this movement during different weather conditions.

Monitoring of all cracking should be conducted frequently. Always contact a building inspector should cracks widen, lengthen, or become more numerous. Additionally, your building inspector should also be contacted if associated building elements such as doors and windows become more difficult to operate over time.

Relevant tradespeople, such as carpenters, painters and plasterers, should be appointed to perform remedial works, as deemed necessary.

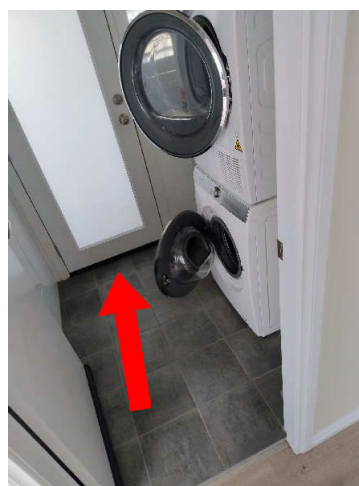
Finding 3.22

Building: Main Building
Location: Laundry
Finding: Door - Binding/jamming

Information: Binding and/or jamming of laundry door was evident during standard operation at the time of inspection. This defect inhibits the functionality of the affected door as well as creating potential for secondary defects to associated building elements, such as damage to the floor covering.

A door that binds to flooring or to the associated door frame may have several causes, ranging from minor defects, such as poor installation of the door or deteriorated hinges, through to major structural issues, such as damage to subfloor structures.

Where door binding/jamming appears to indicate major structural issues, a registered builder specialising in re-stumping should be appointed to provide an estimate on the cost of rectification.

For minor causes, a qualified carpenter or general handyman should be appointed to perform minor rectification works at client discretion.

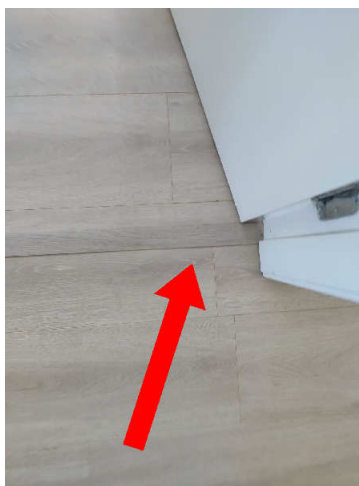
Finding 3.23

Building: Main Building
Location: Bedroom 1
Finding: Floors - bouncy

Bouncy floors generally indicate that the floorboards or the subfloor structures are coming loose from the joists that they are installed on. Bouncy flooring may also be the result of gaps between flooring and stumps or joist structures, which require packing.

The client is advised to seek quotations for required repairs from a Registered Builder specialising in re-stumping. The potential resolution may range from packing gaps in subfloor structures through to replacement of subfloors stumps and refixing of flooring.

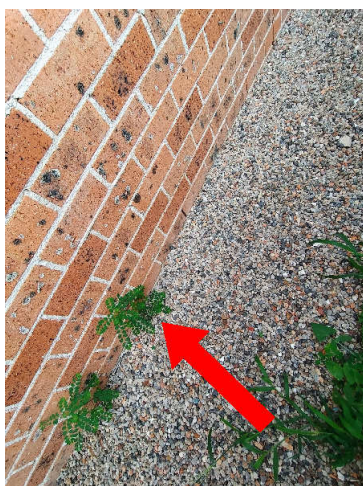
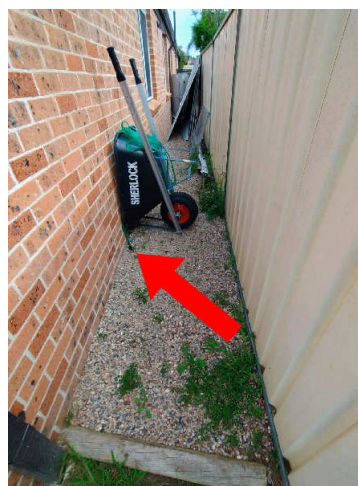
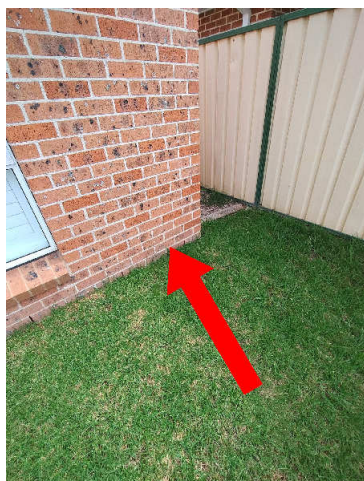
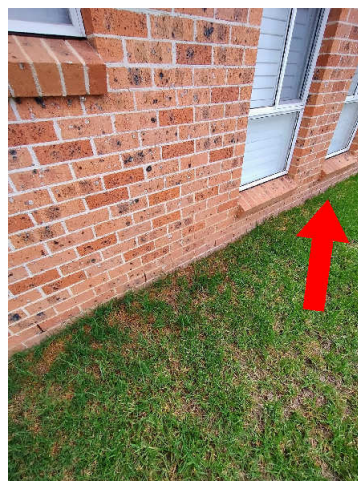
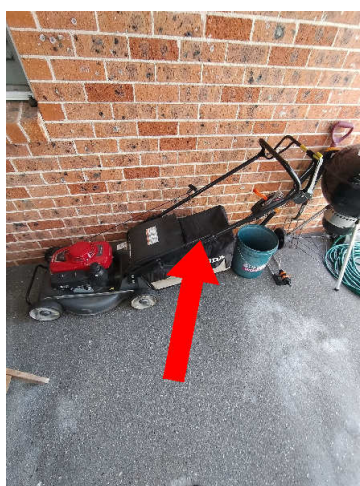
Finding 3.24

Building: Main Building
Location: All External Areas
Finding: Bridging or breaching of termite barriers - weep holes

Weep holes were observed to be covered in some location at the time of inspection.

Weep holes in the exterior brickwork of the property are designed to allow condensation that may build up between the brickwork and subsequent timber framework to drain from within the wall hence preventing any deterioration of the timber building elements.

Additionally build-up of moisture is likely to occur if weep holes are covered further attracting termite activity to these areas.

It is highly recommended that weep holes are left exposed in all areas throughout the external property. Therefore if any termite activity leading into weep holes becomes easily detectable during frequent pest inspections.

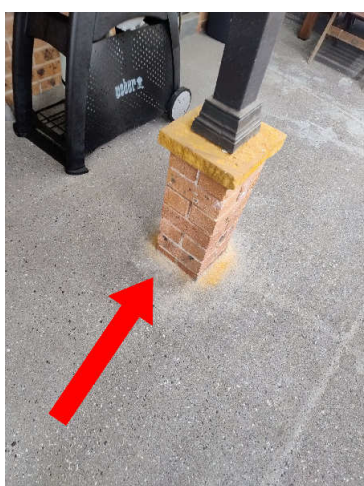
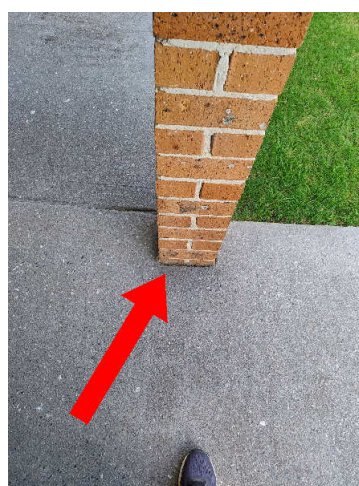
Information: At the time of inspection breaching of termite barriers was observed.

Damp proof course (DPC) is a barrier of impervious material built into a wall or pier to prevent moisture from moving to any part of the building. Where external ground levels are built up over this barrier ingress is provided for moisture from the exterior grounds into the base brickwork or other building material and allowed to rise.

Such conditions attract termites into these damp areas which is likely to lead to infestation if left untreated.

While retrospective fitting of DPC is considered to be impractical works are required in order to prevent the extraction of moisture from the external environment into exterior brickwork or wall materials. Landscaping or re-paving of external grounds may be considered by the client. Regular annual inspections are strongly advised.

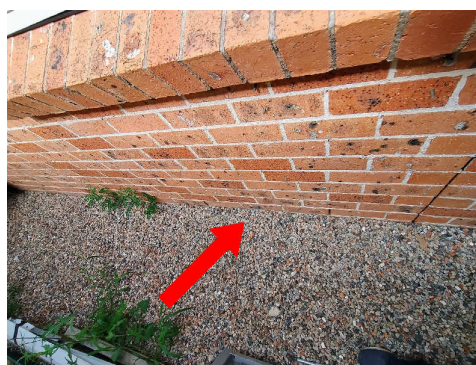
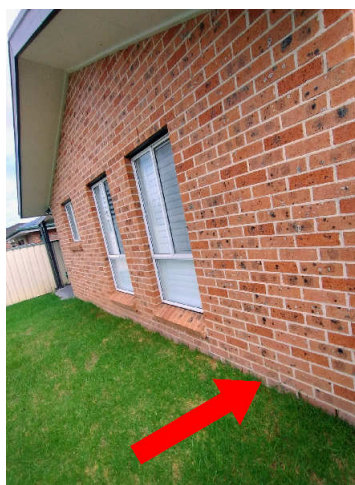
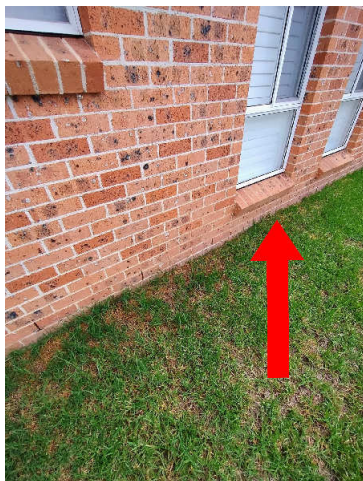
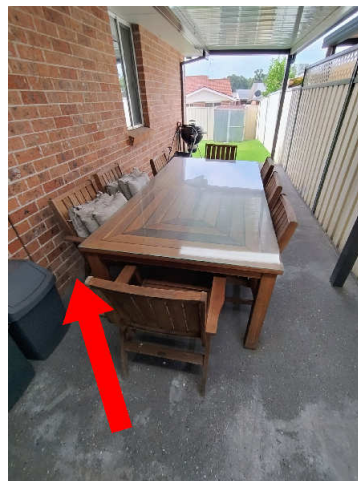
Finding 6.02

Building: Main Building
 Location: All External Areas
 Finding: Slab Edge - Exposure not fully available

If the slab edge is not properly exposed there is a high risk of termite attack. Sometimes, in order to determine the type of slab, a suitably qualified person such as an architect or builder may be required to consult the construction plans.

Where the slab edge cannot be properly inspected, it is highly recommended that termite or timber pest inspections be carried out every 6-12 months to aid protection of the property against infestation.

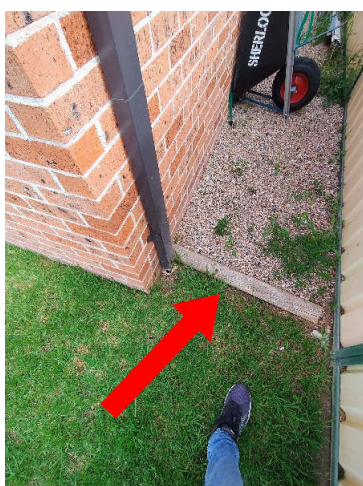
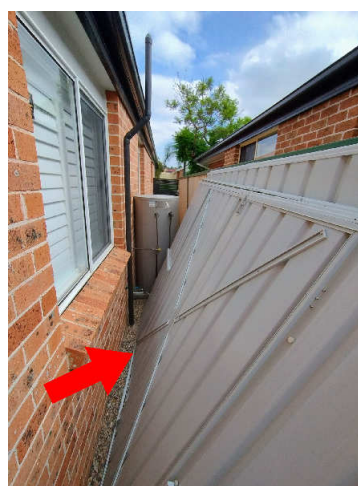
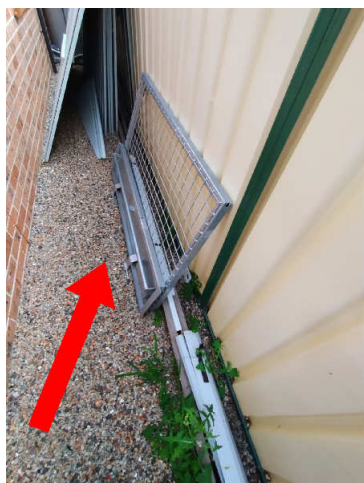
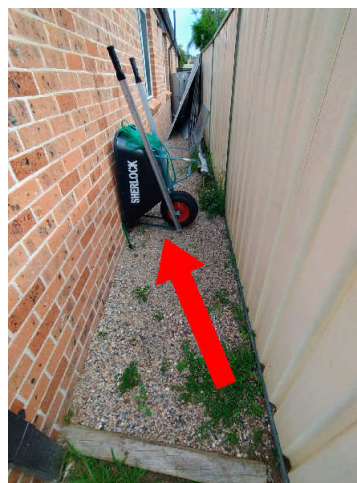
Finding 6.03

Information: The storing of timbers around the external property increases the risk of termite activity being present at the time of inspection. As they are likely to come into contact with weather conditions or excessive moisture wood rot is likely to develop on timbers that are not treated.

It is highly recommended that any stored timbers be immediately removed from areas in which they may attract any termite / timber pest attack. Minimisation of risk / prevention of termite attack is far more adequate than dealing with the presence of termite activity.

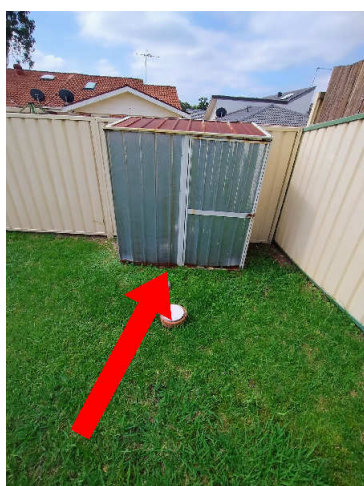
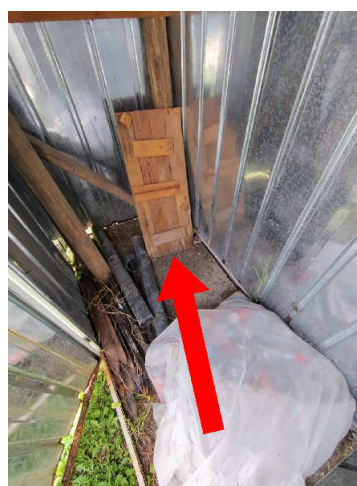
Finding 6.04

Information: The storing of timbers in the storage and around the external property increases the risk of termite activity being present. As they are likely to come into contact with weather conditions or excessive moisture wood rot is likely to develop on timbers that are not treated.

It is highly recommended that any stored timbers be immediately removed from areas in which they may attract any termite / timber pest attack. Minimisation of risk / prevention of termite attack is far more adequate than dealing with the presence of termite activity.

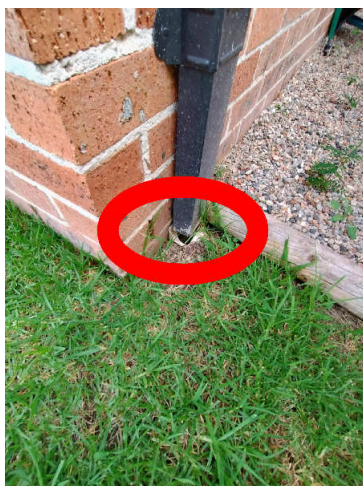
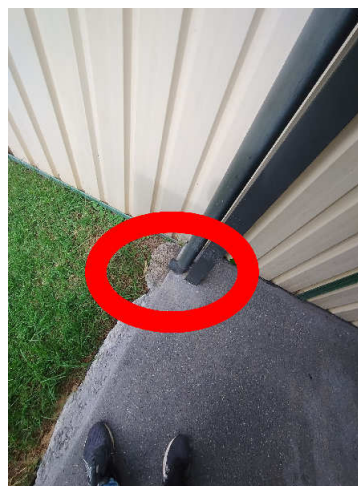
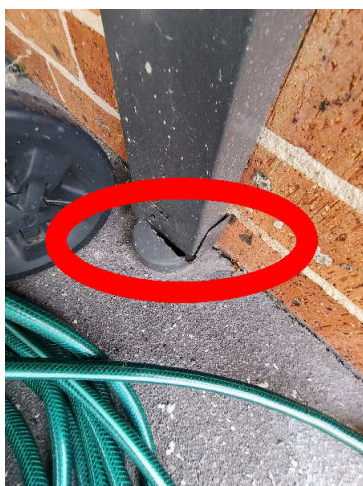
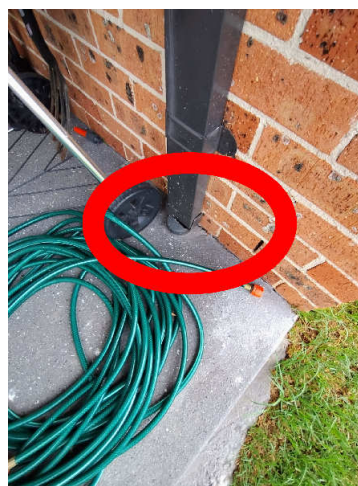
Finding 6.05

Where roof plumbing doesn't drain adequately, the area at the base perimeter can become excessively damp, potentially creating an environment that is susceptible to rust and corrosion of surrounding building elements, as well as attracting termites and other pests.

It is highly recommended that a plumber be appointed to further inspect the area and to install adequate drainage equipment where necessary.

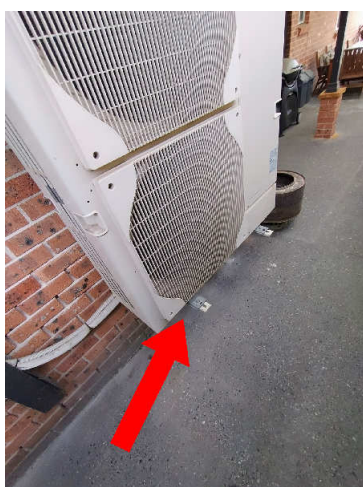
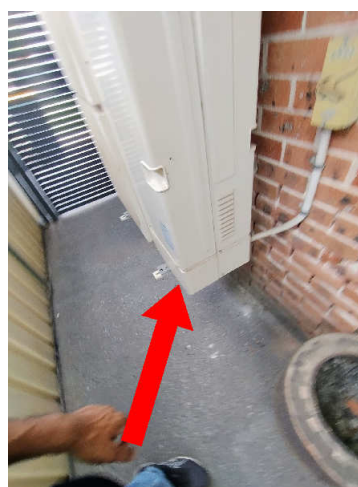
Finding 6.06

Finding: Air conditioner - Not Connected overflow

Information: The Air Conditioner (A/C) overflow was found to be Not connected from storm water drainage and is creating excessive moisture in the surrounding area.

Such leaking creates an environment which is conducive to an array of defects, including water damage to associated building elements and the attraction of termite or timber pest infestation.

It is highly recommended that a licensed plumber be appointed to connect the A/C overflow in order to prevent such an environment from being created. These minor works should be carried out as soon as possible.

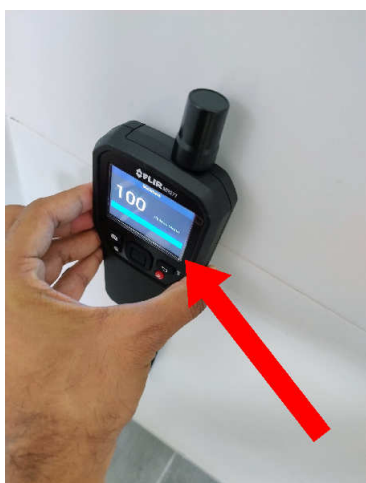
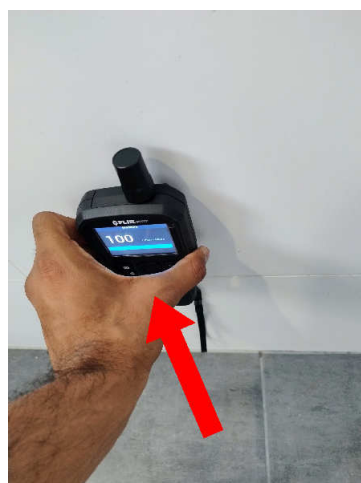
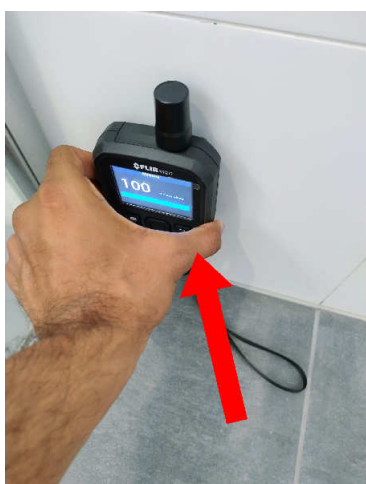
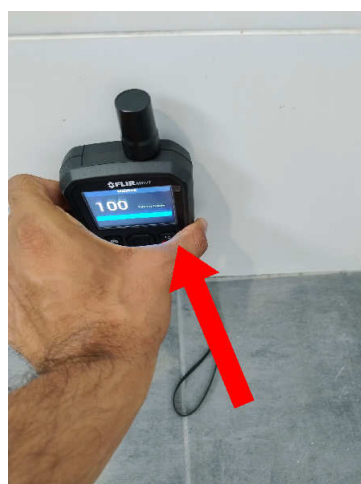
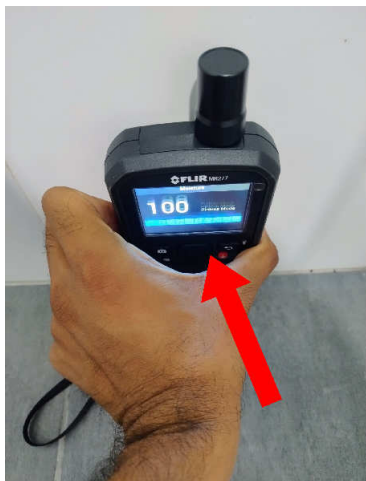
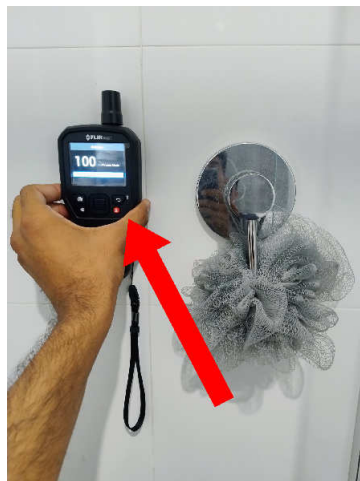
Finding 6.07

Finding: Evidence of Excessive moisture - identified

Evidence of excessive moisture recorded by moisture meter in the shower wall of common bathroom.

Excessive moisture can attract termites and produce conditions that promote fungal growth and wood decay.

Excessive moisture is generally caused by deteriorated, inadequate or missing roof drainage, leaking plumbing pipes or fixtures, poorly plumbed HWS overflows or condenser units and poor site drainage.

Prior to any remedial works being performed a qualified plumber should be appointed to further inspect the property and to identify the cause of the excessive moisture. Works to remove affected building elements may then be necessary and should be performed by an appropriate tradesperson.

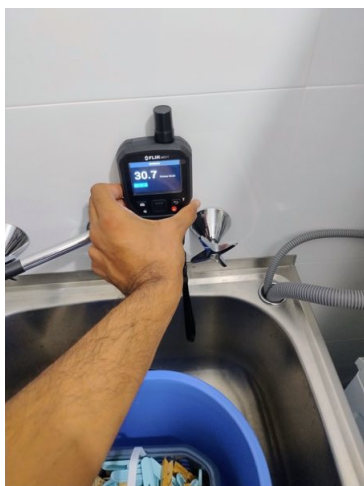
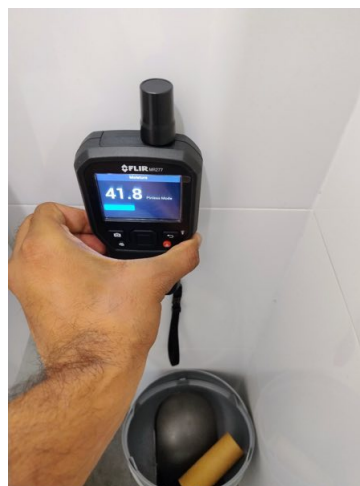
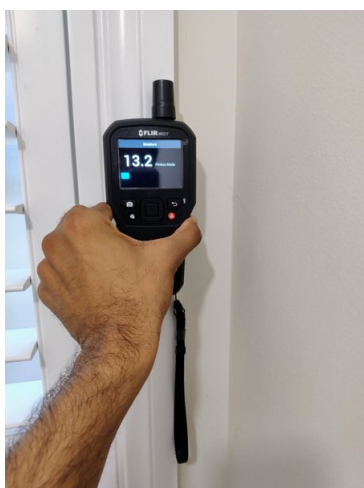
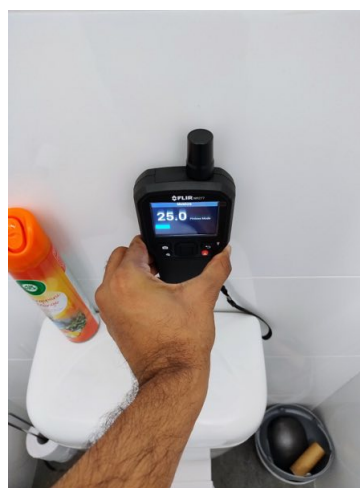
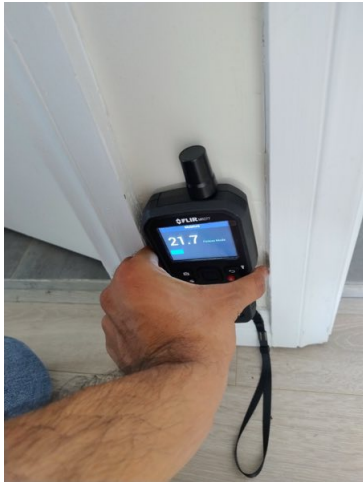
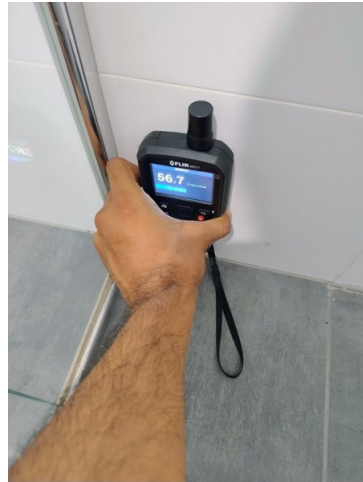
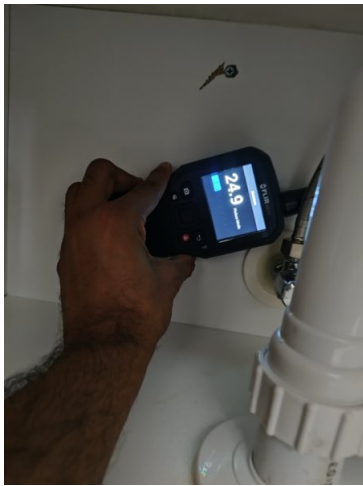
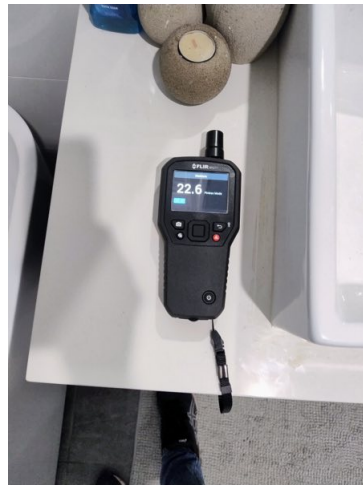
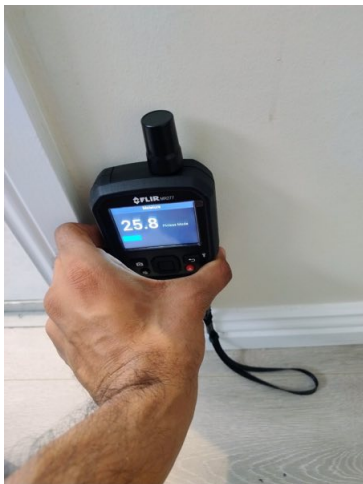
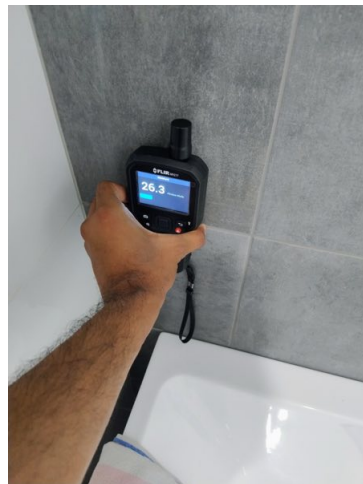
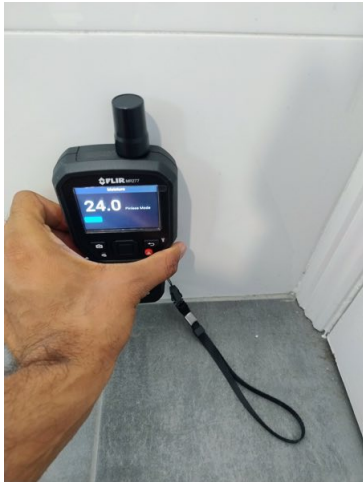
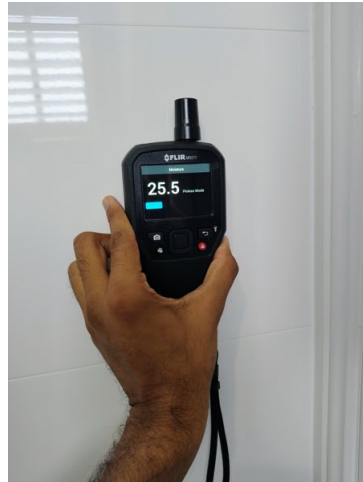
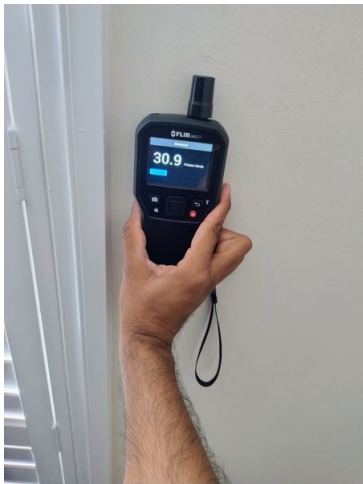
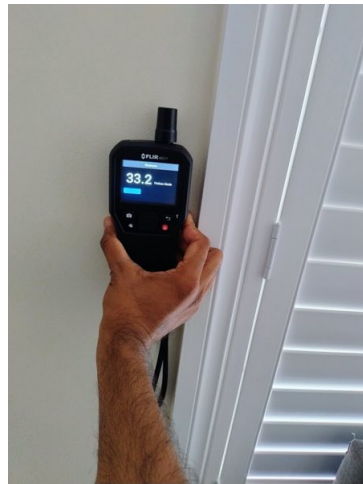
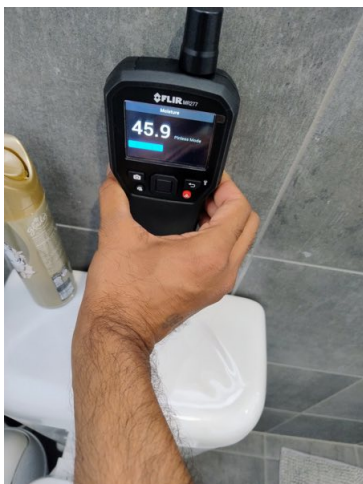
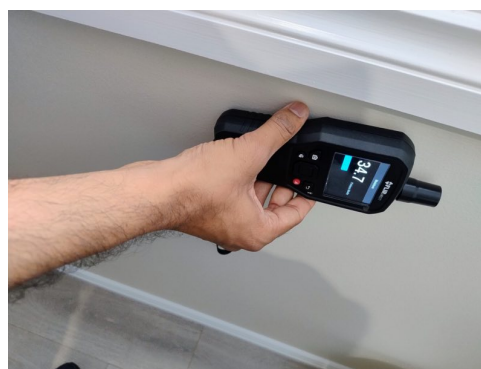
Noted Item

Building: Main Building
Location: All Areas
Finding: Moisture reading taken at different locations
Information: All area moisture reading for reference

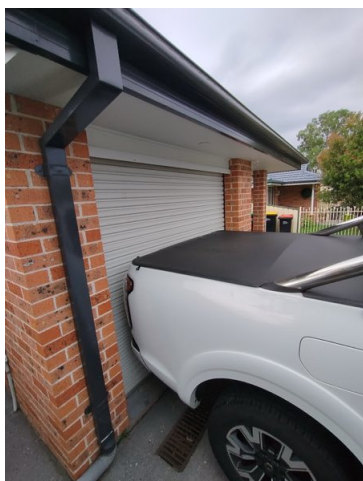
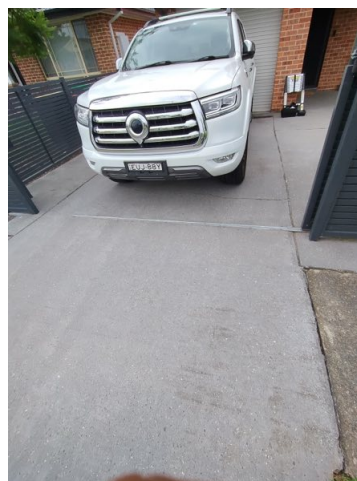
Information: These photographs are an indication of the obstructions and limitations which impeded full inspection of the property at the time of inspection. The insulation covered nearly all the ceiling joists, which are major structural elements of ceiling. The inspection was also limited to areas with an allowable crawl space of 600mm x 600mm, in particular towards the external walls where the roof line diminishes, it was not accessible. These obstructions and limitations can hide an array of defects and should be removed to allow a full inspection to be carried out

Without full access behind these obstructions, defect, activity and damage may be concealed.

These obstructions can hide an array of defects and should be removed to allow full inspection to be carried out. A re-inspection is recommended once the areas are made accessible.

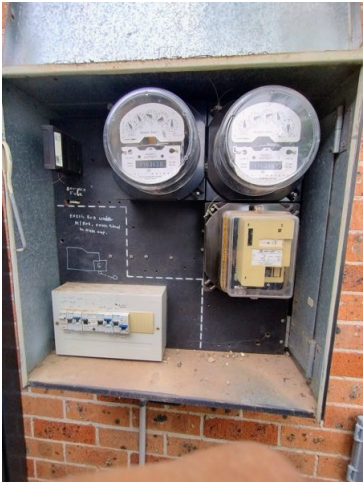
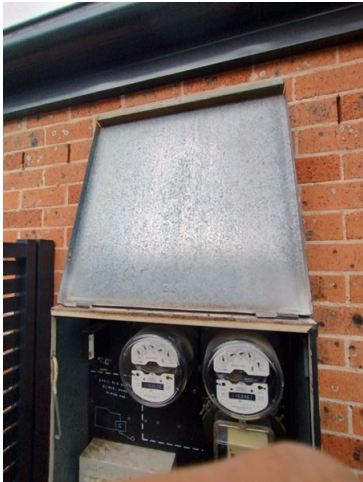
Building:	Main Building
Location:	Meter Box
Finding:	Termite Management System - no evidence of a Termite Management system or Durable notice
Information:	At the time of inspection, it was noted that there is no visible durable notice indicating the installation of a termite management treatment system, as required by current building regulations.

A durable notice, usually in the form of a sticker, found in the main switchboard, should be provided by a licensed pest control contractor upon the installation of a termite management system to inform future occupants or owners of the treatment.

The absence of such a notice may compromise the effectiveness of termite control measures and could lead to potential risks related to termite infestations and damage. It is noted that without further information from the current owner or real estate agent regarding the installation of a termite management treatment system, it is then assumed that there is no termite treatment system installed to the property.

It is strongly recommended that a licensed pest control contractor be engaged to assess the property and to install an appropriate termite management system as a matter of urgency.
