# Building and Timber Pest Inspection Report

Inspection Date: Fri, 20 Feb 2026

Property Address: 25 Munmorah Ave, Charmhaven NSW 2263,  
Australia

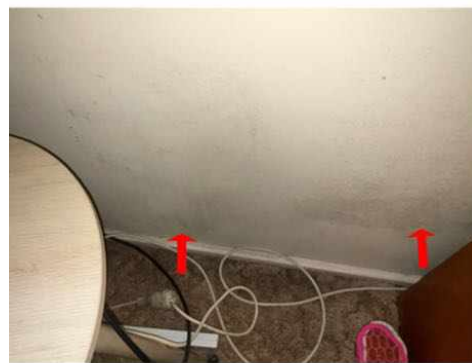
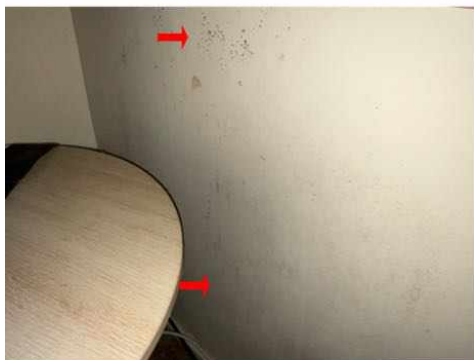
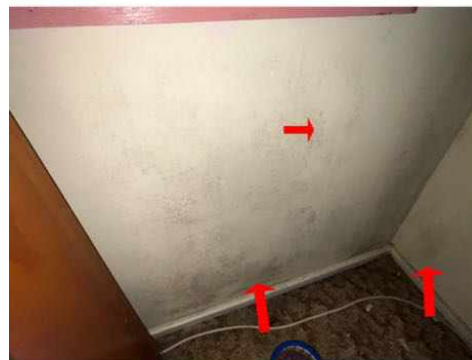
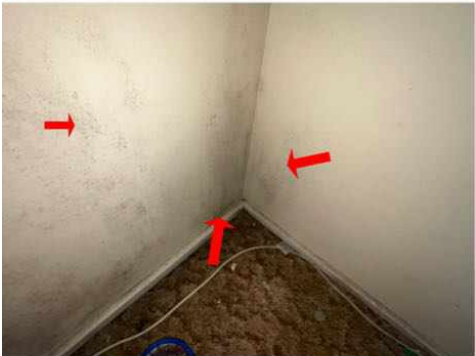
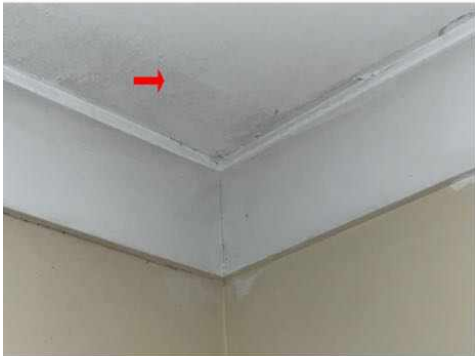
Building: Main Building  
Location: Bedroom > Front, Centre  
Finding: Mould - Present  
Information: Mould appeared was evident to the front centre bedroom wall at the time of the inspection. Where evidence of mould growth was noted, there may be environmental, biological or health issues associated with the report. A specialist inspection by a suitably qualified environmental health inspector is warranted, where mould is extensive or where any queries regarding air quality spores or other related issues apply.

Generally, the client is advised to ensure that the general environment is free of moisture and humidity to aid in the prevention of mould formation and development. Any mould found during the inspection should be cleaned immediately by a cleaning contractor or the homeowner as applicable.

Please note that severely affected building elements may require replacement by a builder or qualified carpenter.

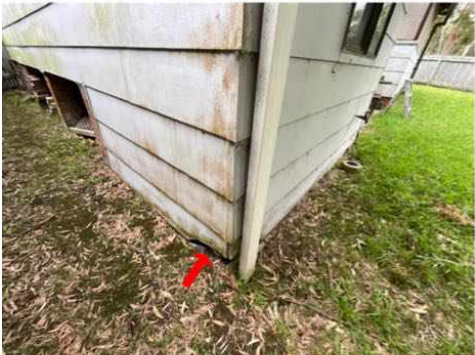
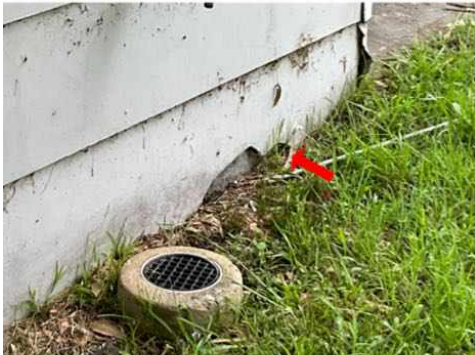
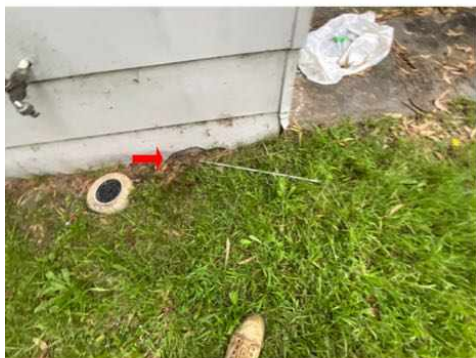
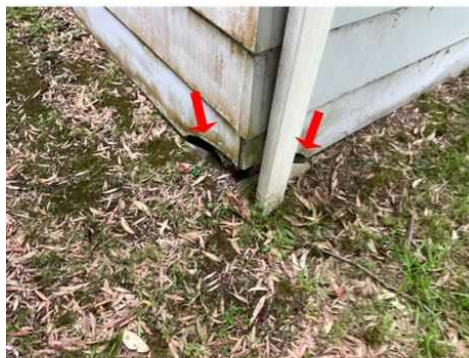
**Finding 1.02**

Building: Main Building  
Location: Exterior walls - rear > Rear Right  
Finding: Asbestos - Suspected ACM Identified on Site  
Information: Broken asbestos cladding was evident to the rear right of the building. Reporting on Asbestos is outside the Scope of this Report. This suspected defect is highlighted as a caution only. We suspect, based on our experience in the building industry, that there is a higher risk of the identified building element containing asbestos.

As Asbestos Reporting is outside the scope of this report, we advise that you consider a separate Asbestos Inspection and Condition Audit, which can include the taking of samples for definitive confirmation of the presence of Asbestos.

In the interim, the client is advised to act with caution, especially when considering any damage to building materials general wear and tear renovations extensions demolition and general maintenance activities due to the suspected presence of Asbestos.

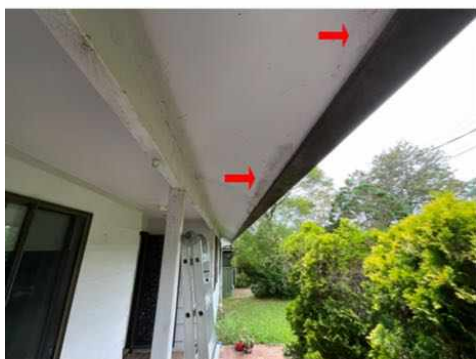
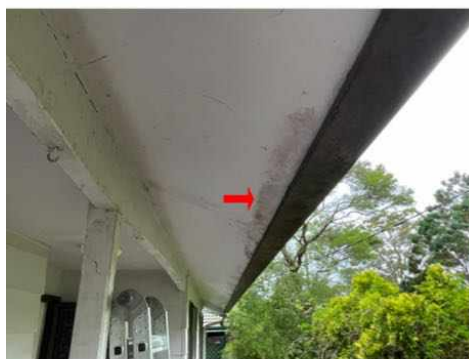
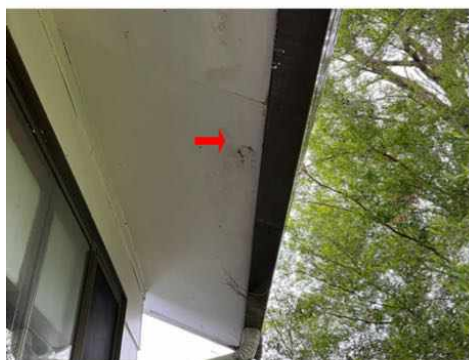
### Finding 1.03

Building:	Main Building
Location:	Eaves > Front
Finding:	Mould - Present
Information:	Mould was present to the eaves at the front of the property at the time of the inspection. Where evidence of mould growth was noted, there may be environmental, biological or health issues associated with the report. A specialist inspection by a suitably qualified environmental health inspector is warranted, where mould is extensive or where any queries regarding air quality spores or other related issues apply.

Generally, the client is advised to ensure that the general environment is free of moisture and humidity to aid in the prevention of mould formation and development. Any mould found during the inspection should be cleaned immediately by a cleaning contractor or the homeowner as applicable.

Please note that severely affected building elements may require replacement by a builder or qualified carpenter.

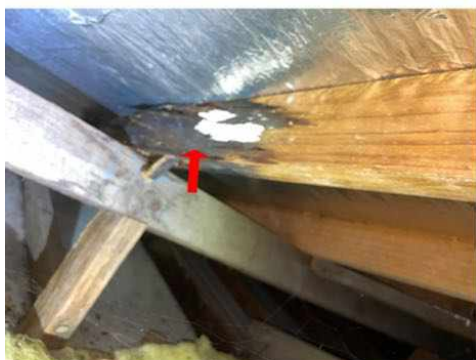
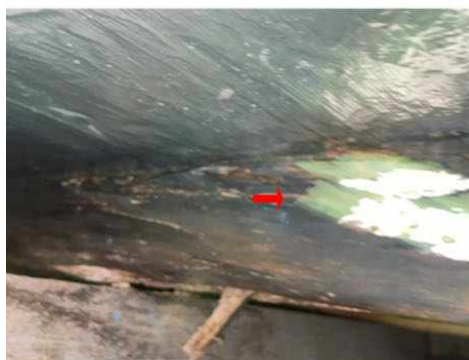
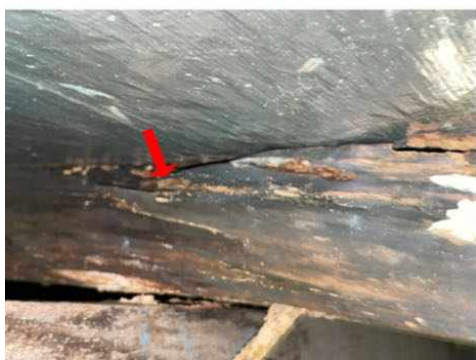
### Finding 2.01

Building:	Main Building
Location:	Roof Void > Front
Finding:	Wood rot - Rafter
Information:	Significant wood rot was found to a rafter in the roof space that showed considerable damage. It was apparent that this area also had termite damage. Based on the rafter being a structural item this is considered a major defect. Wood rot, also known as Fungal Decay, occurs when timbers and other cellulose building materials are exposed to damp conditions on an ongoing basis. This could be the result of exposure to weathering over a prolonged period of time, or the attraction of excessive moisture from other abutting building materials. Contributing factors also include poor air ventilation in the area.

Wood rot is often associated with general damp problems and is evidenced by a 'musty' smell or mould and mildew occurring on surfaces. If left unmanaged, damp conditions can lead to further health problems and the decay of timbers will continue.

Early intervention and regular maintenance, particularly of exterior timbers, will prolong the useful life of these building elements. Prior to any works being performed, the cause of the moisture that has created the visible wood rot should be identified and addressed in a suitable manner. Replacement of affected timbers may then be a necessary step in protecting surrounding building elements from such deterioration.

A qualified plumber may be appointed to assess the cause of excessive moisture and to provide advice on any remedial works as required. A qualified carpenter or builder may also be required to replace affected building materials.

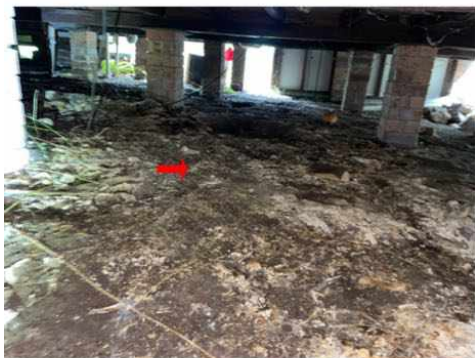
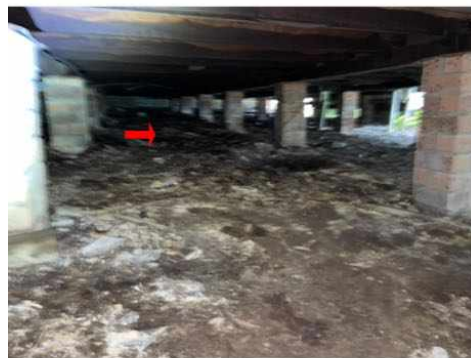
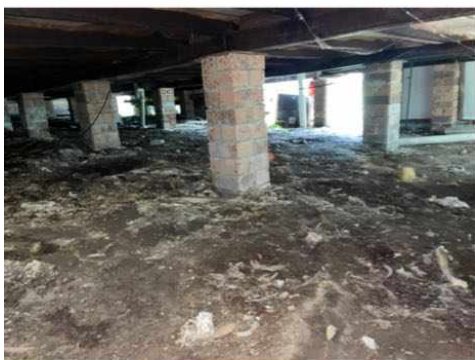
## Finding 2.02

Building:	Main Building
Location:	Subfloor > All Areas
Finding:	Subfloor Stumps - Subsidence
Information:	Although the floor framing appears to be bearing on the stumps, variations in floor levels internally suggest that some subsidence or settlement may have occurred. No major displacement of framing from supports was observed; however, uneven floor levels were noted throughout.

Settlement or subsidence can occur due to soil movement, stump deterioration, moisture variation, or long-term structural movement. If progressive, this may lead to further floor unevenness, cracking to internal linings, misalignment of doors and windows, and additional structural stress.

A builder should inspect the subfloor structure and stump condition to determine the extent and cause of movement. Depending on findings, a structural engineer may be required to assess and specify rectification works. This should be investigated prior to purchase or in the short term to determine structural stability and likely repair costs.

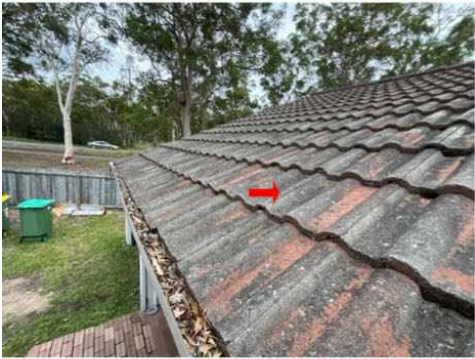
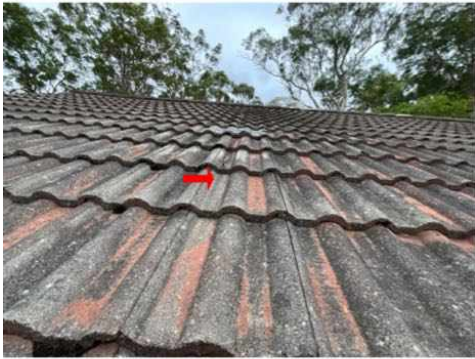
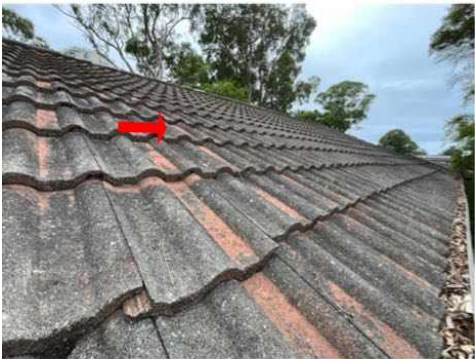
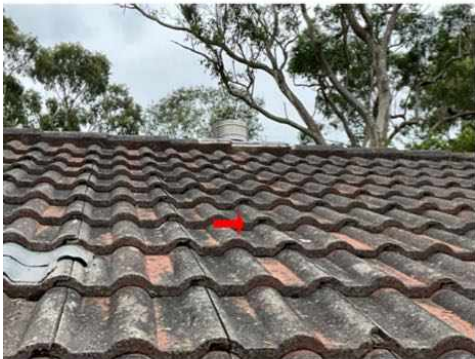
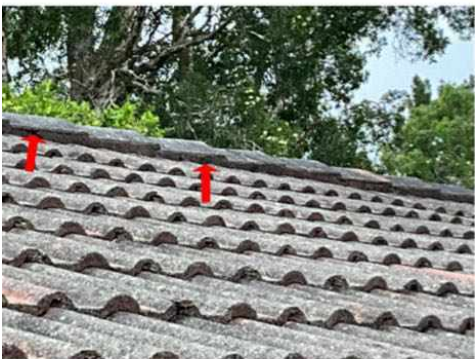
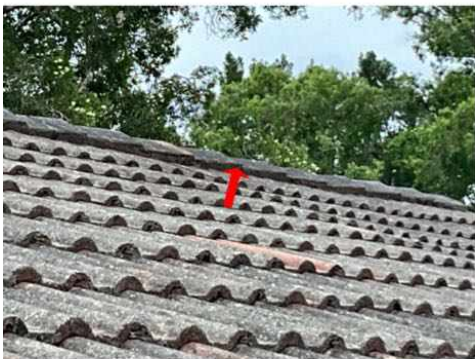
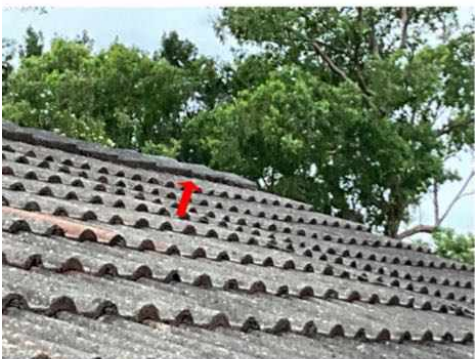
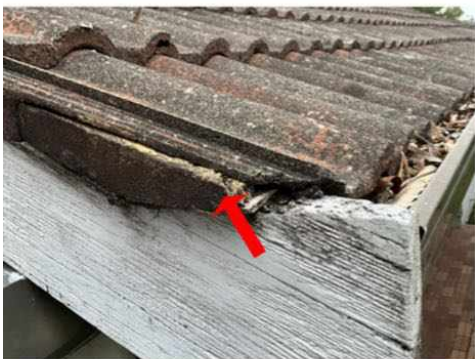
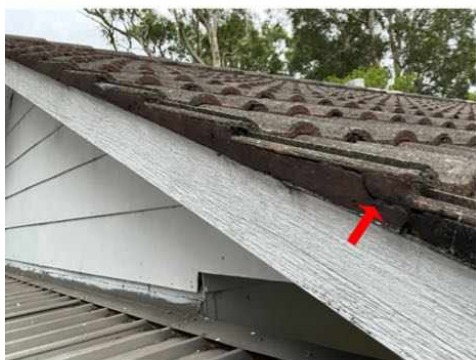
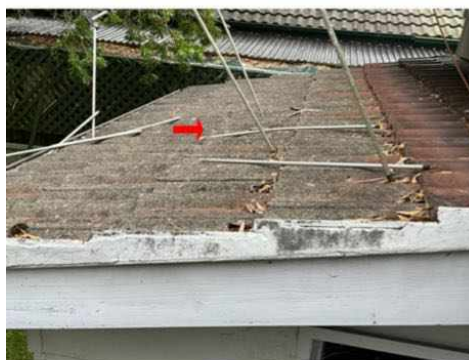
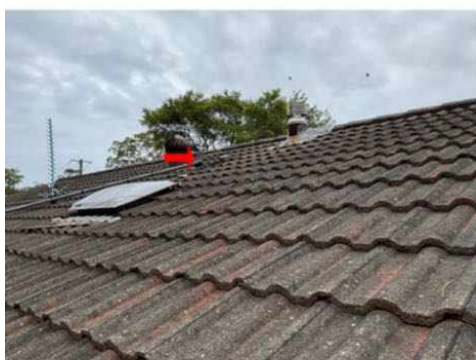
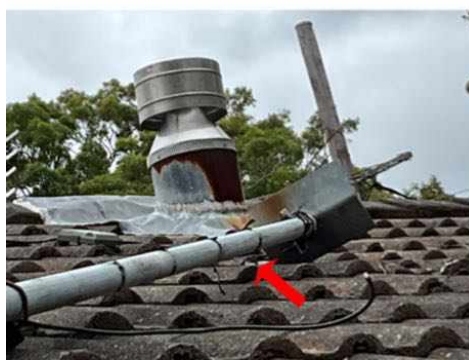
### Finding 2.03

Building:	Main Building
Location:	Roof Exterior > All Areas
Finding:	Roof tiles - Weathered
Information:	Upon inspection of the exterior roofing, the majority of roof tiles were considered to be in a fair condition. While weathering of the tiles is consistent with the age of the property, maintenance works are required.

Isolated areas of mortar have come to the ridge and edges and minor cracking is also present. Re-pointing and re-sealing the may be considered as an interim solution by the client to help preserve and extend the life span of the tiles.

Where left unmanaged, deteriorating roof tiles are likely to lead to a number of secondary defects, including minor water leaks and weather exposure to internal roofing structures. This may already be happening with moisture evident to a number of walls.

Consultation with a roofing contractor is highly advised to gain advice on cost of remedial works that may be required in the short to medium term. Remedial works are likely to increase the longevity of the exterior roofing structure.

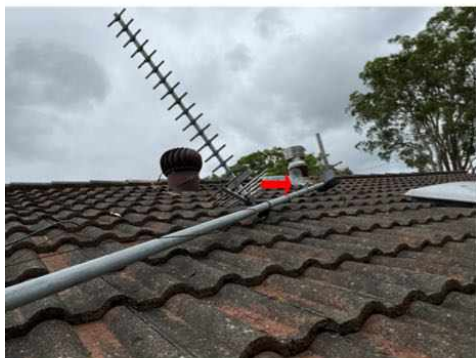
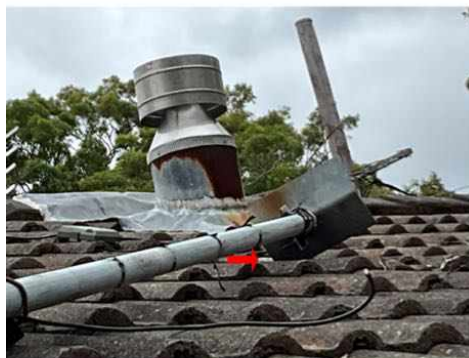
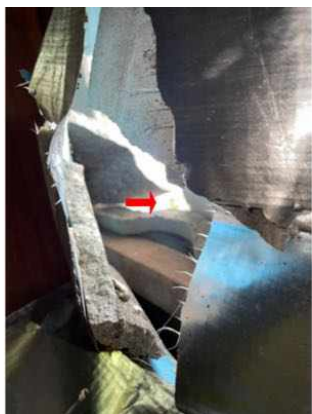
### Finding 2.04

Building:	Main Building
Location:	Roof Exterior > Centre,Rear
Finding:	Roof Tiles - Broken
Information:	Roof tiles were observed to be broken, consistent with impact damage. Moisture intrusion associated with these damaged tiles is evidenced by elevated moisture readings and staining to the kitchen ceiling below.

Broken roof tiles compromise the weatherproofing of the roof covering and allow direct water entry during rainfall. Ongoing ingress may result in deterioration of ceiling linings, insulation, and roof framing timbers, and may contribute to mould growth if not rectified promptly.

A licensed roofer should replace the damaged roof tiles immediately and inspect surrounding tiles and flashing for further impact-related damage. Once the roof covering is made watertight, a builder or plasterer should repair any affected internal ceiling materials. This is considered a short-term priority repair to prevent further damage.

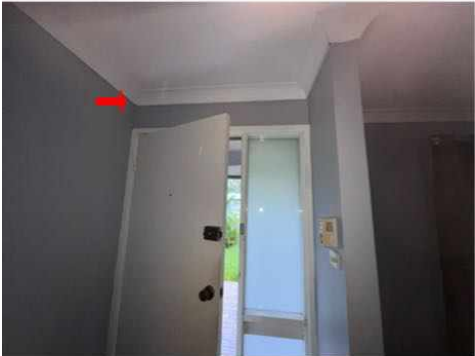
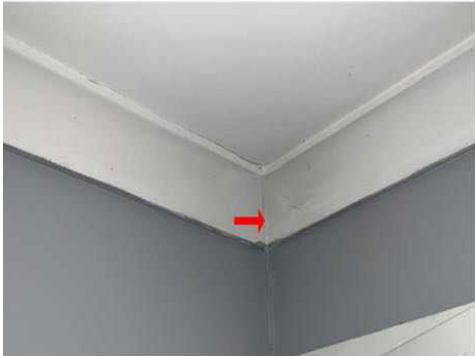
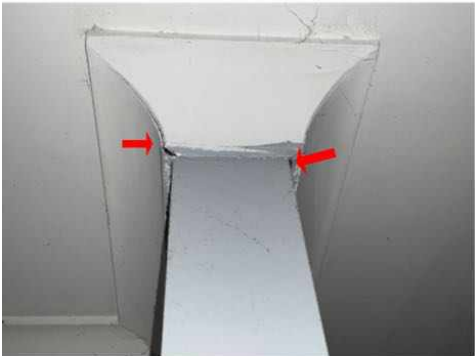
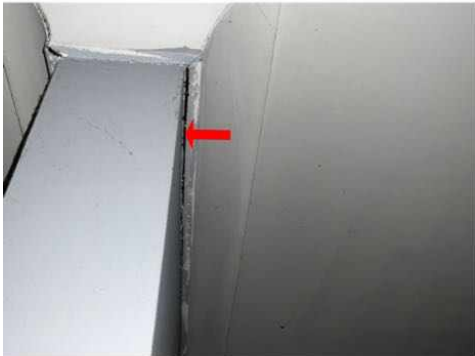
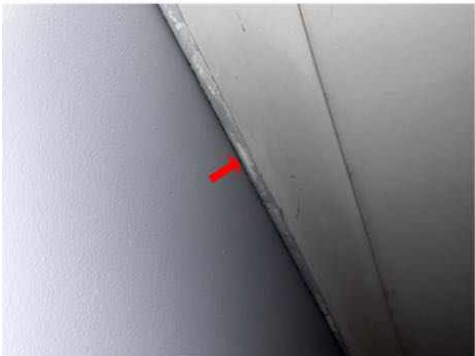
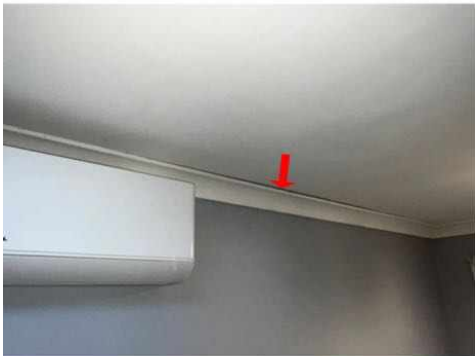
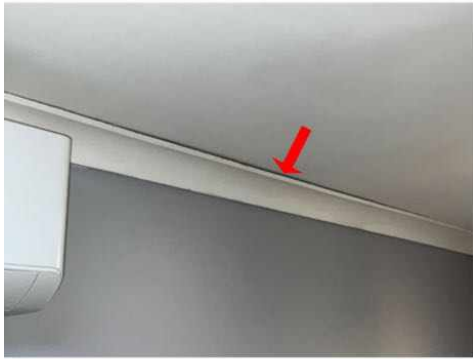
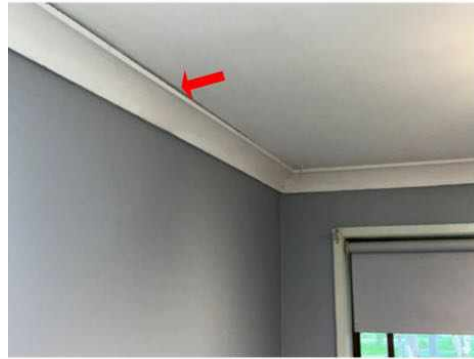
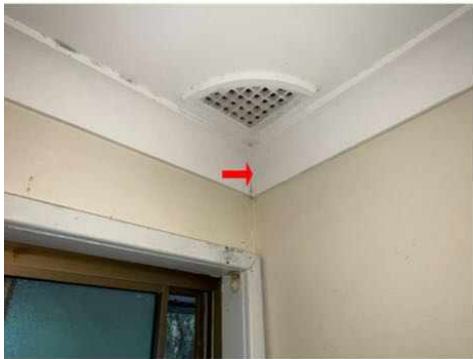
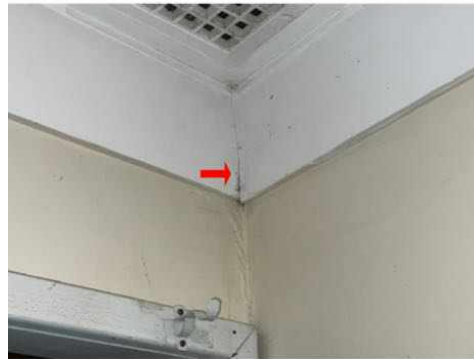
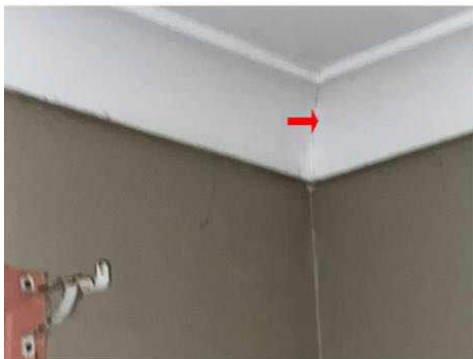
Building:	Main Building
Location:	All Internal Areas > All Areas
Finding:	Cracking - Damage Category 2 - Noticeable (up to 5mm)
Information:	Cracking was evident to the cornice. Noticeable cracks are a common occurrence as a result of many primary defects. Such causes may include age, general wear and tear, expected building movement, general expansion/contraction of building materials in different weather conditions, and/or minor failings in the installation or application of building materials.

Noticeable cracks may result in minor sticking or jamming of associated doors and windows, which require easement. However, noticeable cracks are easily filled and repaired. A plasterer can be consulted to install an expansion joint at this point to allow for this movement during different weather conditions.

Monitoring of all cracking should be conducted frequently. Always contact a building inspector should cracks widen, lengthen, or become more numerous. Additionally, your building inspector should also be contacted if associated building elements such as doors and windows become more difficult to operate over time.

Relevant tradespeople, such as carpenters, painters and plasterers, should be appointed to perform remedial works, as deemed necessary.

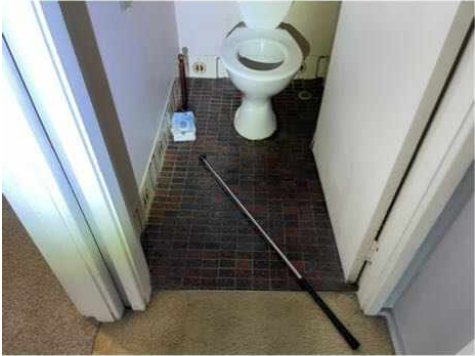
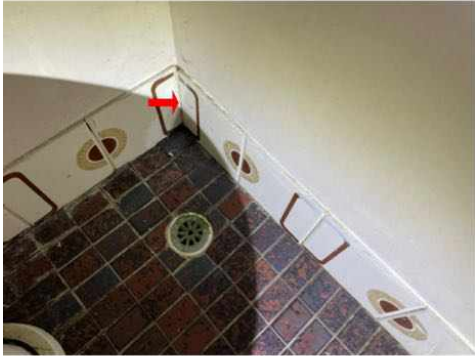
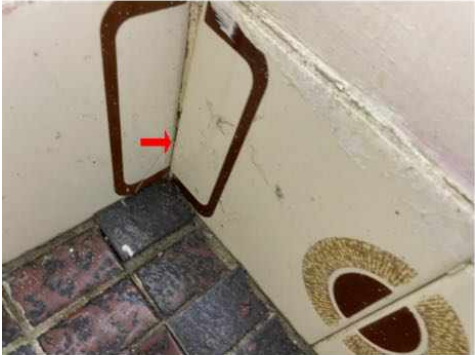
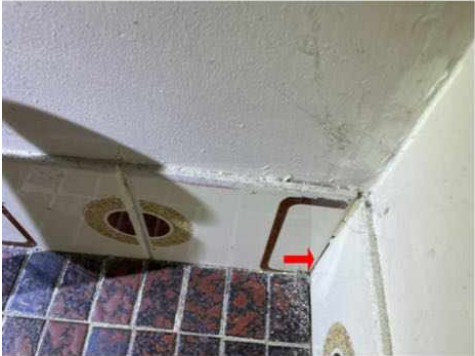
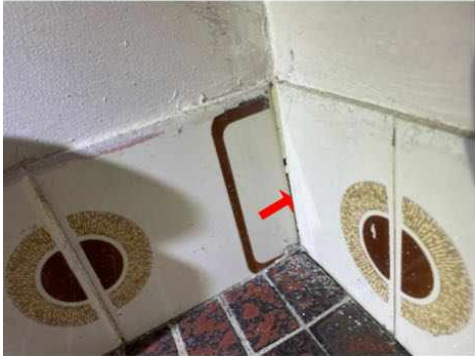
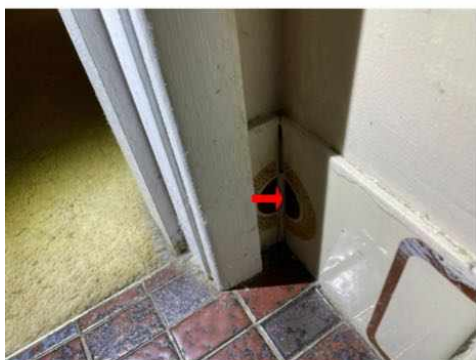
### Finding 3.02

Building:	Main Building
Location:	Toilet (WC) > Rear
Finding:	Tiles and Sealant - Drummy
Information:	Tiles within the toilet area sounded drummy when tapped, and sealant was missing at skirting tile junctions.

Drummy tiles may indicate loss of adhesion and may become loose or crack over time. Missing sealant increases the risk of moisture ingress into wall and floor junctions.

A qualified tiler should assess and re-fix affected tiles and reinstate sealant. Repairs

should be undertaken in the short to medium term.

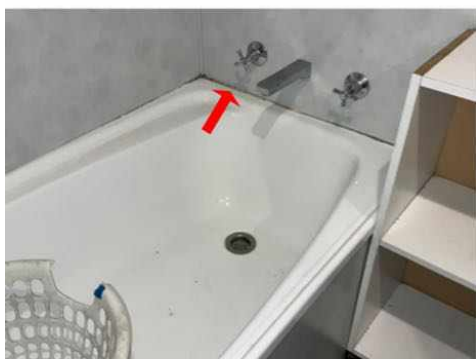
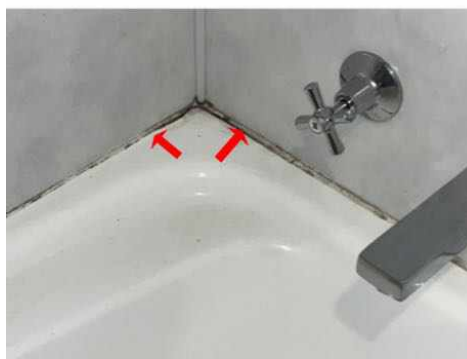
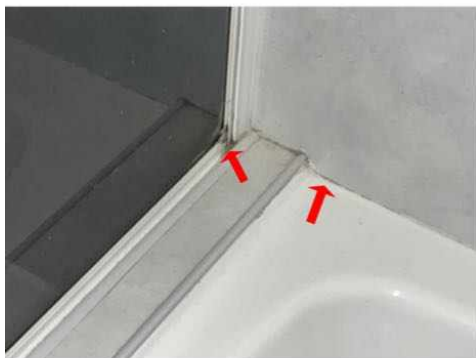
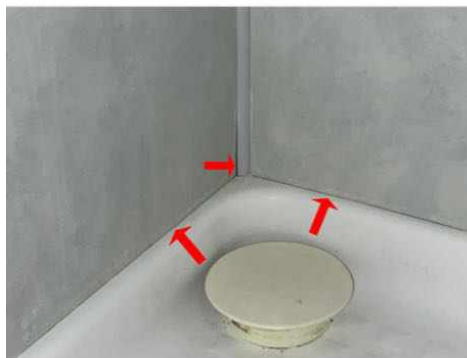
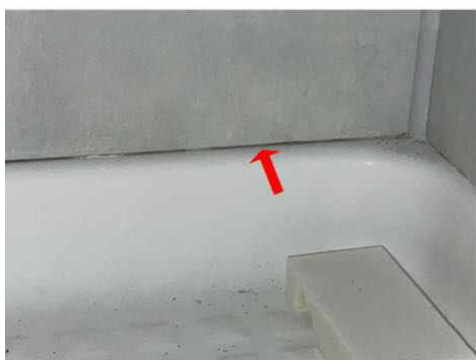
### Finding 3.03

Building:	Main Building
Location:	Bathroom > Rear
Finding:	Sealant and grouting - Missing or damaged
Information:	It was noted on inspection that sealant or grout is degraded to areas of the bathroom.

Different materials and floor areas move at different rates, generally causing cracking to grout or sealant at this point. A flexible sealant is required to allow for expected expansion and contraction, while keeping the joint water tight and protective of all associated building materials.

Flexible and mould resistant materials should be applied to affected areas to prevent any subsequent water damage that is likely to occur. Regular maintenance and replacement of damage or missing or damaged sealant and grout is highly recommended to the wet areas, as this is a regular wear and tear defect. Sealant and grouting in areas that come into regular contact with water should be maintained for the long term care of your property.

A sealant specialist or tiling contractor should be appointed to complete these works as soon as possible

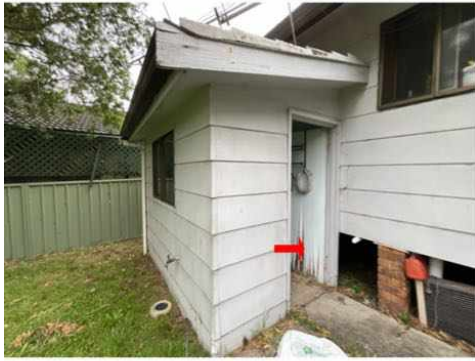
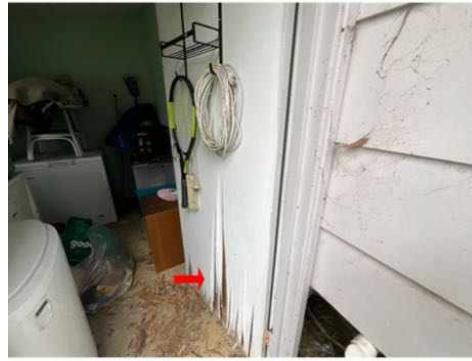
### Finding 3.04

Building:	Main Building
Location:	Laundry > Rear Right
Finding:	Weather damage - Laundry Door
Information:	The laundry door shows significant signs of weather-related deterioration. This appears consistent with ongoing exposure to moisture and general ageing of the painted timber door.

If not addressed, ongoing water ingress to the laundry is likely to cause a number of secondary items.

It is recommended that a suitably qualified carpenter or handyman assess the damage and replace as required.

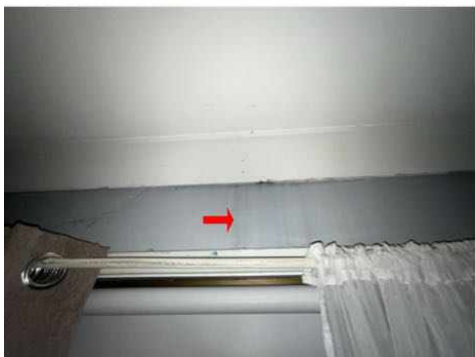
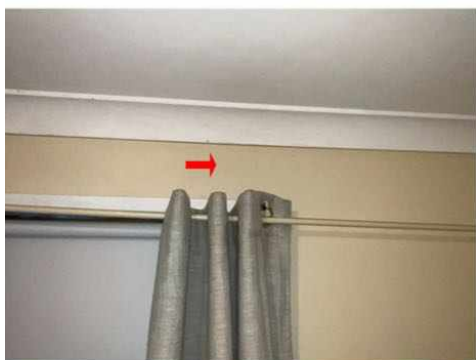
### Finding 3.05

Building:	Main Building
Location:	Living Room, Dining Room > Front,Rear Left
Finding:	Walls - Water stained
Information:	Water staining to sections of the walls to the living and dining room and the rear right bedroom, this was evident to the top of the walls coming from behind the cornice. Water staining indicates that surfaces have been exposed to excessive moisture over time. The minerals and other elements in the water lead to staining, which may graduate to corrosion and deterioration if left unmanaged. No elevated moisture levels were evident on the moisture meter at the time of the inspection.

While mostly an appearance defect, water staining can be indicative of more serious defects, which may be currently concealed by wall linings.

Where water staining is active, a roof plumber must be consulted to identify the cause of the staining and to provide advice on any reparation works that may be required. Replacement of any broken or damaged structures is advised.

Conversely, where water staining is old and inactive, affected building materials may be repaired or replaced at client discretion.

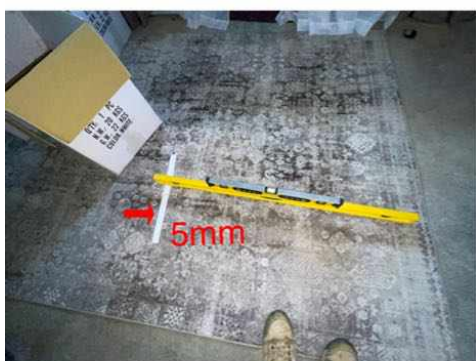
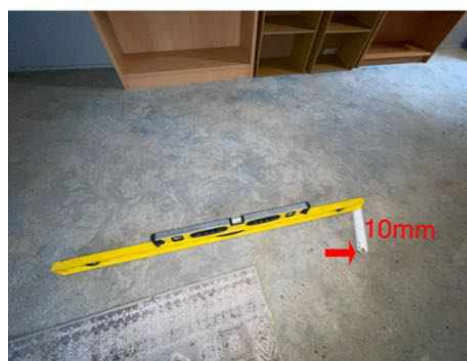
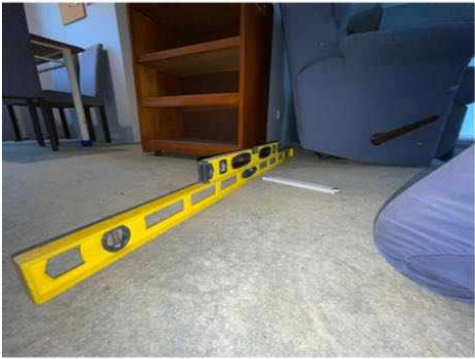
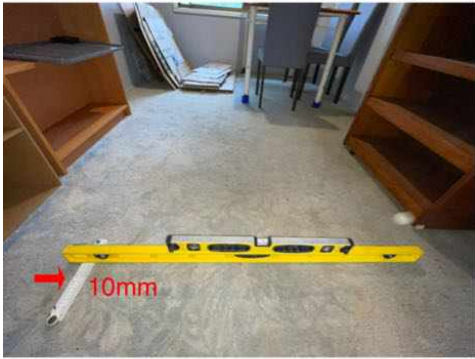
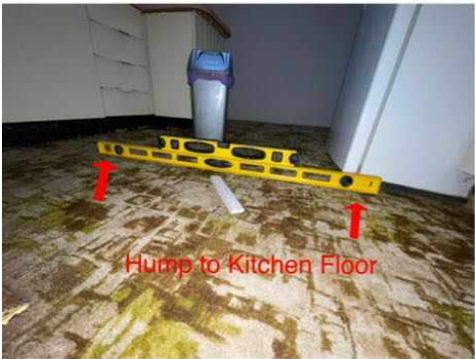
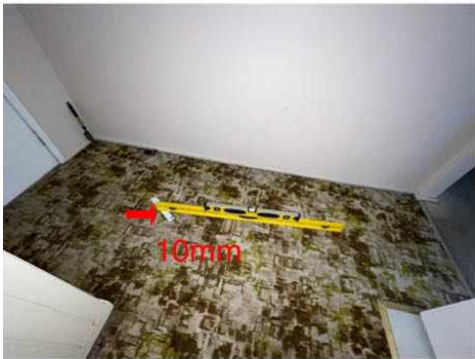
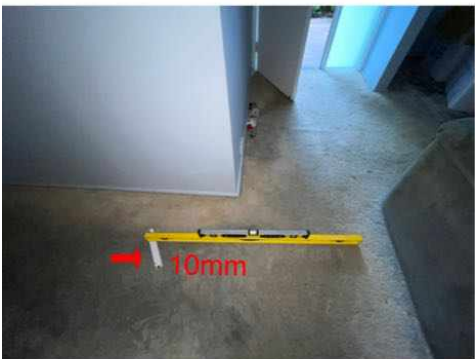
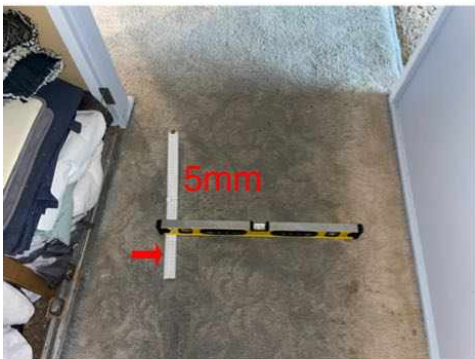
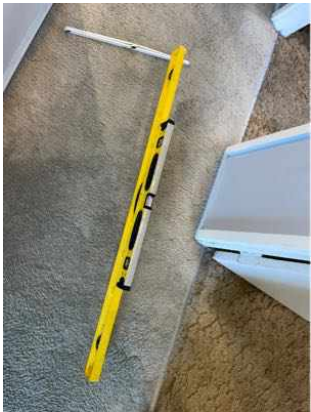
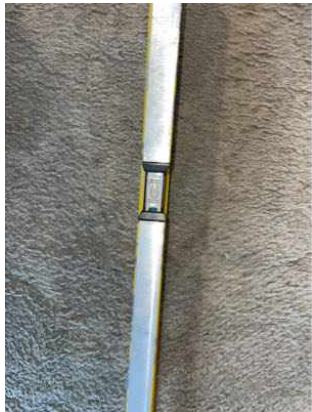
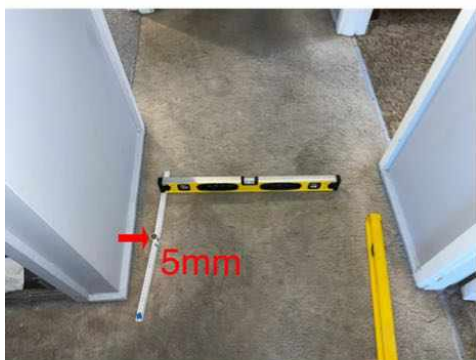
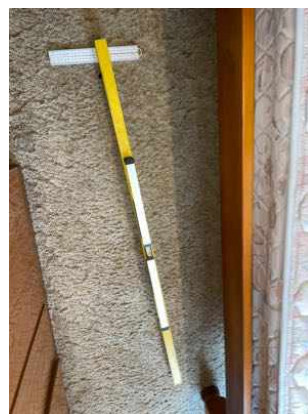
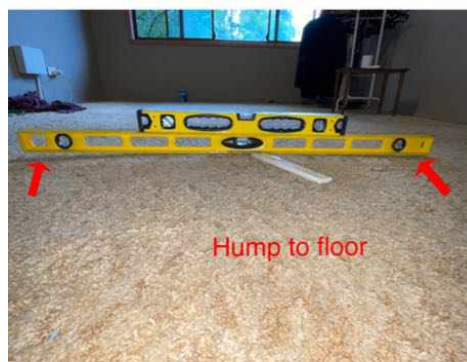
### Finding 3.06

Building:	Main Building
Location:	All Internal Areas > All Areas
Finding:	Flooring - Uneven
Information:	The internal flooring throughout the building is out of level and uneven between 5mm-15mm. Also several rooms appeared to have a significant bow in the floor, this was apparent in the living space, the kitchen and the bathroom. Uneven flooring is likely to indicate minor defects such as expected movement of the foundations of the property, but may also indicate subsidence of the associated subfloor stumps.

It is advised that the flooring be closely monitored to identify any further movement. Where flooring remains relatively unchanged for an extended period of time (i.e. several months), it is likely that this defect has been caused by expected movement of the foundations of the property.

However, where flooring is uneven further, potentially invasive inspection of the subfloor structures and stumps in this area is required. In this case, works to repair are likely to be required, and would be carried out by a builder specialising in re-stumping.

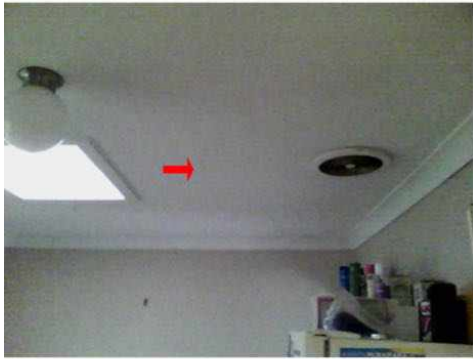
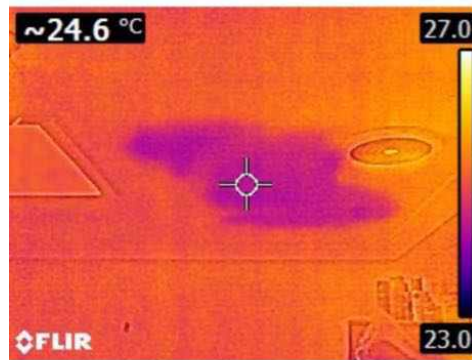
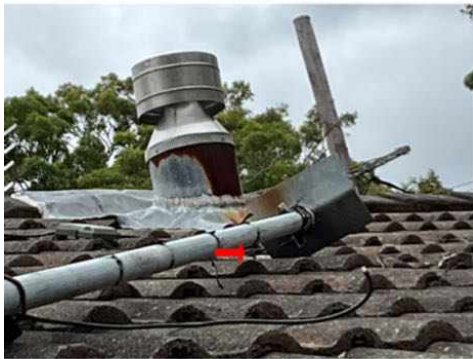
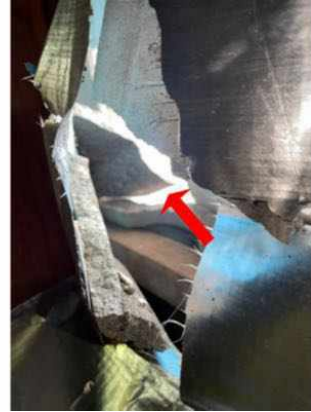
Building:	Main Building
Location:	Kitchen > Rear, Centre
Finding:	Water leak - Active
Information:	Elevated moisture readings were detected to the kitchen ceiling, and a broken roof tile was observed above this area.

Ongoing water ingress can cause deterioration of ceiling linings, insulation, and roof framing timbers, and may contribute to mould growth if not addressed promptly.

A licensed roofer should replace the broken tile immediately to prevent further water ingress. Damaged ceiling materials should be repaired by a plasterer once the leak source is confirmed rectified. This should be repaired immediately.

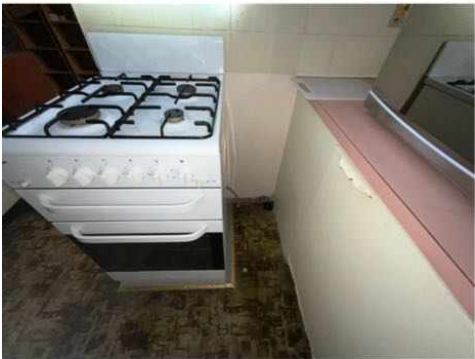
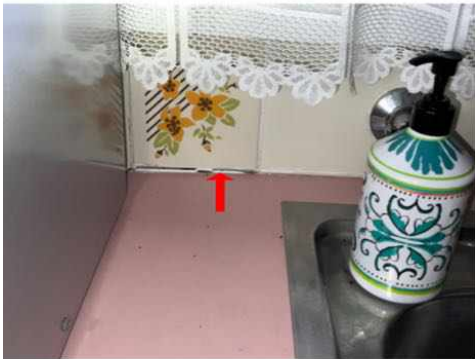
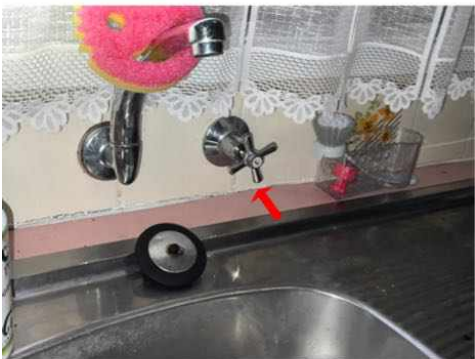
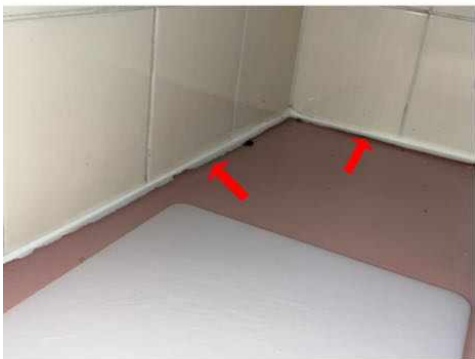
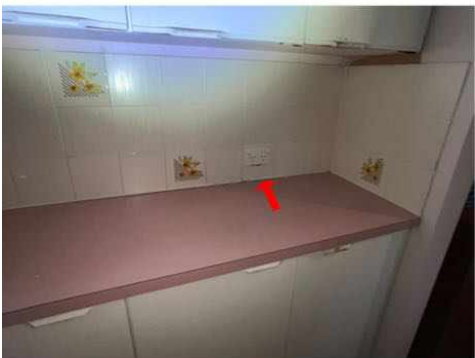
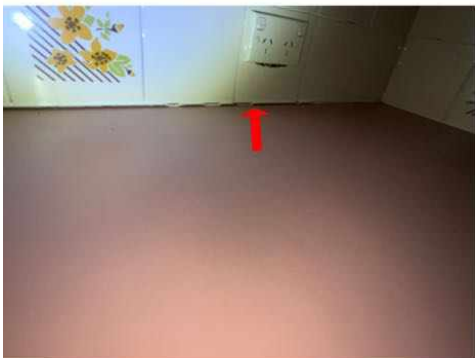
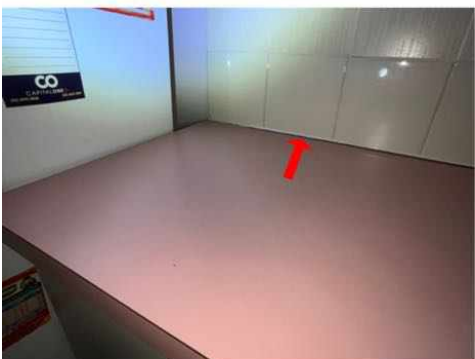
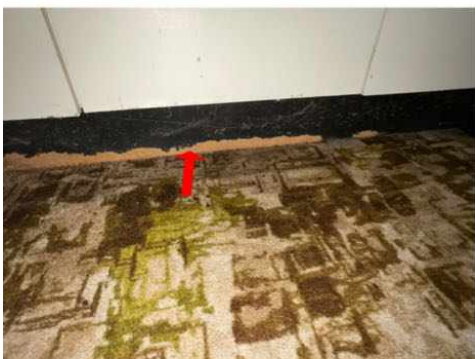
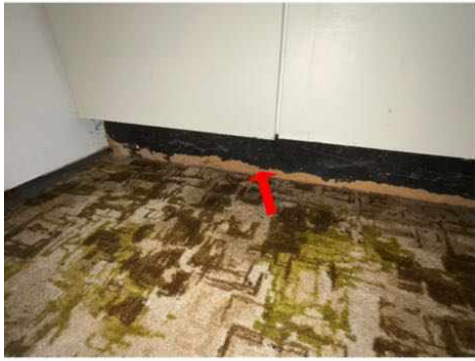
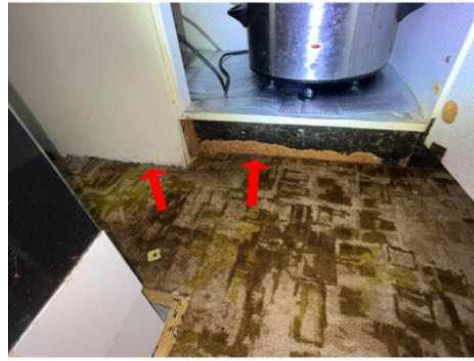
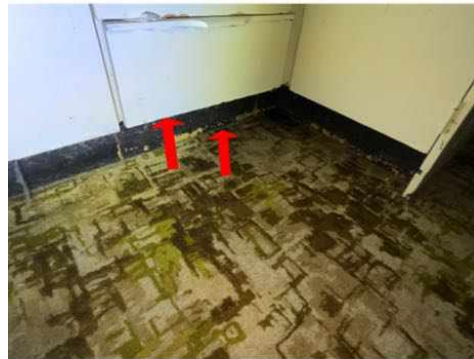
### Finding 3.08

Building:	Main Building
Location:	Kitchen > Rear, Centre
Finding:	Kitchen Joinery - Defects
Information:	The kitchen joinery shows water damage to lower cupboard doors and kickboards, deteriorated sealant, and general wear and tear.

Ongoing moisture exposure may continue to degrade cabinetry and may indicate past or present plumbing leaks.

It is recommended that plumbing connections be checked for leaks and that damaged joinery components be repaired or replaced as required.

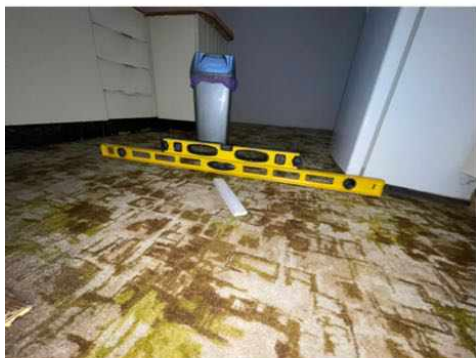
### Finding 3.09

Building:	Main Building
Location:	Kitchen > Rear, Centre
Finding:	Kitchen Flooring - bouncy
Information:	The kitchen flooring exhibited noticeable movement and deflection under load.

Excessive movement may indicate inadequate subfloor support, loose flooring substrate, or deterioration of structural members. Continued deflection may lead to cracking of tiles, damage to cabinetry, and structural stress.

A licensed builder should inspect the subfloor framing and flooring substrate. Rectification may include additional support or replacement of damaged elements. This should be assessed in the short term.

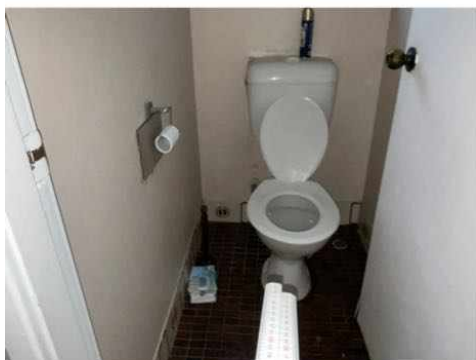
### Finding 3.10

Building:	Main Building
Location:	Toilet (WC) > Rear
Finding:	Toilet Pan - Loose
Information:	The toilet pan was observed to be loose when tested.

A loose toilet can compromise the pan collar seal, resulting in concealed leakage, potential water damage to flooring and subfloor framing, and hygiene concerns.

A licensed plumber should re-secure the toilet and inspect/replace the pan seal as required. This should be rectified promptly.

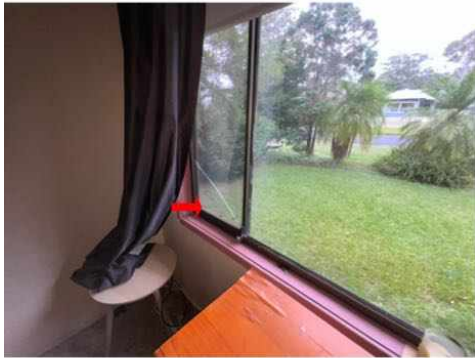
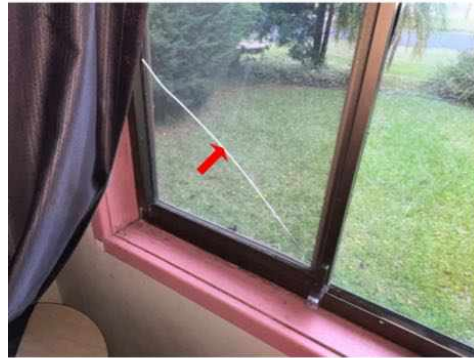
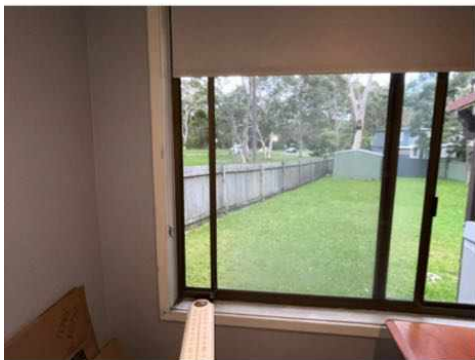
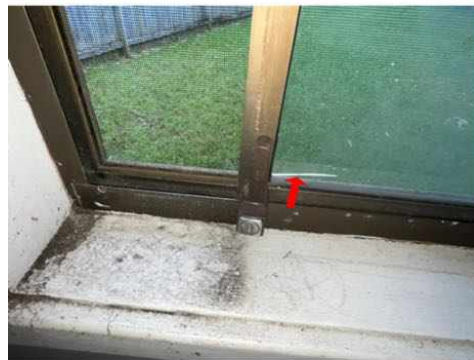
### Finding 3.11

Building:	Main Building
Location:	Bedroom 3, Dining Room > Front,Rear Left
Finding:	Glazing - cracked
Information:	Cracked glazing was observed to windows in the front centre bedroom and dining room.

Cracked glass reduces safety and weather tightness and may deteriorate further.

It is recommended that damaged glazing be replaced by a qualified glazier.

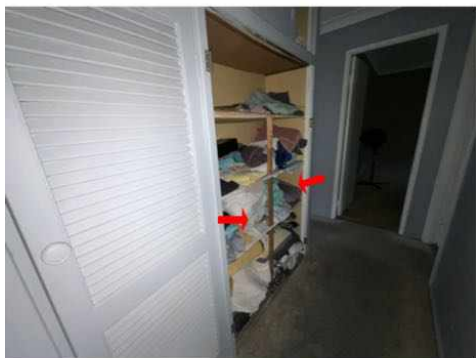
### Finding 3.12

Building: Main Building  
Location: Hallway > Centre  
Finding: Cupboard Doors - Missing  
Information: Cupboard doors to the hallway linen closet were missing at the time of inspection.

This affects functionality and presentation and may indicate incomplete or removed fittings.

It is recommended that replacement doors be installed at the clients discretion.

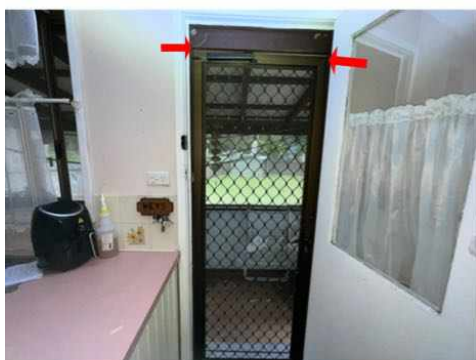
### Finding 3.13

Building: Main Building  
 Location: Kitchen - Outdoor > Rear  
 Finding: Rear Security door - Gap  
 Information: A gap was observed at the top of the rear security door.

Gaps may reduce weather tightness and security and may indicate door frame movement or misalignment.

It is recommended that the door and frame be adjusted or repaired to ensure proper fitment.

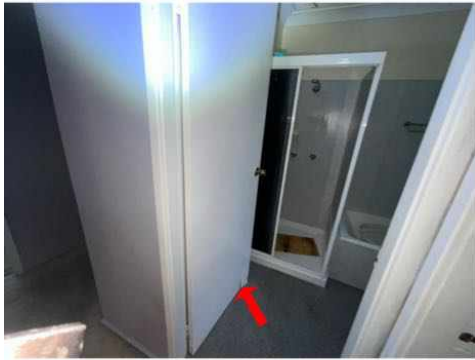
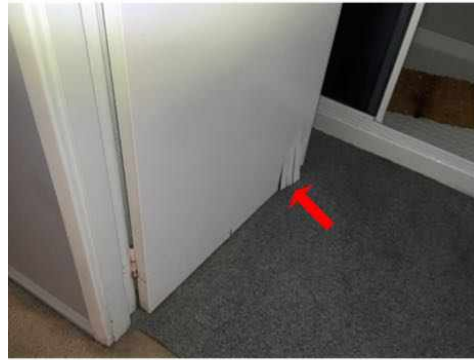
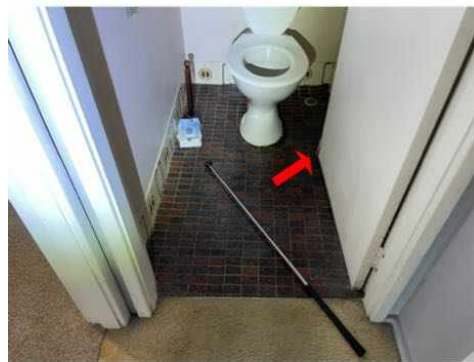
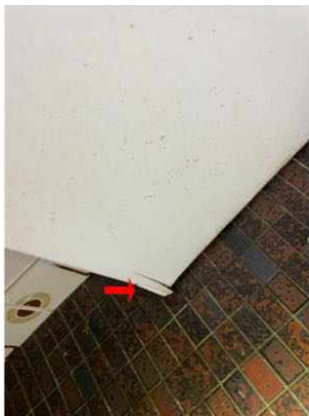
### Finding 3.14

Building: Main Building  
 Location: Bathroom, Toilet > Rear  
 Finding: Doors - Damaged  
 Information: The toilet and bathroom doors show damage including delamination.

Delaminating door skins may worsen over time, particularly in high-moisture areas.

It is recommended that damaged doors be repaired or replaced.
