# Building and Timber Pest Inspection Report

Inspection Date: Fri, 20 Feb 2026

Property Address: 25 Munmorah Ave, Charmhaven NSW 2263,  
Australia

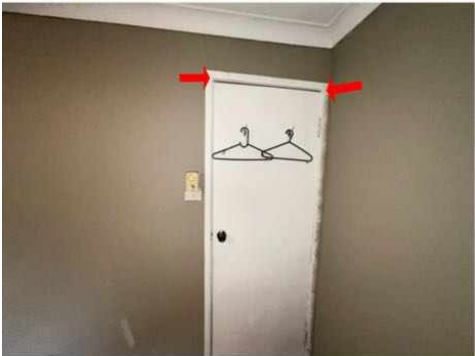
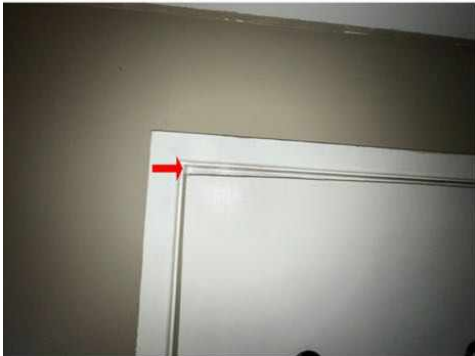
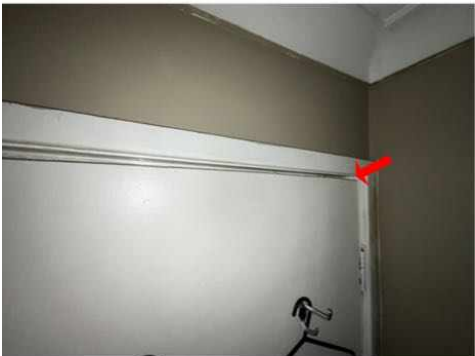
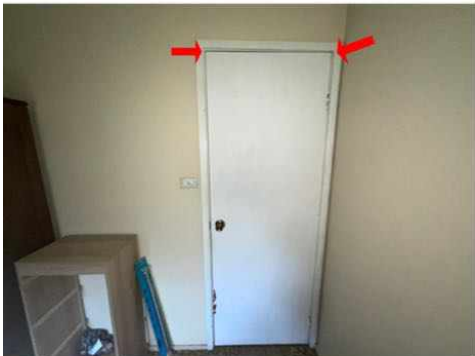
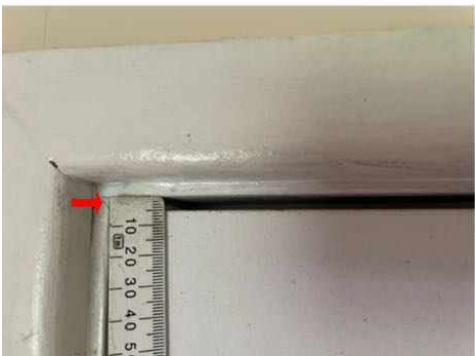
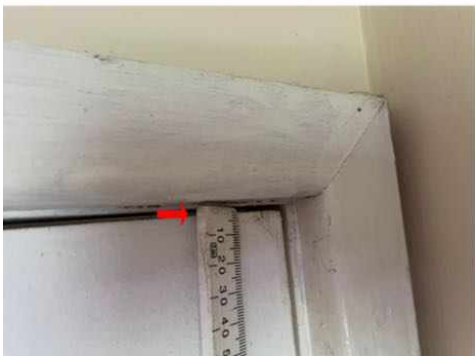
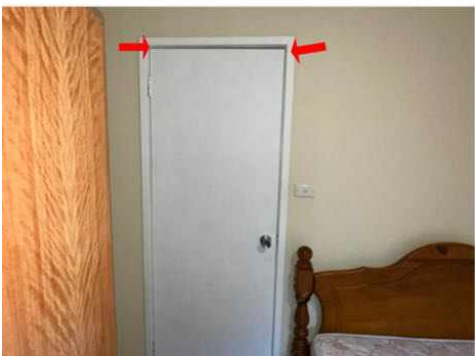
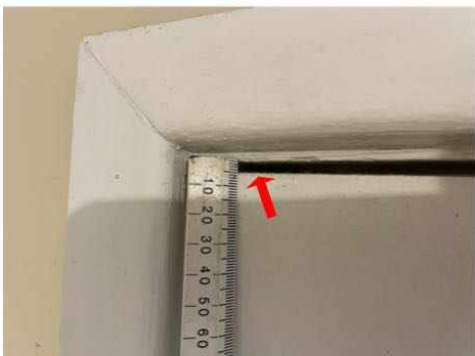
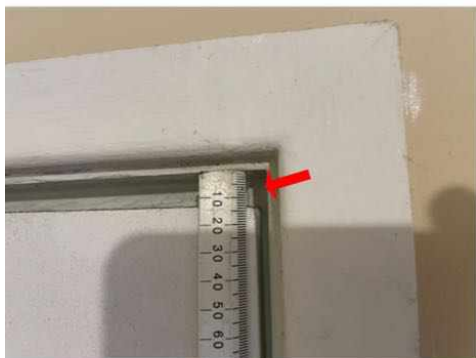
Building: Main Building  
 Location: Bedrooms > Front Right, Centre Right, Rear Right  
 Finding: Door - Gap  
 Information: Uneven gaps were identified between the door and door frame in this area. Where large gaps to the head or foot of door frames appear, it may indicate a variety of defects, ranging from uneven framework, sagging hinges or uneven flooring.

A gap to the head of the door may also indicate movement of the foundation of the property, which is a common occurrence and does not indicate structural damage.

A qualified carpenter should be appointed to perform remedial works to restore the door to a fully operational level.

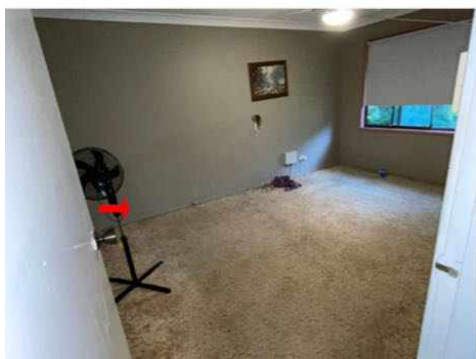
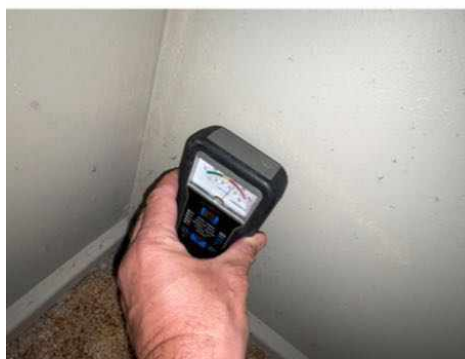
### Finding 3.17

Building:	Main Building
Location:	Bedroom - Front right > Front Right,Front
Finding:	Excessive moisture - identified
Information:	Excessive moisture was evident to the front right bedroom and the front centre bedroom at the time of the inspection. Excessive moisture can attract termites and produce conditions that promote fungal growth and wood decay.

Excessive moisture is generally caused by deteriorated, inadequate or missing roof drainage, leaking plumbing pipes or fixtures, poorly plumbed HWS overflows or condenser units and poor site drainage.

If mould growth has been found there may be environmental biological or health issues involved. In these cases an appropriately qualified inspector should also be contacted.

Prior to any remedial works being performed a qualified plumber should be appointed to further inspect the property and to identify the cause of the excessive moisture. Works to remove affected building elements may then be necessary and should be performed by an appropriate tradesperson.

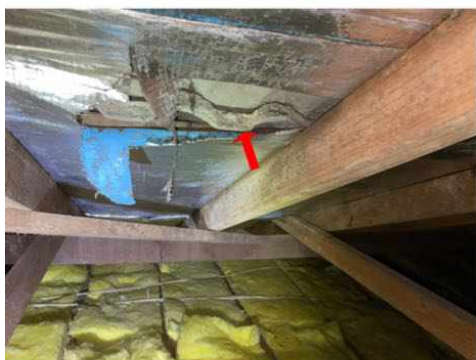
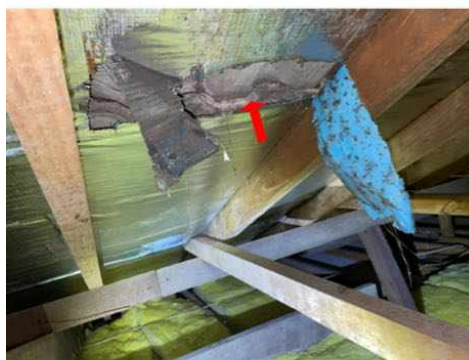
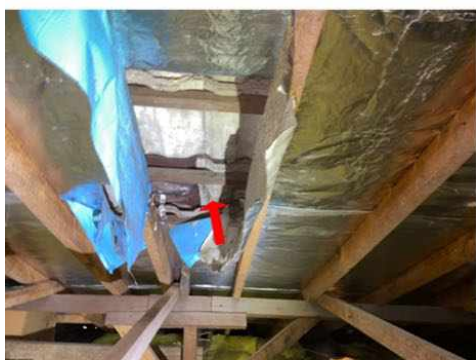
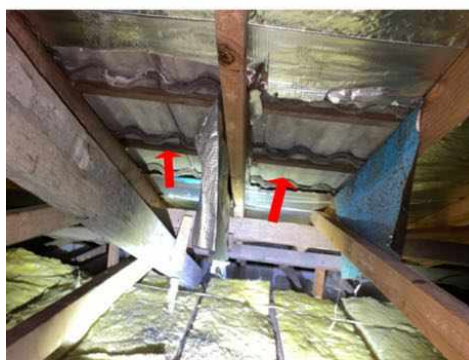
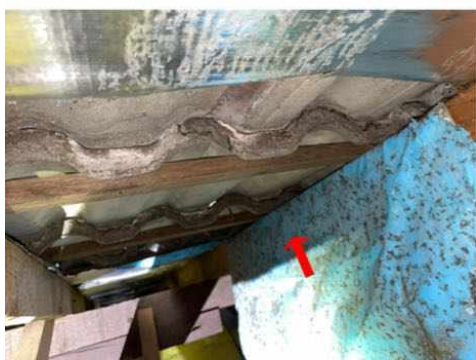
### Finding 3.18

Building:	Main Building
Location:	Roof Void > All Areas
Finding:	Sarking - Damaged
Information:	Some areas of sarking show some damage, including penetrations that has not been taped. Sarking, a laminated aluminium foil applied to the interior of the roof covering, assists in insulating the property and acting as a vapour-barrier to the roof void and, subsequently, to the household.

Where sarking is damaged, both insulation and moisture protection of the property are inhibited. This creates a loss of energy and thus negatively impacts the energy efficiency of the property, allowing potential for moisture ingress from condensation or leaking roof tiles.

It is important to repair any holes or damaged sections of sarking to ensure that the building material is fully functional. A builder or qualified carpenter should be consulted to provide further advice on this defect and to perform rectification works at client discretion.

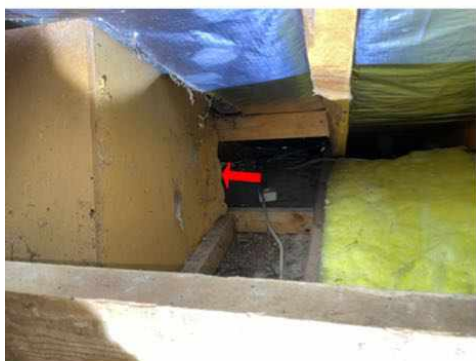
### Finding 3.19

Building:	Main Building
Location:	Roof Void > Centre,Rear
Finding:	Skylight - water damaged shaft
Information:	The skylight section within the roof space shows visible signs of water staining and moisture-related deterioration to surrounding timbers and lining materials. Discolouration and marking were noted to framing elements adjacent to the skylight penetration.

Water ingress at skylights commonly results from failed flashing, deteriorated seals, or inadequate installation detailing. Ongoing moisture intrusion can lead to timber decay, insulation deterioration, mould growth, and potential ceiling damage below if not

rectified.

A licensed roofer should inspect the skylight flashing and surrounding roof detailing to determine the source of ingress and undertake repairs as required. Any water-affected framing or linings should be assessed by a builder and repaired if necessary. This issue should be investigated in the short term to prevent further deterioration.

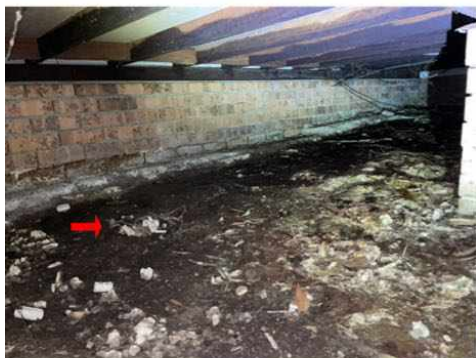
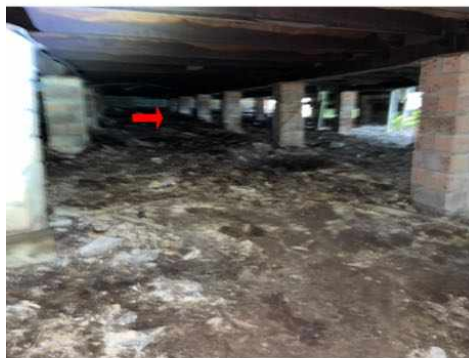
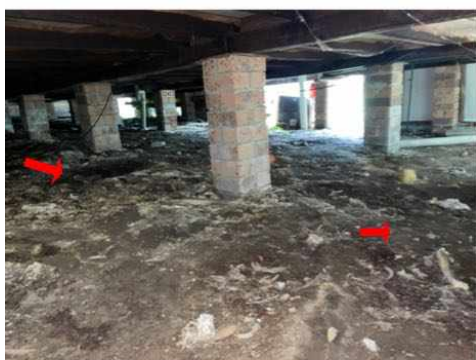
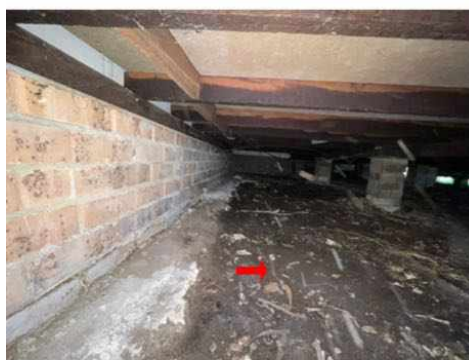
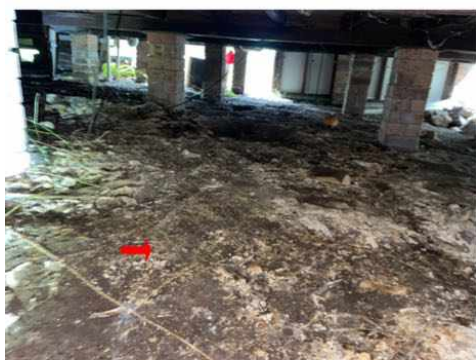
### Finding 3.20

Building:	Main Building
Location:	Subfloor > All Areas
Finding:	Subfloor Site Drainage - Inadequate
Information:	The site drainage within the subfloor area was found to be inadequate at the time of inspection. The exterior ground level was higher than the ground level within the subfloor creating damp brickwork and a moist subfloor area to the front of the building thus creating potential for subsequent water damage to associated building elements. This is also apparent as there appears to be some subsidence to the soils within the subfloor space. Poor site drainage can also lead to subsidence of the stumps which based on the floor levels may have happened to some degree.

It is important that water does not lie against the base of walls; surrounding paths and ground levels should be sloped to drain water away from walls. Stormwater should be carried away by large, regularly cleaned drains. Ground levels may need to be lowered to expose a buried DPC.

Where site drainage is inadequate, installation of an Agricultural (Aggie) Drain may be required. A qualified plumber should be appointed to further inspect the property and perform any remedial works as necessary. Water damage and secondary defects are likely to occur if left unmanaged.

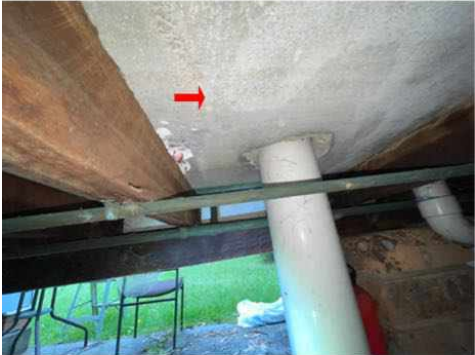
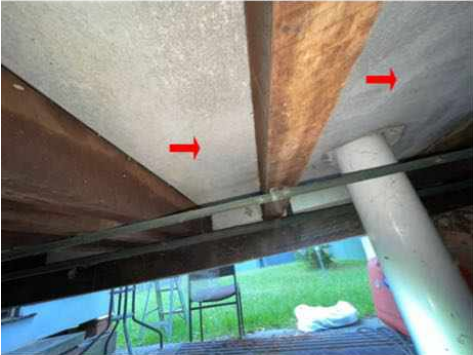
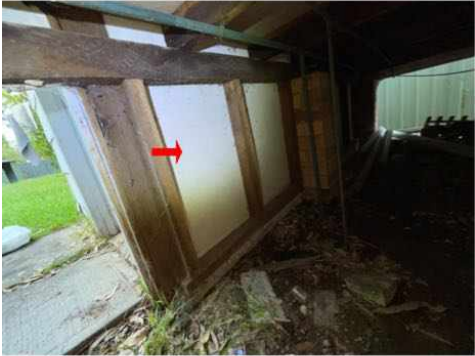
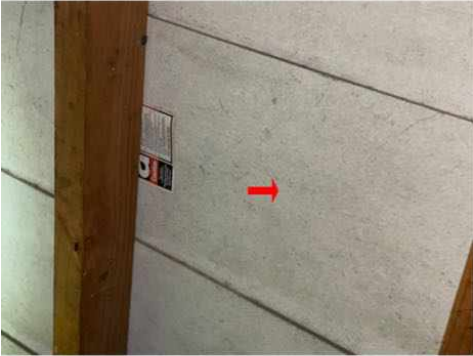
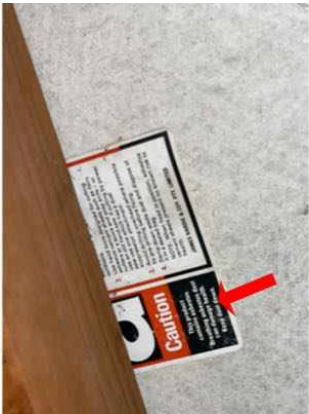
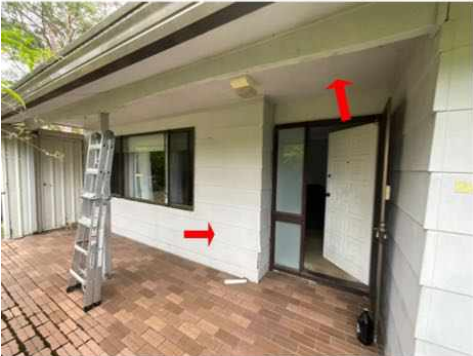
### Finding 3.21

Building:	Main Building
Location:	All External Areas > All Areas
Finding:	Asbestos - Suspected ACM Identified on Site
Information:	The external cladding the flooring below the wet areas, the laundry and eaves are likely to be asbestos. Reporting on Asbestos is outside the Scope of this Report. This suspected defect is highlighted as a caution only. We suspect, based on our experience in the building industry, that there is a higher risk of the identified building element containing asbestos.

As Asbestos Reporting is outside the scope of this report, we advise that you consider a separate Asbestos Inspection and Condition Audit, which can include the taking of

samples for definitive confirmation of the presence of Asbestos.

In the interim, the client is advised to act with caution, especially when considering any damage to building materials general wear and tear renovations extensions demolition and general maintenance activities due to the suspected presence of Asbestos.

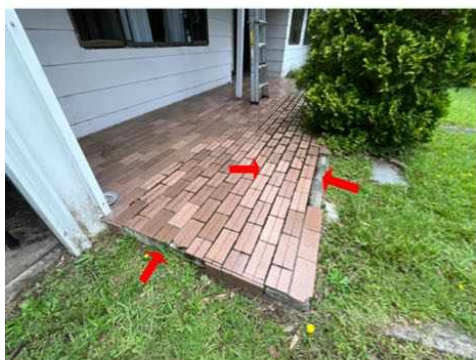
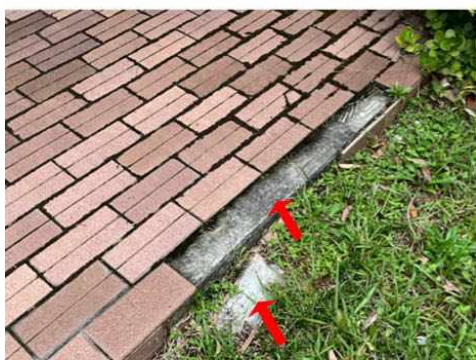
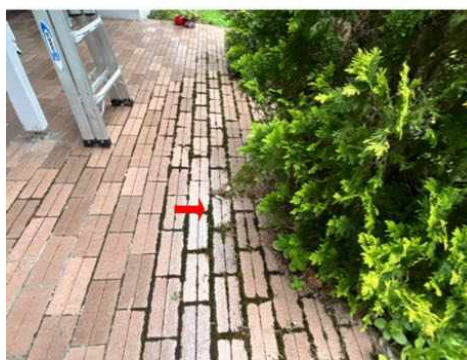
Building:	Main Building
Location:	Porch > Front
Finding:	Porch Tiling - Defects
Information:	The tiling to the front porch area shows multiple cracked tiles, isolated missing tiles, and significant moss growth within mortar joints/grout lines. Some tiles appear uneven and there are open joints where grout has deteriorated or is missing.

Cracked and missing tiles may allow water penetration beneath the tiled surface, potentially leading to further tile lifting, substrate deterioration, or concrete spalling over time. Moss growth indicates ongoing moisture retention, which can accelerate surface degradation and create a slip hazard, particularly in wet conditions.

A qualified tiler or builder should assess the tiled area, remove and replace cracked or missing tiles, re-grout affected joints, and clean/treat the surface to remove moss. Rectification should be undertaken in the short term to prevent further deterioration and reduce safety risks.

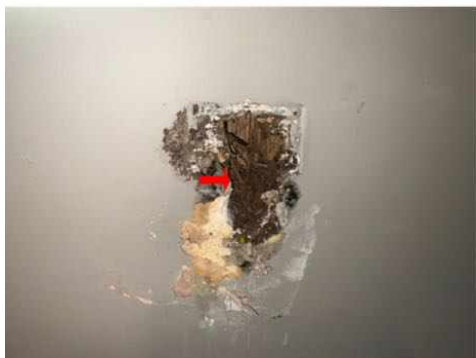
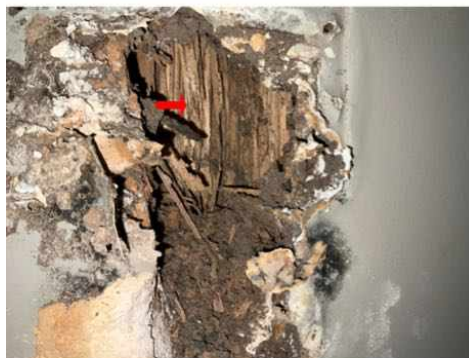
Building:	Main Building
Location:	Bedroom > Front Right
Finding:	Evidence of termite damage - structural
Information:	Despite no live termite or timber pest activity being identified, previous termite damage was found in the the front right bedroom. It is expected the hole in the wall was due to a bait station being installed to manage a termite infestation. This damage is considered to be major and structural in nature based on the amount of damage to this timber. Such damage creates a potential safety hazard, and is likely to worsen and cause further damage to adjoining building materials.

If left unattended, this damage creates an unsafe environment and is likely to lead to the need for major structural works.

A building contractor should be appointed immediately to advise on options to prevent further damage and repair all affected building materials. Until such time, caution

should be taken by all people coming into contact with these building elements and this area.

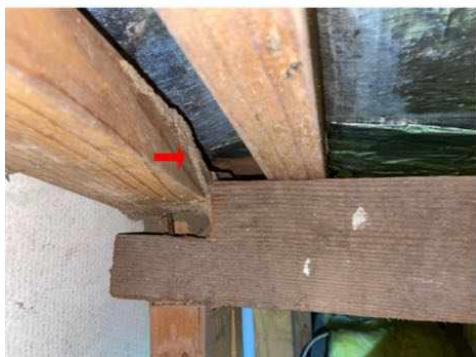
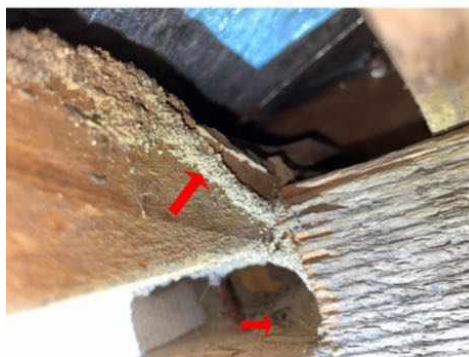
### Finding 5.02

Building:	Main Building
Location:	Roof Void > Centre Right,Front Right,Rear Right
Finding:	Evidence of termite damage - structural
Information:	Despite no live termite or timber pest activity being identified, previous termite damage was found in this area. This damage is considered to be major and structural in nature. Such damage creates a potential safety hazard, and is likely to worsen and cause further damage to adjoining building materials.

If left unattended, this damage creates an unsafe environment and is likely to lead to the need for major structural works.

A building contractor should be appointed immediately to advise on options to prevent further damage and repair all affected building materials. Until such time, caution should be taken by all people coming into contact with these building elements and this area.

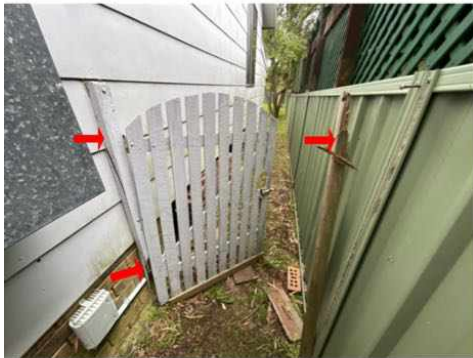
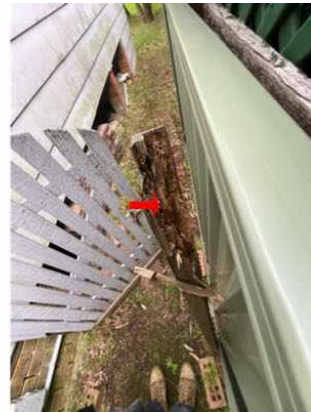
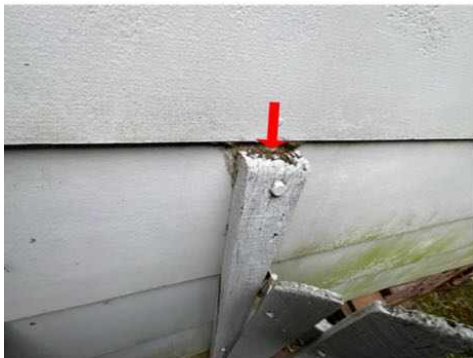
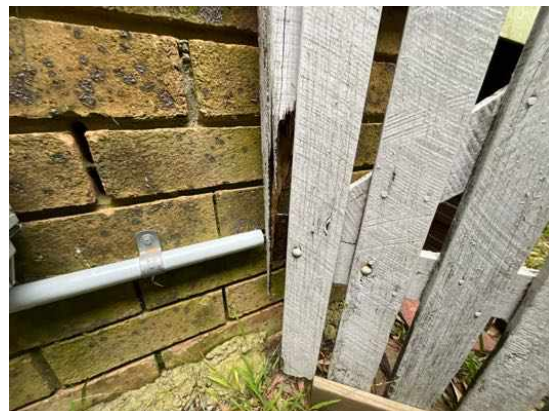
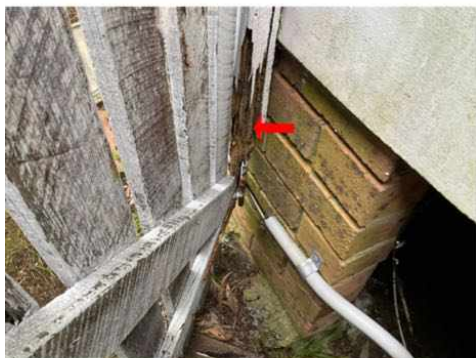
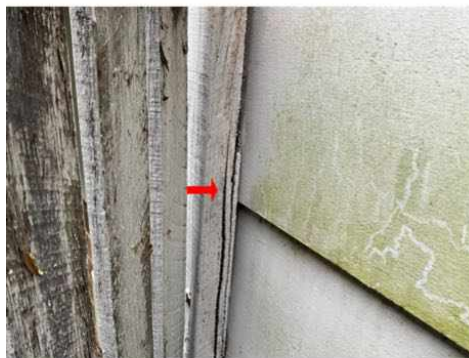
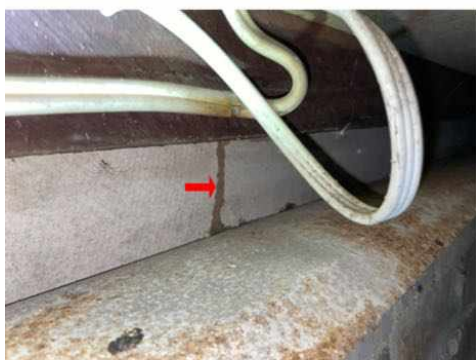
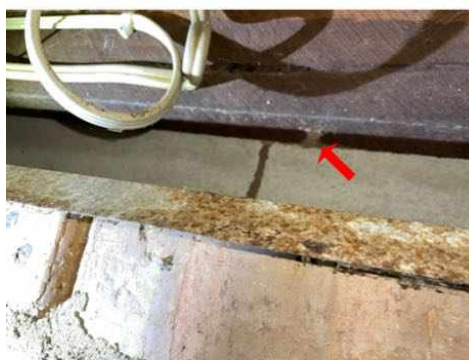
Finding 5.03

Building: Main Building  
Location: Subfloor, Exterior gate > Front Right  
Finding: Evidence of termite damage - minor  
Information: Despite no live termite or timber pest activity being indicated, previous termite damage was found to have affected the gate posts with the termites entering the subfloor space where it appears to enter the wall above. This damage is considered to be inactive and is minor in nature.

It is advised that the area be visually inspected frequently to ensure that the condition of affected building materials does not worsen. At the time of inspection, damage is not structural and is only considered to be superficial.

A building contractor may be appointed to provide a further invasive inspection if further damage is evident.

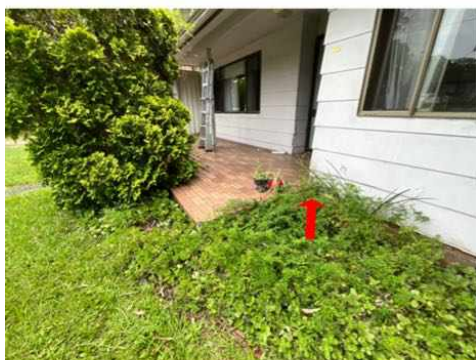
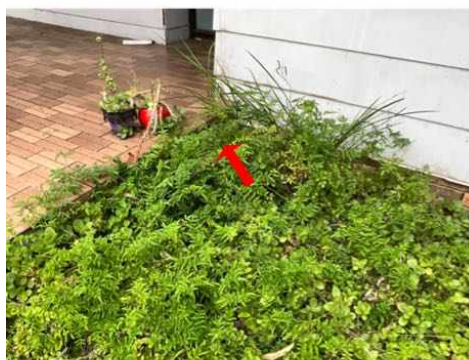
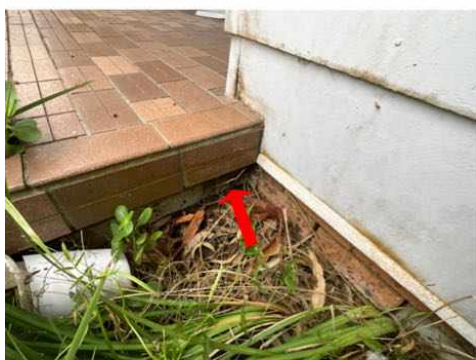
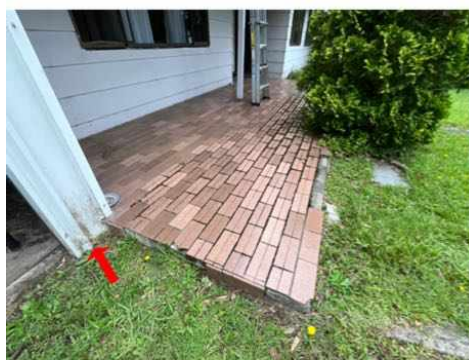
### Finding 6.01

The concrete porch and rear concrete alfresco slab abutting was providing a concealed entry point at the time of the inspection. Where the location of the porch is retrospectively installed against an external wall, this provides a concealed entry point for termites.

The client should consider gaining further advice from a timber pest technician as to treatments required in this area. It is recommended that obtaining such advice be a

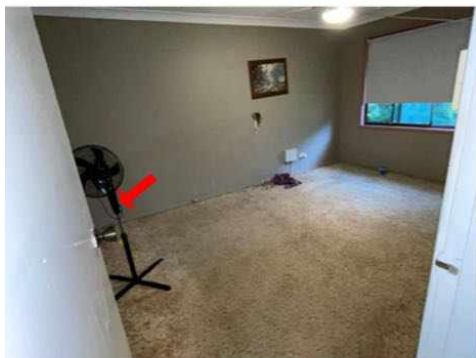
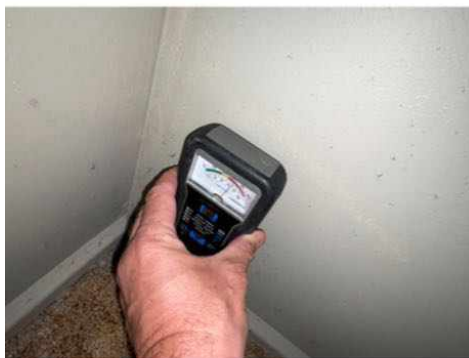
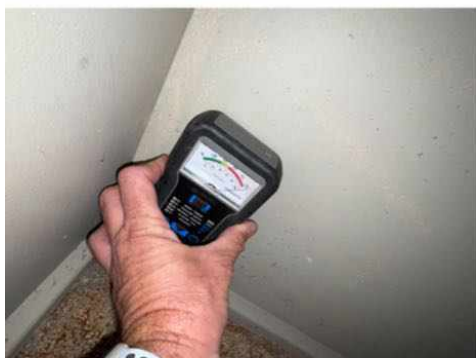
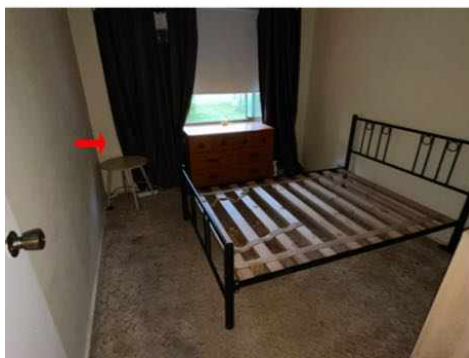
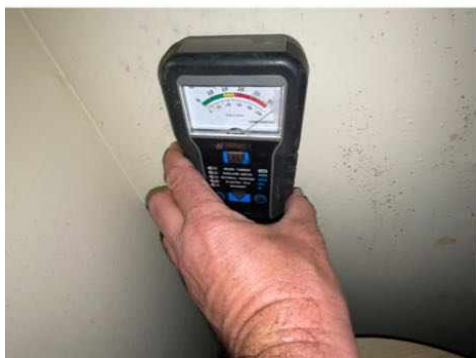
## Finding 6.02

Building:	Main Building
Location:	Bedroom - Front right, Bedroom - Front centre > Front Right, Front
Finding:	Excessive moisture - identified
Information:	Excessive moisture was evident to the front right bedroom and the front centre bedroom at the time of the inspection. Excessive moisture can attract termites and produce conditions that promote fungal growth and wood decay.

Excessive moisture is generally caused by deteriorated, inadequate or missing roof drainage, leaking plumbing pipes or fixtures, poorly plumbed HWS overflows or condenser units and poor site drainage.

Prior to any remedial works being performed a qualified plumber should be appointed to further inspect the property and to identify the cause of the excessive moisture. Works to remove affected building elements may then be necessary and should be performed by an appropriate tradesperson.

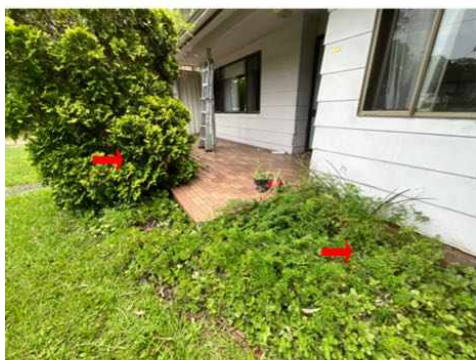
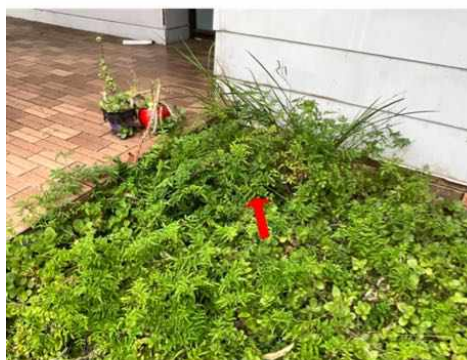
### Finding 6.03

Building: Main Building  
Location: Yard - Front > Front  
Finding: Garden Beds - Conditions Conducive to Termites  
Information: Garden beds were found to be evident in the garden area. These garden beds can include untreated timber, and with a combination of moisture from watering hosing can make conditions conducive to termite activity and termite ingress.

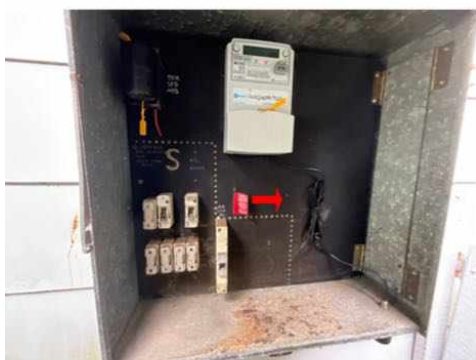
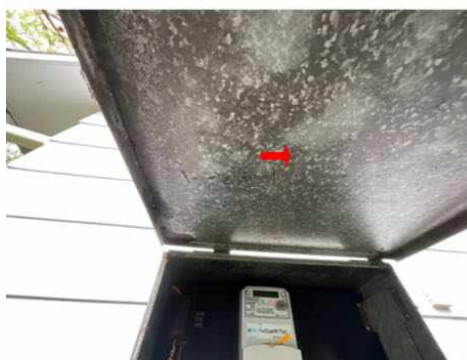
### Finding 6.04

Building:	Main Building
Location:	Meter Box > Front Right
Finding:	Termite Management System - no evidence of a chemical installation
Information:	The application of a post-construction chemical termite barrier is highly recommended for all properties, particularly if live termite activity has been found on the site previously. Such barriers are highly effective in preventing termite attack on any timber building elements throughout the property.

A durable notice should be placed in the switchboard unit to indicate current termite barriers. At the time of inspection, it appeared as though no termite management system has been installed, with no evidence to suggest preventative works taking place.

The client may consider gaining further advice from a pest controller as to the costs and procedures involved with this application. It is recommended that obtaining such advice be a short-term priority.

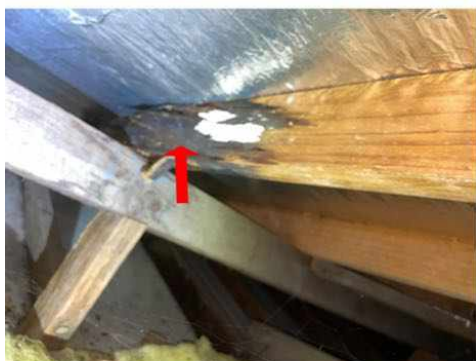
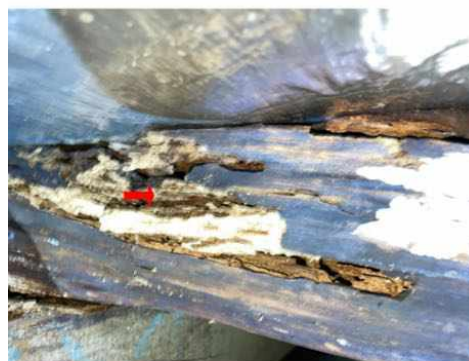
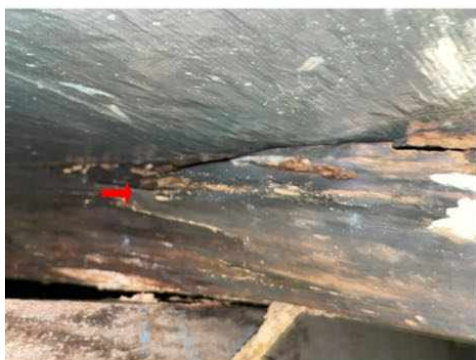
### Finding 7.01

Building:	Main Building
Location:	Roof Void > Front
Finding:	Wood rot - Rafter
Information:	Significant wood rot was found to a rafter in the roof space that showed considerable damage. It was apparent that this area also had termite damage. Based on the rafter being a structural item this is considered a major defect. This building element shows evidence of wood rot. Wood rot, also known as Fungal Decay, occurs when timbers and other cellulose building materials are exposed to damp conditions on an ongoing basis. This could be the result of exposure to weathering over a prolonged period of time, or the attraction of excessive moisture from other abutting building materials. Contributing factors also include poor air ventilation in the area.

Wood rot is often associated with general damp problems and is evidenced by a 'musty' smell or mould and mildew occurring on surfaces. If left unmanaged, damp conditions can lead to further health problems and the decay of timbers will continue.

Early intervention and regular maintenance, particularly of exterior timbers, will prolong the useful life of these building elements. Prior to any works being performed, the cause of the moisture that has created the visible wood rot should be identified and addressed in a suitable manner. Replacement of affected timbers may then be a necessary step in protecting surrounding building elements from such deterioration.

A qualified plumber may be appointed to assess the cause of excessive moisture and to provide advice on any remedial works as required. A qualified carpenter or registered builder may also be required to replace affected building materials.

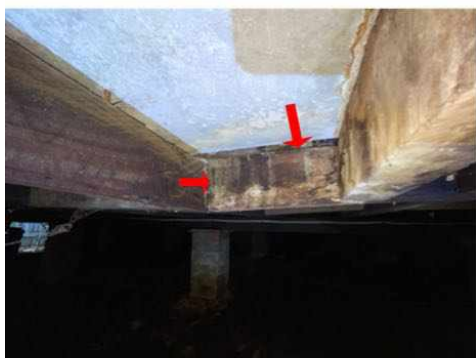
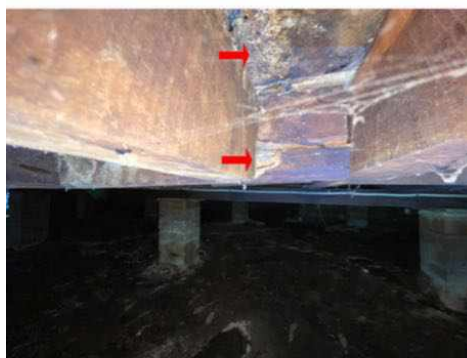
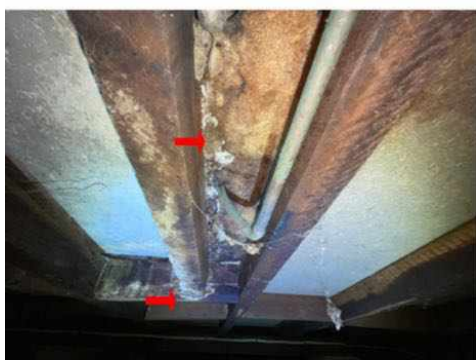
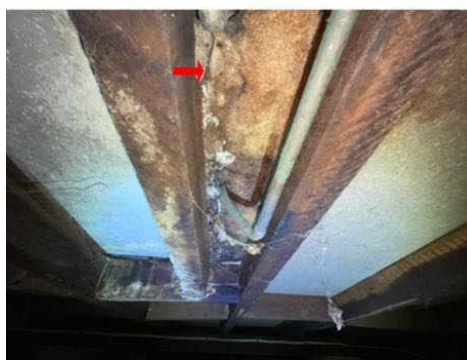
## Finding 7.02

Building:	Main Building
Location:	Subfloor > Rear
Finding:	Wood rot - Timber framing
Information:	Some of the timber below the bathroom/toilet area shows evidence of wood rot. Wood rot, also known as Fungal Decay, occurs when timbers and other cellulose building materials are exposed to damp conditions on an ongoing basis. This could be the result of exposure to weathering over a prolonged period of time, or the attraction of excessive moisture from other abutting building materials. Contributing factors also include poor air ventilation in the area.

Wood rot is often associated with general damp problems and is evidenced by a 'musty' smell or mould and mildew occurring on surfaces. If left unmanaged, damp conditions can lead to further health problems and the decay of timbers will continue.

Early intervention and regular maintenance, particularly of exterior timbers, will prolong the useful life of these building elements. Prior to any works being performed, the cause of the moisture that has created the visible wood rot should be identified and addressed in a suitable manner. Replacement of affected timbers may then be a necessary step in protecting surrounding building elements from such deterioration.

A qualified plumber may be appointed to assess the cause of excessive moisture and to provide advice on any remedial works as required. A qualified carpenter or builder may also be required to replace affected building materials.

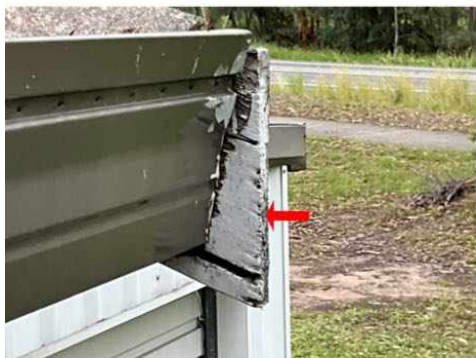
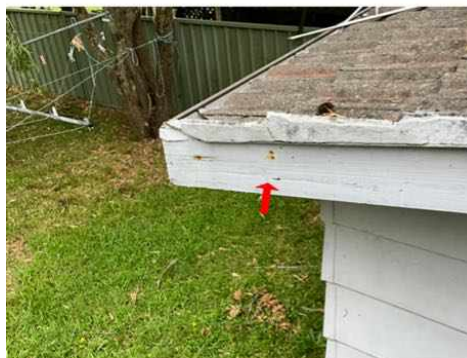
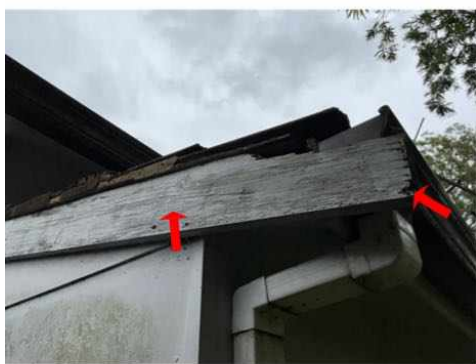
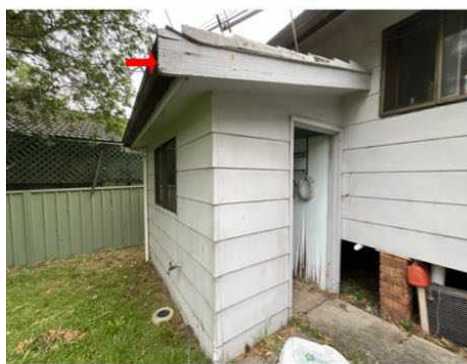
### Finding 7.03

Building:	Main Building
Location:	Roof Exterior > All Areas
Finding:	Fascias - Wood rot
Information:	Wood rot was found to be affecting fascias and barges in this area, evidenced by the presence of mould on the surface in some areas. Wood rot, also known as Fungal Decay, occurs when timbers and other cellulose building materials are exposed to damp conditions on an ongoing basis.

It is likely that this wood rot has developed as a result of faults in the roof plumbing, creating excessive moisture in this areas. Frequent exposure to rain and other weather conditions also make fascias and barges susceptible to accelerated deterioration.

Early intervention and regular maintenance will prolong the useful life of these building elements. Prior to any works being performed, the cause of the moisture that has created the visible wood rot should be identified and addressed in a suitable manner.

It is advised that a roof plumber be appointed to inspect all roof plumbing and subsequently identify the cause of the wood rot. Replacement of affected fascias and barges may then be a necessary step in protecting surrounding building elements from such deterioration.

A qualified plumber may be appointed to assess the cause of excessive moisture and

to provide advice on any remedial works as required. A qualified carpenter or builder may also be required to replace affected building materials.

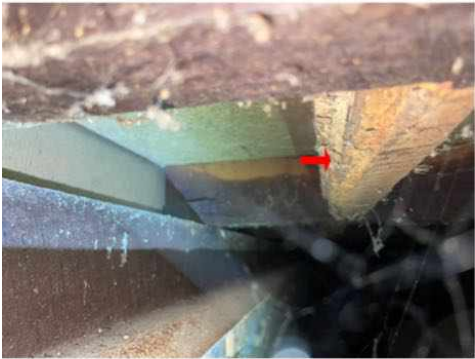
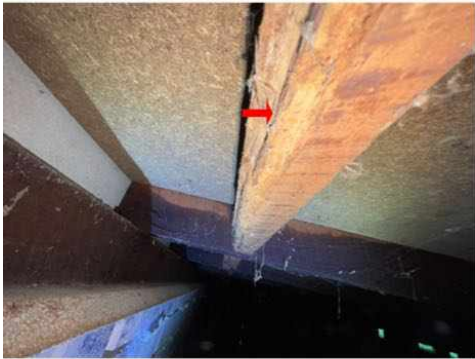
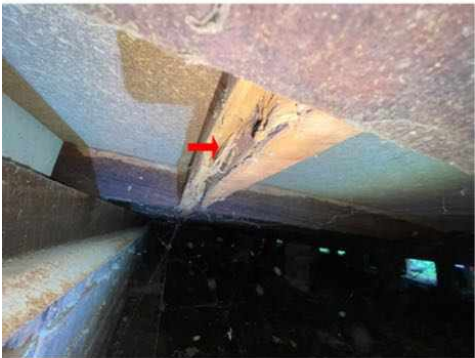
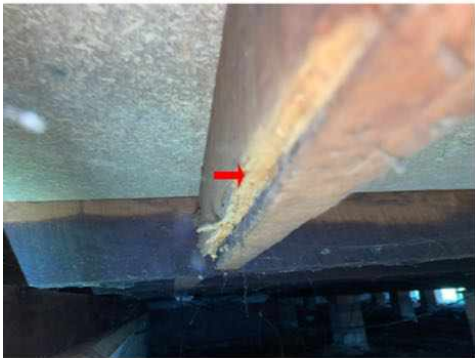
Building:	Main Building
Location:	Subfloor > Front Right
Finding:	Evidence of wood borer activity identified
Information:	Wood borers small beetles that colonise in exposed timber elements are a common timber pest that are regularly mistaken for termites. Although wood borer activity is generally not detrimental to the affected timber they may lead to serious damage and necessitate replacement of certain building elements if left unattended.

The other commonly known borer the Anobium borer is more likely to attack floorboards and may cause severe structural damage to flooring areas.

As no live wood borer activity was identified treatment is not required at this time.

Replacement of affected timbers may be considered by the client for superficial reasons.

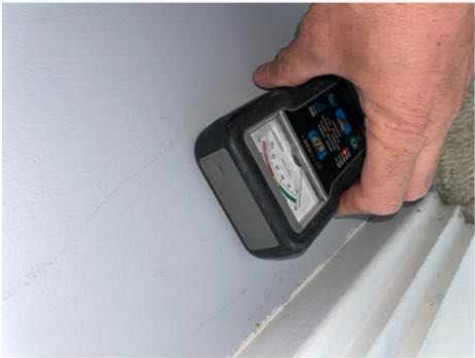
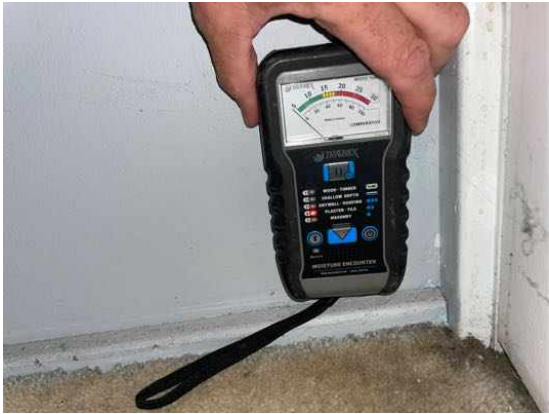
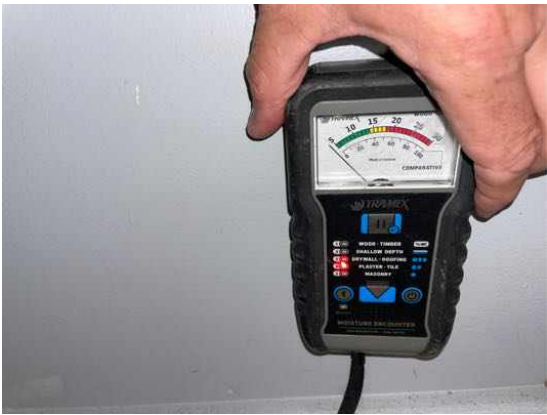
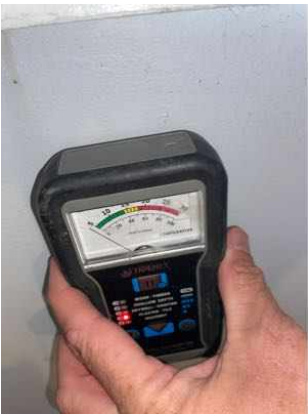
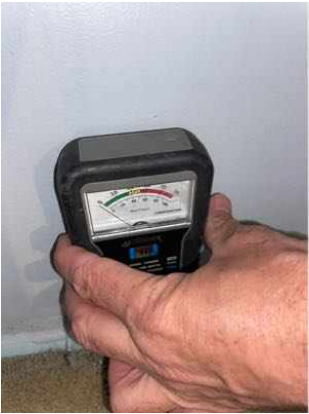
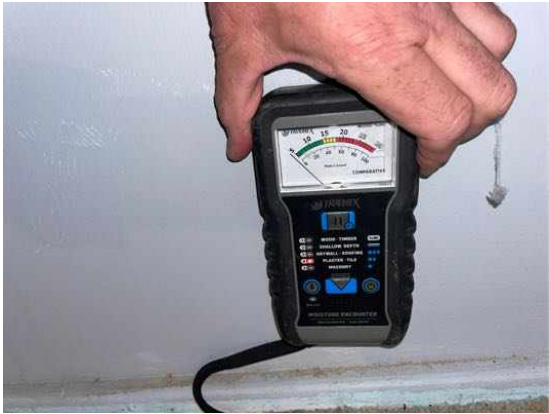
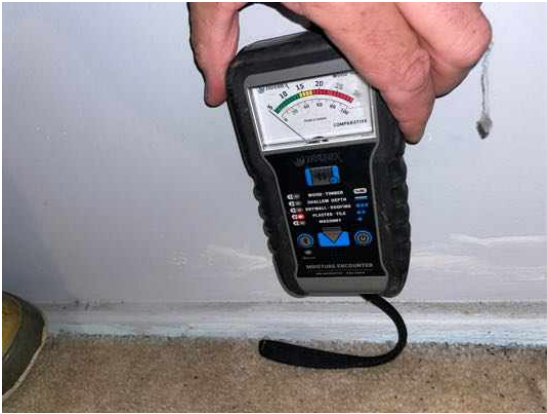
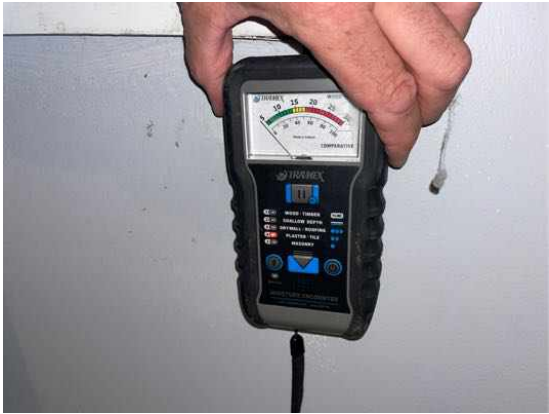
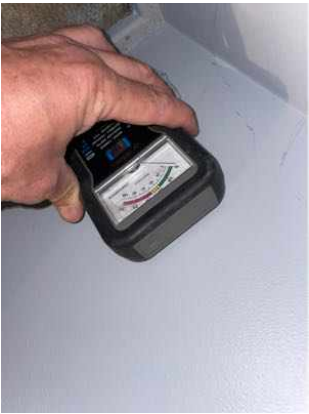
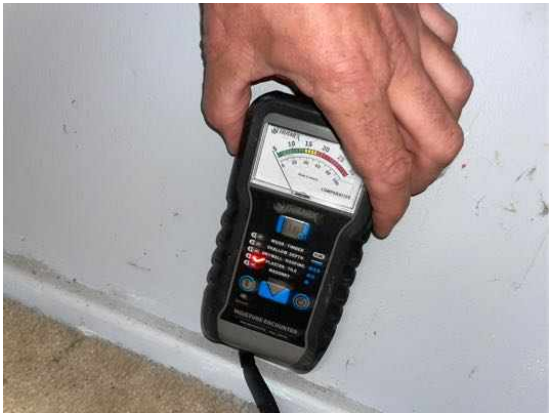
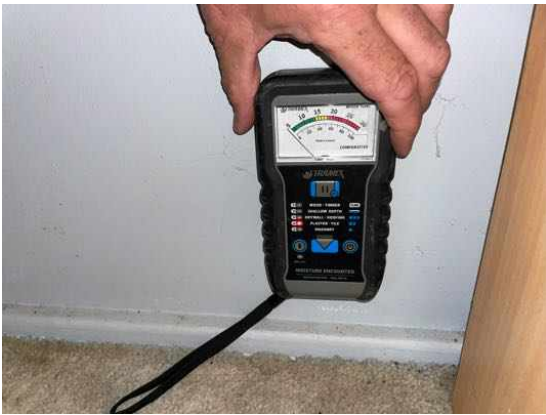
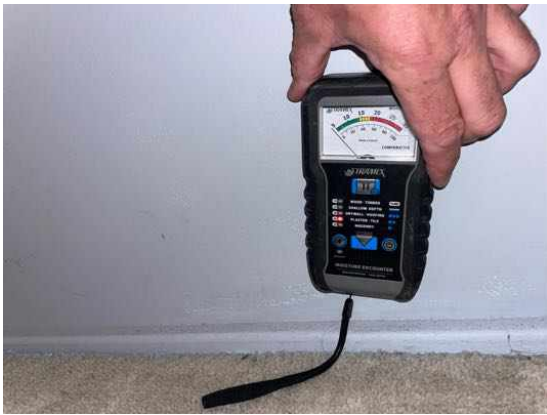
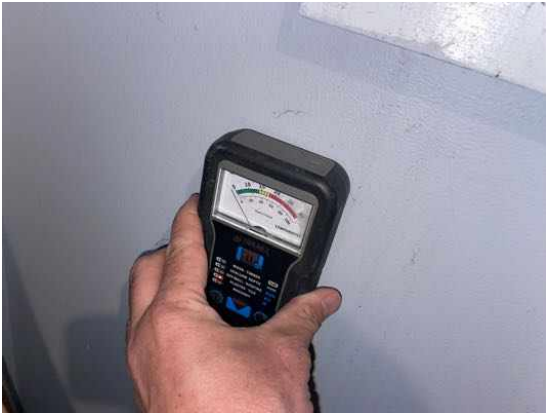
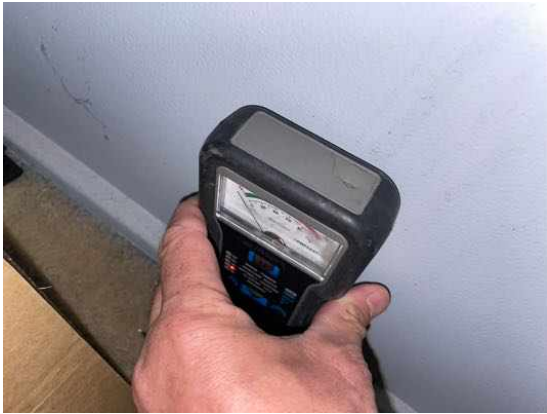
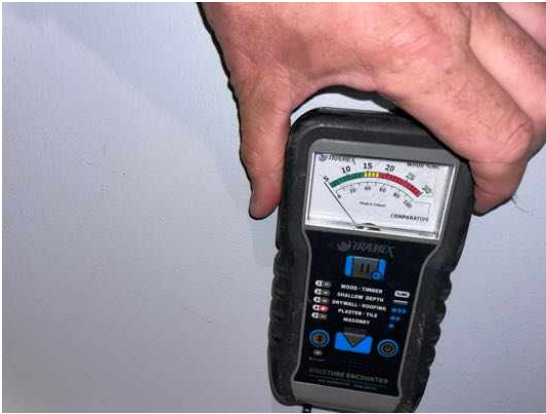
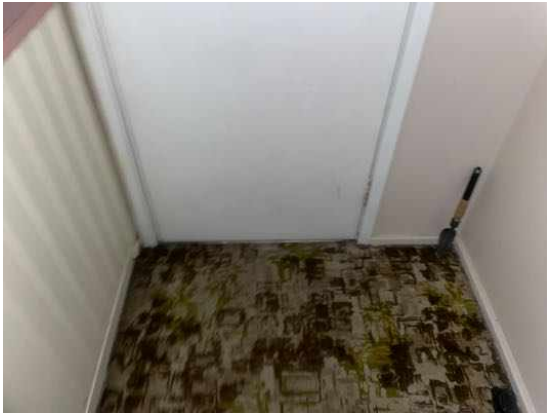
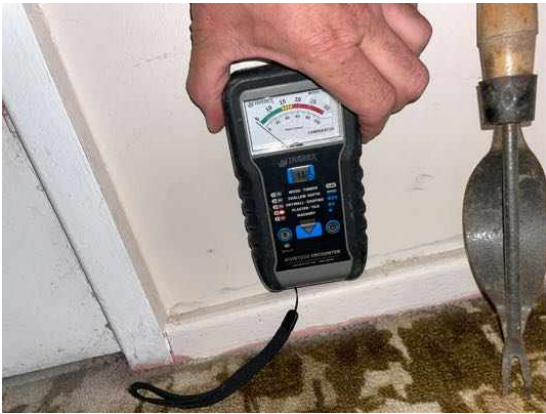
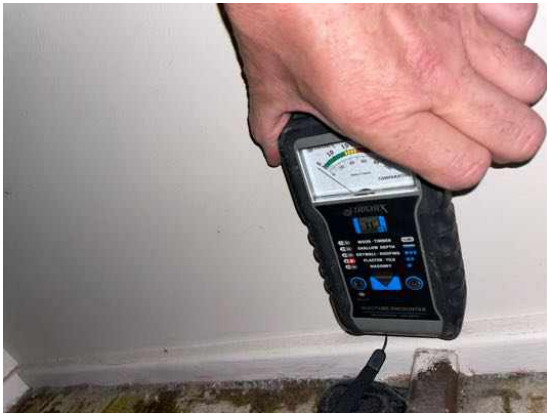
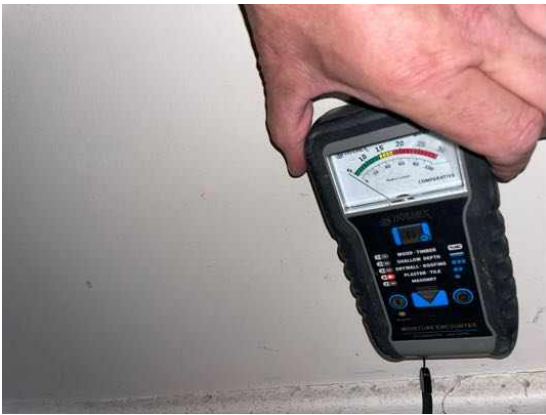
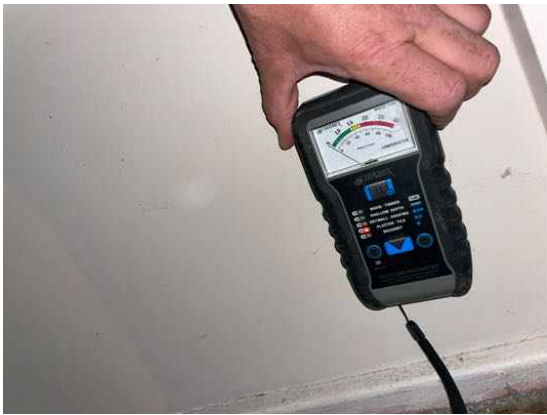
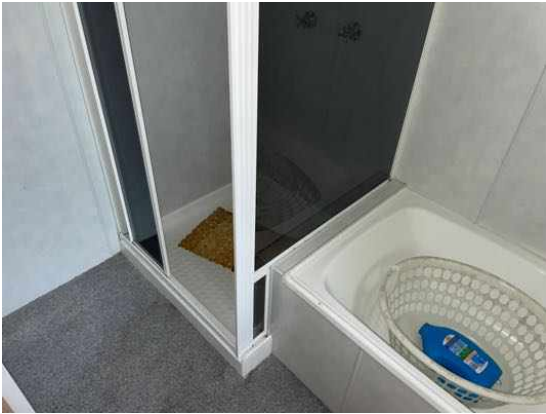
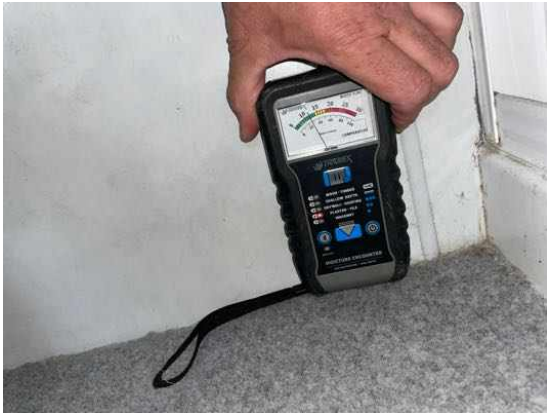
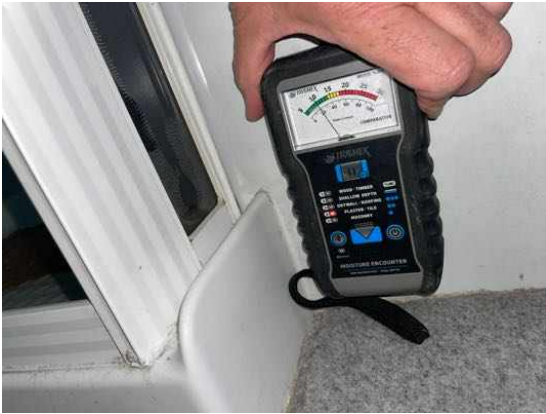
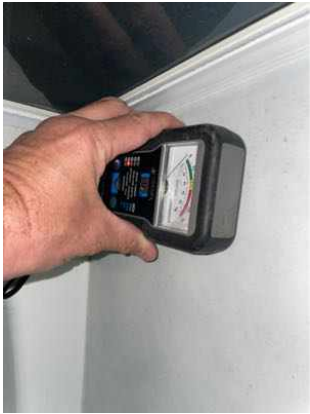
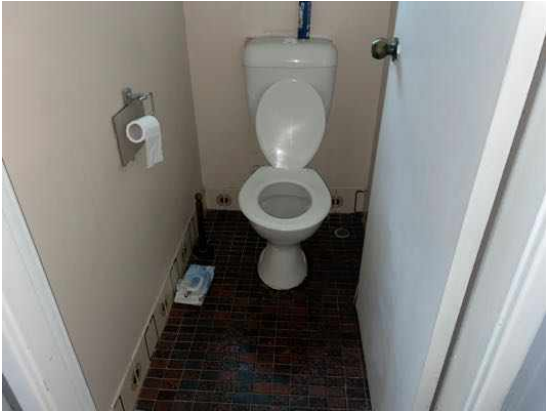
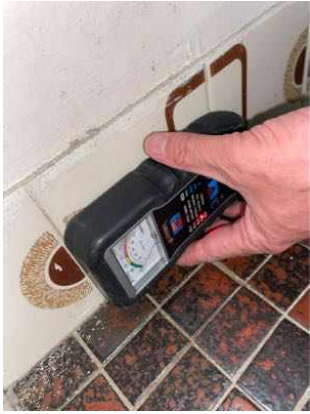
Building: Main Building  
Location: All Internal Areas > All Areas  
Finding: Moisture Readings  
Information: Moisture readings were taken to the wet areas and below and beside windows.
