# Building and Timber Pest Inspection Report

Inspection Date: Sun, 22 Feb 2026

Property Address: 31 Calder St, Schofields NSW 2762,  
Australia

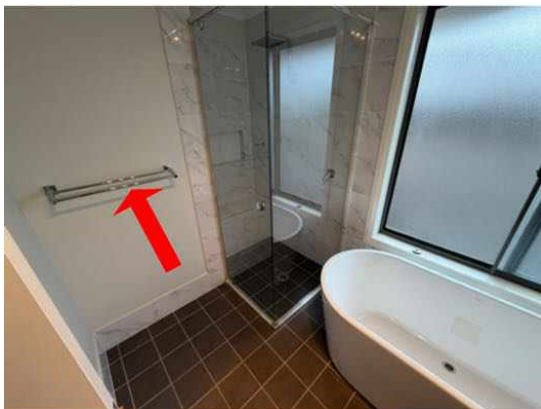
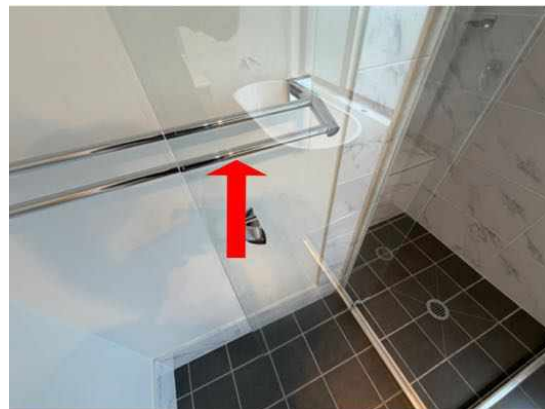
Building:	Main Building
Location:	Bathroom
Finding:	Shower Screen Door Impacting Towel Rail (Safety Hazard)
Information:	The shower screen door was observed to open directly into the metal towel rail located behind the door. No doorstop or limiting device has been installed to prevent the door from contacting the towel rail.

As a result, the door makes impact with the metal fixture during operation. This presents a safety hazard, as repeated impact may cause damage to the shower screen door, including the potential for glass breakage, hardware failure, or loosening of fixings. There is also an increased risk of personal injury should the glass be damaged or shatter.

I recommend to install a suitable doorstop, door limiter, or reposition the towel rail to prevent contact between the shower screen door and the metal towel rail. Any damaged components should be repaired or replaced as required. This should be carried out by a suitably qualified tradesperson.

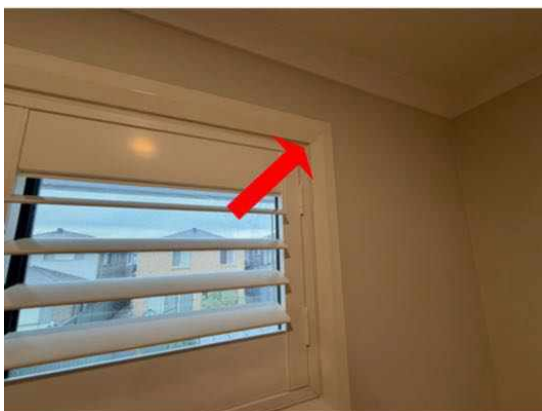
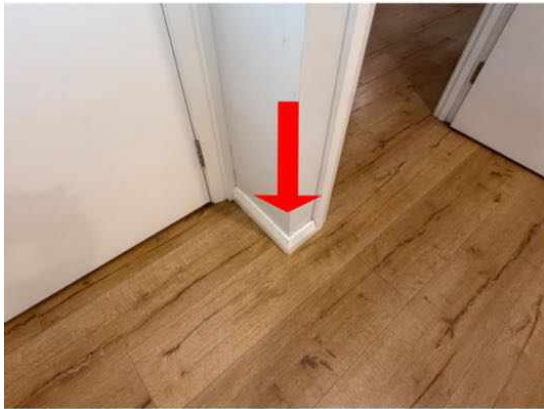
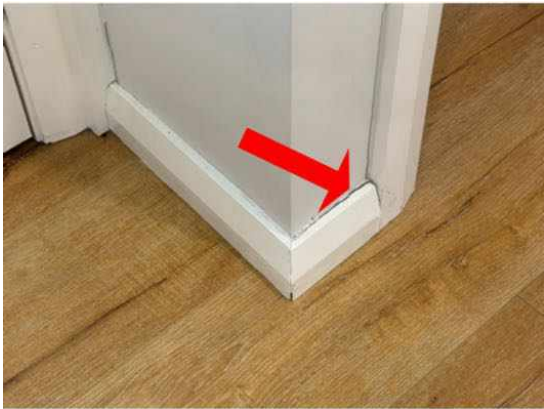
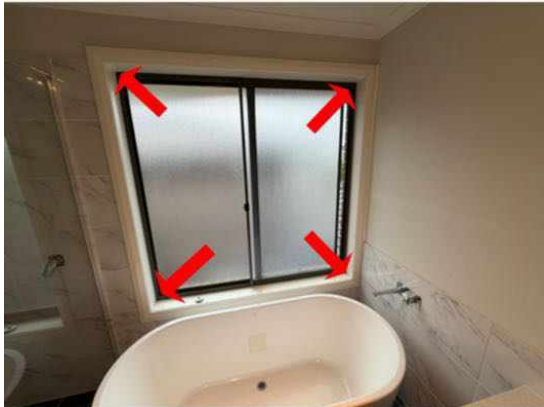
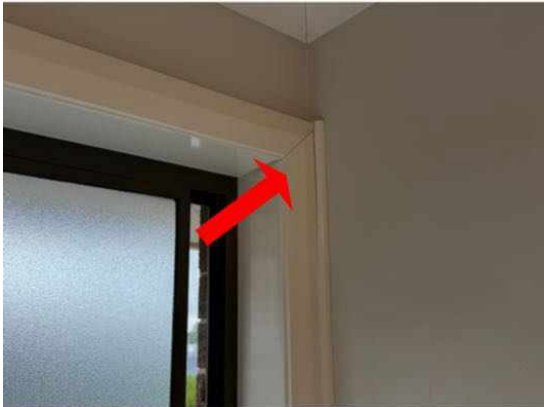
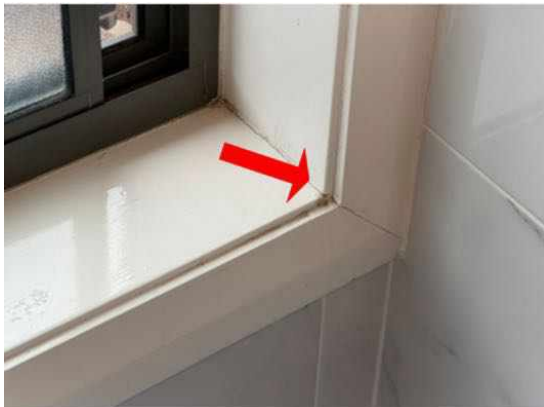
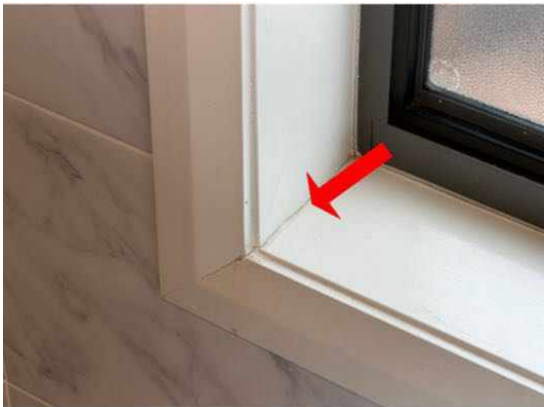
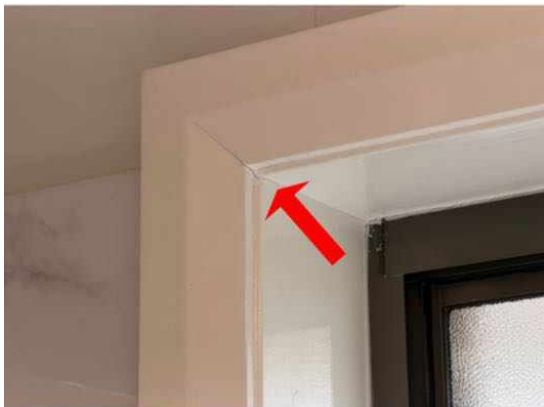
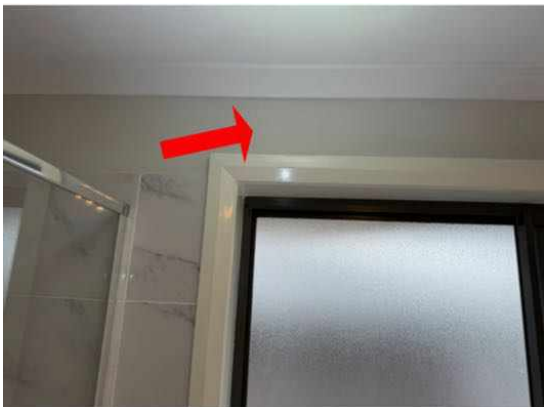
Finding: Cracking - Damage Category 1 - Fine (up to 1mm)

Information: Although fine cracks are quite noticeable, they are often only considered to be an appearance defect, and usually do not indicate any structural damage. Generally, the cause of a fine crack is indicative of a separation between building materials and finishes (e.g. paint, plaster, etc.) along joins.

Cracking of this nature can generally be repaired with minor sanding, filling and/or repainting. Such works should be performed by a qualified painter or a general handyman.

Monitoring of all cracking should be conducted frequently. Always contact a building inspector should cracks widen, lengthen, or become more numerous.

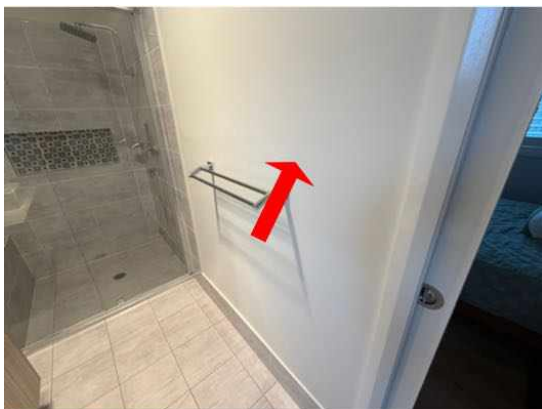
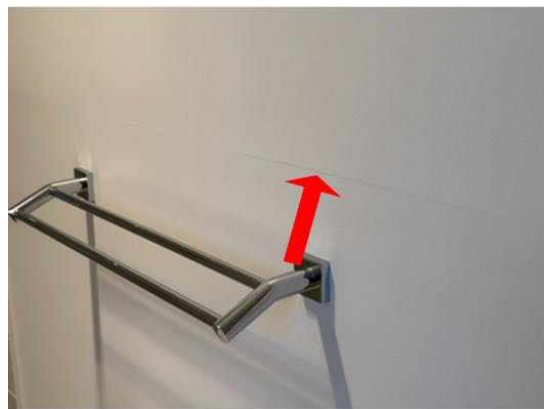
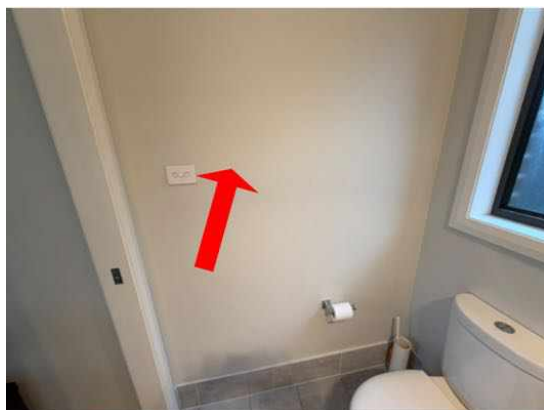
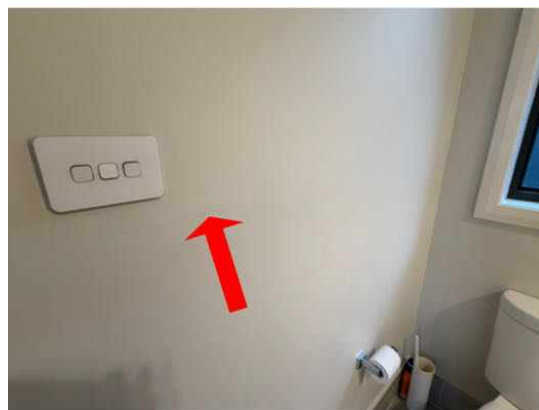
### Finding 3.02

Building:	Main Building
Location:	Ensuite Ground Floor
Finding:	Cracking - Damage Category 1 - Fine (up to 1mm)
Information:	Although fine cracks are quite noticeable, they are often only considered to be an appearance defect, and usually do not indicate any structural damage. Generally, the cause of a fine crack is indicative of a separation between building materials and finishes (e.g. paint, plaster, etc.) along joins.

Cracking of this nature can generally be repaired with minor sanding, filling and/or repainting. Such works should be performed by a qualified painter or a general handyman.

Monitoring of all cracking should be conducted frequently. Always contact a building inspector should cracks widen, lengthen, or become more numerous.

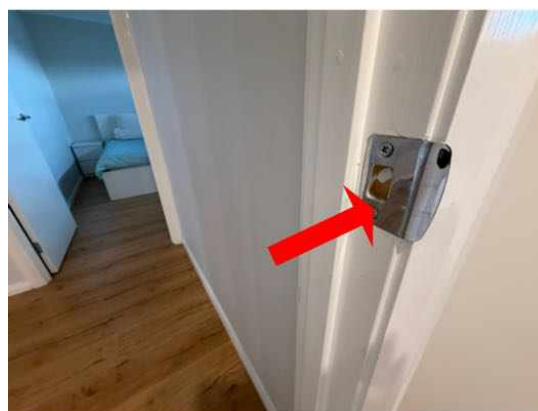
This is a common defect and whether being due to substandard installation or general deterioration of the door hardware.

Readjustment of the striker plate is recommended at client discretion. Works such as these can be completed by a general handyman or qualified carpenter.

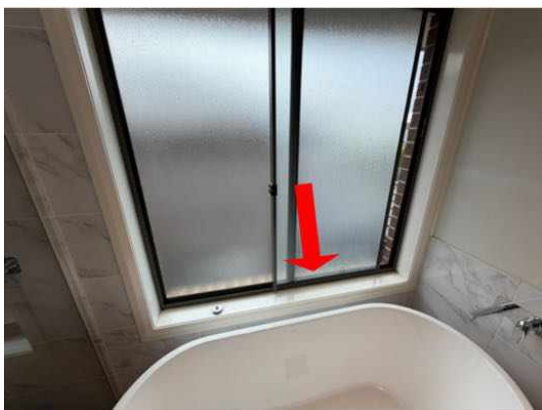
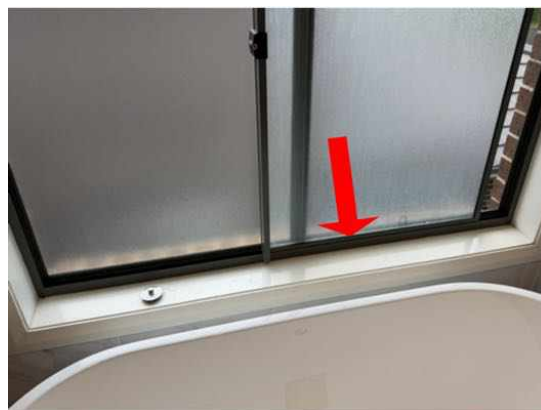
### Finding 3.05

Building: Main Building  
 Location: Bathroom  
 Finding: Windows - Difficult to operate  
 Information: The windows in all areas were jammed and/or difficult to operate at the time of the inspection. Windows provide ventilation to the adjoining area and should be at a fully operational level to ensure user comfort. Restricted function of the window may also pose as a potential safety hazard if required for emergency egress from the building.

Generally, factors such as general age of the building element and a lack of maintenance are the usual causes for this type of defect.

Replacement of window hardware or frame may be required, as well as minor repairs and cleaning. A registered builder or general handy person will be required to repair the window at the owners discretion.

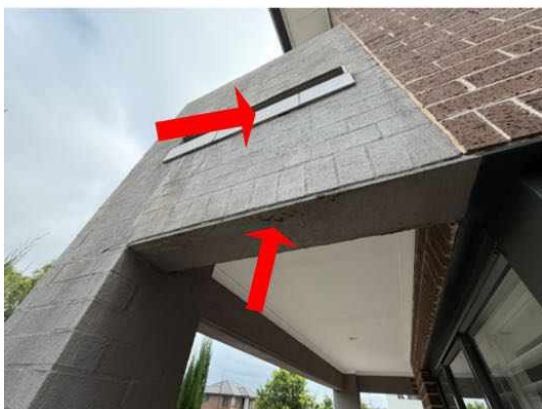
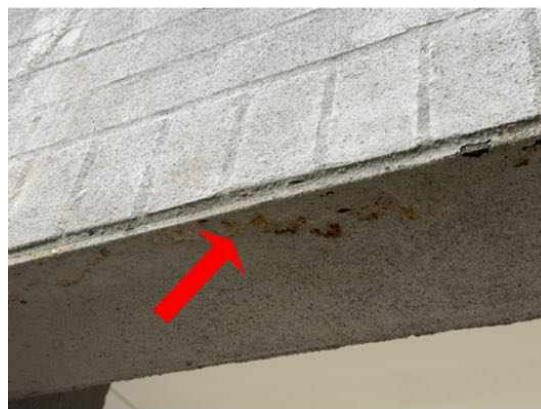
### Finding 3.06

Finding: Balcony-Drainage Causing Lintel Corrosion

Information: The upstairs balcony was observed to fall toward one side where stormwater is not adequately collected or discharged to a suitable drainage point. Instead, water is allowed to overflow the balcony edge, running down the external wall below.

This uncontrolled water discharge was noted to come into direct contact with the steel lintel beneath the balcony. Visible signs of corrosion and rusting are present to the lintel, indicating ongoing moisture exposure.

Prolonged water contact with structural steel components may lead to progressive deterioration, potential loss of protective coatings, and long-term structural implications if not addressed.

A suitable drainage solution should be installed to properly capture and discharge balcony stormwater (e.g. installation of an outlet, gutter, or rainwater head connected to the stormwater system). The affected steel lintel should be assessed, treated for corrosion, and repaired or recoated as necessary. Works should be carried out by suitably qualified tradespersons as a priority.

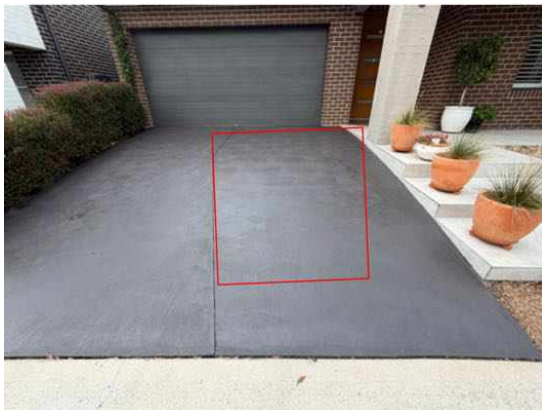
### Finding 3.07

Building: Main Building  
Location: Driveway  
Finding: Cracking - External Concrete Paving Damage Category 0 - Hairline (less than 1mm)  
Information: Hairline cracks were identified in external concrete paving. Hairline cracks are very minor in nature and generally are only ever an appearance defect. To be classified as a Category 0 or hairline crack, the crack width would be less than 0.3mm. While such cracking may be noticeable in some cases, it is common and does not indicate any structural damage.

Generally the cause of a hairline crack in existing concrete paving such as driveways and pathways is indicative of the expansion and contraction of the concrete. Such causes are generally due to environmental factors, such as moisture levels, weather conditions, root systems of nearby trees or the soil types on which they are laid.

Hairline cracks may also be due to poor original installation of the concrete. Factors such as poor compaction of the sub surface and/or inadequate reinforcing of the slab may create cracking and other secondary defects.

Monitoring of all cracking should be conducted frequently. Always contact a building inspector should cracks widen, lengthen, or become more numerous.

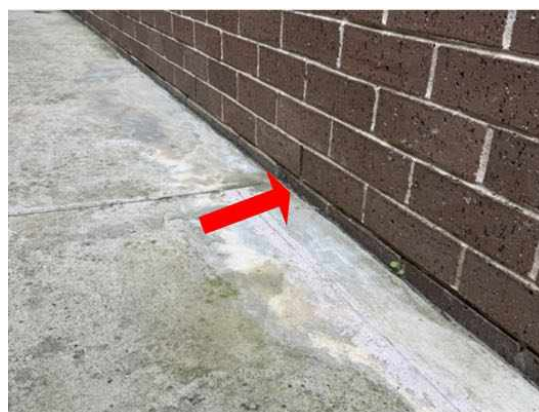
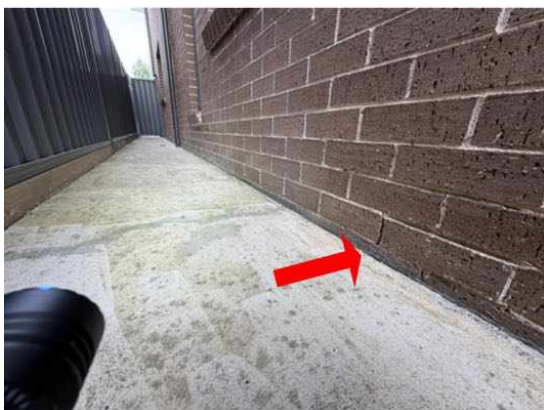
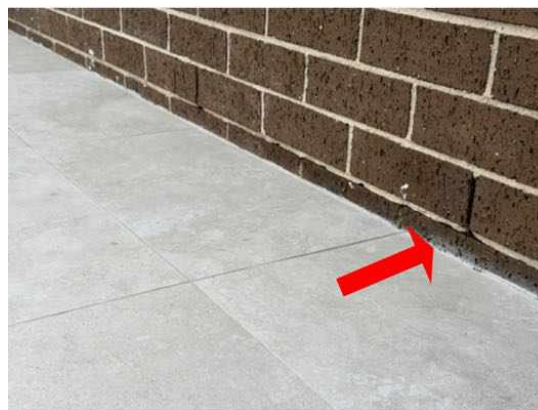
If the slab edge is not properly exposed there is a high risk of termite attack. Sometimes, in order to determine the type of slab, a suitably qualified person such as an architect or builder may be required to consult the construction plans.

Where the slab edge cannot be properly inspected, it is highly recommended that termite or timber pest inspections be carried out every 6-12 months to aid protection of the property against infestation.

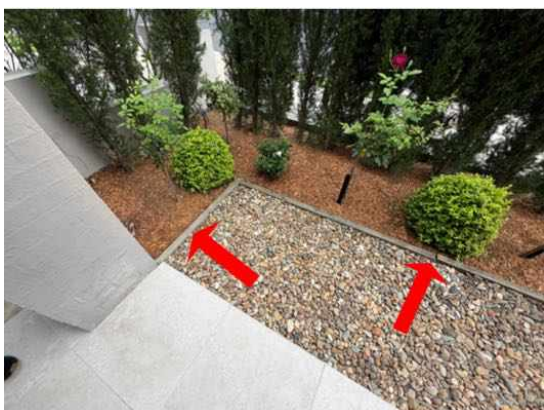
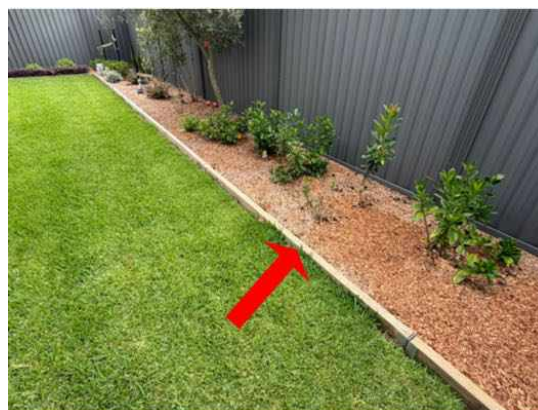
### Finding 6.02

Building:	Yard
Location:	Yard
Finding:	In ground contact
Information:	Any timbers in direct ground contact provide opportunity for concealed termite entry and are likely to be subject to premature rot and decay as the soil retains moisture or damp conditions against the timbers.

Treated Timbers can decay or be poorly treated at manufacturing and as they degrade overtime can allow for termite attack.

Remove any timber that is in direct contact with external grounds. Consider replacement with more durable materials i.e. non timber elements. Frequent pest inspections are advised to readily identify any termite activity in these areas.

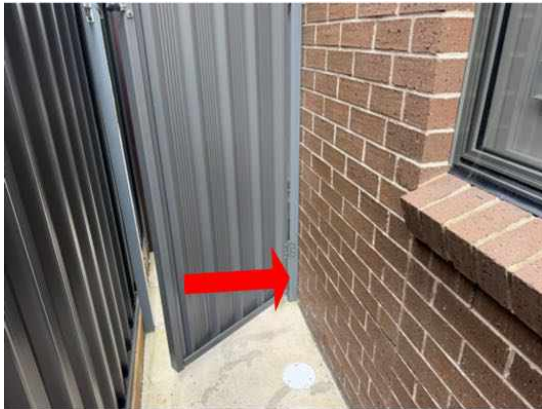
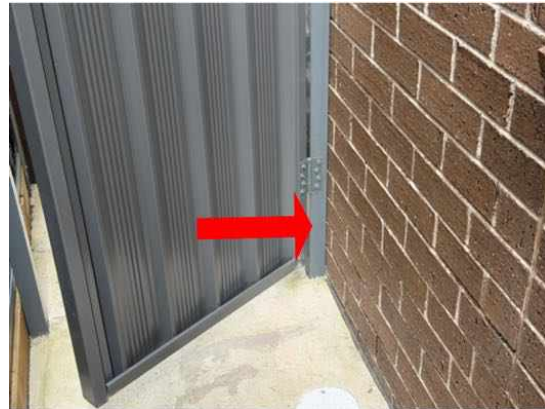
### Finding 6.03

Building:	Main Building
Location:	All Areas
Finding:	Bridging of termite barriers - Fences abutting building
Information:	Bridging is the spanning of a termite barrier or inspection zone so that subterranean termites are provided with passage over or around that barrier.

At the time of inspection it was noted that fences abutting the building on both left and right hand sides created a point for concealed access of termites into the building.

Where any part of an attachment to a building is not isolated and is not provided with a clear gap of at least 25mm from the building, bridging occurs.

The client should consider obtaining further advice from a timber pest technician regarding treatments required in this area. It is recommended that obtaining such advice be a short-term priority.

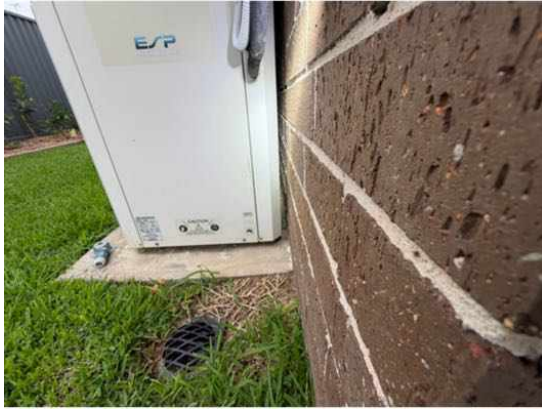
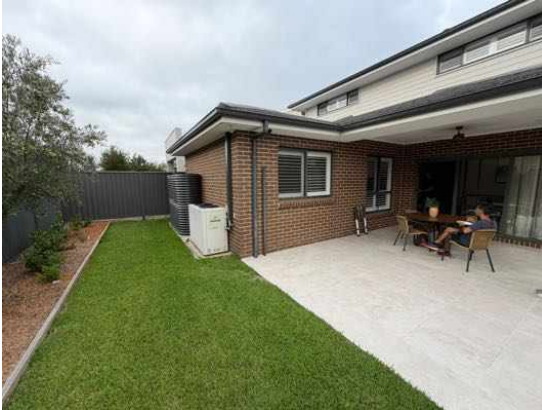
Building: Main Building  
 Location: External Areas/Sub-Floor  
 Finding: Obstructions and Limitations-External Areas/Sub-Floor  
 Information: These photographs are an indication of the obstructions and limitations which impeded full inspection of the external areas at the time of inspection. These obstructions can hide an array of defects and should be removed to allow full inspection to be carried out. A re-inspection is recommended once the areas are made accessible.

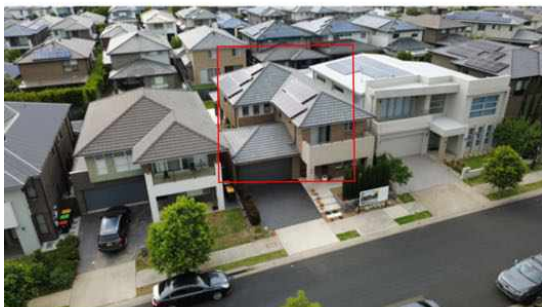
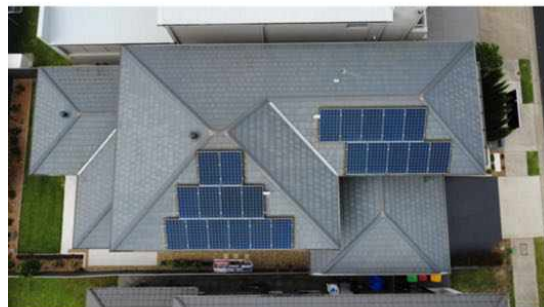
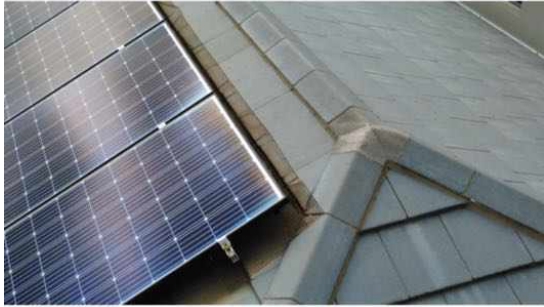
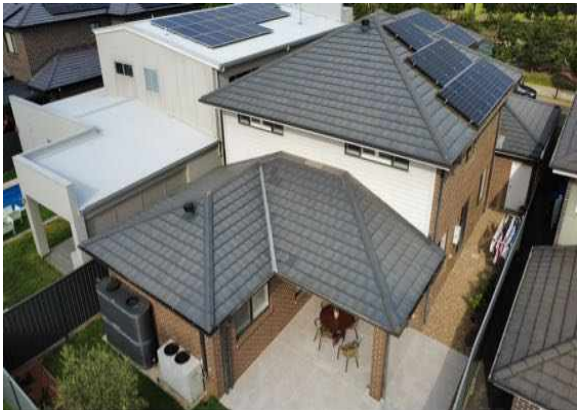
Building:	Main Building
Location:	Roof Exterior
Finding:	Roof tiles - Weathered
Information:	Upon inspection of the exterior roofing, the majority of roof tiles were considered to be in a fair condition. While weathering of the tiles is consistent with the age of the property, maintenance works are required.

Isolated areas of mortar have come loose in the valleys and minor cracking is also present. Re-pointing and re-sealing the may be considered as an interim solution by the client to help preserve and extend the life span of the tiles.

Where left unmanaged, deteriorating roof tiles are likely to lead to a number of secondary defects, including minor water leaks and weather exposure to internal roofing structures.

Consultation with a roofing contractor is highly advised to gain advice on cost of remedial works that may be required in the short to medium term. Remedial works are likely to increase the longevity of the exterior roofing structure.

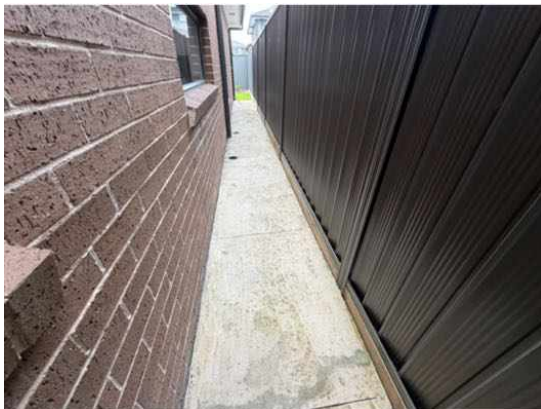
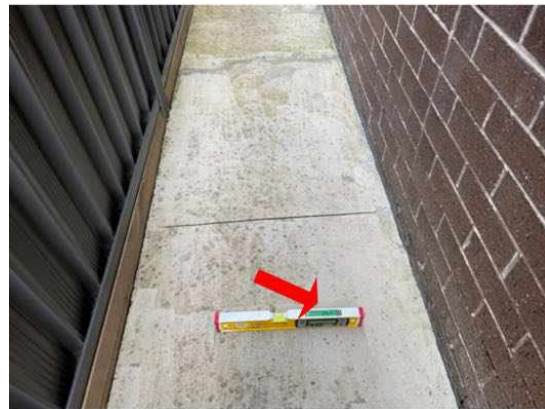
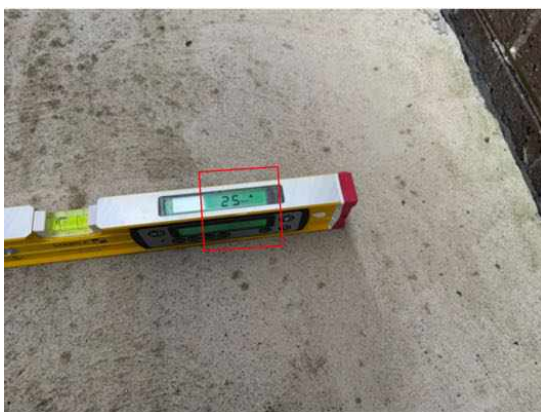
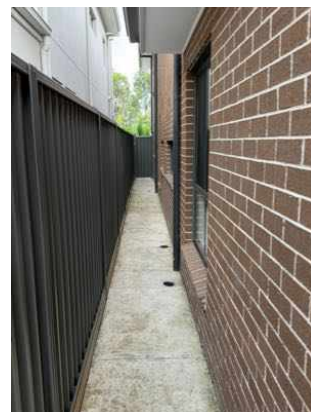
Information: The concrete path located along the right-hand side of the dwelling was observed to fall toward the building rather than away from it. This grading may contribute to water ponding and the potential for moisture accumulation adjacent to the external wall.

Poor surface drainage in this area may increase the risk of moisture ingress, contribute to damp conditions at the base of the structure, and create an environment conducive to termite activity over time. Ongoing ponding may also impact footings, finishes, and surrounding building elements if not addressed.

This item is provided for information only. Consideration should be given to regrading the path surface and/or improving drainage to direct water away from the dwelling. Further assessment by a suitably qualified drainage or plumbing contractor is recommended if required.

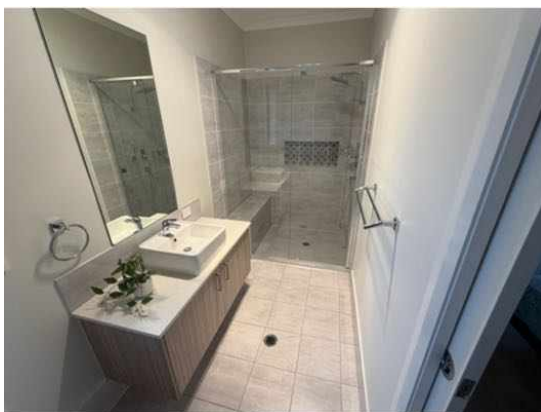
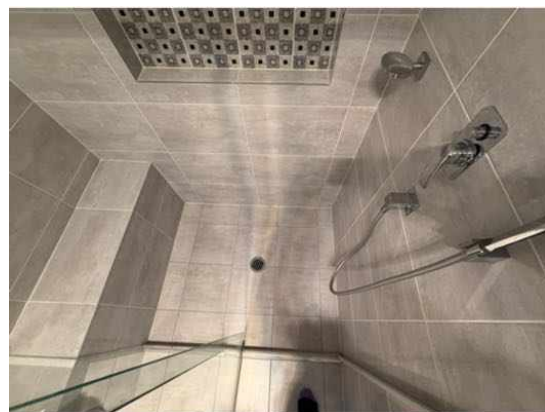
Building: Main Building  
Location: Showers  
Finding: Shower seals recommended  
Information: The waterproofing to the shower recesses were assessed by checking the walls in and around the shower recess for varying moisture content. Although a higher than normal reading was observed, there were no significant variations across the tested areas.

No sign of recent water damage was evident upon a visual inspection of the surrounding walls, where the visual nature of the inspection was possible. Consequently, there is no conclusive evidence of any current shower recess leakage and it is reasonable to assume the shower waterproofing is sound.

Further plumbing inspections are always recommended.

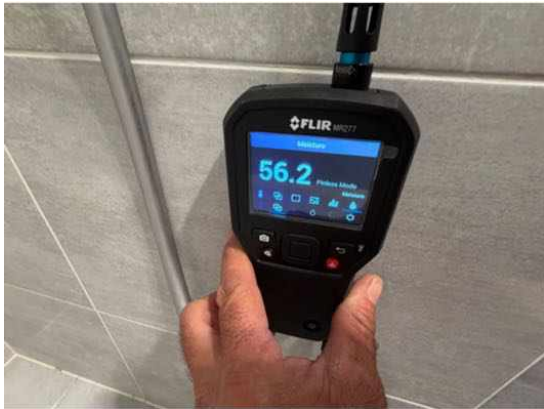
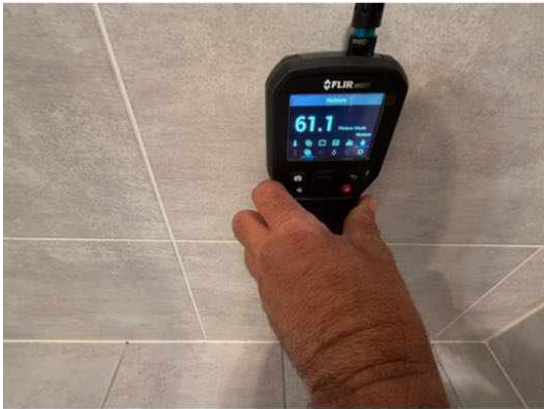
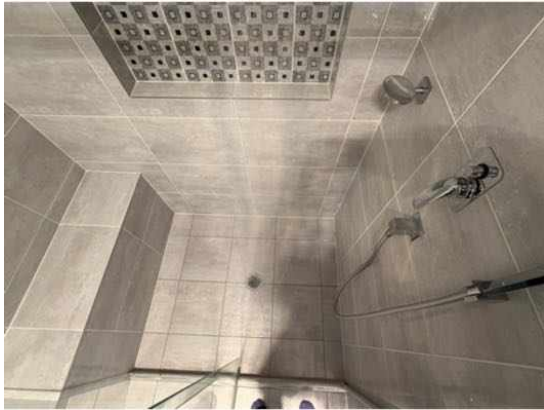
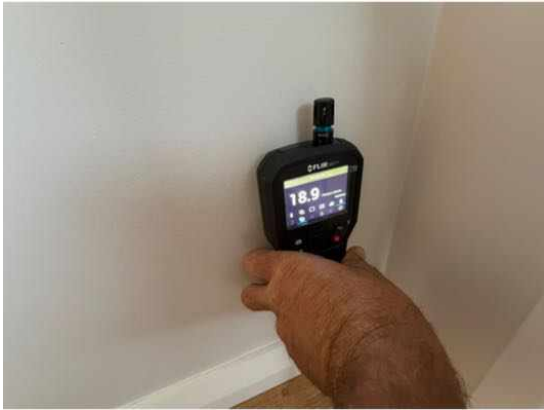
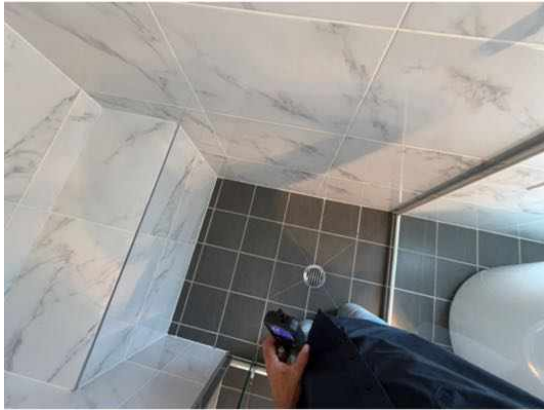
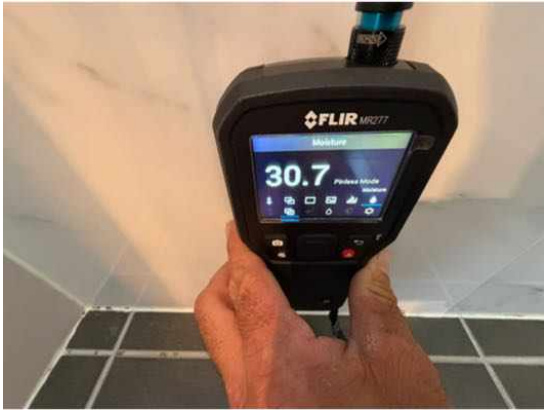
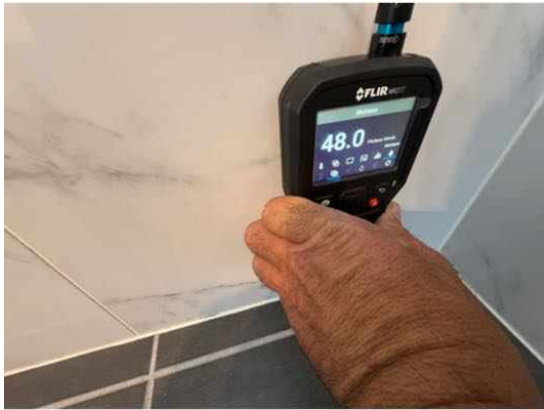
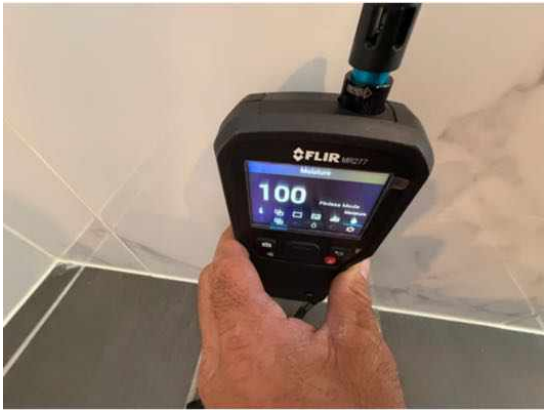
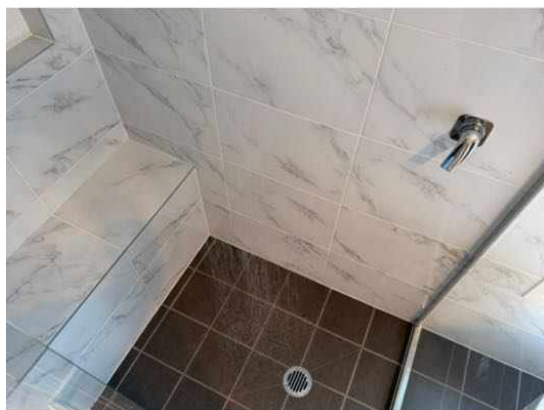
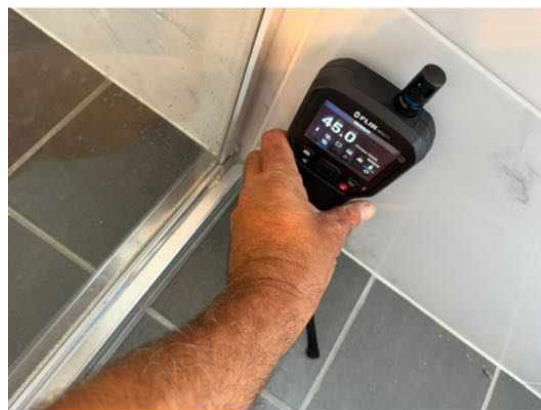
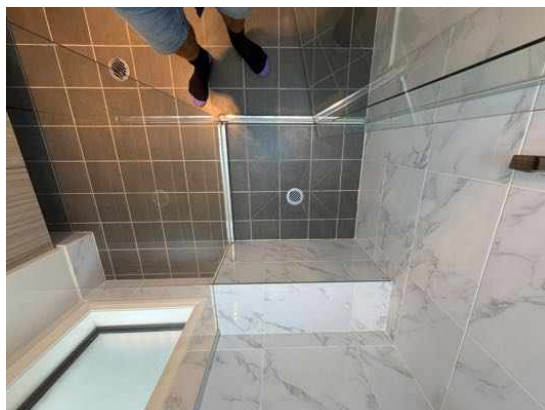
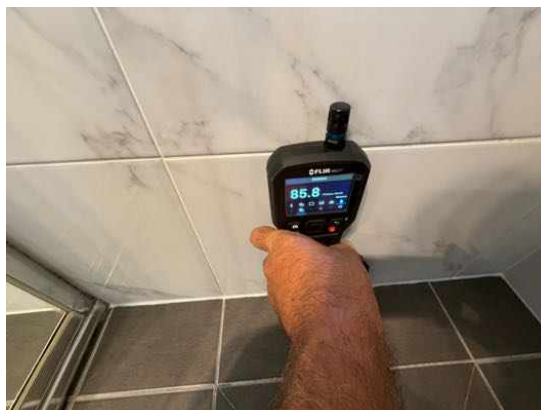
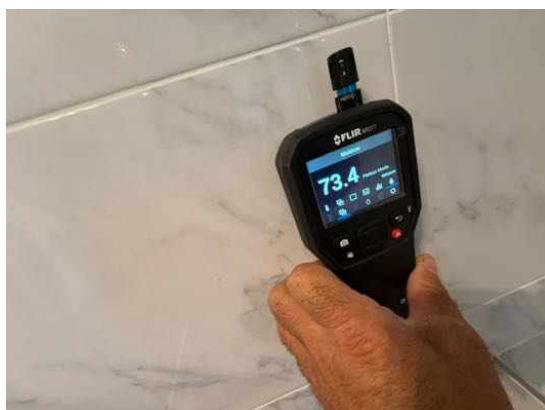
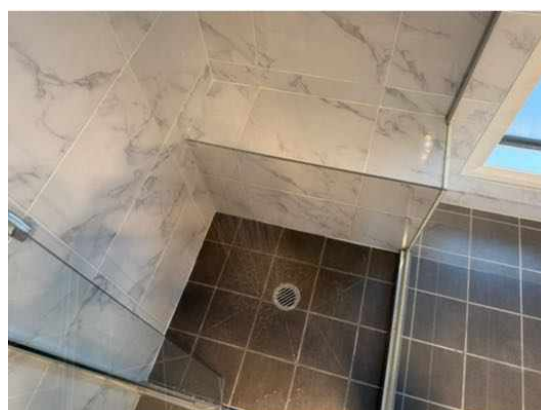
Building:	Main Building
Location:	All Areas
Finding:	FYI-Moisture Readings
Information:	Moisture readings taken during the inspection were recorded using a FLIR MR277 moisture meter, which provides numerical values rather than direct percentage readings. These values are not expressed as a percentage of moisture content but rather as relative indicators of moisture presence within building materials. Each material-such as plasterboard, timber, tile or concrete wall surfaces -has its own baseline range of ambient moisture, and the meter's readings reflect deviations from that baseline.

In short, while percentages are familiar, the meters numeric scale offers a more nuanced and material - sensitive method of identifying moisture issues. Elevated readings – especially those exceeding baseline values by around 20 points or more – are flagged for further investigation, even if no visible damage is present.

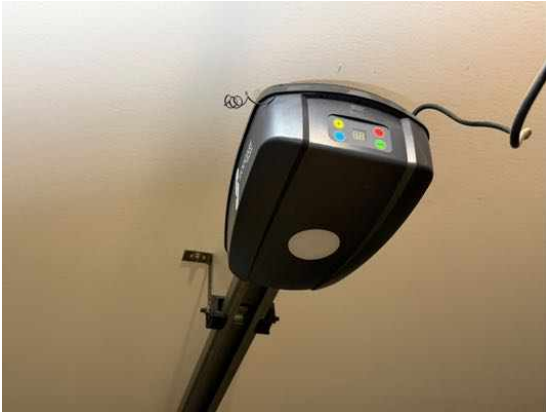
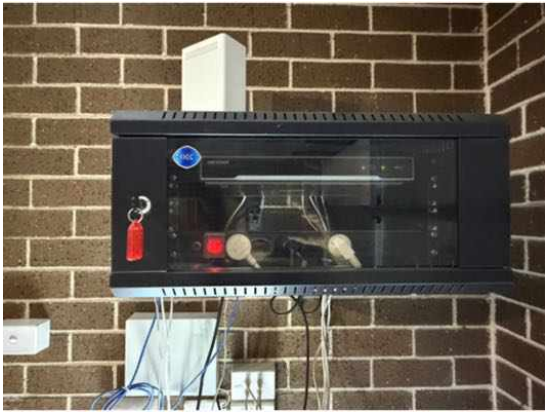
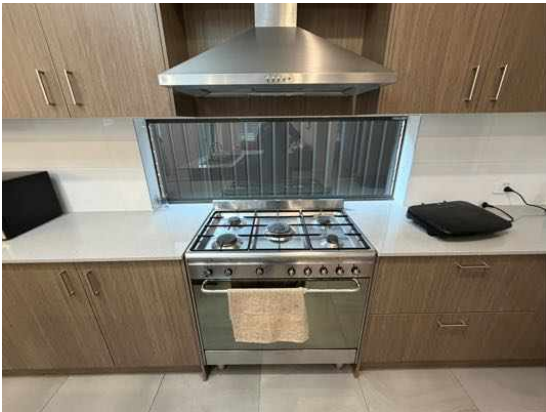
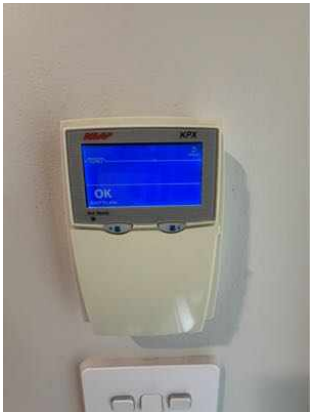
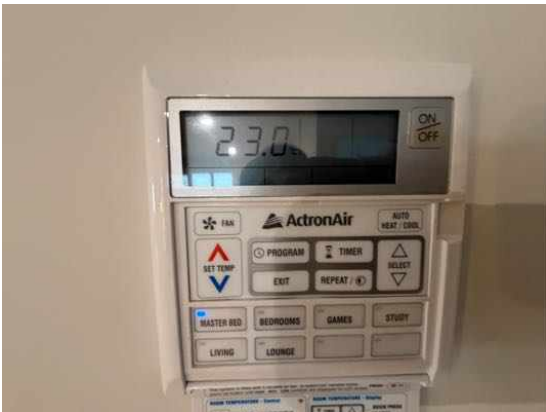
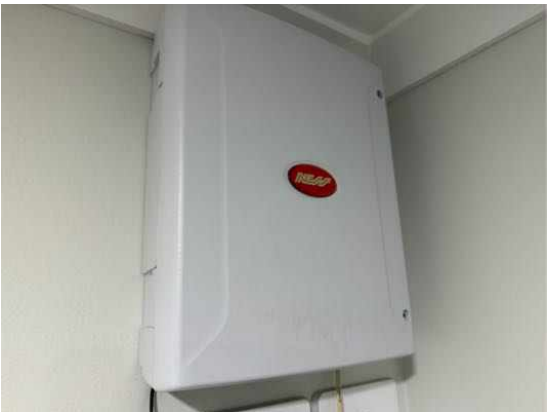
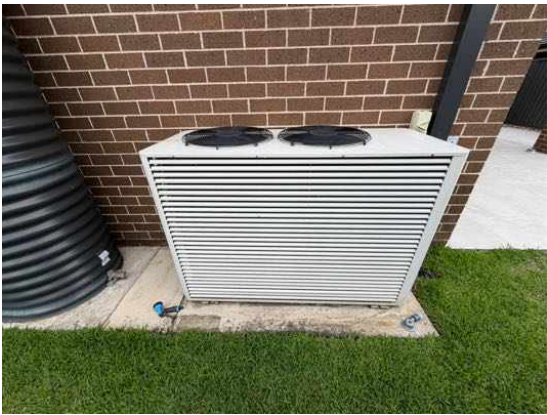
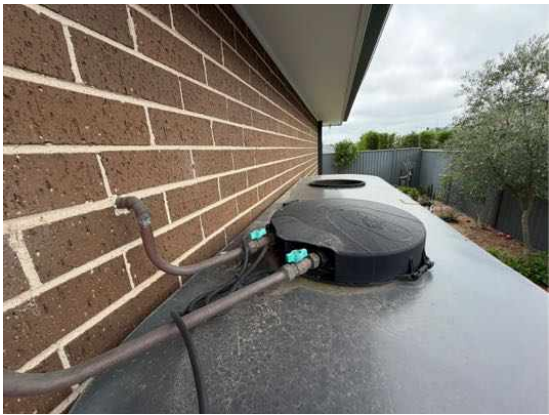
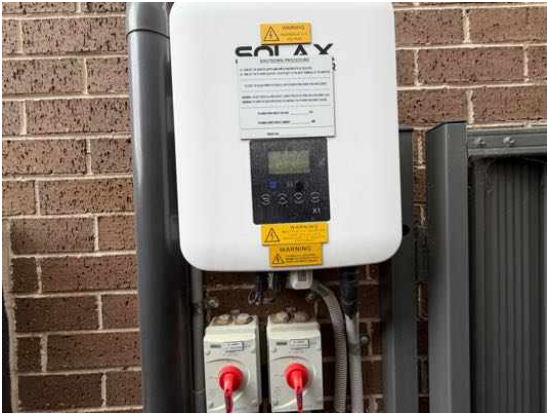
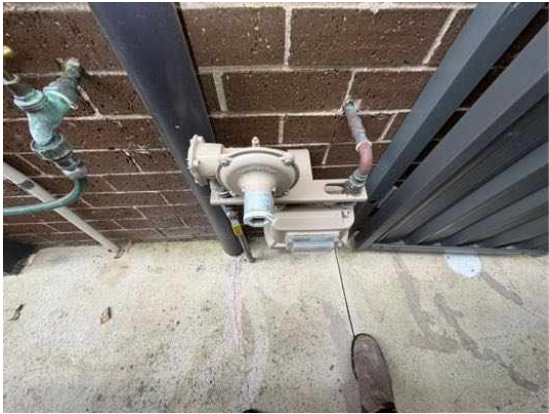
Building: Main Building  
 Location: Plumbing/electrical/gas/aircon/pool equipment etc  
 Finding: FYI-Plumbing and Electrical  
 Information: Plumbing and Electrical inspections are outside the scope of the building inspection and must be conducted by a licensed and registered trades person.

It is highly recommended that the client makes immediate arrangements to have the gas appliances checked by a licensed gas plumber to ensure that the appliances are working safely and efficiently.

We recommend all other installations be checked also.

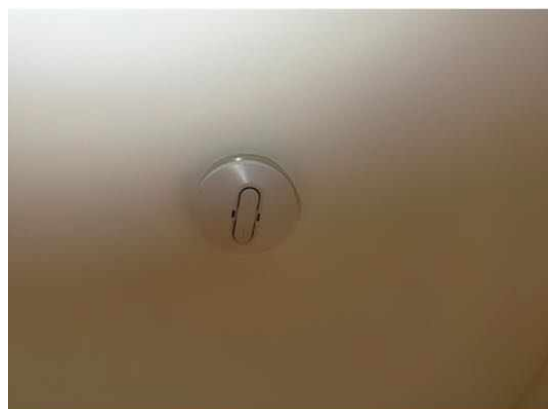
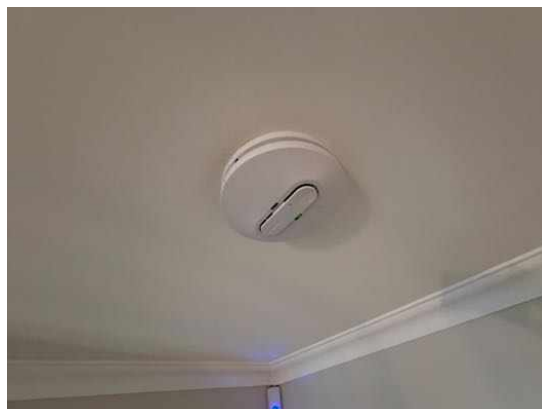
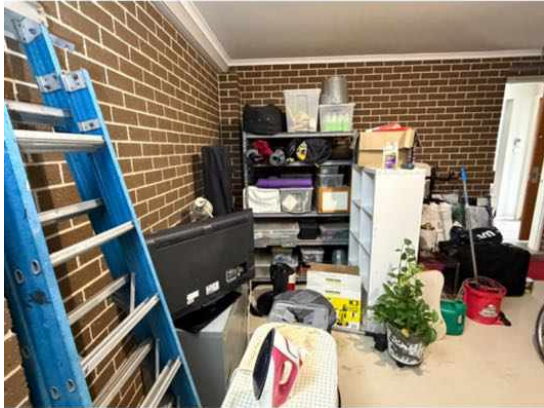
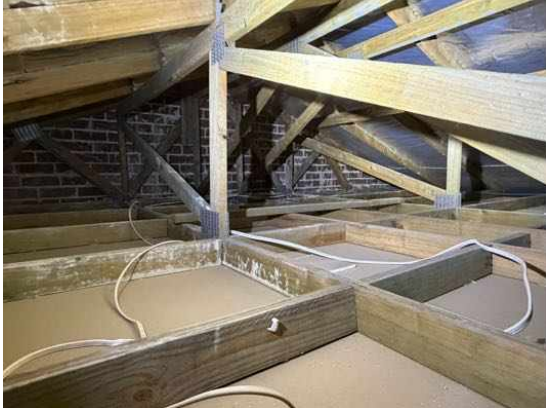
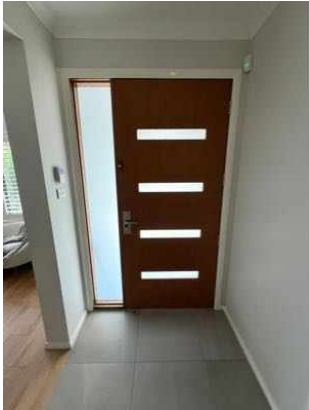
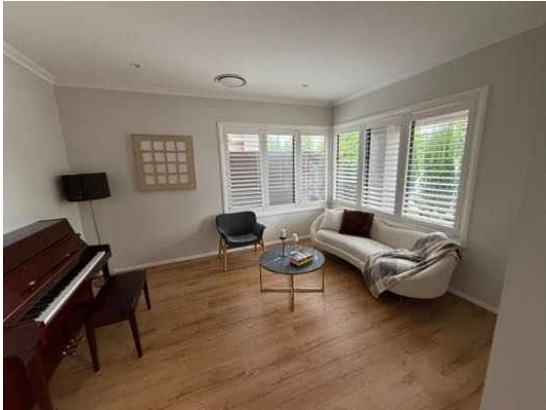
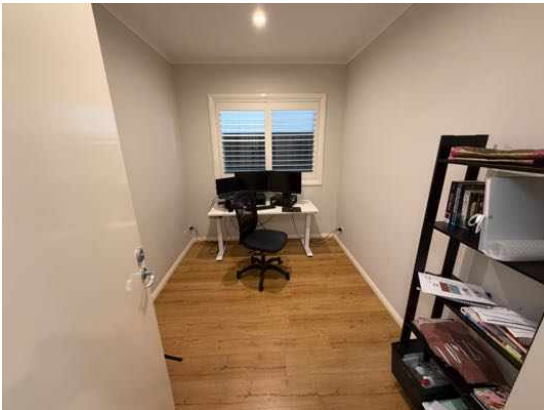
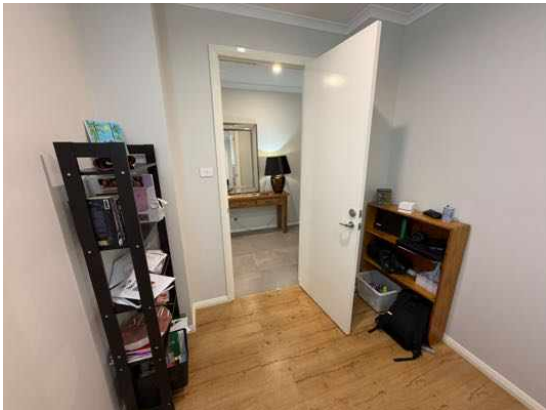
Building: Main Building  
Location: All Areas  
Finding: FYI-Additional Photos  
Information: Additional photos are provided for your general reference and may include obstructions, testing of water and windows, moisture readings or minor maintenance items.
