# Building and Timber Pest Inspection Report

Inspection Date: Sun, 22 Feb 2026

Property Address: 31 Calder St, Schofields NSW 2762,  
Australia

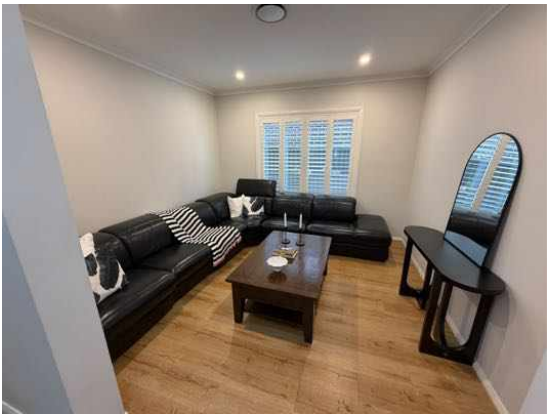
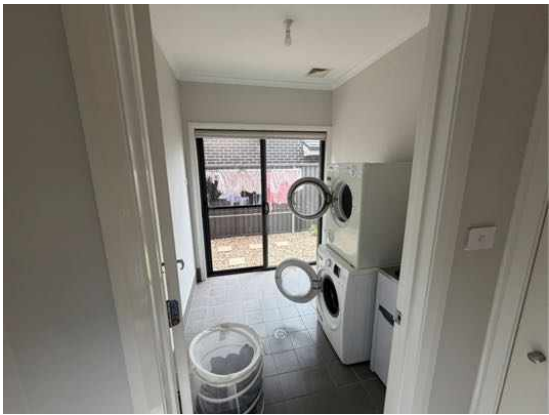
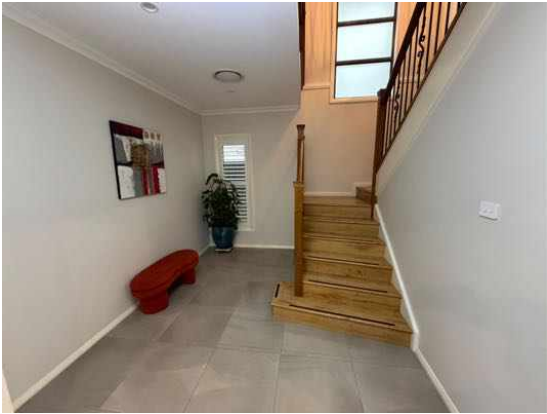
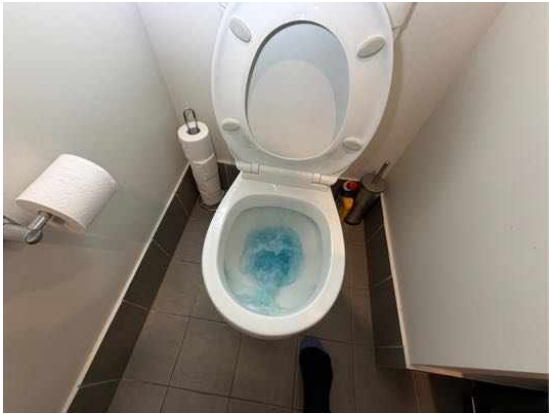
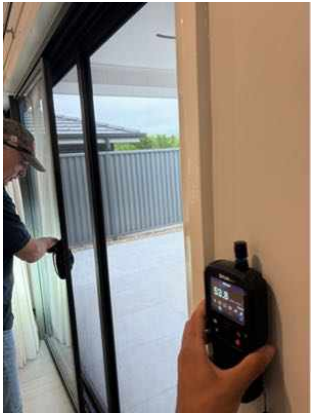
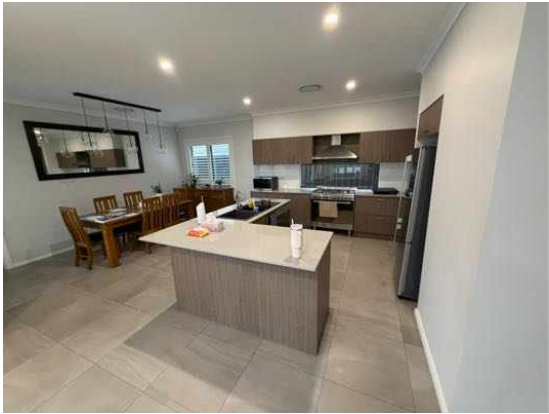
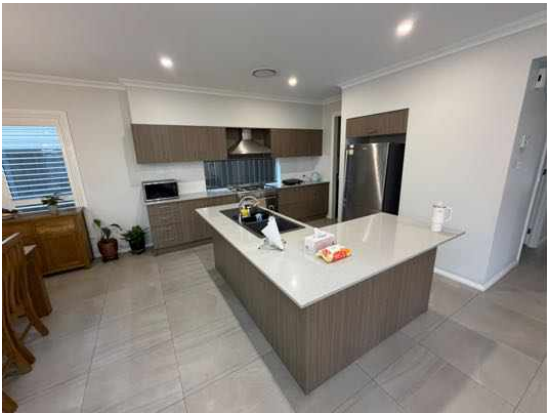
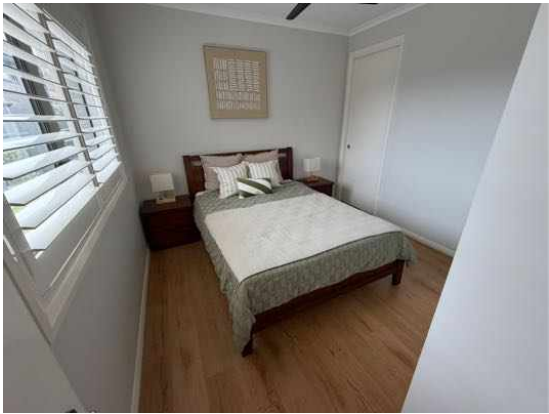
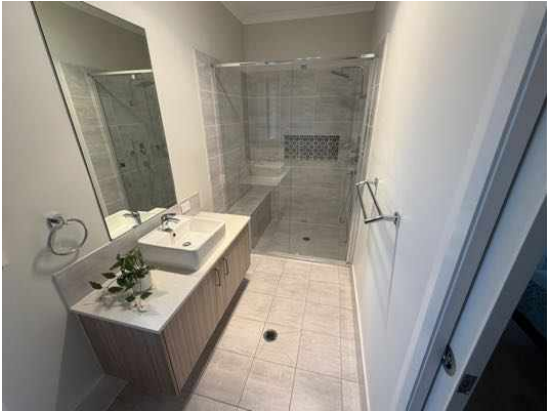
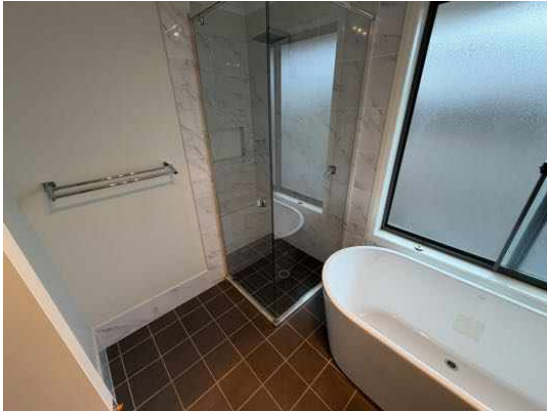
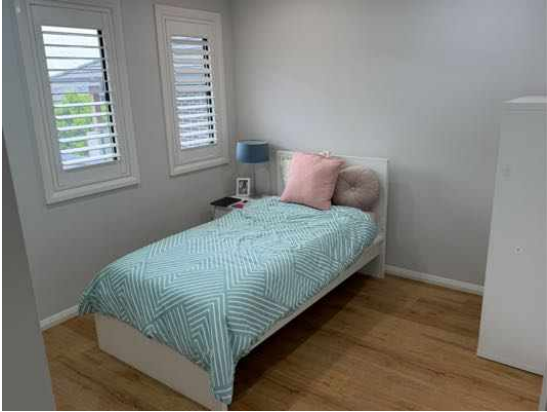
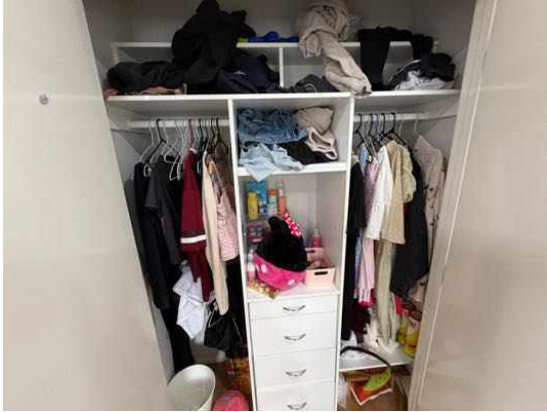
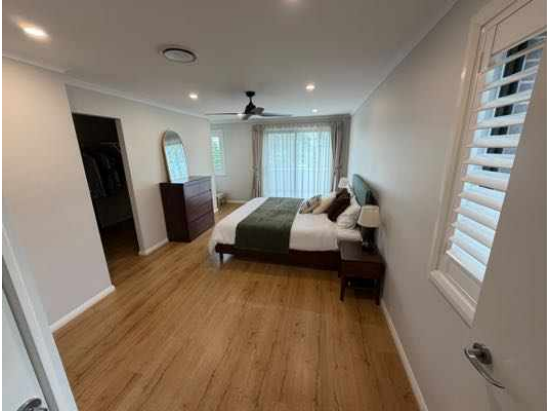
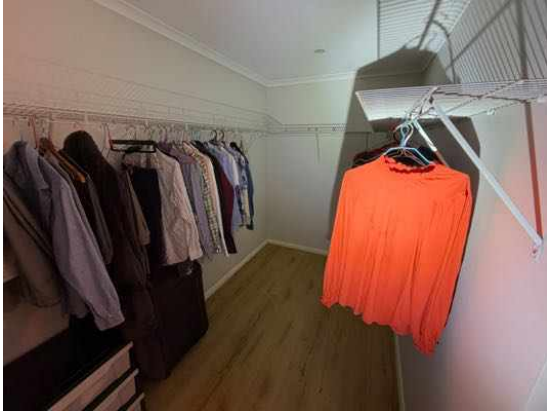
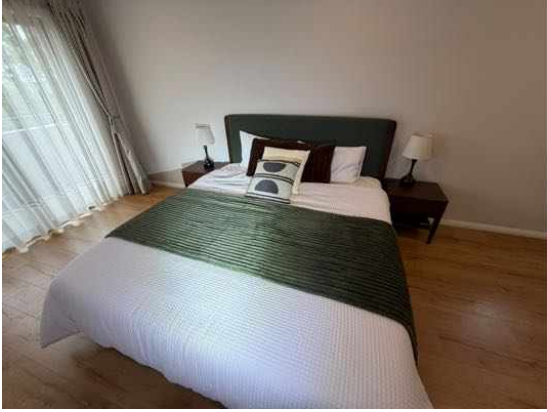
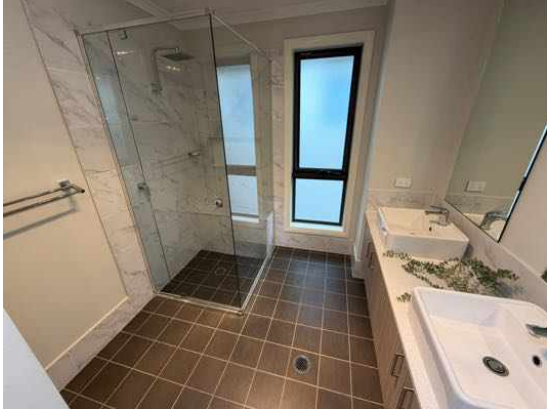
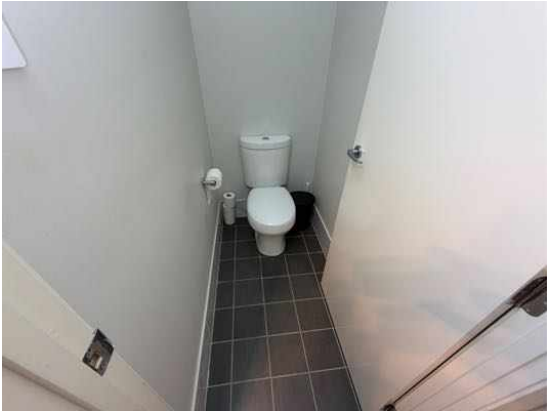
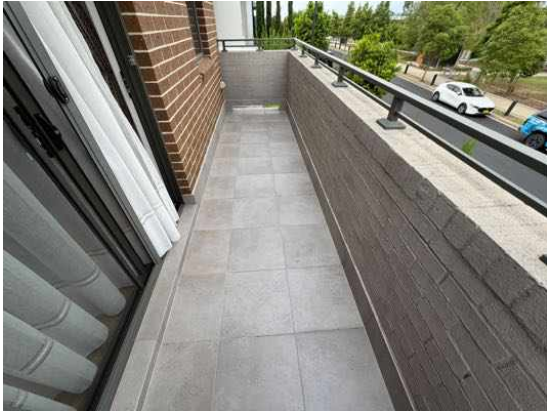
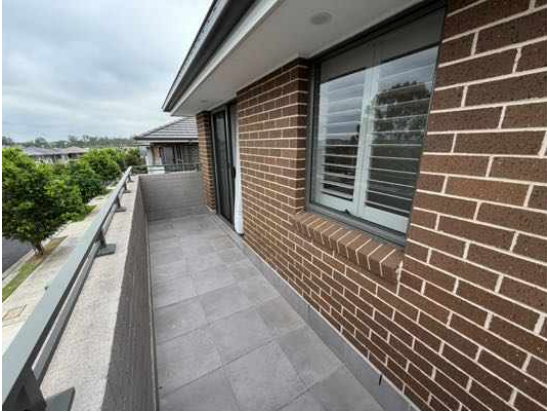
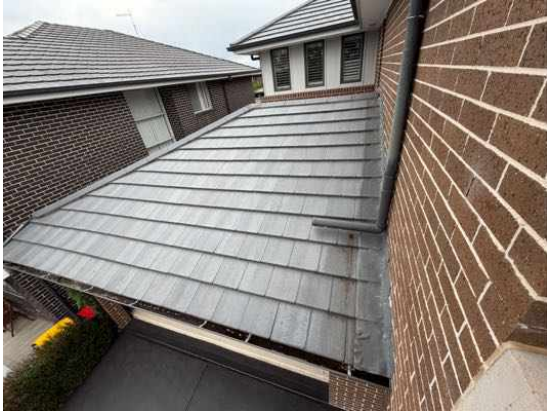
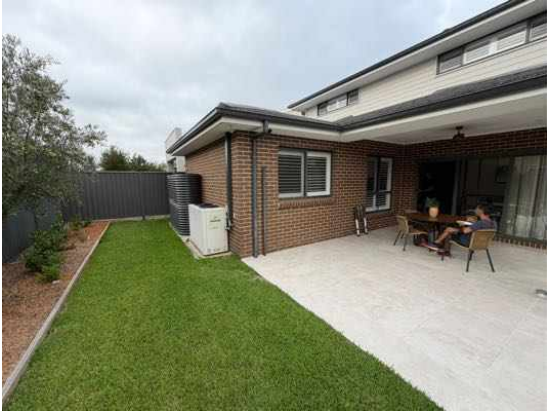
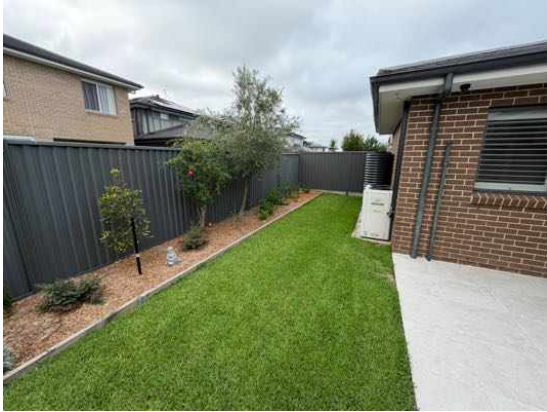
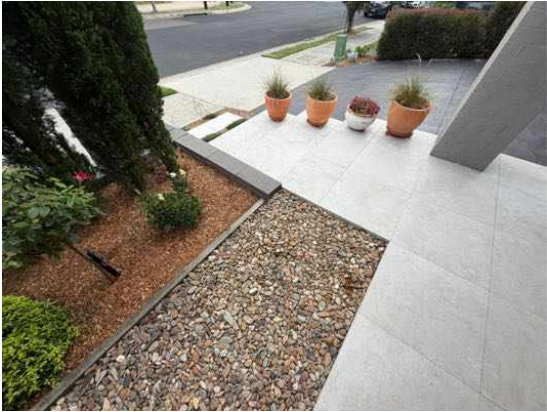
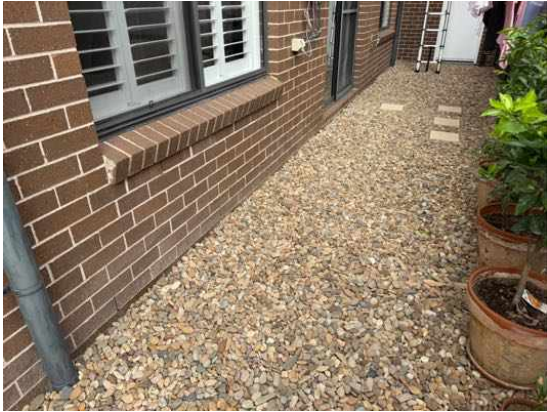
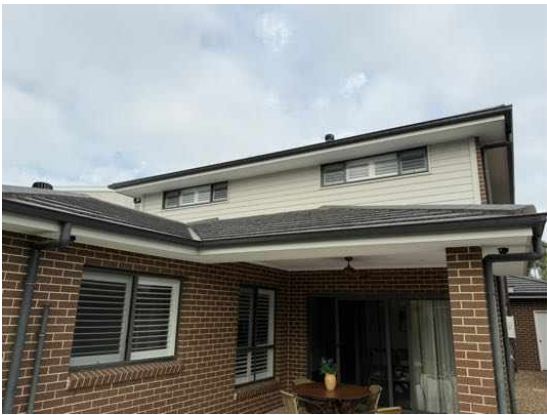
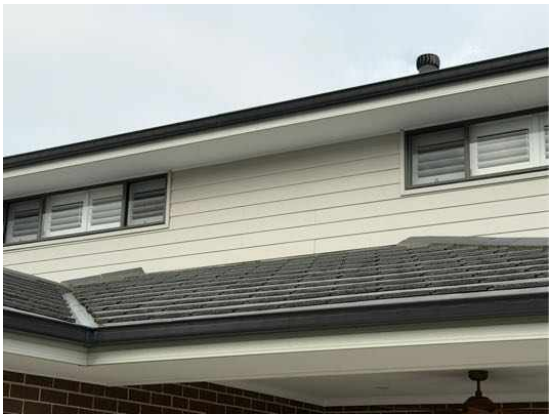
Building: Main Building  
Location: All Areas  
Finding: FYI-Additional Photos  
Information: Additional photos are provided for your general reference and may include obstructions, testing of water and windows, moisture readings or minor maintenance items.
