# Building and Timber Pest Inspection Report

Inspection Date: Thu, 6 Nov 2025

Property Address: Wondara, 233 Logans Rd, Carabost NSW  
2650, Australia

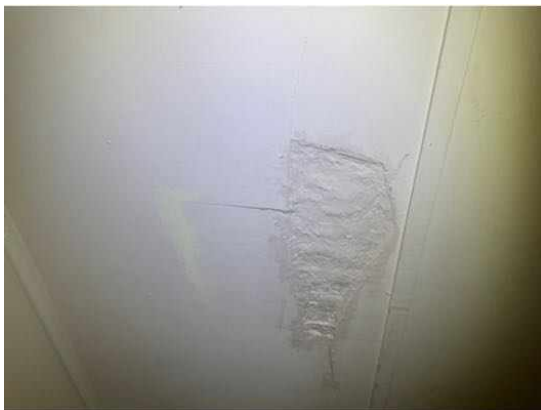
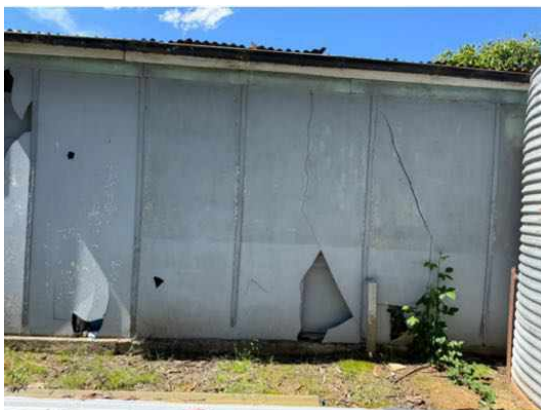
Building:	Main Building
Location:	Internal Walls, Shed Cladding
Finding:	Asbestos - Damaged Suspected ACM
Information:	This suspected defect is highlighted as a caution only as reporting on asbestos is outside the scope of this report. Several areas of damaged suspected ACM were identified throughout the building and shed.

It is advised that the client consider a separate Asbestos Inspection and Condition Audit, which can include the taking of samples for definitive confirmation of the presence of Asbestos, carried out by a licensed Asbestos Inspector.

In the interim, no works should be conducted to these areas without further specialist advice, and the area should be avoided to avoid potential safety hazards.

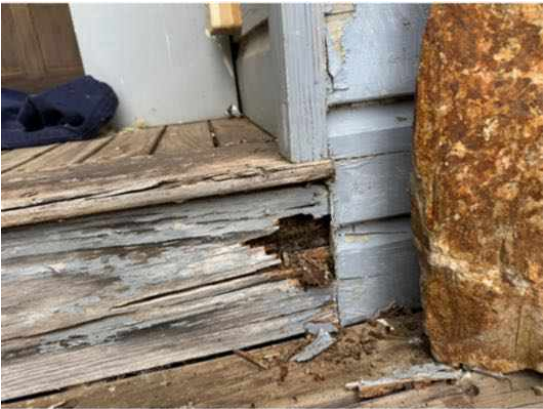
Building:	Main Building
Location:	Roof framing & beams, Shed framing and beams, verandah posts
Finding:	Structural Members - Termite Damage & Fungal Decay
Information:	It appears several structural members have been affected by termite damage and fungal decay, including but not limited to areas of the roof framing, verandah posts, a subfloor bearer and the shed framing.

This inhibits the structural integrity of the building. Recommend consulting with a registered builder and structural engineer promptly to provide further advice & remedial works to avoid further deterioration of the building. It is also advised that the client engage a licensed tradesperson to conduct a more invasive inspection to identify the extent of the termite damage and rectify accordingly. A more invasive inspection may reveal secondary building defects.

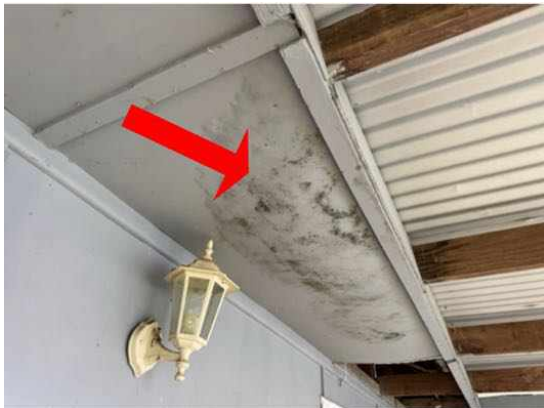
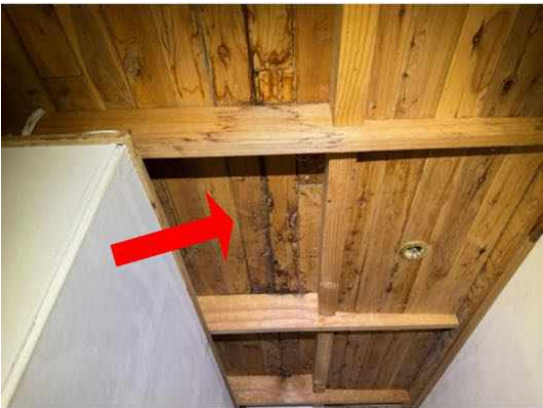
**Finding 2.02**

Building: Main Building  
 Location: Eaves, Internal Timber Ceilings, Roof Framing  
 Finding: Ceiling & Roof Leaks Present  
 Information: High moisture and areas of leaking were identified to several areas of the timber ceiling, roof framing and eaves. Potential causes of leaking include damaged plumbing fittings and fixtures, or deterioration of the roof plumbing.

This creates an environment conducive to termite activity & water damage to surrounding building materials. Recommend engaging a licensed roof plumber or roofing contractor promptly to provide remedial works.

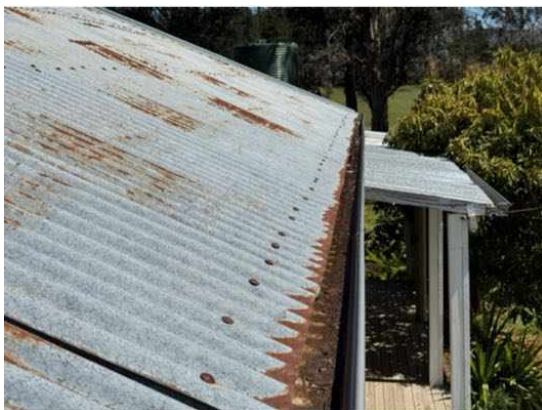
Building:	Main Building
Location:	Roof Exterior
Finding:	Roof Exterior - Weathered, Rust & Loose
Information:	The roof exterior was found to be in a weathered condition at the time of inspection evidenced by loose screws and roof sheeting, and areas of rust.

Where left unmanaged, deteriorating and damaged roof sheeting and plumbing is likely to lead to secondary defects, including water leaks.

It is advised that the client consult with a licensed roofing contractor at their earliest convenience, to provide further advice on remedial works that are required and to ensure all roof sheeting is secure.

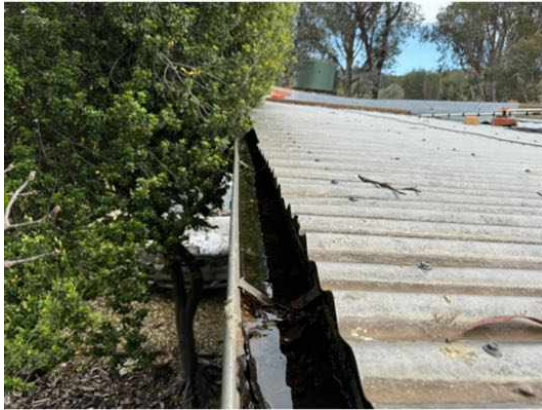
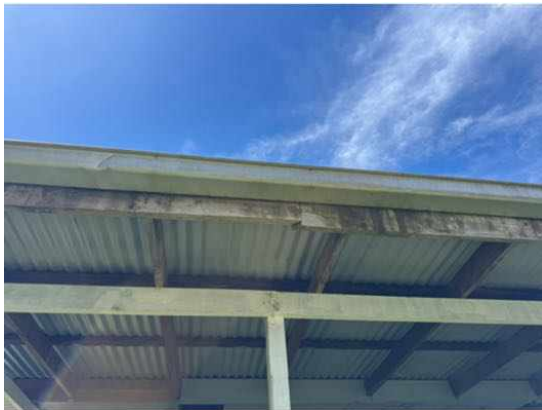
### Finding 3.03

Building:	Main Building
Location:	Guttering >
Finding:	Gutters - Debris, Water Pooling, Rust, Not Connected
Information:	Areas of water pooling, debris and rust were identified throughout the guttering. The gutter to the front elevation was also found to be disconnected from drainage, creating an environment conducive to termites. Water pooling & rust of the gutters is likely to lead to deterioration and overflows of the roof plumbing if neglected.

Recommend engaging a licensed roof plumber in the short term, to provide further advice to ensure adequate roof drainage is achieved. All debris should be removed from the gutters promptly to avoid overflows.

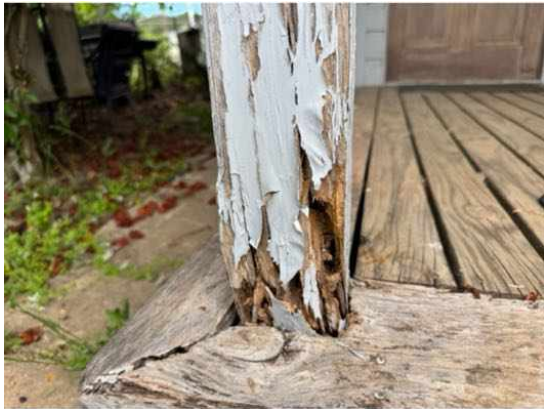
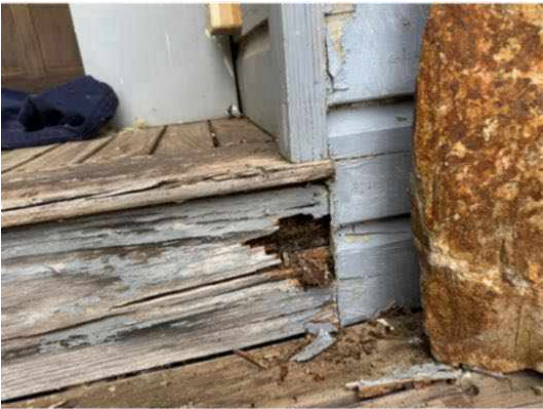
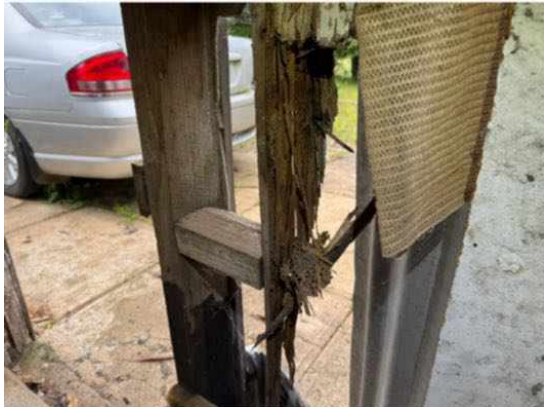
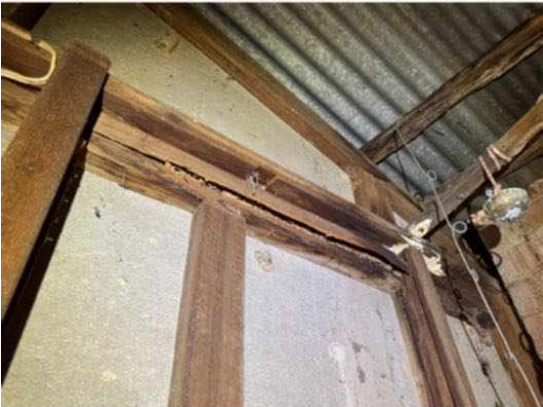
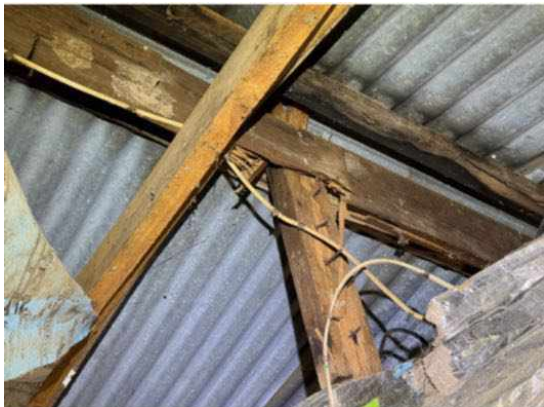
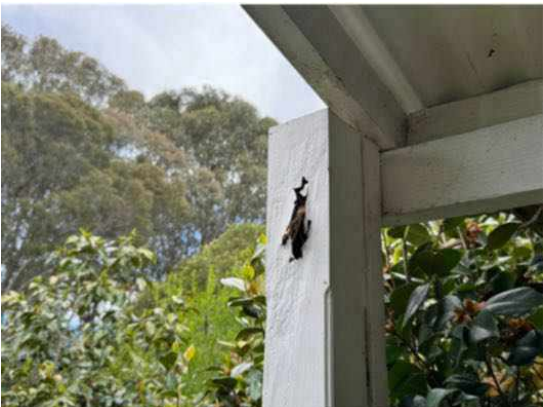
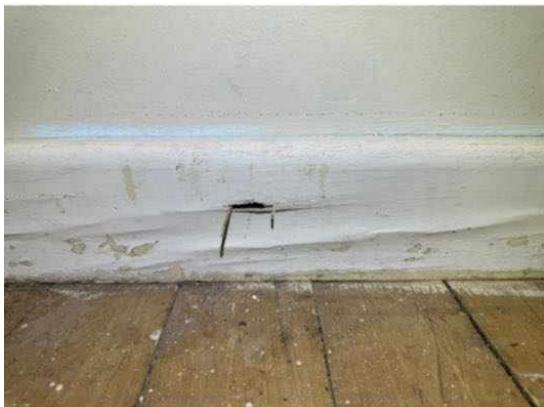
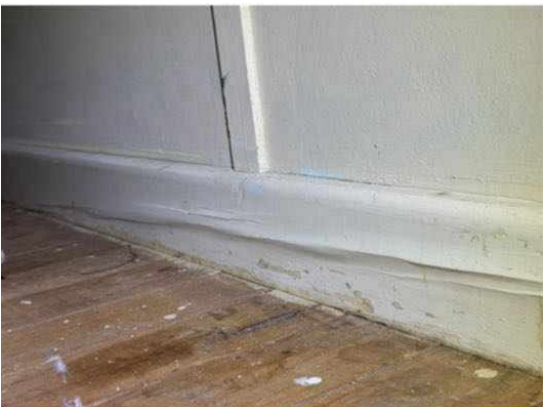
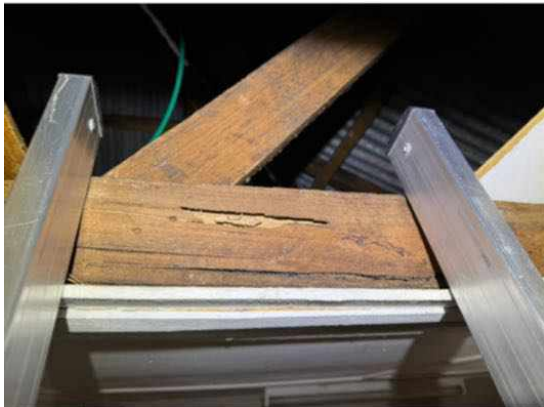
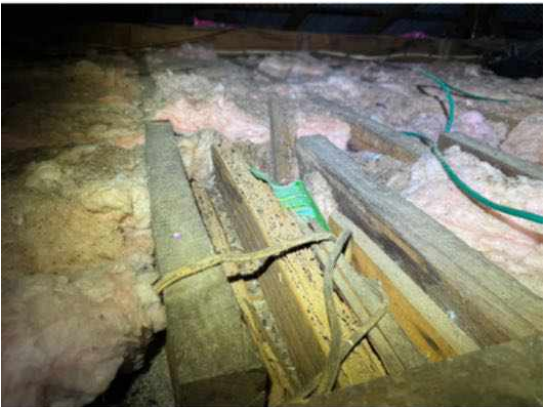
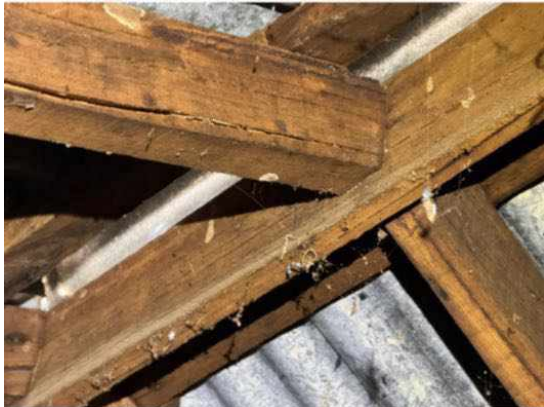
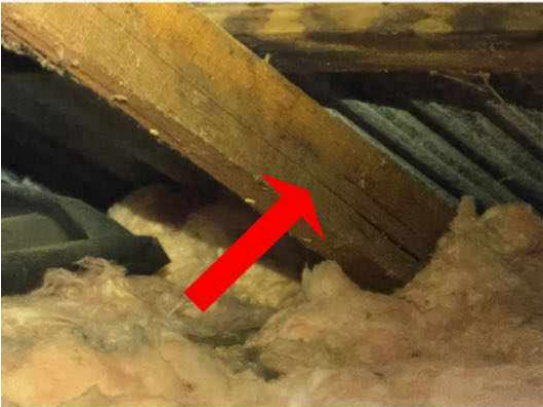
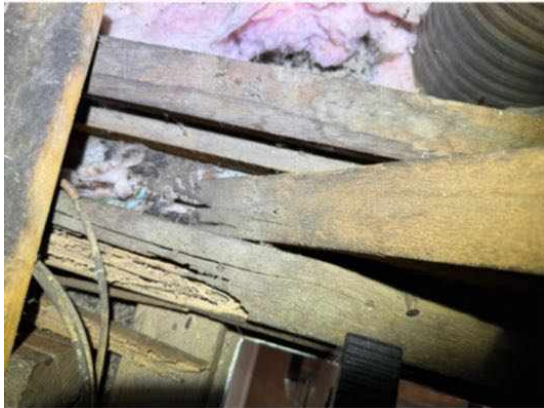
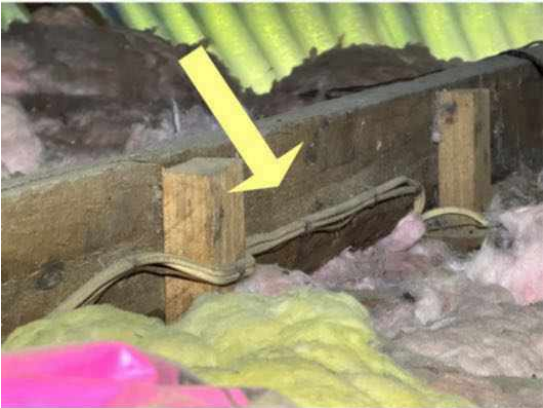
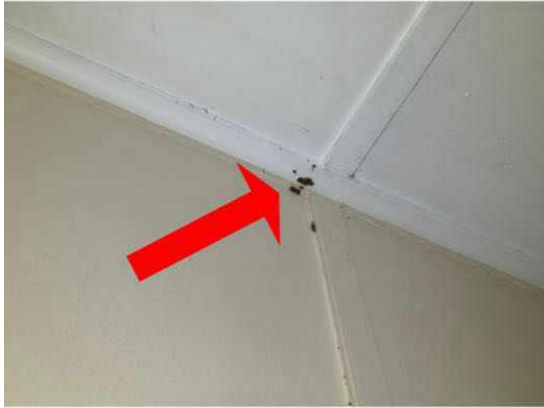
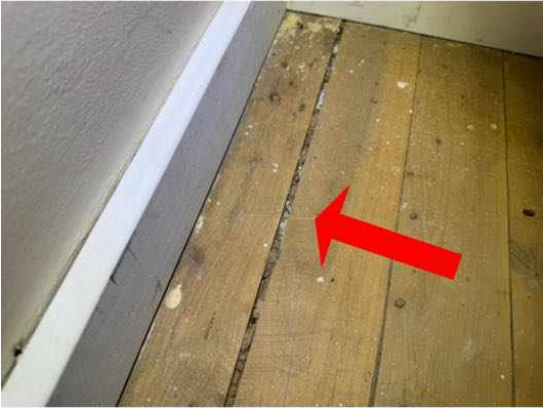
### Finding 5.01

Building:	Main Building
Location:	Verandah Posts, skirting boards, Shed framing & Beams, Roof Framing, Front Bedroom Ceiling, Floorboards
Finding:	Evidence of termite workings & damage
Information:	Termite damage & workings were identified in several areas including, but not limited to, a tree stump, the verandah posts, a subfloor bearer, shed framing, roof framing, skirting boards, and front bedroom ceiling.

The client should engage a licensed pest controller promptly, to provide further advice regarding installation of a termite treatment.

6 monthly ongoing termite inspections, conducted by a qualified termite inspector, are also recommended

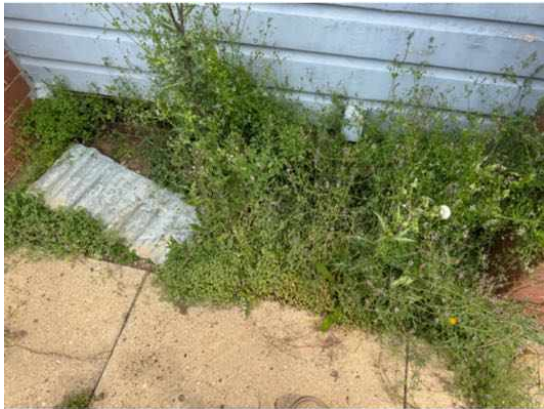
Where insufficient drainage of taps, roof plumbing, hot water system & aircon overflows, and garden beds against the house are present, water pooling is likely to occur, and can create areas conducive to timber pests and potential damage to the subfloor structure overtime, if neglected.

Recommend consulting with a licensed plumber in the short term to further assess and provide remedial advice.

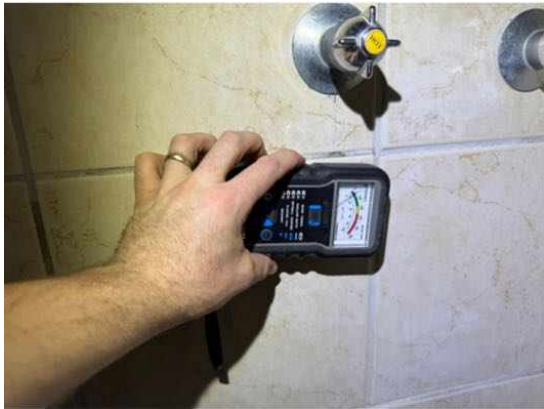
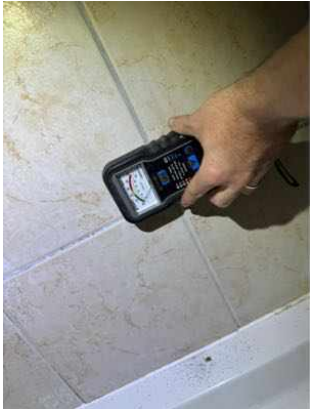
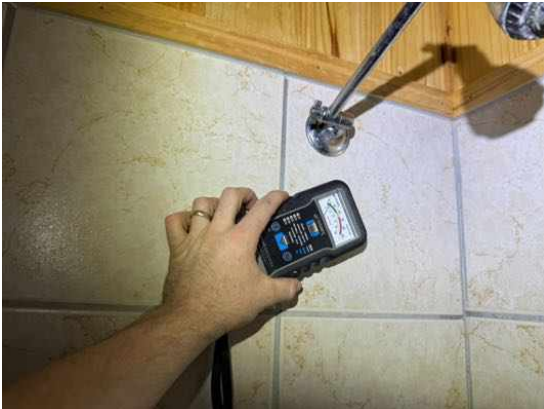
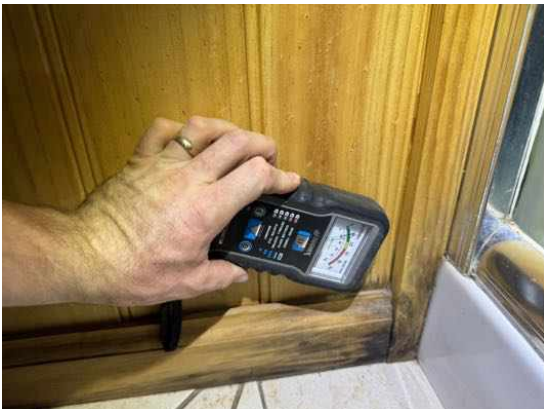
Building: Main Building  
 Location: All Areas  
 Finding: FYI Moisture Readings  
 Information: These photos are the moisture readings taken near plumbing fixtures and fittings, for your information.

No excessive moisture was evident in these areas at the time of inspection.
