Building and Timber Pest Inspection Report

Inspection Date: Thu, 26 Mar 2026

Property Address: 126 Vantage Blvd, Craigieburn VIC 3064,
Australia

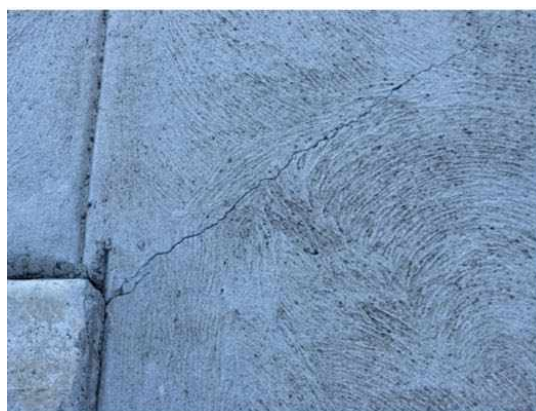
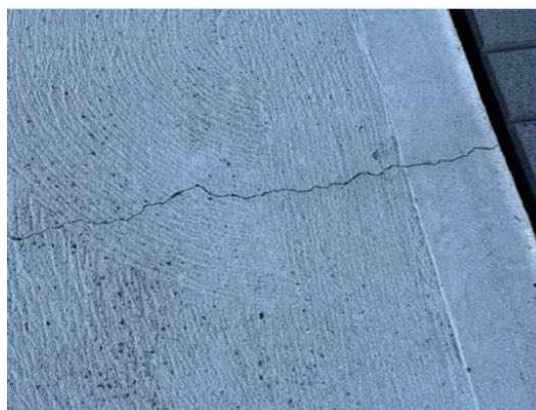
Generally the cause of a hairline crack in existing concrete paving such as driveways and pathways is indicative of the expansion and contraction of the concrete. Such causes are generally due to environmental factors, such as moisture levels, weather conditions or the soil types on which they are laid.

Monitoring of all cracking should be conducted frequently. Always contact a building inspector should cracks widen, lengthen, or become more numerous.

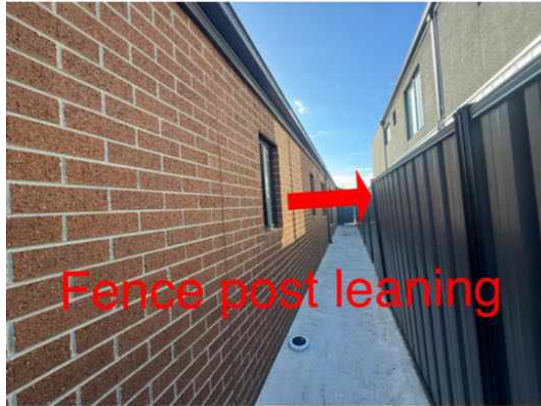
If left unattended, it is likely that further damage may occur. It is suspected that repair of the fencing may be required in the medium term.

A licensed fencing contractor should be appointed to provide further advice and perform rectification works as necessary at the clients discretion.
