Building and Timber Pest Inspection Report

Inspection Date: Tue, 27 Jan 2026

Property Address: 22 Tortola Pl, Parrearra QLD 4575, Australia

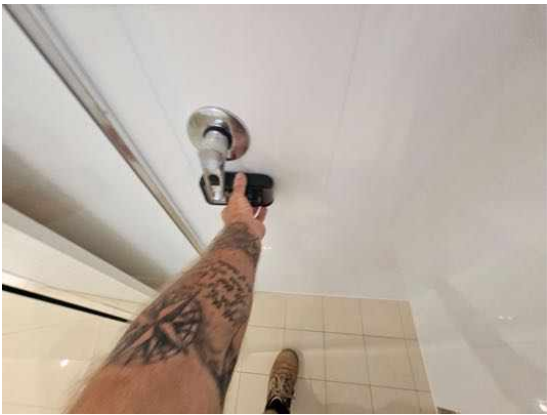
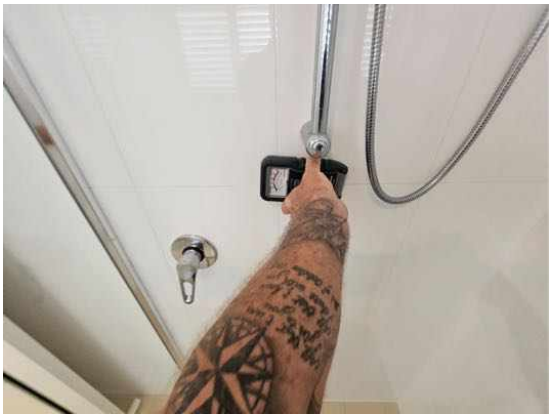
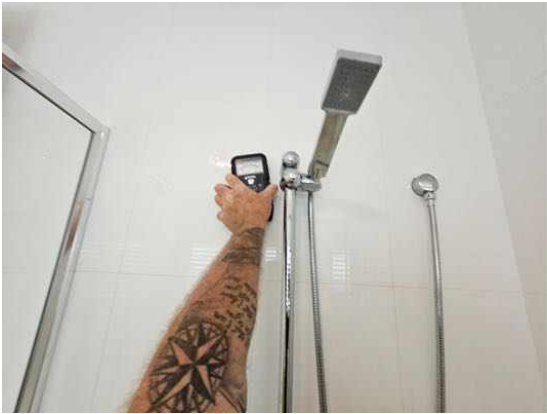
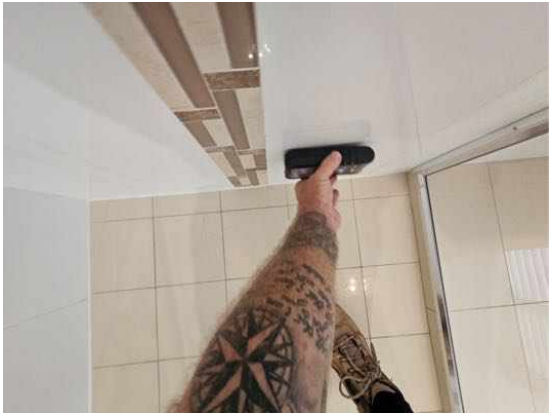
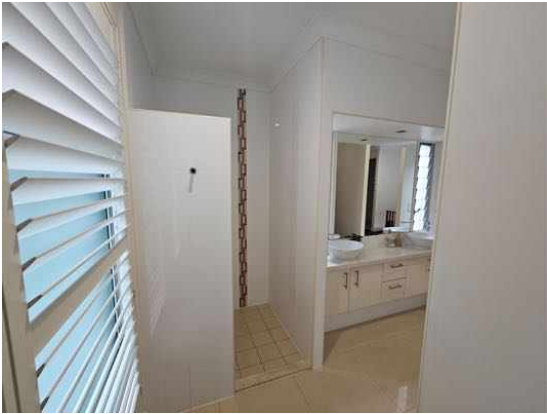
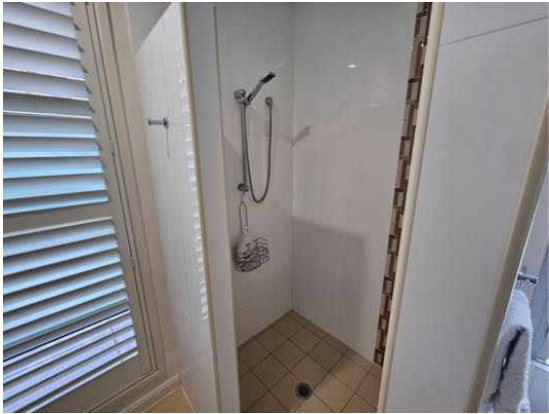
Building: Main Building
 Location: All Areas
 Finding: Additional Photos - Obstructions and Limitations
 Information: These photographs are an indication of the obstructions and limitations which impeded full inspection of the property at the time of inspection. These obstructions can prevent full inspections of the areas shown.

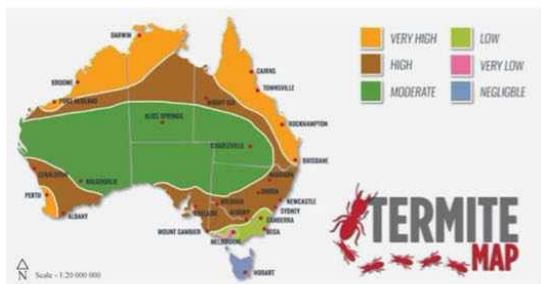
Review the attached map for Australia's termite zones and their risk profile.

It is recommended that a licensed timber pest controller be contacted to assess the properties needs and provide costings for an annual inspection programme.

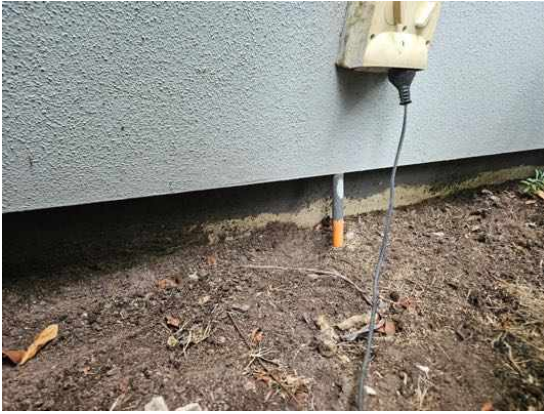
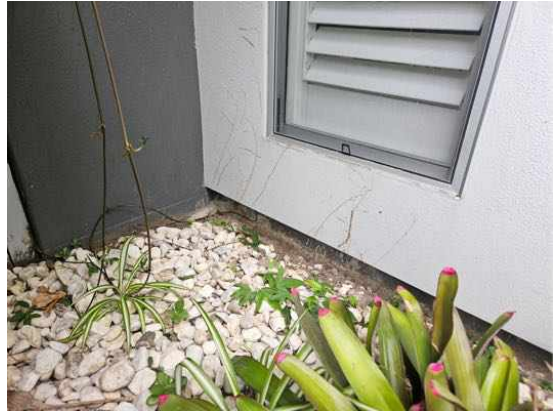
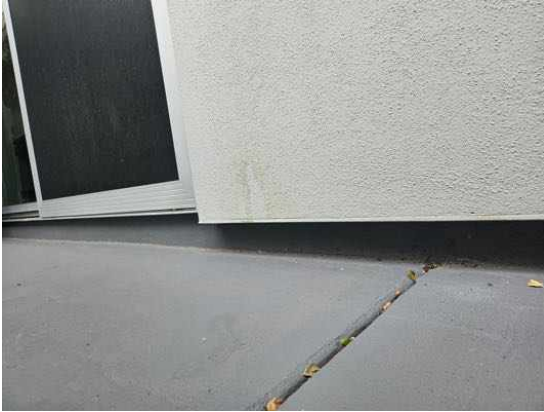
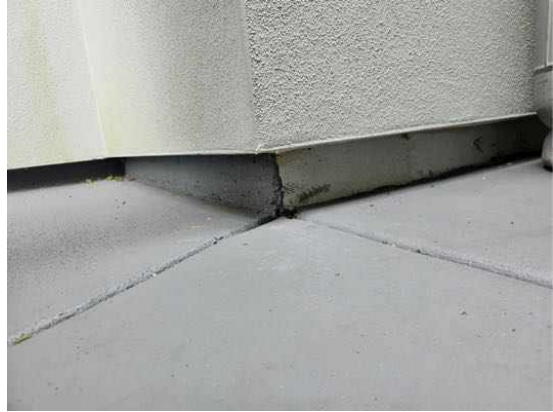
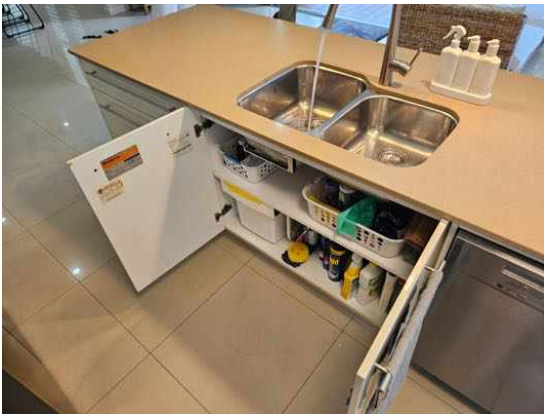
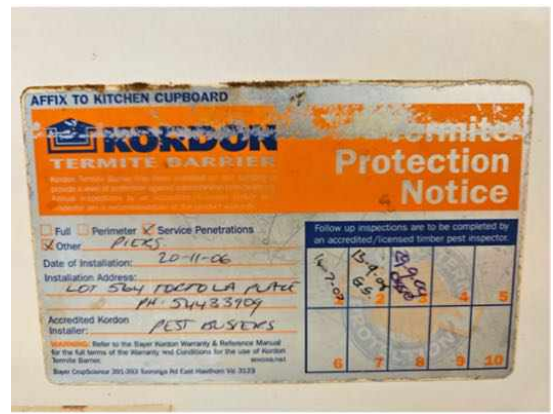
The building employs a physical barrier system to the slab penetrations, and a visual exposed slab edge to the perimeter. In order for a barrier system to be effective, the property must have regular inspections at intervals of not greater than 12 months. Depending on the risk profile attributed to the property, these inspections may be recommended at lesser time periods.
