# Building and Timber Pest Inspection Report

Inspection Date: Fri, 30 Jan 2026

Property Address: 9 Arakoon Avenue, Penrith, NSW 2750

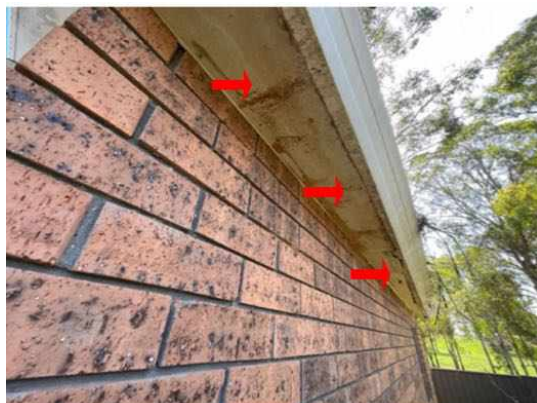
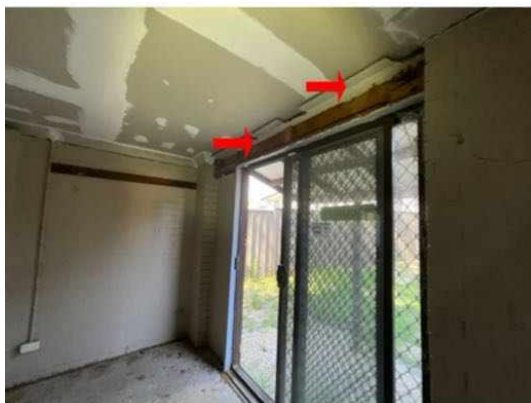
#### Finding 1.02

Building:	Main Building
Location:	Studio
Finding:	Asbestos - Suspected ACM Identified on Site
Information:	Reporting on Asbestos is outside the Scope of this Report. This suspected defect is highlighted as a caution only. We suspect, based on our experience in the building industry, that there is a higher risk of the identified building element containing asbestos.

As Asbestos Reporting is outside the scope of this report, we advise that you consider a separate Asbestos Inspection and Condition Audit, which can include the taking of samples for definitive confirmation of the presence of Asbestos.

In the interim, the client is advised to act with caution, especially when considering any damage to building materials general wear and tear renovations extensions demolition and general maintenance activities due to the suspected presence of Asbestos.

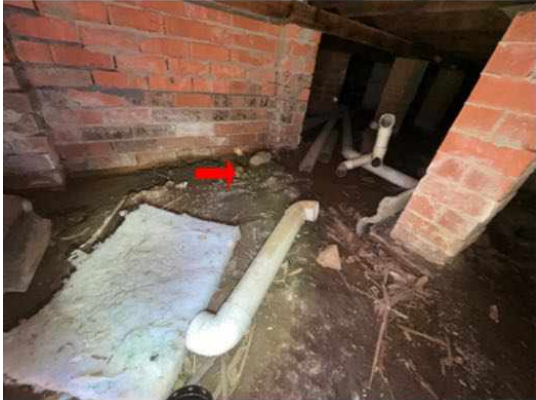
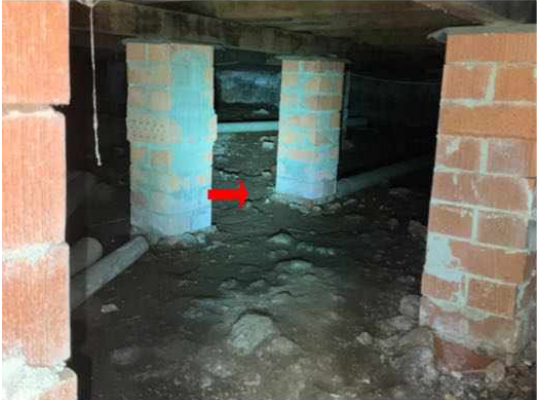
### Finding 2.01

Building:	Main Building
Location:	Subfloor
Finding:	Site drainage— Inadequate
Information:	The site drainage in this area was found to be inadequate at the time of inspection, creating potential for subsequent water damage to associated building elements. This is additionally conducive to termite activity.

It is important that water does not lie against the base of walls; surrounding paths and ground levels should be sloped to drain water away from walls. Downpipes should not discharge stormwater onto lower walls or plinths. Stormwater should be carried away by large, regularly cleaned drains. Ground levels may need to be lowered to expose a buried DPC.

Where site drainage is inadequate, installation of an Agricultural (Aggie) Drain may be required. A licensed plumber should be appointed to further inspect the property and perform any remedial works as necessary. Water damage and secondary defects are likely to occur if left unmanaged.

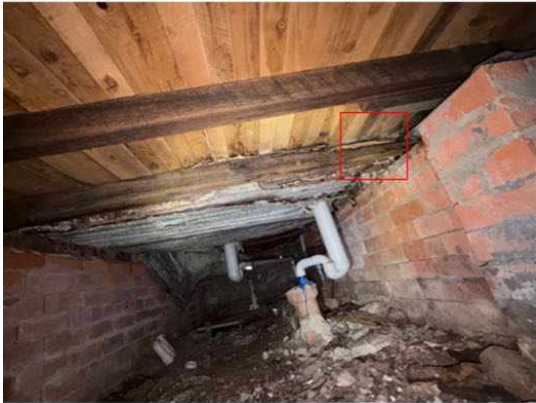
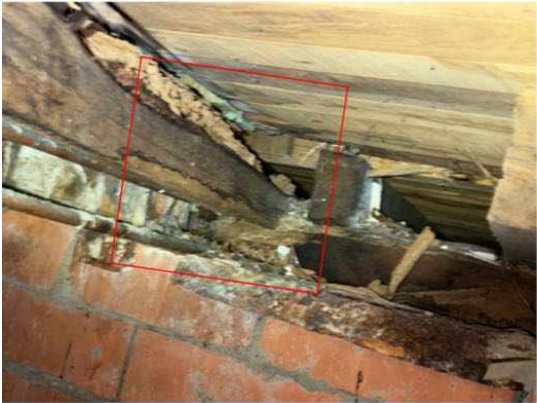
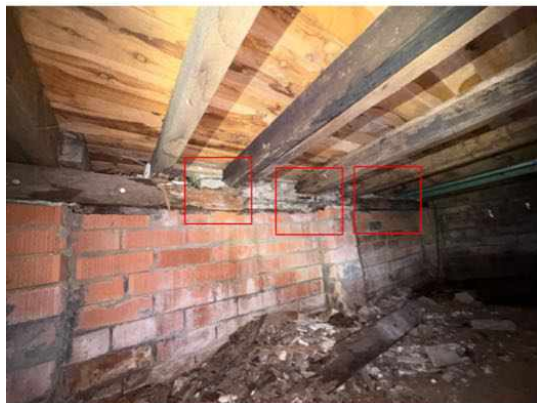
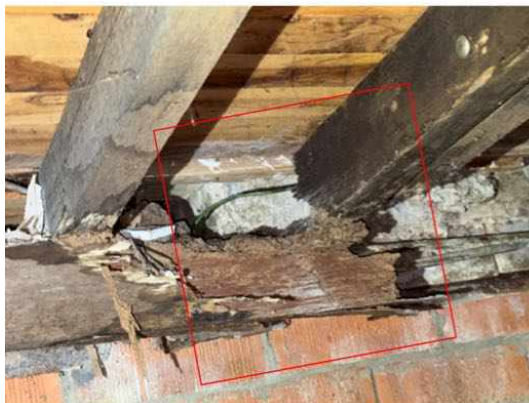
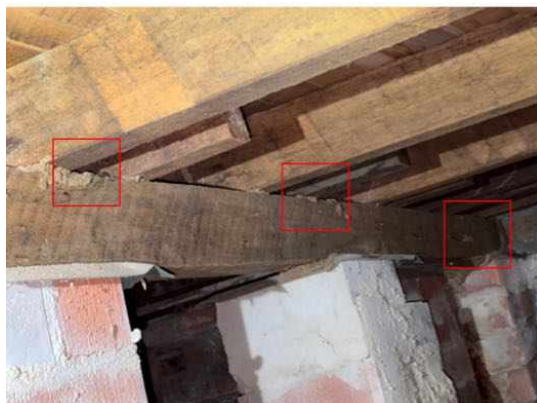
**Finding 2.02**

Building: Main Building  
Location: Subfloor  
Finding: Evidence of termite damage  
Information: Despite no live termite or timber pest activity being indicated, previous termite damage was found to have affected this area or otherwise termite workings were identified at the time of inspection. This damage is considered to be inactive, however structural in nature.

A termite specialist should be appointed urgently to complete an invasive inspection and installing a termite chemical treatment.

A licensed builder should then be appointed to replace or reinforce all structural damages.

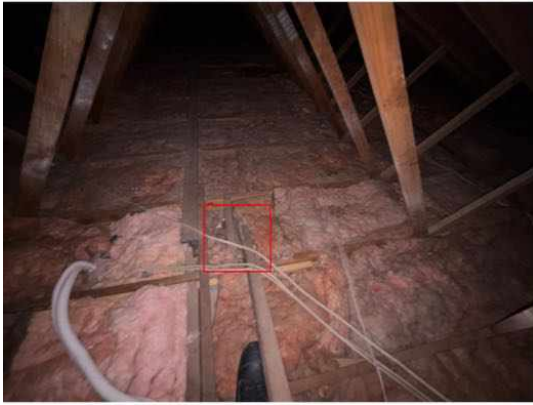
### Finding 2.03

Building:	Main Building
Location:	Roof Void
Finding:	Evidence of termite damage
Information:	Despite no live termite or timber pest activity being indicated, previous termite damage was found to have affected this area or otherwise termite workings were identified at the time of inspection. This damage is considered to be inactive, however structural in nature. Due to safety concerns, further access and inspection of the roofvoid was not completed.

A termite specialist should be appointed urgently to complete an invasive inspection and installing a termite chemical treatment.

A licensed builder should then be appointed to replace or reinforce all structural damages.

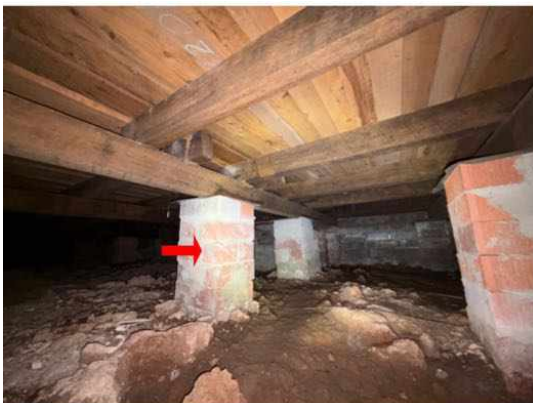
### Finding 3.01

Building:	Main Building
Location:	Subfloor
Finding:	Piers - Leaning
Information:	Pier to the subfloor structure is leaning, indicating that its structural integrity may have been affected. The cause of this instability is likely to be caused by movement / minor subsidence of the pier due to moisture.

Although only minor the pier should be monitored to avoid potential structural damage, which is likely to lead to a range of major and minor defects. Improving site drainage is recommended to avoid further movement / subsidence of the affected pier.

If further movement is evident appointment of a structural engineer is advised to assess the condition of the piers and provide advice on remedial works that may be required.

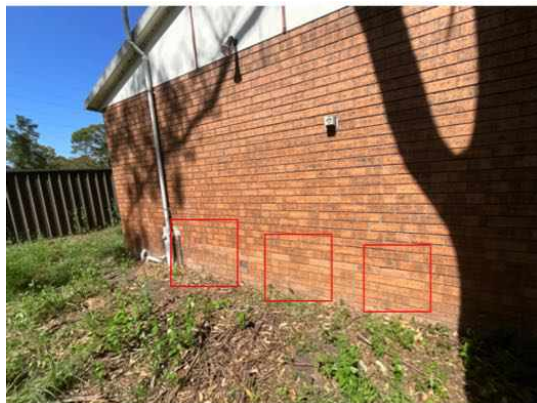
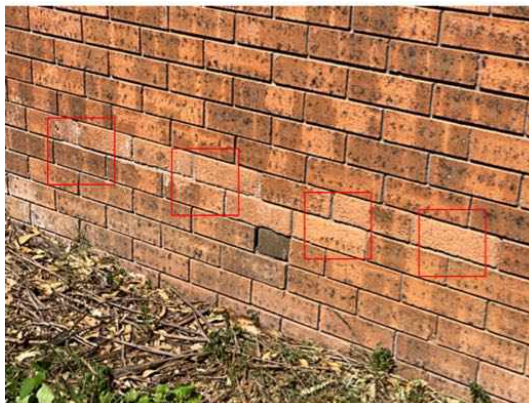
### Finding 3.02

Building:	Main Building
Location:	Studio
Finding:	Brickwork and Mortar - Deteriorated (Erosion)
Information:	This wall section was found to be deteriorated. Mortar, or `bedding`, is the material which fills joints and intersections between bricks in masonry walls and structures.

Commonly referred to as corrosion or erosion, the bricks and mortar are aged and likely to have been affected by a variety of factors, including moisture, salt-based deterioration, and more.

Mortar and brickwork should be replaced to ensure the structure remains in their intended location and to prevent gaps, which would allow water or moisture ingress and secondary damage as a result.

This can be addressed by a licensed bricklayer where areas of deterioration are localised and easily accessible.

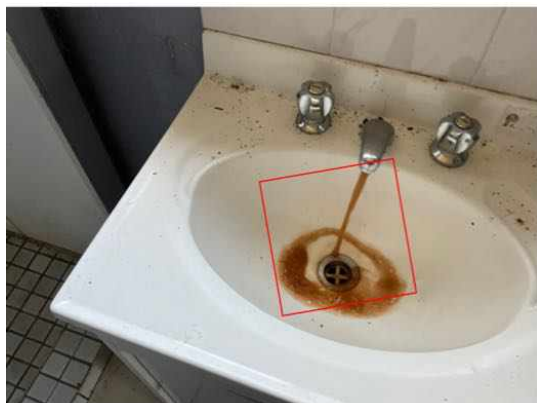
Building:	Main Building
Location:	Studio
Finding:	Tap - Rust in water
Information:	The water emitting from the tap in this area is rusty-coloured and undiluted. It is

suspected that this is a direct result of the erosion and deterioration of associated pipework, which is contaminating the water as it passes through the affected sections.

While this is a common defect and is relatively expected in a property of this age and condition, eroding pipework can have damaging implications to associated building elements if left unmanaged.

Replacement of this pipework appears to be necessary. A licensed plumber should be appointed to further inspect the pipework and provide any remedial works as required.

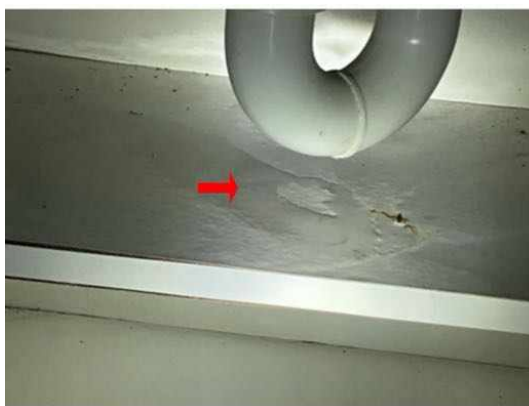
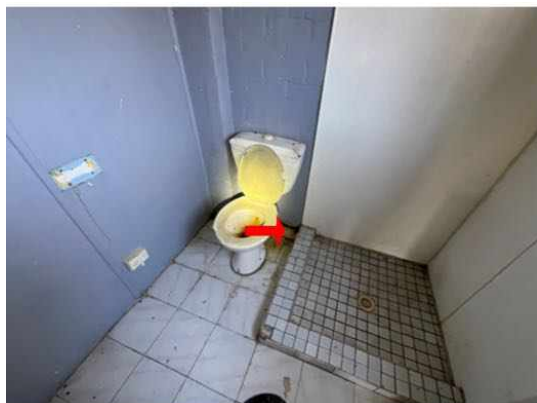
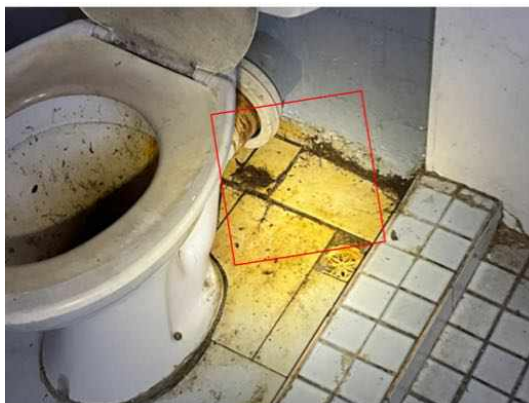
### Finding 3.05

Building:	Main Building
Location:	Studio
Finding:	Damp or wet - leak
Information:	Damp or wet conditions are generally a direct result of poor drainage an active leak or poor ventilation (or a combination of the three). Dry conditions should be maintained to prevent secondary building defects from developing.

If left unattended damp or wet conditions may have many consequences including the development of fungal decay and/or wood rot as well as providing an environment that may be conducive to termite or timber pest attack.

A qualified plumber should be appointed immediately to identify the cause of the excessive moisture in order to prevent further damage. The water leak should be resolved prior to any repairs of the damaged area which may require localised replacement of building materials and refinishing..

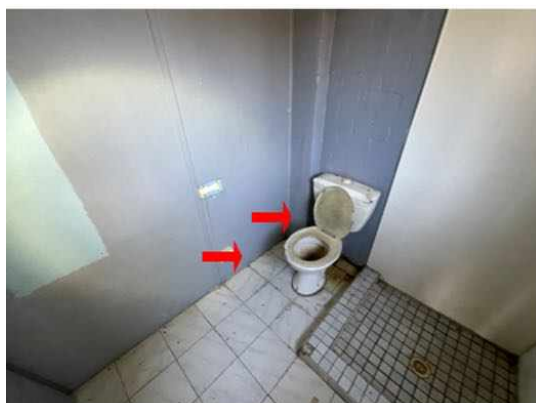
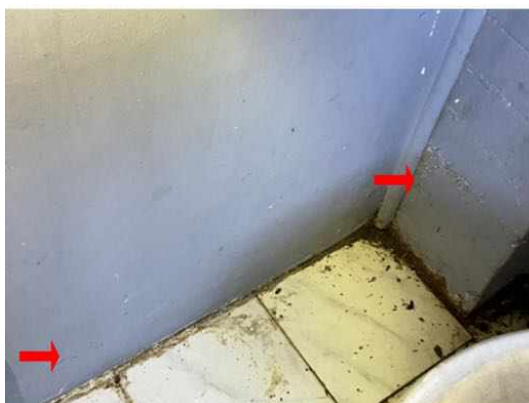
### Finding 3.06

Building:	Main Building
Location:	Studio
Finding:	Water Damage
Information:	Water damage is generally an indication of excessive moisture being present, usually via a leak.

Where water damage is evident, the primary requirement is to identify and rectify the source of the leak. A licensed plumber should be appointed as soon as possible to identify the leak and perform rectification works as necessary, ensuring the water damage is restricted.

Once the leak is repaired, consultation with relevant tradespeople, including carpenters, plasterers and painters, is advised.

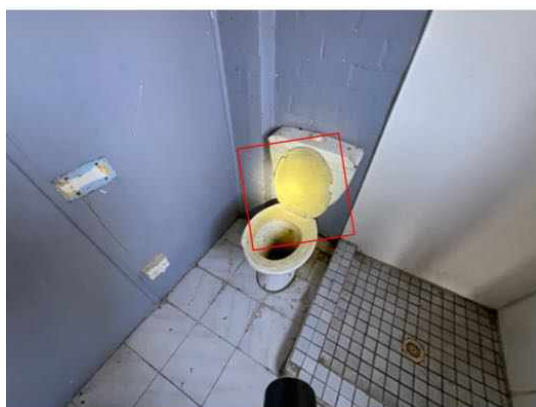
### Finding 3.07

Building:	Main Building
Location:	Studio
Finding:	Toilet - Not flushing
Information:	The toilet did not flush at the time of inspection.

Non-operational building elements such as this are vital to the function of the household and must be fixed.

A qualified plumber should be appointed immediately to repair the toilet and return it to an operational state.

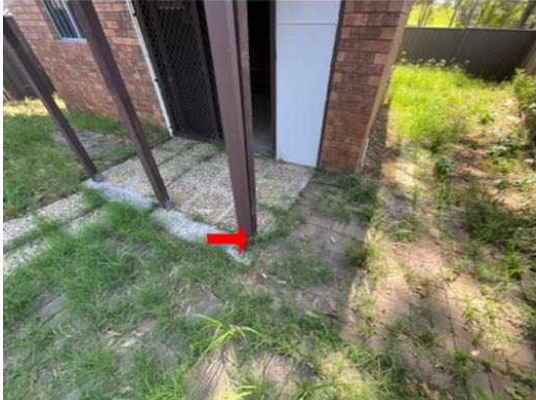
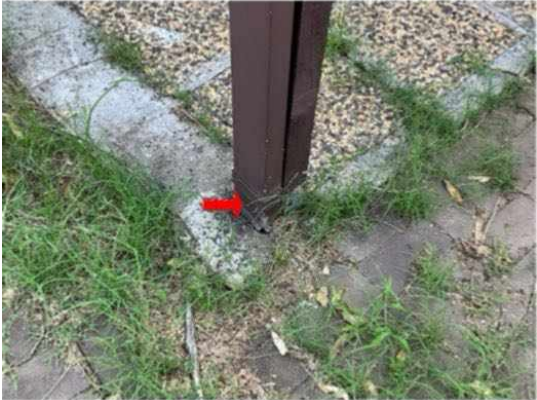
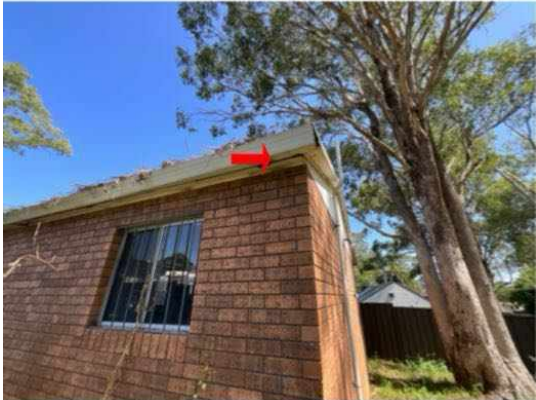
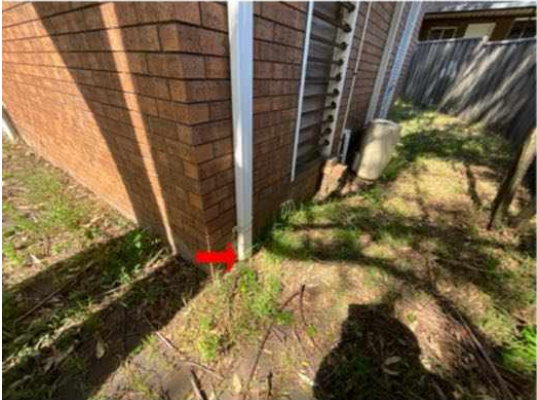
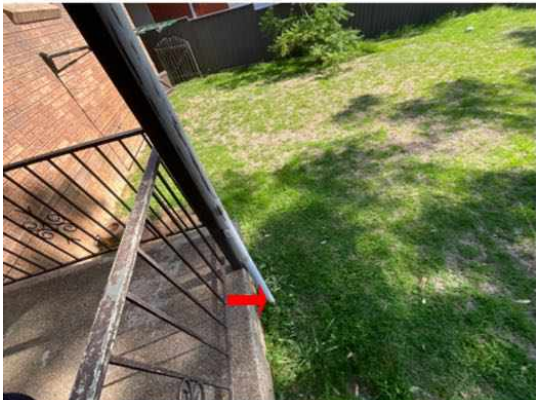
### Finding 3.08

Building:	Main Building
Location:	Multiple areas
Finding:	Stormwater drain - Not connected
Information:	The roof plumbing is not adequately connected to stormwater drainage on the site. This disconnection negatively impacts the functional capacity of the roof plumbing.

Where roof plumbing doesn't drain adequately, the area at the base perimeter can become excessively damp, potentially creating an environment that is susceptible to rust and corrosion of surrounding building elements, as well as attracting termites and

It is highly recommended that a plumber be appointed to further inspect the area and to install adequate drainage equipment where necessary.

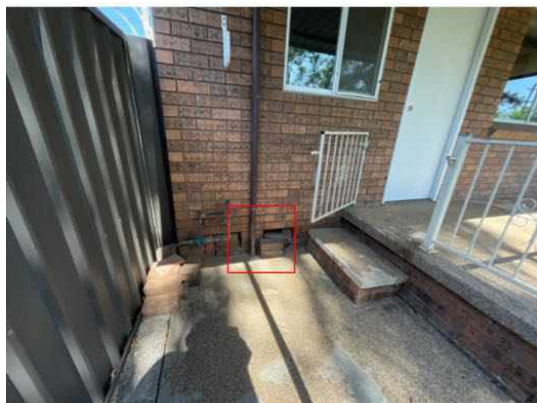
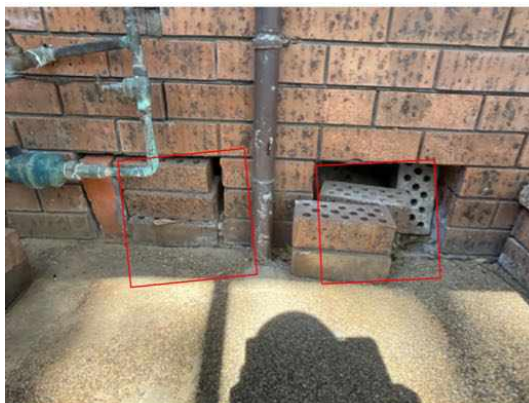
**Finding 3.09**

Building:	Main Building
Location:	Exterior walls - rear
Finding:	Unconventional handyman work
Information:	This handyman work appears to have been completed to a substandard level and does not comply with regular building practices. Where handyman work is not

completed satisfactorily, accelerated deterioration of the associated building elements is likely to occur and secondary defects to surrounding structures may develop.

It is highly recommended that the substandard work be rectified by professional services. Works to improve this area are likely to increase the safety and the operation of the associated building elements.

The client should exercise care when coming into the immediate vicinity of the substandard works. Rectification works are advised as soon as possible by the appropriate trades.

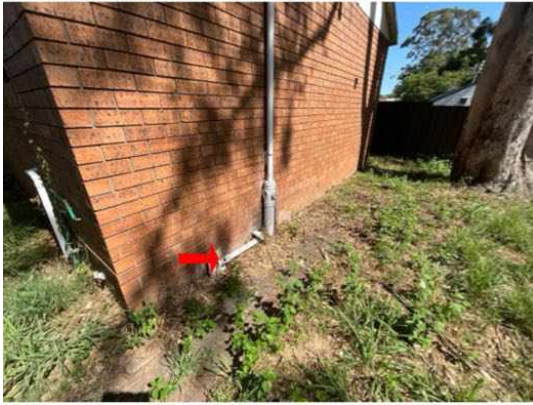
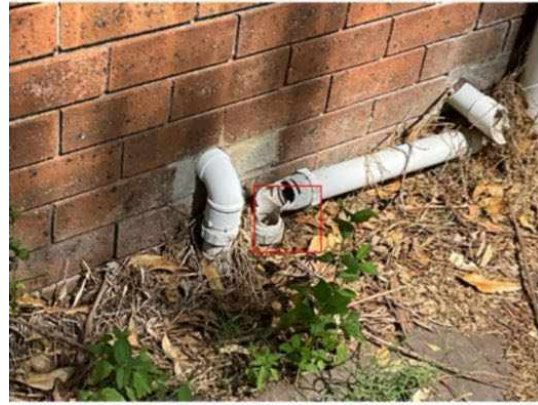
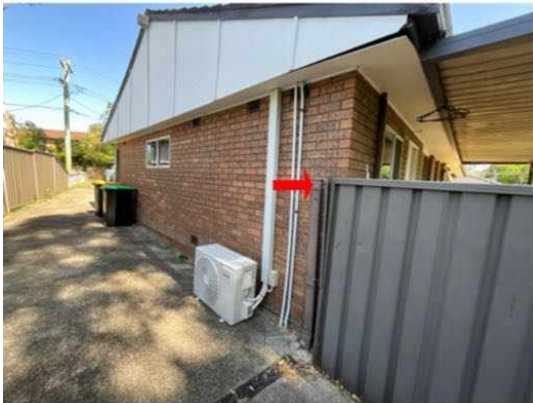
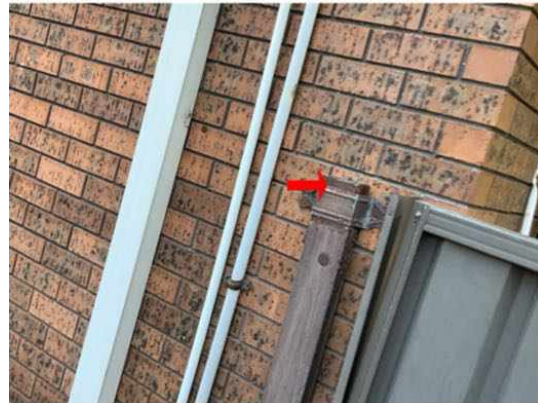
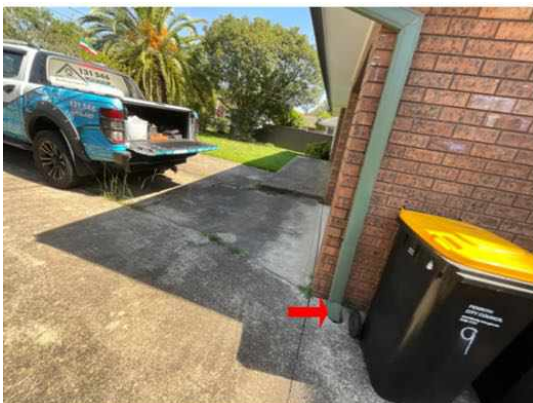
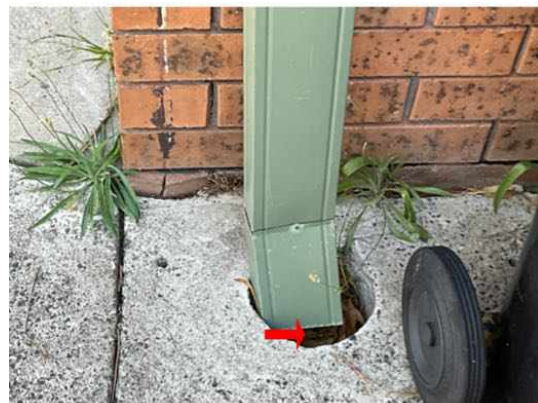
### Finding 3.10

Building:	Main Building
Location:	Multiple areas
Finding:	Plumbing - Point of connection non-compliant
Information:	At the time of inspection it was noted that connections between above ground pipe work and below ground sewer/storm water systems were incomplete.

Additionally, where sewer pipes are concerned, gases can escape from unsealed connections which can pose a serious health risk.

Engagement of a certified plumber is strongly recommended to ensure all connection points are sealed in accordance with the plumbing construction guidelines.

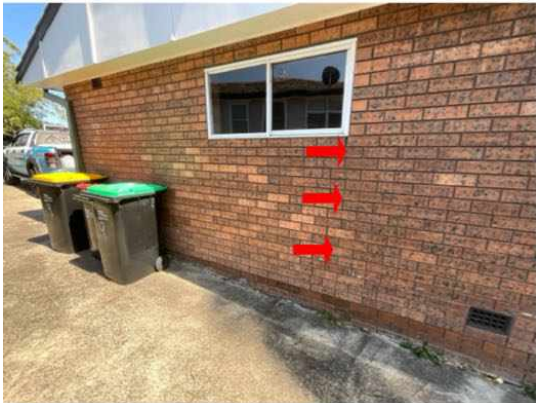
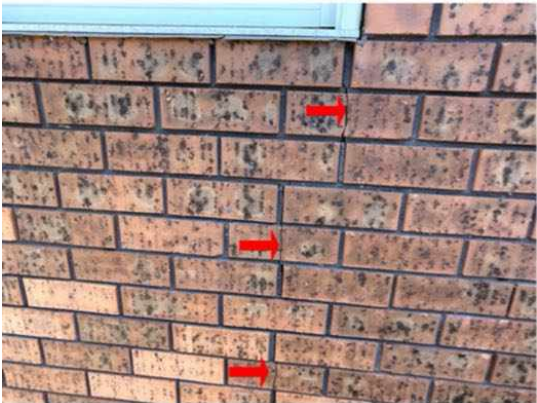
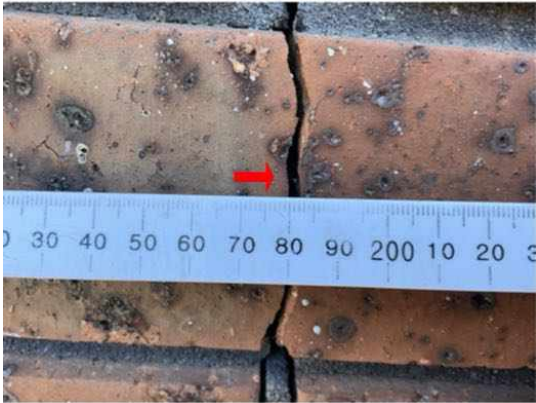
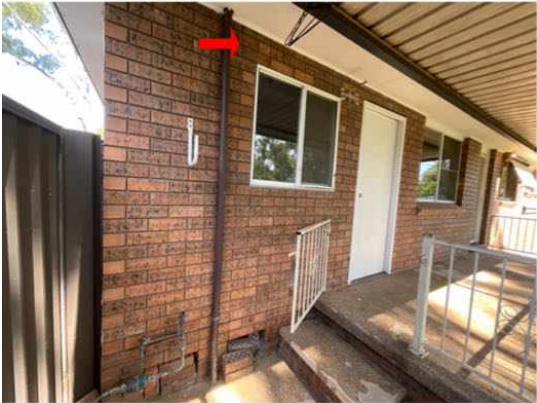
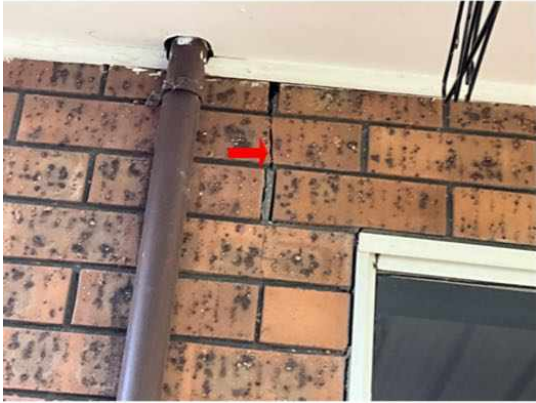
Building:	Main Building
Location:	Multiple areas
Finding:	Damage to Masonry Walls (Cracks)- Category 2
Information:	It has been observed that damage to masonry walls caused by movement of slabs, footings, or other causes, has occurred. The degree of damage falls within Category 2, described as noticeable cracks which are easily filled. Such cracking may cause doors and/or windows to stick slightly, and are generally less than 5mm in width.

Damage of this category is required to be monitored for a period of 12 months, after which time a crack rated at Category 2 or above is considered a defect requiring rectification, such as minor repairs and repointing. Always contact your building

inspector should cracks widen, lengthen, or grow more numerous.

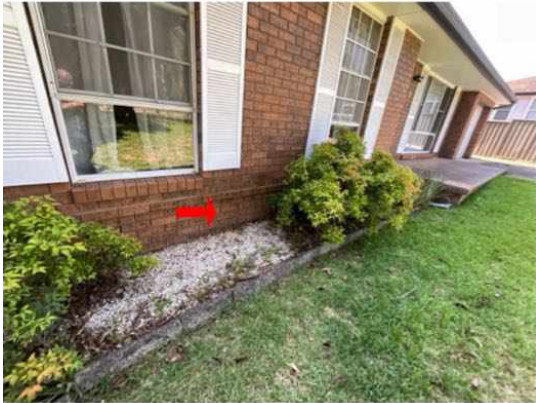
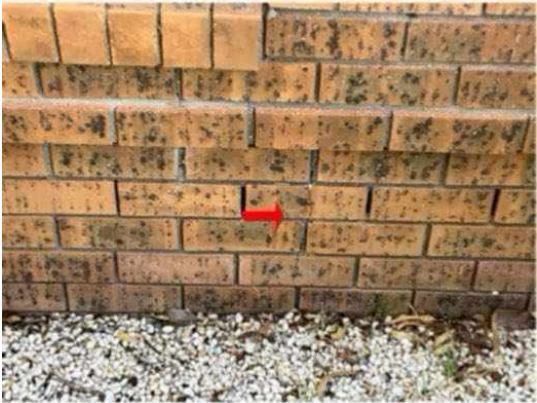
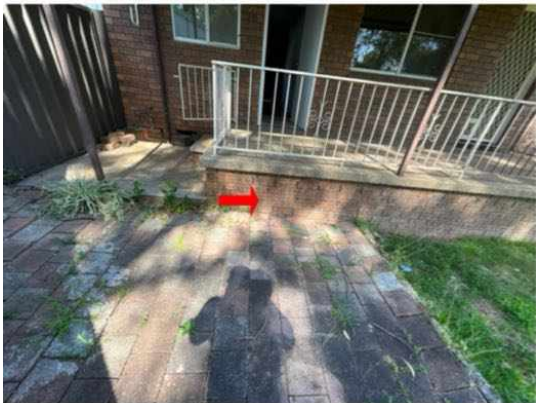
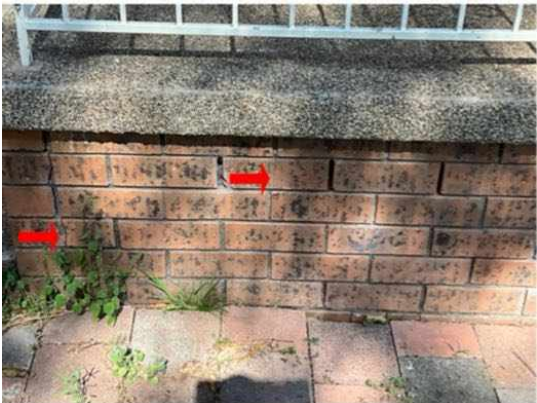
**Finding 3.12**

Building: Main Building  
Location: Multiple areas  
Finding: Damage to Masonry Walls (Cracks) - Category 1  
Information: It has been observed that damage to masonry walls caused by movement of slabs, footings, or other causes, has occurred. The degree of damage falls within Category 1, described as fine cracks, which are less than 1.0mm in width limit, and that do not need repair.

Damage of this category is not considered a defect for rectification. Always contact your building inspector should cracks widen, lengthen, or become more numerous.

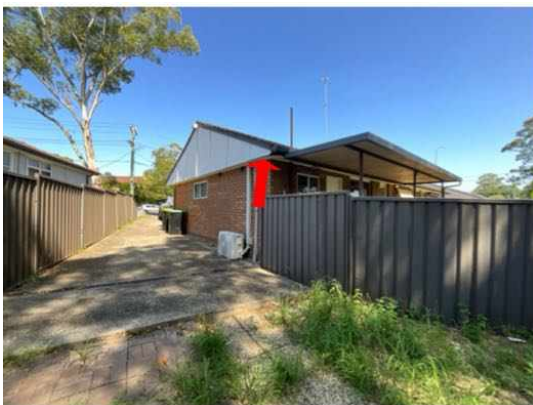
### Finding 3.13

Finding: Beads - Damaged

Information: Beading acts (like cornice or skirtings) to cover the intersection or joins of building materials. It was noted at the time of inspection that beading in this area has deteriorated. This deterioration is suspected to have been caused by general ageing and frequent exposure to weather, which is expected in a building of this age and condition.

Beading is important in weatherproofing the surrounding building elements and preventing pest ingress. Furthermore, beading works to protect the joins of building materials, which are more susceptible to deterioration and decay.

Repair or replacement of the beading is advised to ensure the protection and longevity of any associated building elements. Such works may be performed by a general handyman or qualified carpenter.

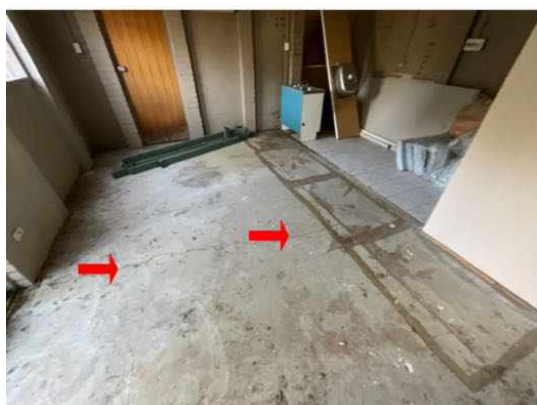
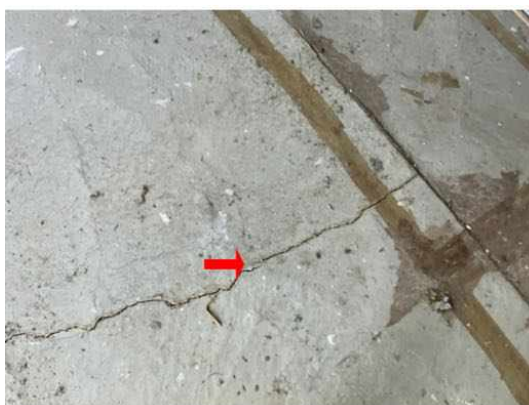
### Finding 3.15

Finding: Crack in concrete slab - Category 1

Information: A crack coded as Category 1 was identified in the slab. A Category 1 crack is

described as a fine but noticeable crack, with the slab at an otherwise reasonable level.

To be considered Category 1, the approximate width of the crack is less than 1.0mm, or a less than 10mm change in offset when a 3m straight edge is placed over the defect.

Category 1 cracks should be monitored for a period of 12 months. At the end of the monitoring period, identified cracks that are rated greater than Category 2 are considered defects, and require rectification.

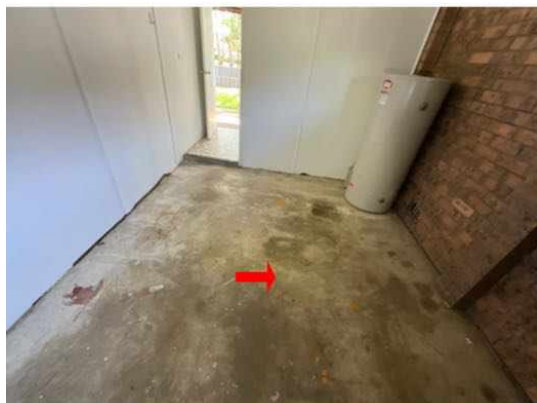
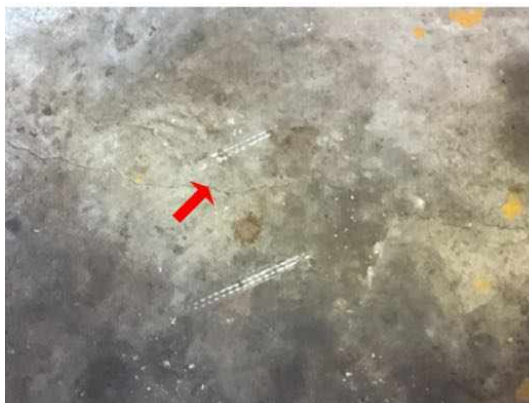
### Finding 3.16

Building: Main Building  
 Location: Studio  
 Finding: Cracked floor tiles  
 Information:

Cracking in the floor tiles was evident in this area at the time of inspection. It is suspected that this cracking has occurred as a result of minor settlement or shrinkage.

Cracked tiles throughout the household detract from the overall appearance of the affected areas however it is unlikely to create or lead to any secondary defects.

While not considered a matter of urgency, replacement of cracked floor tiles is recommended at the clients discretion. A licensed tiling contractor may be appointed to perform these works. Where cracks become more numerous, contact a licensed building inspector for further investigation.

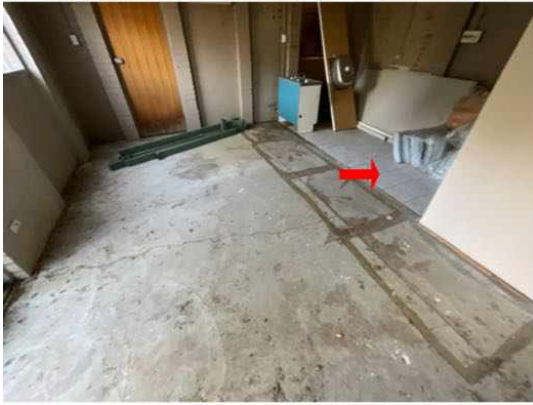
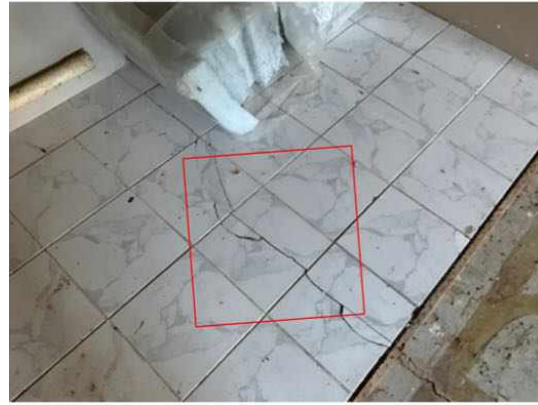
### Finding 3.17

Building:	Main Building
Location:	Studio
Finding:	Incomplete or substandard works
Information:	The works to this area appear to be incomplete or have been completed to a substandard level.

Works that have not been completed to a satisfactory level create potential for the development of building defects and may impede on the safety and integrity of the overall structure.

It is highly recommended that the relevant trades be appointed to complete these works and ensure the safety of the area and the longevity of all associated building elements.

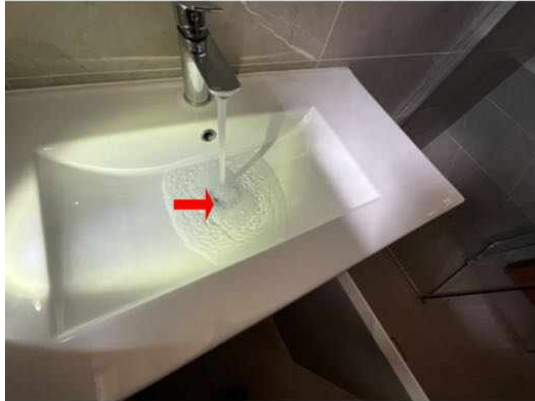
### Finding 3.31

Building: Main Building  
Location: Laundry  
Finding: Fitting or fixture - Loose sink  
Information:

The laundry sink in this area is loose and can be moved with minimal force applied by hand. The sink should be fixed firmly to the wall and/or floor.

If left unmanaged, the sink may move and cause damage to pipes, fitting and finishes.

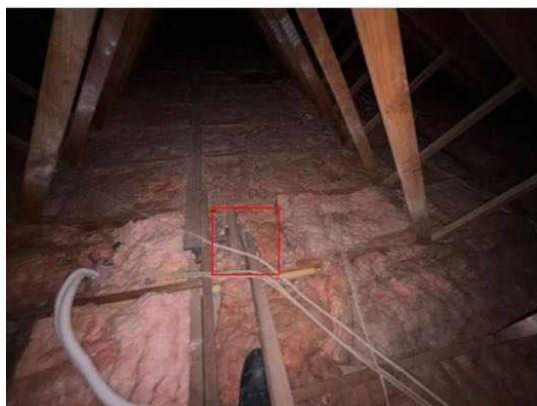
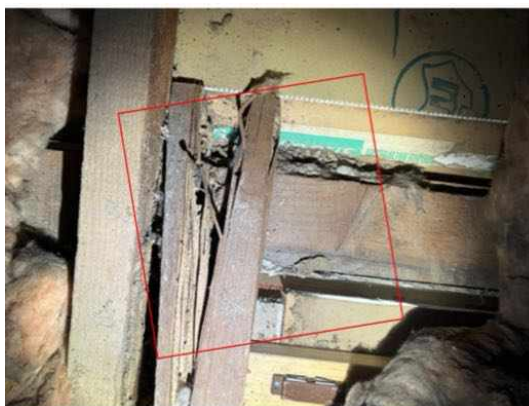
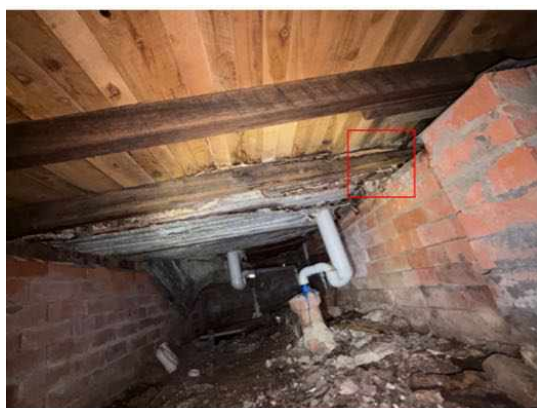
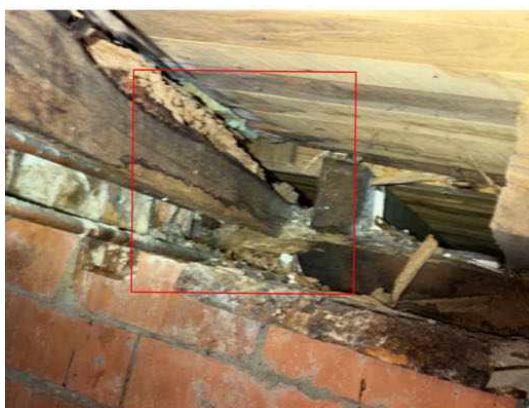
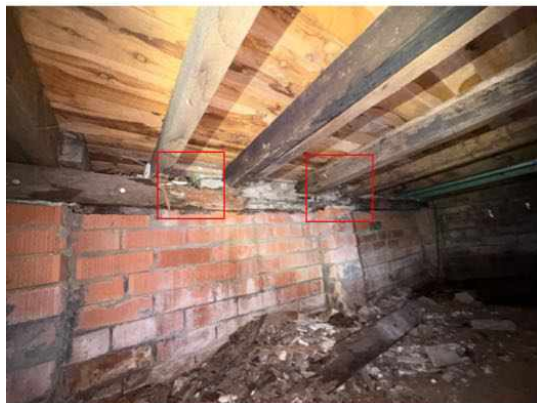
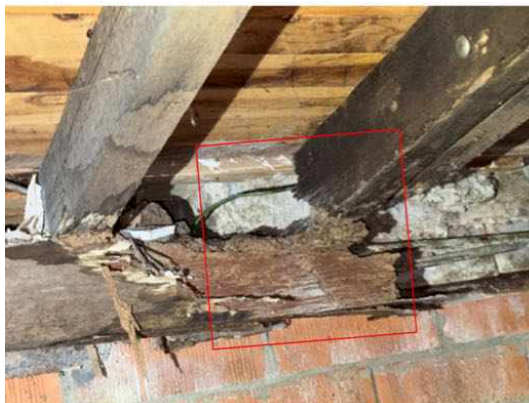
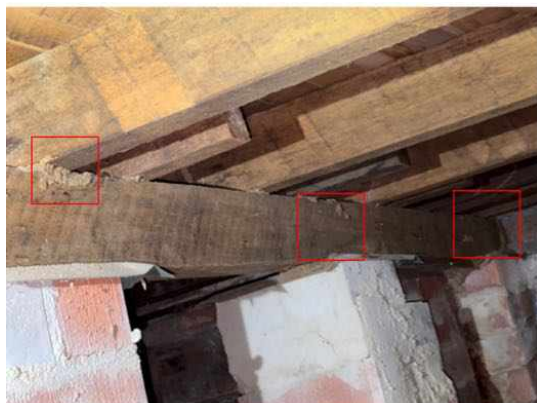
Building: Main Building  
Location: Roof Void, subfloor  
Finding: Evidence of termite damage  
Information: Despite no live termite or timber pest activity being indicated, previous termite damage was found to have affected this area or otherwise termite workings were identified at the time of inspection. This damage is considered to be inactive, however structural in nature. Due to safety concerns, further access and inspection of the roofvoid was not completed.

A termite specialist should be appointed urgently to complete an invasive inspection and installing a termite chemical treatment.

A licensed builder should then be appointed to replace or reinforce all structural damages.

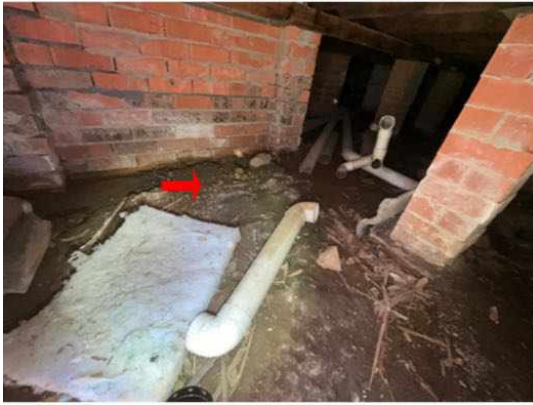
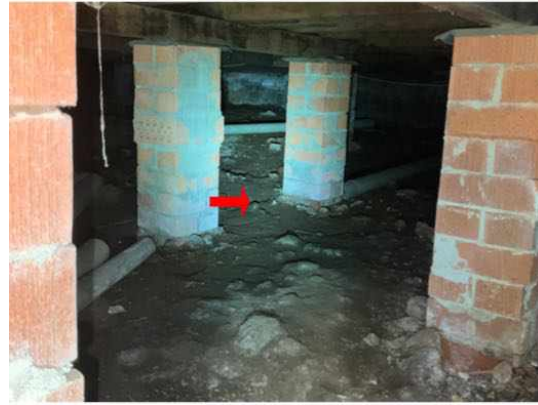
### Finding 6.01

Building:	Main Building
Location:	Subfloor
Finding:	Site drainage— Inadequate
Information:	The site drainage in this area was found to be inadequate at the time of inspection, creating potential for subsequent water damage to associated building elements. This is additionally conducive to termite activity.

It is important that water does not lie against the base of walls; surrounding paths and ground levels should be sloped to drain water away from walls. Downpipes should not discharge stormwater onto lower walls or plinths. Stormwater should be carried away by large, regularly cleaned drains. Ground levels may need to be lowered to expose a buried DPC.

Where site drainage is inadequate, installation of an Agricultural (Aggie) Drain may be required. A licensed plumber should be appointed to further inspect the property and perform any remedial works as necessary. Water damage and secondary defects are likely to occur if left unmanaged.

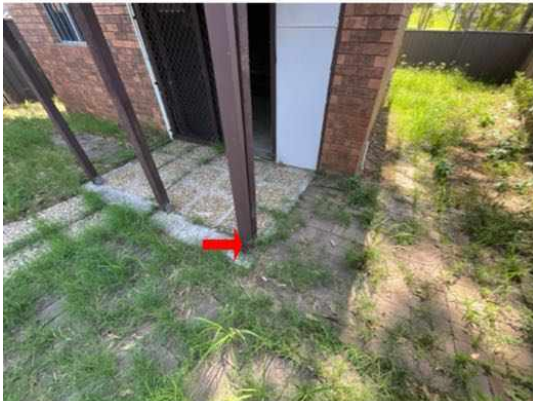
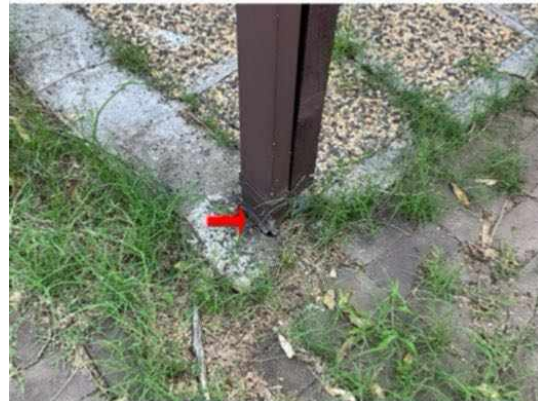
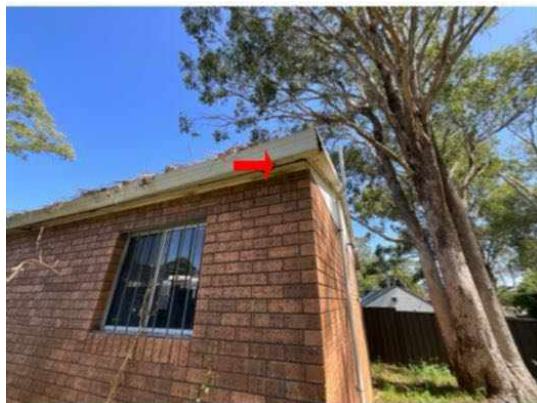
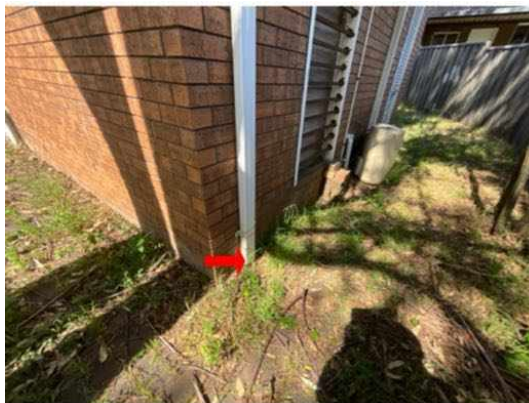
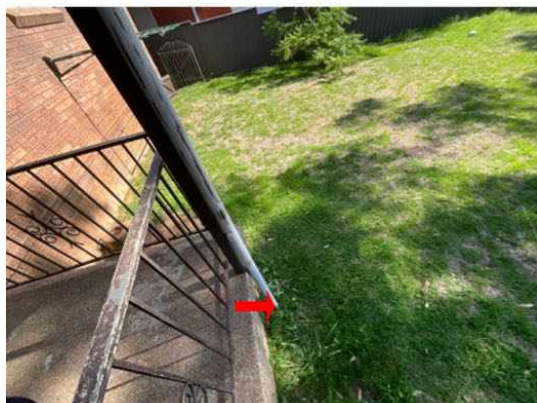
### Finding 6.02

Building:	Main Building
Location:	Multiple areas
Finding:	Stormwater drain - Not connected
Information:	The roof plumbing is not adequately connected to stormwater drainage on the site. This disconnection negatively impacts the functional capacity of the roof plumbing.

Where roof plumbing doesn't drain adequately, the area at the base perimeter can become excessively damp, potentially creating an environment that is susceptible to rust and corrosion of surrounding building elements, as well as attracting termites and other pests.

It is highly recommended that a plumber be appointed to further inspect the area and to install adequate drainage equipment where necessary.

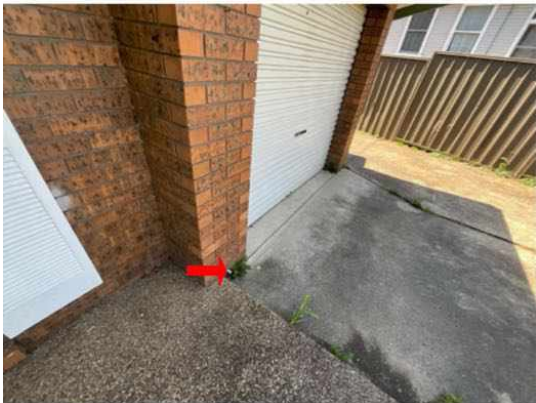
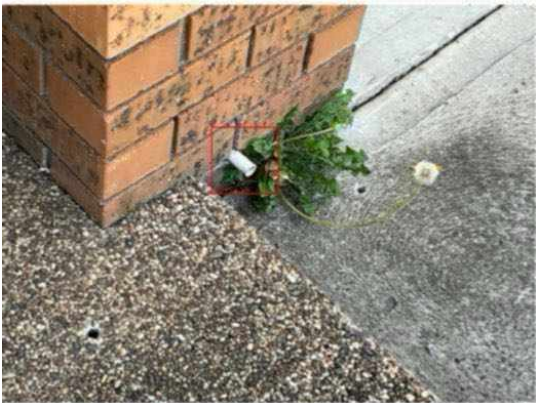
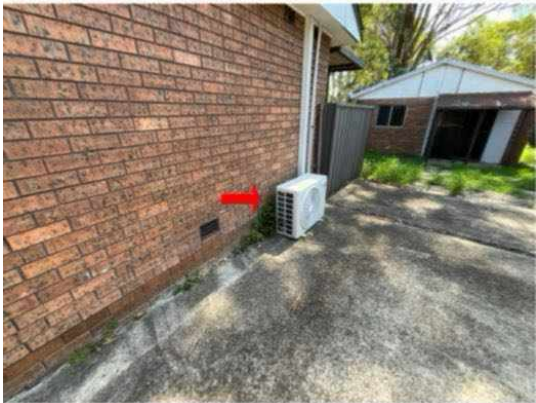
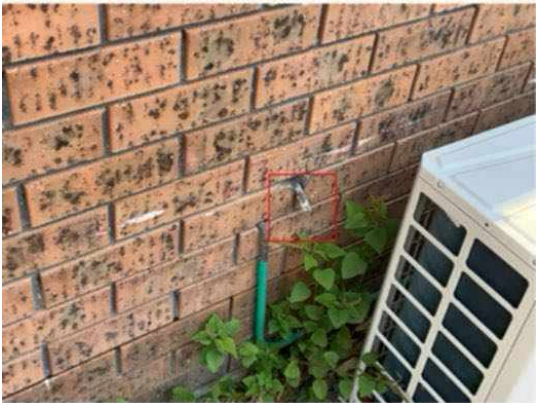
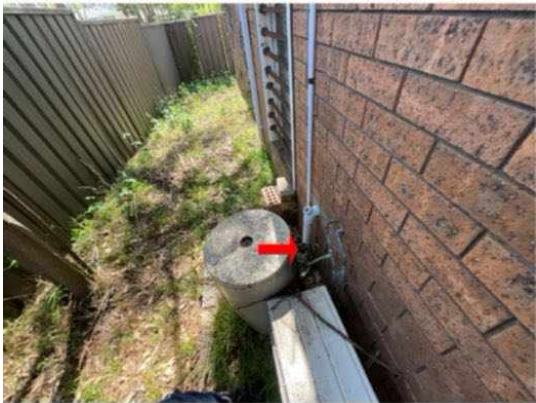
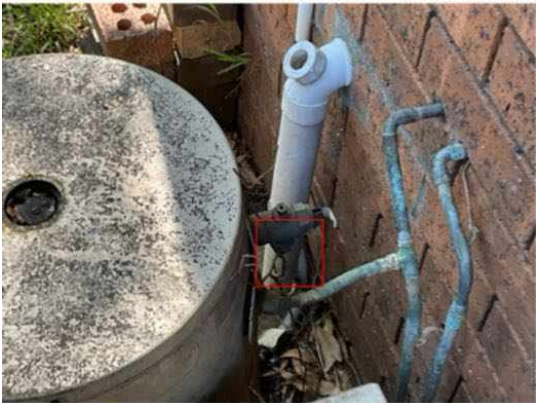
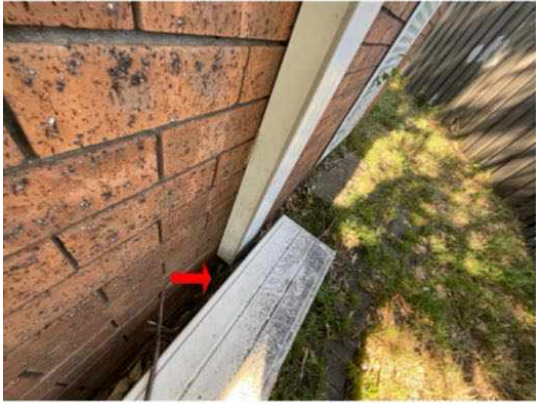
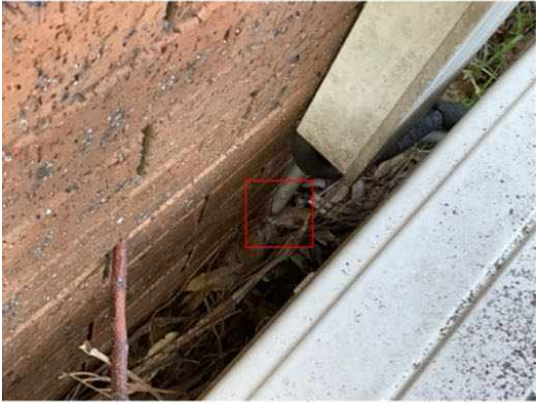
### Finding 6.03

Building:	Main Building
Location:	Yard - Side
Finding:	Overflow - Not plumbed for drainage
Information:	The overflow is not plumbed or connected to suitable drainage, which can result in the surrounding area becoming excessively damp.

These damp conditions can lead to secondary defects such as rot, rust or corrosion of associated building elements, the formation of fungal decay, or even the creation of potential slip hazards. When coupled with poor site drainage, pooling of water may also attract termite activity to this area.

It is highly recommended that a licensed plumber be appointed to install adequate drainage to the overflow. These works will ensure that the area remains dry and free of any secondary defects.

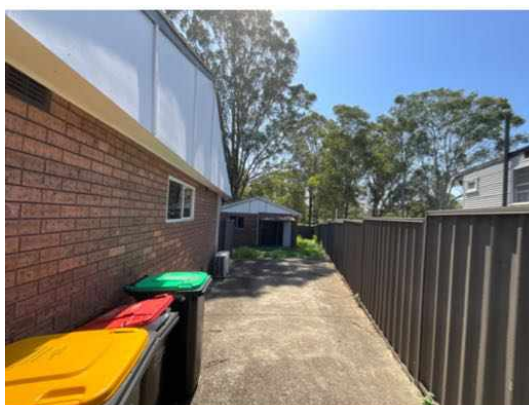
### Finding 6.05

Building:	Main Building
Location:	Vegetation
Finding:	Vegetation - Abutting property
Information:	Vegetation against external wall may have an invasive root system. If there are weak points in the brick work or concrete slab, it is possible for the roots to gain entry into these areas. Once the roots have gained entry, it is possible for termites to gain concealed entry via these roots. It is recommended to remove the vegetation and root system where possible.

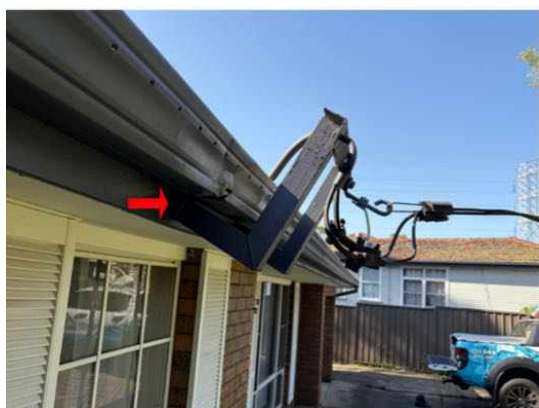
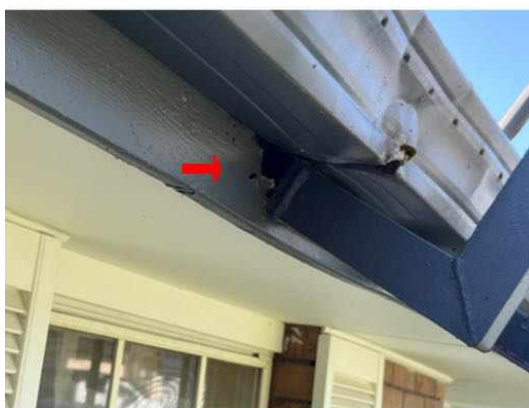
Building:	Main Building
Location:	Front Elevation
Finding:	Wood rot/decay

**Information:** This building element shows evidence of wood rot. Wood rot, also known as Fungal Decay, occurs when timbers and other cellulose building materials are exposed to damp conditions on an ongoing basis. This could be the result of exposure to weathering over a prolonged period of time, or the attraction of excessive moisture from other abutting building materials. Contributing factors also include poor air ventilation in the area.

Wood rot is often associated with general damp problems and is evidenced by a `musty` smell or mould and mildew occurring on surfaces. If left unmanaged, damp conditions can lead to further health problems and the decay of timbers will continue.

Early intervention and regular maintenance, particularly of exterior timbers, will prolong the useful life of these building elements. Prior to any works being performed, the cause of the moisture that has created the visible wood rot should be identified and addressed in a suitable manner. Replacement of affected timbers may then be a necessary step in protecting surrounding building elements from such deterioration.

A licensed plumber may be appointed to assess the cause of excessive moisture and to provide advice on any remedial works as required. A licensed carpenter may also be required to replace affected building materials.

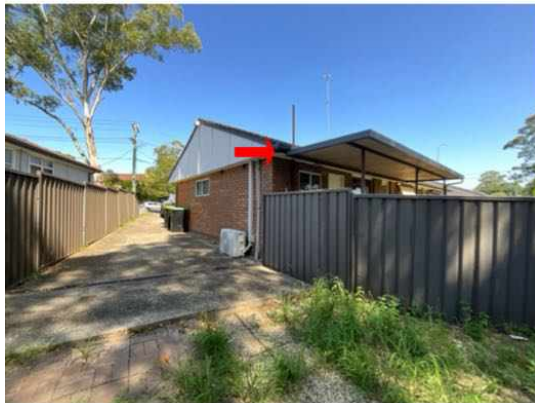
## Finding 7.02

**Building:** Main Building  
**Location:** Fascias  
**Finding:** Fascias - Wood rot/decay  
**Information:** Wood rot was found to be affecting fascias and barges in this area, evidenced by the presence of mould on the surface in some areas. Wood rot, also known as Fungal Decay, occurs when timbers and other cellulose building materials are exposed to damp conditions on an ongoing basis.

It is likely that this wood rot has developed as a result of faults in the roof plumbing, creating excessive moisture in this areas. Otherwise frequent exposure to rain and other weather conditions also make fascias and barges susceptible to accelerated deterioration.

Early intervention and regular maintenance will prolong the useful life of these building elements. Prior to any works being performed, the cause of the moisture that has created the visible wood rot should be identified and addressed in a suitable manner.

It is advised that a roof plumber be appointed to inspect all roof plumbing and subsequently identify the cause of the wood rot. Replacement of affected fascias and barges may then be a necessary step in protecting surrounding building elements from such deterioration.

A licensed plumber may be appointed to assess the cause of excessive moisture and to provide advice on any remedial works as required. A licensed carpenter may also be required to replace affected building materials.

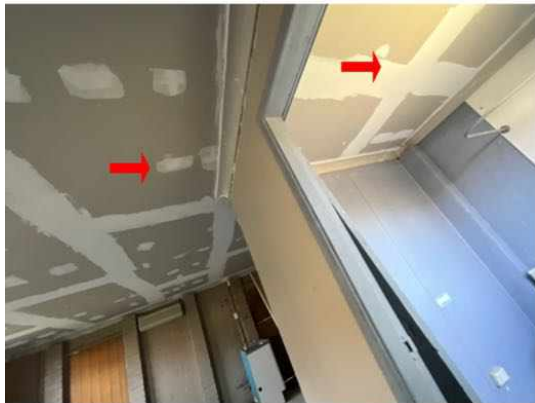
Building: Main Building  
 Location: Studio  
 Finding: Roof void - Access not possible  
 Information:

Access to the roof void was not possible because no access panel was located at the time of inspection.

It is highly advised a licensed carpenter be appointed immediately to install an appropriate access panel for maintenance purposes.

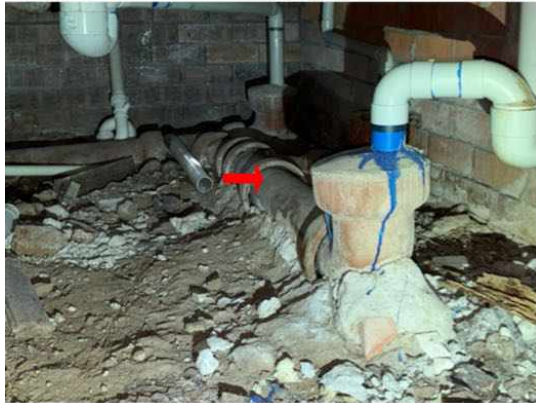
Building: Main Building  
 Location:  
 Finding: Pipework - Old urban wear pipes  
 Information: Old urban wear pipes were identified at the time of inspection.

Consultation with a licensed plumber is advised. CCTV inspection on pipes may be required.
