# Building and Timber Pest Inspection Report

Inspection Date: Fri, 30 Jan 2026

Property Address: 9 Arakoon Avenue, Penrith, NSW 2750

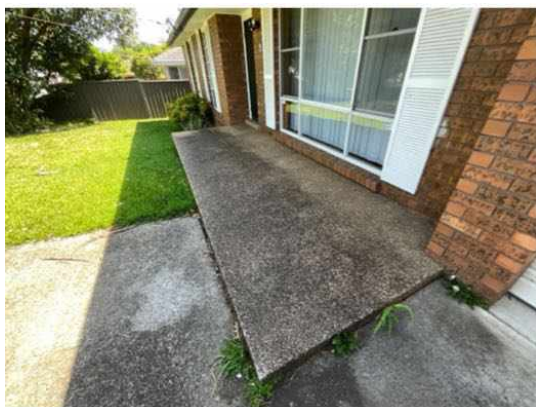
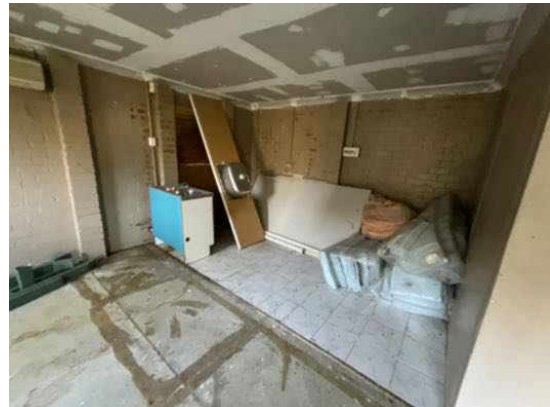
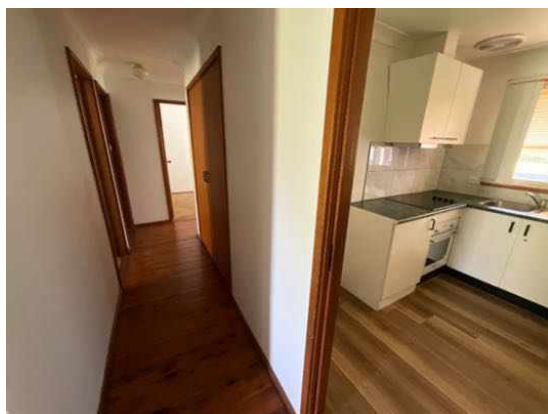
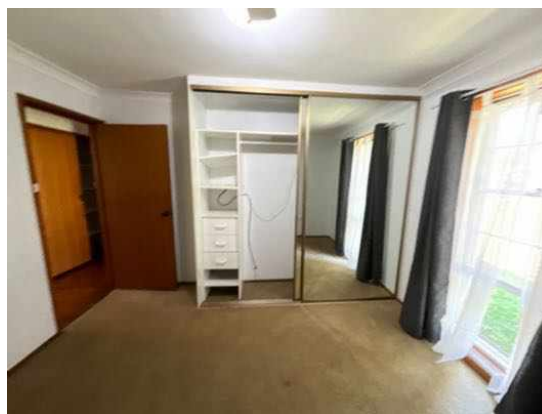
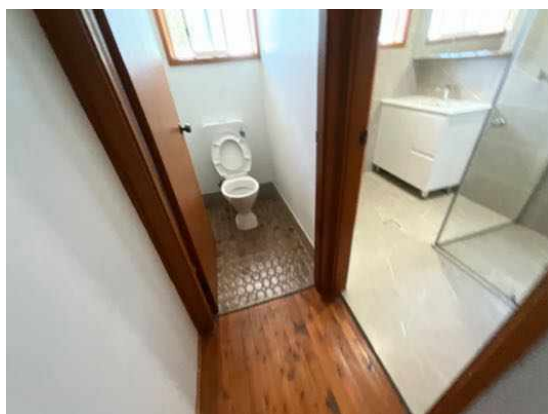
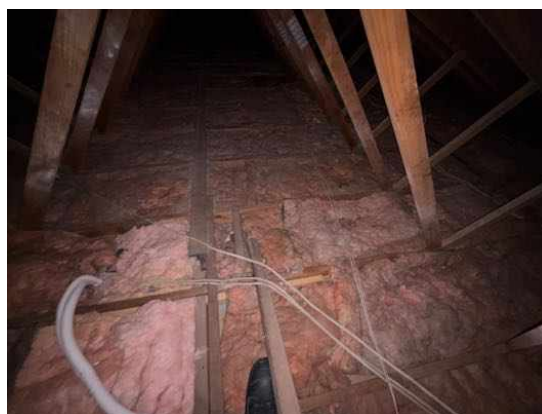
Building: Main Building  
 Location: All Areas  
 Finding: Additional Photos - Obstructions and Limitations  
 Information:

These photographs are an indication of the obstructions and limitations which impeded full inspection of the property at the time of inspection. These obstructions can hide an array of defects and should be removed to allow full inspection to be carried out. A re-inspection is recommended once the areas are made accessible.
