Building and Timber Pest Inspection Report

Inspection Date: Thu, 9 Apr 2026

Property Address: 7/17-21 Brisbane Street, Oxley Park NSW
2760

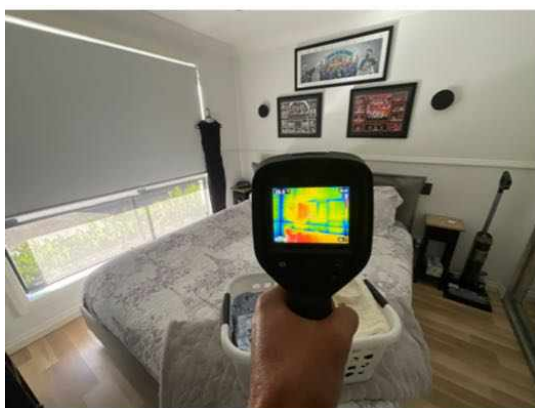
Termites release heat in the form of carbon dioxide and build mud tubes with high moisture content, which can create irregular heat patterns on surfaces such as walls, ceilings, and floors.

At the time of the inspection, no abnormalities indicating live termite activity were observed. However, it's important to note that various factors—such as obstructions, ambient temperature, and wall material/thickness—can impact the accuracy of thermal readings. In cases where surfaces are visually restricted or obstructed, a comprehensive thermal scan may not always be feasible.

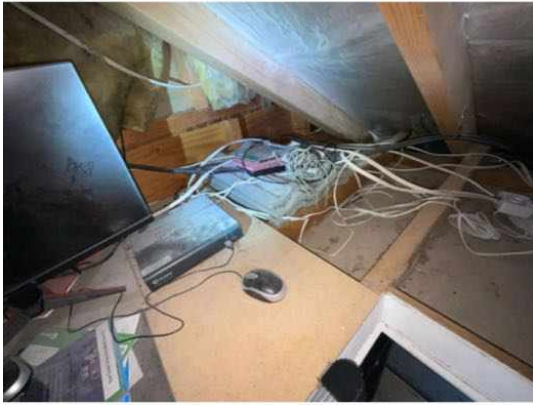
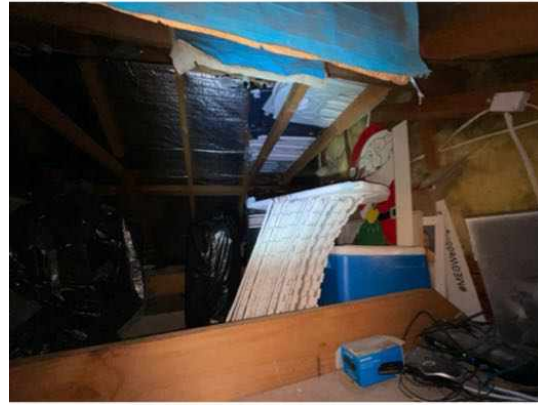
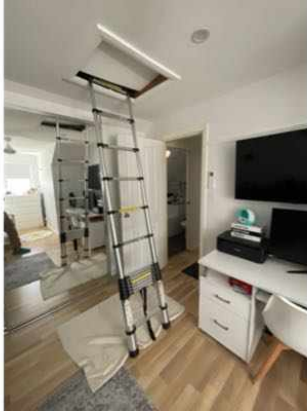
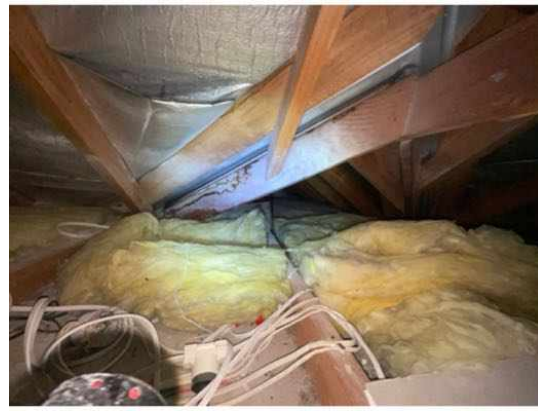
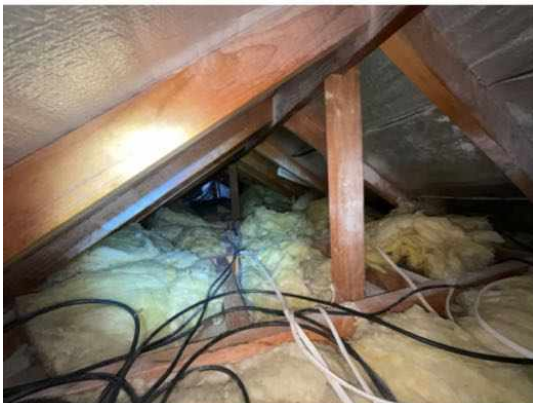
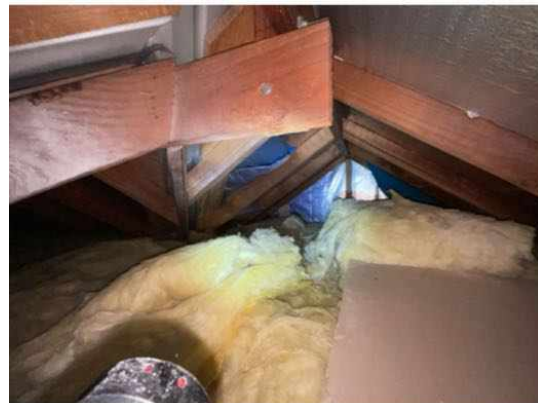
Building: Main Building
 Location: Roof Void
 Finding: Roof Void – Limited Accessibility..
 Information: Observation:

Installation of an additional manhole is recommended to facilitate a re-inspection and enable a more thorough assessment of the roof void in the future. This will help ensure that all structural elements and concealed areas are properly evaluated.

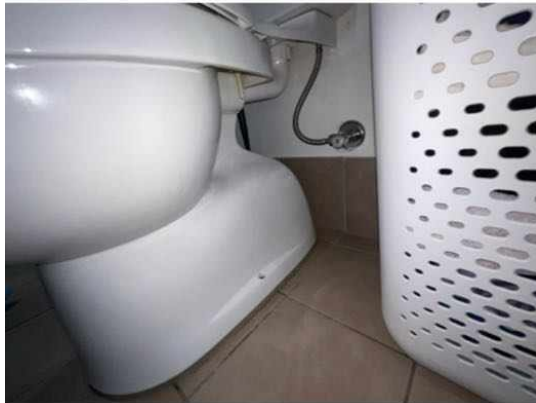
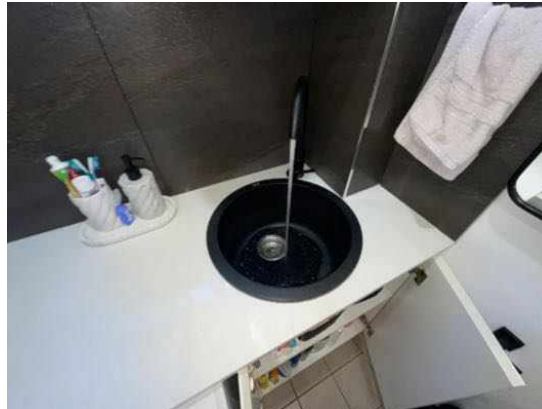
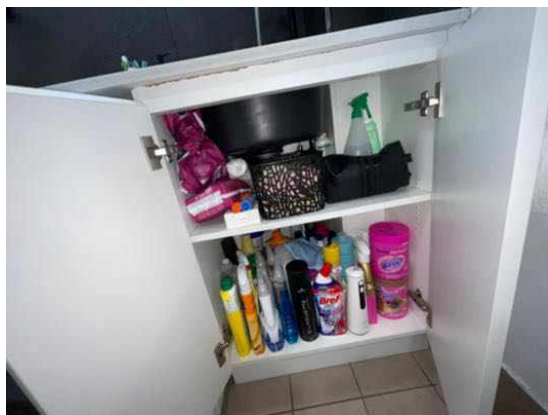
Building: Main Building
 Location: Kitchen
 Finding: Kitchen Sink – Overall Condition & Recommendations.
 Information: Observations:

Alternatively, the assumption should be made that leakage may occur, particularly where historical or environmental conditions are conducive. The visual nature of this inspection cannot detect issues concealed behind wall/floor linings or cabinetry, and invasive investigation may be necessary to confirm the true condition of adjacent or hidden structures.

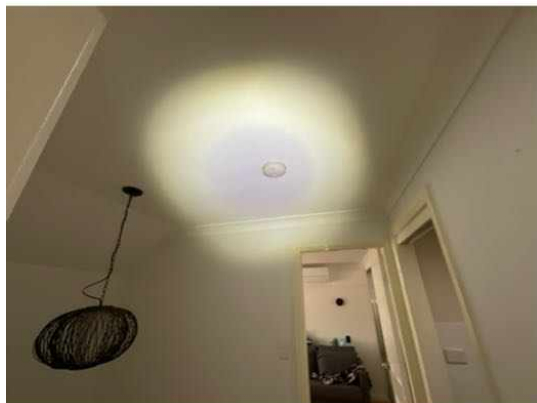
Building:	Main Building
Location:	All Areas
Finding:	Smoke Detectors / Alarms.
Information:	Reporting on the presence, type, location, or compliance of smoke detectors or alarms, including hard-wired smoke detection systems and their legislative requirements, is outside the scope of this inspection report.

- All smoke detectors be tested monthly by the homeowner.
- All systems comply with the requirements of AS 3786 and any applicable state-based legislation.
