# Building and Timber Pest Inspection Report

Inspection Date: Wed, 4 Mar 2026

Property Address: 38 Hoyle St, Tocumwal NSW 2714, Australia

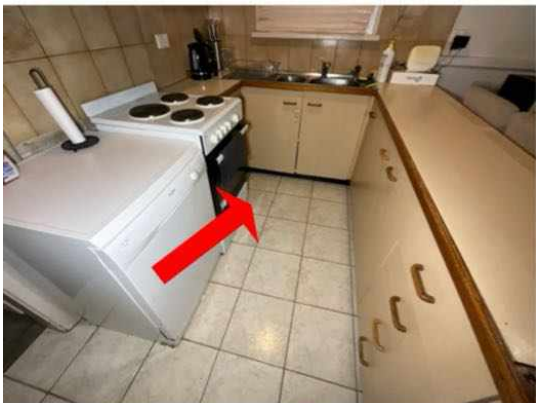
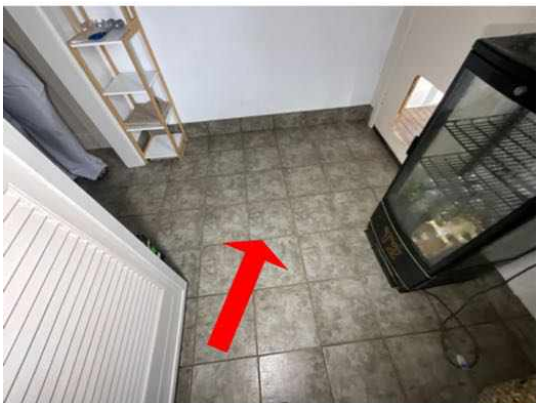
Finding 3.02

Building: Building 1  
 Location: All Internal Areas  
 Finding: Flooring - Uneven  
 Information: The internal flooring in this area is out of level and uneven. Uneven flooring is likely to indicate minor defects such as expected movement of the foundations of the property, but may also indicate subsidence of the associated subfloor stumps.

It is advised that the flooring be closely monitored to identify any further movement. Where flooring remains relatively unchanged for an extended period of time (i.e. several months), it is likely that this defect has been caused by expected movement of the foundations of the property.

However, where flooring is uneven further, potentially invasive inspection of the subfloor structures and stumps in this area is required. In this case, works to repair are likely to be required, and would be carried out by a registered builder specialising in re-stumping.

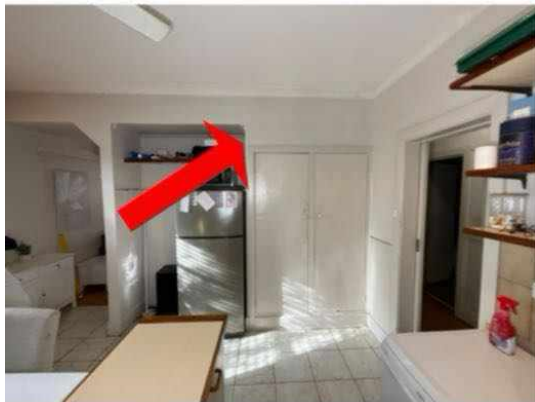
Building: Building 1  
Location: Living Room, kitchen, bed 1,3  
Finding: Cracking - Damage Category 1 - Fine (up to 1mm)  
Information: Although fine cracks are quite noticeable, they are often only considered to be an appearance defect, and usually do not indicate any structural damage. Generally, the cause of a fine crack is indicative of a separation between building materials and finishes (e.g. paint, plaster, etc.) along joins.

Cracking of this nature can generally be repaired with minor sanding, filling and/or repainting. Such works should be performed by a qualified painter or a general handyman.

Monitoring of all cracking should be conducted frequently. Always contact a building inspector should cracks widen, lengthen, or become more numerous.

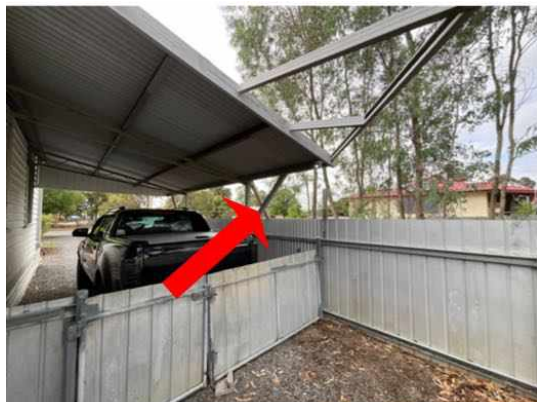
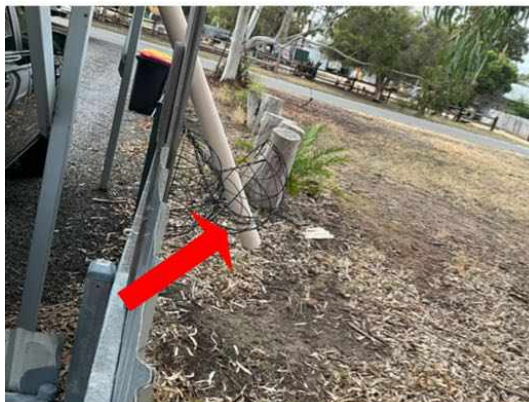
Where roof plumbing doesn't drain adequately, the area at the base perimeter can become excessively damp, potentially creating an environment that is susceptible to rust and corrosion of surrounding building elements, as well as attracting termites and other pests.

It is highly recommended that a plumber be appointed to further inspect the area and to install adequate drainage equipment where necessary.

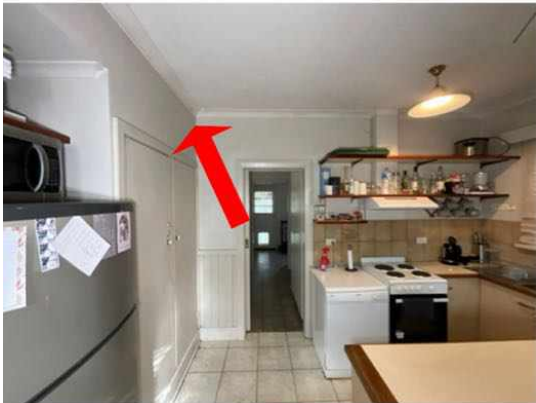
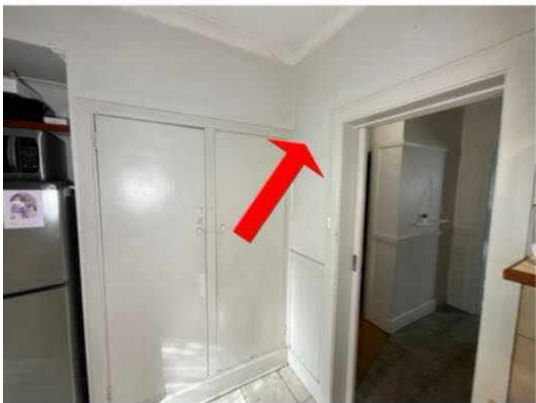
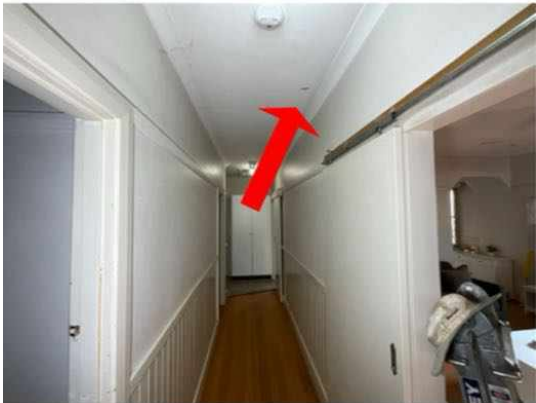
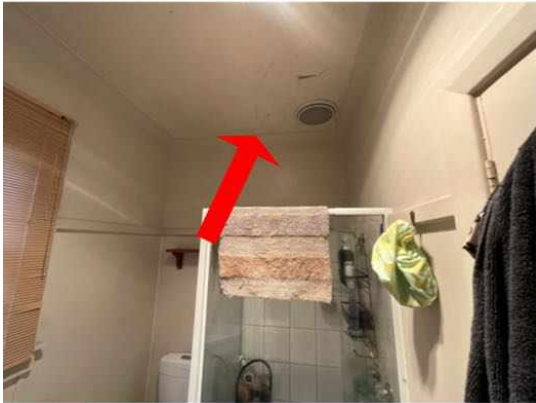
The presence of excessive moisture can have major implications on associated building elements if left unattended. While only seemingly minor at this stage, the damage cannot be determined due to the paint obstructing any further inspection of the damage.

A qualified Painter should be contacted at the Owner's discretion to re-paint the area.

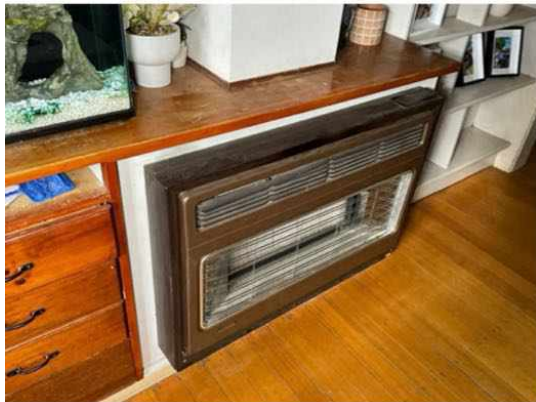
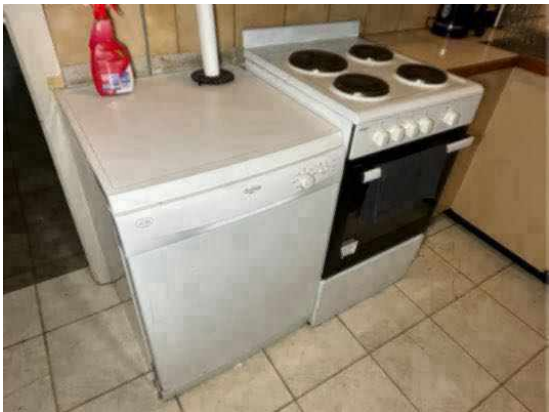
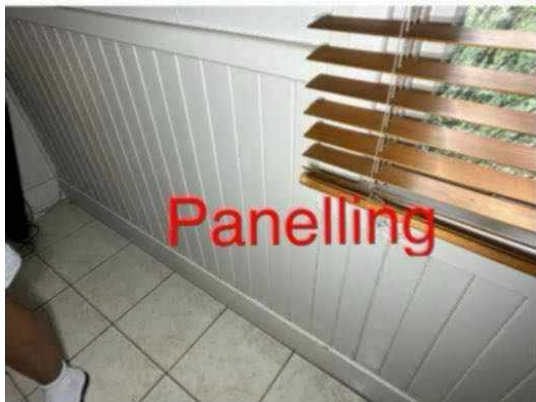
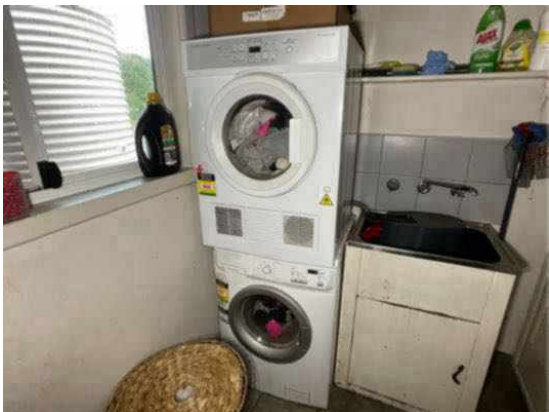
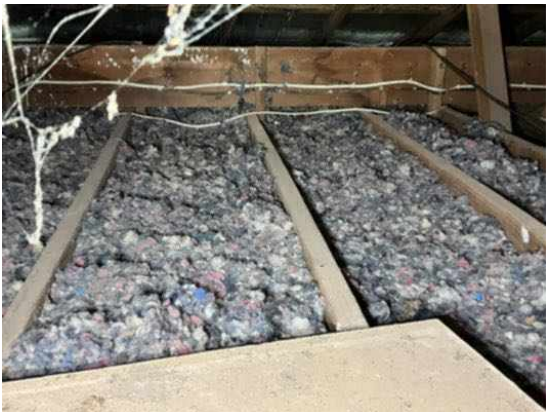
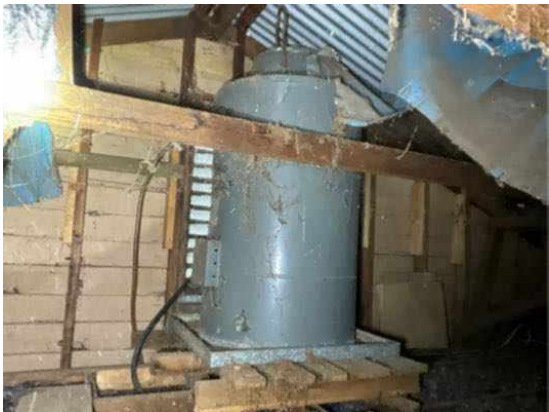
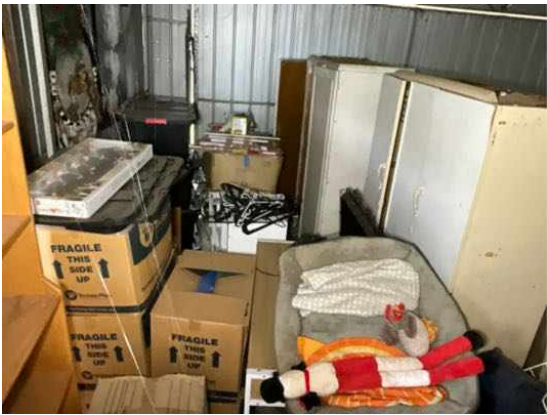
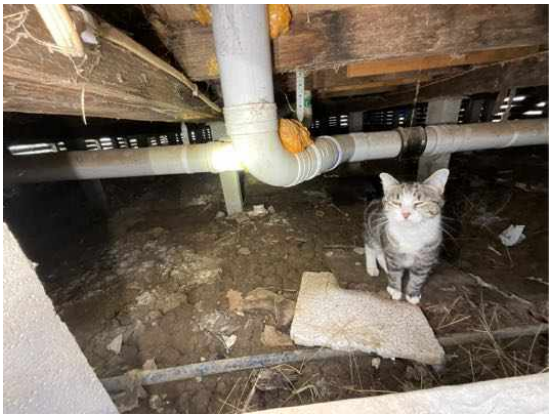
**Noted Item**

Building: Building 1  
Location: All Areas  
Finding: Additional Photos - Obstructions and Limitations  
Information: These photographs are an indication of the obstructions and limitations which impeded full inspection of the property at the time of inspection. These obstructions can hide an array of defects and should be removed to allow full inspection to be carried out. A re-inspection is recommended once the areas are made accessible.
