Building Inspection Report

Inspection Date: Wed, 28 Jan 2026

Property Address: 20 Princeton St, MOUNT DUNEED, VIC,
3217, Australia

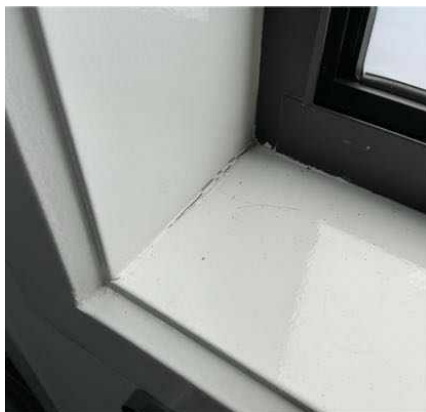
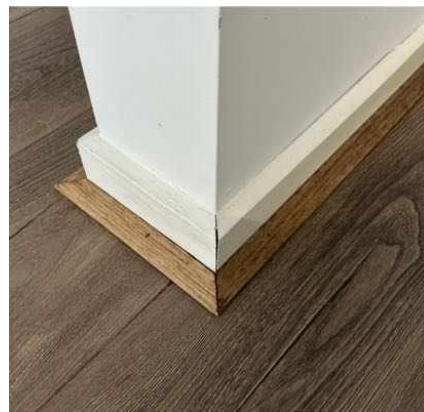
Defects 3.01

Building: Main Building
Location: All Internal Areas
Finding: Cracking to Painted Architraves and Skirting Boards
Information: Cracks were observed opening up in various sections of the painted architraves and skirting boards. These cracks may be associated with minor building movement, timber shrinkage, or inadequate surface preparation prior to painting.

- Aesthetic presentation is compromised by visible cracking.
- Potential ongoing movement may lead to further deterioration or require repeated maintenance.
- May indicate underlying workmanship or preparation issues.

This condition is not uncommon following recent painting, particularly in timber joinery, and is typically considered a maintenance item unless associated with significant structural movement.

- Engage a qualified painter or builder to assess the extent of cracking and undertake necessary repairs, which may include filling, sanding, and repainting affected areas.
- Monitor for any signs of worsening or recurring movement over time.

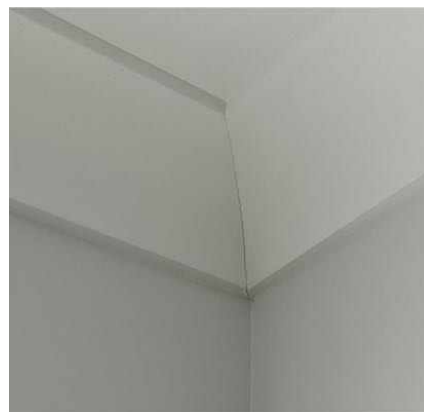
Defects 3.03

Building:	Main Building
Location:	All Internal Areas
Finding:	Cracking to Internal Wall Linings
Information:	Cracking was observed to internal wall linings during the inspection. These types of cracks are generally considered common and are typically the result of natural building movement, age-related wear, thermal expansion and contraction, or minor installation-related issues in plasterboard or supporting framing members.

The cracking noted is typical of minor building movement and does not currently present as structural. Regular monitoring and cosmetic repair will assist in preserving the internal presentation and allow early intervention if future issues arise.

- Engage a qualified plasterer to repair cracks and consider installing expansion joints if necessary to accommodate ongoing building movement.
- Arrange for repainting by a qualified painter following any plaster repairs.
- Monitor cracks over time for signs of progression (e.g. widening, lengthening, or new cracks forming).
- If deterioration continues or operational issues with doors/windows arise, seek further assessment from a building inspector or structural engineer.

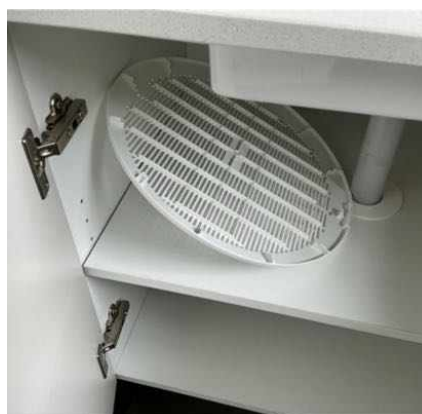
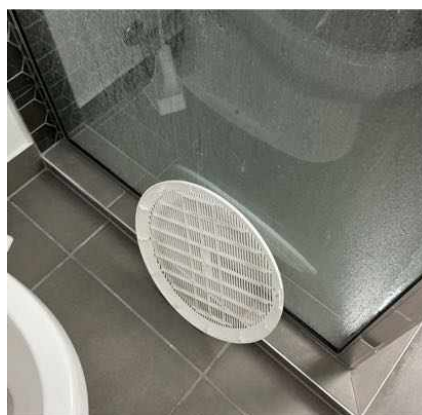
Defects 3.07

Building:	Main Building
Location:	Ensuite & Bathroom
Finding:	Exhaust Fan Covers Not Reinstalled
Information:	At the time of inspection, one or more bathroom exhaust fan covers were observed to be missing. The fan housings were visible within the ceiling, indicating the covers have not been reinstalled. Based on the condition and location, this is most likely the result of the covers being removed for cleaning and not refitted.

- The exhaust fans are unfinished in appearance and not operating as intended.
- Exposed fan housings may allow dust or debris to enter the fan unit.
- The missing covers reduce the effectiveness of ventilation and detract from presentation.

In summary, the missing exhaust fan covers represent a minor defect that requires reinstatement to restore proper function and finish.

- Reinstall the correct exhaust fan covers to all affected locations.
- Confirm fans operate correctly once covers are refitted.

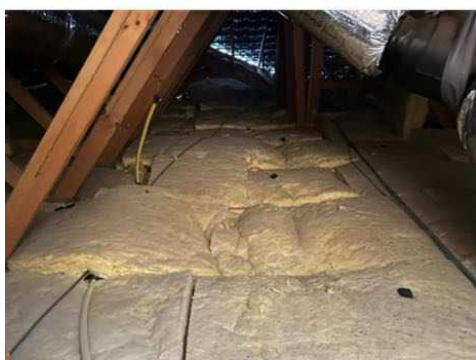
While no active infestation was confirmed at the time of inspection, further assessment and preventative measures are recommended to reduce the risk of future rodent activity within the roof space.

- A licensed pest control contractor should be engaged to assess the extent of rodent activity and confirm whether the issue is active or historical.
- Any contaminated insulation or materials should be removed and replaced as required following pest treatment.
- Entry points to the roof void should be identified and sealed where practicable to reduce the likelihood of recurrence.

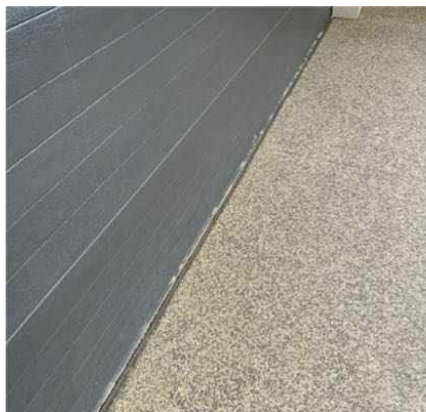
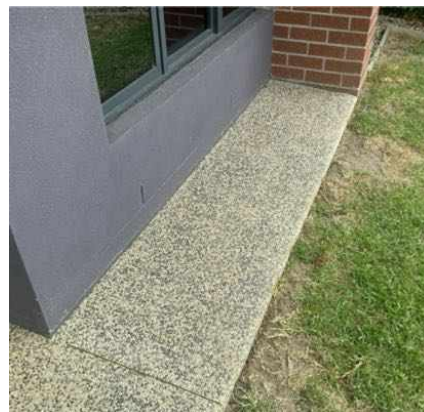
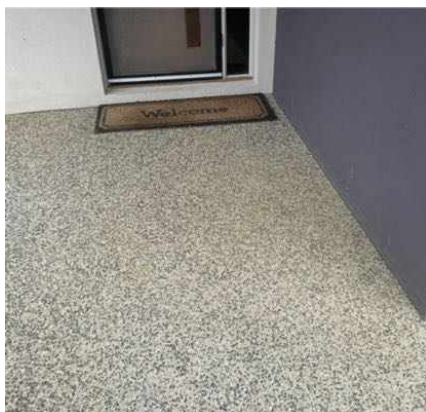
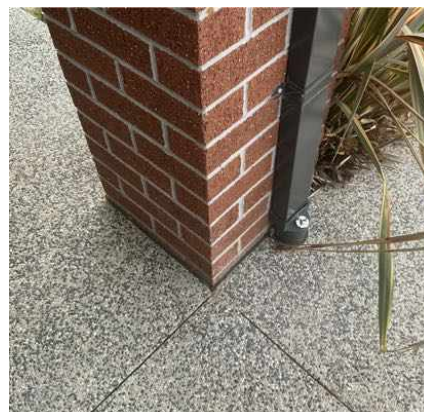
Defects 3.10

Building:	Main Building
Location:	Concrete Paving
Finding:	Unsealed Perimeter Joints to External Paving and Wall Junctions
Information:	<p>At the time of inspection, it was observed that perimeter joints between the external concrete paving and adjacent wall elements—including brickwork, rendered cladding, door thresholds, and downpipe penetrations—have not been adequately sealed. These junctions form critical transition points between dissimilar materials and are intended to accommodate movement while maintaining the weatherproof integrity of the building envelope.</p>

In summary, the lack of sealing to perimeter joints represents a building envelope defect that may allow moisture ingress and contribute to long-term deterioration if not addressed. Prompt rectification is recommended to reduce the risk of future damage.

- All perimeter joints between external paving and wall elements should be thoroughly inspected.
- Unsealed or inadequately sealed joints should be cleaned and sealed with an appropriate flexible, exterior-grade sealant suitable for movement.
- Works should be undertaken in a manner that ensures continuity of the building's weatherproof barrier around the full perimeter of the dwelling.

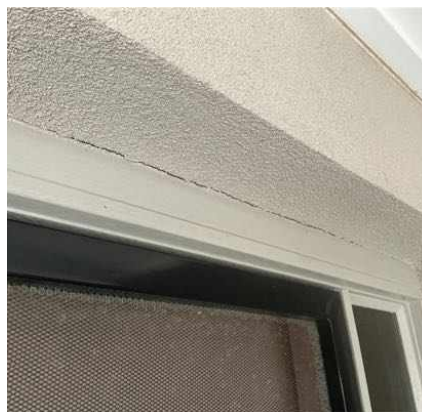
Defects 3.11

Building:	Main Building
Location:	Front Door
Finding:	Cracked Sealant to Infill Panel at Lintel Junction
Information:	At the time of inspection, cracking was observed to the sealant applied at the junction between the external infill panel and the lintel above the window opening. The sealant has separated along sections of the joint, reducing the effectiveness of the weather seal at this location.

In summary, cracking to the sealant at the infill panel and lintel junction presents a potential moisture ingress point and should be rectified to maintain weather tightness and reduce the risk of future internal damage.

- The junction should be monitored following rectification to ensure the seal remains intact.

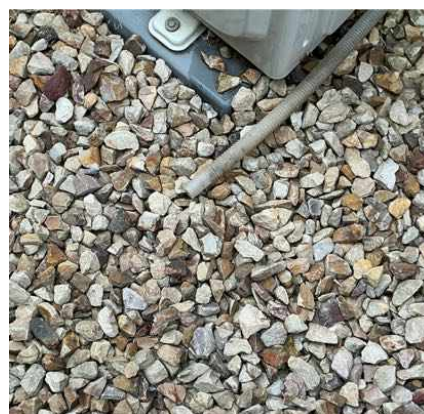
Although this is a relatively minor plumbing oversight, it presents an ongoing risk to nearby building elements and termite management. Correction is typically straightforward and should be planned as part of post-settlement maintenance to preserve building durability and reduce pest-related risks.

- Engage a licensed plumber to assess and reroute the overflow pipe into a compliant drainage system, ensuring water is directed safely away from the property.
- Monitor adjacent building elements for signs of moisture damage, corrosion, or fungal growth.
- Ensure that landscaping, garden beds, or other features around the area do not trap moisture against the building.
- Incorporate this item into ongoing property maintenance schedules to reduce the risk of long-term damage or pest attraction.

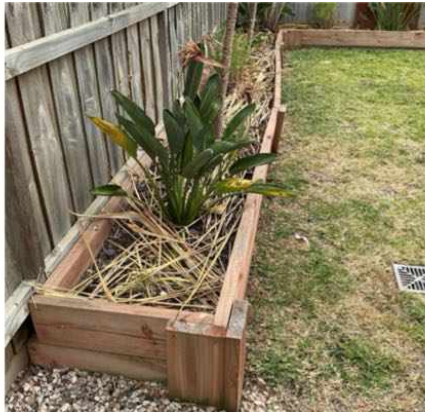
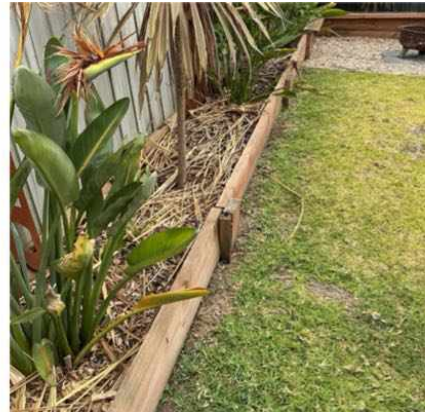
Defects 3.15

Building:	Main Building
Location:	Backyard
Finding:	Waviness in Retaining Wall Alignment
Information:	The retaining wall exhibits visible waviness and misalignment, which may indicate underlying structural weakness. This condition is often caused by soil pressure, footing instability, or water ingress behind the wall. Over time, lateral soil movement and hydrostatic pressure can worsen existing deformation, potentially resulting in further movement, cracking, or failure of the wall structure.

A structural assessment is essential to determine the appropriate remedial strategy. Early intervention may reduce future repair costs and prevent further structural degradation.

- Engage a structural engineer to assess the wall and determine the cause and severity of the deformation.
- Undertake remedial works as recommended, which may include reinforcement, rebuilding, or improving drainage behind the wall.
- Monitor the wall for progressive movement if immediate works are not undertaken.

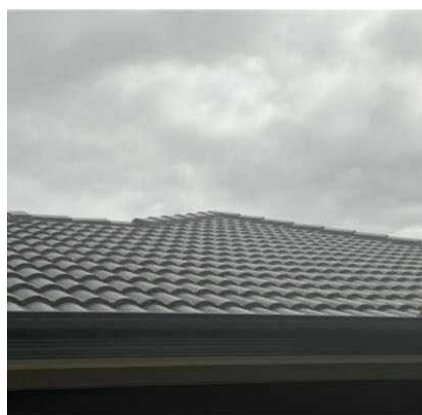
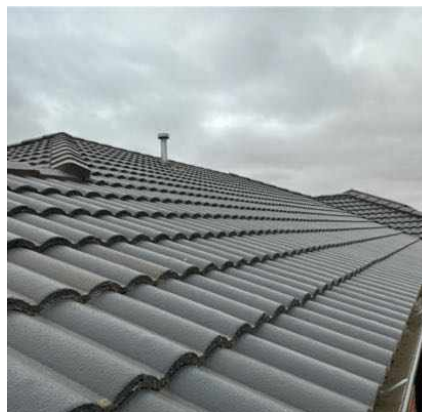
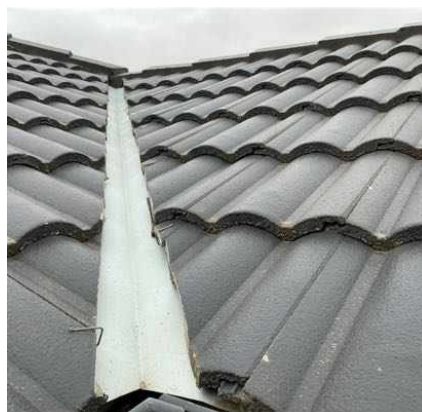
Noted Item

Building: Main Building
Location: Roof Exterior
Finding: General Weathering of Roof Tiles - Good

Overall, the observed condition is considered minor and consistent with normal wear and tear. The roof does not present as defective at the time of inspection, however routine maintenance will assist in preserving its long-term performance.

- Allow for routine roof maintenance as part of general property upkeep, including localized re-bedding or re-pointing where required.
- Monitor the condition of ridge and hip bedding during regular maintenance cycles.
- Ensure gutters and valleys remain clear to support effective water shedding.
