Building Inspection Report

Inspection Date: Tue, 24 Mar 2026

Property Address: 27a Streeters Rd, North Plympton SA 5037,
Australia

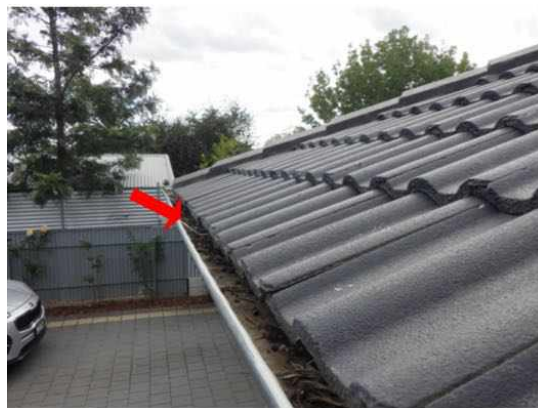
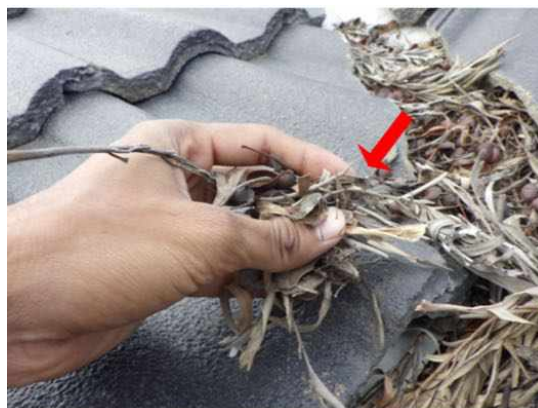
Defects 2.01

Blocked gutters are likely to lead to high levels of moisture in the affected areas. Such moisture will not only cause rust and decay of the associated building materials, but can also provide conditions that are conducive to termite and timber pest activity. Blockages in gutters should therefore be removed immediately to ensure dry conditions are maintained.

Consult a Licensed Plumber for further specific advice on remedial works that may be required. In the interim, it is highly advised that blocked gutters be removed by the homeowner or a general handyman as a matter of urgency.

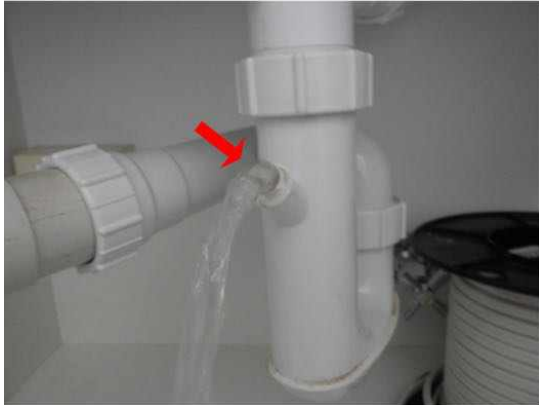
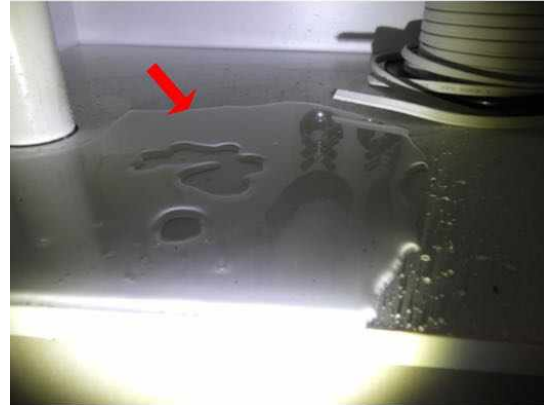
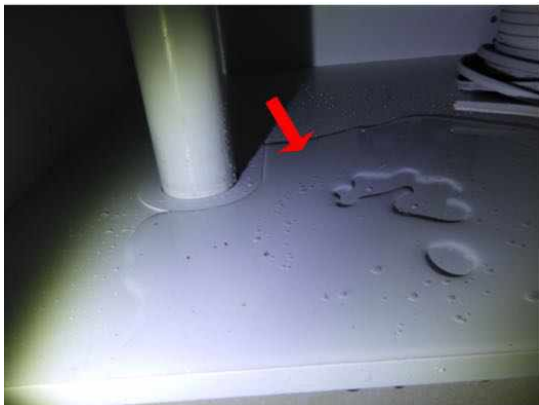
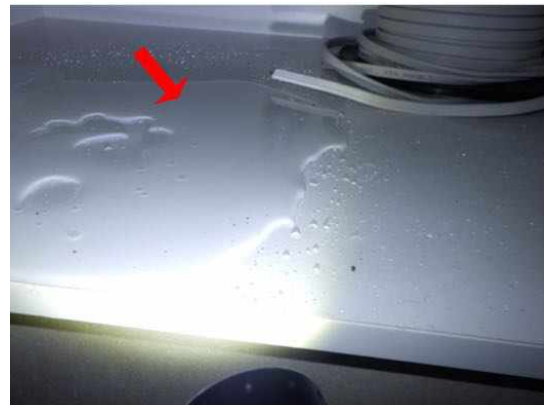
Defects 2.02

Building:	Building 1
Location:	Laundry
Finding:	Laundry Area – Washbasin Plumbing – Leaking
Information:	At the time of inspection it was noticed that plumbing associated with the washbasin in the laundry area was leaking during standard operation.

Leaks associated with plumbing fixtures should be addressed promptly, as prolonged leakage may contribute to moisture ingress, deterioration of surrounding building elements, and potential secondary defects.

Repair of the leaking plumbing component is recommended. It is highly recommended that an appropriately qualified plumber be engaged as soon as possible to assess and carry out any necessary remedial works.

Such works should be performed prior to the development of secondary defects to ensure adequate functionality of all associated building elements.

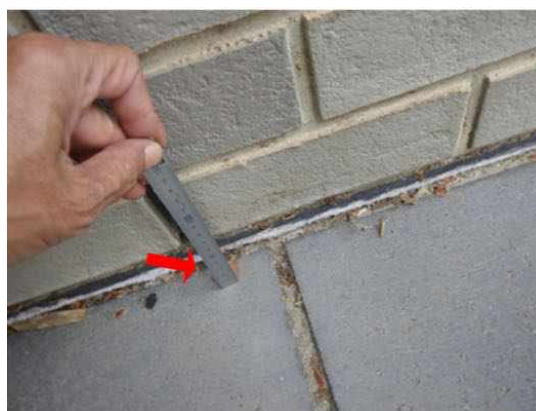
Defects 3.01

If the slab edge is not properly exposed there is a high risk of termite attack. Sometimes, in order to determine the type of slab, a suitably qualified person such as an architect or builder may be required to consult the construction plans.

Where the slab edge cannot be properly inspected, it is highly recommended that termite or timber pest inspections be carried out every 6-12 months to aid protection of the property against infestation.

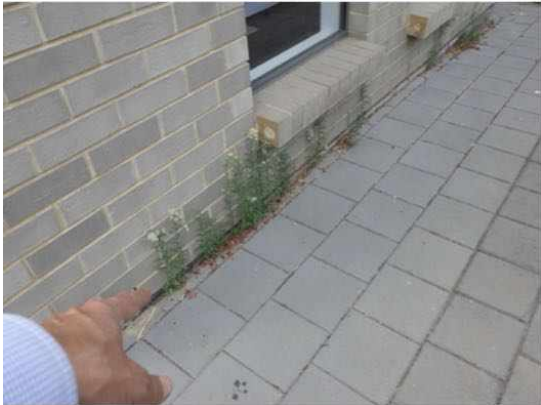
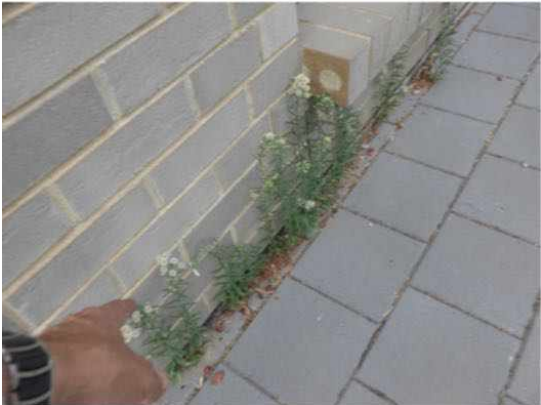
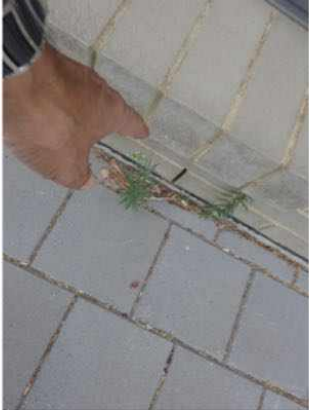
Defects 3.02

Building:	Building 1
Location:	All External Areas
Finding:	Bridging - Vegetation
Information:	Where vegetation obstructs inspection of building elements, also known as bridging as it provides a bridging point for the access of termites, full inspection can not be achieved. Consequently moisture or dampness may be present and the areas becomes conducive to termite activity. Plants against or very close to buildings provide cover, shade and can provide an environment that is attractive to termite infestation.

The removal and replanting of species that do not provide "cover" or cutting back of existing vegetation will assist greatly in preventing Bridging from occurring.

The removal of any such materials that may be conducive to termite activity should be carried out as soon as possible and arrange re inspection to minimize the risk of termite attack.

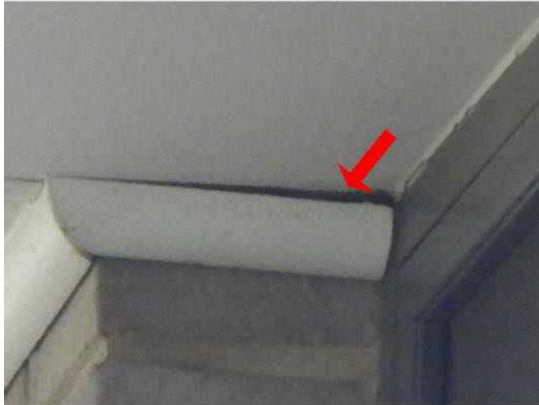
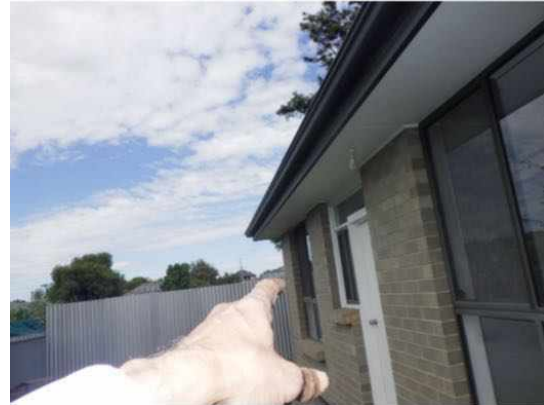
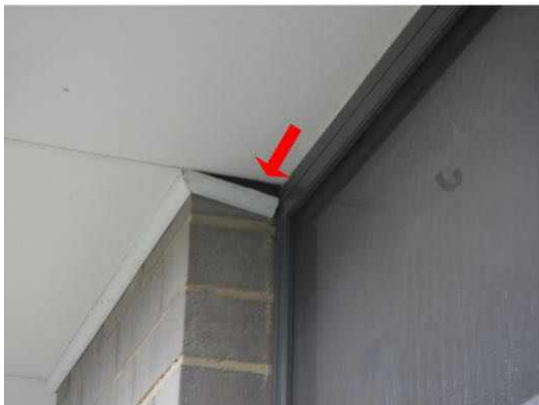
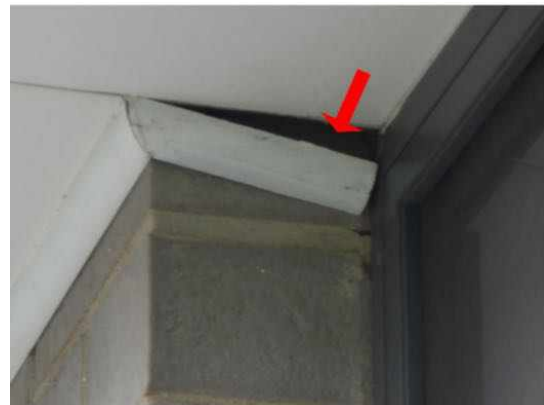
Defects 3.03

Building:	Building 1
Location:	All External Areas
Finding:	Building element - Damaged / Loose from its original fixing
Information:	At the time of inspection it was noticed that eaves guad lining was damaged / loose from its original fixing in few sections around the property.

Breakage occurs generally when the building materials have either aged and decayed, or as a result of damage (accidental or deliberate).

Repair and/or replacement of broken elements is advised to ensure that additional secondary defects do not arise as a consequence. Such works are necessary, as all building elements play a key role in the operation and function of the overall structure and its performance.

A relevant tradesperson should be appointed to repair or replace the affected building element prior to any subsequent damage being caused.

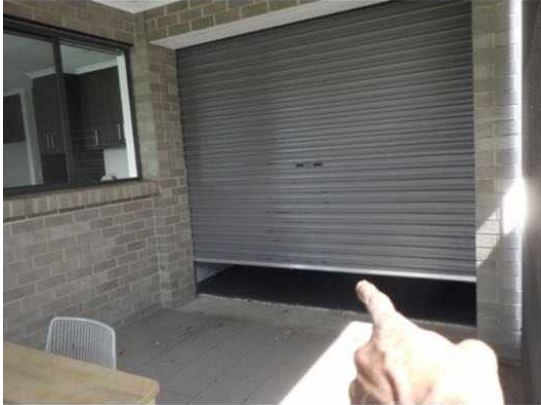
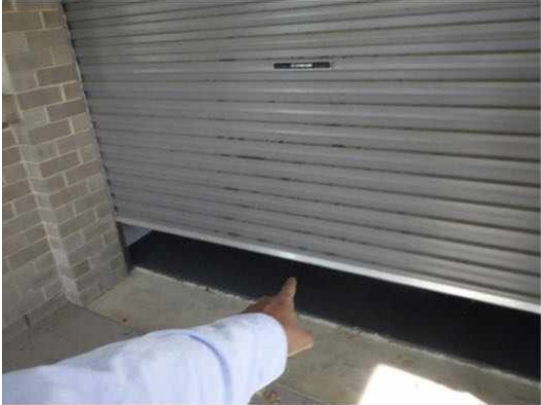
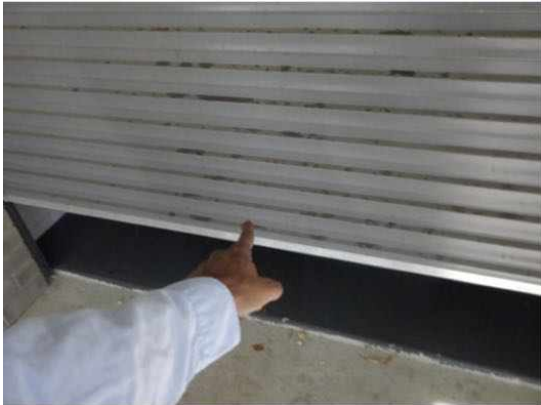
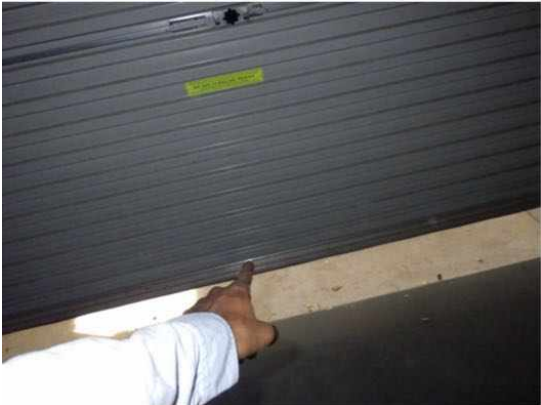
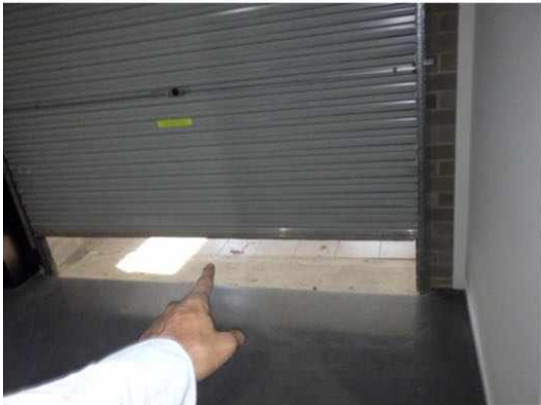
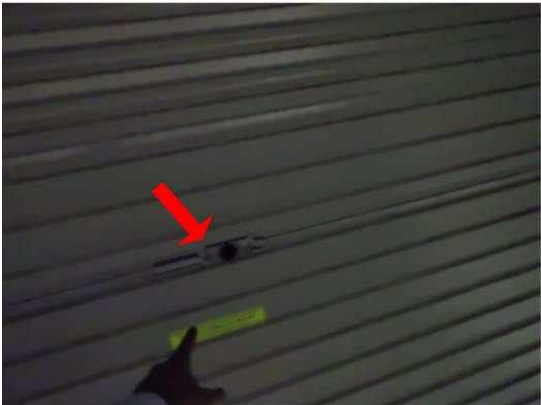
Defects 3.04

Building:	Building 1
Location:	All External Areas
Finding:	Garage Roller Door (Rear) – Not Operating / Not Locking
Information:	At the time of inspection it was noticed that the rear garage roller door was not locking properly at the lower base. As a result, the door was able to move upwards and was not secured in its closed position.

Non-operational building elements should be addressed to ensure the intended function, security, and performance of the building structure are maintained. Where building elements are not operating as intended, secondary defects or security concerns may arise over time.

Repair and/or replacement of the faulty building element is recommended. It is highly recommended that an appropriately qualified tradesperson be engaged to assess and carry out any necessary remedial works

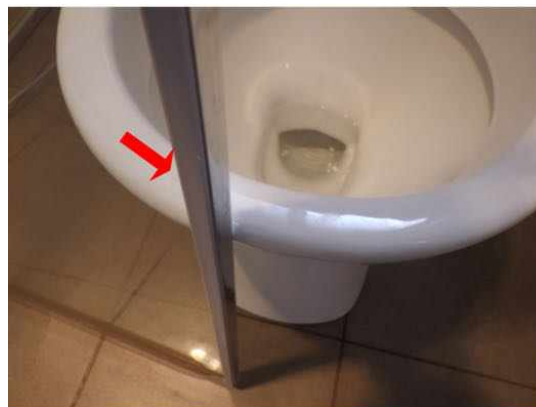
Defects 3.05

Building: Building 1
Location: Bathroom- Ensuite
Finding: Shower screen touching -Toilet assembly during standard operation
Information: At the time of inspection it was noticed that shower screen door is touching to the toilet assembly and creating a potential safety hazard in this area. It advised that

builder should take appropriate measures to avoid/ reduce the impact of shower screen hitting during door operations.

A qualified glazier is required to repair the shower screen as soon as possible. Please be advised that any persons coming into contact with the shower screen should do so with due caution to avoid any personal injury that may ensue.

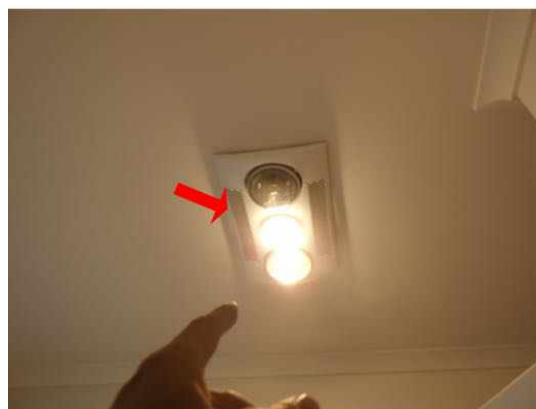
Defects 3.07

Building: Building 1
 Location: Bathroom 2
 Finding: Bathroom -2 – Exhaust Fan Operation
 Information: At the time of inspection it was noticed that the exhaust fan installed within this bathroom-2 area was making unusual noise / partially obstructing during standard operation at the time of testing.

This may indicate wear, internal obstruction, loose components, or mechanical deterioration affecting normal performance.

It is advised that an appropriate qualified tradesperson be appointed to assess the exhaust fan and carry out repairs or replacement as required to ensure satisfactory operation.

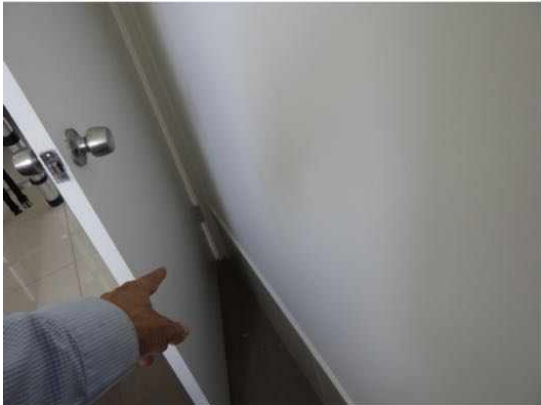
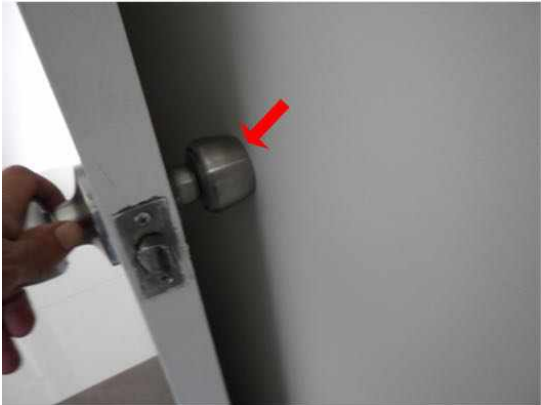
Defects 3.08

Building: Building 1
 Location: Laundry
 Finding: Door stop - Missing
 Information: The door stop is missing or is inadequate to stop the door handle from damaging the wall. Although some building elements may seem irrelevant or unnecessary, all building elements play a key role in the operation and function of the overall structure and its performance.

Re-installation or replacement of the door stop is advised as soon as possible to prevent any subsequent damage to the door or associated structures. A general handyman may be appointed to perform these works at client discretion.

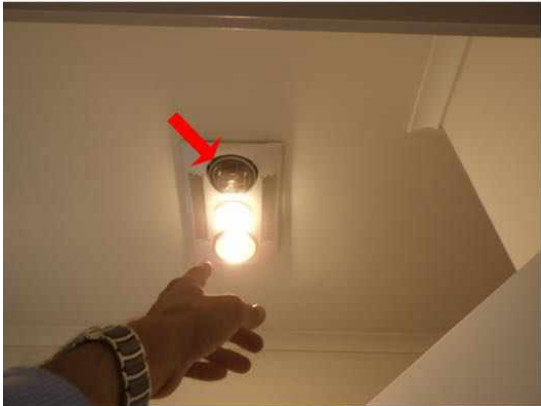
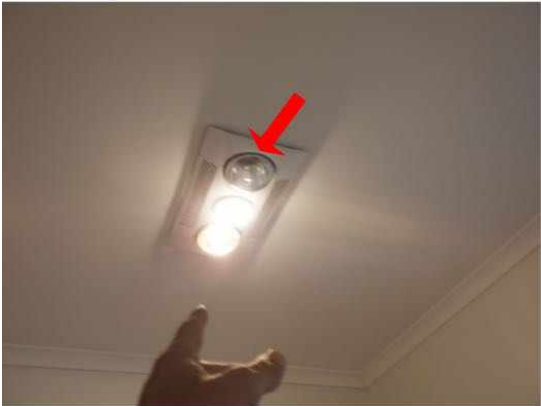
Defects 3.09

Building: Building 1
Location: Bathroom
Finding: Building element - Not operating
Information: At the time of inspection it was noticed one globe in both bathrooms were not operational. Non-operational items should be addressed to ensure that the full function of the building structure is available. Where some building elements are not operating as intended, it is possible that secondary building defects could arise due to their non-operation.

Repair and/or replacement of the faulty building element is recommended. It is highly recommended that the relevant tradesperson be engaged to perform any necessary works.

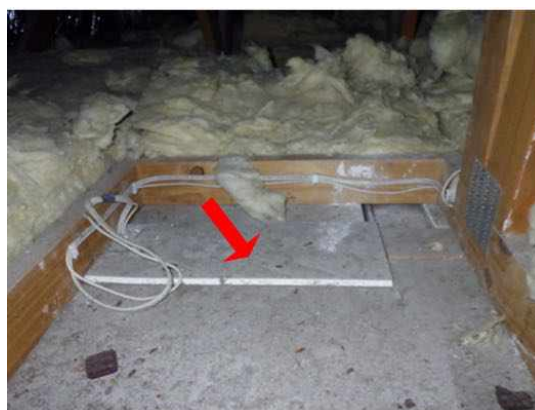
Defects 3.11

Building:	Building 1
Location:	All Internal Areas
Finding:	Insulation - Missing
Information:	Upon inspection of the roof void it was noted that insulation is not present in few sections of roof space area. Apart from that at the time of inspection it was also noticed that insulation is present in other sections of the roof space area.

Insufficient insulation will result in a comparatively higher cost to heat and cool a property as there is a lack of Insulation (or uneven coverage of insulation) which works as a barrier to heat transfer. This helps to keep out unwanted heat in summer and preserves warmth inside your home in winter. It can also help soundproof your home from unwanted airborne noise transfer.

Where insulation is absent, the area does not meet current Australian Standards. Installation of adequate insulation is required and should be conducted as soon as possible.

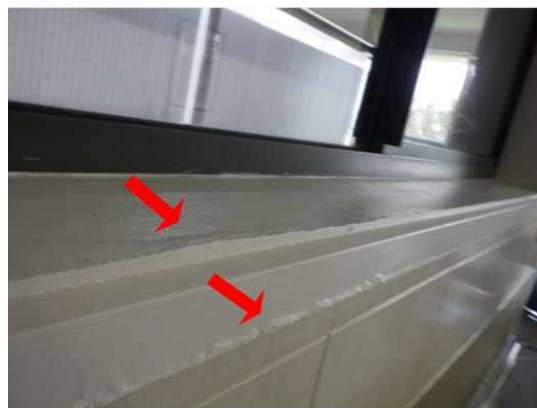
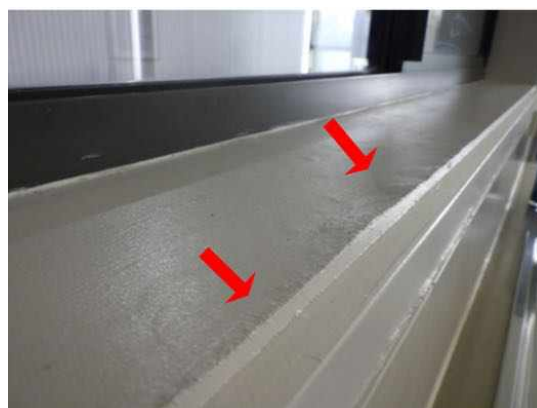
Defects 3.12

Building:	Building 1
Location:	Kitchen

Finding: Building element - Swollen
Information: Swollen building elements generally indicate that the building materials have been affected by excessive moisture over a prolonged period of time, and have swollen as a result. The formation and development of mould/fungi or mildew is also a likely consequence of excessive moisture, which may pose major respiratory issues for occupants, particularly the elderly, the very young and those with existing illnesses and could be potential health safety hazards. In these cases an appropriately qualified inspector/tester should also be contacted for advice and/or technical assistance.

The structural integrity of swollen building elements can not be guaranteed, and further damage is likely to develop if left unmanaged. Excessive moisture is likely to lead to the development of secondary damage to any associated building elements, which may necessitate major reparation works if prolonged.

Rectification of the cause of the water leak should be addressed prior to any remedial works to the swollen building elements. A licensed plumber should be appointed immediately to identify the cause of the leak and provide advice on remedial works as necessary, Repair and/or replacement of swollen building elements should be conducted as a matter of urgency by a registered builder or qualified carpenter.

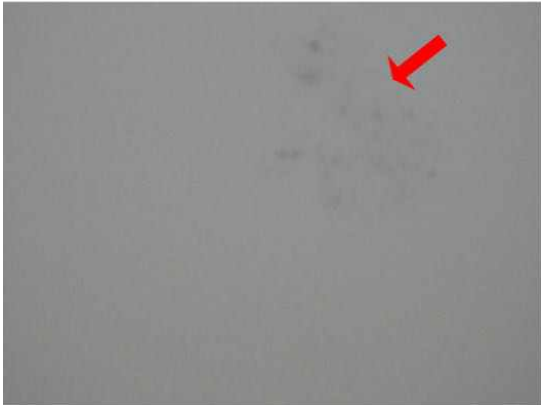
Defects 3.13

Information: At the time of inspection it was noticed that few sections of ceilings were scuffed in this bedroom area. Scuffed surfaces, while detracting from the overall appearance of the affected building element, do not indicate any operational or structural damage. This degree of surface damage is consistent with general wear and tear and minor impact damage, normally accumulated over a number of years.

Marked surfaces may be left as is at the discretion of the client; no repairs or replacement are necessarily required, as this is an appearance defect. However, the client may wish to seek quotations for the cost to refurbish or replace the identified building element.

A general handyman or plasterer may be appointed to rectify marked surfaces if considered necessary by the client.

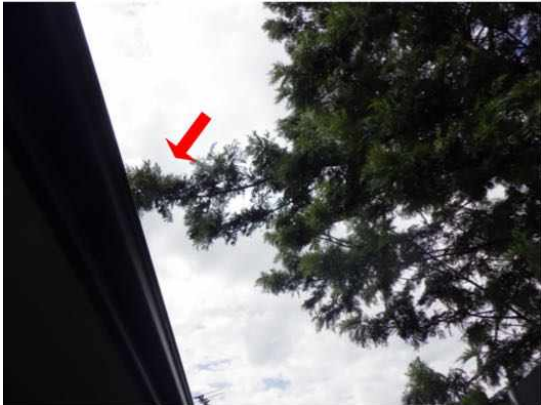
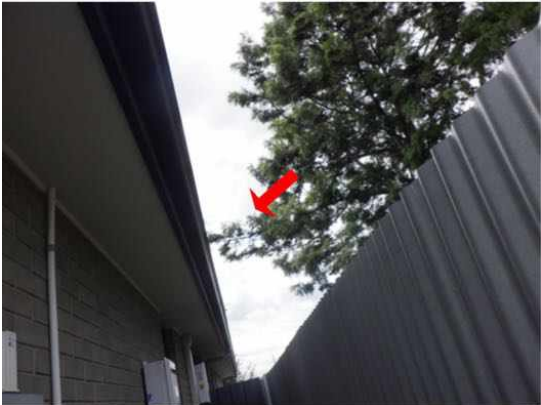
Noted Item

Building:	Building 1
Location:	All External Areas
Finding:	Trees - Overhanging and filling gutters
Information:	Overhanging trees often result in excessive amounts of leaf debris accumulating in gutters.

Gutters are a critical part of the building's management of storm water and rain. It is therefore important that they be kept clear to prevent secondary damage to associated building elements, including exterior and interior walls, ceiling linings and any adjoining building elements. Where gutters are blocked, pooling of rainwater is likely to occur, fast-tracking rust and corrosion of the roof plumbing elements.

It is highly advised that all overhanging tree branches be removed as soon as possible to prevent any further damage. Repair and/or replacement of sections of damaged guttering may also be required where the extent of the damage necessitates.

Such works should be performed by the homeowner; however, appointment of a landscape contractor or an arborist may be required. Consultation with a licensed roof plumber is required where guttering has been damaged.

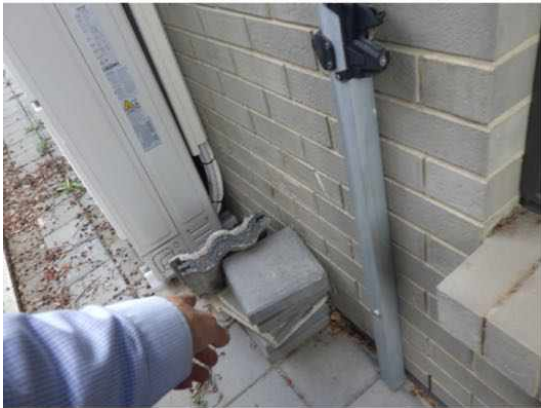
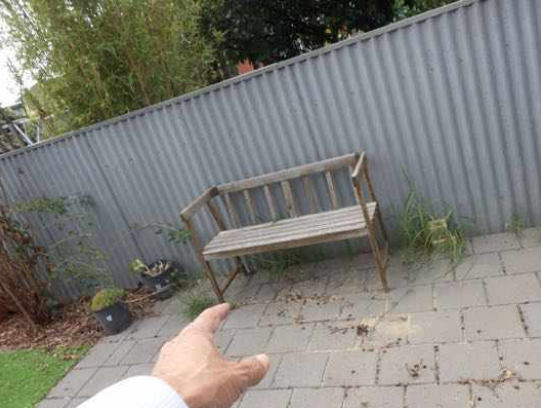
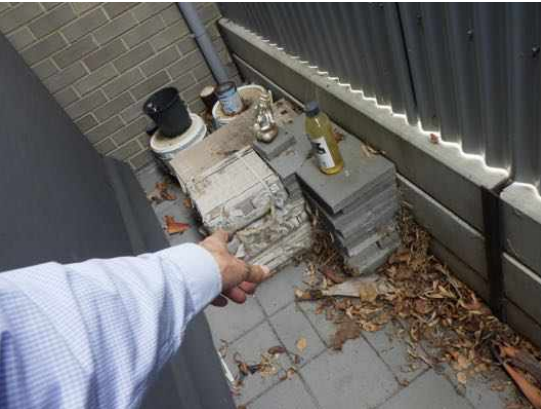
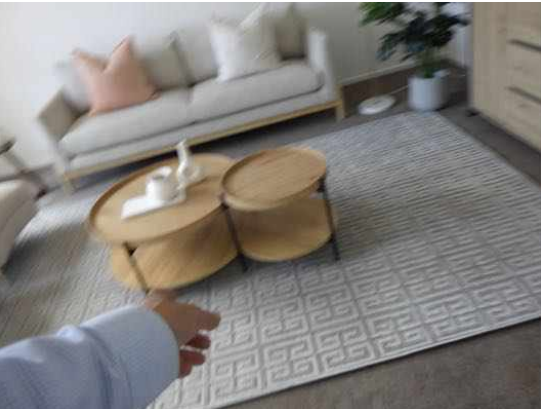
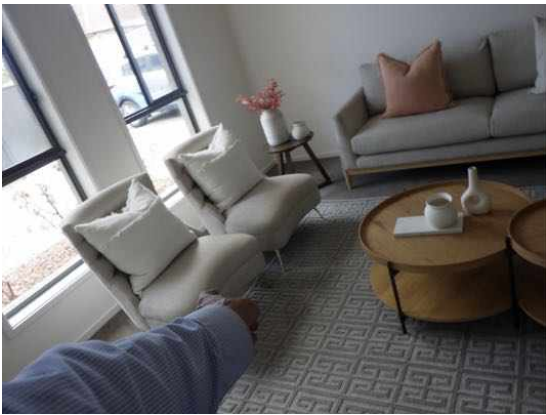
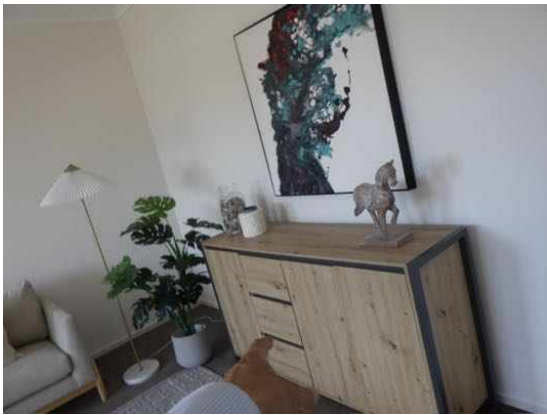
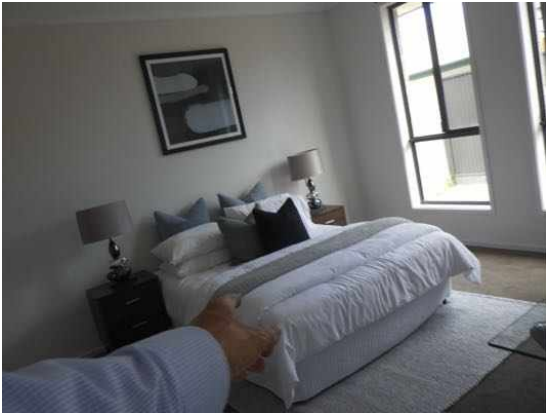
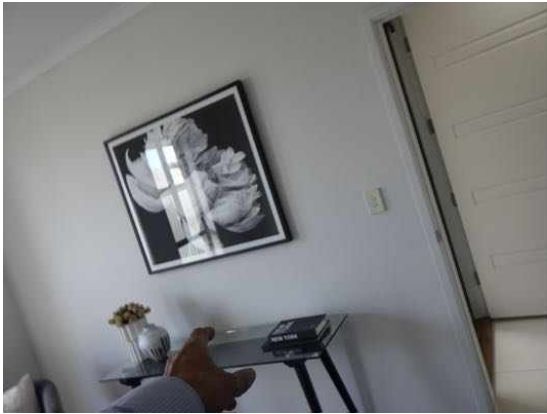
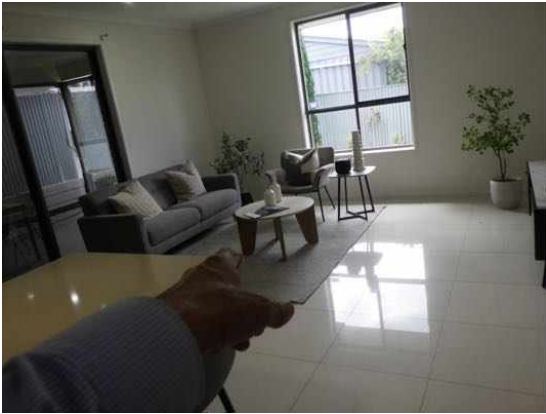
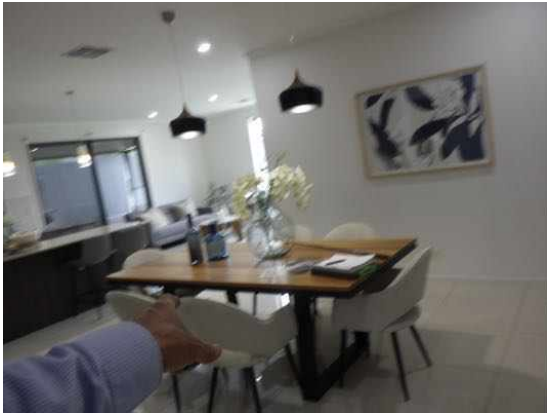
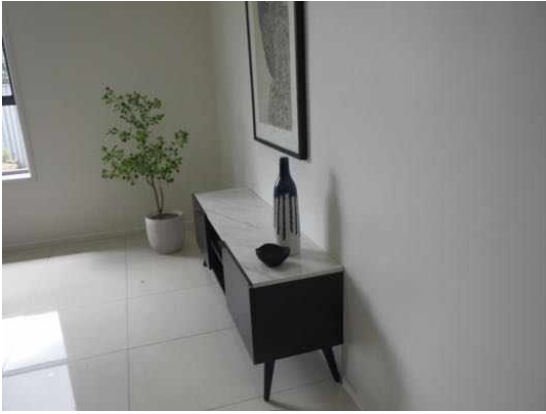
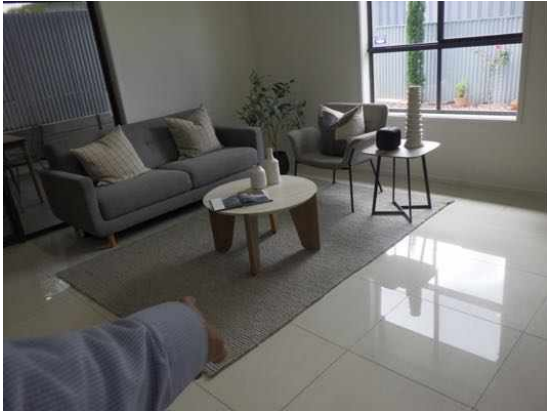
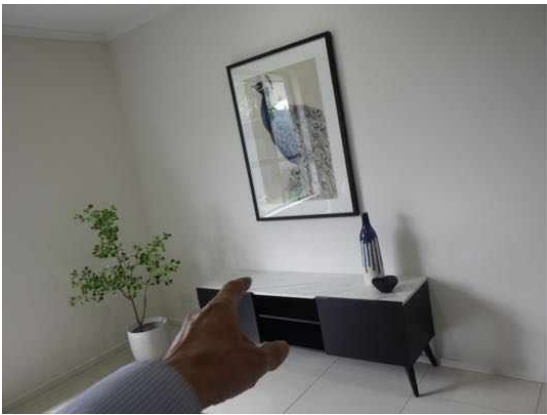
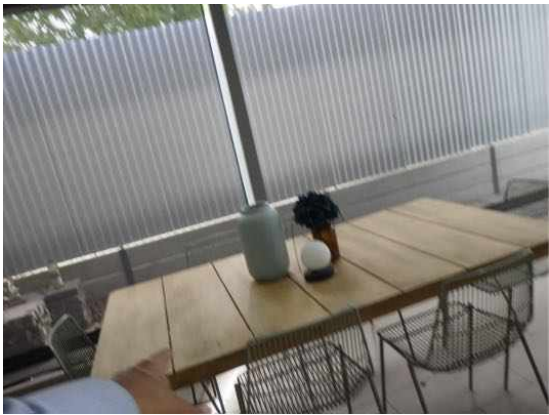
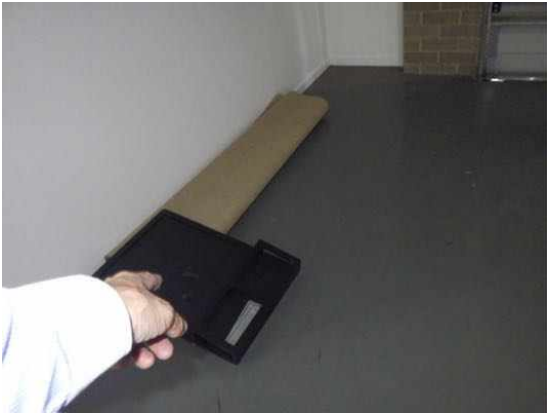
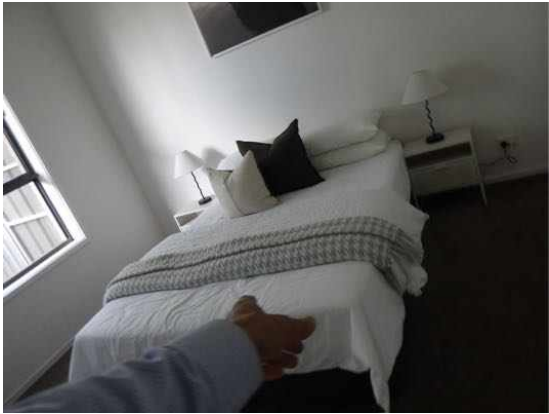
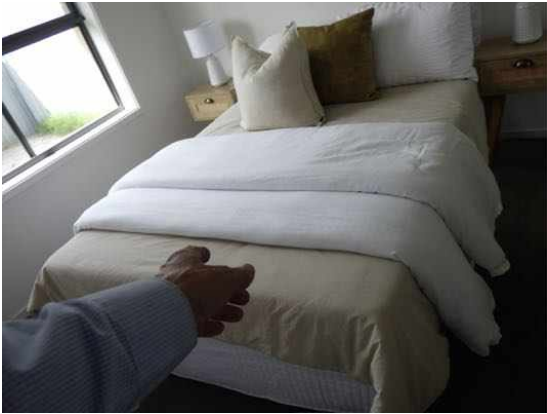
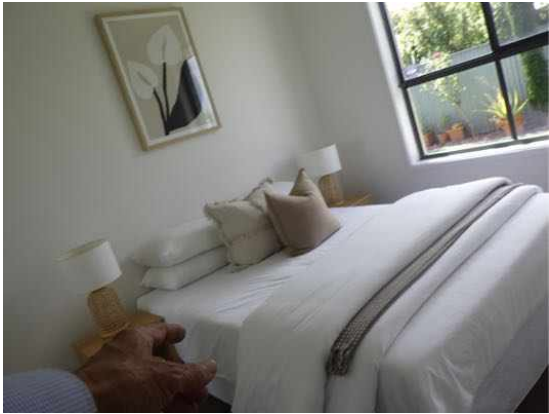
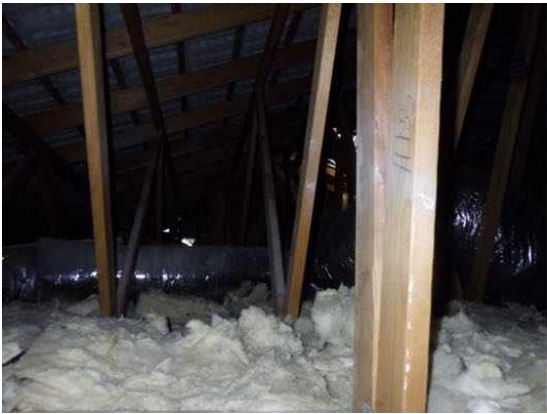
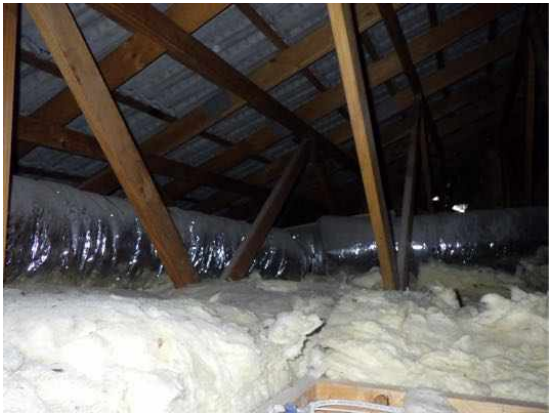
Building: Building 1
Location: All Areas
Finding: Additional Photos - Obstructions and Limitations
Information: These photographs are an indication of the obstructions and limitations which impeded full inspection of the property at the time of inspection. These obstructions can hide an array of defects and should be removed to allow full inspection to be carried out. A re-inspection is recommended once the areas are made accessible.
