Building Inspection Report

Inspection Date: Tue, 24 Mar 2026

Property Address: 27a Streeters Rd, North Plympton SA 5037,
Australia

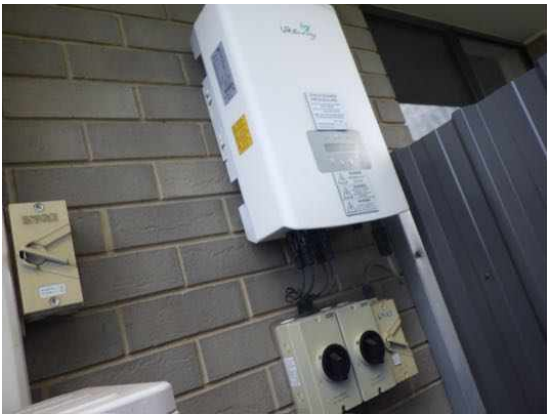
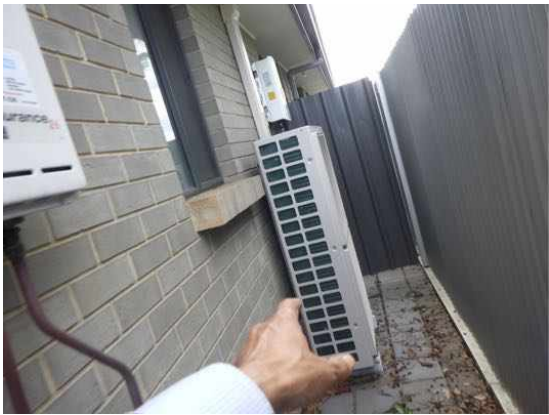
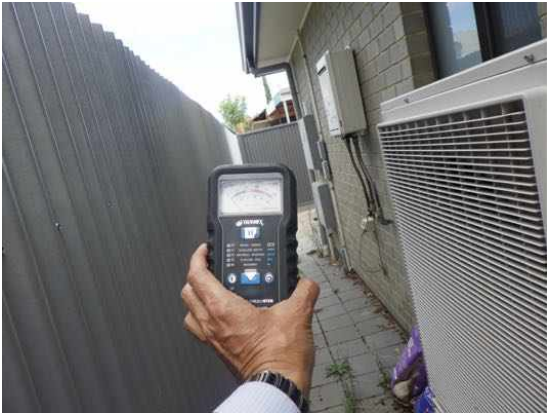
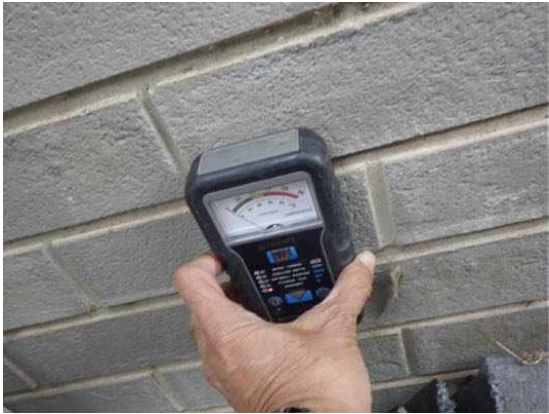
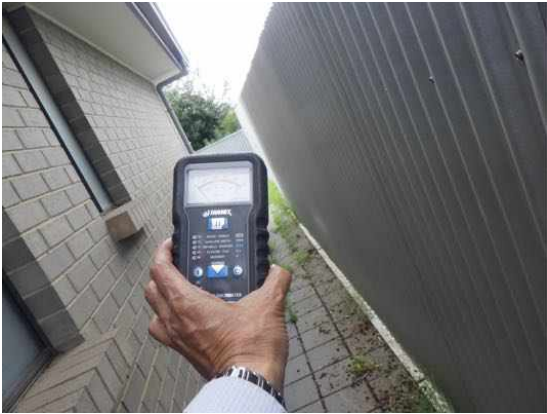
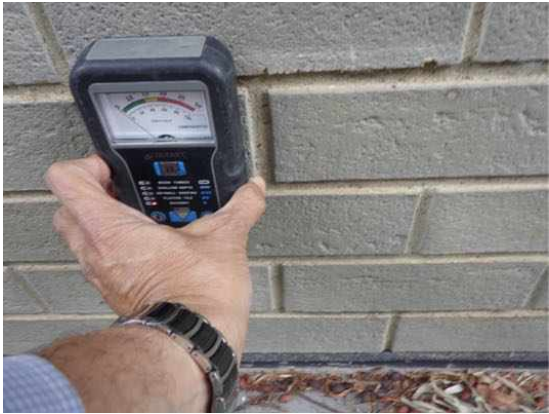
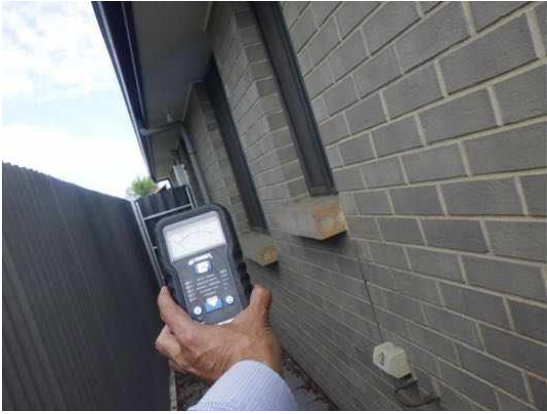
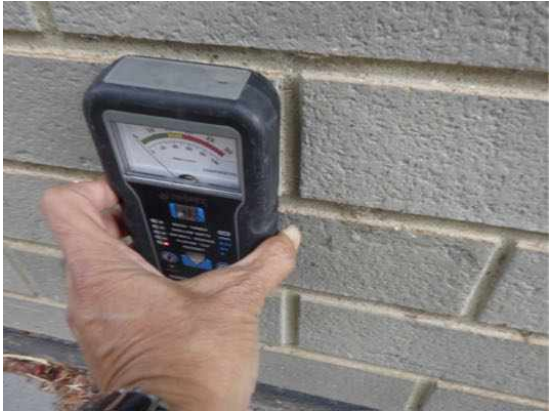
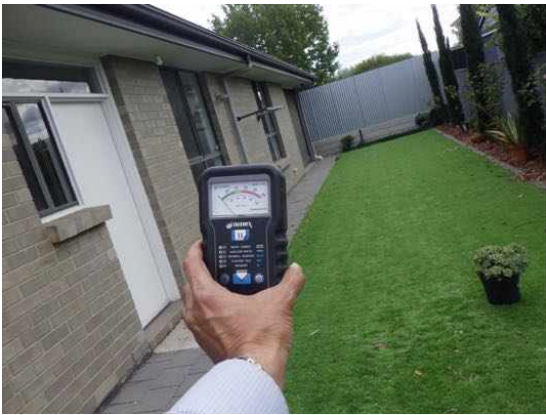
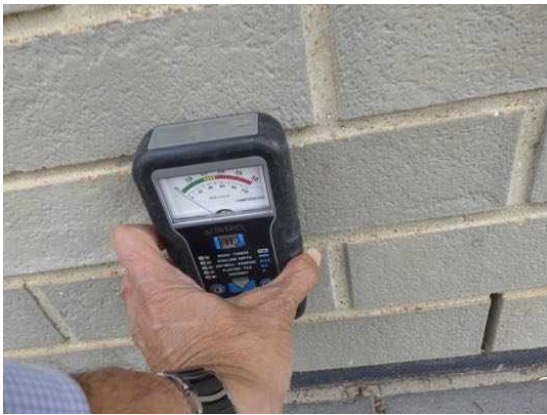
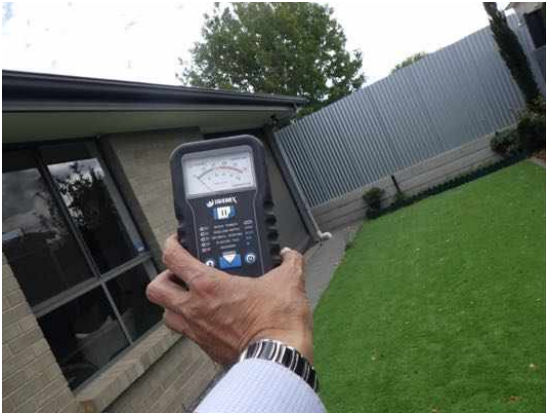
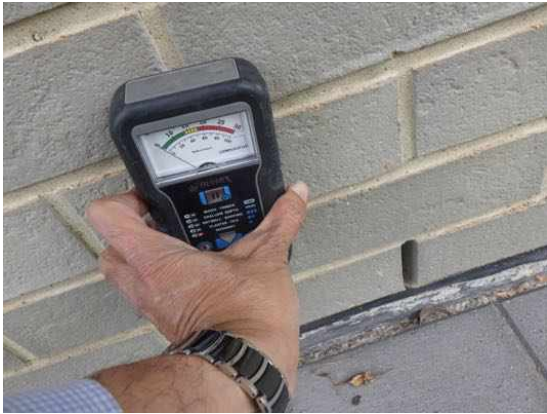
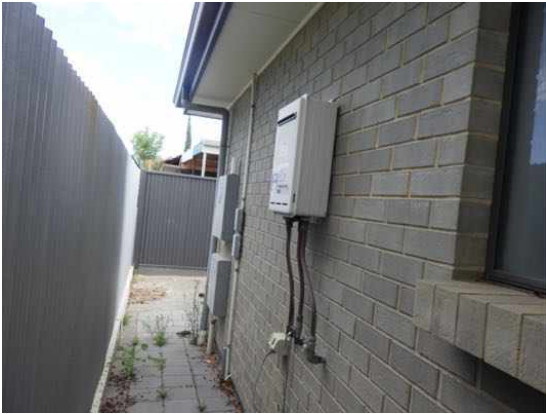
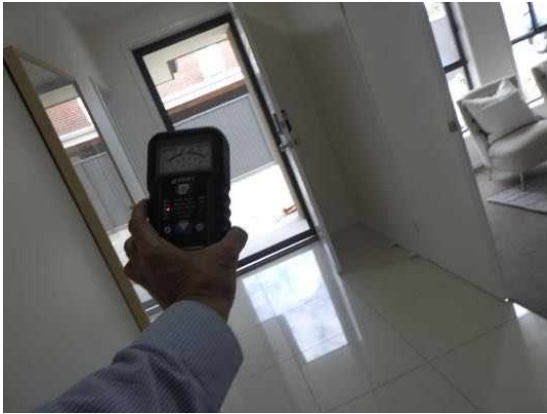
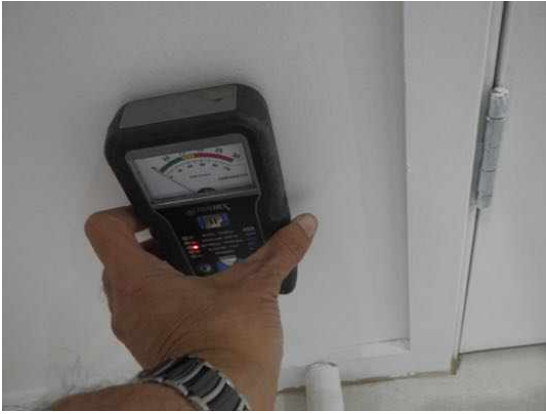
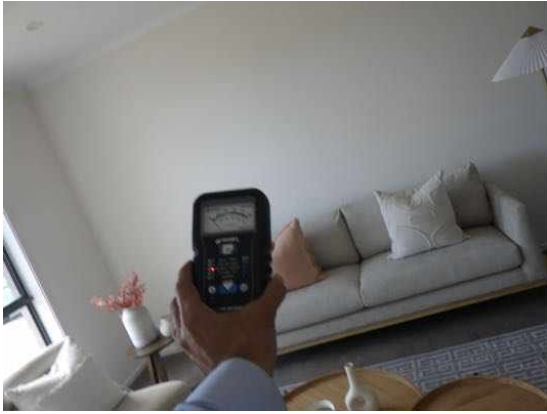
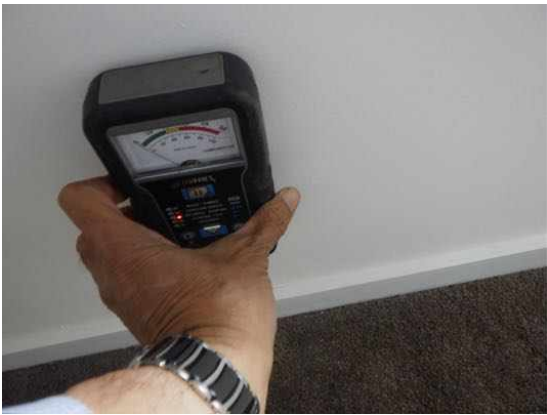
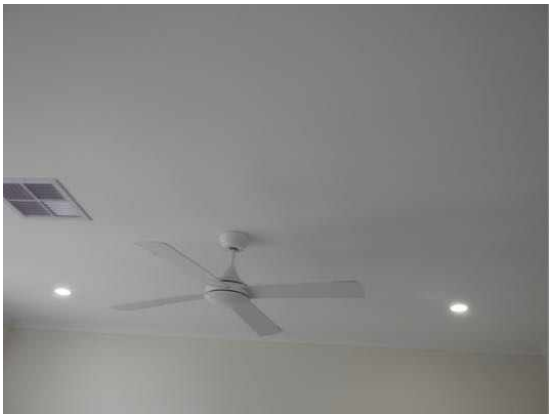
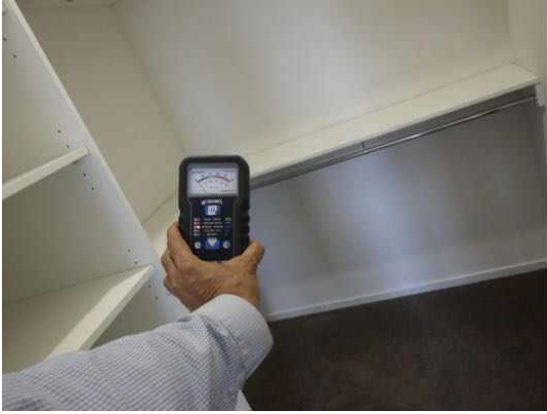
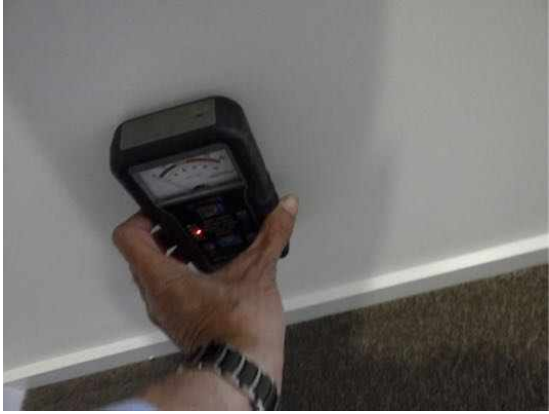
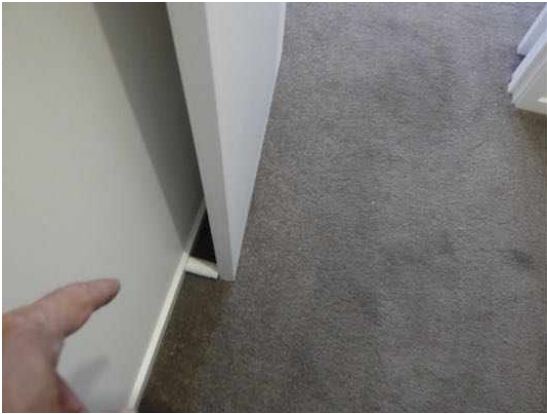
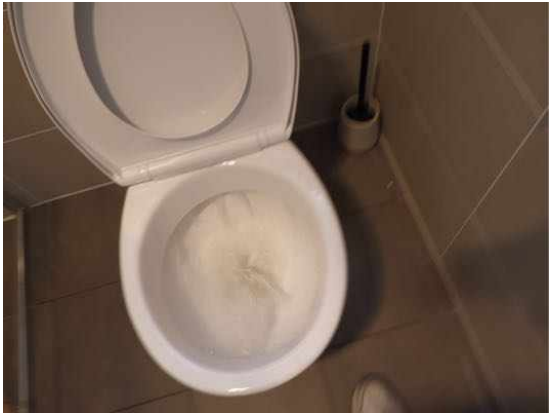
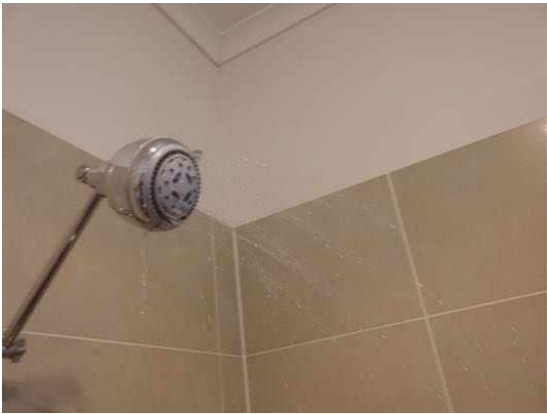
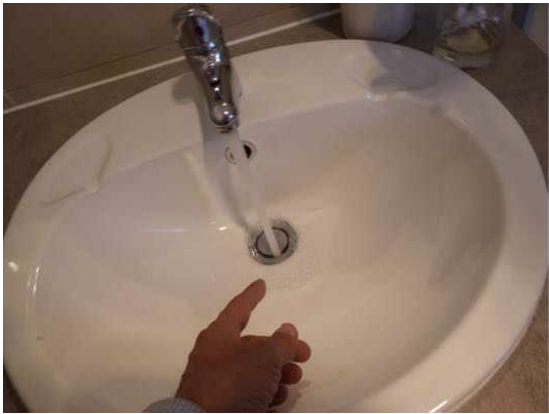
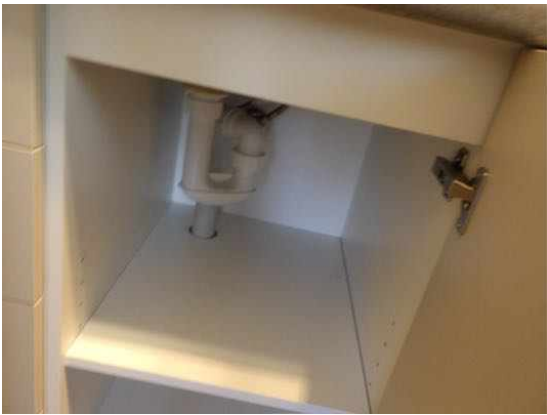
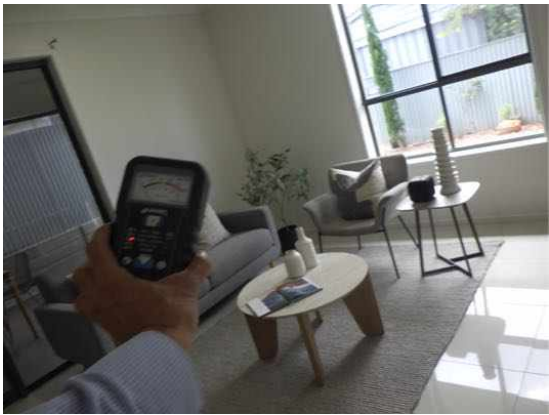
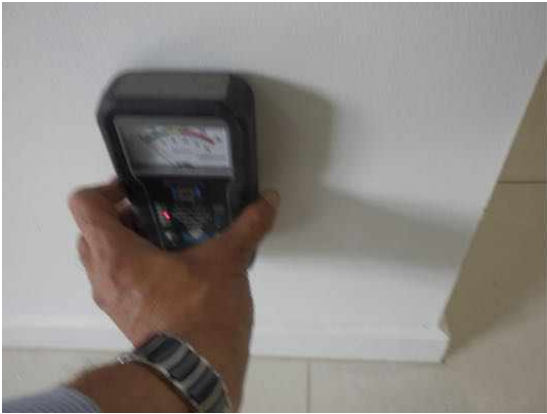
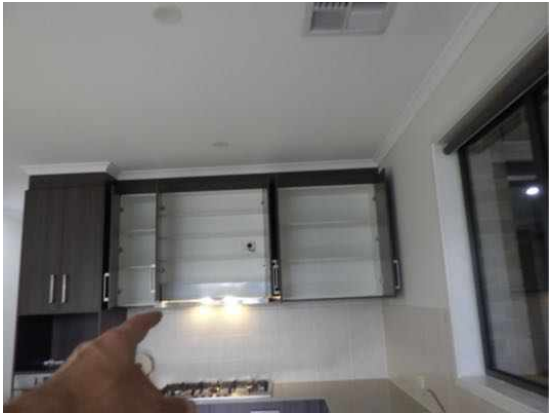
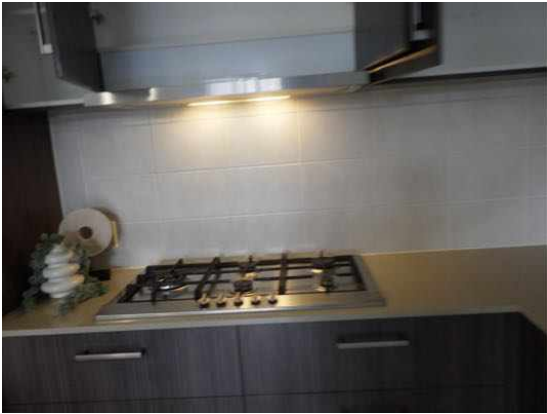
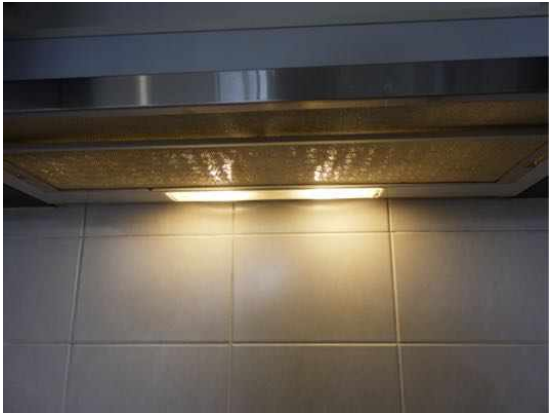
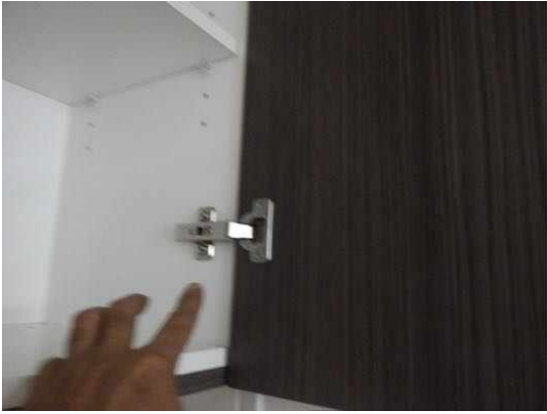
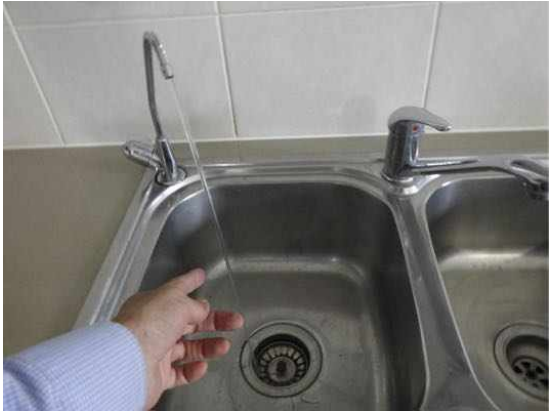
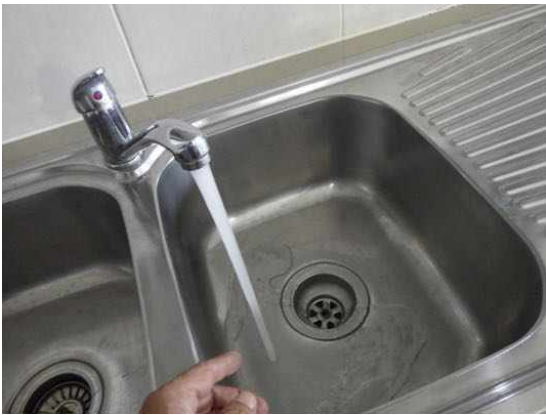
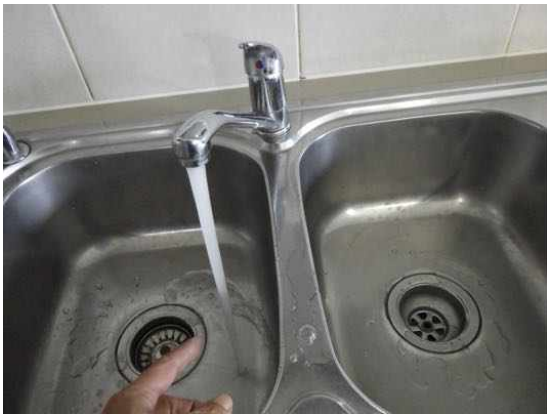
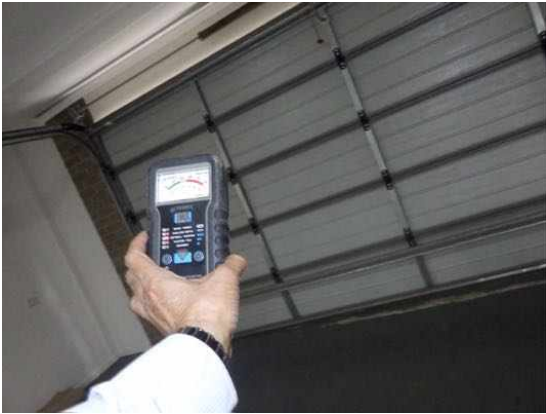
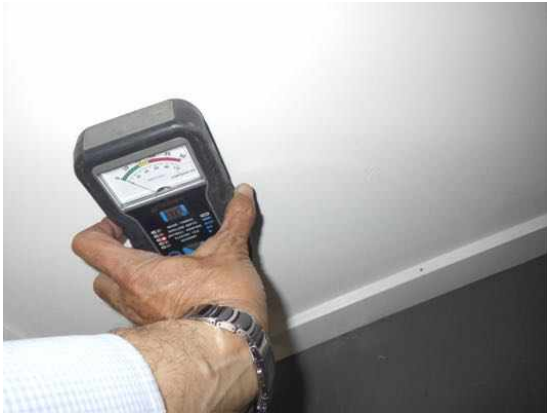
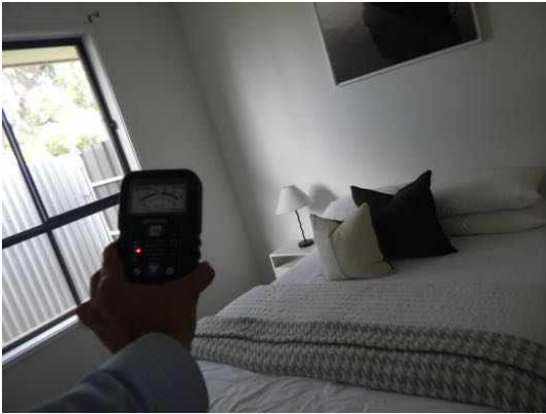
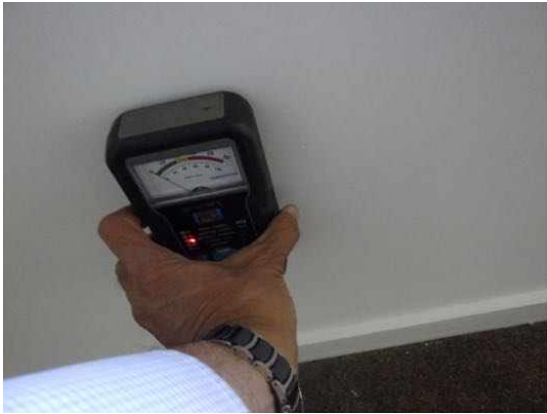
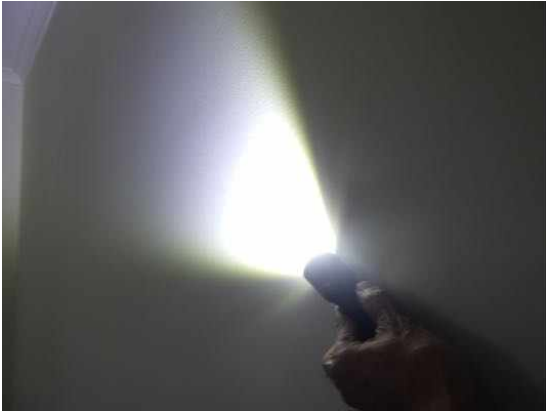
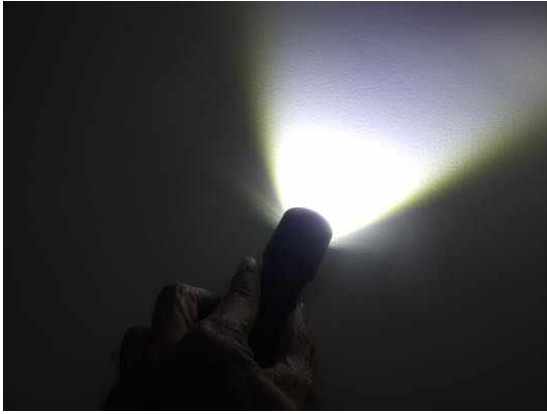
Building: Building 1
Location: All Areas
Finding: Additional Photos - Obstructions and Limitations
Information: These photographs are an indication of the obstructions and limitations which impeded full inspection of the property at the time of inspection. These obstructions can hide an array of defects and should be removed to allow full inspection to be carried out. A re-inspection is recommended once the areas are made accessible.
