# Building and Timber Pest Inspection Report

Inspection Date: Tue, 27 Jan 2026

Property Address: 5 James Ruse Cl Windsor, NSW, Australia

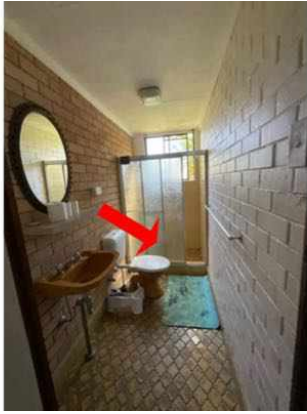
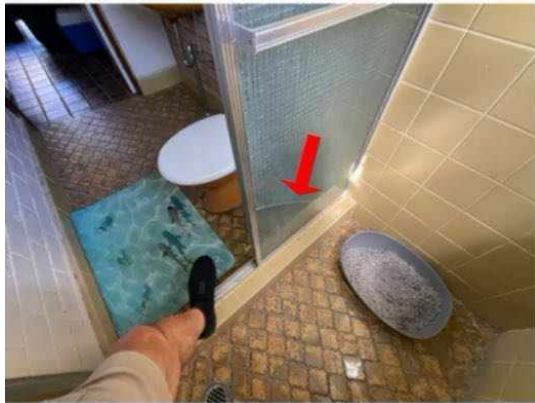
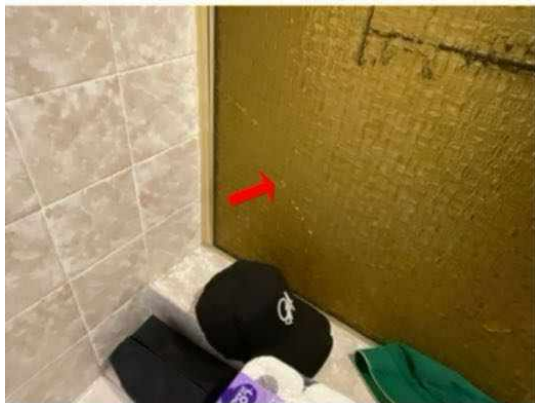
Building:	Main Building
Location:	Bathrooms
Finding:	Damaged Shower Screen Glass Panel.
Information:	Major Defect – Bathroom Shower Screen (Cracked Glass Panel)

During the inspection of the bathrooms, the shower screen glass panels were observed to have sustained visible and significant cracking. The cracking is clearly evident and extends through the glass panel, indicating that the integrity of the glass has been compromised. Based on the condition observed at the time of inspection, the damage is considered major. Any additional stress, vibration, or minor impact may cause the crack to propagate further or result in sudden and complete failure of the glass panel.

Cracked shower screen glass presents a serious safety hazard. Tempered or toughened glass, when compromised, can fail without warning and shatter into multiple fragments, creating a high risk of personal injury to occupants. Continued use of the shower in its current condition significantly increases the likelihood of glass failure. In addition, deterioration of the crack over time is likely, which will ultimately require full replacement of the shower screen assembly rather than minor repair.

It is strongly recommended that a qualified glazier be engaged as a matter of urgency to assess the extent of the damage. The cracked glass panel should be repaired or, more likely, fully replaced to restore the shower screen to a safe and compliant condition. Until appropriate remedial works are completed, occupants should exercise extreme caution and avoid using or coming into contact with the affected shower screen to minimise the risk of injury.

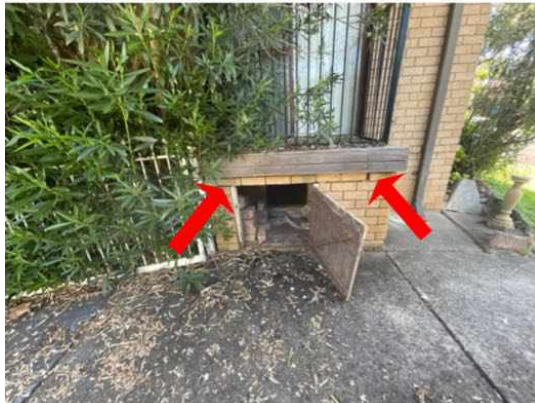
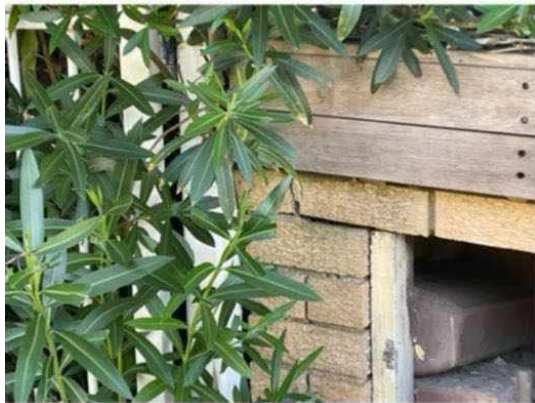
Building:	Main Building
Location:	Exterior walls - rear
Finding:	Major Defect – Deteriorated Masonry Wall.
Information:	Observation:

At the time of inspection, the masonry retaining wall in this area was found to be defective and showing signs of deterioration. Cracking and visible movement were noted, which are consistent with long-term site and drainage-related issues. While only limited further deterioration may be occurring at present, the wall supports a small landing adjacent to the rear sliding door, and any ongoing movement is likely to adversely affect the stability of this structure.

The condition of the wall indicates it has been compromised and may continue to deteriorate if left unmanaged. Progressive movement or failure of the wall could affect the supported landing and present a potential safety risk to occupants. As the wall contributes to the support of an access area, this issue is considered a major defect.

It is recommended that a qualified bricklayer or suitably experienced building

contractor be engaged to assess the wall and carry out necessary remedial works. Prompt attention is advised to maintain structural stability, limit further movement, and reduce potential safety hazards.

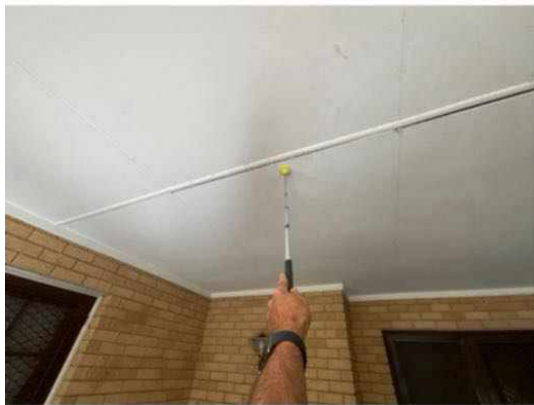
Uneven sagging ceiling linings were observed in this location, the condition appeared to be minor and cosmetic in nature, however, repairs are recommended.

This is a common occurrence in homes of similar age and construction, often caused by the gradual deterioration or loosening of original fixings, such as nails, screws, or adhesives used to secure ceiling sheets.

- Remedial works may be recommended to improve appearance and prevent further sagging. These may include:

- Re-gluing or re-adhering the ceiling sheeting
- Re-securing sheets using appropriate modern fixings
- These works can be carried out by a qualified plasterer or painter,
- Ongoing monitoring is advised to detect any worsening of the condition or further movement over time.

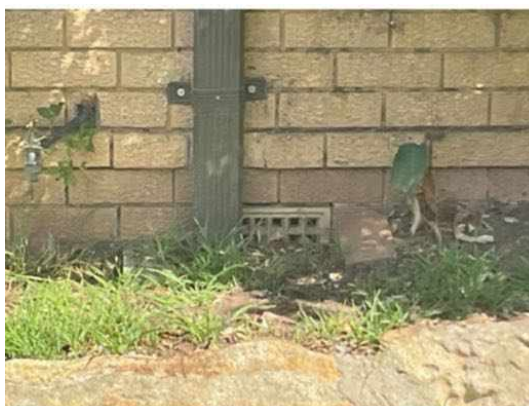
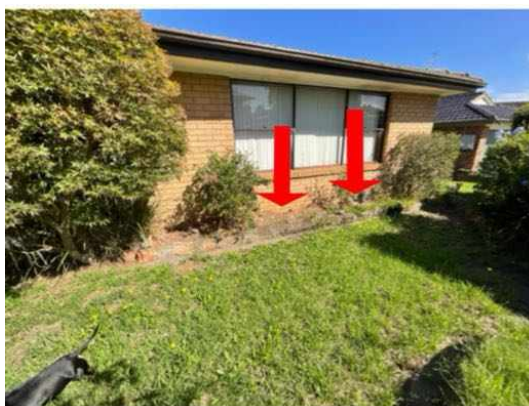
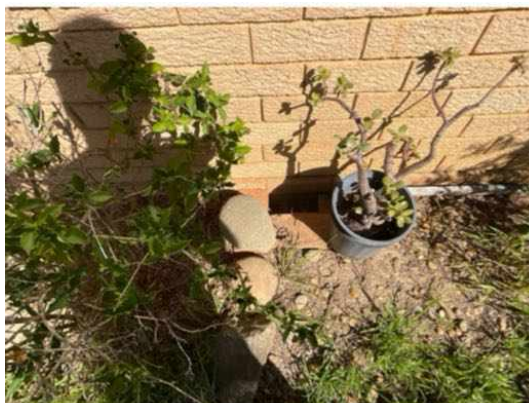
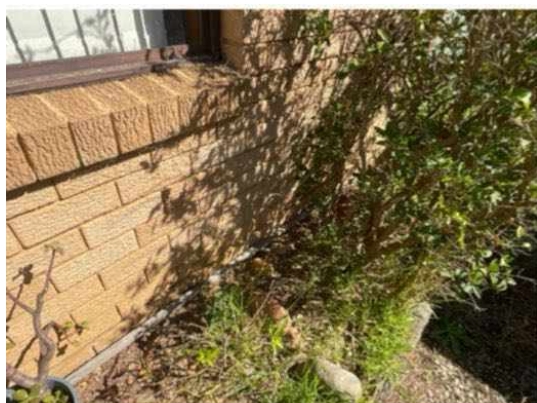
Building: Main Building  
 Location: Exterior walls - front  
 Finding: Subfloor ventilation - Too low.  
 Information: Subfloor Ventilation and Ground Levels – Moisture Risk

Subfloor wall vents in the inspected locations were found to be positioned too low due

to substandard external landscaping and ground levels. The external ground raised adjacent to the building perimeter, increasing the likelihood that rainwater can enter the subfloor via the vents during wet conditions.

Ongoing moisture ingress into the subfloor can result in persistently elevated moisture levels. If left unrectified, these conditions may promote fungal growth, timber decay, deterioration of mortar and brickwork, and cracking or subsidence of supporting piers. Elevated moisture levels also increase the susceptibility of the property to termite and other timber pest activity. Secondary water damage is likely to occur over time if the issue remains unmanaged.

Perimeter landscaping and ground levels should be rectified to expose and ensure adequate airflow through vents and fall away from the building. As a general guide, paved surfaces should fall away from the structure by a minimum of 25 mm over the first metre, and bare ground should fall away by approximately 50 mm over the first metre. This will assist in preventing moisture from pooling against the building and entering the subfloor.

Where site drainage is inadequate or rectification is complex, a qualified plumber and landscaping contractor should be engaged to further assess the site and undertake appropriate remedial works to achieve and maintain a dry subfloor environment.

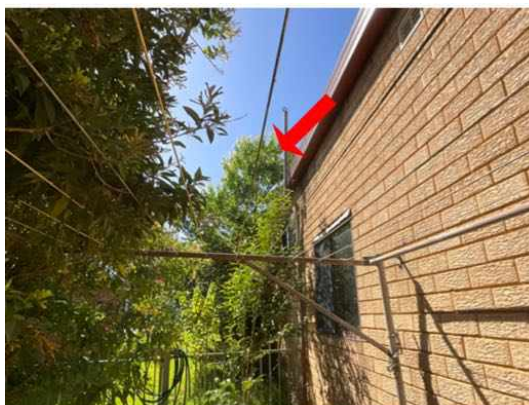
Building: Main Building  
 Location: Exterior - Rear and Right side  
 Finding: Overhanging Trees and Gutter Maintenance – Observations & Recommendations.  
 Information: Overhanging tree branches were observed above the roofline, contributing to the accumulation of leaf litter and debris within the gutters. This condition can adversely affect the performance of the roof plumbing system, particularly during periods of heavy rainfall.

Blocked or restricted gutters impede the effective discharge of stormwater, increasing the likelihood of water pooling or overflow. This may result in accelerated rusting and corrosion of gutters and downpipes, as well as the creation of damp conditions that

- Prune or remove overhanging tree branches to minimise debris accumulation.
- Clean all gutters and downpipes to restore full drainage capacity.
- Consider the installation of gutter guards as a preventative measure, particularly in heavily treed areas.

General gutter cleaning may be undertaken by the homeowner; however, pruning of larger branches should be carried out by a suitably qualified arborist or landscape contractor. A licensed roof plumber should be engaged to assess the condition of the guttering system and undertake any necessary remedial works. Regular maintenance will assist in preserving roof plumbing components, protecting the building envelope, and reducing the risk of moisture-related damage or pest activity.

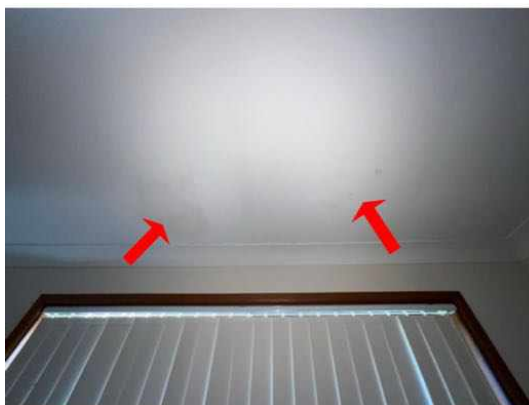
Building:	Main Building
Location:	Living Room
Finding:	Ceiling - Water stained.
Information:	Observation:

Additionally, it is important to note that even minor damage to roofing materials—such as lifted flashings, cracked tiles, or poorly sealed penetrations—can allow water ingress that may lead to costly internal damage. Close-up inspection by a roofing contractor is advised to assess the condition of the roof coverings and associated fixtures more accurately.

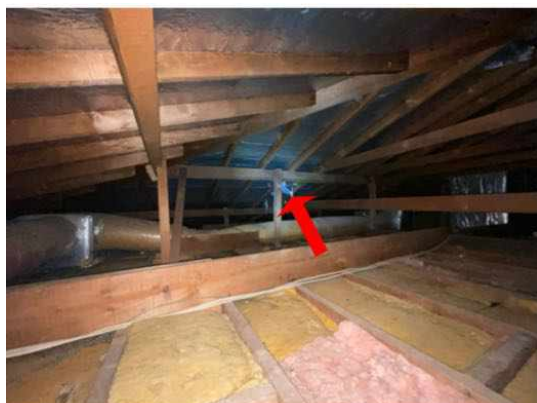
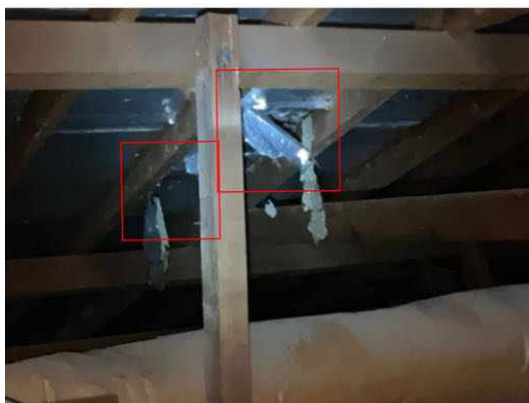
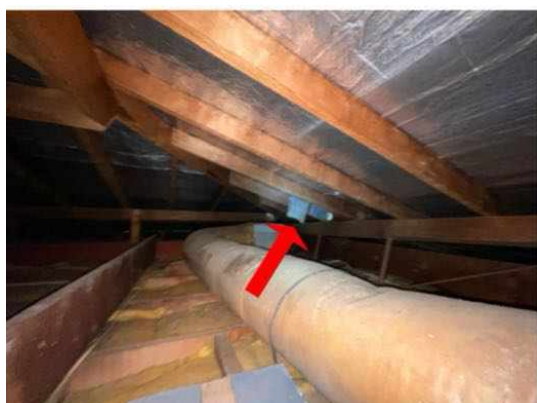
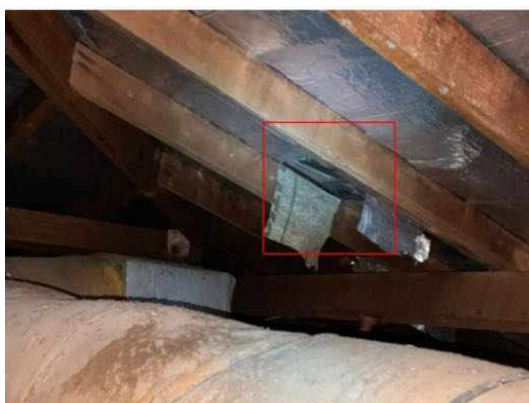
Building:	Main Building
Location:	Roof Void

Any holes or damaged sections of sarking should be repaired or replaced to restore full functionality. These works should be completed by a roofing contractor or other suitably qualified tradesperson.

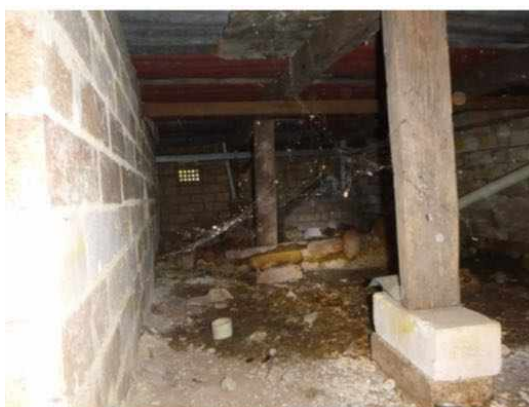
Building:	Main Building
Location:	Exterior walls - front
Finding:	Subfloor Ventilation Issue: Wall vents adjacent ground.
Information:	Findings:

It is strongly recommended that all residual formwork timber and loose timber debris be immediately removed from the subfloor and surrounding areas of the property.

Preventative action—such as maintaining a clean, dry, and well-ventilated subfloor—is significantly more effective and less costly than dealing with active termite infestation or structural timber damage at a later stage.

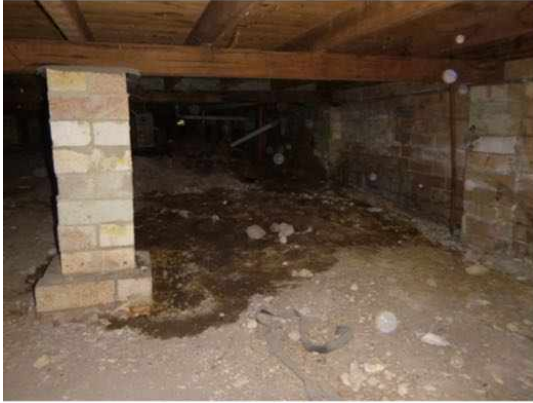
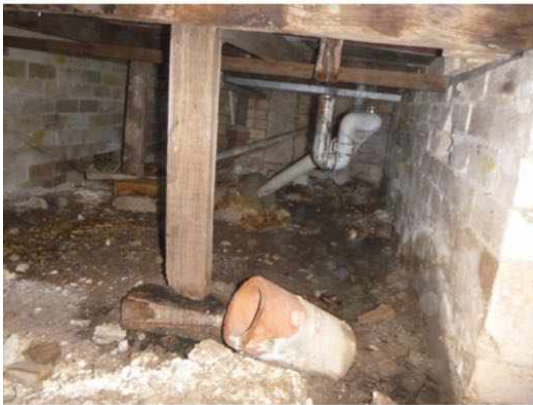
Risk Assessment:

High – Conducive to concealed termite activity and fungal growth and should be rectified promptly.

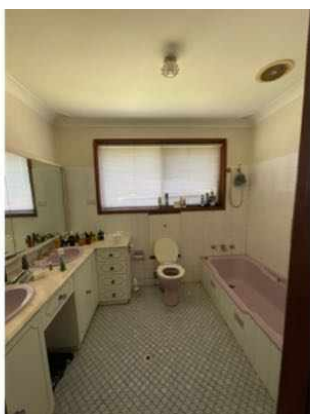
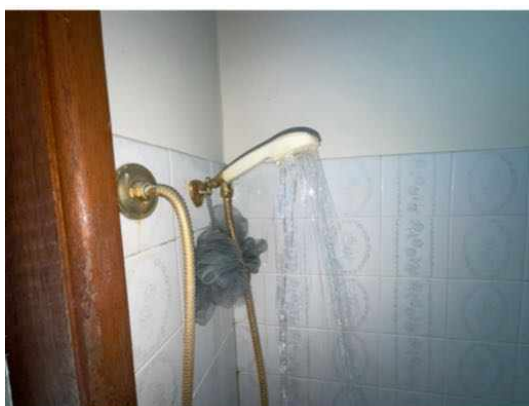
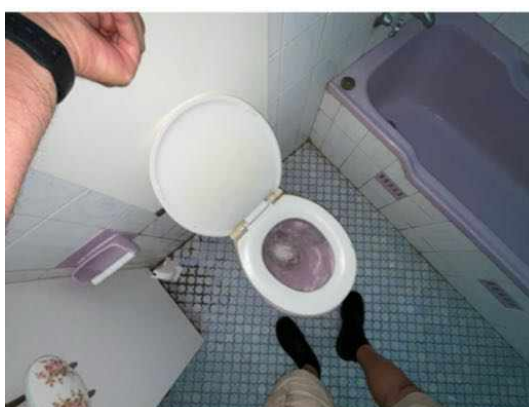
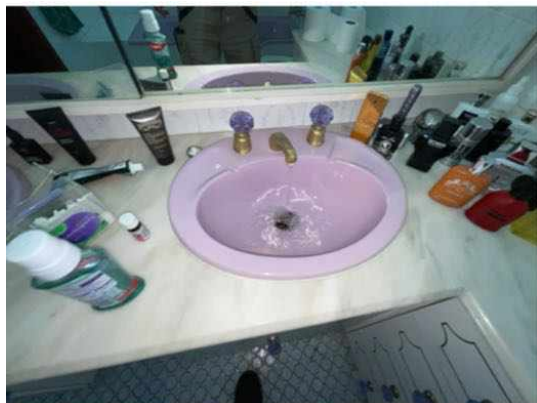
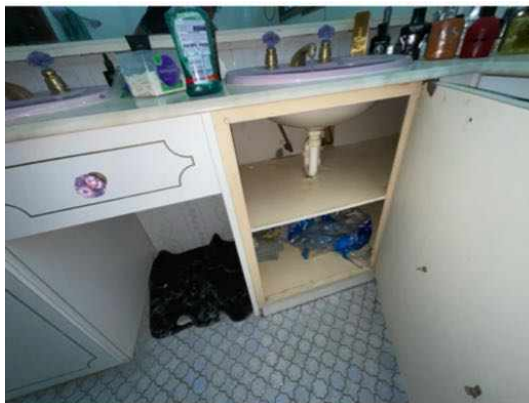
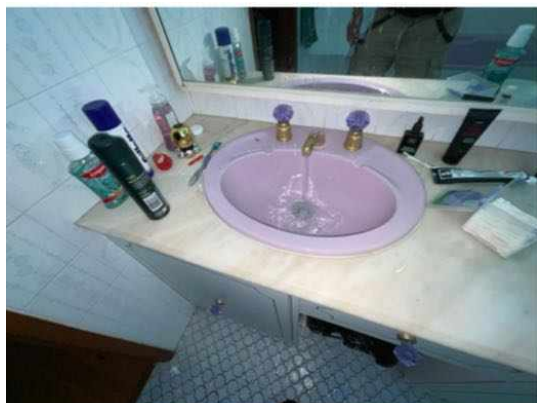
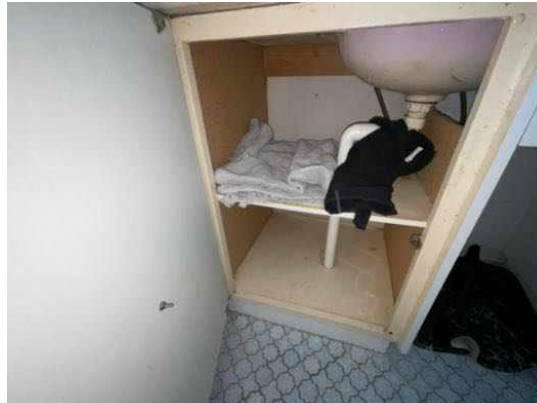
- The condition of grout appeared to be poor , with some areas potentially requiring maintenance or replacement.
- Grout in wall and/or floor junctions may crack and deteriorate over time. It is recommended to remove any rigid grout from junctions and replace with flexible, mould-resistant sealant in accordance with best building practices.

- Mould growth was noted in some areas of grout/sealant. Cleaning or, if necessary, replacing affected grout or sealant is recommended to maintain hygiene and waterproofing integrity.

- Further monitoring is recommended after the basin(s) are placed under regular use to confirm ongoing performance and cleanliness.
- Water damage was noted to the vanity unit, appearing minor.
- Stored items inside the vanity obstructed full visibility during the inspection. It is advised that the area be re-inspected once all obstructions are removed.

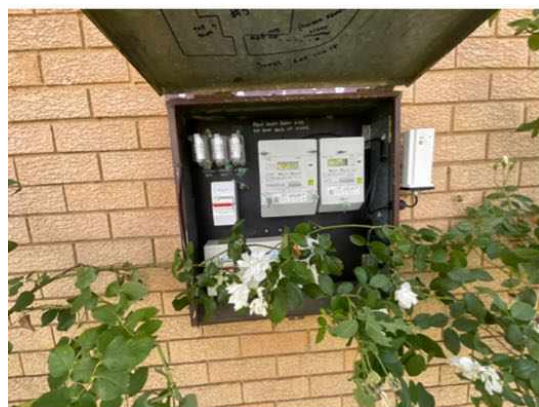
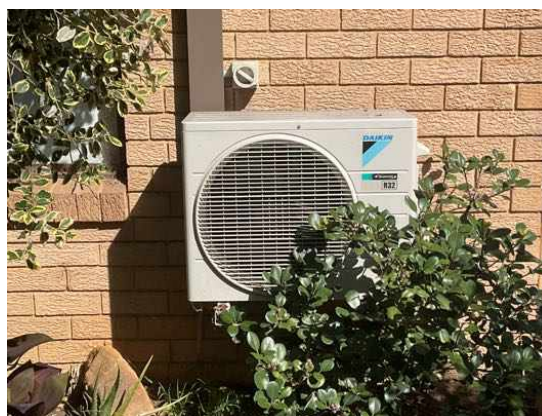
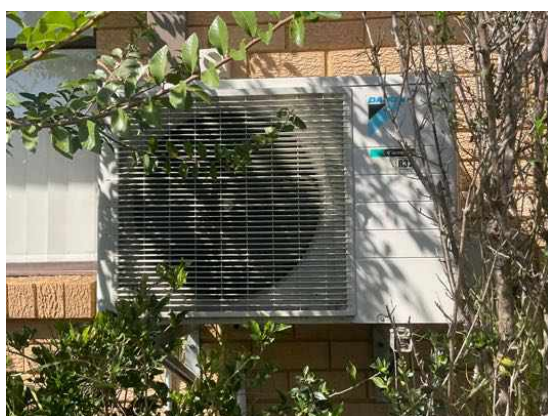
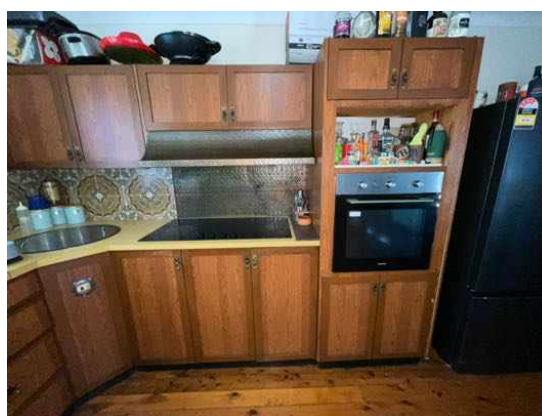
Building: Main Building  
 Location: All Areas  
 Finding: Plumbing, Electrical & Gas Installations – Scope and Recommendations.

- Any gas appliances (if applicable) must be inspected by a licensed gas plumber to confirm they are operating safely and efficiently.
- We also recommend that all other plumbing and electrical installations be thoroughly checked by qualified professionals to ensure they are functioning correctly and meet current safety and compliance standards.

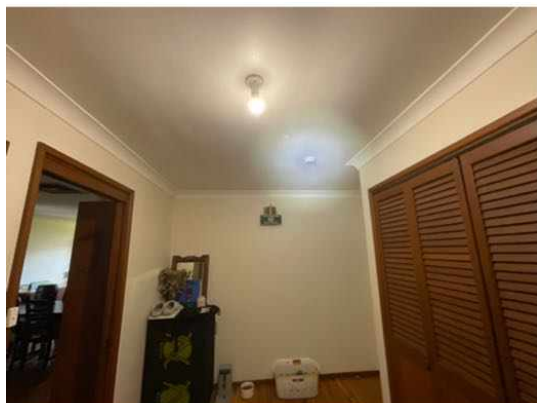
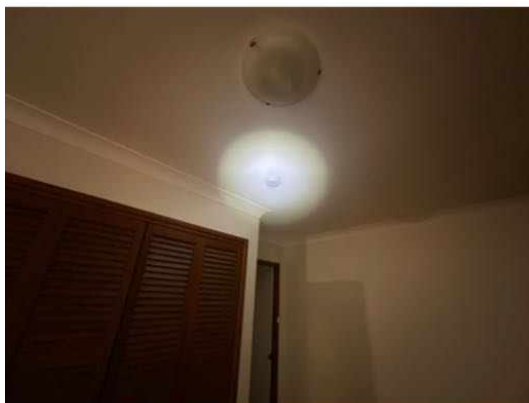
Building: Main Building  
 Location: All Areas  
 Finding: Smoke Detectors / Alarms.  
 Information: Reporting on the presence, type, location, or compliance of smoke detectors or alarms, including hard-wired smoke detection systems and their legislative

To ensure compliance and safety, further inspection and/or advisory services from a qualified specialist are recommended. These services can confirm the sufficiency, type, location, and functionality of all smoke detection devices within the property.

- All smoke detectors be tested monthly by the homeowner.
- All systems comply with the requirements of AS 3786 and any applicable state-based legislation.
