Building and Timber Pest Inspection Report

Inspection Date: Fri, 23 Jan 2026

Property Address: 13 Marsanne Place Eschol Park NSW 2558

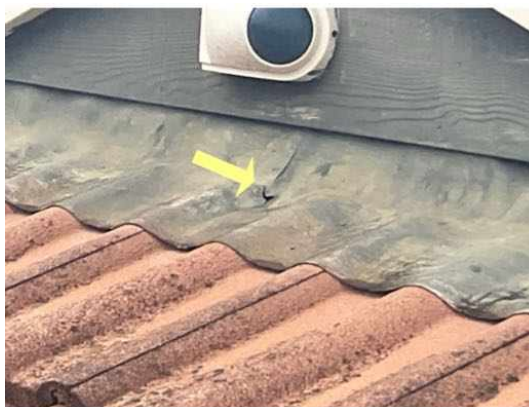
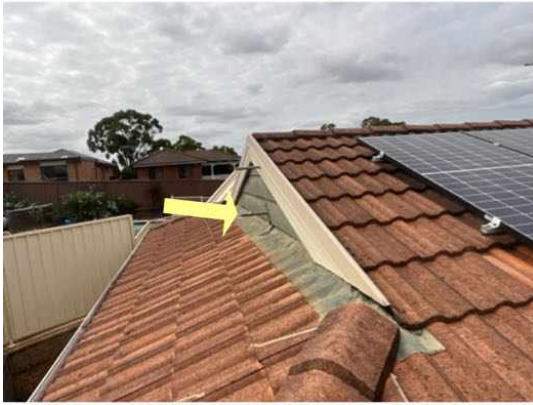
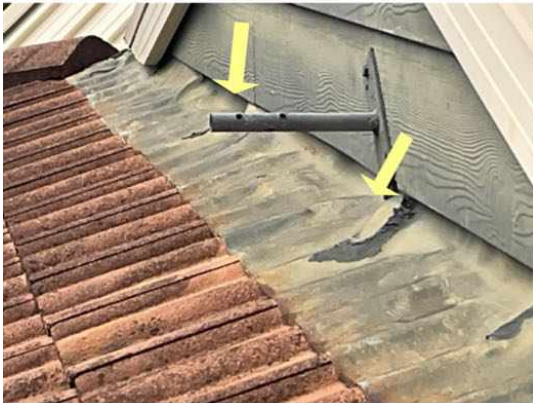
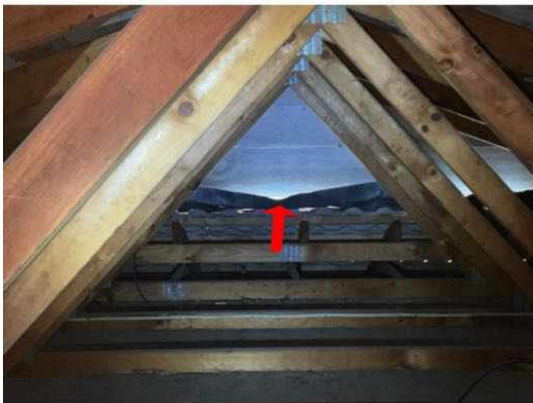
Finding 3.01

Building: Main Building
 Location: Roof Exterior
 Finding: Roof Flashing - Defect & Recommendation (cracked).
 Information: Observation:

Cracking and displacement was observed in sections of the roof flashings. These materials, typically composed of metal, lead, or similar weather-resistant components,

Damaged or deteriorated flashings significantly increase the risk of water penetration into the internal structure of the property. Over time, this can result in:

It is recommended that a licensed roofing plumber or qualified carpenter be engaged as soon as possible to assess and repair the affected flashings. Prompt remediation will help prevent further water damage and ensure the roof plumbing system remains functional and weatherproof.

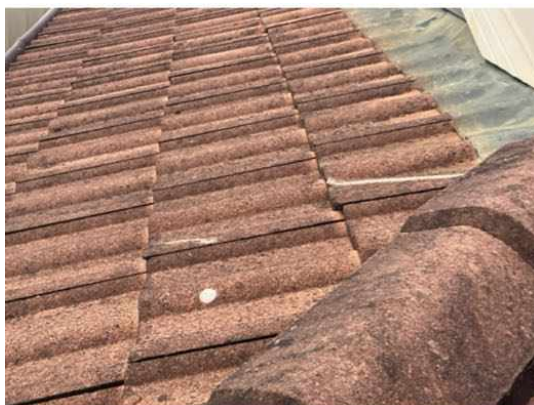
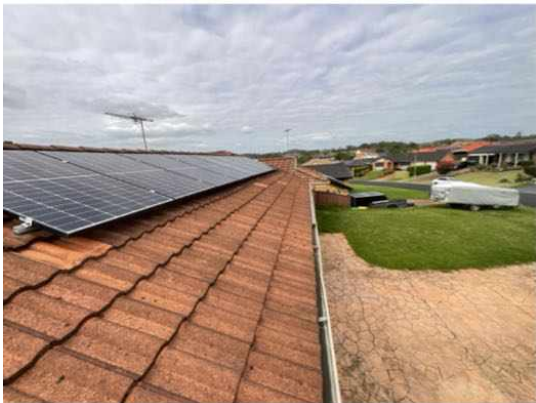
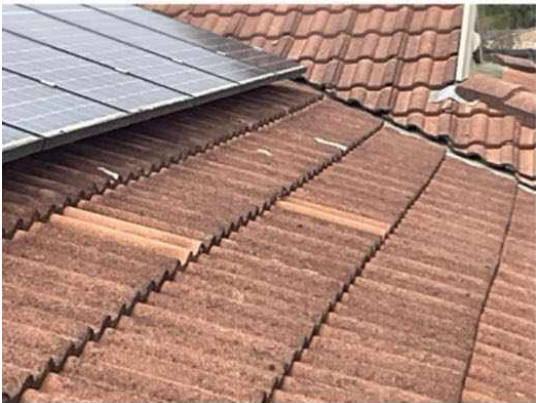
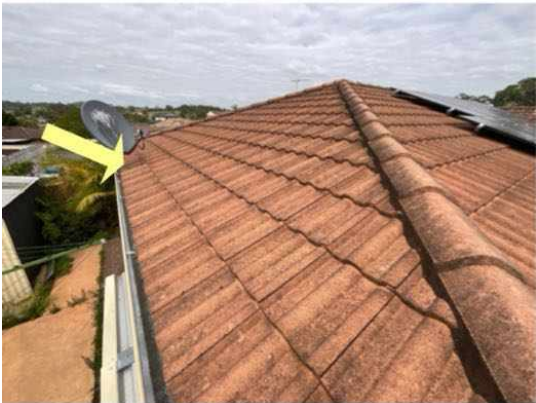
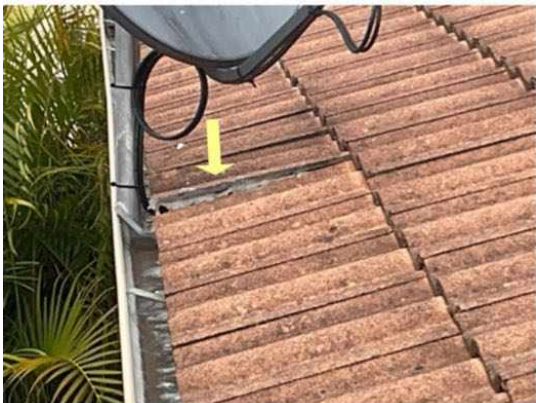
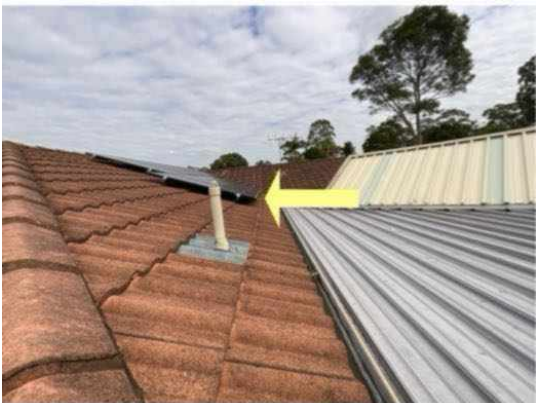
Finding 3.02

Building: Main Building
 Location: Roof Exterior
 Finding: Roof Tile Inspection Summary
 Information: 1. Access & Limitations

Inspector's Comments

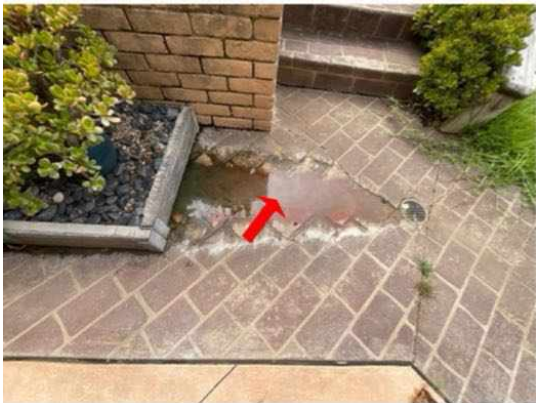
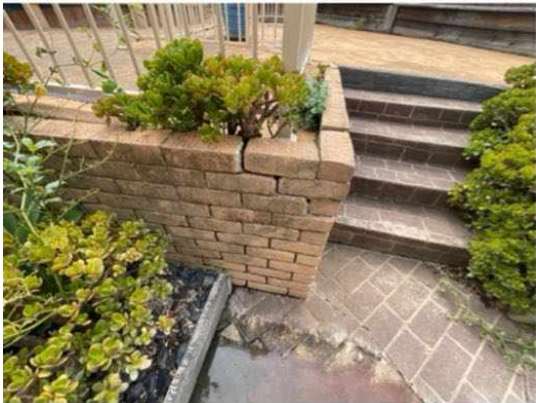
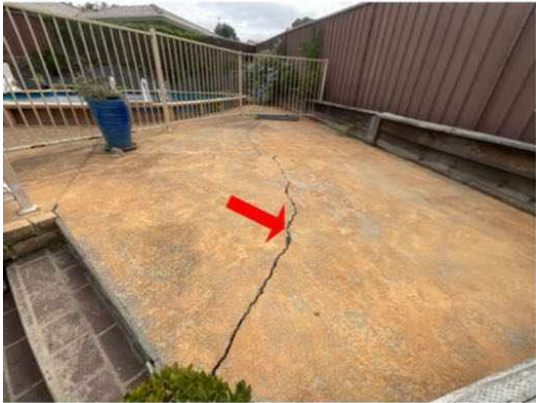
Finding 3.04

Building: Yard
Location: Exterior yard - right side
Finding: Site/Yard Drainage – Below Average.
Information: Defect – Below Average Site Drainage

It is recommended that the strip drain be cleaned and cleared of all debris to restore proper drainage function and prevent water pooling. Ongoing periodic maintenance should be undertaken to ensure continued performance. Where remedial works or modifications to the drainage system are required, a licensed plumber should be engaged to carry out the works in accordance with relevant standards.

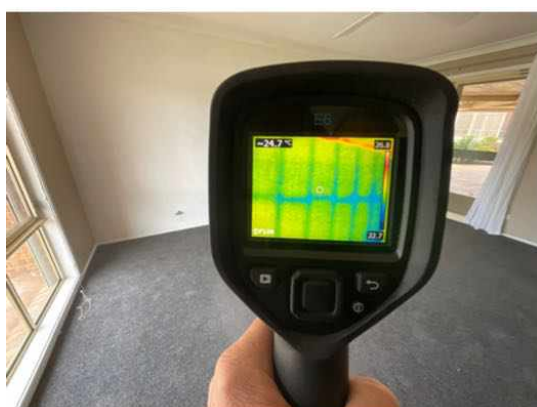
At the time of the inspection, no abnormalities indicating live termite activity were observed. However, it's important to note that various factors—such as obstructions, ambient temperature, and wall material/thickness—can impact the accuracy of thermal readings. In cases where surfaces are visually restricted or obstructed, a comprehensive thermal scan may not always be feasible.

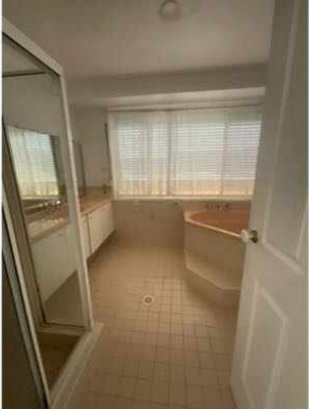
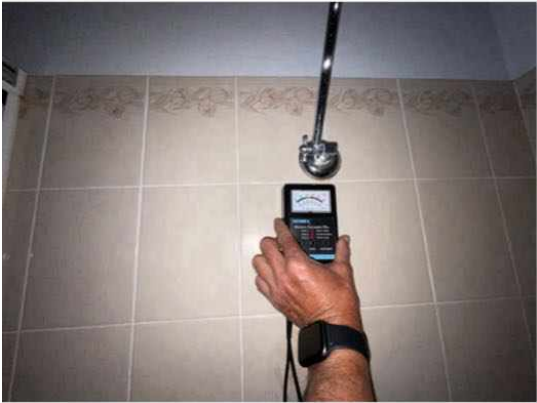
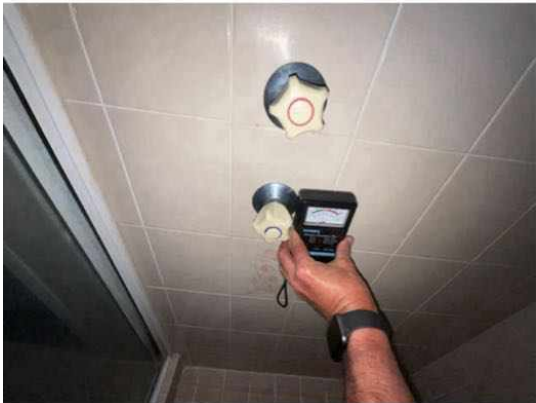
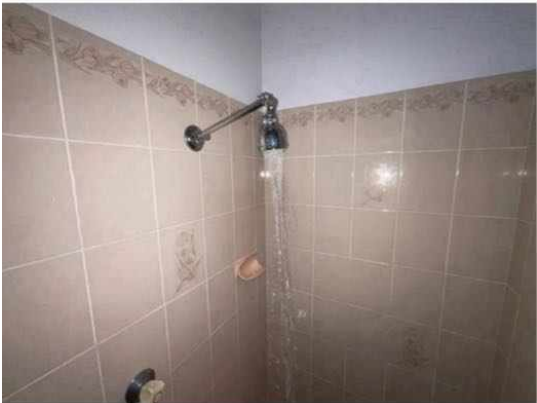
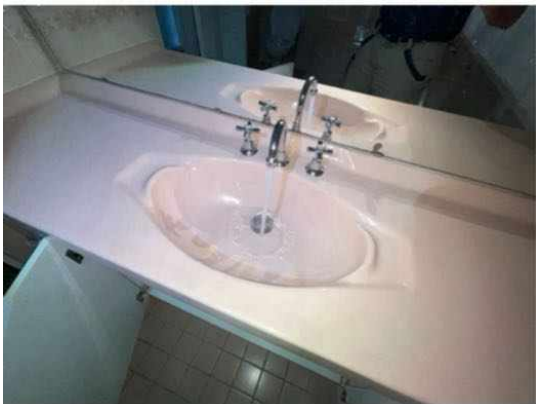
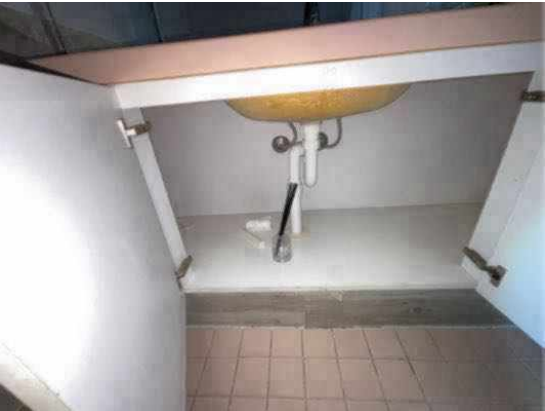
Building: Main Building
Location: Bathroom
Finding: Wet Areas - Bathroom(s) - Overall Condition & Recommendations.
Information: Overall Condition & Recommendations

- Leaks were observed during flushing. The toilet operated normally, and the toilet pan appeared to be securely fixed to the floor.

- Flood testing of the shower recess is recommended. This may reveal inadequacies in the waterproofing or shower screens, which could lead to water damage in surrounding areas.

- Grout in wall and/or floor junctions may crack and deteriorate over time. It is recommended to remove any rigid grout from junctions and replace with flexible, mould-resistant sealant in accordance with best building practices.

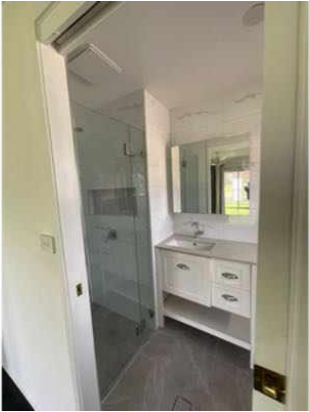
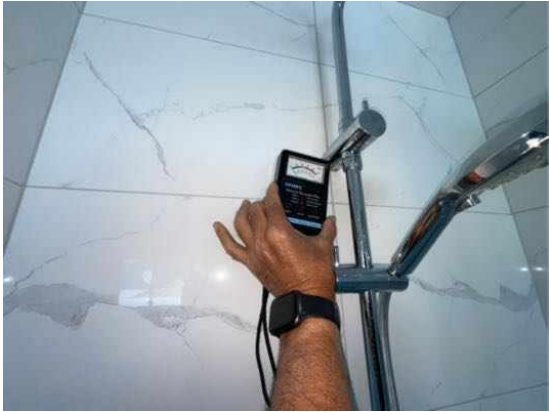
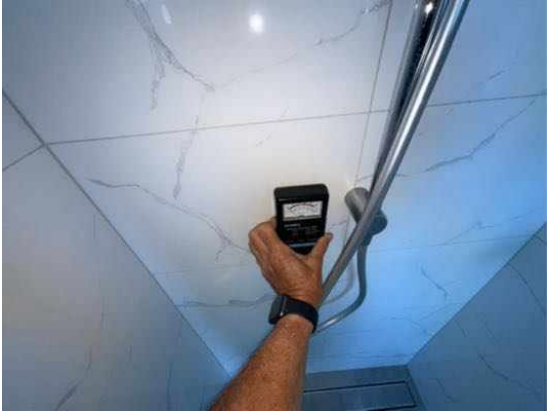
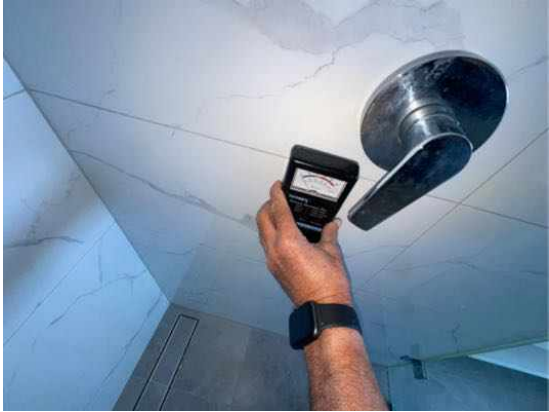
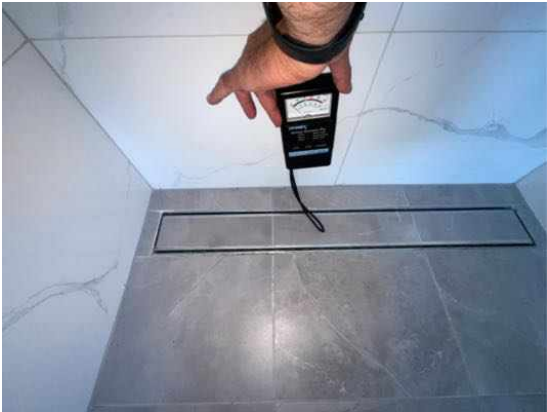
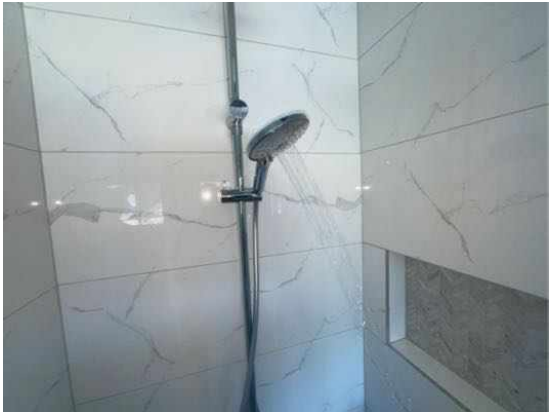
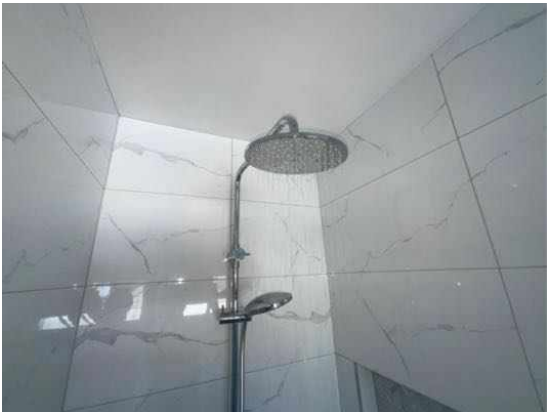
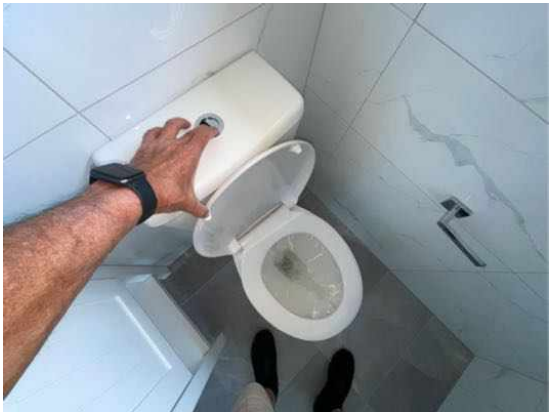
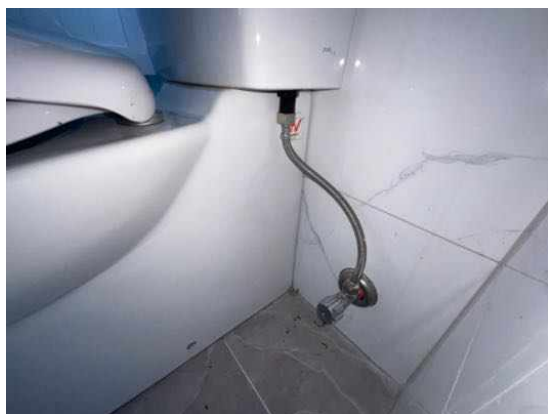
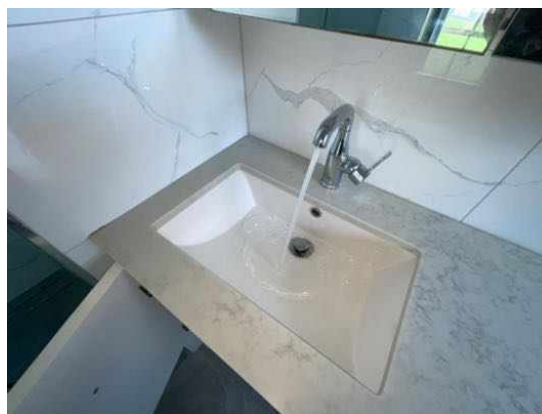
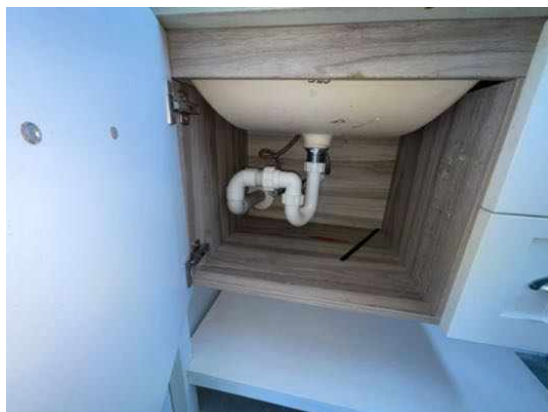
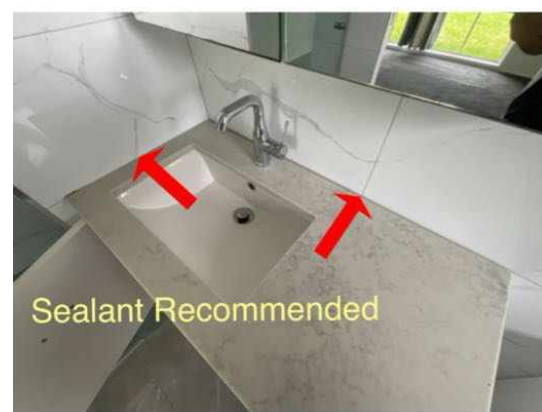
- No leaks were observed during flushing. The toilet operated normally, and the toilet pan appeared to be securely fixed to the floor.

- Basin(s) were water tested and inspected, with no leaks or blockages identified in the plumbing or drainage system at the time of inspection.
- Further monitoring is recommended after the basin(s) are placed under regular use to confirm ongoing performance and cleanliness.
- No visible water damage was observed to the vanity cabinetry at the time of inspection.

- Sealant to the wall junctions is missing.
- It is recommended that flexible, mould-resistant sealant be applied or replaced where missing or degraded to prevent future water ingress.
- Regular maintenance of sealant and grouting in wet areas is essential to prolong the life of surrounding materials and reduce the risk of water damage.

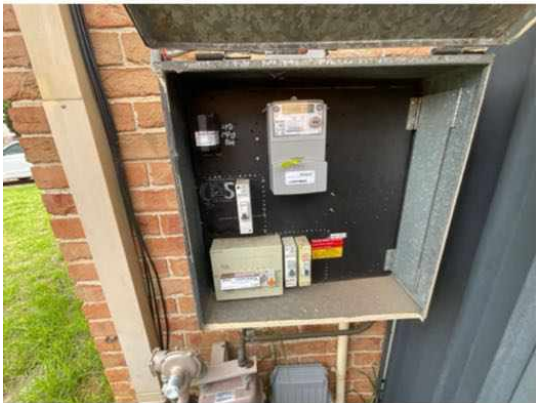
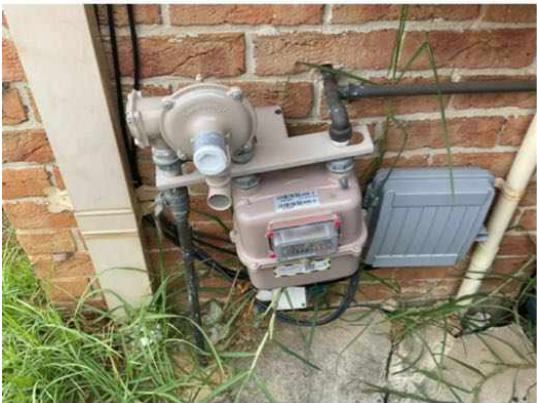
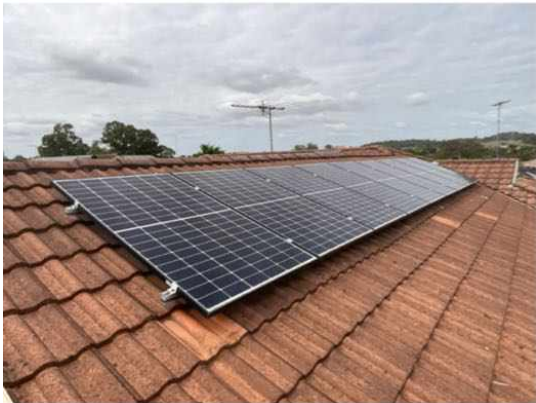
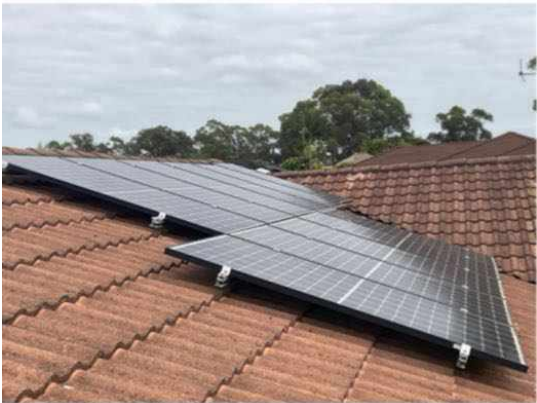
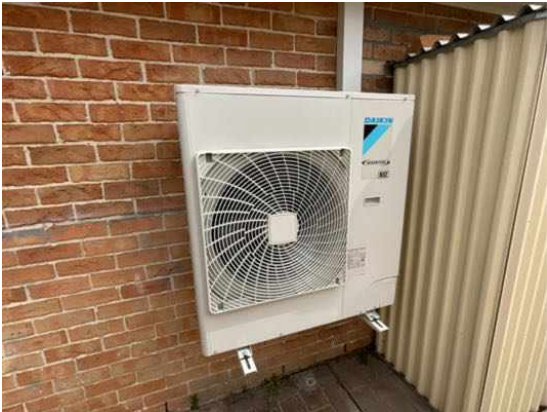
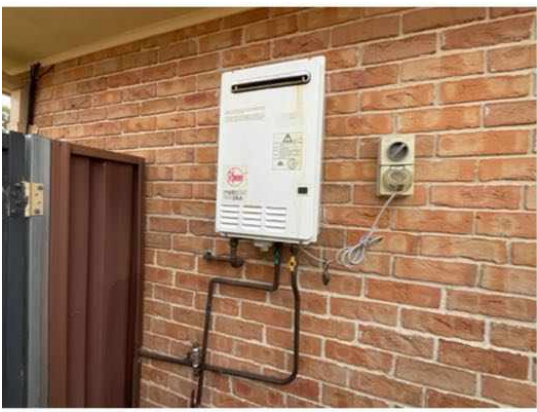
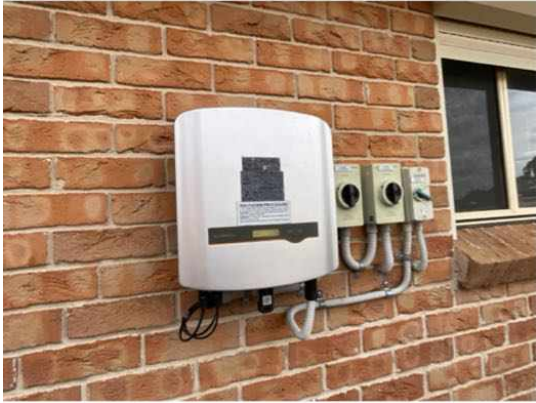
Finding: Plumbing, Electrical & Gas Installations – Scope and Recommendations.

Additional photos have been supplied with this report for your general reference.

- Any gas appliances (if applicable) must be inspected by a licensed gas plumber to confirm they are operating safely and efficiently.
- We also recommend that all other plumbing and electrical installations be thoroughly checked by qualified professionals to ensure they are functioning correctly and meet current safety and compliance standards.

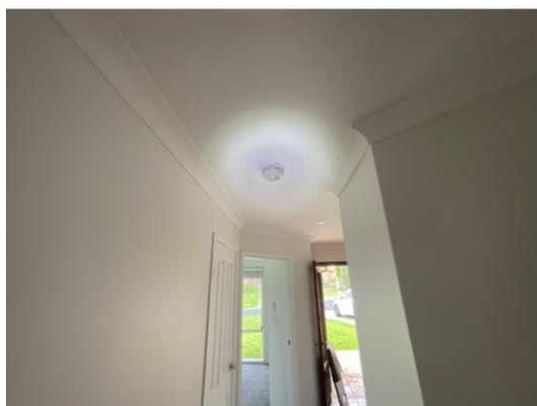
Building:	Main Building
Location:	All Areas
Finding:	Smoke Detectors / Alarms.
Information:	Reporting on the presence, type, location, or compliance of smoke detectors or alarms, including hard-wired smoke detection systems and their legislative requirements, is outside the scope of this inspection report.

To ensure compliance and safety, further inspection and/or advisory services from a qualified specialist are recommended. These services can confirm the sufficiency, type, location, and functionality of all smoke detection devices within the property.

- All smoke detectors be tested monthly by the homeowner.
- All systems comply with the requirements of AS 3786 and any applicable state-based legislation.
