Building Inspection Report

Inspection Date: Mon, 16 Mar 2026

Property Address: 207 Beach Rd, Black Rock VIC 3193,
Australia

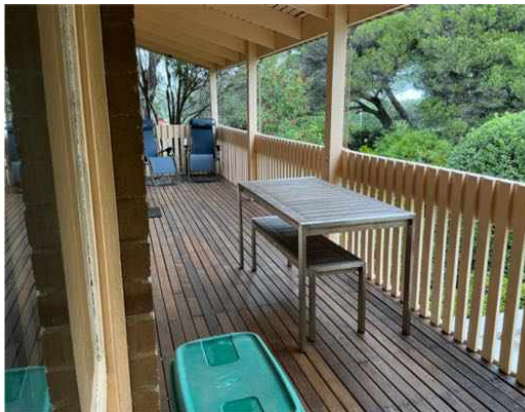
Defects 1.02

External timber structures are also constantly exposed to weather elements and can deteriorate in an accelerated manner, ongoing assessments are required.

It is highly recommended that a Structural Engineer further assess the external timber

balcony or deck to inform the client of its load capacity. Regular maintenance inspections by competent practitioners is needed.

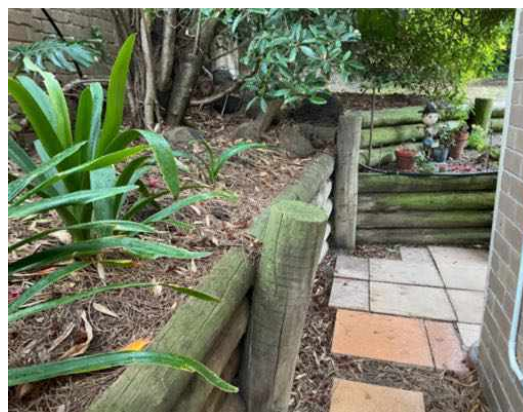
Defects 1.04

Building: Main Building
Location: All Areas
Finding: Retaining wall - Defective
Information: The retaining wall in this area was found to be defective at the time of inspection. Generally, defective retaining walls are caused by poor original design or material use. However, deteriorated retaining walls may also be a result of substandard construction, poor site drainage or unmanaged stormwater flows.

If left unmanaged, the retaining wall may become a safety hazard if it continues to destabilise. Where retaining walls further rot and decay, an environment is created that is conducive to termite and pest infestation.

Significant repair and replacement should be expected. Where retaining walls are considered structural walls, a structural engineer / surveyor should be consulted regarding required remedial works. Otherwise, a landscaper or retaining wall installer may be appointed to repair or replace the wall, at the discretion of the client.

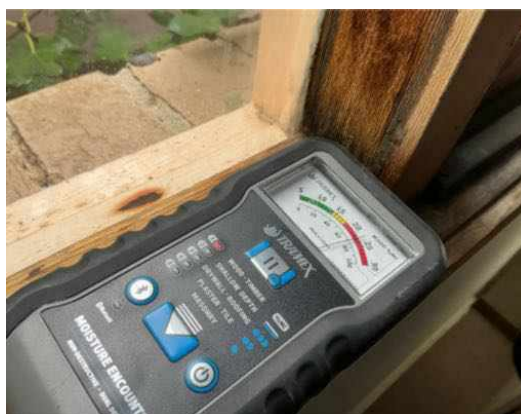
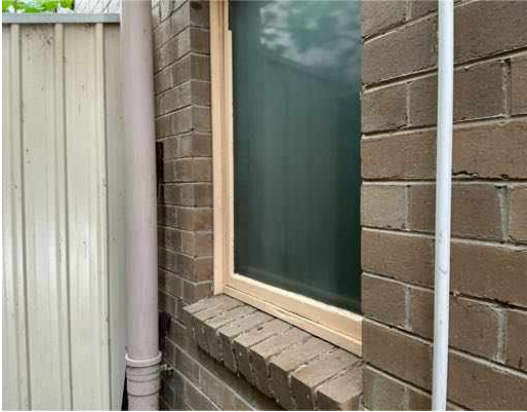
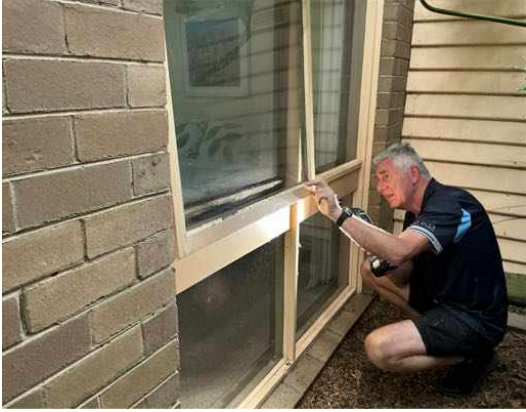
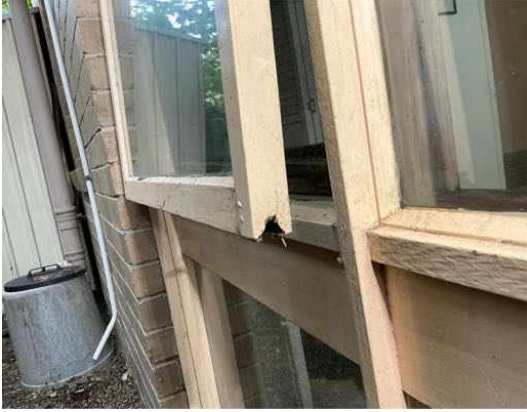
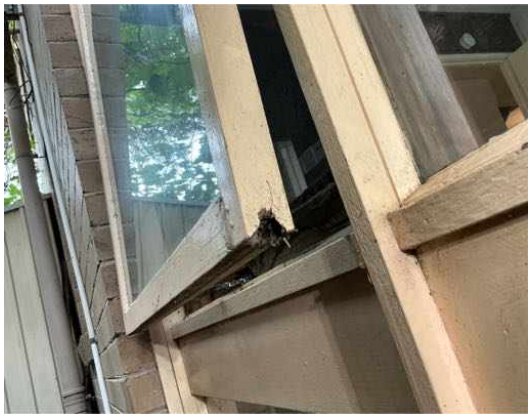
Defects 3.01

Building:	Main Building
Location:	All Areas
Finding:	Windows - Wood rot
Information:	Wood rot was found to be affecting external windows. Wood rot, also known as Fungal Decay, occurs when timbers and other cellulose building materials are exposed to damp conditions on an ongoing basis.

It is likely that this wood rot has developed as a result of frequent exposure to rain and other weather conditions. It is suspected that failure to maintain the window frames over a prolonged period has resulted in them deteriorating at an accelerated rate, increasing their susceptibility to the development of wood rot. Leaks in roof plumbing or associated pipework may have also contributed to the formation of the wood rot in this area.

Early intervention and regular maintenance will prolong the useful life of these building elements. Prior to any works being performed, any associated pipework or roof plumbing should be inspected by a licensed plumber for faults or leaks.

Repair and/or replacement of affected window frames may be a necessary step in protecting surrounding building elements from such deterioration. Remedial works should be performed by a qualified carpenter or registered builder as soon as possible to prevent any further damage.

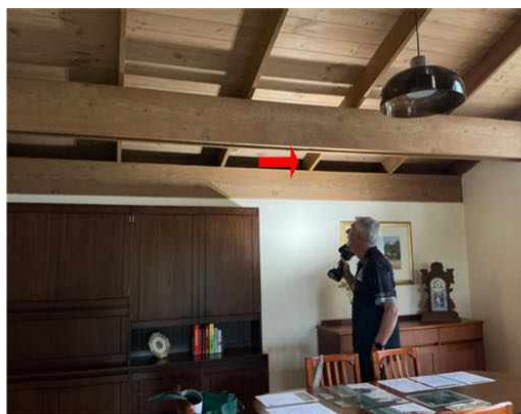
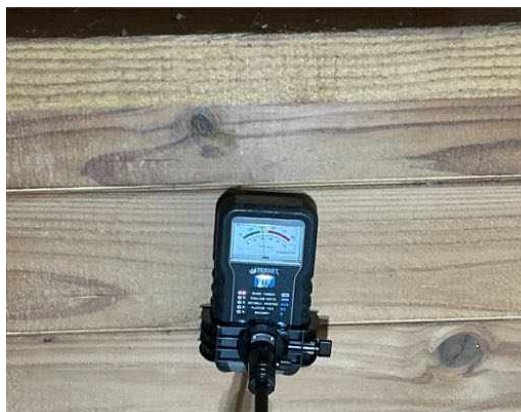
Defects 3.02

Building: Main Building
Location: Dining Room
Finding: Ceiling - Water stained
Information: Water staining to ceiling linings in this area was evident at the time of inspection. Water staining indicates that surfaces have been exposed to excessive moisture over time. The minerals and other elements in the water lead to staining, which may graduate to corrosion and deterioration if left unmanaged.

While mostly an appearance defect, water staining can be indicative of more serious defects, which may be currently concealed by interior ceilings.

Where water staining is active, a licensed plumber must be consulted to identify the cause of the staining and to provide advice on any reparation works that may be required. Replacement of any damaged structures is advised.

Conversely, where water staining is old and inactive, affected building materials may be repaired or replaced at client discretion.

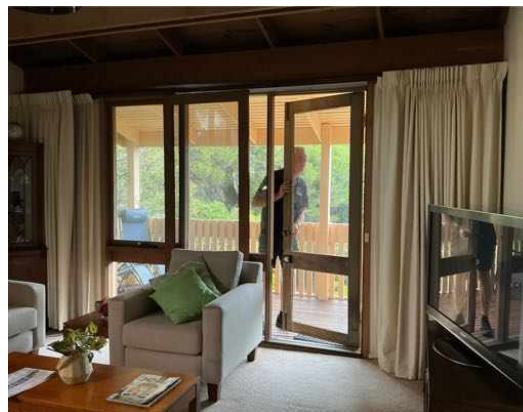
Defects 3.03

Building:	Main Building
Location:	Kitchen
Finding:	Sticking or jamming
Information:	Building elements which are sticking or jamming are difficult to operate and don't function as intended. There are a variety of causes for sticking and jamming.

The most usual causes are swelling of timbers due to moisture, bulging or bowing of metal frames, or general material deterioration. Generally, sticking and jamming building elements indicate that their frames are uneven or out of level, generally as result of movement to surrounding walls and floors.

Easement will be required, which usually depends on the building materials used. This may involve some sanding and/or application of a lubricant. It will almost always include ensuring the areas are cleaned and free of any debris that may be detrimental to their operational state.

Appointment of a carpenter or general handyman is recommended to rectify any sticking/jamming building elements.

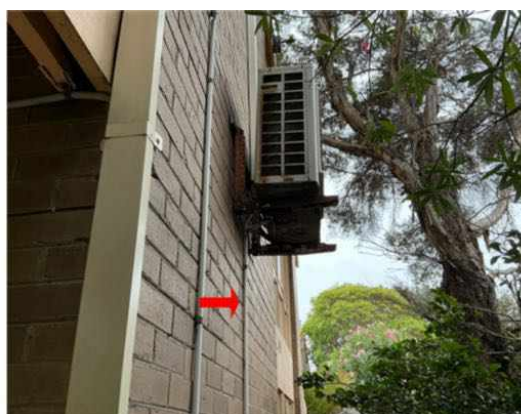
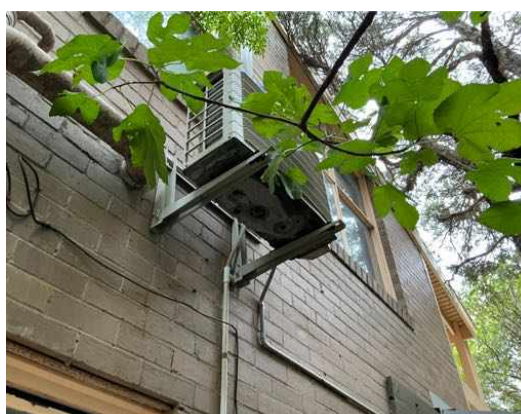
Defects 3.08

Such leaking creates an environment which is conducive to an array of defects, including water damage to associated building elements and the attraction of termite or timber pest infestation.

It is highly recommended that a licensed plumber be appointed to connect the A/C overflow in order to prevent such an environment from being created. These minor works should be carried out as soon as possible.

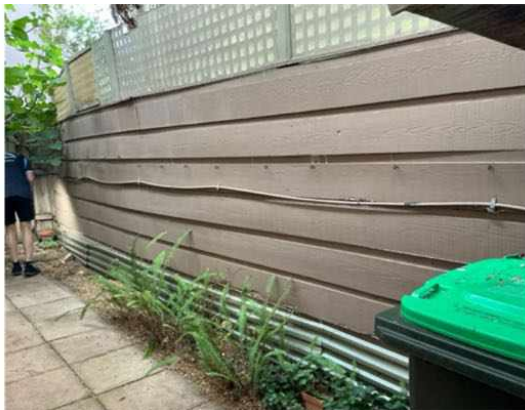
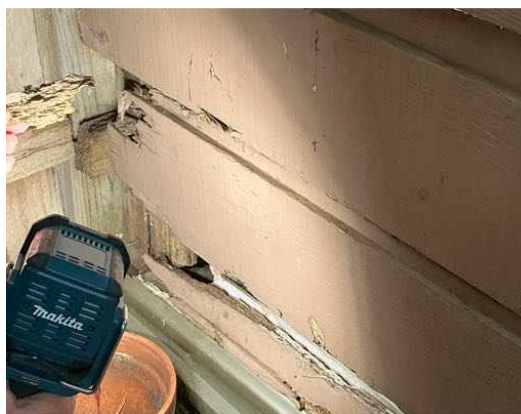
If left unattended, it is likely that further damage will occur. It is suspected that repair of several elements of the fencing may be required however replacement may be a consideration of the client also.

A licensed fencing contractor should be appointed to provide further advice and perform rectification works as necessary.

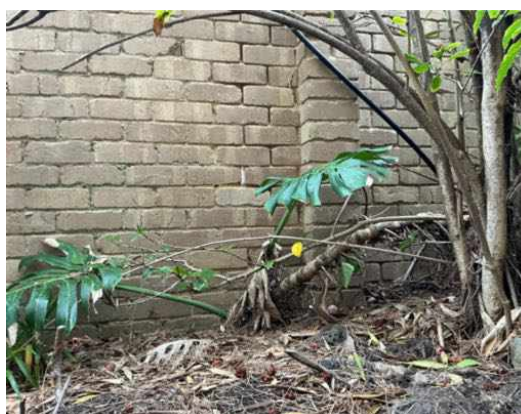
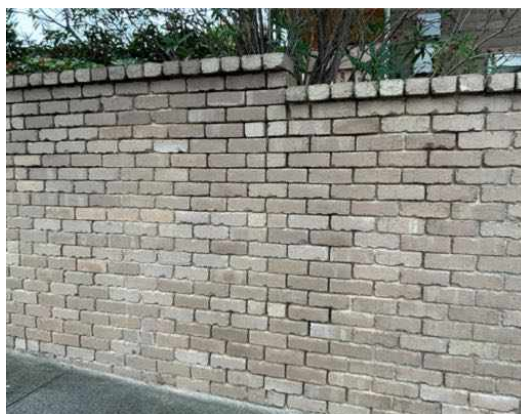
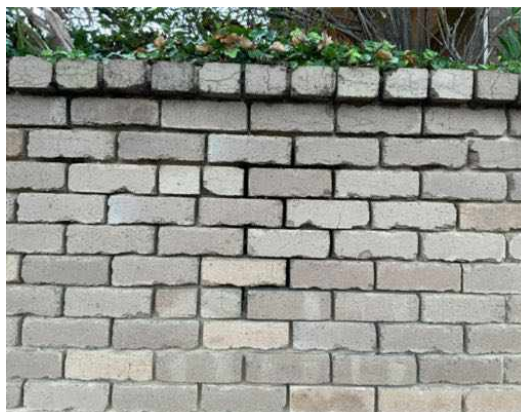
Defects 3.12

Building:	Main Building
Location:	Brick fence
Finding:	Brickwork - Deteriorated mortar
Information:	Mortar, or 'bedding', is the material which fills joints and intersections between bricks in masonry walls and structures. Sections of mortar in this brickwork were identified as having deteriorated, which is generally expected for a property of this age and condition.

Mortar may deteriorate as a result of age of building materials, minor movement of bricks, or frequent exposure to weathering. Mortar should be replaced to ensure that bricks remain in their intended location and to prevent gaps, which would allow water or moisture ingress and secondary damage as a result.

Mortar deterioration can be addressed by a bricklayer where areas of deterioration are localised and easily accessible. Alternatively, appointment of a registered builder is advised, to repoint large areas of decaying mortar. Where secondary structural defects have become evident, consultation with a structural engineer may be required.

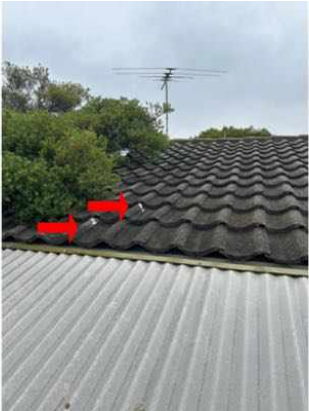
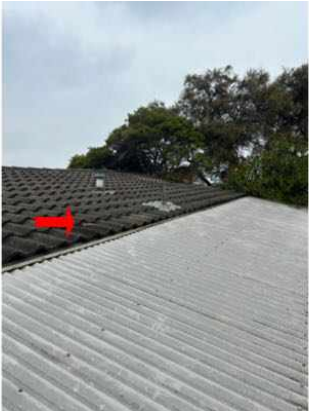
Defects 3.13

Building:	Main Building
Location:	All Areas
Finding:	Roof tiles - Broken
Information:	Upon inspection of the exterior roof covering, broken roofing tiles were identified. Broken and friable roof tiles are generally the result of ageing and weathering of what is essentially a porous material.

Replacement of broken tiles is required and should be performed by a roofing contractor as soon as possible.

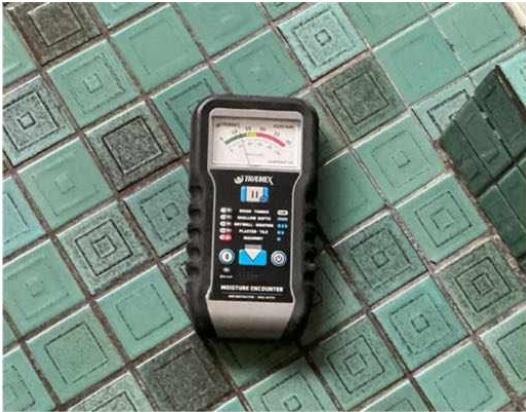
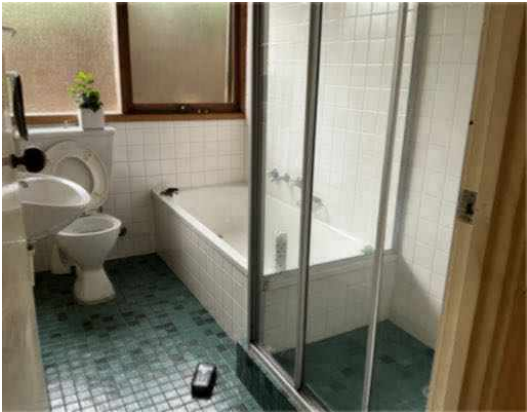
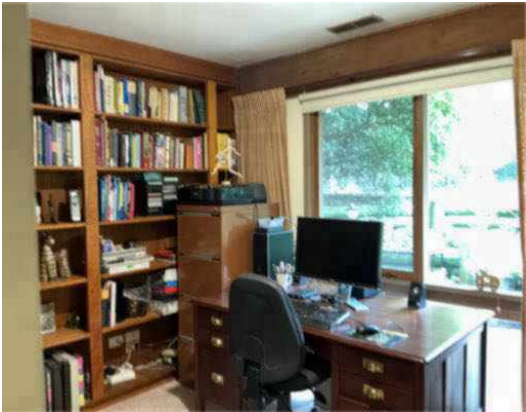
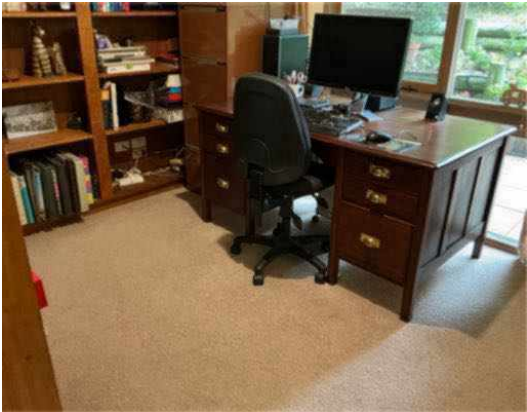
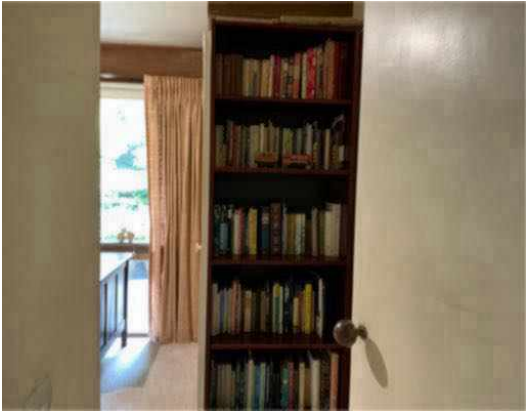
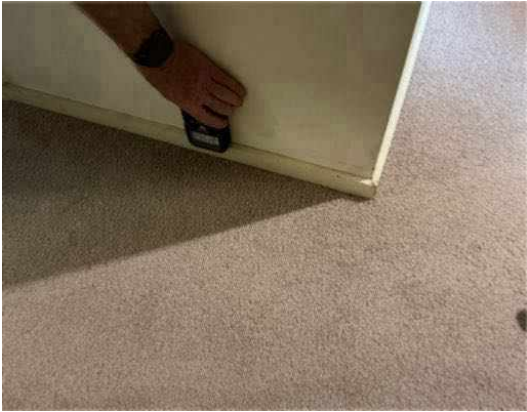
Noted Item

Building: Main Building
Location: All Areas
Finding: Additional Photos - Obstructions and Limitations
Information: These photographs are an indication of the obstructions and limitations which impeded full inspection of the property at the time of inspection. These obstructions can hide an array of defects and should be removed to allow full inspection to be carried out. A re-inspection is recommended once the areas are made accessible.

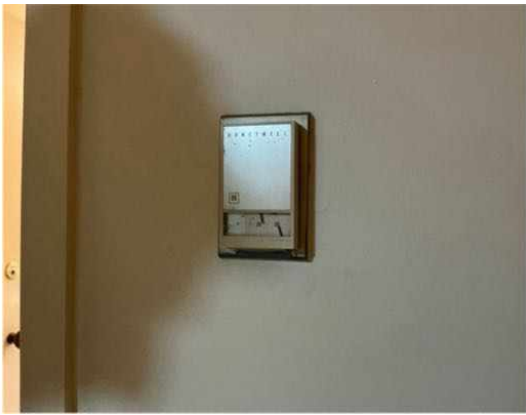
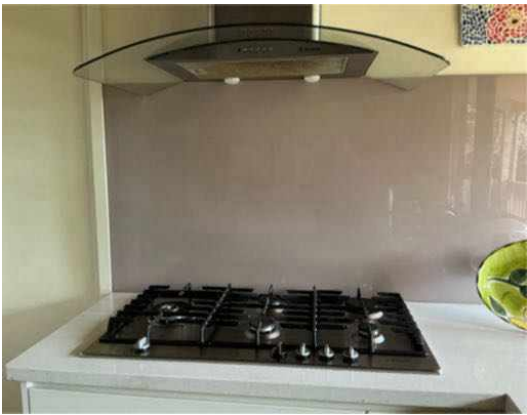
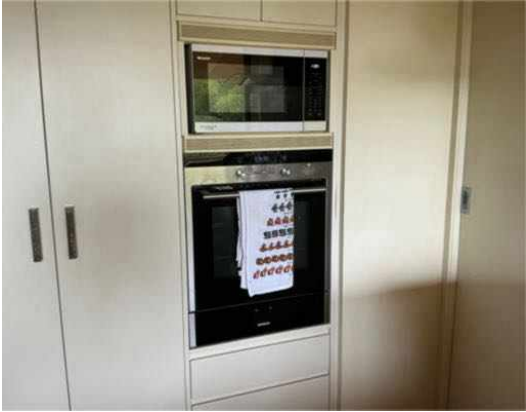
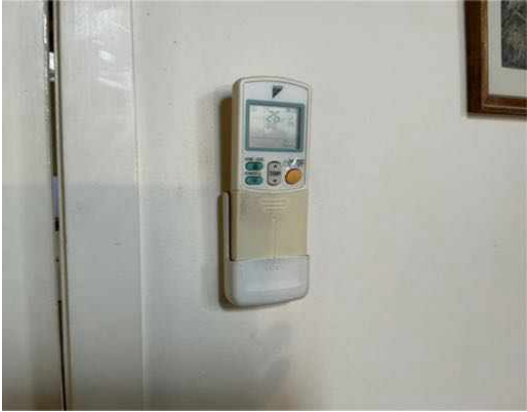
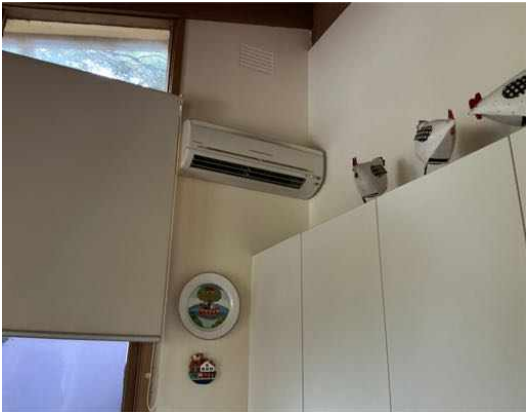
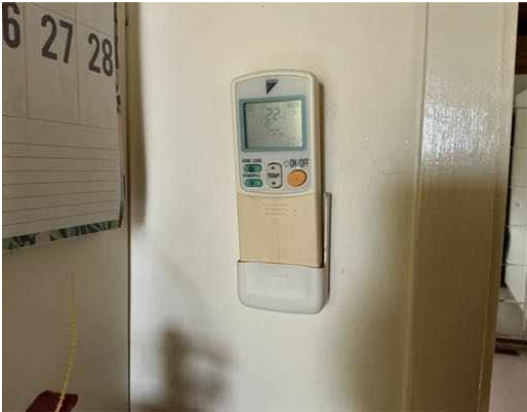
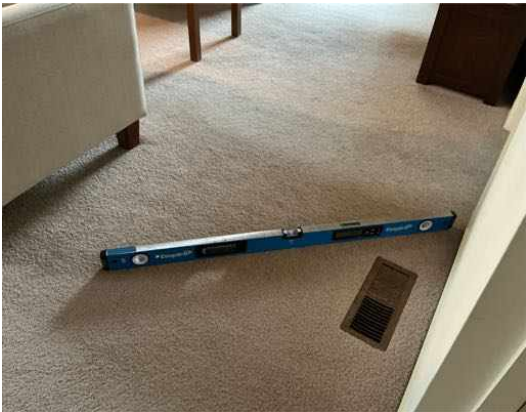
Building:	Main Building
Location:	All Areas
Finding:	Warranty - Expired
Information:	Where appliances are beyond their warranty period, the owner should be prepared to meet the cost of replacement or repair of the item at any time. The operation of the appliance can not be guaranteed and further inspection by an appropriately qualified tradesperson may be required.

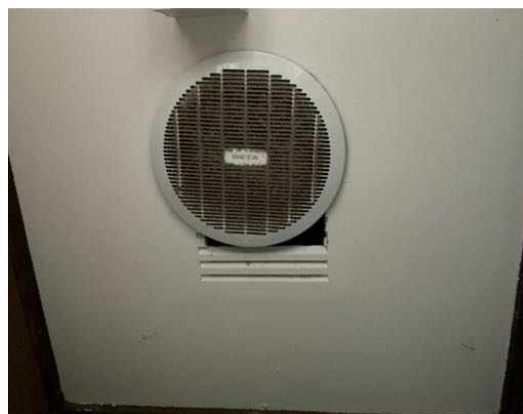
Building: Main Building
 Location: Ensuite - Master
 Finding: Unconventional handyman work
 Information: This handyman work appears to have been completed to a substandard level and does not comply with regular building practices. Where handyman work is not completed satisfactorily, accelerated deterioration of the associated building elements is likely to occur and secondary defects to surrounding structures may develop.

It is highly recommended that the substandard work be rectified by professional services. Works to improve this area are likely to increase the safety and the operation of the associated building elements.

The client should exercise care when coming into the immediate vicinity of the substandard works. Rectification works are advised as soon as possible by the appropriate trades.

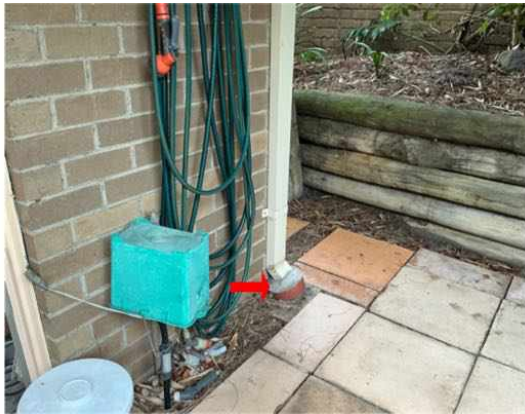
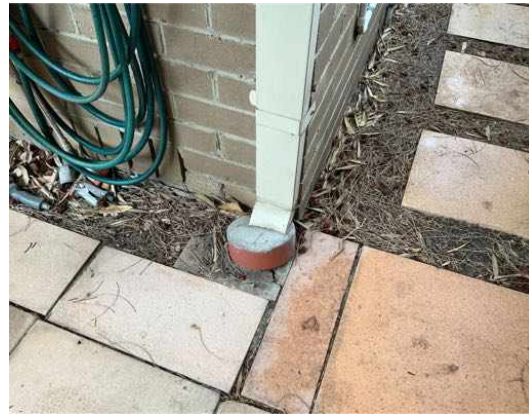
Information: Terracotta drainage pipes (sometimes referred to as clay or vitrified clay pipes) have been used for many many years. The use of clay drainage pipes dates back to the Romans, who used the clay pipe system as it was easy to manufacture, straightforward to lay and, for the most part, reliable. However, due to the rigid and brittle nature of clay or terracotta pipes problems can begin to occur over time. Even if they're functioning fine now, clay pipes will need replacing eventually.

The average lifespan of a clay pipe sewer system is 60 years — which means an upgrade is decades overdue for many homes. For your peace of mind you may wish to have your sewer pipes inspected and replaced before a major problem occurs
