Building Inspection Report

Inspection Date: Wed, 4 Mar 2026

Property Address: 10/3-17 Taylor St, Parkdale VIC 3195,
Australia

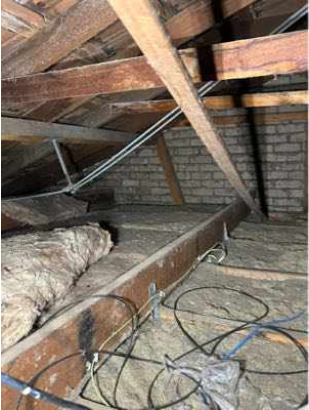
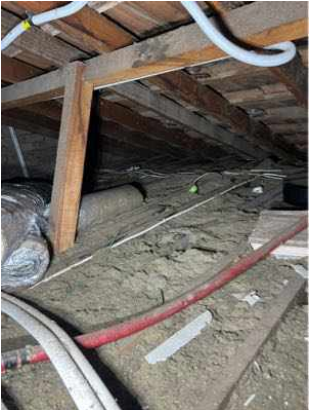
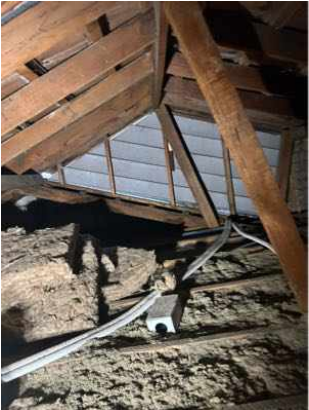
Building:	Main Building
Location:	All Areas
Finding:	Insulation - Reduced in volume
Information:	<p>Insul-fluff is common in many older homes and is a loose form of insulation that is 'blown' into roof voids. While this type of insulation was considered effective at the time of installation, modern materials have surpassed it as the preferred insulator.</p> <p>This type of insulation is susceptible to settling and reducing in volume, detracting from its effectiveness and resulting in an overall loss of energy within the household. Additionally, the reduction in volume has led to an uneven distribution of insulation within the ceiling void, further detracting from its effectiveness.</p>

It is highly advised that this insulation be removed and replaced with a more appropriate material. This will ensure that the property is adequately insulated and will promote an increase in energy efficiency within the property. An insulation contractor should be appointed to provide further advice on replacement options and to perform works as necessary.

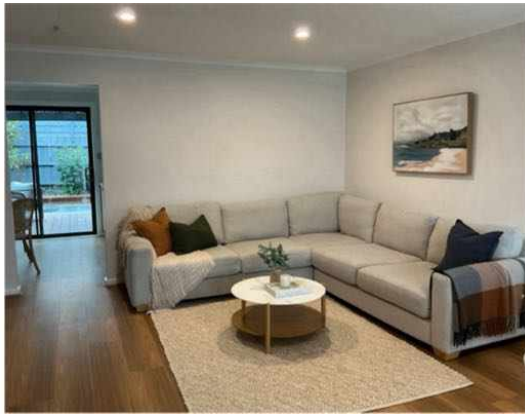
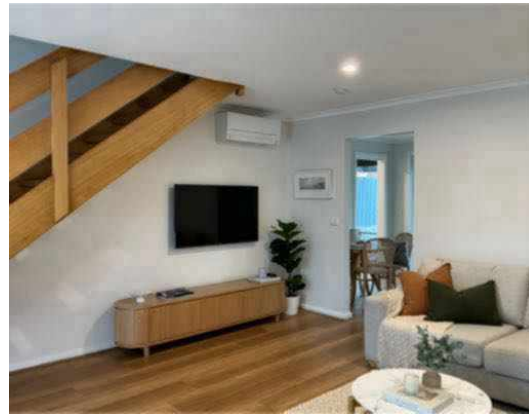
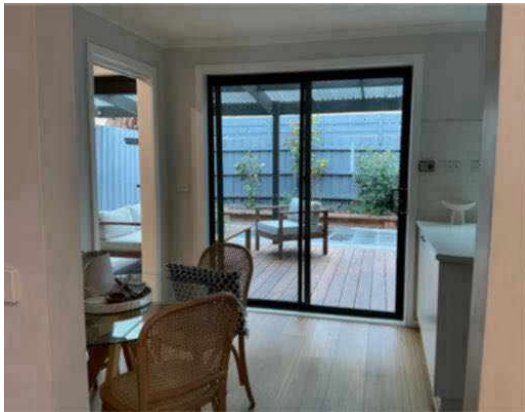
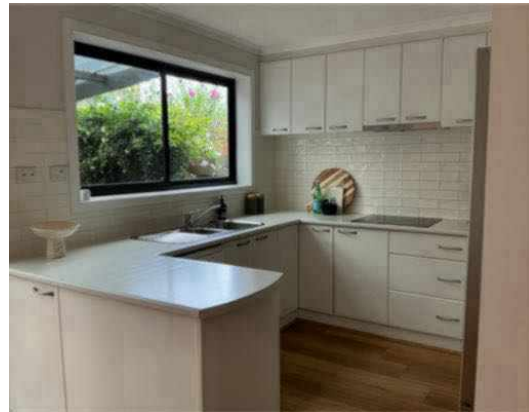
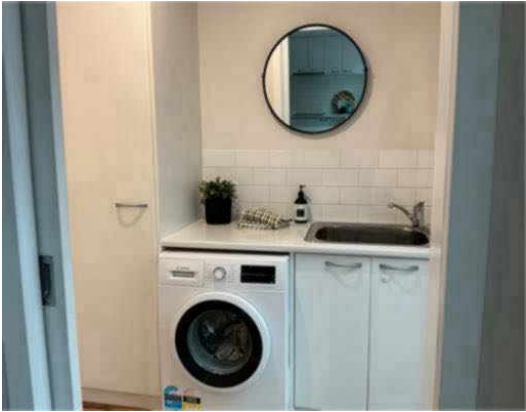
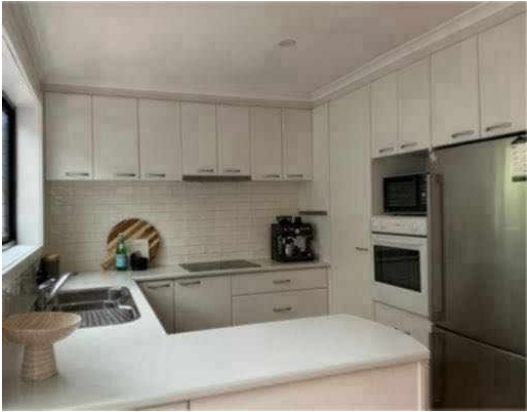
Building: Main Building
Location: All Areas
Finding: Additional Photos and Obstructions and Limitations
Information: These are additional photographs and photographs of the obstructions and limitations inside and outside (furniture, landscaping etc) which may impede full inspection of the property at the time of inspection. These obstructions can hide an array of defects and may be removed to allow full inspection to be carried out. A re-inspection may be made if clients require once the areas are made accessible.

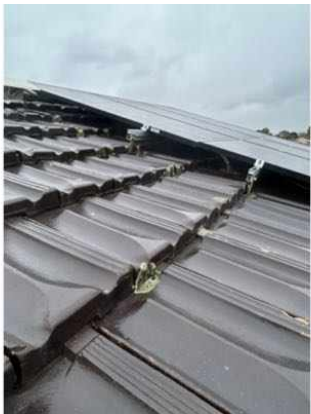
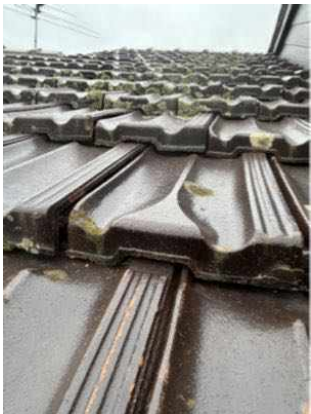
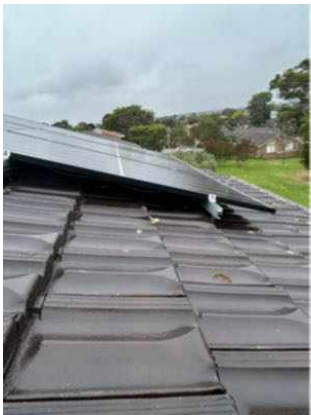
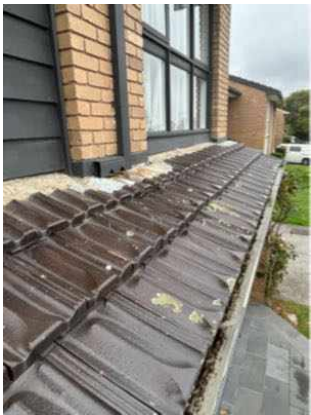
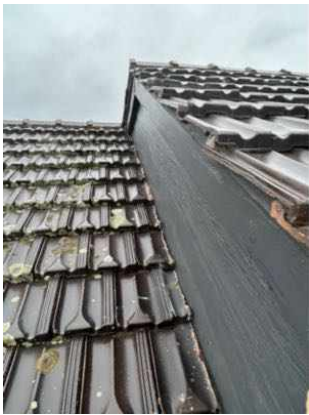
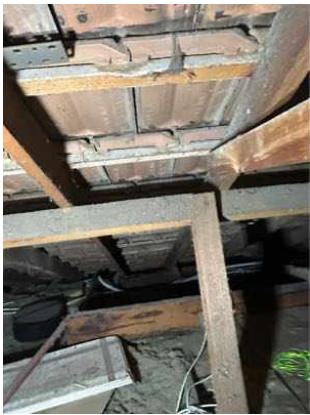
Building: Main Building
Location: All Areas
Finding: Additional Photos - Obstructions and Limitations
Information: These photographs are an indication of the obstructions and limitations which impeded full inspection of the property at the time of inspection. These obstructions can hide an array of defects and should be removed to allow full inspection to be carried out. A re-inspection is recommended once the areas are made accessible.
