# Building and Timber Pest Inspection Report

Inspection Date: Fri, 13 Mar 2026

Property Address: 12 Birkdale Cl, Wantirna VIC 3152, Australia

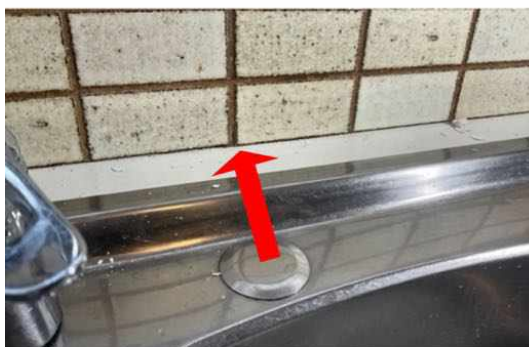
Sealant is missing or degraded in this area. Sealant is used to protect gaps and crevices in building materials to ensure that they are water-tight and prevent water penetration to the associated structures.

Where sealant is missing or degraded , a tiling contractor should be appointed immediately to re-apply any silicone where necessary. Failure to do so may lead to water damage to the surrounding area.

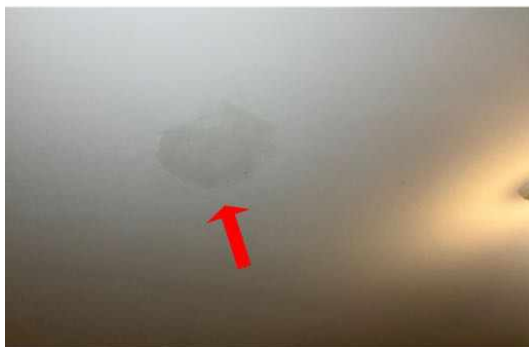
Finding: Ceiling marked - no current moisture noted  
 Information: At the time of inspection, there appeared to be some marks to the ceiling in this area. It is unclear how the marks have occurred. It is suspected that there may have been some patching and repainting carried out to the ceiling.

At the time of the inspection, there was no moisture within the marked area of the ceiling when tested with a moisture meter.

It is recommended that the area be monitored for any changes or increase in marks. Should this occur, consultation with a roofing plumber should be undertaken to determine the source of the leak and make necessary repairs.

Should no changes occur, the area may be repainted at the discretion of the homeowner.

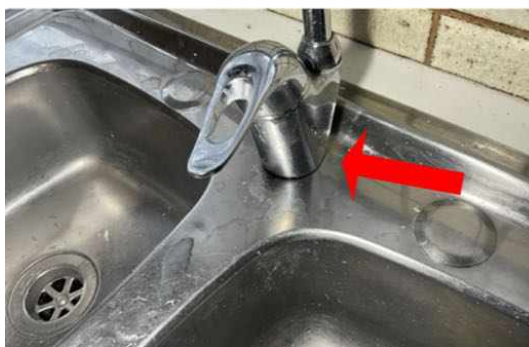
Finding: Tap - Loose

Where taps or spouts are loose, a qualified plumber should be appointed to re-fix the plumbing fitting as a matter of urgency.

Failure to act on this defect may cause the the tap to further deteriorate and cause leaking.

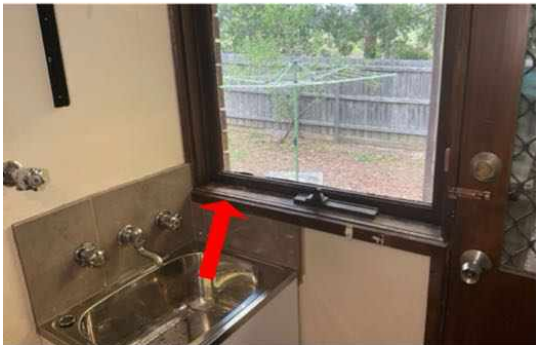
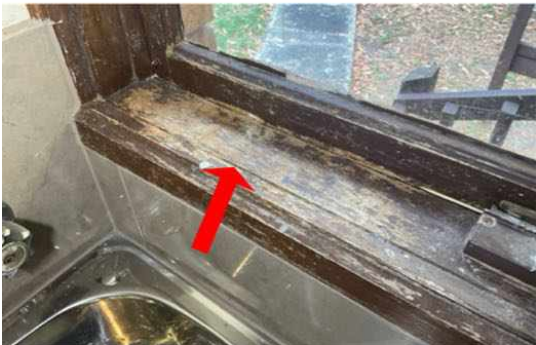
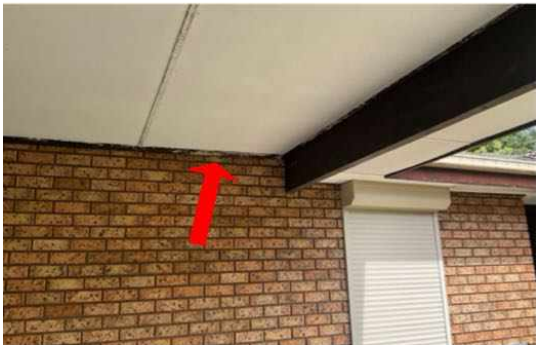
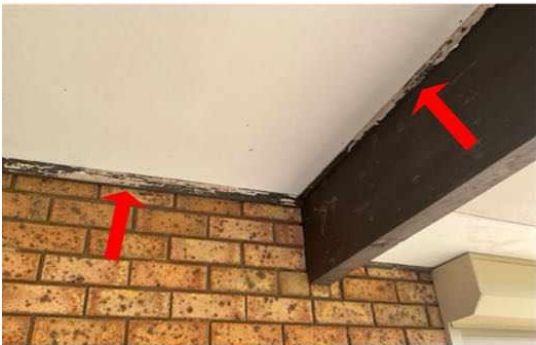
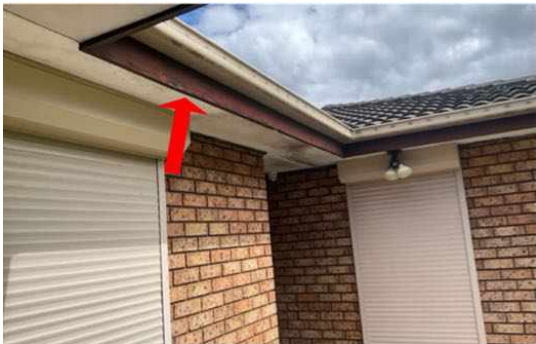
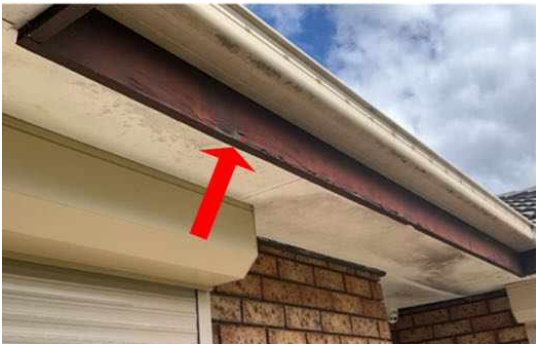
Please note: other timbers around the property may be weathering slightly but not showing here

Adequate treatment of these timbers is required as soon as possible by a painting contractor or general handyman.

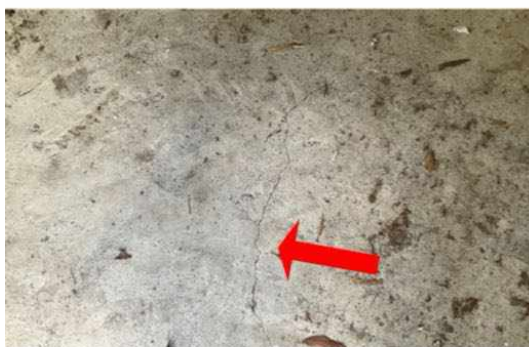
Fine cracks may also be due to poor original installation of the concrete. Factors such as poor compaction of the sub surface and/or inadequate reinforcing of the slab may create cracking and other secondary defects.

Monitoring of all cracking should be conducted frequently. Always contact a building inspector should cracks widen, lengthen, or become more numerous.

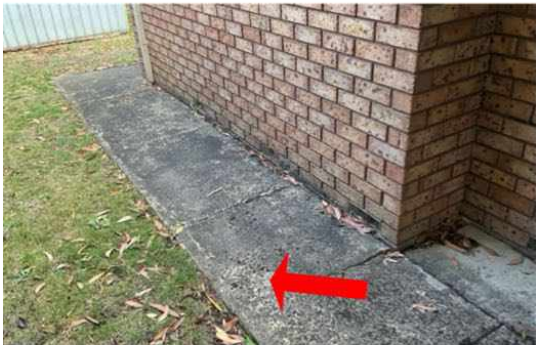
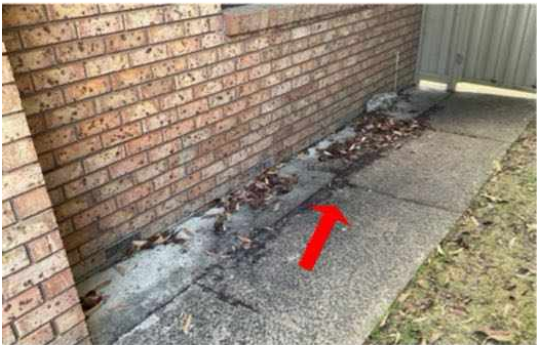
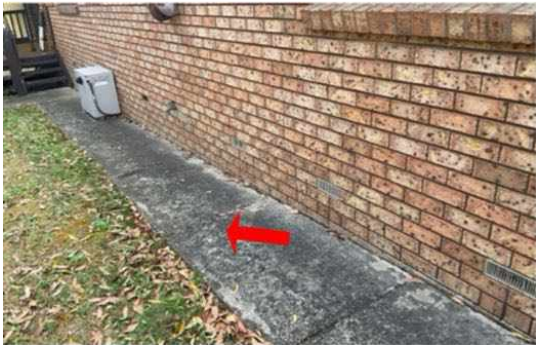
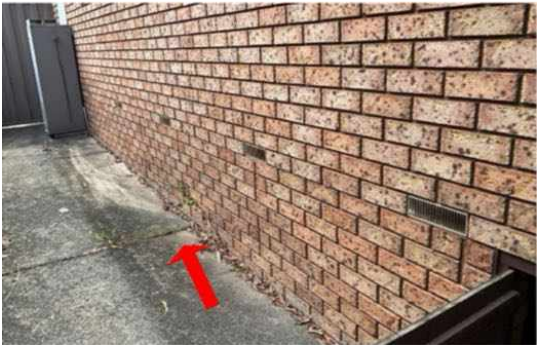
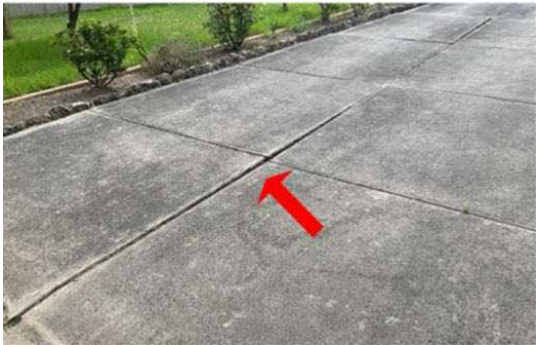
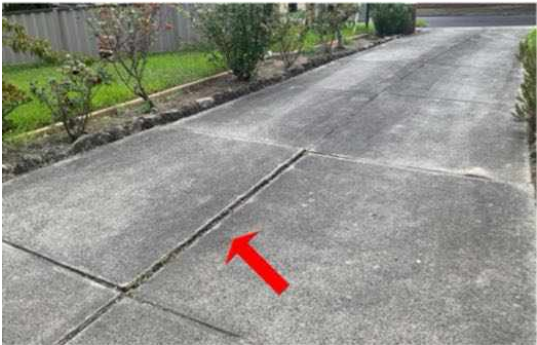
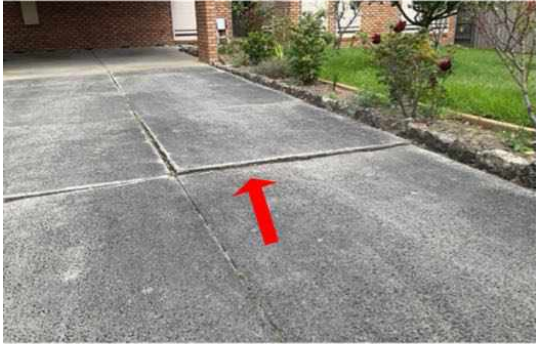
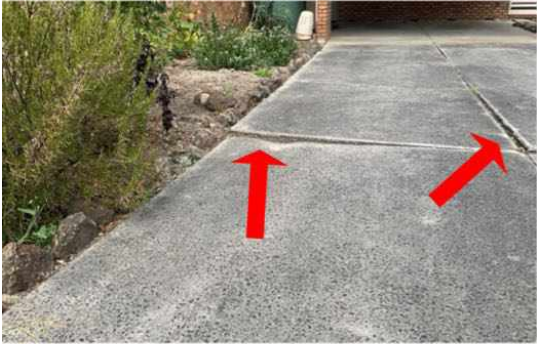
Subsidence is generally found in older paving, and may also present as a trip hazard as consequence of an uneven or curved surface.

General age and expected deterioration of the paved areas is a common cause of this type of defect. However, damage may also have occurred due to environmental factors. Such factors include variable moisture and weather conditions, the presence of trees and their roots having a settling or lifting affect on the soil, or the effect of load bearing over a sustained period of time.

Damage to this degree may also be due to poor original installation of the pavers . Factors such as poor compaction of the sub surface may create cracking, subsidence and other secondary defects.

Repairs and/or replacement will be to be required to prevent further damage and to reduce hazards associated, such as tripping. A landscaper should be engaged to inspect the pavers and repair / rectify the subsided and cracked pavers.

Monitoring of the area should be conducted frequently.

Always contact a building inspector should subsidence increase.

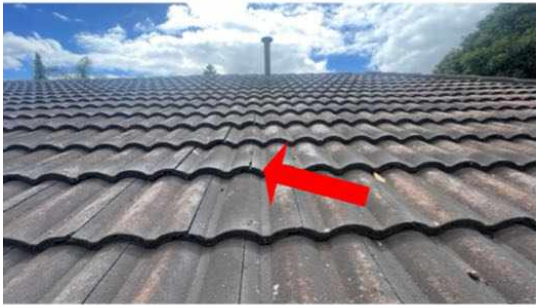
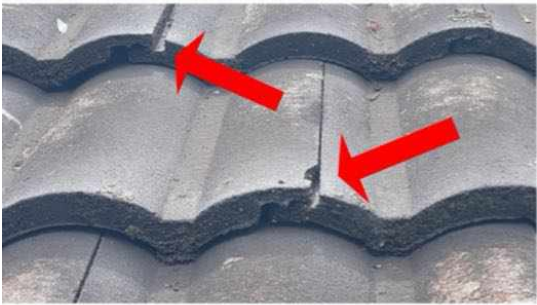
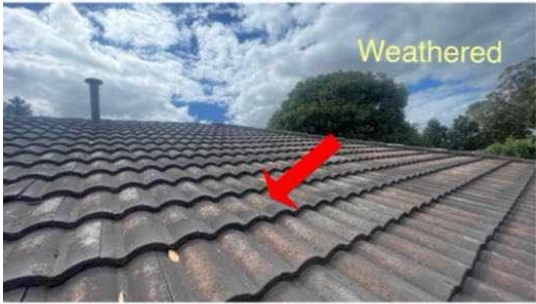
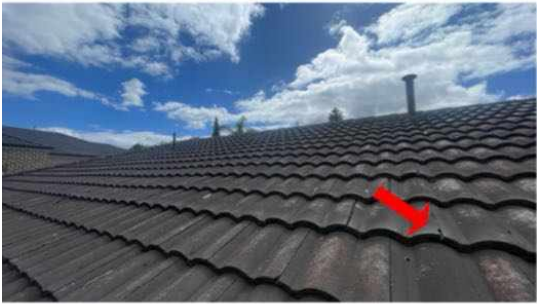
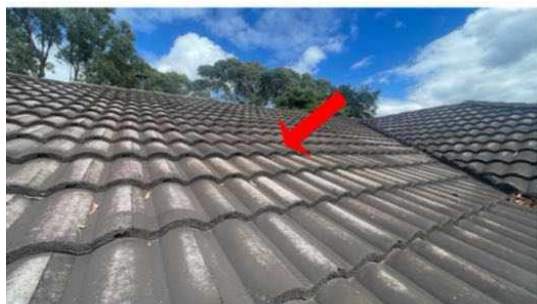
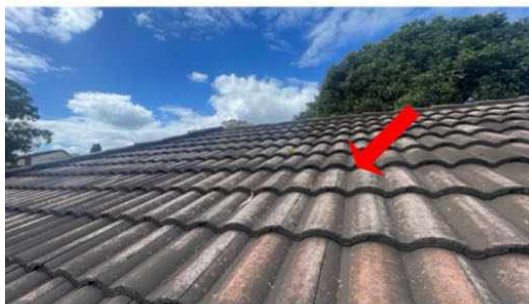
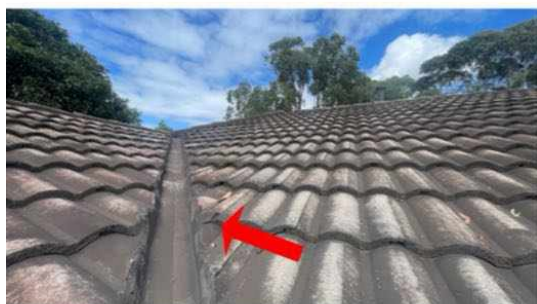
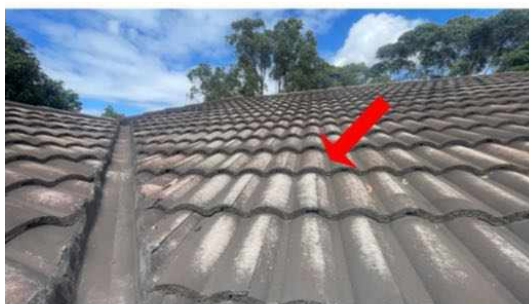
Information: Upon inspection of the exterior roofing, the majority of roof tiles were considered to be in a fair condition. While weathering of the tiles is consistent with the age of the property, maintenance works are required.

Areas of minor chipping of tiles was noted. Some tiles had also moved slightly from their original placements ( this is quite common ) which can result in gaps being evident between tiles that may allow moisture to enter the roof space. Cracking to the mortar around the ridge and hip capping was also observed. Repairs are required.

Consultation with a roofing contractor is highly advised to gain advice on remedial works that will be required . Where left unmanaged, damage can likely to lead to a number of secondary defects, including water leaks and weather exposure to internal roofing structures.

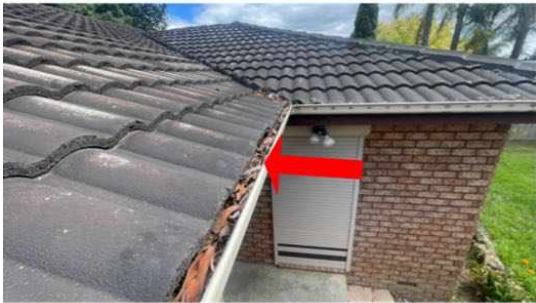
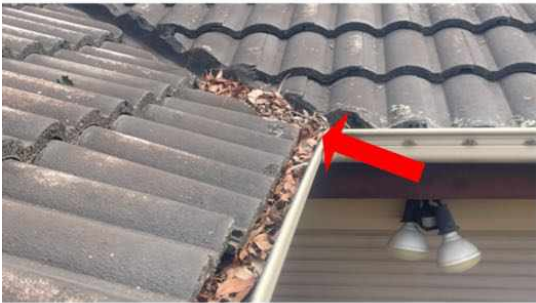
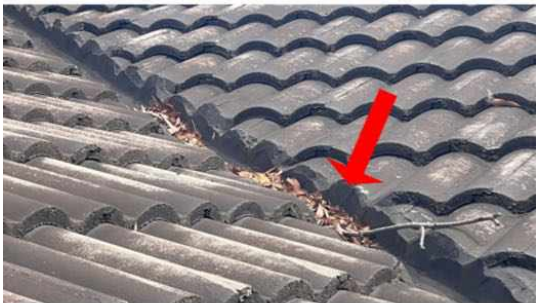
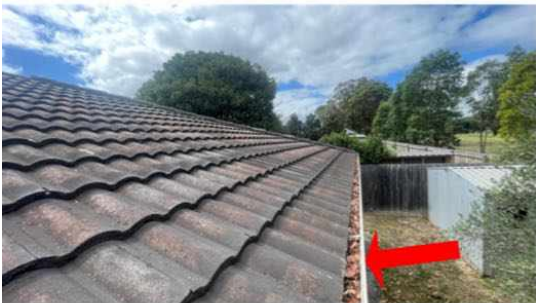
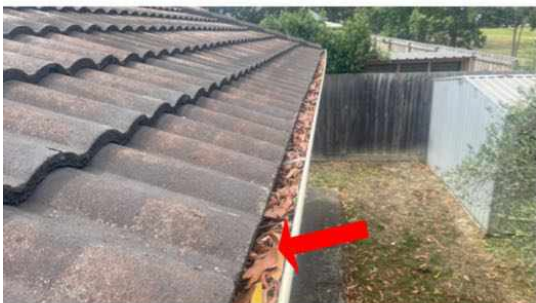
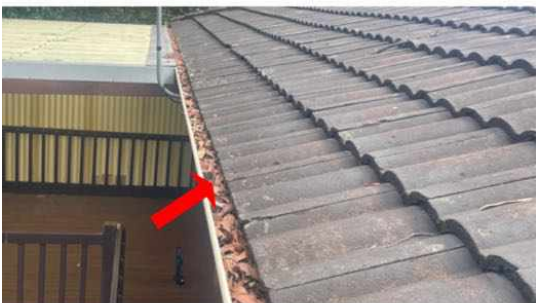
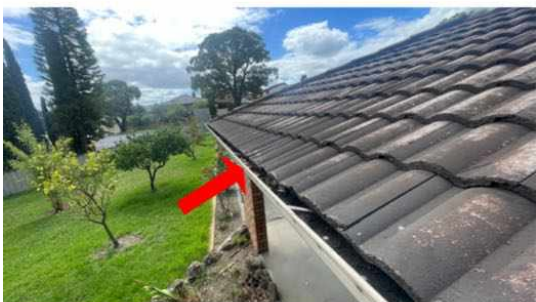
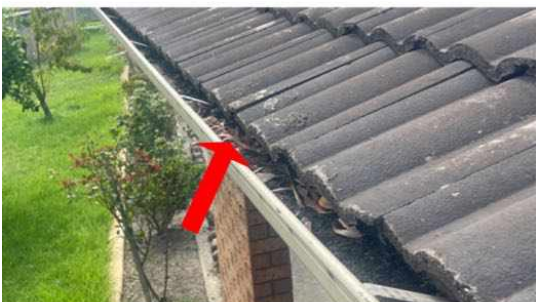
### Finding 3.21

Building:	
Location:	Roof Exterior
Finding:	Gutters - require cleaning
Information:	The gutters to various areas around the property were blocked and require cleaning.

Blocked gutters are likely to lead to high levels of moisture in the affected areas. Such moisture will not only cause rust and decay of the associated building materials, but can also provide conditions that are conducive to termite and timber pest activity. Blockages in gutters should therefore be removed immediately to ensure dry conditions are maintained.

It is highly advised that blocked gutters be cleared by the homeowner or a general handyperson as a matter of urgency. Failure to do so may result in moisture entering the property causing more significant damage.

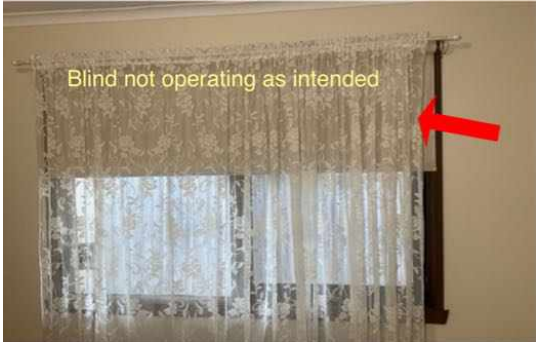
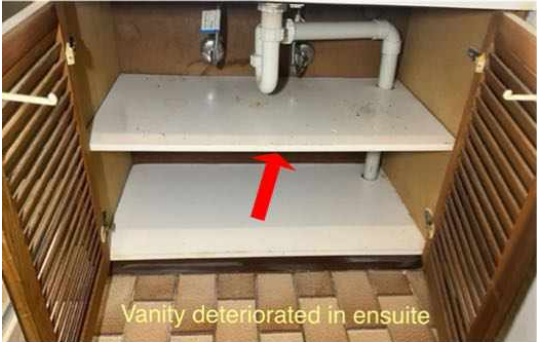
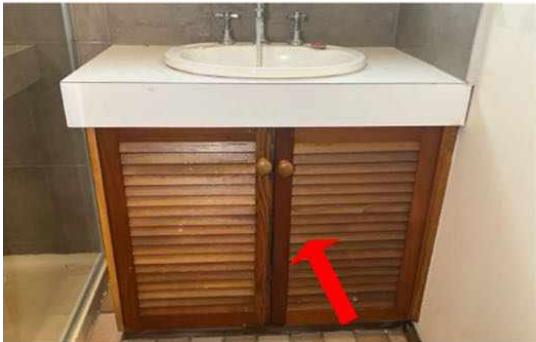
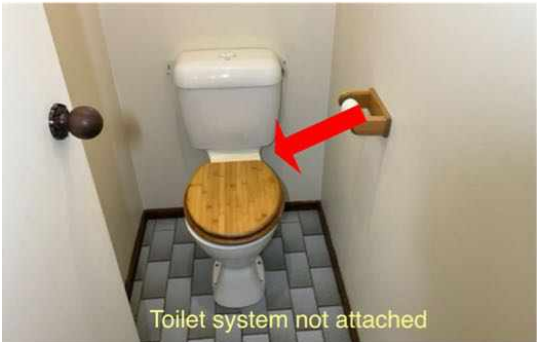
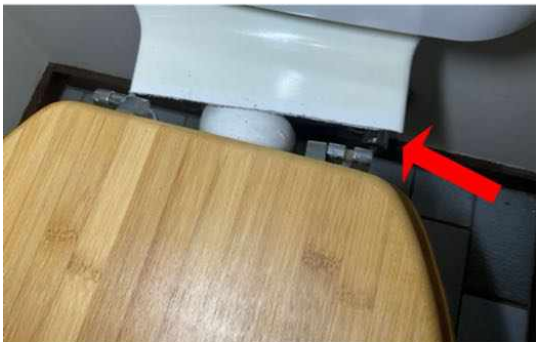
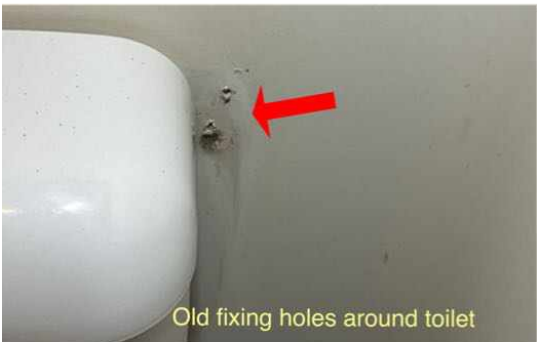
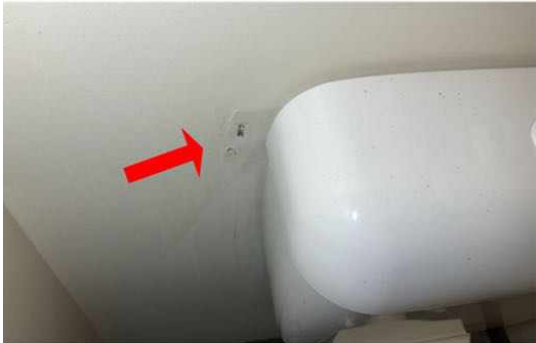
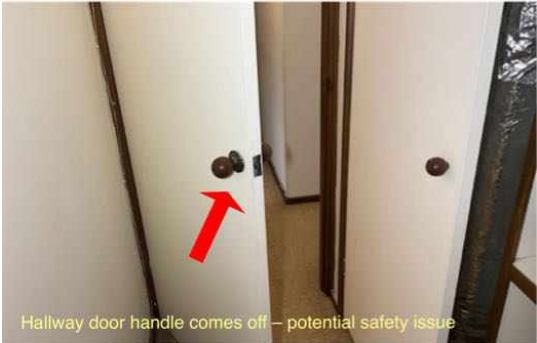
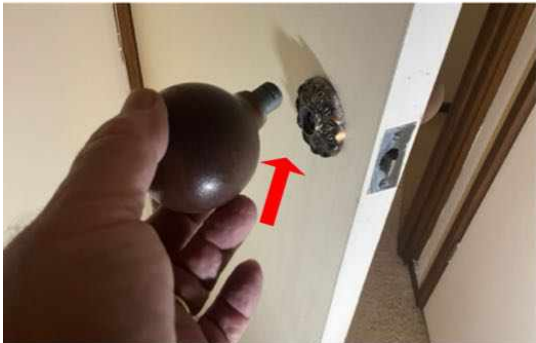
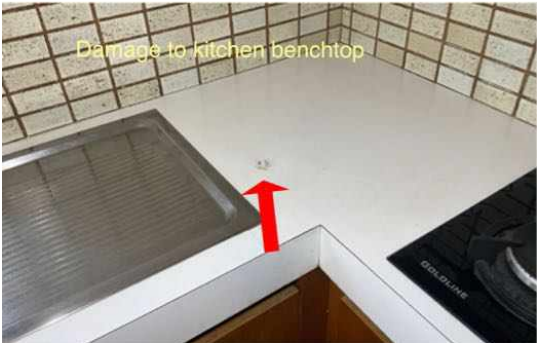
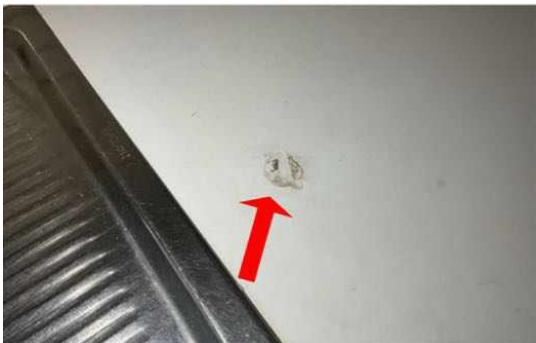
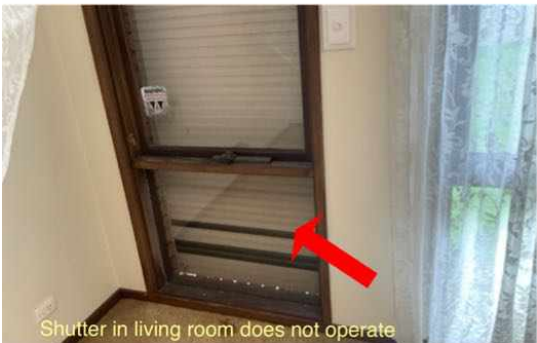
Finding 3.22

Building:  
Location: All Areas  
Finding: Additional Photos - minor defects  
Information: Additional photos are provided for your general reference. Arrows have been included where necessary to highlight areas of importance.

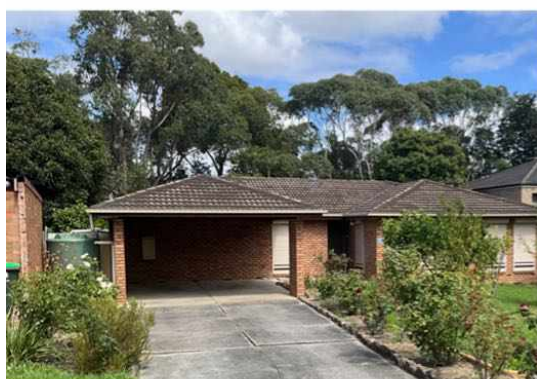
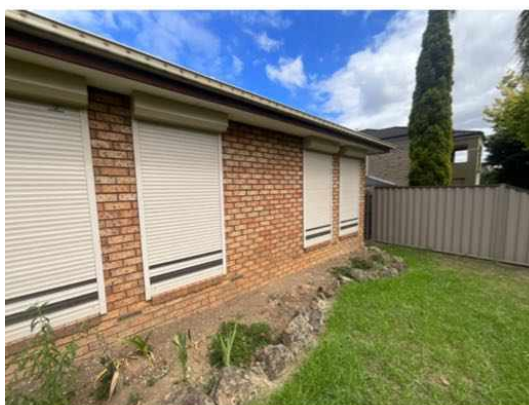
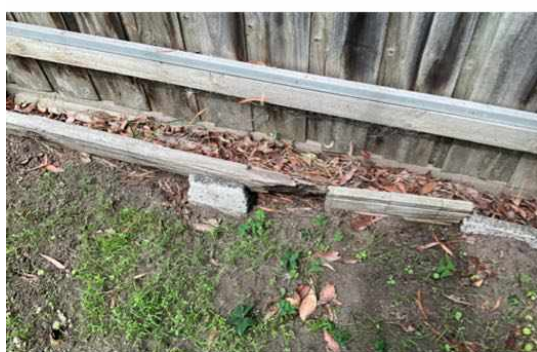
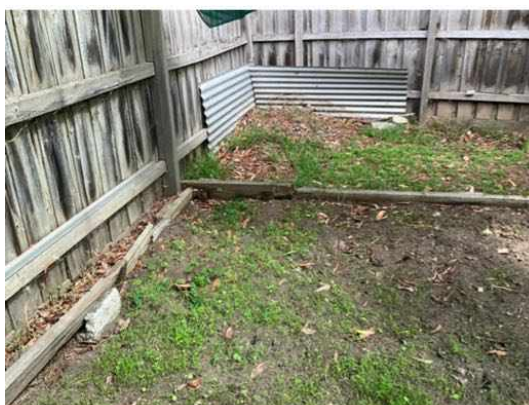
Building:  
 Location: All External Areas  
 Finding: Garden Beds - Conditions Conducive to Termites  
 Information: Garden beds were found to be evident around and against the property. These garden beds can include untreated timber, and with a combination of moisture from rainfall and hosing, can make conditions conducive to termite activity and termite ingress.

The removal and replanting of species that do not provide "cover" or cutting back of existing vegetation will assist greatly in preventing this from occurring.

Where removal of any such materials that may be conducive to termite activity is not possible or practical regular monitoring of the areas should be carried out to minimize the risk of potential termite attack.

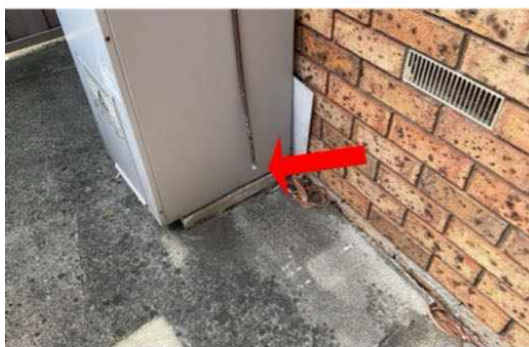
These damp conditions can lead to secondary defects such as rot, rust or corrosion of associated building elements or the formation of fungal decay. When coupled with poor site drainage, pooling of water may also attract termite activity to this area.

It is recommended that a qualified plumber be appointed to install adequate drainage to the overflow or that it be diverted away from the edge of the building. These works will ensure that the area remains dry and free of any secondary defects.

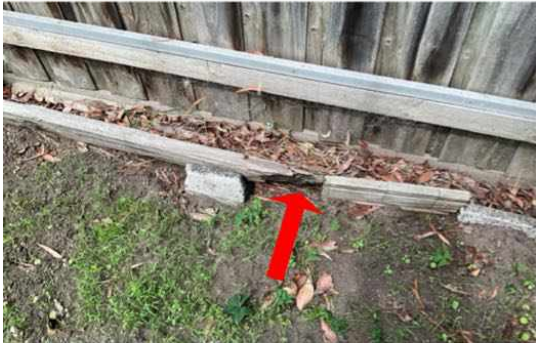
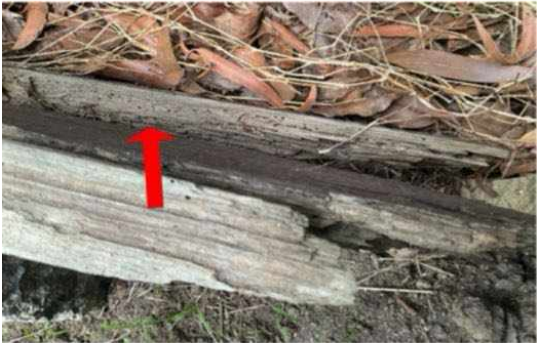
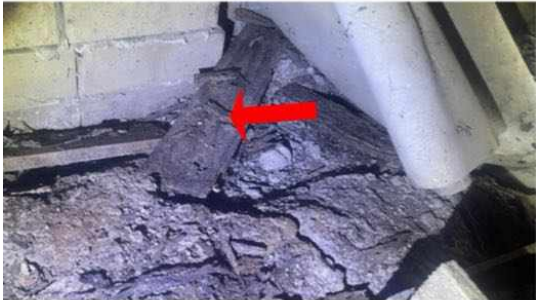
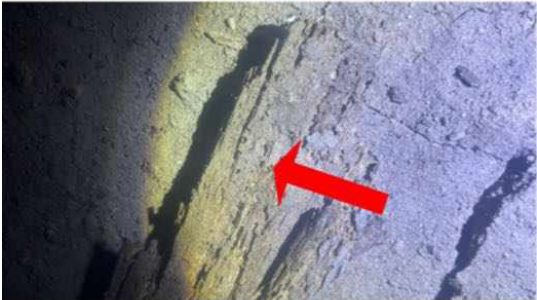
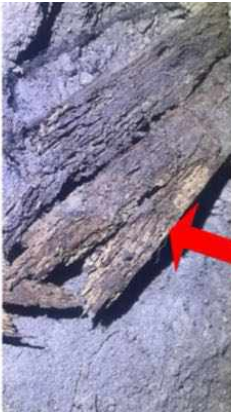
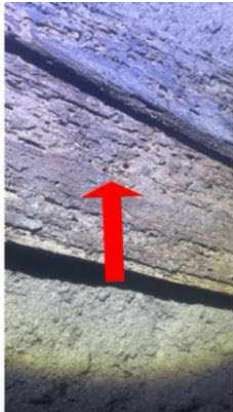
Information: At the time of inspection, some previous wood borer damage was noted to some timbers around the property.

Wood borers are small beetles that colonise in exposed timber elements and are a common timber pest that are regularly mistaken for termites. Although wood borer activity is generally not detrimental to the affected timber they may lead to serious damage and necessitate replacement of certain building elements if in large numbers and left unattended.

Please note, there is a high chance that undetected wood borers may be within some of the subfloor timbers. Borers lay their eggs within the timber prior to the timbers being used, and may lay dormant for many years within the timbers. They can then develop and bore their way out of the timber leaving pin holes and minor damage to the timber. They are not as destructive as termites and generally only cause superficial damage (termites will keep eating the timbers and cause major damage)

As no live wood borer activity was identified treatment is not required at this time. Replacement of affected timbers may be considered by the client for superficial reasons.

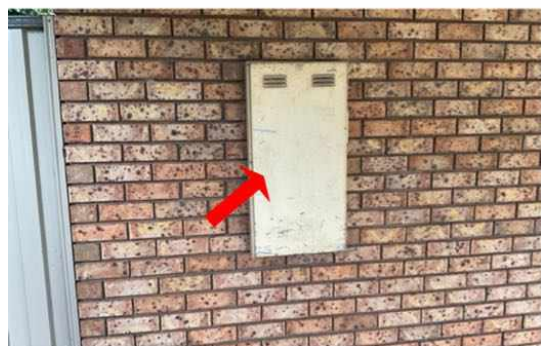
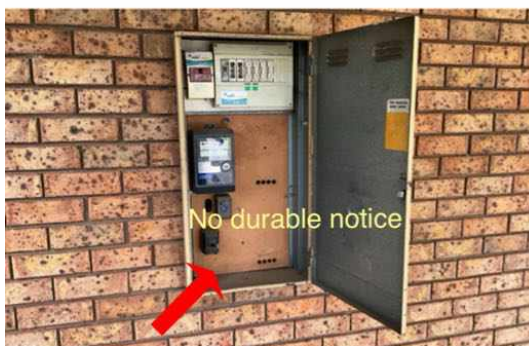
Building:  
 Location: Meter Box  
 Finding: Termite Management System - no evidence of a chemical installation  
 Information: The application of a post-construction chemical termite barrier is highly recommended for all properties, particularly if live termite activity has been found on the site previously. Such barriers are highly effective in preventing termite attack on any timber building elements throughout the property.

The client may consider gaining further advice from a pest controller as to the costs and procedures involved with this application. It is recommended that obtaining such

advice be a short-term priority.

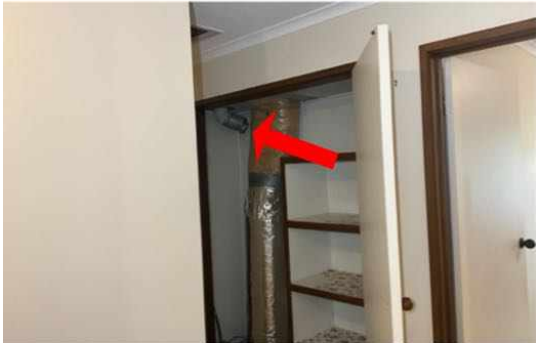
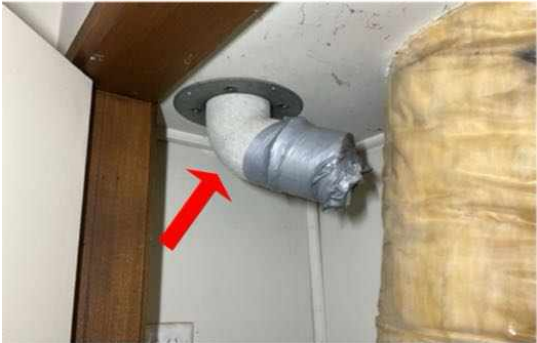
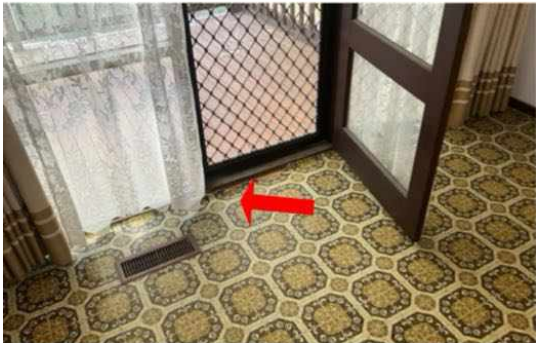
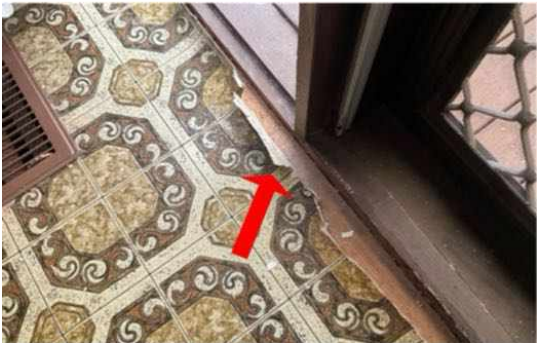
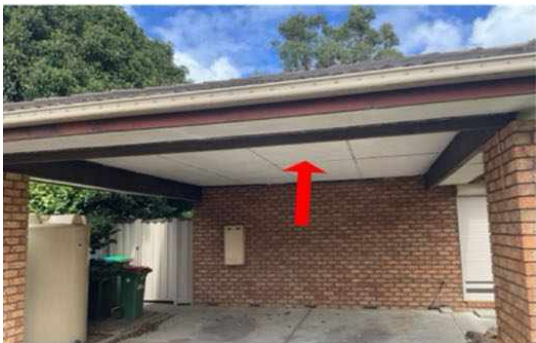
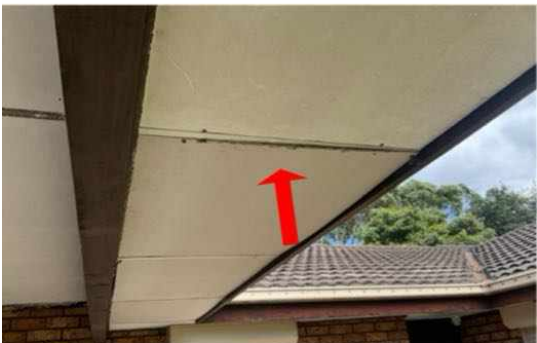
Information: Reporting on Asbestos is outside the Scope of this Report. This suspected defect is highlighted as a caution only. We suspect, based on our experience in the building industry, that there is a higher risk of the property containing asbestos.

Please note: given the age of the property, there may be other areas which may contain asbestos material. Caution should be taken if undertaking any renovations. It is highly recommended an inspection and possible testing be carried out prior to any renovations being carried out, particularly in ( but not limited to) the kitchen, laundry and bathrooms areas. Consultation with your Jims Building consultant should be undertaken regarding this.

As Asbestos Reporting is outside the scope of this report, we advise that you consider a separate Asbestos Inspection and Condition Audit, which can include the taking of samples for definitive confirmation of the presence of Asbestos.

In the interim, the client is advised to act with caution, especially when considering any damage to building materials general wear and tear renovations extensions demolition and general maintenance activities due to the suspected presence of Asbestos.

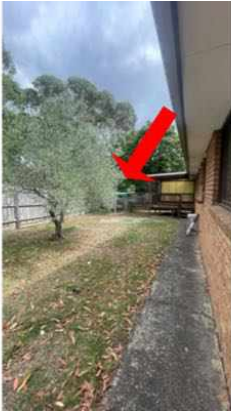
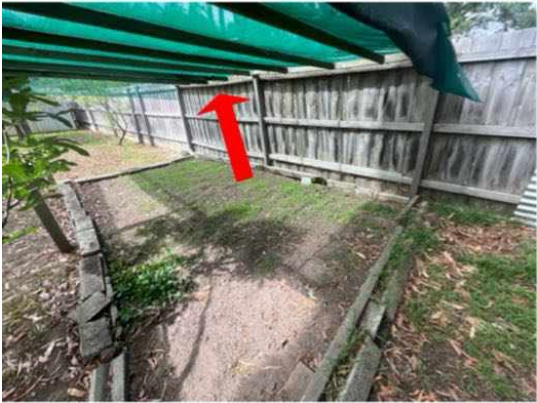
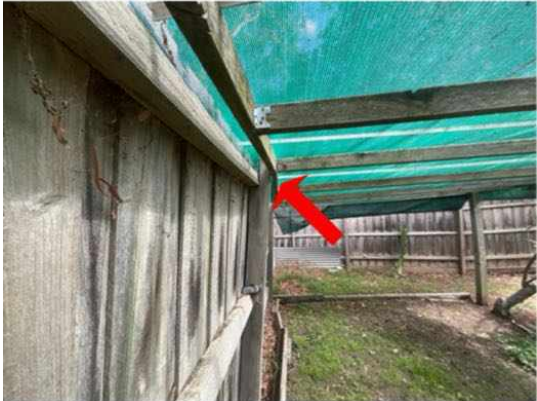
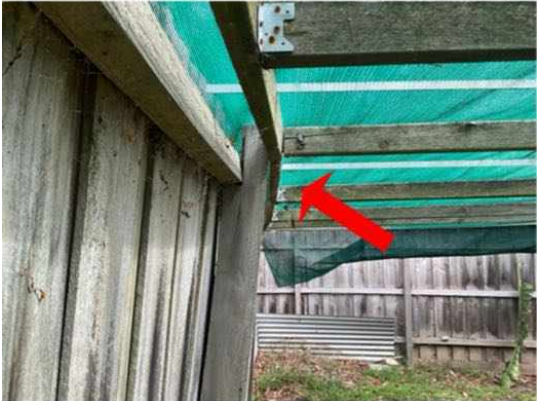
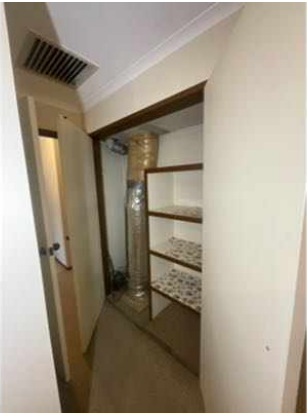
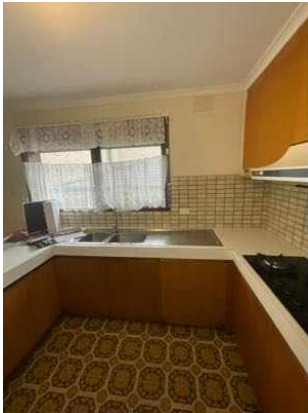
Building:  
Location: All Areas  
Finding: Additional Photos - Obstructions and Limitations  
Information: These photographs are an indication of the obstructions and limitations which impeded full inspection of the property at the time of inspection. These obstructions can hide an array of defects and should be removed to allow full inspection to be carried out. A re-inspection is recommended once the areas are made accessible.
