# Building and Timber Pest Inspection Report

Inspection Date: Wed, 18 Feb 2026

Property Address: 2 Sturt Cl, Grange SA 5022, Australia

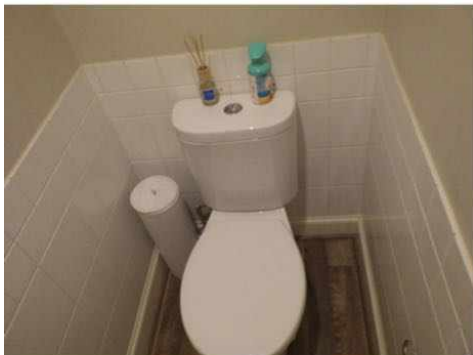
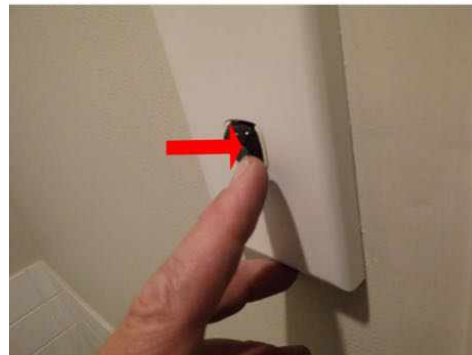
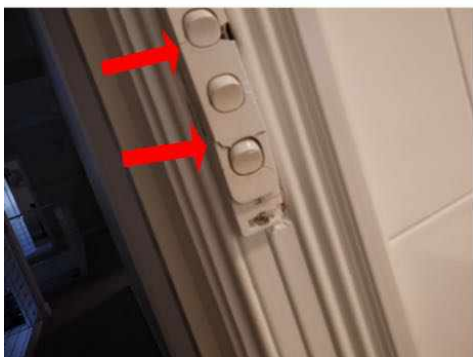
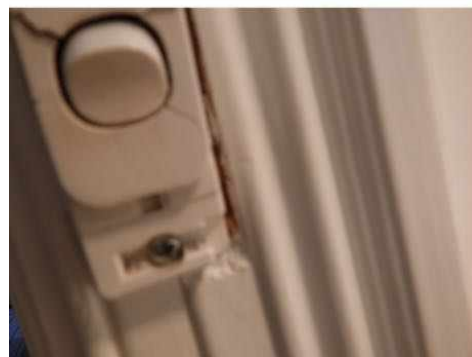
Building:	Building 1
Location:	Main bathroom and lower toilet
Finding:	Light switch - Damaged
Information:	A light switch in the lower vanity was found to be damaged at the time of inspection. Damage occurs generally when the building materials have aged and decayed, but may also be indicative of impact damage to the building element (accidental or deliberate).

Left unmanaged, the fitting is unlikely to cause further damage to surrounding building elements. However, the broken fitting may expose electrical works, and may create a minor safety hazard if there is potential contact with persons in the area.

Repair and/or replacement of the damaged fittings is advised. A Licensed electrician should be appointed immediately to repair/replace the switch mechanism.

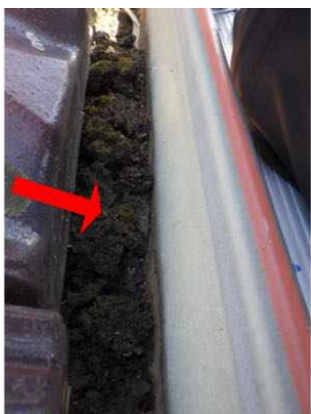
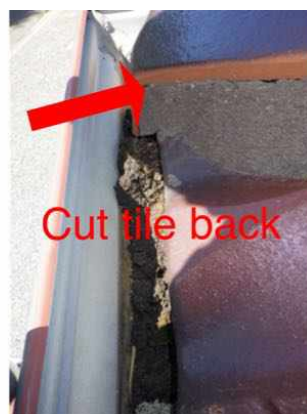
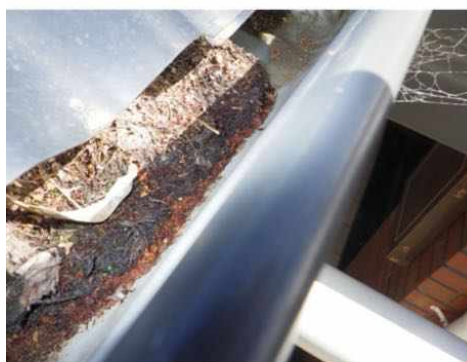
Blocked gutters are likely to lead to high levels of moisture in the affected areas. Such moisture will not only cause rust and decay of the associated building materials, but can also provide conditions that are conducive to termite and timber pest activity. Blockages in gutters should therefore be removed immediately to ensure dry conditions are maintained.

Consult a Licensed Plumber for further specific advice on remedial works that may be required. In the interim, it is highly advised that blocked gutters be removed by the homeowner or a general handyperson as a matter of urgency.

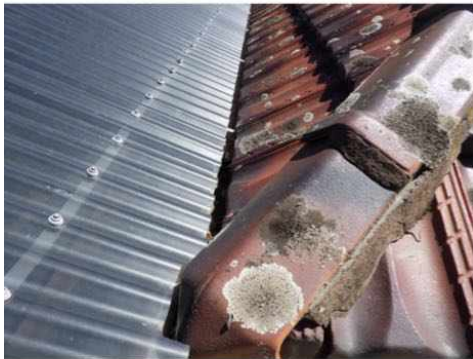
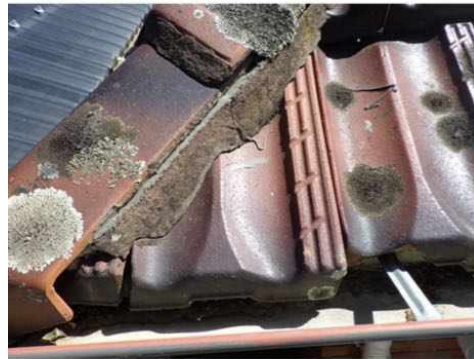
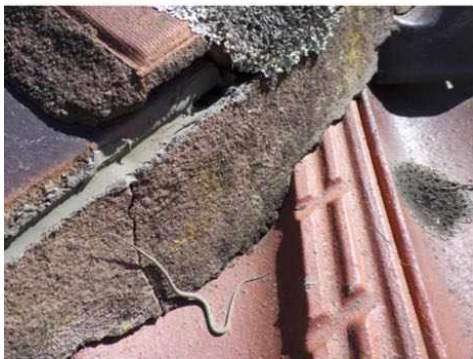
### Finding 3.02

Building:	Building 1
Location:	Roof Exterior
Finding:	Mortar - Deterioration
Information:	Mortar, or 'bedding', is the material which fills joints and intersections between tiles and other building elements on the exterior roof covering, such as gable ends, hip capping and valleys. Upon inspection of the exterior roof, it was noted that sections of the mortar show varying levels of deterioration. Most of the ridge capping appears to be in acceptable condition however two small areas appear to require maintenance.

Mortar generally deteriorates as a result of frequent exposure to weather conditions over a prolonged period of time. Mortar that is deteriorating may allow water ingress into the roof void, putting associated building elements and roofing structures at risk of water damage.

Deteriorated mortar also detracts from the functionality of roof tiles and other roofing elements, potentially decreasing weather tightness and roof drainage.

Mortar deterioration can be attended to by a handyperson where areas of deterioration are localised and easily accessible. Otherwise, consultation with a roofing contractor is advised where greater works are required.

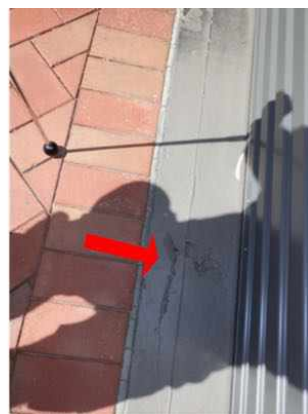
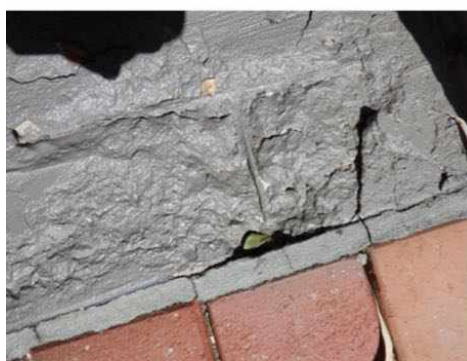
### Finding 3.03

Building:	Building 1
Location:	Garage
Finding:	Concrete damage (cancer)
Information:	There is what appears to be minor concrete damage evident to a small section of floor in the garage of the dwelling as per the following photos.

Concrete cancer is the common term used to describe a number of factors which cause concrete construction to deteriorate.

Generally, water penetration causes the concrete reinforcement to rust and expand, creating stresses on the surrounding concrete and in turn causing it to spall (or break

away). Alternatively, if the cement component is too alkaline, reactions with the general atmosphere occurs and chalking or cracks appear which allow rainwater to penetrate.

Concrete cancer may also originate from poor original water proofing or protection of the slab edge.

Repairs could be carried out by a structural repair company and a licensed Concretor at the discretion of the client.

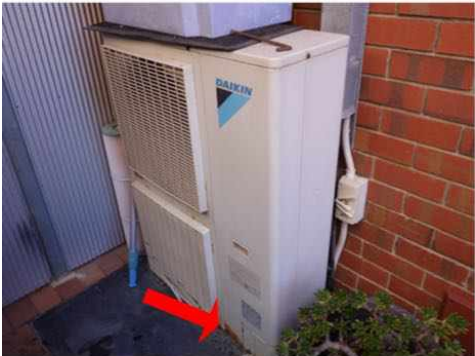
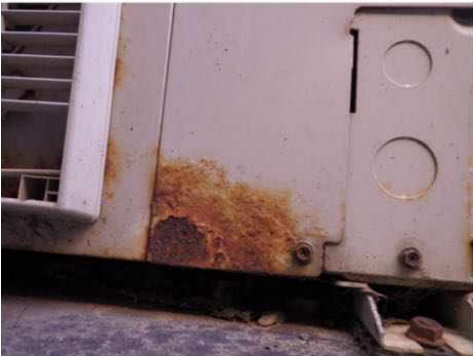
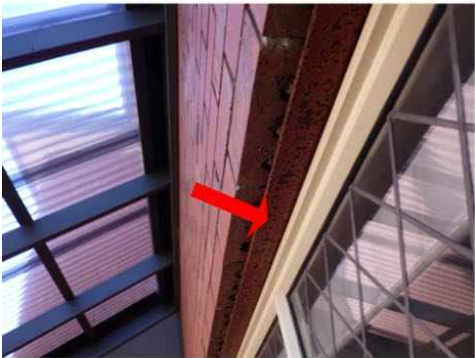
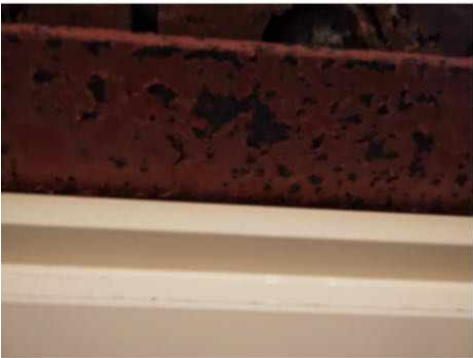
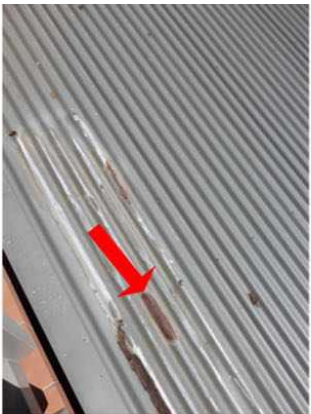
### Finding 3.05

Building:	Building 1
Location:	All Areas
Finding:	Building element - Rusted or corroded
Information:	Minor surface rust and corrosion appears to external elements including but not limited to exterior AC unit steel lentils to brickwork and a roof roofing sheet of the veranda, which is likely to have developed as a result of excessive exposure to moisture and the proximity to the ocean.

As surface rust provides no protection to the underlying iron, the deteriorating condition is likely to worsen if not addressed in the short-term future.

Where possible, the use of galvanized (treated) metals or aluminium coated metals aid in rust prevention, as does regular general maintenance. Rust formation can be controlled with coatings, such as paint, that isolate the iron from the environment.

Rusting and corrosion should be managed by ideally removing or limiting the affected surface from exposure to moisture, then treating the rust to slow the deterioration and could be carried out by appropriate licensed contractors.

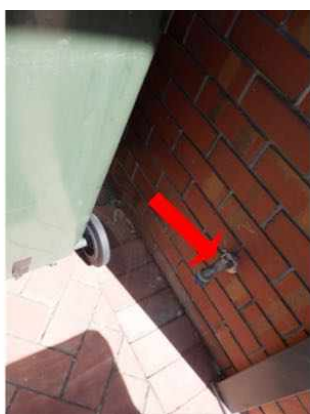
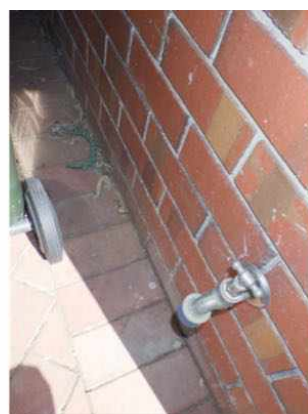
Finding 6.02

Building: Building 1  
 Location: All External Areas  
 Finding: Air conditioner and or external tap - No drainage  
 Information: Moisture around the perimeter of the building should be minimised to ensure that the area is kept dry and stable which in turn reduces the risk of water damage and termite infestation.

There appears to be no drainage points set up to the air conditioning unit, and or the external tap. While this is not a legal requirement it is recommended to reduce the risk of moisture related issues and the creation of an environment conducive to termite activity.

It is recommended that a licensed plumber be appointed to set up drainage in order to prevent such an environment from being created.

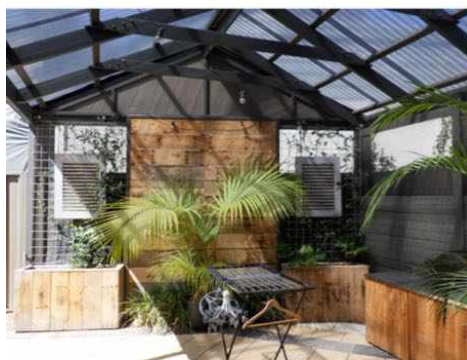
### Finding 6.03

Building: Building 1  
 Location: Yard - Back  
 Finding: Untreated or non-durable timbers in a hazardous environment  
 Information: To reduce the risk of timber pest attack it is essential that timber used in a hazardous environment (e.g. in direct contact with the ground or frequently exposed to damp conditions) is of sufficient durability and/or is adequately preservative treated.

Untreated timbers in direct contact with the ground are likely to develop severe wood rot and/or fungal decay if left unattended creating attraction for subterranean termites to infest the timbers from surrounding areas.

If untreated or non-durable timbers are found to be in a hazardous environment it is highly advised that replacement of these building elements be performed as soon as possible to aid the protection of the property against termite / timber pest attack.

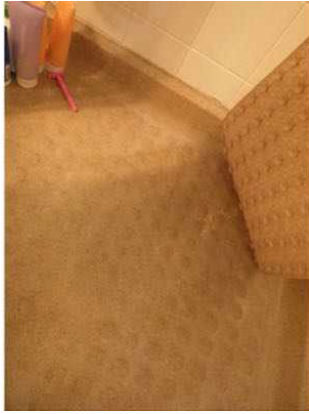
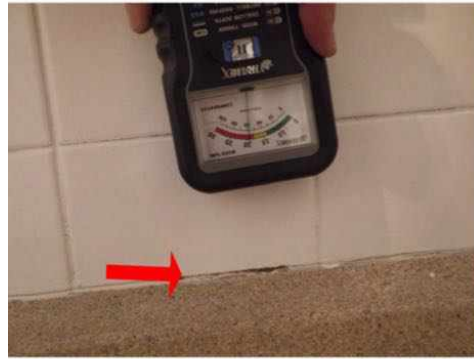
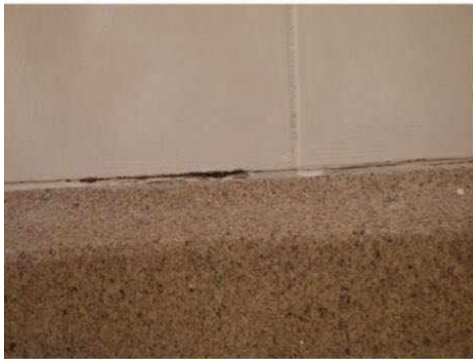
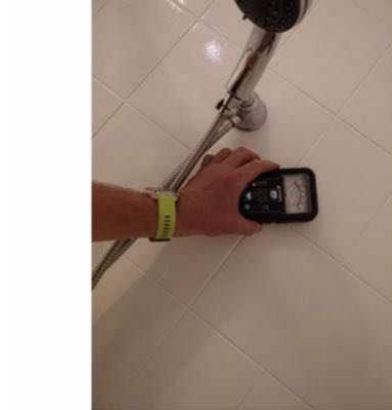
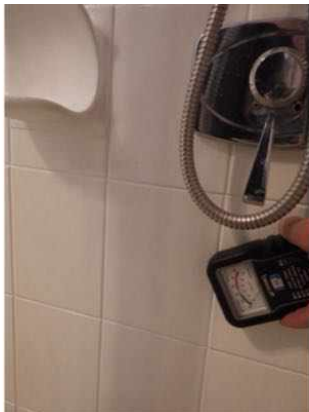
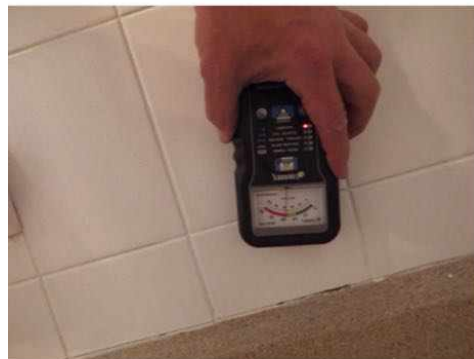
#### Finding 6.04

Building:	Building 1
Location:	Bathroom
Finding:	Sealant - maintenance required
Information:	It was noted on inspection that sealant is showing signs of deterioration to the main bathroom. There were no abnormally high readings for moisture in the area.

Secondary defects can occur if maintenance is not carried out ranging from moisture in walls to deterioration of adjacent building elements

Flexible and materials should be applied to affected areas to prevent any subsequent water damage that can occur. Regular maintenance and replacement of damaged/ deteriorated sealant and grout is highly recommended as this is a regular wear and tear defect.

Repairs are required and should be carried out by a licensed bathroom sealant specialist immediately.

Silicone and grout generally need repair at least every 5 years and as such close monitoring should be carried out in the future after repairs are carried out.

Repair sealant and grout to main bathroom

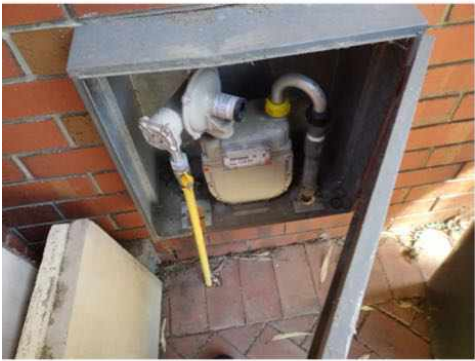
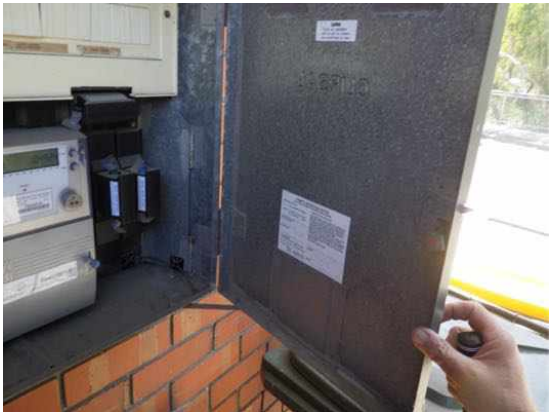
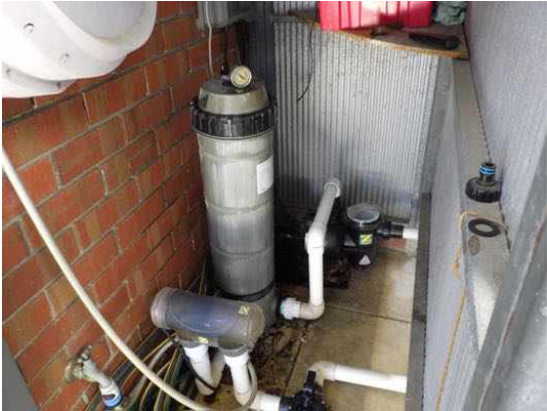
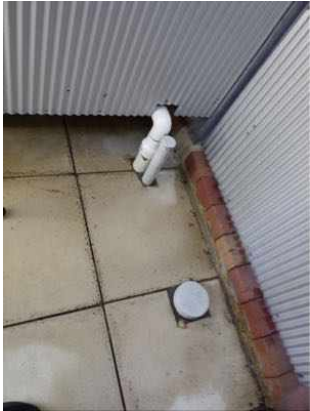
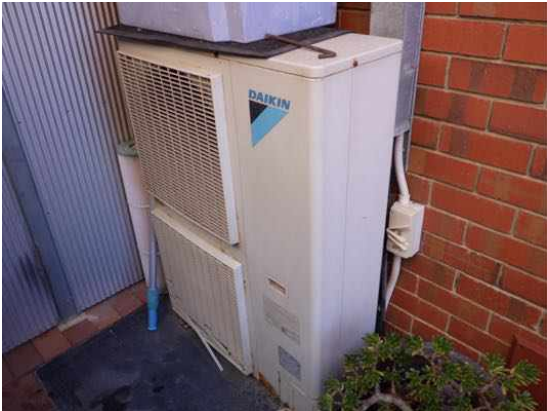
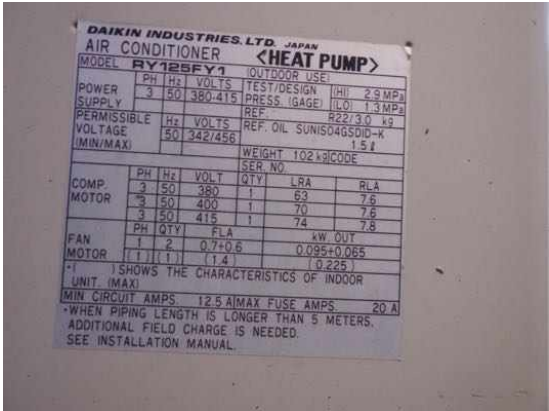
#### Noted Item

Building: Building 1  
 Location: All Areas  
 Finding: Additional Photos  
 Information: Additional photos are provided for your general reference.

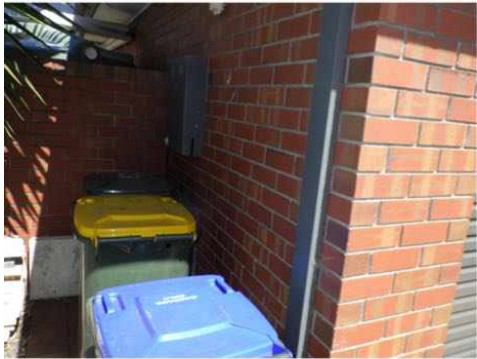
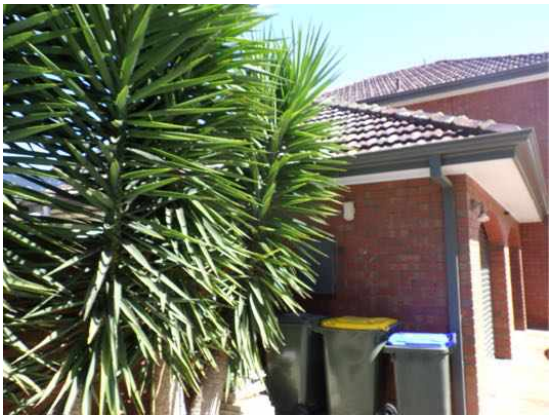
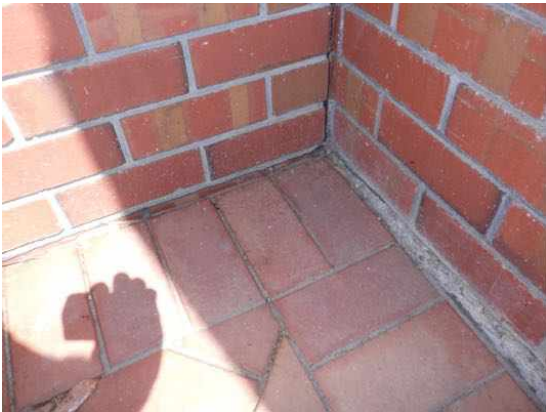
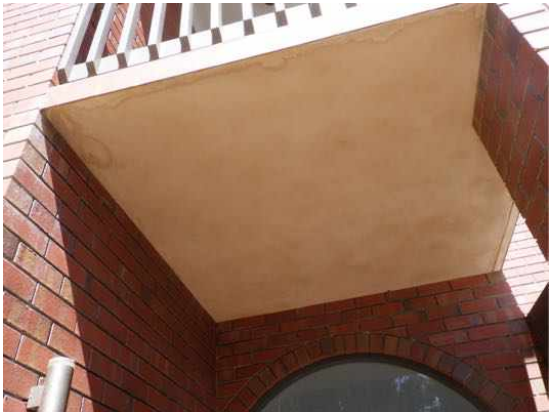
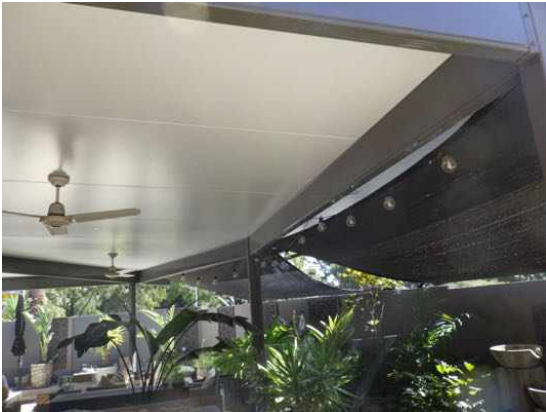
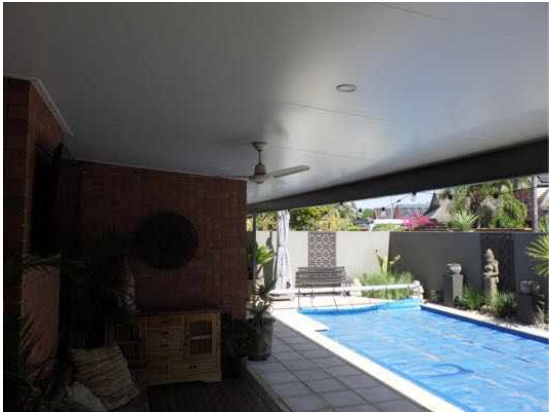
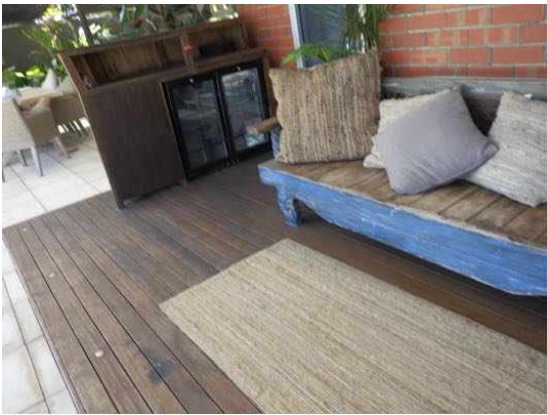
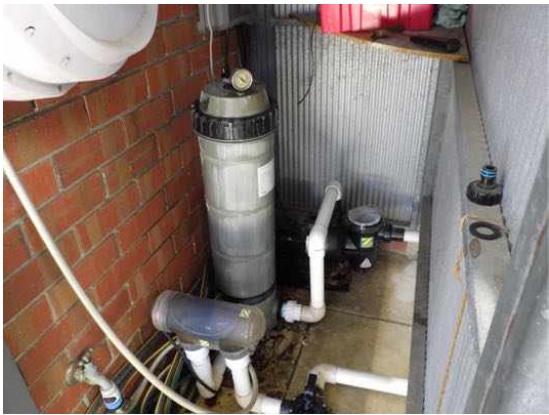
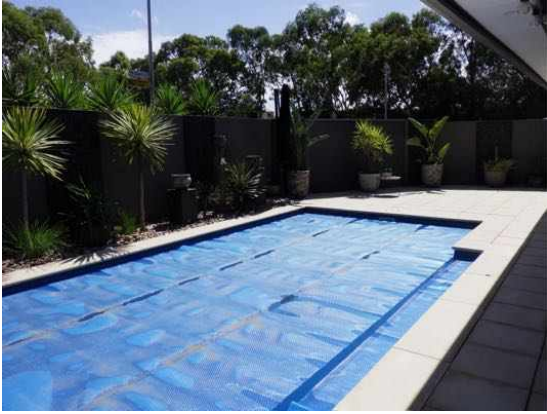
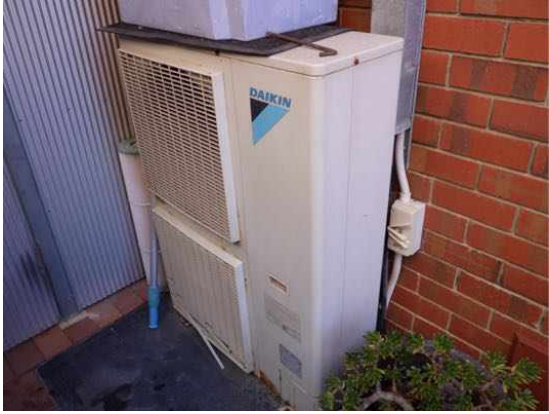
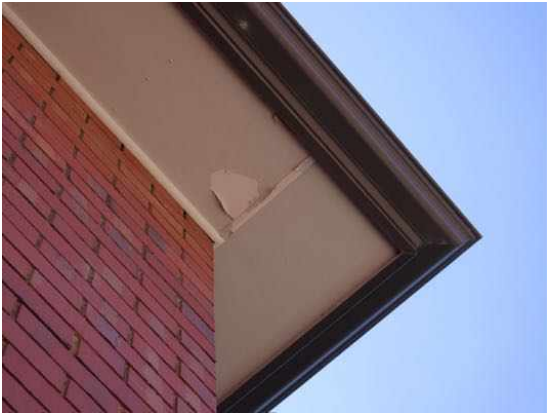
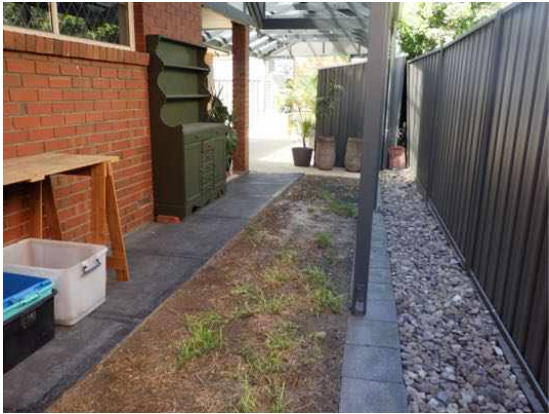
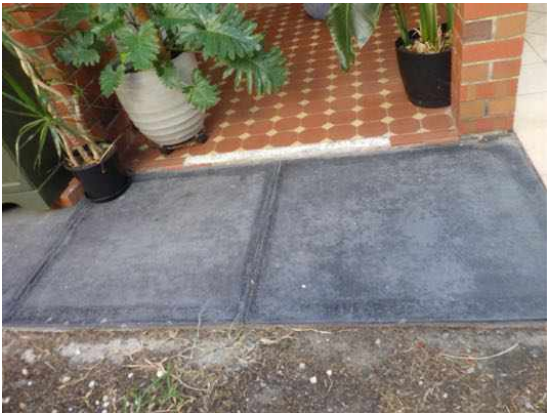
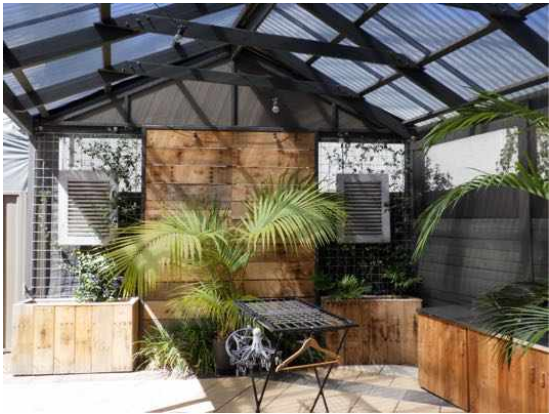
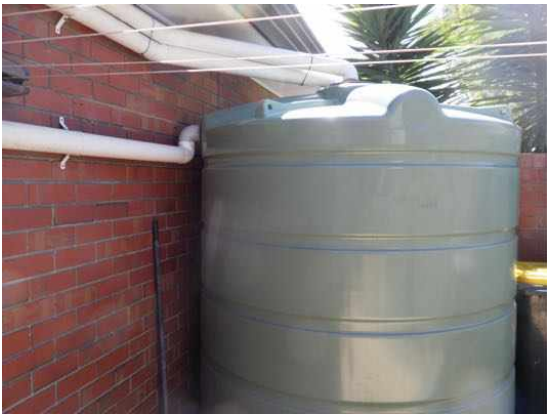
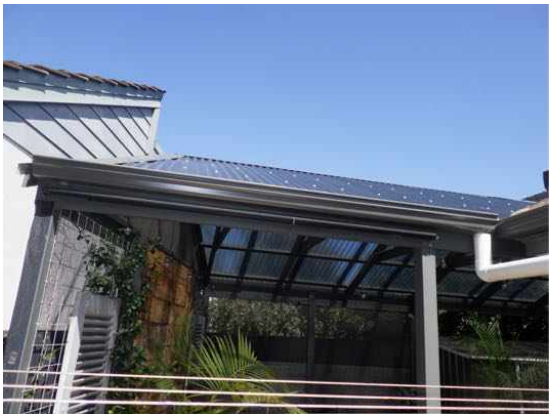
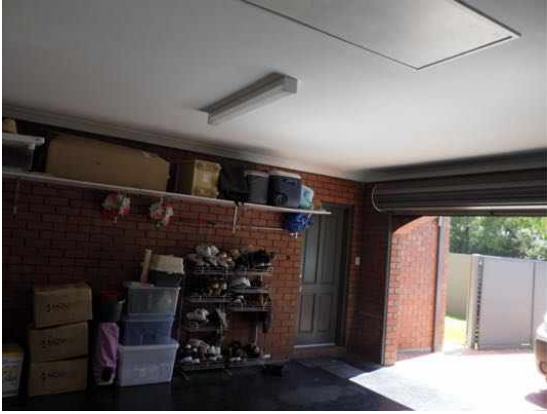
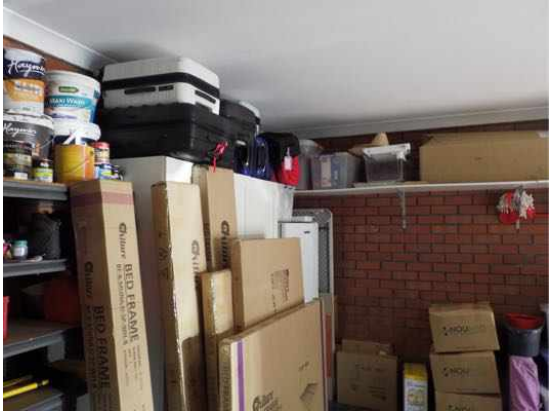
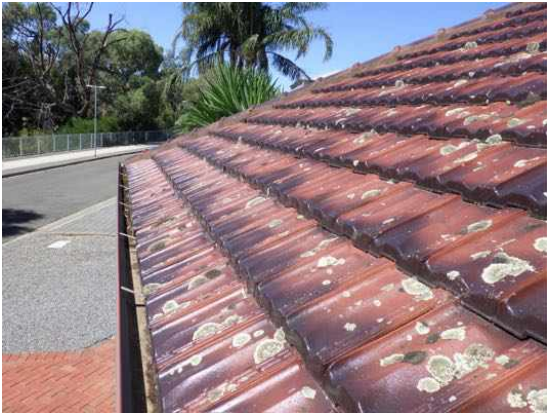
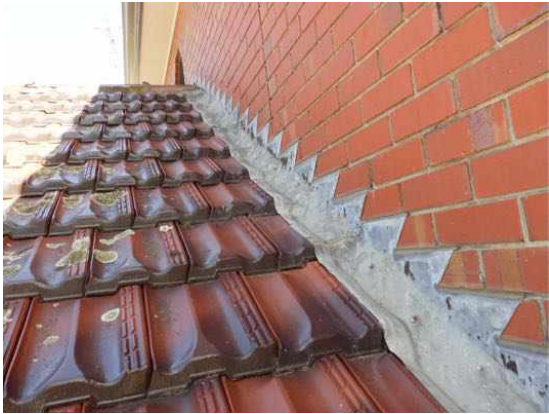
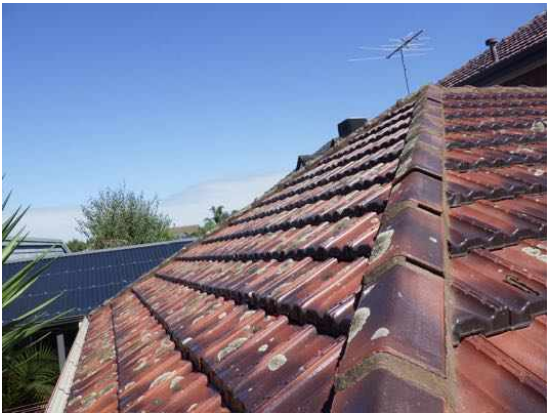
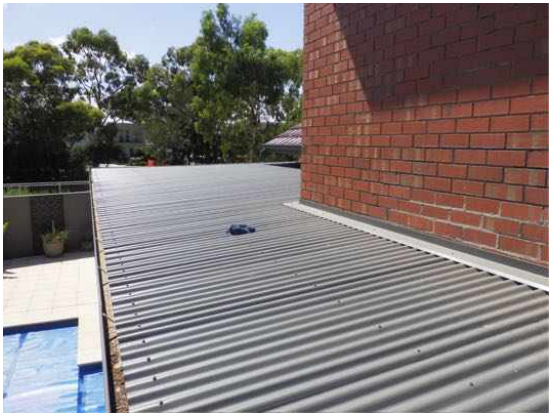
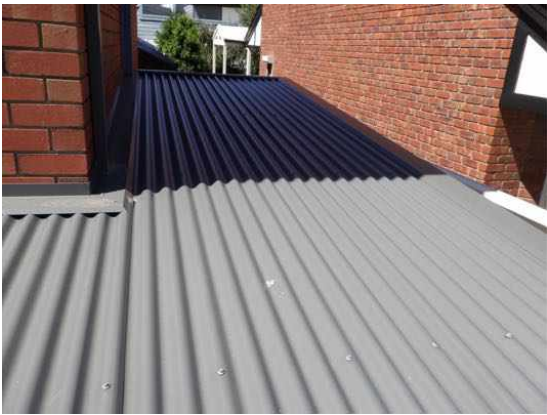
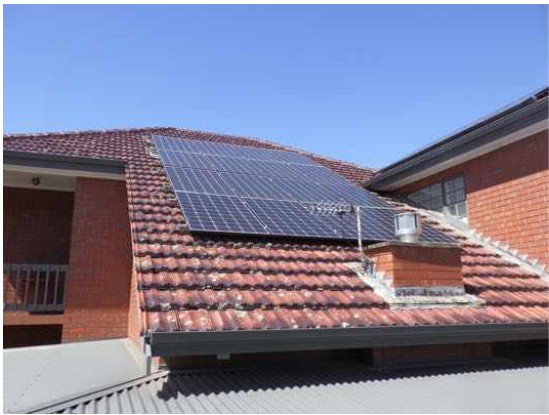
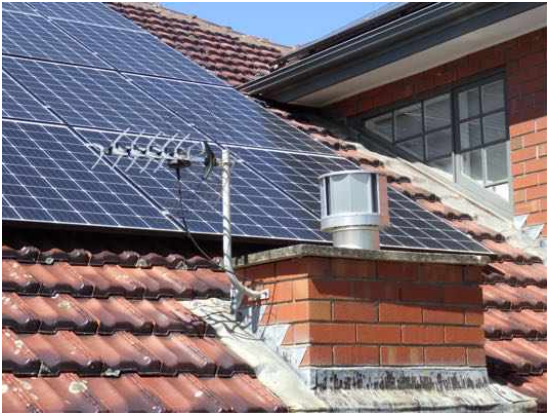
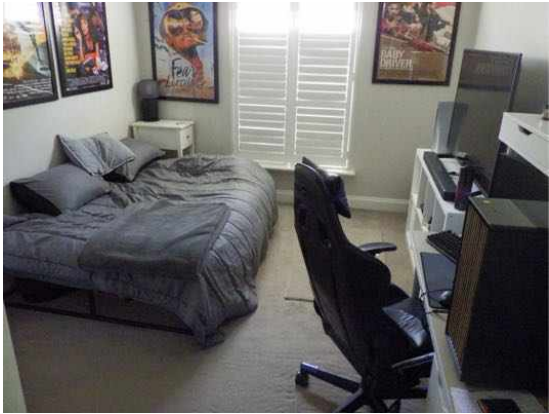
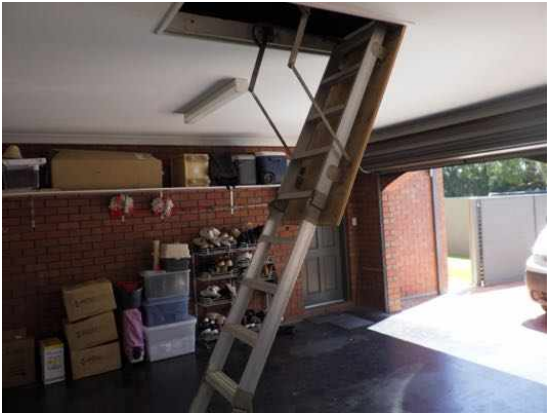
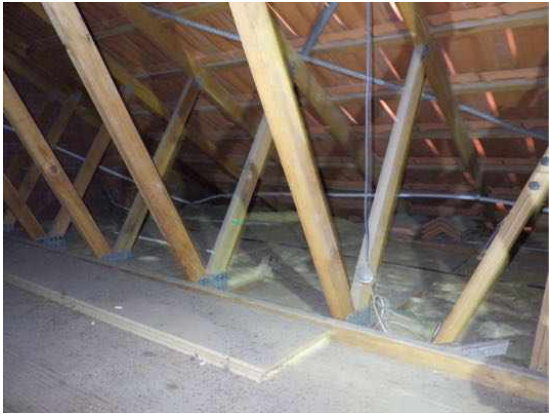
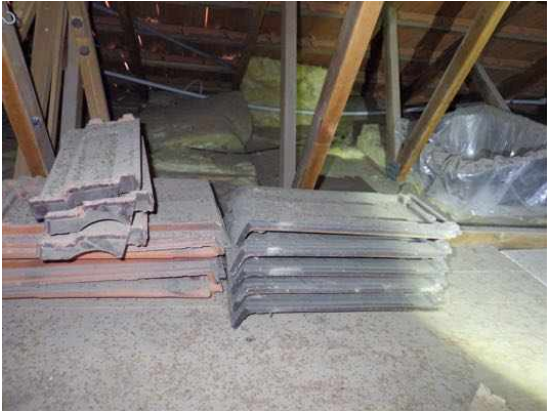
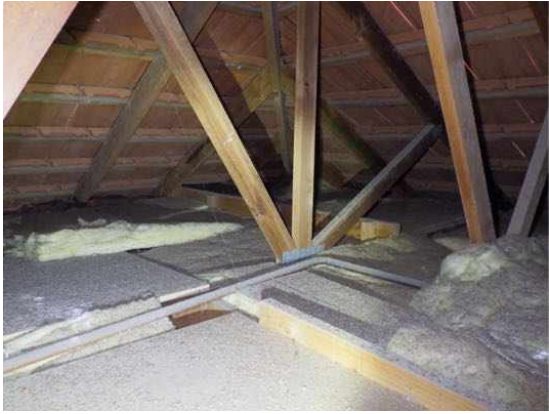
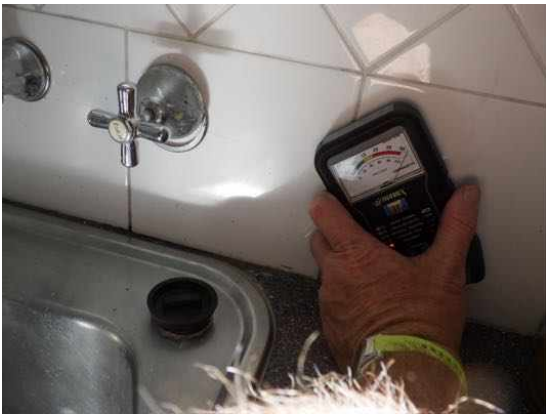
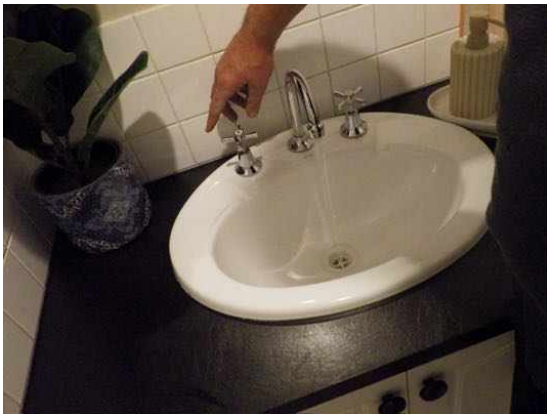
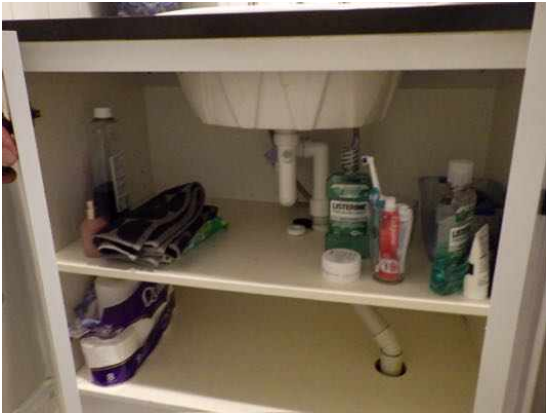
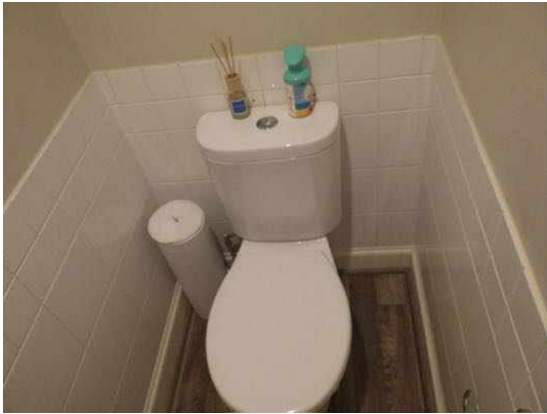
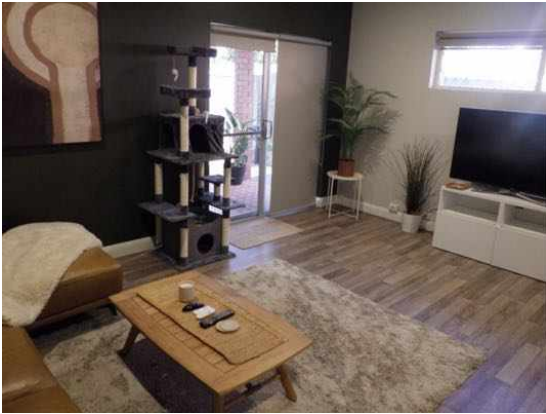
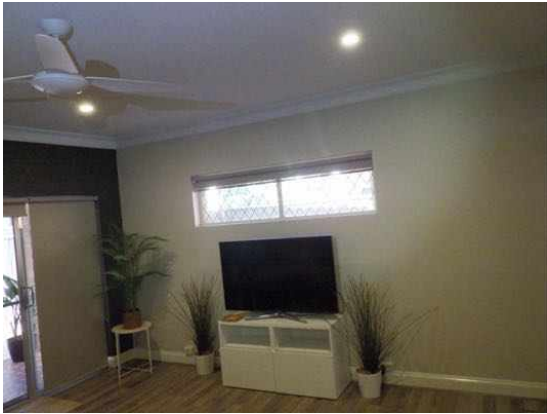
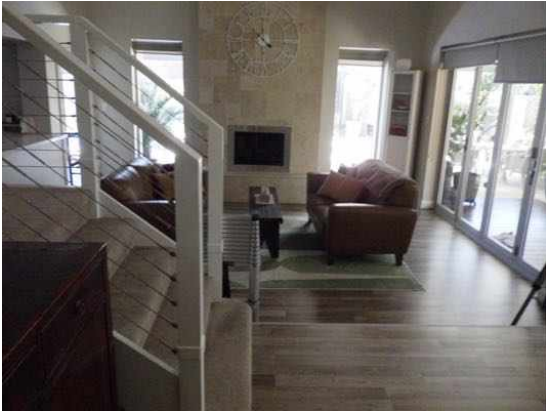
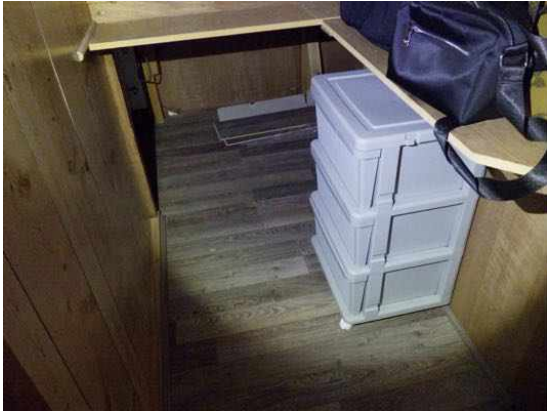
Building: Building 1  
Location: All Areas  
Finding: Additional Photos - Obstructions and Limitations  
Information:

These photographs are an indication of the obstructions and limitations which impeded full inspection of the property at the time of inspection. These obstructions can hide an array of defects and should be removed to allow full inspection to be carried out.

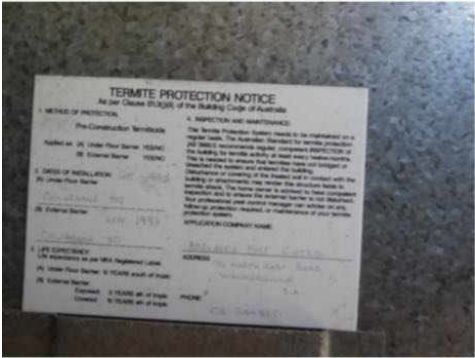
Where a Termite Management System has been identified you should refer to the type of barrier date of installation warranty conditions and any documentation provided by a builder or past owner.

Most chemical termite management systems expire and require replenishment and all physical systems are primarily designed to prevent concealed entry.

Consult the company who installed the barrier to confirm whether the system is still under warranty.

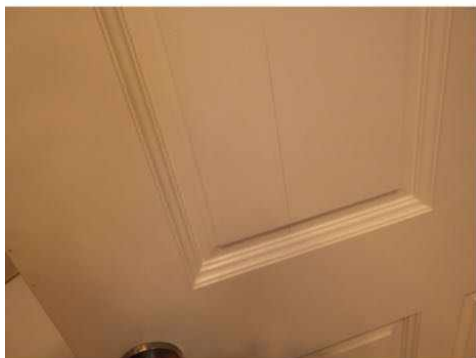
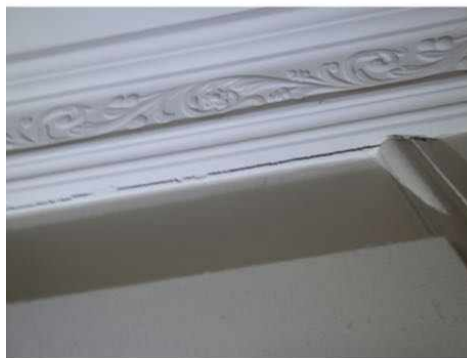
Building:	Building 1
Location:	All External Areas
Finding:	Minor defect
Information:	Minor defects were evident throughout the dwelling at the time of inspection, which are consistent with normal wear and tear and considered appropriate for a property of this age.

These defects are typical of ongoing material ageing, settlement, and general use over time, and include, but are not limited to:

- Minor cracking to internal wall and ceiling linings
- Minor deteriorated eaves paint
- Tiles missing to external porch tiling.
- Vanity drain plug jammed.

While these defects are not considered structurally significant at present, they should be addressed as part of routine and ongoing property maintenance to prevent further deterioration. Repairs and maintenance works should be carried out by appropriately licensed and qualified tradespeople to ensure the continued serviceability and longevity of the dwelling.
