Building and Timber Pest Inspection Report

Inspection Date: Tue, 13 Jan 2026

Property Address: 20 Hickory Rd, Bonnyrigg NSW 2177,
Australia

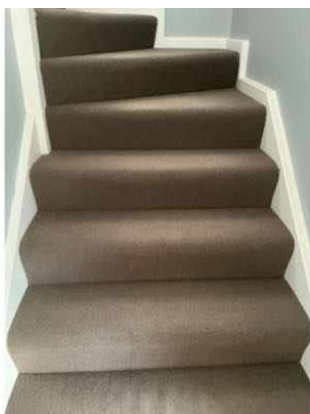
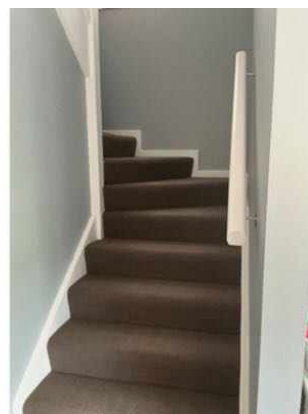
Building:	Main Building
Location:	Stairs - Internal
Finding:	Staircase - Squeaking
Information:	The internal timber staircase produces noticeable squeaking and creaking noises when in use, particularly when ascending or descending. This type of issue is common in older timber staircases and typically results from movement between components, such as treads, risers, and stringers, where joints have loosened over time.

Possible Causes:

Loosened Fixings or Joints: Nails or screws holding the stair components may have loosened, allowing timber parts to move slightly against each other.

Timber Shrinkage or Warping: Natural expansion and contraction of the timber over time—often due to changes in humidity or temperature—can create gaps that cause friction and noise.

Lack of Adhesive or Mechanical Fastening: In some cases, staircases may have been constructed without adequate adhesive or mechanical fixings between components.

It is recommended that the staircase be assessed by a qualified carpenter or builder to identify loose or failing joints. Repairs may involve re-securing treads and risers, injecting adhesive where gaps have formed, or replacing worn components. If structural issues are suspected, reinforcement or partial reconstruction may be necessary to ensure the stairs remain safe, stable, and quiet in use.

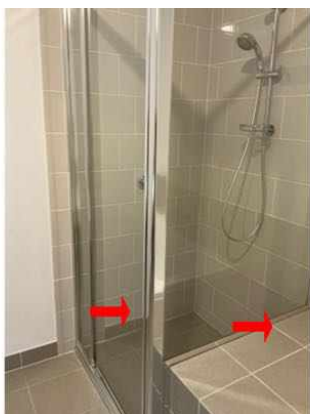
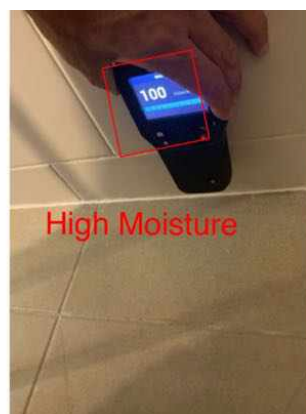
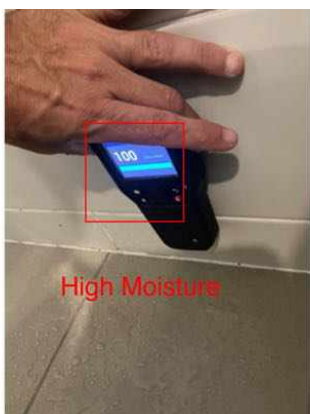
Finding 3.05

Building:	Main Building
Location:	Bathroom
Finding:	Shower damp - Monitor
Information:	Damp is evident to the lower 300mm of wall to the shower alcove. There is no high reading around the taps nor are there high readings transferring to the other side of the wall. Both sealant and grout appear in acceptable condition at present.

This defect is quite common, and is suspected to have been caused by moisture permeating or leaching through the grouting and perhaps gaps in the sealant.

Damp (or structural damp) refers to the presence of unwanted moisture in the structure of a building, either as the result of intrusion from outside, or condensation from within the structure. In the shower area, internal water leaks or other sources of excessive moisture are generally the cause of damp.

Unmanaged damp in the shower recess is likely to facilitate the formation and development of mould and fungi growth, decaying associated building materials and compromising their structural integrity. It is important to address damp conditions, as the World Health Organisation notes that excess moisture leads - on almost all indoor materials - to growth of microbes such as moulds, fungi and bacteria, which subsequently emit spores and other matter into the indoor air. Exposure to these contaminants is associated with a wide range of respiratory and other health-related problems.

Monitoring the area is advised and if any visual signs of excessive moisture appear (peeling paint, mould) then consultation with a qualified plumber or bathroom specialist would be advised to identify the cause of damp and to perform remedial works as required.

Always ensure that sealant and grout is in good condition to prevent any moisture issues occurring in the future.

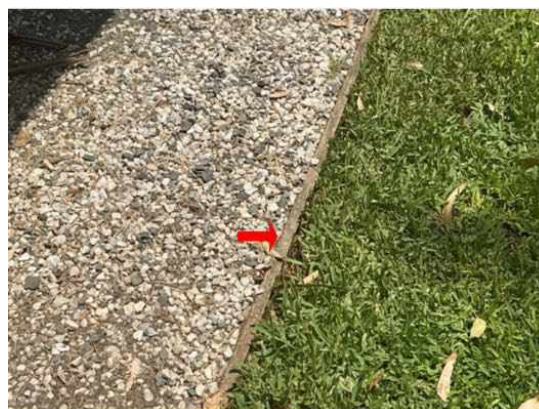
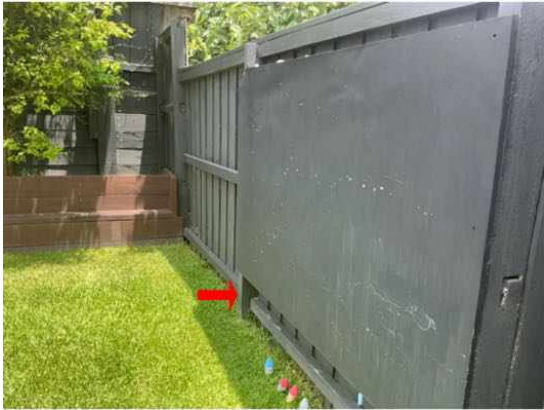
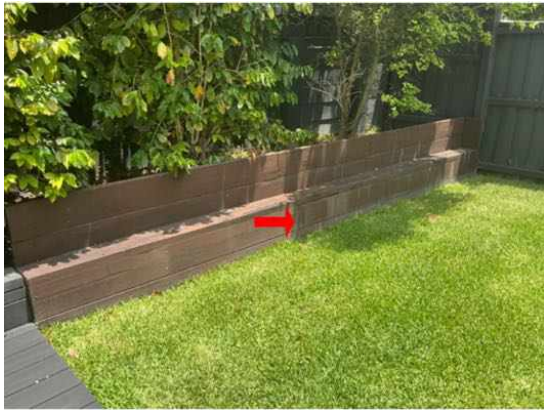
Building:	Main Building
Location:	All External Areas
Finding:	Timber Materials In Direct Ground Contact- Conducive to Termites
Information:	Timber elements that are in direct contact with the ground and exposed to moisture or damp conditions are highly conducive to termite activity. This susceptibility arises because timber, when in contact with soil and dampness, creates an environment that is particularly attractive to termites, encouraging infestation and potential structural compromise. Whether the timber is used as part of the building construction or incorporated into fencing, the presence near or on the ground can become a pathway for termites to access and damage the property.

When exposed to excessive moisture, timber begins to deteriorate developing condition such as wood decay or rot. These compromised areas of timber are even more appealing to termites as they are easier to infest and consume. This is especially true for untreated or non-durable timber, which lacks the protective treatments that can deter or withstand termite attacks. Termites can use these weakened moisture laden elements as a bridge into other parts of the structure, creating an entry point for potential infestations that can spread and cause extensive damage if left unchecked.

For any timber in direct contact with the external ground special attention is required the combination of moisture untreated wood and direct ground contact not only accelerate the decay process but also provide subterranean termites with a straightforward means of ingress into the structure this can lead to termites moving undetected into other vulnerable areas resulting in potentially significant structural issues and costly repairs.

To mitigate the risk of termite activity it is imperative that any such materials or timber elements be appropriately treated or removed as soon as possible. Timbers that are necessary for use should be made durable through appropriate treatments and maintained to ensure they do not create conditions conducive to termites. Additionally the client is advised to schedule regular termite treatments to maintain an effective barrier against infestations and ensure ongoing protection.

Regular inspections, proactive maintenance and consistent termite treatment are essential steps in minimising the risk of termite attack and protecting the structural integrity of the property. Taking these preventative measures is crucial for maintaining a termite free environment and avoiding potentially costly damage and future repairs.

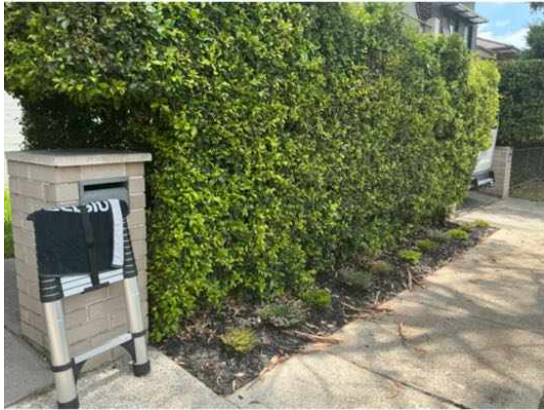
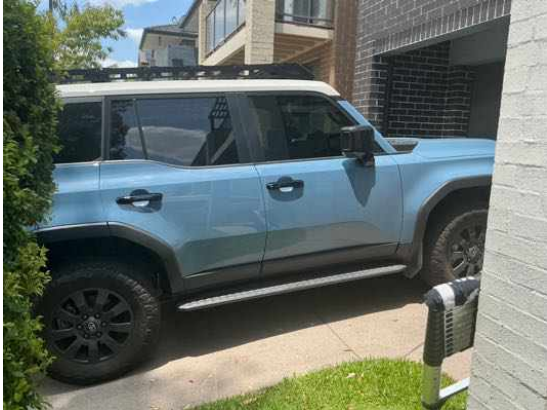
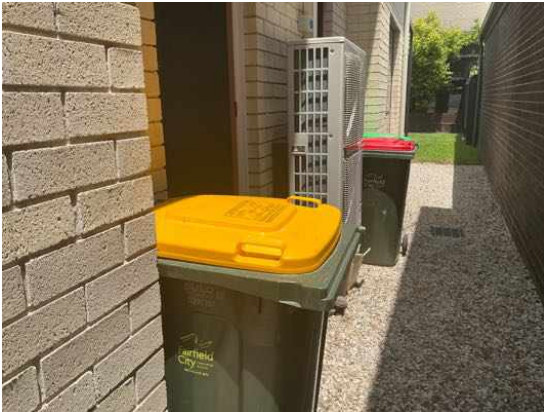
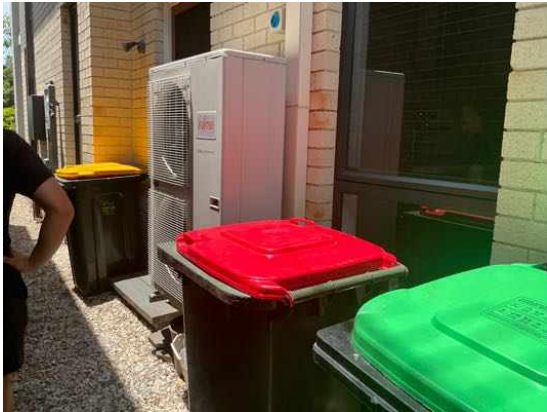
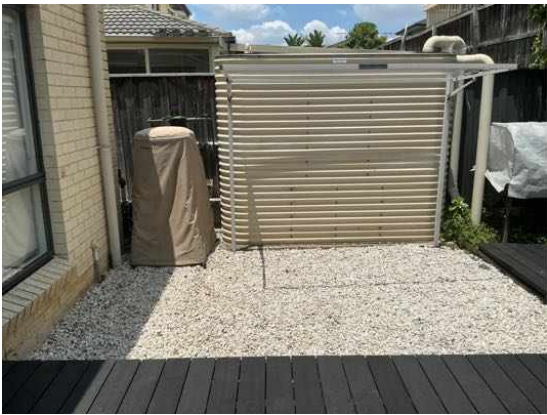
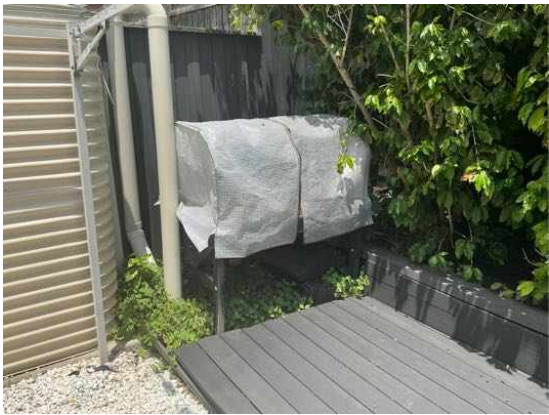
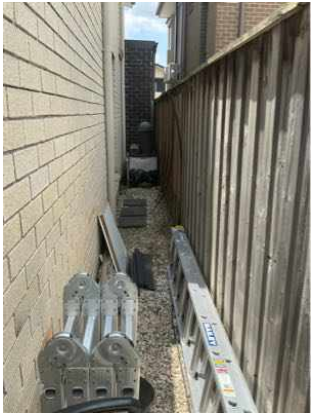
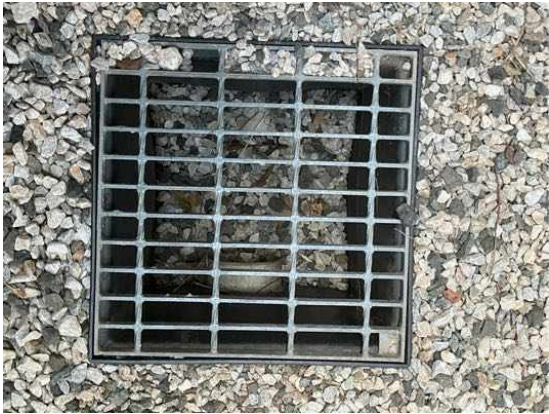
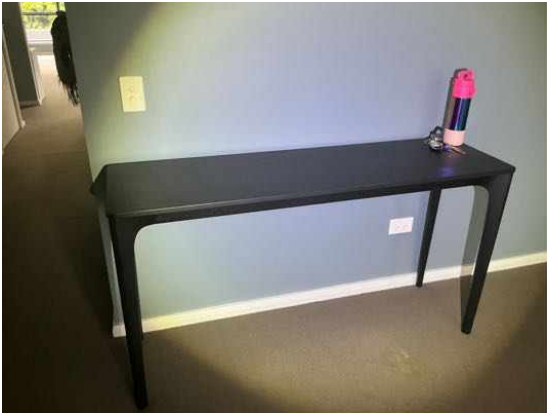
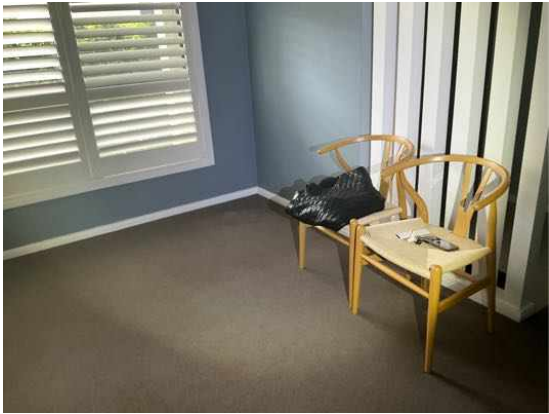
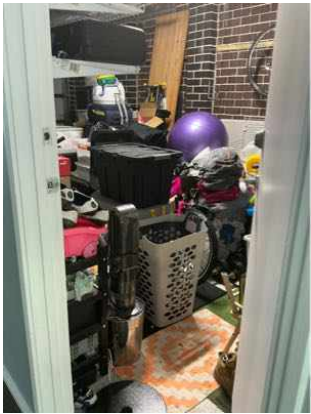
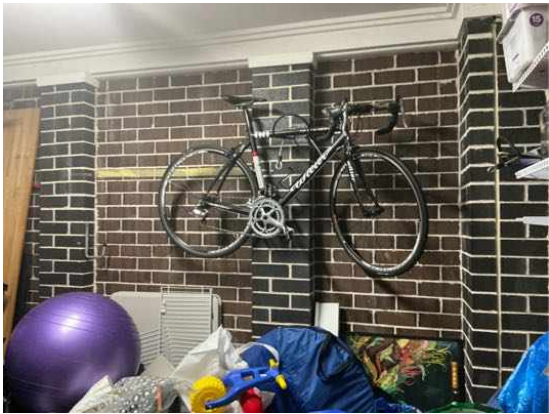
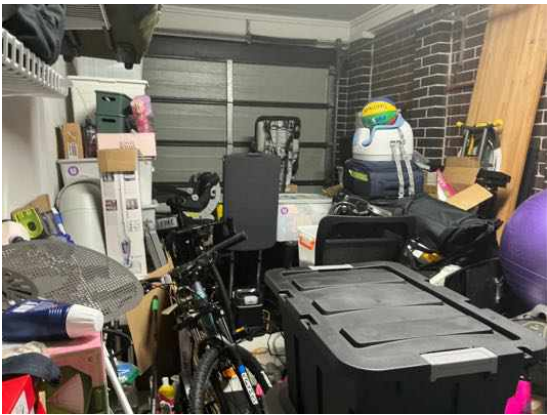
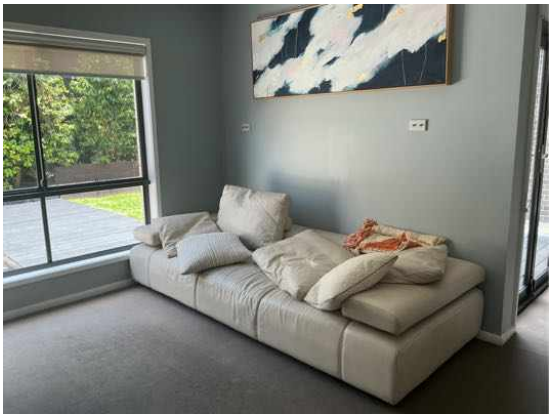
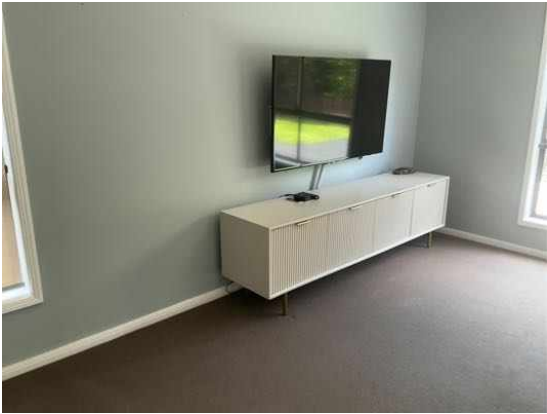
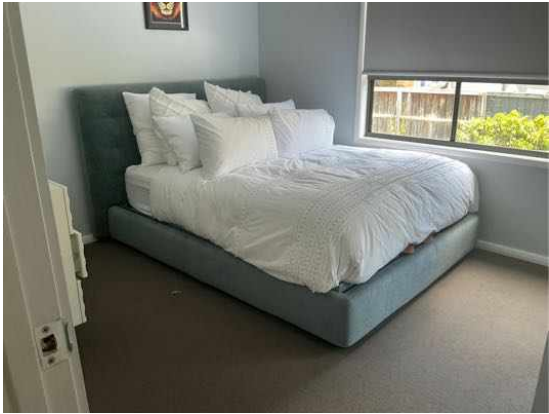
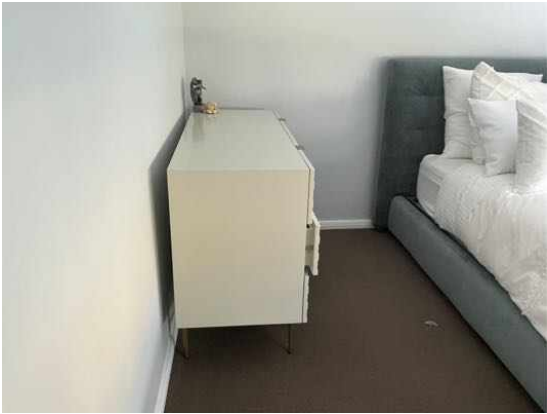
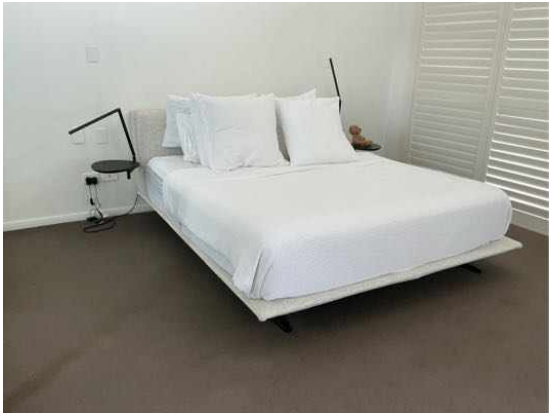
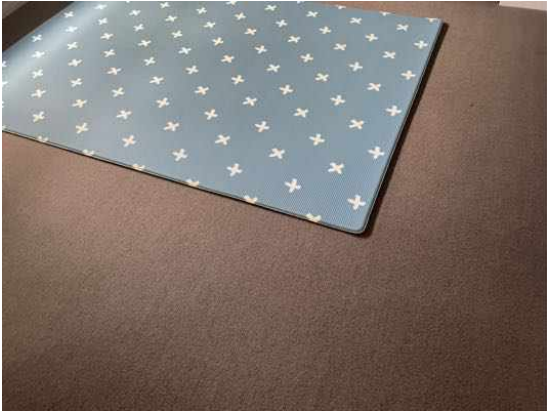
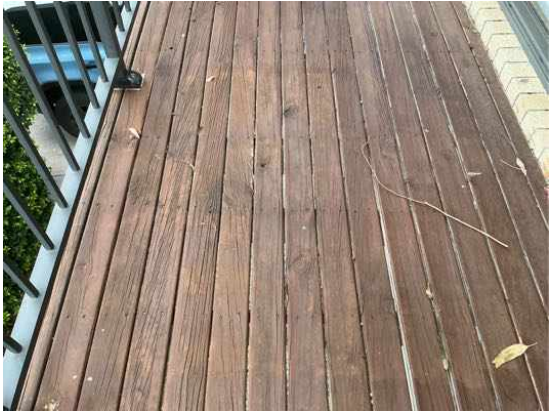
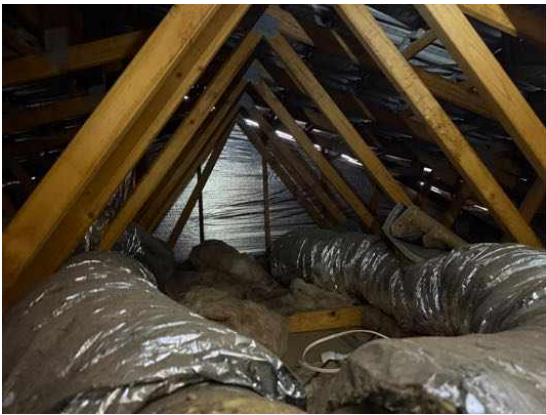
Building: Main Building
Location: All Areas
Finding: Additional Photos - Obstructions and Limitations
Information: These photographs are an indication of the obstructions and limitations which impeded full inspection of the property at the time of inspection. These obstructions can hide an array of defects and should be removed to allow full inspection to be carried out. A re-inspection is recommended once the areas are made accessible.

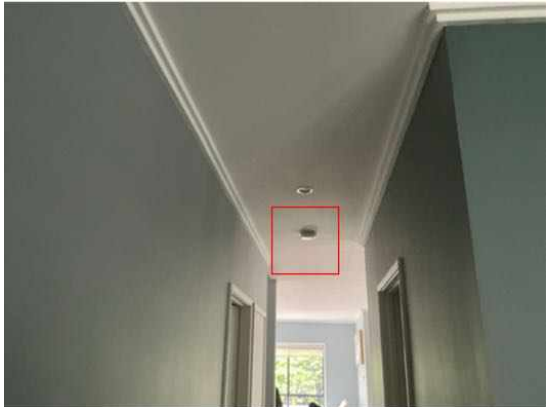
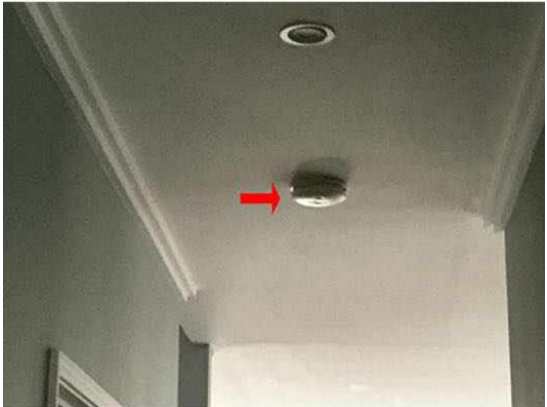
Building: Main Building
Location: All Internal Areas
Finding: Smoke Detectors and Alarms
Information: Reporting on Smoke Detectors or Alarms, including hard wired smoke detection systems and their legislative requirements, is outside the Scope of this Report.

Always ensure sufficient working and suitable smoke detectors are installed prior to occupying any building. Additionally, it is advised that all smoke detectors be tested by the homeowner on a monthly basis.

Please refer to AS3786 and state based legislation, which may also apply.

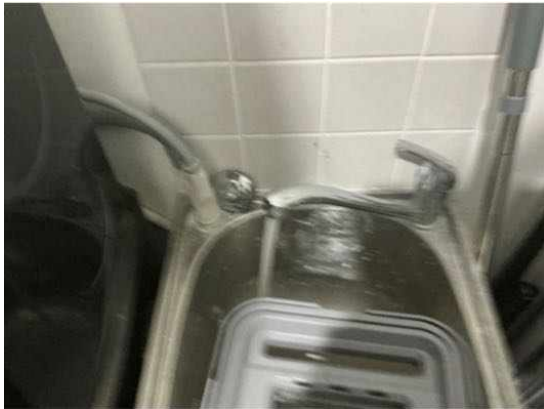
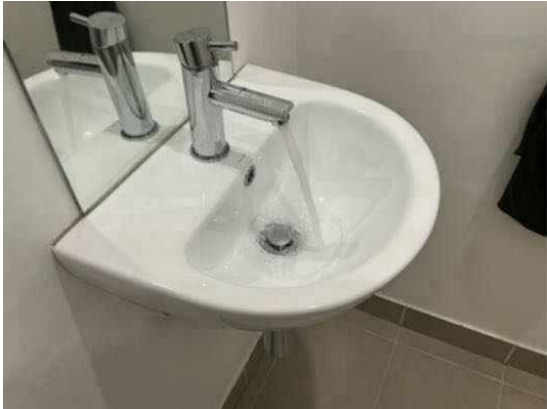
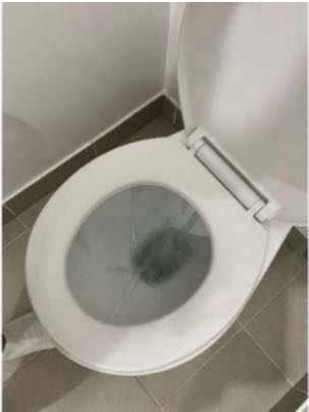
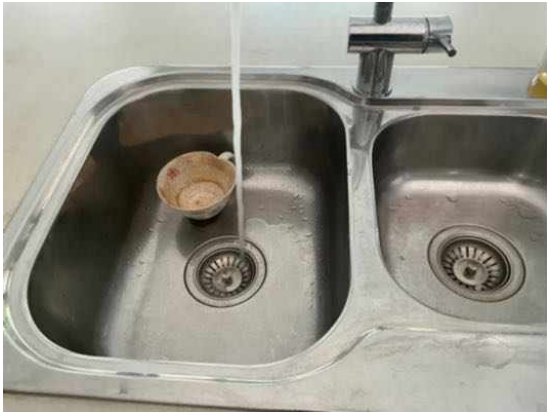
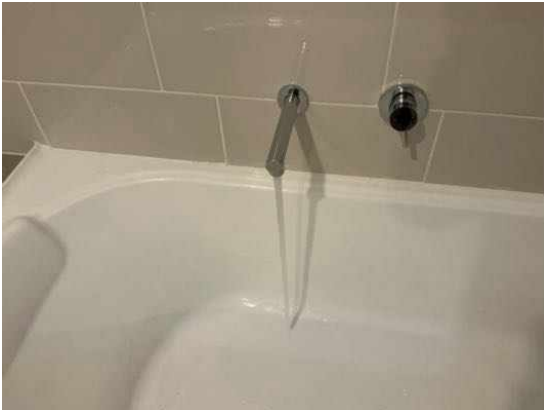
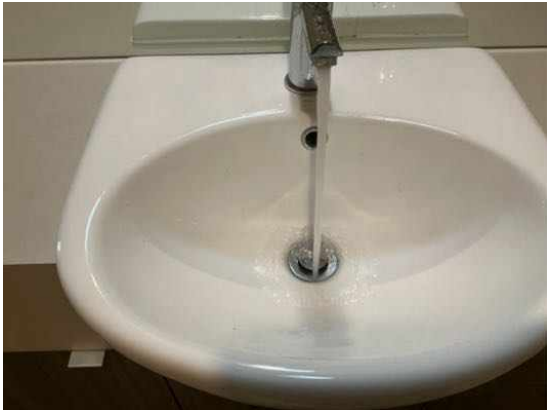
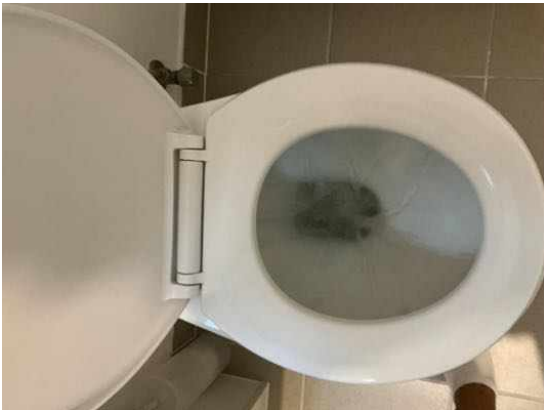
Building: Main Building
 Location: All Wet Areas
 Finding: Taps, Drainage and Toilets Tested
 Information: During the inspection, taps, draining systems and toilets were checked for both water flow and drainage efficiency, as well as inspected for any visible signs of leakage at the time of the inspection. No issues were noted in these areas, unless highlighted in a separate, no immediate remedial work appears to be necessary for these items. Any relevant photo's Documenting these inspections may be found in the additional photo section for reference.

However, it is important to note that while a thorough inspection of cupboards and cabinetry was conducted the presence of instructions such as stored items or fixtures may have limited full visibility of potential water damage or hidden defects. These obstructions can conceal underlying issues that may not be immediately visible during the initial inspection. Furthermore, conditions can change after the inspection has been carried out and defects or damage could be revealed once obstructions are removed or as time progresses.

Given this, it is strongly recommended that a reinspection be conducted after all obstructions have been removed from the cupboards to allow for a full thorough assessment of these areas. This will ensure that any concealed damage or defects are identified and addressed in a timely manner. Regular maintenance and monitoring of plumbing and drainage systems are also advised to insure long-term functionality and to prevent future problems from arising.

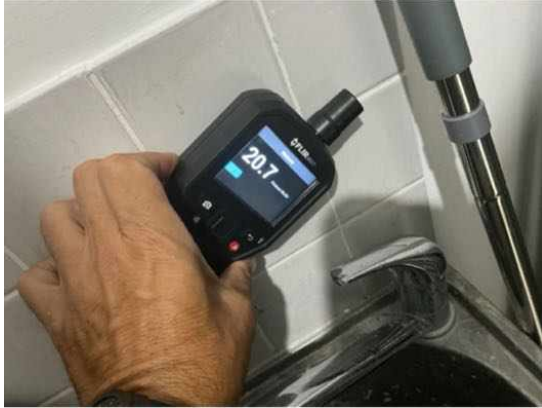
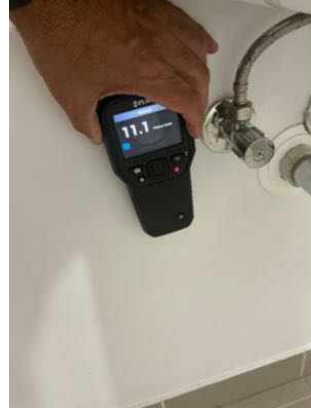
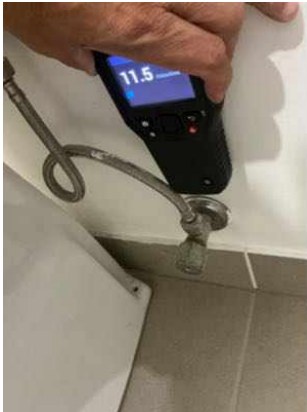
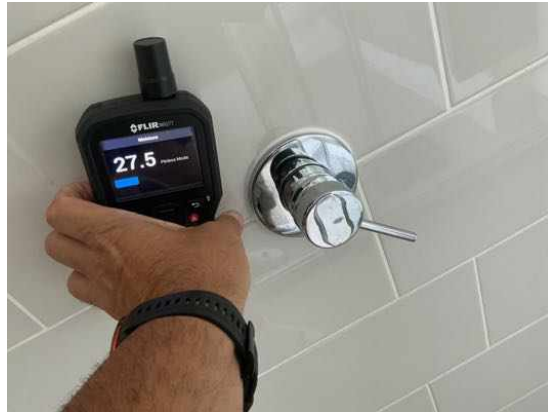
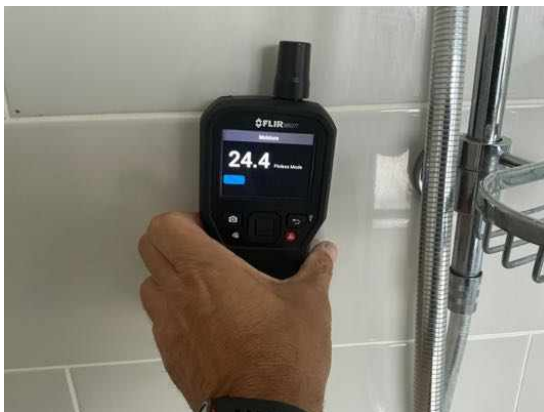
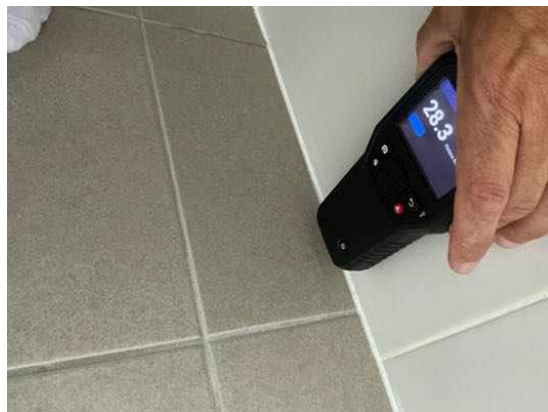
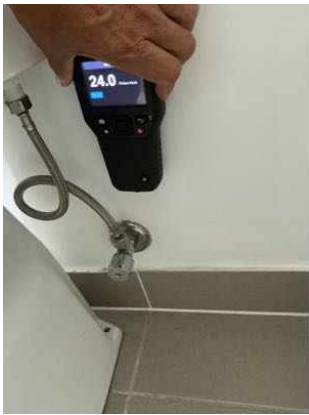
Building: Main Building
Location: All Internal Areas
Finding: Photos added Moisture Readings - Wet Areas
Information: Additional photos are provided for your general reference.

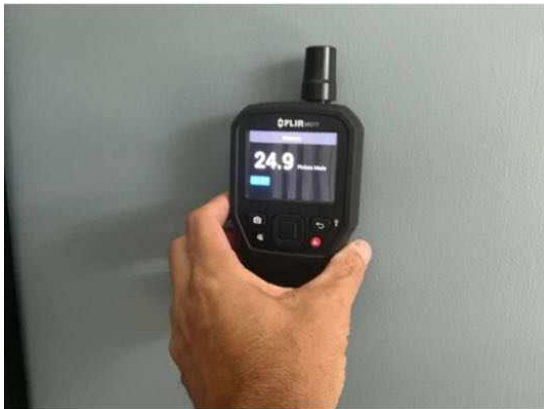
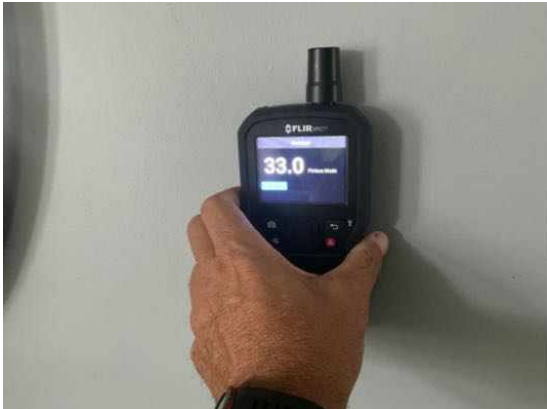
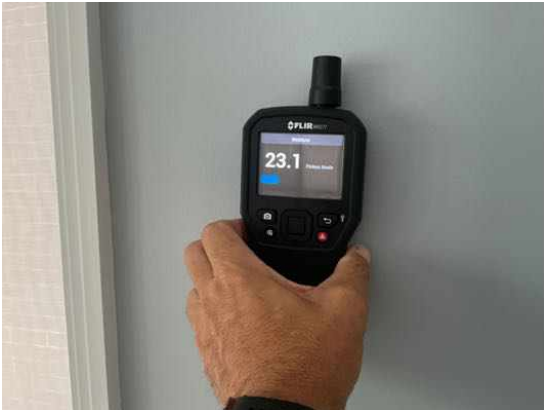
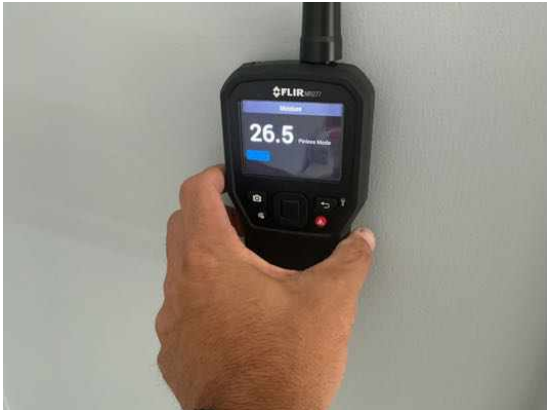
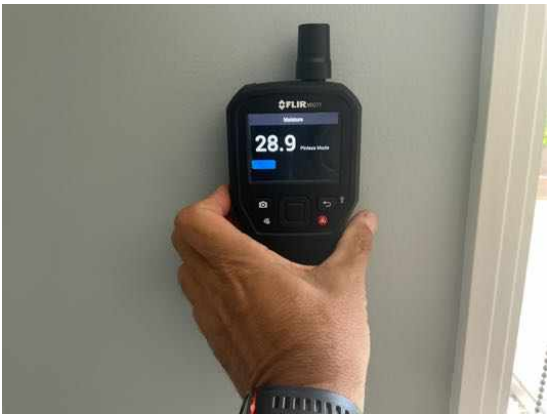
Building: Main Building
Location: All Internal Areas
Finding: Photos added Moisture Readings - Other Areas
Information: Additional photos are provided for your general reference.

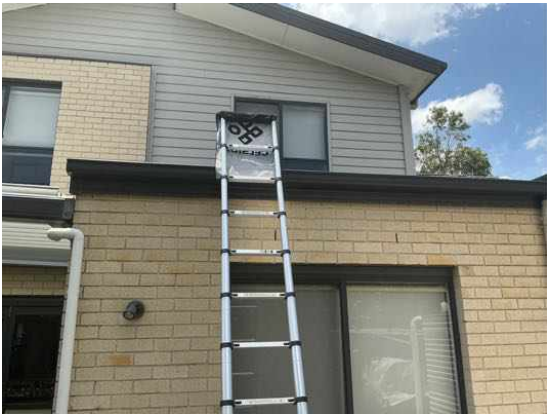
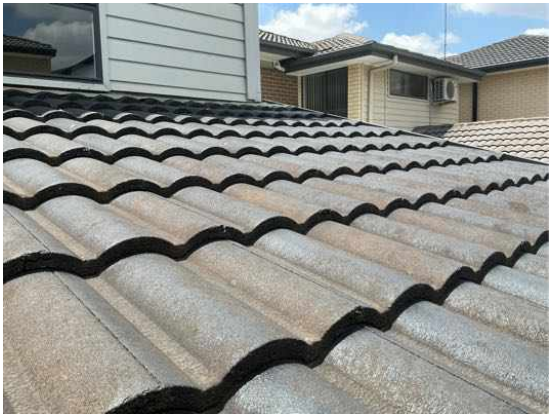
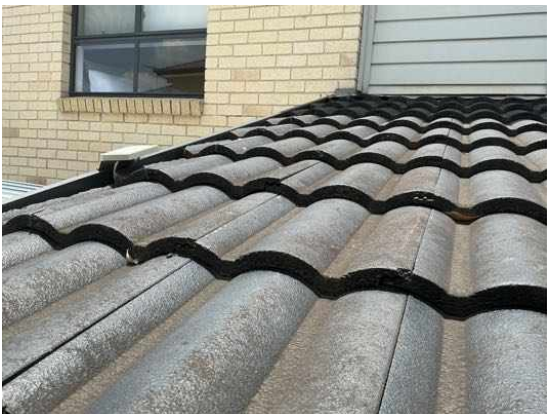
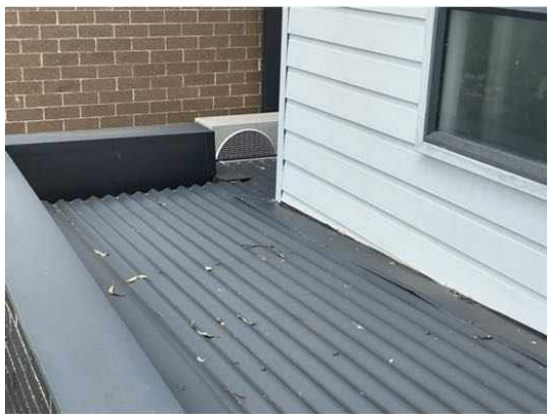
Building: Main Building
Location: Roof Exterior
Finding: Additional Photos Roof
Information: Additional photos are provided of the general roof area for your general reference at the time of inspection.

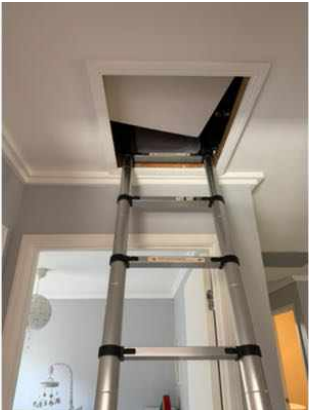
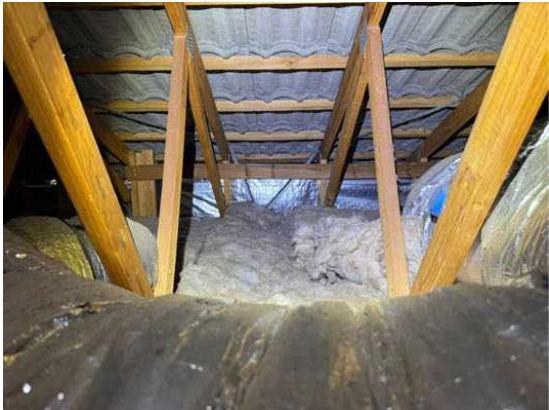
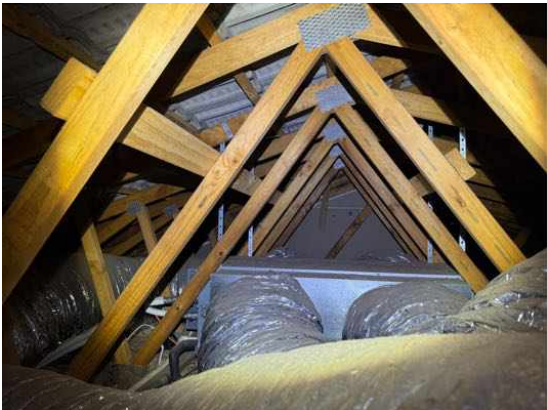
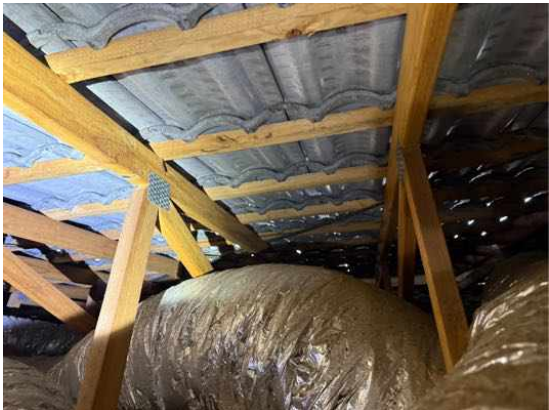
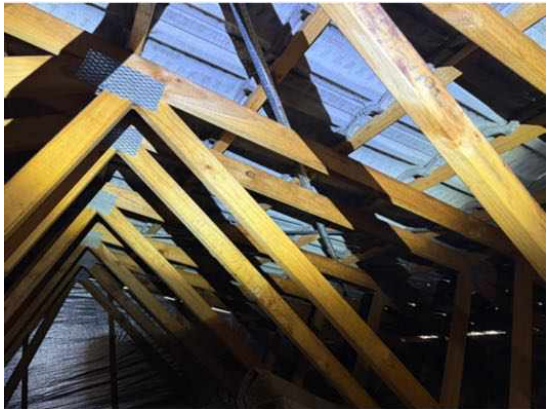
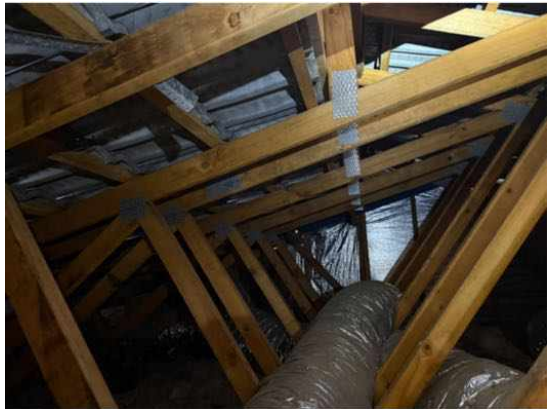
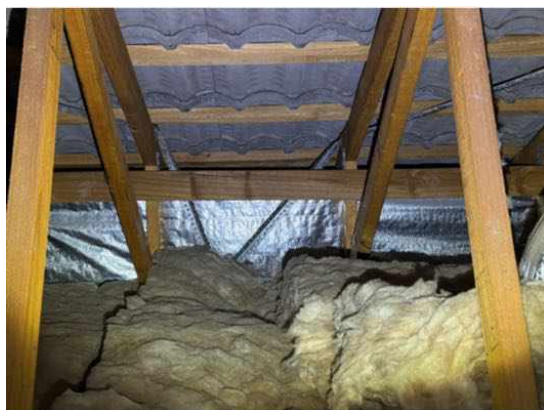
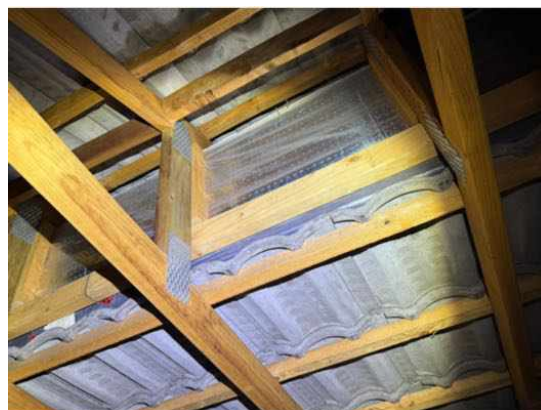
Building: Main Building
Location: Roof Void

Finding: Additional Photos Roof Void

Information: Additional photos are provided of the general roof void for your general reference at the time of inspection.

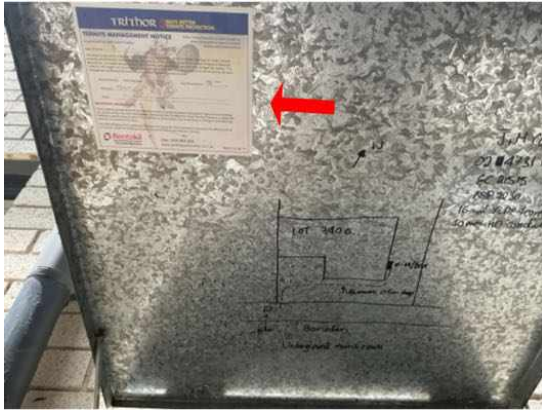
Evidence of this sticker has been located in the meter box. Please see photos attached

Where a Termite Management System has not been identified you should consult a licensed pest inspector immediately to undergo further investigation in what measures would be necessary to maintain a functional pest management system. It is also recommended that a Licensed Pest Controller attend to determine the viability of the current or past treatments
