Building Inspection Report

Inspection Date: Wed, 8 Apr 2026

Property Address: Unit 3/11 Katta Ct, ASHWOOD, VIC, 3147,
Australia

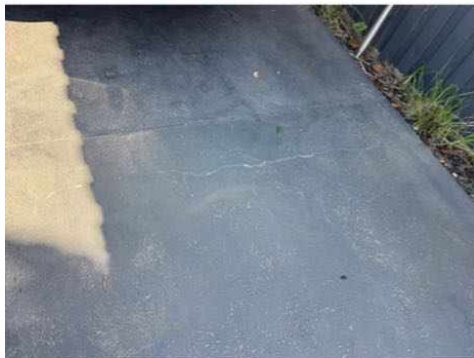
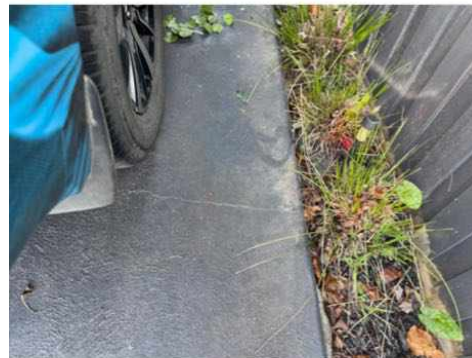
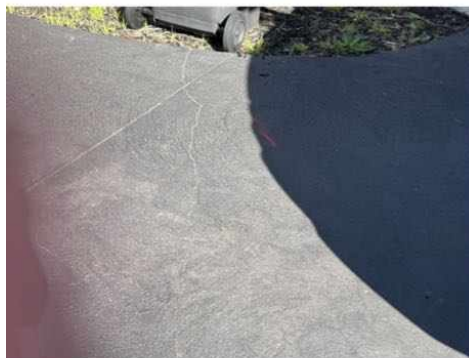
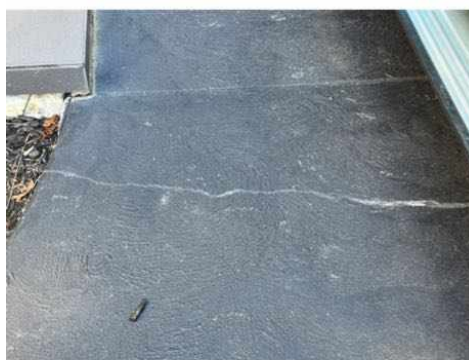
Defects 3.01

Building:	Building 1
Location:	All Areas > All Areas
Finding:	Concrete driveway cracks
Information:	Numerous cracks on the driveway were observed at the time of the inspection. Concrete cracks are a common occurrence as a result of many primary defects. Such causes may include age, general wear and tear, expected building movement, general expansion/contraction of building materials in different weather conditions, and/or minor failings in the installation or application of building materials. Monitoring of all cracking should be conducted periodically. Contact a relevant tradespersons should cracks become trip hazards for occupants.

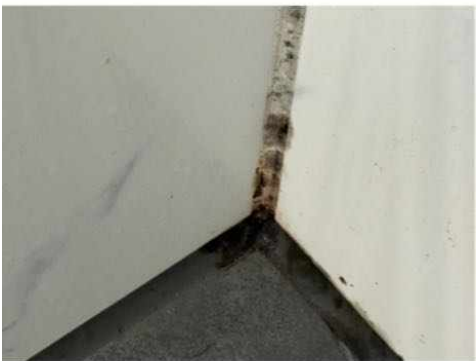
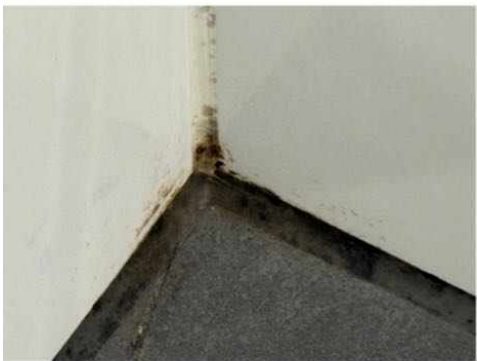
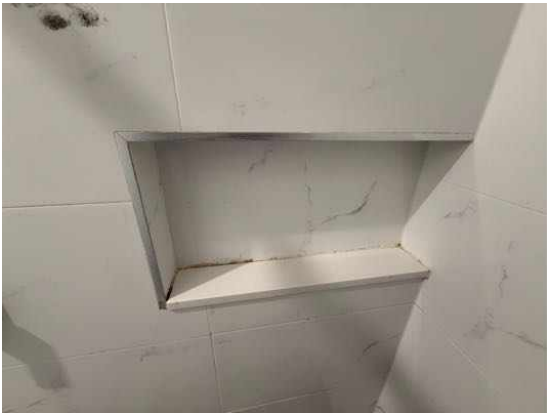
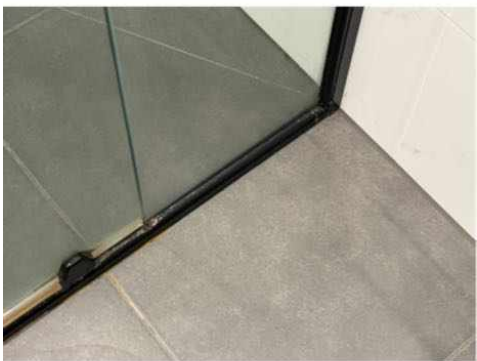
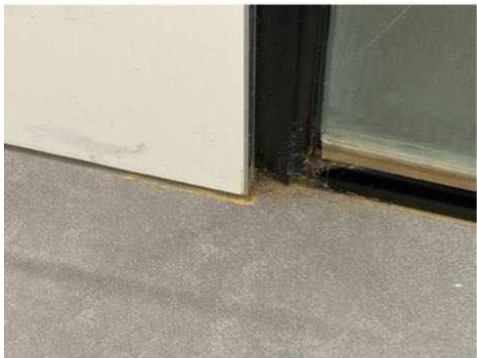
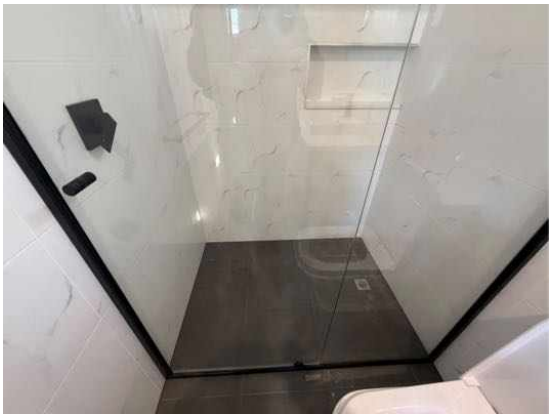
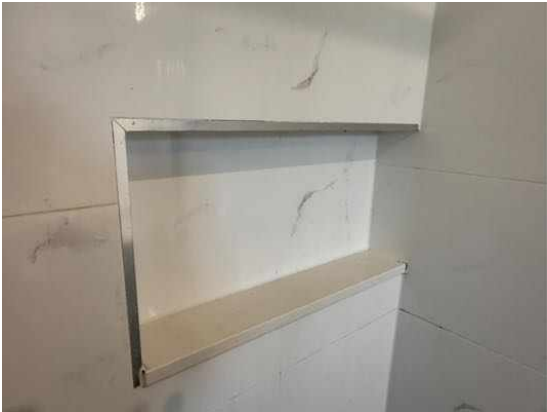
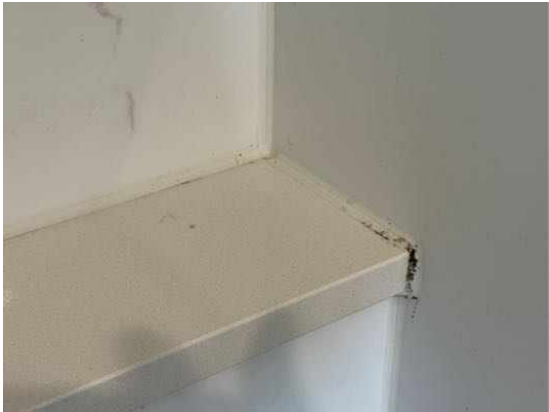
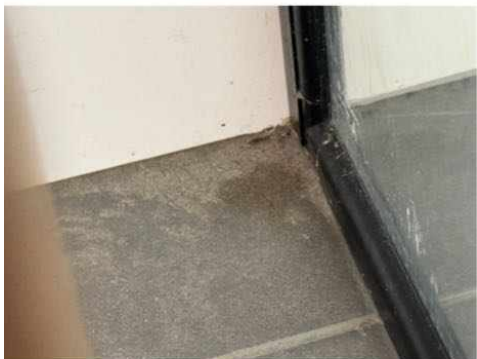
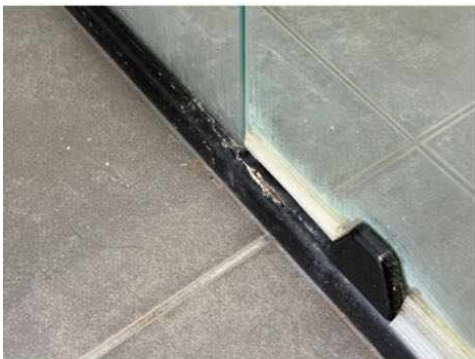
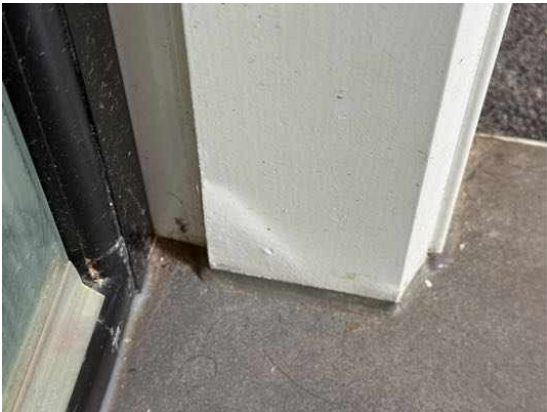
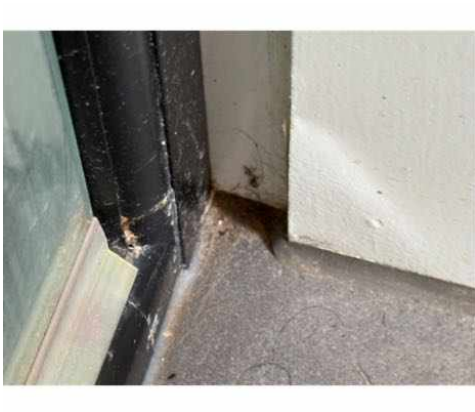
Defects 3.03

Building:	Building 1
Location:	All Areas > All Areas
Finding:	Sealant and grout in bathrooms - en-suite
Information:	It was observed on inspection that sealant or grout has been degraded due to excessive mould build up in the bathrooms and or en-suites, especially to the tiled shower alcove areas. Where there appears to be mould to the sealant and or grout, it is likely that it will require scraping out and replacing.

Different materials on the walls and floor areas move at different rates, generally causing cracking to grout or sealant at this point. A flexible sealant is required to allow for expected expansion and contraction, while keeping the joint water tight and protective of all associated building materials. Flexible and mould resistant materials should be applied to affected areas to prevent any subsequent water damage that is likely to occur.

Regular maintenance and replacement of any missing or damaged sealant and grout is highly recommended to the wet areas, as this is a regular wear and tear defect. Sealant and grouting in areas that come into regular contact with water should be maintained for the long term care of your property. A sealant specialist or tiling contractor should be appointed to complete these works as soon as possible.

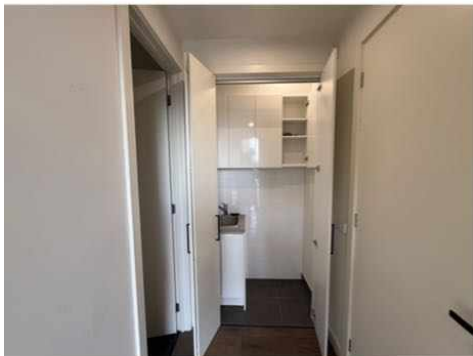
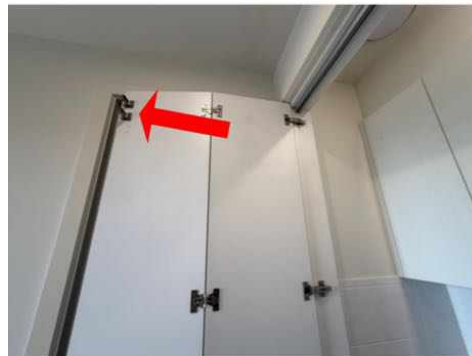
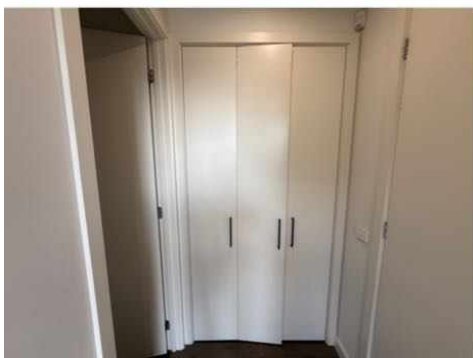
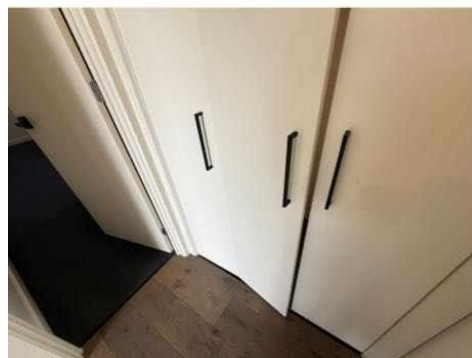
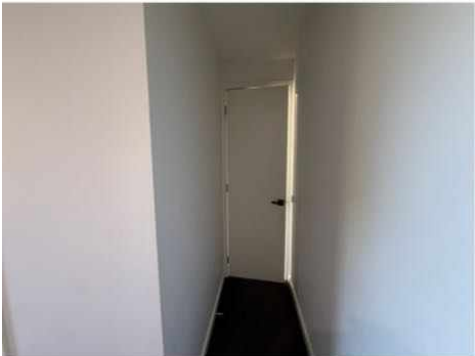
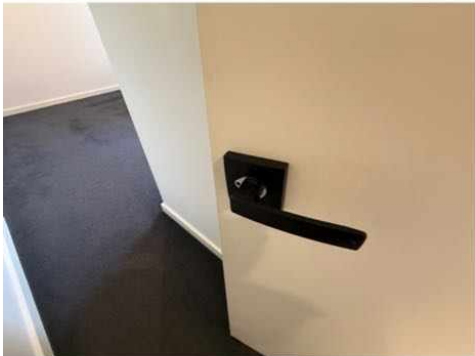
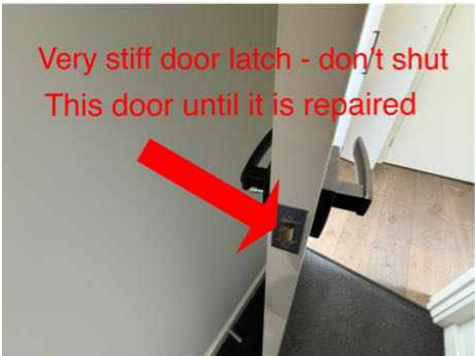
Defects 3.04

Building: Building 1
Location: Bathroom > All Areas
Finding: Doors and sliding doors
Information: The doors and sliding doors throughout the property were observed to require some remedial work and maintenance to make sure they operate as intended. Generally these type of maintenance items are due to such as age and a lack of maintenance. Renewal or replacement of some door hardware is recommended where deemed to be necessary and required, as well as minor repairs and cleaning. Where door handles, door latches are hard to operate, these types of defects will make it difficult for all occupants to safely egress the interior areas, in some cases the door hardware could cause an occupant to be stuck in a room. All door hardware should be rectified to ensure they operate easily during standard operation. These doors and door hardware defects may inhibit a safe and timely egress in the case of an emergency.

Some of these doors require some minor adjustment to ensure their functionality is not affected, they are suspected to be creating some secondary defects to associated building elements, such as damage to the associated door frames and or floor coverings in left unmanaged. A qualified carpenter will be required to carry out remedial work on the affected doors.

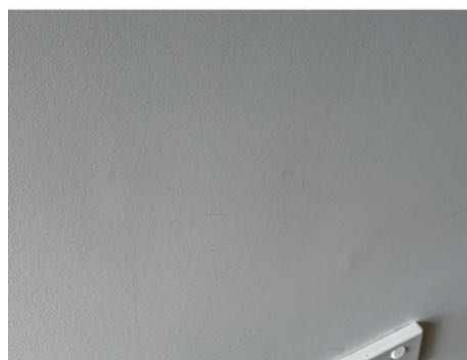
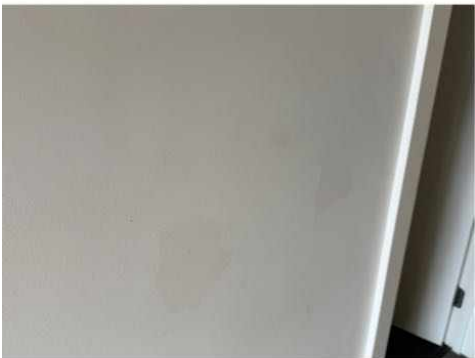
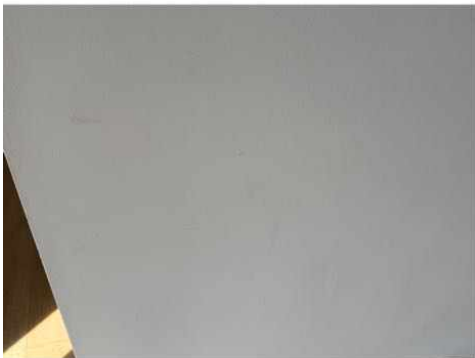
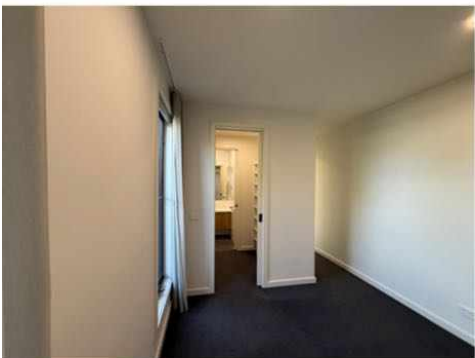
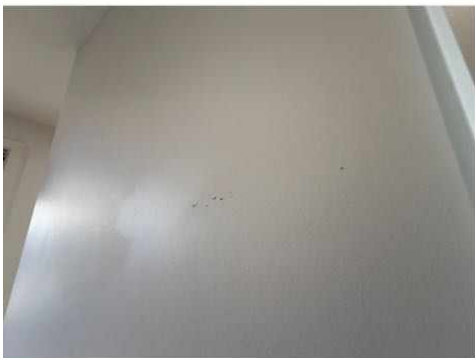
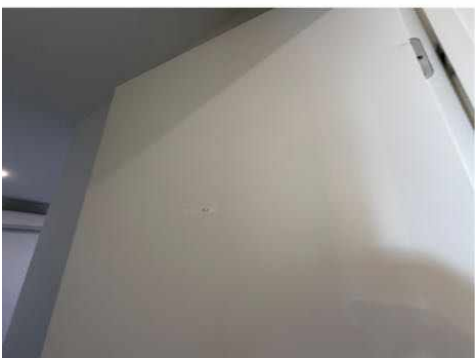
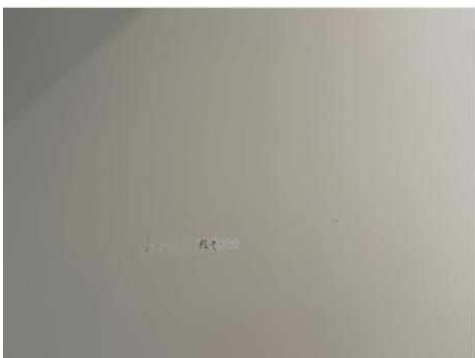
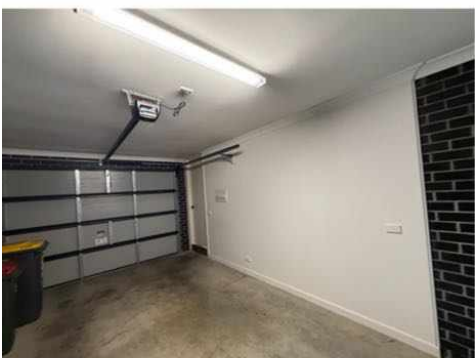
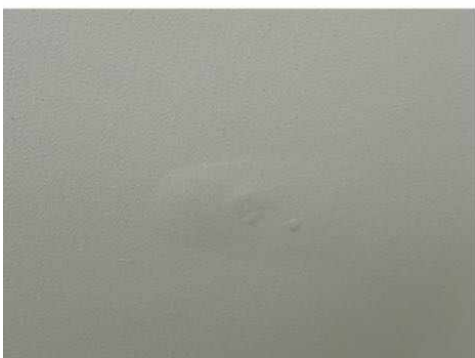
Defects 3.05

Building:	Building 1
Location:	All Areas > All Areas
Finding:	Painting show some minor marks and blemishes
Information:	At the time of the inspection the interior paint work is considered to be in a reasonably good condition showing some marks and blemishes throughout the home. These painted surfaces and finishes where it shows marks and blemishes should be sanded back, filled, leveled and painted where deemed to be necessary. The build should appoint the qualified painter to rectify any areas showing these minor defects, marks, blemishes. Re-painting in some areas may be necessary and would improve the overall condition and aesthetics throughout the home, this would ensure these areas are protected and finished adequately and professionally against further deterioration.

Incomplete, inadequate paint protection, damaged and deteriorated paint finishes, can mostly be considered appearance defects, however poor and unmaintained paint finishes can also lead to the development of secondary building defects over time. Incomplete areas of paint finish exposes these areas to moisture and secondary damage, potentially accelerating the deterioration of underlying building materials.

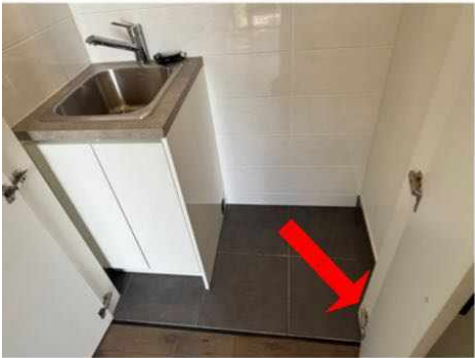
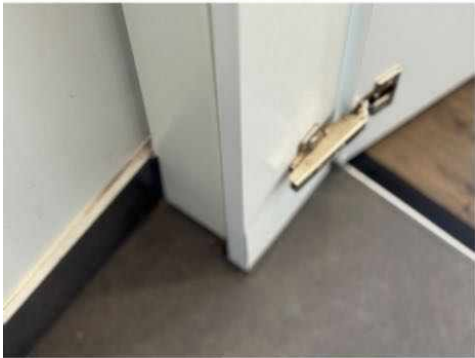
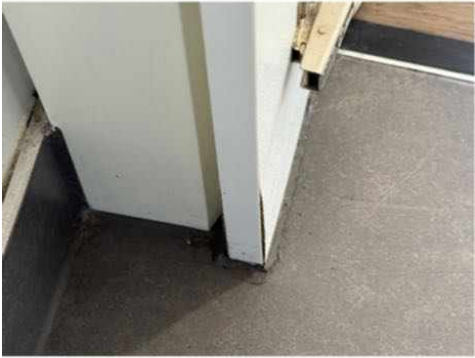
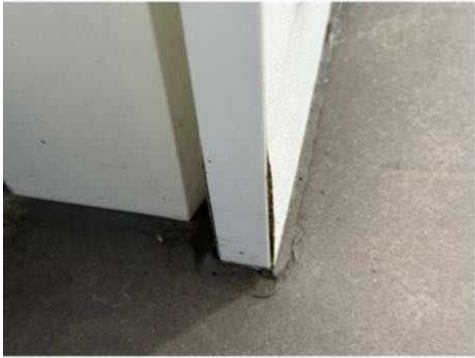
Defects 3.06

Building: Building 1
 Location: Top bathroom > All Areas
 Finding: Minor moisture damage to bathroom and laundry door jambs
 Information: Minor moisture damage to the bathroom door jamb, the bottom left hand side of the door jamb showed signs of moisture damage. Door jamb shows minor damage to the bottom area of the door jamb which may be consistent to moisture at the time of occupants showering. Client may elect to rectify or leave as is, however it is recommended that this area be closely monitored for further moisture damage. Client is recommended to take more caution during and after showering.

Minor moisture damage to Laundry door jamb :- Minor moisture damage to the laundry door jamb, the bottom right hand side door jamb showed signs of previous moisture. The door jamb has minor area of damage which may be consistent to some water and moisture at some previous time, possibly a washing machine mishap at some time. No other damage was visibly observed at the time of the inspection. The damage is not suspected to require any remedial action. Client may elect to rectify or leave as is, this is at the client's discretion.

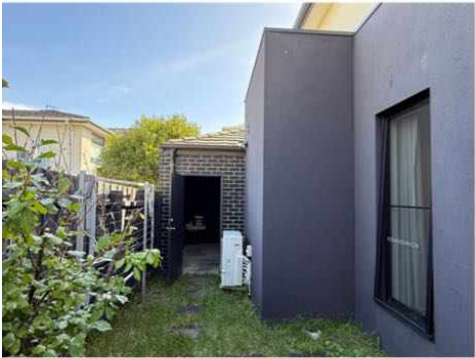
Defects 3.09

Building:	Building 1
Location:	Rear areas > All Areas
Finding:	Exterior perimeter moisture
Information:	It was observed at the time of inspection, the home site was considered to be reasonably flat and therefore has little to no water runoff and during wet weather or heavier rain periods it may become wet and rain sodden. Client must try ensure to keep any excessive moisture away from the home. If deemed to be required the client may consider additional agriculture (aggy) drainage is added to eliminate excessive moisture from around the perimeter exterior areas. Client must try to maintain dry conditions in these type of areas, this will improve the exterior perimeter conditions and makes a healthier exterior environment. It is considered to be very important to

prevent and to protect against the development of potentially harmful wet and mouldy conditions.

Client must ensure not to build up around the perimeter areas, types of obstructions would include things such things as garden beds trees and shrubs etc. Maintaining dry conditions and preventing secondary damage such as excessive moisture, mould, wood rot and pest activity, the development of mould and mildew may lead to respiratory safety hazards for occupants if left unmanaged for extended periods of time.

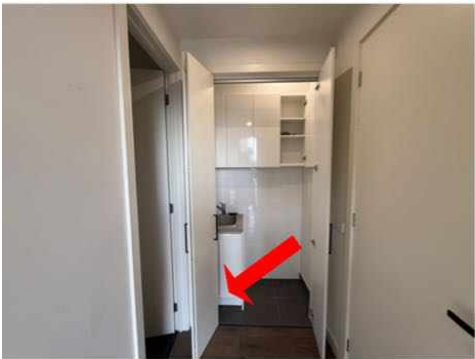
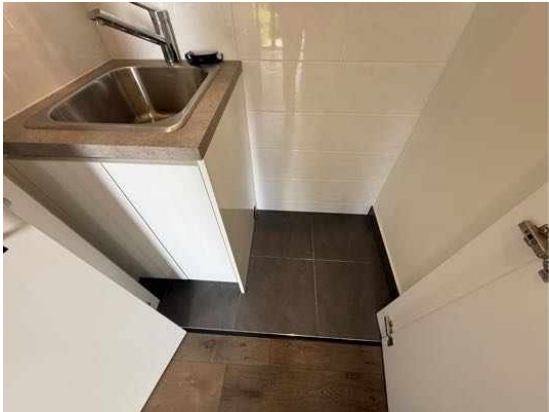
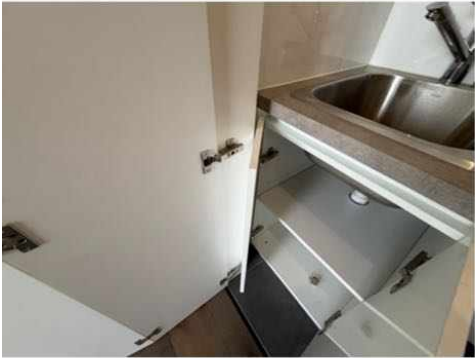
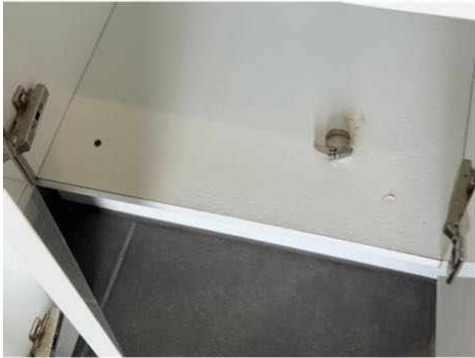
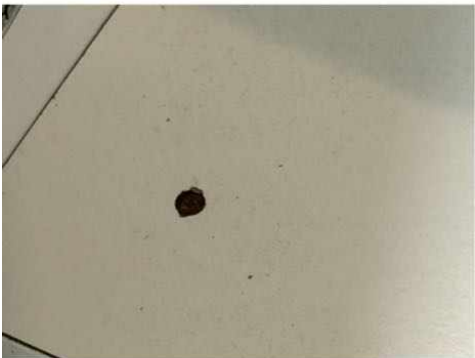
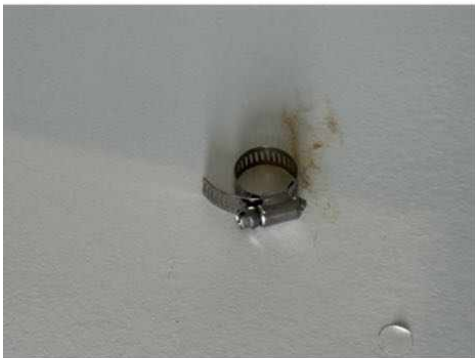
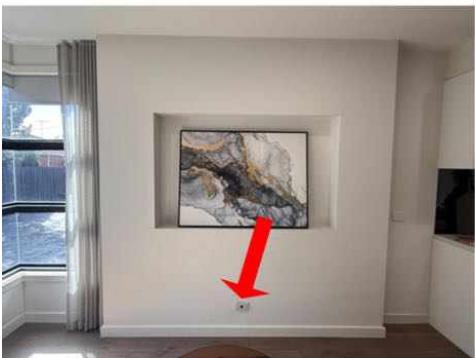
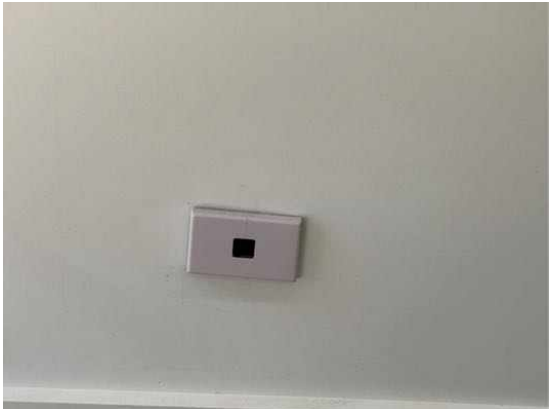
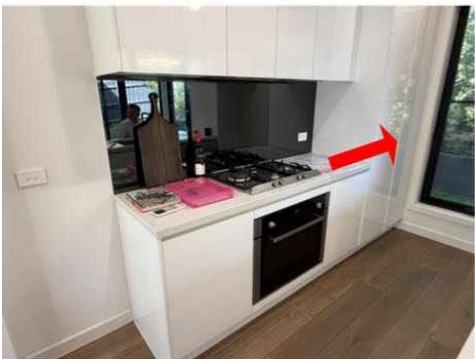
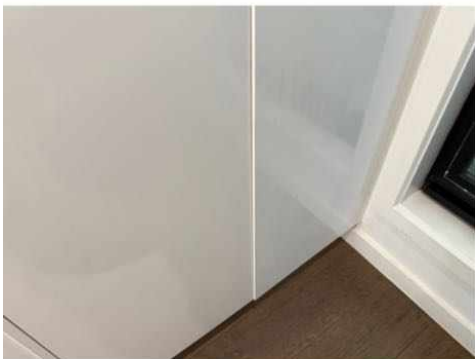
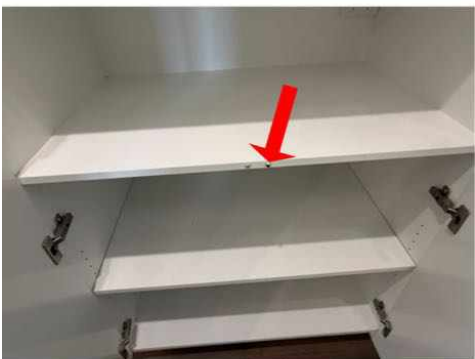
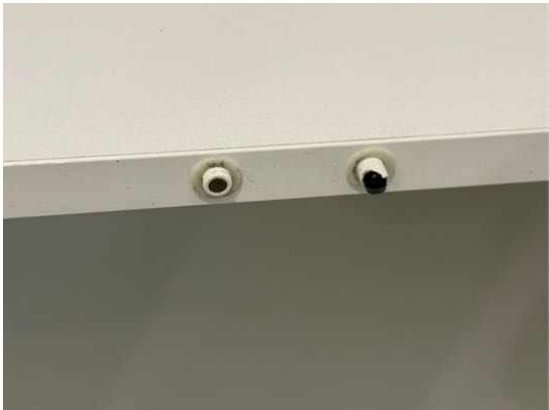
Noted Item

Building: Building 1
Location: All Areas > All Areas
Finding: Additional Photos
Information: Additional photos are provided for either future maintenance items for clients attention and or general reference. Arrows may have been included to highlight areas of importance. Please discuss these photos with your building consultant for clarification.

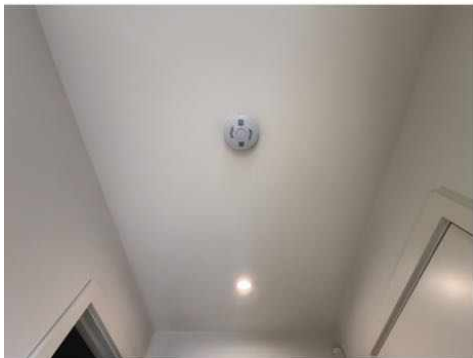
Building: Building 1
 Location: All Areas > All Areas
 Finding: Smoke detectors and alarms
 Information: Reporting on Smoke Detectors or Alarms, including hard wired smoke detection systems and their legislative requirements, is outside the Scope of this Report. Please note that this defect is highlighted as a caution only. We suspect, based on our experience in the building industry, that smoke detectors are sometimes get overlooked, or they may be in a poor condition, so we recommend that they always should be addressed prior to occupation to improve occupant safety.

Always ensure sufficient working and suitable smoke detectors are installed prior and during to occupying any building. Additionally, it is advised that all smoke detectors be tested by the homeowner on a monthly basis.

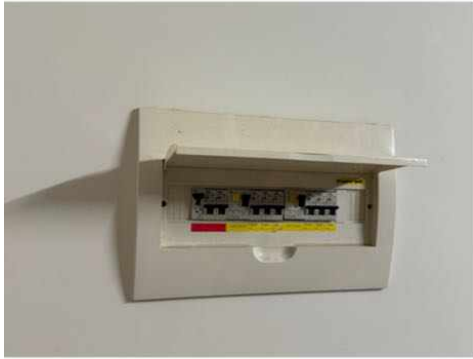
Building: Building 1
 Location: All Areas > All Areas
 Finding: Termite Management System - no evidence of a chemical installation or durable notice
 Information: At the time of the inspection no application of a chemical termite barrier or durable notice was observed. Such barriers are highly effective and highly recommended for all properties in preventing termite attack on any timber building elements throughout the property.

A durable notice should be placed in the switchboard unit or in the another accessible area to indicate current termite barriers. At the time of inspection, no evidence to suggest preventative works taking place. The client may consider gaining further advice from builders or a pest controller and as to the costs and procedures involved with this application. It is recommended that obtaining such advice be a short-term priority.
