## Building Inspection Report

Inspection Date: Sat, 21 Feb 2026

Property Address: 17A Doctors Rd, Morphett Vale SA 5162,  
Australia

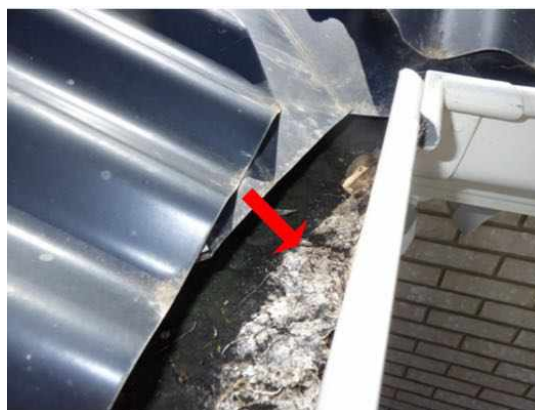
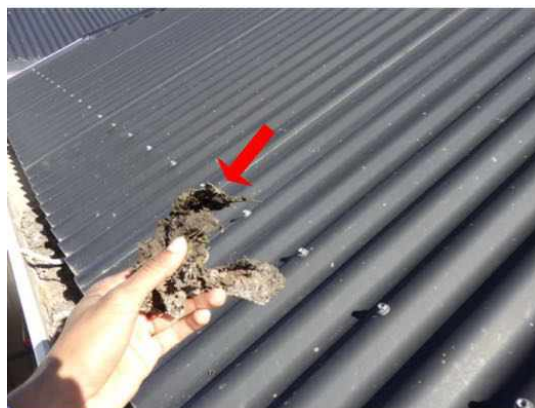
Blocked gutters are likely to lead to high levels of moisture in the affected areas. Such moisture will not only cause rust and decay of the associated building materials, but can also provide conditions that are conducive to termite and timber pest activity. Blockages in gutters should therefore be removed immediately to ensure dry conditions are maintained.

Consult a Licensed Plumber for further specific advice on remedial works that may be required. In the interim, it is highly advised that blocked gutters be removed by the homeowner or a general handyperson as a matter of urgency.

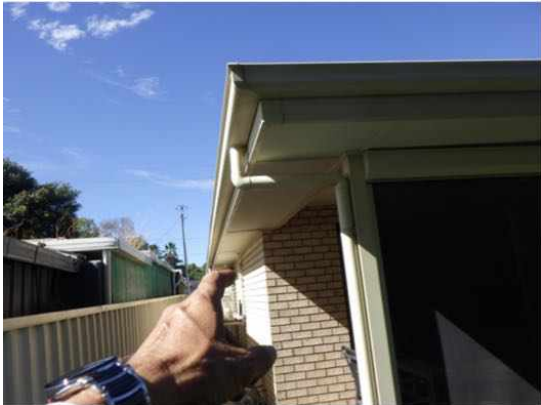
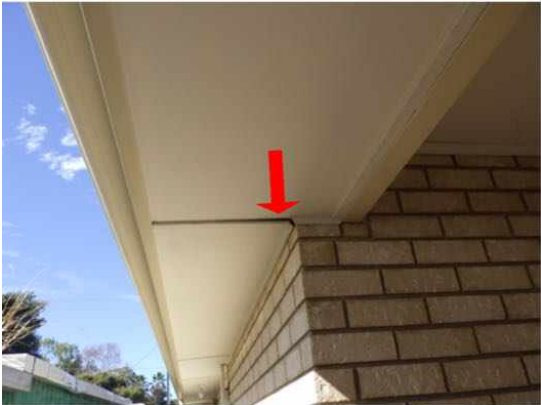
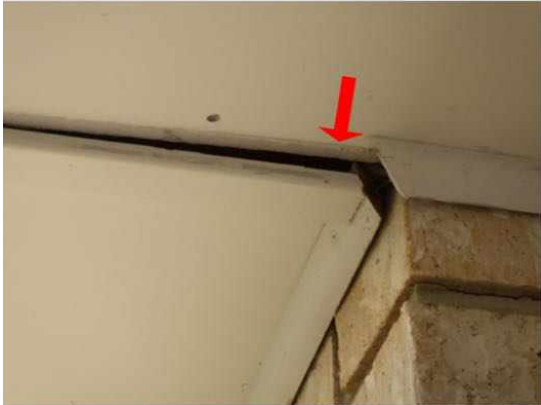
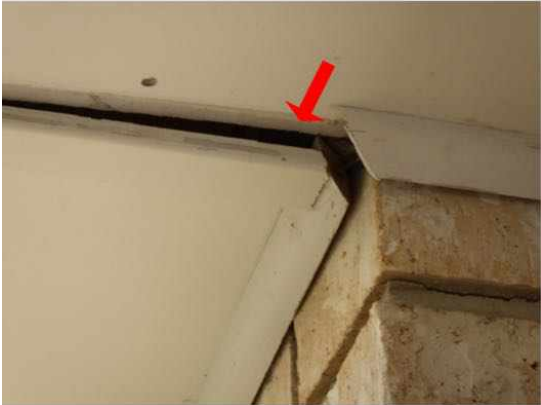
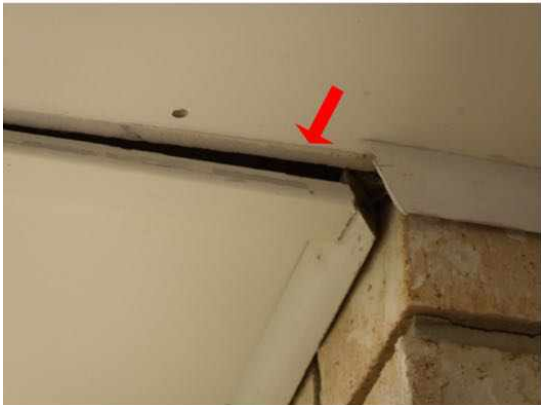
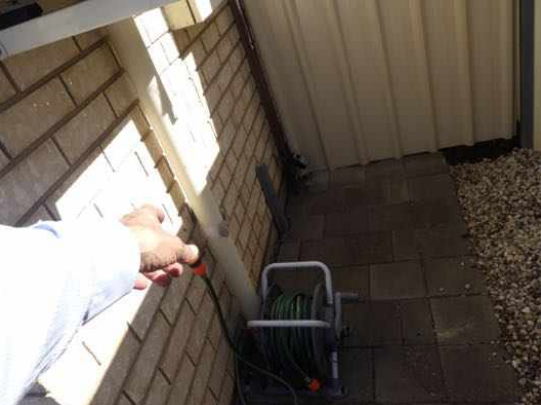
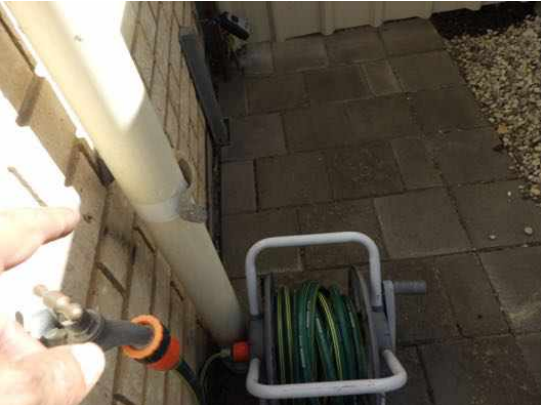
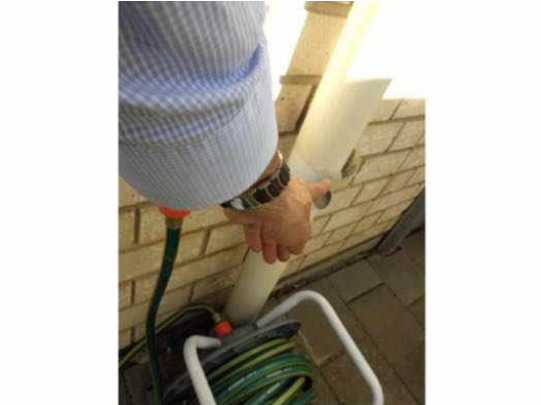
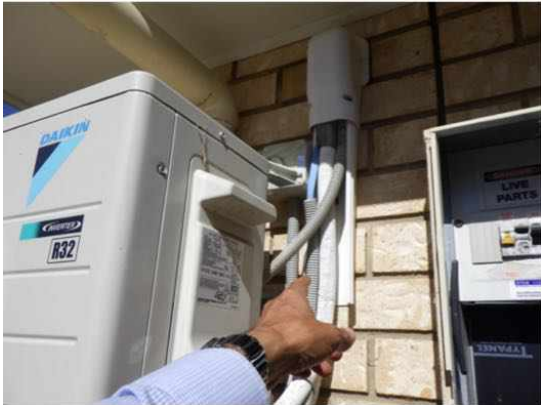
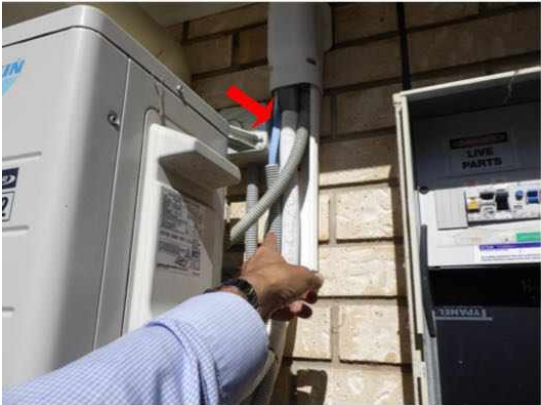
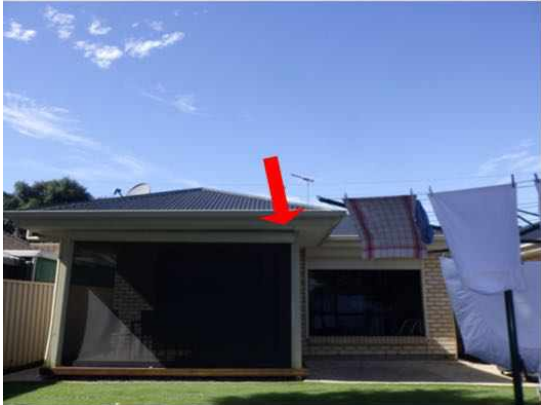
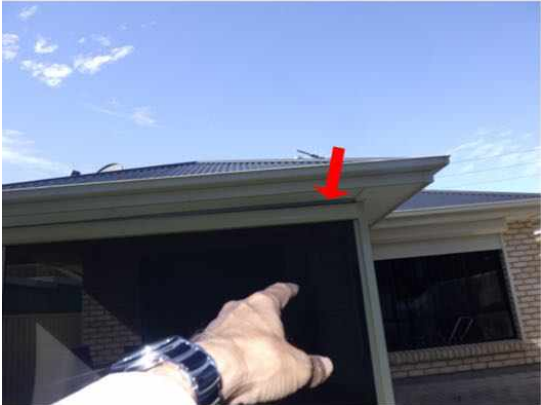
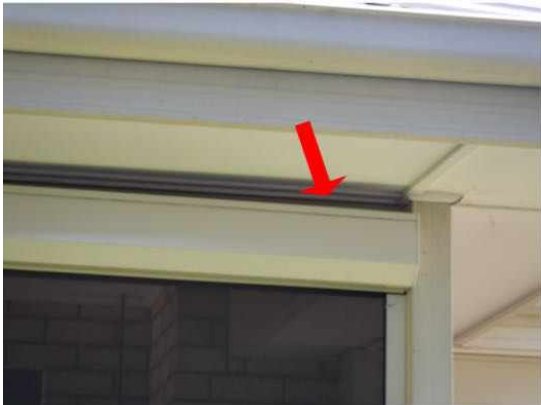
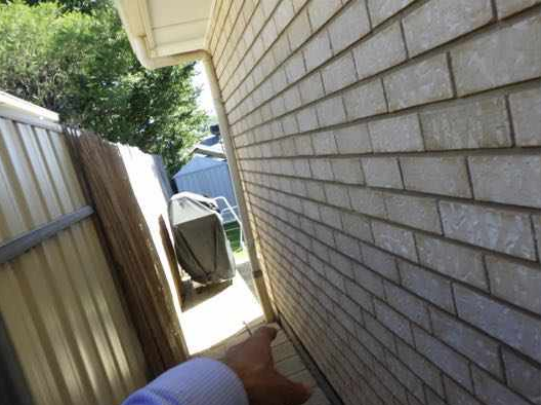
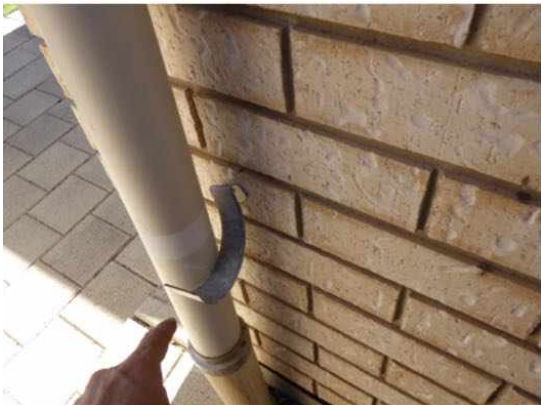
### Defects 3.02

Building:	Building 1
Location:	All External Areas
Finding:	Building element - Damaged/ Loose from its original fixing.
Information:	At the time of inspection it was noticed that few building elements were damaged / loose from its original fixing around the property.

Breakage occurs generally when the building materials have either aged and decayed, or as a result of damage (accidental or deliberate).

Repair and/or replacement of broken elements is advised to ensure that additional secondary defects do not arise as a consequence. Such works are necessary, as all building elements play a key role in the operation and function of the overall structure and its performance.

A relevant tradesperson should be appointed to repair or replace the affected building element prior to any subsequent damage being caused.

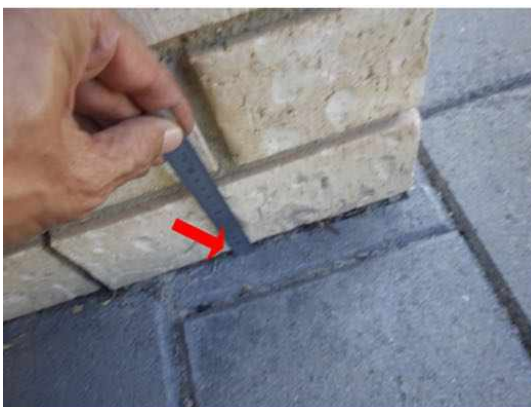
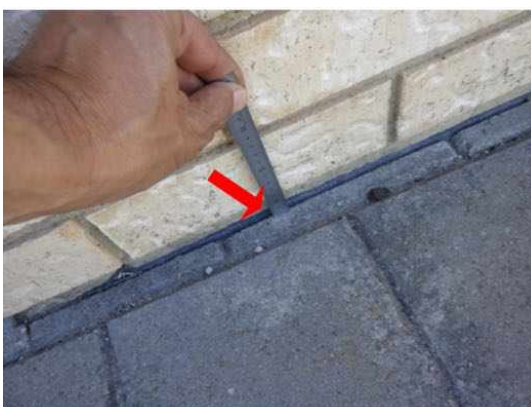
Defects 3.03

Building: Building 1  
Location: All External Areas  
Finding: Slab Edge - Exposure compromised  
Information: At the time of inspection it was noticed that slab edge exposure has been compromised in few sections around the property.

If the slab edge is not properly exposed there is a high risk of termite attack. Sometimes, in order to determine the type of slab, a suitably qualified person such as an architect or builder may be required to consult the construction plans.

Where the slab edge cannot be properly inspected, it is highly recommended that termite or timber pest inspections be carried out every 6-12 months to aid protection of the property against infestation.

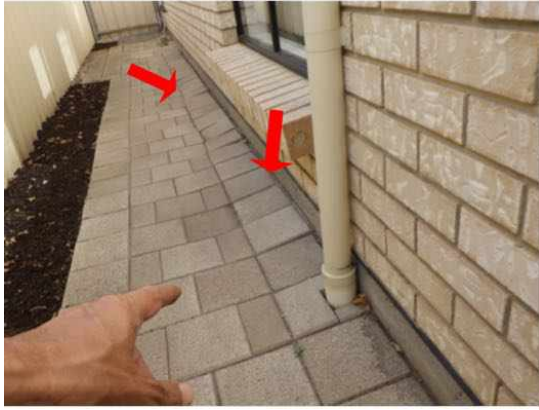
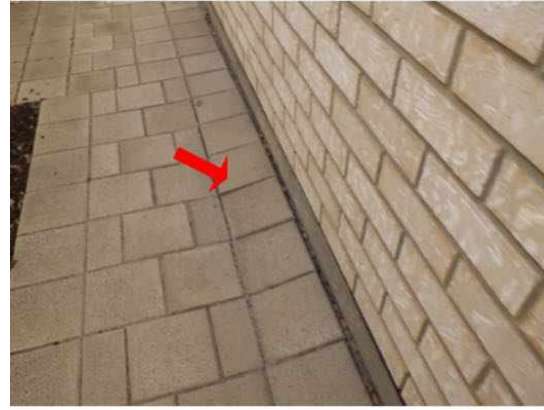
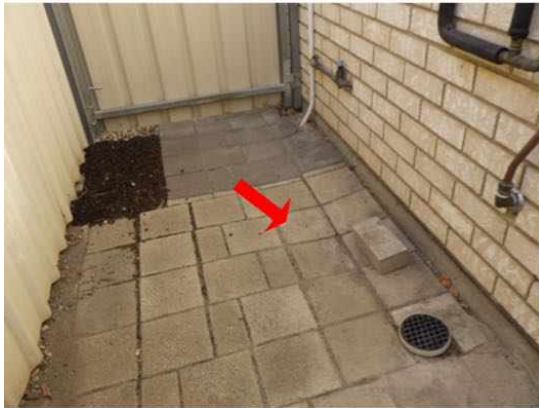
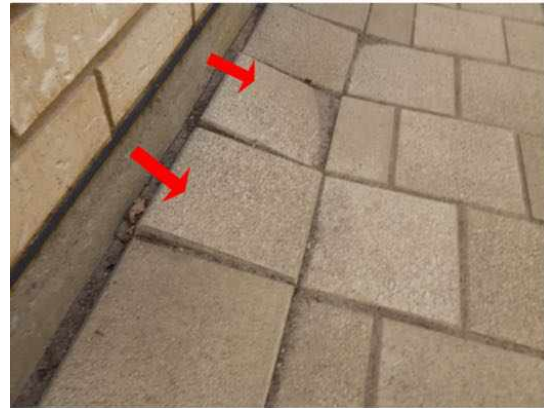
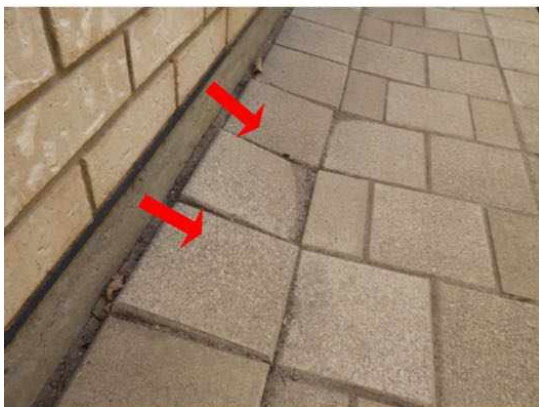
### Defects 3.04

Building: Building 1  
Location: All External Areas  
Finding: Paving - Uneven  
Information: Sections of the external paved area are uneven, creating a potential trip hazard. It appears as though the area has been subject to rough installation, or that paving sections have lifted due to movements in the foundation of the property.

Where paving creates a trip hazard, personal injury may ensue if due caution is not taken by all persons within this area.

Re-paving of the area is required as soon as possible to remedy this situation. Further consultation with a specialist concreter is advised.

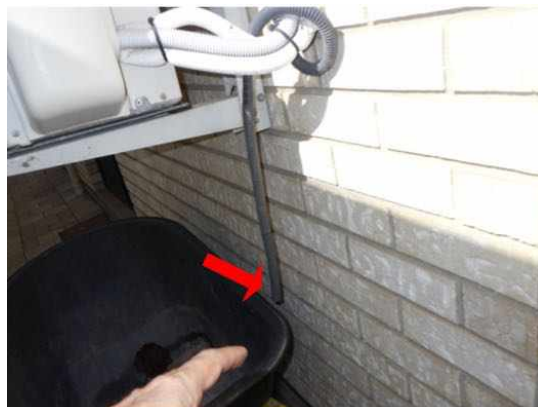
### Defects 3.05

Building:	Building 1
Location:	All External Areas
Finding:	Air conditioner - Disconnected overflow
Information:	The Air Conditioner (A/C) overflow was found to be disconnected from storm water drainage and is creating excessive moisture in the surrounding area.

Such leaking creates an environment which is conducive to an array of defects, including water damage to associated building elements and the attraction of termite or timber pest infestation.

It is highly recommended that a licensed plumber be appointed to connect the A/C overflow in order to prevent such an environment from being created. These minor works should be carried out as soon as possible.

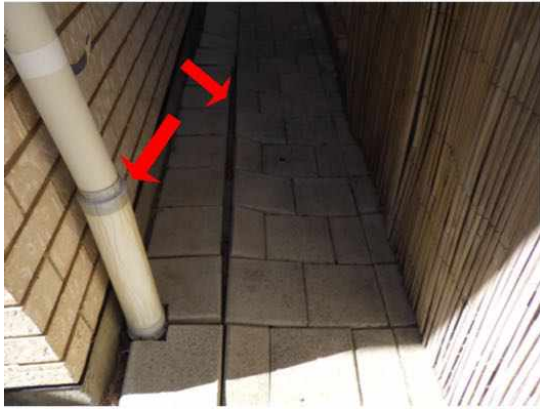
### Defects 3.06

Building:	Building 1
Location:	All External Areas
Finding:	External Walls – Rear – Downpipes (Misaligned / Loose)
Information:	At the time of inspection, it was noted that the downpipe servicing the rear external wall was misaligned and loose from its original fixing. This condition may affect the effective discharge of roof stormwater and may contribute to moisture-related issues to adjacent building elements.

In addition, it was observed that the external paving in this area is uneven, creating a potential trip hazard and increasing the risk of water ponding against the building.

Misalignment or damage to building components may occur due to age-related deterioration, movement, impact damage, or inadequate original installation. If left unrectified, such conditions may lead to further deterioration and the development of secondary defects, including moisture ingress and damage to surrounding structures.

Repair and/or replacement of the affected components is recommended to restore

proper function and to minimise the risk of further damage. All building elements play an important role in the overall performance of the structure.

It is recommended that a suitably qualified and experienced tradesperson be engaged to realign and secure the downpipe and to assess and rectify the uneven paving as required, prior to any additional damage occurring.

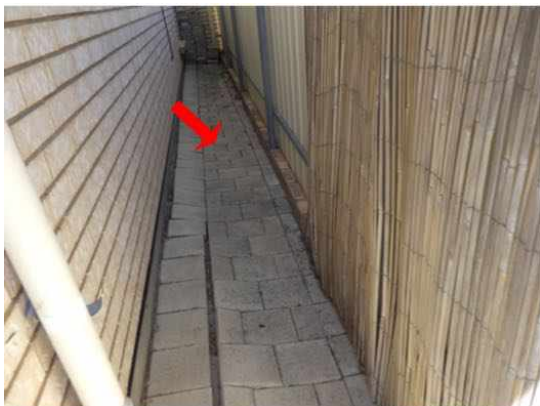
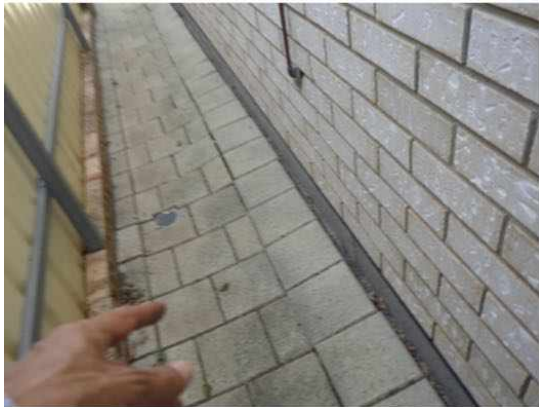
### Defects 3.07

Building:	Building 1
Location:	All External Areas
Finding:	Water pooling - against property
Information:	Water appears to be pooling against the house. It is suspected that this is a result of poor site drainage but may also be due to excessive moisture from an unidentified source.

Where water is pooling against the house water damage to the external wall cladding is imminent.

Such water pooling also increases the risk of termite activity and the development of fungal decay in the area.

Consult a Licensed Plumber regarding the cost of potential site drainage rectification works.

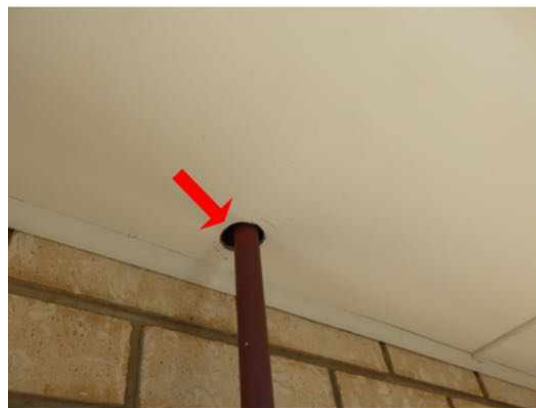
### Defects 3.08

Building:	Building 1
Location:	All External Areas
Finding:	Surface - Holes
Information:	At the time of inspection it was noticed that holes in the eaves in this area.

Holes in surfaces are generally indicative of impact damage, whether accidental or deliberate, or a failing of the surface material.

Where holes are apparent in the surface of a building material, the surface is no longer sealed against water penetration or further impact damage, which may lead to additional damage to the surrounding surface.

Repair or replacement of the affected building element is recommended as soon as possible to ensure that any secondary defects are minimised. A qualified carpenter or general handyperson should be appointed to perform these works.

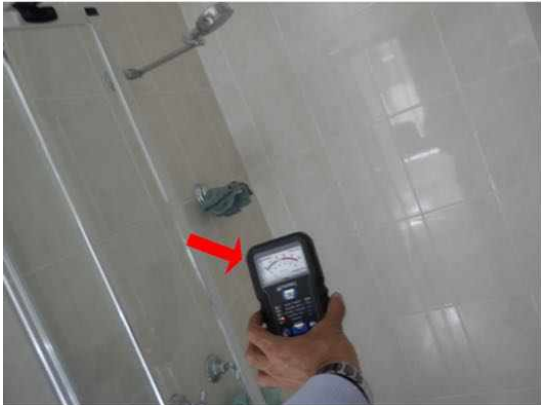
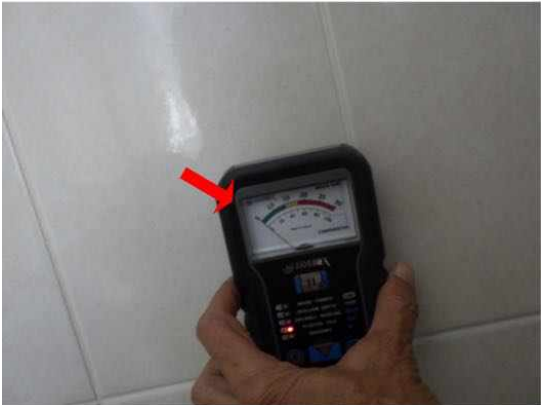
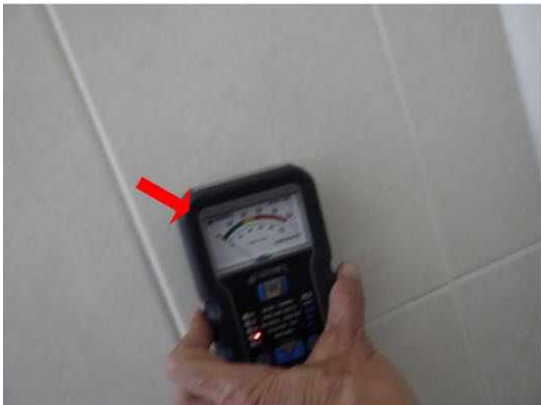
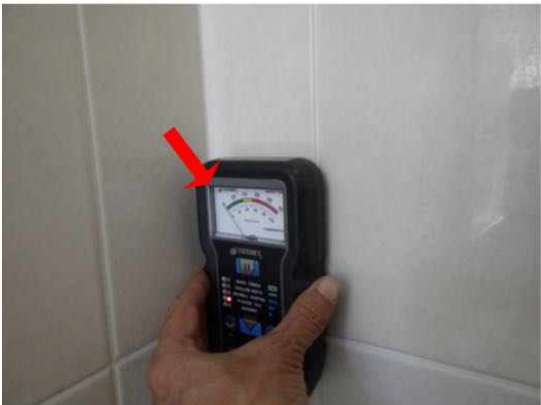
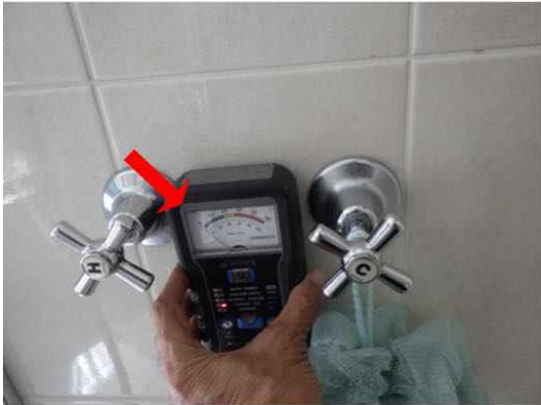
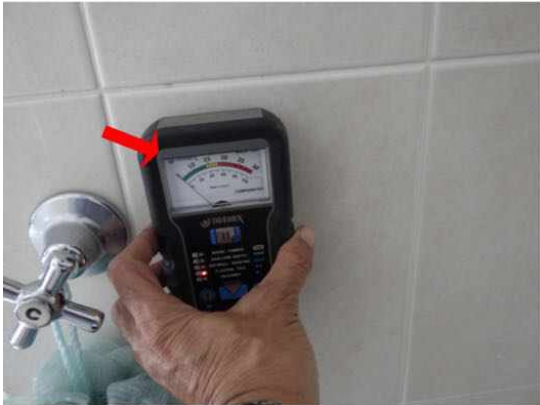
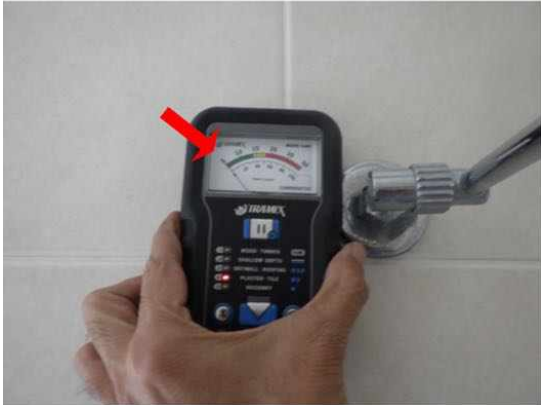
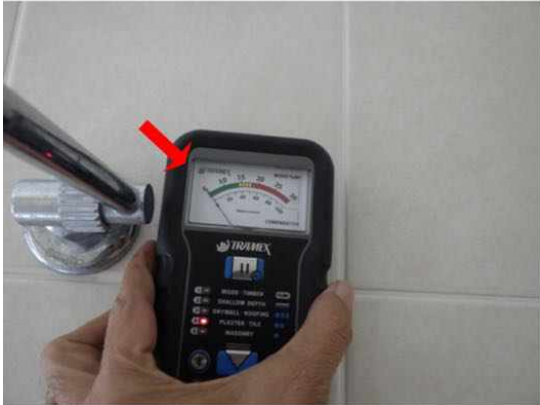
Damp (or structural damp) refers to the presence of unwanted moisture in the structure of a building, either as the result of intrusion from outside, or condensation

from within the structure. In the shower area, internal water leaks or other sources of excessive moisture are generally the cause of damp.

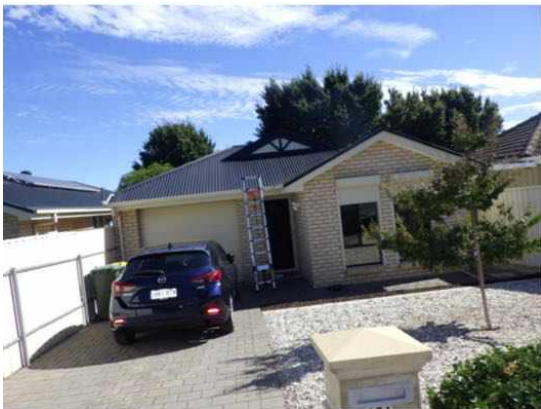
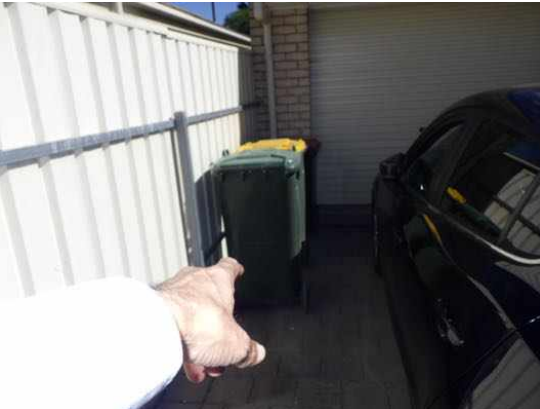
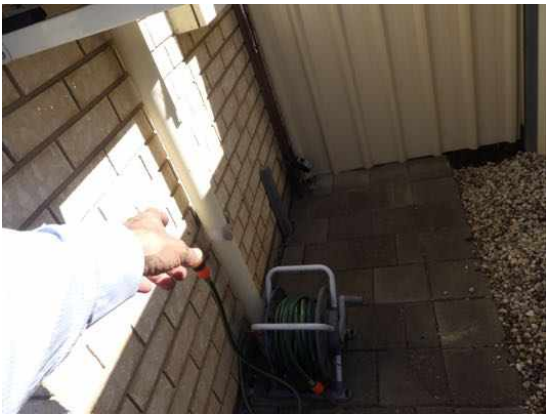
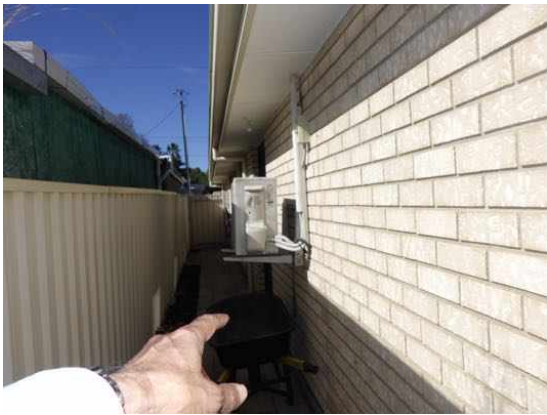
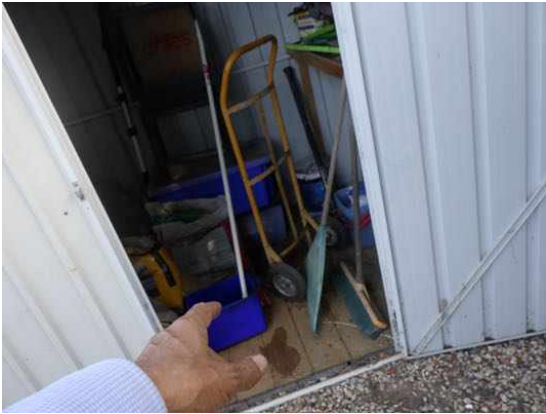
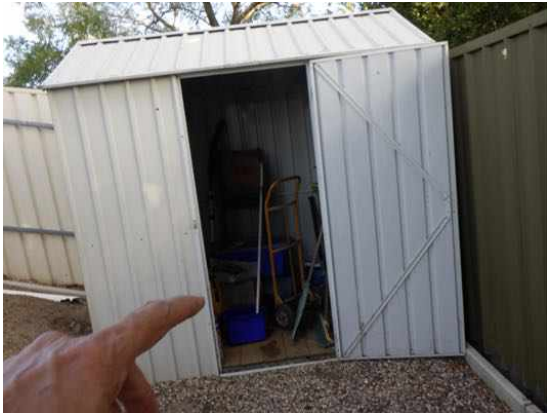
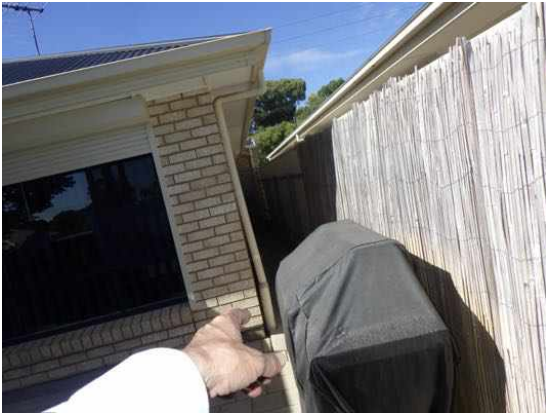
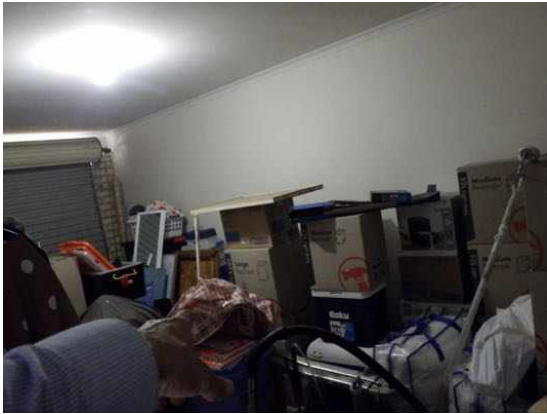
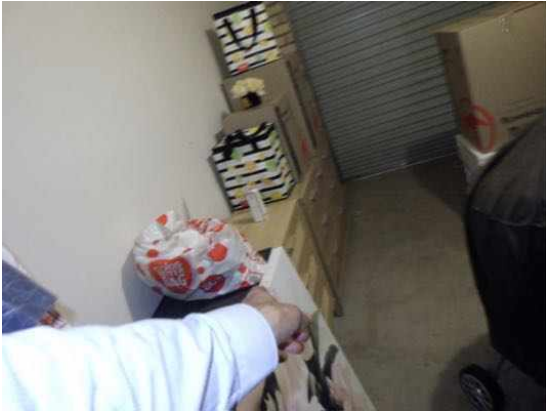
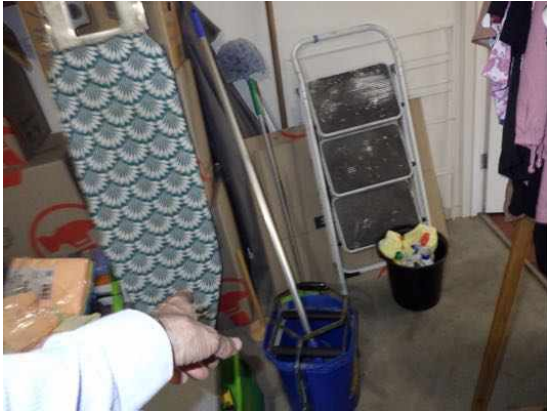
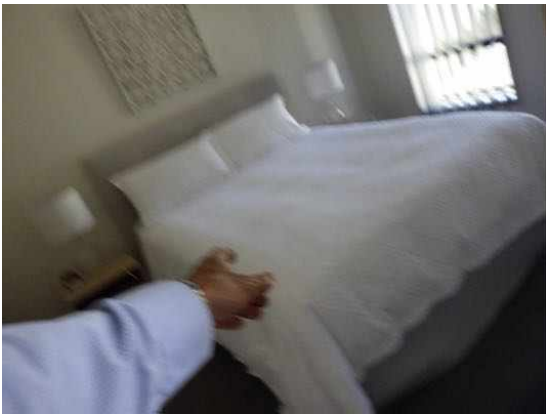
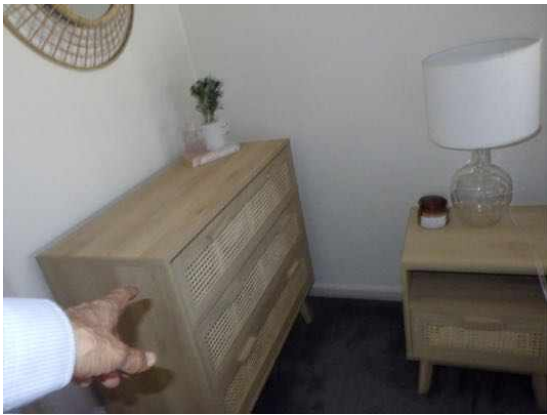
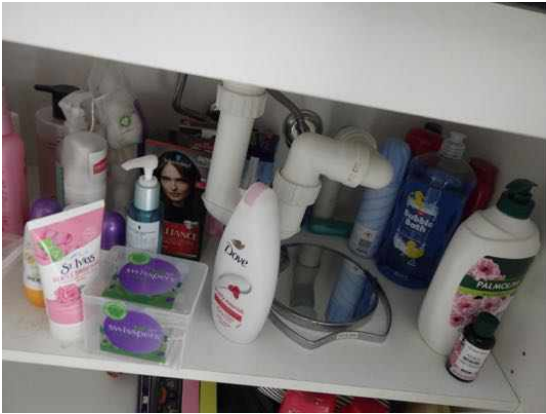
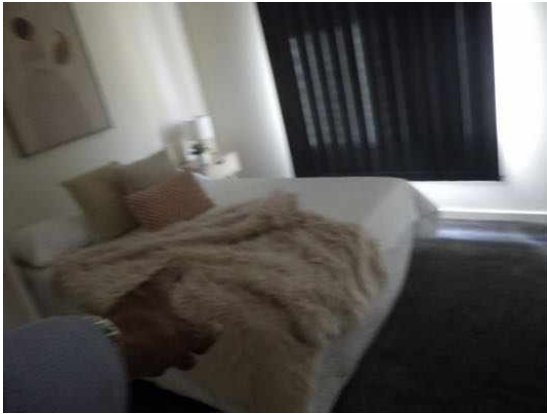
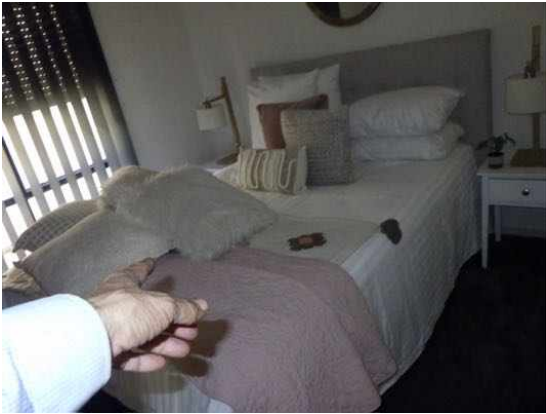
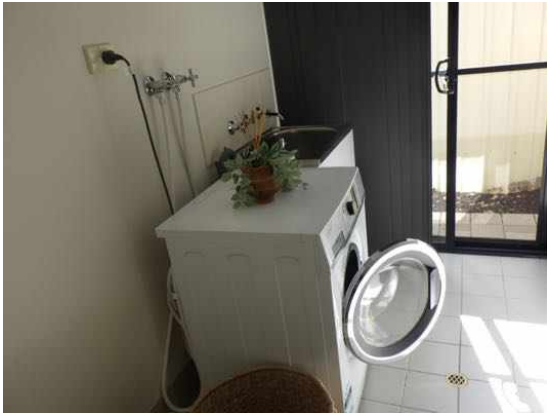
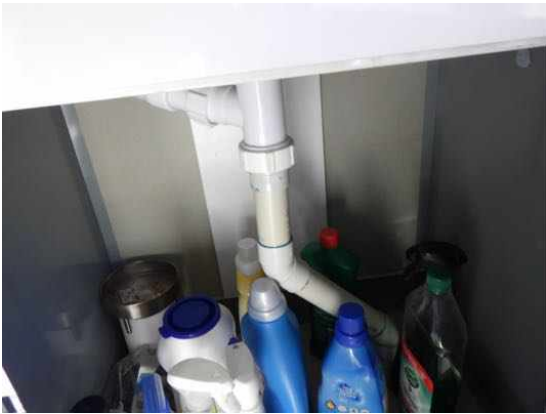
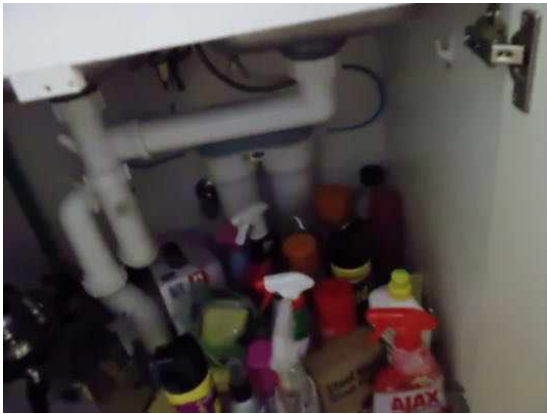
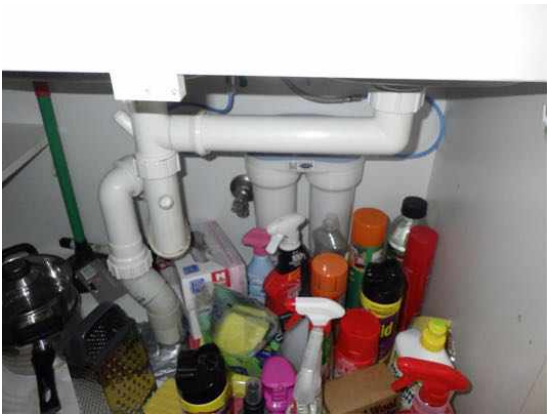
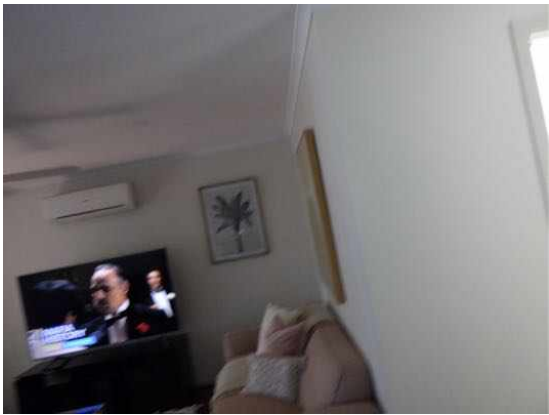
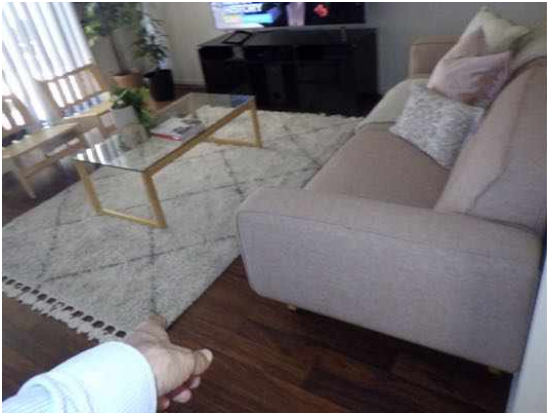
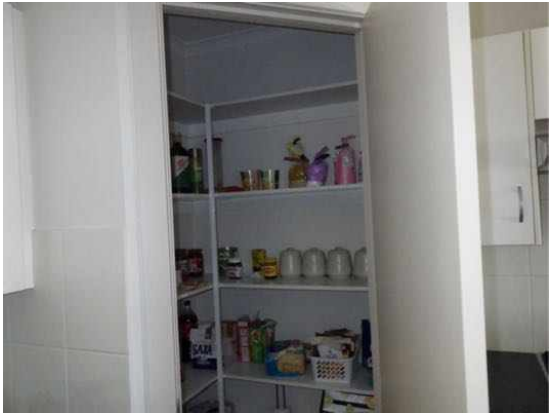
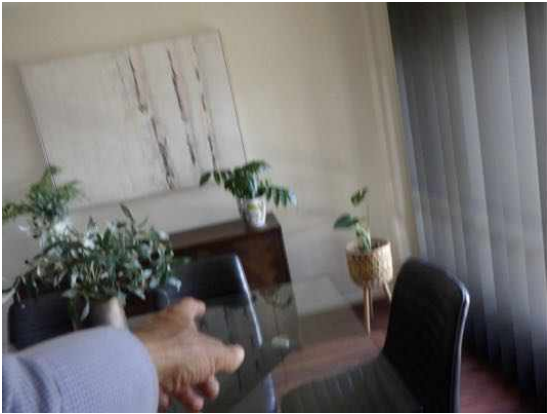
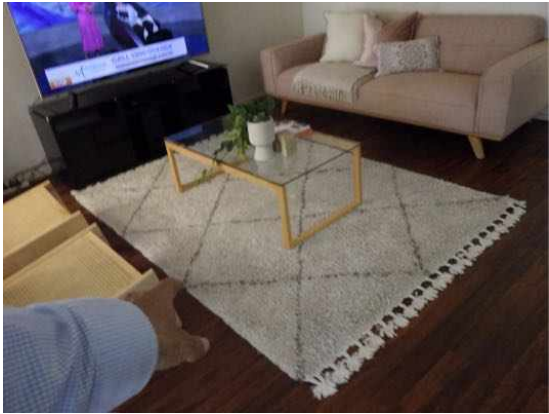
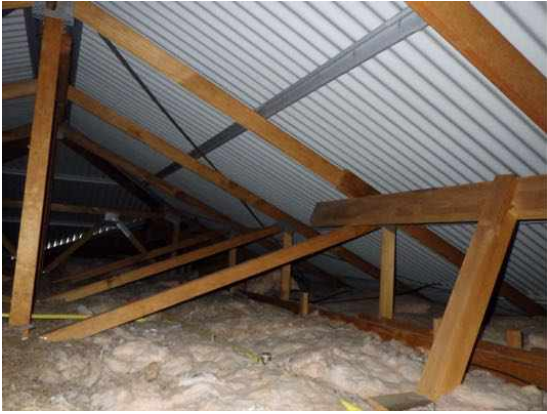
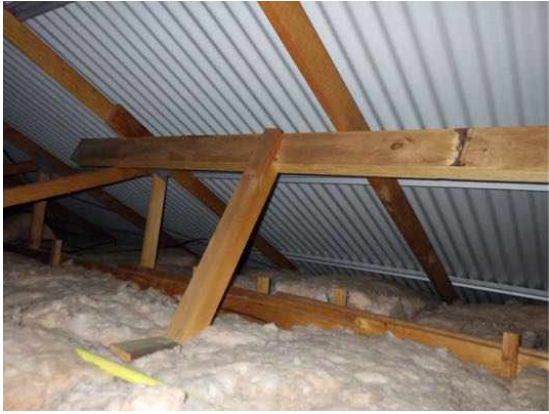
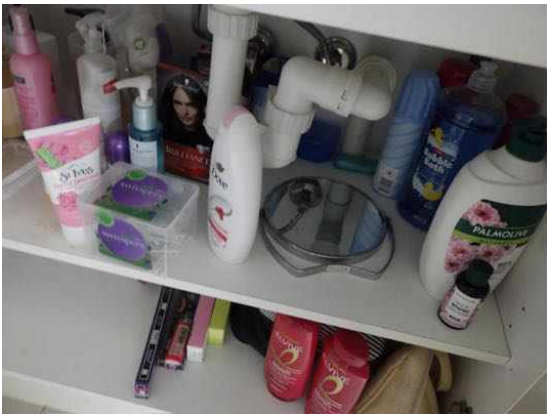
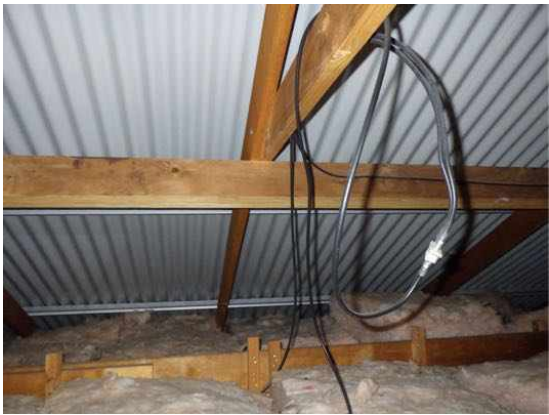
Building: Building 1  
Location: All Areas  
Finding: Additional Photos - Obstructions and Limitations  
Information: These photographs are an indication of the obstructions and limitations which impeded full inspection of the property at the time of inspection. These obstructions can hide an array of defects and should be removed to allow full inspection to be carried out. A re-inspection is recommended once the areas are made accessible.

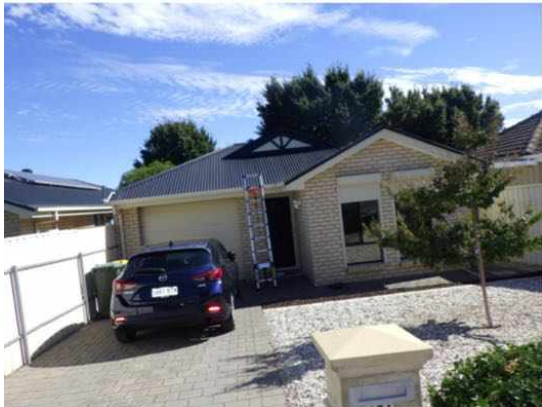
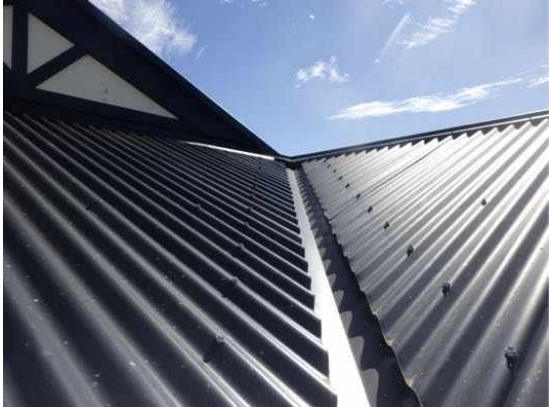
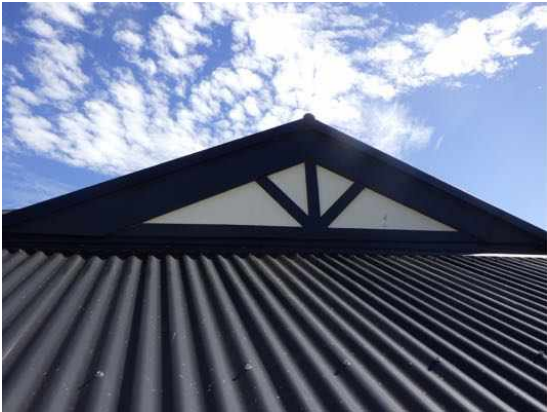
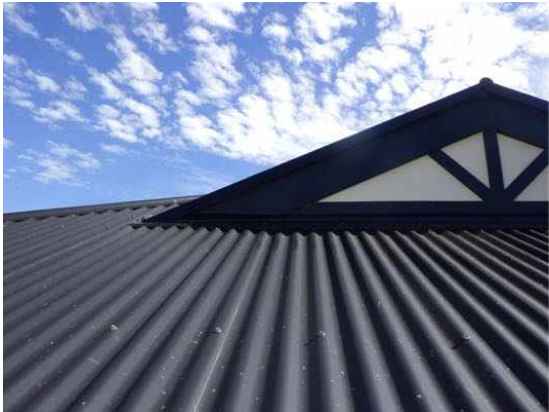
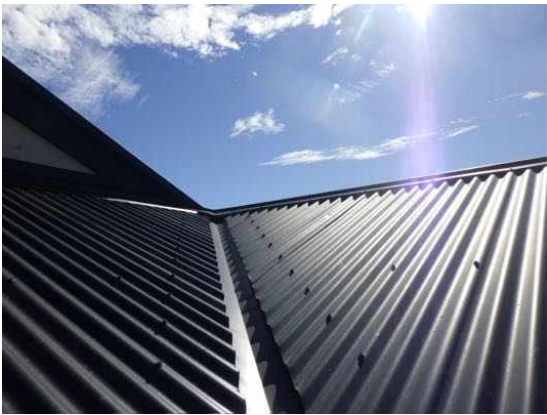
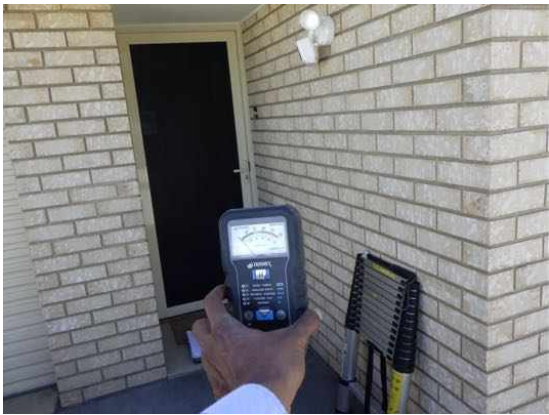
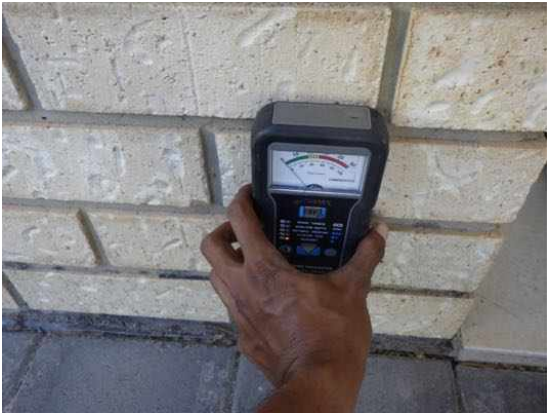
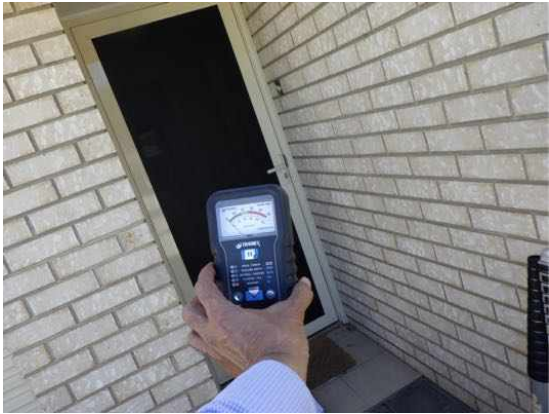
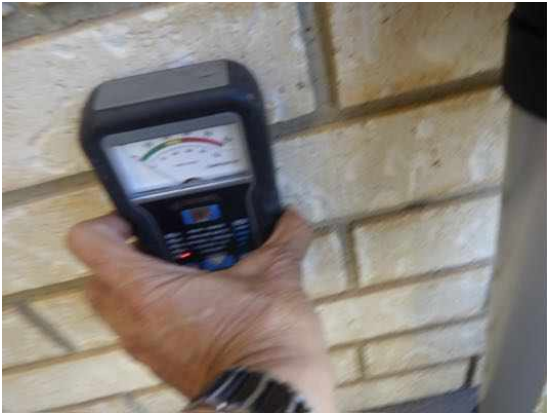
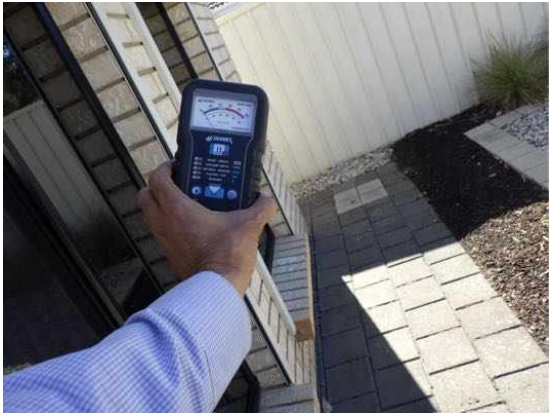
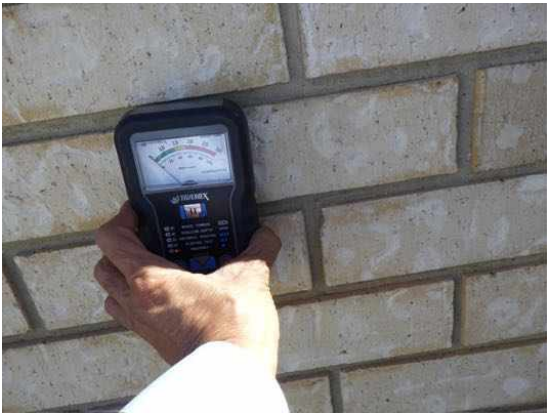
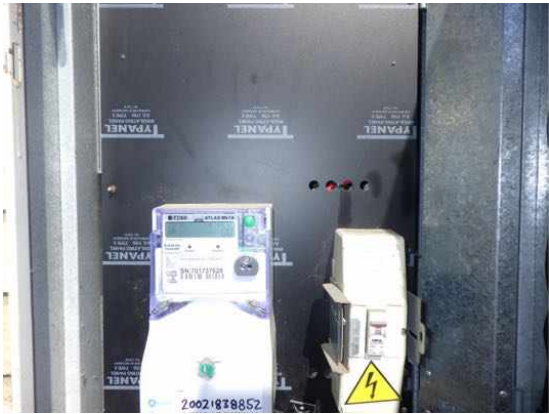
Building: Building 1  
Location: All Areas  
Finding: Additional Photos  
Information: Additional photos are provided for your general reference
