## Building Inspection Report

Inspection Date: Sat, 21 Feb 2026

Property Address: 17A Doctors Rd, Morphett Vale SA 5162,  
Australia

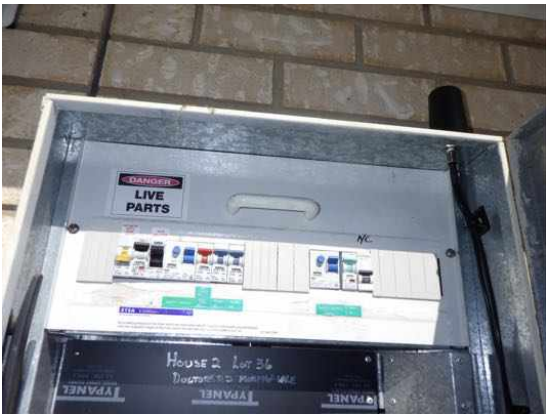
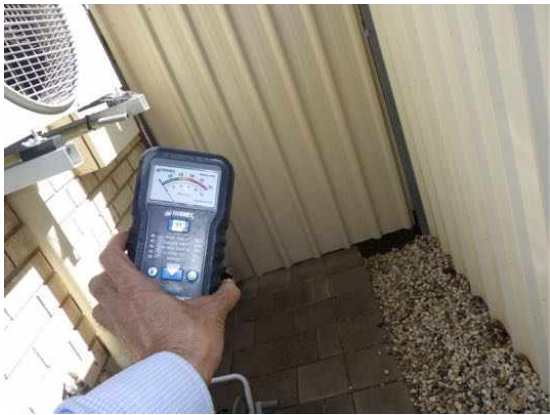
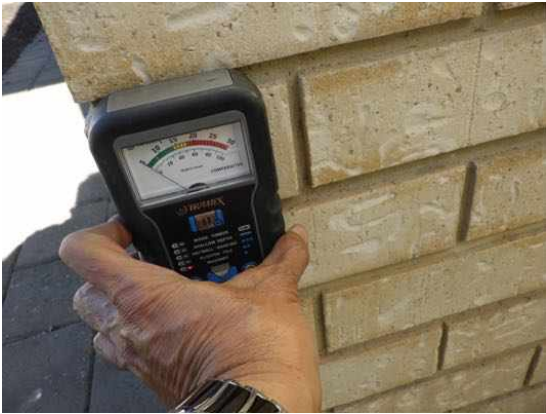
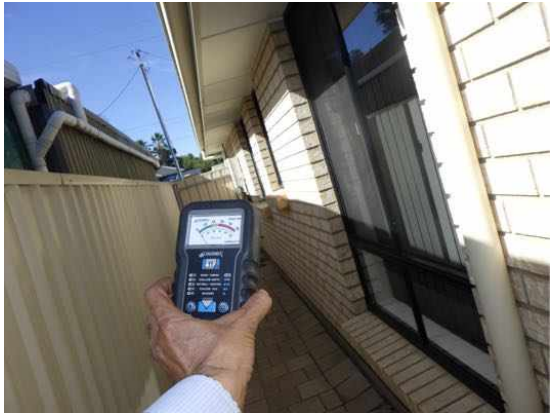
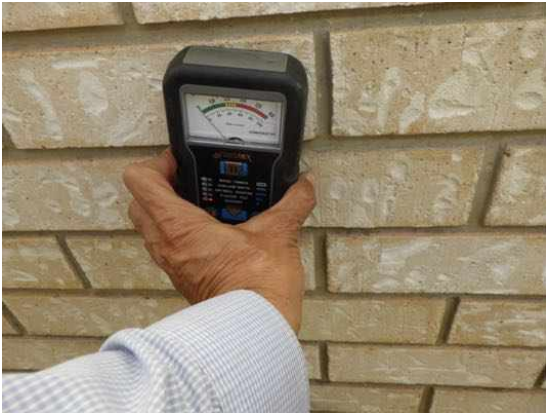
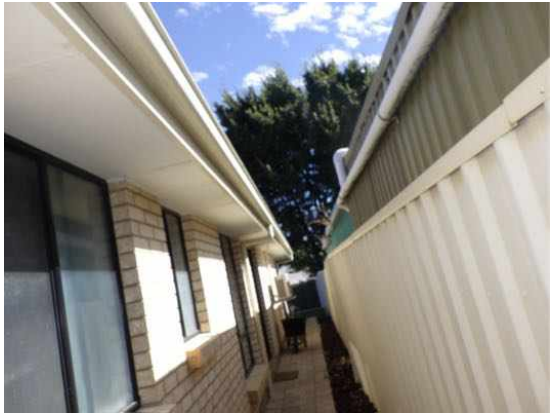
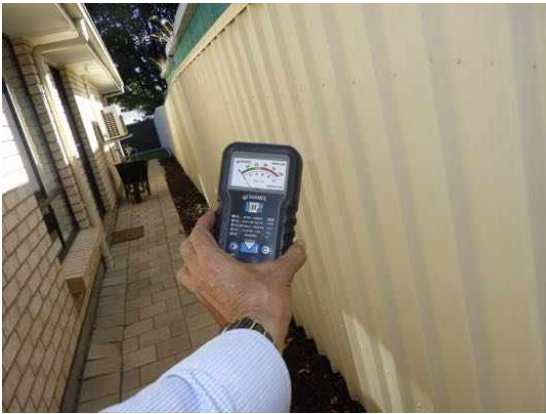
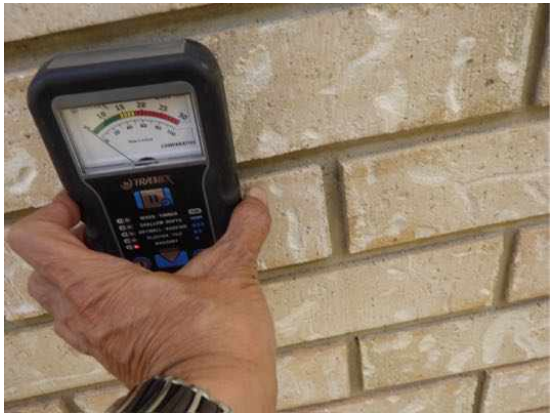
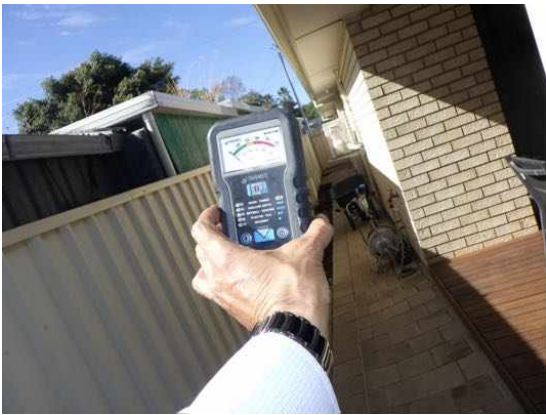
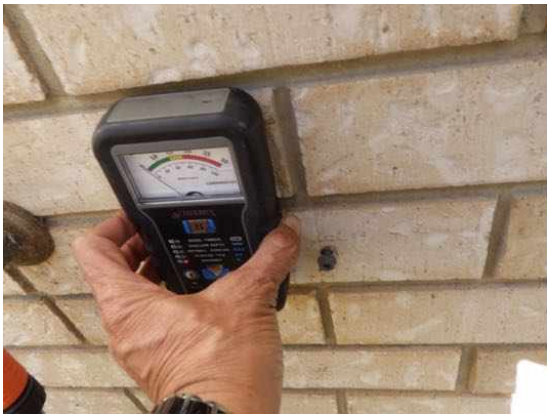
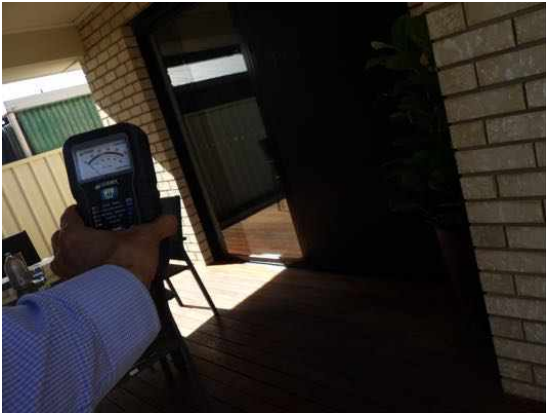
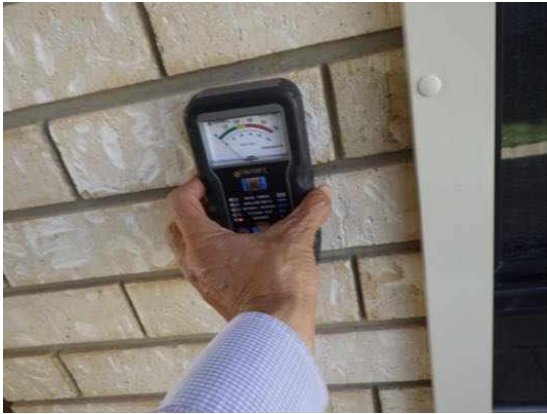
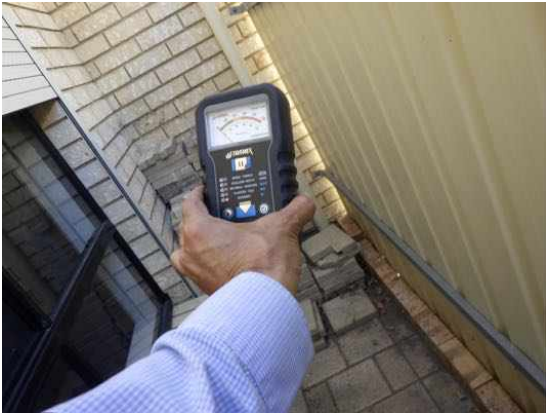
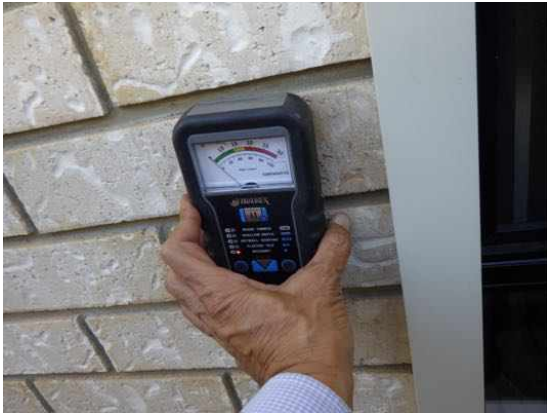
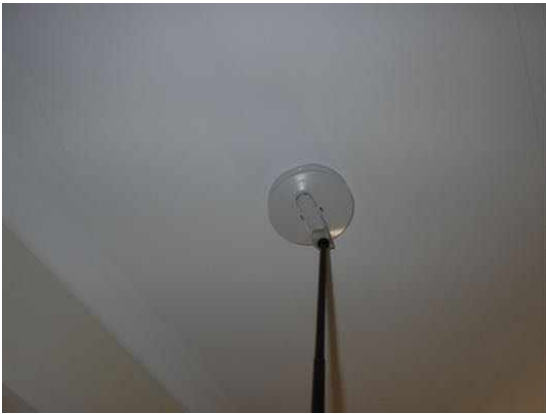
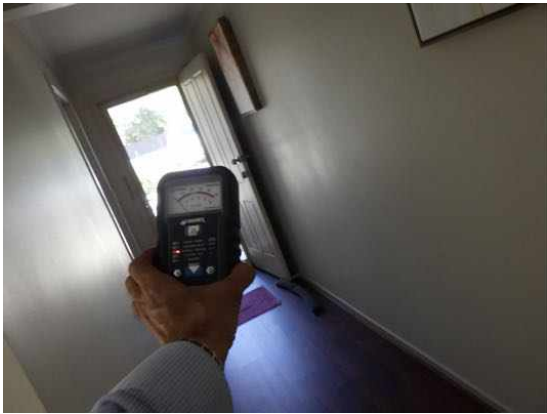
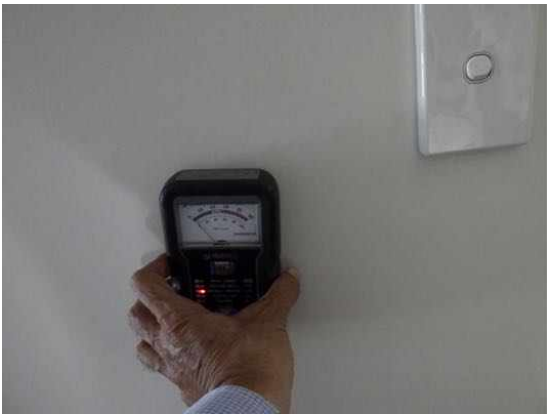
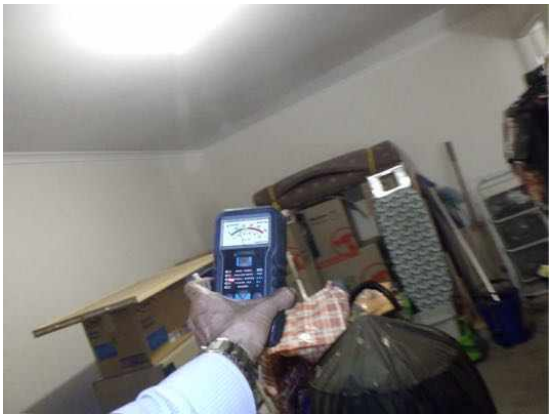
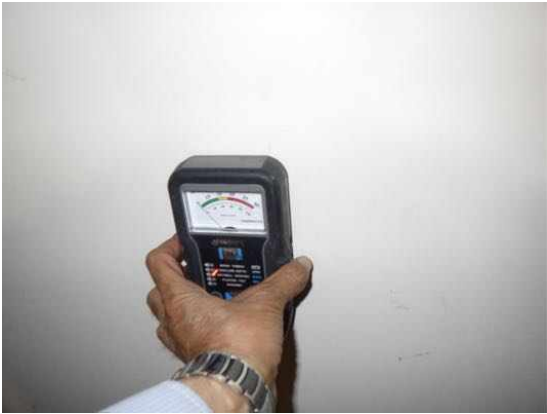
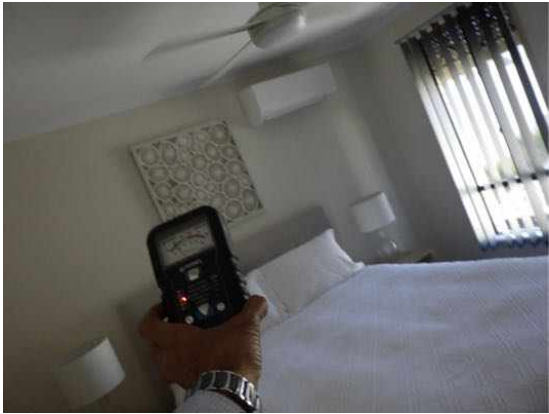
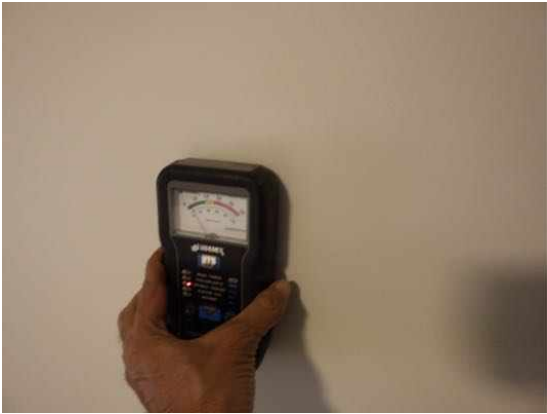
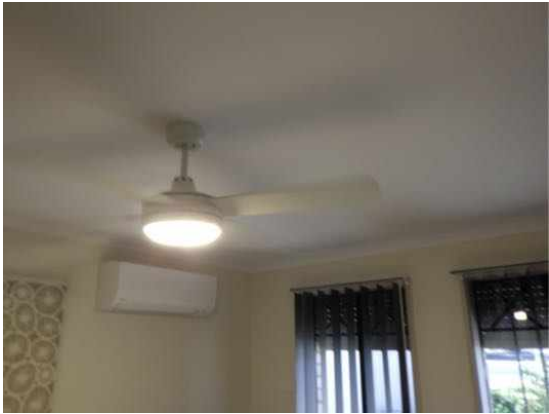
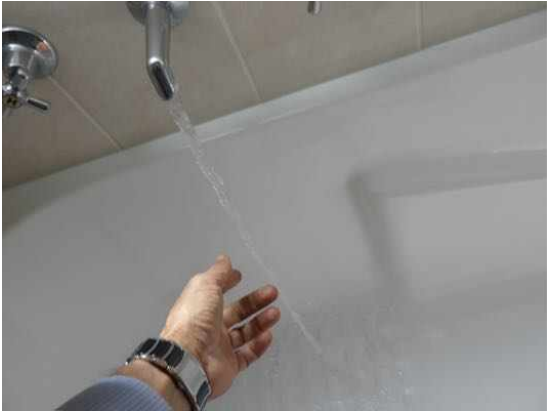
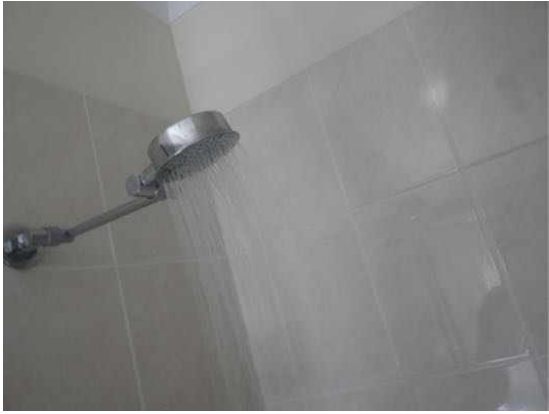
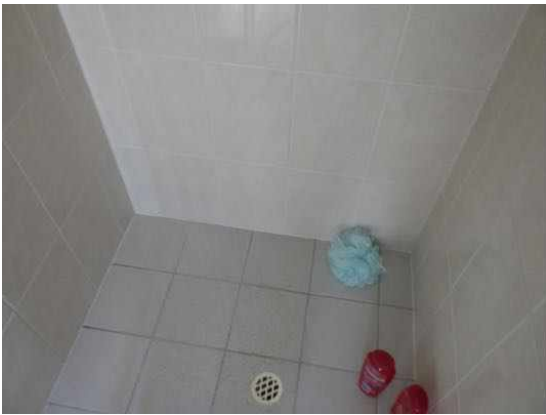
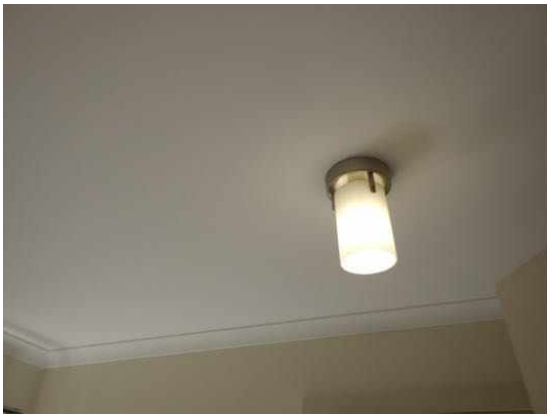
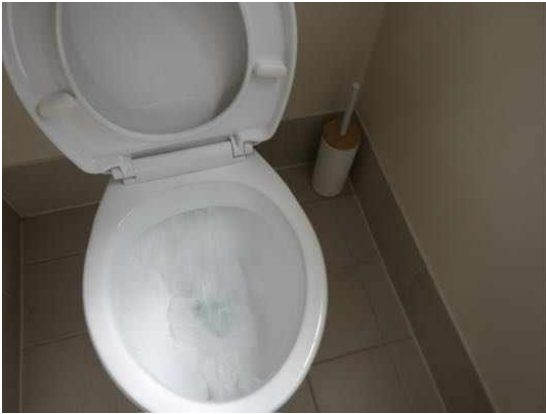
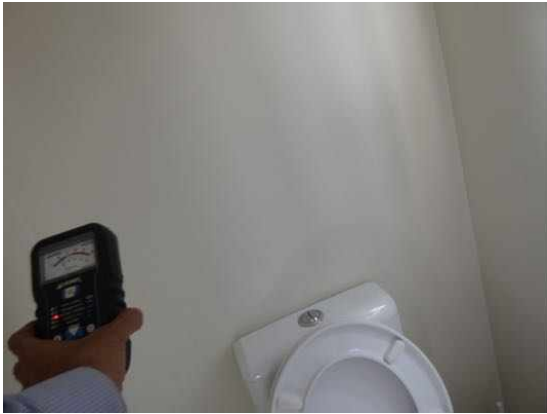
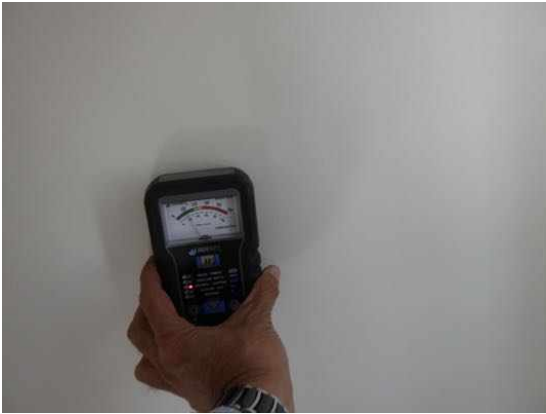
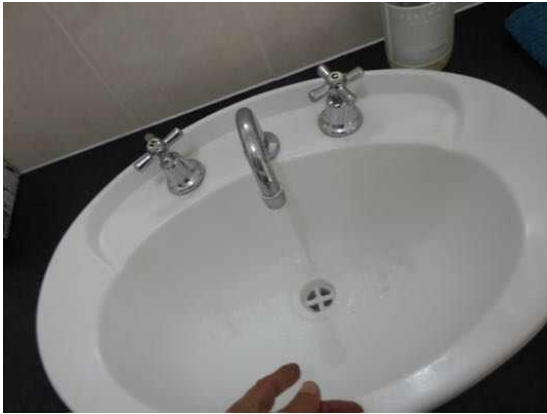
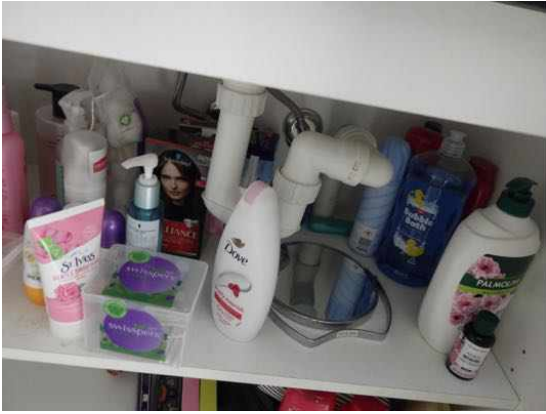
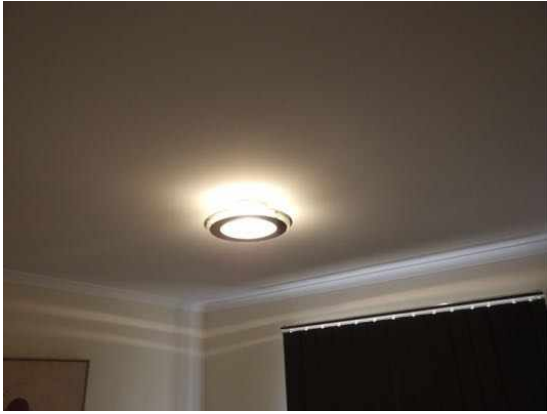
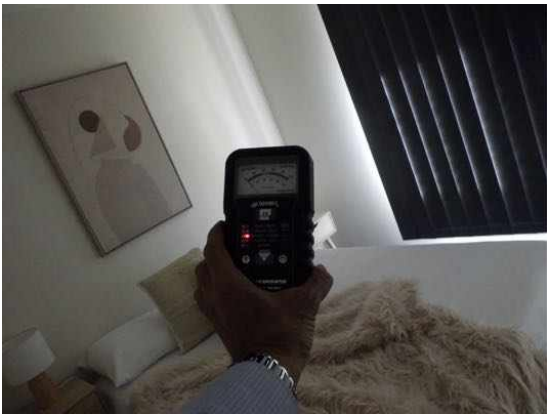
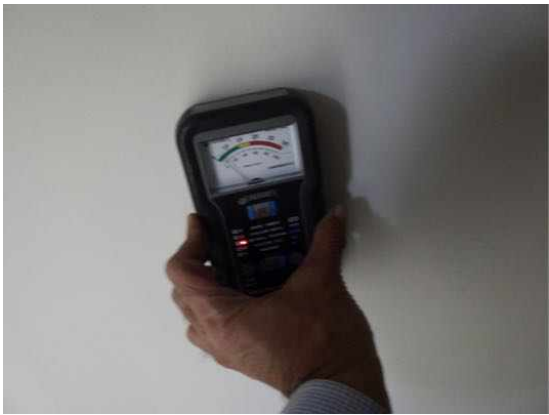
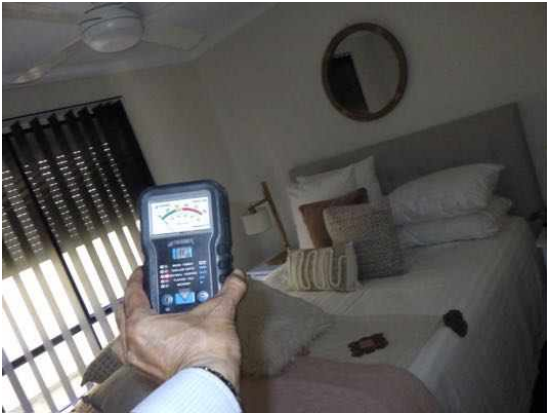
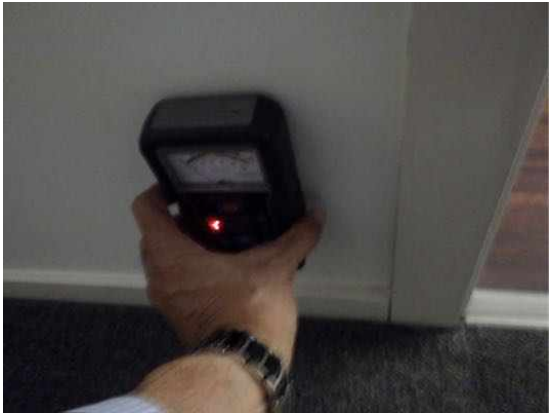
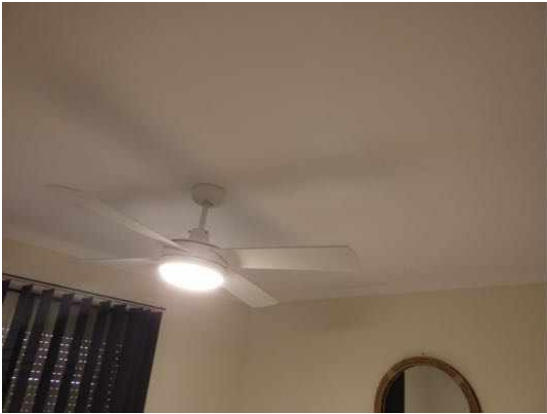
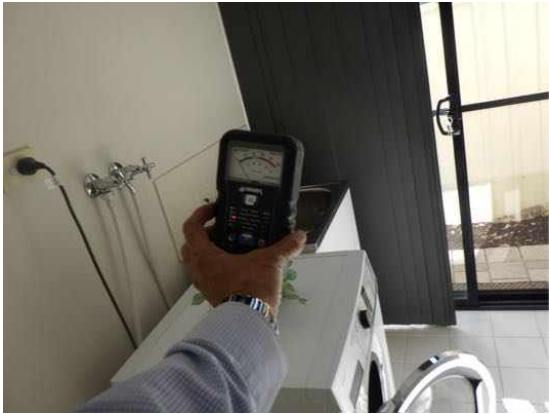
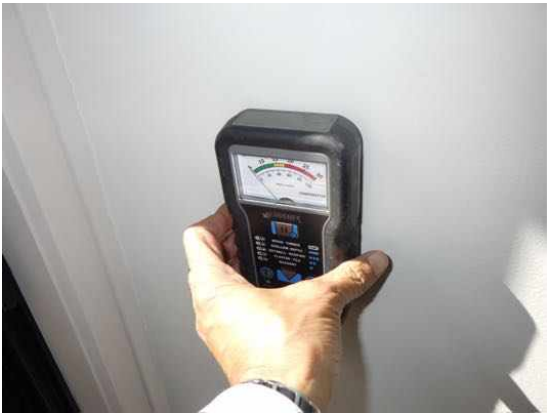
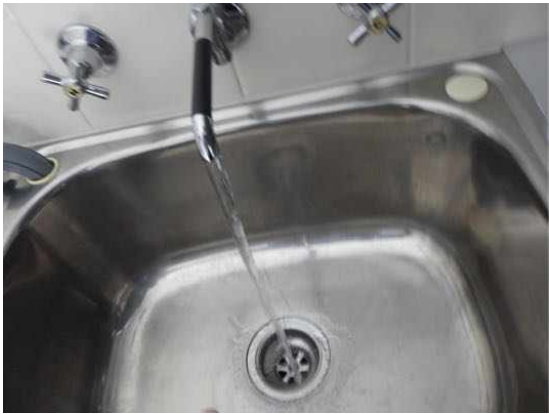
Building: Building 1  
Location: All Areas  
Finding: Additional Photos - Obstructions and Limitations  
Information: These photographs are an indication of the obstructions and limitations which impeded full inspection of the property at the time of inspection. These obstructions can hide an array of defects and should be removed to allow full inspection to be carried out. A re-inspection is recommended once the areas are made accessible.
