Building and Timber Pest Inspection Report

Inspection Date: Tue, 3 Feb 2026

Property Address: 7 Mallee Ct, Thurgoona NSW 2640,
Australia

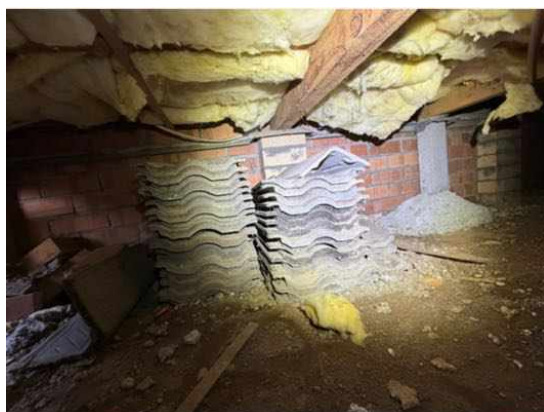
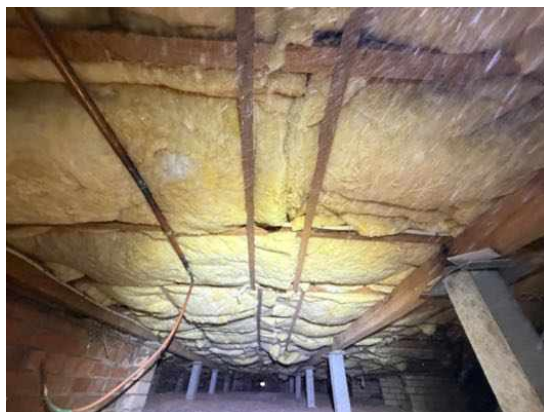
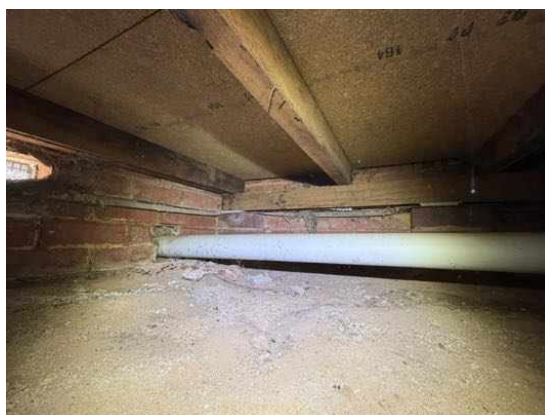
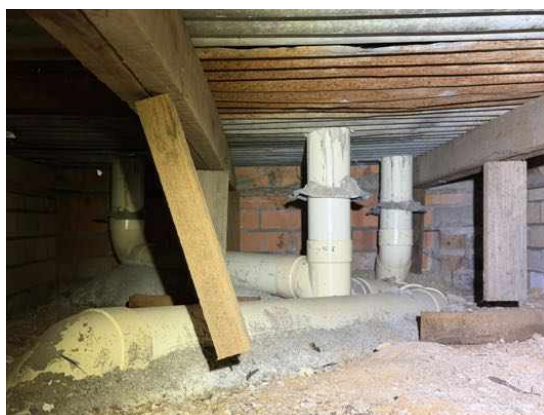
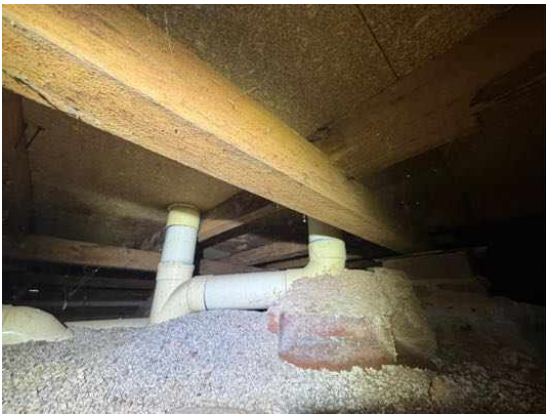
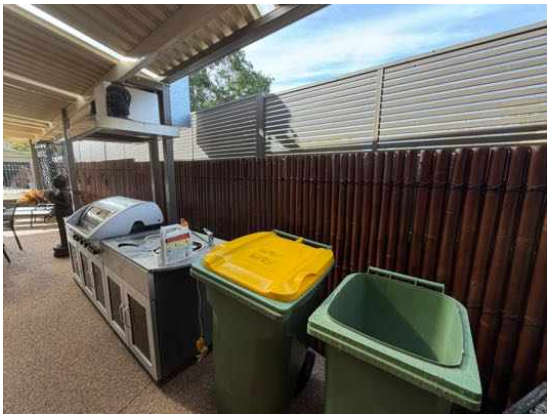
Building: Main Building
Location: All Areas
Finding: Additional Photos - Obstructions and Limitations
Information: These photographs are an indication of the obstructions and limitations which impeded full inspection of the property at the time of inspection. These obstructions can hide an array of defects and should be removed to allow full inspection to be carried out. A re-inspection is recommended once the areas are made accessible.
