# Building and Timber Pest Inspection Report

Inspection Date: Sat, 31 Jan 2026

Property Address: 113 Thompson St, Earlwood NSW 2206,  
Australia

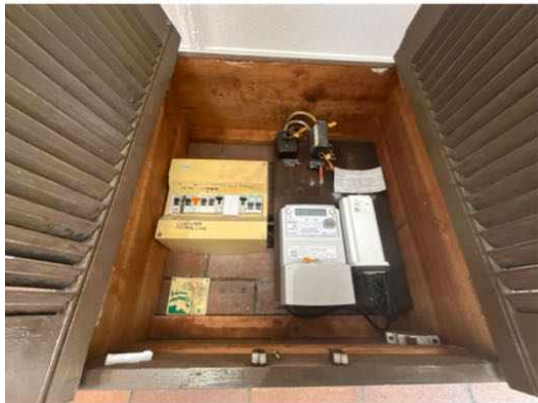
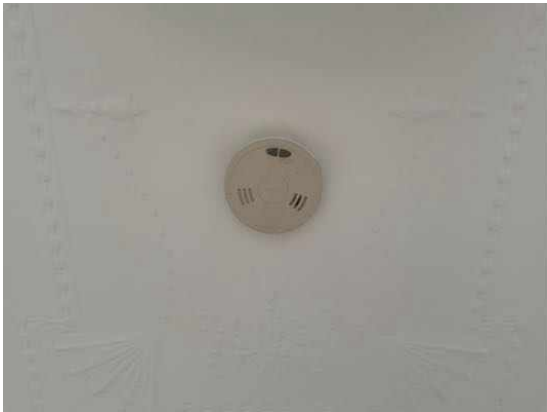
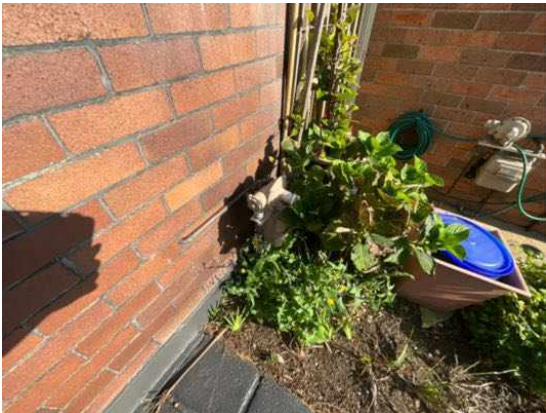
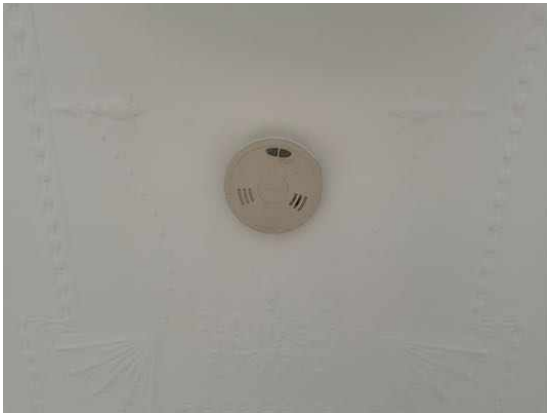
Building: Main Building  
Location: All Areas  
Finding: Photos Added  
Information: Additional photos are provided for your general reference.

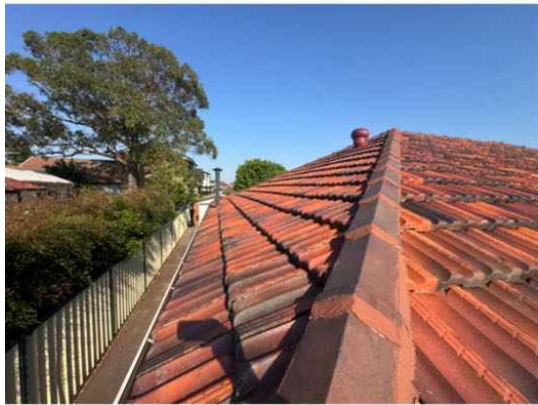
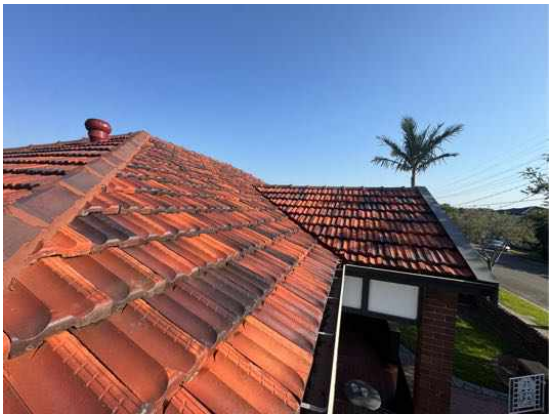
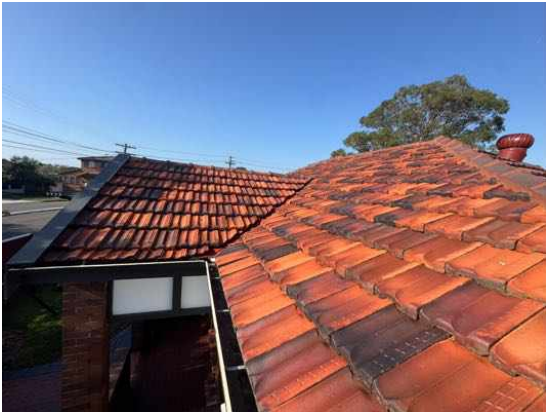
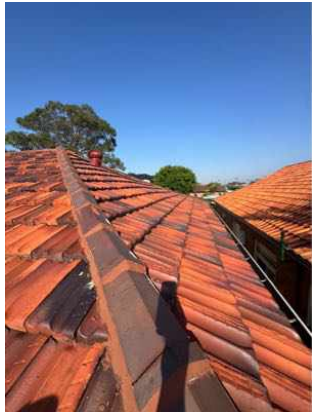
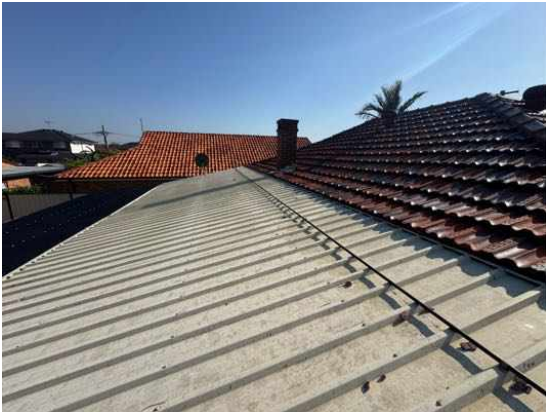
Building: Main Building  
Location: Roof Exterior  
Finding: Photos Added  
Information: Additional photos are provided for your general reference.

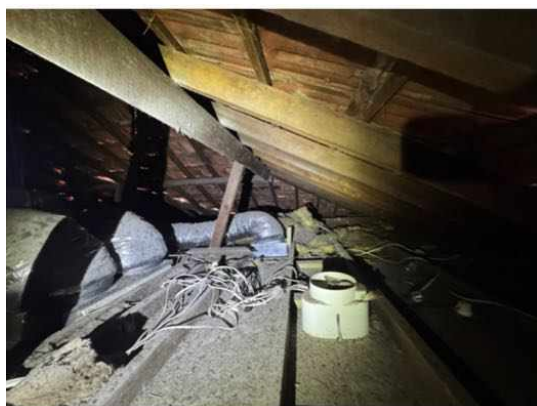
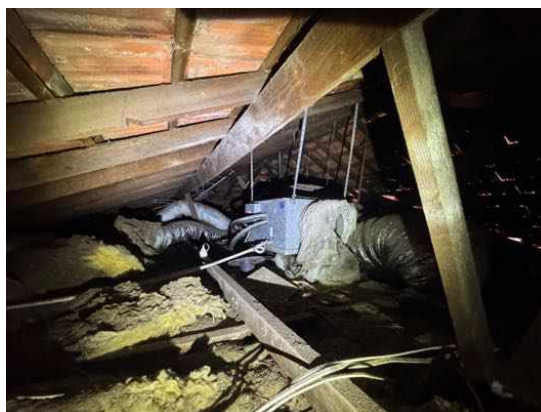
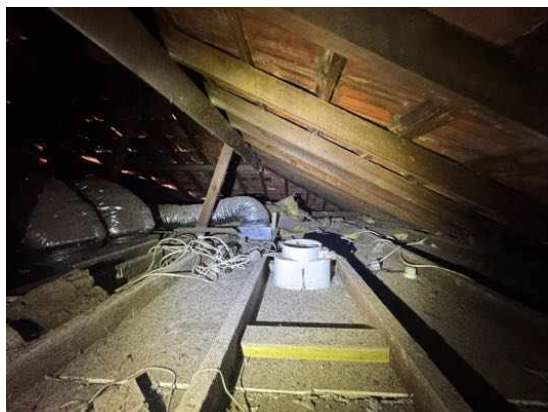
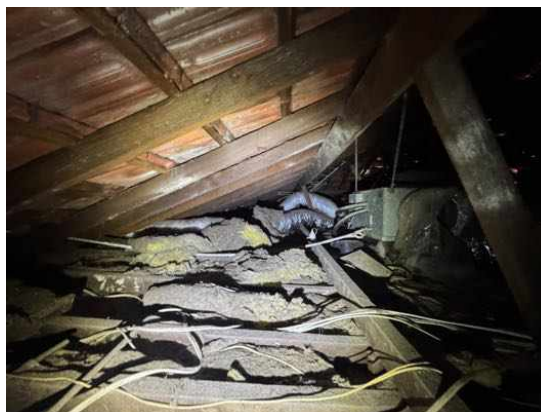
Building: Main Building  
Location: Roof Void  
Finding: Photos Added  
Information: Additional photos are provided for your general reference.
