Building Inspection Report

Inspection Date: Wed, 4 Feb 2026

Property Address: 29/17-19 Jenkins Rd, Carlingford NSW
2118, Australia

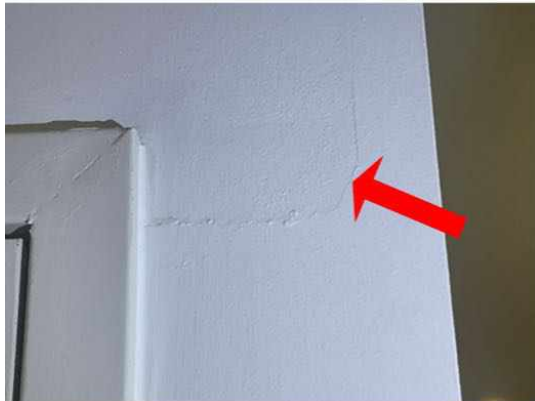
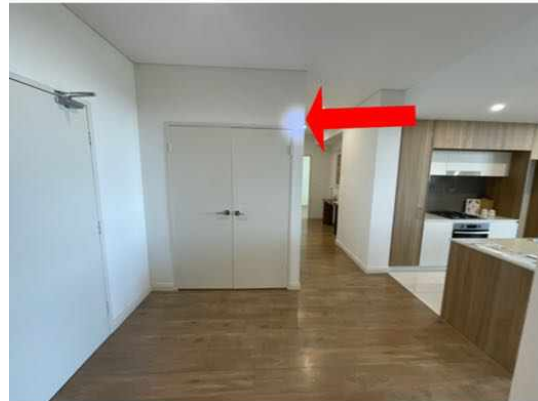
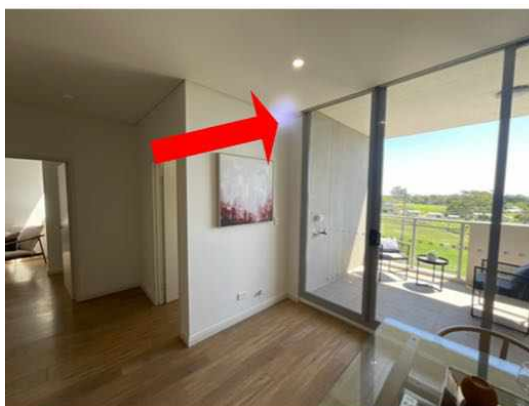
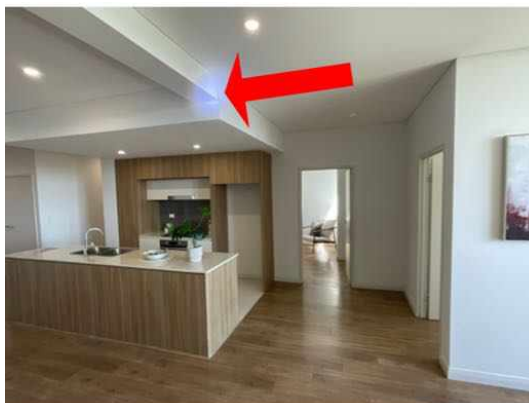
Defects 3.01

Building:	Main Building
Location:	All Internal Areas
Finding:	Cracking - Damage Category 1 - Fine (up to 1mm)
Information:	Although fine cracks are quite noticeable, they are often only considered to be an appearance defect, and usually do not indicate any structural damage. Generally, the cause of a fine crack is indicative of a separation between building materials and finishes (e.g. paint, plaster, etc.) along joins.

Cracking of this nature can generally be repaired with minor sanding, filling and/or repainting. Such works should be performed by a qualified painter or a general handyman.

Monitoring of all cracking should be conducted frequently. Always contact a building inspector should cracks widen, lengthen, or become more numerous.

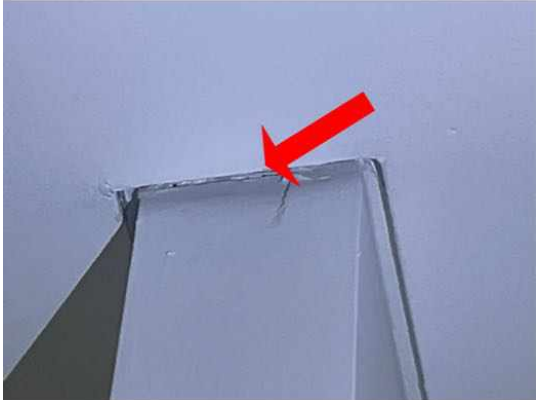
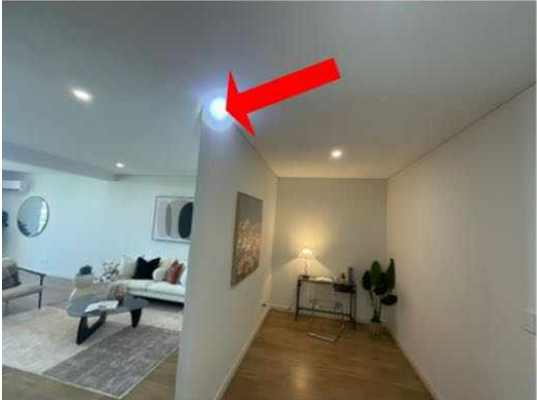
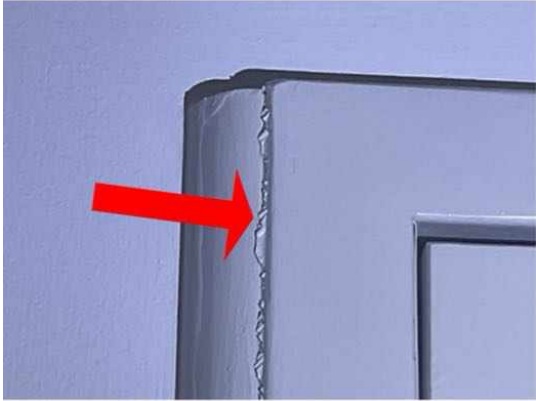
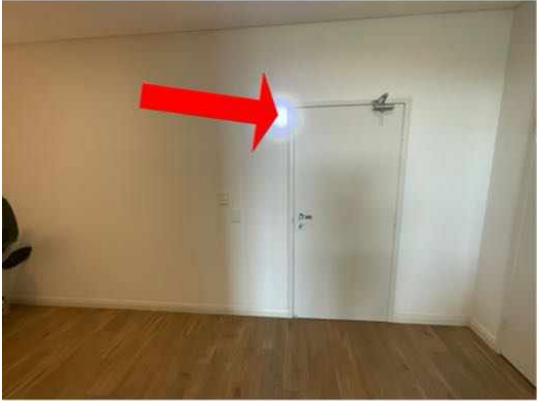
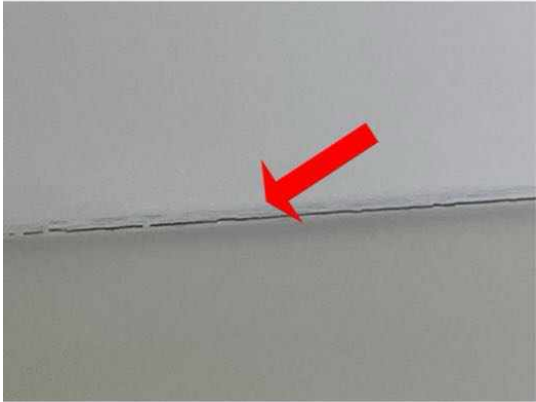
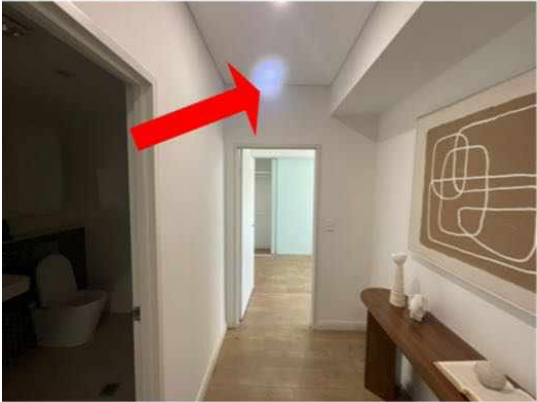
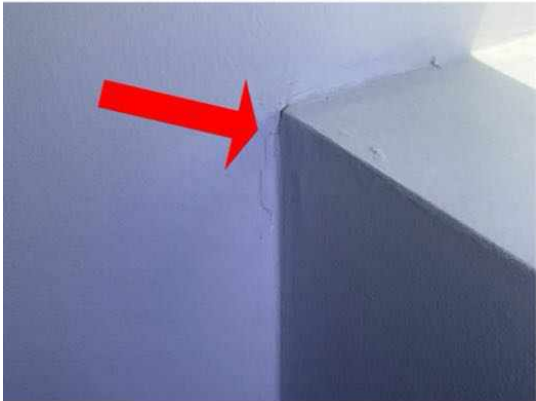
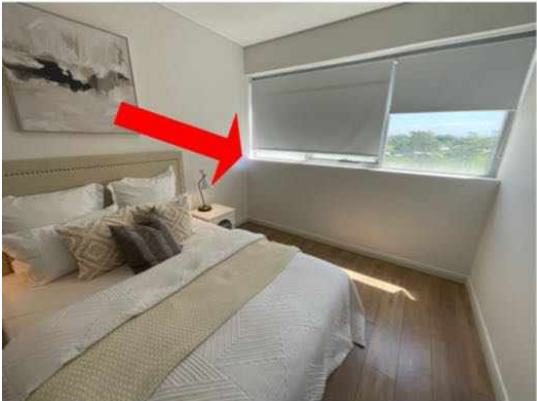
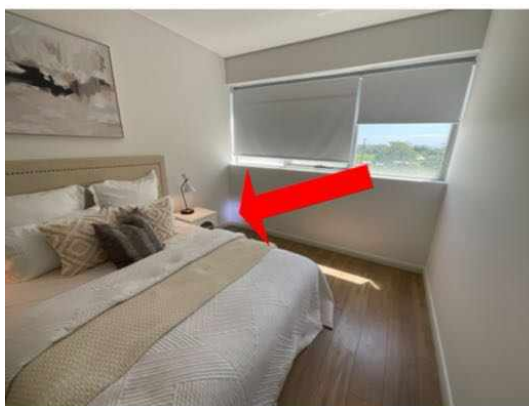
Defects 3.02

Building:	Main Building
Location:	All Internal Areas
Finding:	Paint finish - Substandard, Wear and Tear
Information:	The paint finish in this area was found to have been completed to a substandard level or wear and tear as the normal deterioration of a property from ordinary, everyday use. Exposure to the elements, time, as well as day to day living can cause fair wear and tear.

If this applies, further areas of poor and incomplete finishes could develop over time. Furthermore, substandard, wear and tear paint finishes in areas exposed to moisture, e.g. external areas or wet areas, could lead to deterioration of underlying building materials.

Substandard, wear and tear paint finishes should be sanded back, filled, leveled and repainted, as applicable. Where inadequate paint protection has led to the deterioration of the associated building element, repair and/or replacement of this building element may be required.

A painting contractor should be appointed as soon as possible to perform necessary works to aid the appearance of the affected area and to ensure that the area is protected against further deterioration. Alternatively, the homeowner following manufacturer instructions may be able to provide this service.

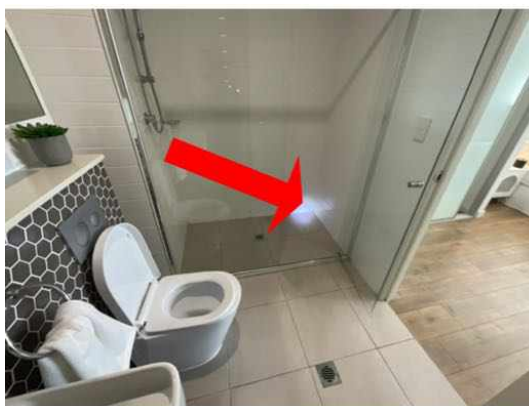
Defects 3.04

Finding: Shower Screen – Missing / Incomplete Work

Information: At the time of inspection, the shower recess was observed without a shower screen installed. The absence of a shower screen may result in water splashing outside the shower area, increasing the risk of water damage to floor finishes, wall linings, and adjoining areas.

The shower screen is required to ensure proper containment of water and to support compliance with NCC 2022 Vol 2 – Part 10.2 (Wet Areas) and AS 3740 – Waterproofing of domestic wet areas.

A compliant shower screen should be supplied and installed by a suitably qualified contractor prior to occupation.

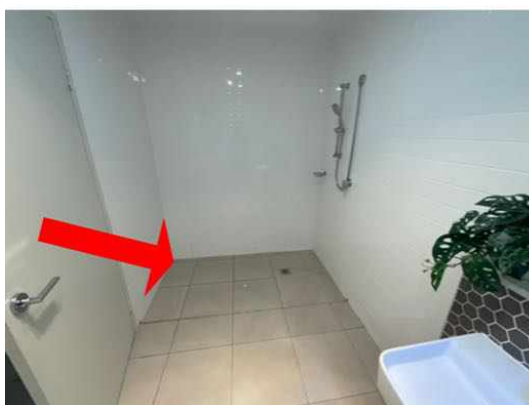
Defects 3.05

Information: Damp is evident to the lower 300mm of wall to the bathroom alcove. This defect is

quite common, and is suspected to have been caused by moisture permeating through the grouting in this area, which shows evidence of deterioration. Leaking pipes within the adjoining wall is also a possible cause. Damp (or structural damp) refers to the presence of unwanted moisture in the structure of a building, either as the result of intrusion from outside, or condensation from within the structure. In the bathroom area, internal water leaks or other sources of excessive moisture are generally the cause of damp. Unmanaged damp in the bathroom recess is likely to facilitate the formation and development of mould and fungi growth, decaying associated building materials and compromising their structural integrity. It is important to address damp conditions, as the World Health Organisation notes that excess moisture leads - on almost all indoor materials - to growth of microbes such as moulds, fungi and bacteria, which subsequently emit spores and other matter into the indoor air. Exposure to these contaminants is associated with a wide range of respiratory and other health-related problems. Consultation with a qualified plumber or bathroom specialist is advised immediately to identify the cause of damp and to perform remedial works as required. Where excessive mould growth is present, further inspection by a specialist environmental health inspector should also be considered. Always ensure that sealant and grout is in good condition to prevent any moisture issues occurring in the future.

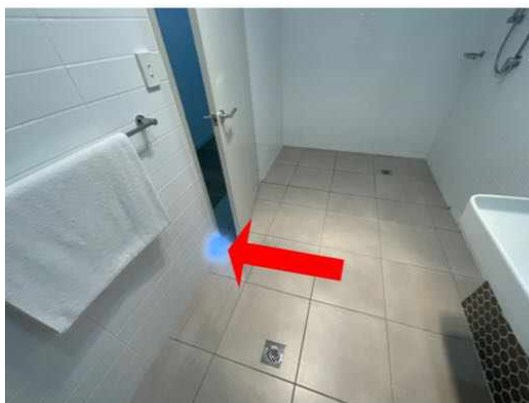
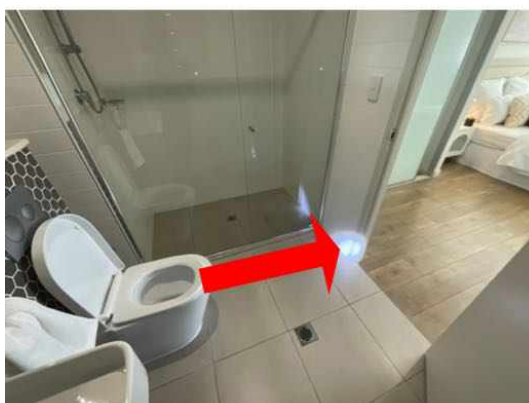
Defects 3.06

Location: Bathroom
 Finding: Door - swelling and damage at the bottom edge
 Information: Swollen and damaged door base in bathroom due to moisture exposure. Edges show fraying and surface degradation.

Replace or seal the affected door. Ensure door edges are properly sealed to prevent future water damage.

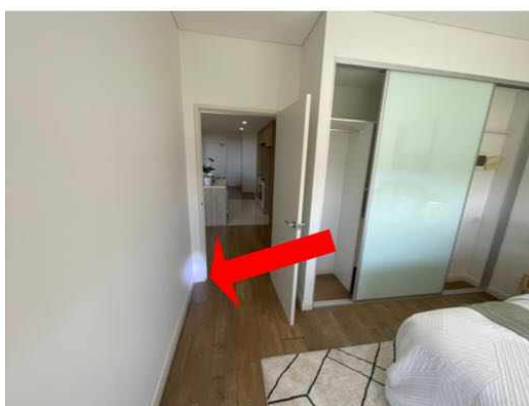
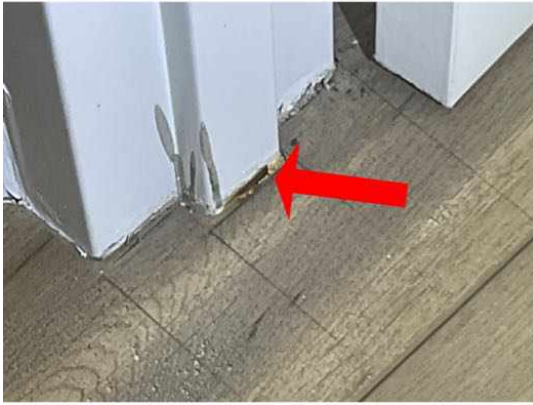
Defects 3.12

Building:	Main Building
Location:	All Internal Areas
Finding:	Incomplete or substandard works
Information:	The works to this area appear to be incomplete or have been completed to a substandard level.

Works that have not been completed to a satisfactory level create potential for the development of building defects and may impede on the safety and integrity of the overall structure.

It is highly recommended that the relevant trades be appointed to complete these works and ensure the safety of the area and the longevity of all associated building elements.

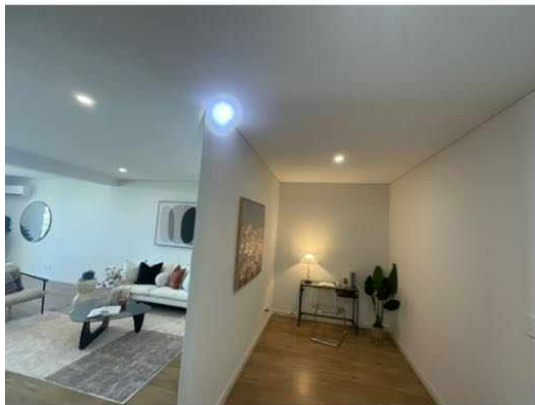
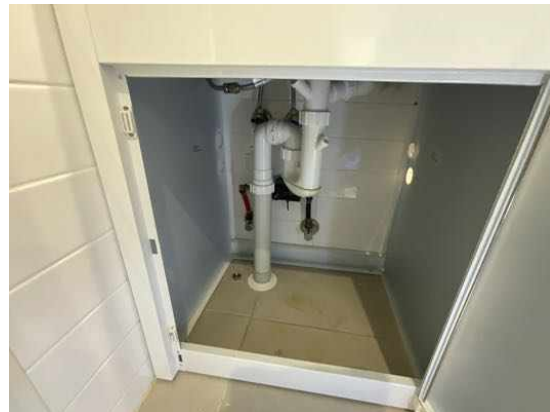
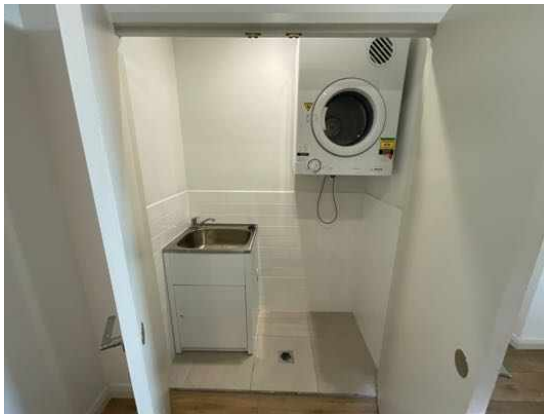
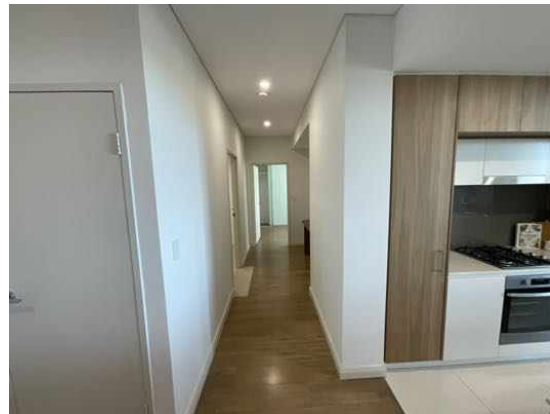
Noted Item

Building: Main Building
Location: All Areas
Finding: Additional Photos - Obstructions and Limitations
Information: These photographs are an indication of the obstructions and limitations which impeded full inspection of the property at the time of inspection. These obstructions can hide an array of defects and should be removed to allow full inspection to be carried out. A re-inspection is recommended once the areas are made accessible.

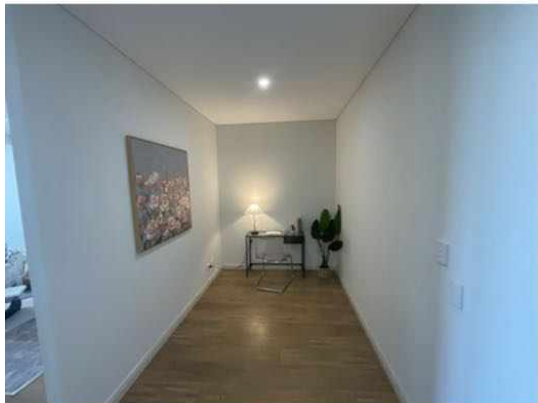
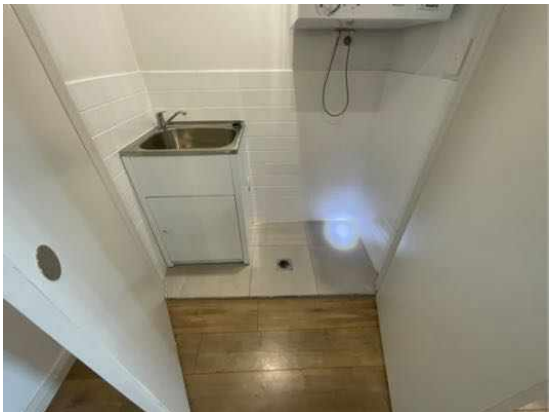
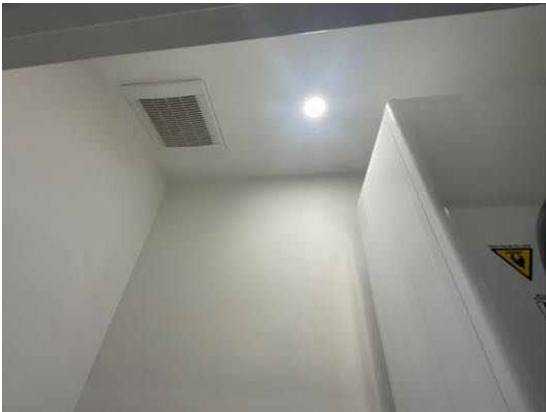
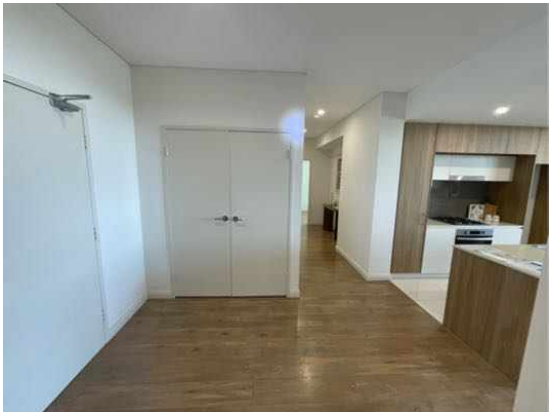
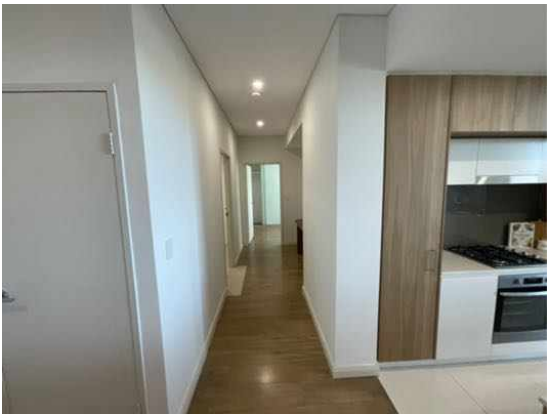
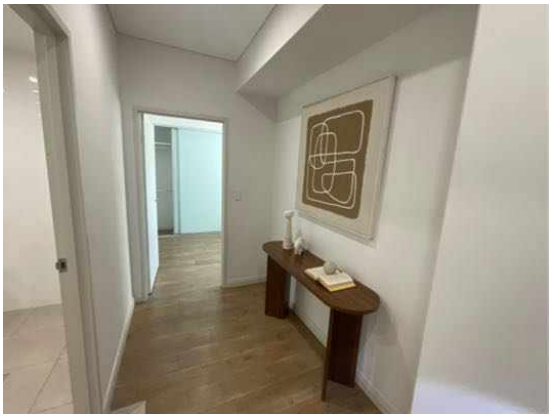
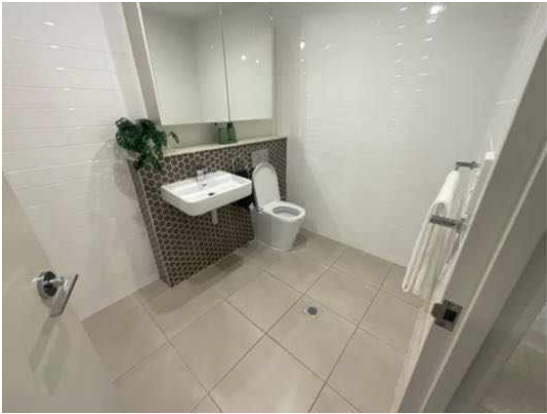
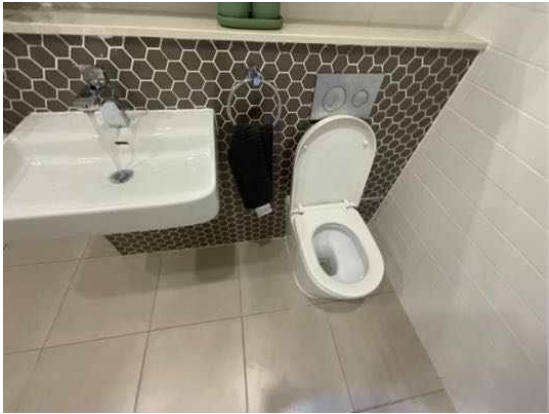
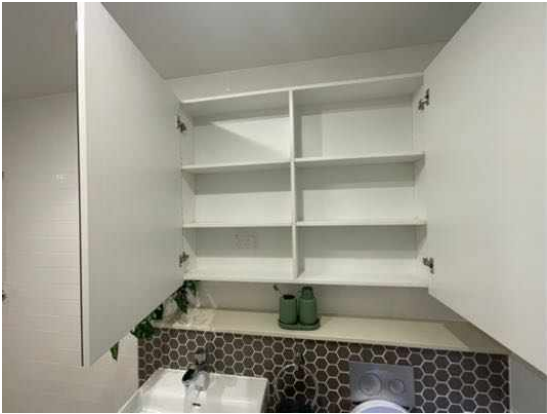
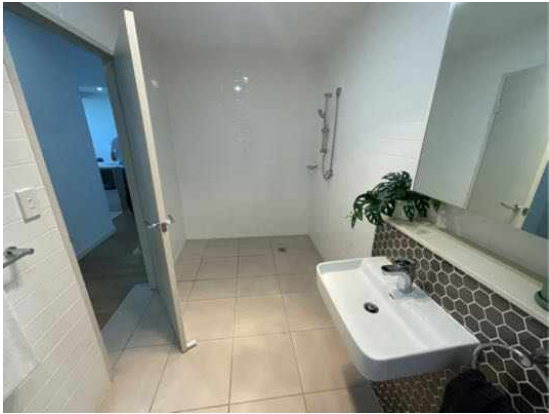
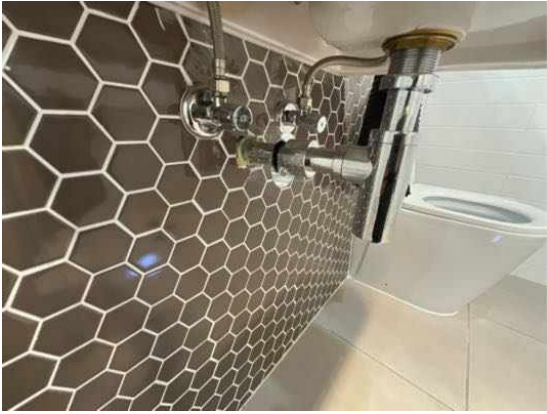
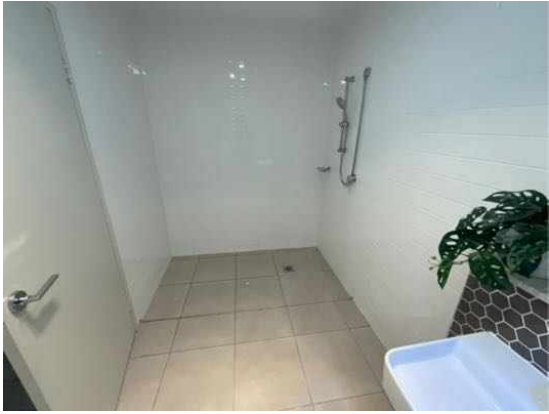
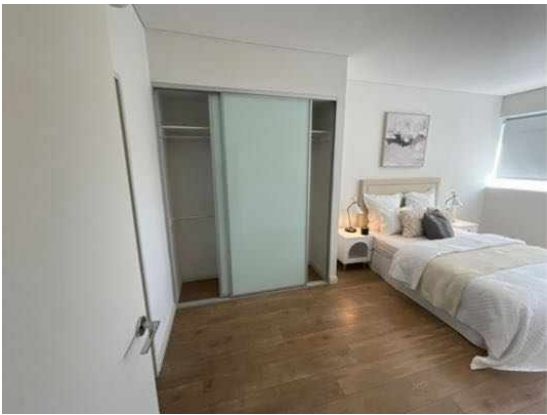
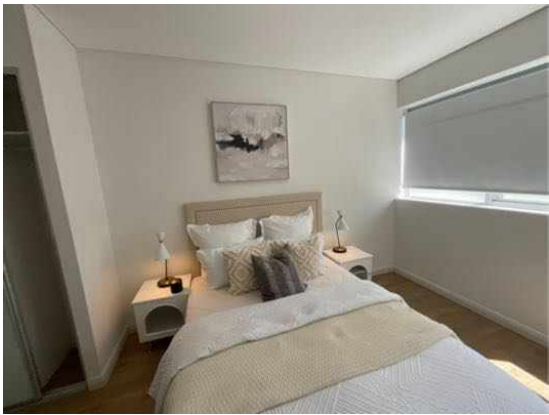
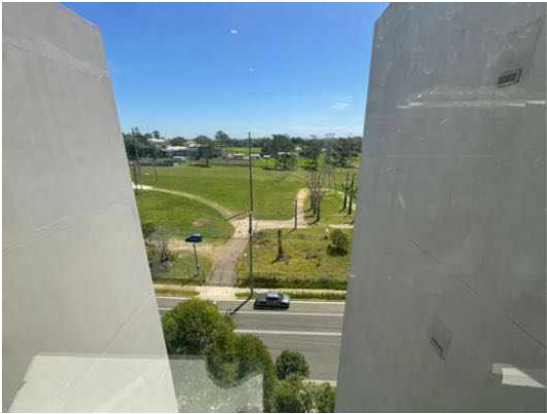
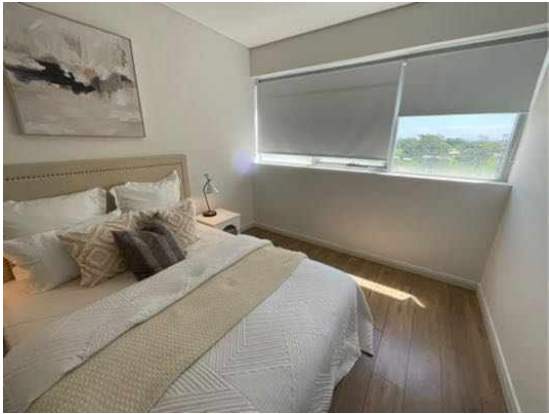
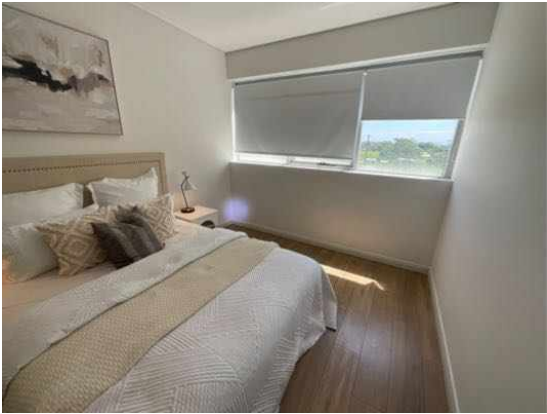
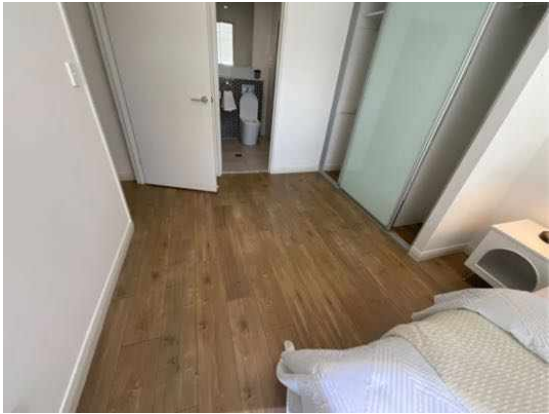
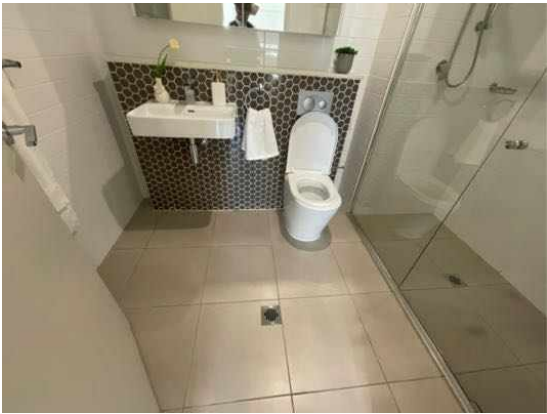
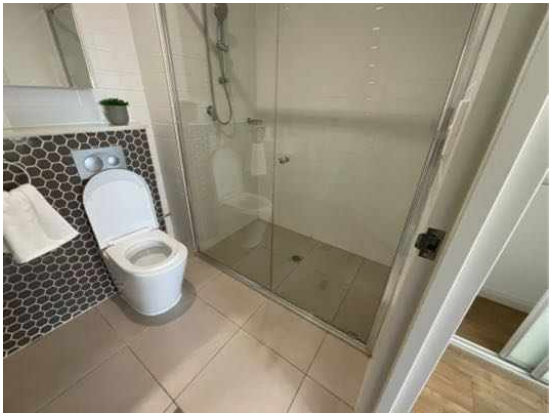
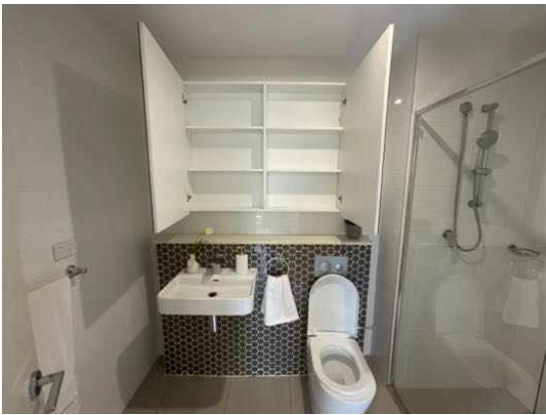
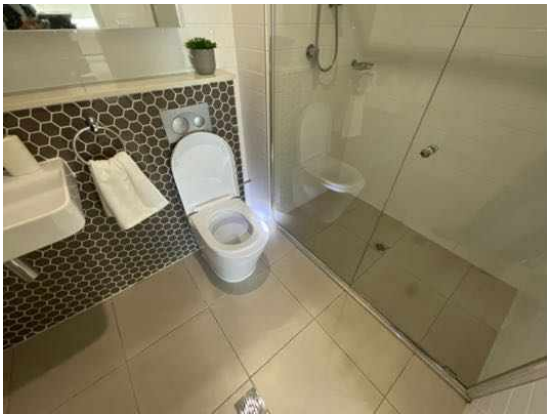
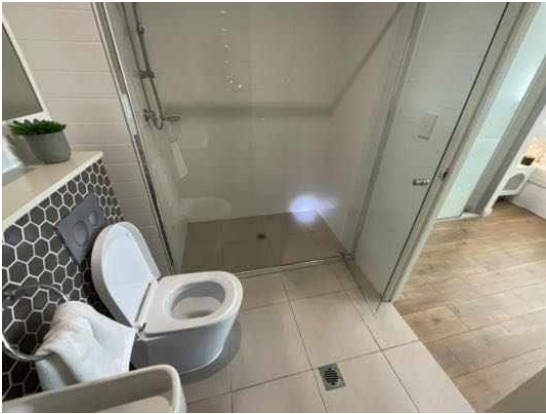
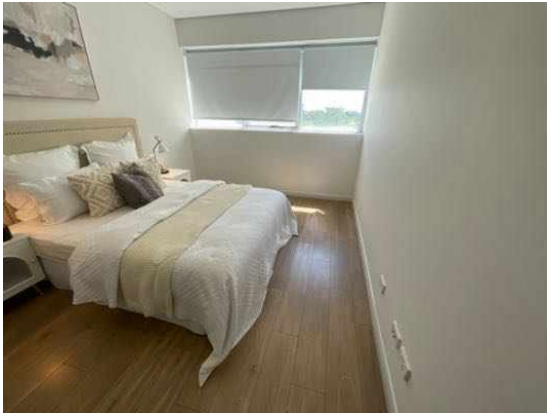
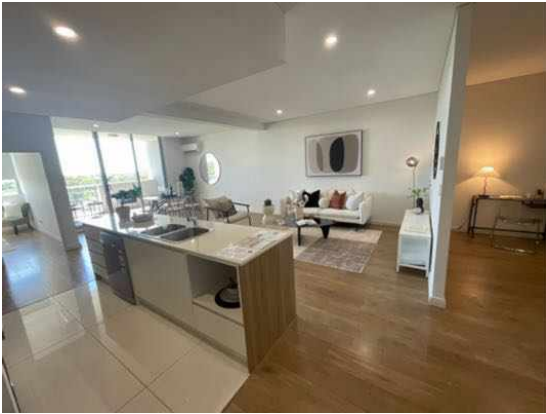
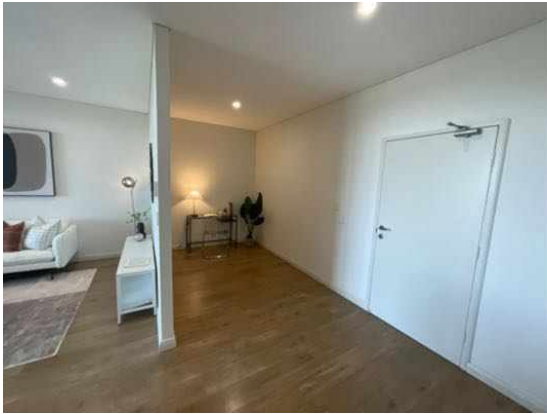
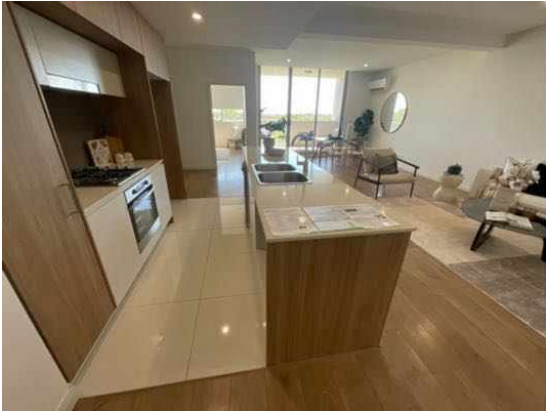
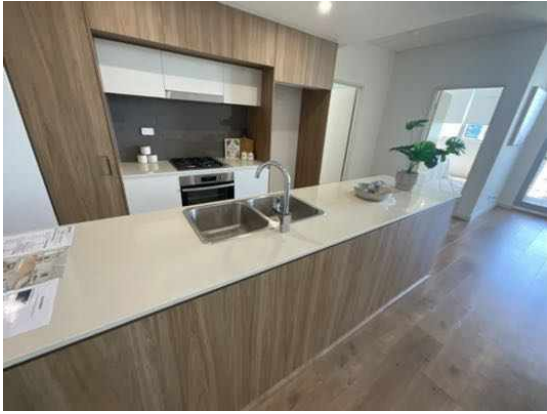
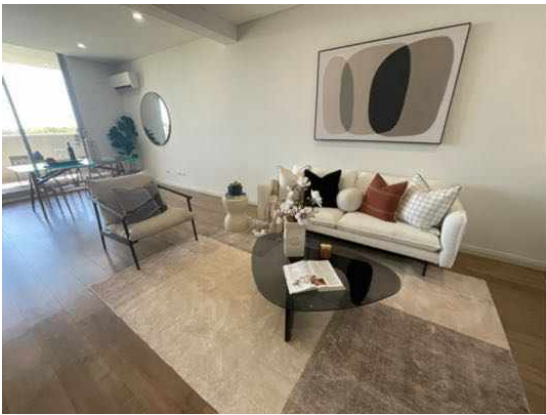
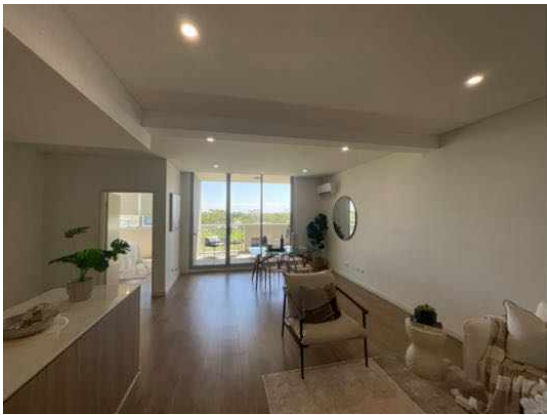
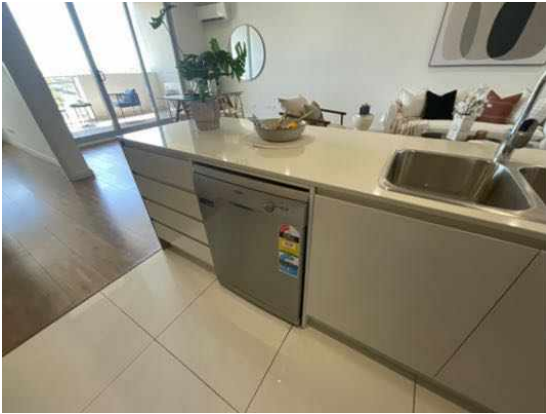
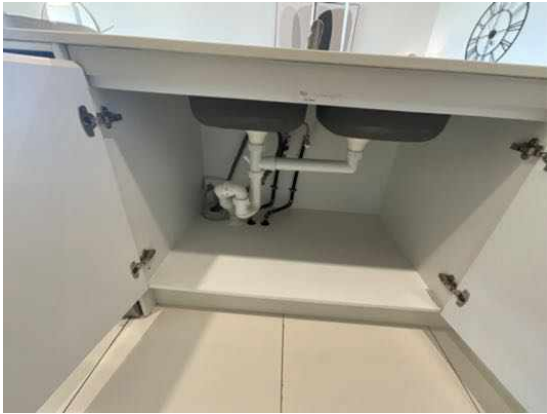
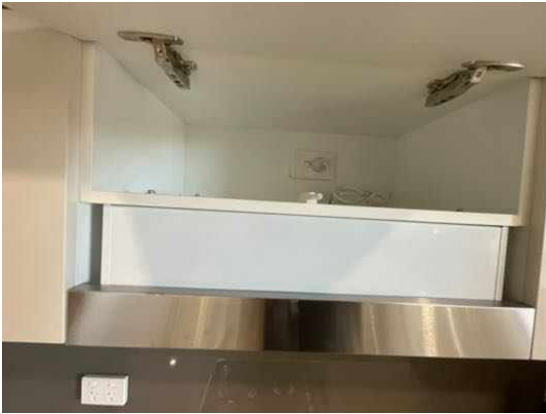
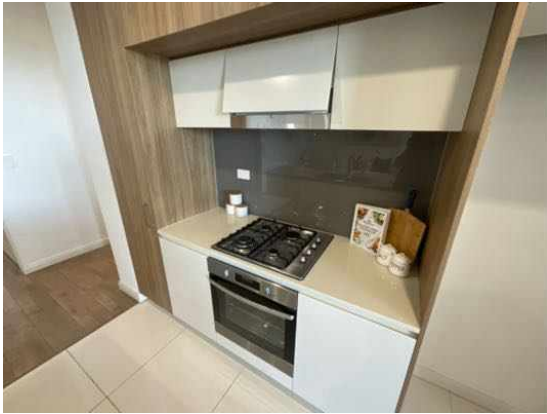
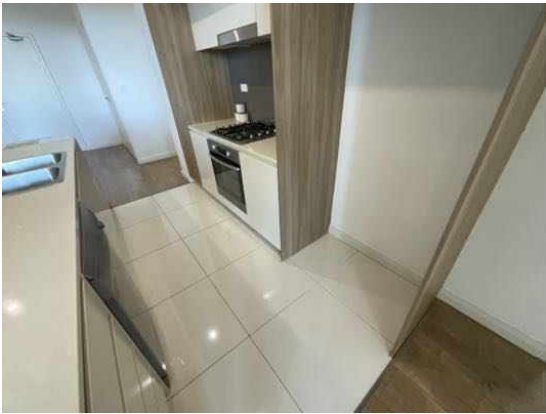
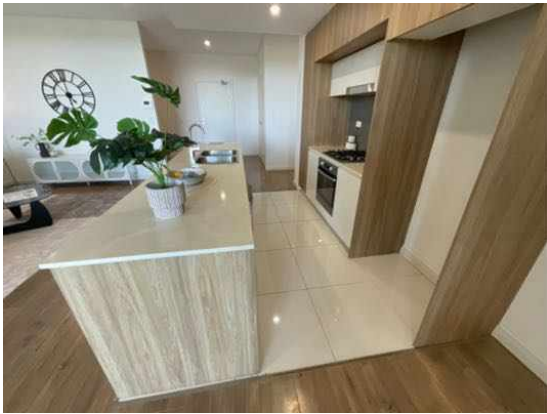
Building: Main Building
Location: All Areas
Finding: Additional Photos
Information: Additional photos are provided for your general reference. Arrows have been included to highlight areas of importance. Please discuss these photos with your building consultant for clarification.
