Building Inspection Report

Inspection Date: Wed, 4 Feb 2026

Property Address: 29/17-19 Jenkins Rd, Carlingford NSW
2118, Australia

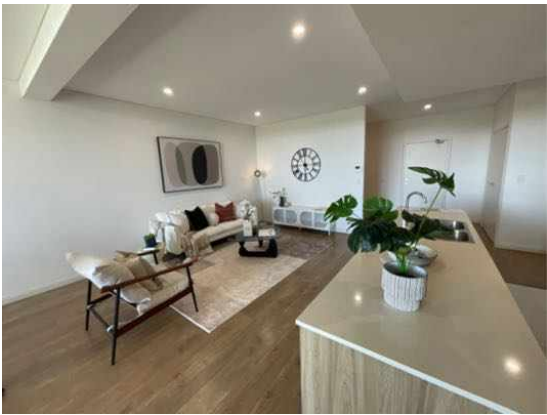
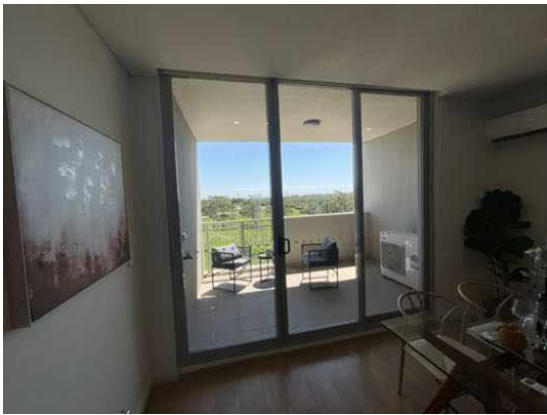
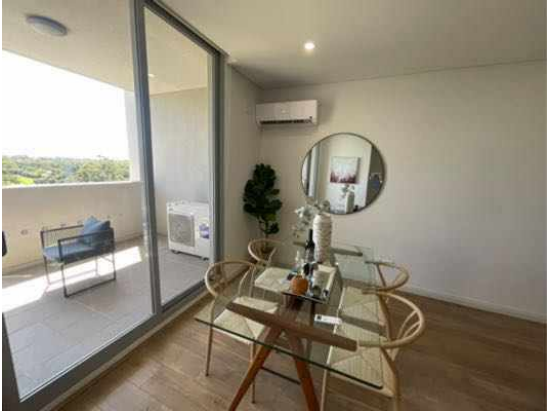
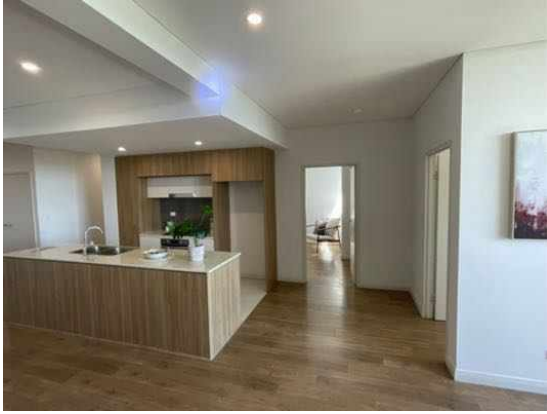
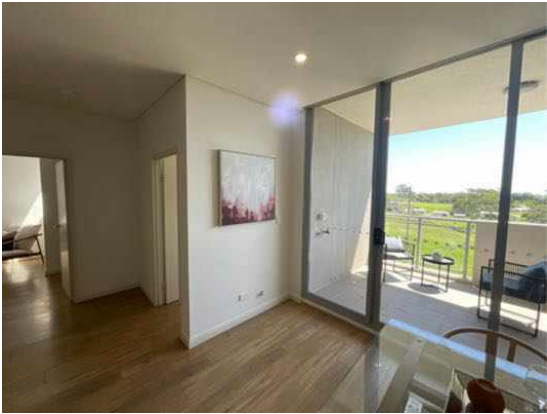
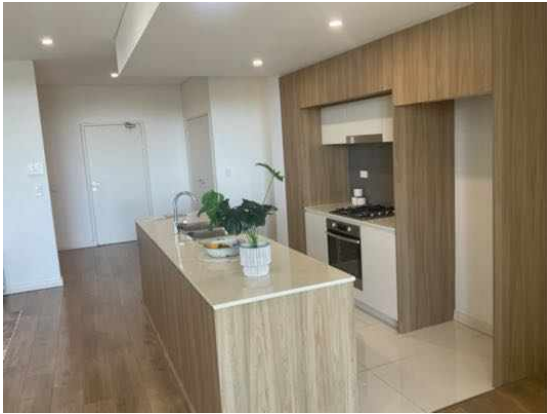
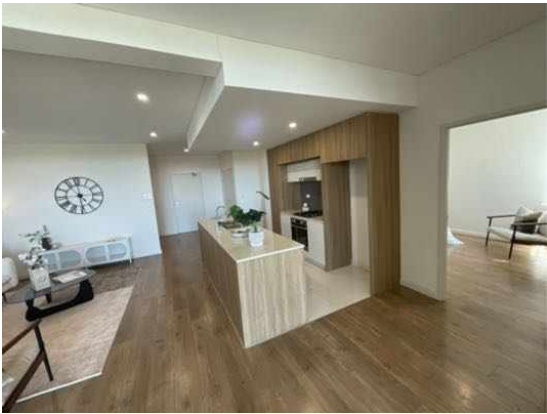
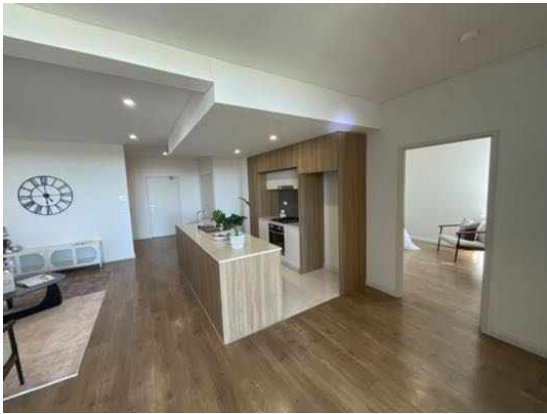
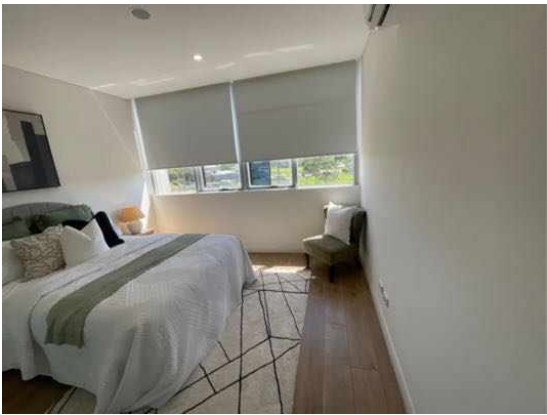
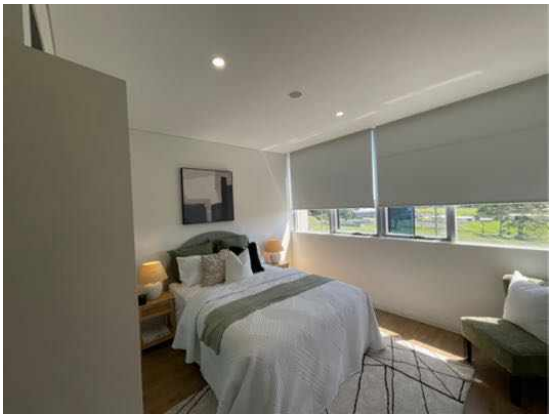
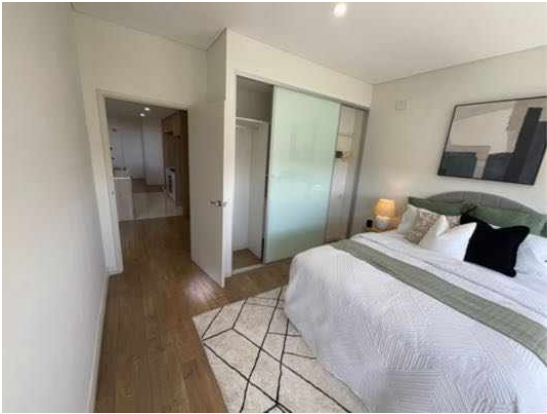
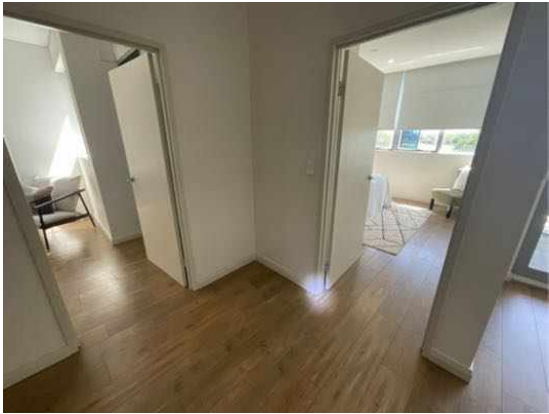
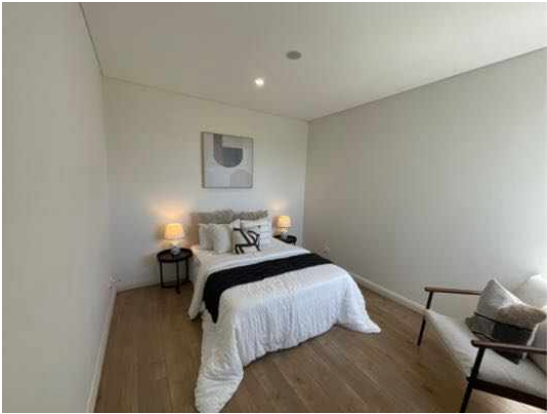
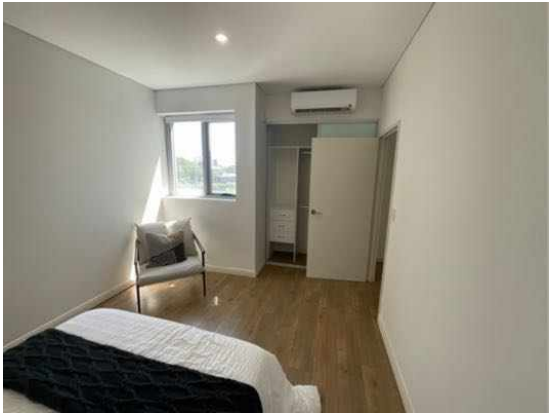
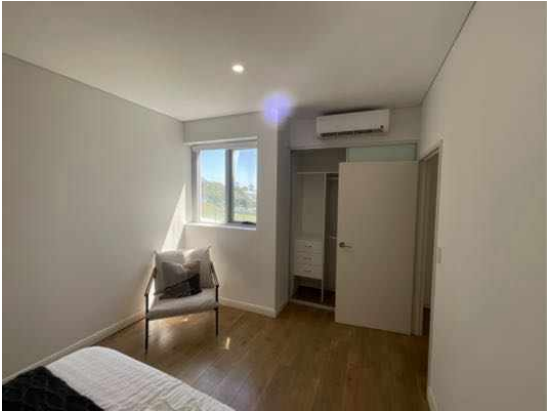
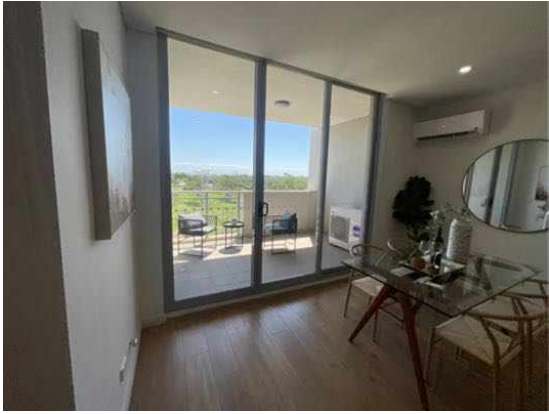
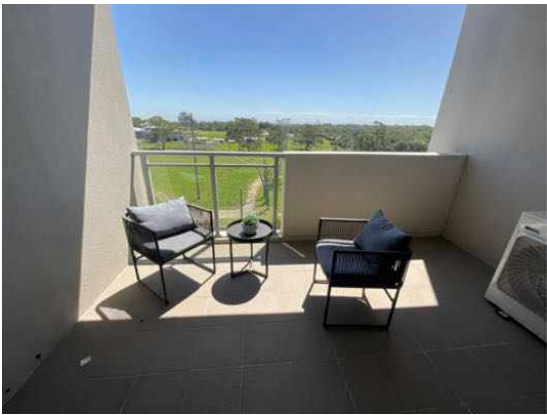
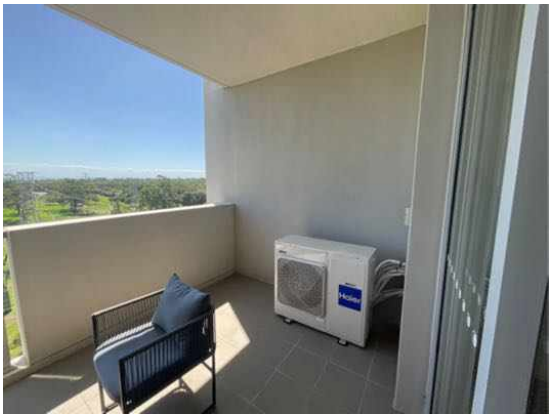
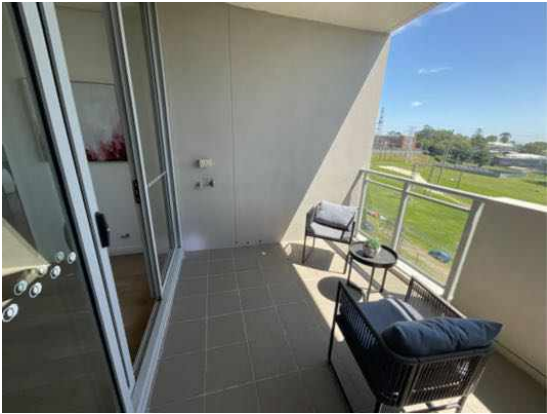
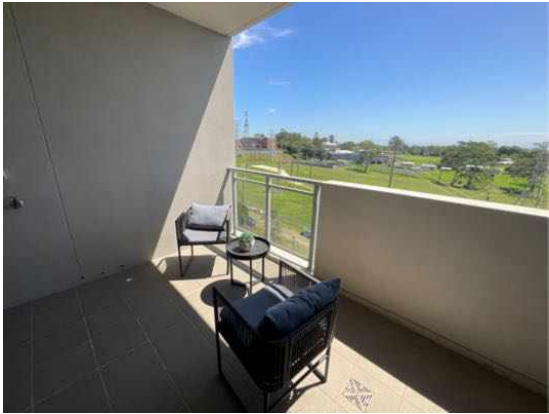
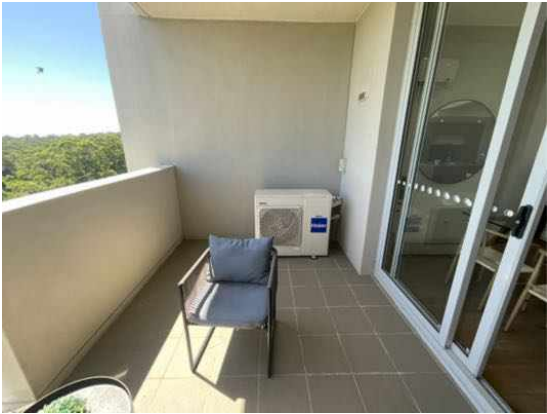
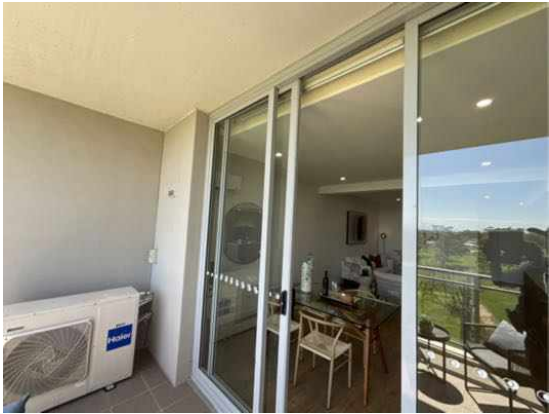
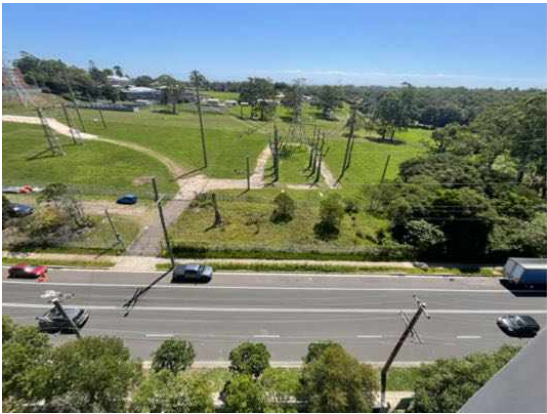
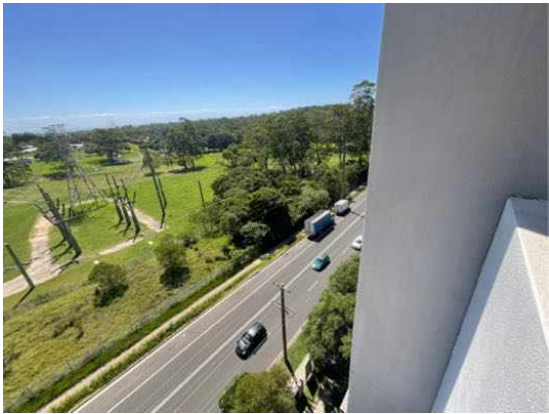
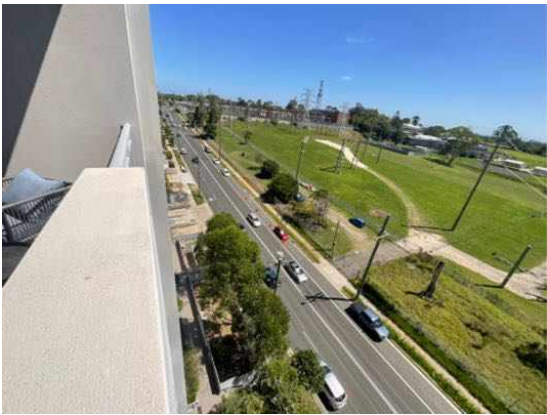
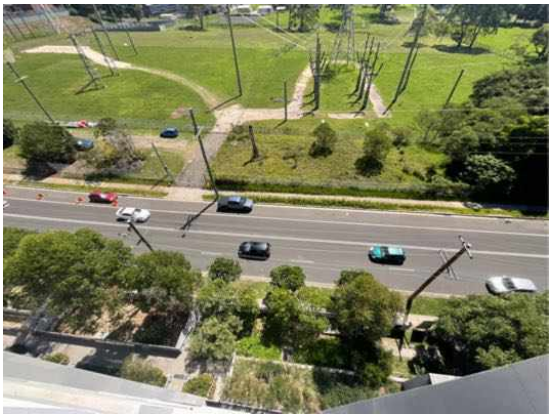
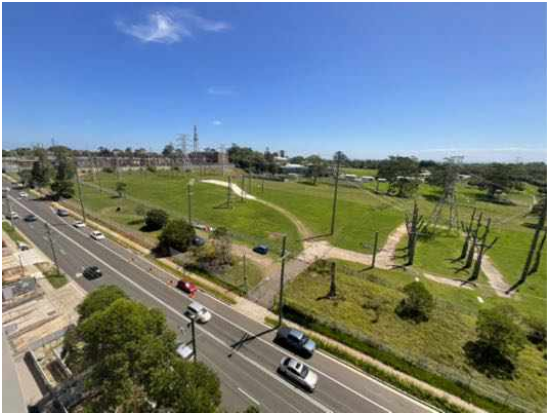
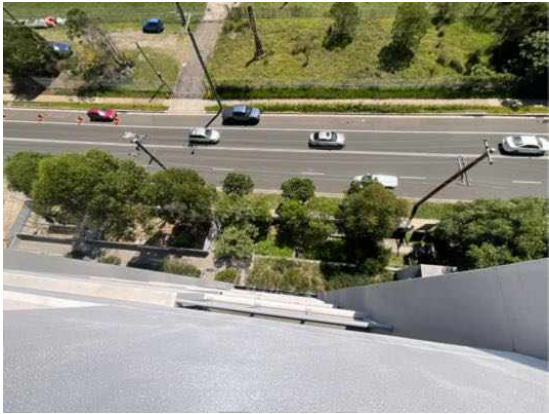
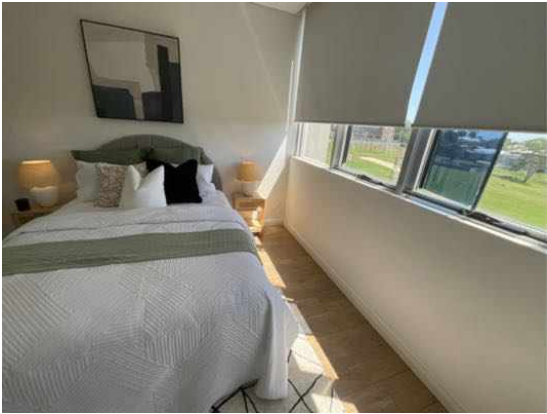
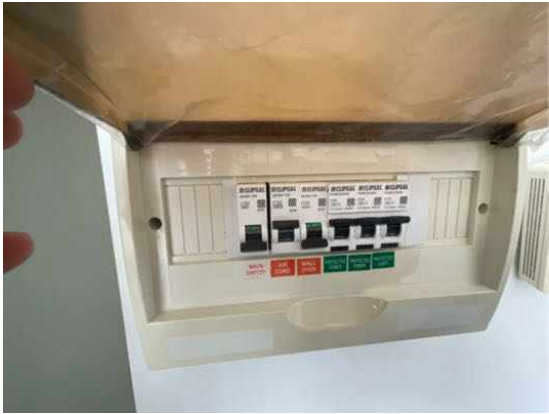
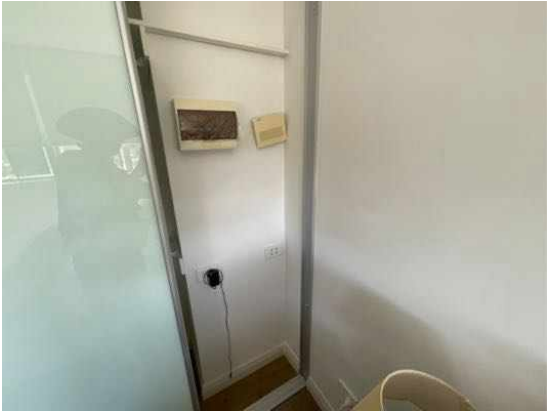
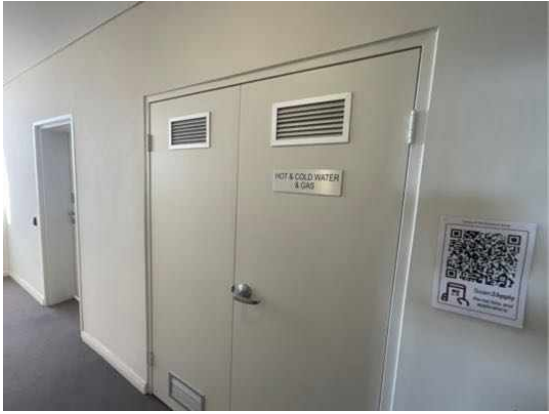
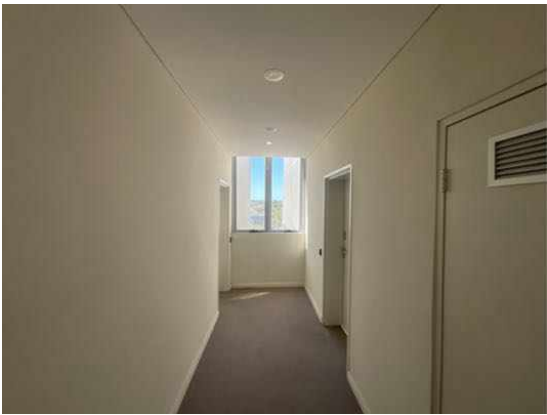
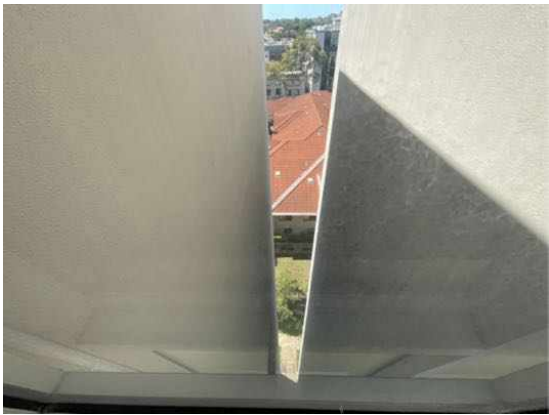
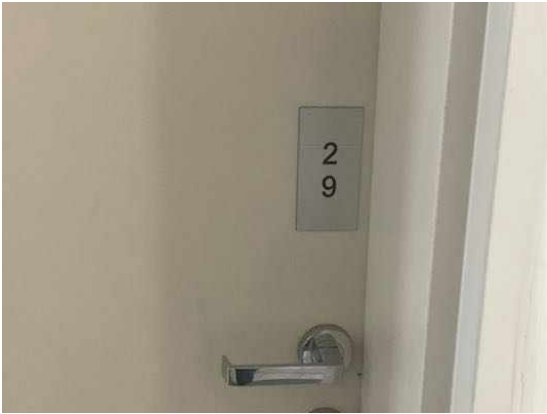
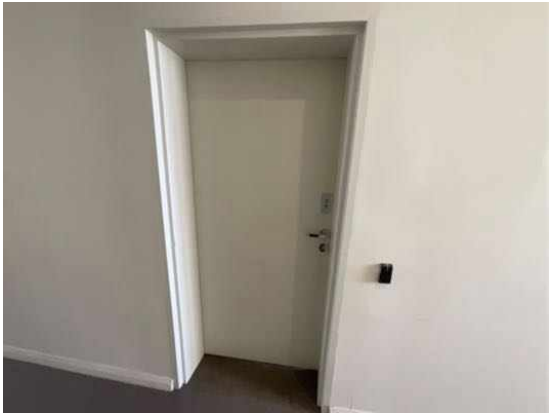
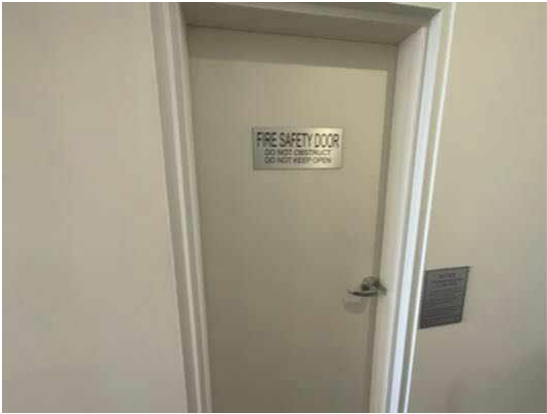
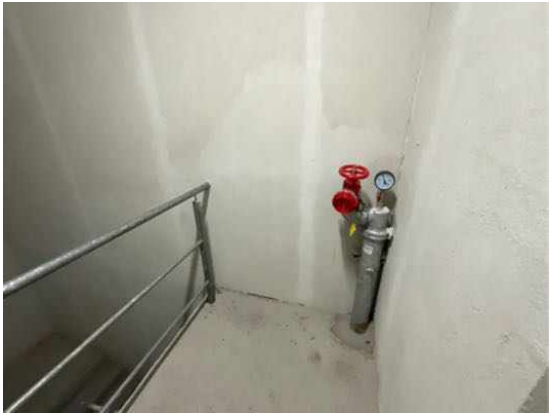
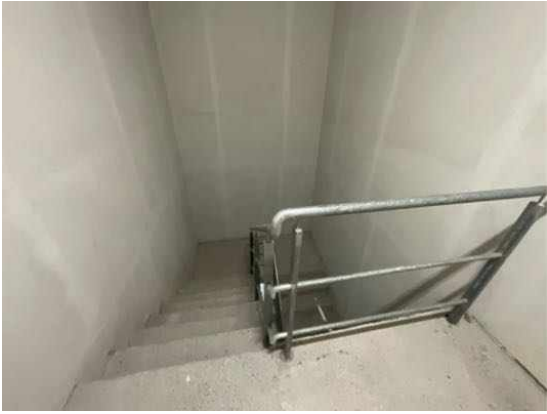
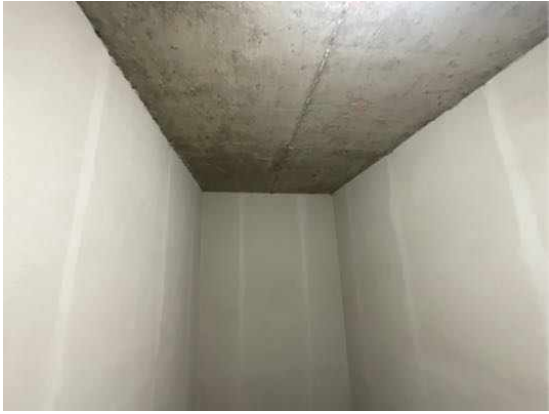
Building: Main Building
Location: All Areas
Finding: Additional Photos - Obstructions and Limitations
Information: These photographs are an indication of the obstructions and limitations which impeded full inspection of the property at the time of inspection. These obstructions can hide an array of defects and should be removed to allow full inspection to be carried out. A re-inspection is recommended once the areas are made accessible.
