Building and Timber Pest Inspection Report

Inspection Date: Wed, 18 Mar 2026

Property Address: 3 & 3A St Johns Rd, Campbelltown NSW
2560, Australia

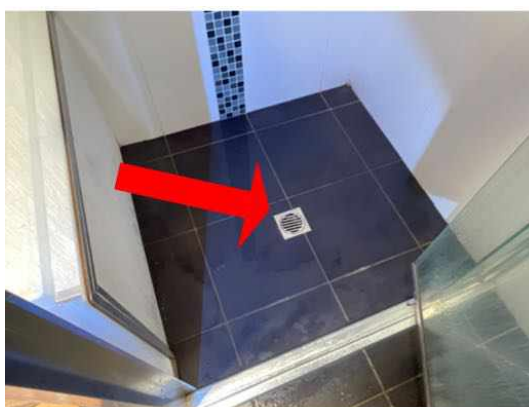
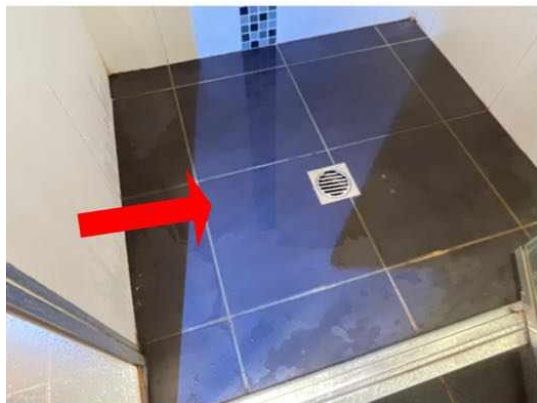
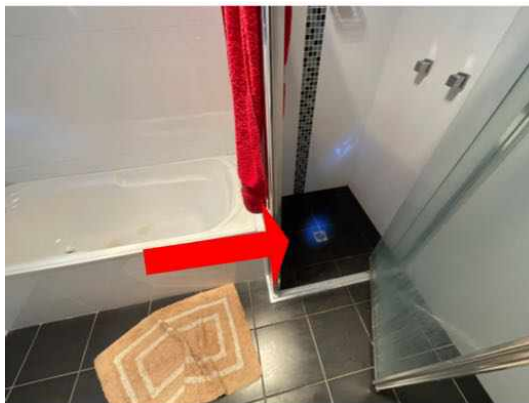
Building: Main Building
Location: Bathroom
Finding: Shower base - Water pooling
Information: Evidence of water pooling around the floor waste in the shower recess was noticed at the time of inspection. It is suspected that this excessive moisture is attributed to insufficient fall in the shower floor tiles.

This pooling is minor overall but is still considered unsatisfactory, as standard tiling practices would not permit this situation to occur. Pooling water around floor wastes can create a slip hazard in extreme cases and create conditions that are conducive to mould growth over time. Where left unmanaged, the degradation of sealant and grouting is also likely to occur, possibly necessitating further repair works.

Remedial works may involve some sections of tiling and flooring repair and replacement. A tiling contractor or bathroom specialist should be appointed to provide further advice on reparation options and to perform works as necessary.

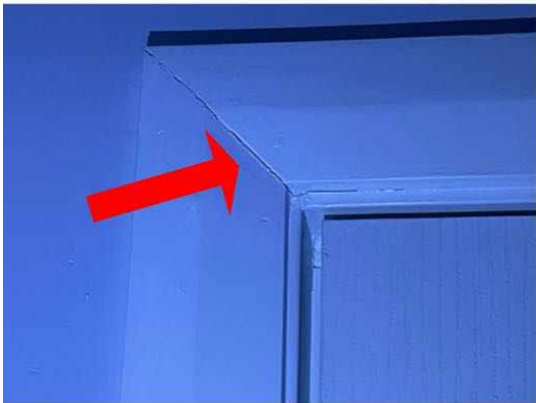
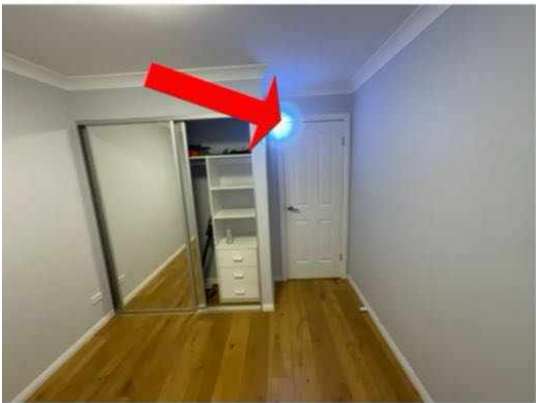
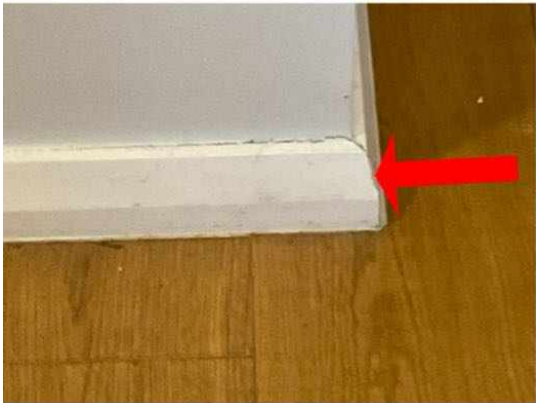
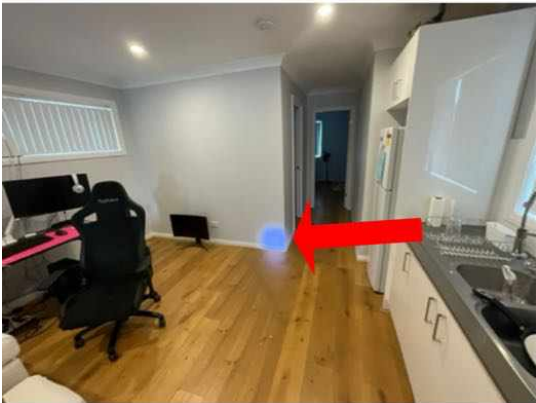
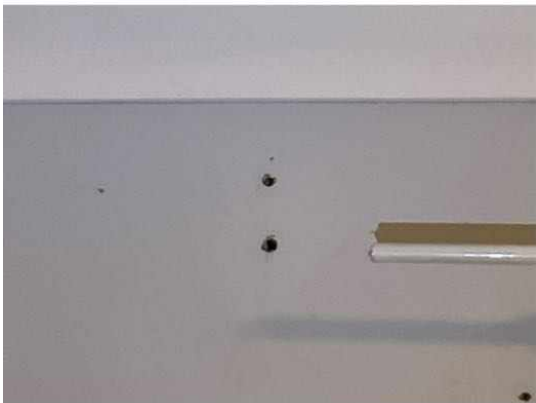
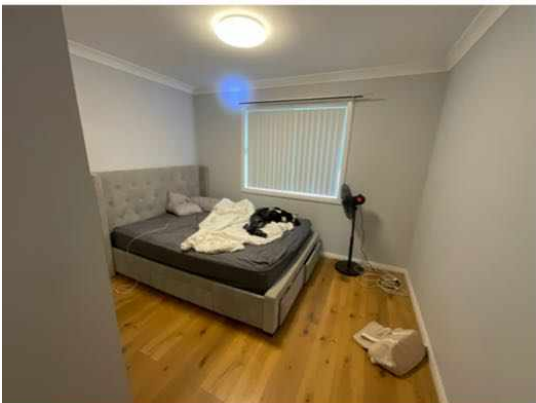
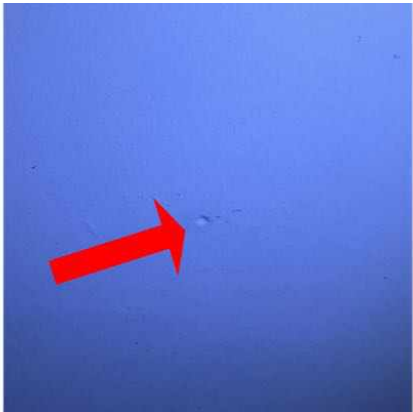
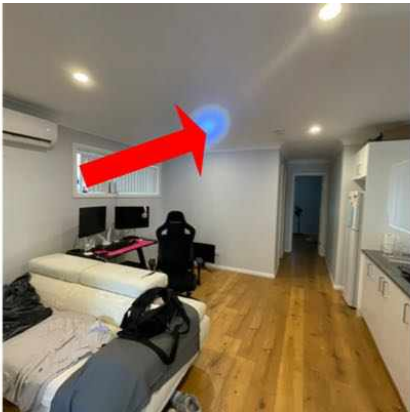
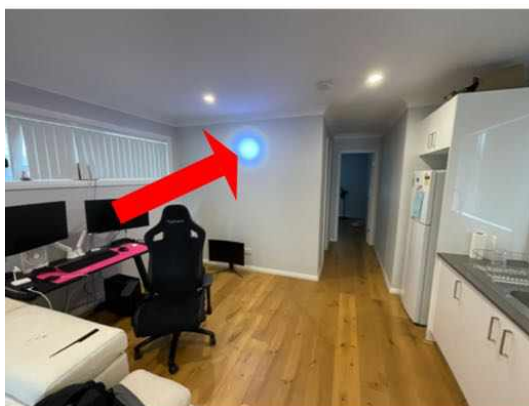
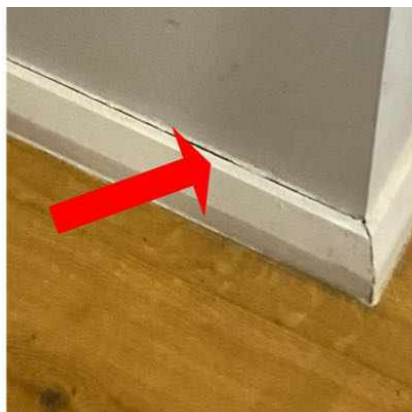
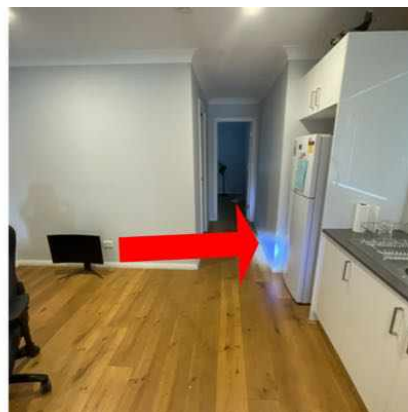
Finding 3.01

Building:	Granny-Flat
Location:	All Internal Areas
Finding:	Paint finish - Substandard, Wear and Tear
Information:	The paint finish in this area was found to have been completed to a substandard level or wear and tear as the normal deterioration of a property from ordinary, everyday use. Exposure to the elements, time, as well as day to day living can cause fair wear and tear.

If this applies, further areas of poor and incomplete finishes could develop over time. Furthermore, substandard, wear and tear paint finishes in areas exposed to moisture, e.g. external areas or wet areas, could lead to deterioration of underlying building materials.

Substandard, wear and tear paint finishes should be sanded back, filled, leveled and repainted, as applicable. Where inadequate paint protection has led to the deterioration of the associated building element, repair and/or replacement of this building element may be required.

A painting contractor should be appointed as soon as possible to perform necessary works to aid the appearance of the affected area and to ensure that the area is protected against further deterioration. Alternatively, the homeowner following manufacturer instructions may be able to provide this service.

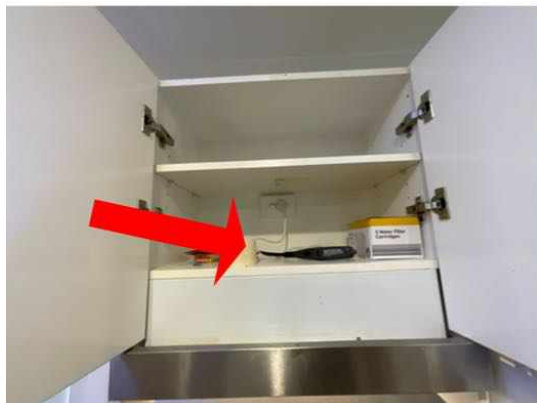
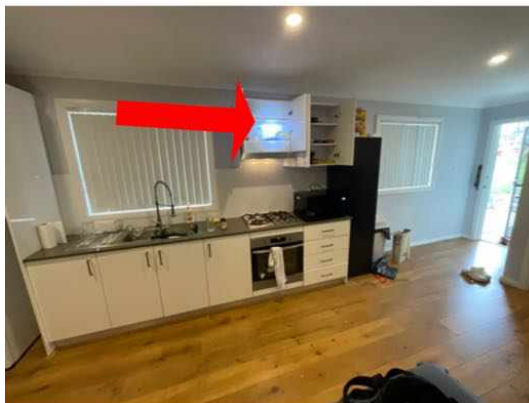
Finding 3.02

Building:	Granny-Flat
Location:	Kitchen
Finding:	Rangehood - Flue disconnected
Information:	The range hood flue has become disconnected and is allowing the emission of steam and evaporative moisture into the ceiling space above.

While this does not create high potential for secondary defects, development of grease is likely to occur in the surrounding area, necessitating regular cleaning and maintenance.

Consultation with a licensed electrician may be required to reconnect the flue and thus allow the emission of gases into the external environment. Works should be completed at client discretion.

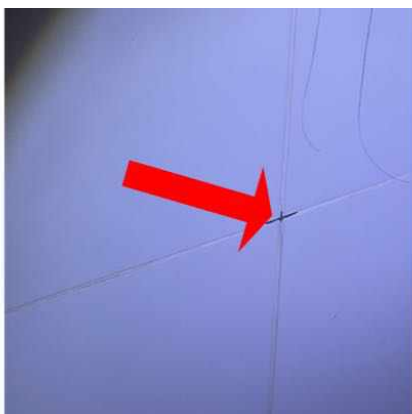
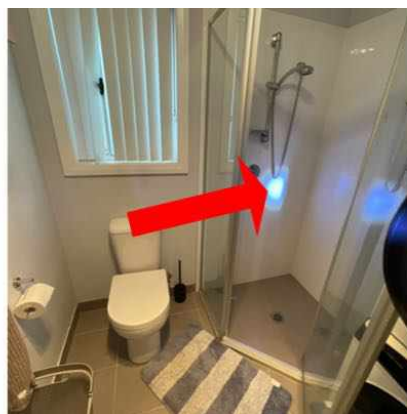
Finding 3.03

Building:	Granny-Flat
Location:	Bathroom
Finding:	Sealant and grouting - Missing or damaged
Information:	It was noted on inspection that sealant or grout is degraded to the tiled shower alcove and or other areas of the bathroom.

Different materials and floor areas move at different rates, generally causing cracking to grout or sealant at this point. A flexible sealant is required to allow for expected expansion and contraction, while keeping the joint water tight and protective of all associated building materials.

There appears to be excessive mould to the sealant and grout which will likely require scraping out and replacement.

Flexible and mould resistant materials should be applied to affected areas to prevent any subsequent water damage that is likely to occur. Regular maintenance and replacement of damage or missing or damaged sealant and grout is highly recommended to the wet areas, as this is a regular wear and tear defect. Sealant and grouting in areas that come into regular contact with water should be maintained for the long term care of your property.

A sealant specialist or tiling contractor should be appointed to complete these works as soon as possible

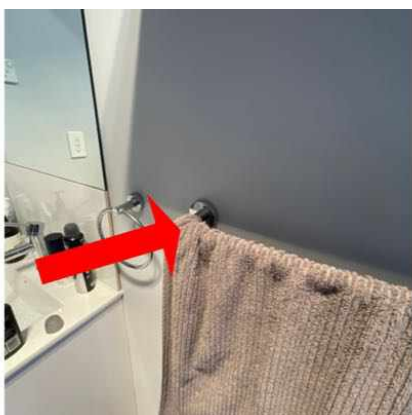
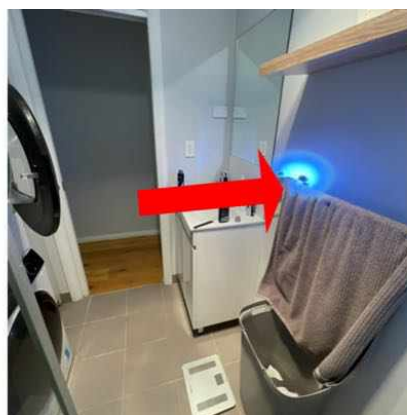
Finding 3.04

Building:	Main Building
Location:	Bathroom
Finding:	Bathroom holders - Loose
Information:	The bathroom holder was found to be loose at the time of inspection. While not a major operational defect, function can deteriorate if the problem is left unmanaged.

It is advised that the homeowner performs remedial works to re-attach the bathroom holder to its original fixing. A general handyperson may be required to perform these works.

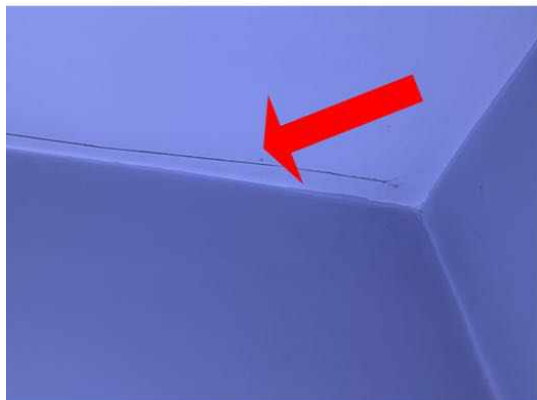
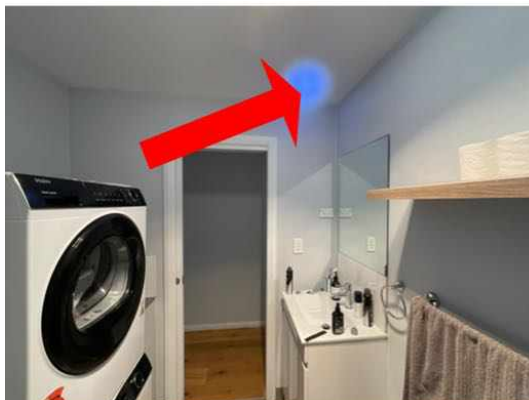
Finding 3.05

Building:	Granny-Flat
Location:	Bathroom
Finding:	Cracking - Damage Category 1 - Fine (up to 1mm)
Information:	Although fine cracks are quite noticeable, they are often only considered to be an appearance defect, and usually do not indicate any structural damage. Generally, the cause of a fine crack is indicative of a separation between building materials and finishes (e.g. paint, plaster, etc.) along joins.

Cracking of this nature can generally be repaired with minor sanding, filling and/or

repainting. Such works should be performed by a qualified painter or a general handyman.

Monitoring of all cracking should be conducted frequently. Always contact a building inspector should cracks widen, lengthen, or become more numerous.

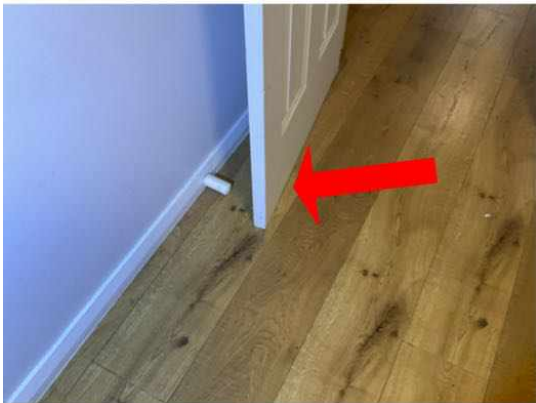
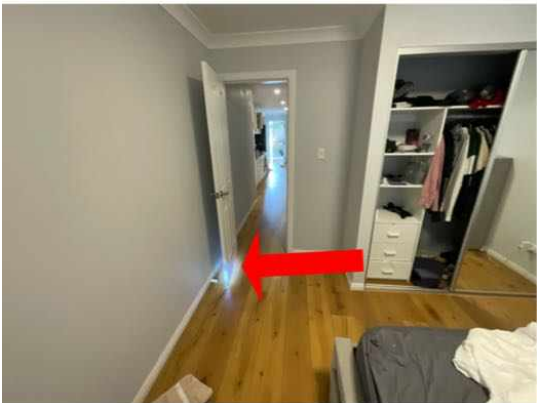
Finding 3.06

Building:	Granny-Flat
Location:	Bedroom
Finding:	Door - Binding/jamming
Information:	Binding and/or jamming of this door is evident during standard operation. This defect inhibits the functionality of the affected door as well as creating potential for secondary defects to associated building elements, such as damage to the floor covering.

A door that binds to flooring or to the associated door frame may have several causes, ranging from minor defects, such as poor installation of the door or deteriorated hinges, through to major structural issues, such as damage to subfloor structures.

Where door binding/jamming appears to indicate major structural issues, a registered builder specialising in re-stumping should be appointed to provide an estimate on the cost of rectification.

For minor causes, a qualified carpenter or general handyperson should be appointed to perform minor rectification works at client discretion.

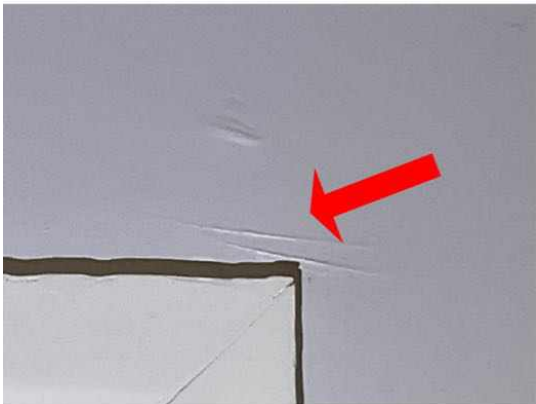
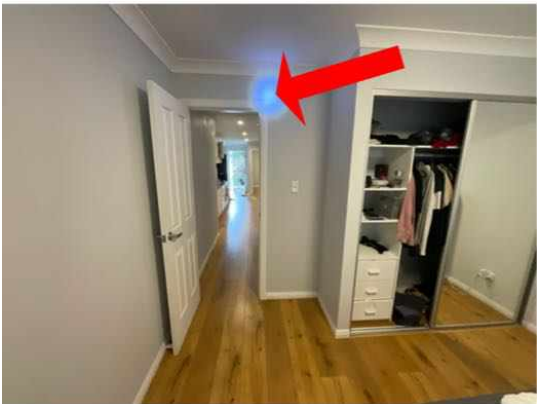
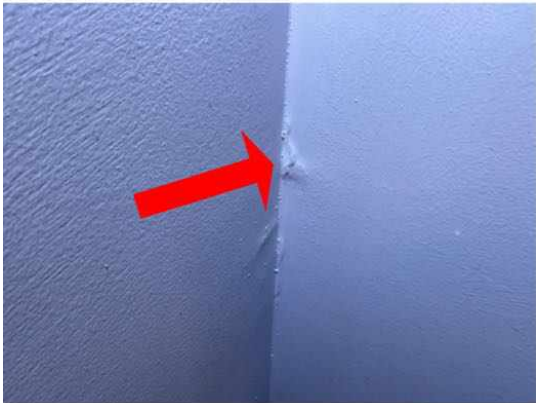
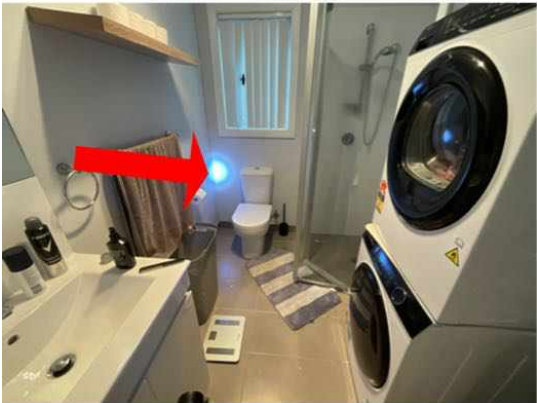
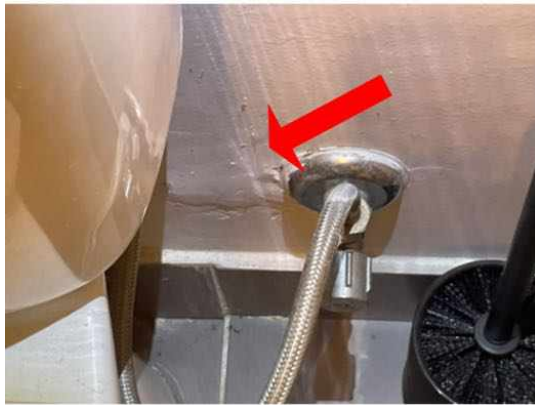
Finding 3.07

Building: Granny-Flat
Location: All Internal Areas
Finding: Plasterboard finish - defective
Information: The finish of the plasterboard in the identified area is defective as it falls below Level 4 category finish as defined in AS 2589.1 Section 6.6 Levels of Finishes for Plasterboard Surfaces. The key features of a Level 4 finish include: joints and fasteners adequately concealed joints and interior angles to have tape embedded in joint compound and at least 2 coats of joint compound to each joint angle fasteners accessories. A level 4 finish should be smooth and free of tool marks or ridges.

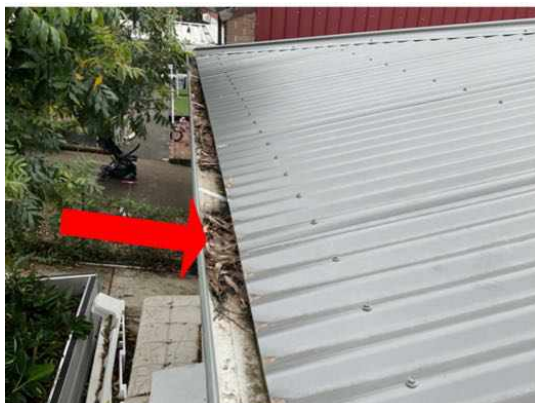
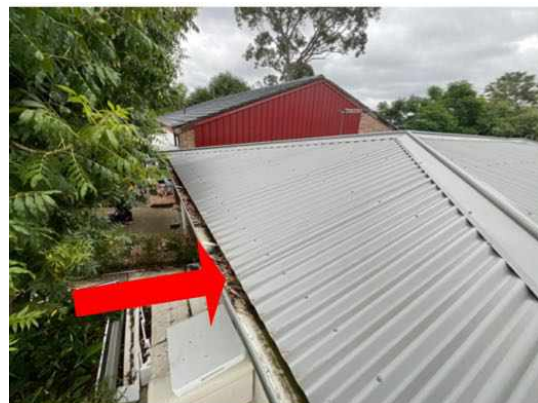
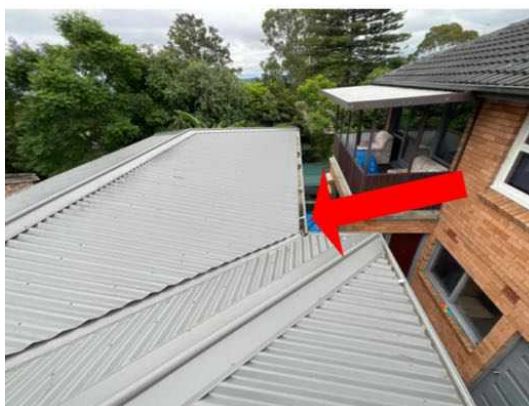
Finding 3.08

Building:	Granny-Flat
Location:	Roof Exterior
Finding:	Gutters - Blocked
Information:	Roof plumbing structures, such as guttering and downpipes, should be free of all debris to prevent blockages. Blockages of the guttering and downpipes will lead to pooling and accumulated water overflows, which is likely to subsequently flood eaves and exterior walls.

Blocked gutters are likely to lead to high levels of moisture in the affected areas. Such moisture will not only cause rust and decay of the associated building materials, but can also provide conditions that are conducive to termite and timber pest activity. Blockages in gutters should therefore be removed immediately to ensure dry conditions are maintained.

Consult a Licensed Plumber for further specific advice on remedial works that may be required. In the interim, it is highly advised that blocked gutters be removed by the homeowner or a general handyperson as a matter of urgency.

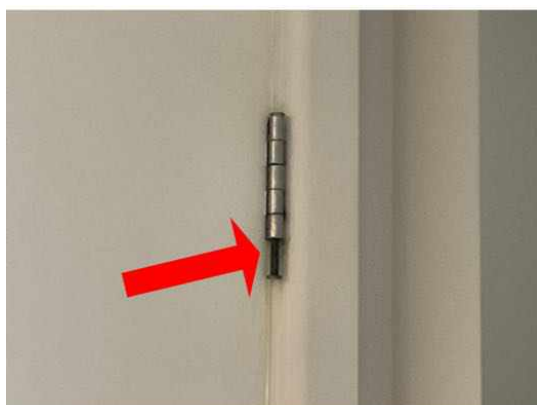
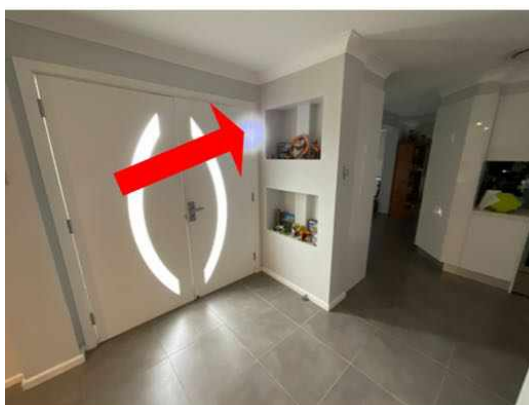
Finding 3.09

Building:	Main Building
Location:	Entry
Finding:	Door - Loose hinges
Information:	This door is not level and detract from the operational state of the door jamb. Upon further inspection, it was noted that the hinges to the door have deteriorated over time and, as a result, have come loose from their original fixing. To improve operation of the affected door, a general handyman may be appointed to replace the faulty hinges. Such works should be completed at discretion of the client.

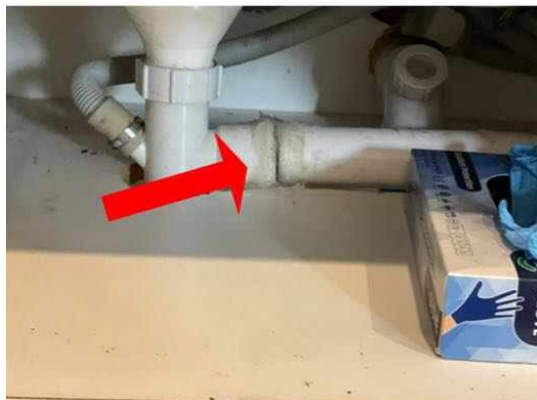
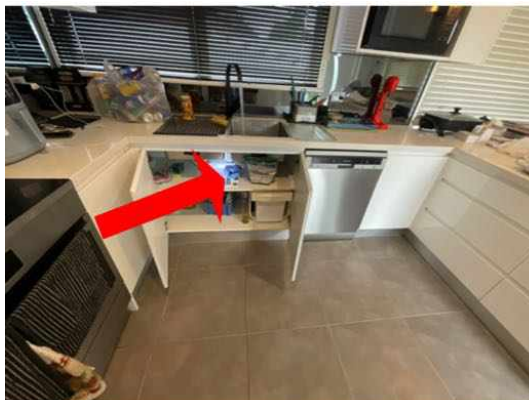
Finding 3.10

Building:	Main Building
Location:	Kitchen
Finding:	Water leak - Internal
Information:	A water leak was found in this area at the time of inspection. Internal water leaks can be detrimental to surrounding building elements; their potential causes include damage to plumbing fittings and fixtures, through to water damage and deterioration of associated building elements.

Rust, corrosion, decay and water damage are potential outcomes where a minor water leak is left unattended. More serious defects may also result, such as electrical

hazards, or water damage to structural building elements.

In extreme cases, structural damage may develop due to a prolonged water leak. It is highly advised that internal water leaks be addressed by a licensed plumber as a matter of relative urgency.

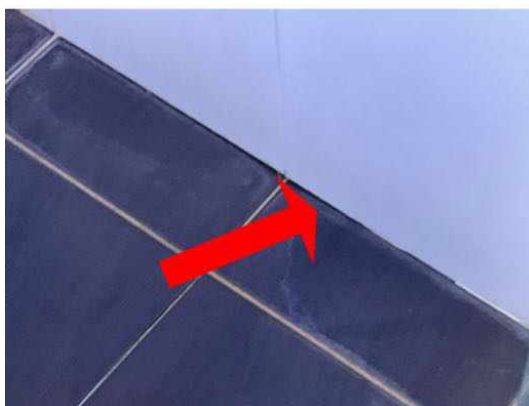
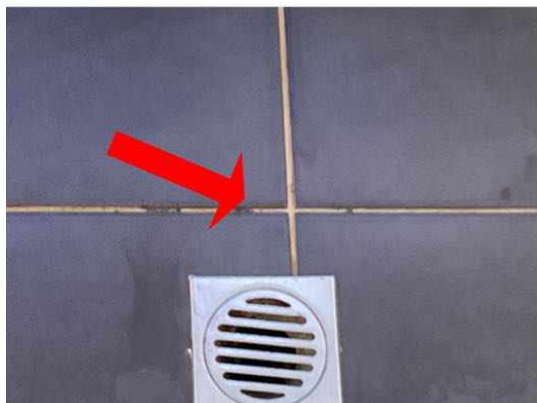
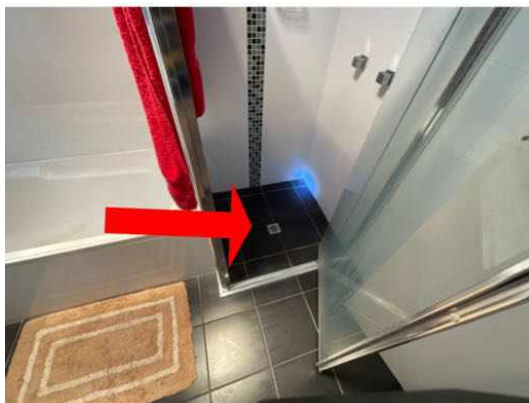
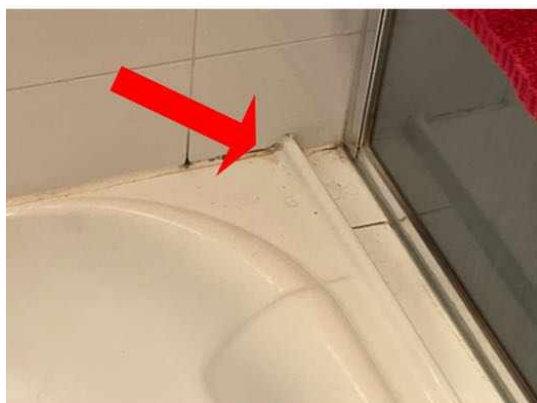
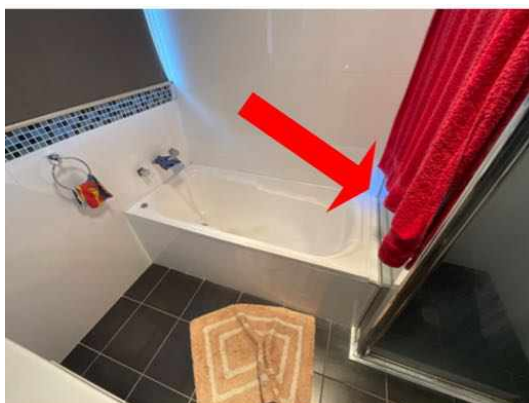
Building:	Main Building
Location:	All Areas
Finding:	Sealant and grouting - Missing or damaged
Information:	It was noted on inspection that sealant or grout is degraded to the tiled shower alcove and or other areas of the bathroom.

Different materials and floor areas move at different rates, generally causing cracking to grout or sealant at this point. A flexible sealant is required to allow for expected expansion and contraction, while keeping the joint water tight and protective of all associated building materials.

There appears to be excessive mould to the sealant and grout which will likely require scraping out and replacement.

Flexible and mould resistant materials should be applied to affected areas to prevent any subsequent water damage that is likely to occur. Regular maintenance and replacement of damage or missing or damaged sealant and grout is highly recommended to the wet areas, as this is a regular wear and tear defect. Sealant and grouting in areas that come into regular contact with water should be maintained for the long term care of your property.

A sealant specialist or tiling contractor should be appointed to complete these works as soon as possible

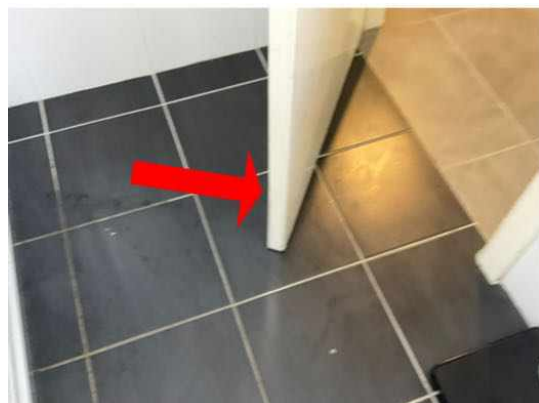
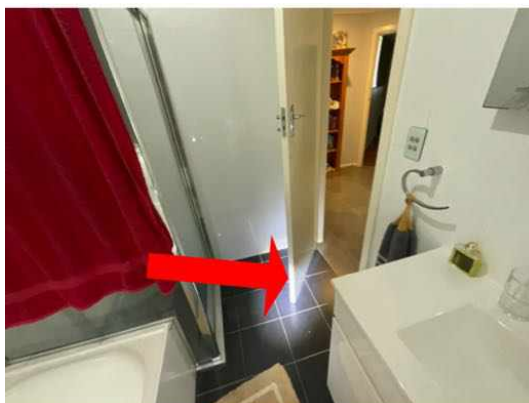
Finding 3.12

Building:	Main Building
Location:	Bathroom
Finding:	Door - Binding/jamming
Information:	Binding and/or jamming of this door is evident during standard operation. This defect inhibits the functionality of the affected door as well as creating potential for secondary defects to associated building elements, such as damage to the floor covering.

A door that binds to flooring or to the associated door frame may have several causes, ranging from minor defects, such as poor installation of the door or deteriorated hinges, through to major structural issues, such as damage to subfloor structures.

Where door binding/jamming appears to indicate major structural issues, a registered builder specialising in re-stumping should be appointed to provide an estimate on the cost of rectification.

For minor causes, a qualified carpenter or general handyman should be appointed to perform minor rectification works at client discretion.

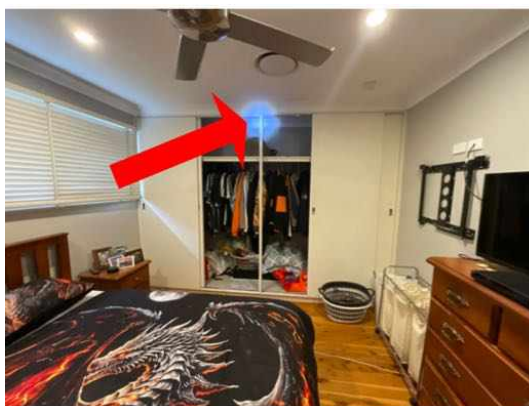
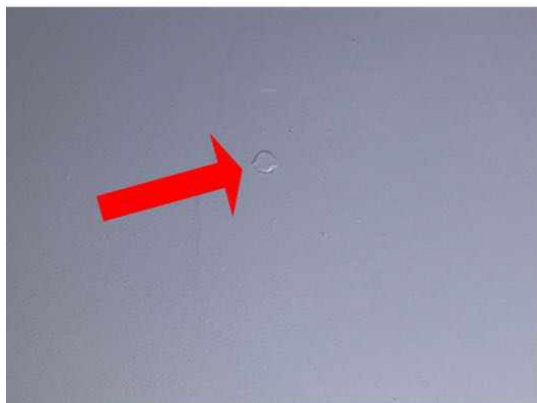
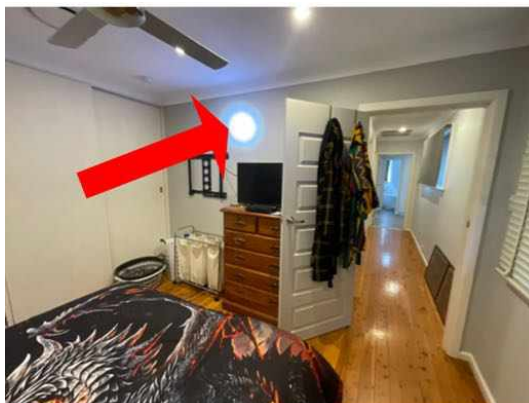
Finding 3.13

Building:	Main Building
Location:	Bedroom
Finding:	Nail Pops to Ceilings and Walls
Information:	Numerous nail pops are visible on the ceiling and some wall surfaces. These appear as raised or broken sections of plaster where fasteners have moved, causing the plasterboard surface to lift or crack around the fixing points.

Nail pops are generally caused by movement of the building frame, shrinkage of timber, or insufficient fixing of plasterboard during construction. While usually cosmetic, they can worsen over time, affect the surface finish, and may indicate minor frame movement.

According to the Guide to Standards and Tolerances 2017 (NSW), nail pops are considered a defect if they are readily visible from a normal viewing position within 12 months of completion, or if they are excessive in number.

A licensed plasterer should be engaged to repair the affected areas. Typical rectification involves re-securing the plasterboard, applying compound over fasteners, sanding, and repainting. If excessive nail pops continue to appear, further investigation into frame movement or structural settlement may be warranted.

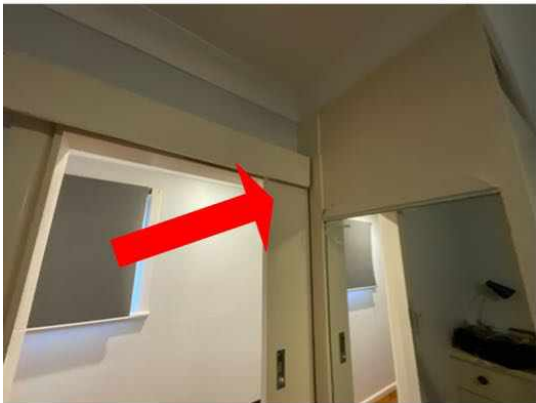
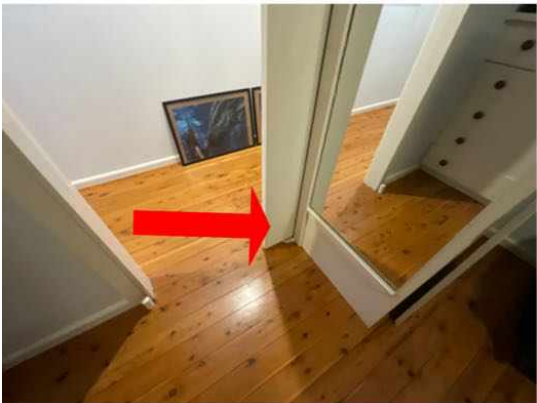
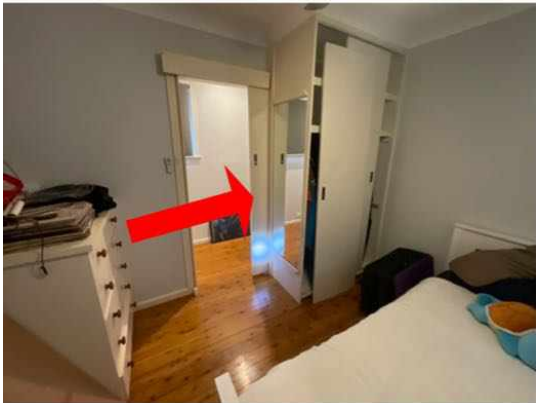
Finding 3.14

Building:	Main Building
Location:	Bedroom
Finding:	Sliding Door - Stiff to slide
Information:	The door in this area was jammed and difficult to slide along the associated tracks at the time of the inspection. Restricted function of the affected door may pose as a potential safety hazard if required for emergency egress from the building.

Generally, factors such as general age of the building element and a lack of maintenance are the usual causes for this type of defect.

Replacement of door hardware or tracks may be required, as well as minor repairs and cleaning. A registered builder or general handy person will be required to repair the affected doors.

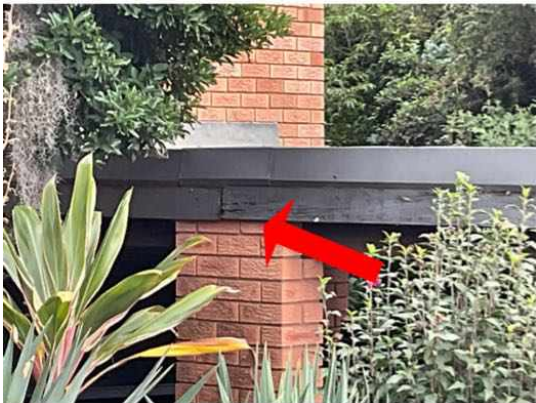
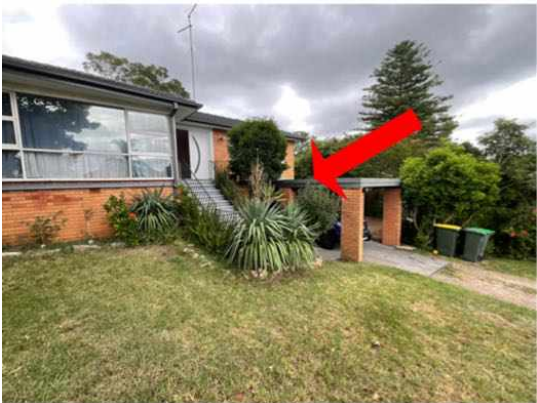
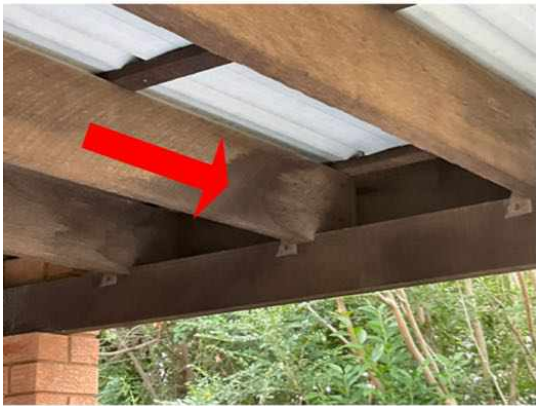
Finding 3.15

Building: Main Building
Location: All External Areas
Finding: External Timber - Weather damaged
Information: Damaged external timber were found during the inspection. External timber structures are constantly exposed to weather elements and can deteriorate in an accelerated manner, ongoing assessments are required.

It is highly recommended that a Structural engineer further assess the external timber balcony/deck to inform the client of its load capacity. Regular maintenance inspections by competent practitioners is needed.

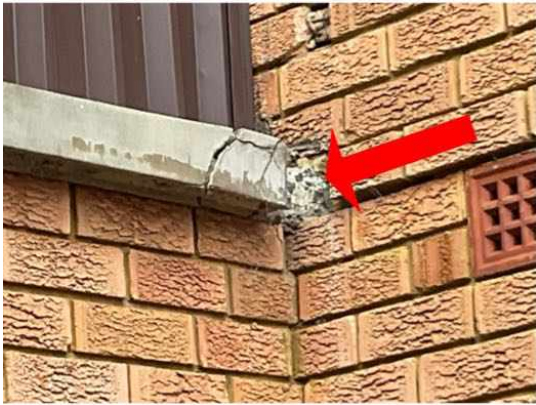
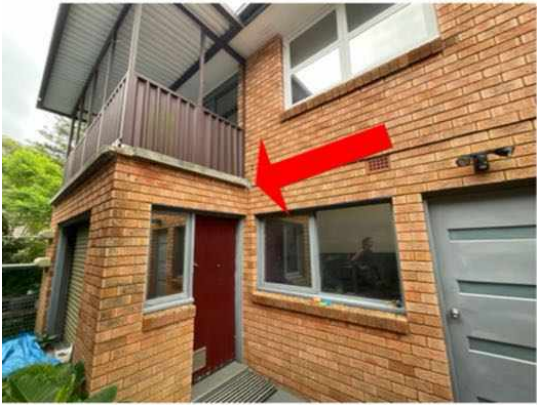
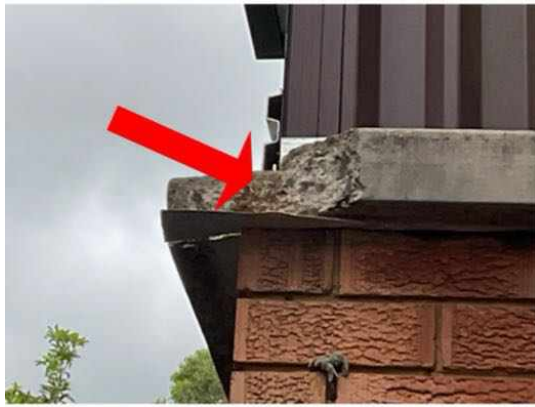
Finding 3.16

Building: Main Building
Location: Balcony
Finding: Concrete Slab - damaged
Information:

At the time of inspection, damaged concrete slab were identified. Significant deterioration is apparent in concrete slab, with areas showing signs of erosion, crumbling, and loss of material, likely due to environmental exposure or aging or building structure moving.

Evidence of structural instability is present in both the brickwork and concrete, with sections showing signs of leaning, bulging, or displacement, posing safety hazards and requiring immediate attention

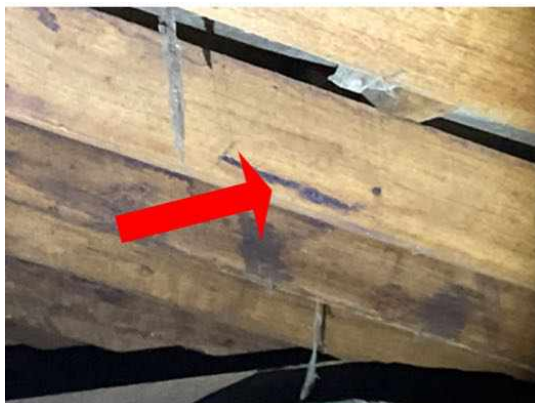
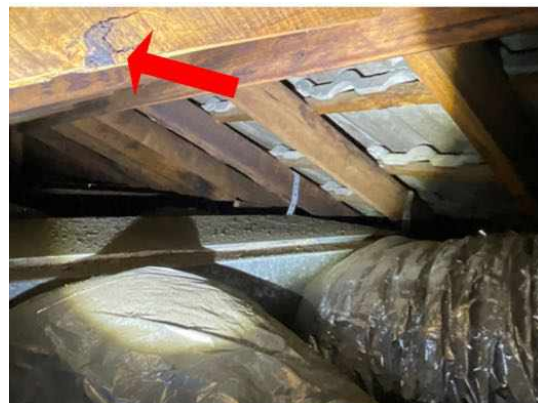
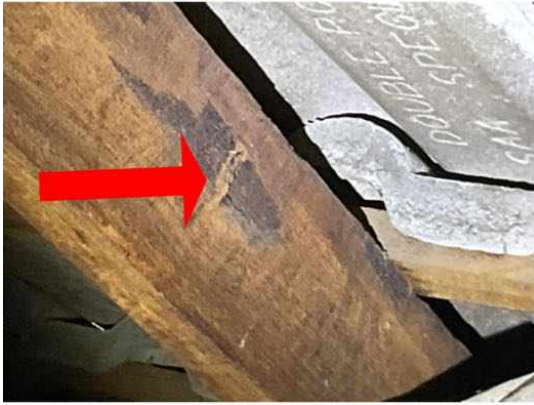
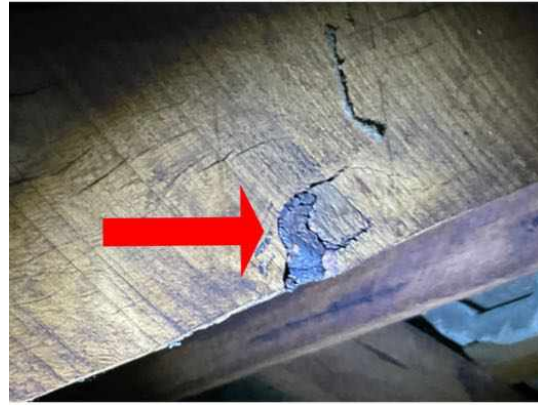
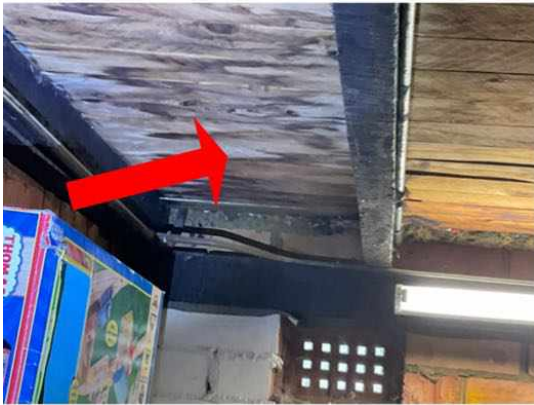
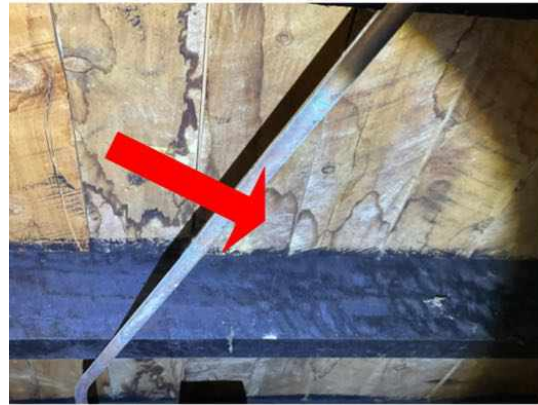
Finding 3.17

Building:	Main Building
Location:	Roof Void / Subfloor
Finding:	Chemical delignification identified
Information:	Chemical delignification also known as wood defibration refers to the chemical breakdown of timber building elements. This breakdown of the Lignin deteriorates the wood impacting on the structural integrity and tensile strength of the affected building element.

Chemical delignification is most common near marine environments due to the high levels of salt in the air however this deterioration may also occur in other areas where timber elements are frequently exposed to damaging gases chemicals etc.

Where timber building elements have deteriorated repair and / or replacement is required immediately to ensure the safety of the associated structures. The likely cause of the defibration should also be investigated and dealt with accordingly.

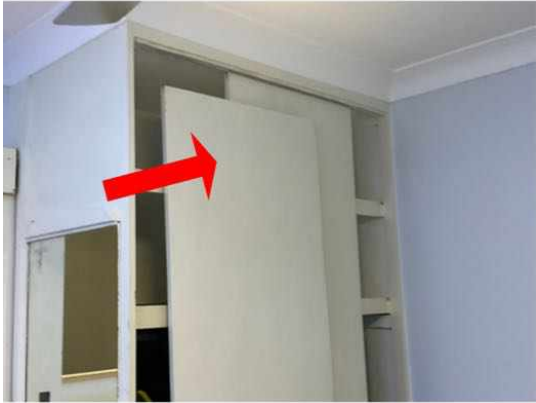
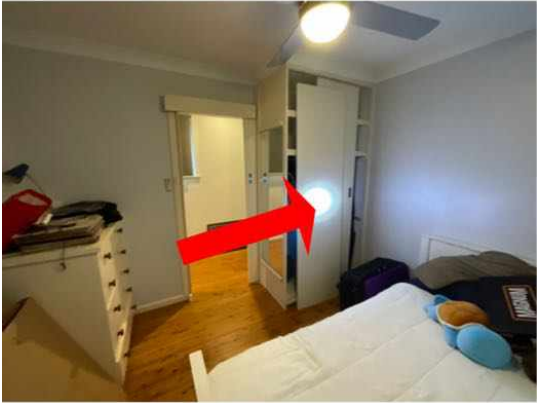
Finding 3.18

Building:	Main Building
Location:	Bedroom
Finding:	Misaligned Sliding Door – Wardrobe
Information:	The sliding door to the wardrobe was found to be misaligned. The door panels are not sitting level within the tracks and do not close flush, resulting in poor operation and uneven appearance.

The builder/tradesperson is to realign the sliding door panels by adjusting the rollers and track guides to ensure smooth operation and flush closure in accordance with manufacturer's installation requirements.

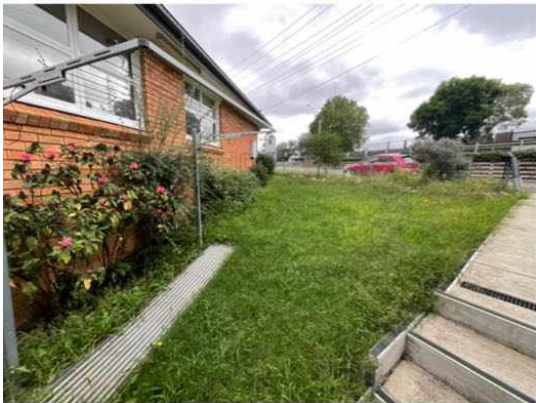
Finding 6.01

Building: Main Building
 Location: All Areas
 Finding: Garden Beds - Conditions Conducive to Termites
 Information: Garden beds were found to be evident in the garden area. These garden beds can include untreated timber, and with a combination of moisture from watering hosing can make conditions conducive to termite activity and termite ingress.

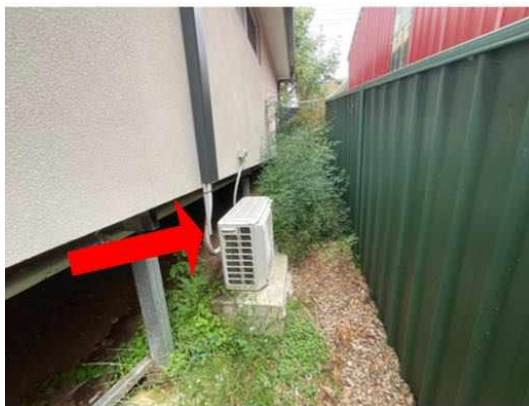
Finding 6.02

Building:	Main Building
Location:	All Areas
Finding:	Air conditioner - Disconnected overflow
Information:	The Air Conditioner (A/C) overflow was found to be disconnected from storm water drainage and is creating excessive moisture in the surrounding area.

Such leaking creates an environment which is conducive to an array of defects, including water damage to associated building elements and the attraction of termite or timber pest infestation.

It is highly recommended that a licensed plumber be appointed to connect the A/C

overflow in order to prevent such an environment from being created. These minor works should be carried out as soon as possible.

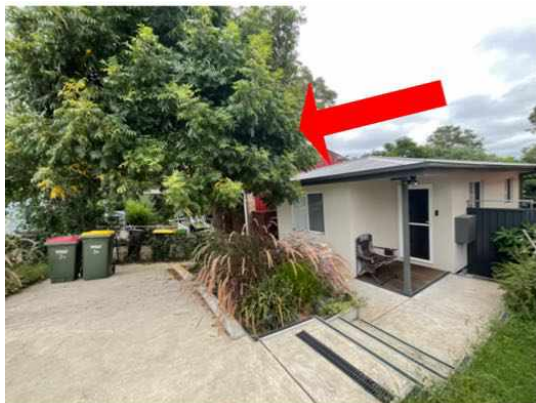
Finding 6.03

Building:	Main Building
Location:	All Areas
Finding:	Trees - Overhanging and filling gutters
Information:	Overhanging trees often result in excessive amounts of leaf debris accumulating in gutters.

Gutters are a critical part of the building's management of storm water and rain. It is therefore important that they be kept clear to prevent secondary damage to associated building elements, including exterior and interior walls, ceiling linings and any adjoining building elements. Where gutters are blocked, pooling of rainwater is likely to occur, fast-tracking rust and corrosion of the roof plumbing elements.

It is highly advised that all overhanging tree branches be removed as soon as possible to prevent any further damage. Repair and/or replacement of sections of damaged guttering may also be required where the extent of the damage necessitates.

Such works should be performed by the homeowner; however, appointment of a landscape contractor or an arborist may be required. Consultation with a licensed roof plumber is required where guttering has been damaged.

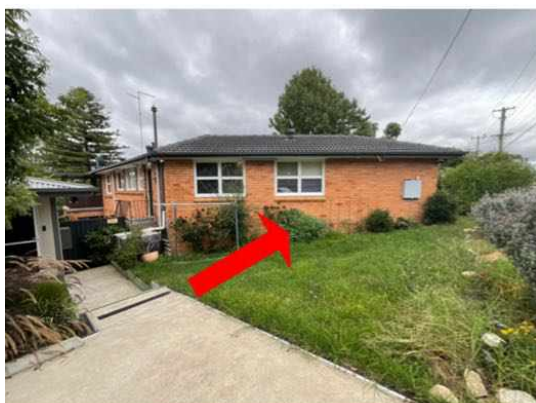
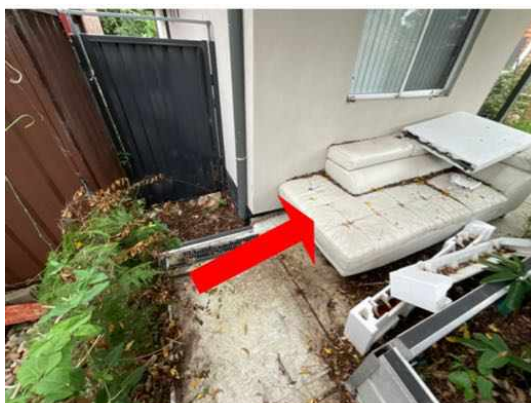
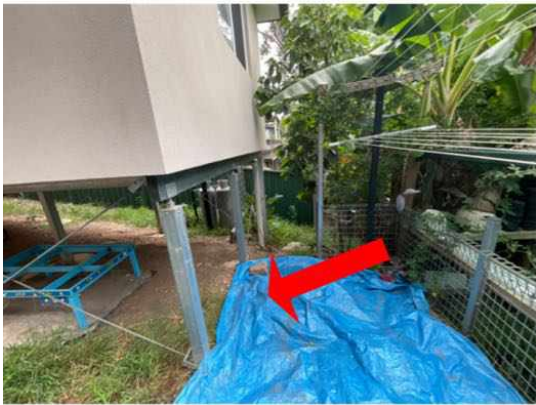
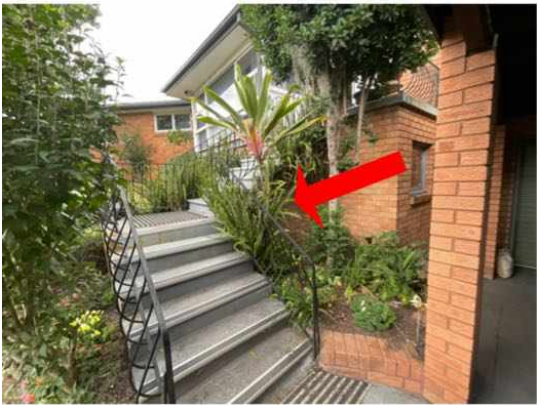
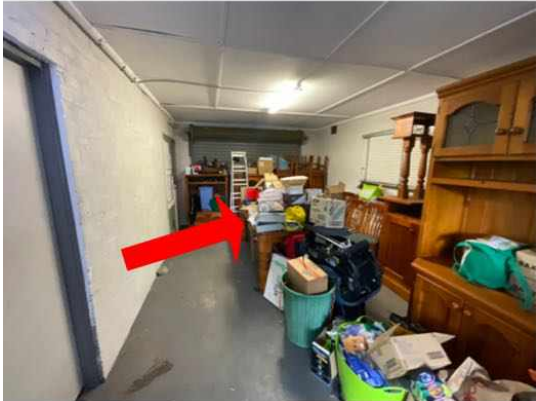
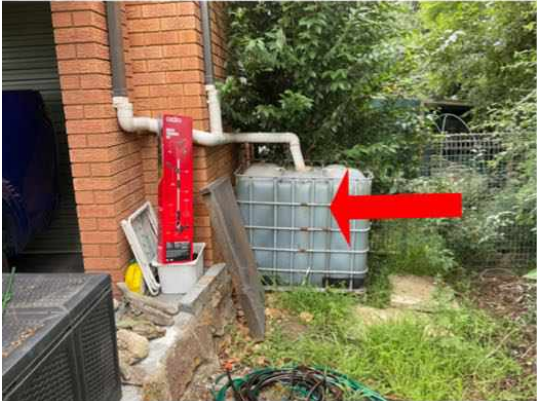
Finding 6.04

Building:	Main Building
Location:	All Areas
Finding:	Bridging of termite barrier/inspection zones
Information:	Bridging is the spanning of a termite barrier or inspection zone so that subterranean termites are provided with passage over or around that barrier.

Where bridging has occurred, full inspection is prevented and termites may enter a property in a concealed or undetectable manner.

It is recommended that minimum 75mm clearance below the bottom of weep or ventilation holes be maintained where possible, otherwise annual inspections should be conducted by a licensed pest control company. Vegetation should also be kept clear of walls to allow regular inspection of all areas.

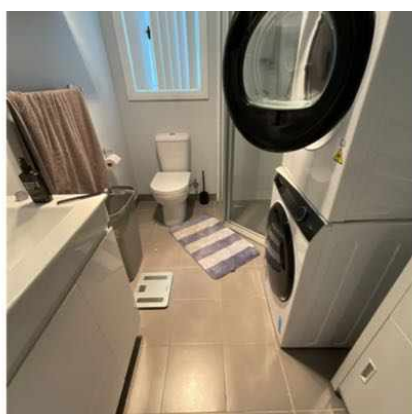
Noted Item

Building: Main Building
 Location: All Areas
 Finding: Water Proofing Membranes - Information Only
 Information: Internal Water Proofing Membranes, are crucial in preventing water ingress into the property is important to know that the Membrane System used is to Australian Standards and has been installed correctly. Please refer to the original Building Documents or Maintenance Schedule for the relevant information including; - Membrane used and Manufacturers Specifications. - The Installer and Installation Certification. Especially with older property's where this information is unavailable, all wet areas should be monitored. Generally new waterproofing with a certificate may only have a guarantee of 8yrs. If any leaks, water staining, peeling or bubbling of the paint become evident to any adjacent walls or ceilings below a licensed builder or waterproofing specialist is recommended to investigate further.

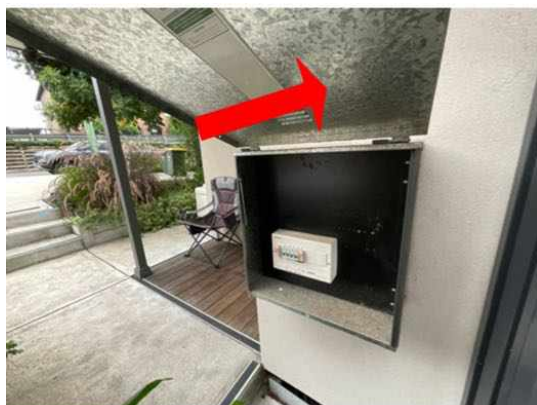
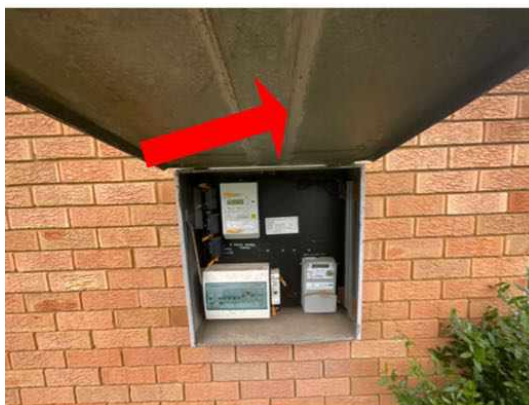
Noted Item

A durable notice should be placed in the switchboard unit to indicate current termite barriers. At the time of inspection, it appeared as though no termite management system has been installed, with no evidence to suggest preventative works taking place.

The client may consider gaining further advice from a pest controller as to the costs and procedures involved with this application. It is recommended that obtaining such advice be a short-term priority.
