Building and Timber Pest Inspection Report

Inspection Date: Wed, 18 Mar 2026

Property Address: 3 & 3A St Johns Rd, Campbelltown NSW
2560, Australia

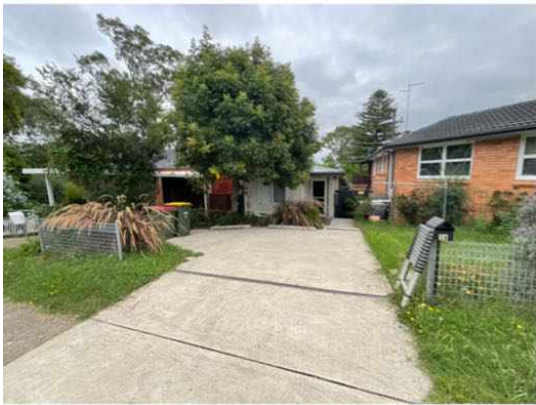
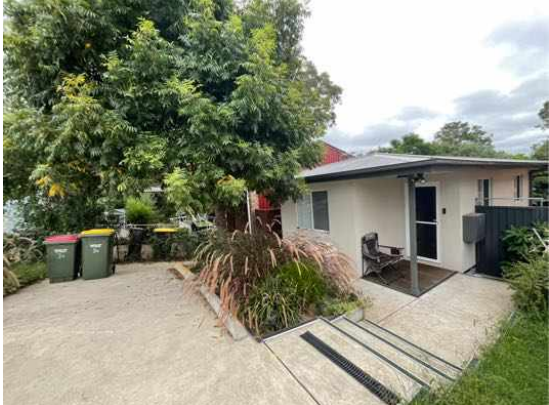
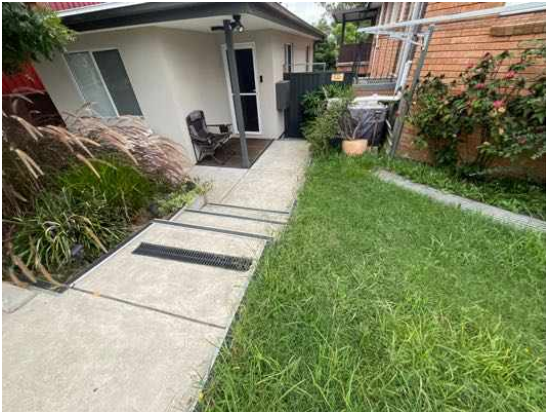
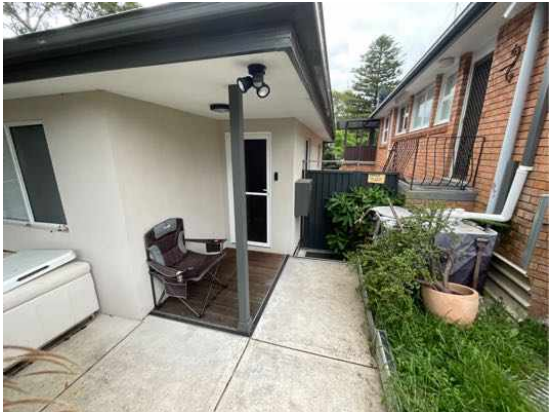
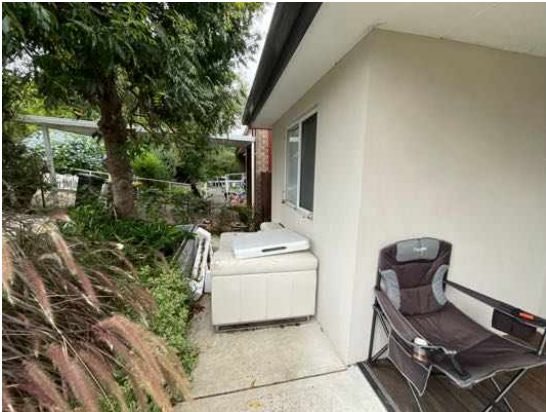
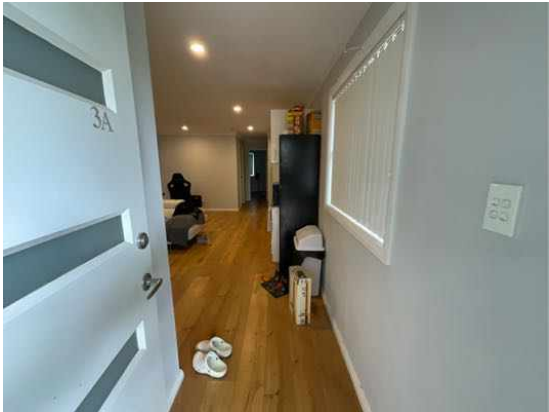
Noted Item

Building: Main Building
 Location: All Areas
 Finding: Additional Photos - Obstructions and Limitations
 Information: These photographs are an indication of the obstructions and limitations which impeded full inspection of the property at the time of inspection. These obstructions can hide an array of defects and should be removed to allow full inspection to be carried out. A re-inspection is recommended once the areas are made accessible.

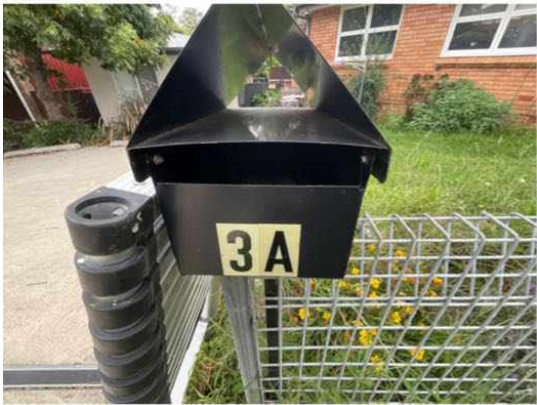
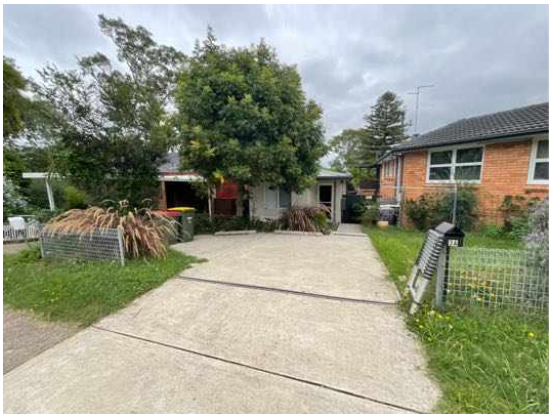
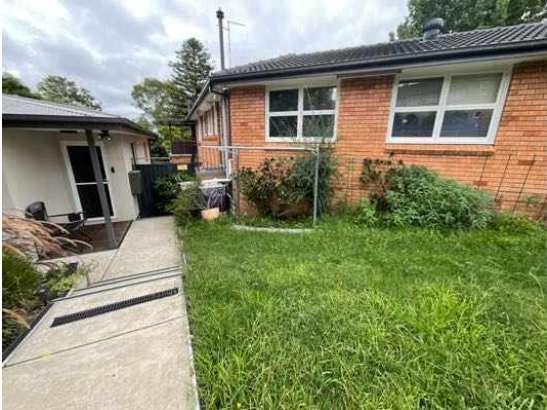
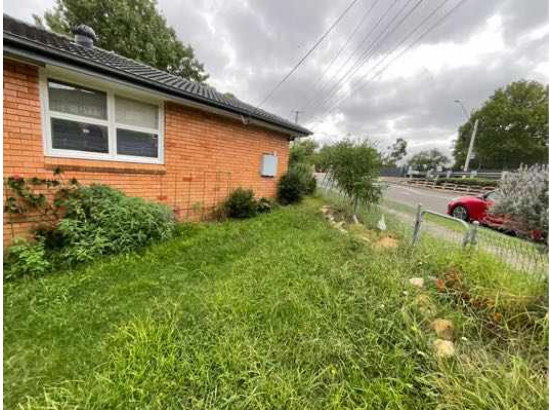
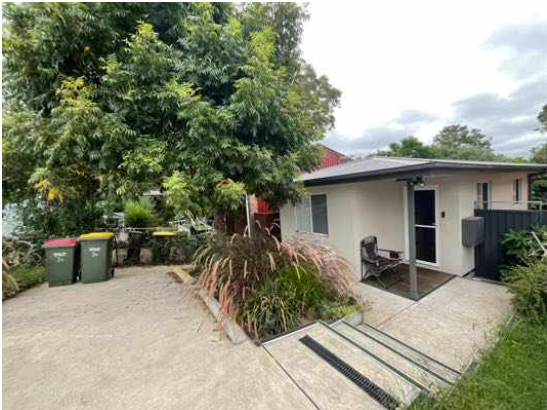
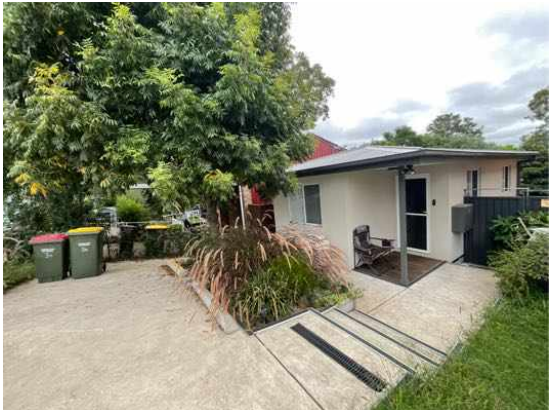
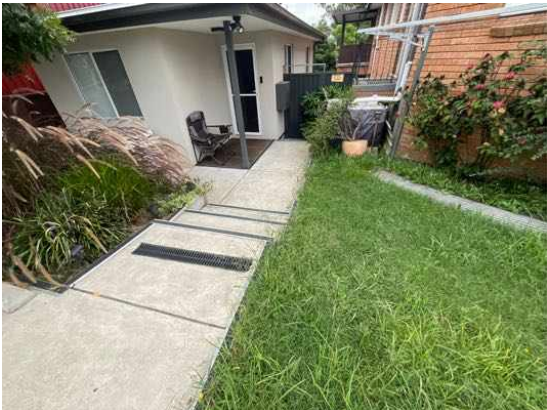
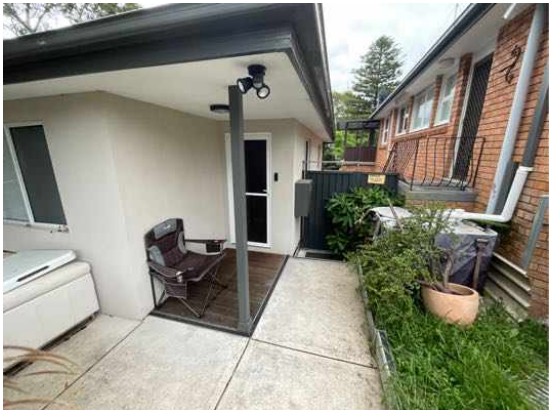
Noted Item

Building: Main Building
Location: All Areas
Finding: Additional Photos
Information: Additional photos are provided for your general reference
