Building and Timber Pest Inspection Report

Inspection Date: Wed, 21 Jan 2026

Property Address: 1 Temora Rise, Berwick VIC 3806, Australia

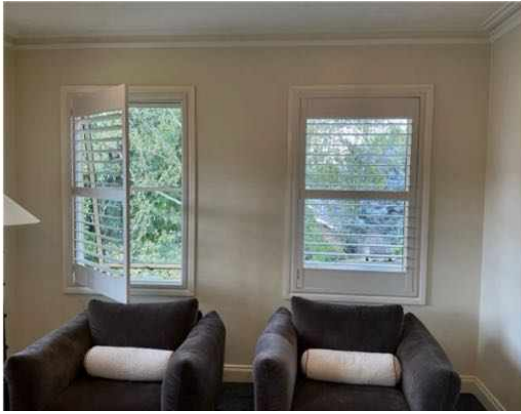
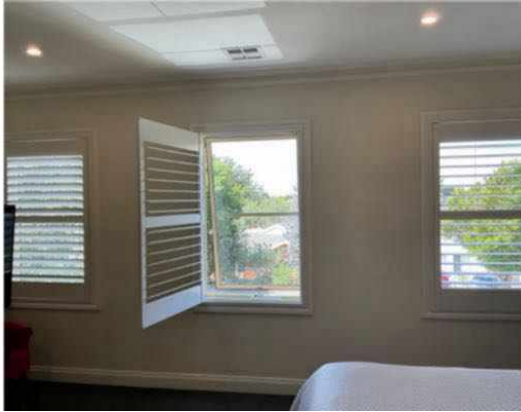
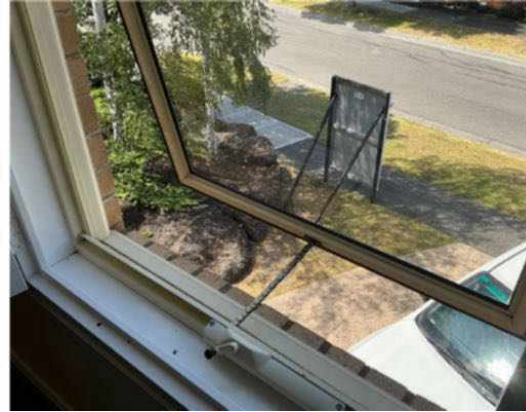
Finding 1.02

Building:	Main Building
Location:	Upper windows
Finding:	Upper floor windows open too far
Information:	The inspection identified that some upper-floor windows in this double-story property do not meet the safety guidelines for openable windows in elevated spaces. Specifically, these windows open wider than the maximum allowable width of 125mm, creating a potential fall hazard. Openable windows in elevated spaces must be restricted in their opening width or fitted with barriers to prevent accidental falls. Installing restrictors or compliant barriers will enhance safety and ensure the property adheres to Australian safety standards, providing a safer environment for all occupants, particularly young children.

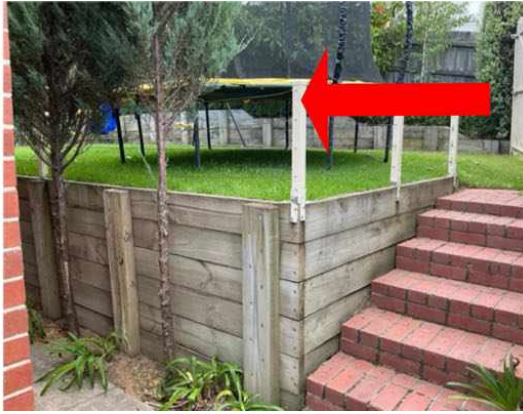
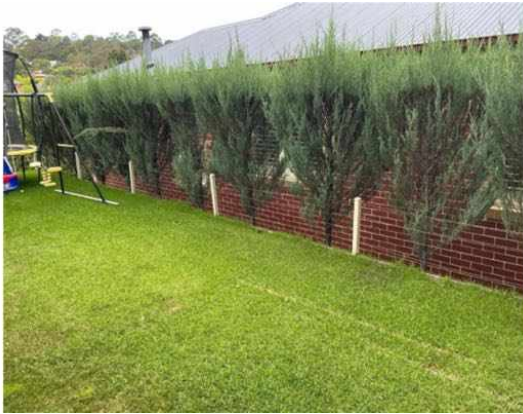
Finding 1.03

Building:	Main Building
Location:	Yard - Back
Finding:	Balustrades Suspected Non-Compliance
Information:	The balustrades near the rear retaining walls were measured and found to less than the present building regulation requirement of 1000mm high.

This defect creates a potential safety hazard and should be rectified as soon as possible to ensure the safety of the area and to meet present building standards and regulations.

A registered builder should be contacted to discuss possible rectification solutions.

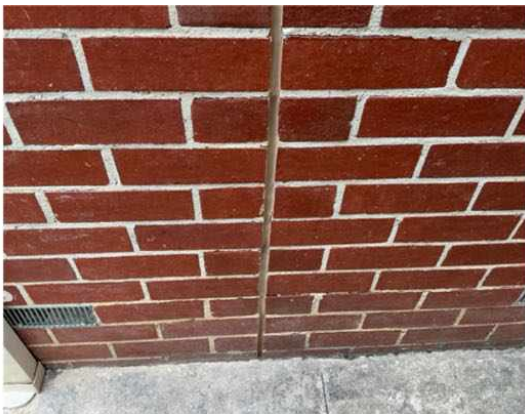
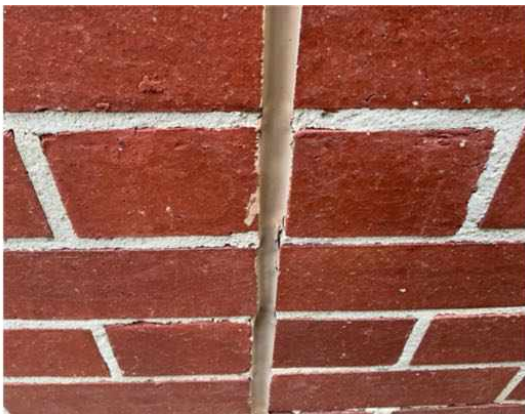
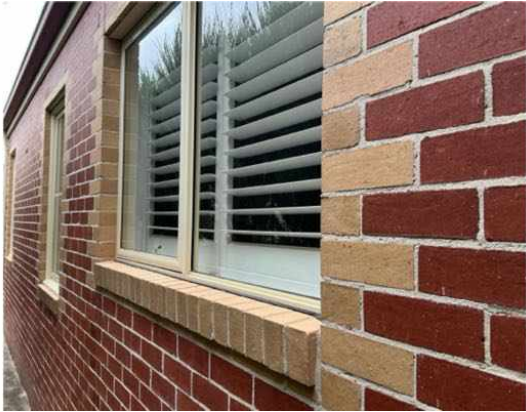
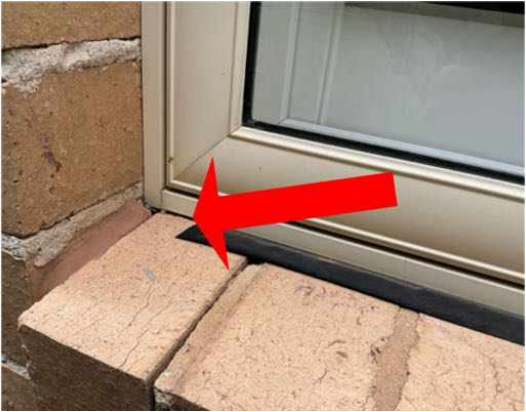
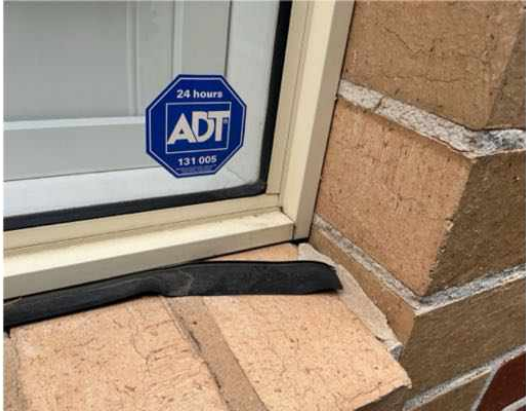
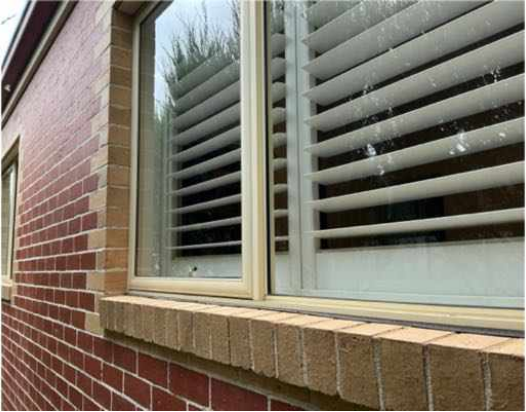
Finding 3.01

Building:	Main Building
Location:	Exterior walls
Finding:	A few gaps to the exterior walls/windows
Information:	A few gaps were noticed to some of the exterior walls/windows to the building. These gaps can let in water, drafts, and pests. Overtime moisture ingress may cause damage to internal walls, mould growth, or structural issues. Gaps also reduce the energy efficiency of the property. Recommend engaging a caulker to seal gaps with an exterior grade flexible sealant that is UV and weather resistant to reduce the risk of pest/water penetration to the building as soon as possible.

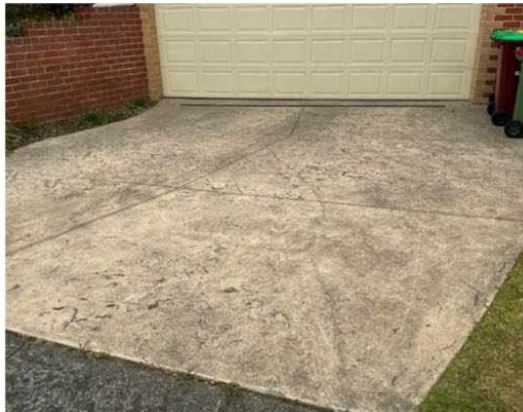
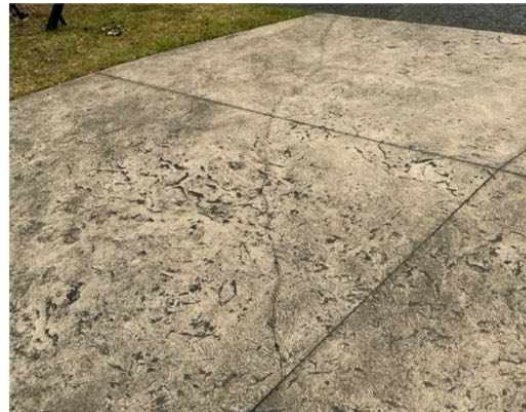
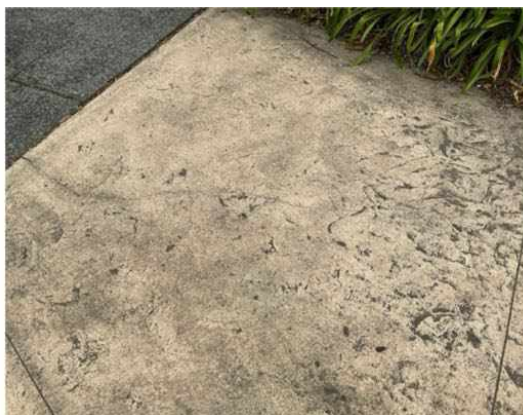
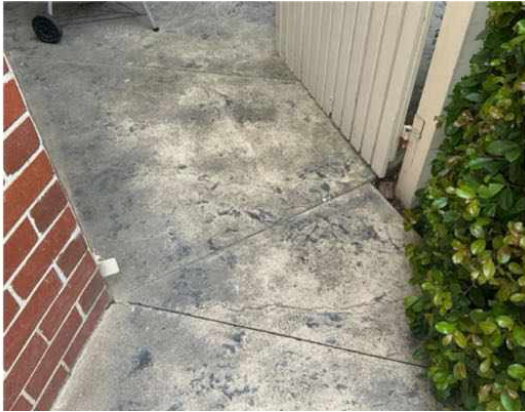
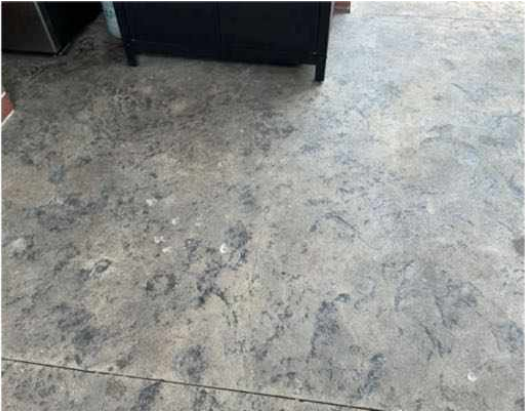
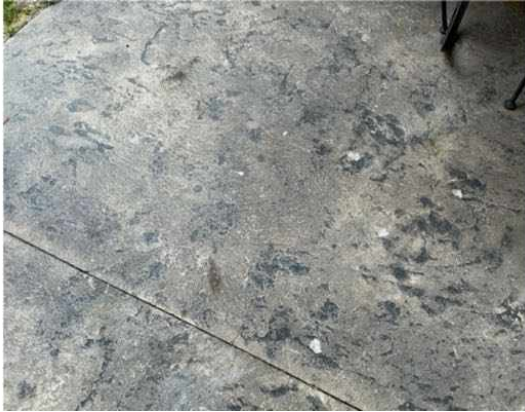
Finding 3.02

Building:	Main Building
Location:	Driveway and pathways
Finding:	Driveway/pathways Cracking Concrete Paving Damage Category 1 - Fine (less than 2mm)
Information:	Fine cracks were identified in the driveway and pathways concrete paving. Although fine cracks are quite noticeable, they are often only considered to be an appearance defect, and usually do not indicate any structural damage. To be considered a Category 1 or fine crack, the crack is found to be less than 2mm in width.

Generally the cause of a hairline crack in existing concrete paving such as driveways and pathways is indicative of the expansion and contraction of the concrete. Such causes are generally due to environmental factors, such as moisture levels, weather conditions, root systems of nearby trees or the soil types on which they are laid.

Fine cracks may also be due to poor original installation of the concrete. Factors such as poor compaction of the sub surface and/or inadequate reinforcing of the slab may create cracking and other secondary defects.

Monitoring of all cracking should be conducted frequently. Always contact a building inspector should cracks widen, lengthen, or become more numerous.

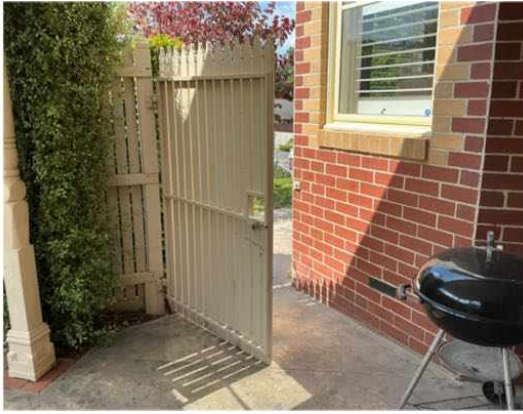
Finding 3.03

Building: Main Building
Location: Yard - Back
Finding: Gate - Binding/jamming
Information: Binding and/or jamming of the gate was evident during standard operation. This defect inhibits the functionality of the affected gate as well as creating potential for secondary defects to associated building elements.

A gate that binds to the associated frame may have several causes, ranging from minor defects, such as poor installation of the gate or deteriorated hinges.

For minor causes, a qualified carpenter or general handyperson should be appointed to perform minor rectification works at client discretion.

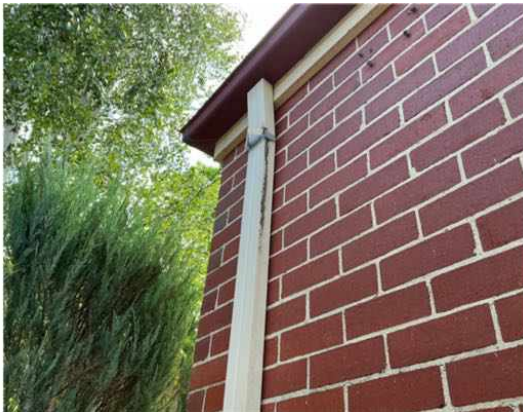
Finding 3.04

Building:	Main Building
Location:	Exterior walls - left side
Finding:	Down pipe clip loose
Information:	The left hand rear down pipe clip is loose/damaged due to poor installation.

It is recommended that a plumber be appointed to further inspect the area and to install/repair clips where necessary at the owners discretion.

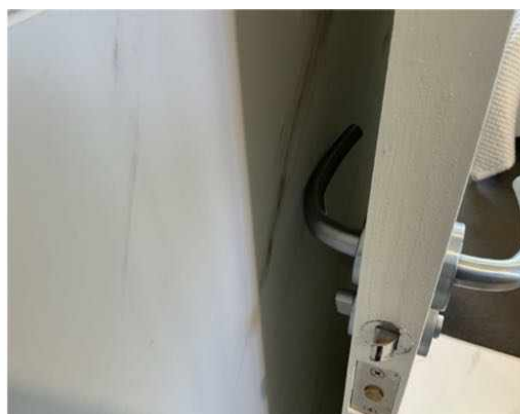
Building:	Main Building
Location:	Ensuite - Master
Finding:	Door stop missing ensuite
Information:	The door stop to the ensuite is missing and is unable to stop the door furniture from damaging the wall. Although some building elements may seem irrelevant or unnecessary, all building elements play a key role in the operation and function of the overall structure and its performance.

Re-installation or replacement of the door stop is advised as soon as possible to prevent any subsequent damage to the door or associated structures. A general handyman may be appointed to perform these works at client discretion.

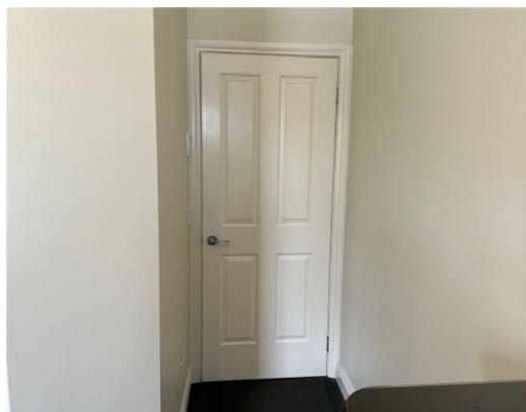
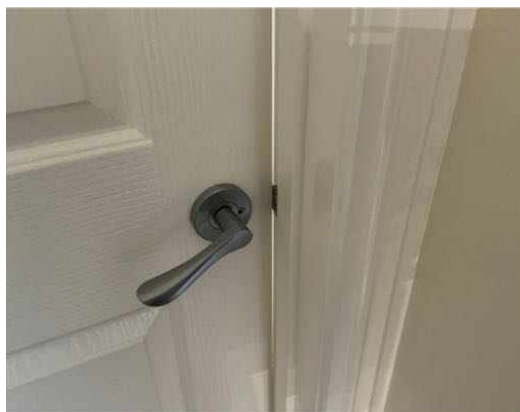
Finding 3.07

Building: Main Building
 Location: Bedroom - Master
 Finding: Door - Binding/jamming bedroom
 Information: Binding and/or jamming of the master bedroom door is evident during standard operation. This defect inhibits the functionality of the affected door as well as creating potential for secondary defects to associated building elements, such as damage to the floor covering.

A door that binds to flooring or to the associated door frame may have several causes, ranging from minor defects, such as poor installation of the door or deteriorated hinges.

For minor causes, a qualified carpenter or general handyperson should be appointed to perform minor rectification works at client discretion.

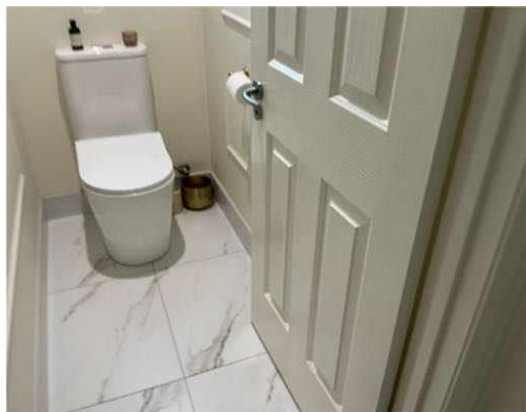
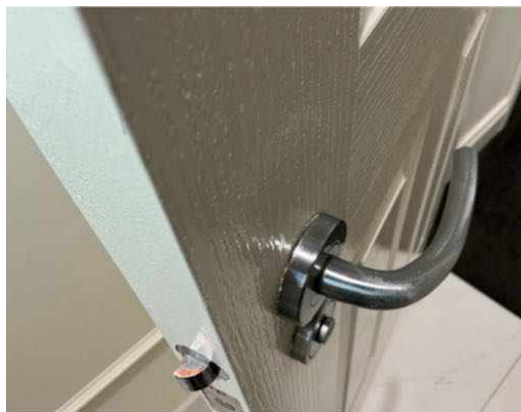
Finding 3.10

Building:	Main Building
Location:	Toilet (WC)
Finding:	Loose door handle
Information:	The door handle to the toilet door is loose. Door handles can come loose over a period of time or operation. Reccomend engaging a carpenter to repair to reduce the risk of further deterioration at the owners discretion.

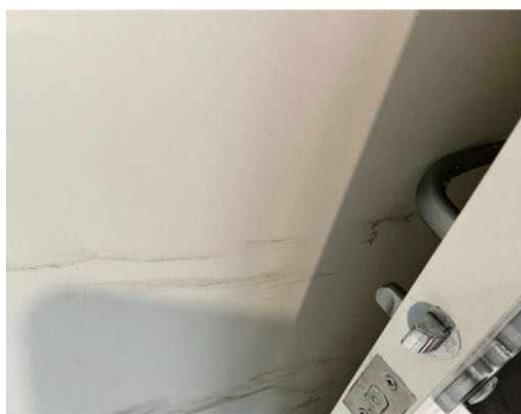
Finding 3.11

Building:	Main Building
Location:	Bathroom
Finding:	Door stop missing
Information:	The door stop to the bathroom is missing and is unable to stop the door furniture from damaging the wall. Although some building elements may seem irrelevant or unnecessary, all building elements play a key role in the operation and function of the overall structure and its performance.

Re-installation or replacement of the door stop is advised as soon as possible to prevent any subsequent damage to the door or associated structures. A general handyman may be appointed to perform these works at client discretion.

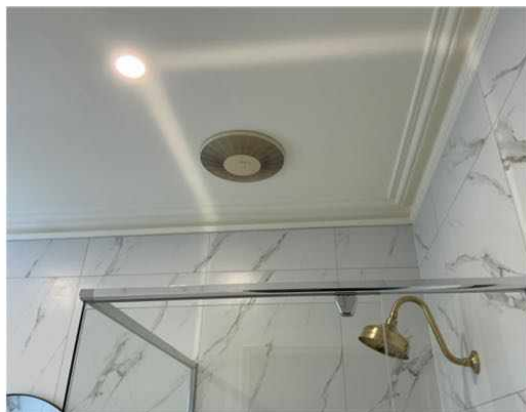
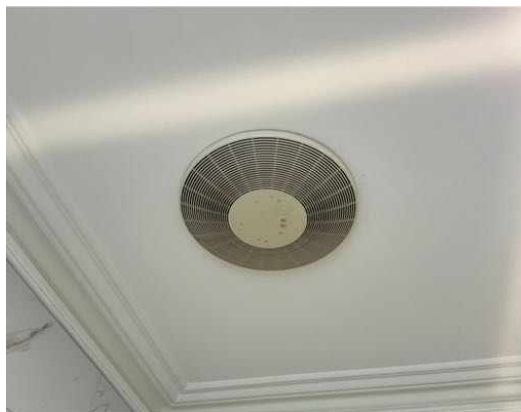
Finding 3.12

Building:	Main Building
Location:	Bathroom
Finding:	Fan not working
Information:	The fan to the bathroom is not working. Recommend engaging an electrician to repair /replace to make operational at the owners discretion.

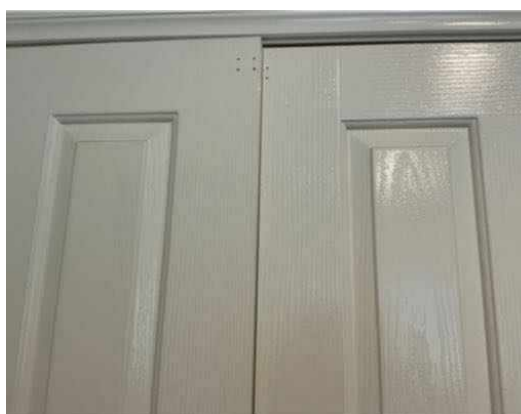
Finding 3.13

Building: Main Building
 Location: Bedroom 3
 Finding: Door - Binding/jamming bedroom
 Information: Binding and/or jamming of bedroom 3 cupboard doors is evident during standard operation. This defect inhibits the functionality of the affected door as well as creating potential for secondary defects to associated building elements, such as damage to the floor covering.

A door that binds to flooring or to the associated door frame may have several causes, ranging from minor defects, such as poor installation of the door or deteriorated hinges.

For minor causes, a qualified carpenter or general handyperson should be appointed to perform minor rectification works at client discretion.

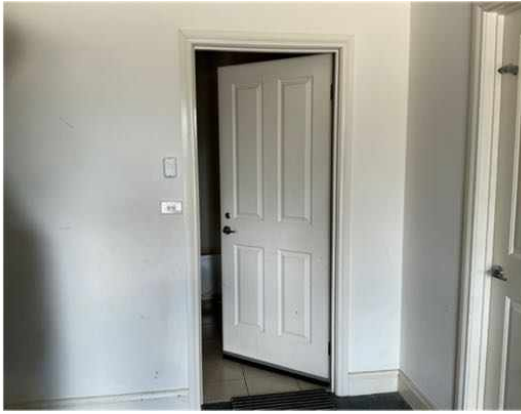
Building:	Main Building
Location:	Garage
Finding:	Door - Binding/jamming garage
Information:	Binding and/or jamming of the garage door is evident during standard operation. This defect inhibits the functionality of the affected door as well as creating potential for secondary defects to associated building elements, such as damage to the floor covering.

A door that binds to flooring or to the associated door frame may have several causes, ranging from minor defects, such as poor installation of the door or deteriorated hinges.

For minor causes, a qualified carpenter or general handyperson should be appointed to perform minor rectification works at client discretion.

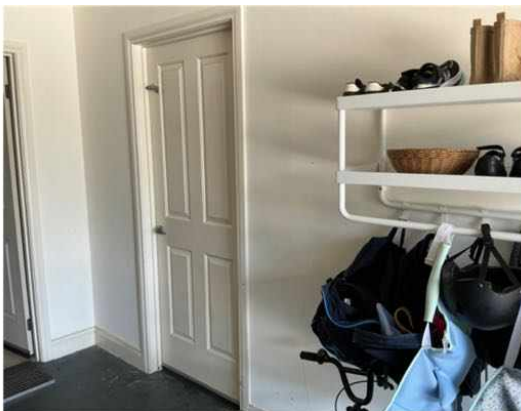
Information: Binding and/or jamming of the subfloor door is evident during standard operation. This defect inhibits the functionality of the affected door as well as creating potential for secondary defects to associated building elements, such as damage to the floor covering.

A door that binds to flooring or to the associated door frame may have several causes, ranging from minor defects, such as poor installation of the door or deteriorated hinges.

For minor causes, a qualified carpenter or general handyperson should be appointed to perform minor rectification works at client discretion.

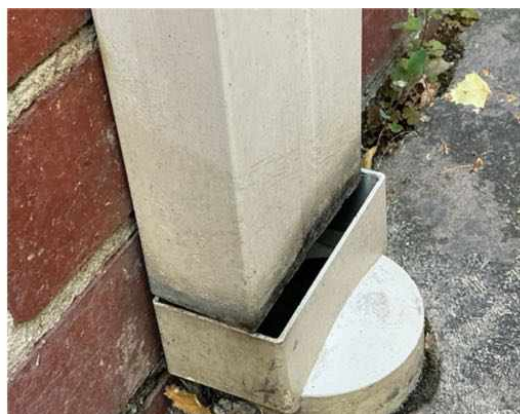
Finding 6.02

Building:	Main Building
Location:	Yards
Finding:	Site drainage - poor/inadequate
Information:	The site drainage to parts of the yards was found to be inadequate at the time of inspection, creating potential for subsequent water damage to associated building elements. Excessive moisture will attract termites.

Where site drainage is inadequate, installation of an Agricultural (Aggie) Drain may be required. A qualified plumber should be appointed to further inspect the property and perform any remedial works as necessary. Water damage and secondary defects are likely to occur if left unmanaged.

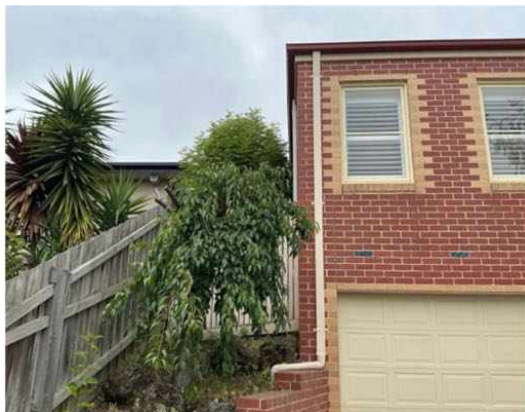
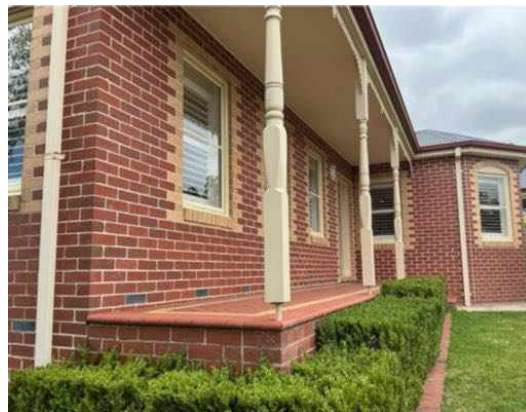
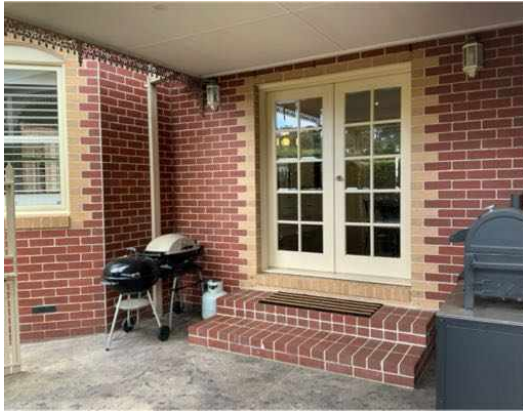
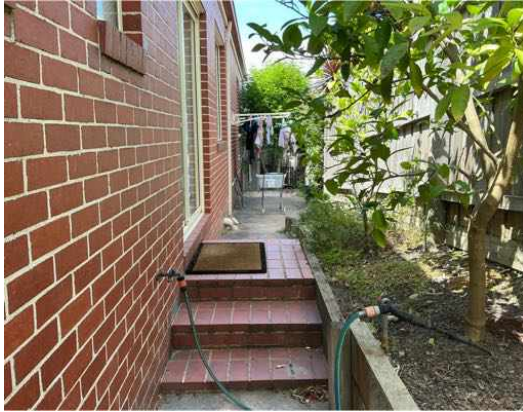
Finding 6.05

Building:	Main Building
Location:	Various parts of the building
Finding:	In ground contact
Information:	<p>Any timbers in direct ground contact provide opportunity for concealed termite entry and are likely to be subject to premature rot and decay as the soil retains moisture or damp conditions against the timbers.</p> <p>Remove untreated timber that is in direct contact with external grounds. Consider replacement with more durable materials i.e. treated timber or non timber elements. Frequent pest inspections are advised to readily identify any termite activity in these areas.</p>

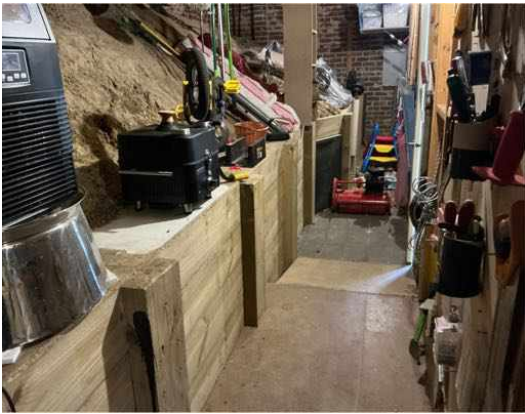
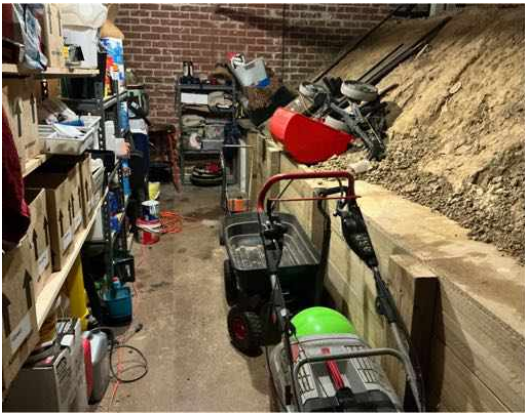
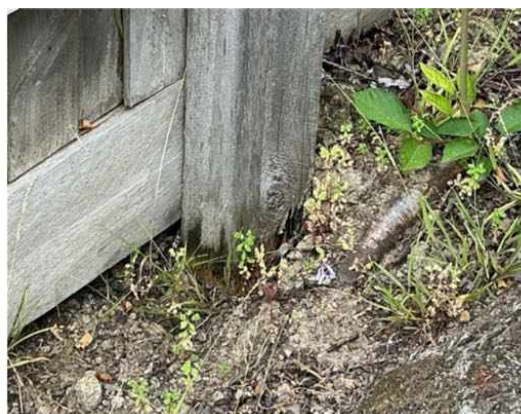
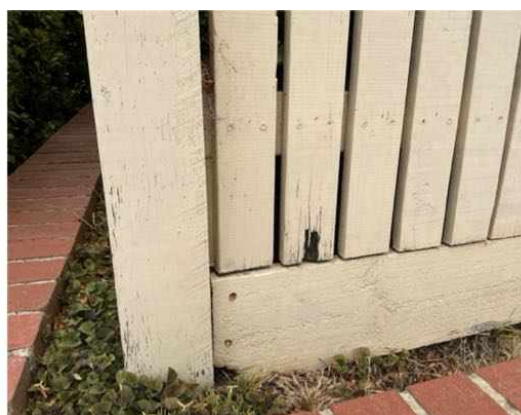
Finding 7.01

Finding: Fencing retaining walls - wood rot-fungal decay

Information: It was noted at the time of inspection that sections of the fencing and retaining walls to the property have deteriorated and have fungal decay/wood rot present and the fence is leaning near the gate. Typically fencing deteriorates due to age and or wear, rot and or rust which is generally expected for a structure of this age, due to prolonged exposure to weather conditions. Sometimes inadequate installation or maintenance can be to blame.

If left unattended, it is likely that further damage will occur. It is suspected that repair of several elements of the fencing may be required however replacement may be a consideration of the client also.

A licensed fencing contractor should be appointed to provide further advice and perform rectification works as necessary.

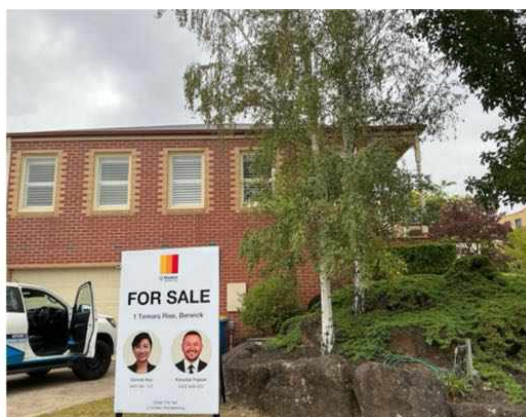
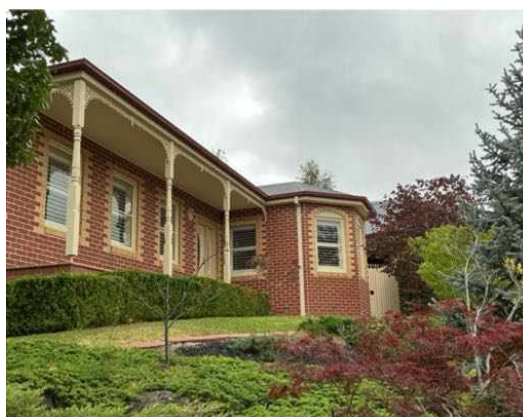
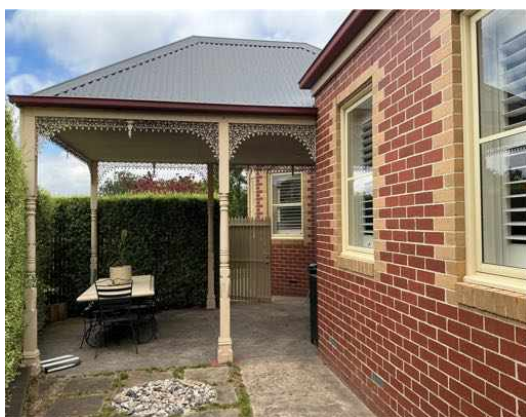
Building: Main Building
 Location: All External Areas
 Finding: Additional Photos - Obstructions and Limitations
 Information: These photographs are an indication of the obstructions and limitations which impeded full inspection of the property at the time of inspection. These obstructions can hide an array of defects and should be removed to allow full inspection to be carried out. A re-inspection is recommended once the areas are made accessible.

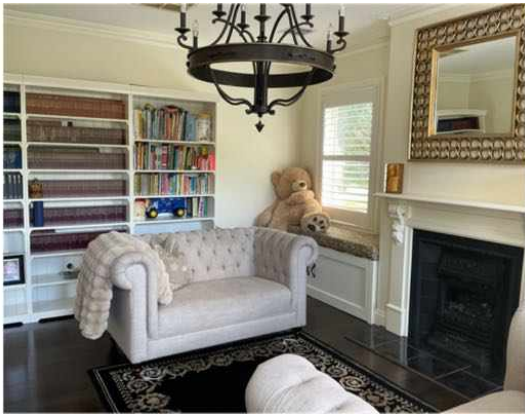
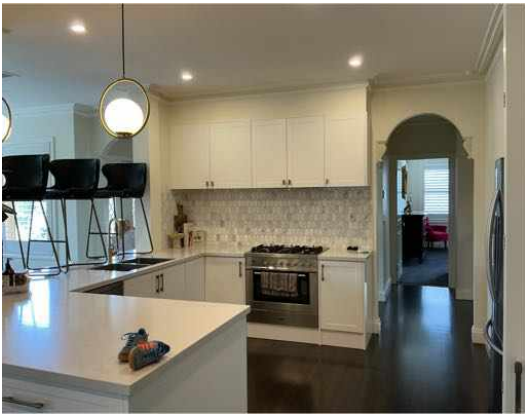
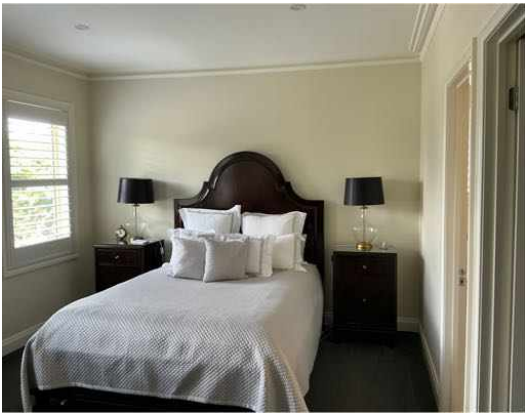
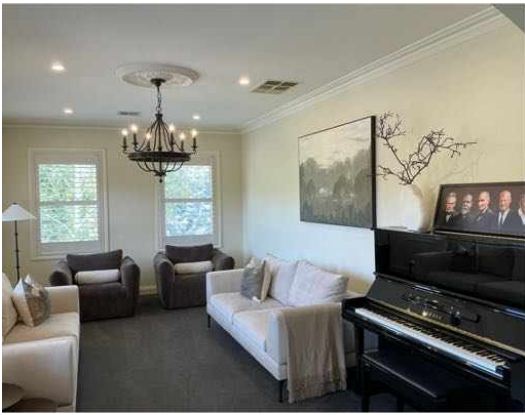
Building: Main Building
 Location: All Internal Areas
 Finding: Additional Photos - Obstructions and Limitations
 Information: These photographs are an indication of the obstructions and limitations which impeded full inspection of the property at the time of inspection. These obstructions can hide an array of defects and should be removed to allow full inspection to be

carried out. A re-inspection is recommended once the areas are made accessible.

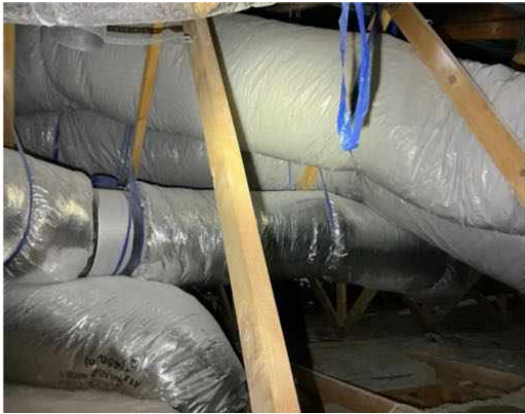
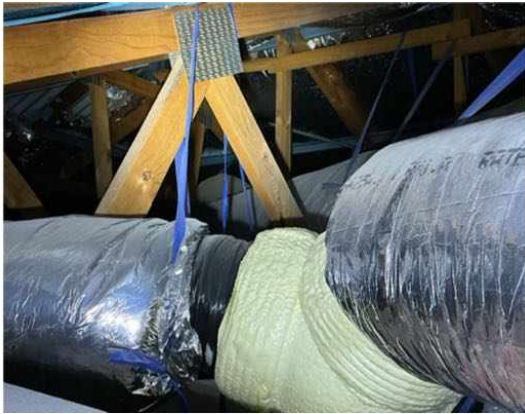
Building: Main Building
 Location: Roof Void
 Finding: Obstructions and Limitations -roof cavity
 Information: These photographs are an indication of the obstructions and limitations which impeded full inspection of the roof cavity at the time of inspection. These obstructions can hide an array of defects and should be removed to allow full inspection to be carried out. A re-inspection is recommended once the areas are made accessible.

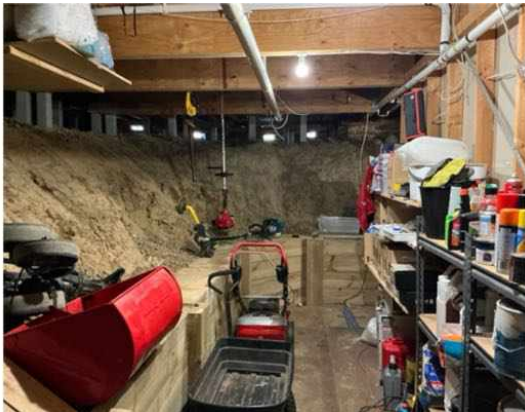
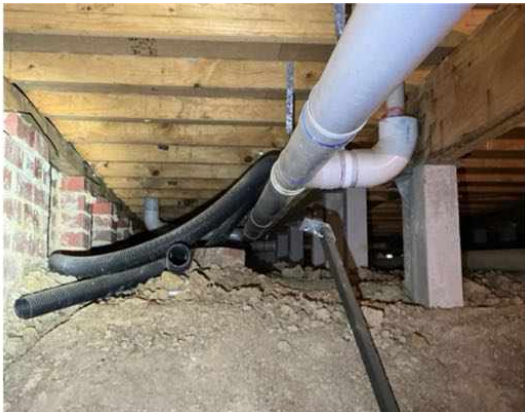
Building: Main Building
Location: Subfloor
Finding: Obstructions and Limitations -subfloor
Information: These photographs are an indication of the obstructions and limitations which impeded full inspection of the subfloor at the time of inspection. These obstructions can hide an array of defects and should be removed to allow full inspection to be carried out. A re-inspection is recommended once the areas are made accessible.

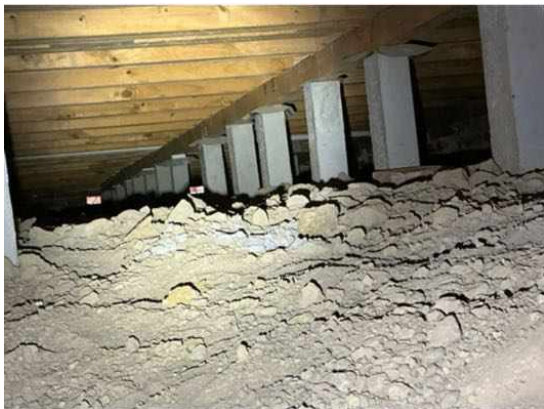
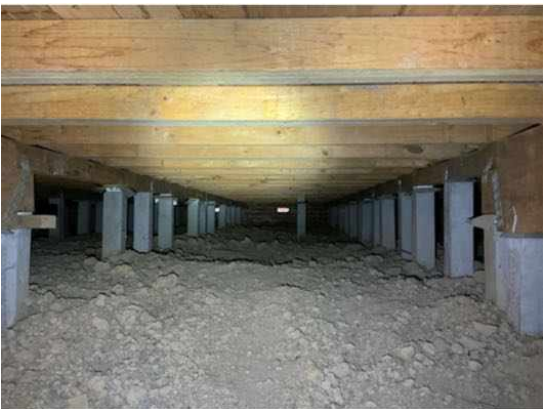
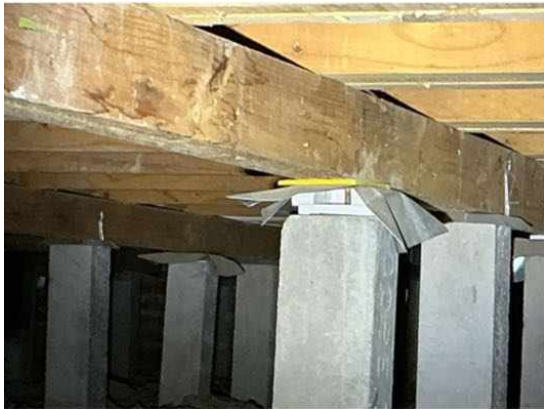
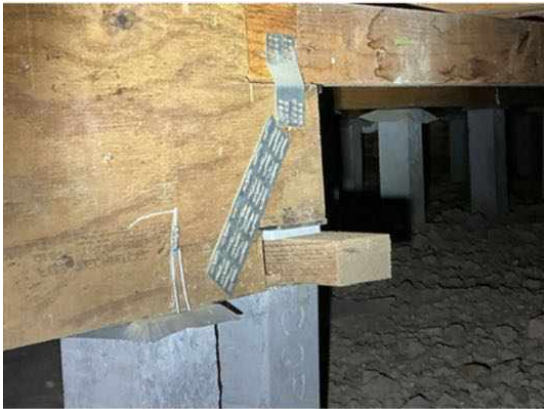
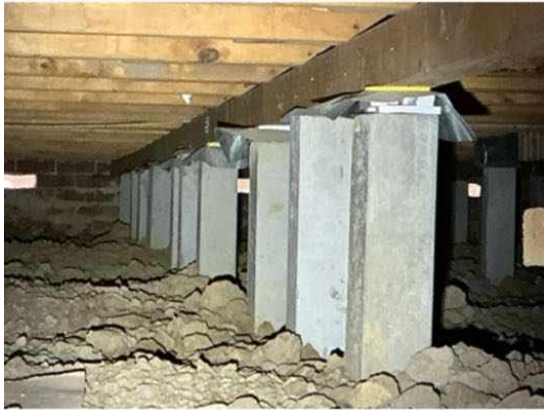
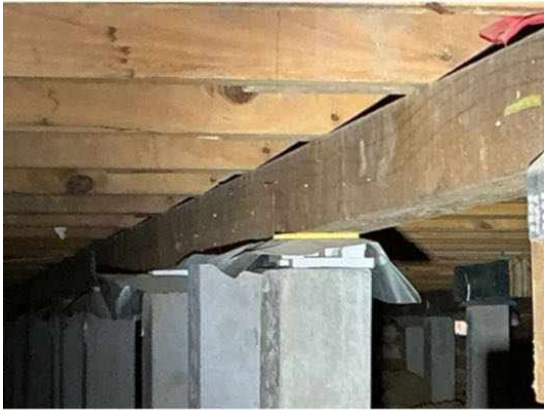
Building: Main Building
Location: Subfloor
Finding: Subfloor has been re stumped
Information: On inspection of the subfloor, it was noticed that the building has been re -stumped previously.

No documentation relating to these works was available at the time of inspection.

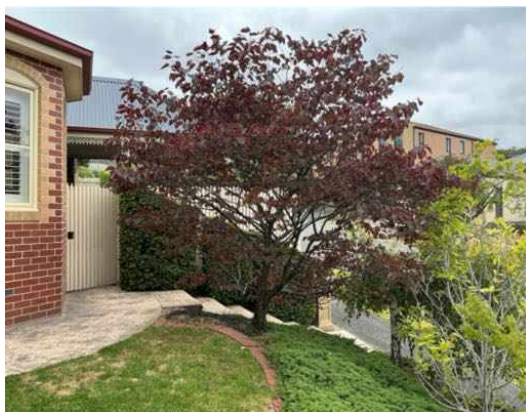
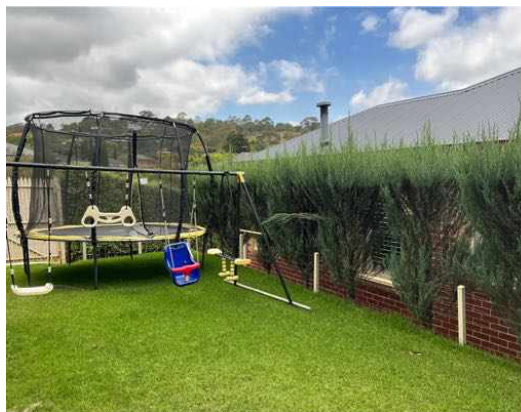
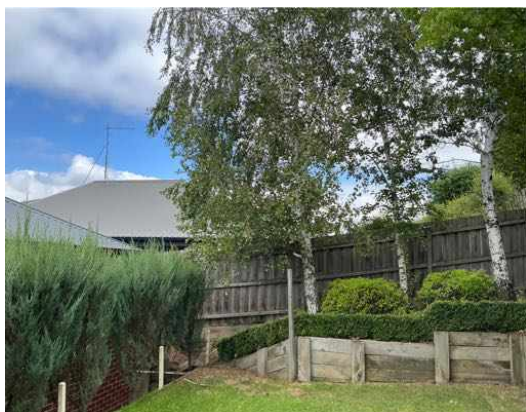
Building: Main Building
Location: Yards
Finding: large trees near property
Information: Some large trees are growing near the structure. Tree roots can cause major foundation and plumbing related issues. Recomend engaging an arborist to further investigate and advise on the severity of the root systems and any rectification works that may be required to reduce the risk of property damage and deterioration.

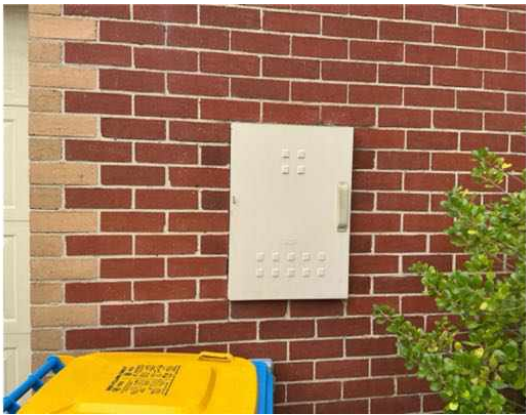
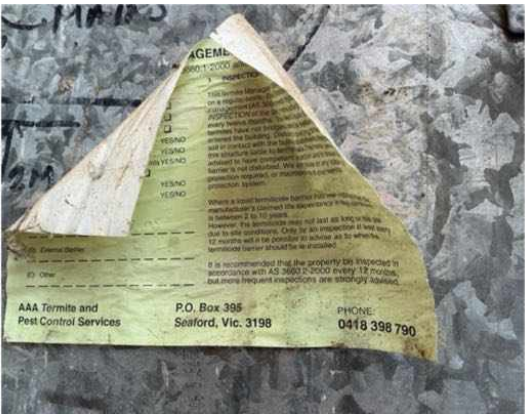
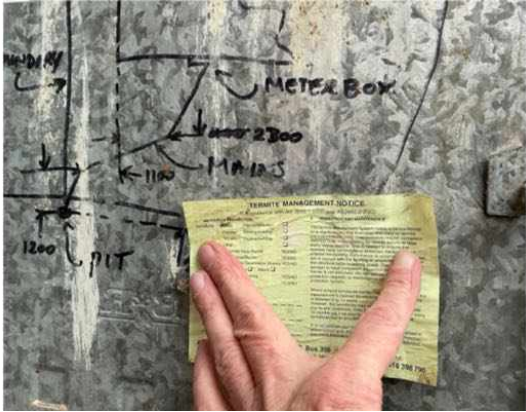
Where a Termite Management System has been identified you should refer to the type of barrier date of installation warranty conditions and any documentation provided by a builder or past owner. Consult the company who installed the barrier to confirm whether the system is still under warranty.

Most chemical termite management systems expire and require replenishment and all physical systems are primarily designed to prevent concealed entry.
