Building and Timber Pest Inspection Report

Inspection Date: Thu, 26 Feb 2026

Property Address: 401/10 Norfolk St, Liverpool NSW 2170,
Australia

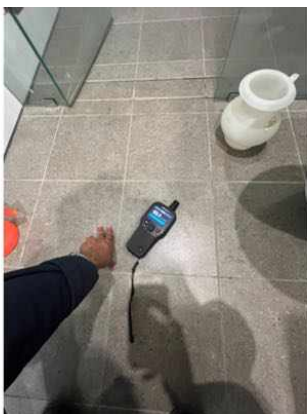
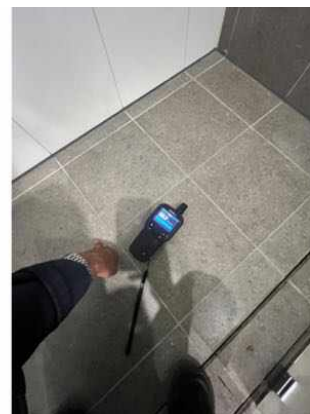
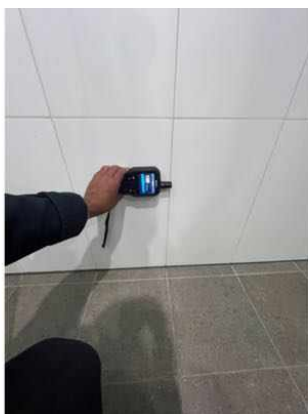
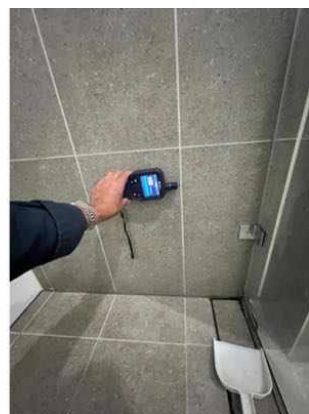
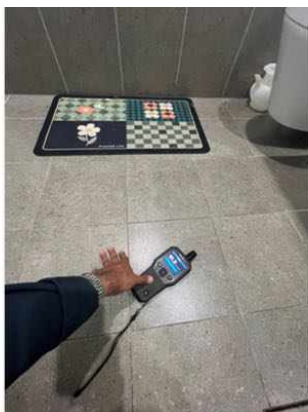
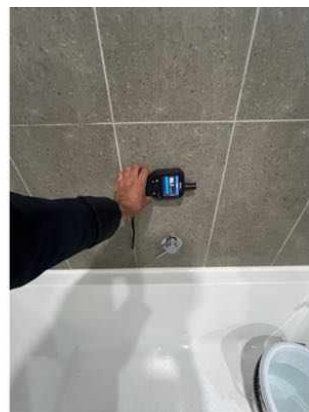
Building: Main Building
Location: Bathrooms
Finding: Elevated Moisture Bathroom (No visible deterioration noted)
Information: Elevated moisture levels were detected to tiled surfaces in bathroom/shower areas. Persistent moisture ingress can lead to concealed damage, including timber rot and mould growth.

Elevated moisture readings in tiled wet areas can occur from normal shower use, age/deterioration of waterproofing membranes, plumbing leaks or moisture absorption through grout lines. While no damage was visible, elevated readings may indicate moisture retention behind tiles, which can be a conducive condition for future deterioration if not monitored.

Monitor the area over time for signs of drumming, efflorescence, tile movement, or grout deterioration. If concerns arise, a licensed waterproofing specialist can perform further investigation (e.g., pressure testing, membrane assessment).

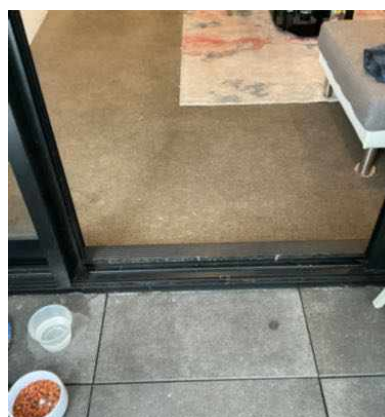
Finding 3.03

Building:	Main Building
Location:	Balcony
Finding:	Balcony Floor Level Differential
Information:	The balcony finished surface appears to be close to, or at the same level as, the internal floor. Standard construction practice requires a step-down of approximately 50 mm unless a fully engineered threshold drainage system is provided. No such drainage features were visible during inspection. This configuration increases the risk of water ingress, and confirmation of the balcony waterproofing detail through strata/building management is recommended.

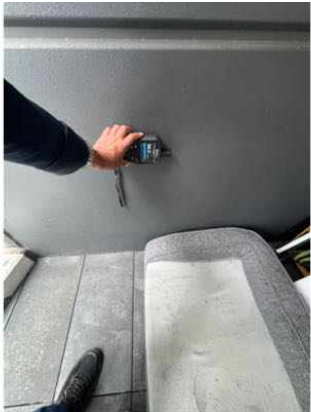
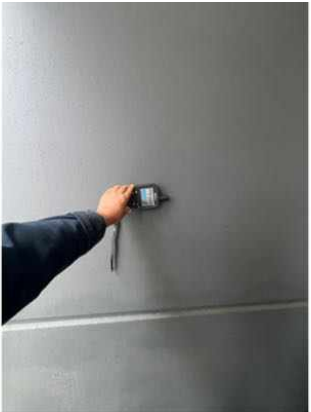
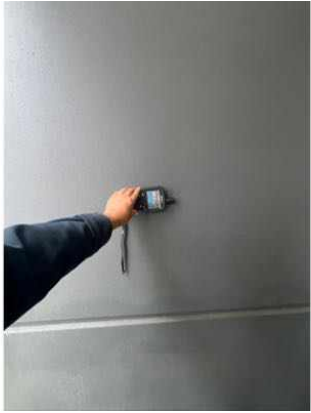
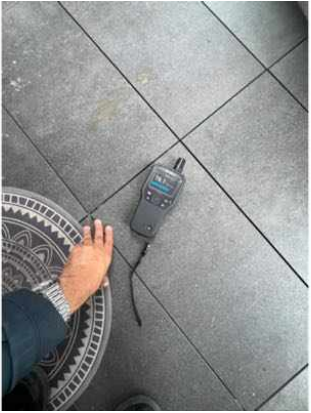
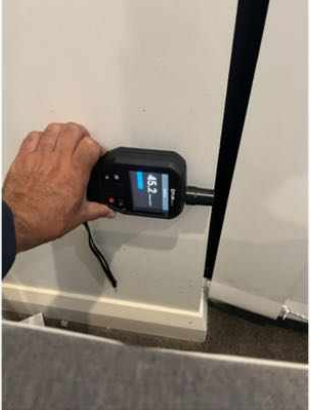
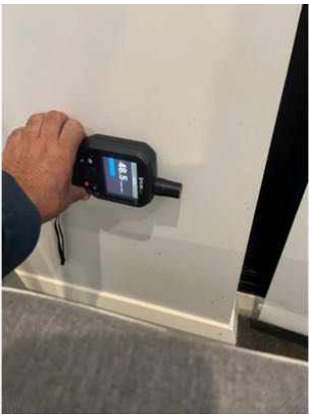
Finding 3.04

Building:	Main Building
Location:	Balcony
Finding:	Elevated Moisture Detected - Strata
Information:	Slightly Elevated moisture levels were detected in skirting any lower walls adjacent to balcony area . The areas should be monitored for and changes to existing conditions e.g damp , paint bubbling of staining.Further invasive investigation by a licensed plumber or waterproofing specialist is recommended to confirm the source and extent of water ingress if condition persists. As this relates to a multi-residential building, the source of water ingress may involve common property, a suitably qualified

waterproofing contractor is recommended to determine cause, responsibility, and scope if required.

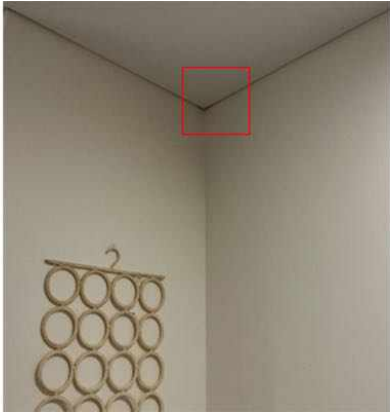
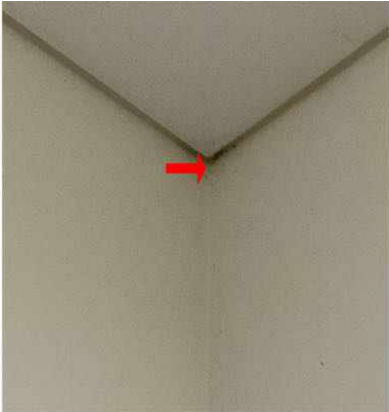
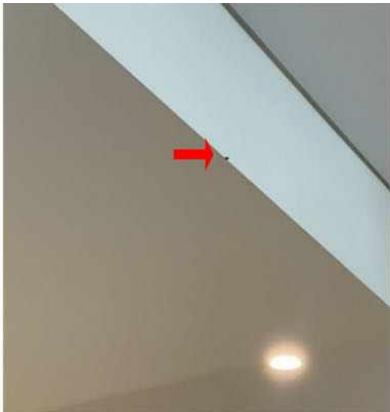
Finding 3.05

Building: Main Building
Location: All Internal Areas
Finding: Pest Activity
Information: Signs consistent with accumulated droppings , cobwebs were observed along wall junctions and ceiling corners, consistent with possible prior or current pest activity within wall and/or roof void cavities. Such areas can provide concealed access pathways for rodents or insects, and the extent of activity or any associated concealed damage to framing or services could not be determined within the scope of this visual inspection. Recommend assessment by a licensed pest control contractor to confirm activity status and implement treatment if required.

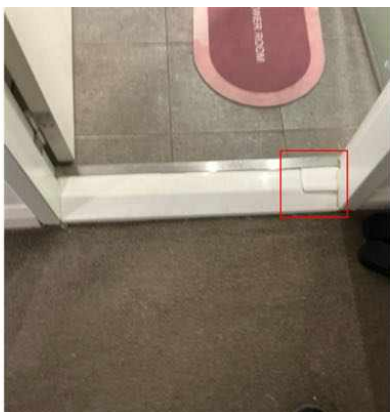
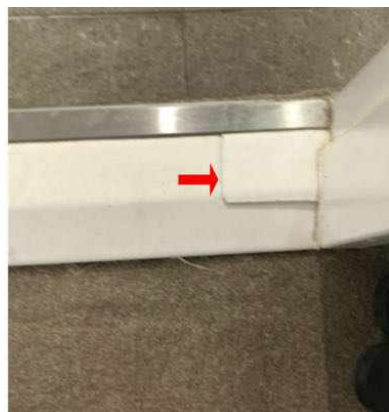
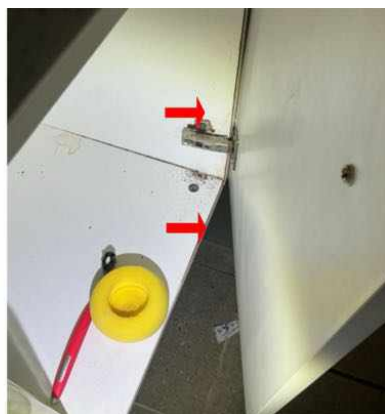
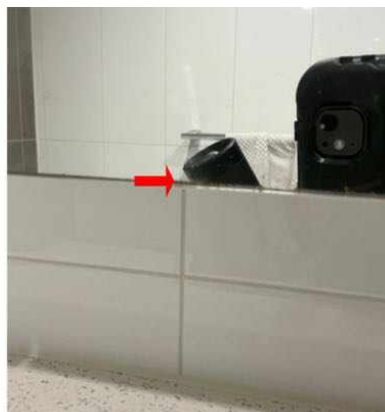
Finding 3.06

Building:	Main Building
Location:	All Internal Areas
Finding:	Building element - Damaged - Plaster damaged , trim damaged bathroom , vanity moisture damage bathroom , mirror desilvering bathroom
Information:	Breakage occurs generally when the building materials have either aged and decayed, or as a result of damage (accidental or deliberate).

Repair and/or replacement of broken elements is advised to ensure that additional secondary defects do not arise as a consequence. Such works are necessary, as all building elements play a key role in the operation and function of the overall structure and its performance.

A relevant tradesperson should be appointed to repair or replace the affected building element prior to any subsequent damage being caused.

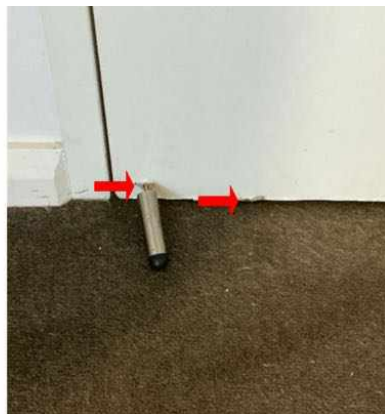
Finding 3.07

Building:	Main Building
Location:	All Internal Areas - Front door
Finding:	Delamination of timbers
Information:	Delamination is one means by which composite materials (e.g. layered timber composites) may fail over time. In laminated materials, repeated cyclic stresses may lead to the formation of mini-structures of separate layers, with significant loss of mechanical toughness. Water penetration or the presence of excessive moisture also generally contributes to delamination.

Where building materials have become delaminated, they lose their structural strength, and are likely to have a variety of appearance and serviceability defects as a result.

Delamination of timbers may be repaired where the area affected is minor and/or easily accessible, by gluing and screwing layers back together. However, this is an interim repair, and where delamination has occurred, the client should plan for the replacement of affected timbers sooner than would otherwise be expected.

All timber structures affected by delamination should be replaced as soon as possible to avoid any further damage. Repair and replacement estimates should be sought from a registered builder or qualified carpenter.

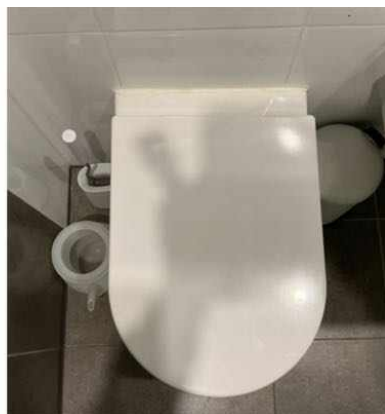
Finding 3.08

Information: The installation of this building element appears to have been completed to a substandard level of workmanship or is incomplete. Generally substandard repairs or installation are related to poor workmanship, the use of inappropriate materials, or a failure to complete installation to a suitable standard.

Toilet seat alignment appears slightly uneven relative to horizontal tile datum. Recommend adjustment of seat hinge fixings. Pan level could not be confirmed visually and would require physical verification.

Recommend a licensed plume right to access and rectify if required

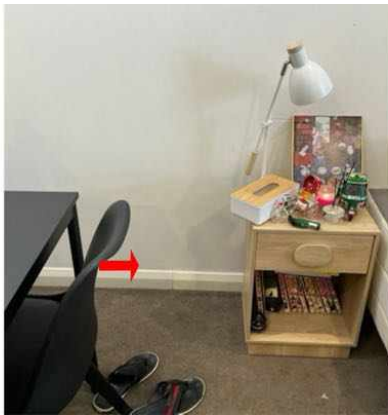
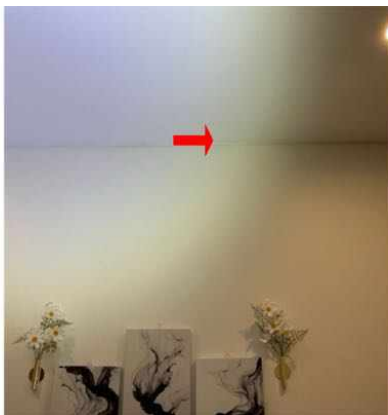
Finding 3.09

Finding: Paint finish and hairline cracking to some areas

Information: The paint finish in this area was identified as being incomplete at the time of inspection including some hairline minor cracking.

Whilst incomplete or missing paint finish is generally an appearance defect, it can also lead to the development of secondary building defects over time. Incomplete areas of paint finish expose the area to moisture, potentially accelerating the deterioration of underlying building materials.

Incomplete paint finishes should be sanded back, filled, leveled and painted, as applicable. Where inadequate or missing paint protection has led to the deterioration of the associated building element, repair and/or replacement of this building element may be required.

A painting contractor should be appointed as soon as possible to perform necessary works to aid the appearance of the affected area and to ensure the area is protected against further deterioration. Alternatively, the homeowner following manufacturer instructions may perform these works.

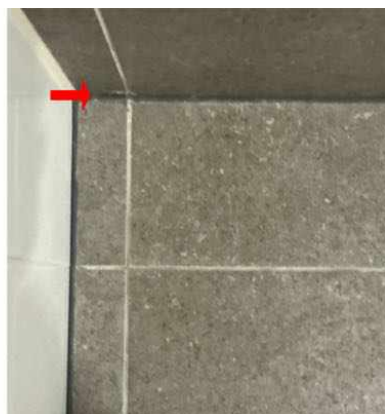
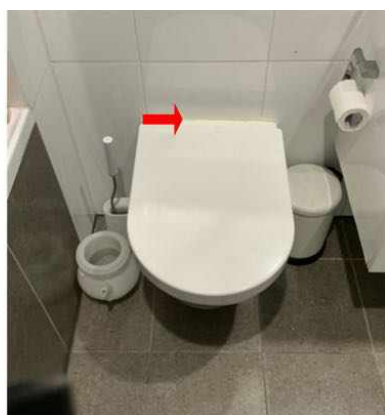
Building:	Main Building
Location:	All Internal Areas
Finding:	Sealant and grouting - Missing or degraded (Excessive silicone use)
Information:	It was noted on inspection that sealant or grout is degraded. There is also evidence of poor workmanship and excessive use of sealant. Silicone should never be used as a first line of defence against waterproofing. Further inspection by a licensed waterproofing contractor is highly recommend

Different materials and floor areas move at different rates, generally causing cracking to grout or sealant at this point. A flexible sealant is required to allow for expected expansion and contraction, while keeping the joint water tight and protective of all associated building materials.

There appears to be excessive mould to the sealant and grout which will likely require scraping out and replacement.

Flexible and mould resistant materials should be applied to affected areas to prevent any subsequent water damage that is likely to occur. Regular maintenance and replacement of damage or missing or damaged sealant and grout is highly recommended to the wet areas, as this is a regular wear and tear defect. Sealant and grouting in areas that come into regular contact with water should be maintained for the long term care of your property.

A sealant specialist or tiling contractor should be appointed to complete these works as soon as possible

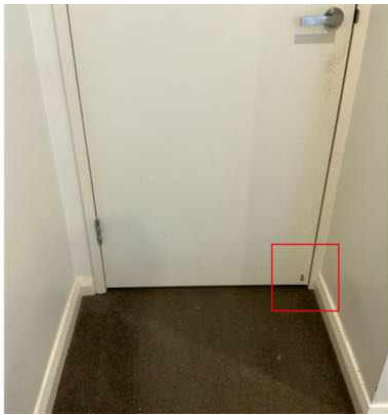
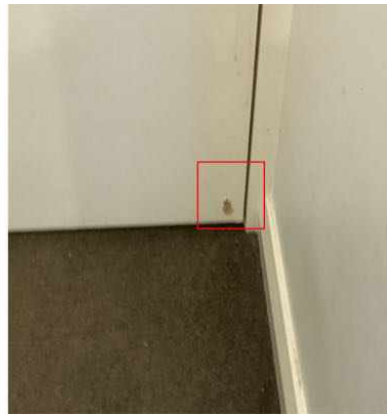
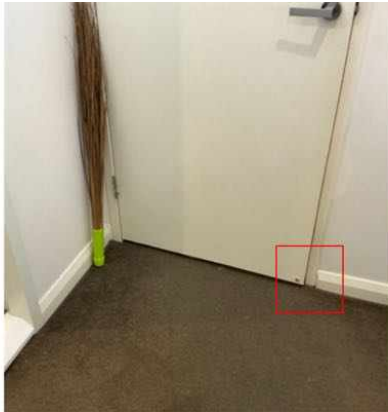
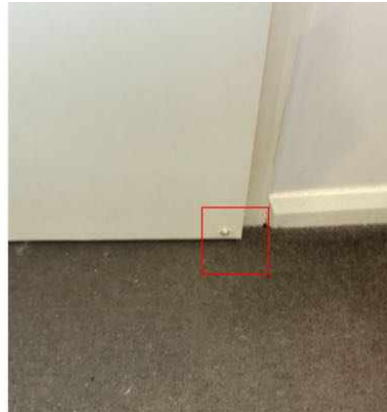
Finding 3.11

Building:	Main Building
Location:	Bedroom
Finding:	Door stop - Missing to some areas
Information:	The door stop is missing or is inadequate to stop the door handle from damaging the wall. Although some building elements may seem irrelevant or unnecessary, all building elements play a key role in the operation and function of the overall structure and its performance.

Re-installation or replacement of the door stop is advised as soon as possible to prevent any subsequent damage to the door or associated structures. A general handyman may be appointed to perform these works at client discretion.

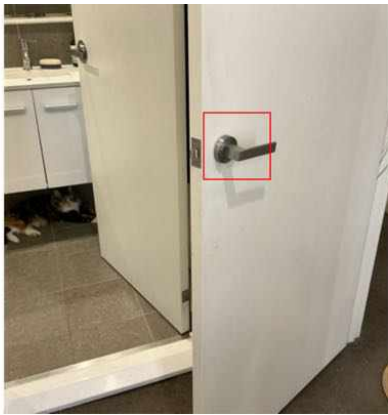
Finding 3.12

Building: Main Building
 Location: Bedroom master
 Finding: Door - Broken/loose handle
 Information: The door handle in this area was found to be broken at the time of inspection. Breakage occurs generally when the building materials have aged and decayed, but may be indicative of impact damage (accidental or deliberate).

Repair and/or replacement of the broken door handle is advised to improve the operational state of the associated door.

A qualified carpenter or general handyman should be appointed to repair/replace the door handle at the client's discretion.

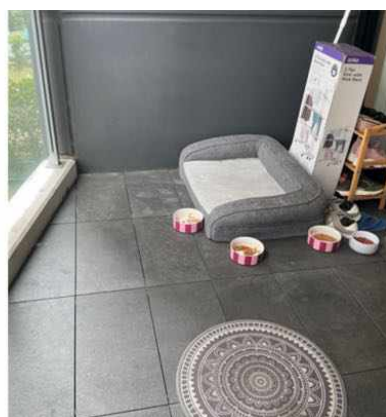
Building:	Main Building
Location:	Balcony
Finding:	Pedestal Paver System - Balcony
Information:	The balcony appears to incorporate a raised pedestal paver system. Minor movement of individual pavers can be characteristic of this system, however, any excessive rocking or instability should be assessed and adjusted to ensure even support and minimise trip hazards. Ongoing maintenance of pedestal alignment and drainage beneath the pavers is recommended.

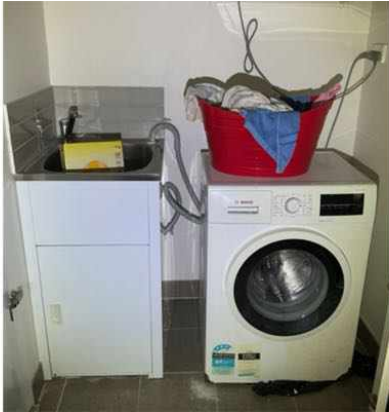
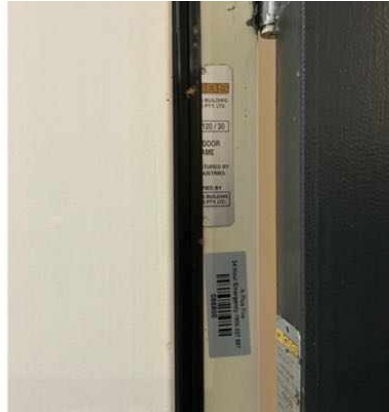
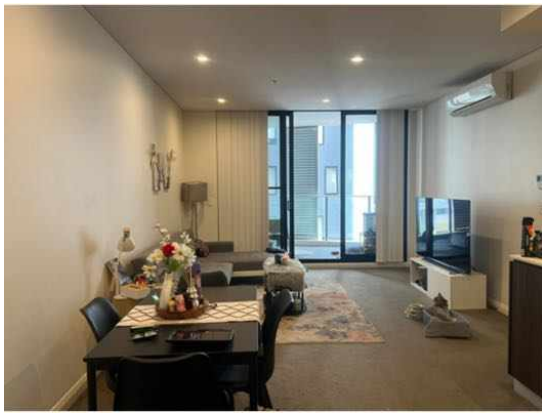
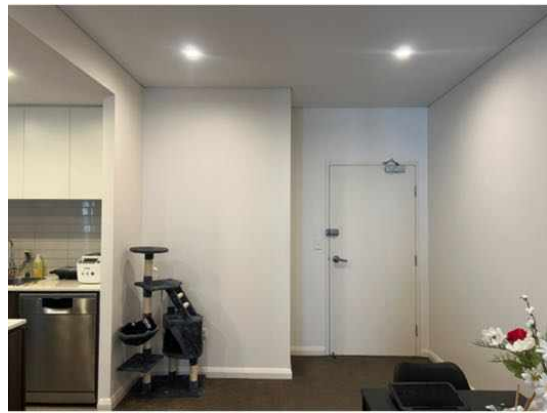
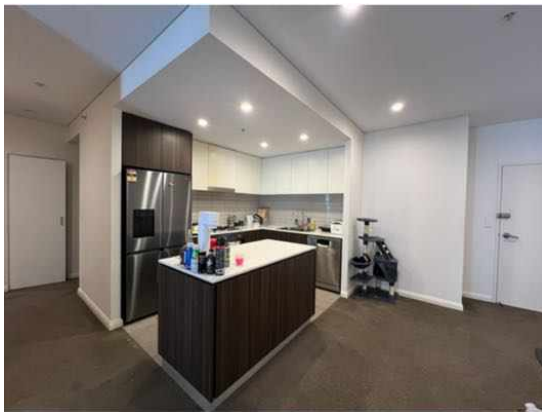
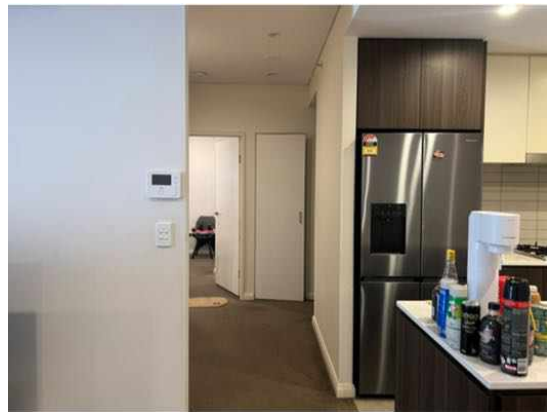
Building:	Main Building
Location:	All Internal Areas
Finding:	Additional Photos - Obstructions and Limitations
Information:	These photographs are an indication of the obstructions and limitations which impeded full inspection of the property at the time of inspection. These obstructions

can hide an array of defects and should be removed to allow full inspection to be carried out. A re-inspection is recommended once the areas are made accessible.

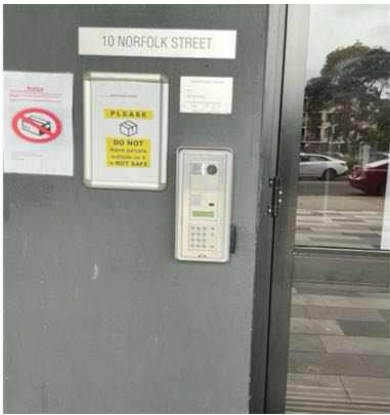
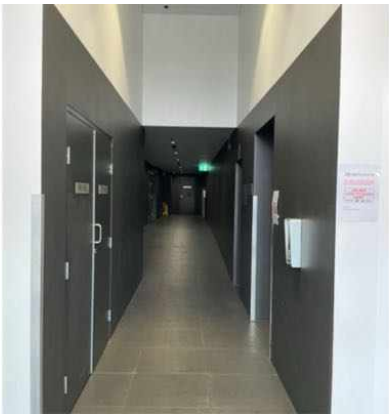
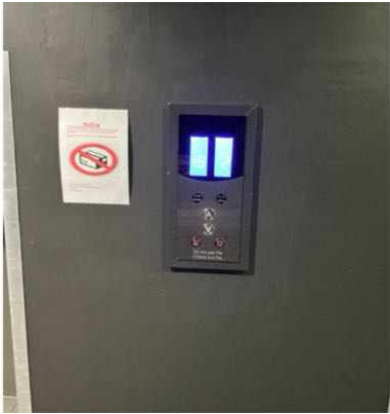
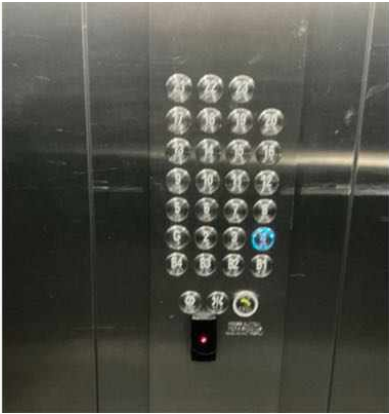
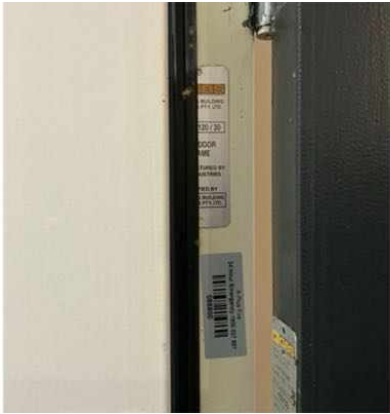
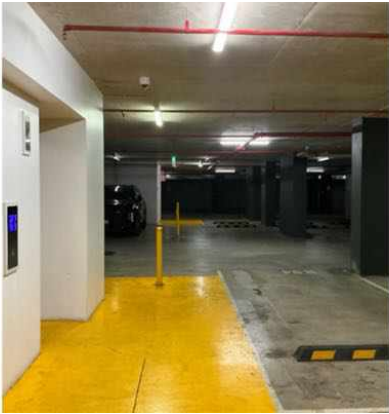
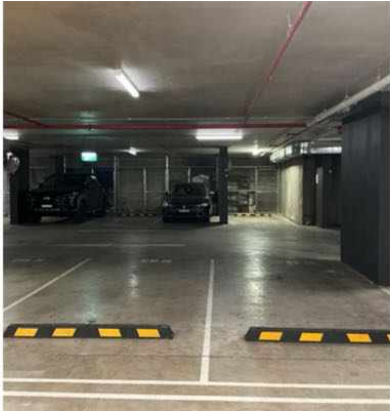
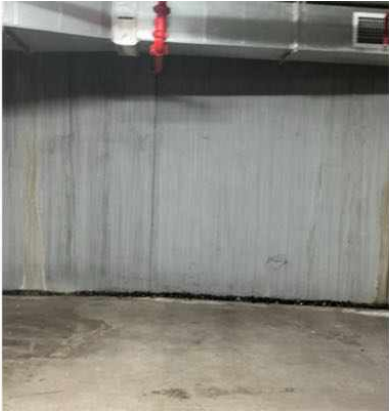
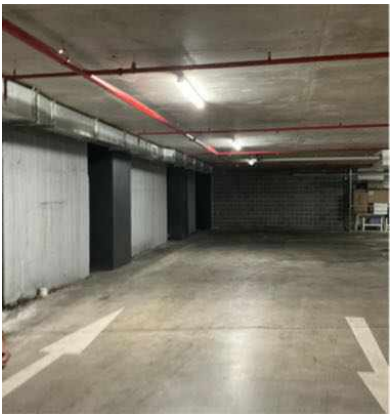
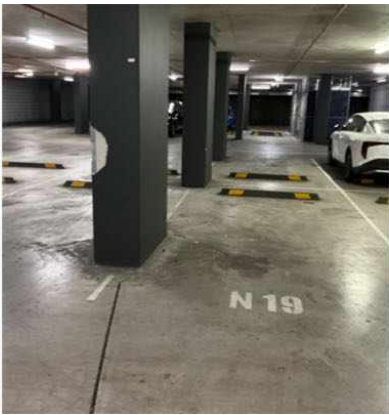
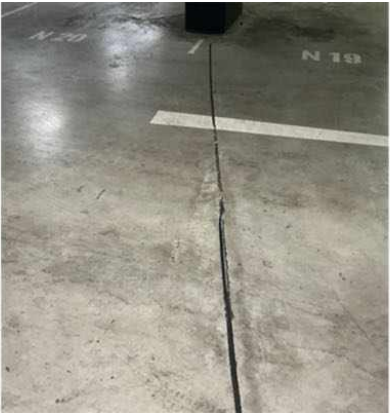
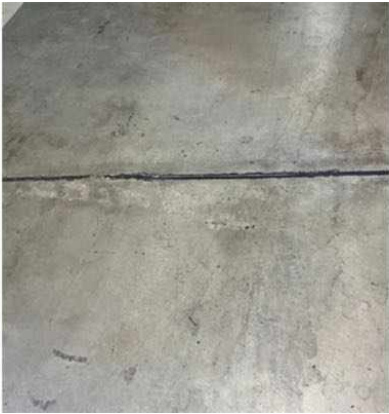
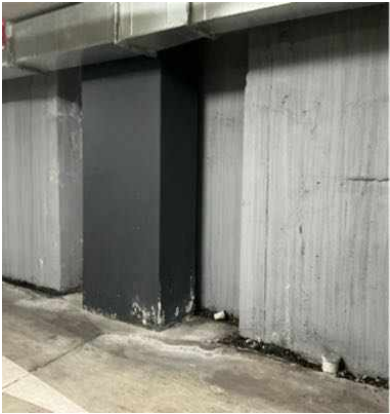
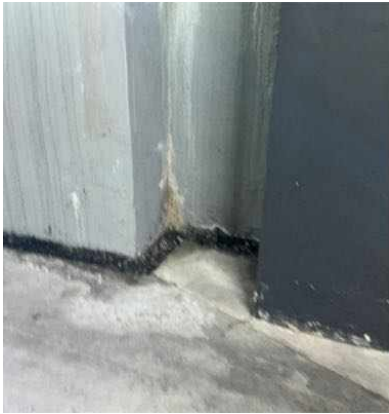
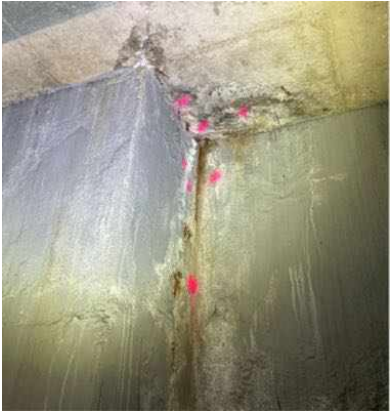
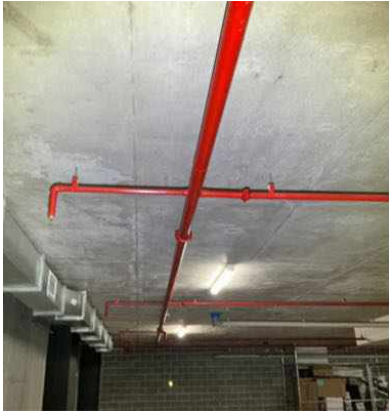
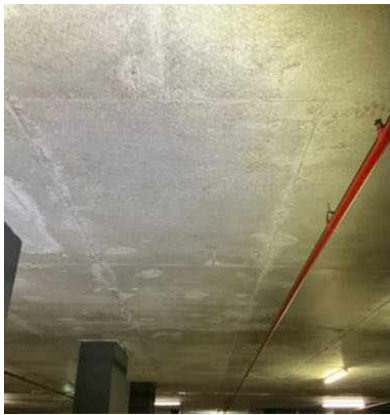
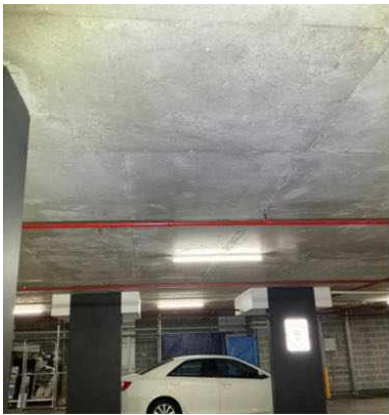
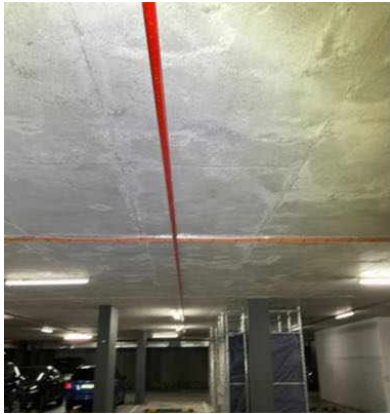
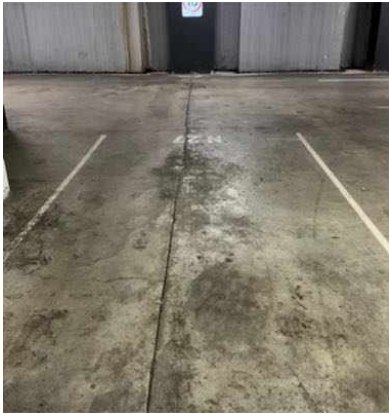
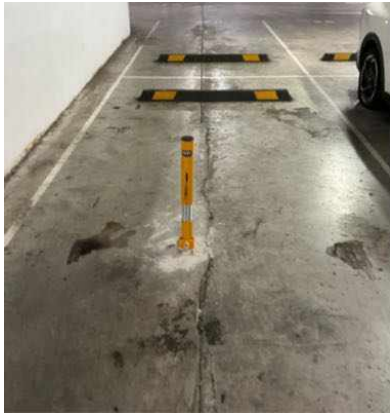
Building: Main Building
 Location: All External Areas
 Finding: Additional Photos - Obstructions and Limitations
 Information: These photographs are an indication of the obstructions and limitations which impeded full inspection of the property at the time of inspection. These obstructions can hide an array of defects and should be removed to allow full inspection to be carried out. A re-inspection is recommended once the areas are made accessible.

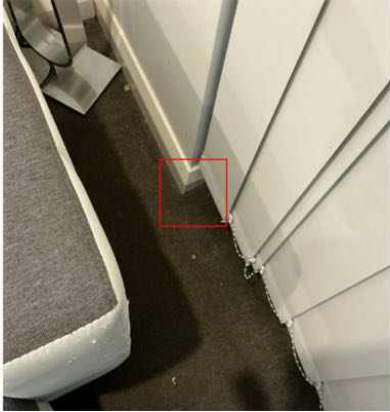
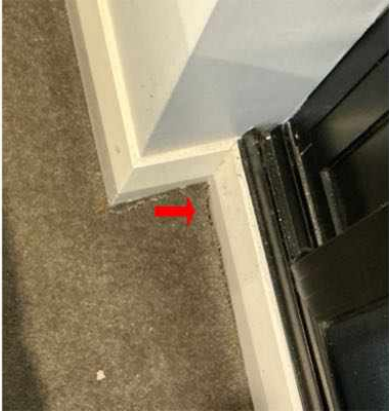
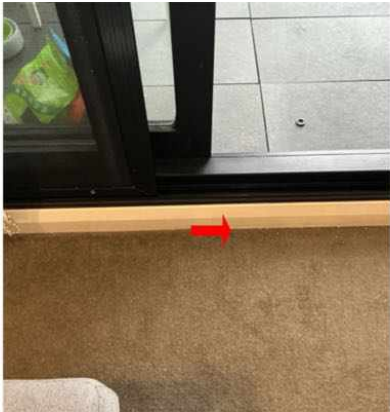
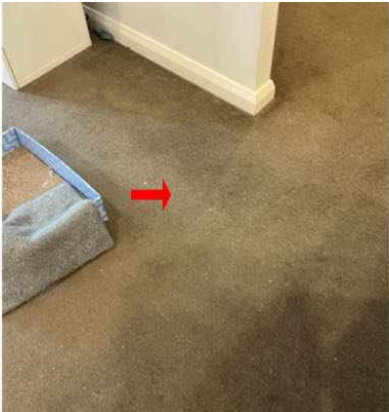
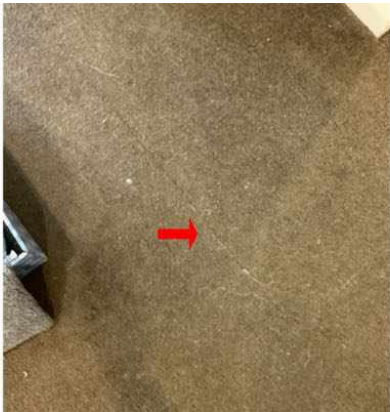
Building: Main Building
Location: All Internal Areas
Finding: Carpet Wear and Shading
Information: -Carpet throughout shows pile flattening, shading, staining , and visible traffic patterns..

Condition is consistent with normal wear and tear. Professional steam cleaning is recommended to improve appearance.
